**Engineering and Organizational Issues Related to  
the World Trade Center Terrorist Attack**

**Overview of Damage to Buildings  
Near Ground Zero**

**By Michel Bruneau, Andrew Whittaker and Andrei Reinhorn**

March 2002

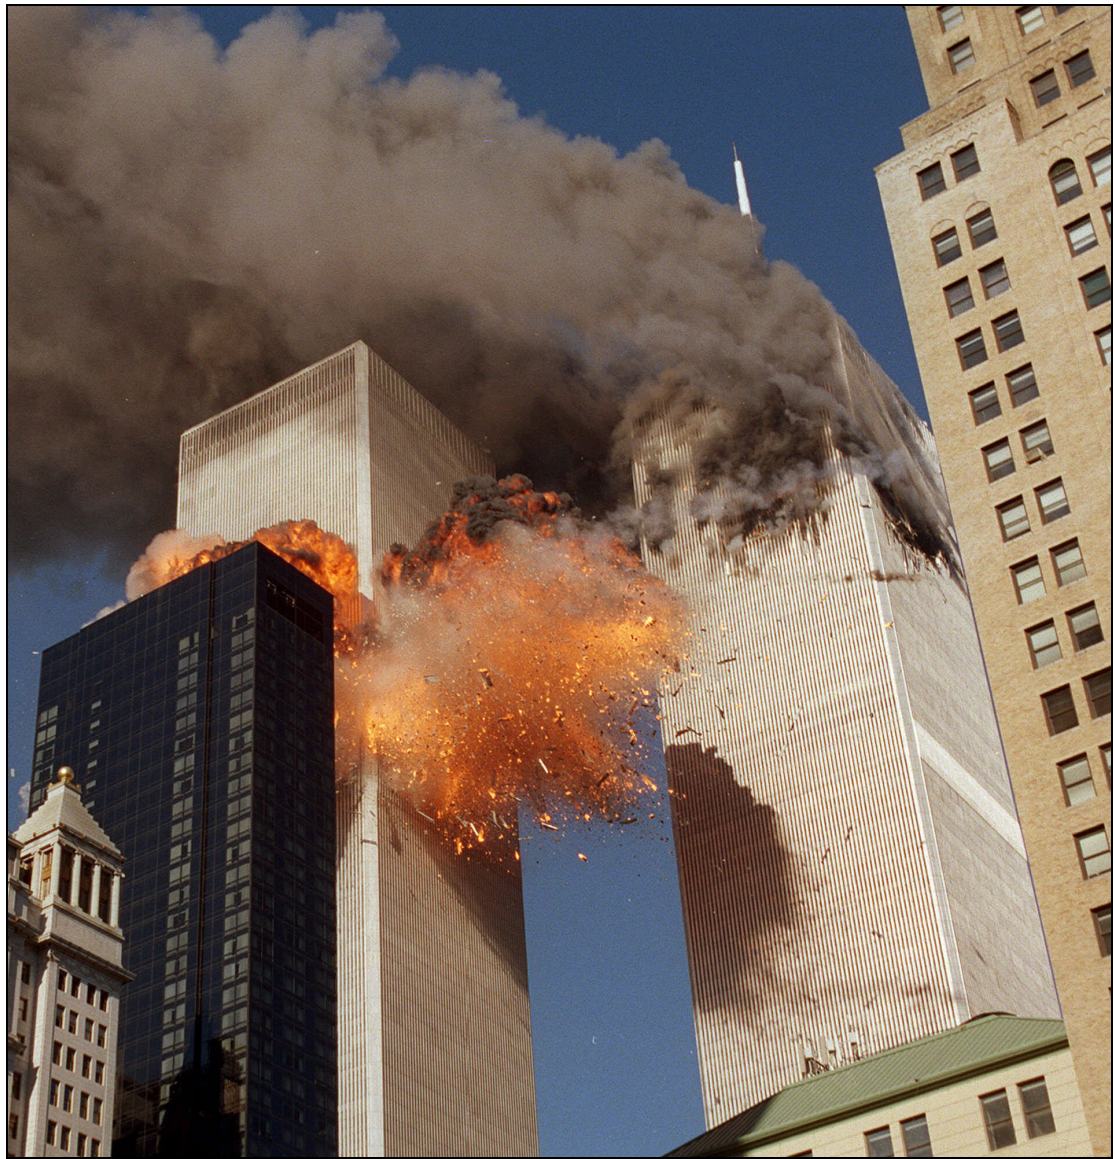
In both cases, jet fuel ignited at impact. Debris from the planes and the buildings were ejected into the adjacent space and buildings, principally in the directions of impact. Some of these debris were ablaze (see Figure 2.1). The fuel-fed fires raged at the stories where the collisions occurred, and propagated to the stories above. The extent of the spread and intensity of the fires are unknown.

*Figure 2.1. Explosion following the plane impact into the South Tower*

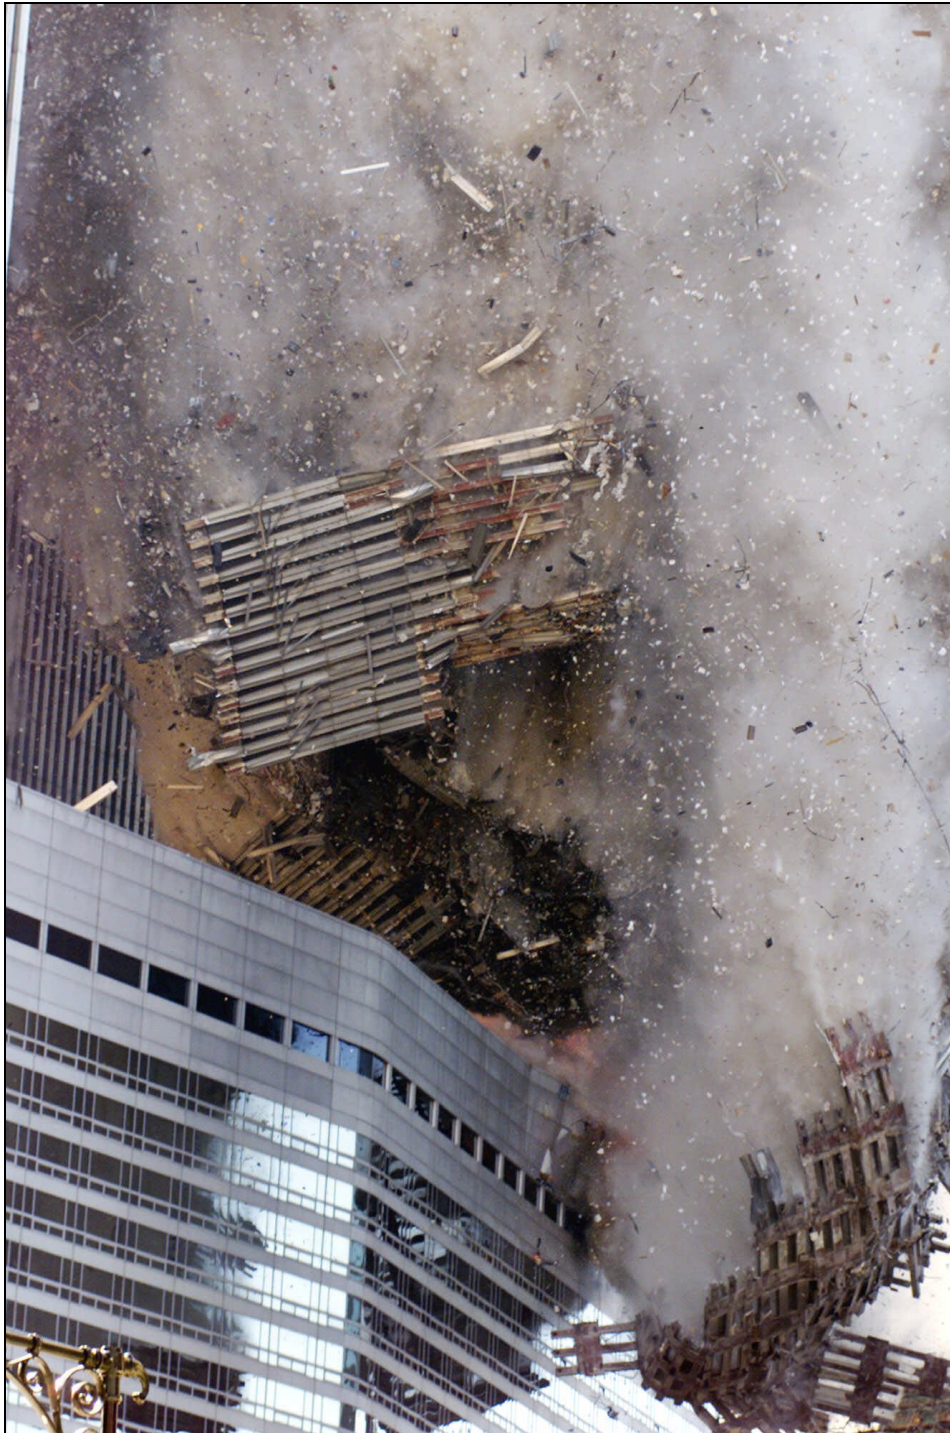
*Figure 2.2. Large segments of the World Trade Center perimeter frame fell on adjacent buildings during the collapse of the towers*

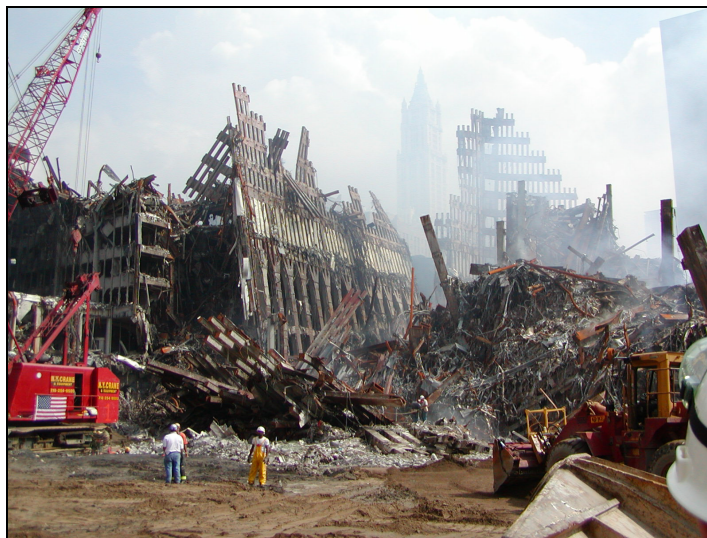
The only recognizable portions of WTC 1 and 2 on September 21, 2001, were parts of the exterior tube described above that remained standing in the debris pile (Figure 3.5). Some evidence of the building modular construction described in the previous paragraph could be observed from these parts of the building structural shell (Figure 3.6). The typical four-bolt column splices could be also observed (Figure 3.7), along with the hole on the side of each hollow rectangular column that provided access for erection of the frames (Figure 3.7, bottom photograph). As will be seen in the subsequent sections, some of these three-column modules became multi-ton projectiles that impacted and damaged adjacent buildings as the towers collapsed. The interior of the building shell (see Figure 3.6, top photographs) shows some evidence of where the supporting seats were located for the floor joists.

*Figure 3.5. Portions of the perimeter tubes of WTC 1 and 2 remained standing in the debris pile (as of September 21, 2001)*

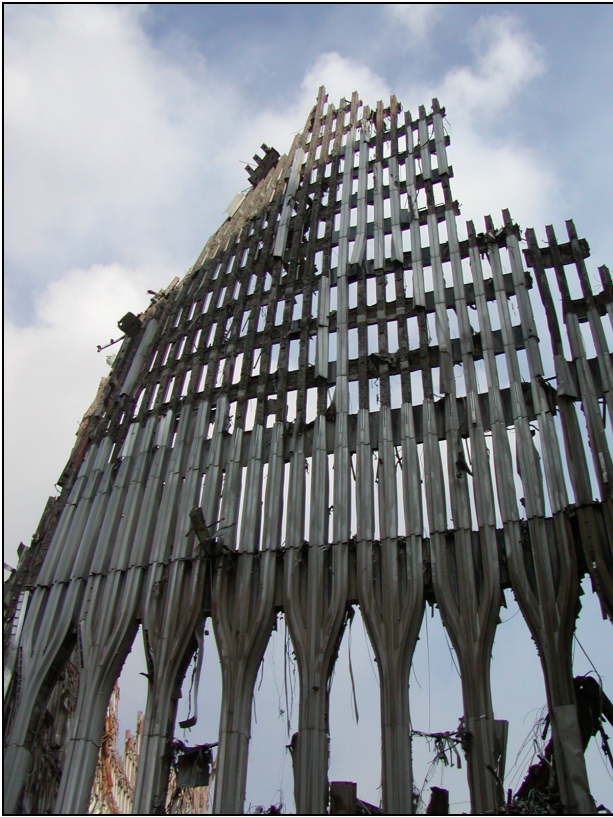
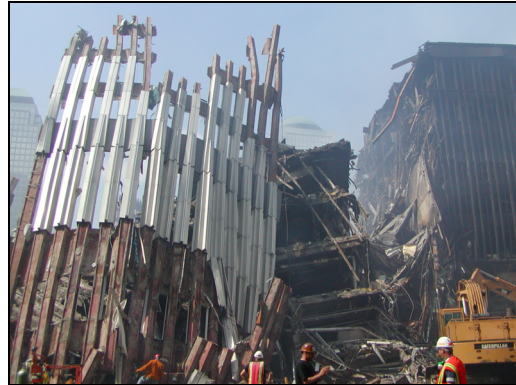
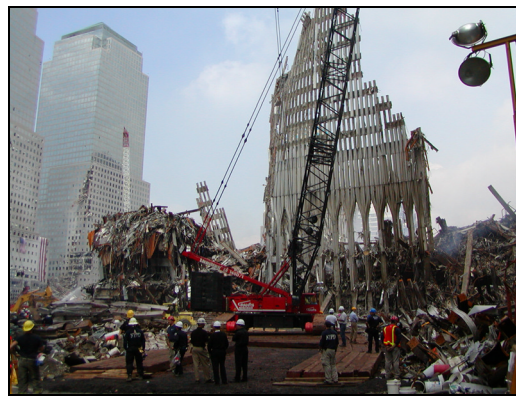
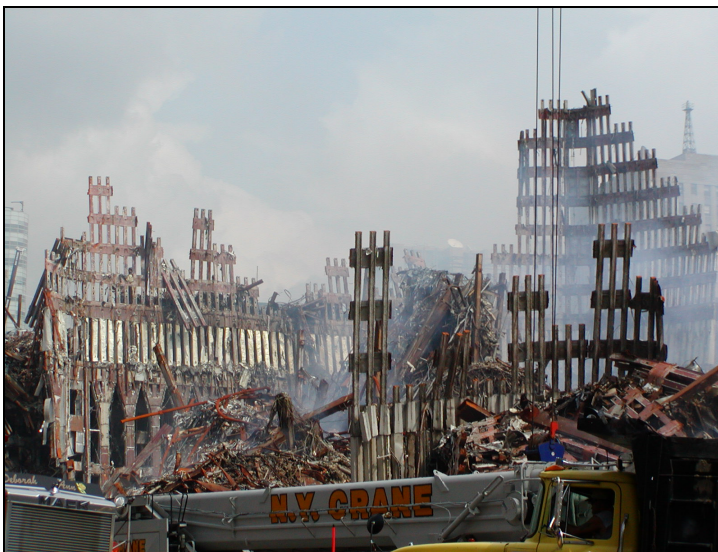
*Figure 3.5. (continued).  
Portions of the perimeter  
tubes of WTC 1 and 2 that  
remained standing in the  
debris pile (as of September  
21, 2001)*

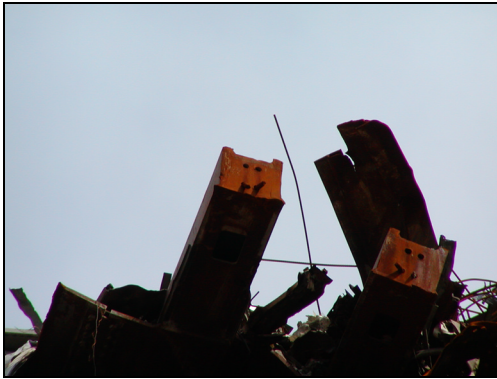
*Figure 3.7. Typical four-bolt column splices and access holes on the side of hollow rectangular columns*

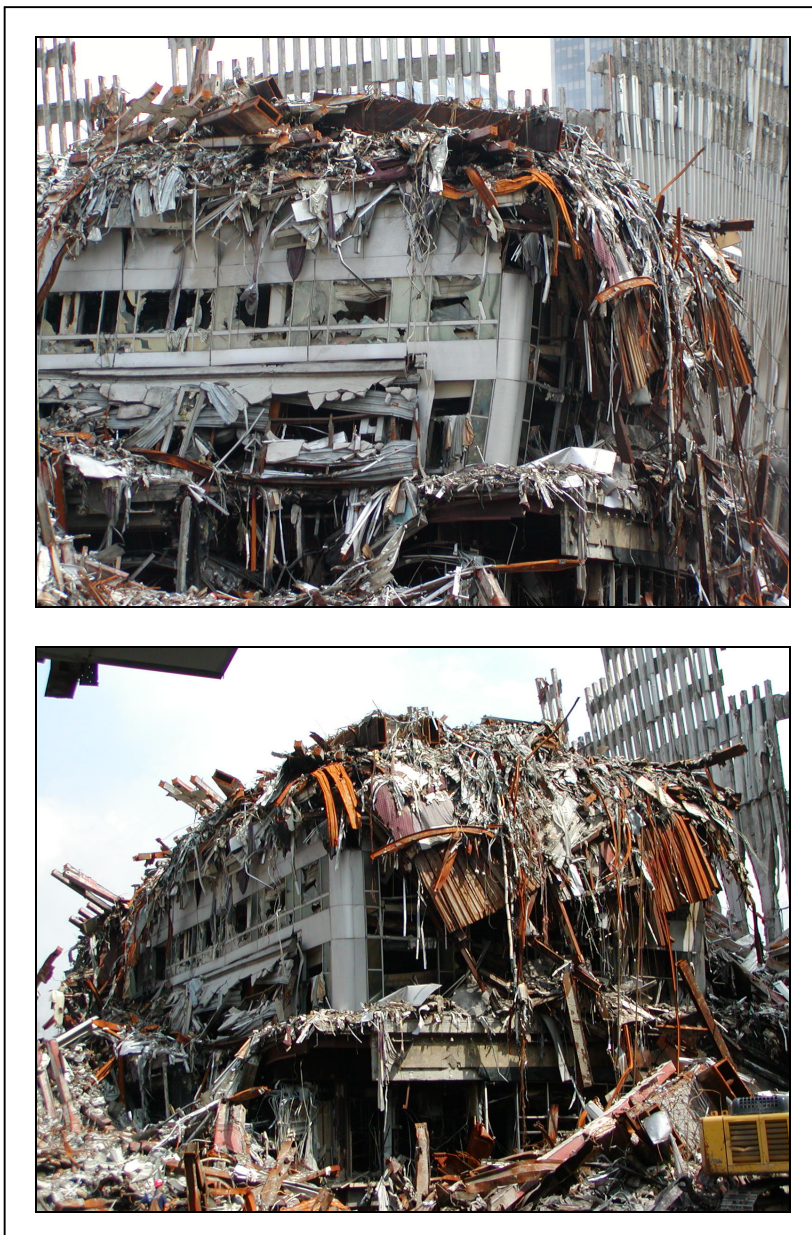
World Trade Center 3 (WTC 3) served as the Vista Hotel (formerly the Marriott hotel), and was located at the base of the two twin towers, immediately adjacent to and to the west of WTC 2 and to the south of WTC 1. It was effectively destroyed by falling debris from the collapse of the towers (see Figure 3.8). Although the building was a total loss, the fact that stories remain standing, albeit in a state of extreme damage, instead of being totally destroyed, could be partly due to the fact that the falling debris from the collapsing towers, for the most part, remained within their plan footprints.

*Figure 3.8.  
Debris falling  
destroyed WTC 3*

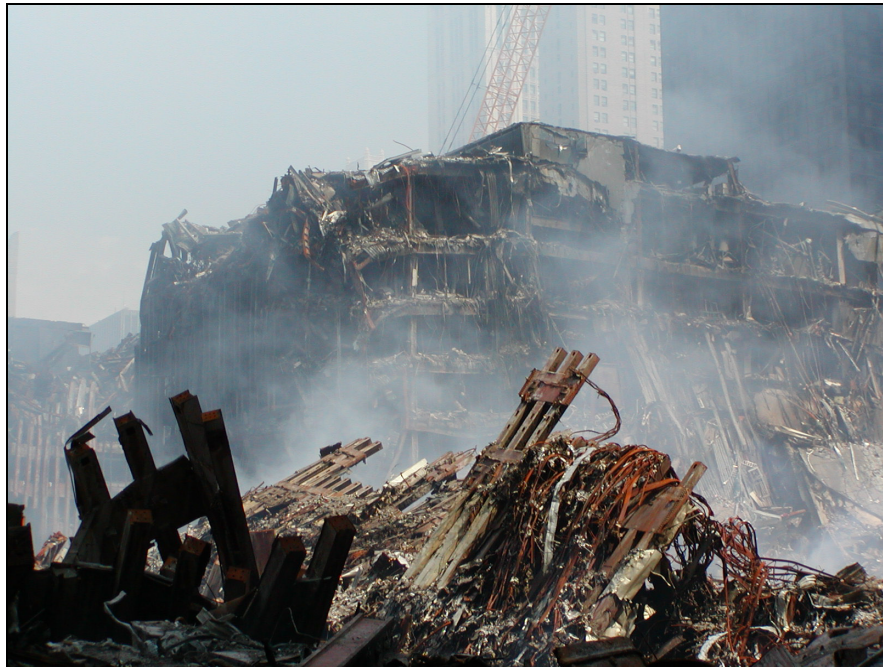
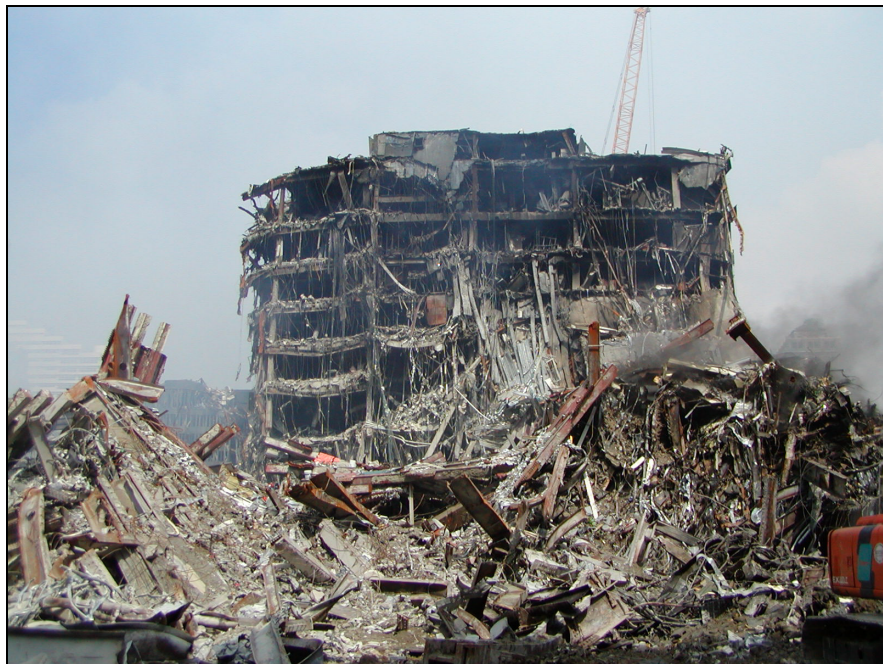
World Trade Center 4 (WTC 4) was similarly impacted by falling debris. The large permanent deformations (sagging) of many beams in that building (Figure 3.9) can be attributed to a combination of impact forces from falling debris and extensive fire damage.

*Figure 3.9.  
Falling and  
burning debris  
destroyed  
WTC 4*

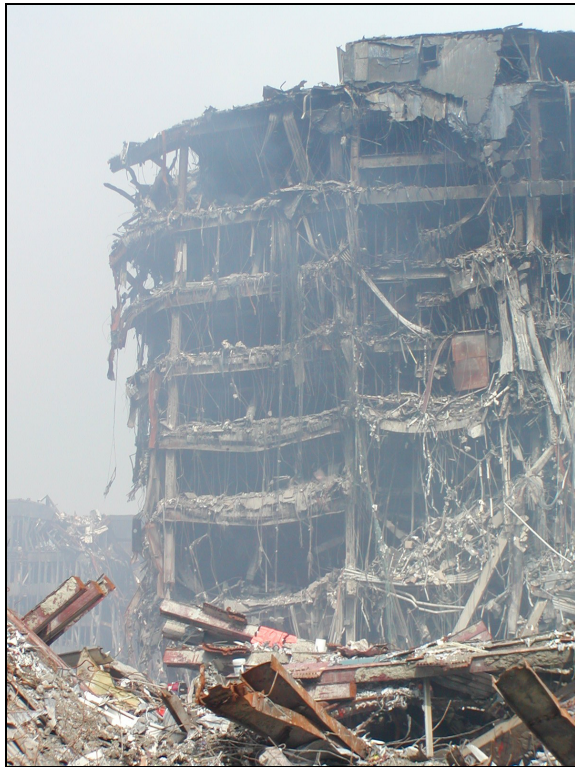
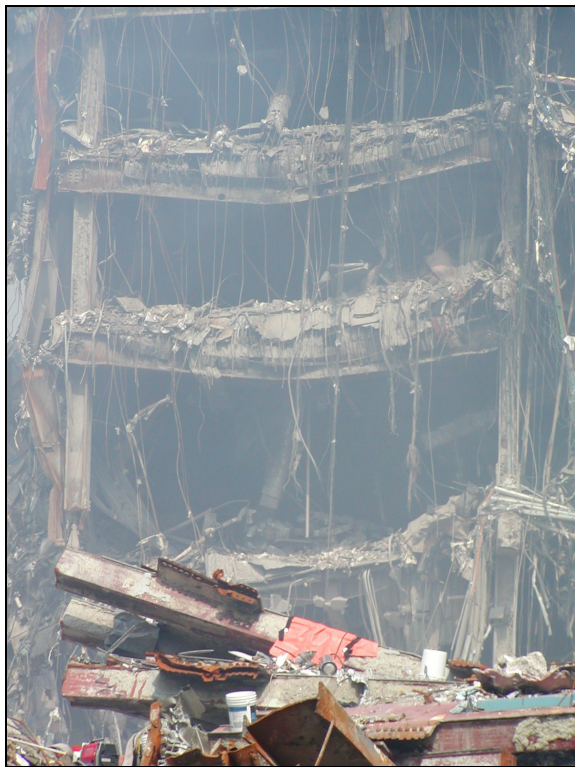
*Figure 3.9. (continued).  
Falling and burning debris  
destroyed WTC 4*

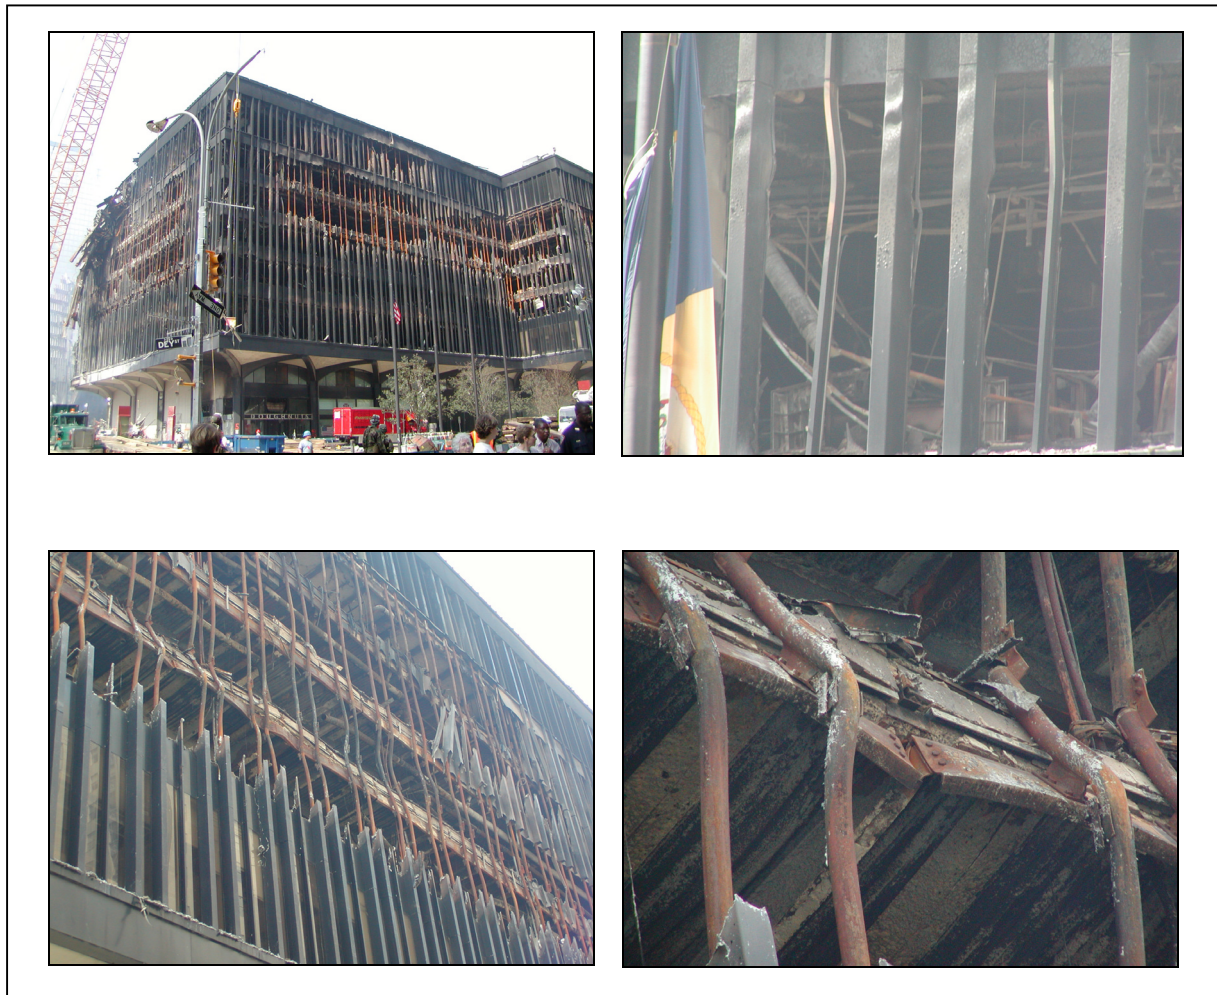
World Trade Center 5 (WTC 5) was located somewhat further from the towers than WTC 3 and 4, and was likely not showered by as much falling debris as these buildings were. However, parts of the building were still severely impacted. World Trade Center 6 (WTC 6) was immediately adjacent to WTC 1, and suffered tremendous damage. Both buildings were apparently hit by burning debris following the plane impact, and extensive fire-related damage was observed. Large heat distortion of structural members was observed in WTC 5 (Figure 3.10). Similar damage was also observed in WTC 6 (Figure 3.11).

*Figure 3.10. Fire related damage to WTC 5*

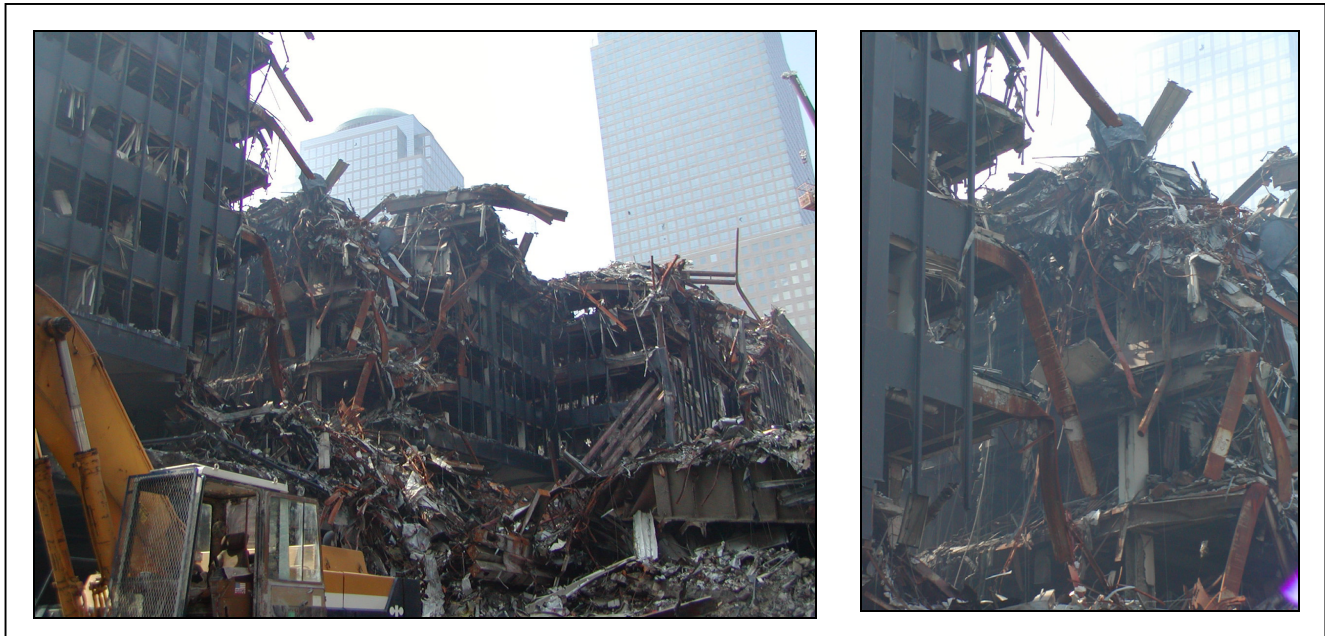
*Figure 3.11. Impact and fire-related damage to WTC 6*

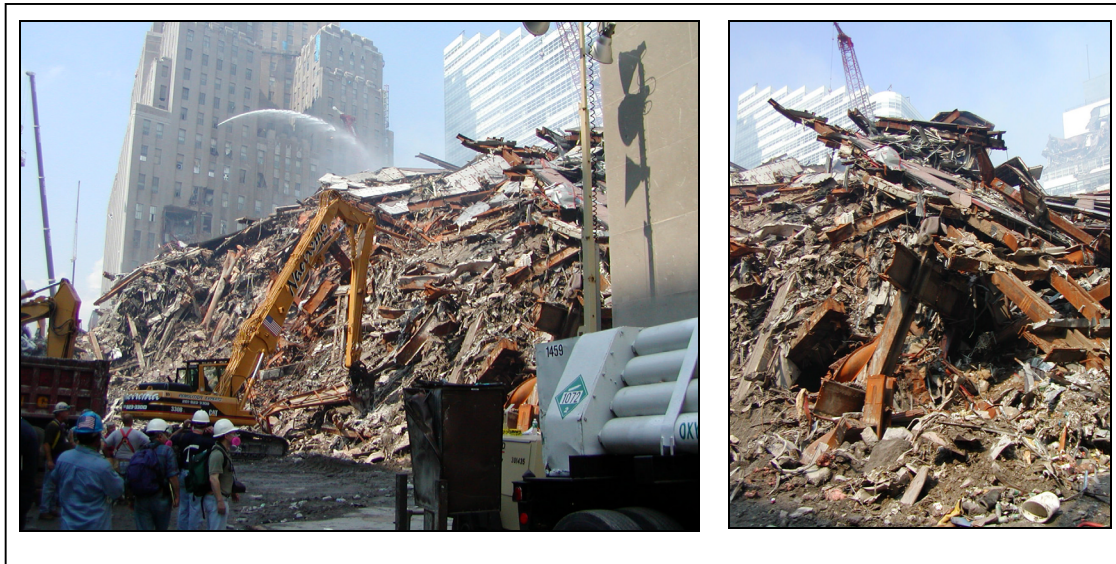
At 5:25 p.m. on September 11, 2001, WTC 7 collapsed as a consequence of damage and uncontrolled fire. The resulting debris pile was approximately seven stories high (Figure 3.12). Little reliable information on the collapse sequence can be surmised from the debris. Portions of conventional steel moment-resisting frames were observed in the debris pile (Figure 3.13), as well as distorted segments of beam stubs welded to columns with bolted splices a few feet away from the columns (Figure 3.14).

*Figure 3.12. WTC 7 collapsed as a consequence of damage and uncontrolled fire*

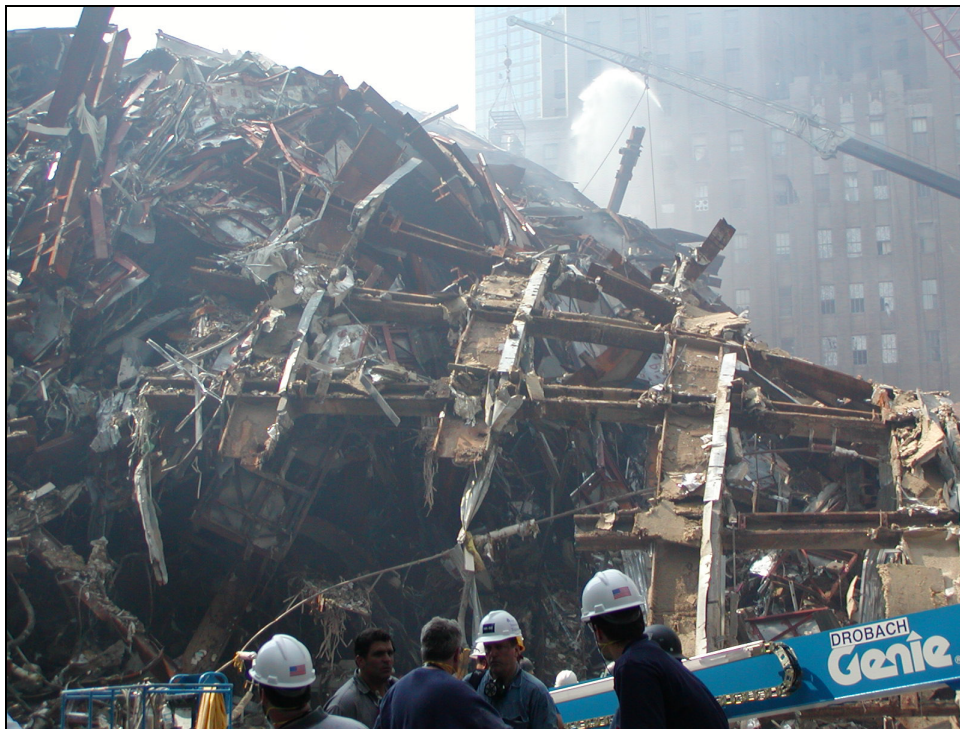
*Figure 3.13. Portions of conventional steel moment-resisting frames were observed in the debris pile*

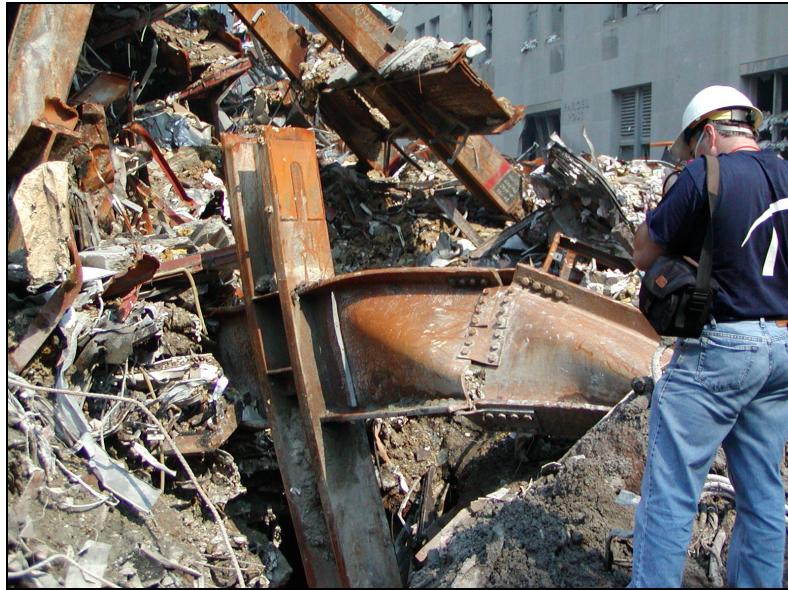
*Figure 3.14 Distorted segments of beam stubs welded to the columns*

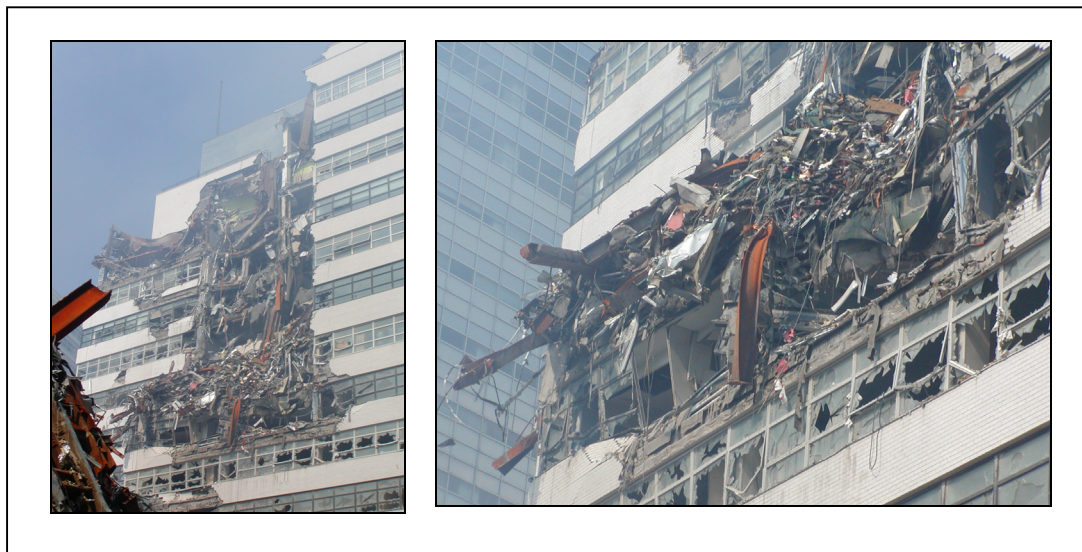
As WTC 7 collapsed, it fell partly on an adjacent building at 30 West Broadway, causing significant damage (Figure 3.15, south face and Figure 3.16, west face). Beams were permanently distorted by the impact (Figure 3.17).

*Figure 3.15. Damage to the south face of a building at 30 West Broadway due to impact from the collapse of WTC 7*

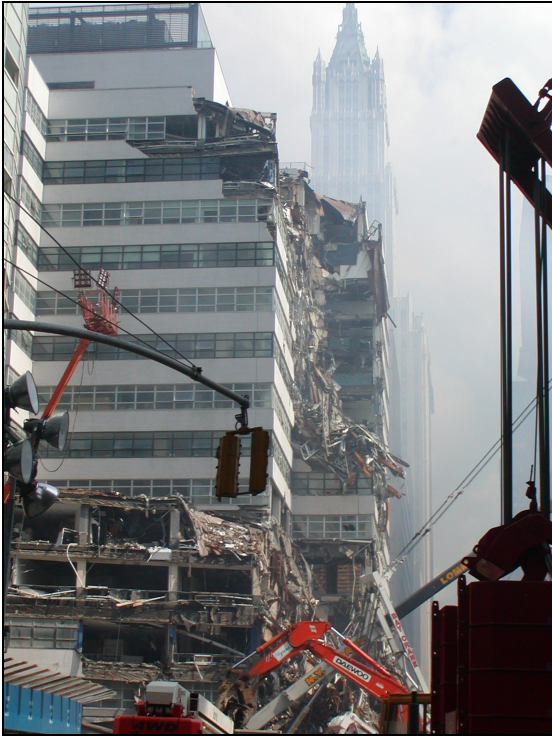
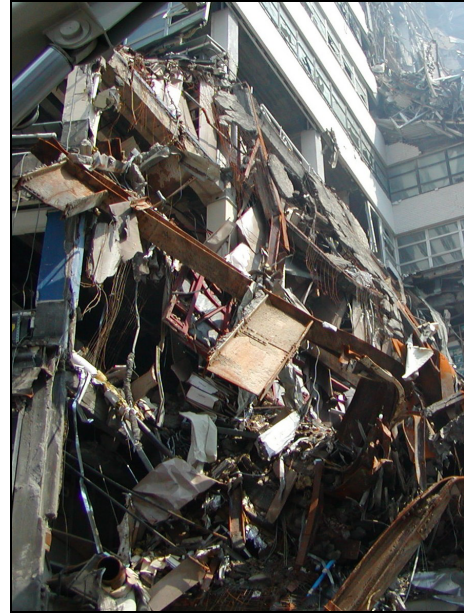
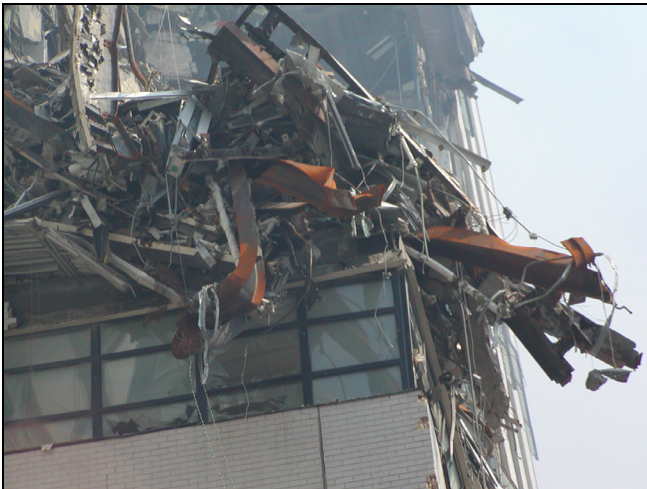
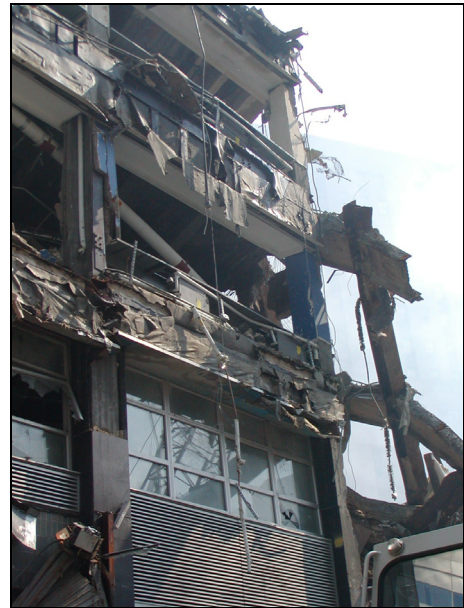
*Figure 3.16 Damage to the west face of a building at 30 West Broadway due to impact from the collapse of WTC 7*

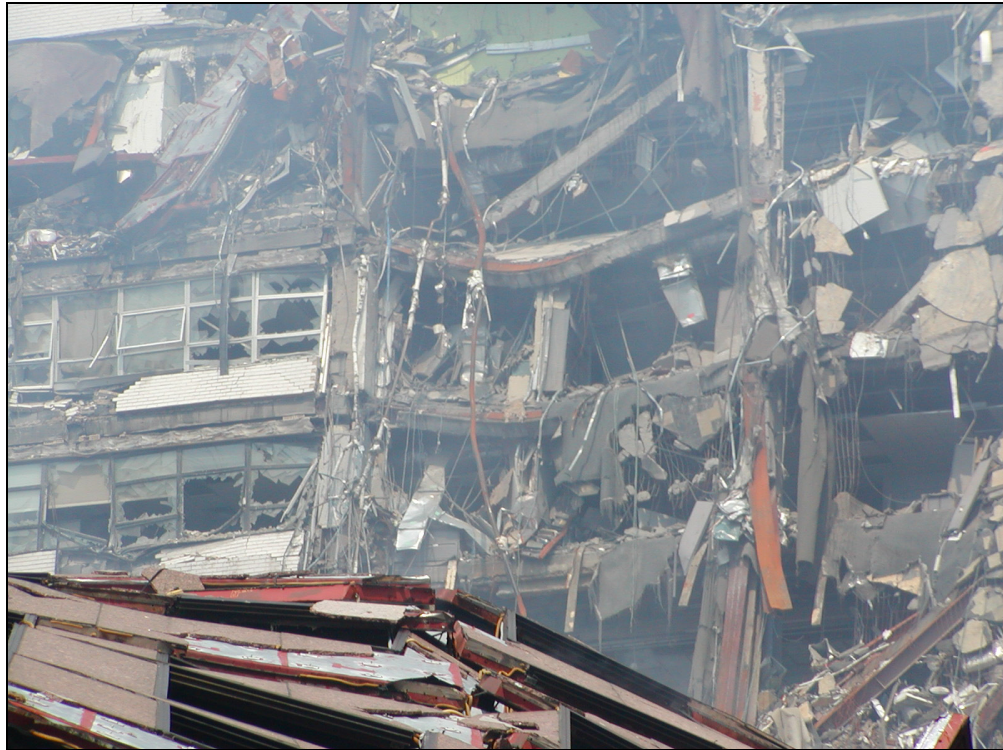
*Figure 3.17. Beams in the building at 30 West Broadway were permanently distorted by the impact of falling debris*

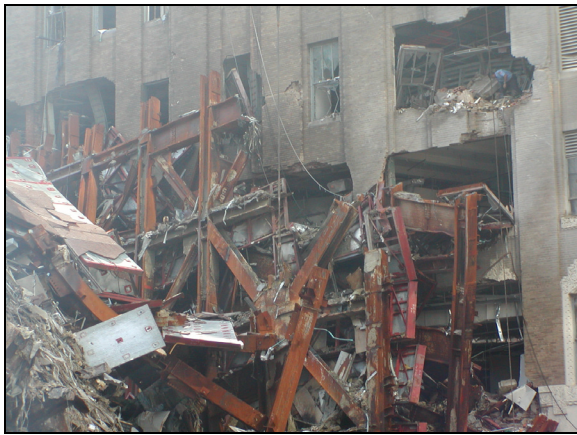
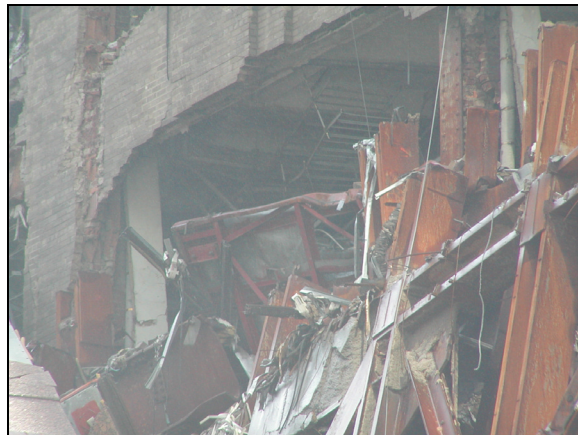
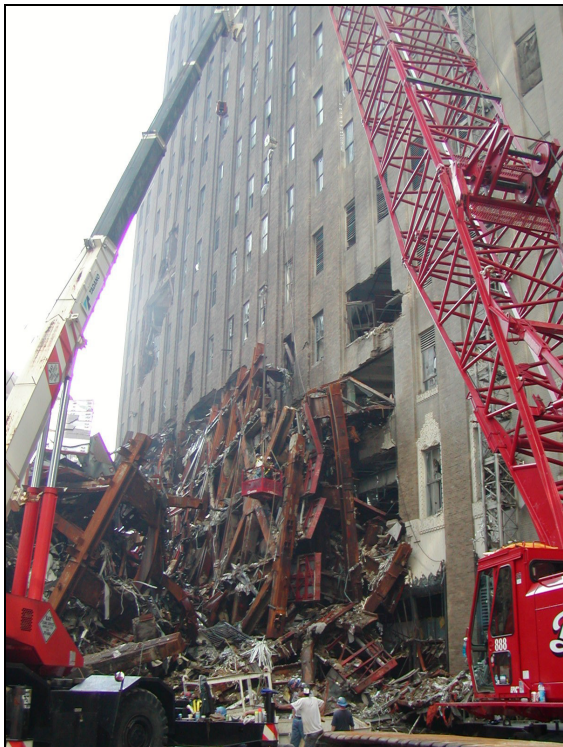
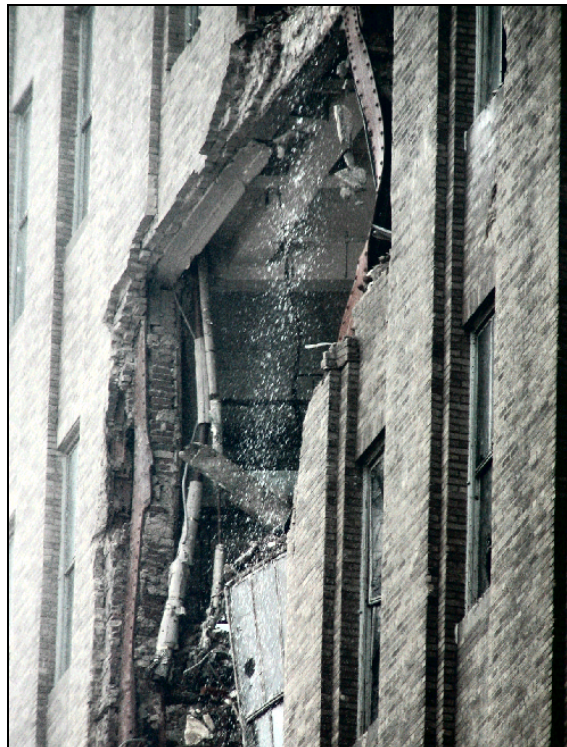
The collapse of World Trade Center 7 damaged the adjacent Verizon building. Damage to the west façade of that building is shown in Figure 3.18. Large segments of the WTC 7 braced framing were lodged against the Verizon building, which also suffered notable perforations in its framing and cladding. In particular, a steel column was severely distorted, presumably by debris impact (Figure 3.18, bottom right photo).

*Figure 3.18. Damage to the west façade of the Verizon Building*

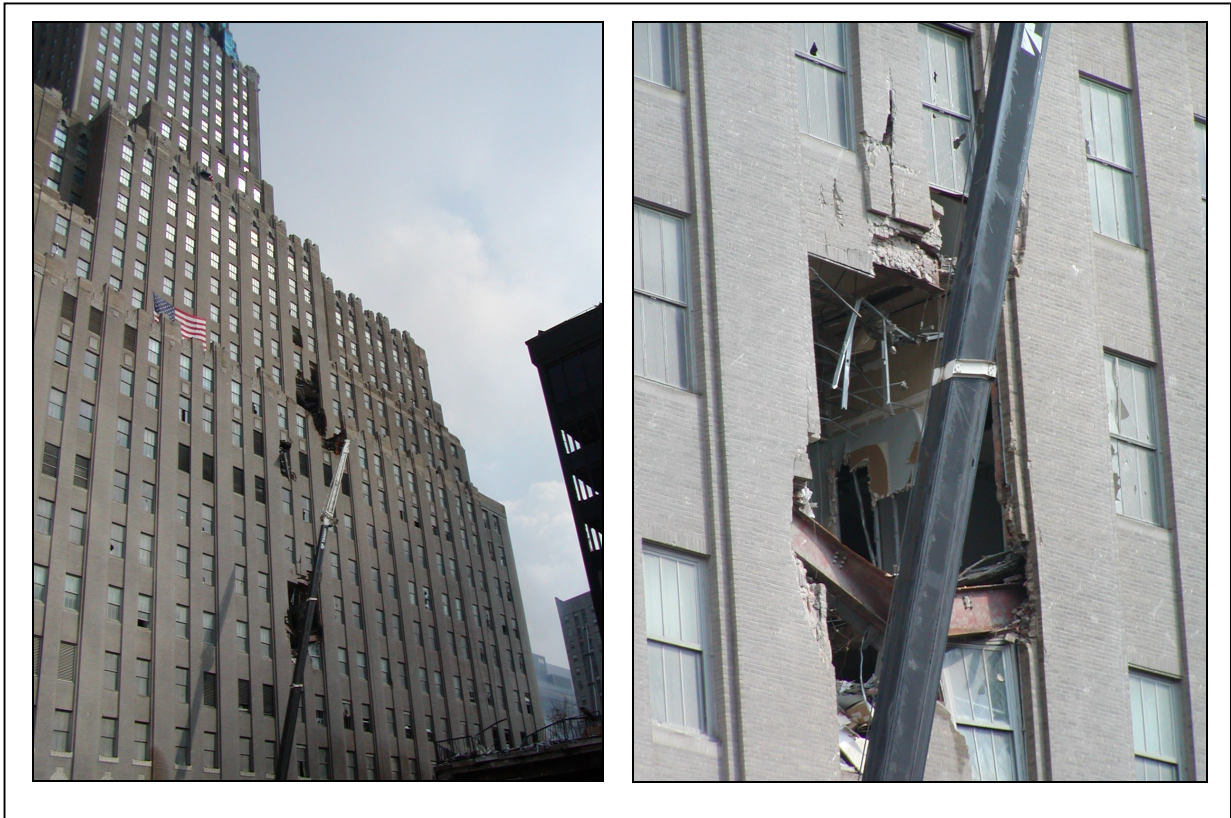
Limited relatively minor damage was also observed to the south façade, possibly produced by debris from the collapse of WTC 1 (Figure 3.19).

*Figure 3.19. Minor damage to south façade of the Verizon building*

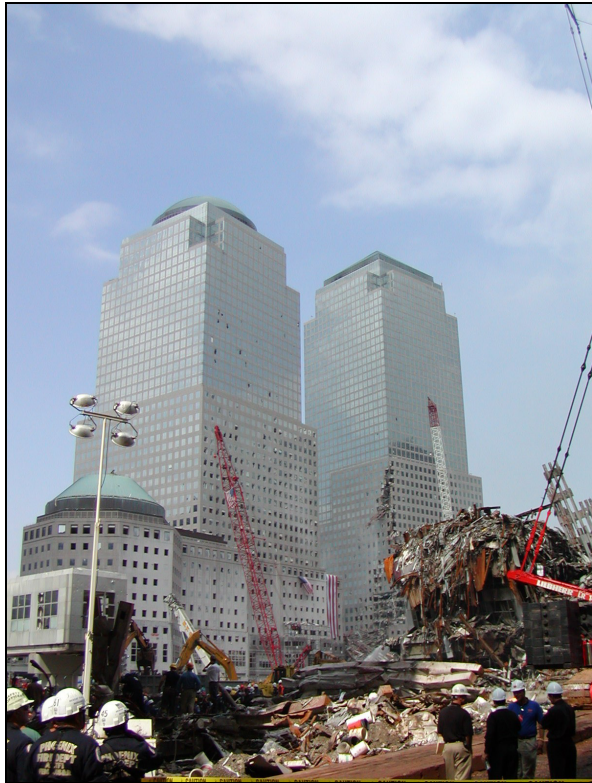
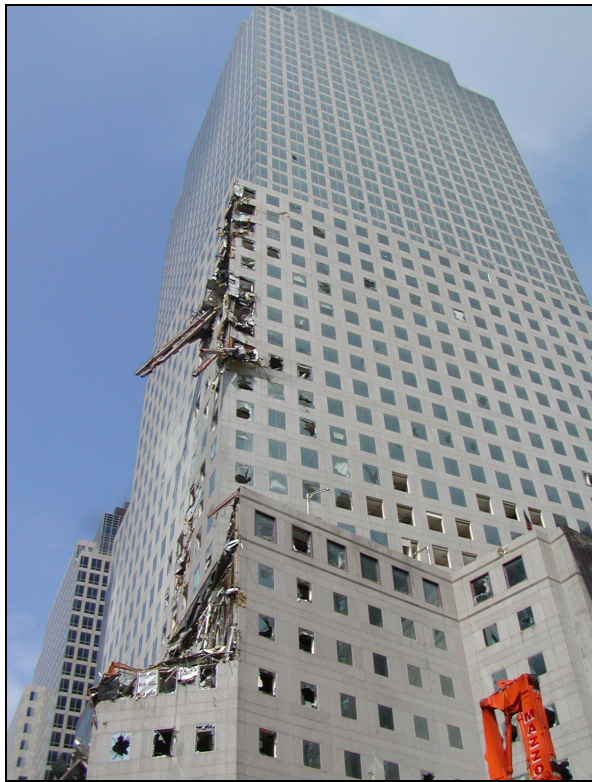
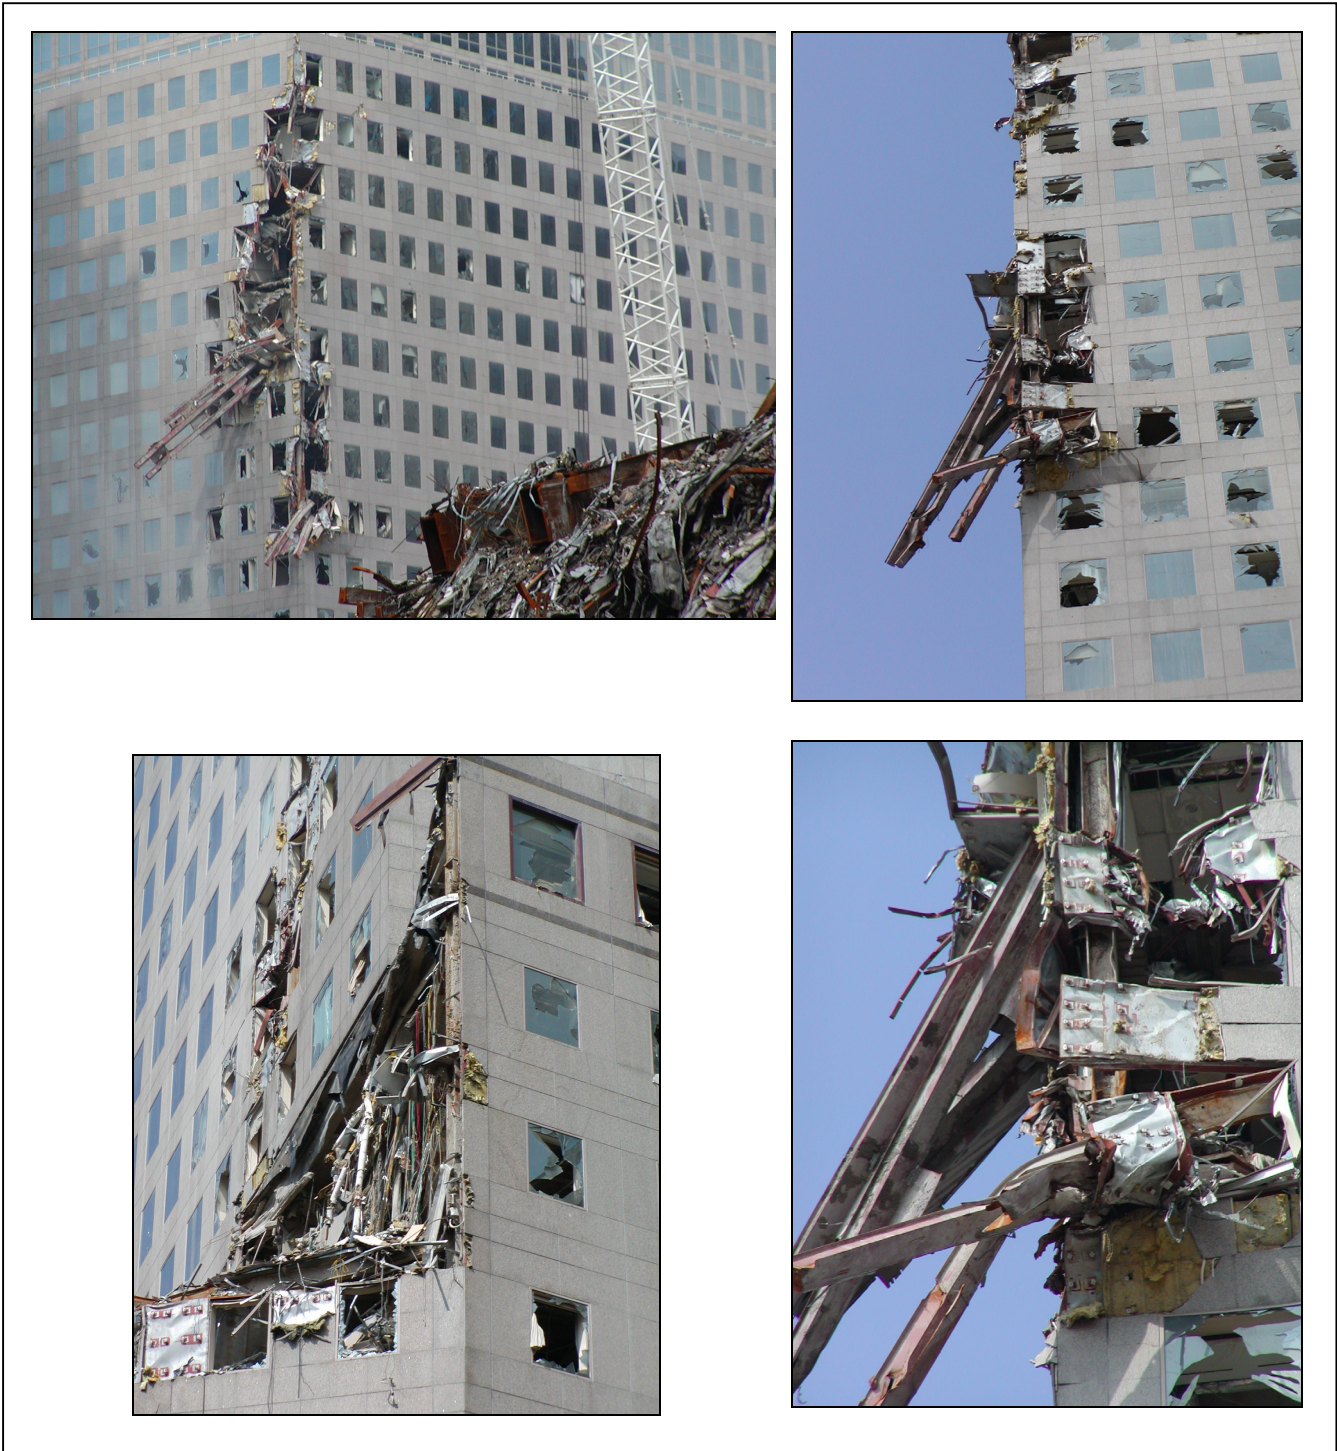
A number of the perimeter column modules (see Figure 3.2) from the collapsing towers penetrated the façade of 3 World Financial Center, significantly damaging the building's outer shell (see Figure 3.20). Parts of perimeter-column modules from one of the towers were still protruding from the façade of the World Financial Center tower during the two site visits. These pieces of debris had been secured to the building at the time of the first visit on September 21, awaiting a solution to remove them without jeopardizing the integrity of the gravity-load-resisting system.

*Figure 3.20. Damage to the façade of 3 World Financial Center*

*Figure 3.20. (continued) Damage to the façade of 3 World Financial Center*

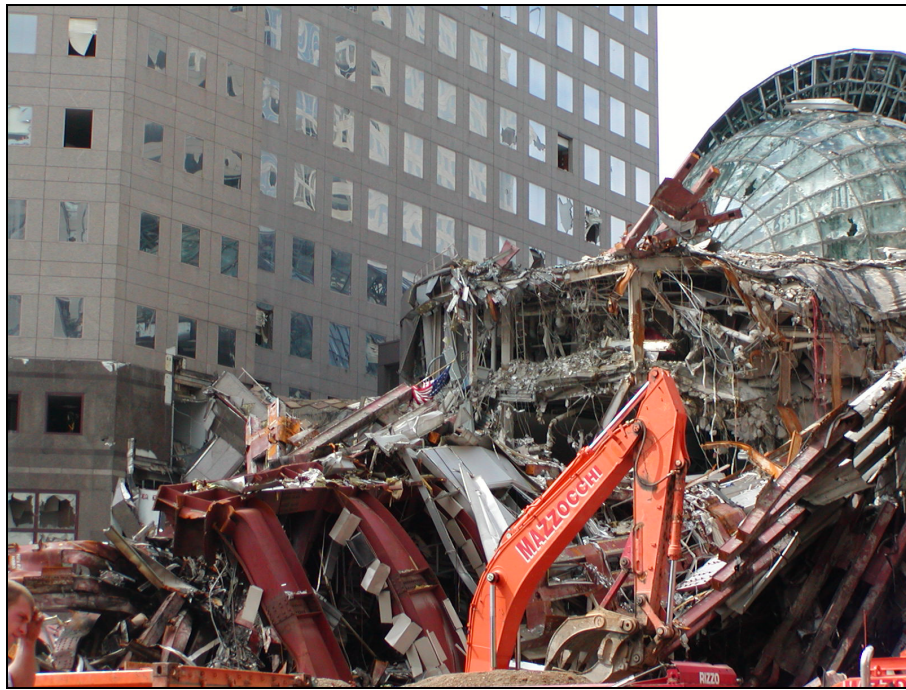
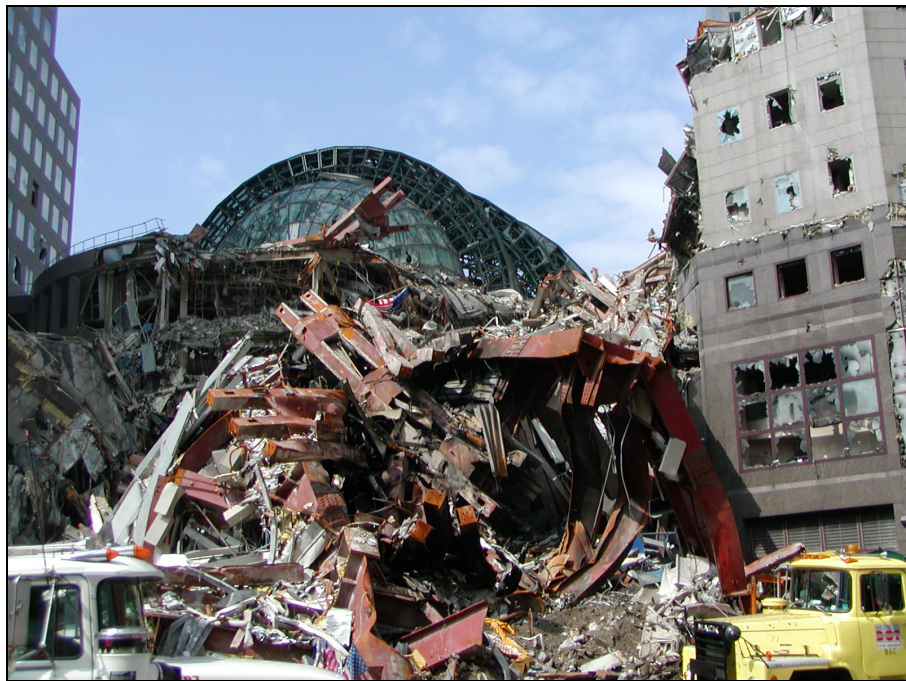
The Winter Garden, located between the two towers of World Financial Center, was severely damaged as numerous pieces of debris penetrated the glass-ceiling of this steel-framed building (see Figure 3.21).

*Figure 3.21.  
Severe damage to  
the east side of the  
Winter Garden*
