**Engineering and Organizational Issues Related to  
the World Trade Center Terrorist Attack**

**Overview of Damage to Buildings  
Near Ground Zero**

**By Michel Bruneau, Andrew Whittaker and Andrei Reinhorn**

March 2002

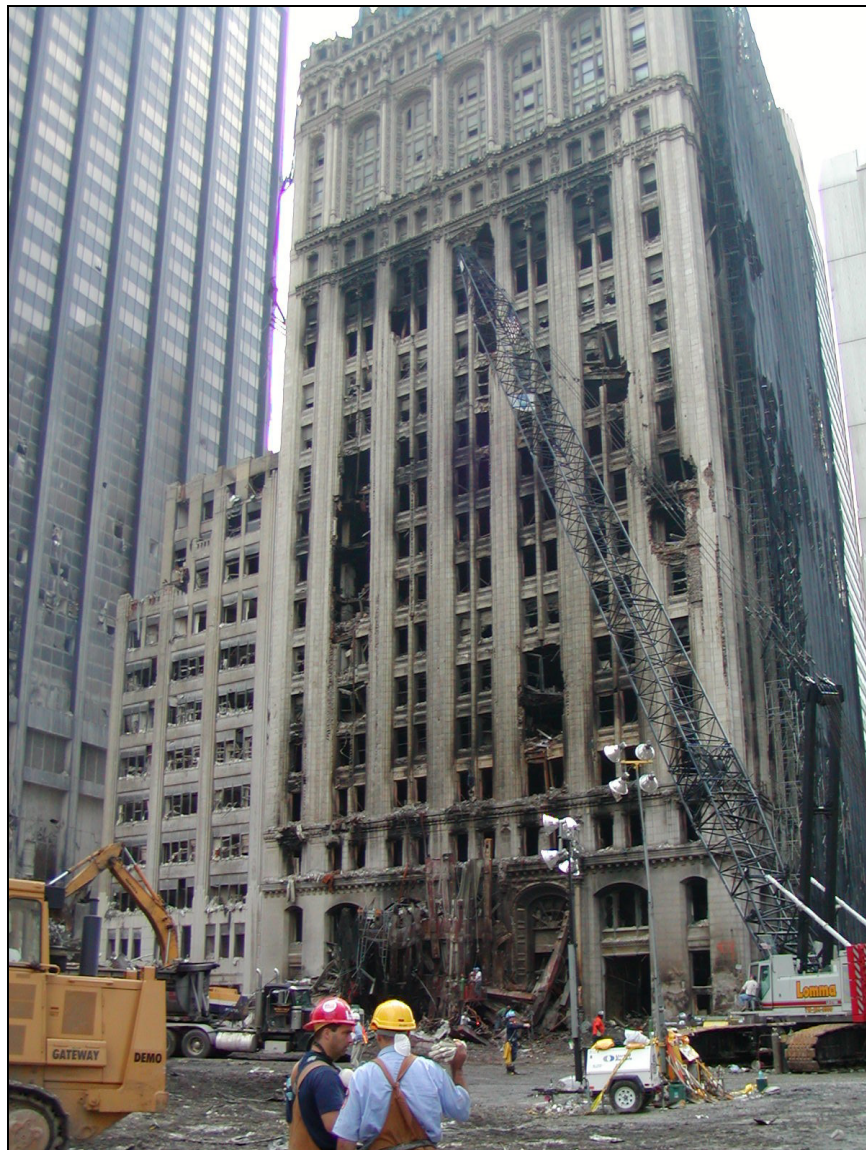
The 90 West Street building was hit by burning debris from the collapse of World Trade Center 2, which started a number of small fires as evinced by damage to the façade (Figure 3.22). A large multi-ton segment of the façade of WTC 2 lodged at the base of the building, but caused only modest damage to the building (Figure 3.23).

*Figure 3.22. 90 West Street building*

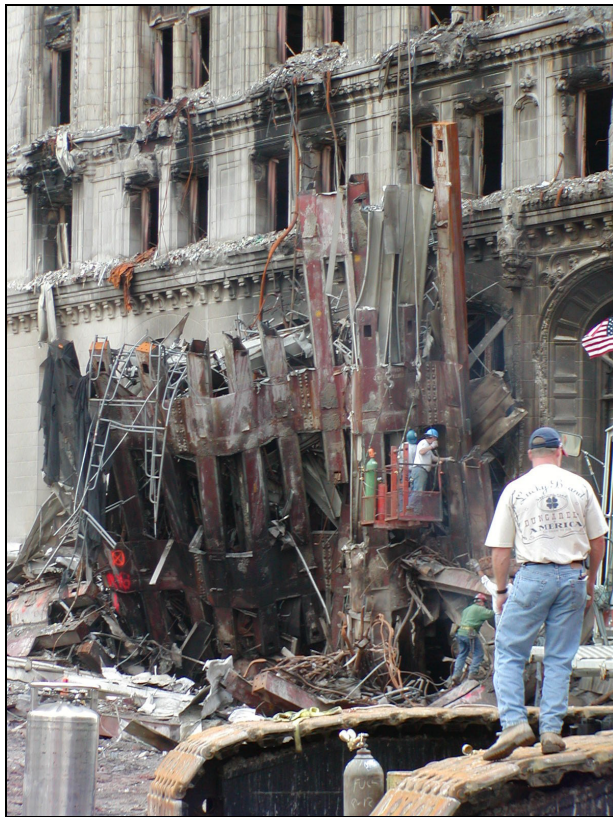
*Figure 3.23. Large multi-ton segment of the façade of the WTC 2 lodged at base of the 90 West Street building*

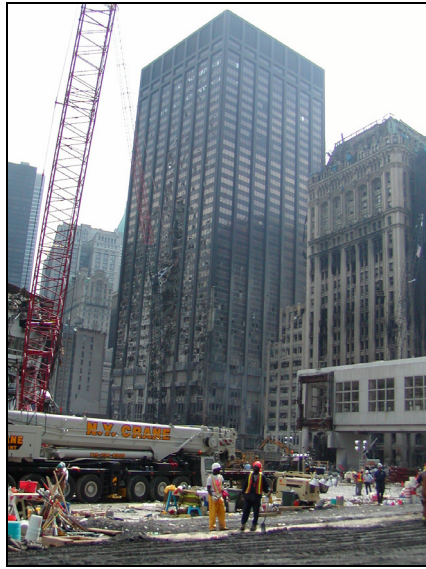
The Banker's Trust Building at 130 Liberty Street was badly damaged by falling debris from the collapse of World Trade Center 2 (Figure 3.24). A large piece of debris, a perimeter column module from WTC 2, that was still lodged in the 6<sup>th</sup> story of the building at the time of the site visits, ripped a twenty story gash in the north façade of the building, from the 26<sup>th</sup> to the 6<sup>th</sup> story (see Figure 3.25), obliterating a column from the perimeter frame at that location, with much interior damage (see Figure 3.26).

*Figure 3.24. Banker's Trust Building, 130 Liberty Street*

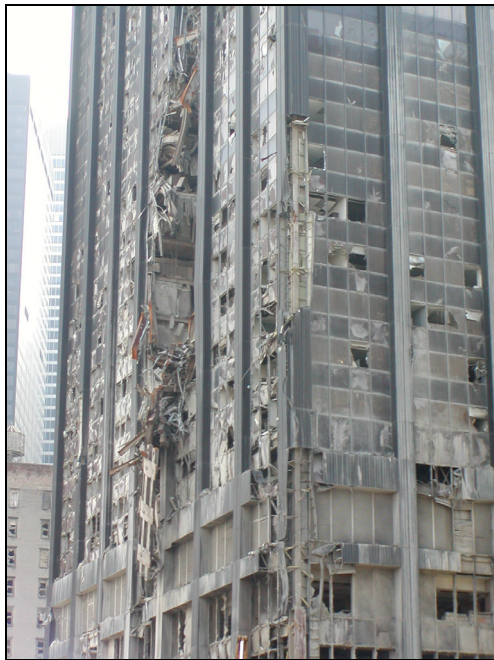
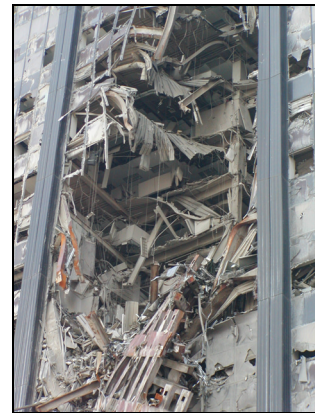
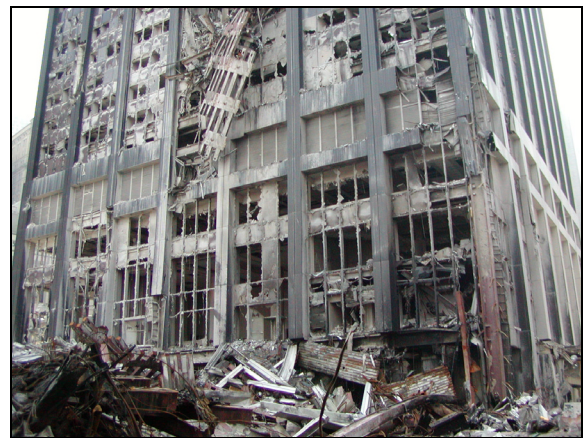
*Figure 3.25. Twenty story gash in the north façade of the building, from the 26<sup>th</sup> to the 6<sup>th</sup> story*

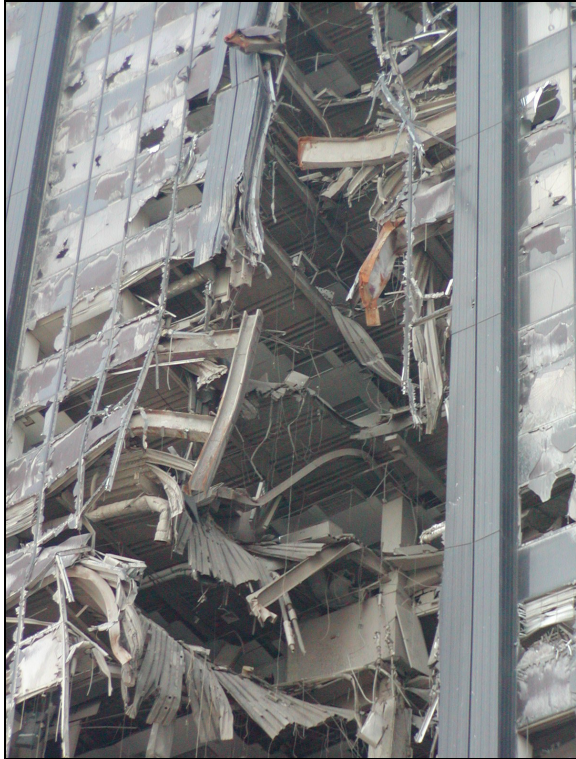
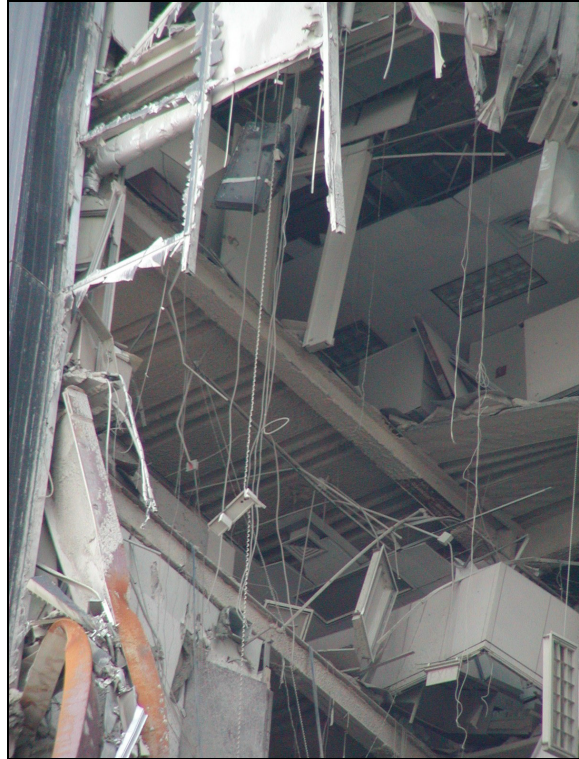
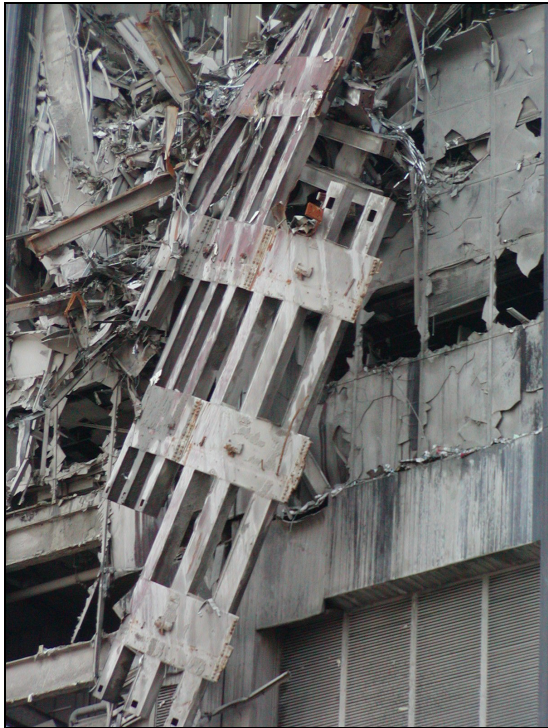
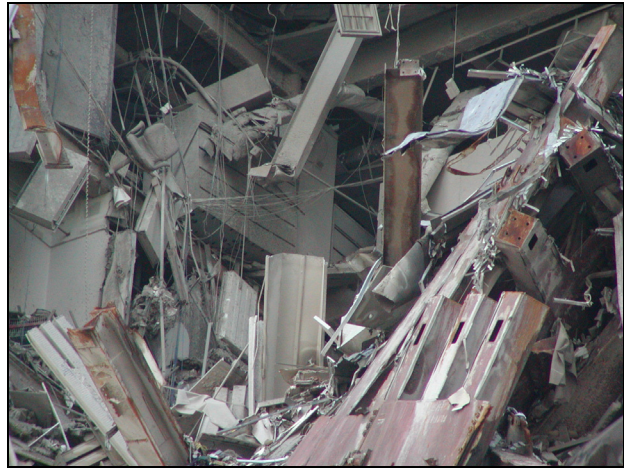
*Figure 3.26. Exterior and interior damage to the Banker's Trust Building*

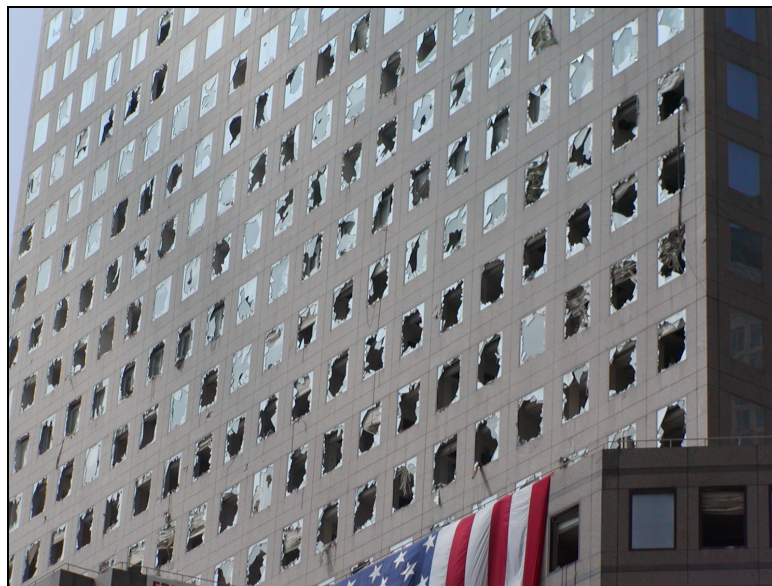
In some instances, extensive nonstructural damage was observed in the absence of visible structural damage. For example, all the windows were broken in a building immediately located across from the collapsed World Trade Center 7. Two World Financial Center exhibited similar damage (Figure 3.27). However, in some instances, many of these windows were also broken by the fire-fighting crews. The Millennium Hilton, across Church Street from WTC 5, suffered major cladding damage, but appeared to be otherwise structurally sound (Figure 3.28).

*Figure 3.27. Broken windows in 2 World Financial Center*

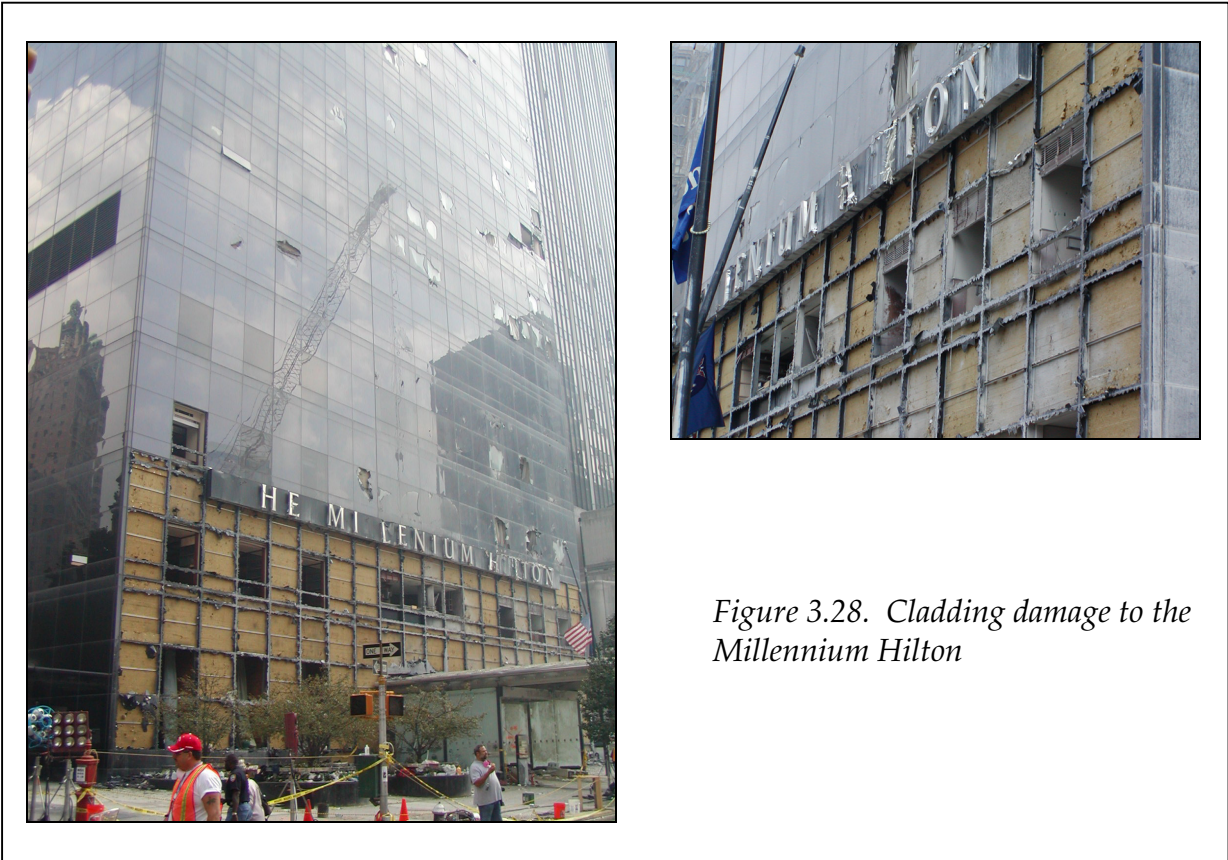
*Figure 3.28. Cladding damage to the Millennium Hilton*

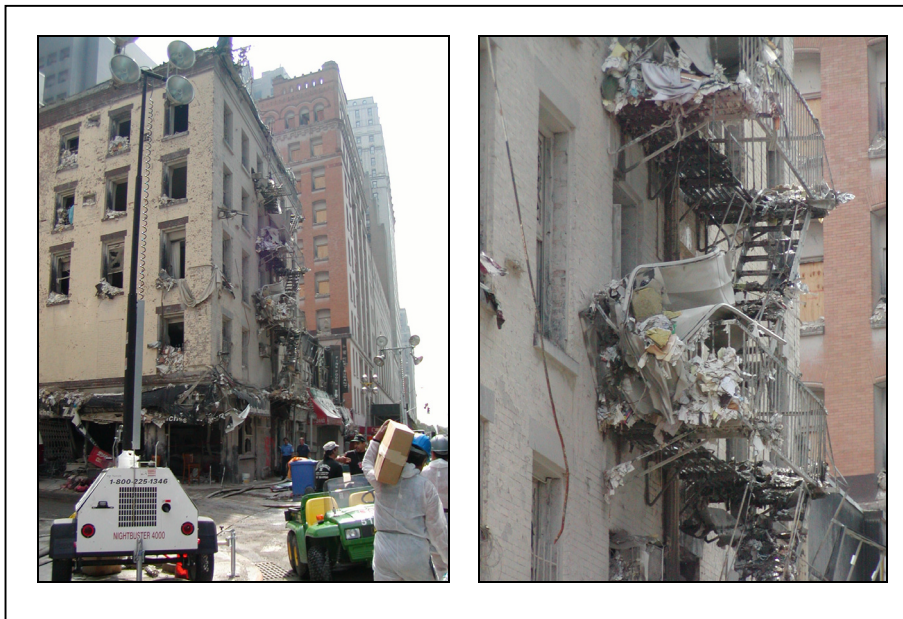
Finally, although the miscellaneous debris were removed from the street by the time of the reconnaissance visit, some assessment of the quantity of dust and miscellaneous debris that probably littered the entire site on September 11 was provided by the amount of such debris still present at less accessible locations, such as in the emergency stairs of a small building adjacent to Ground Zero (Figure 3.29). Among the debris from the towers was a substantial amount of paper, which accumulated on the outside windows of buildings in the area.

*Figure 3.29. Debris in the emergency stairs of a small building near Ground Zero*
