A Summary of MCEER
Reconnaissance Efforts

OVERVIEW OF THE WEST SUMATRA EARTHQUAKE OF SEPTEMBER 30, 2009

Dyah Kusumastuti, Made Suarjana, I Wayan Sengara and Rildova

Special Report MCEER-10-SP01

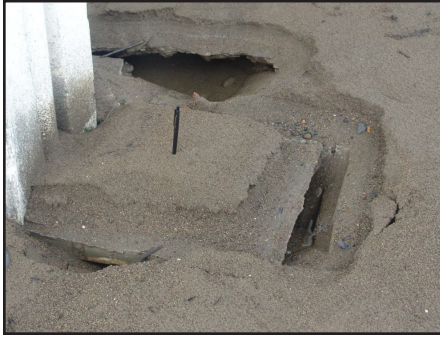
Liquefaction was observed in areas close to the shoreline, where saturated loose to medium dense sand and silty-sand conditions exist (see Figure 2).

Figure 2. Example of liquefaction

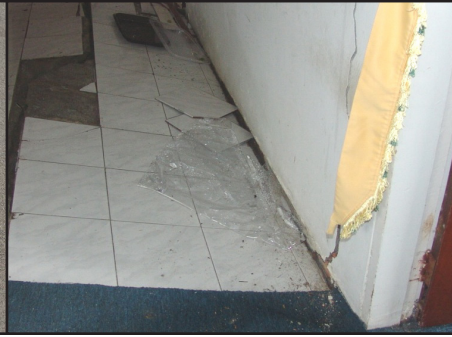
The liquefaction and deformation induced foundation settlements were identified to have caused floor damage and some additional structural damage to buildings (Figure 3).

Figure 3. Foundation and ground deformations that caused damage to a building

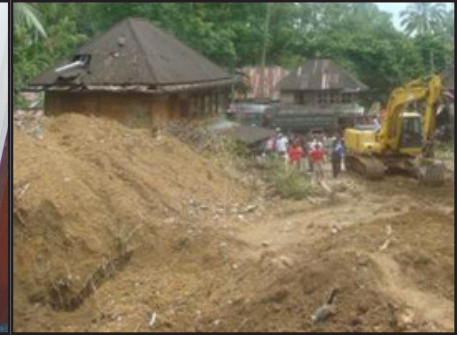
Figure 4. Landslide at Gunung Nan Tigo (Source: Indonesian Department of Education)

Landslides and slope stability failures were also observed during the earthquake. The earthquake has caused landslides and collateral debris-flows in the hills surrounding Lake Maninjau. The most damaging landslide occurred at Gunung Nan Tigo in Padang Pariaman District, which completely demolished some villages and caused many fatalities (Figure 4).

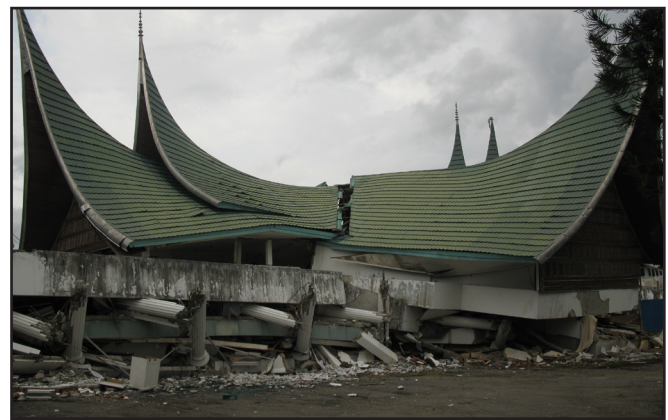
Figure 5. Total collapse mechanism of a government office building in Padang

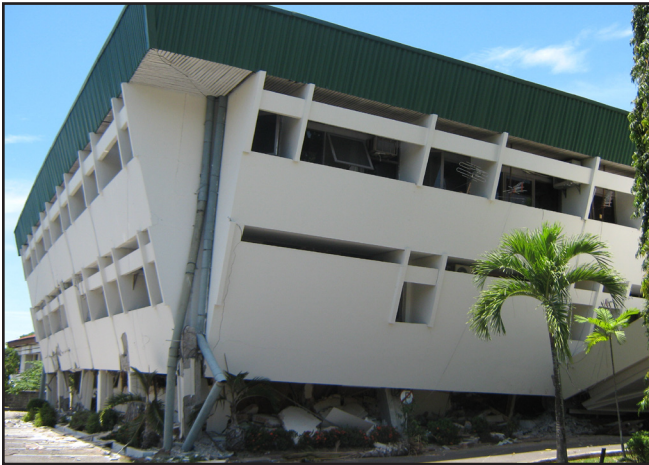
Figure 6. Soft story mechanism of a government office building in Padang

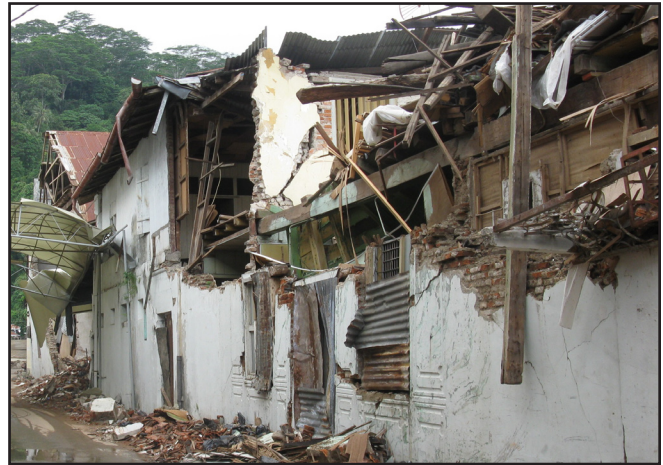
Typical structural damage to non-engineered structures was mainly caused by failure of walls and confining elements. The main problems were poor materials, such as low strength concrete, mortar, and brick materials, and inadequate structural elements and detailing as in the case of engineered structures.

Figure 8. Damage to non-engineered structures in Padang

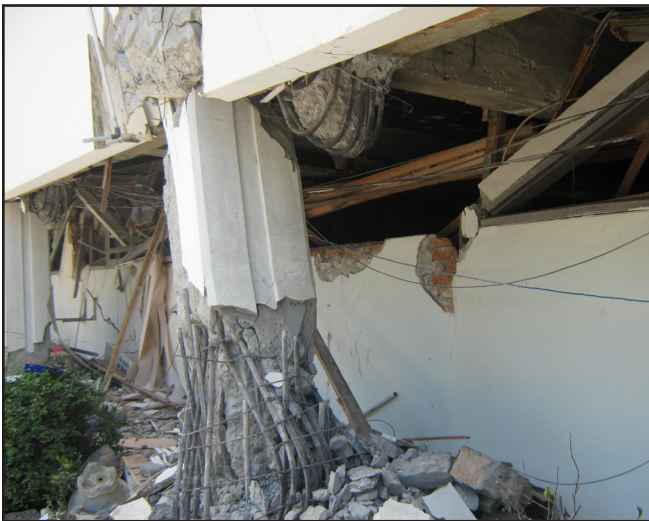
Most buildings that were damaged by the earthquake had poor detailing, such as sparse confinement with small diameter transverse reinforcement, no detailing on connections, non-seismic hooks, and use of plain rebars. Poor layouts with structural irregularities and large openings on the ground floor of the building also contributed to that unsatisfactory response, causing soft-story and/or weak story collapse mechanism, structural pounding, and torsion.

Figure 7. Poor detailing on RC structural members

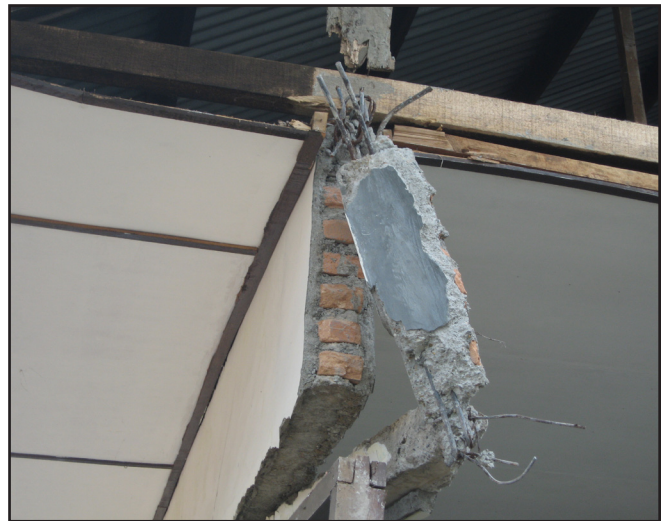
Figure 9. Failure of weak confining frame with poor detail (inadequate development/embedment length, sparse stirrups)

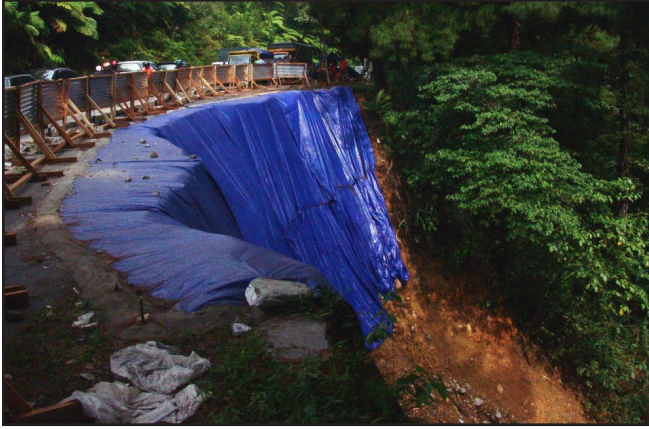
Infrastructure damage such as embankments of roads and bridges was also identified. The failure was due to the marginal slope stability safety factor of embankments and cut. Damage to bridges was identified with ground settlement within the fill of the approach, as well as displacements of abutments and side walls. Ground settlement or deformation could also be associated with lateral spread during strong shaking of the abutment slopes. In some areas, landslides forced road closures. However, no traffic disruptions due to bridge damage were observed.

Figure 10. Slope stability failures of a road at Lubuk Selasih KM 18+00

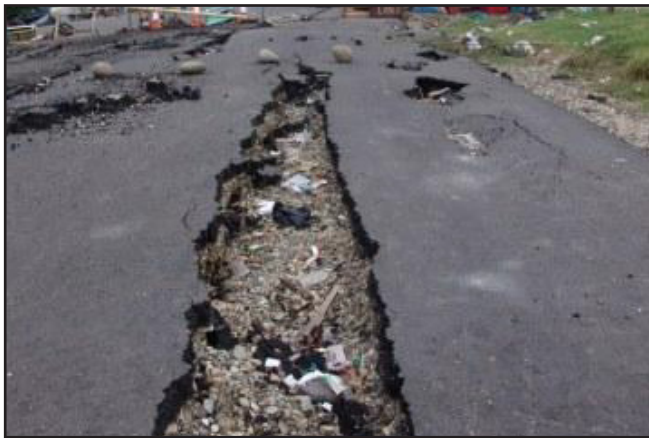
Figure 11. Damage to a road located along the shoreline in Padang due to lateral spread or slope stability of the road embankment

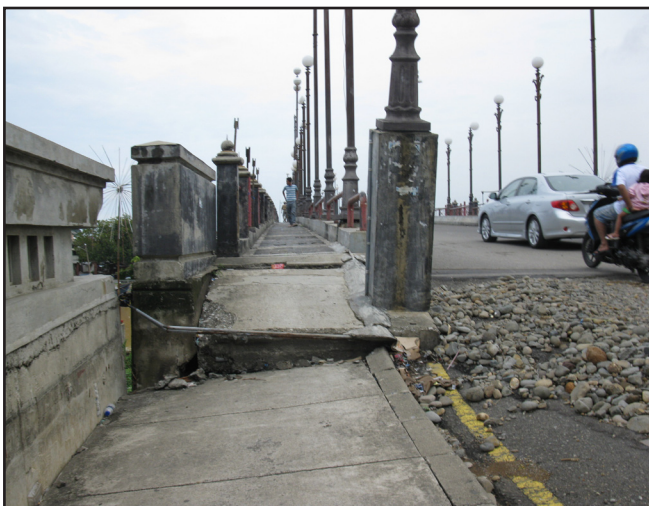
Figure 12. Damage to a bridge due to ground settlement within the fill of the approach and displacements of the abutment side walls
