Effects of the 1985 Michoacan Earthquake on Water Systems and Other Buried Pipelines in Mexico

A.G. Ayala and M.J. O'Rourke

Technical Report NCEER-89-0009

March 8, 1989

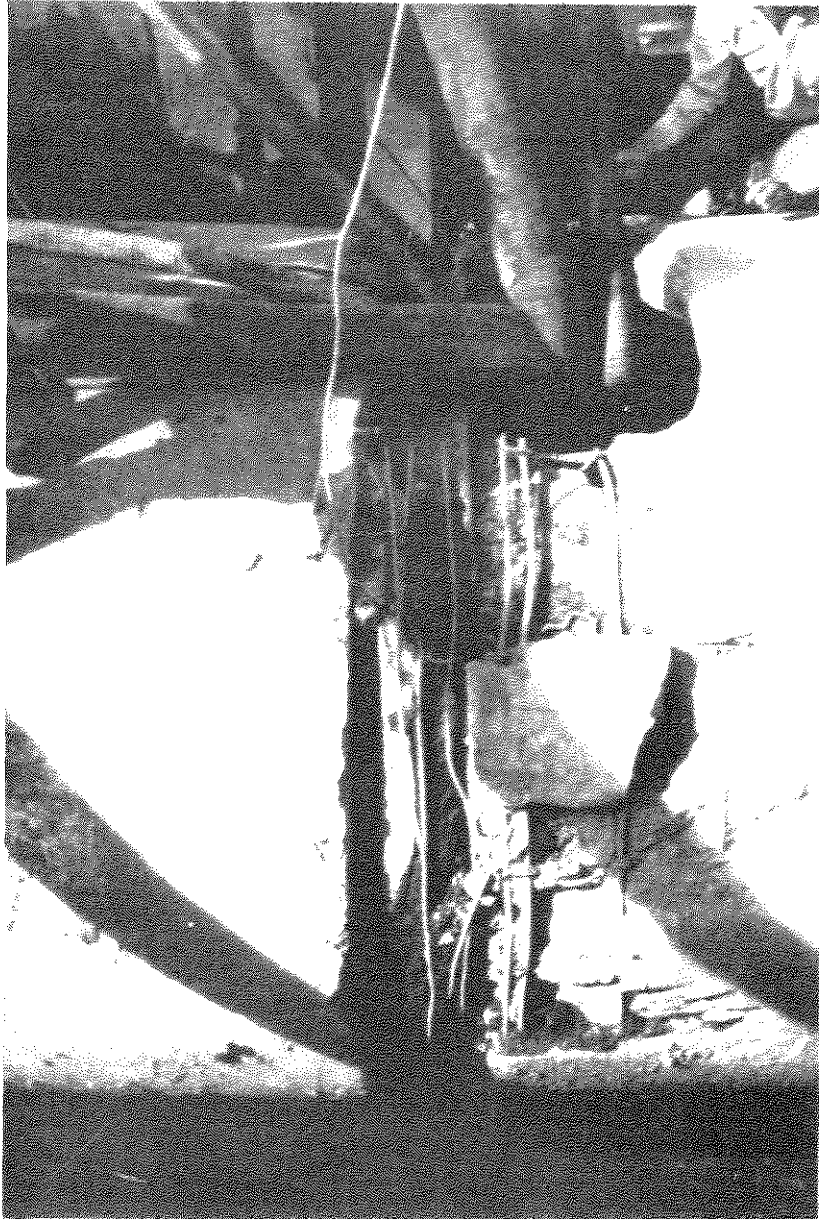
The 1979 Guerrero earthquake damaged a 72"φ buried reinforced concrete aqueduct at 10 locations along its 6 kilometer length in southeast Mexico City. Figures 2-2 and 2-3 show typical damage. Pipeline failures were mainly the result of tension and/or compression at joints. In order of incidence, the failures were due to compressional crushing at the bells, pull out accompanied in some instances by rotation at the joints. An evaluation of the damage indicates that the failures were due to a lack of flexibility in the system as opposed to a lack of strength, [1] and [2]. The repair method used consisted of either replacing the broken pipes or repairing the joints with a bolted steel collar. Unfortunately neither of these procedures improve the deformation characteristic (ie, flexibility) of the pipeline joints. Replacing the broken pipes theoretically returns the system to its pre-earthquake

FIGURE 2-2 Aqueduct Damage During 1979 Guerrero Earthquake

condition, hence leaving it vulnerable to future seismic damage. Repairing with a bolted steel collar has the effect of marginally reducing the overall flexibility of the system as a whole, and does not prevent damage at adjacent joints during future earthquakes.

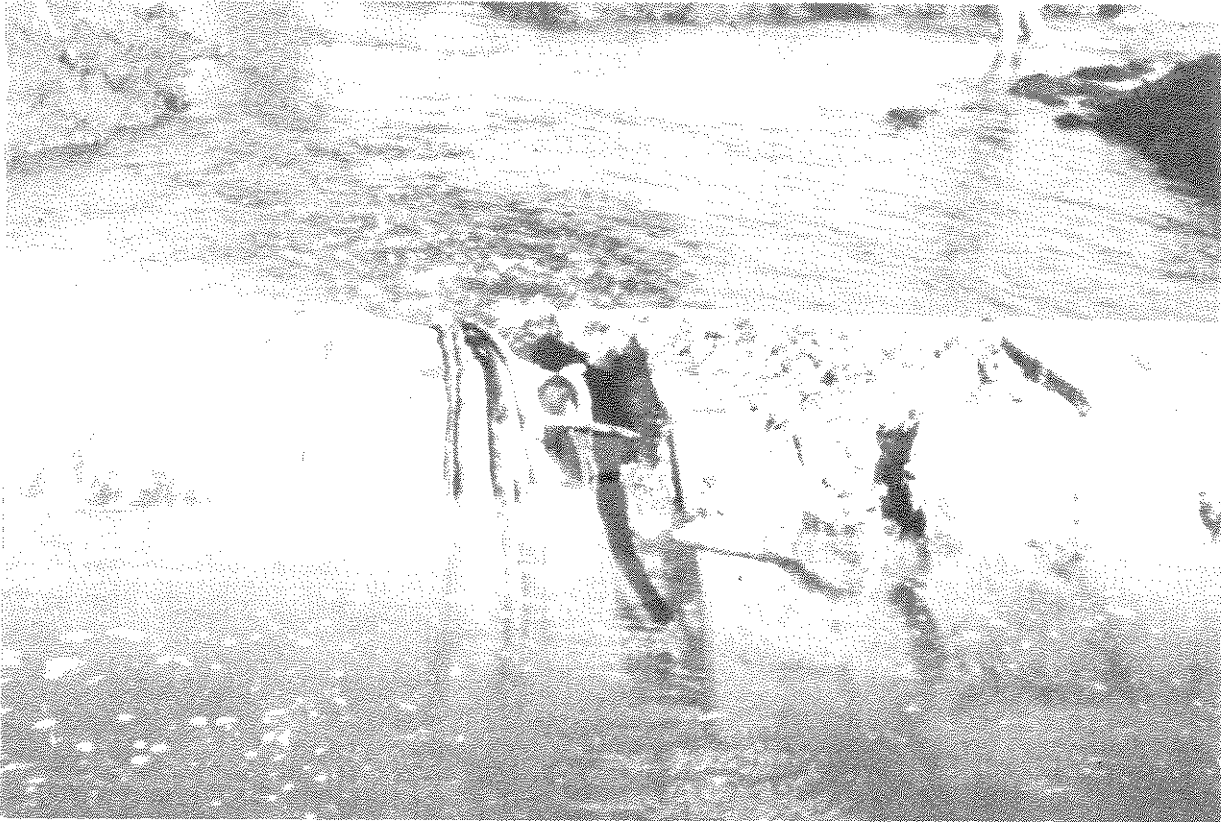
FIGURE 2-3 Aqueduct Damage During 1979 Guerrero Earthquake

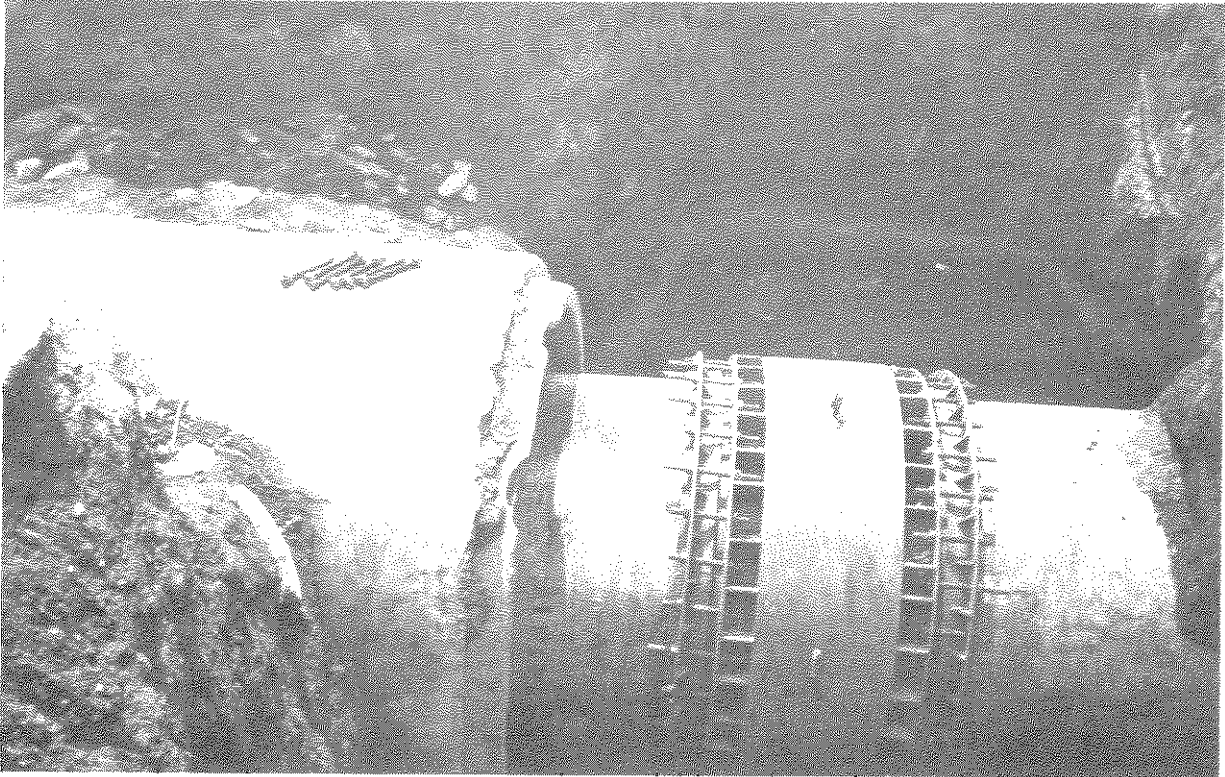
FIGURE 4-4 Steel Saddle On Damaged Pipe

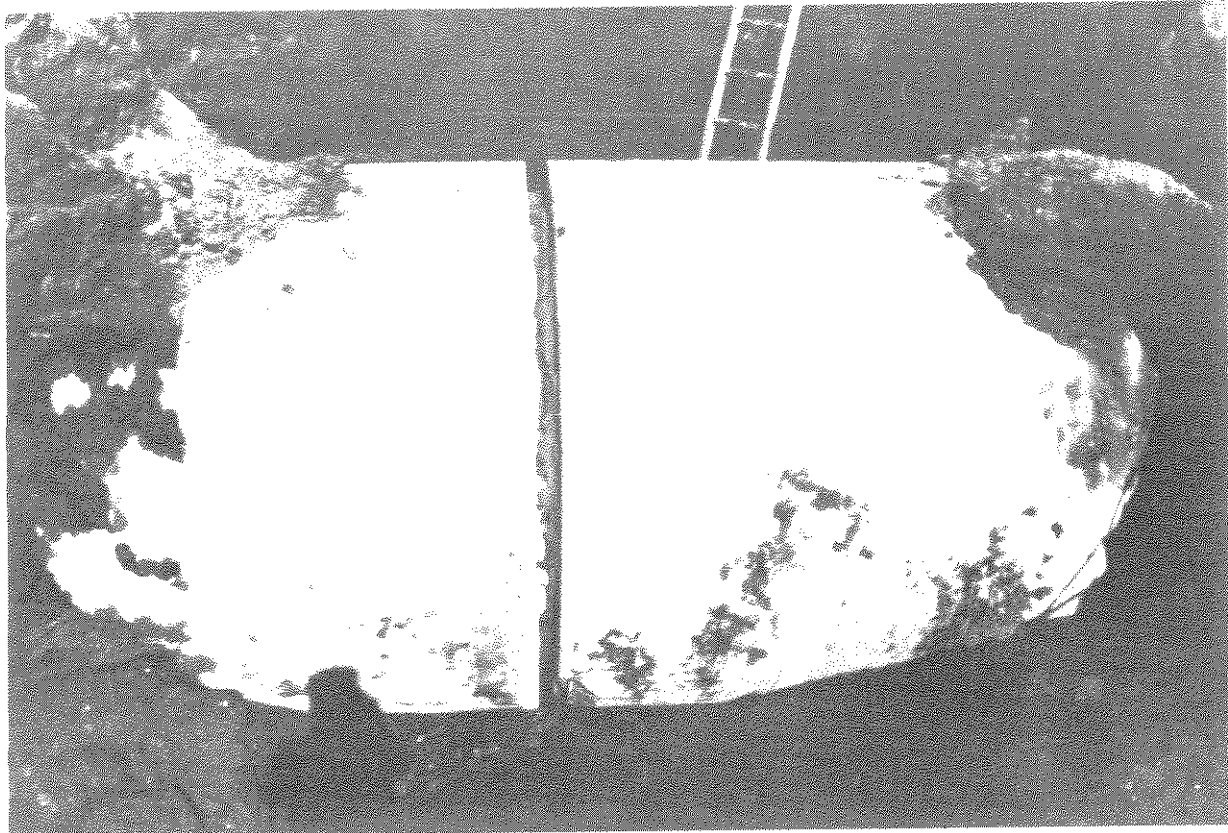
FIGURE 6-3 Joint Separation In A 72"φ 'Lock Joint' Pipe,
1985 Michoacan Earthquake

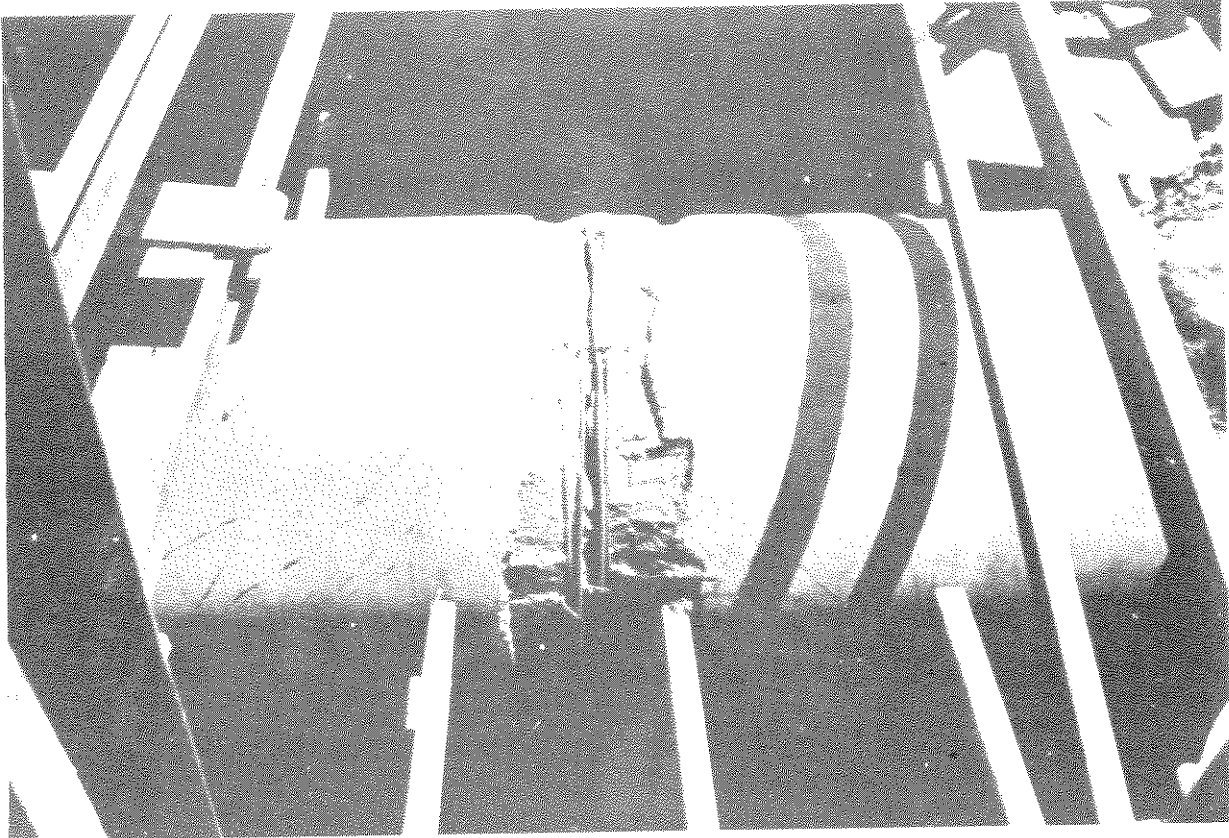
FIGURE 6-4 Crushing Failure In A 72"φ 'Lock Joint' Pipe,
1985 Michoacan Earthquake

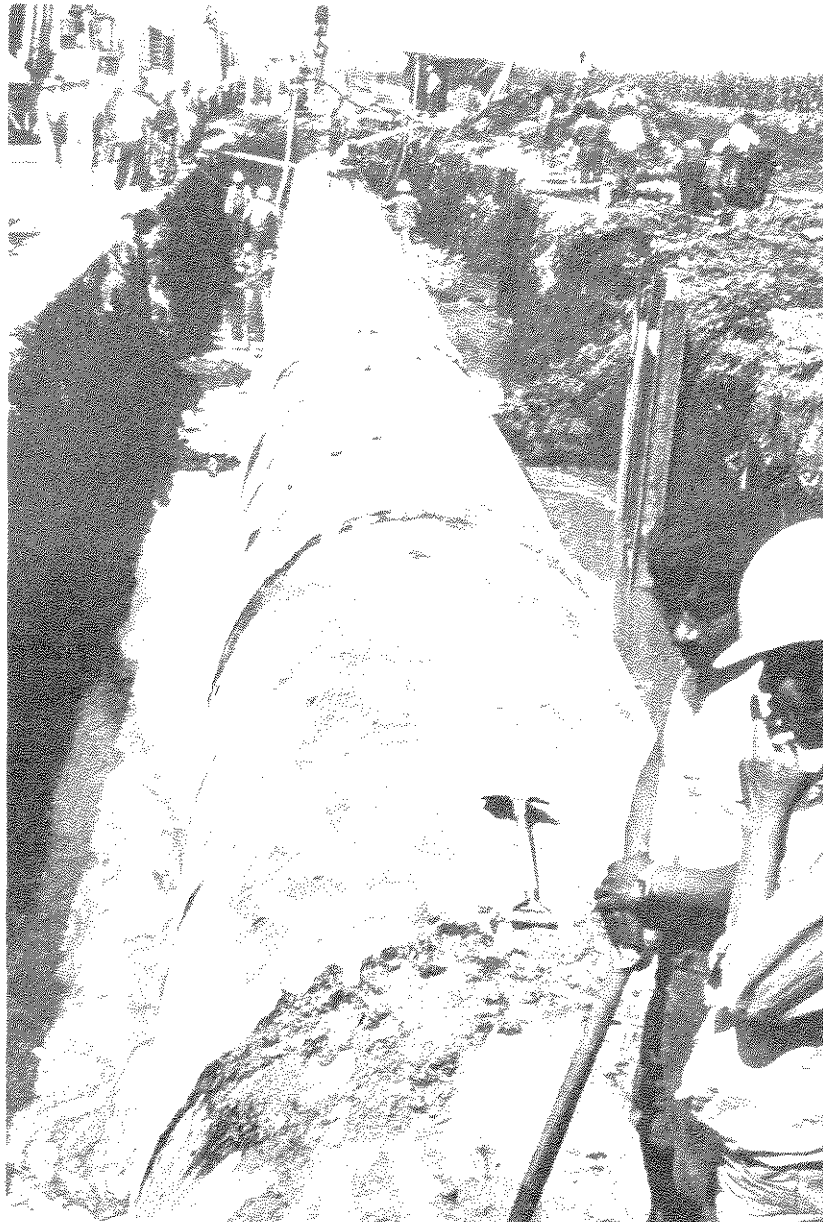
FIGURE 6-5 Joint Separation At 11 Points Close To A "T" Junction, 1985 Michoacan Earthquake

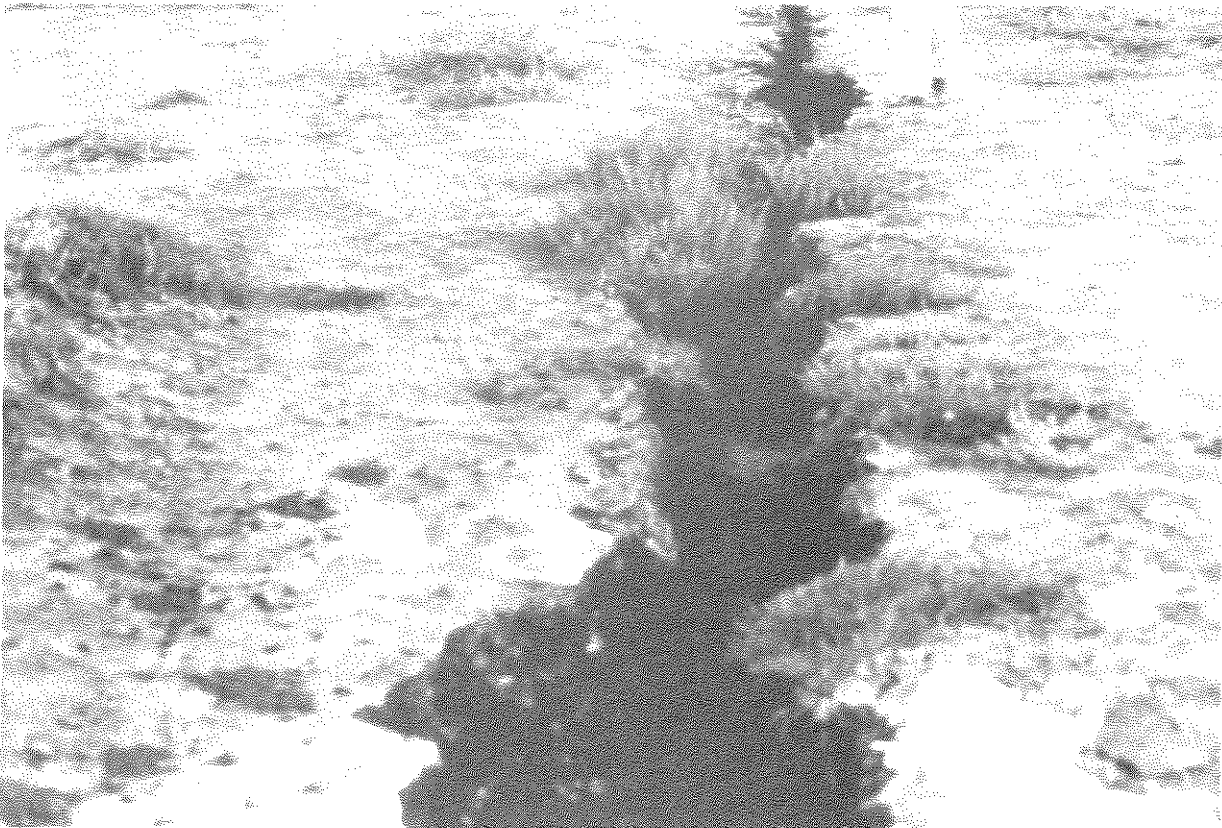
FIGURE 6-6 Severe Ground Cracking In The Vicinity Of The Aqueducts,
1985 Michoacan Earthquake

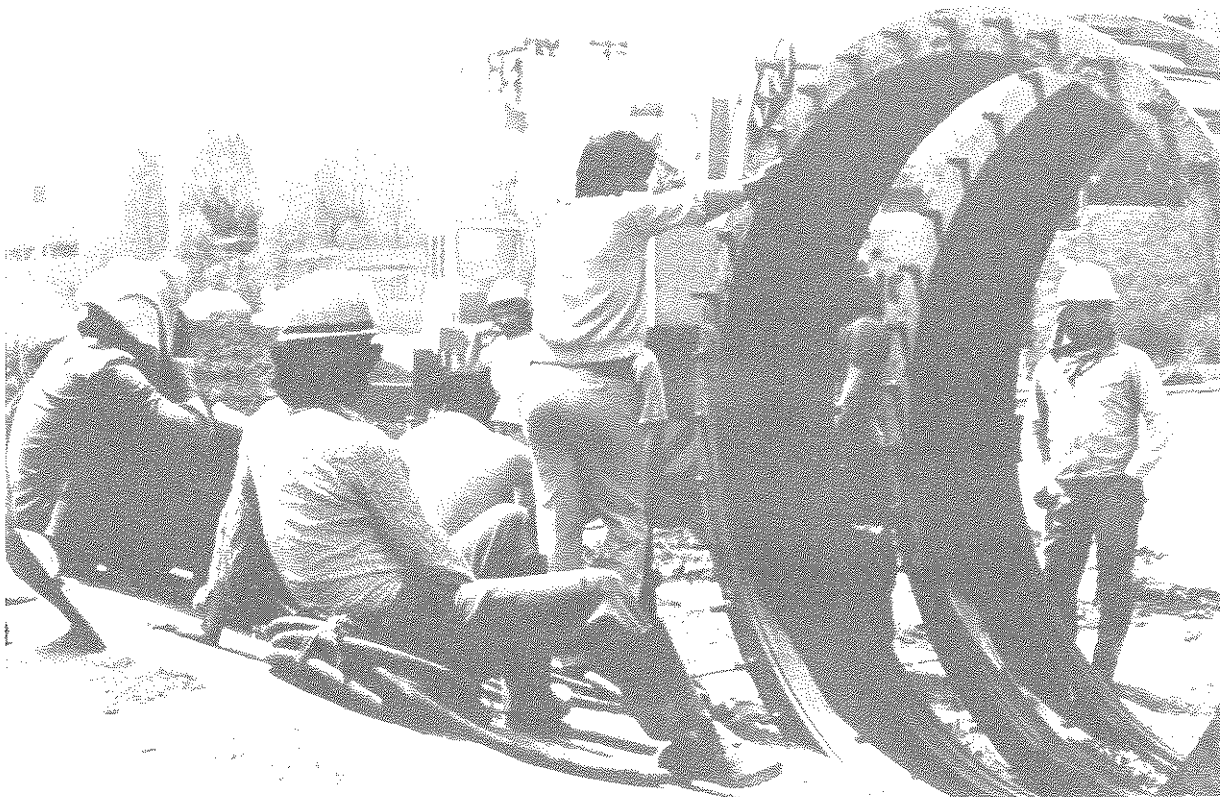
FIGURE 6-12 View Of A Steel Repair Saddle

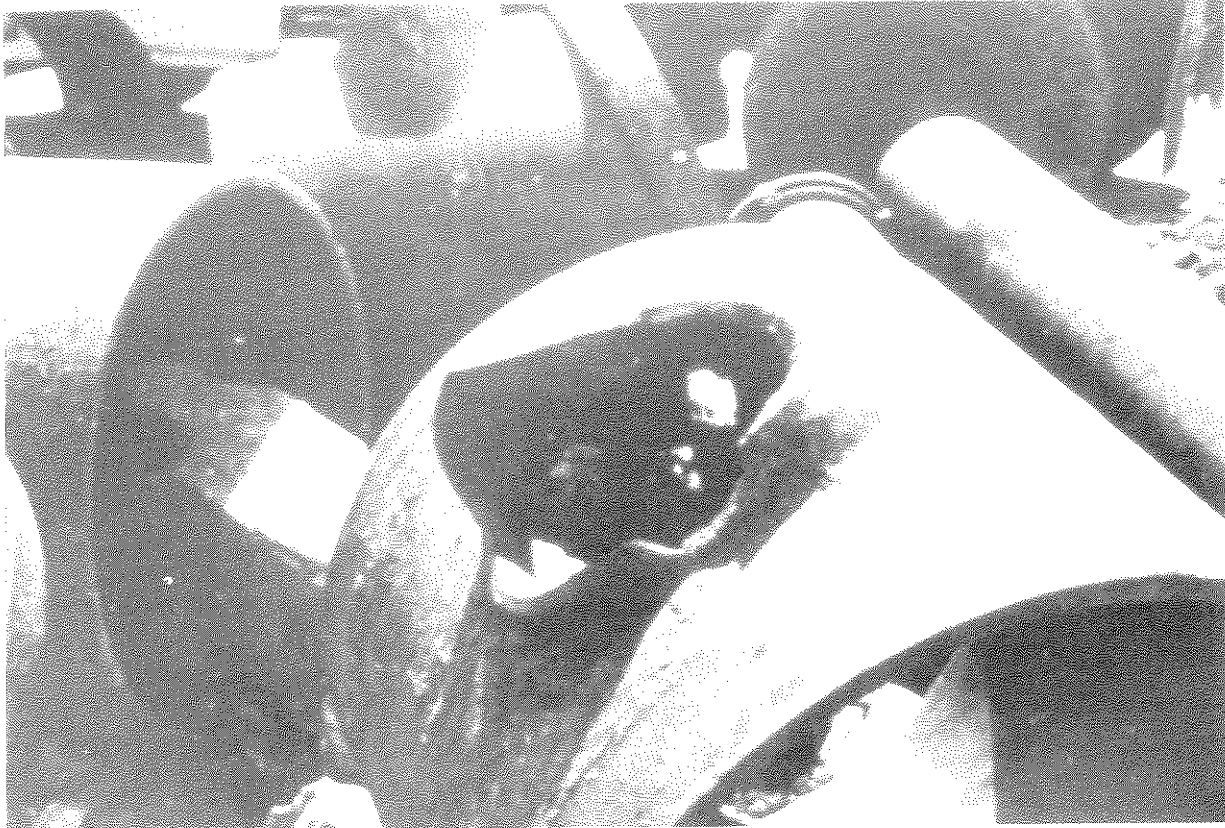
FIGURE 6-13 Fractured Cast Iron "T", 1985 Michoacan Earthquake

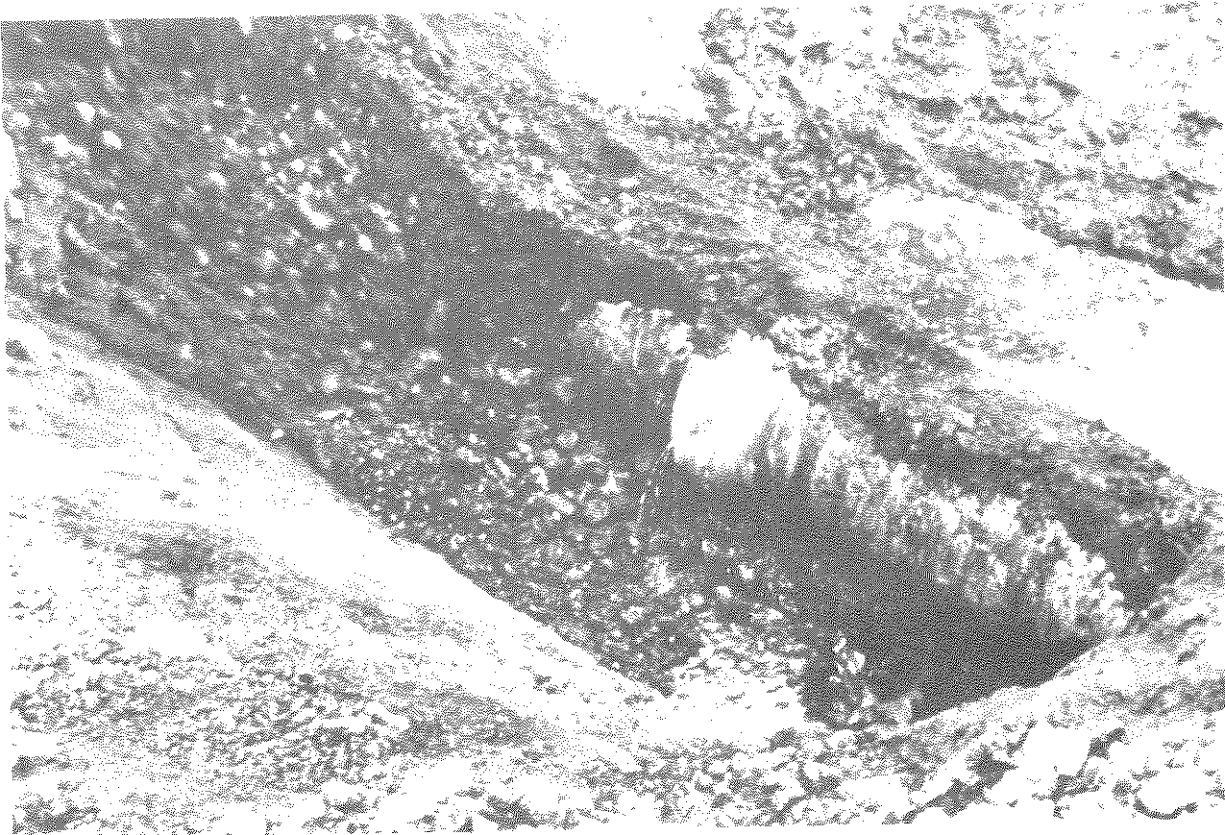
FIGURE 6-16 Leak At The Bell Of An Asbestos Cement Pipe, 1985 Michoacan Earthquake

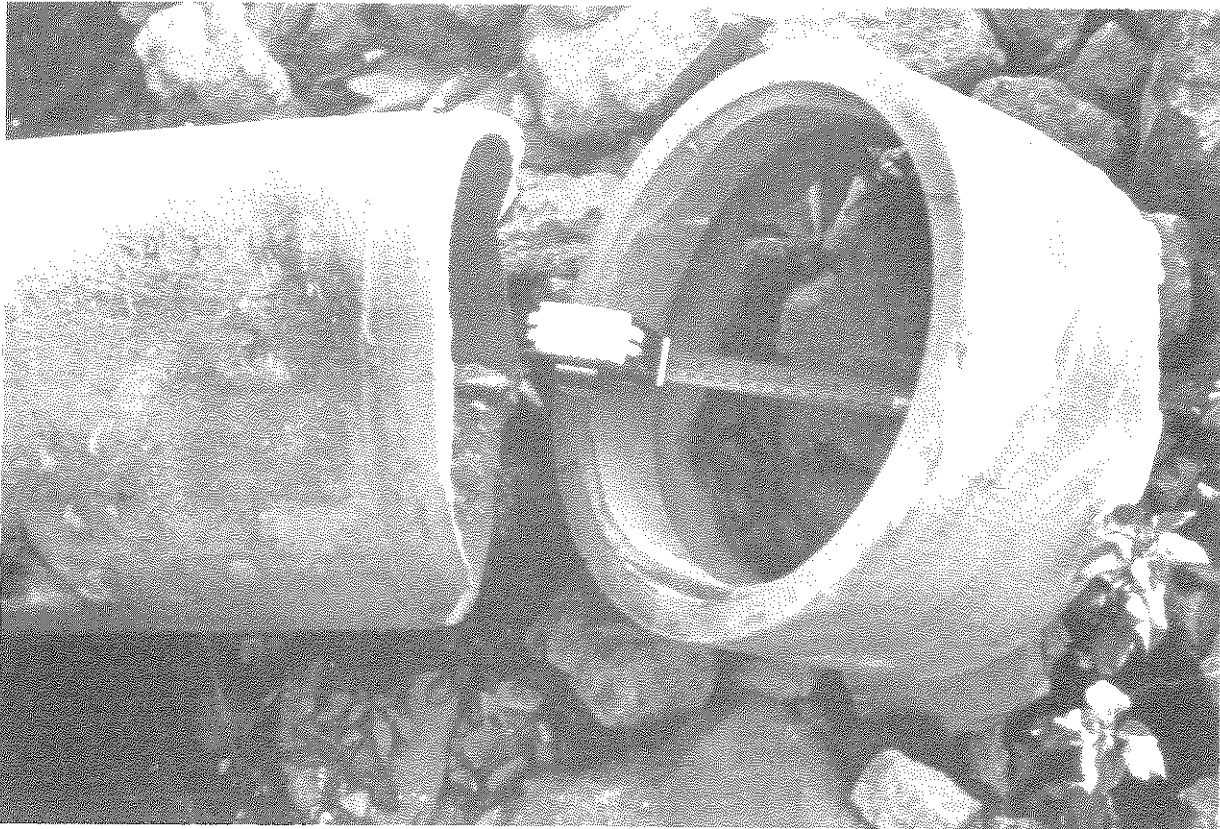
FIGURE 6-17 Break Near Joint Of An Asbestos Cement Pipe, 1985 Michoacan Earthquake

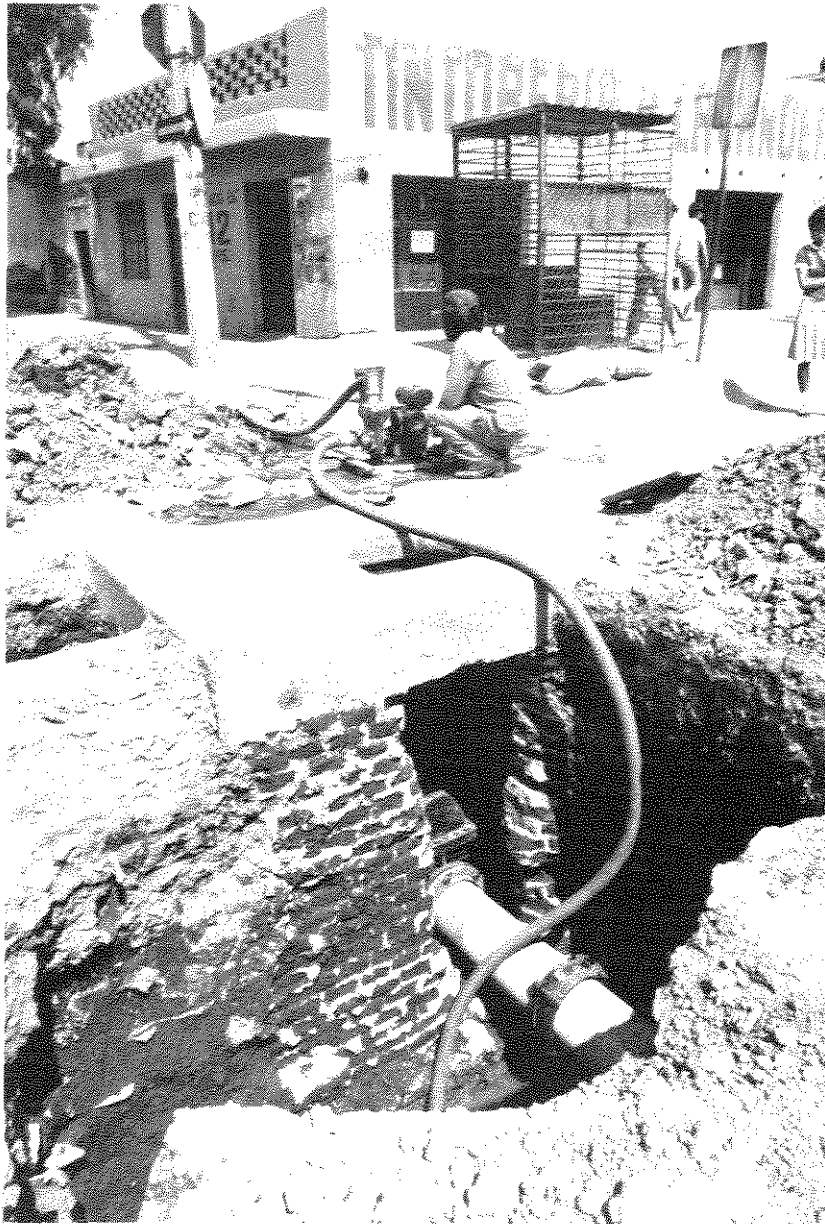
FIGURE 6-18 Repaired Leak At A Valve Box

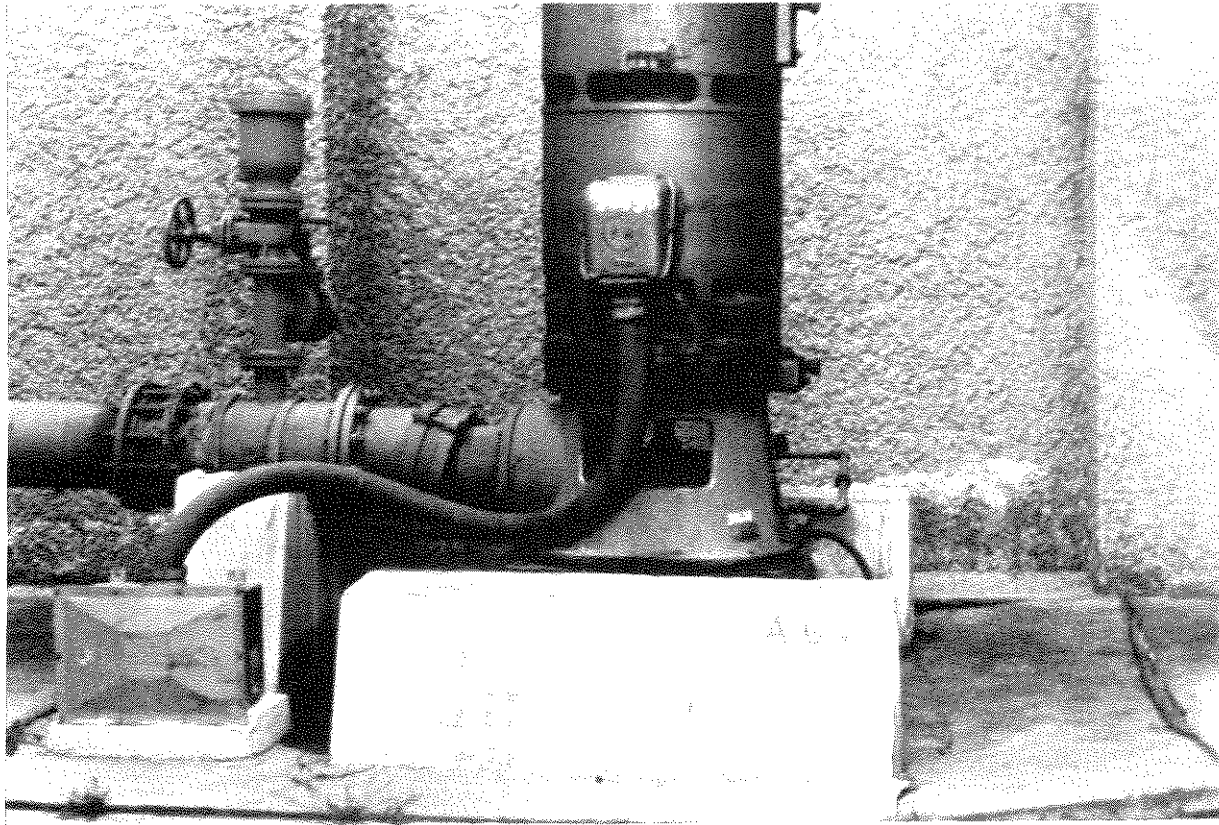
FIGURE 6-19 Well Damage At 'La Caldera' Tank, 1985 Michoacan Earthquake

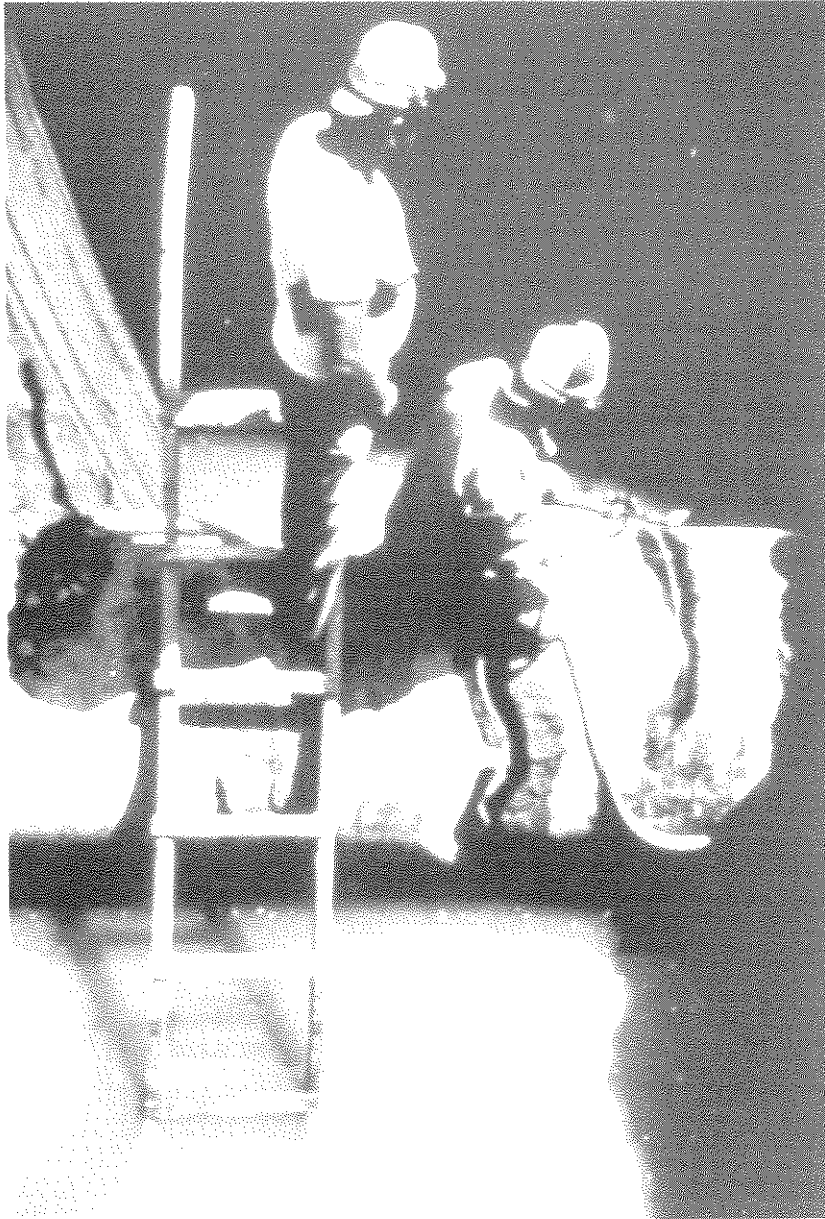
FIGURE 7-2 Local Buckling Failure Of Ciudad Nezahualcoyotl Pipeline - 1985
Michoacan Earthquake

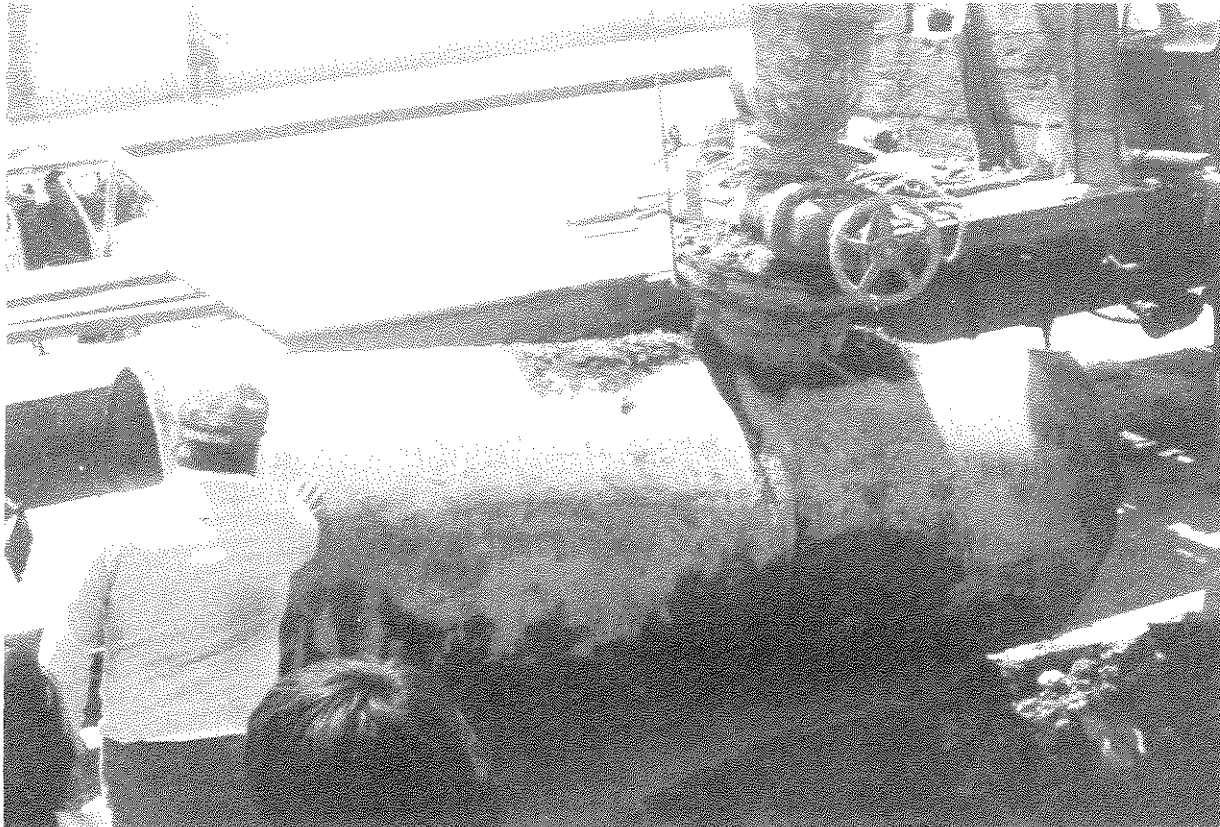
FIGURE 7-3 Wrinkling Deformation Close To A Valve Location, Ciudad Nezahualcoyotl Pipeline, 1985 Michoacan Earthquake

As mentioned previously, the observed locations of compressional wrinkling were at 300 to 500 meter spacings. Note that at any particular instant in time, the procedure described above suggests that areas of high compressive stress would occur at a spacing of about 520m. That is high compression regions are a wavelength apart, or 520m for the critical quarter wavelength of 130m.

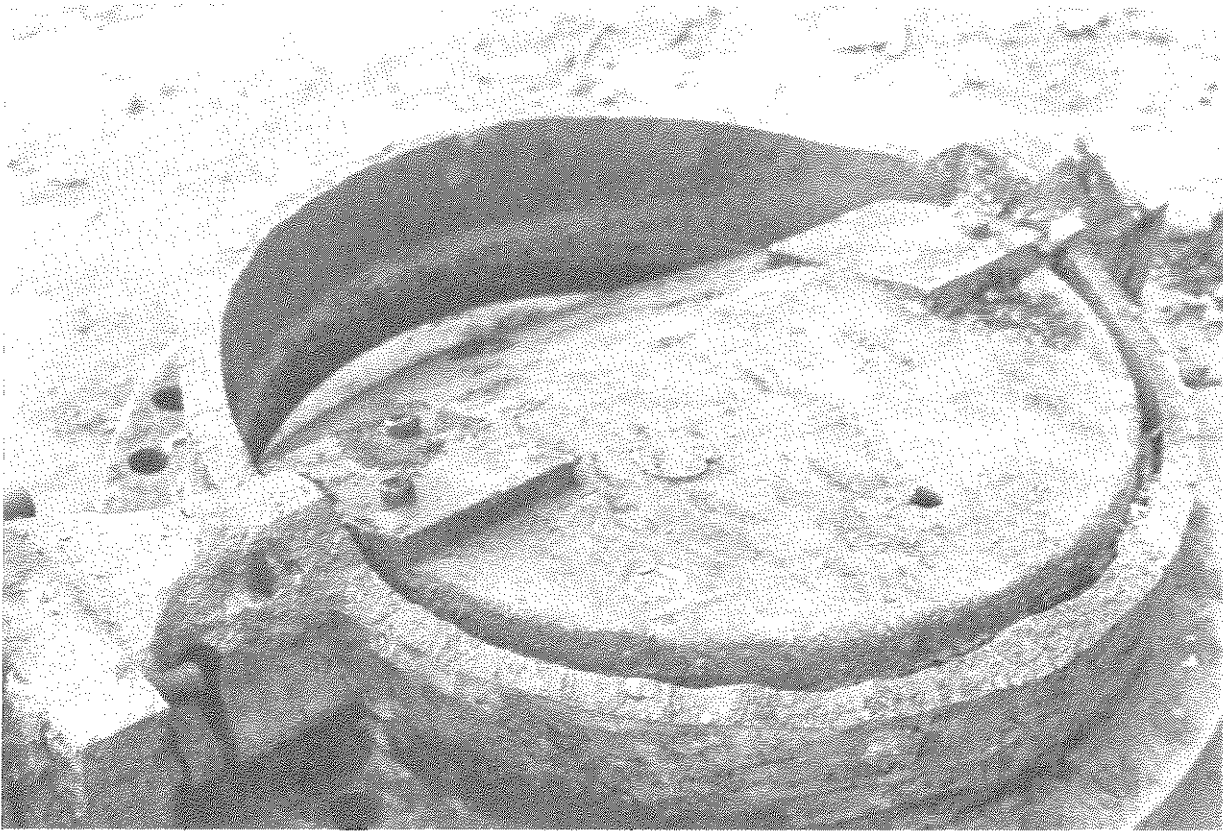
FIGURE 7-4 Broken Butterfly Valve

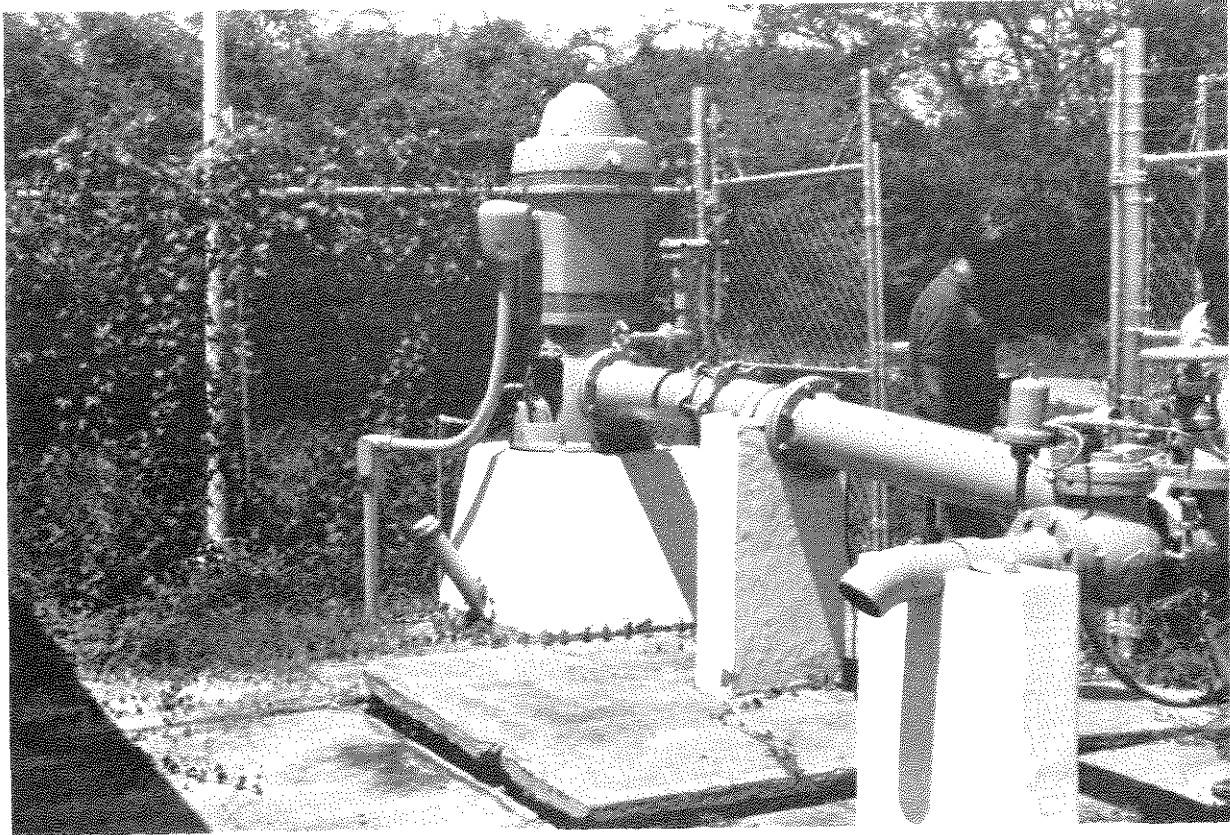
FIGURE 9-2 Damage To A Well, Epicentral Region - 1985 Michoacan Earthquake

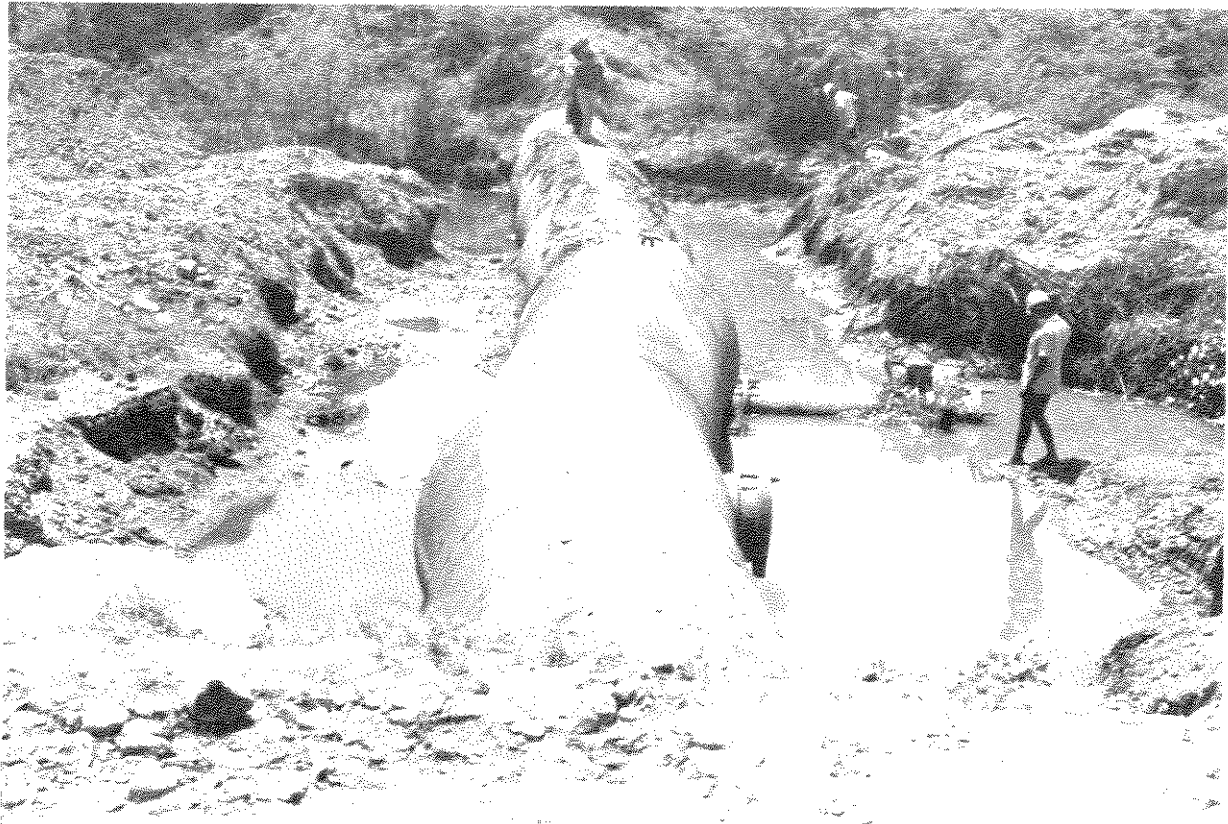
FIGURE 9-3 Damage To A 72"φ Above Ground Pipeline, Epicentral Region, 1985 Michoacan Earthquake
