The Northridge, California Earthquake of January 17, 1994: General Reconnaissance Report

Edited by J. Goltz

Technical Report NCEER-94-0005

March 11, 1994

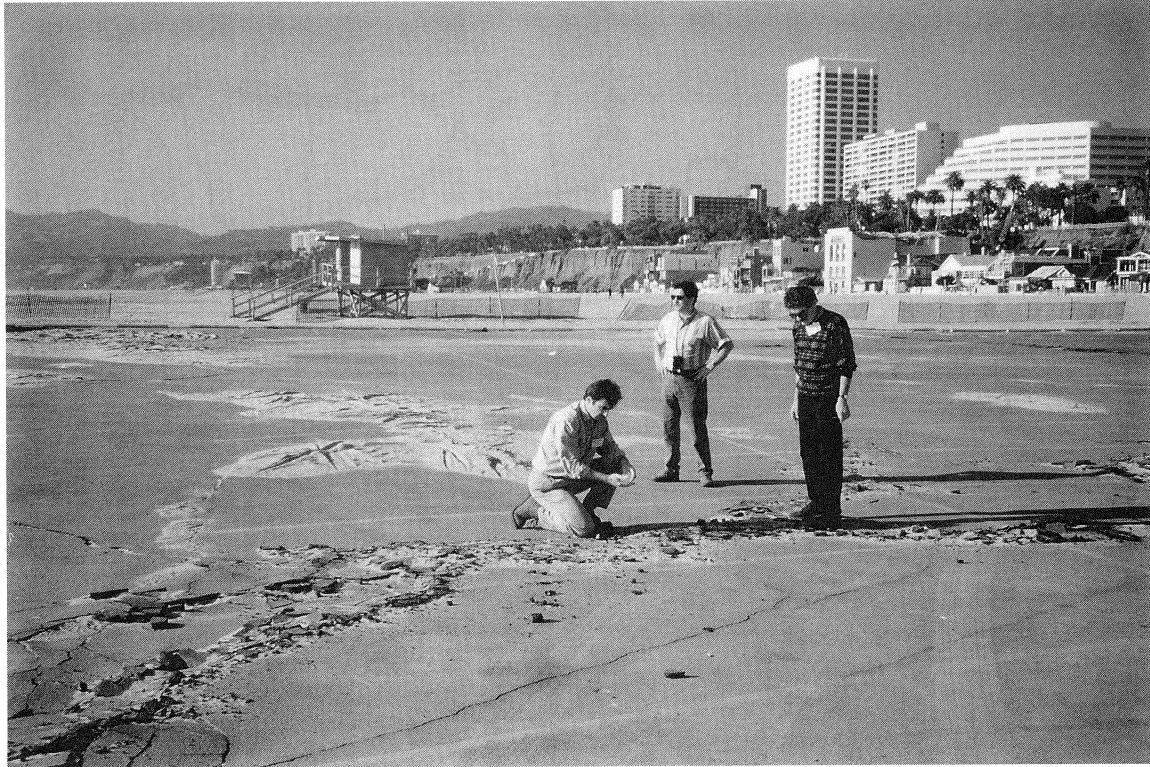
FIGURE 2-6 Liquefied Sand Ejected from Cracks in the Pavement of the Parking Lot in Santa Monica Beach

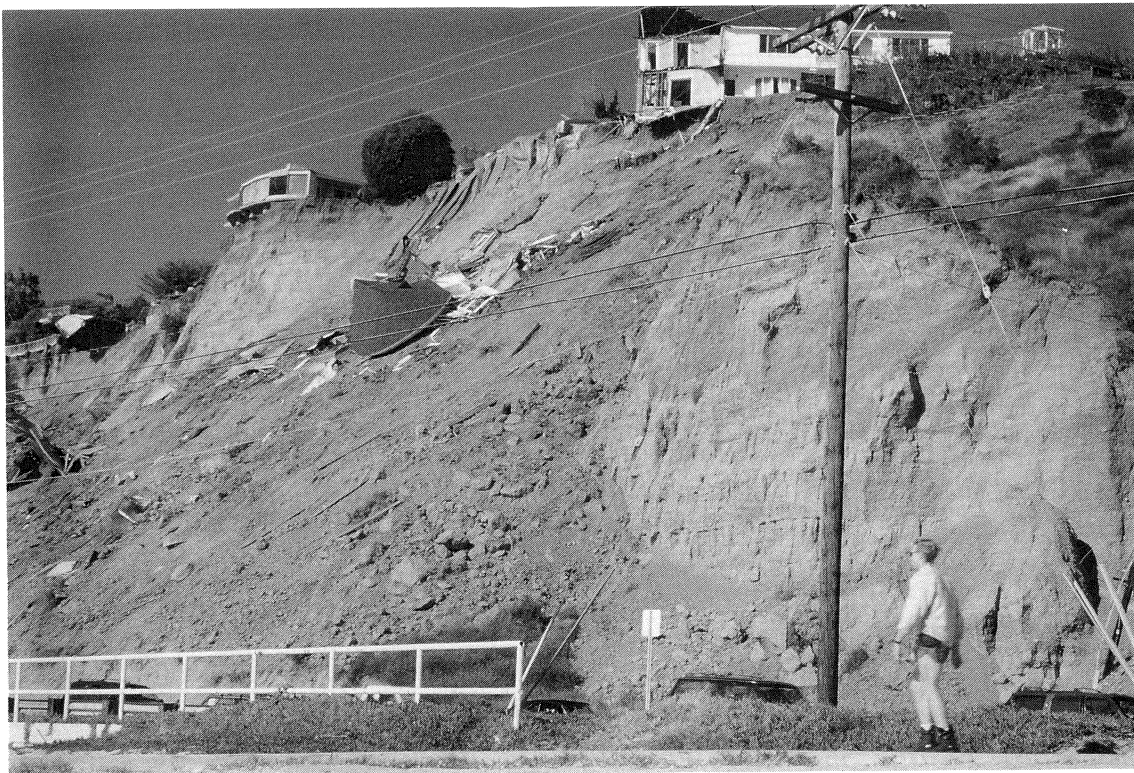
FIGURE 2-11 Landslides in Santa Monica Along Pacific Coast Highway

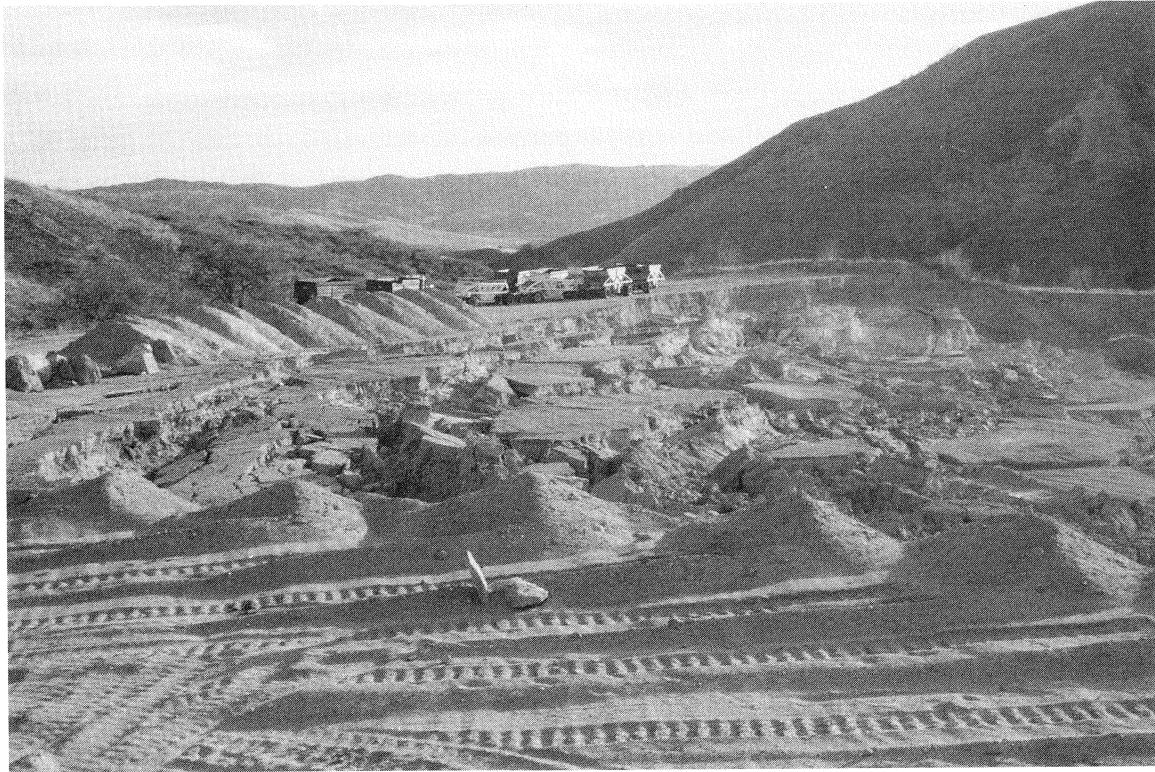
FIGURE 2-12 Slope Failure in Simi Valley at a Rock Quarry

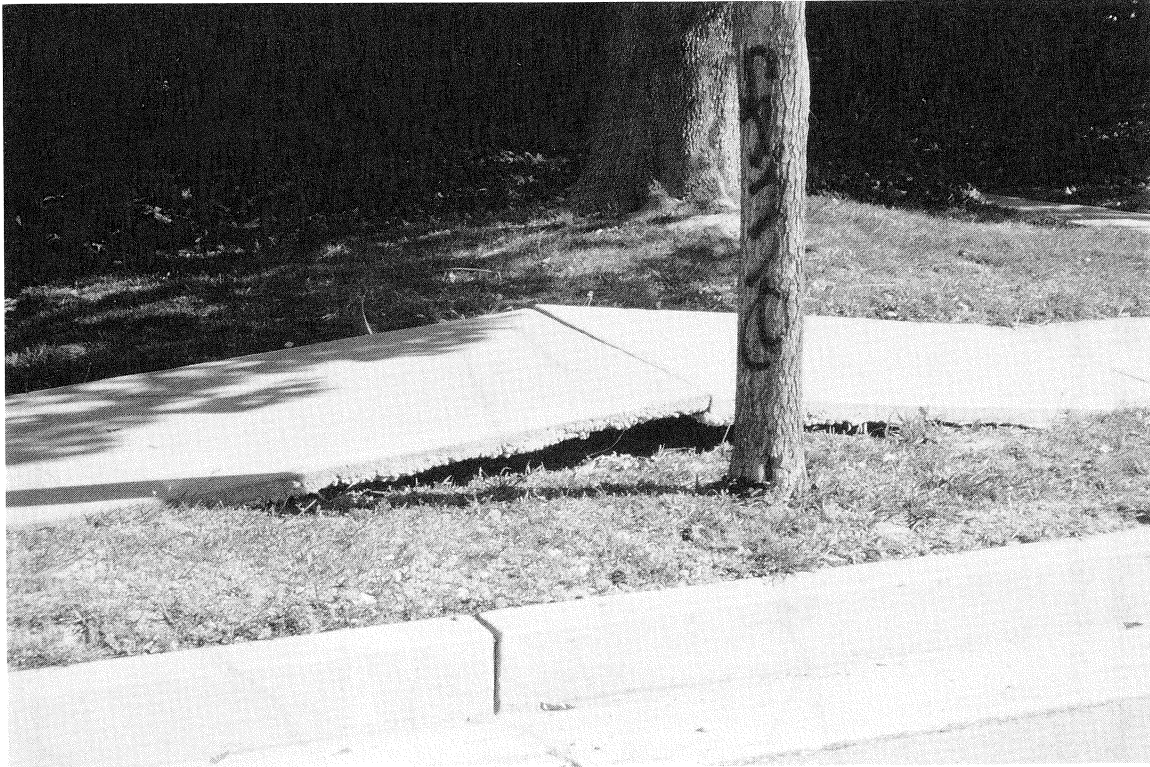
FIGURE 2-14 Compressive Ground Deformation Along Balboa Boulevard in Granada Hills

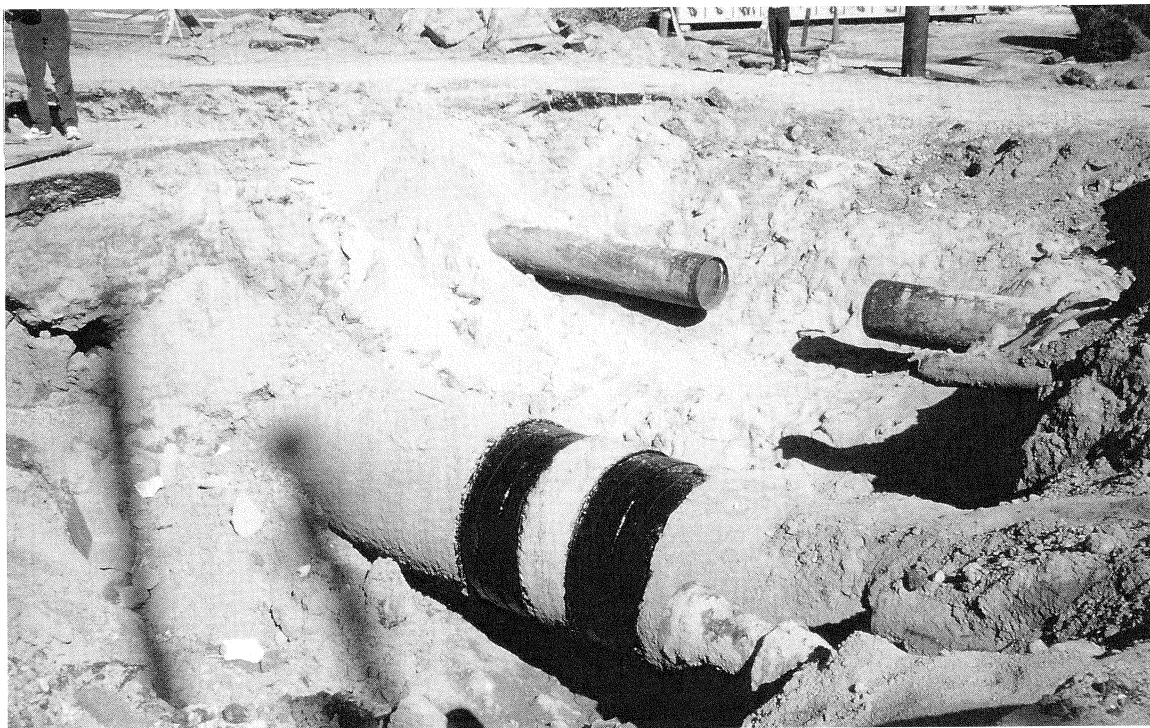
FIGURE 2-15 Section of the Water Main Along Balboa Boulevard that had to be Repaired After the Earthquake

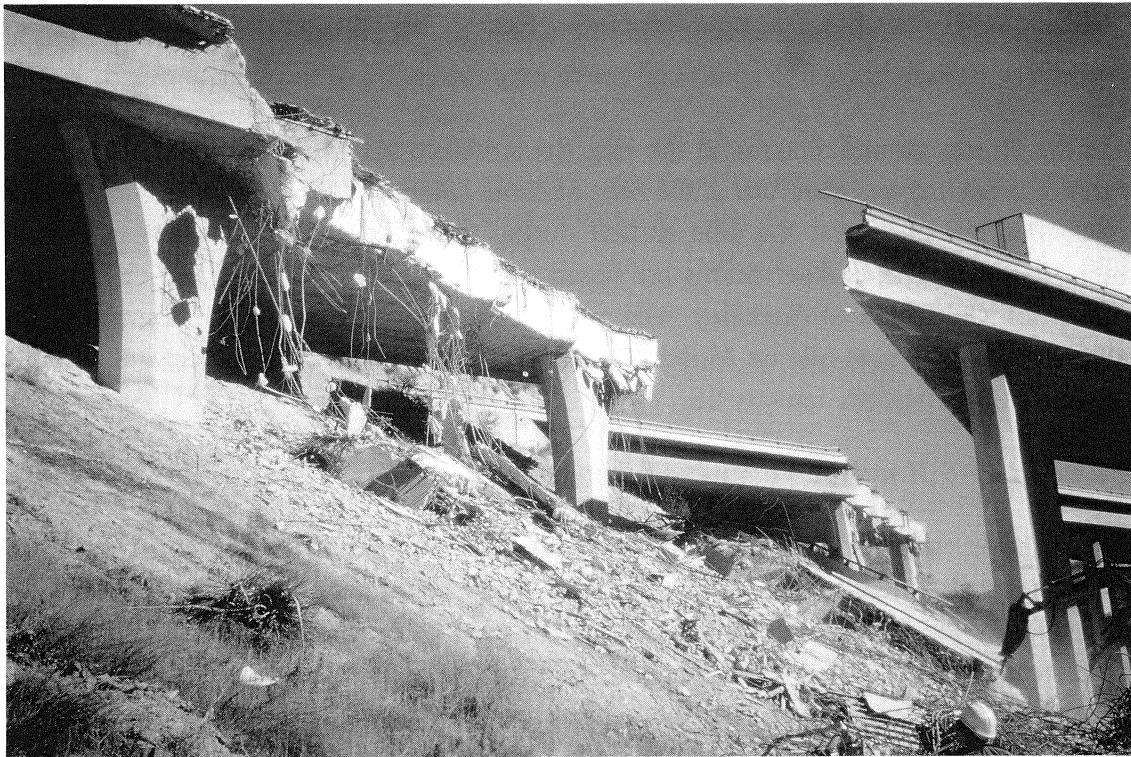
**FIGURE 3-2 Gavin Canyon Undercrossing -
Collapsed End Spans After Demolition**

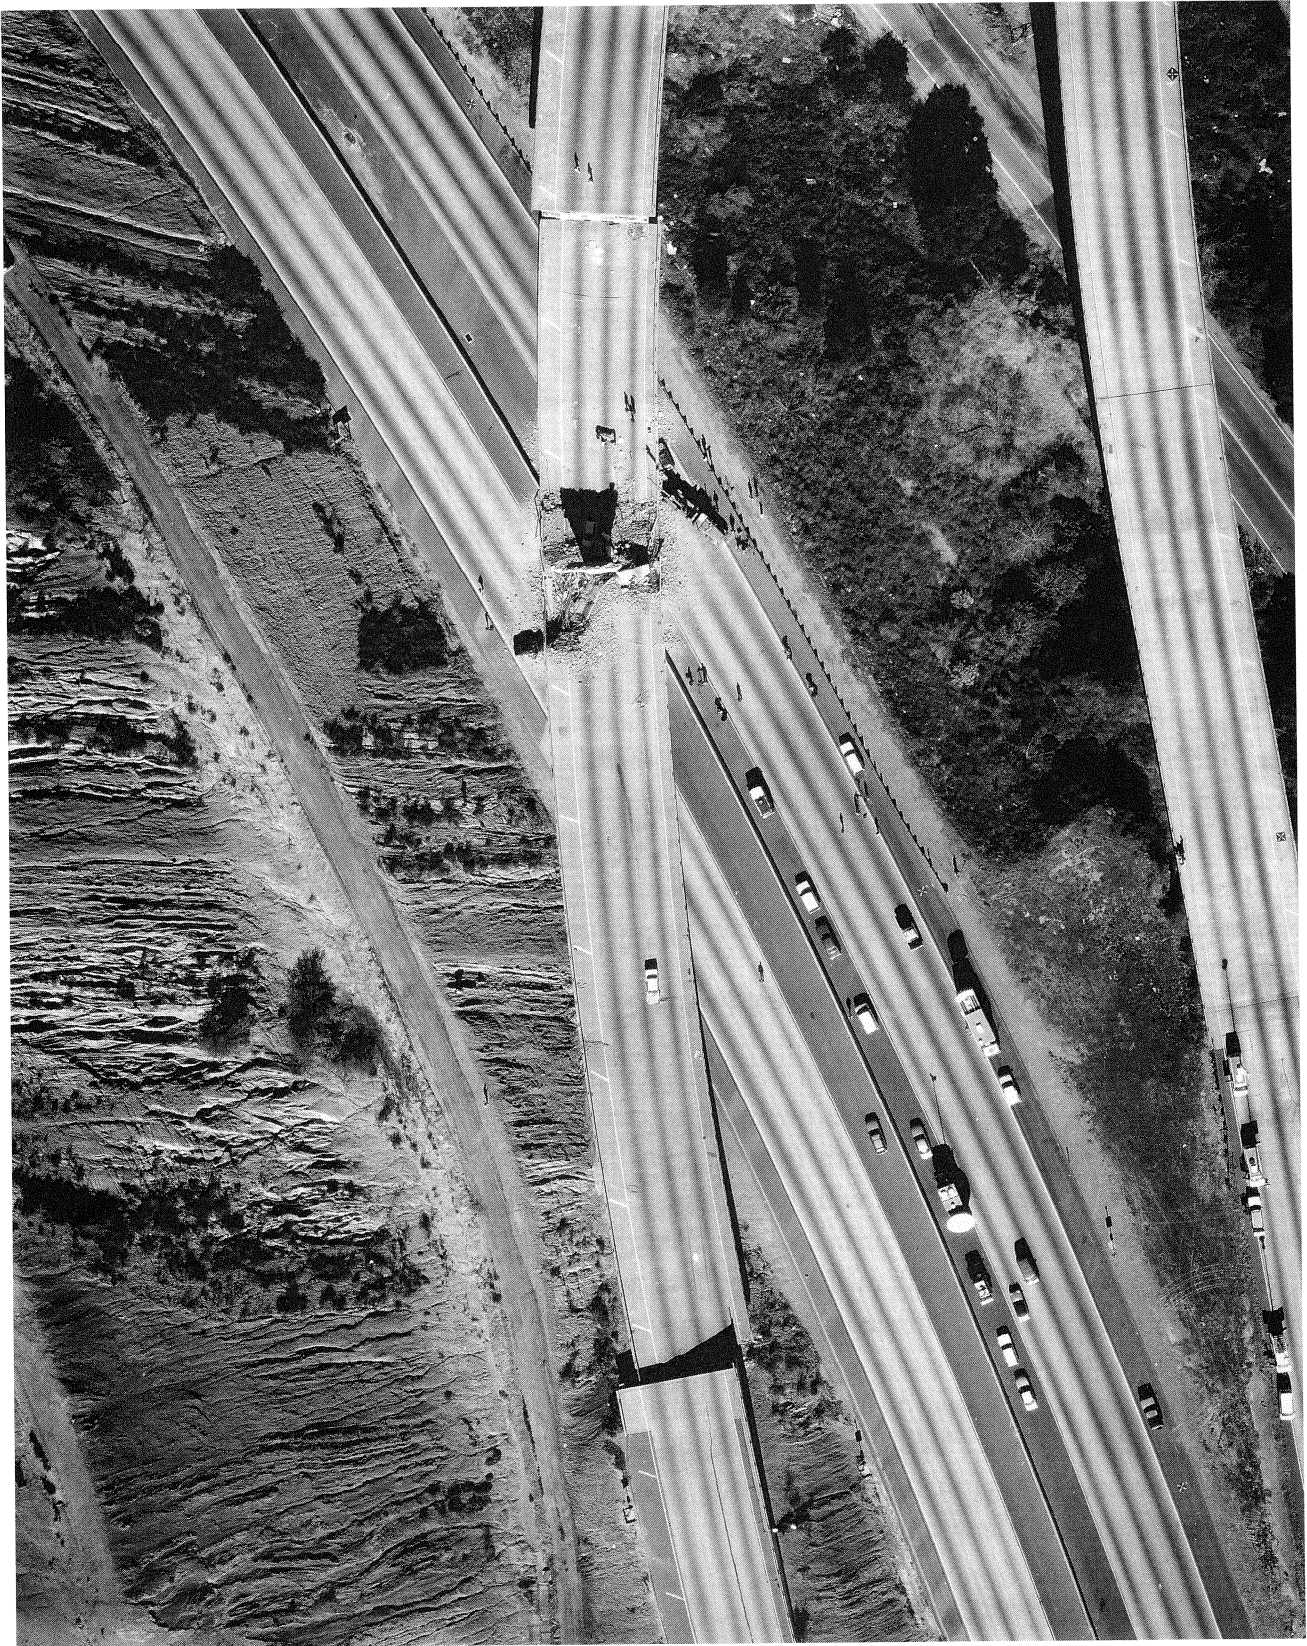
**FIGURE 3-5 SR14/I-5 Separation and Overhead (Southbound) -
Aerial View of Collapse**

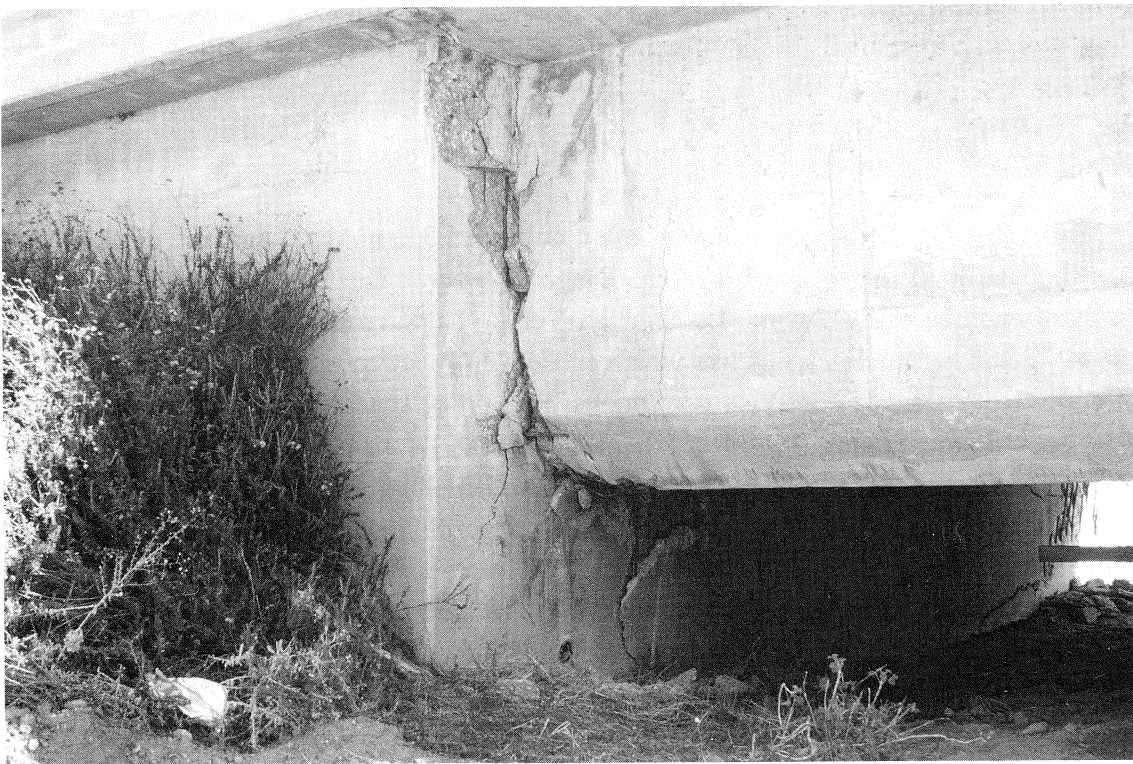
**FIGURE 3-7 SR14/I-5 South Connector -
Damage to Abutment 10**

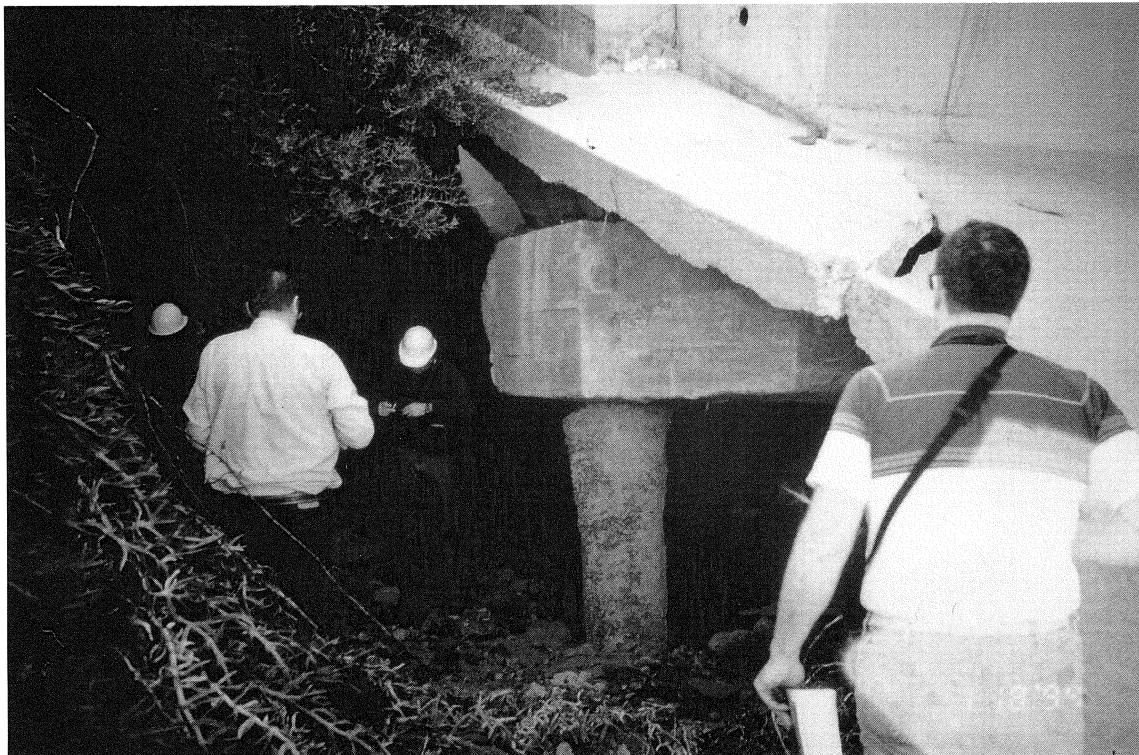
**FIGURE 3-11 Balboa Boulevard Overcrossing -
Soil Erosion at South Abutment Due to Ruptured Water Lines**

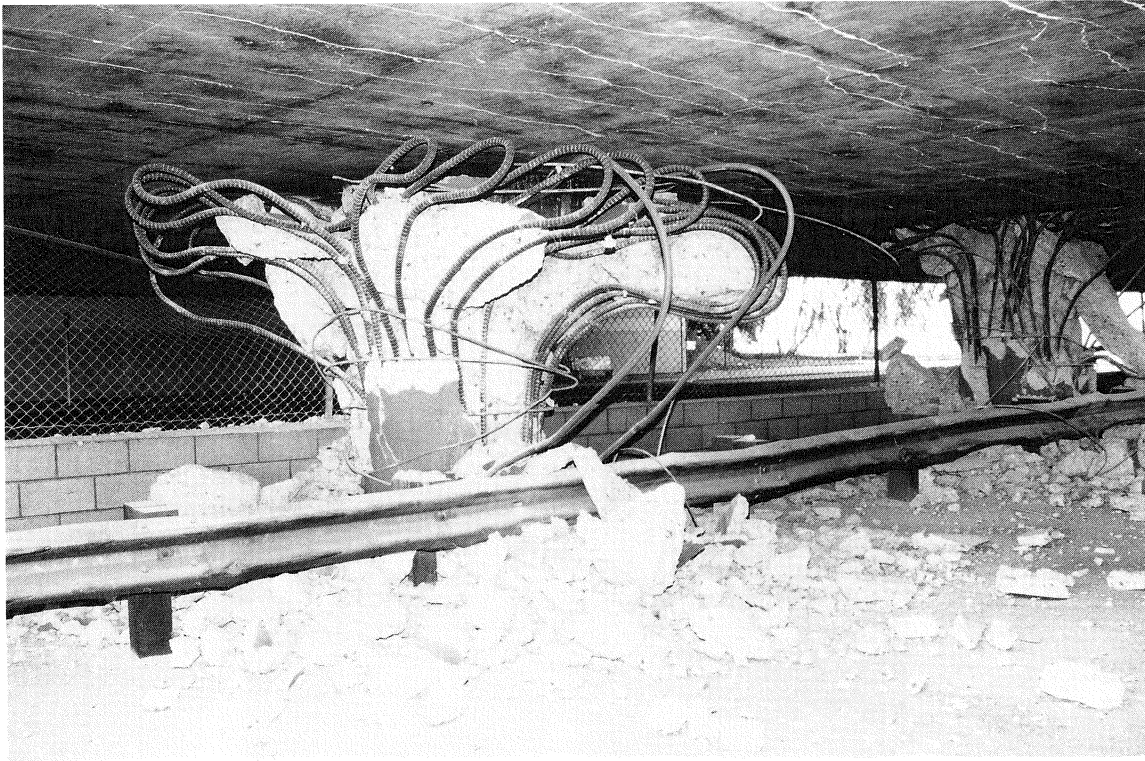
**FIGURE 3-12 Fairfax-Washington Undercrossing -
Total Column Failure in Bent 3**

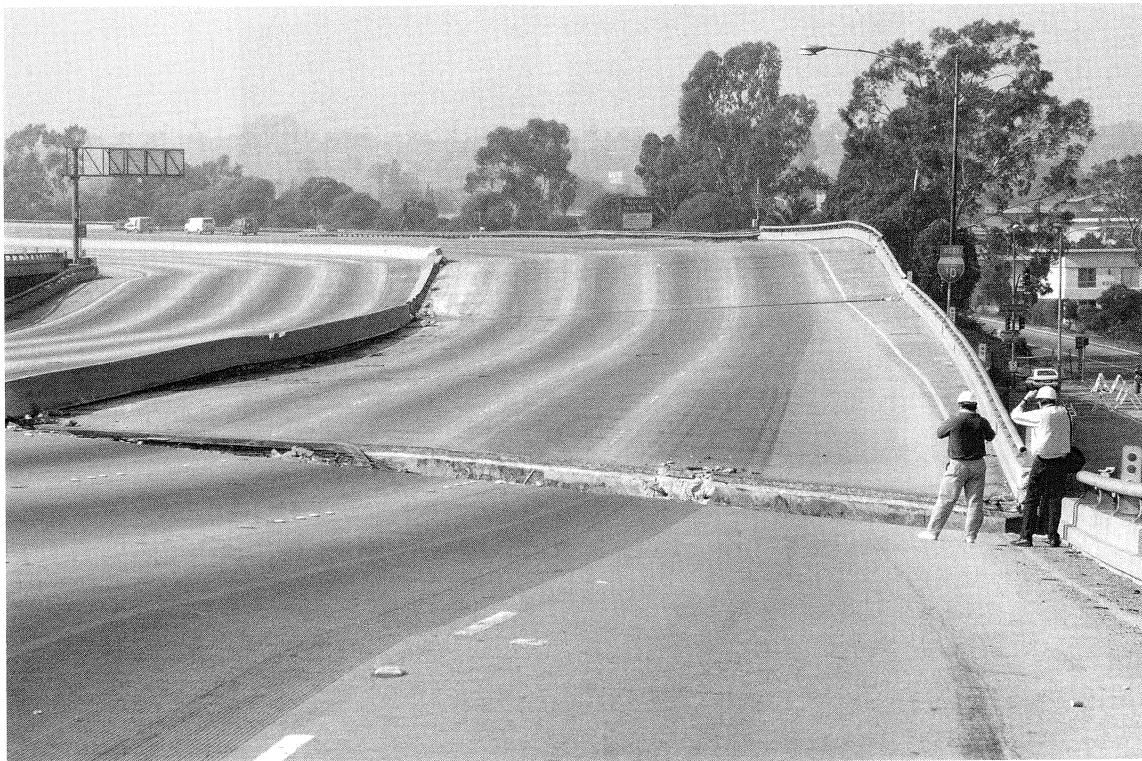
**FIGURE 3-13 La Cienega-Venice Undercrossing -
Superstructure Settlement Due to Column Failures**

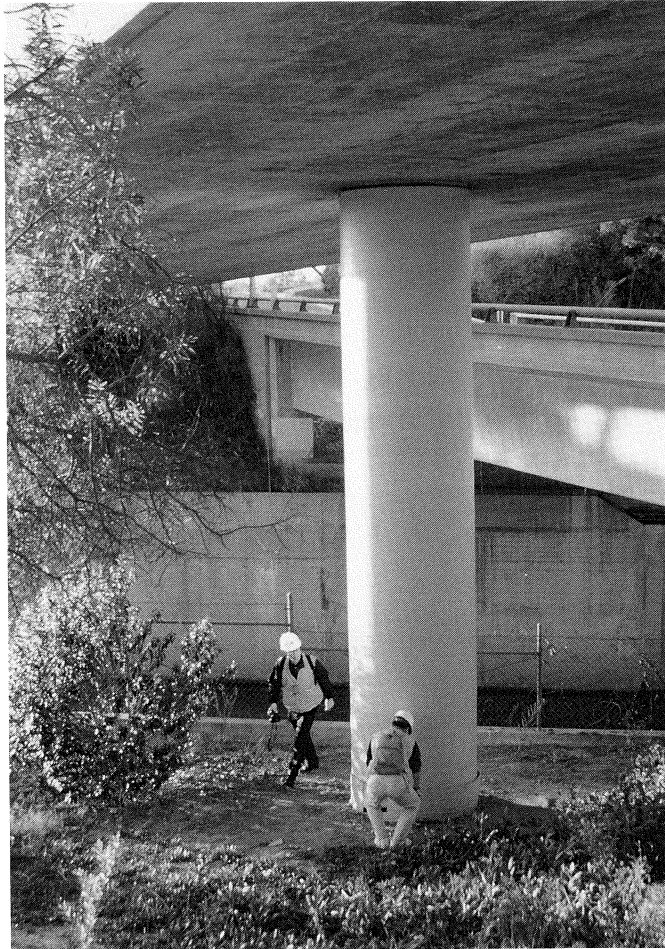
**FIGURE 3-14 Ballona Creek Undercrossing on I-10 -
Single Column Bent Retrofitted with Steel Jacket**

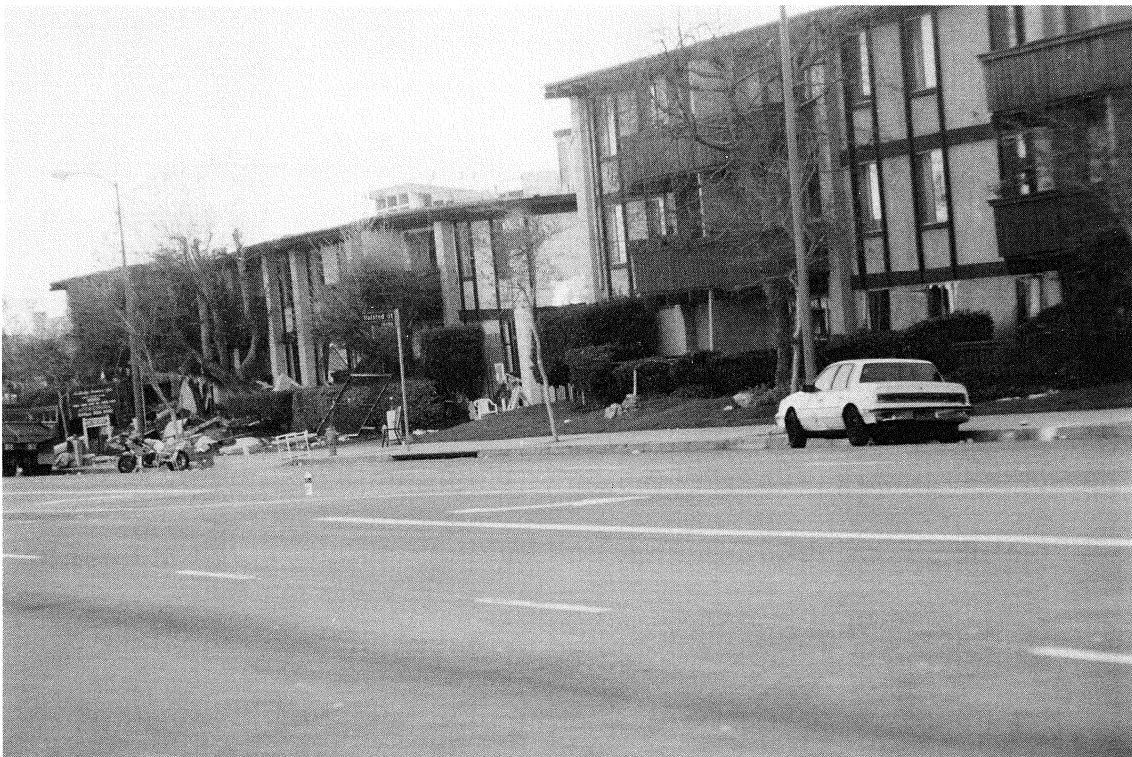
FIGURE 3-21 Apartment House Collapsed (Left) on Reseda Boulevard in Northridge

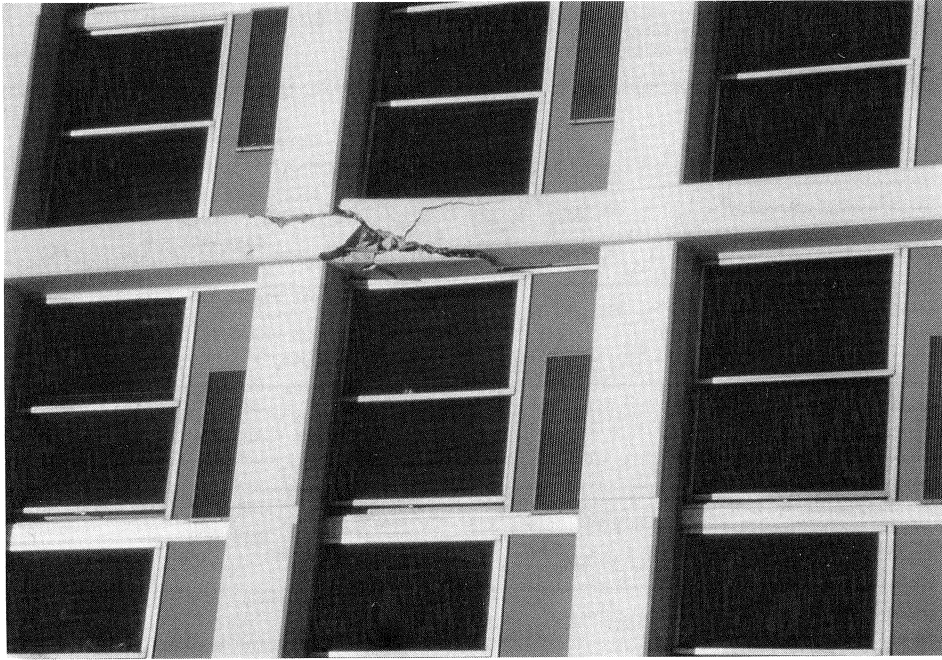
**FIGURE 3-25 Damaged Columns in Seven-Story Hotel
in Van Nuys**

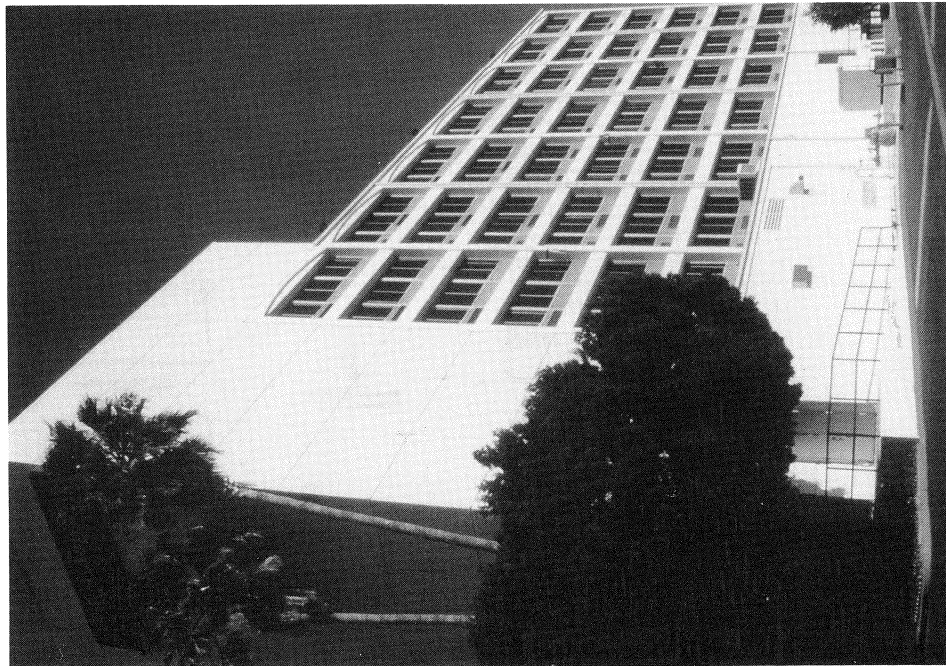
**FIGURE 3-24 Damaged Seven-Story Hotel in
Van Nuys**

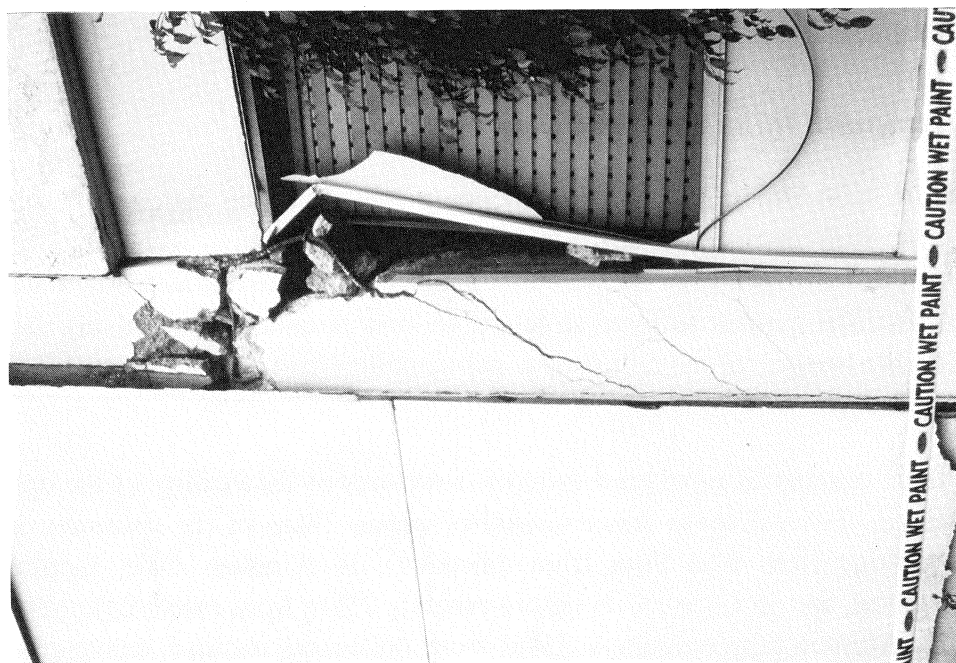
FIGURE 3-27 Column Shear Failure at First Floor of Hotel Building in Sherman Oaks

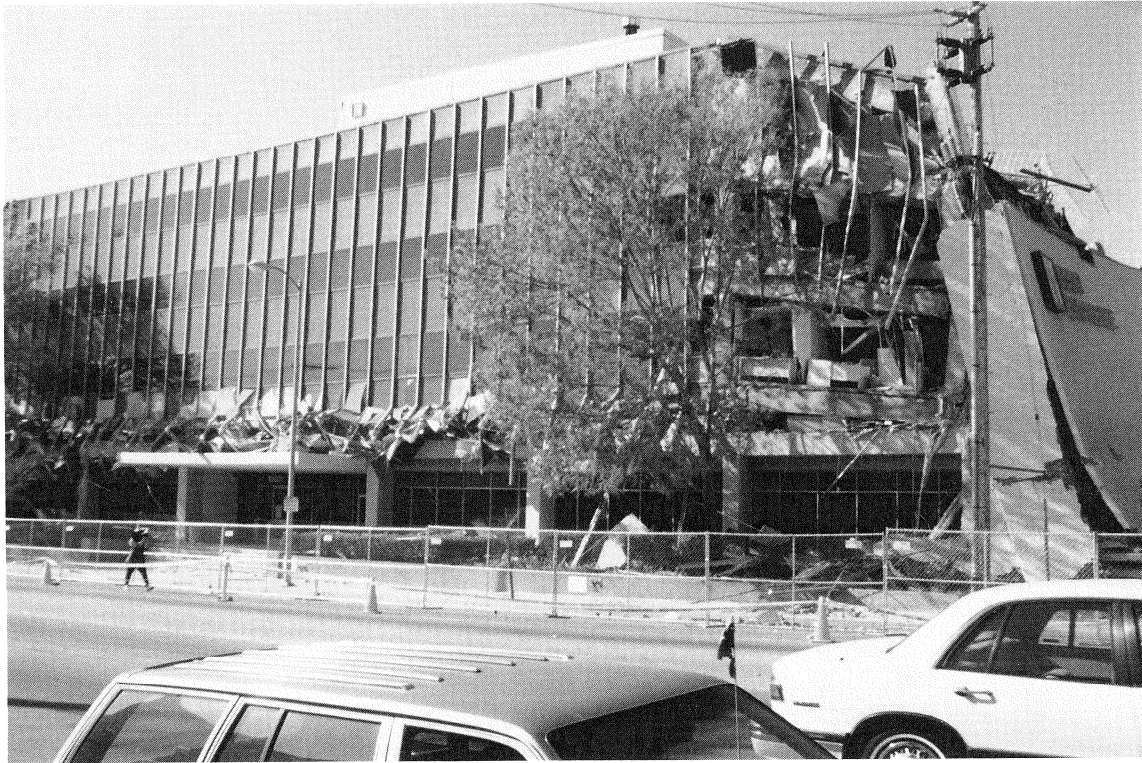
FIGURE 3-28 Collapse of Five-Story Reinforced Concrete Office Building on Balboa Boulevard, Northridge

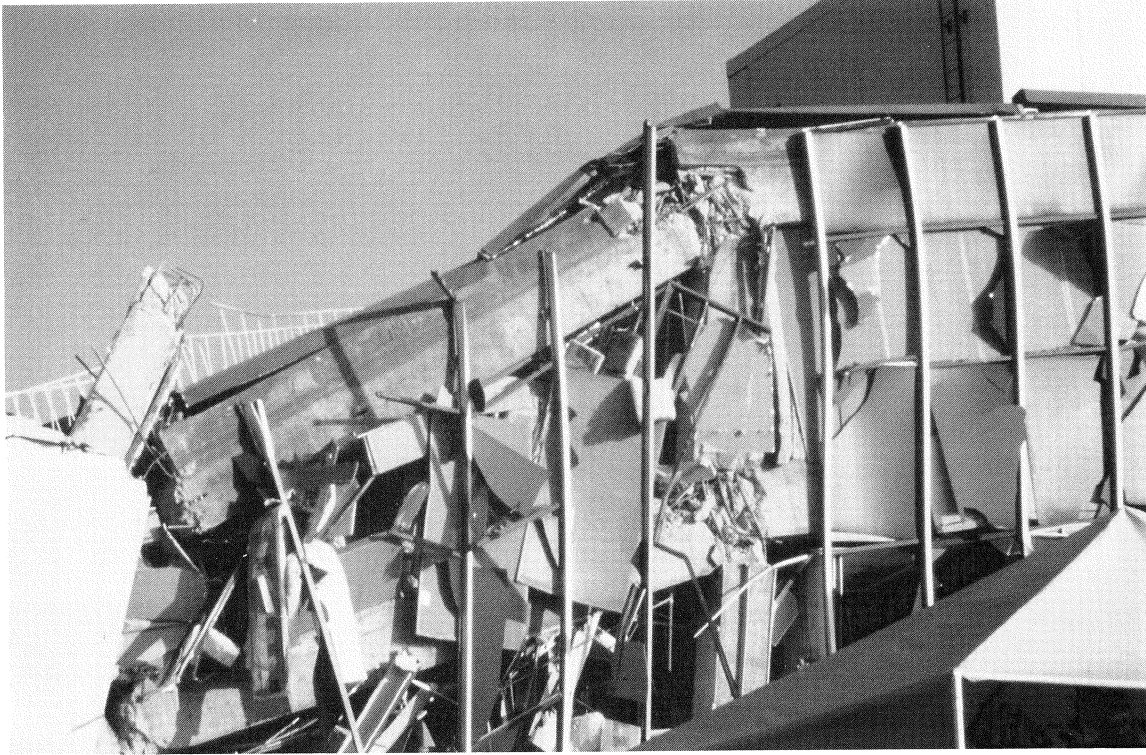
FIGURE 3-30 Beam Joint Failure in Office Building in Northridge

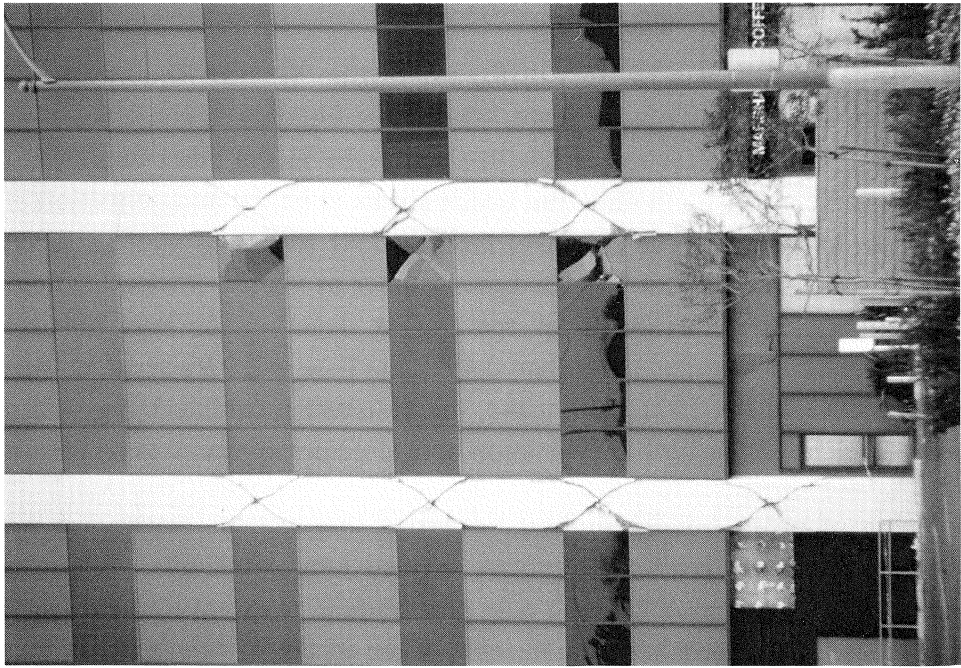
FIGURE 3-33 Typical Shear Cracking Failure from Load Reversals of Short Columns

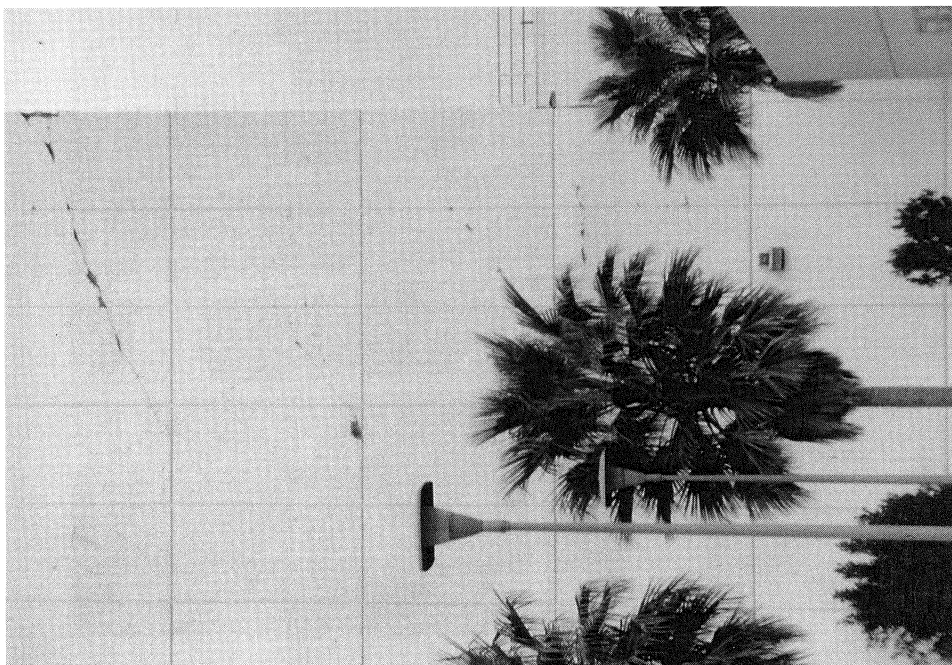
FIGURE 3-35 Damaged Shear Wall in Sherman Oaks

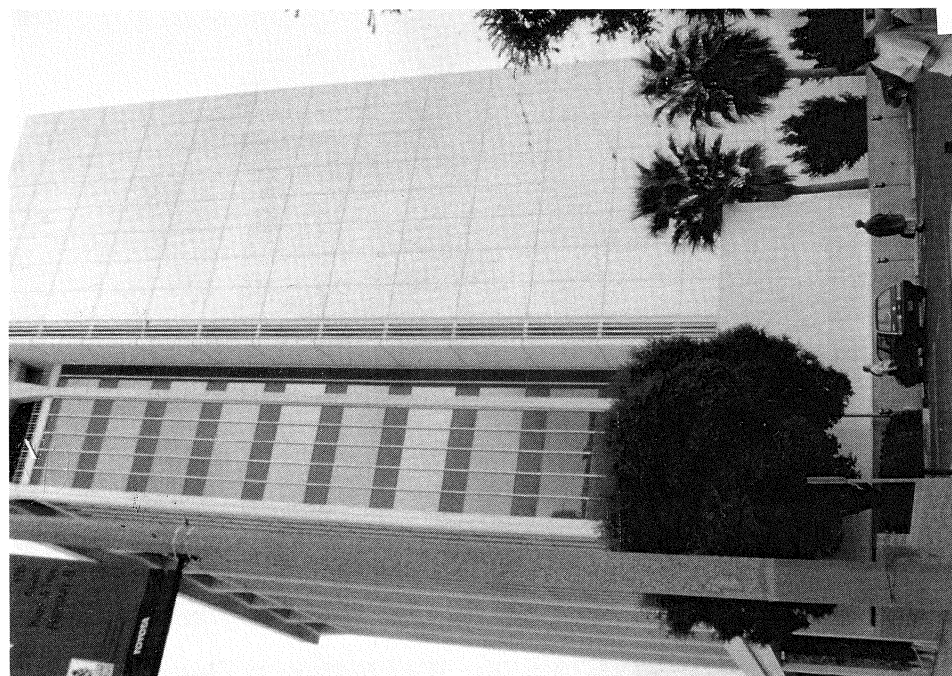
**FIGURE 3-34 Office Building with Damaged Shear Walls
in Sherman Oaks**

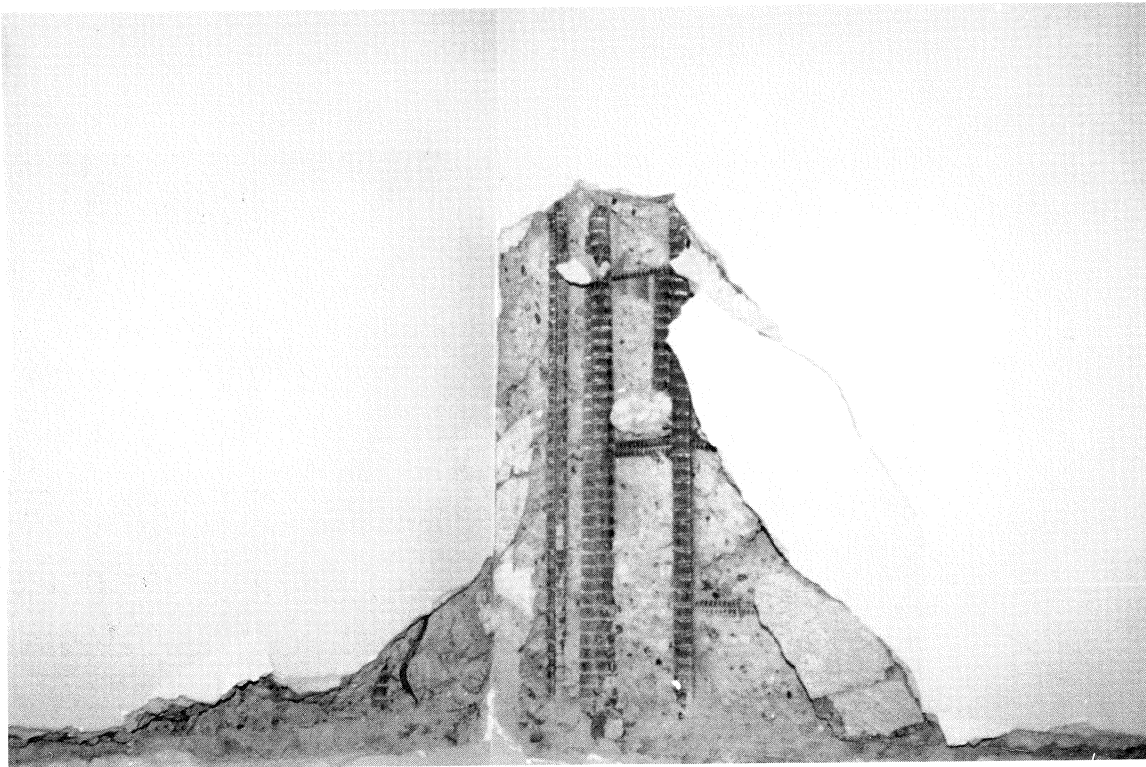
**FIGURE 3-37 Shear Wall Failure at Floor Construction
Joint in Office Building Near Epicenter**

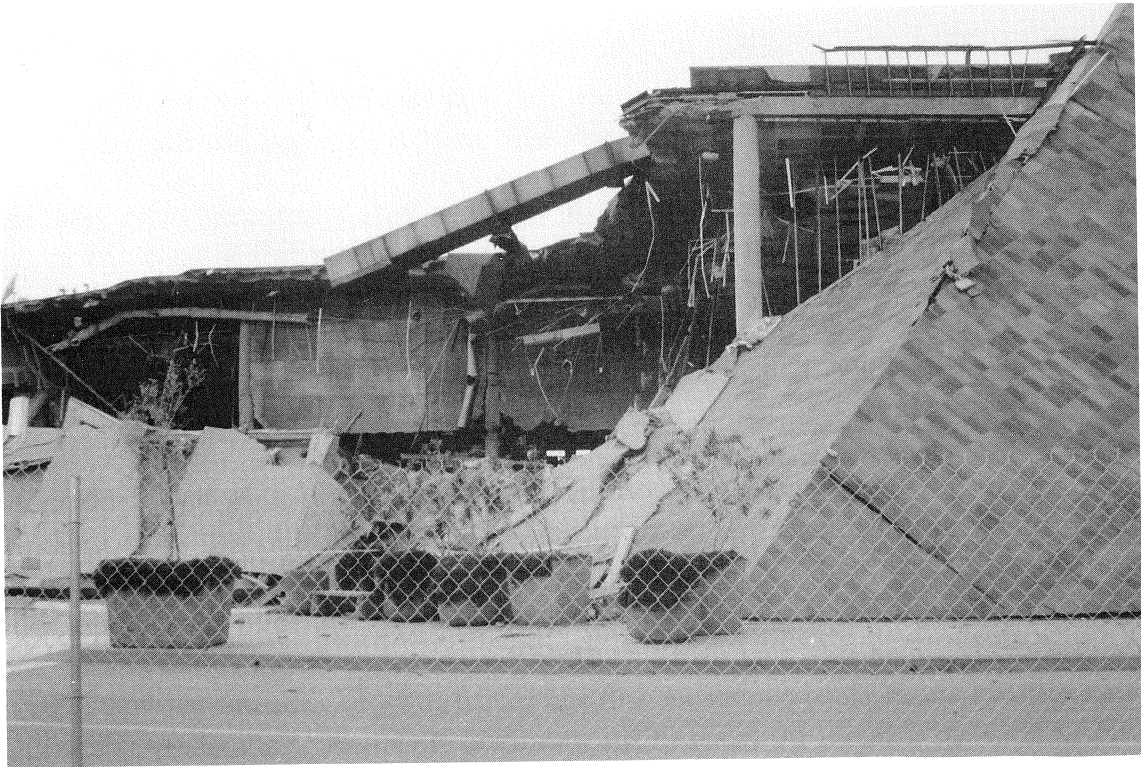
FIGURE 3-38 Collapse of Floors and Roof at Northridge Fashion Center

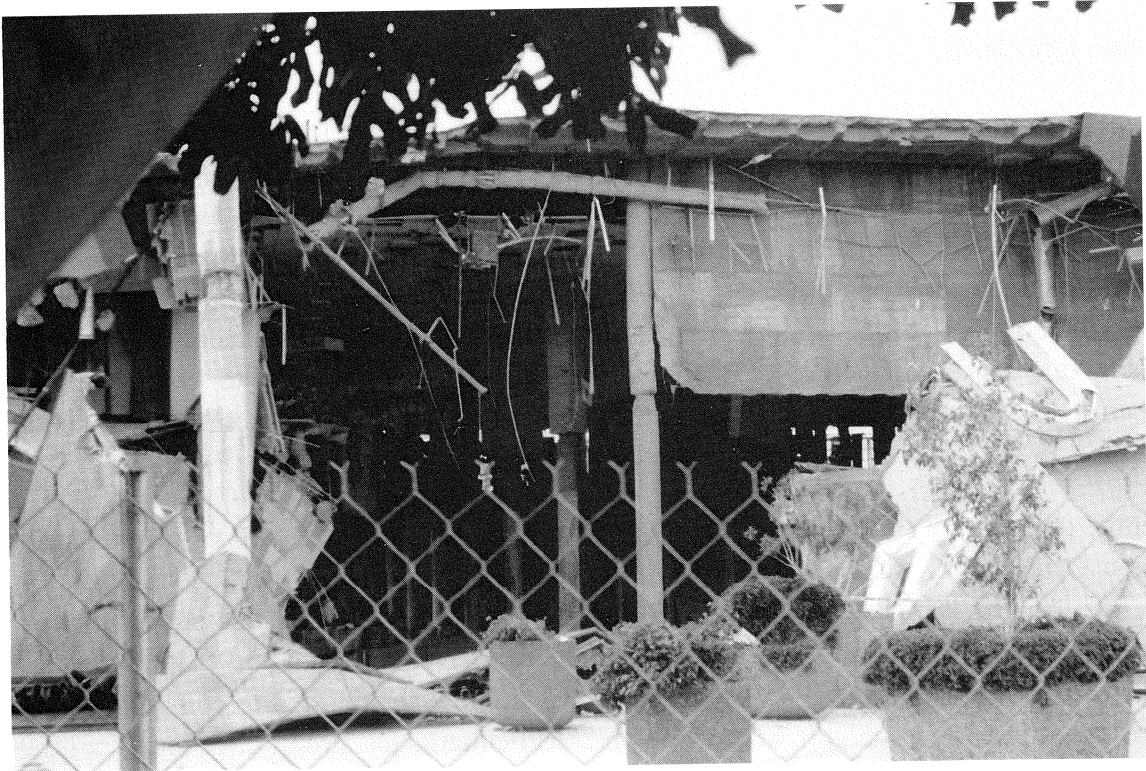
**FIGURE 3-39 Remnants of Infills After Floor
Punching at Northridge Fashion Center**

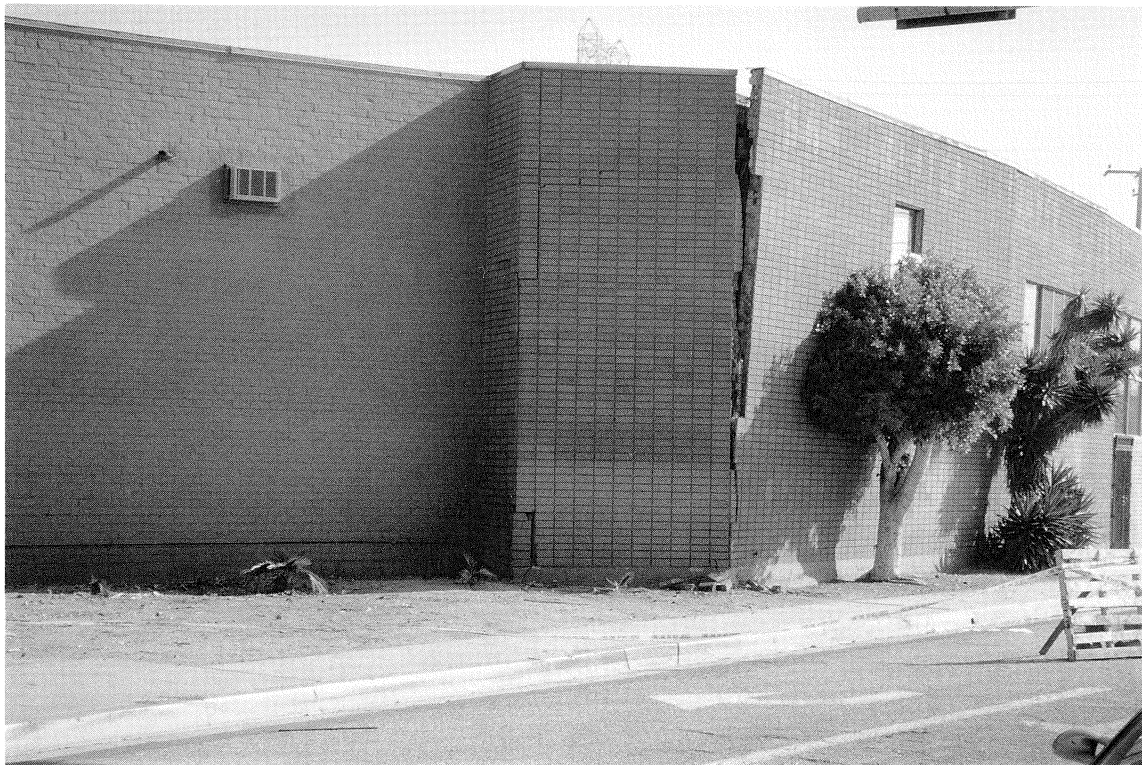
FIGURE 3-43 Failure of Reinforced Masonry Wall Without Horizontal Ties

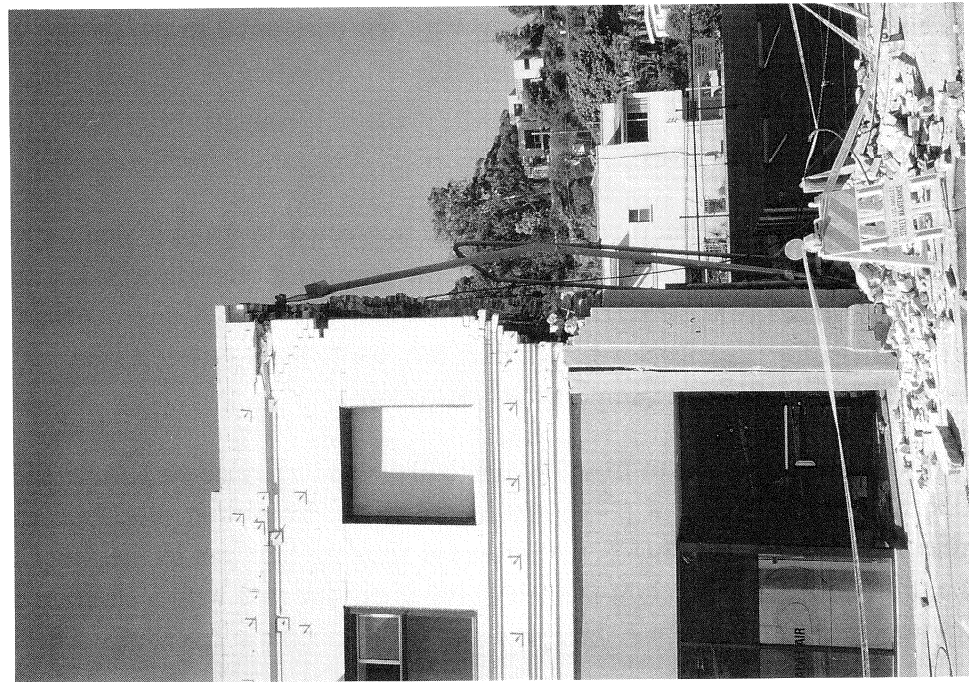
FIGURE 3-44 Damage of Retrofitted Masonry Structures

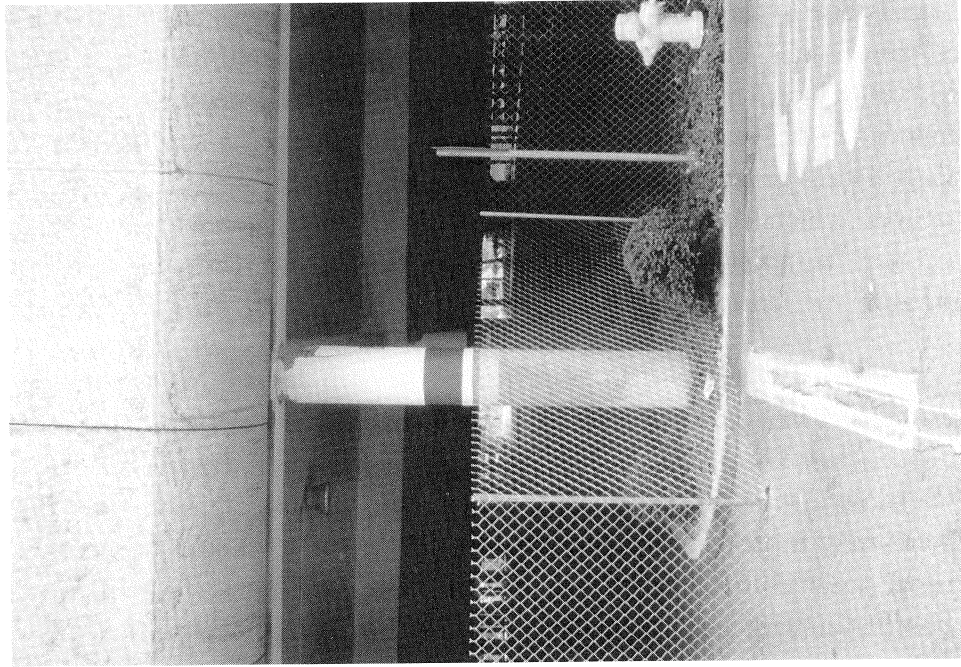
FIGURE 3-45 Column Sidesway Mechanism in Parking Garage at Northridge Fashion Center
