The Northridge, California Earthquake of January 17, 1994: General Reconnaissance Report

Edited by J. Goltz

Technical Report NCEER-94-0005

March 11, 1994

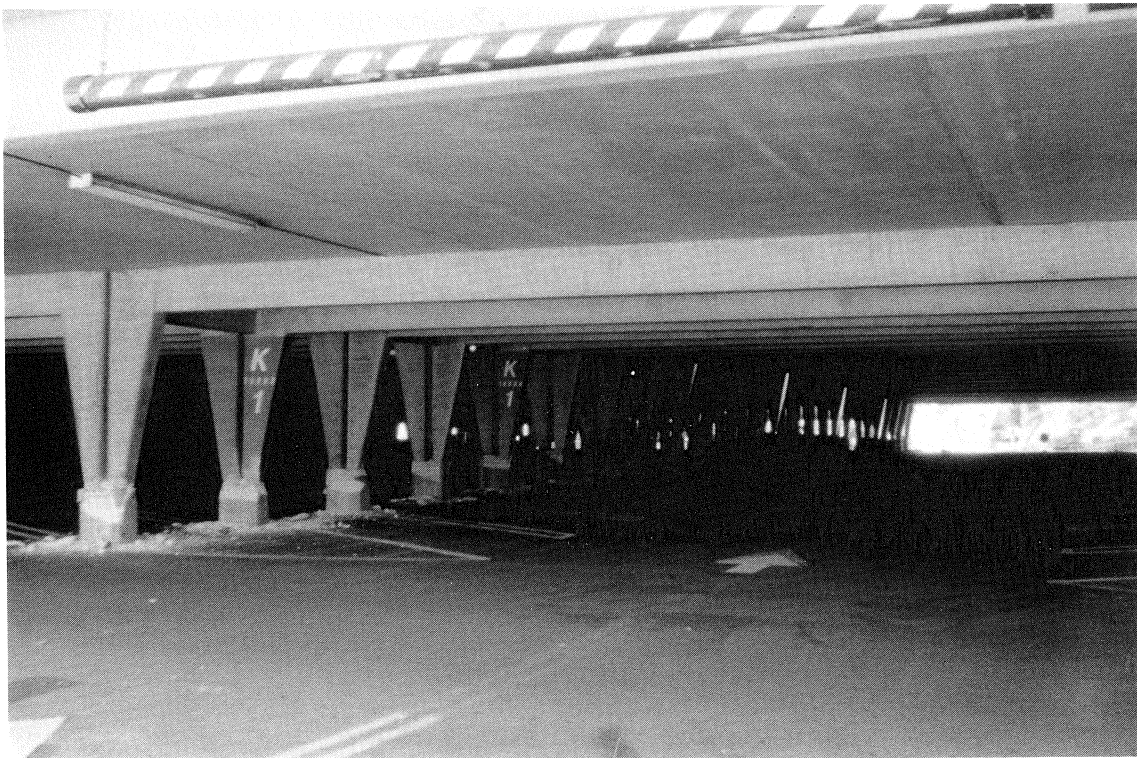
FIGURE 3-51 Shifted Columns Above Pedestal in the Short Spans Direction

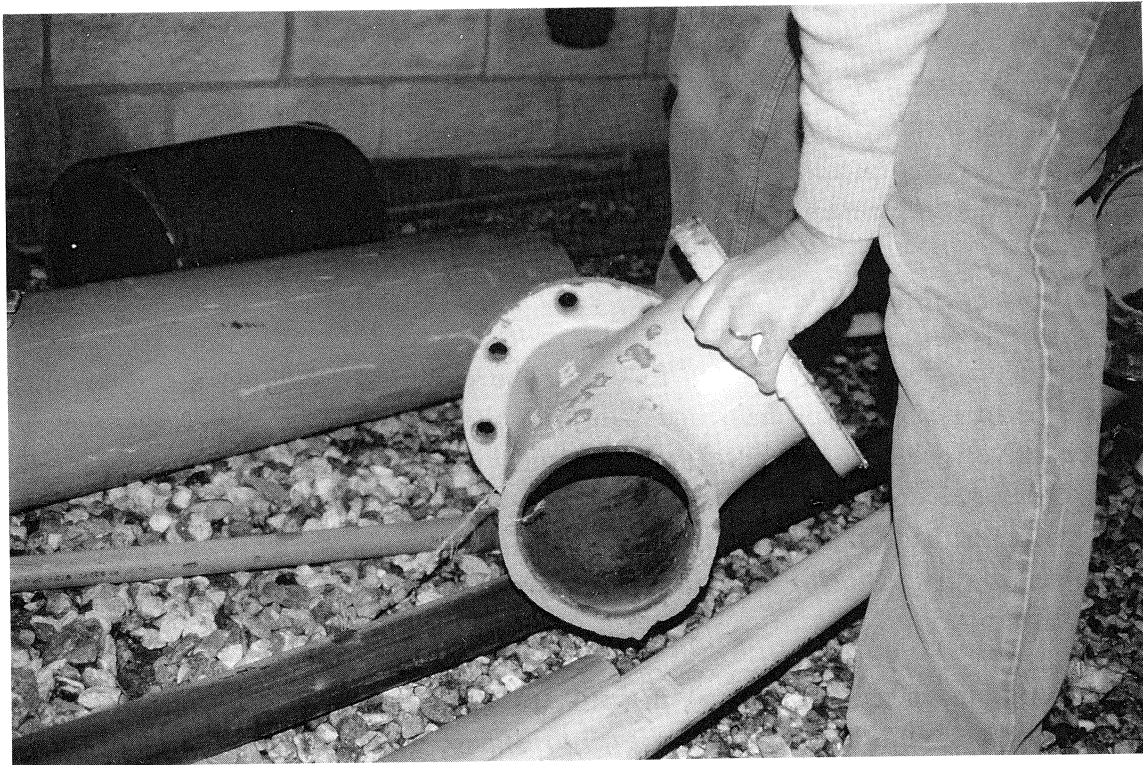
FIGURE 3-54 Process Tank Anchorage Failures Led to Excessive Piping Loads, Resulting in Failures in Flanged Piping

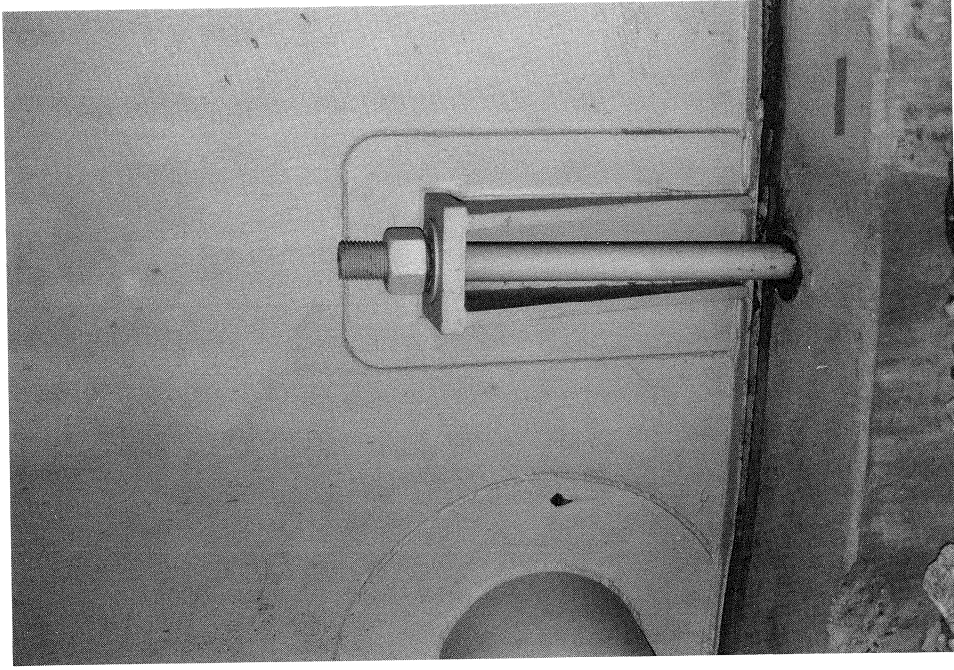
FIGURE 3-57 Most Recent Vintage Anchored Storage Tanks Were Not Damaged by the Earthquake - This Tank Was an Exception, Pulling Anchor Bolts About 1/4 Inch

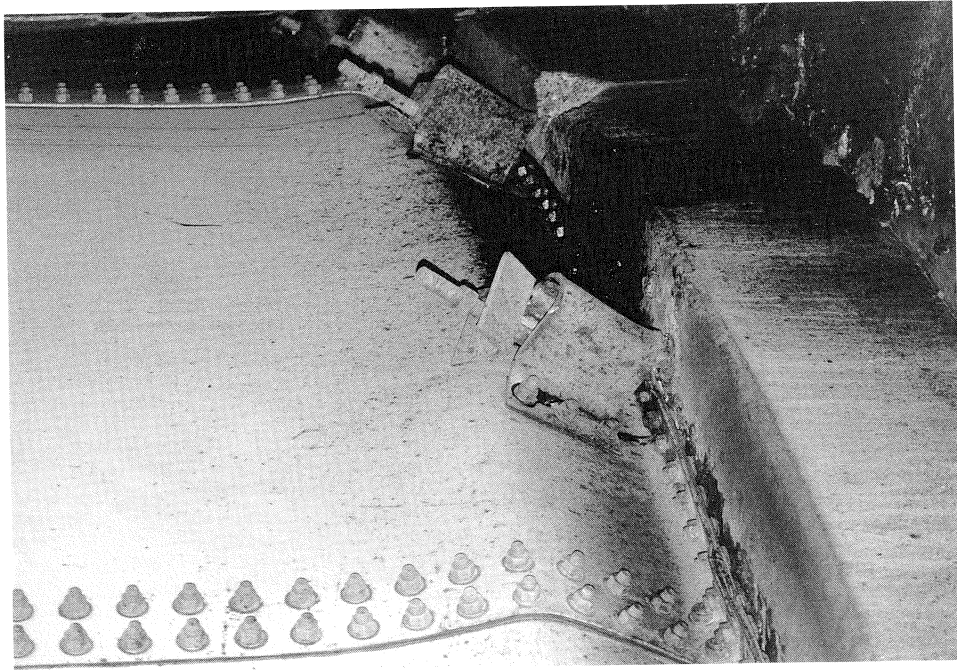
FIGURE 3-56 Older Storage Tanks Sustained Pulling of Anchor Bolts, Elephant's Foot Buckling and Leaks at Bolted Seams

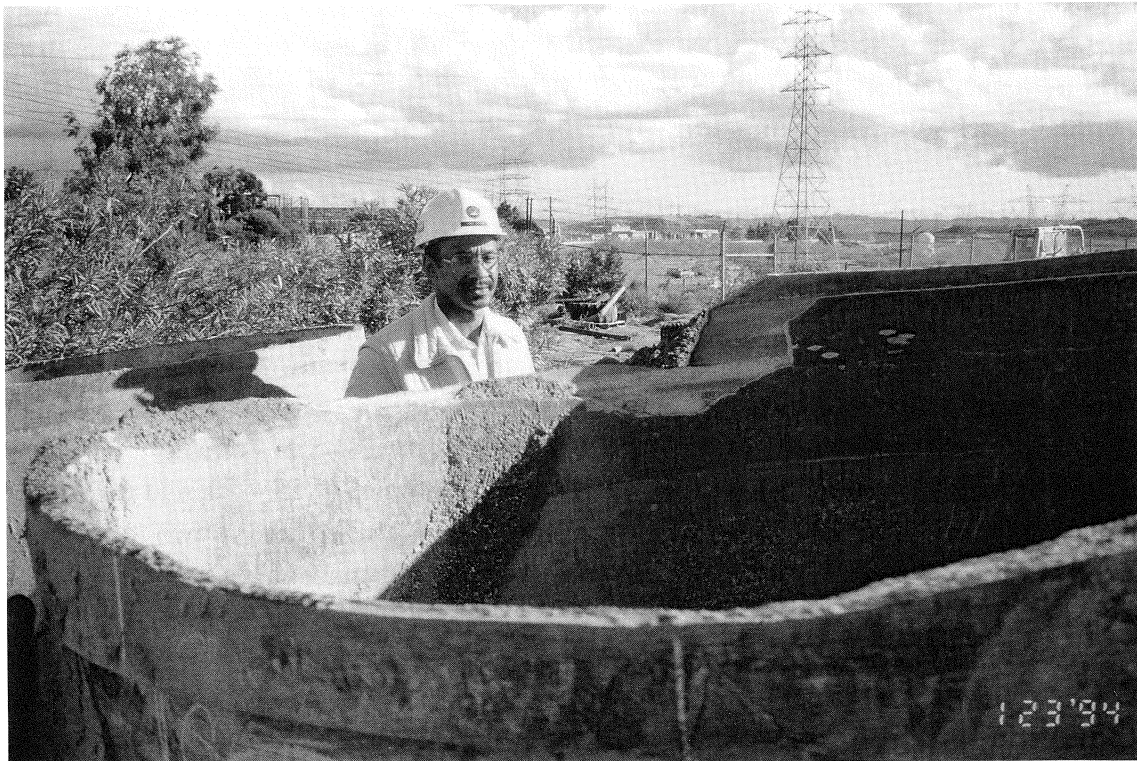
FIGURE 4-3 Damaged Section (Tensile Failure) of 84-inch Diameter Inlet Line at the 550-mgd Water Treatment Plant - Failure Due to Liquefaction and Lateral Spreading of Local Soils

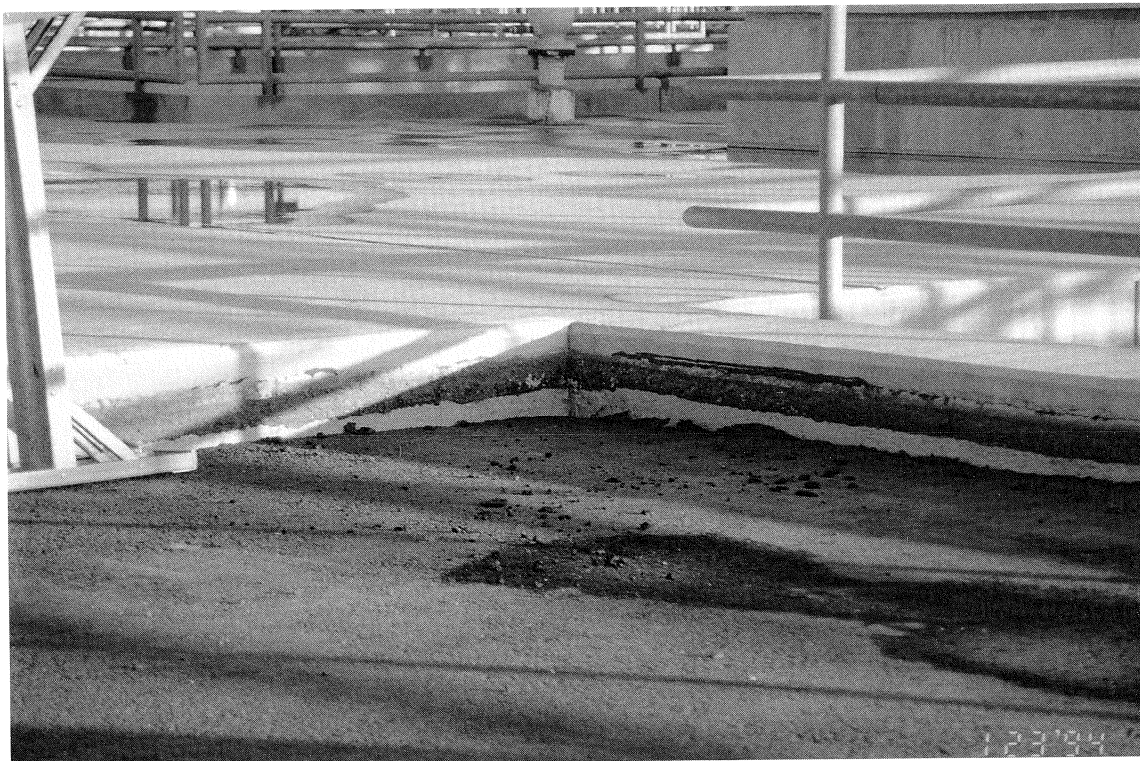
FIGURE 4-4 Typical Six to Eight Inch Settlement of Soils Adjacent to Concrete Basins at the 600-mgd Water Treatment Plant - Settlement Severed Several Buried Electrical Conduits and Chlorine Solution Lines

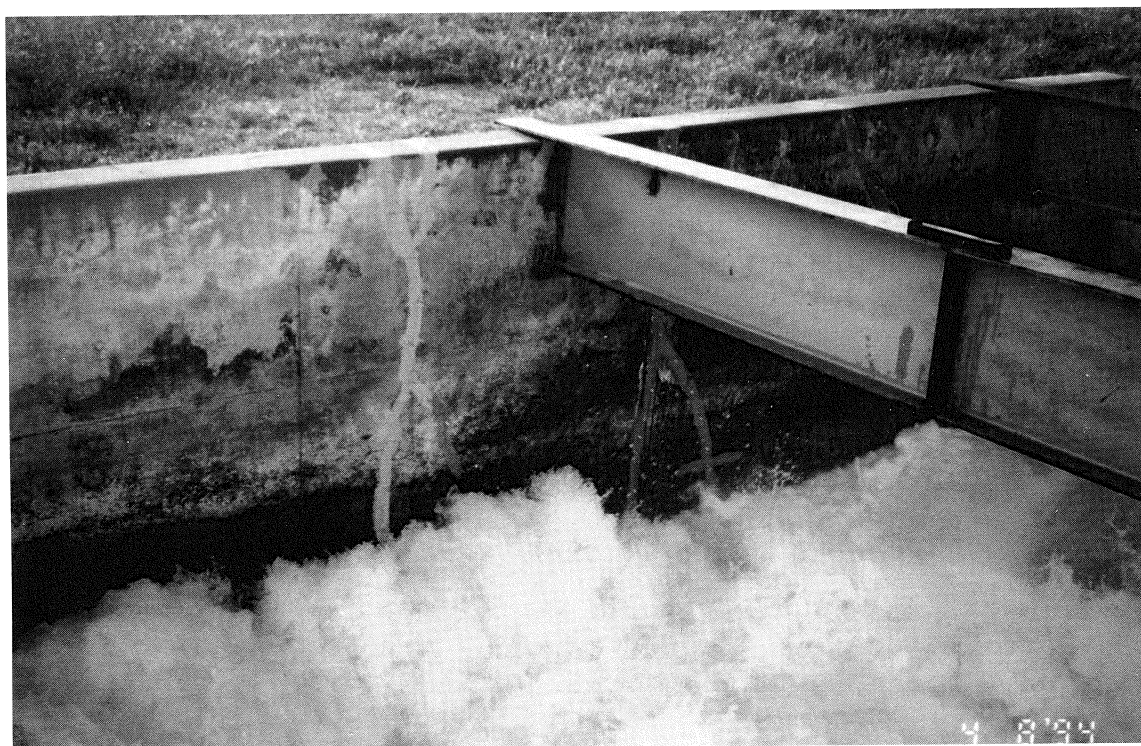
FIGURE 4-5 Typical Repaired Cracks (by Epoxy Injection and Concrete Patch) in the Los Angeles Aqueduct - Cracks were Primarily Caused by Settlement of Supporting Soils

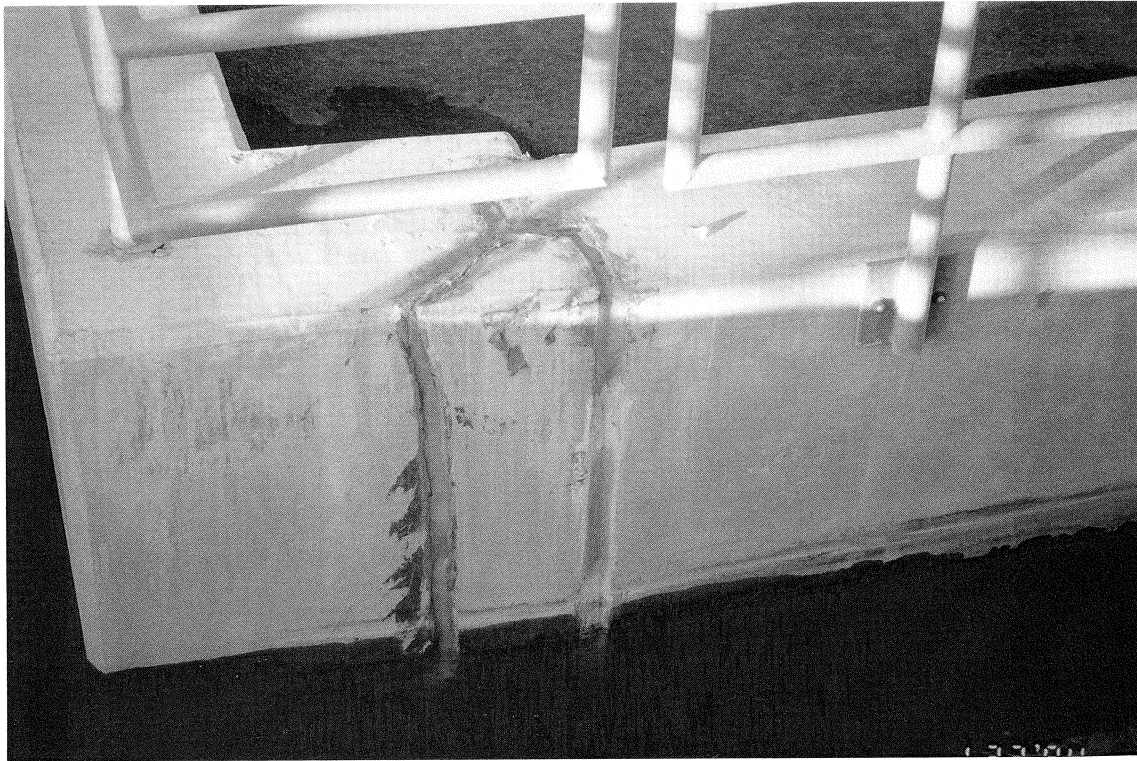
FIGURE 4-6 Typical Repaired Cracks (up to One Inch Wide, by Elastic Sealant) in Concrete Basins of the 600-mgd Water Treatment Plant in the San Fernando Valley

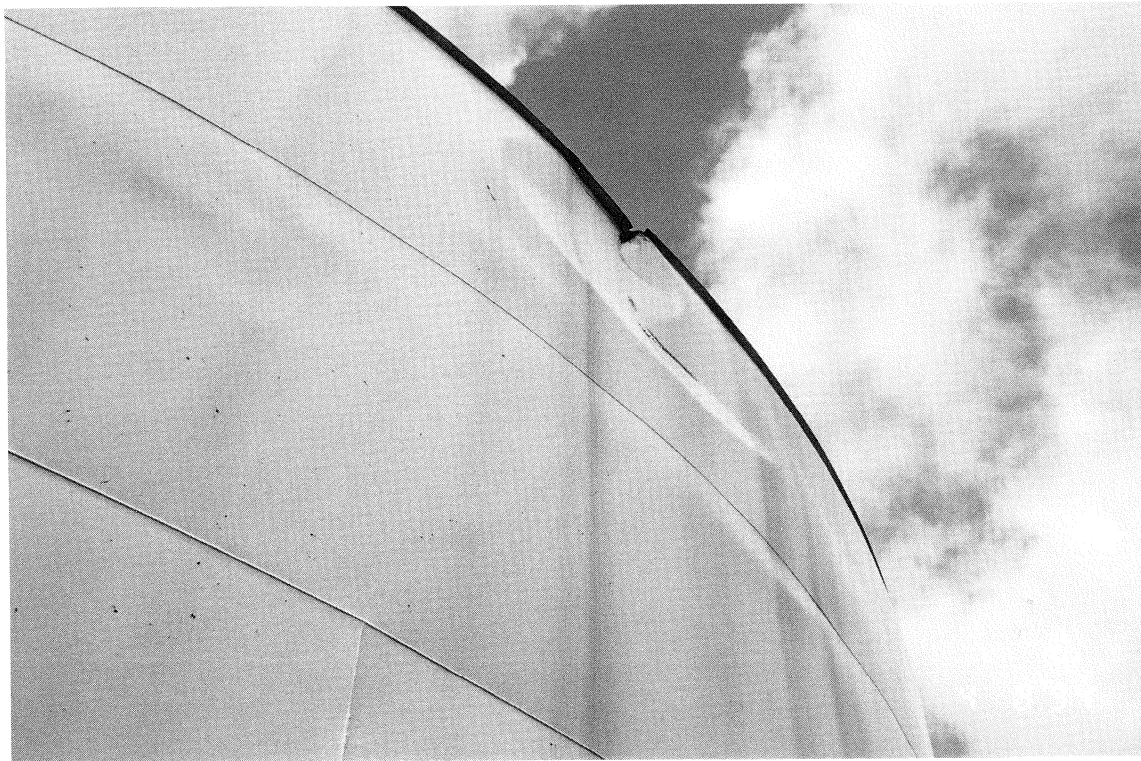
FIGURE 4-8 Sloshing and Suction Damage to Top of Welded Water Storage Tank in the Santa Clarita Valley - Internal Roof Trusses of this Tank Collapsed

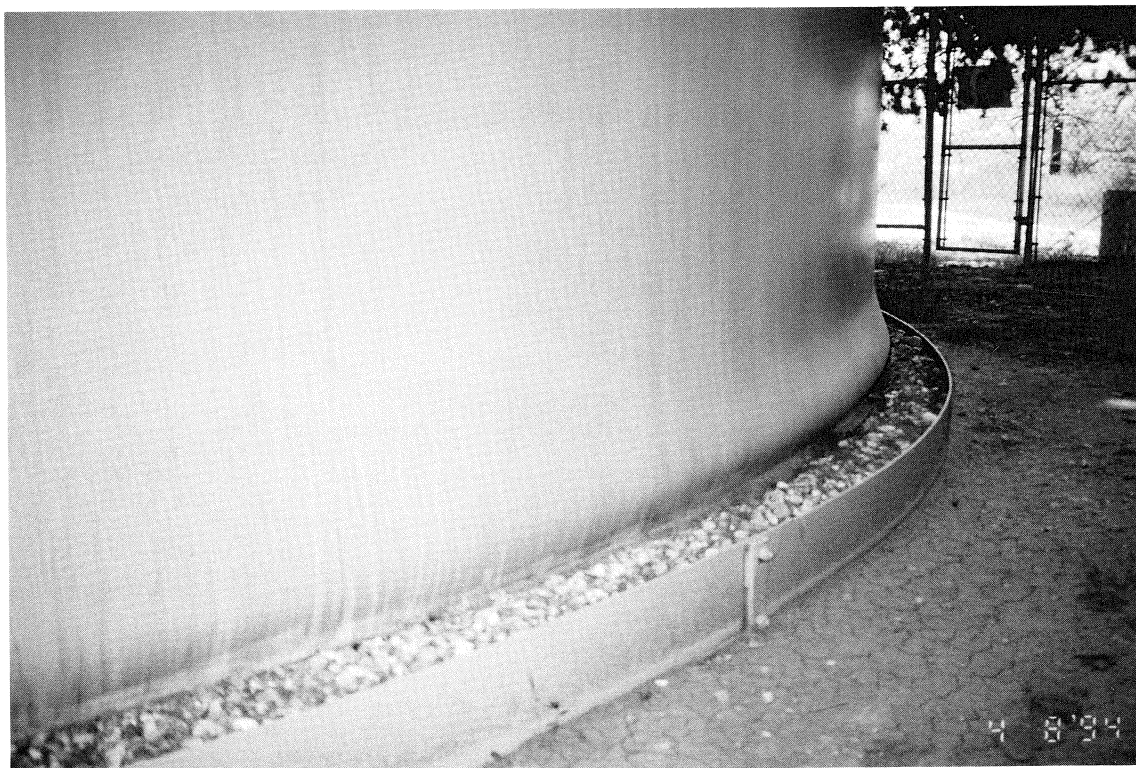
FIGURE 4-9 Elephant's Foot Buckling of Water Storage Tank in the Santa Clarita Valley

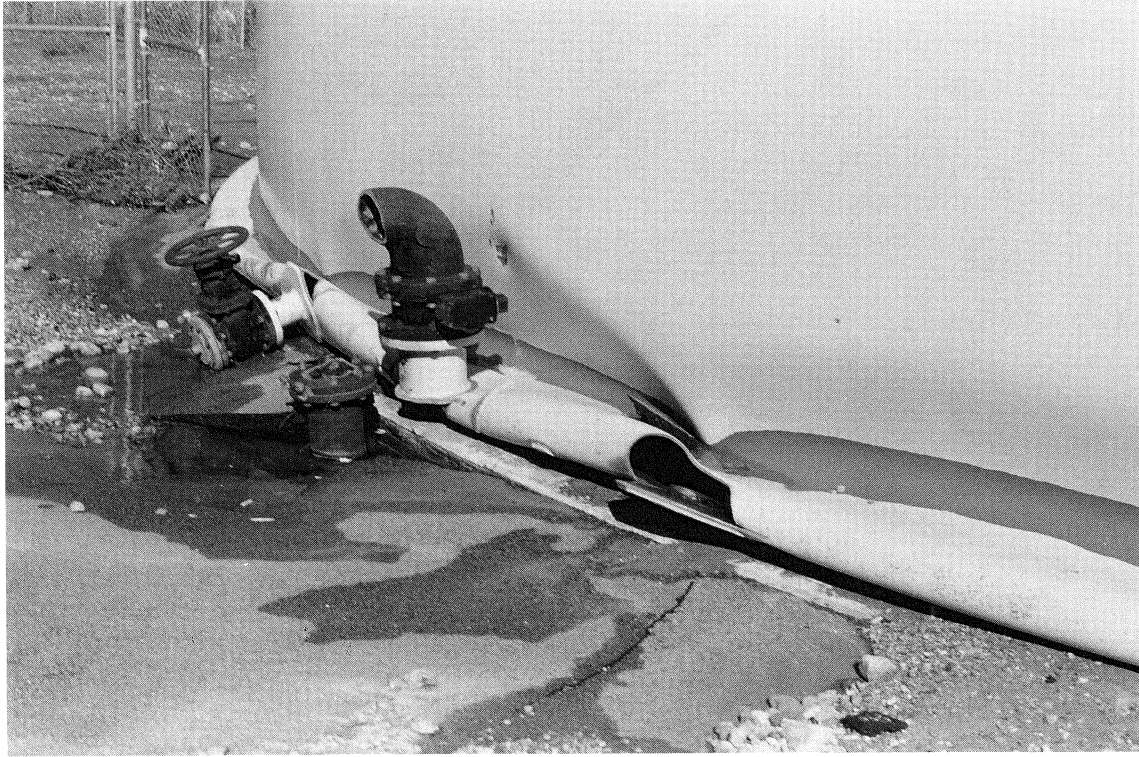
FIGURE 4-10 Damaged Welded Water Storage Tank in the Santa Clarita Valley - Rocking of Tank Caused Elephant's Foot Buckling at the Tank Base and Damaged Inlet and Outlet Lines

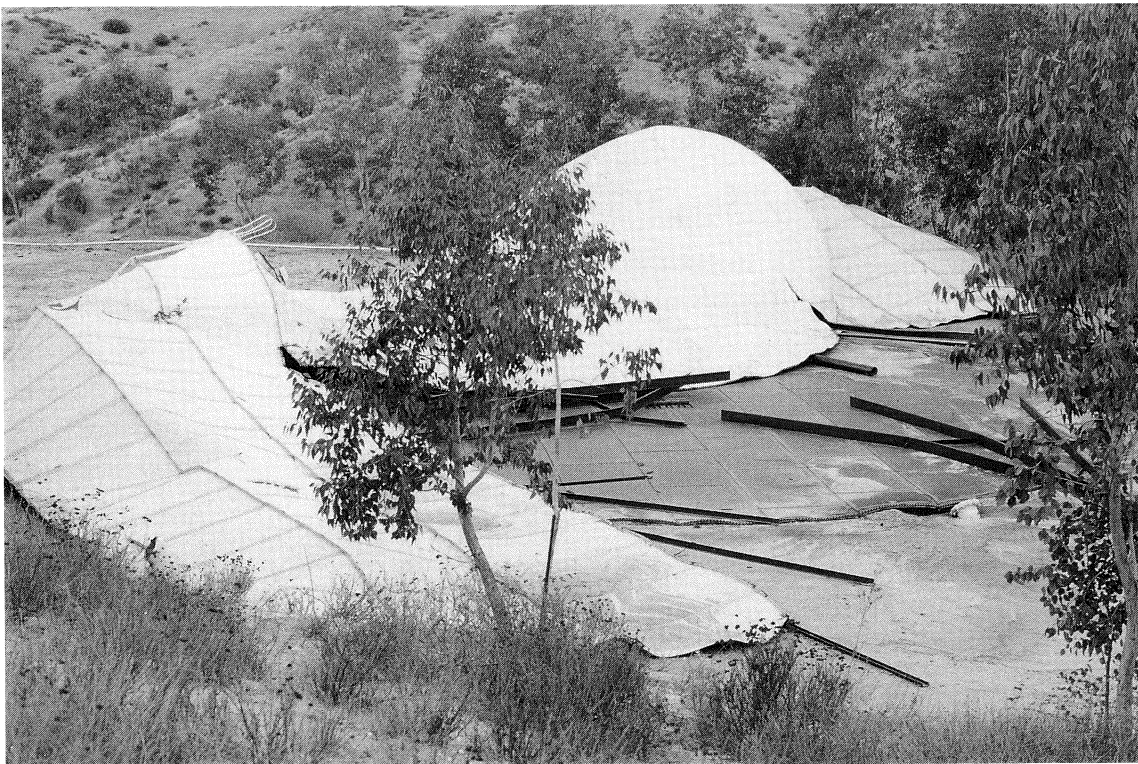
FIGURE 4-11 Collapsed Bolted Water Storage Tank in the Santa Clarita Valley

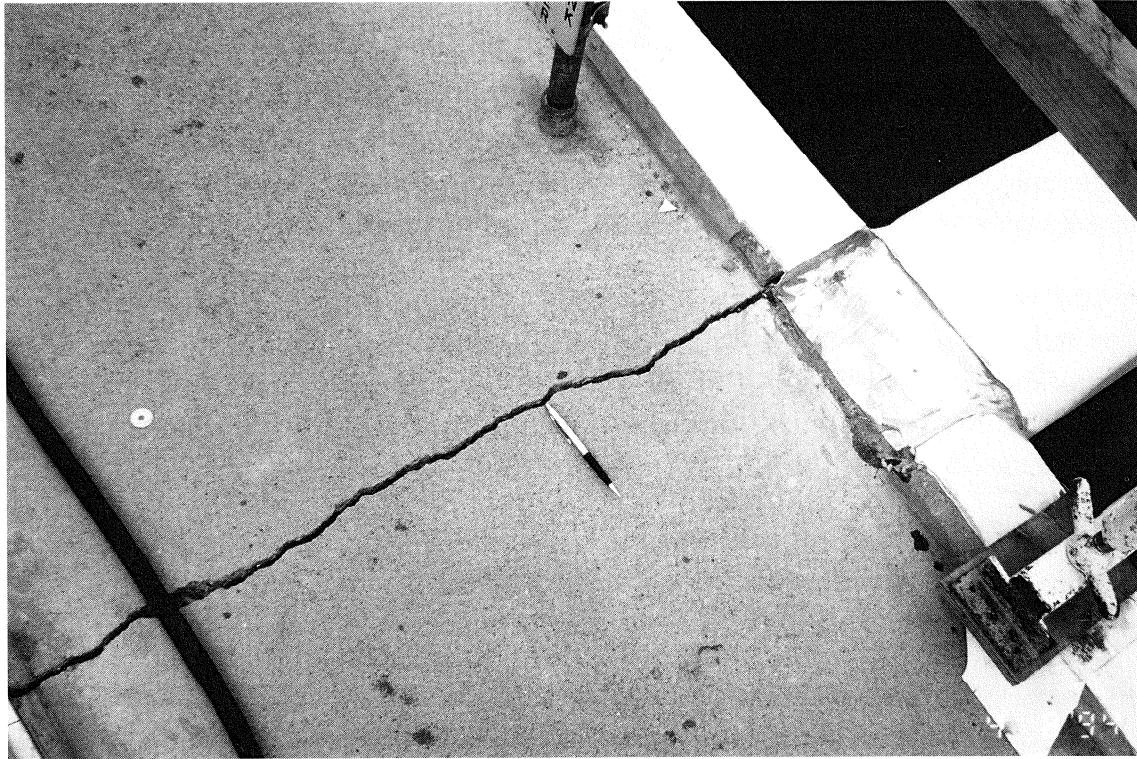
FIGURE 4-12 Typical Cracks (up to 1/2 Inch Wide) in Concrete Basins in the 15-mgd Wastewater Treatment Plant in the Santa Clarita Valley

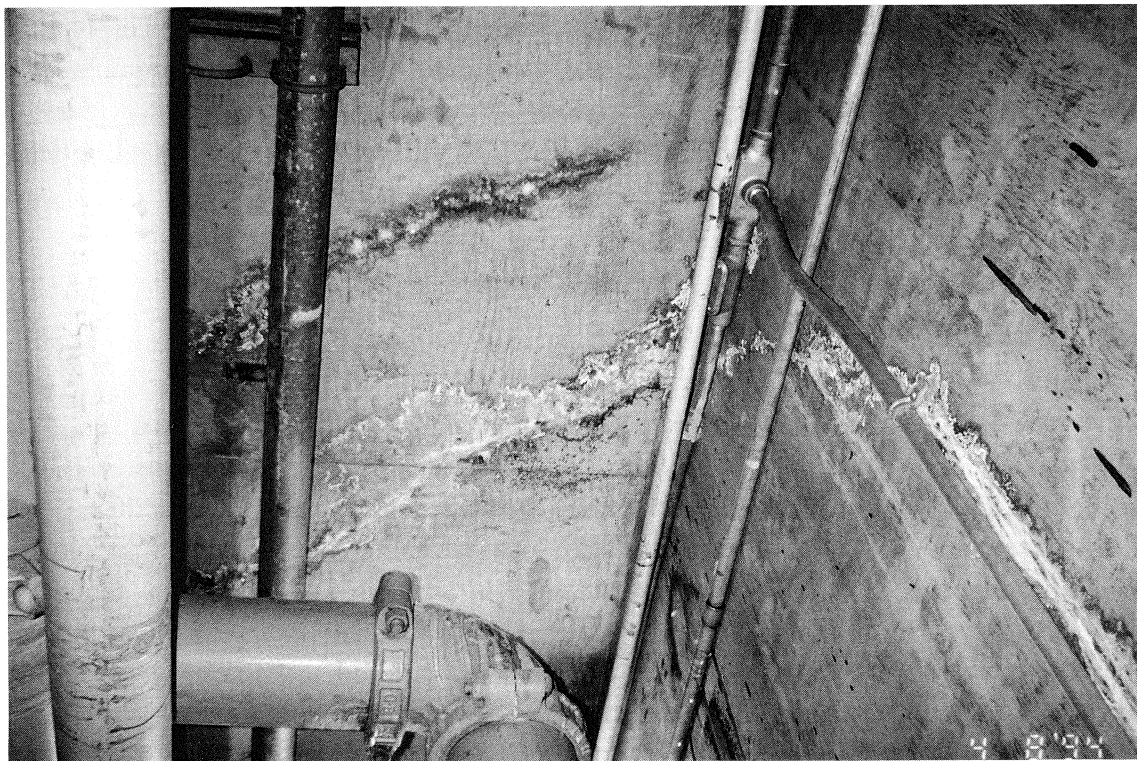
FIGURE 4-13 Repaired Cracks (by Epoxy Injection) in Concrete Basins of 15-mgd Wastewater Treatment Plant in the Santa Clarita Valley

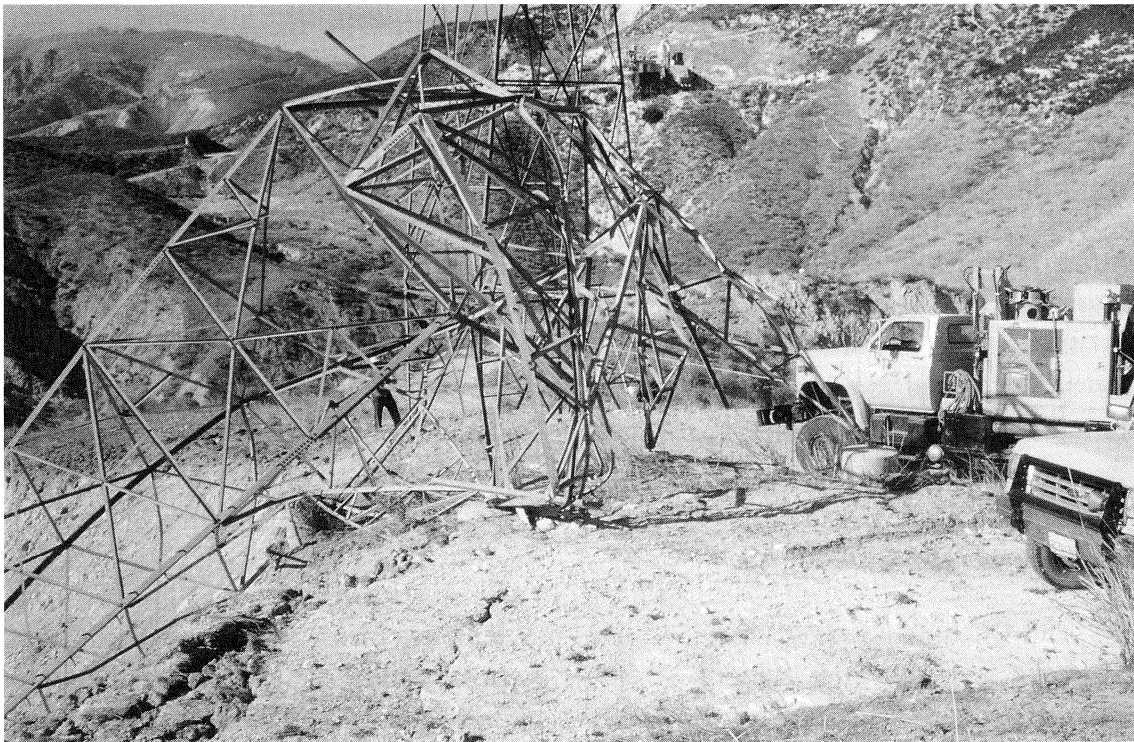
FIGURE 4-15 Several Electrical Transmission Towers Failed During the Earthquake - Foundation Distress was Observed at Most of the Failed Towers

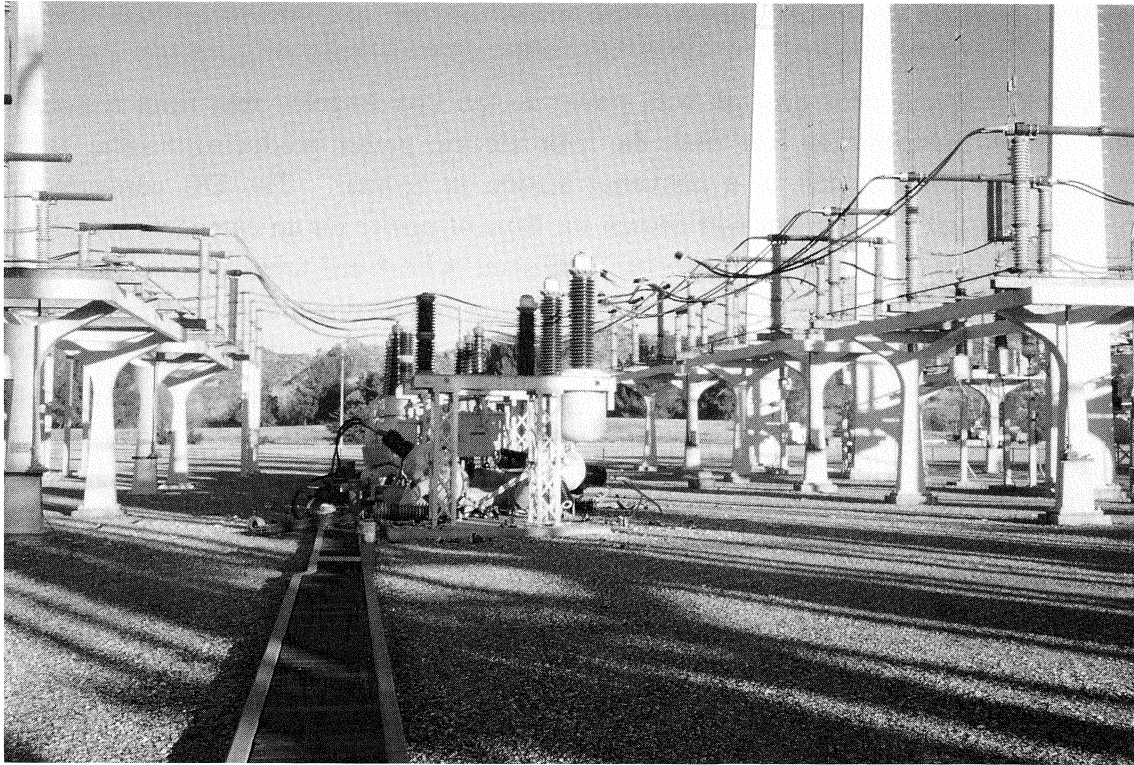
FIGURE 4-16 High Voltage Substation Apparatus Supported by Brittle Porcelain Insulators were Damaged at Several Substations

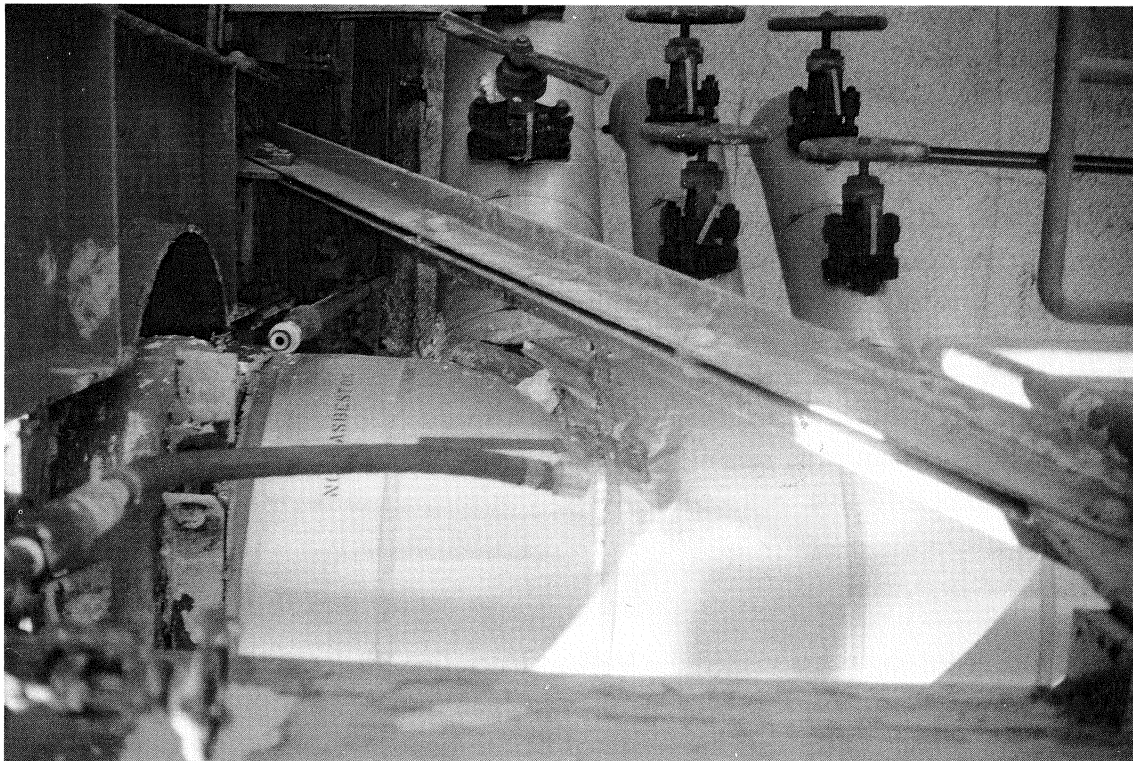
FIGURE 4-17 Electric Generating Plants Sustained Primarily Minor and Cosmetic Damage such as Crushed Piping Insulation due to Movement of Steam Pipes

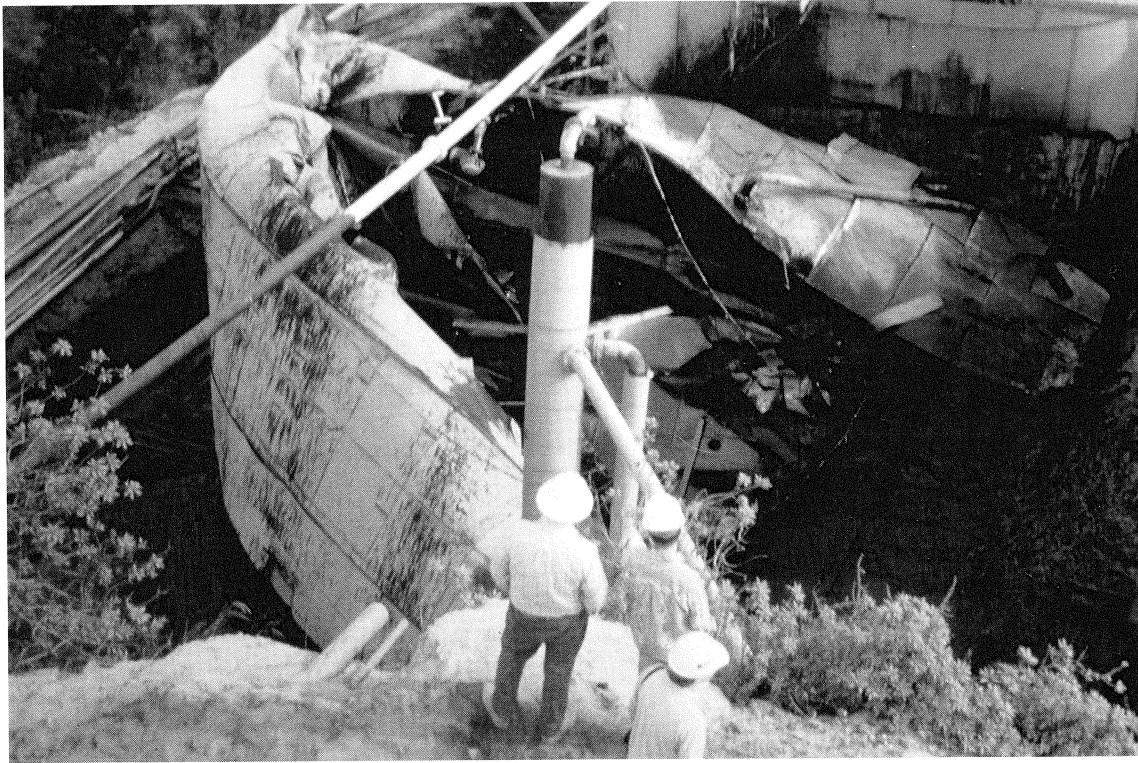
FIGURE 4-20 Collapsed Oil Tank in the Aliso Canyon Gas Storage Facility

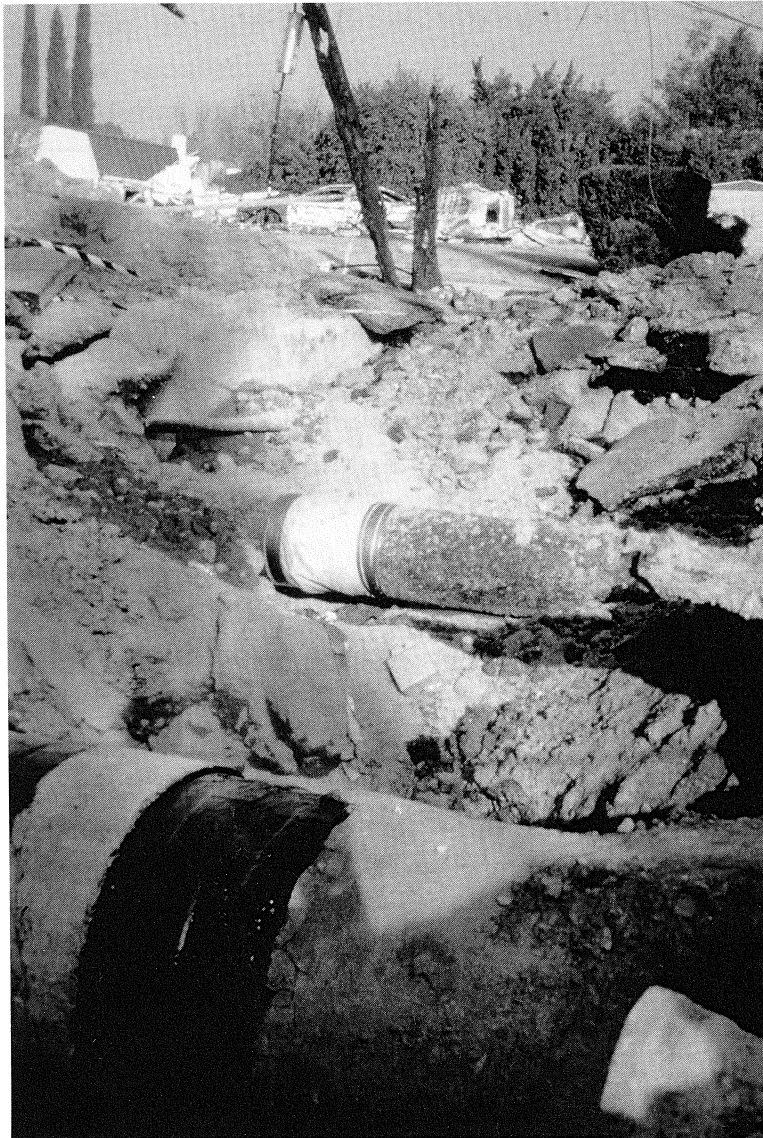
FIGURE 4-24 Damaged Water Trunk and Gas Transmission Pipelines at the Zone of Tensile Ground Deformation and Fire on Balboa Boulevard

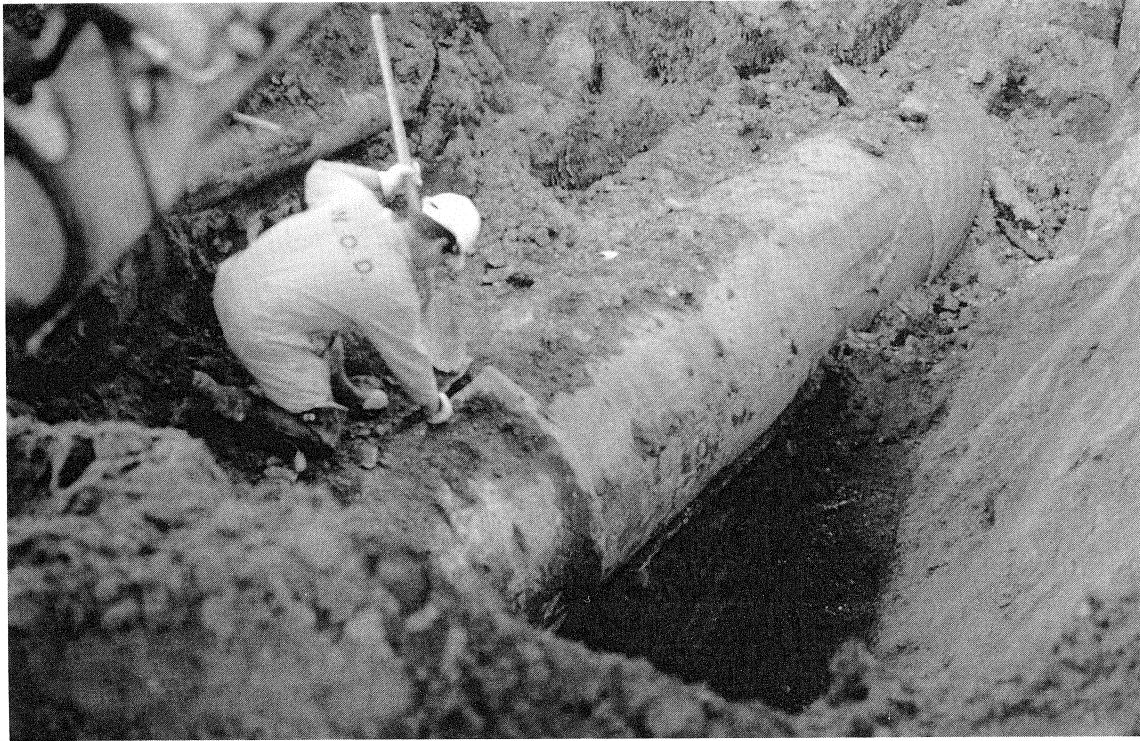
FIGURE 4-25 Compressive Failure of a Welded Slip Joint of the Granada Trunk Line on Balboa Boulevard

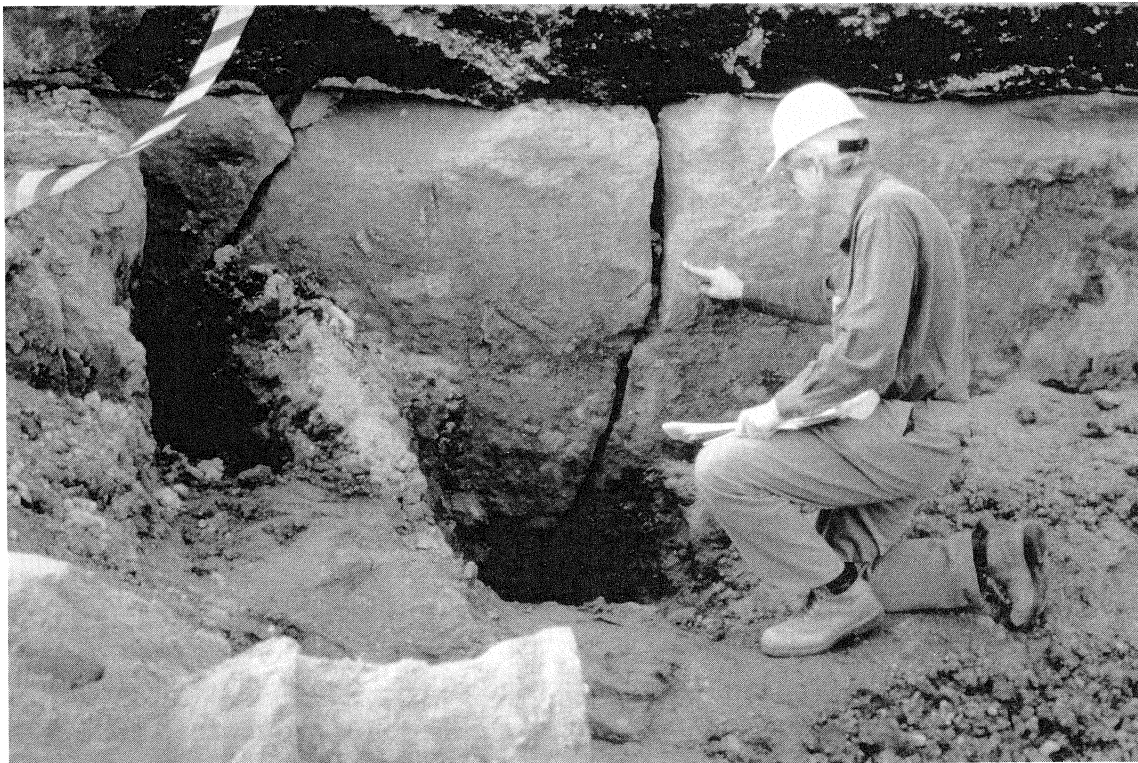
FIGURE 4-26 Subsurface Cracks at the Zone of Tensile Ground Deformation on Balboa Boulevard

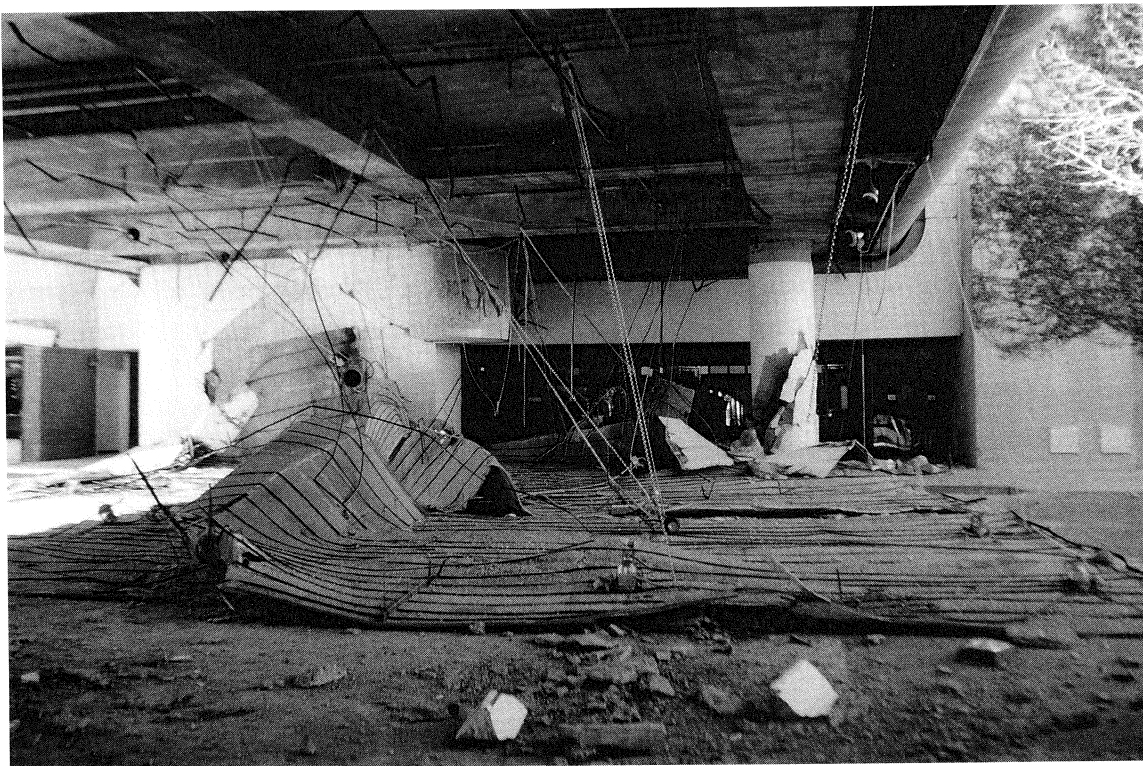
FIGURE 5-2 Stucco Breezeway Ceiling Detached from Concrete Frame at the Northridge Fashion Center

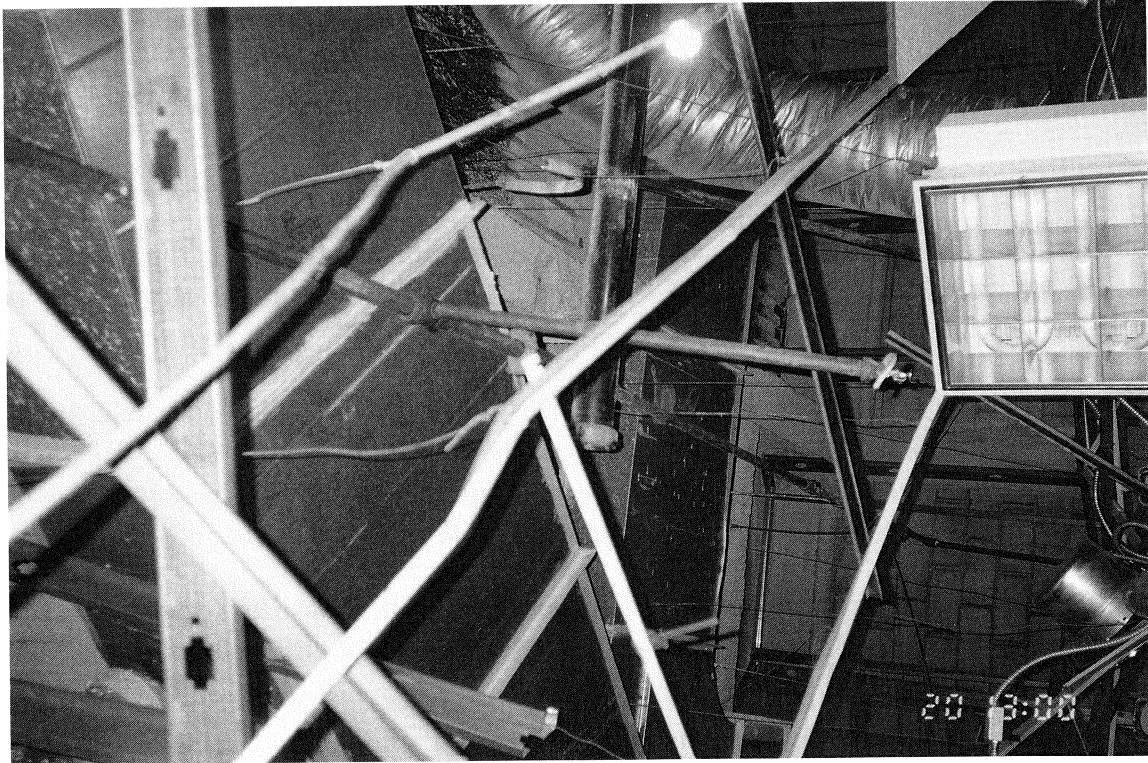
FIGURE 5-3 Broken Fire Sprinkler Head (Riser Connection) due to Interaction with Suspended Ceiling at a Department Store in Los Angeles

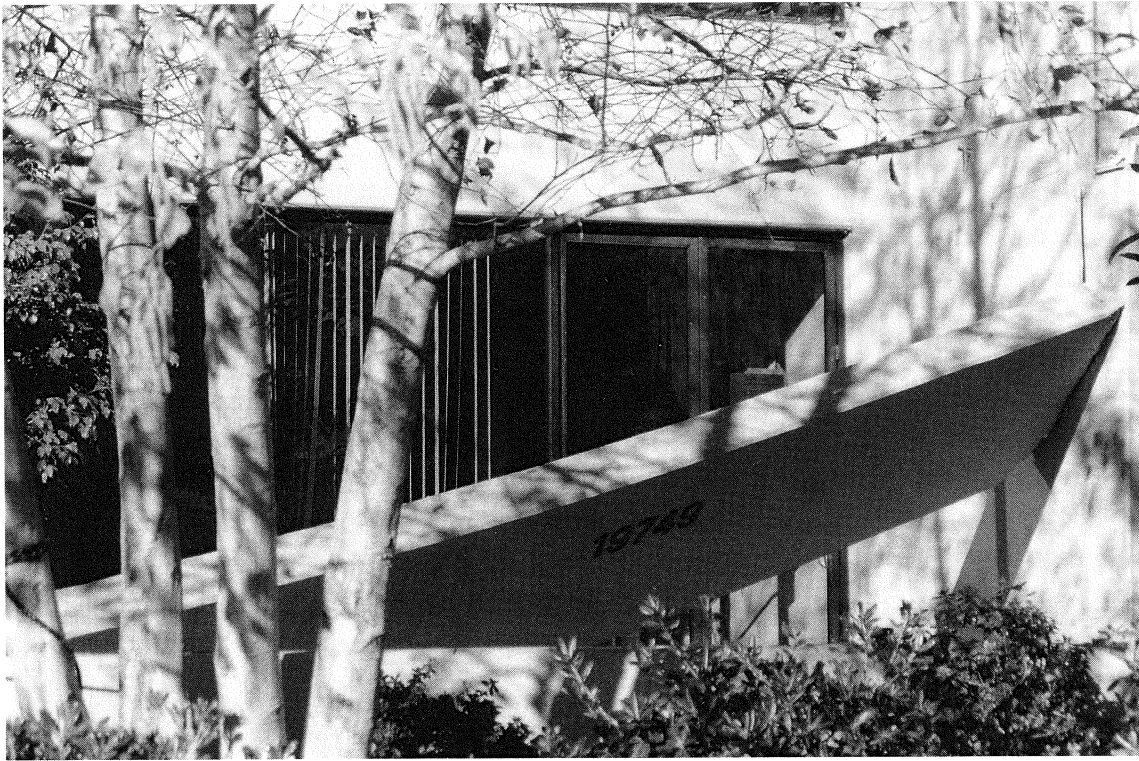
FIGURE 5-4 Failure of Concrete Facade Anchorage Details

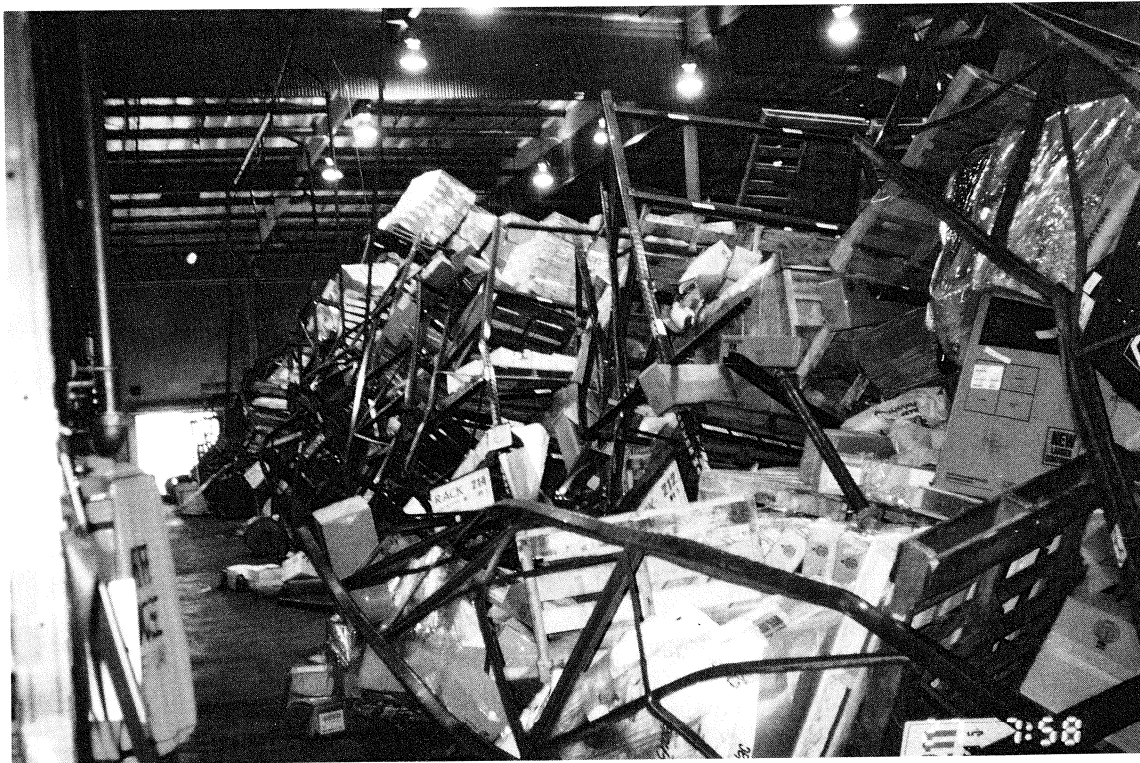
FIGURE 5-5 Collapse Of Warehouse Racks In Santa Monica

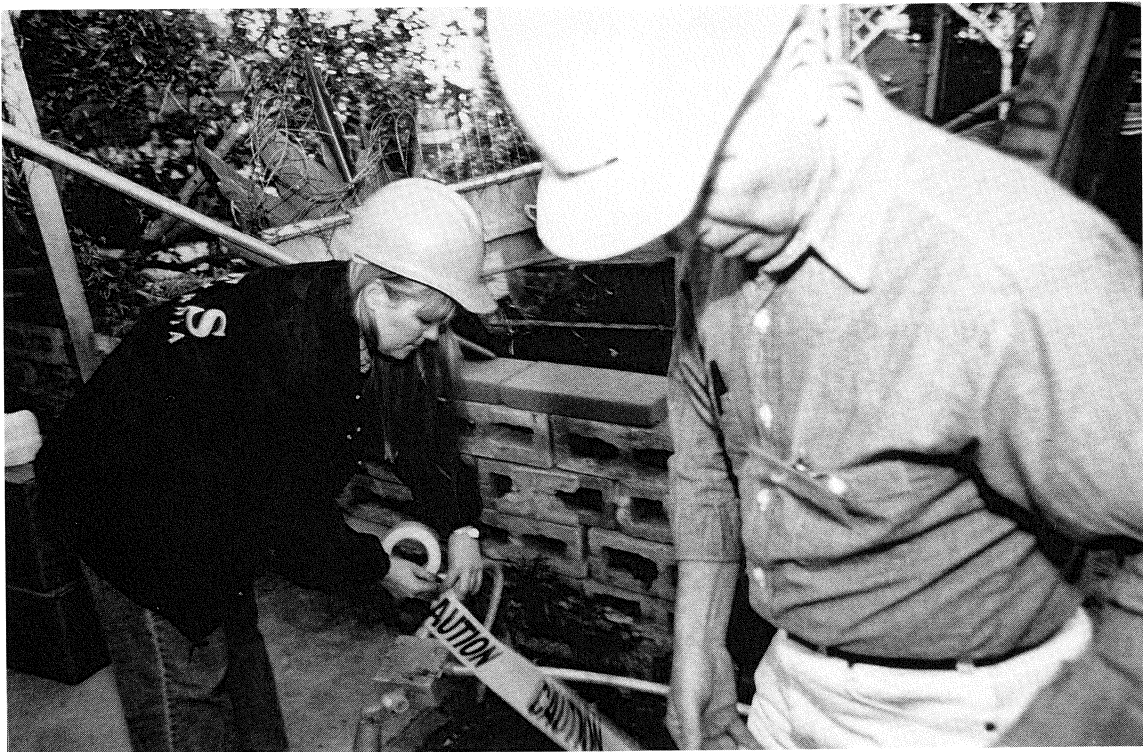
FIGURE 6-3 Inspectors Cordon Off Damaged Residence in Northridge
