The Northridge, California Earthquake of January 17, 1994: General Reconnaissance Report

Edited by J. Goltz

Technical Report NCEER-94-0005

March 11, 1994

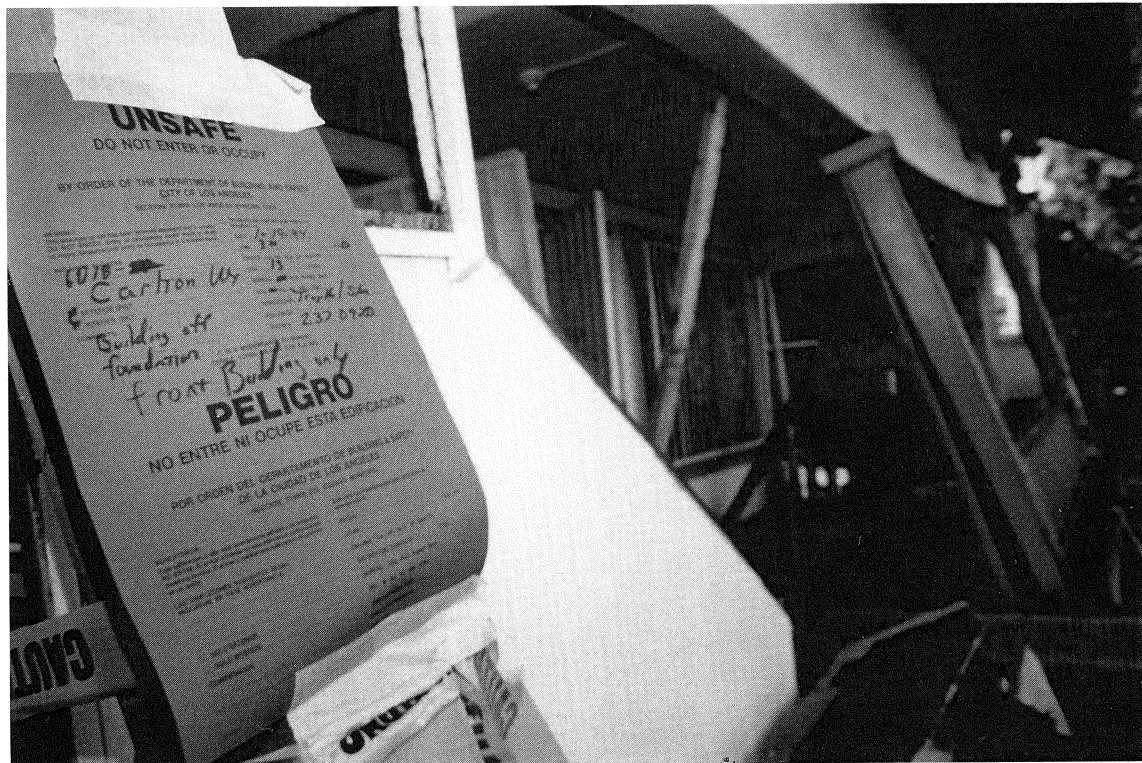
FIGURE 6-4 "Red-tagged" Residence in San Fernando Valley
