Overview of Building Damages in 921 Chi-Chi Earthquake

K.C. Tsai¹⁾ Chiang Pi Hsiao²⁾ Michel Bruneau³⁾

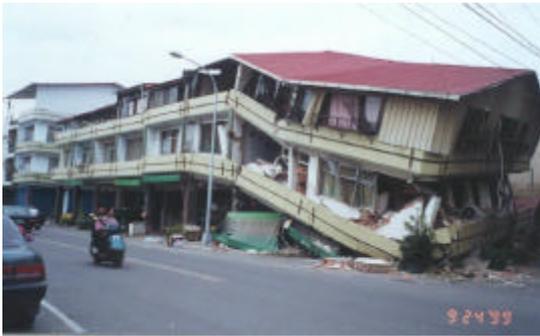
configurations. A large percentage of buildings that collapsed due to the main shock or strong aftershocks are old unreinforced clay block masonry cottages and non-engineered and one-to-three stories reinforced concrete frame structures constructed with brick in-fill partitions and exterior walls. Many collapsed buildings had a pedestrian corridor and open front at the ground floor, and only one wall at the back of the building along the street direction (Photo 1). This type of building damage

Photo 1 Collapse of the typical building having pedestrian corridor

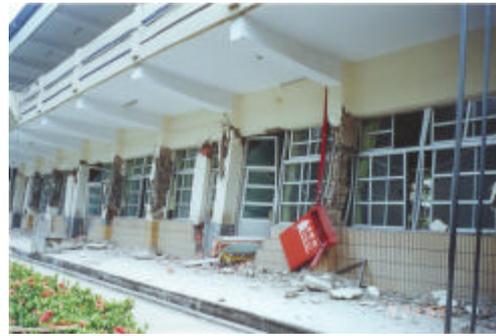
accounts for the majority of the complete building collapses near the epicenter due to severe ground shakings. Many school buildings suffered extensive and severe damages. The "short-column" type of damage in these reinforced concrete structures is rather common in the direction parallel to the exterior corridor outside the classrooms where windows above half-height in-fill shortened the effective length of almost all the columns (Photo 2).

Photo 2 Shear failure of RC columns due to the short column effect

4. In light of the damages observed in the school buildings, it is recommended that the lateral force resisting system in the direction parallel to the exterior corridor for new school buildings be carefully configured in order to avoid the occurrence of "short column" brittle failure mode. The observed damages also suggest the urgent need of retrofitting the existing vulnerable school buildings.

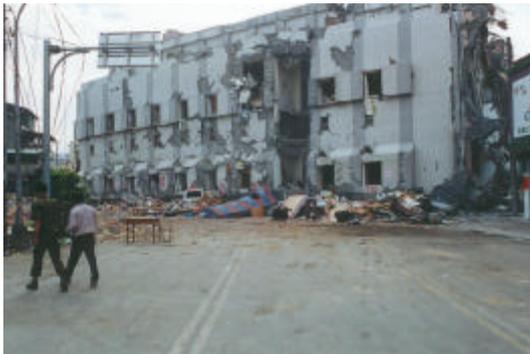
However, in the affected area, more than two dozen modern 10-to-20 stories apartment buildings overturned or collapsed. These were reinforced concrete moment resisting frames, most of them constructed with cast-in-place 15cm thick exterior wall and 12cm thick partition walls (Photo 3). The observed damages on reinforced concrete structures suggested a large effect of masonry and lightly reinforced concrete non-structural components. These buildings were typically designed following requirements for moment resisting frames identical to the Uniform Building Code

Photo 3 Collapse of a apartment building in Fengyuan

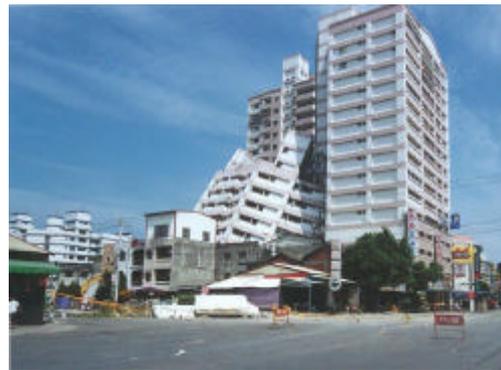
Many of them appear to have tall floor and open plaza features in the ground level. Commonly encountered were failed columns with widely spaced stirrups (unconfined plastic hinge zone), splices with inadequate development length or located in the hinge region, light or in-existent joint transverse reinforcement, stirrups with 90°, etc. Strong-beam weak-columns systems apparently common, might have resulted in numerous story collapses following excessive column damage. This was particularly frequent in the first story of buildings, as the larger openings and higher story height there translate into a lower structural stiffness and strength, leading to "soft-story" mechanisms (photo 4).

Photo 4 Collapse of a high-rise apartment building in Dali

3. The extensive vulnerability of the existing building inventory, as revealed by this earthquake, must be addressed before other equally destructive earthquakes strike again in the country. A particular attention should be paid to buildings having soft stories and open front. This requires the establishment of priorities, timetable, policies and criteria for seismic retrofit. It is not fiscally possible to retrofit all structures in cities having extensive building inventories, but key post-emergency building (such as hospitals and other critical facilities) require special measures to ensure that they will be made available.
