Engineering and Organizational Issues Before,
During and After Hurricane Katrina

Advanced Damage Detection for Hurricane Katrina:
Integrating Remote Sensing and VIEWS™
Field Reconnaissance

J. Arn Womble, Shubharoop Ghosh, and Beverley J. Adams (Team Leader)
ImageCat, Inc.

March 2006

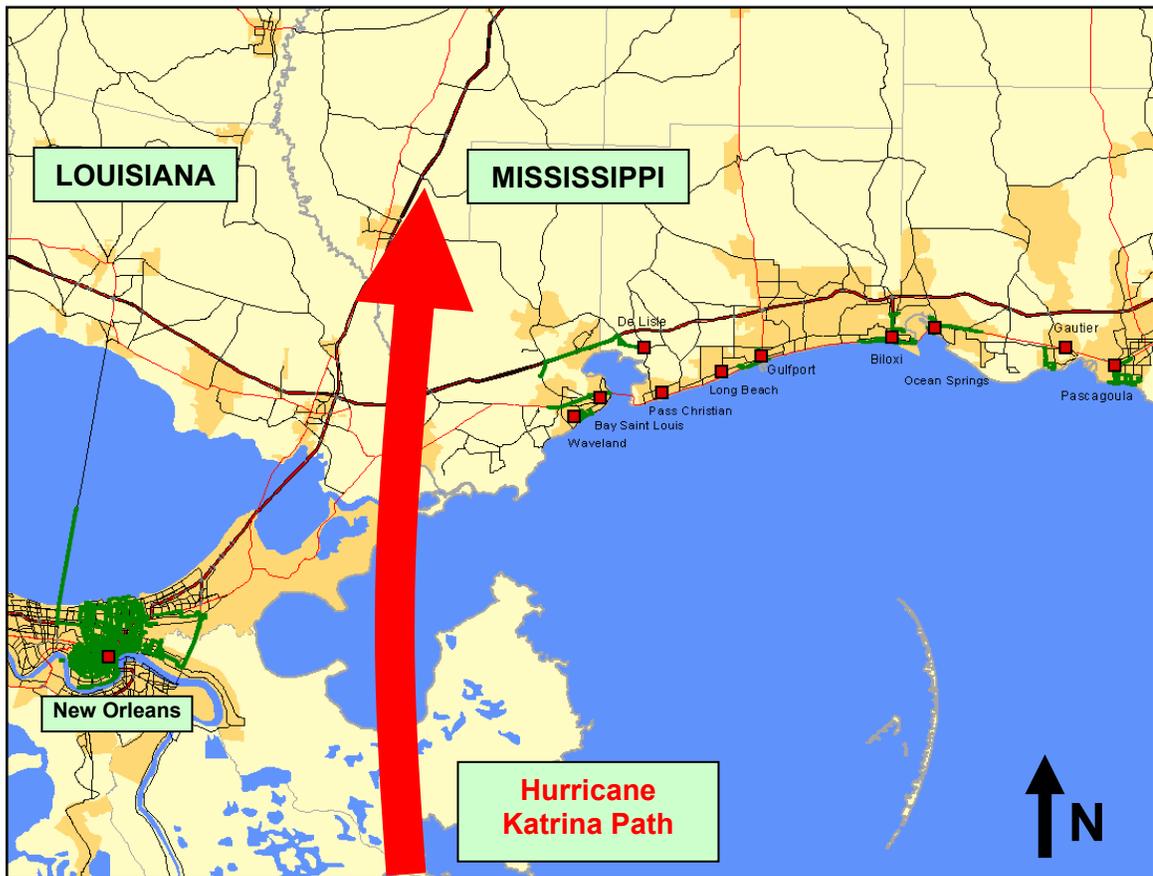
Figure 1-1. Orientation map showing approximate path of Hurricane Katrina, in relation to New Orleans and the Mississippi coast.

Hurricane Katrina first made landfall in the U.S. on August 23, 2005 in southern Florida as a Category 1 hurricane. After entering the warm waters of the Gulf of Mexico, it rapidly strengthened to a Category 3 hurricane and ultimately reached Category 5 status less than 12 hours later. On August 28, Katrina reached peak intensity with sustained winds exceeding 170 mph and a central pressure of 902 mb, (which at that time was the fourth-lowest central pressure recorded for an Atlantic Basin hurricane). The storm's intensity subsequently weakened in the 18 hours before its second landfall. Despite this weakening, the size of the hurricane continued to expand, with hurricane-level winds (exceeding 73 mph) extending more than 100 miles from the center and with tropical-storm-level winds (39-73 mph) extending more than 200 miles from the center. On the morning of August 29, 2005, Hurricane Katrina made landfall as a Category 3 hurricane (Knabb et al., 2005) near the Louisiana-Mississippi border (Figure 1-1).

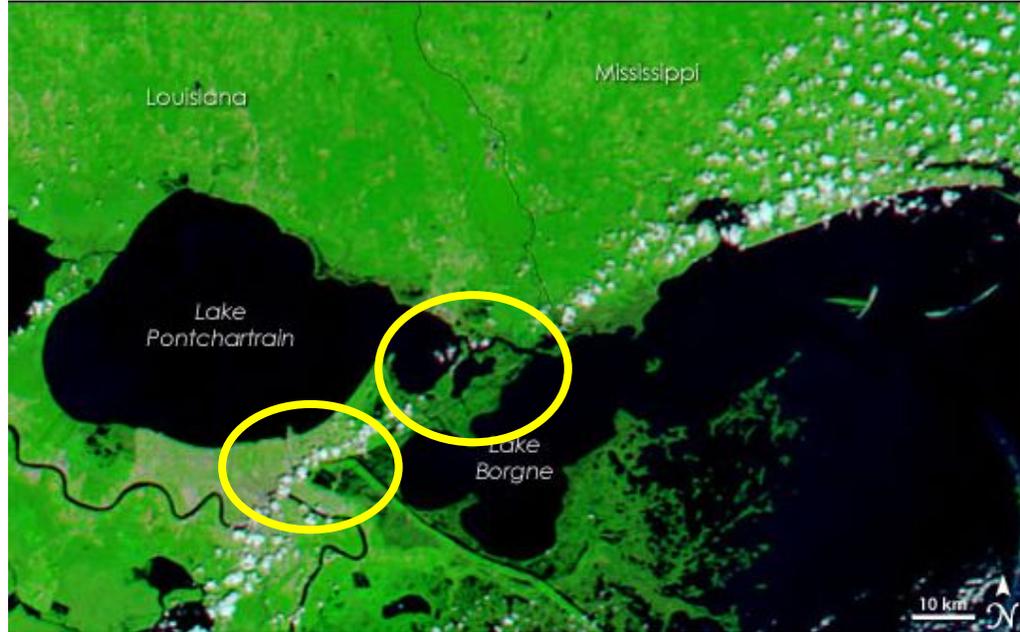
Figure 2-3. NASA's Aqua-MODIS 250-m imagery shows pre-hurricane conditions on August 27 and post-hurricane flooding extent in New Orleans and nearby areas on August 31.

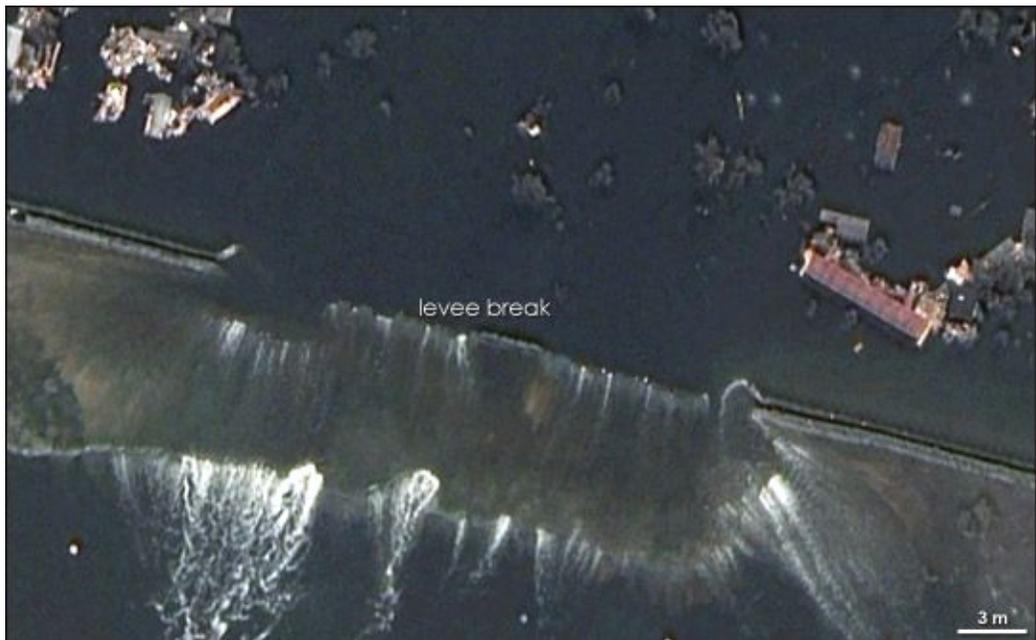
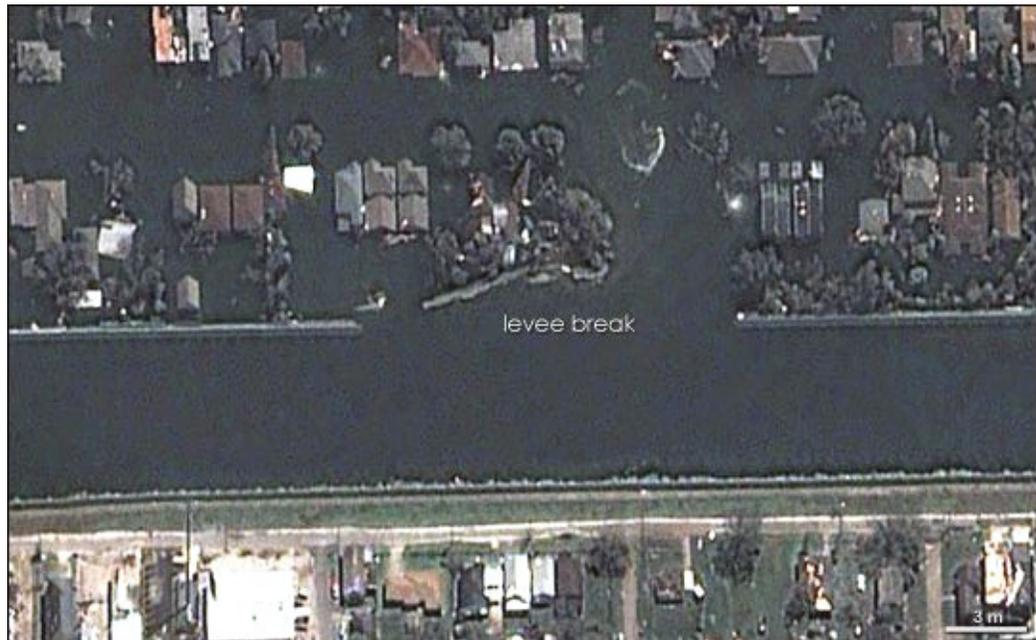
Figure 2-10. QuickBird 61-cm high-resolution satellite imagery shows flood waters entering New Orleans through levee breaches on August 31.

For New Orleans, high-resolution images were available to show the progress of flooding. Cloud-free OrbView images of August 30 show flood areas (Figure 2-9). QuickBird images from August 31 also show flooding, as well as water pouring through levee breaches at Surekote Road and at the 17th Street Canal (Figure 2-10). Subsequent image collections (Table 2-3) by IKONOS, OrbView, and QuickBird throughout September, October, and November continue to show the progression of flooding and receding flood waters.

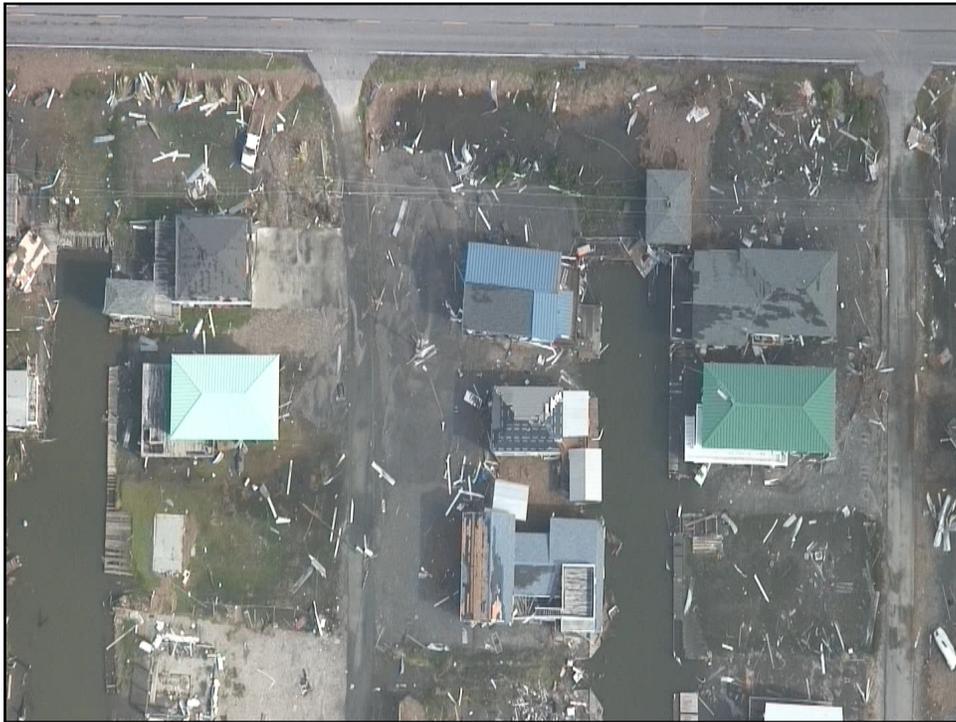
Figure 2-11. VIEWS™ high-definition aerial imagery acquired from an elevation of 5000 ft shows flooding as well as minor wind damage to roofs in New Orleans.

One day after Hurricane Katrina made landfall in Louisiana, devastation to New Orleans and the Gulf Coast was recorded through rapid imagery capture under the ImageCat Post-disaster Damage Verification (PDV) program. GPS-referenced, 5-15 cm resolution imagery was acquired by airborne deployment of the VIEWS™ field data collection and visualization system, full details of which are provided in Chapter 5. Georeferenced high-definition video and still photographs recorded the initial storm flooding and subsequent overtopping of the levees surrounding New Orleans (Figure 2-11). Captured on August 29th, prior to either cloud-free post-storm satellite or NOAA airborne coverages, the information provided the earliest known remote sensing coverage of damage within New Orleans.

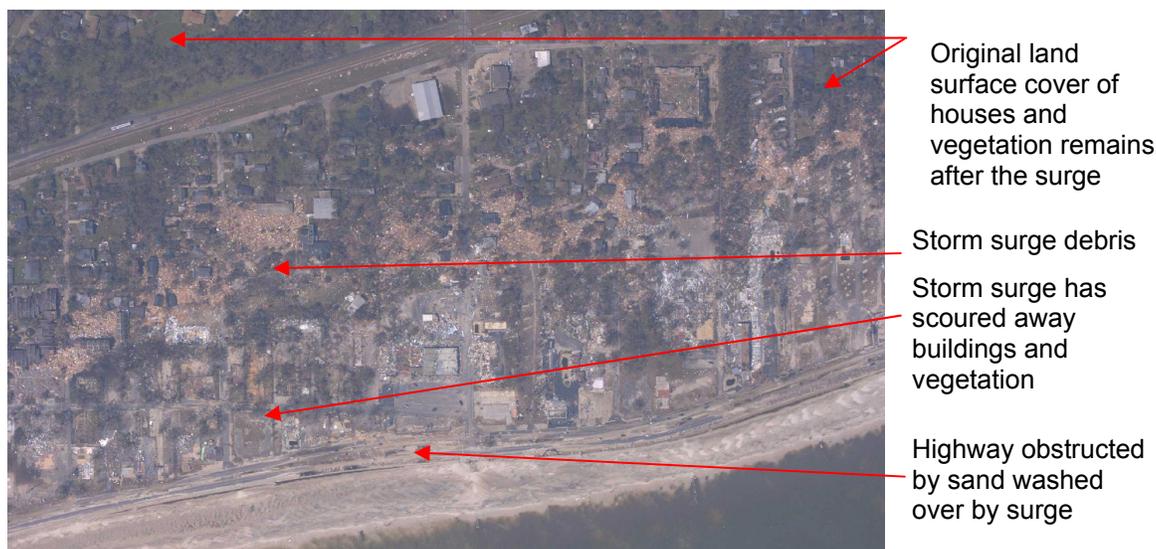
Figure 4-4. Sample of NOAA aerial imagery (ID 24330689) at Gulfport, Mississippi.

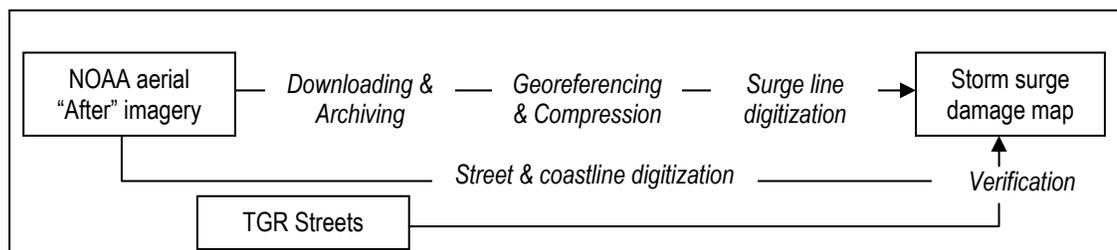
Figure 4-5. Methodology employed for neighborhood-scale storm-surge damage detection.

Figure 4-5 summarizes the methodology employed for damage assessment. To delineate the position of the surge line, and thereby identify neighborhoods experiencing a high proportion of collapsed structures, MCEER researchers at ImageCat began by downloading and archiving the online NOAA database, which initially comprised ~350 (and was subsequently expanded to several thousand) images, using a proprietary

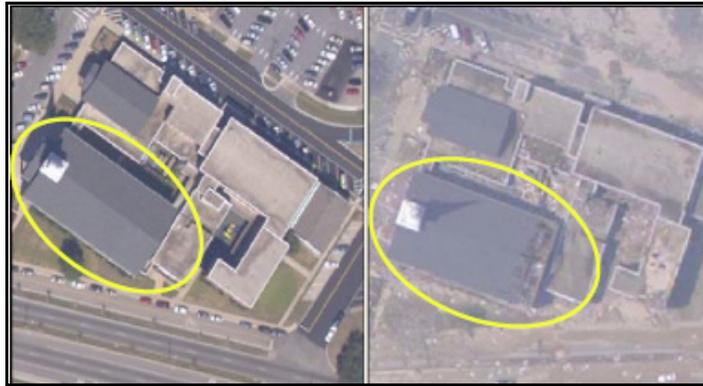
Figure 4-13. Aerial photo of this Gulfport church reveals wind-pressure damage to the roof, but not the fact that the exterior walls of the building were demolished, leaving only the structural steel frame and roof.

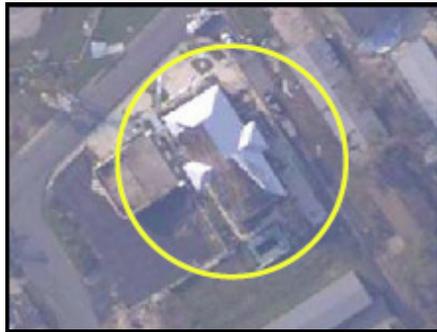
Figure 4-14. Aerial photo reveals wind-pressure damage to the roof cladding, and low-density debris nearby. This portion of Bay St. Louis was not affected by storm surge.

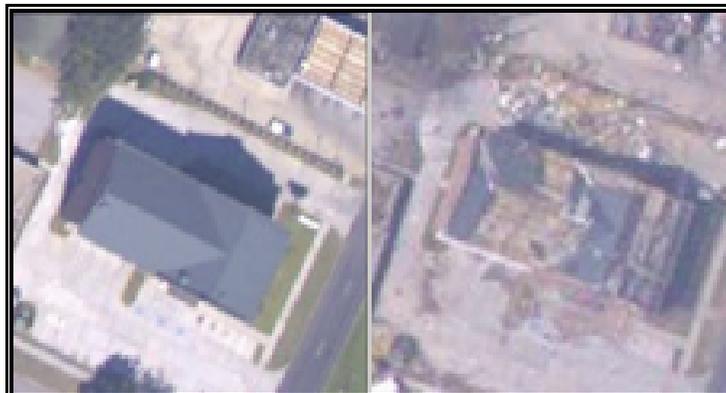
Figure 4-15. Before-and-after aerial photos reveal wind-pressure damage to the roof cladding, and low-density debris nearby. This building was not noticeably damaged by storm surge.

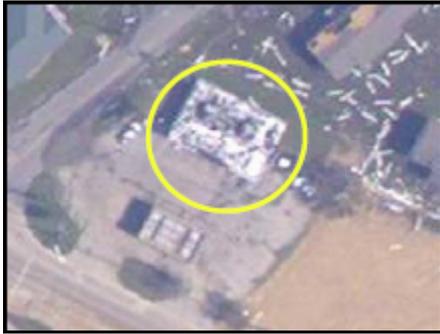
Figure 4-16. Aerial photo reveals wind-pressure damage to the roof cladding, and low-density debris nearby. This portion of Waveland was not affected by storm surge.

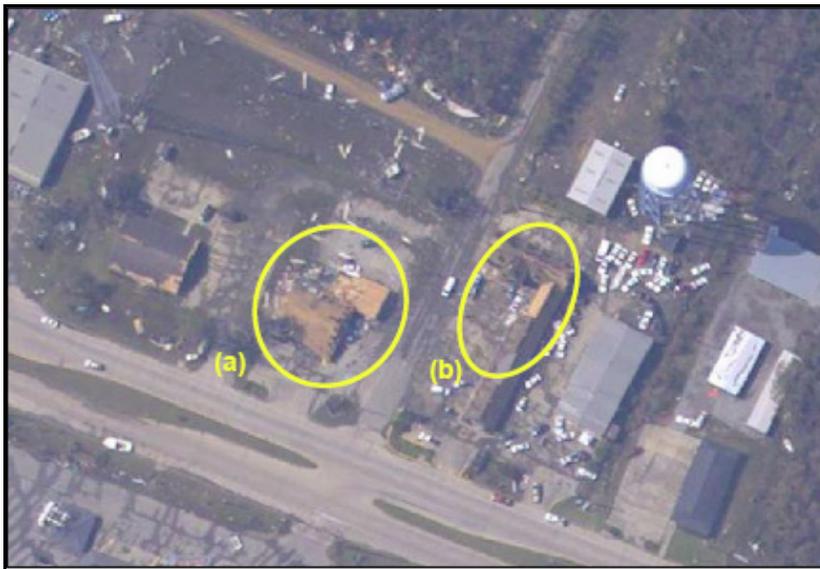
Figure 4-17. Aerial photo reveals wind-pressure damage to roof cladding, and low-density debris nearby. This portion of Waveland was not affected by storm surge.

This detailed visual assessment revealed that structures situated inland - typically more than ½ to 1 mile from the shore - were affected by the *wind pressures acting alone*, and as such, serve as an example of “pure” wind-pressure damage. For most portions of the Mississippi Coast, wind damage to individual structures consisted of the removal of roof coverings (Figures 4-13 to 4-16) – particularly near the edges, where wind pressures are highest, with occasional removal of roof decking and partial collapse of the roof structure (Figure 4-17). In addition to removal of roof-cladding elements, areas of wind-pressure damage are distinguishable from storm-surge damage by the low-density appearance of windborne debris nearby (Figure 4-17).

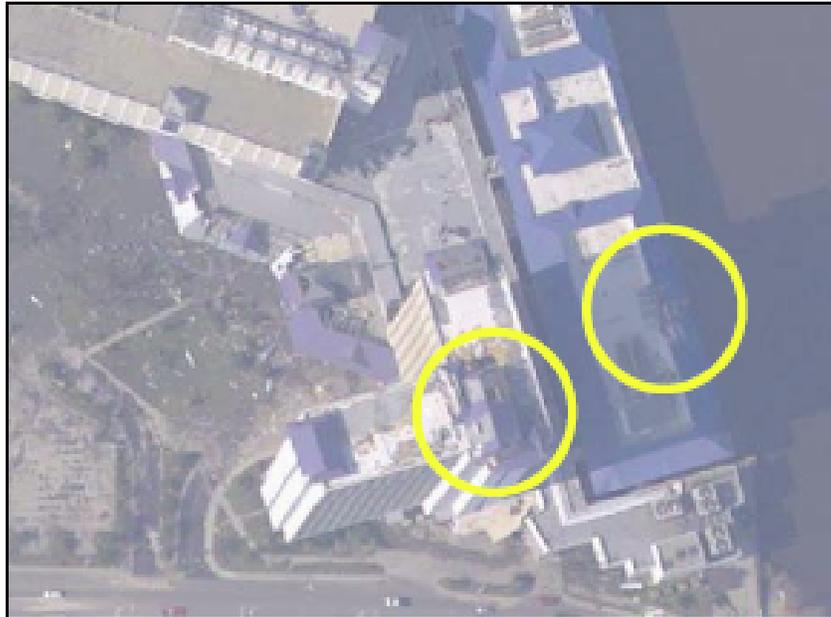
Figure 4-18. Aerial photo reveals wind-pressure damage to roof cladding of high-rise hotel.

While the Remote Sensing Damage Scale in Table 4-1 has been developed for residential structures, continuing research is focused on the development of formal damage scales for other building categories (e.g., commercial and industrial). Within affected areas along the Mississippi Coast, wind-pressure damage to tall buildings generally has a different appearance to that of low-rise buildings, in that wall surfaces often sustained more damage than roof surfaces for these buildings. While damage to roof coverings is still readily detectable via remote sensing imagery (Figure 4-18), damage to cladding elements on exterior walls is difficult to observe in vertical overhead imagery. Oblique images are preferred for the detection and assessment of such damage. In the absence of oblique imagery, ground-based observations may be necessary to confirm damage extent.

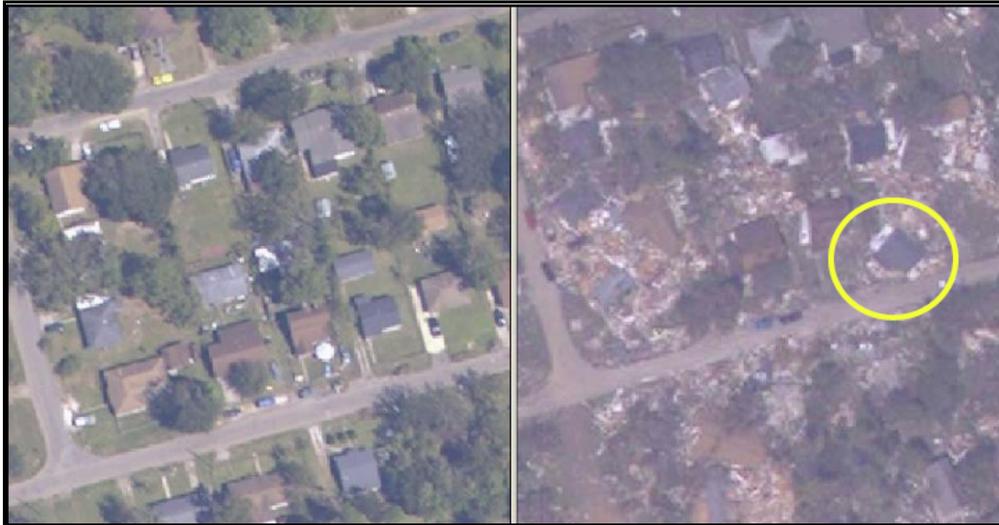
Figure 4-19. NOAA aerial images, acquired before and after Hurricane Katrina, show a residential neighborhood in Pascagoula subjected to severe storm surge. Dense areas of debris and skewed rooftops show evidence of severe storm-surge damage but little wind-pressure damage to the roofs.

For most waterfront areas in Mississippi, storm surge proved far more damaging than wind pressures. The NOAA aerial images reveal numerous instances in which roofs experienced minimal wind damage, yet the portions of the buildings beneath were washed away. In several areas, roof assemblies were found virtually intact but detached from the building beneath and washed some distance away. As such, roofs that appeared intact in the remote sensing imagery but were surrounded by areas of dense debris and/or displaced from their original locations were indicative of destruction by storm surge (Figures 4-19 and 4-20).

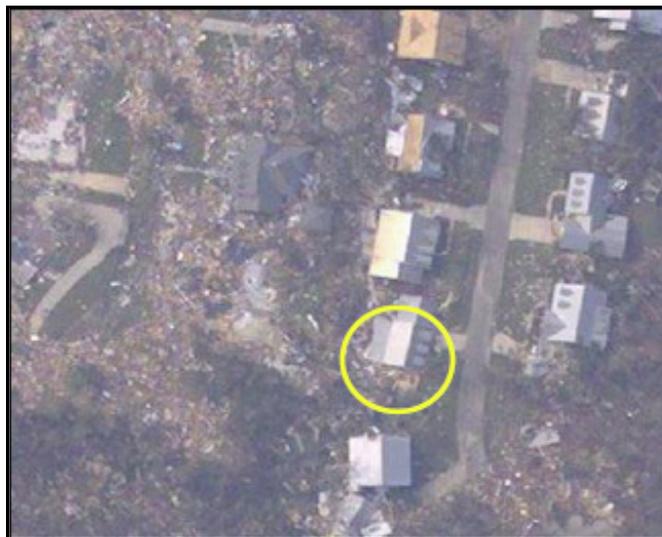
Figure 4-20. NOAA aerial image of a Bay St. Louis neighborhood indicates storm-surge damage (presence of dense debris), but intact roofs show there is little wind-pressure damage.

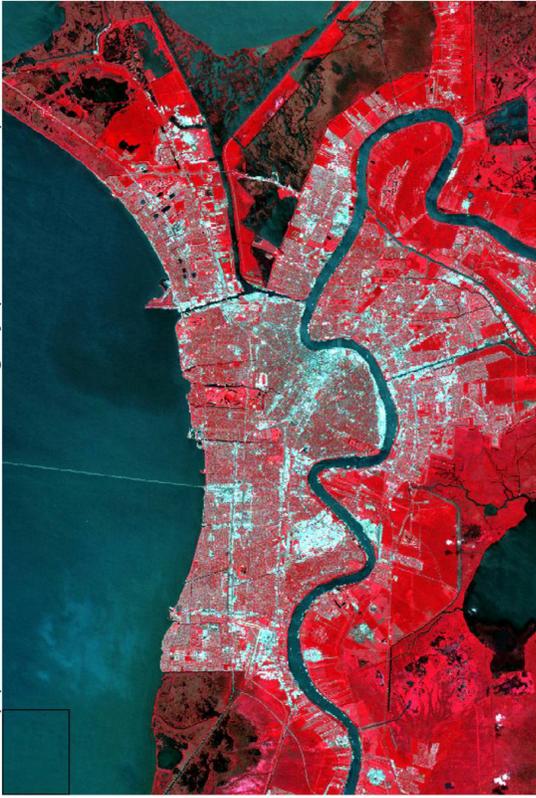
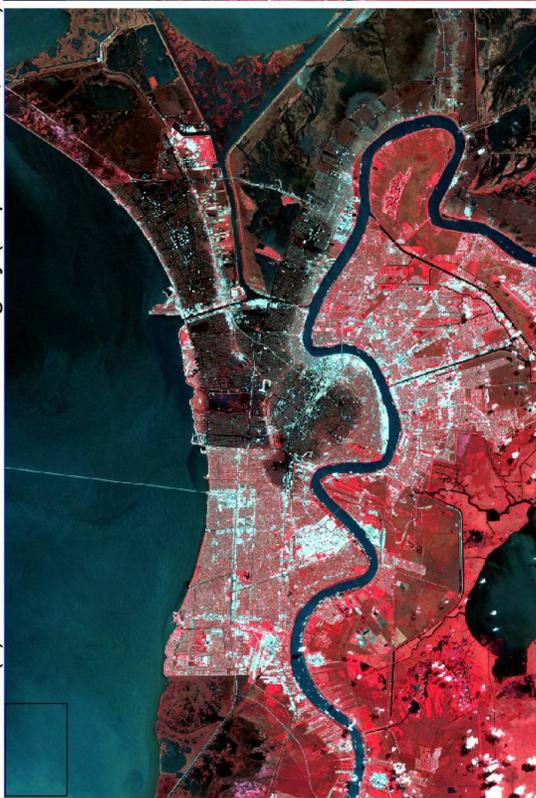
Figure 4-27. Temporal sequence of false-color composite images (Landsat-5 Bands 4, 3, 2) for New Orleans, acquired before and after Hurricane Katrina. Flooding that is evident in western districts on August 30 (see yellow annotation) is no longer apparent on September 7. Extensive flooding within central and eastern districts has subsided by October 9, leaving a distinctive spectral signature (see blue annotation).

Comparison of the pre-storm Landsat imagery from June 2005 (Figure 4-27a) with post-event Landsat imagery from August 30, 2005 (Figure 4-27b) suggests that in the immediate aftermath of Hurricane Katrina, flooding occurred throughout western, eastern, and central districts of New Orleans. Multi-temporal analyses are also useful for monitoring the evolving disaster situation. For example, while flooding remains evident throughout central and eastern districts in the September 7 Landsat-5 imagery (Figure 4-27c), inundation that was observed during the PDV survey (Section 4.3.1) and Landsat coverage of August 30 (noted in yellow in Figure 4-27b) is no longer apparent. This finding suggests that flood waters retreated at different rates throughout the city, which may in turn be linked to the source of flood water (overtopping versus levee breach).

The September 7 Landsat coverage in Figure 4-27c clearly depicts widespread inundation within central and eastern districts; due to dense cloud cover and no-data values, it is difficult to determine if these areas are also inundated in the August 30 Landsat-7 scene. Within the false-color composite comprising near-infrared, red, and green bands, flooding is characterized by a low spectral return (dark reflection). From detailed visual inspection, this low return can be traced to the location of levee breaches (see Section 4.3.3).

The boundary of inundation was delineated for New Orleans as a series of polygons, based on expert interpretation of the spectrally enhanced September 3 QuickBird coverage. For the Landsat-5 coverage (see Figure 4-27), the flooded area was identified based on the lower reflectance of water as compared with non-flooded ground-surface features. Given the high spatial resolution of the imagery, it was possible to distinguish inundated areas to

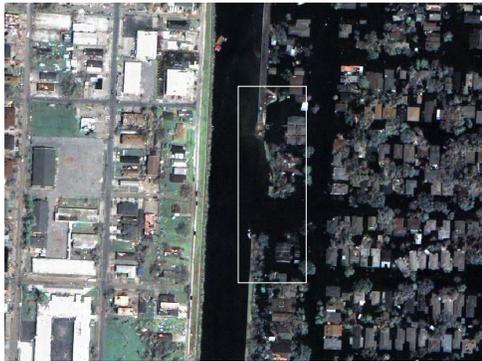
Levee breach at the 17th Street Canal near the Hammond Highway bridge. The non-flooded area on the west side of the canal is Jefferson Parish, and the flooded area on the east side is Orleans Parish. This image shows the dramatic difference between flood and no-flood areas.

Each of the levee-failure locations was identified using expert interpretation of a pansharpened natural-color composite of the QuickBird imagery. Figure 4-33 shows a visually based interpretation of the levee-breach sites. Areas surrounding the levee failures were inspected using the composite image to extract information concerning:

Figure 4-33. 61-cm natural-color QuickBird images used to visualize the levee-breach locations.

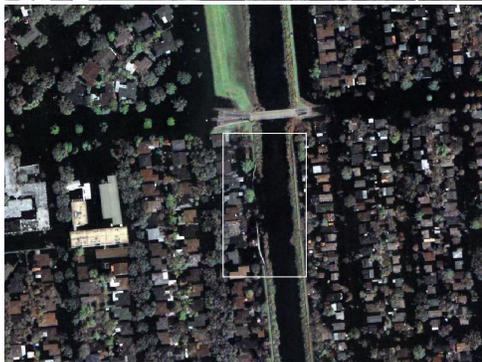
A failed section of the west bank of the London Avenue Canal levee south of the Robert E. Lee Boulevard Bridge.

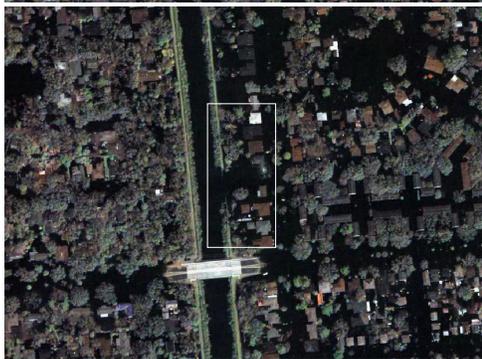
A failed section of the east bank of the London Avenue Canal levee north of the Mira Beau Avenue Bridge.

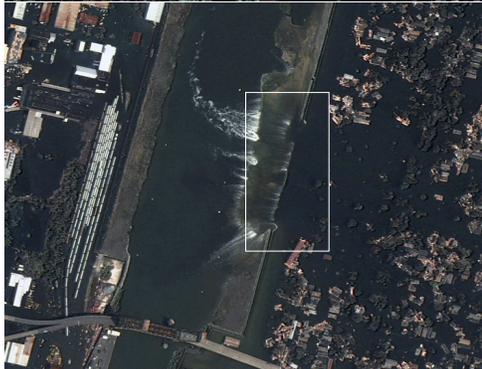
Levee breach located on the east side of the Industrial Canal between Florida Avenue and North Claiborne Avenue, causing flooding in the Lower Ninth Ward. The destruction of buildings in this area of high-velocity flooding is evident from the scattering of the building roofs.

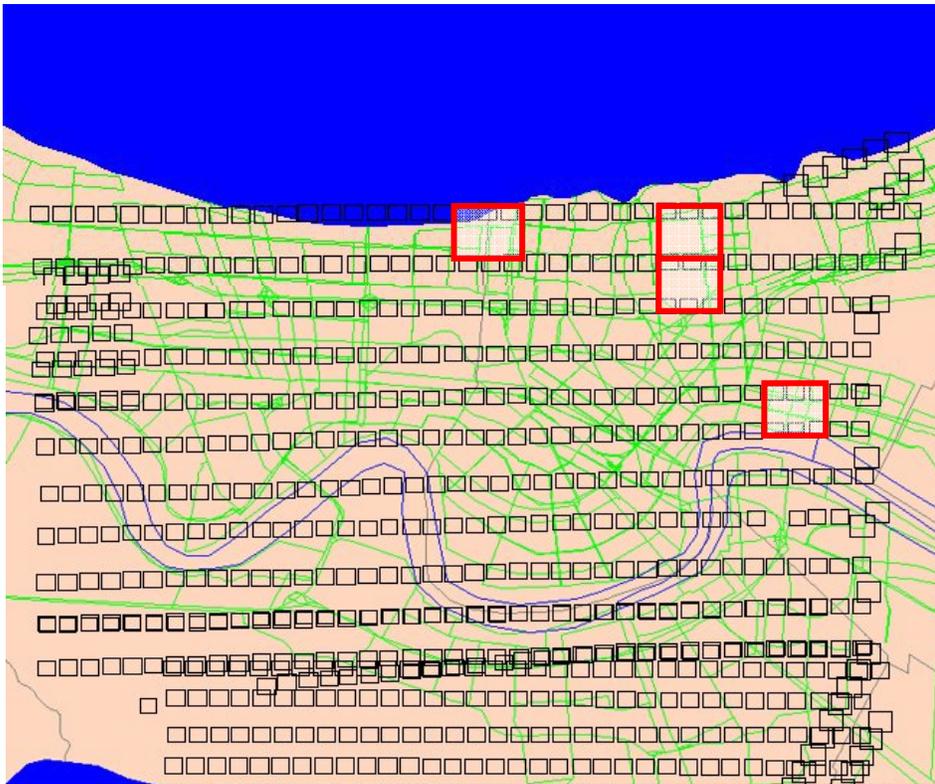
Figure 4-34. Location of NOAA aerial images for the New Orleans area acquired following Hurricane Katrina. Imagery for the major levee breach locations is indicated with the red boxes.

The aerial-photo index shown in Figure 4-34 shows the locations of post-hurricane imagery of the New Orleans area acquired and posted online by NOAA. The sets of images used for the visual inspection of damage around the levee-breach locations are indicated by red boxes. Figure 4-35 demonstrates the characterization and interpretation of the levee-breach sites within New Orleans, using the NOAA images. The finer spatial resolution of the aerial images (37 cm) provides additional detail about the hazard effects of the high-velocity flows near the breaches. Although image processing was not required to use the NOAA aerial images for visual interpretation, georeferencing operations were necessary for use with other spatial data sets (e.g., GIS data within the VIEWSTM reconnaissance system).

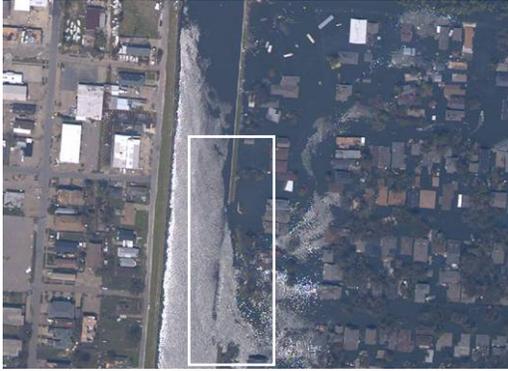
NOAA aerial image of levee breach at the 17th Street Canal near the Hammond Highway bridge.

Figure 4-35. 37-cm natural color NOAA images used to view the levee-breach locations (Aerial images from NOAA).

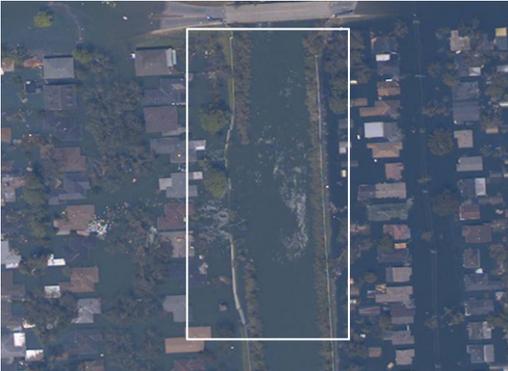
NOAA aerial image of a failed section of the west bank of the London Avenue Canal levee south of the Robert E. Lee Boulevard Bridge.

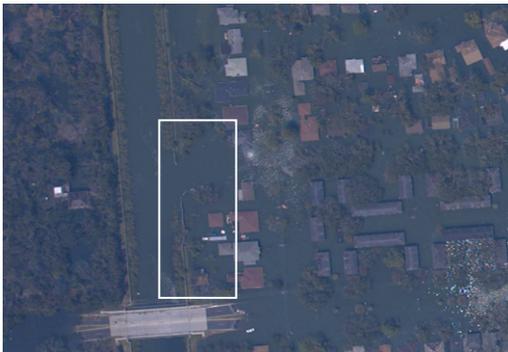
NOAA aerial image of a failed section of the east bank of the London Avenue Canal levee north of the Mira Beau Avenue Bridge.

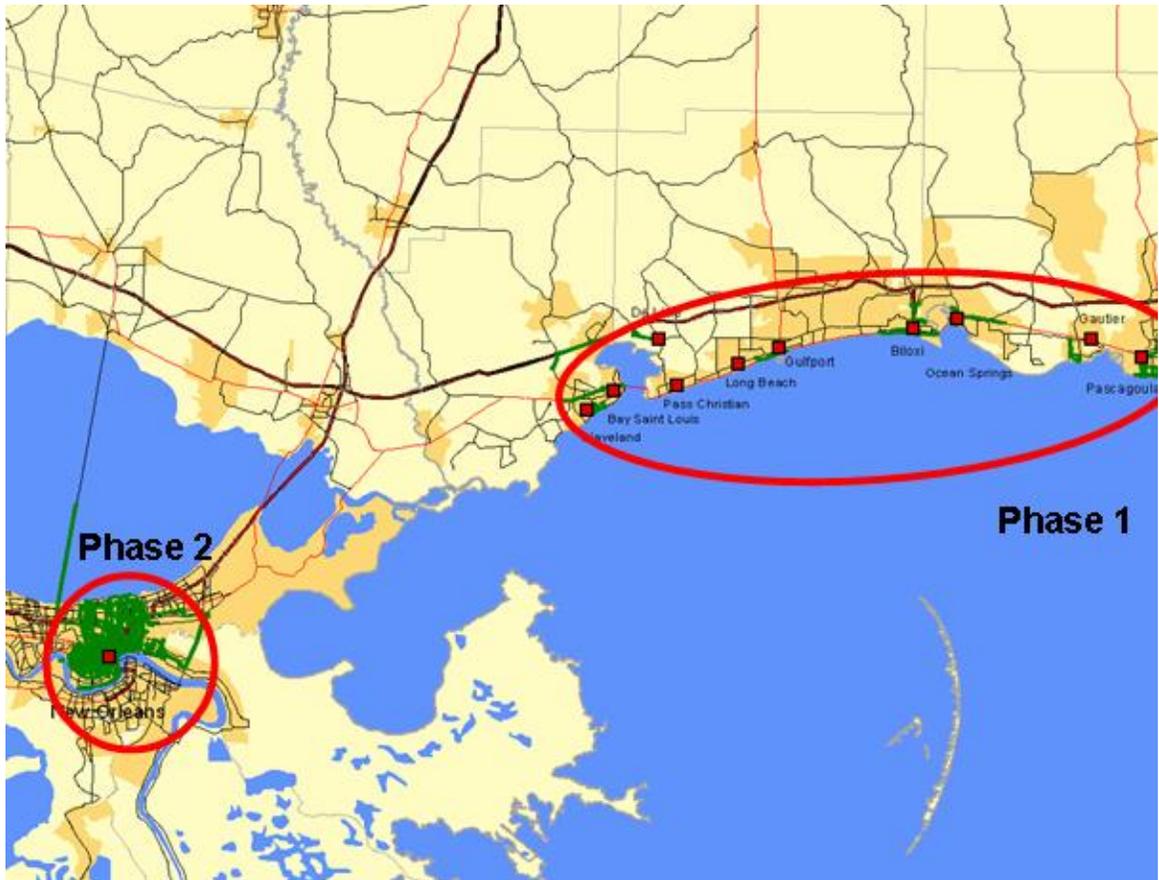
Figure 5-1. Geographic extent of the two-phased deployment showing the GPS route (green symbols) followed by the MCEER advanced technology field teams in coastal Mississippi (Phase 1) and New Orleans (Phase 2).

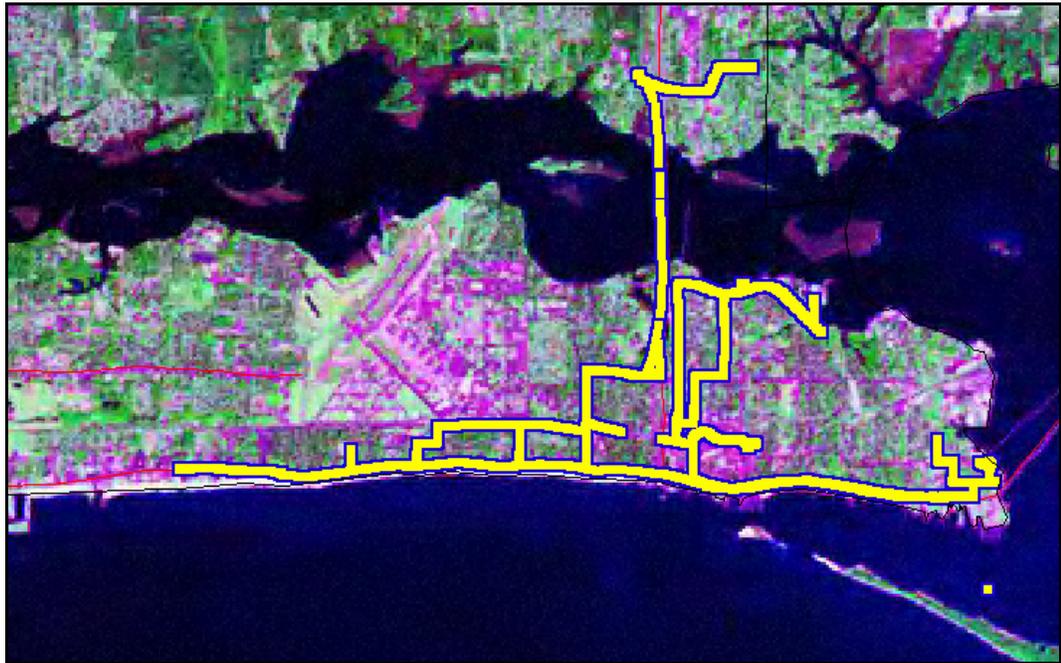
Figure 5-4. VIEWS™ deployment route in Biloxi, Mississippi.

Figure 5-4 shows the VIEWS™ deployment route within the coastal city of Biloxi. Biloxi experienced heavy wind damage to the cladding of several high-rise buildings. A few casinos on barges were washed ashore, and numerous spans of the U.S. Highway 90 bridge were removed from their supporting piers. Wind-pressure damage consisted of the loss of roof coverings on numerous buildings, the loss of cladding on tall buildings, and isolated structural damage to the roofs of low-rise buildings.

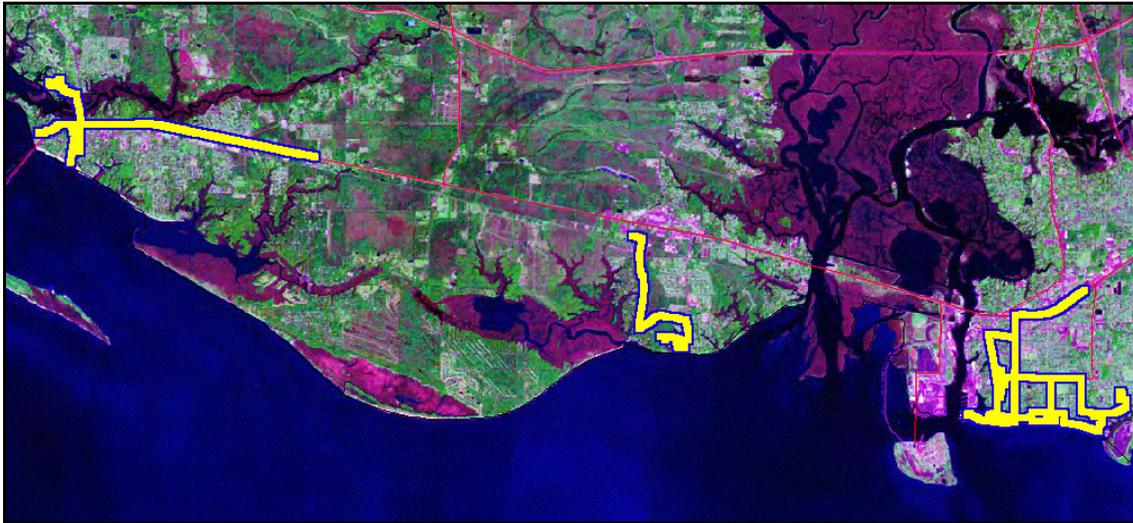
Figure 5-5. VIEWS™ deployment route in Ocean Springs, Gautier, and Pascagoula, Mississippi.

Figure 5-5 shows the routes surveyed by the MCEER advanced technology field team in Ocean Springs, Gautier, and Pascagoula. In Pascagoula, many homes along the beach were swept off their foundations by the storm surge, while other homes remained in place but lost ground-floor walls and contents to the storm surge. Several waterfront homes near Ocean Springs and Gautier also were swept from their foundations or showed evidence of the storm surge washing through their ground floors. The storm-surge damage in Ocean Springs, Gautier, and Pascagoula was primarily confined to the first-floor level of the homes. Overall wind-pressure damage was minor compared to other areas of the Mississippi Coast, and consisted primarily of partial loss of roof coverings, with isolated buildings sustaining more severe damage due to wind pressures.

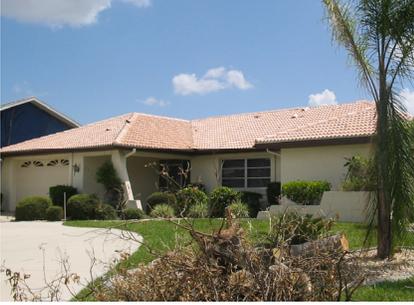
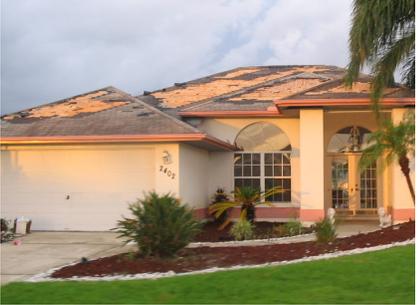
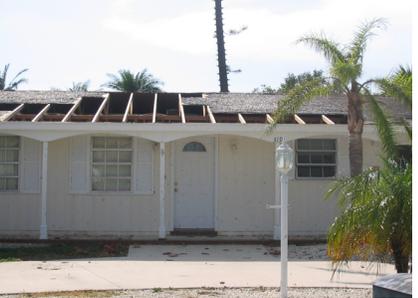
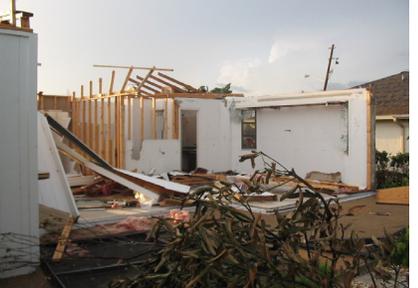
Table 5-3. Comparison of HAZUS-Hurricane and Remote Sensing Residential Building Damage Scales for a Full Range of Wind Damage States

| HAZUS-Hurricane Damage States (from Table 5.2) | Remote sensing Damage States (from Table 4.1) | Examples of Damage Observed in Field Studies |

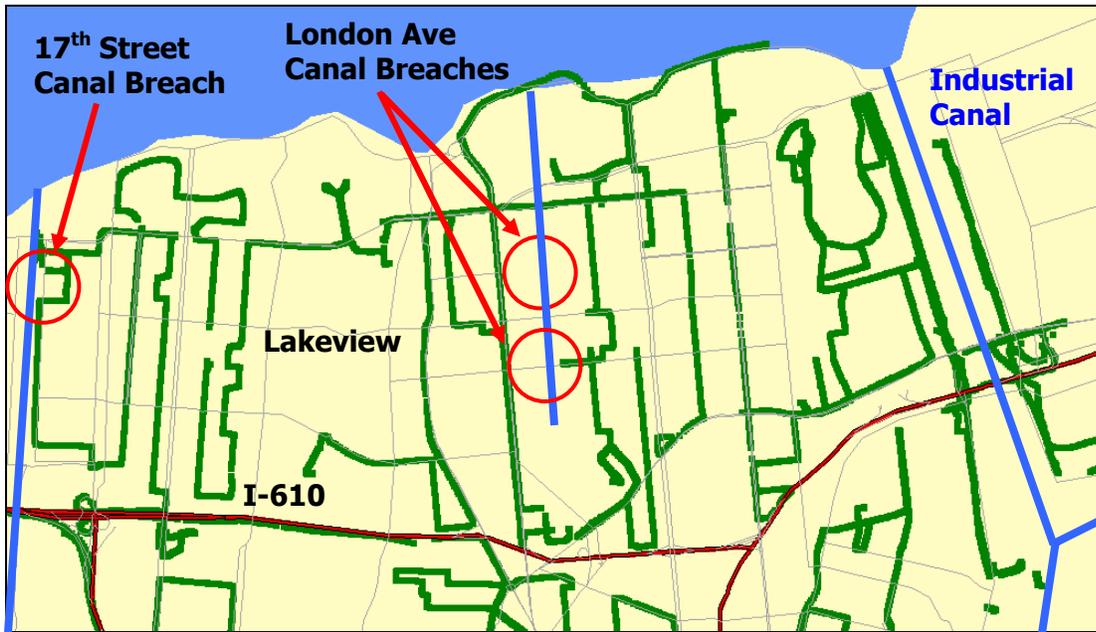
(a) Zone 1 map with GPS points shown in green

Zone 1 (Figure 5-8a) consists of the area between the 17th Street Canal and the Industrial Canal, north of I-610 in Orleans Parish. Buildings surveyed in this zone consisted primarily of residential buildings (approximately 95%), with some major educational institutions, government facilities, and parks. Two major levee breaches (along the 17th Street Canal and the London Avenue Canal) were located in this zone. The satellite image in Figure 5-8b shows the presence of floodwaters throughout this zone, as well as the GPS tracks delineating the survey route.

Figure 5-8. GPS points denoting the routes traversed in Zone 1 in New Orleans. The VIEWS™ system was used to record these routes with georeferenced HDV and digital photographs.

Inundation flooding, varying in depth from approximately 2 to 10 ft, was observed throughout this zone, while only minor damage from wind pressures was observed. Residential structures near the levee breaches were either severely damaged or completely destroyed by the velocity flooding. Some non-flooded residences were identified in the lakeshore areas and along Gentilly Boulevard but amounted to less than 10% of the residential structures surveyed in Zone 1.

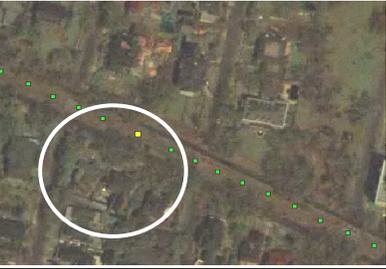
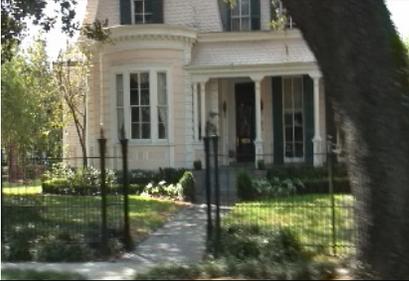
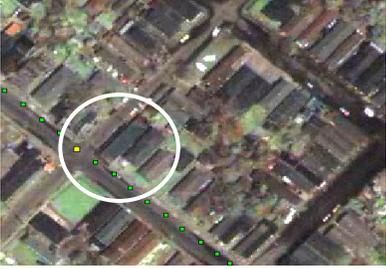
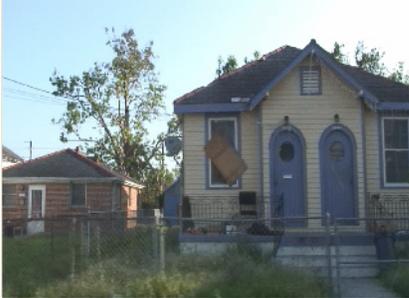
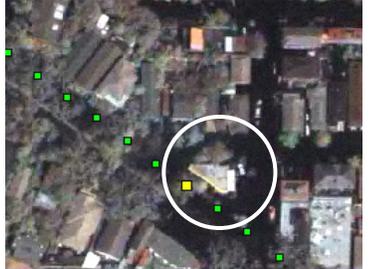
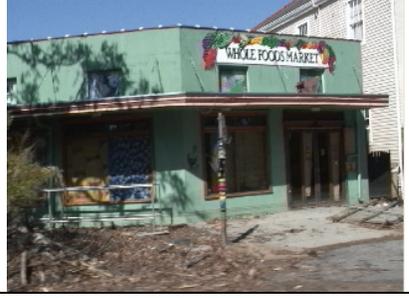
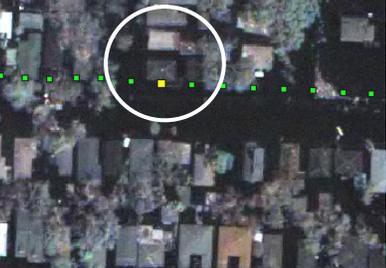
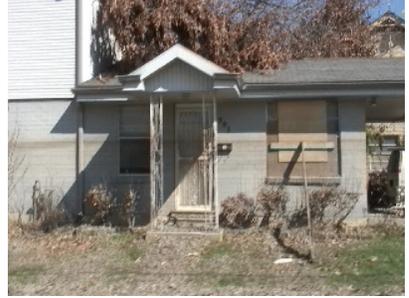
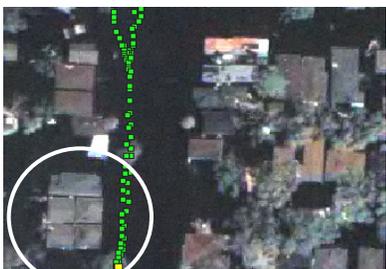
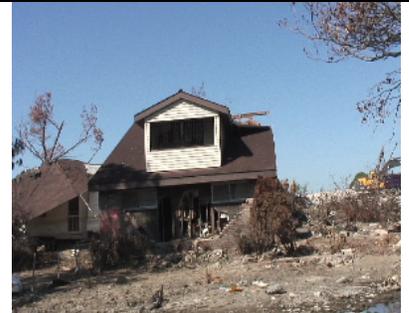
Figure 5-12(a). Classification of VIEWS™ data in New Orleans using the combined Wind and Flood (WF) Damage Scale of Table 5-5. Locations of these buildings are shown in Figure 5-12b.

The following sections provide examples of buildings in New Orleans that fall into each of the damage states described by the combined WF Damage Scale. Figure 5-12 provides examples of each damage state as depicted on high-resolution remote sensing imagery and VIEWS™ HDV ground observation data collected during the survey.

the assessed damage states (WF-0 to WF-4) of individual buildings according to the combined Wind-Flood (WF) Damage scale of Table 5-5. (Figure 5-12 provides examples of damage classification of VIEWS™ ground observation data collected during the survey.)

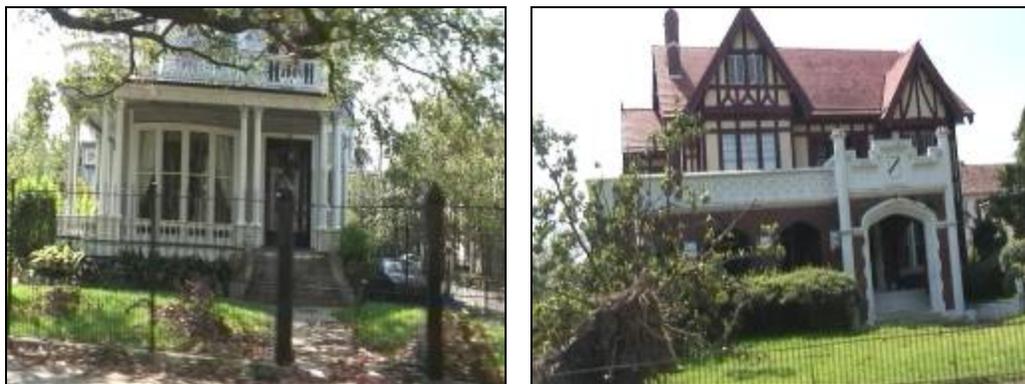
Figure 5-13. Examples of buildings in the Garden District area classified in the WF-0 ("No Damage or Very Minor Damage") category.

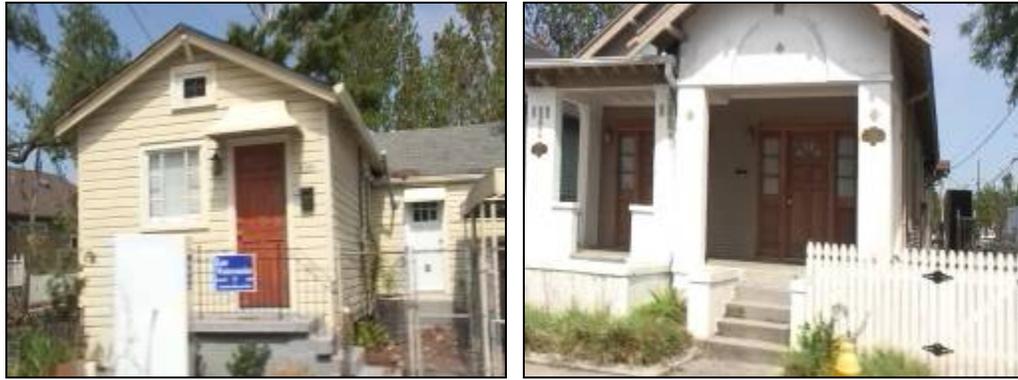
Figure 5-14. Examples of buildings classified in the WF-1 (“Minor Damage”) category in an area of no flooding.

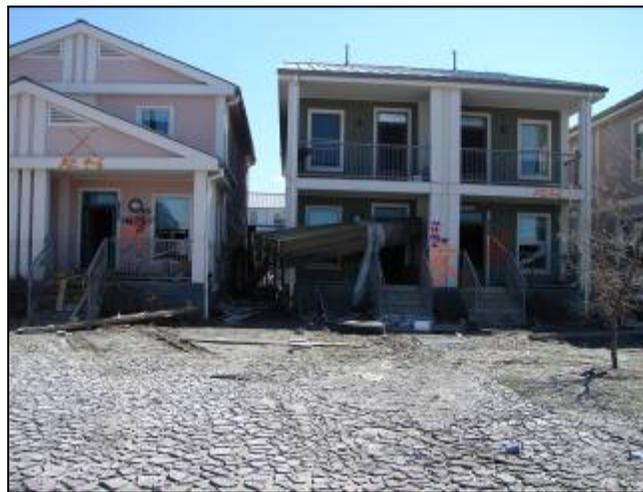
Figure 5-15. Example of buildings in the WF-2 (“Moderate Damage”) category in a newly developed neighborhood.

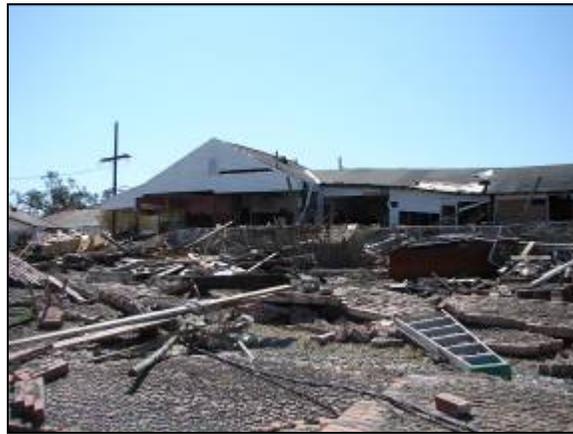
Figure 5-16. Examples of buildings in the WF-3 (“Severe Damage”) category, in an older section of eastern New Orleans.

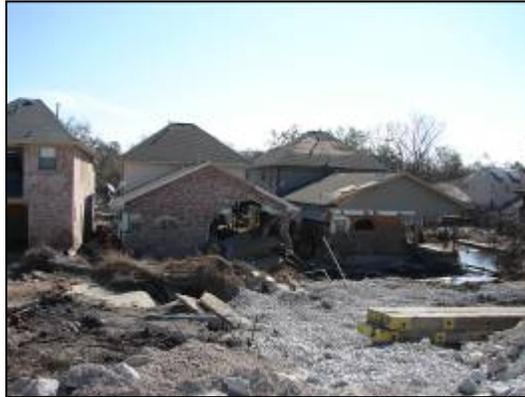
Destruction was observed for homes where flood depth above the finished floor exceeded 8 feet. Many homes in the high-velocity flood area (at levee breaches) also fell into this category because of the structural failure caused by the moving water. For most houses in this category, damage attributed directly to wind pressures would be classified as either “Minor Damage” or “Moderate Damage,” consistent with observations that wind-pressure damage was secondary to flooding damage for a majority of buildings in New Orleans. Examples of buildings in the WF-4 damage state are given in Figures 5-17 and 5-18.

Figure 5-17. Standing buildings within the high-velocity flooding zone adjacent to the 17th Street Canal levee breach. These buildings exemplify the WF-4 (“Destruction”) damage state.

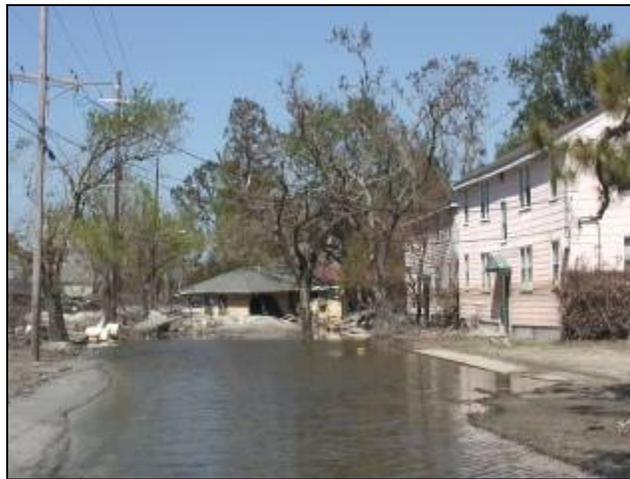
Figure 5-18. Building washed away from its foundation in a high-velocity flooding zone adjacent to the London Avenue Canal levee breach. This building is representative of the WF-4 (“Destruction”) damage state.

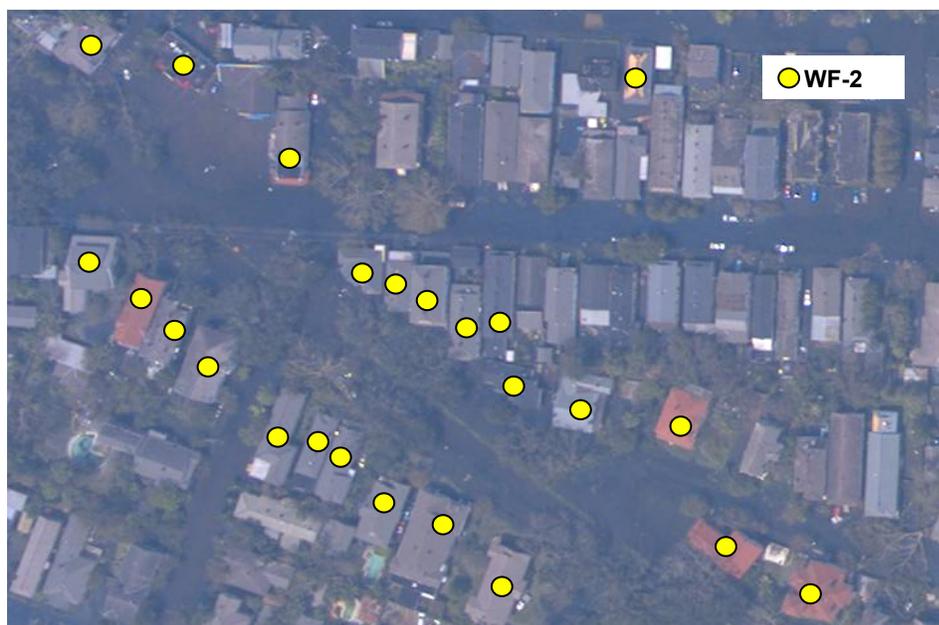
Figure 5-21. Example of per-building visual assessment of combined wind and flood damage showing buildings with Damage State WF-2.
