Engineering and Organizational Issues Before,
During and After Hurricane Katrina

Advanced Damage Detection for Hurricane Katrina:
Integrating Remote Sensing and VIEWS™
Field Reconnaissance

J. Arn Womble, Shubharoop Ghosh, and Beverley J. Adams (Team Leader)
ImageCat, Inc.

March 2006

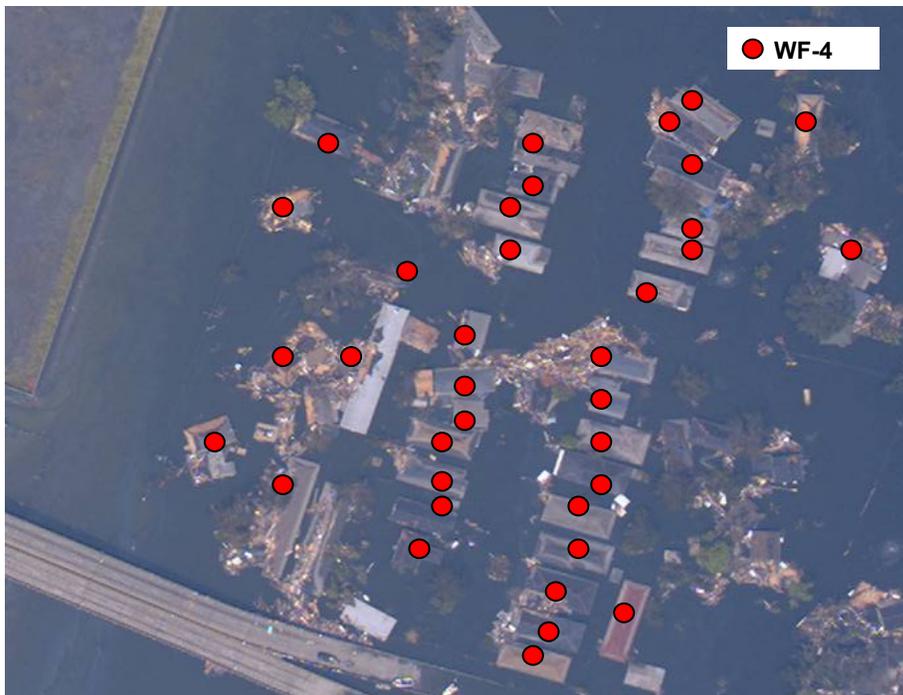
Destruction was observed for homes where flood depth above the finished floor exceeded 8 feet. Many homes in the high-velocity flood area (at levee breaches) also fell into this category because of the structural failure caused by the moving water. For most houses in this category, damage attributed directly to wind pressures would be classified as either “Minor Damage” or “Moderate Damage,” consistent with observations that wind-pressure damage was secondary to flooding damage for a majority of buildings in New Orleans. Examples of buildings in the WF-4 damage state are given in Figures 5-17 and 5-18.

Figure 5-23. Example of per-building visual assessment of combined wind and flood damage showing buildings with Damage State WF-4.

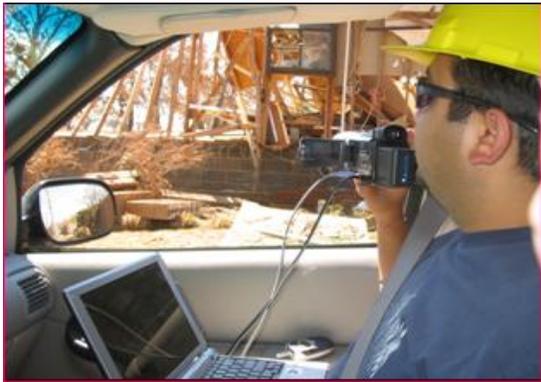
Figure 6-5. Examples of the VIEWS™ reconnaissance system deployed in Mississippi and New Orleans following Hurricane Katrina.

As described in Chapter 5, the Data Collection module of the VIEWS™ system was used to acquire a library of post-Hurricane Katrina imagery, the potential applications of which include ground truthing. During field reconnaissance activities, MCEER advanced technology field teams collected more than 27 hours of georeferenced HD video in Mississippi and New Orleans, from which a library of approximately 46,000 still images were extracted. Figure 6-5 shows the VIEWS™ Data Collection module in action.

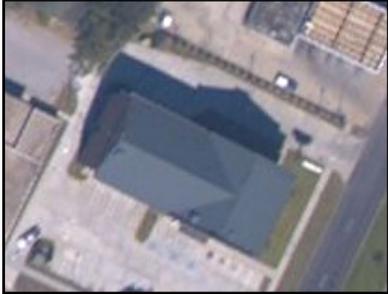
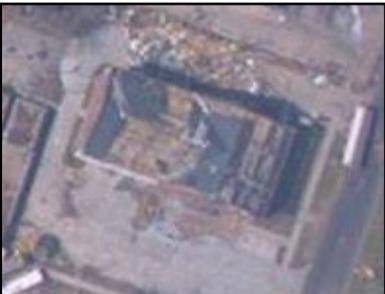
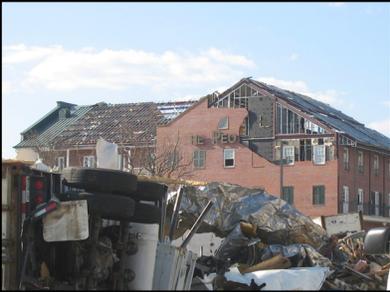
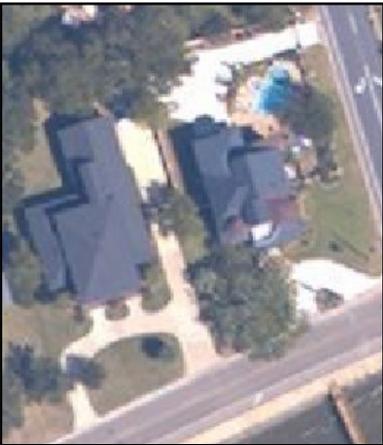
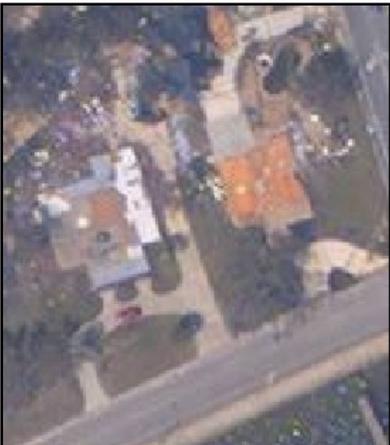
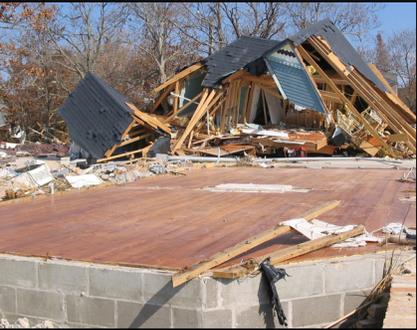
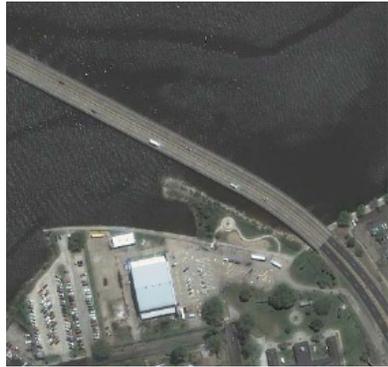
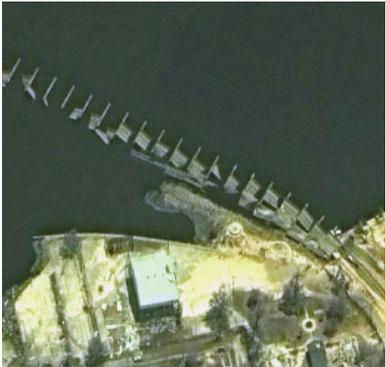
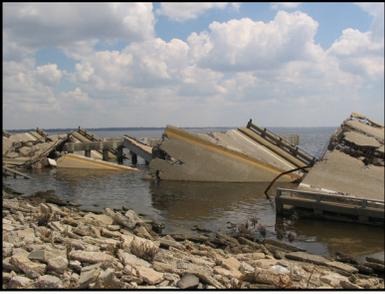
| Remote sensing Images | | Ground-Truthing Images |
|---|---|---|
| <i>Wind Pressure - industrial</i> | | |
| <i>Storm Surge - residential</i> | | |
| <i>Storm Surge - infrastructure</i> | | |

Figure 6-7. Examples of pre-storm and post-storm remote sensing imagery with corresponding ground-truthing images.

Through the use of Hurricane Katrina VIEWS™ data, comparable correlations can be made for other hazards, such as flooding and storm surge, in addition to further validation of wind-pressure relationships. Although present research has concentrated on residential buildings, correlations may also be developed for alternate construction and/or occupancy classes (e.g., commercial and industrial properties) and for additional infrastructure elements, including roads, bridges, and utility lifelines. Figure 6-7 illustrates the way in which integrated remote sensing data and in-field observations provide the building blocks for new damage scales incorporating these

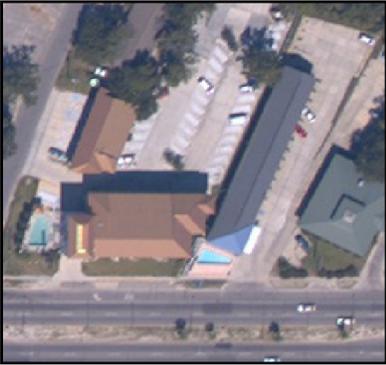
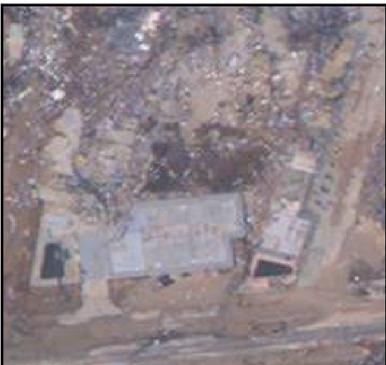
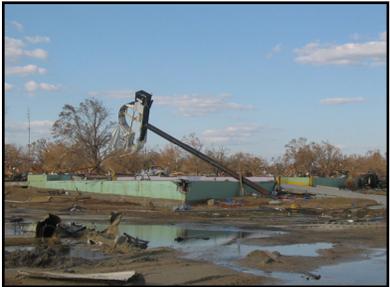
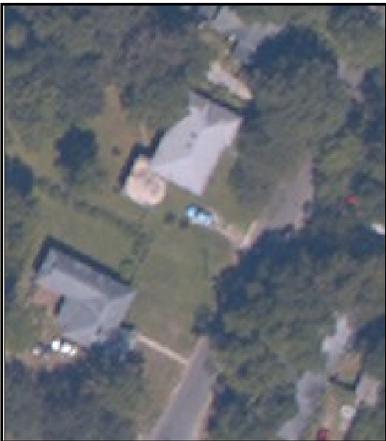
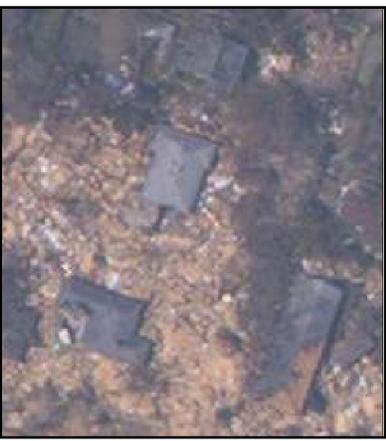
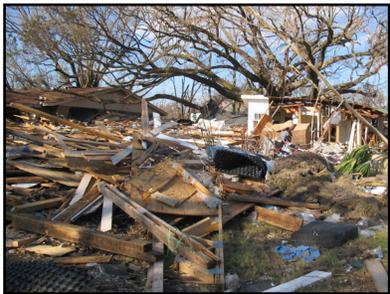
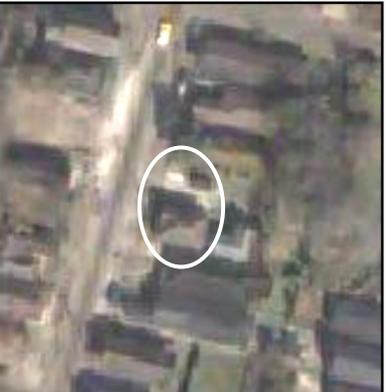
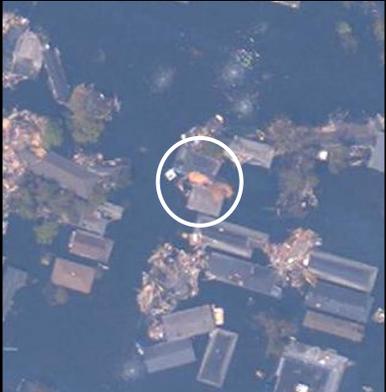
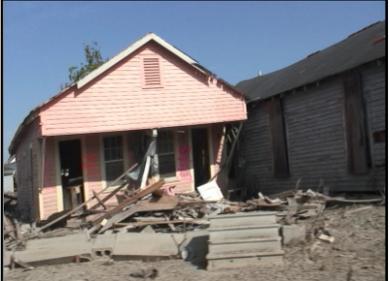
| <p><u>Storm Surge – hotel</u></p> <p>Photo Credit: NOAA</p> | <p>Photo Credit: NOAA</p> | |
| <p><u>Storm Surge - residential</u></p> <p>Photo Credit: NOAA</p> | <p>Photo Credit: NOAA</p> | |
| <p><u>Flooding- residential</u></p> <p>Photo Credit: DigitalGlobe and Google Earth</p> | <p>Photo Credit: NOAA</p> | |

Figure 6-7 (continued). Examples of pre-storm and post-storm remote sensing imagery with corresponding ground-truthing images.

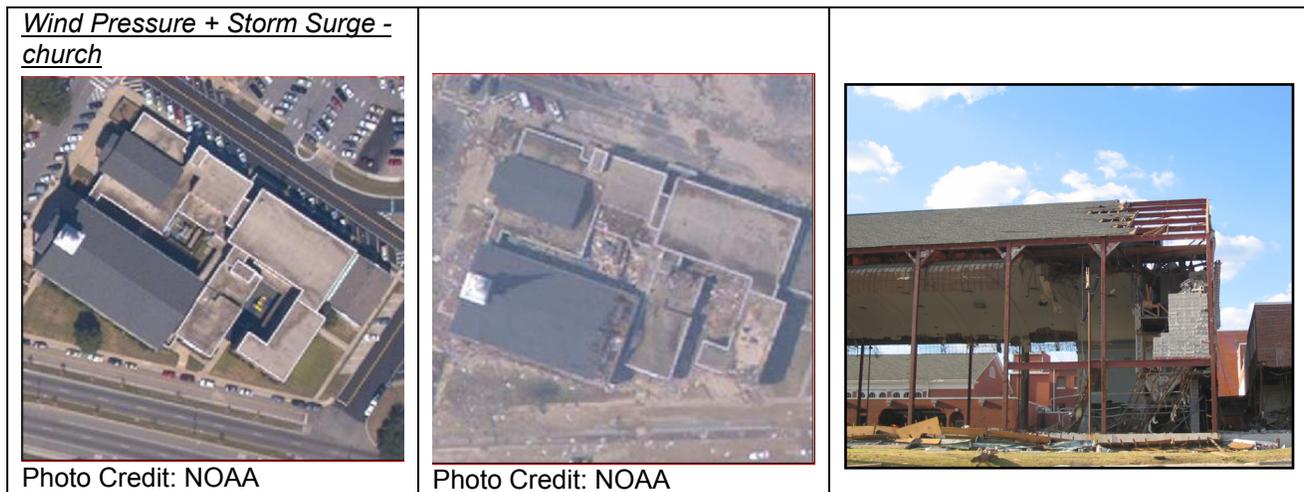
Figure 6-7 (continued). Examples of pre-storm and post-storm remote sensing imagery with corresponding ground-truthing images.
