DAMAGE TO THE HIGHWAY SYSTEM FROM THE PISCO, PERU EARTHQUAKE OF AUGUST 15, 2007

Technical Report MCEER-07-0021

This damage assessment report is the product of a field investigation undertaken in September 2007 after the M_w 8.0 August 15, 2007 Pisco, Perú earthquake. It provides a brief description of the event and the consequential damage to the highway system. It relies on government reports issued immediately after the event that include investigations from leaders in Perú's academia, and the authors' field observations. The purpose of the report is to document the performance of structures designed according to AASHTO specifications and to help assess the adequacy of the standards used at the time of construction. Another important benefit of the task is the exchange of information for the mutual benefit of engineers and policy makers here in the U.S. and in Perú.

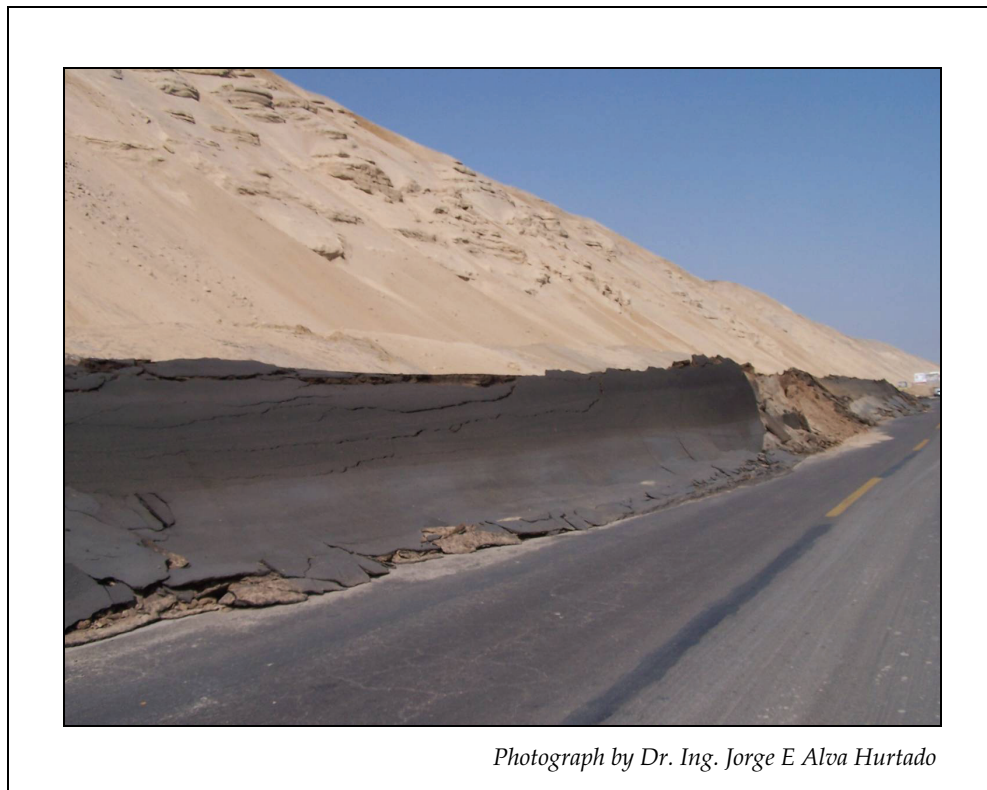
Figure 5-2. East shoulder of Pan-American Highway at km 178 pushed up onto sand dune after lateral displacement of roadway during liquefaction and “sloshing” of supporting ground.

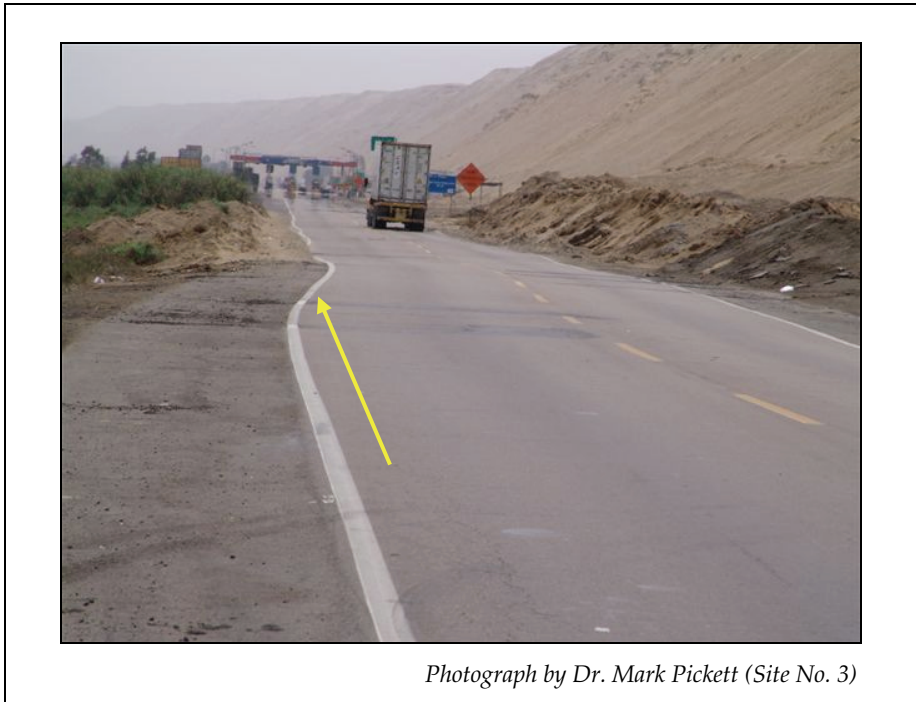
Figure 5-4. Note the white edge line. This is evidence of lateral displacement of the roadway at km 188 due to liquefaction at the toe of slope and reflection of seismic ground waves against the more rigid sand dune on the east side of the highway.

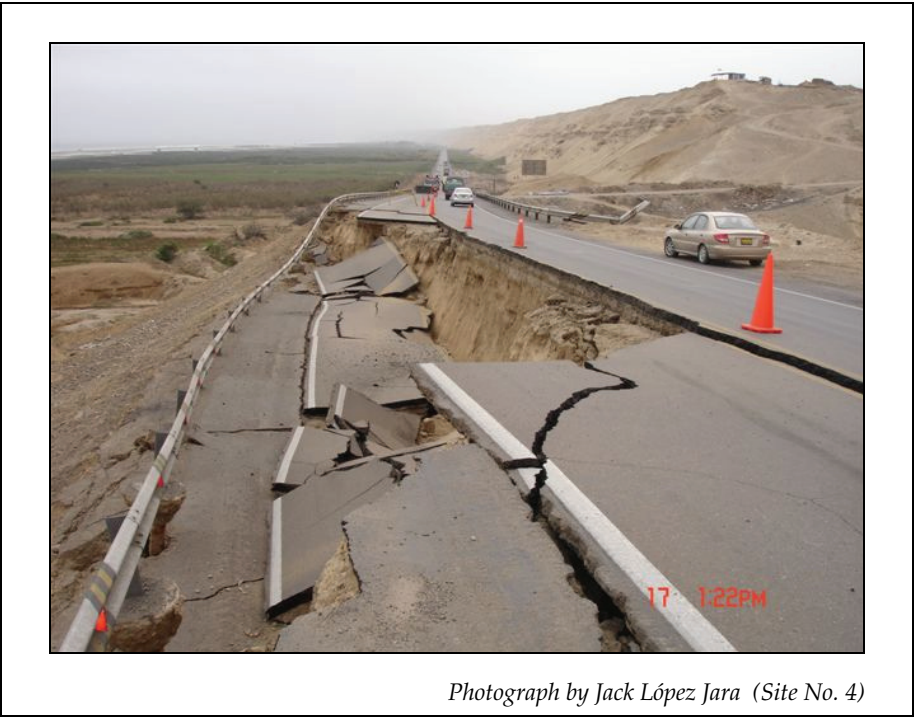
Figure 5-6. Embankment and roadway failure at km 190. The picture was taken facing north. Note the Pacific Ocean in the top left of the photo. The damage was caused by amplification of the ground shaking. Liquefaction of the wet coastal silts and sands led to lateral spreading and the embankment failure.

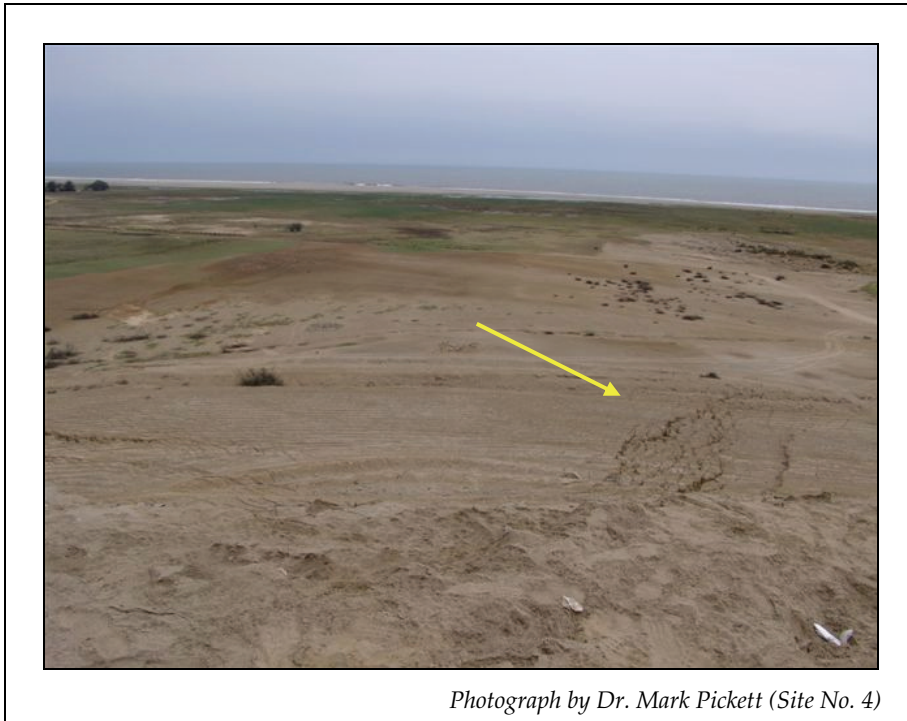
Figure 5-7. View from the Pan-American Highway looking West toward the Pacific Ocean. Notice the cracking of the earth from liquefaction and lateral spreading that led to the massive embankment failure at km190

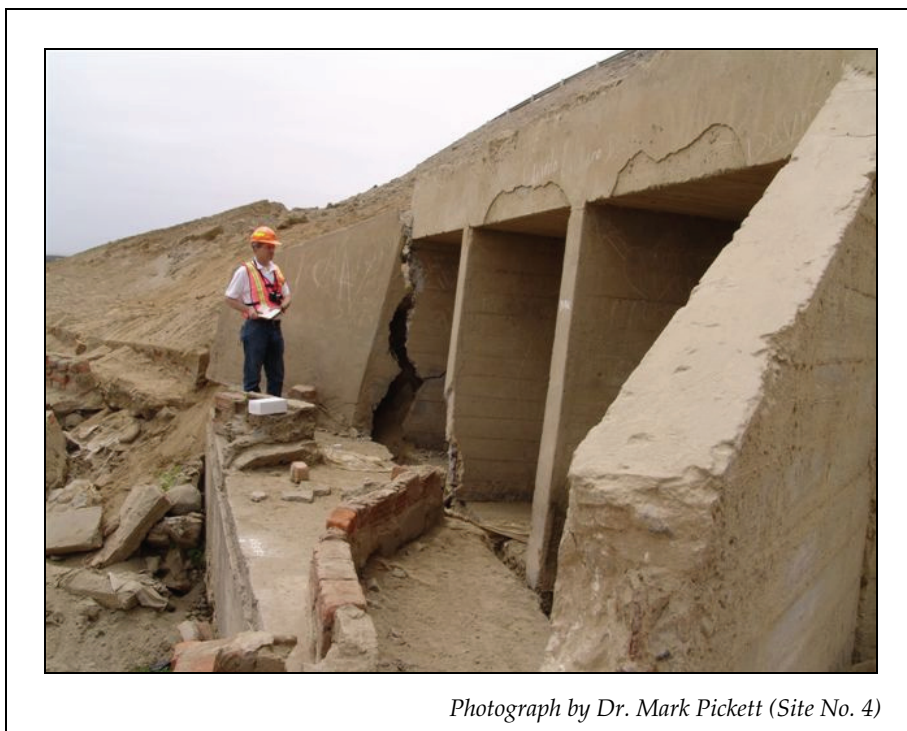
Figure 5-8. Outlet end of failed box culvert at km 190.

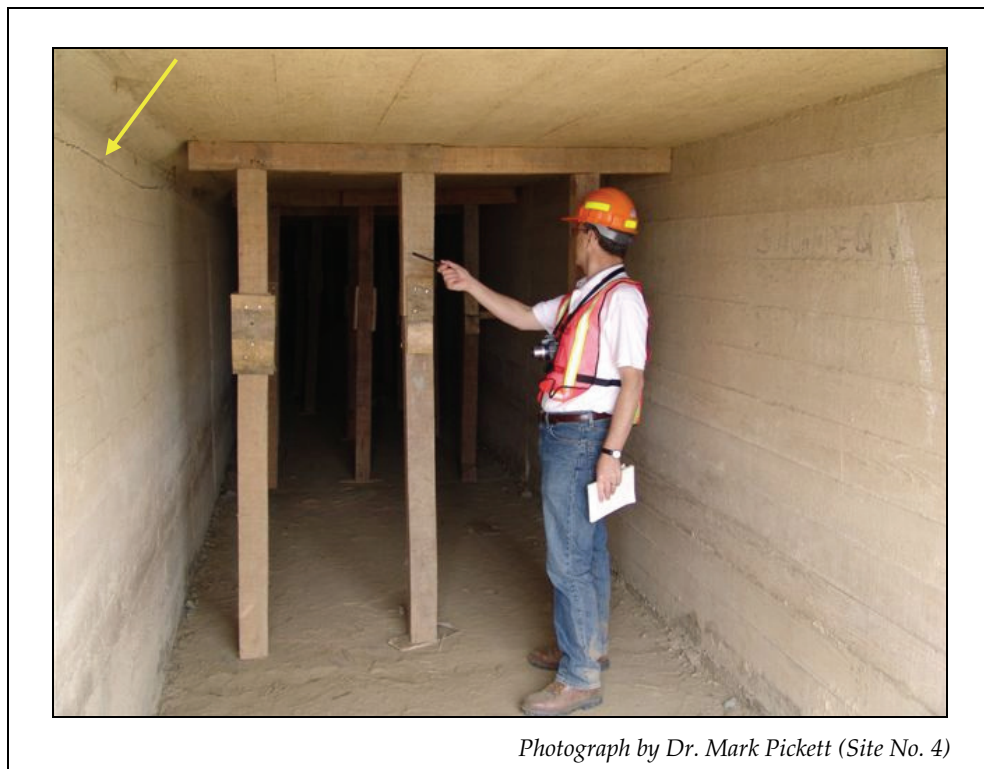
Figure 5-10. Timber shoring and a horizontal crack in a concrete box culvert km 190.

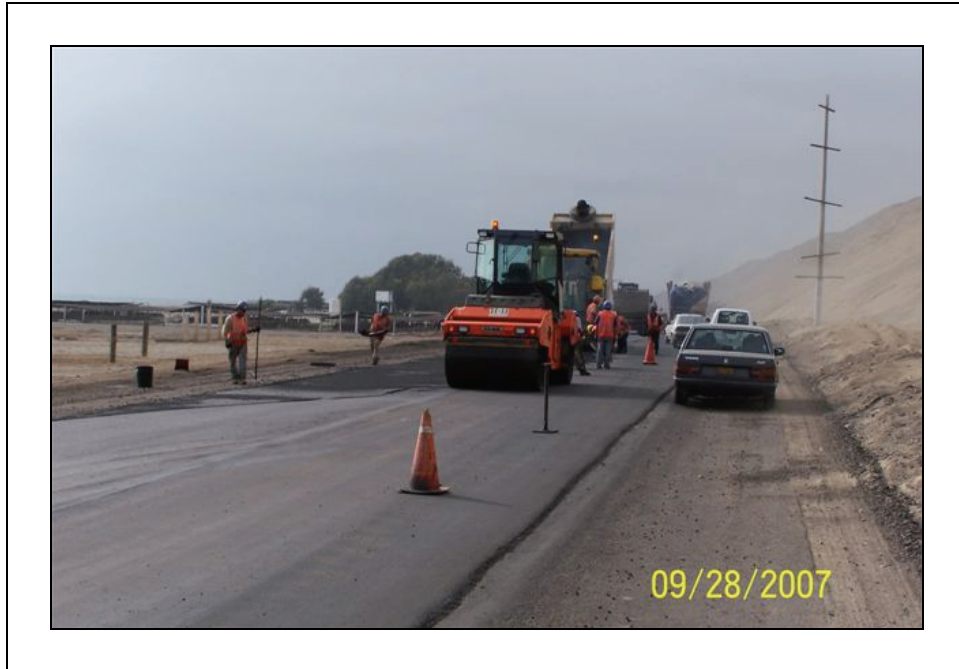
Figure 5-15. This is one of the many sections of the Pan-American Highway that needed pavement repairs after the earthquake. Paving was still going on six weeks after the event.

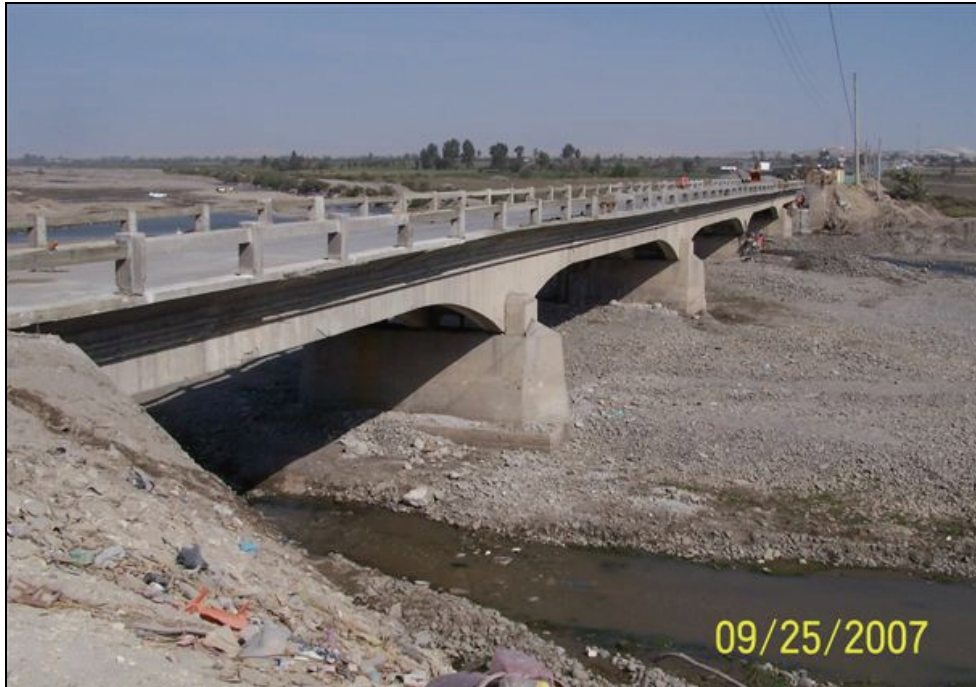
Figure 5-16. Five-span Humani Bridge on the Pan-American Highway at km 224

Although all five spans of the bridge remain standing, there was evidence of liquefaction in the sandy soils and evidence of strong shaking (see figures 5-16 through 5-26). The abutments and piers are built on massive walls, similar to caissons but are not supported by piles. According to record plans obtained by Ing. Jack López Jara, the 4 m (13.1') high pier stems rest on solid concrete caissons that are founded 7.8 m (25.6') into the stream bed. There was no indication of tipping or settlement of the piers.

a. This bridge was still closed for repair five weeks after the earthquake

Prior to the earthquake, the government had already been planning to build a new bridge at this site within the next few years. A few suggestions are provided in Appendix B of this report.

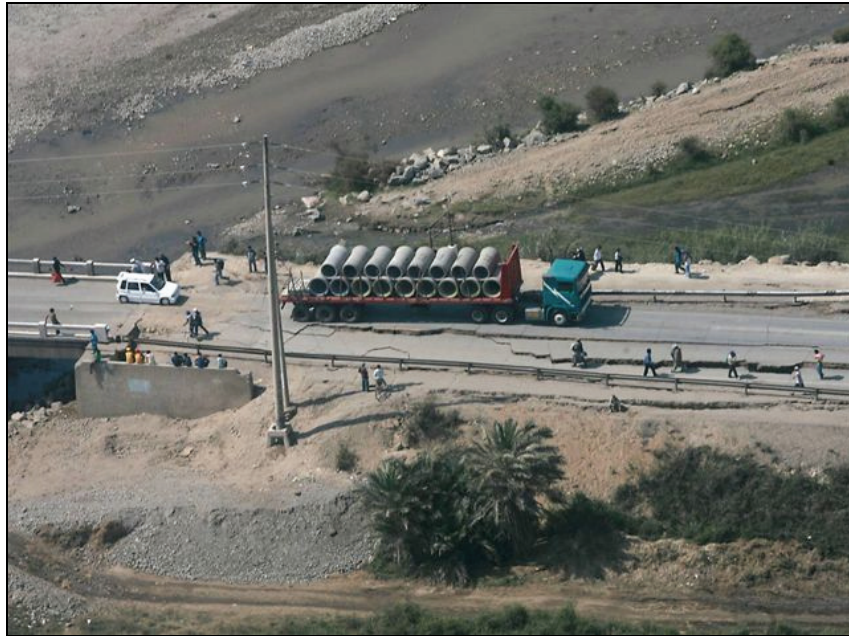
Photograph by Dr. Aloa (Site No. 5)

Figure 5-17. Pavement damage at the approach to the Huamani Bridge caused by soil liquefaction and lateral spread of embankments.

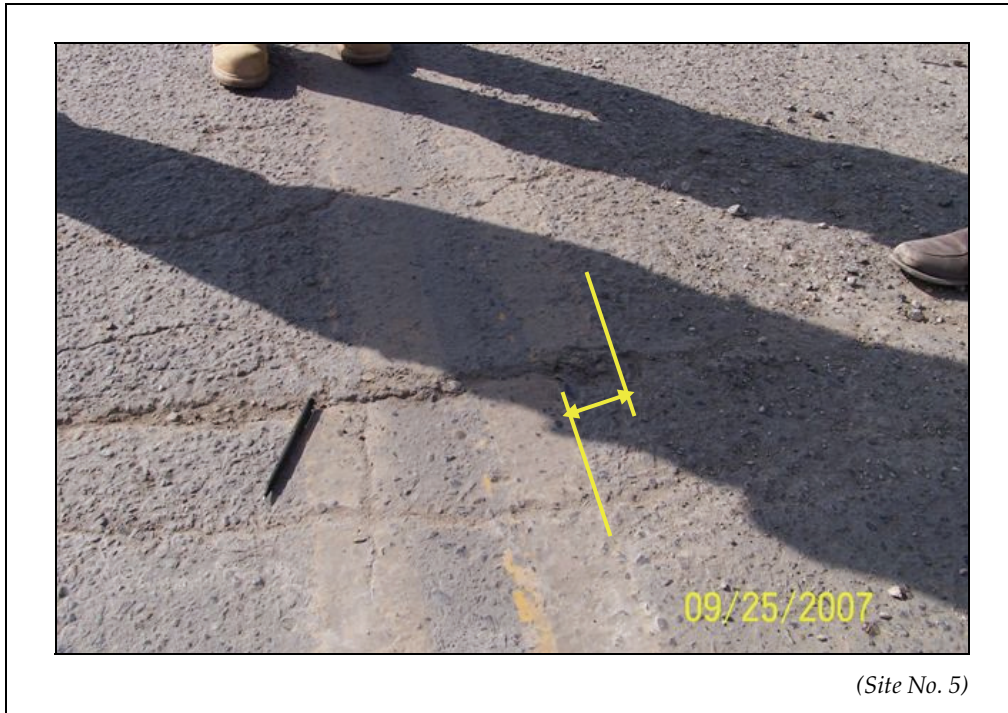
(Site No. 5)

Figure 5-21. Horizontal displacement of the superstructure is evident by the shift in the centerline at a joint

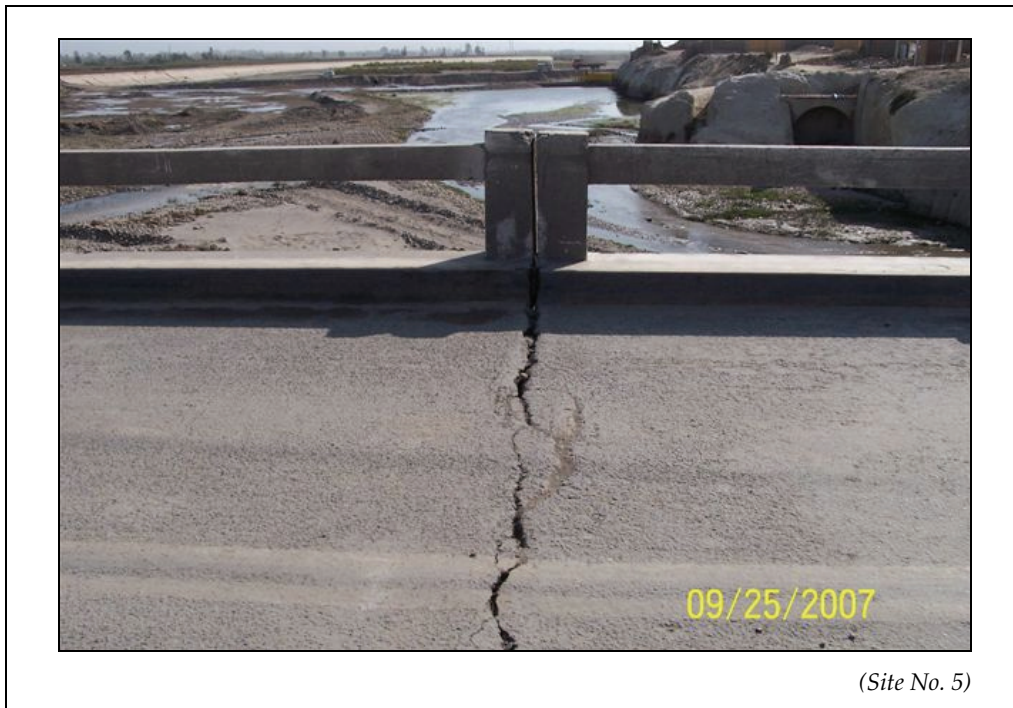
(Site No. 5)

Figure 5-22. Cracked deck due to horizontal movement of the span.

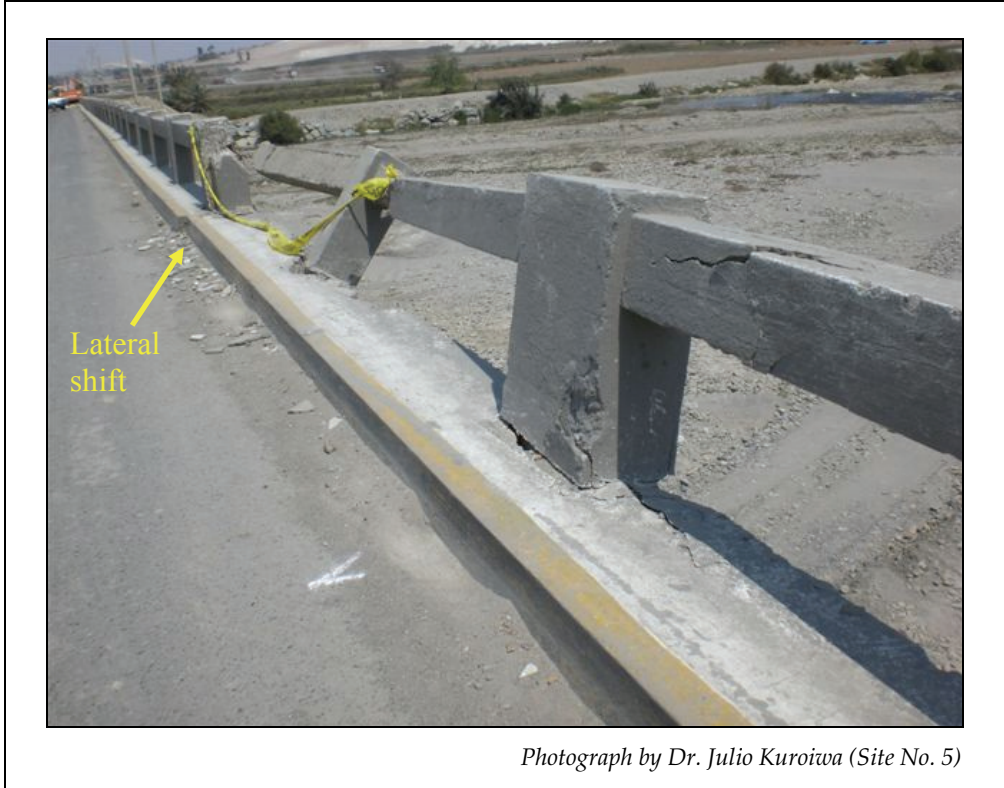
Photograph by Dr. Julio Kuroiwa (Site No. 5)

Figure 5-23. Broken railing and shift in curbside resulting from lateral movement of the span. Corrosion probably played a role in failure of the barrier.

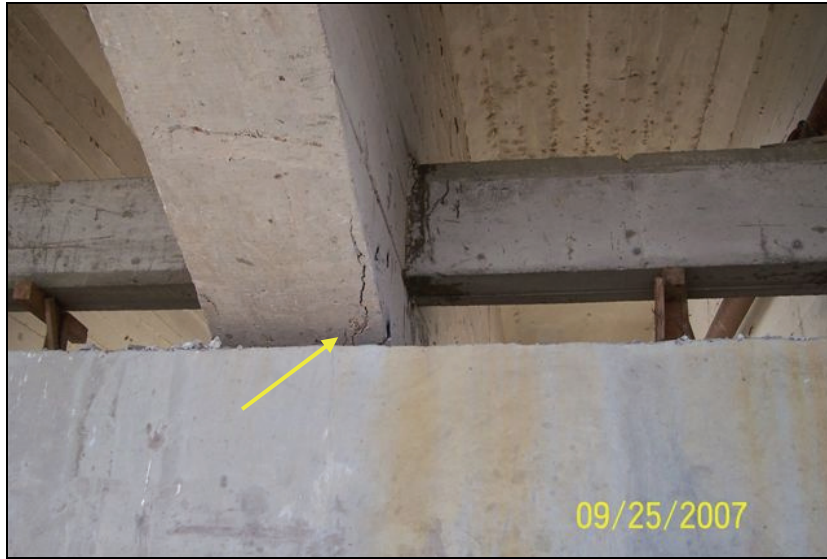
a. Interior beam

Figure 5-25. Crack at end of concrete beam due to horizontal loading at a pier with fixed bearings.

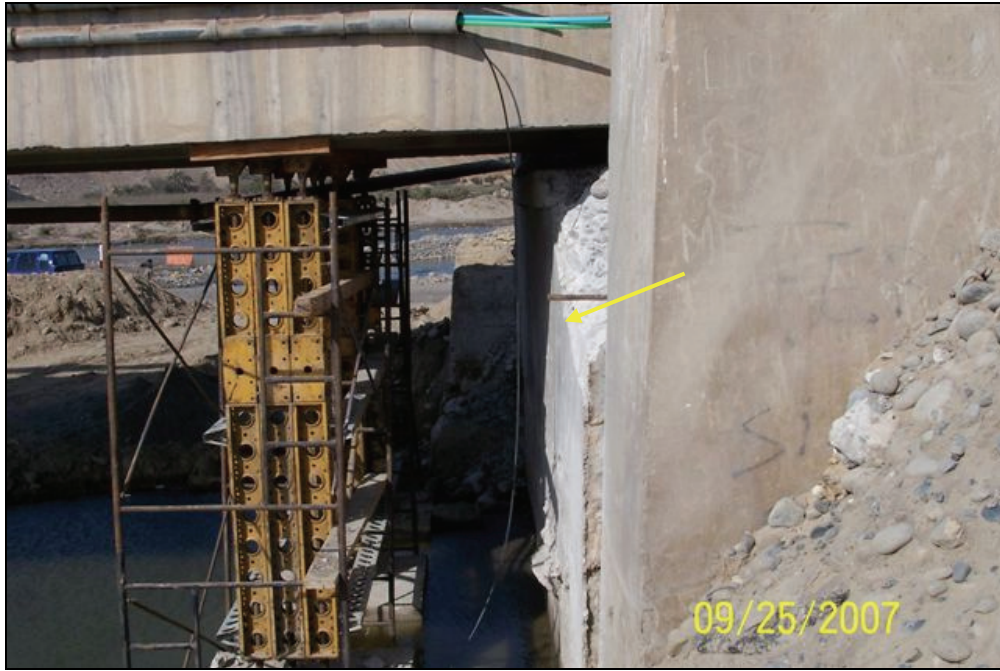
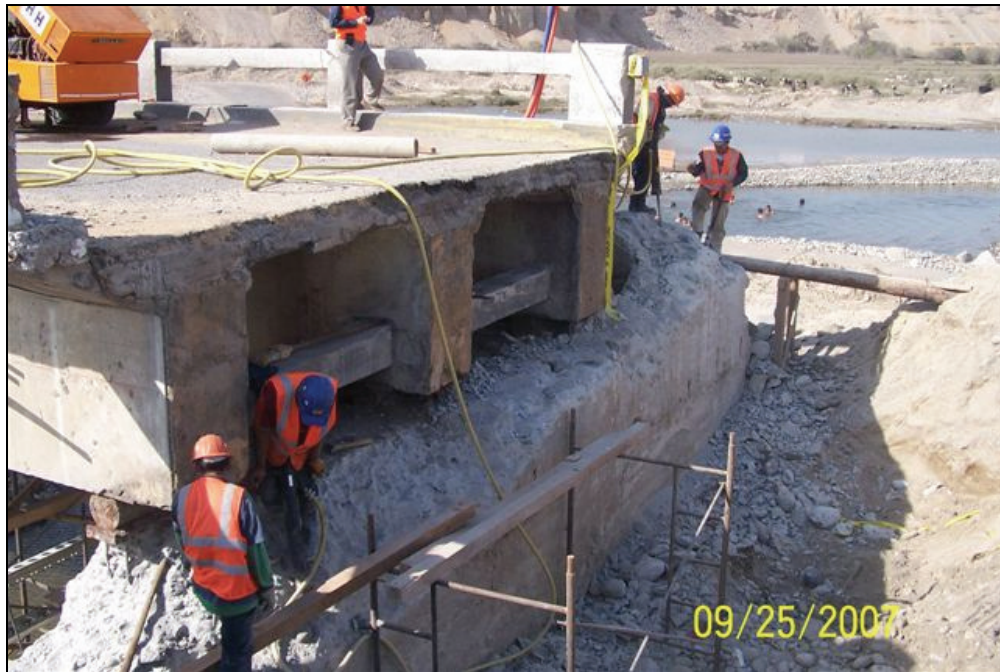
a. South end of span is supported while tipped abutment is replaced

b. Ongoing reconstruction of South Abutment

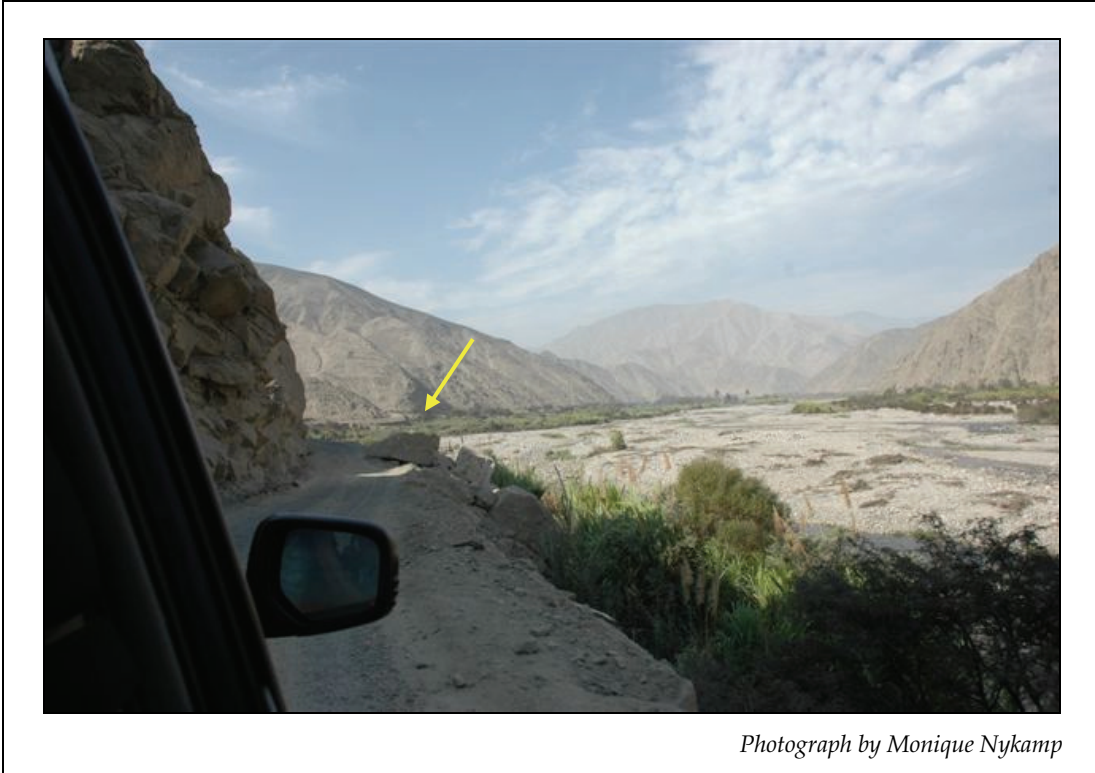
Figure 5-28. Typical terrain along Departmental Route 100. The road tracks the mountain on the left and is subject to rockfalls as is seen in this photo.

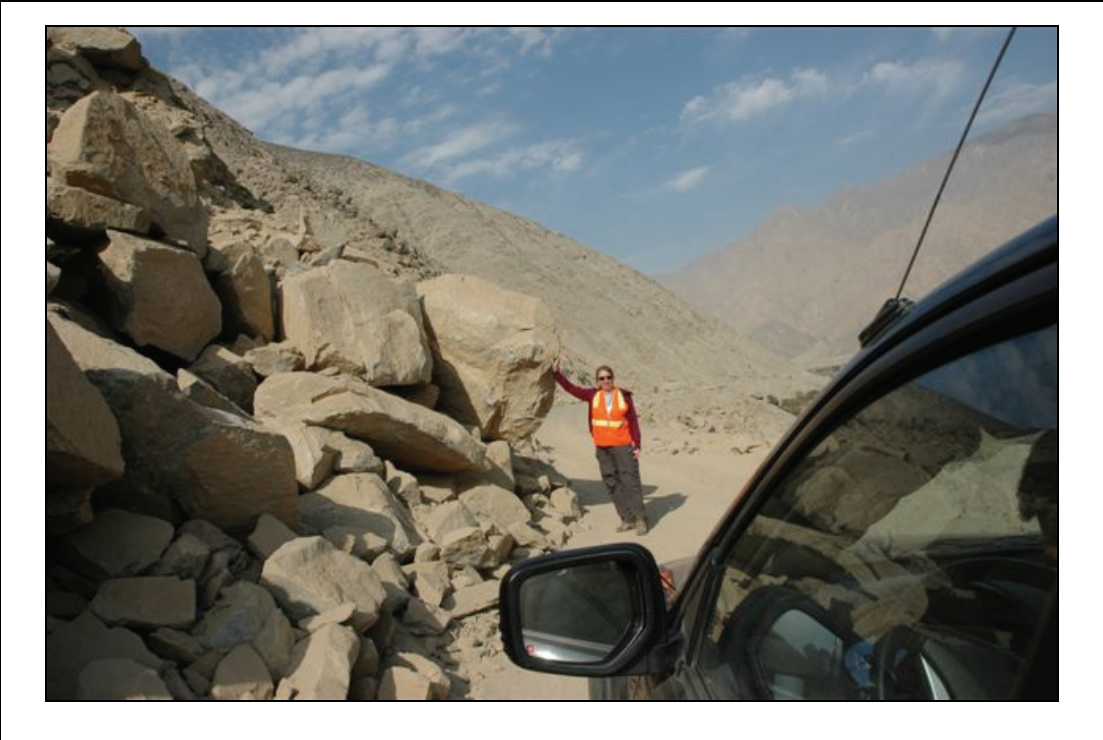
Figure 5-29. Monique Nykamp and remains of several rockfalls that blocked Departmental Route 100 at km 29.

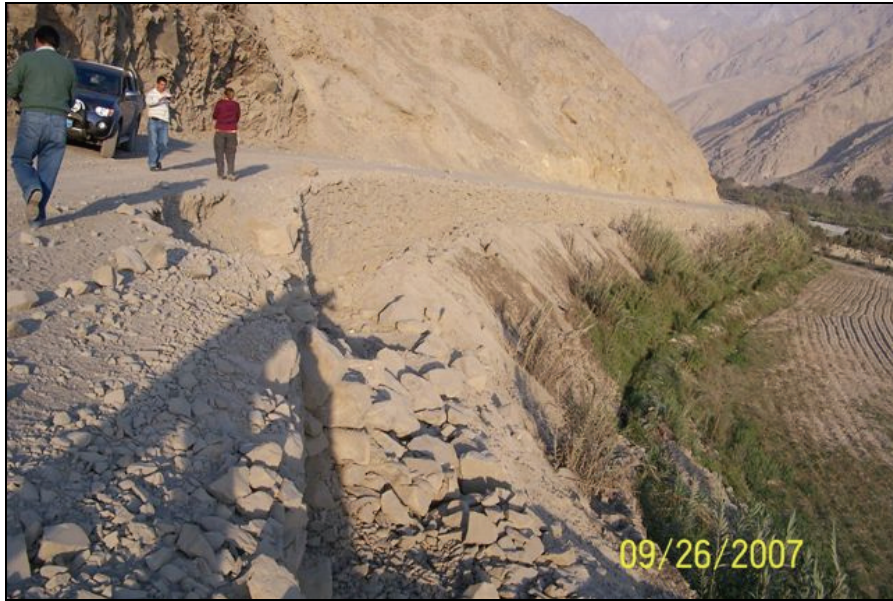
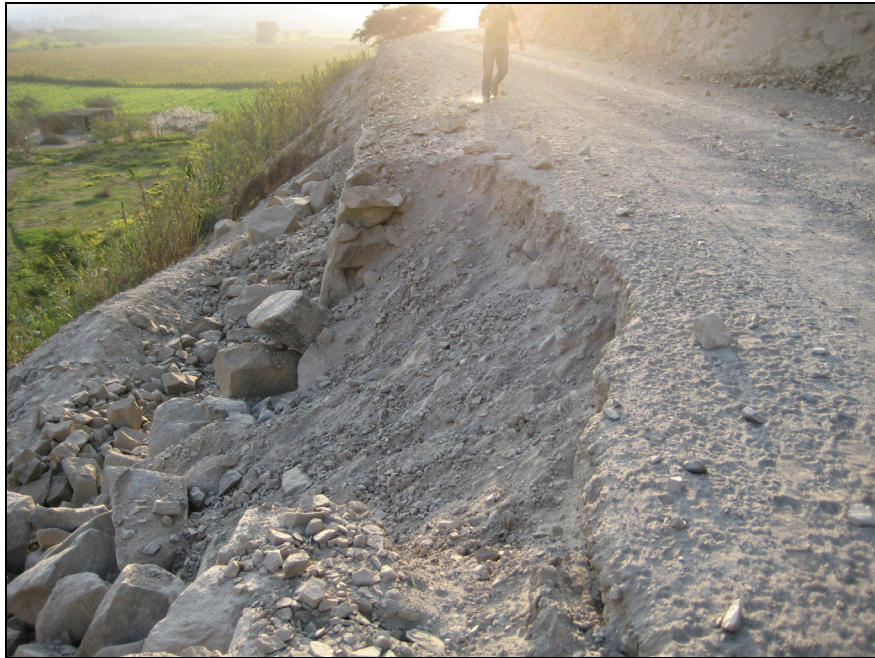
Figure 5-30 Damage on Route 100 at km 27

a. Failed retaining wall

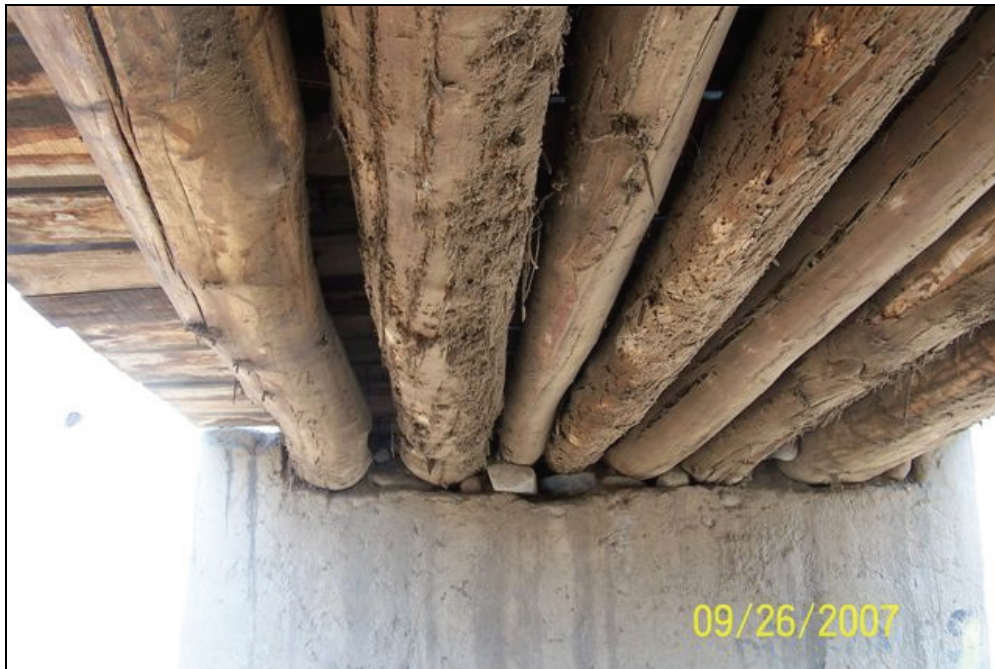
(Site No. 6)

Figure 5-32. Being relatively light, this one-span log bridge fared well in the earthquake.

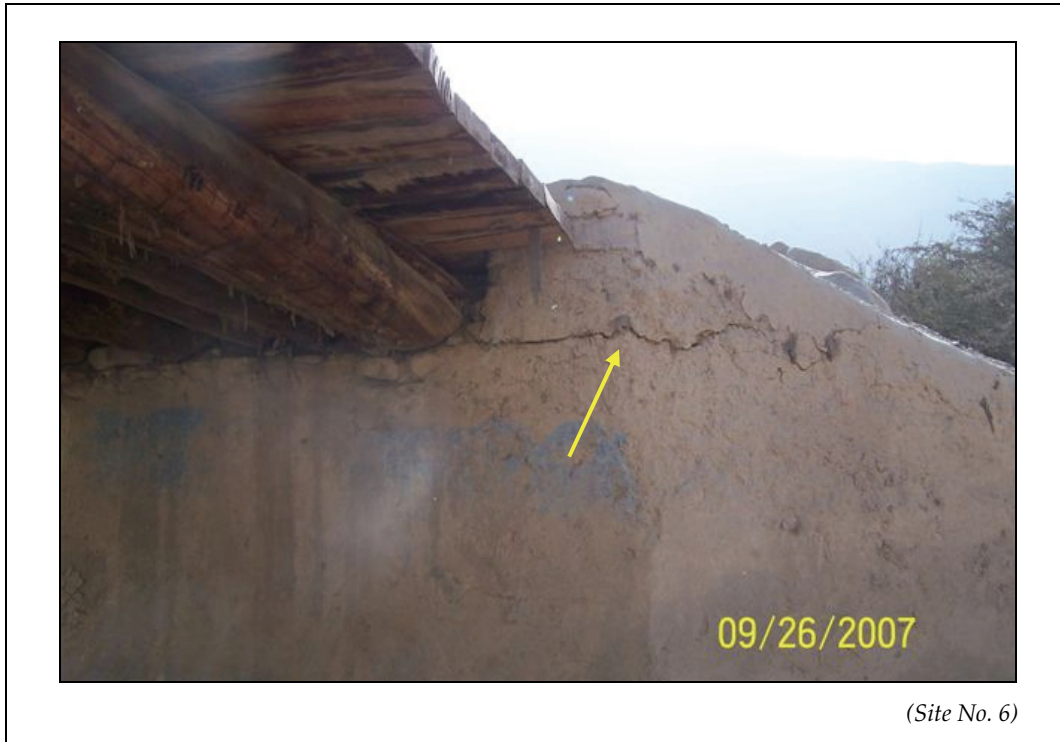
(Site No. 6)

Figure 5-33. Slight cracking may have been from horizontal loads imposed by the superstructure.

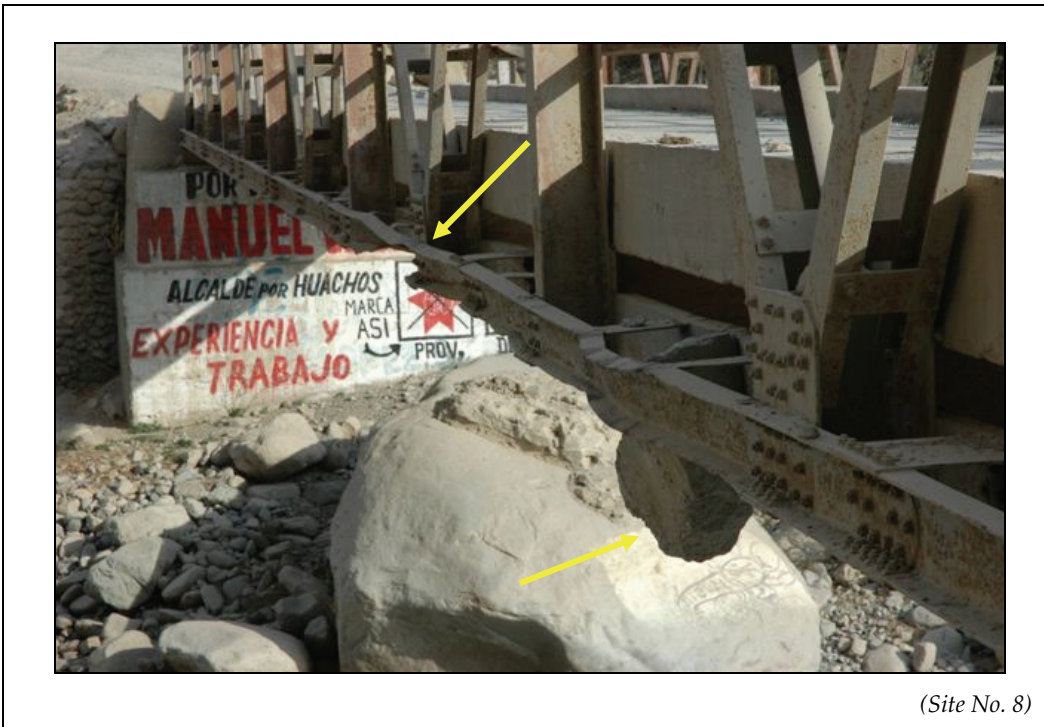
(Site No. 8)

Figure 5-36. Puente Huachinga at km 39. This steel truss bridge has suffered severe damage to the bottom chord from presumably previous debris impact (top arrow). There is a large granite boulder jammed between the two channels of the bottom chord that has fallen from the adjacent mountain from this earthquake (bottom arrow).

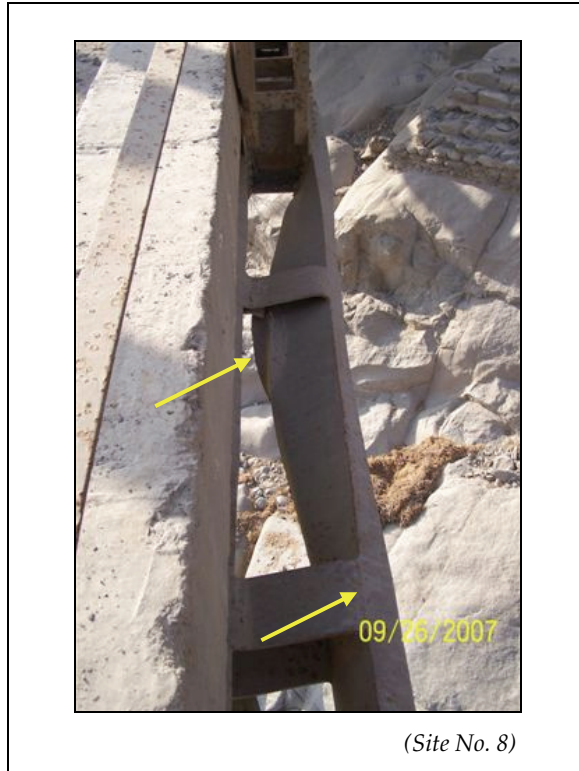
Figure 5-37. Puente Huachinga at km 39. It is uncertain whether this bottom chord damage was caused by falling boulders from this event or whether it remains from a previous hazard, such as El Niño effect flooding that last occurred in 1998. This deformation can limit the capacity of this tension member and put additional stress in the undamaged channel. Figure 5-38 shows a close-up of the crack that the lower arrow is pointing to.

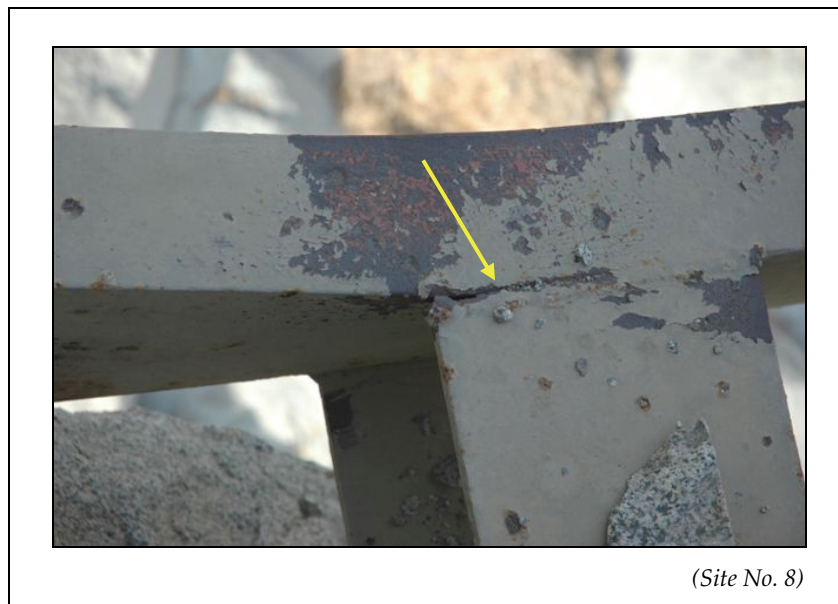
Figure 5-38. Cracked weld along bottom chord resulting from distortion of the channel after impact from debris. There is potential for this type of crack to propagate into the primary member and cause sudden failure.

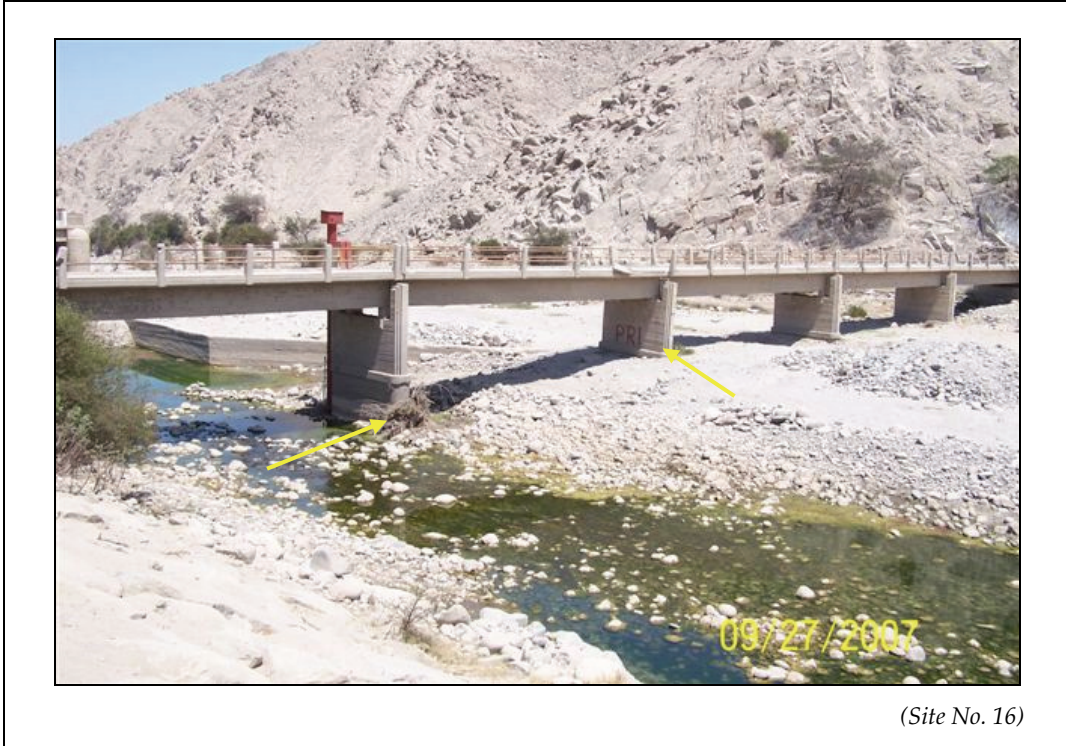
(Site No. 16)

Figure 5-39. Puente Los Molinos. Note the pre-existing scour (>2m or 6') at Pier No. 1 (as identified from left to right) (see arrow) and tipped Pier No. 2 shown with the arrow on the right.

Although the bridge could be considered fragile because of the previous scour and the newer cracking of the structural members, it is a vital link in the transportation system. During the inspection, several fully loaded trucks crossed the bridge hauling out rubble from nearby towns.

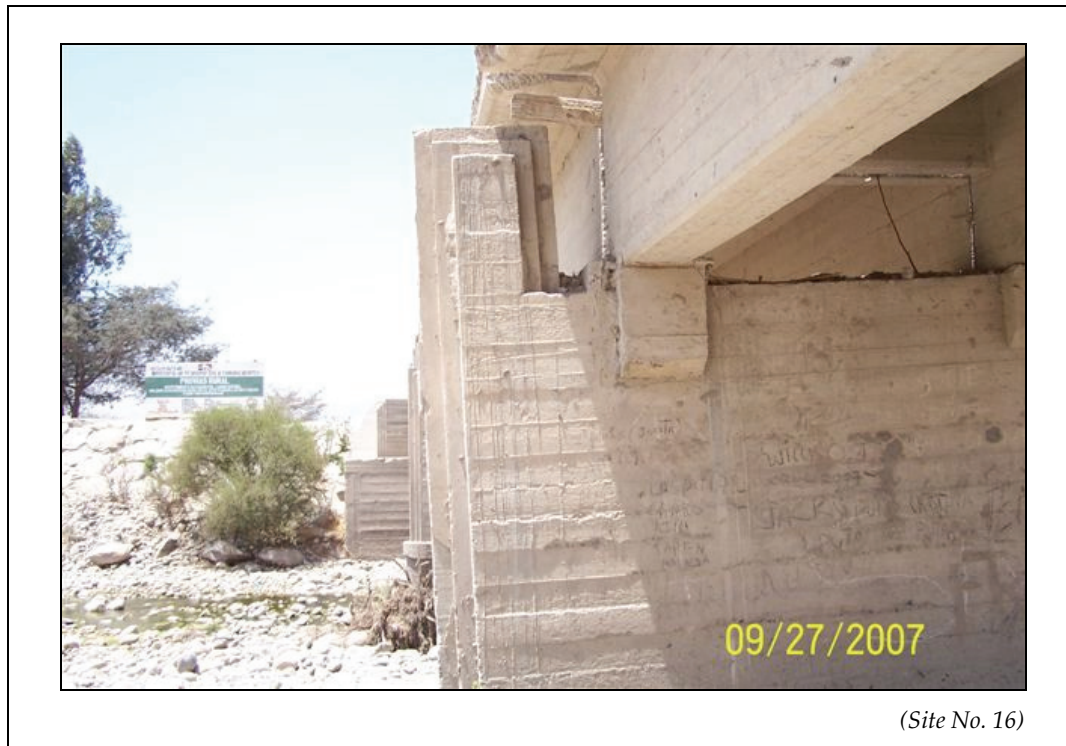
(Site No. 16)

Figure 5-40. Tipped pier resulting from El Niño flooding of 1998.

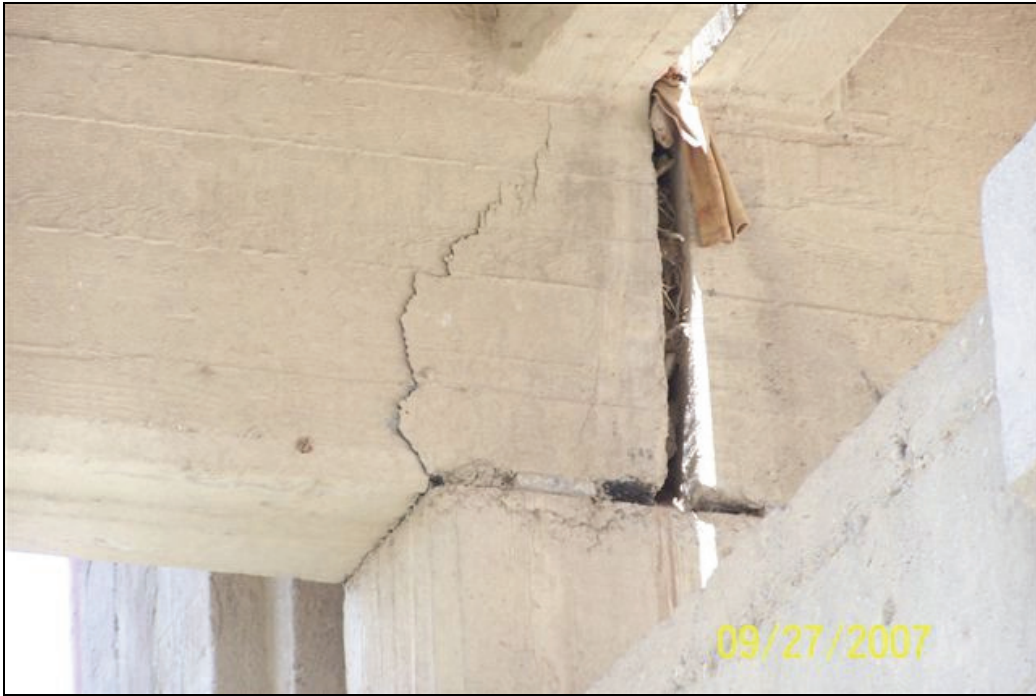
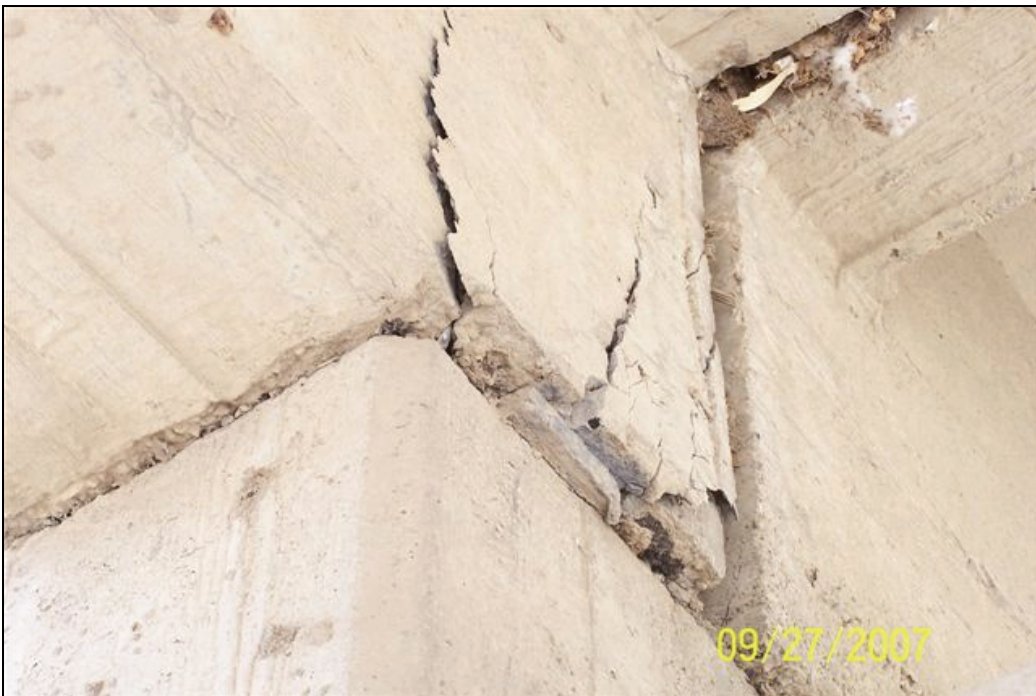
a. What appears to be a fresh shear crack in concrete beam at Pier No. 1 pedestal

b. Another serious shear crack probably caused by earthquake-induced lateral motion

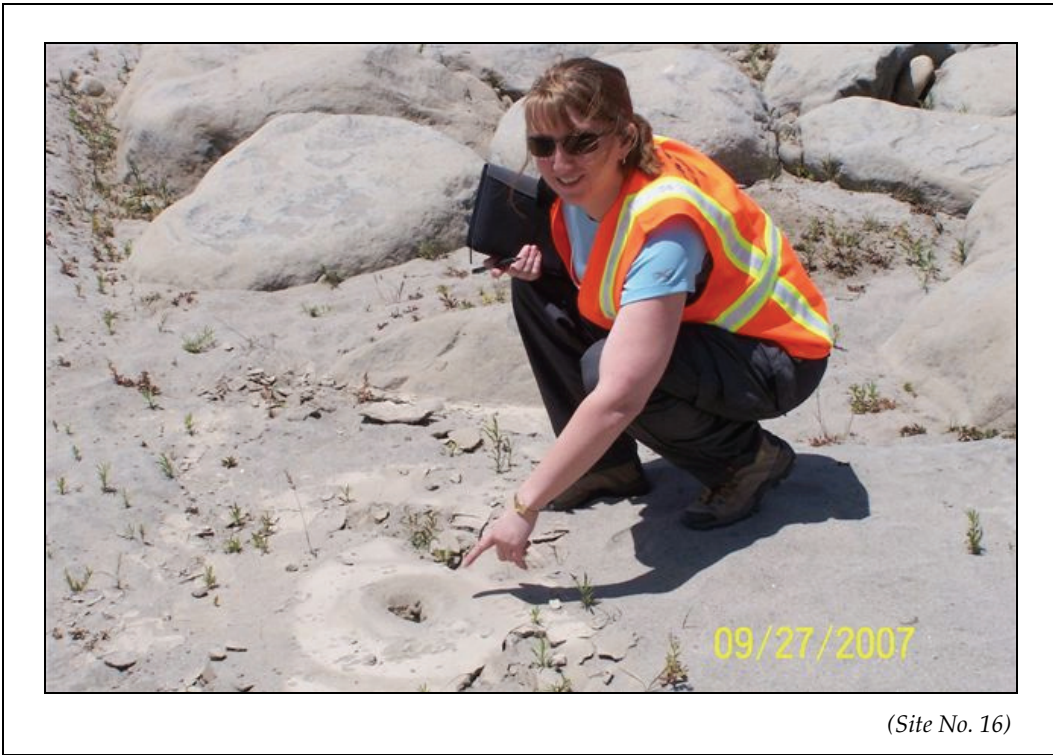
Figure 5-44. Monique Nykamp pointing to sand boil as evidence of liquefaction in river bed of Rio Ica at Puente Los Molinos.

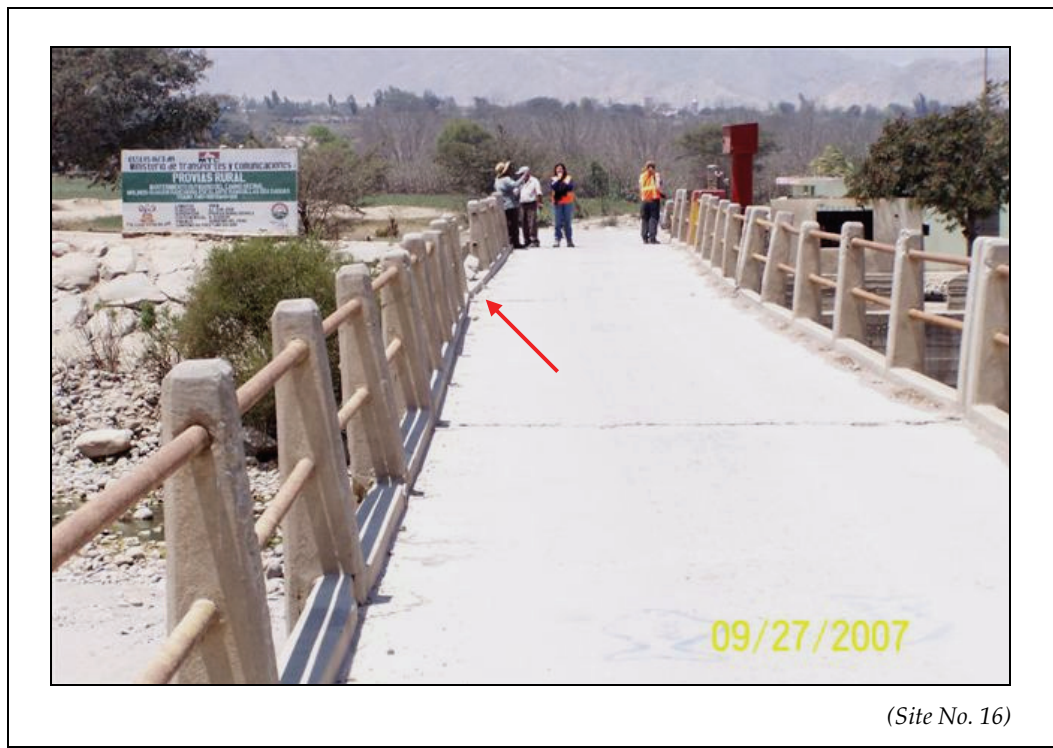
Figure 5-45. Lateral shift of the superstructure.

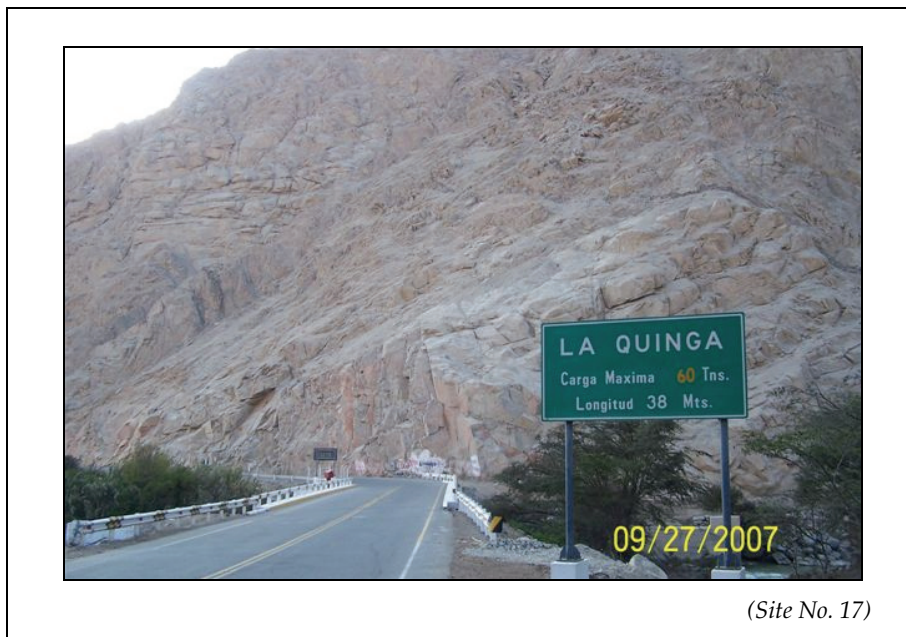
Figure 5-47. The rocky terrain above Puente Quinga presents a danger of impact from boulders. The bridge showed evidence of slight lateral motion that resulted in minor cracking of the approach curbing.
