DAMAGE TO THE HIGHWAY SYSTEM FROM THE PISCO, PERU EARTHQUAKE OF AUGUST 15, 2007

Technical Report MCEER-07-0021

This damage assessment report is the product of a field investigation undertaken in September 2007 after the M_w 8.0 August 15, 2007 Pisco, Perú earthquake. It provides a brief description of the event and the consequential damage to the highway system. It relies on government reports issued immediately after the event that include investigations from leaders in Perú's academia, and the authors' field observations. The purpose of the report is to document the performance of structures designed according to AASHTO specifications and to help assess the adequacy of the standards used at the time of construction. Another important benefit of the task is the exchange of information for the mutual benefit of engineers and policy makers here in the U.S. and in Perú.

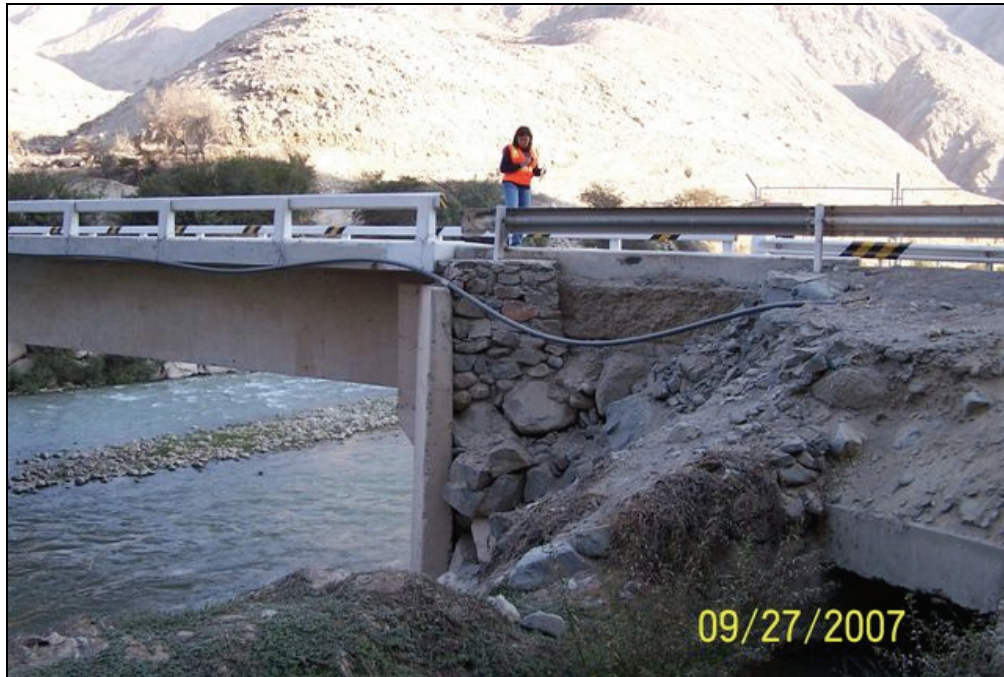
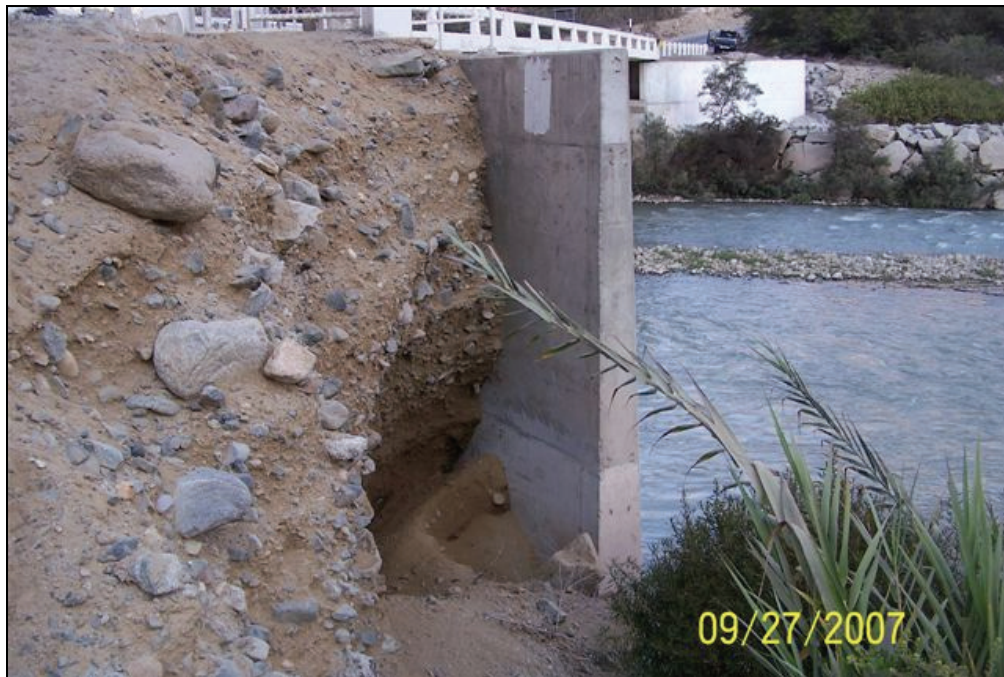
a. Loss of rock wingwall and backfill at the left side of the abutment, possibly aggravated by the earthquake

b. Erosion at the right side of the same abutment. Round rocks in the gravel make the site more susceptible to loss of material

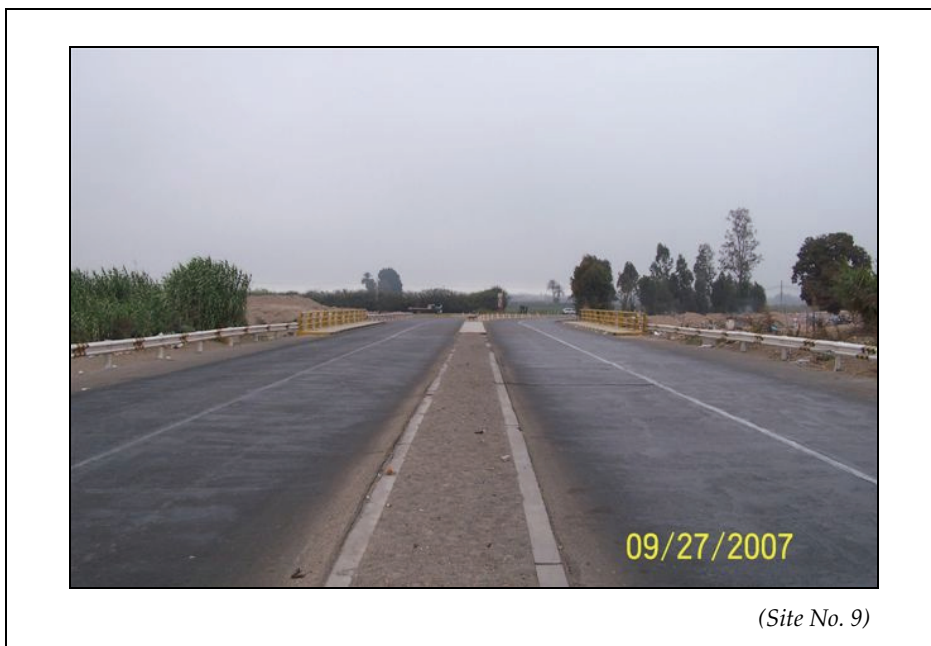
Figure 5-50. Concrete bridge near the epicenter that performed well.

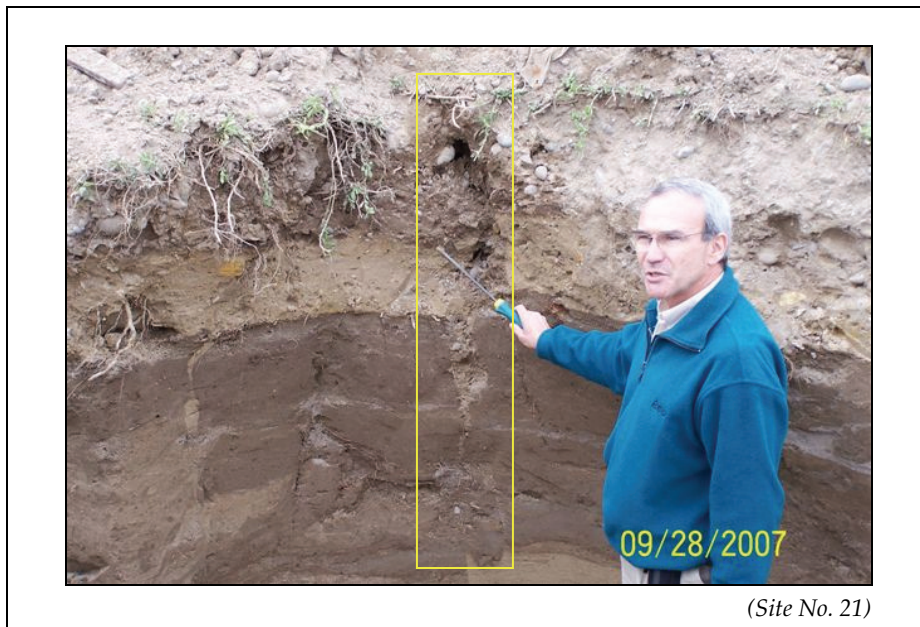
Figure 5-52. Geologist Dr. Carlos Costa, UNSL in Argentina pointing out soil layers within cross section of sand boil during paleoliquefaction study. He was working with Patricio Valderrama, Perú Geological Survey.

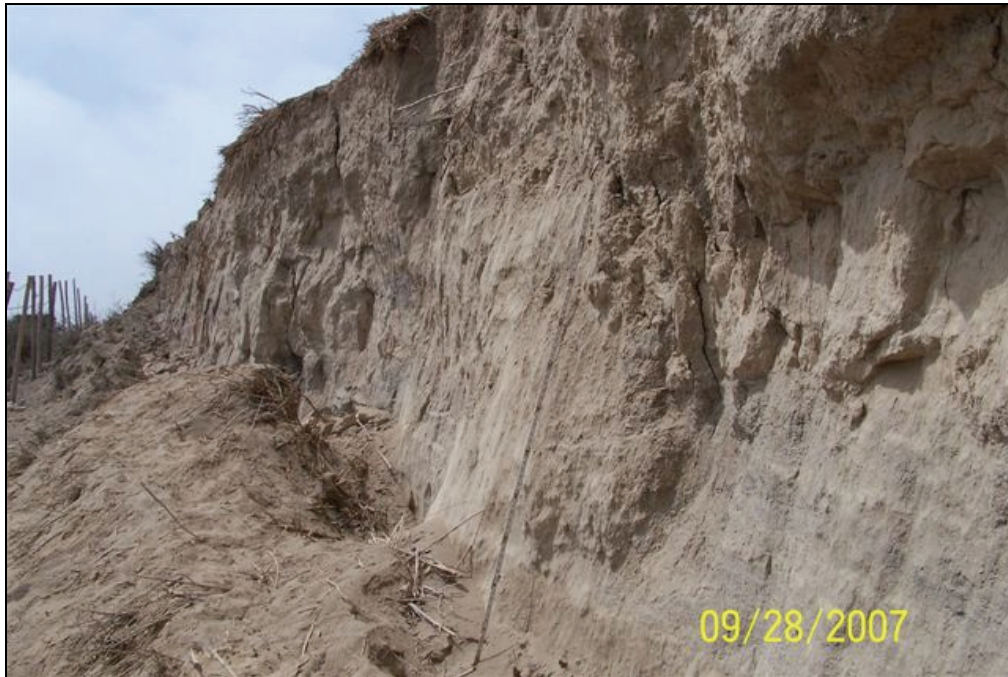
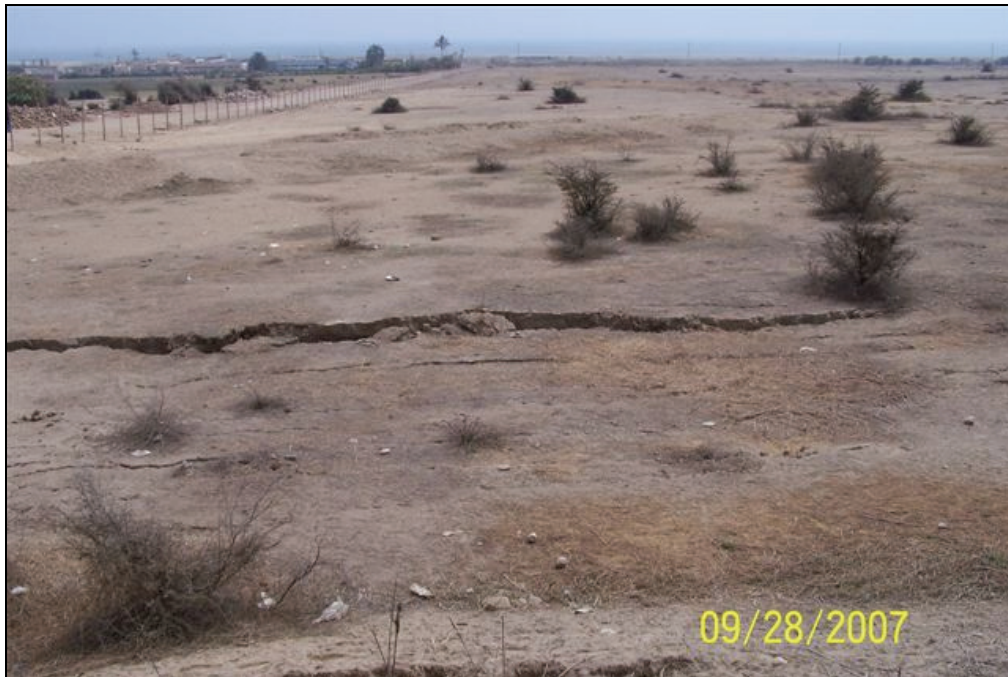
Figure 5-53. Road to the beach at Sunampe.

a. Three meter (10') escarpment remaining at Sunampe after coastal shelf slid toward the ocean

b. Surface cracks remaining at Sunampe after coastal shelf slid toward the ocean

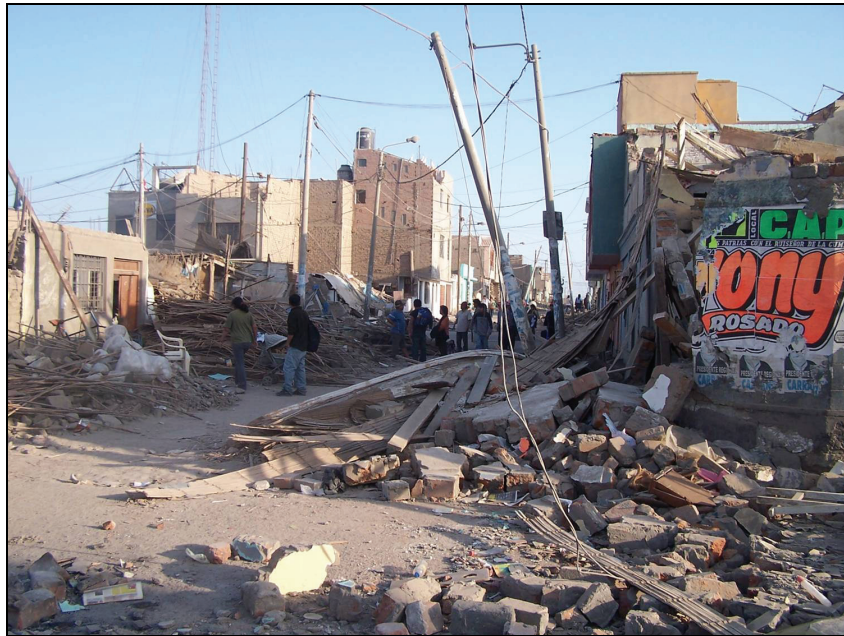
Figure 5-56. This photo is indicative of the extensive disruption of an urban street in Pisco. It is Calle Independencia.

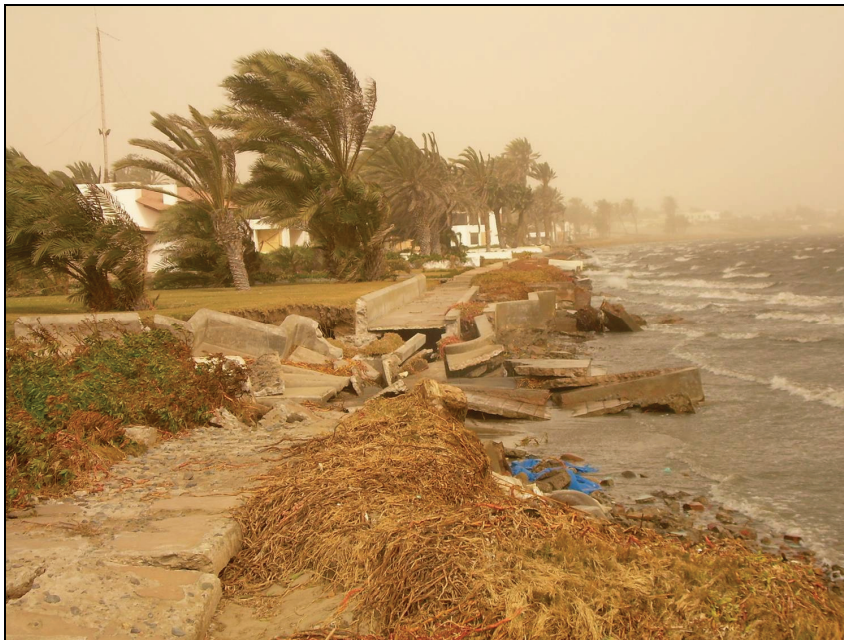
Figure 5-57. Damage from a tsunami that swept up on Paracas.
