# Remote Sensing for Resilient Multi-Hazard Disaster Response

## Volume V: Integration of Remote Sensing Imagery and VIEWS™ Field Data for Post-Hurricane Charley Building Damage Assessment

Technical Report MCEER-08-0024

November 17, 2008

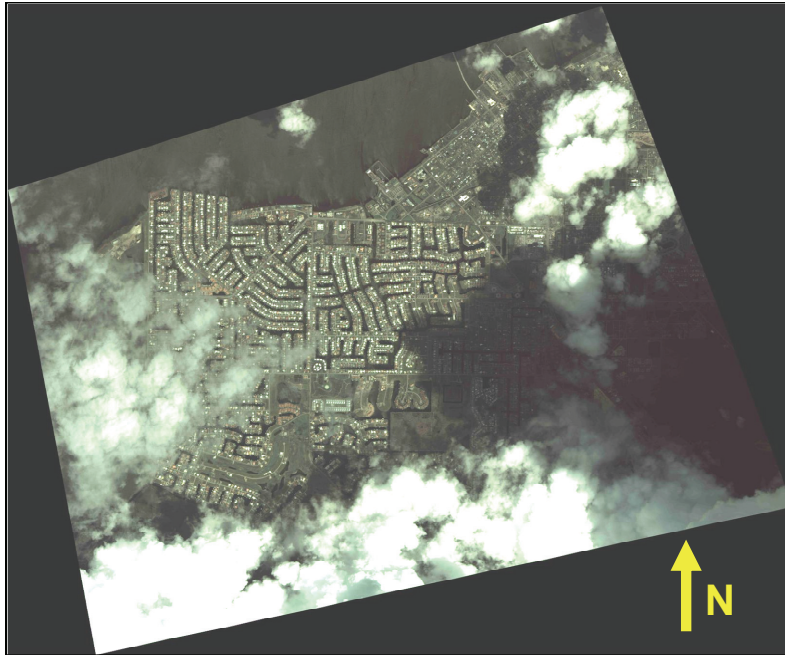
**Figure 2-1 Quickbird Multispectral Image of Punta Gorda, FL, Acquired One Day After Hurricane Charley. Image Date: August 14, 2004. Credit: DigitalGlobe, Inc. <[www.digitalglobe.com](http://www.digitalglobe.com)>.**

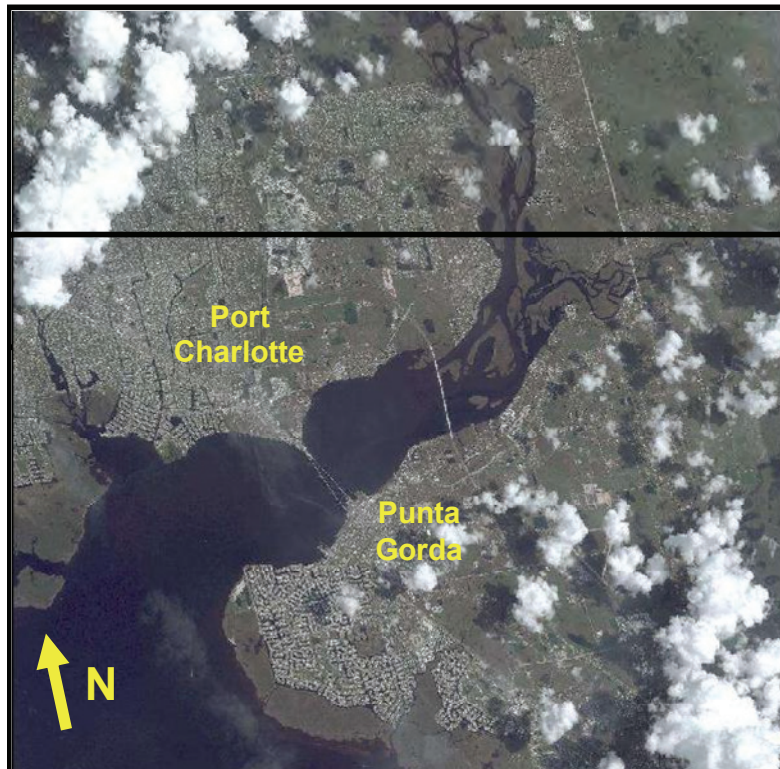
**Figure 2-2 Quickbird Satellite Images Covering Port Charlotte and Punta Gorda, FL, Acquired Six Days After Hurricane Charley. Image Date: August 19, 2004. Credit: DigitalGlobe, Inc. <[www.digitalglobe.com](http://www.digitalglobe.com)>.**

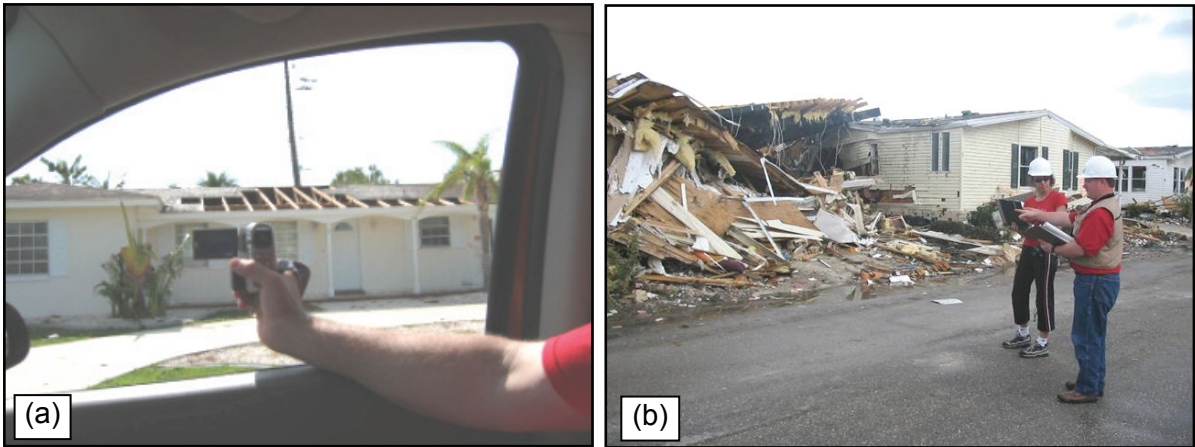
**Figure 2-5 Deployment of the VIEWS™ Field Reconnaissance System in Hurricane Charley for Field Data Collection (a) from Moving Vehicle and (b) on Foot**

The VIEWS™ field survey for Hurricane Charley was conducted primarily from a high-profile moving vehicle driven at an optimal speed of about 10 mph (figure 2-5a). Detailed damage assessments were conducted on foot at approximately 15 sites, where the ground-survey teams devoted additional time to documenting damage and obtaining detailed photographic records (figure 2-5b). The reconnaissance teams focused on temporal changes (“damage”) in the before-and-after satellite images, together with FEMA damage maps to select a wide range of damage levels for the ground-truthing survey.

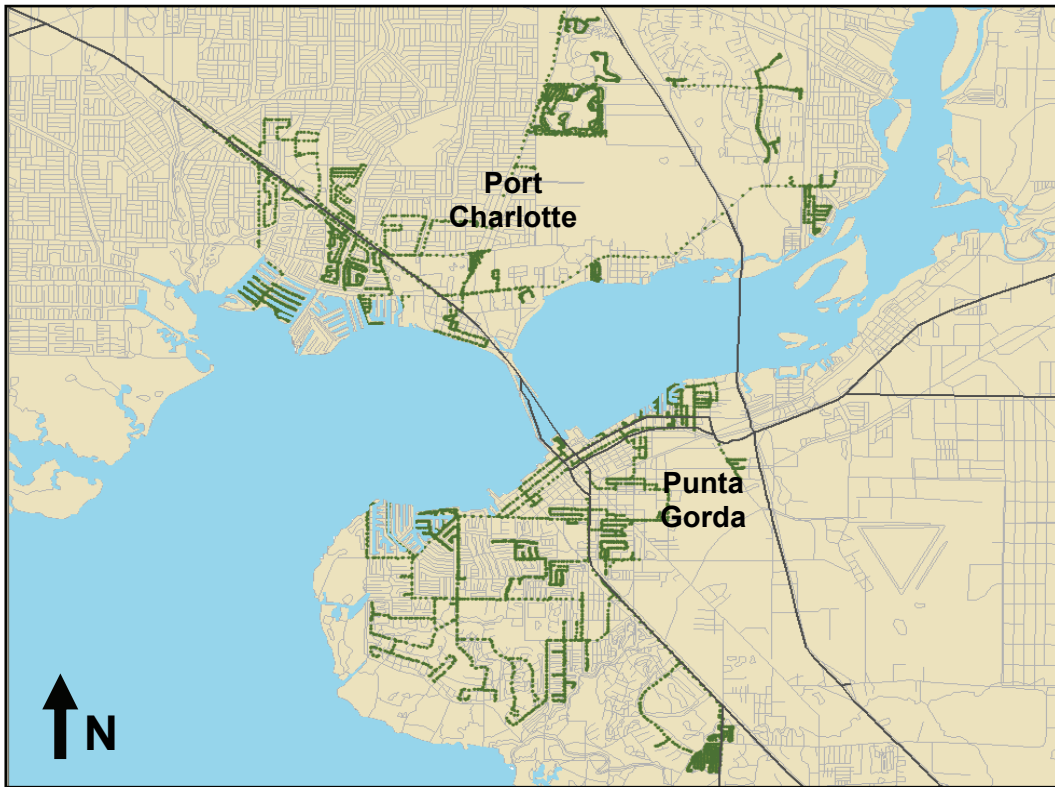
**Figure 2-6 Locations of Ground Survey for Hurricane Charley in Punta Gorda and Port Charlotte**

timeframe, averaging approximately 2,500 buildings per day (figure 2-6). Following hurricane Ivan, 12 hours of georeferenced video and 1200 photographs were collected.

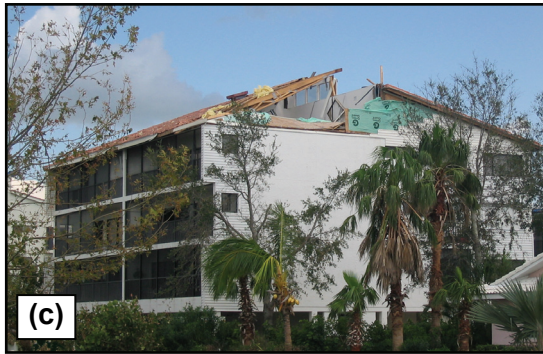
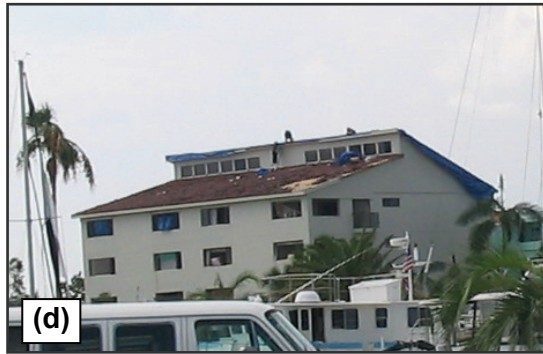
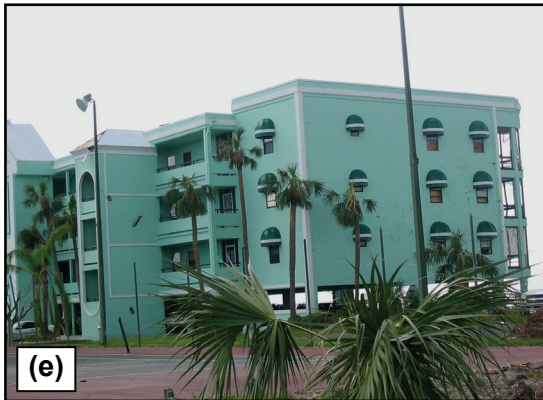
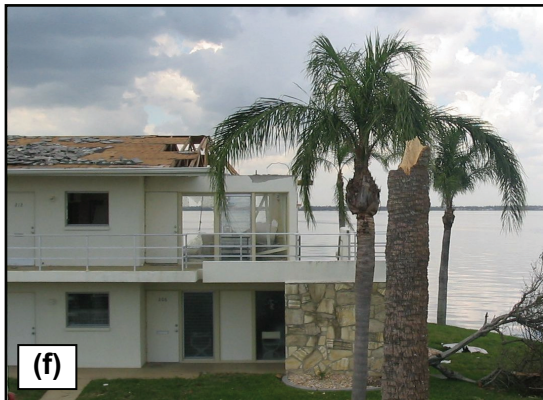
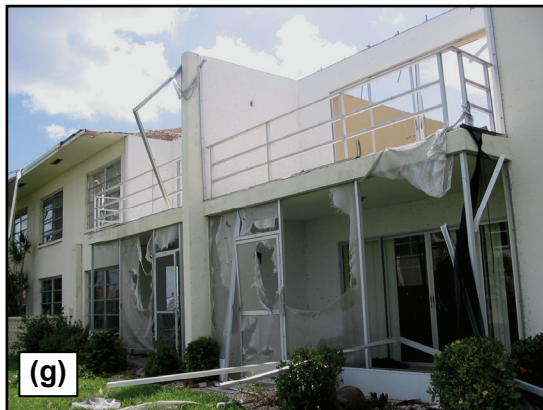
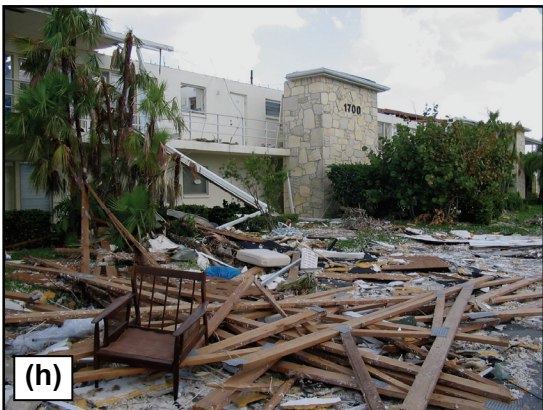
**Figure 2-7 (continued). Comparison of Pre- and Post Storm Building Conditions in Satellite Images, Along with Ground-Survey Photos. Ground-Survey Photos Demonstrate: (c) Partial Roof Deck Failure (Combined Internal And External Pressures); (d) Shingles Partially Removed but Deck Intact; (e) Scoured Roof Gravel (Not Visible from Ground Survey); (f) Partial Roof Structure Failure; (g) Severe Roof Structure Failure; (h) Windborne Debris from Nearby Building Deposited on a Parking Lot, Roadway, and Tennis Court. From Womble (2005).**

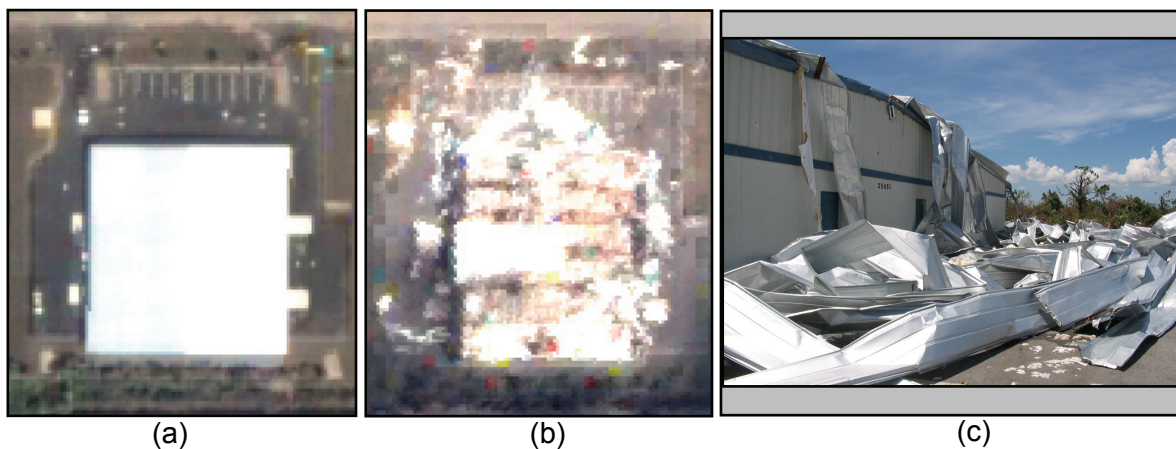
**Figure 3-1 Example of Wind Damage to Metal Warehouse Building: (a) Pre-Storm Quickbird 61-cm Imagery (Mar. 23, 2004); (b) Post-Storm Quickbird 61-cm Imagery (Aug. 14, 2004); (c) Ground-Truthing Photo. Credit: DigitalGlobe, Inc. <[www.digitalglobe.com](http://www.digitalglobe.com)>.**

As shown in figures 3-1 and 3-2, the presence of roof damage is clearly visible in the post-storm images as a change in overall shape or as the appearance patches with different colors and/or textures. The Quickbird images of 61- to 80-cm resolution shown in figures 3-1 and 3-2 are adequate to detect damage (i.e., the absence of metal panels from the post-hurricane imagery). Higher-resolution images (e.g., 37-cm NOAA aerial images) can better resolve the underlying structural supports in areas where cladding pieces have been removed (figure 3-2c).

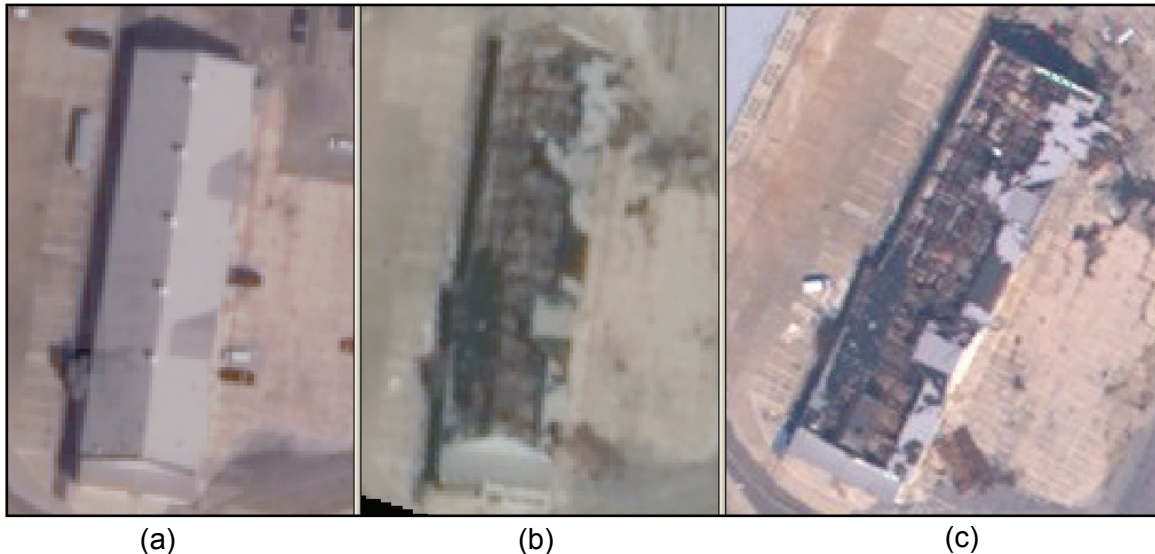
**Figure 3-2 Example of Windstorm Damage to Metal Warehouse Building: (a) Pre-Storm Quickbird 61-cm Imagery (Mar. 12, 2004); (b) Post-Storm Quickbird 80-cm Imagery (Sept. 21, 2004); (c) NOAA 37-cm Aerial Imagery (Sept. 2004). Credits: DigitalGlobe, Inc. and NOAA.**

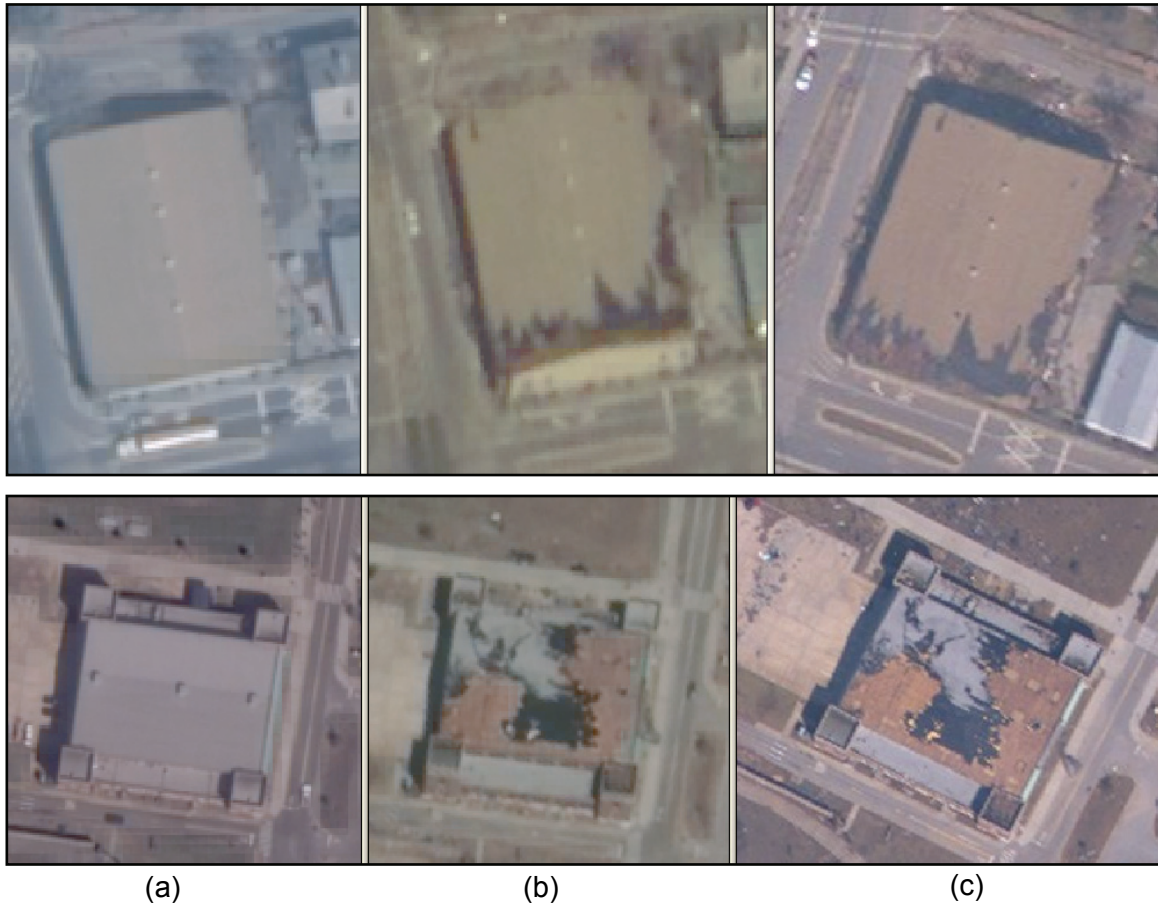
**Figure 3-3 Examples of Wind Damage to Flat-Roof Commercial and Industrial Buildings, Pensacola, FL: (a) Pre-Storm Quickbird 62-cm Imagery (Mar. 12, 2004); (b) Post-Storm Quickbird 80-cm Imagery (Sept. 21, 2004); (c) Post-Storm NOAA Aerial 37-cm Imagery (Sept. 2004). Credits: DigitalGlobe, Inc. <[www.digitalglobe.com](http://www.digitalglobe.com)> and NOAA.**

of the roof covering have been removed (or where gravel has been scattered), exposing additional layers of BUR, roof decking, or a building cavity beneath. These damage areas typically have a ragged and streaked form due to scattered tearing of the roof coverings from their mechanical or adhesive fastenings and in this way can typically be distinguished from the blocked appearance of damage to metal-panel roofs.

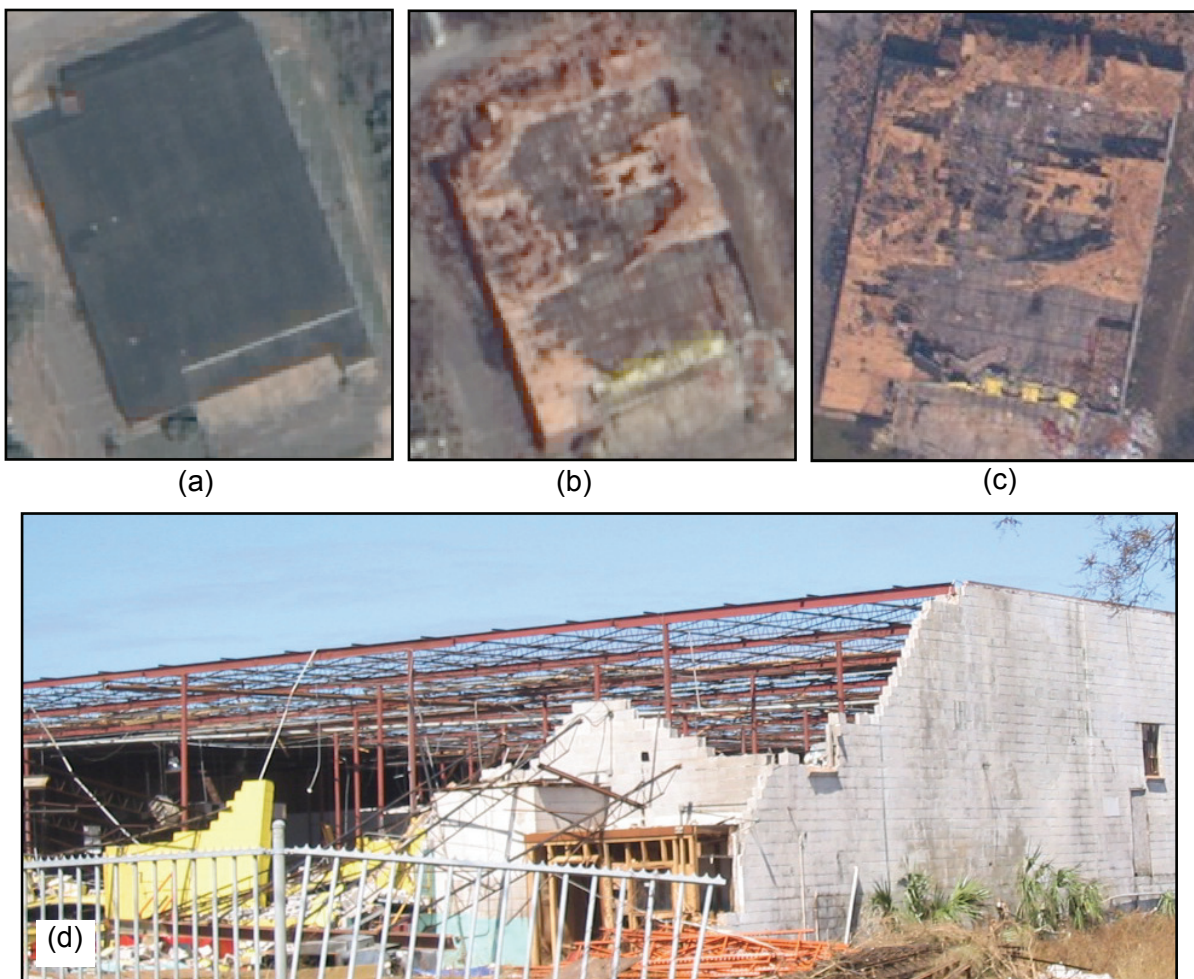
**Figure 3-4 Example of Wind Damage to Flat-Roof Commercial/Industrial Building: (a) Pre-Storm Quickbird 62-cm Imagery (Mar. 12, 2004); (b) Post-Storm Quickbird 80-cm Imagery (Sept. 21, 2004); (c) Post-Storm NOAA Aerial 37-cm Imagery (Sept. 2004); (d) Ground-Survey Photo. Credits: DigitalGlobe, Inc. <[www.digitalglobe.com](http://www.digitalglobe.com)> and NOAA.**

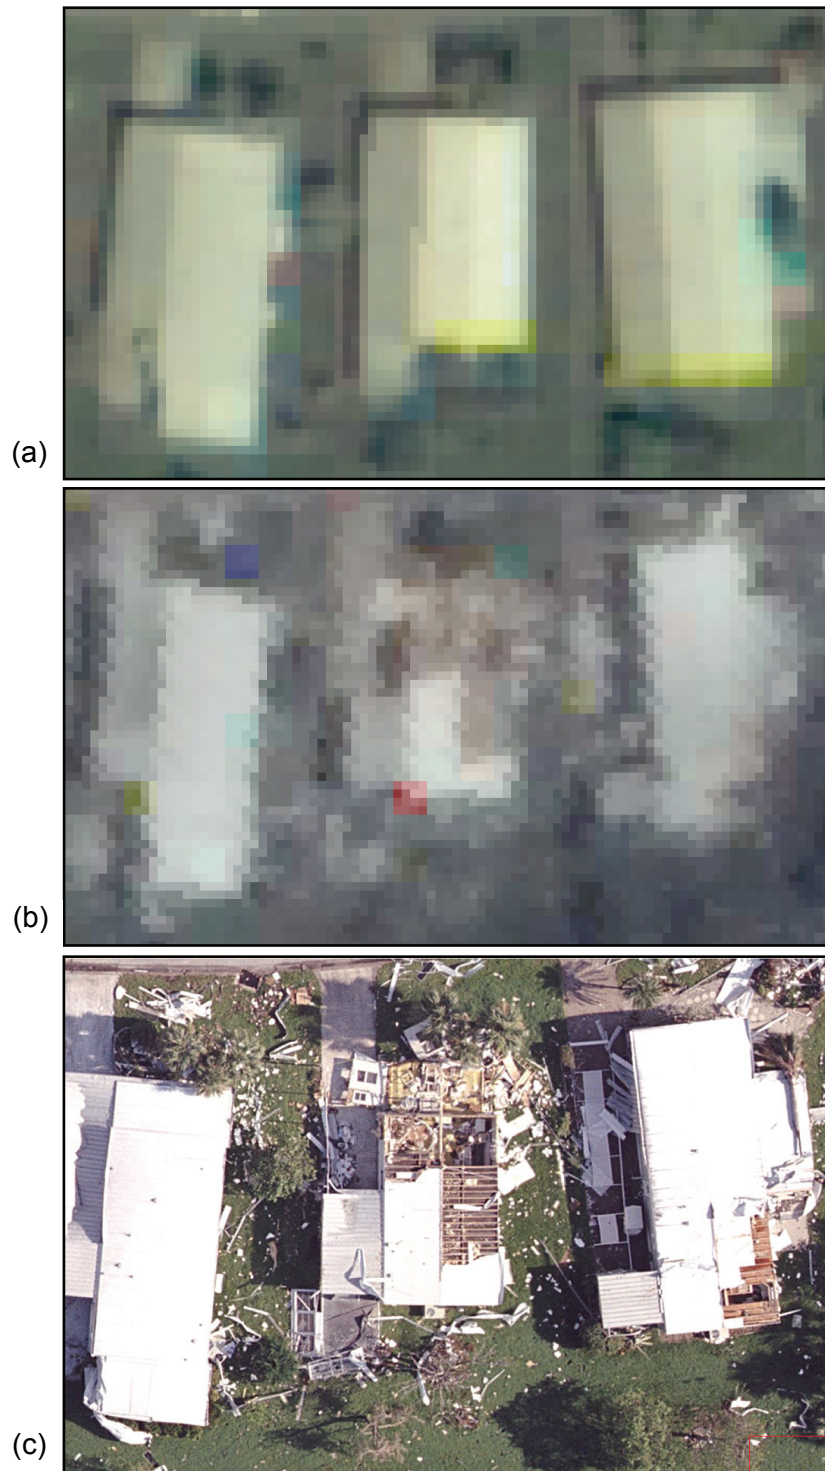
**Figure 3-6 Comparison of Satellite and Digital Aerial Images Showing Windstorm Damage to Manufactured Homes: (a) Pre-Storm Quickbird 61-cm Imagery (Mar. 23, 2004); (b) Post-Storm Quickbird 75-cm Imagery (Aug. 19, 2004); (c) Digital Aerial 5-cm Imagery (Aug. 29, 2004). Credits: DigitalGlobe, Inc. <[www.digitalglobe.com](http://www.digitalglobe.com)> and DMK Associates.**

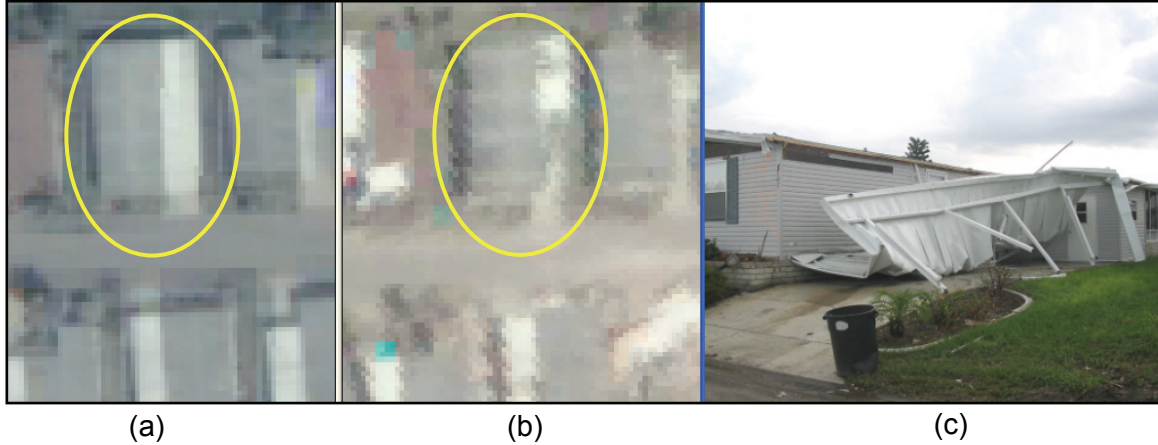
**Figure 3-7 Examples of Windstorm Damage To Manufactured Homes. Damage to Attached Structures (Carpports and Covered Patios) is Often More Severe than the Main Structure. (a) Pre-Storm Quickbird 61-cm Imagery (Mar. 23, 2004); (b) Post-Storm Quickbird 75-cm Imagery (Aug. 19, 2004); (c) Ground-Truthing Photo. Credit: DigitalGlobe, Inc. <www.digitalglobe.com>.**

7). Metal components of these attachments also tend to be a source of debris. Because these attachments appear similar to the main manufactured-home units themselves in remote sensing images (e.g., metallic and rectangular), they can be difficult to distinguish and can therefore lead to false indications of damage to the main structure.

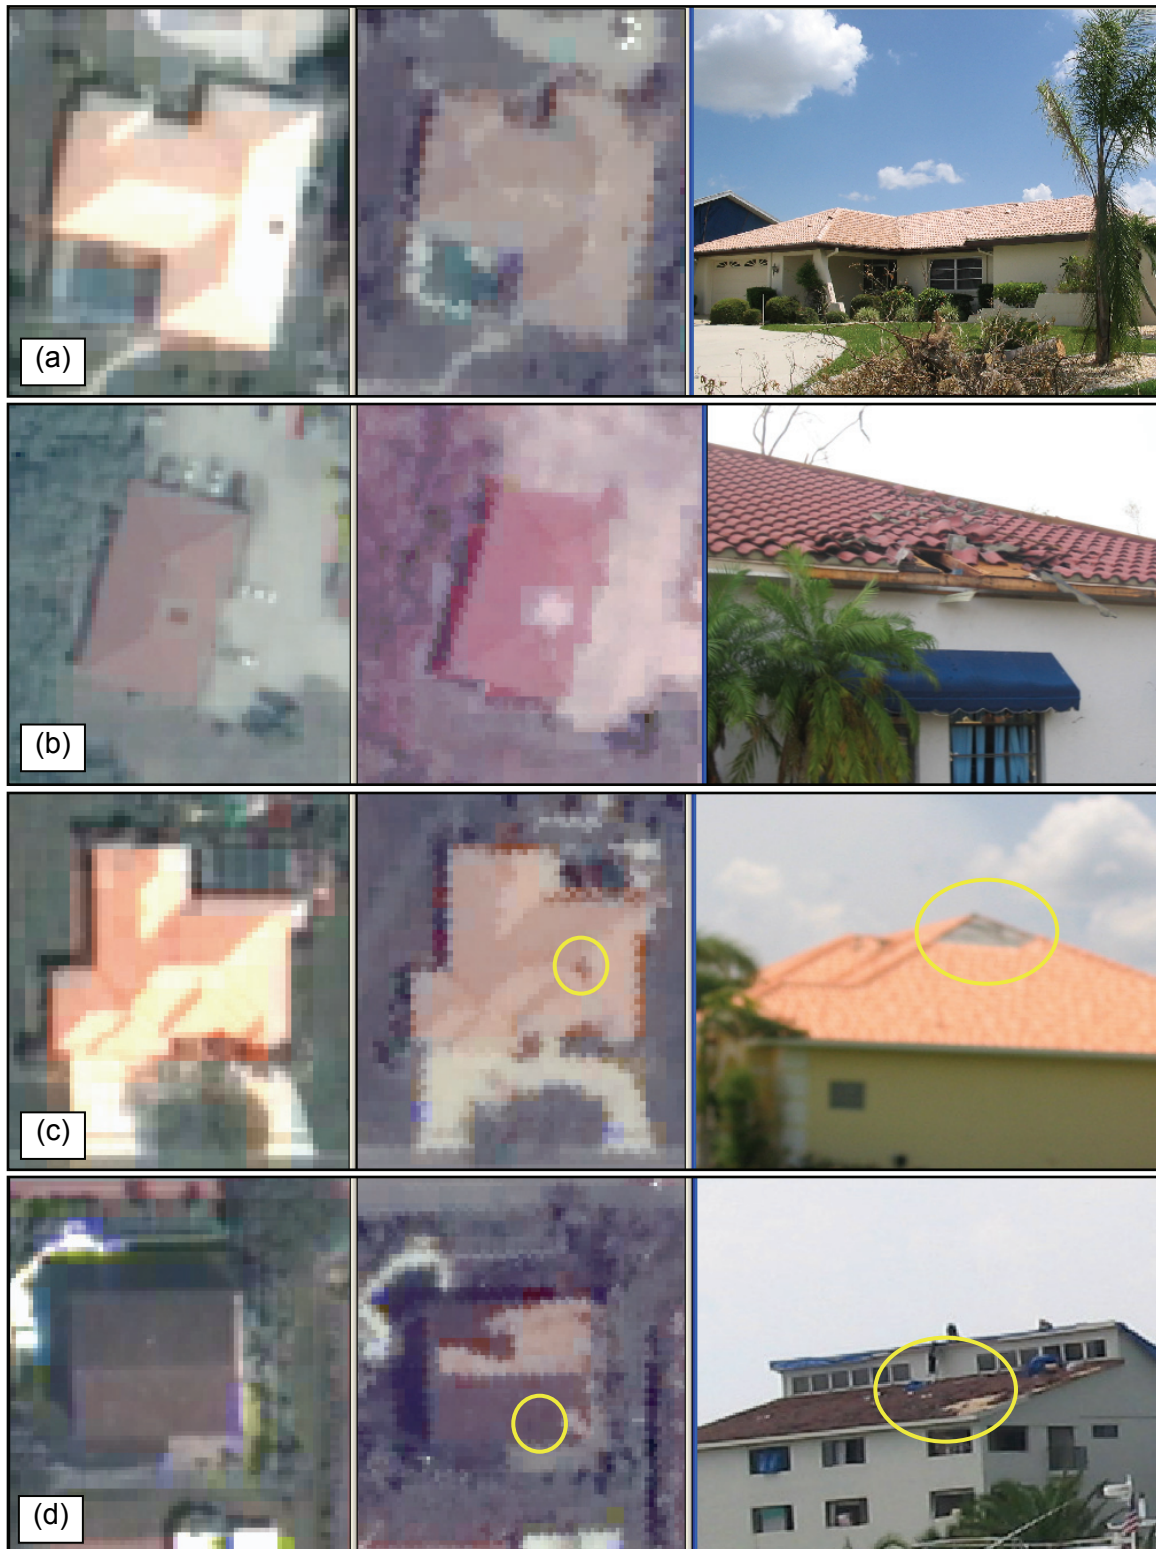
**Figure 3-8 Examples of Windstorm Damage to Residential Buildings: Pre- and Post-Storm Quickbird Satellite Images and Ground-Truthing Photos. Credit: DigitalGlobe, Inc. <[www.digitalglobe.com](http://www.digitalglobe.com)>.**

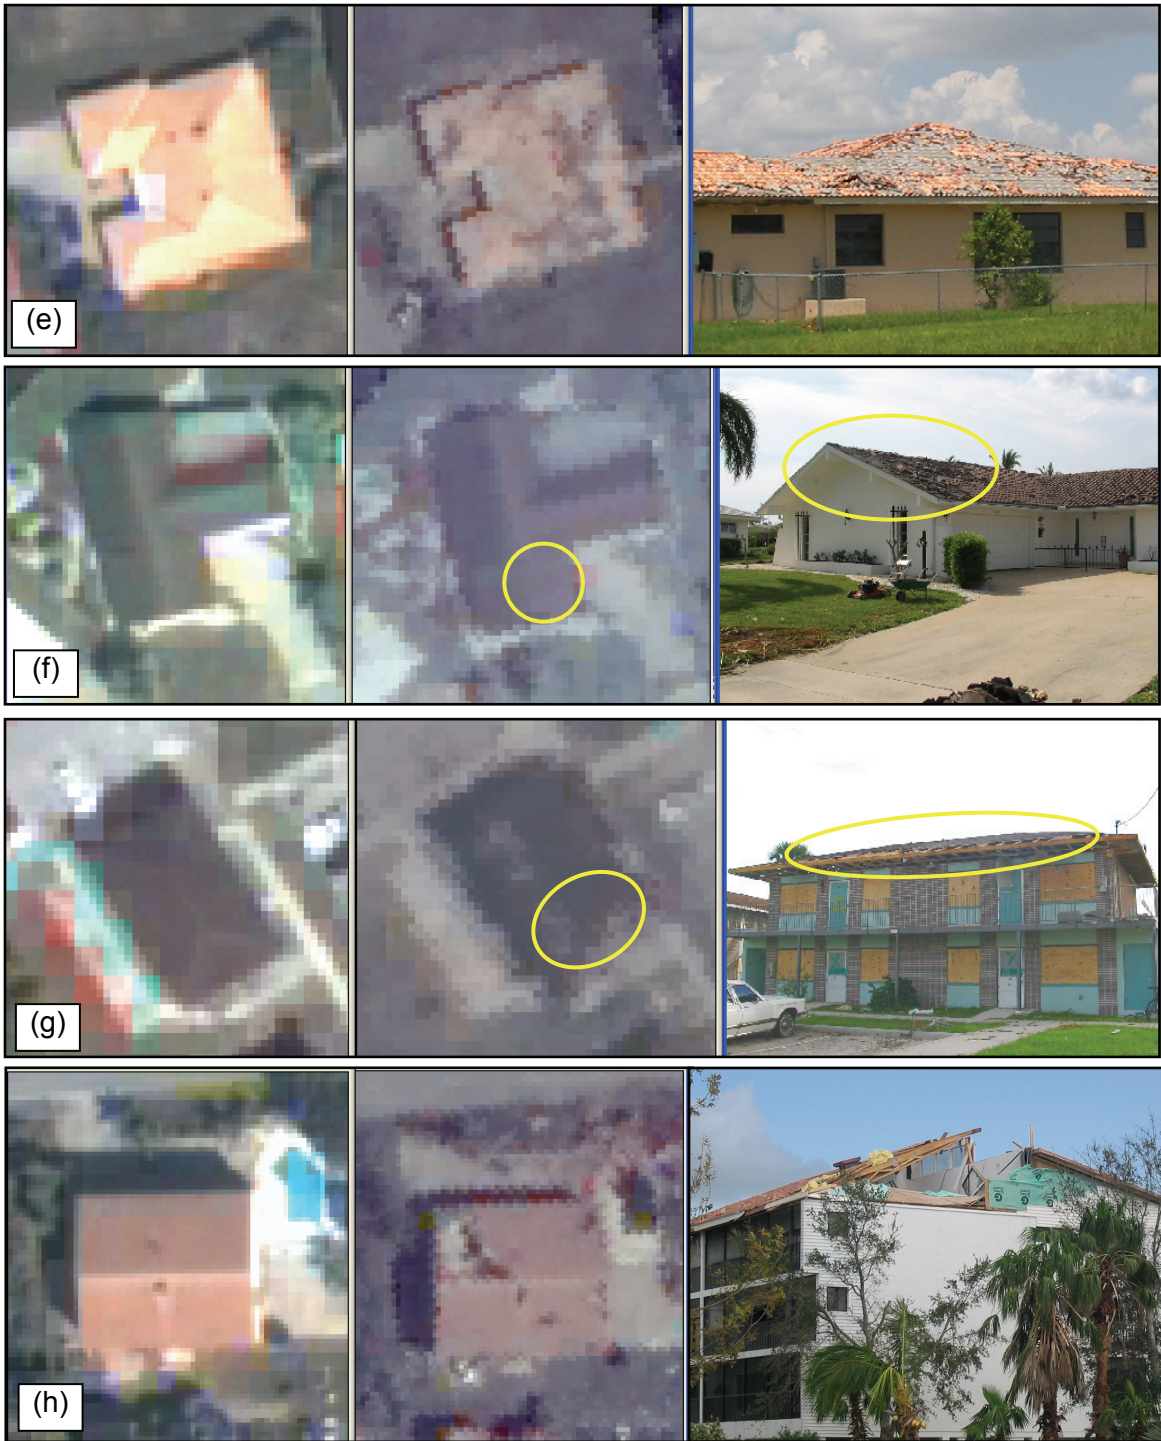
**Figure 3-8 (continued) Examples of Windstorm Damage to Residential Buildings: Pre- and Post-Storm Quickbird Satellite Images and Ground-Truthing Photos. Credit: DigitalGlobe, Inc. <[www.digitalglobe.com](http://www.digitalglobe.com)>.**

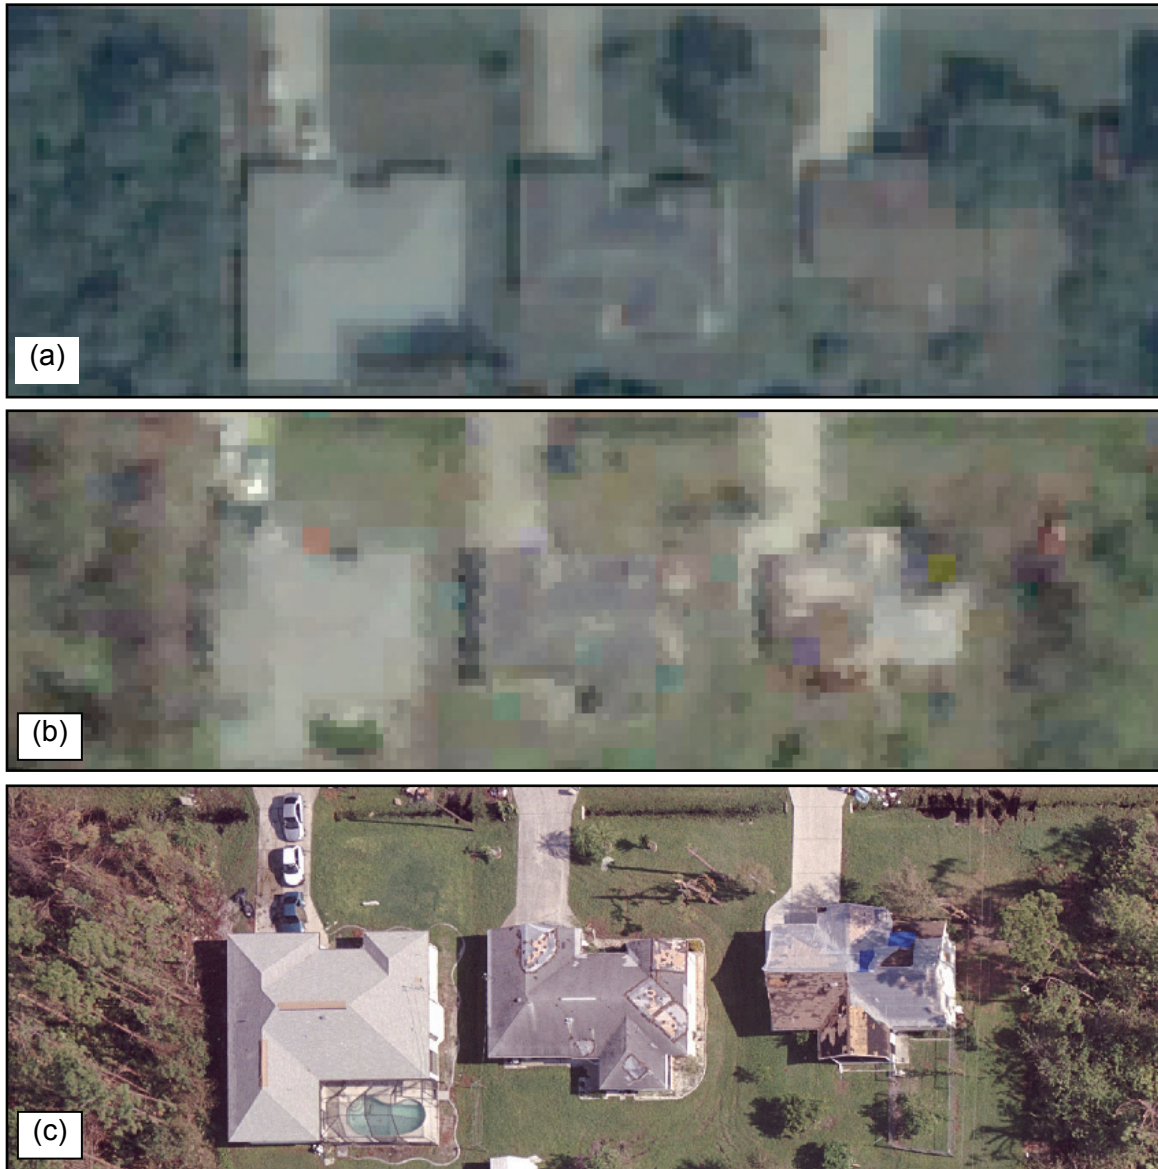
**Figure 3-9 Comparison of Spatial Resolutions for Images of Residential Buildings (Hurricane Charley): (a) Pre-Storm 61-cm Quickbird Images; (b) Post-Storm 75-cm Quickbird Images; (c) Post-Storm 5-cm Digital Aerial Images. Credits: DigitalGlobe, Inc. <[www.digitalglobe.com](http://www.digitalglobe.com)> and DMK Associates.**

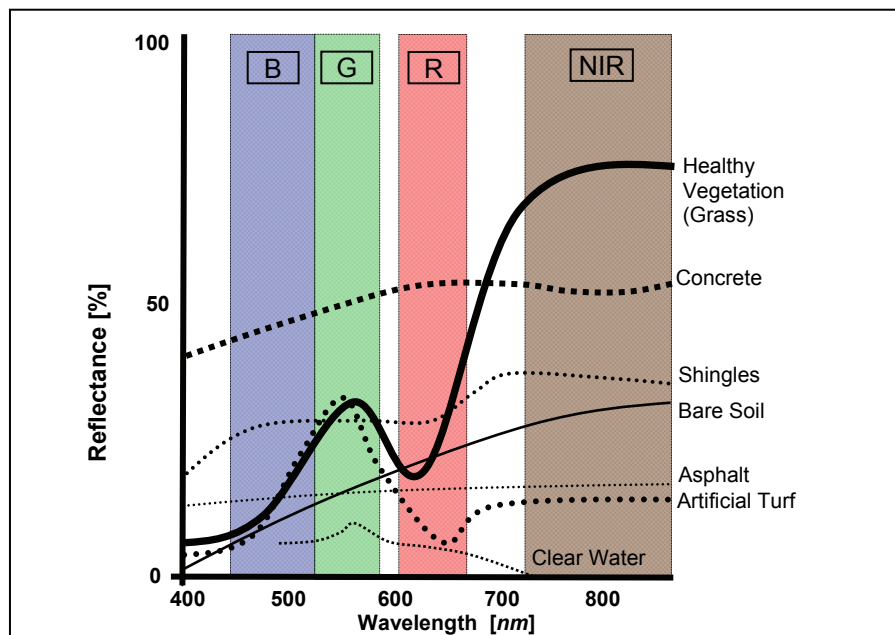
Figure 4-1 Spectral Reflectance Curves for Selected Materials in the Visible Wave-Lengths (400-700 nm) and Near-Infrared Wavelengths (700-900 nm), Superimposed with Quickbird Multispectral Bands (B-G-R-NIR). Adapted from Jensen (2000).

Spectral characteristics of damage were investigated. Characteristic spectral reflectance curves can be used to identify different materials within an optical image. Figure 4-1 shows spectral reflectance curves for materials commonly found in urban scenes, superimposed with Quickbird multispectral bands (blue, green, red, and near-infrared: B-G-R-NIR). While the human eye perceives light in the visible range (nominally B-G-R bands), optical satellite systems such as Quickbird measure reflected light in bands of the visible range as well as the NIR range. Vegetation and common construction materials also have important distinguishing spectral characteristics in the NIR wavelengths, and thus satellite systems can perceive spectral information beyond what the human eye can.

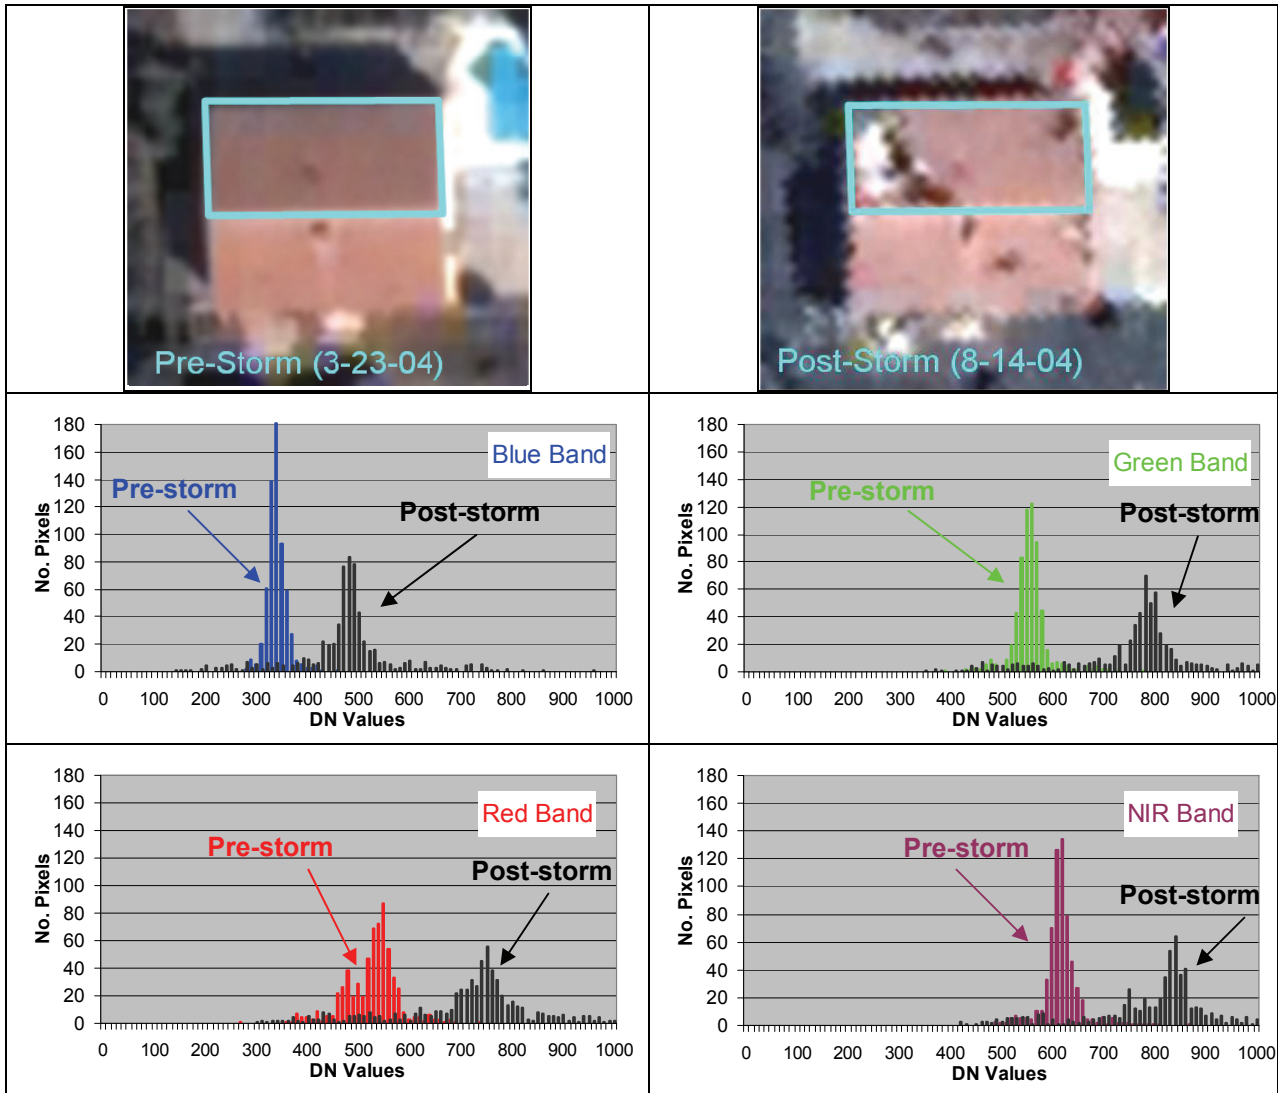
**Figure 4-2 Sample Comparison of Pre- and Post-Storm Object Histograms for a Single Roof Slope (Facet). In Each Spectral Band, the Histograms Experience a Shift in Mean Values Due to Physical Change as Well as Illumination Differences, and a Change in Standard Deviation Due to Physical Changes. Credit: DigitalGlobe, Inc. <www.digitalglobe.com> and Womble (2005).**

Physical changes in buildings can be illustrated quantitatively with the use of object histograms formed from the pixels constituting an object, such as an individual roof slope (facet). For example, pre- and post-storm histograms for a single roof facet are shown in figure 4-2. For each multispectral band, the pre- and post-storm histograms are superimposed on the same plot. These histograms help to demonstrate the appearance of damage to the roof facet from a remote sensing perspective. Shifts in mean values are attributed to both illumination differences (shadows) and to physical changes. Changes in dispersion (e.g., standard deviation or variance) are attributed to physical changes in the roof facet and are interpreted as damage.

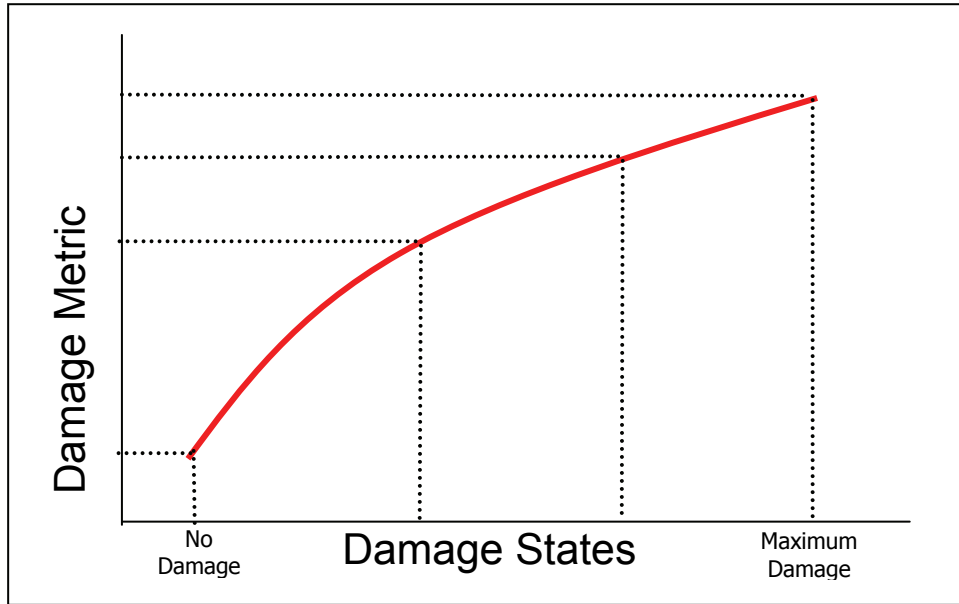
**Figure 4-3 Idealized *Windstorm Damage Profile*, Relating Damage Metrics to Actual Damage States**

(9) Formulation of “windstorm damage profiles”, which are plots of damage metrics (Step 8) versus actual damage states (from Step 4). Figure 4-3 shows an idealized windstorm damage profile. The windstorm damage profiles define the correlation between remote sensing measures of damage to roof facets and the actual damage states of those roof facets. The windstorm damage profiles form the basis for the automated assessment of windstorm damage based on characteristic changes in remote sensing imagery. The concept of damage profiles for earthquake damage on a regional basis is presented in Eguchi et al. (2003). The present research has modified the use of the damage profiles for windstorm damage, applied to individual building roof facets rather than geographic areas.

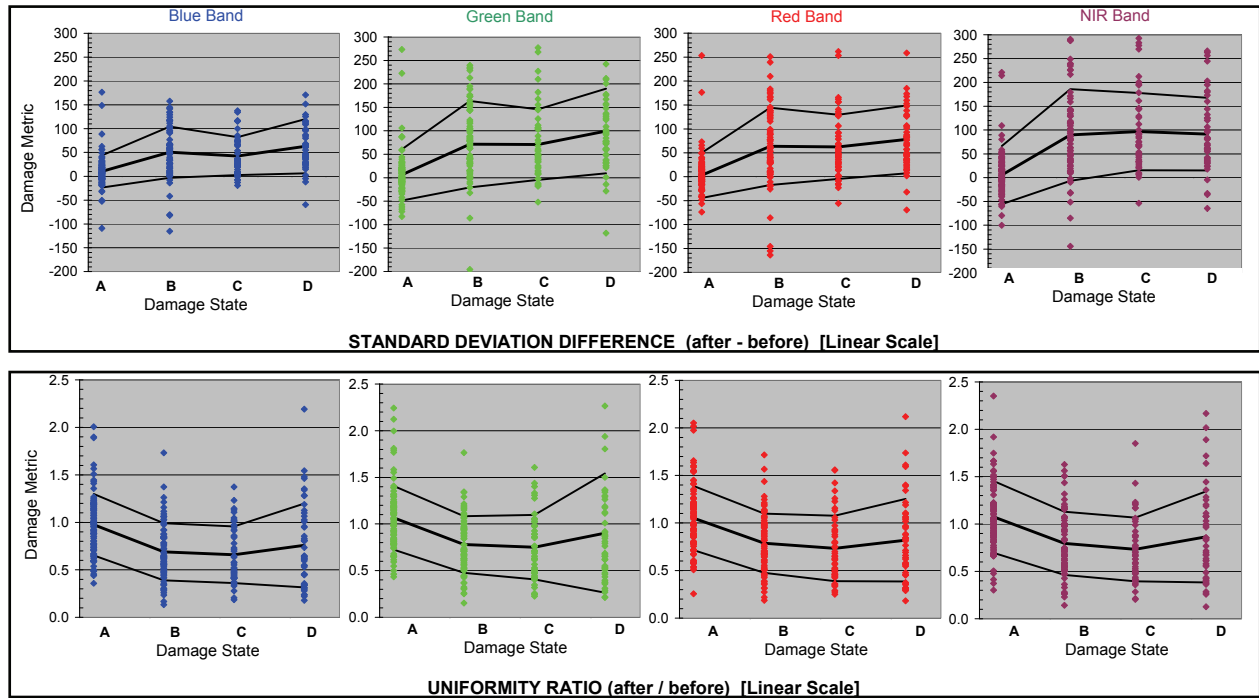
**Figure 4-4 Sample Windstorm Damage Profiles for the Study Sample Of Buildings Subjected to Hurricane Charley and Ivan. The Damage Profiles are Separated by Spectral Bands. Damage Metrics are Based on Before-and After Comparison of Satellite Images of 267 Roof Facets from 77 Buildings. Damage States are Defined by the Remote Sensing Damage Scale in Table 3-2 and are Based on Ground-Truthing Surveys Performed with the VIEWS™ System. Trend Lines Indicate Group Means and (Mean ± 1 Standard Deviation). From Womble (2005).**

The sample damage profiles exhibit overall trends for the variation of damage metrics with damage states. The damage profiles exhibit strong trends for the distinction of “no-damage” (RS-A) from “damage” conditions (RS-B, RS-C, and RS-D), but the data contain too much scatter to accurately assign a damage state based on a given value of damage metric. Distinctions between mid-level damage states (RS-B or RS-C) are difficult to make for damage profiles with large data spread, as shown here.

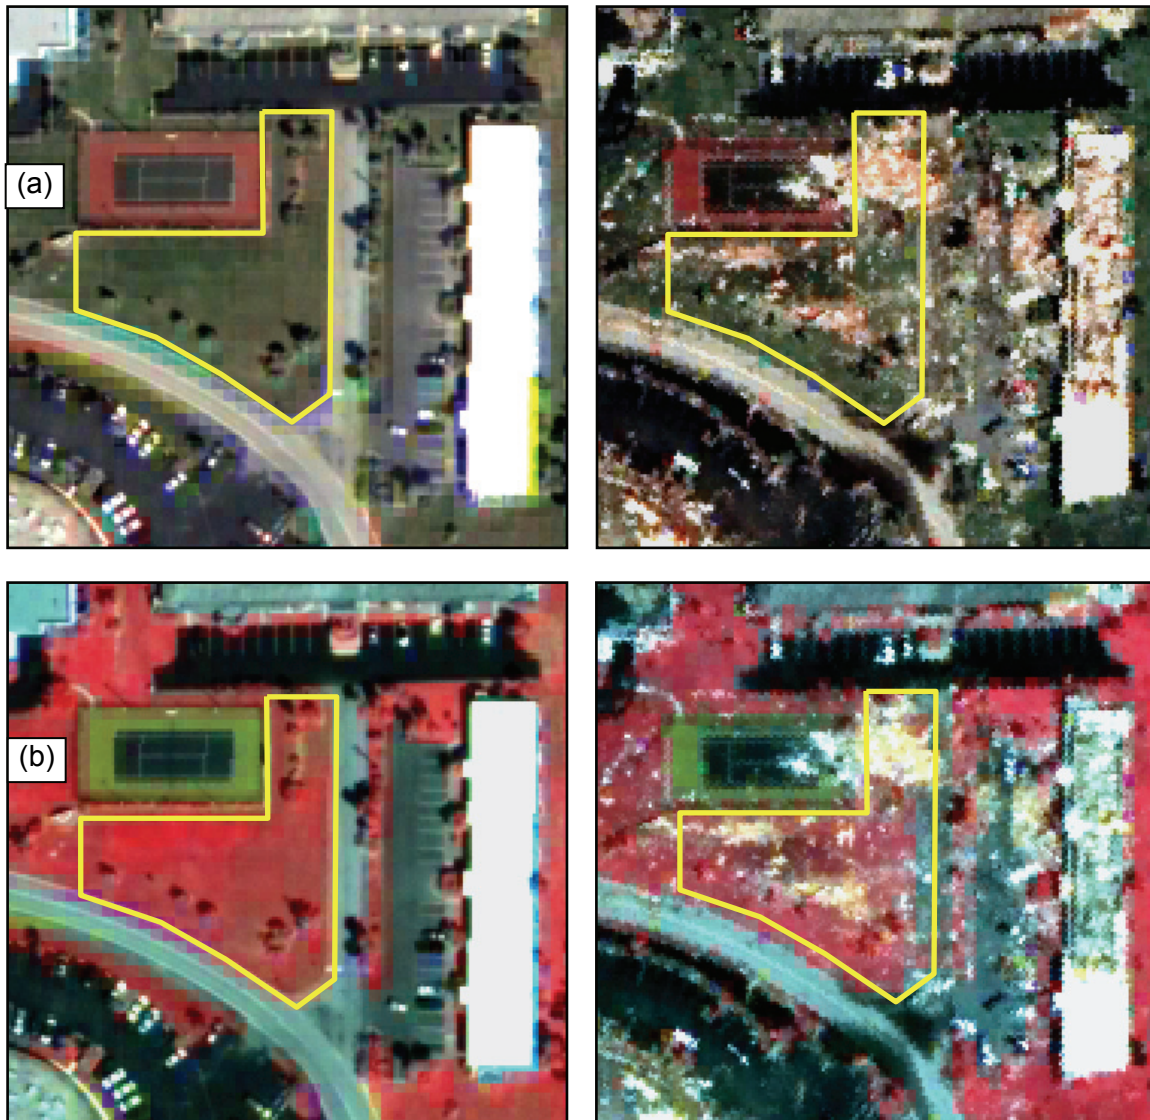
**Figure 5-1 Example of Windborne Debris Spread. Quickbird Images from Before and After Hurricane Charley Show Windborne Debris from a Nearby Building Spread Across a Vegetated (Lawn) Area (Delineated in Yellow). Images are Shown in (a) Natural Color (B-G-R Bands) and (b) False-Color (G-R-NIR bands) to Highlight the Spectral Signature of Debris Atop the Vegetation Area. Credit: DigitalGlobe, Inc. <[www.digitalglobe.com](http://www.digitalglobe.com)> and Womble (2005).**

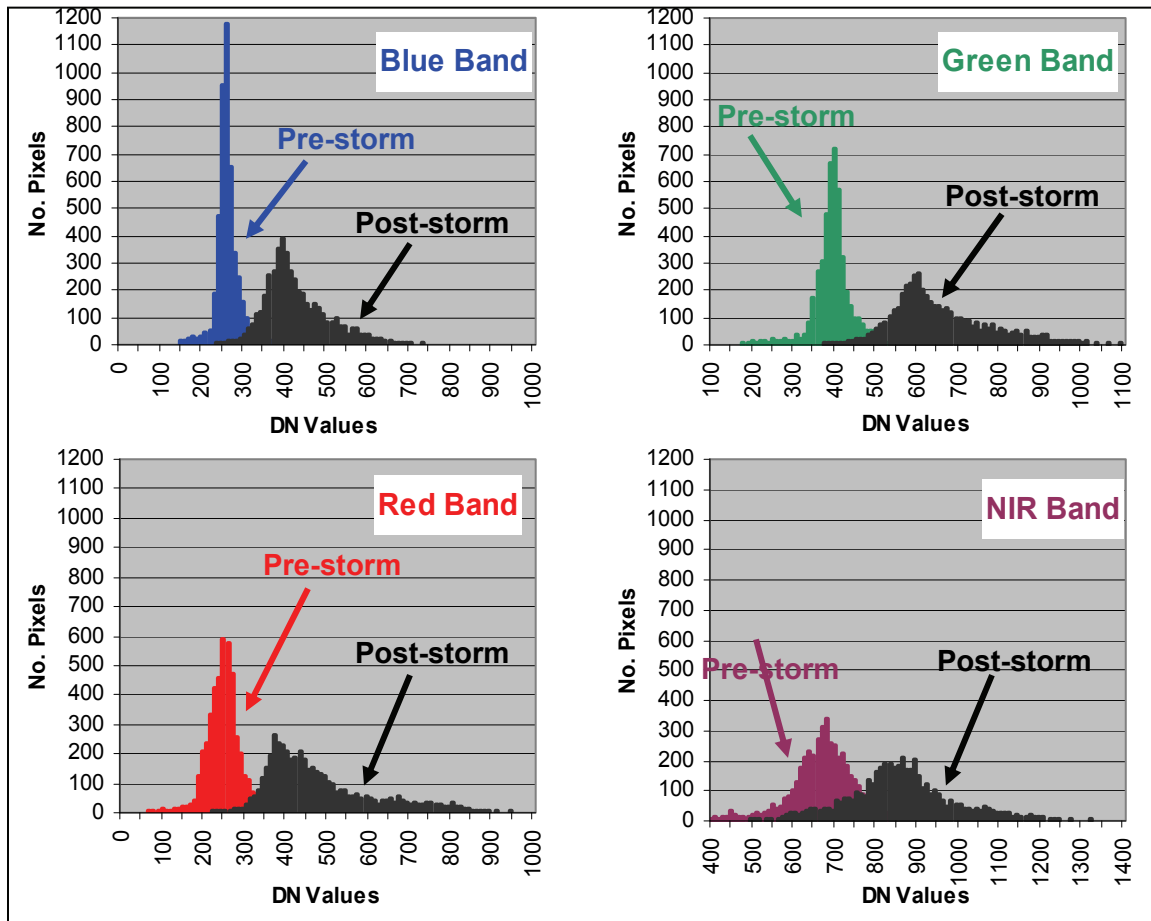
Figure 5-2 Spectral-Band Histograms for the Lawn Area Delineated in Figure 5-1. For Each Spectral Band, the Pre-Storm Values are Plotted in the Band Color, and Post-Storm Values are Plotted in Black. From Womble (2005).
