# Remote Sensing for Resilient Multi-Hazard Disaster Response

## Volume V: Integration of Remote Sensing Imagery and VIEWS™ Field Data for Post-Hurricane Charley Building Damage Assessment

Technical Report MCEER-08-0024

November 17, 2008

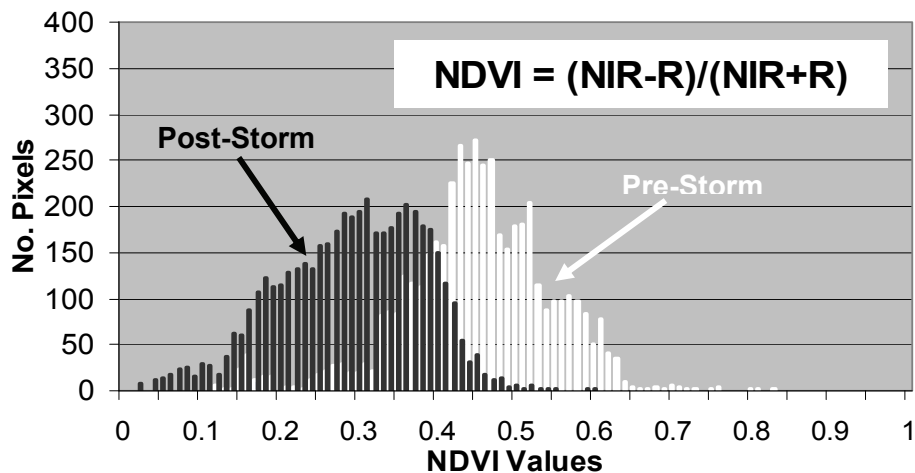
Figure 5-3 Pre-and Post-Storm Histograms of NDVI Values for the Lawn Area Delineated in Figure 5-1. For Each Spectral Band, the Pre-Storm Values are Plotted in the Band Color, and Post-Storm Values are Plotted in Black. From Womble (2005).

A histogram of pre- and post-storm NDVI values (figure 5-3) is also demonstrated for the pre- and post-storm area. The leftward shift of the NDVI distribution for the post-storm case is indicative of the vegetated surface being covered by other materials (debris). The NDVI analysis may thus be used to detect the presence of debris within a given area.

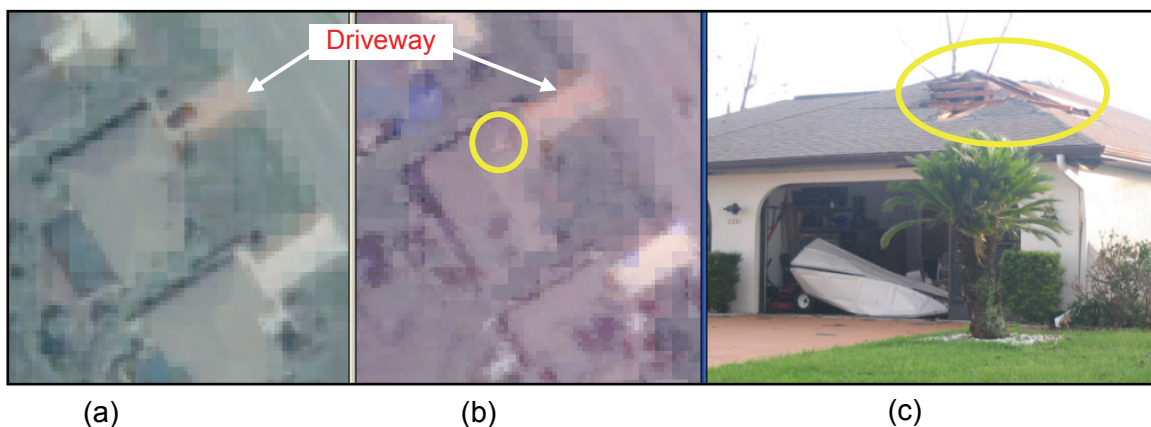
**Figure 6-1 Examples of Surrogate Indices for Garage Door Failures. The Presence of a Driveway Visible in the (a) Pre-Storm and (b) Post-Storm Quickbird Images Indicates the Presence of a Garage Door. The Roof Damage Above the Garage Indicates the *Possibility* of a Failed Garage Door, Permitting Wind Pressurization of the Building Interior. Credit: DigitalGlobe, Inc. <www.digitalglobe.com>.**

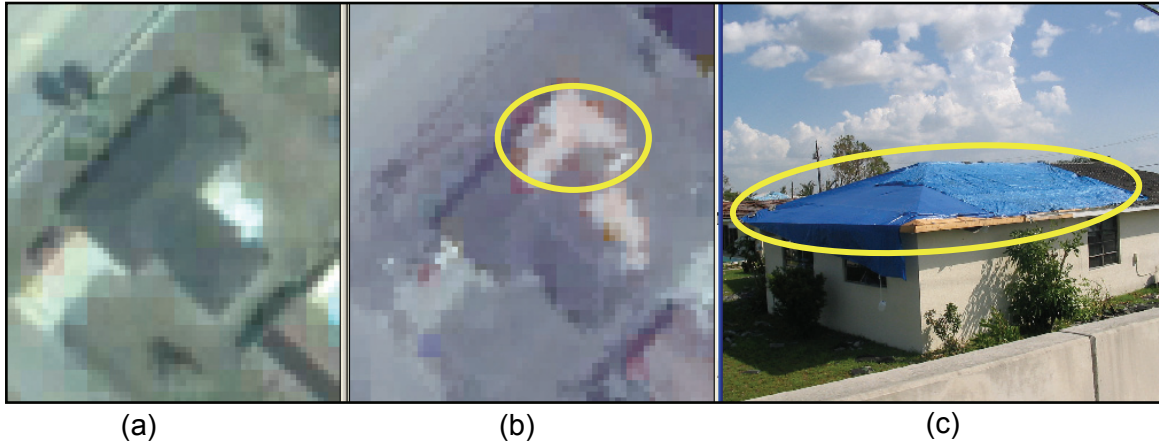
**Figure 6-2 Quickbird Images Collected (a) Before and (b) One Day After Hurricane Charley, and (c) Ground-Survey Photo. The Damaged Portion of the Roof is Apparent in the Post-Storm Image, but was Covered with a Blue Tarp Prior to the Ground Survey. Credit: DigitalGlobe, Inc. <www.digitalglobe.com>**

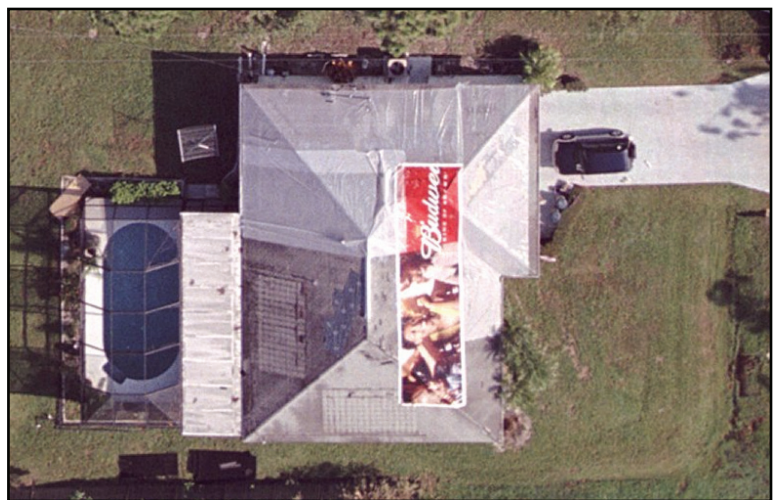
**Figure 6-3 The Appearance of Temporary Roof Coverings on Buildings Indicates the Presence of Damage, but can also Obscure the Damage. Post-Storm Imagery Acquired Before the Roof Covers Appear is also Needed to Assess the Level of Damage to the Roof. Credit: DMK Associates.**

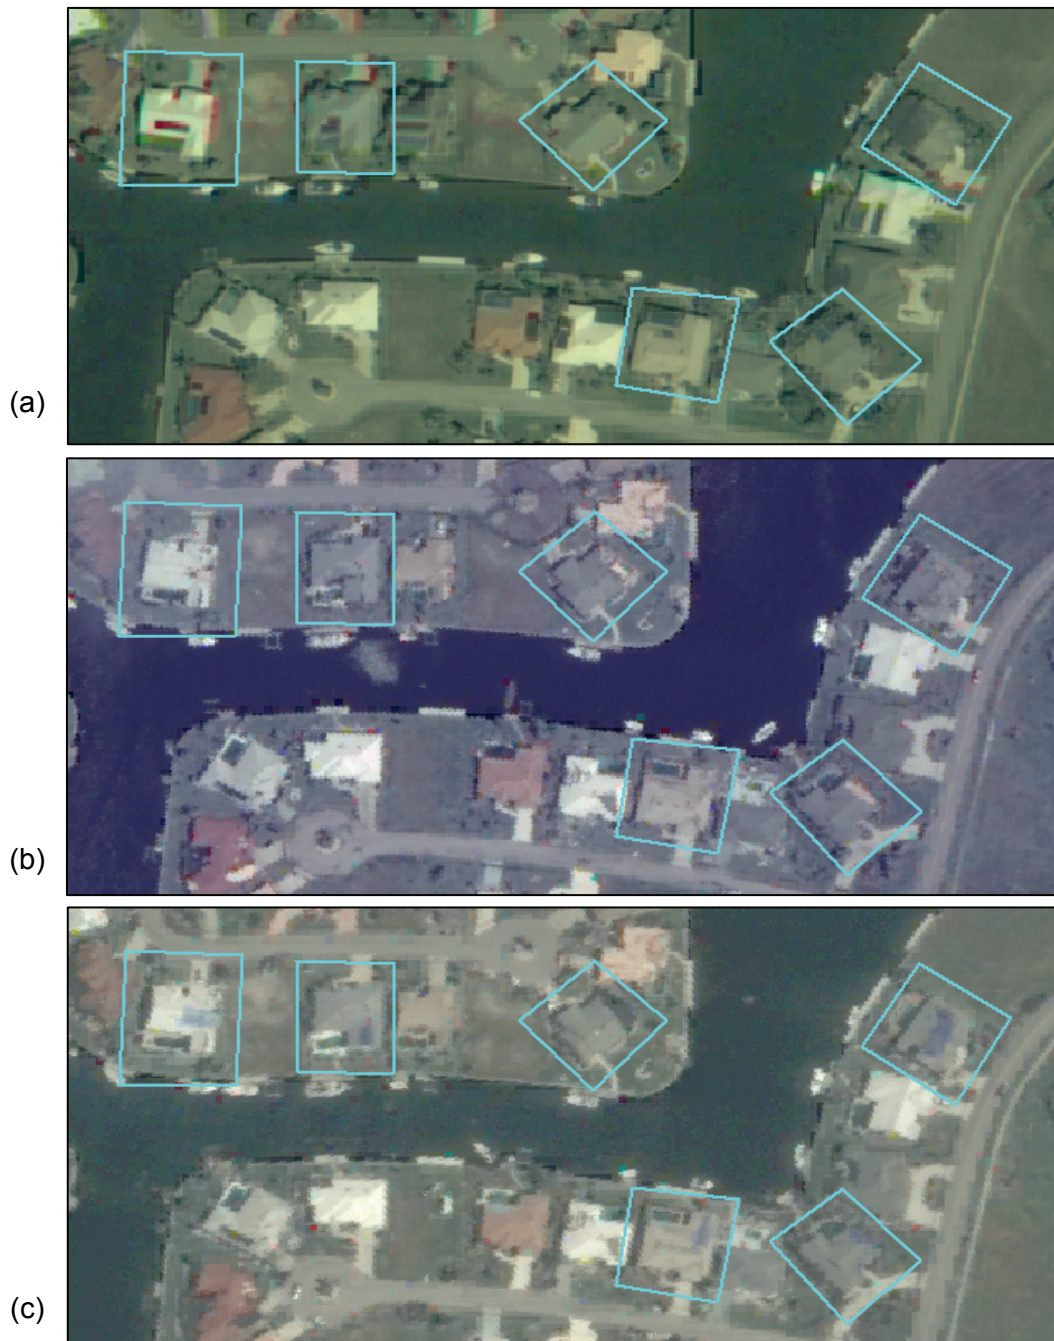
**Figure 6-4 Temporal Image Sequence Showing (a) Pre-Hurricane Condition on March 23, 2004; (b) Condition on August 14, 2004 (One Day Following Hurricane Charley); and (c) Temporary Roof Covers (Blue Tarps) in Place on August 19, 2004. Quickbird Images from DigitalGlobe, Inc. <[www.digitalglobe.com](http://www.digitalglobe.com)>.**

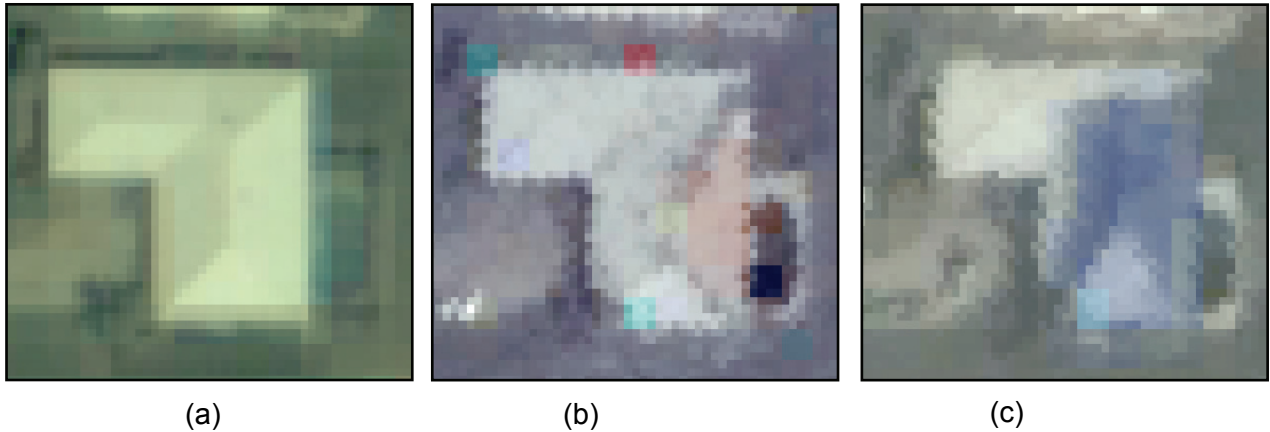
**Figure 6-6 Temporal Image Sequence Showing (a) Undamaged Condition on March 23, 2004; (b) Damaged Roof on August 14, 2004 (One Day Following Hurricane Charley); and (c) Temporary Roof Cover (Blue Tarp) in Place on August 19, 2004 (Indicating the Presence of Damage but Obscuring the Exact Damage Condition). Quickbird Images from DigitalGlobe, Inc. <[www.digitalglobe.com](http://www.digitalglobe.com)>.**

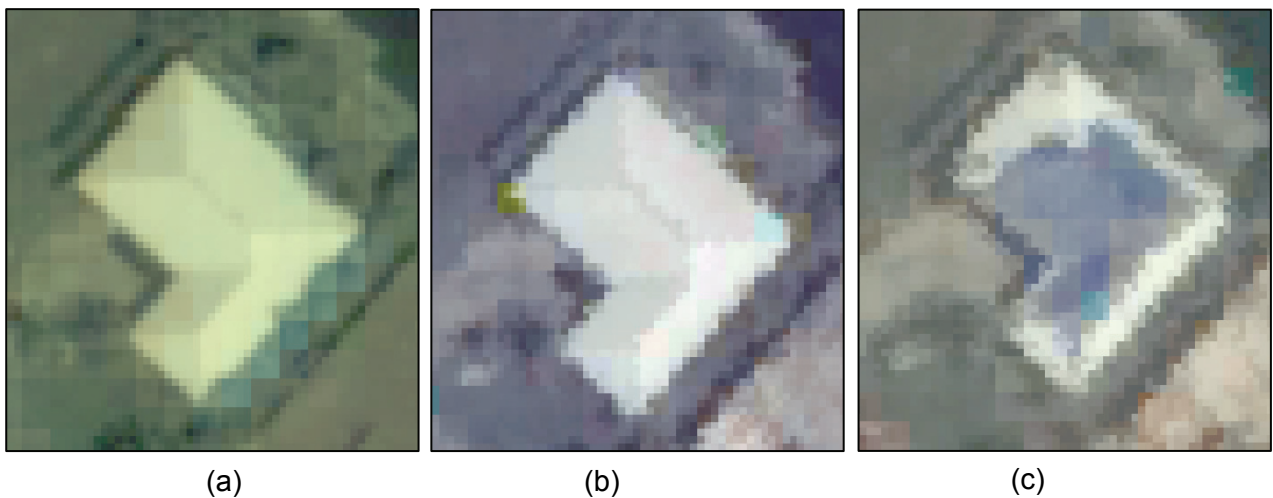
**Figure 6-7 Temporal Image Sequence Showing (a) Undamaged Condition on March 23, 2004; (b) Roof on August 14, 2004 (One Day Following Hurricane Charley) *Without Visible Damage*; and (c) Temporary Roof Cover (Blue Tarp) in Place on August 19, 2004 (Indicating The Presence of Damage). Quickbird Images from DigitalGlobe, Inc. <[www.digitalglobe.com](http://www.digitalglobe.com)>.**
