A Summary of MCEER  
Reconnaissance Efforts

## COLLECTION AND PRELIMINARY ANALYSIS OF AERIAL AND IN-FIELD BUILDING DAMAGE INFORMATION IN THE AFTERMATH OF THE 2007 CALIFORNIA WILDFIRES

**Anneley McMillan, Beverley J. Adams, Shubharoop Ghosh and Charles K. Huyck**  
*ImageCat Inc.*

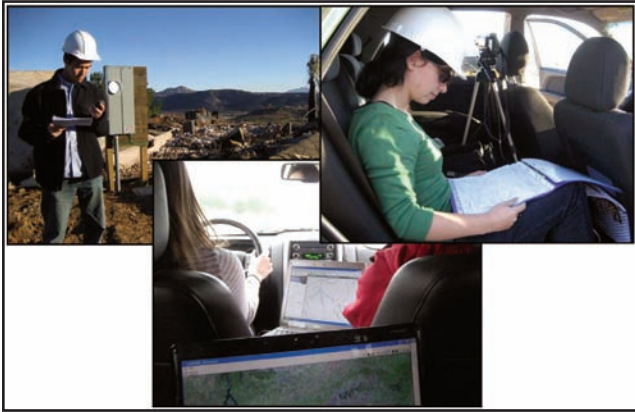
Figure 1. Deployment of the VIEWS™ system.

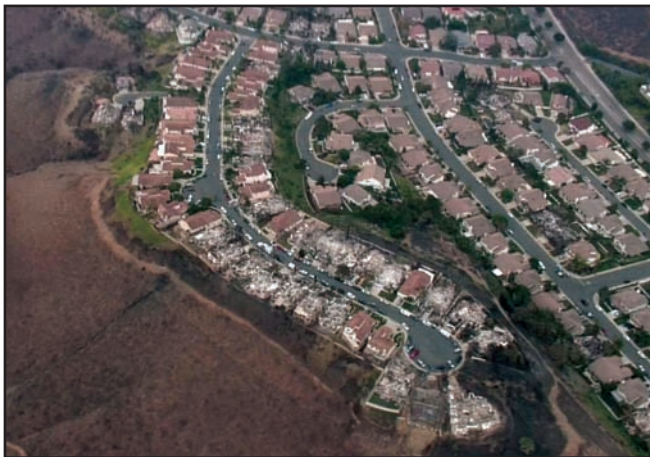
Figure 3. Example of aerial imagery, showing a partially destroyed neighborhood in San Diego.

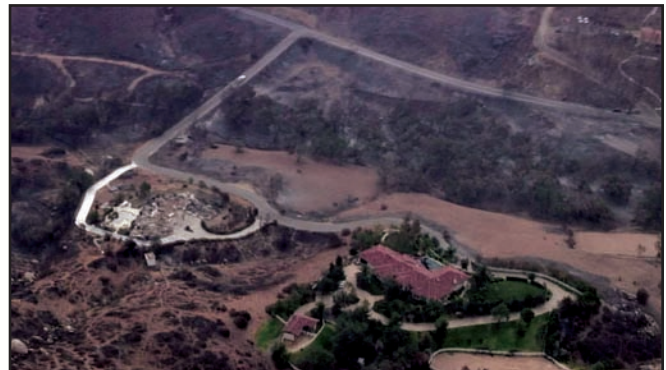
Figure 6. Chaparral burn in Poway, and the patchy nature of the damage to ranch style properties.

damage in this area is very variable and patchy. For instance, Figure 6 shows the burned chaparral around one neighborhood. Buildings are seemingly destroyed at random. The factors determining whether a house in this type of environmental situation is subject to burn or not clearly depends on a number of factors, which may include: ember travel; the quality of house construction; vegetation clearance; and fire management techniques.

There are a couple of distinctive types of construction within the Witch fire area. The first type commonly encountered is shown in Figure 6, ranch type structures, where homes are separated by considerable distances, and are fairly large in size. The second type is the more densely populated areas of Rancho Bernardo, as shown in Figure 7. Again, a fairly random distribution of burned buildings was seen here.

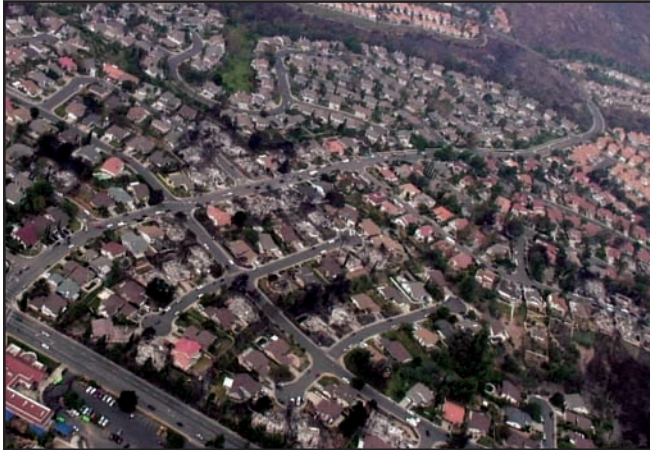
Figure 7. The patchy nature of house destruction through Rancho Bernardo.

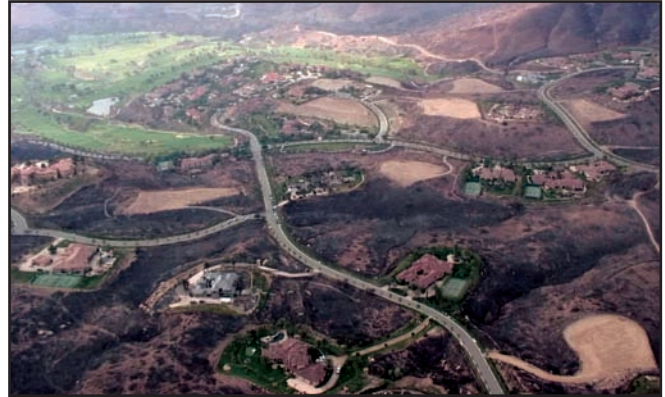
Figure 8. Good vegetation clearance practices helped to avoid house destruction.

The VIEWS™ footage in Figure 8 shows the difference that a well maintained clearance zone around a property can make. The irrigated lawns act as a barrier between the chaparral burn and the property

(i.e., the empty spaces of land are thought to be new construction areas, not destroyed parcels). A large part of fire protection activities involves vegetation clearance. Organizations such as Cal Fire disseminate regulations and information on vegetation clearance parameters around properties. For instance, the current defensible space clearance regulation is 100 feet around properties in California. A defensible

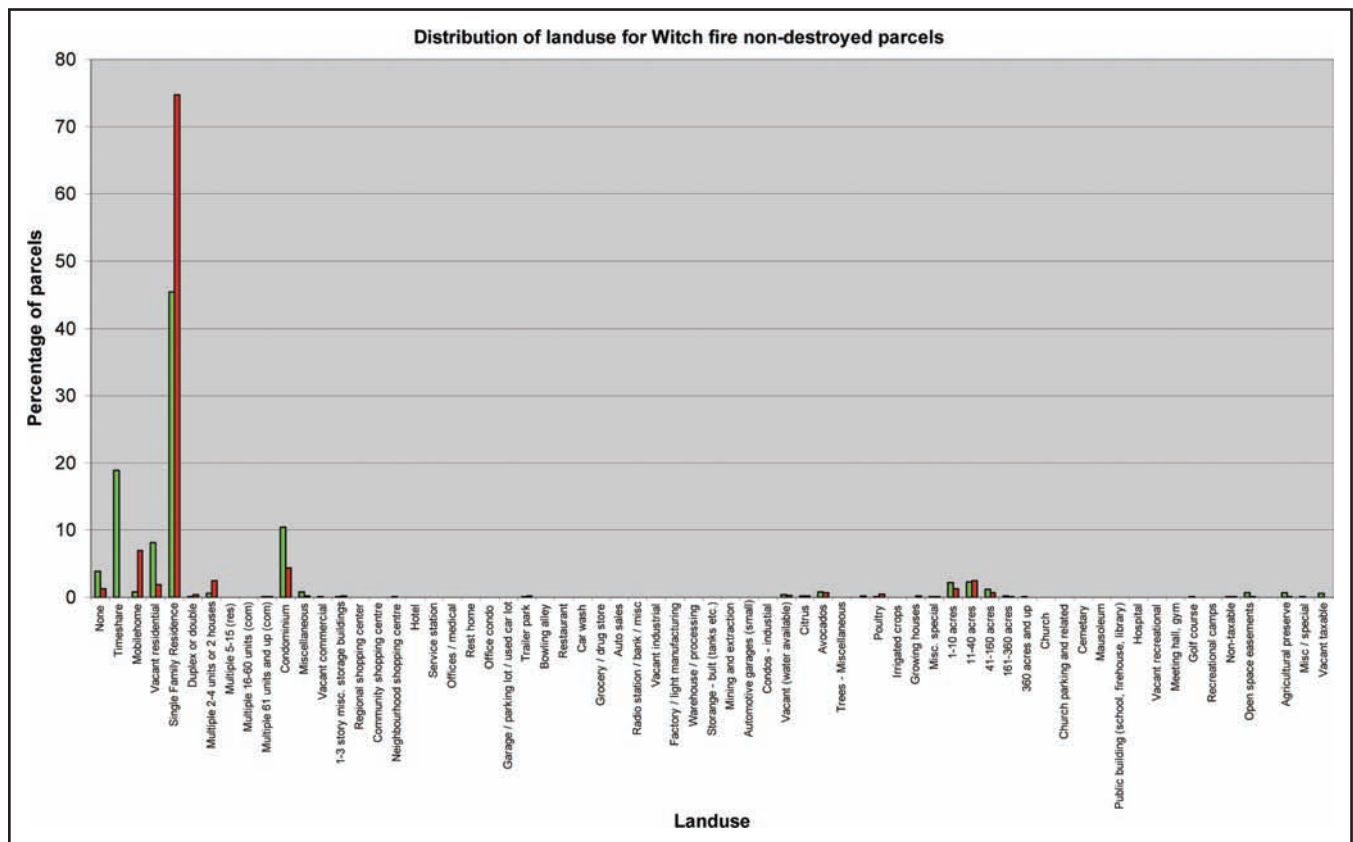
Figure 12. Percentage of parcels by land-use for non-destroyed (green) and destroyed (red) parcels.

Figure 12 shows that the majority of building stock (around 53%) in San Diego is single family residential structures (either occupied or vacant). After this, timeshares, condominiums and mobile homes are very common. Considering the distribution of building stock among buildings that were destroyed, around 76% are single family residential. There is also a number of mobile homes (7%), and multiples of 2-4 units (3%). In terms of targeting information on fire mitigation, this distribution of building stock is important to know. As well as recording a high frequency of damage, residential properties are likely to be the most varied in terms of vegetation and build quality. As shown in Figure 8, it is important that good vegetation clearance practice and building regulations are followed, to hamper fire spreading through whole neighborhoods.

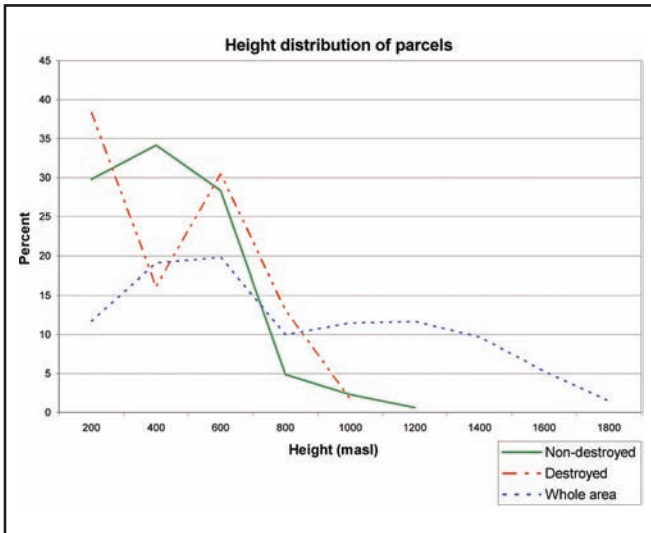
Figure 14. Distribution of elevation for the entire area (burned and non-burned) and affected parcels within the burn area containing destroyed and non-destroyed buildings.

Considering Figure 14, the distribution of parcel elevation for the whole area is shown graphically in relation to the distribution of elevation for parcels affected by the burn, but where no houses were destroyed, and distribution of elevation amongst parcels where houses did burn.

First when examining the elevation for the whole region, there is a range of elevation distributions. The largest proportion of parcels is found from 400-600m. The proportion of parcels decreases

as elevation increases, but parcels are still found at 1600-1800m. The parcels affected by the fire tend to be in the lower elevated areas of the county (i.e., up to 1000m elevation).

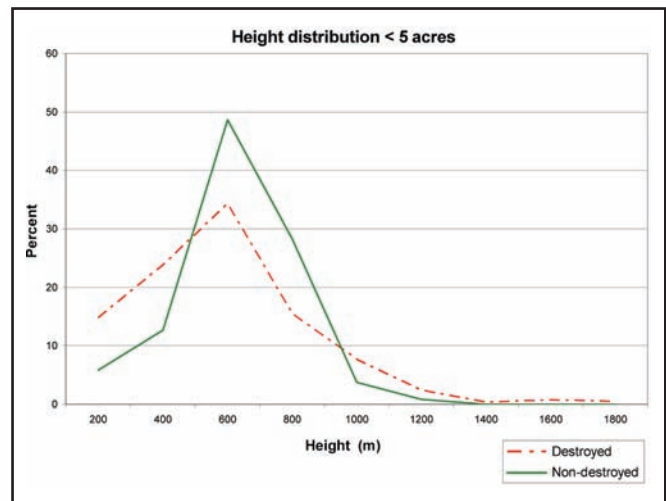
Figure 16. Distribution of elevation for burned and non-burned parcels of > 5 acres. This subset of larger parcels is employed as a surrogate indicator for ranch properties.

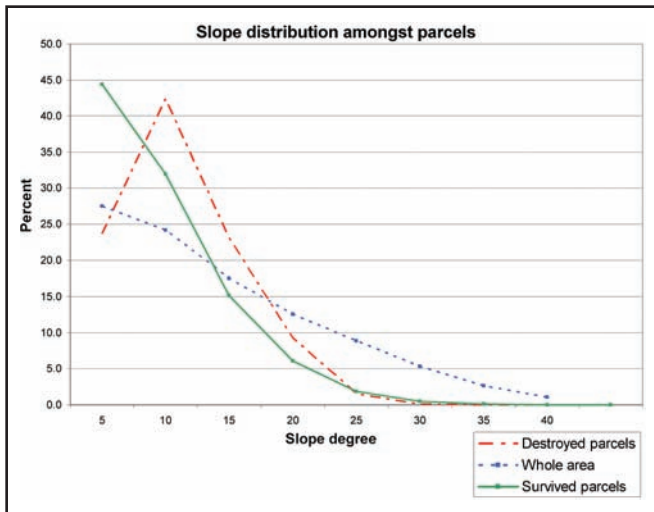
Figure 20. Distribution of slope for the Witch fire.

Figure 20 shows the relationship graphically for the whole area. The proportion of slopes in each degree category is seen to decrease fairly linearly with increasing slope angle. When this global population is compared with the subset of affected parcels (destroyed and non-destroyed, Figure 21), a higher proportion of affected parcels are on relatively flat land, and minimal parcels burned on very steep land >25 degrees. Revisiting Figure 13, the fire appears to have spread downslope and into the valley where a number of residential communities lay. However, within the burn area, parcels where buildings were destroyed are more likely to be on steeper slopes of ~15 degrees.

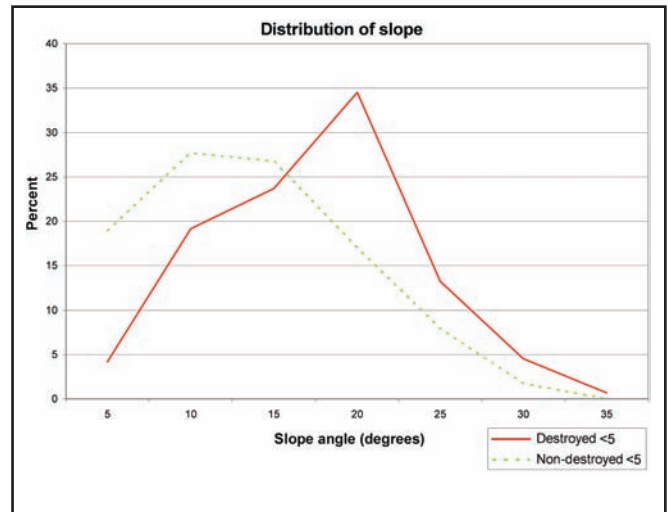
Figure 21. Distribution of slope for the Witch fire for parcels up to 5 acres.

When considering only residential parcels of < 5 acres in size where buildings burned, the majority of parcels are on 15-20 degree slopes. Fewer residential buildings were destroyed on slopes of 0-5 degrees, when compared to the general distribution of burned parcels, as although there are a lot of residential buildings built on very low slopes, these tend to be found in the center of residential communities. As the fire did not generally penetrate far into these areas, there are relatively few parcels in this category.

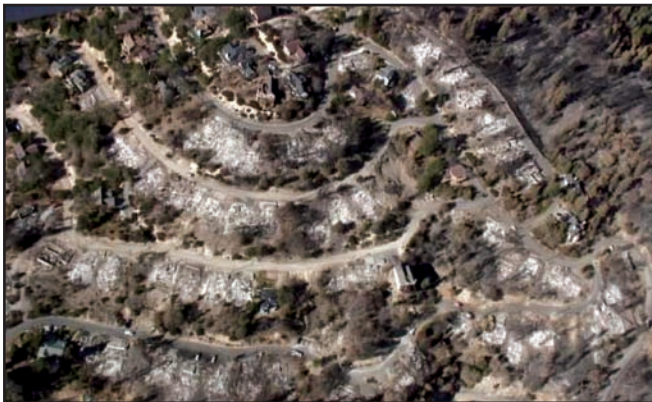
Figure 23. Destruction of houses in the Grass Valley area.

Recalling Table 2, the fuels for the Slide and Grass Valley Fires were different from those that fed the Witch Fire. Rather than the chaparral and grassland that characterized the Witch fires, these fires occurred in the pine forests of the San Bernardino Mountains. Figure 23 shows how the difference in environment affected the type of burn experienced in the area. It shows a group of destroyed houses after the Grass Valley fire. It is possible to see the 'domino' effect of fires spreading through a community, from one home to the next. The homes in this area were in close proximity to trees, which empha-

sizes the importance of vegetation clearance around properties.

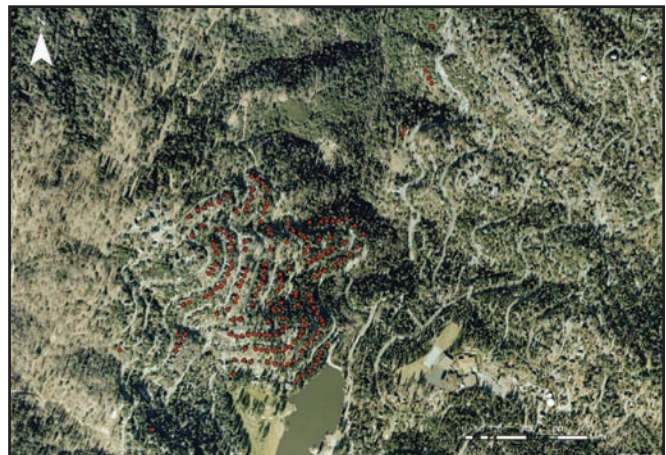
Figure 25. Distribution of burned buildings in Grass Valley Fire.

Figures 25 and 26 show that the distribution of building burn within the Grass and Slide fires differs from that of the Witch fires. They are a lot more concentrated in their destruction, suggesting that the fire front passed through the whole neighborhood, with the ‘domino’ effect of houses setting the next one on fire. That stated, when ground VIEWS™ surveys were taken, even though the rate of building destruction looks high, there are still many homes in between burned buildings that were not touched by the fire.

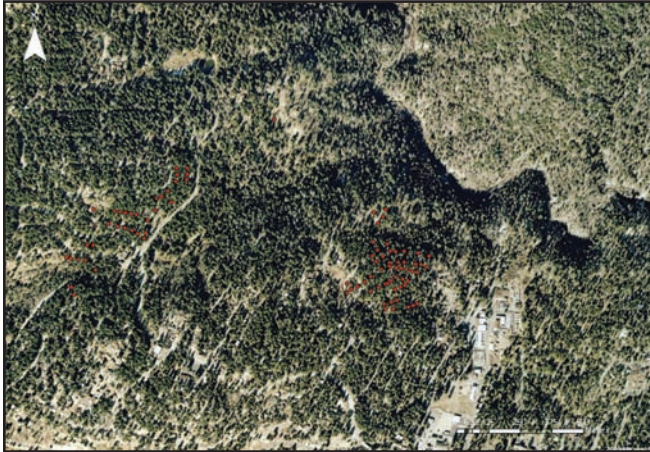
Figure 26. Distribution of burned buildings in Slide Fire.

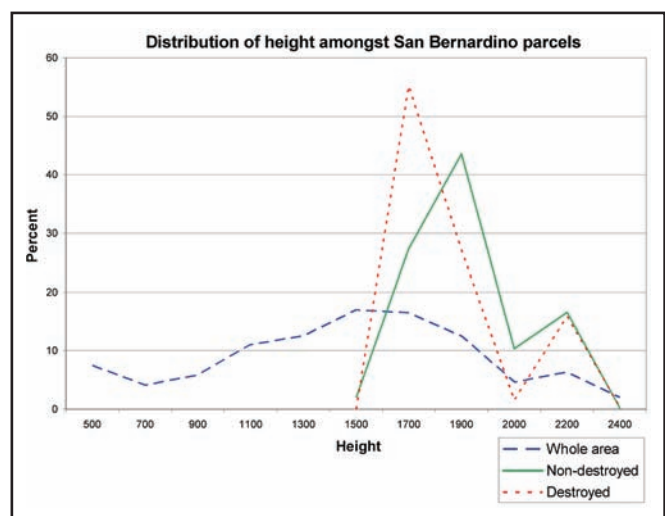
Figure 30. Distribution of elevation amongst San Bernardino parcels.

Figure 30 shows the distribution in elevation in graphical form. Statistics from the whole area are shown in relation to the distribution of elevation for parcels affected by the burn, but where no houses

were destroyed (this is marked as ‘non-destroyed’ parcels on the figure), and distribution of elevation amongst parcels where houses did burn (destroyed).

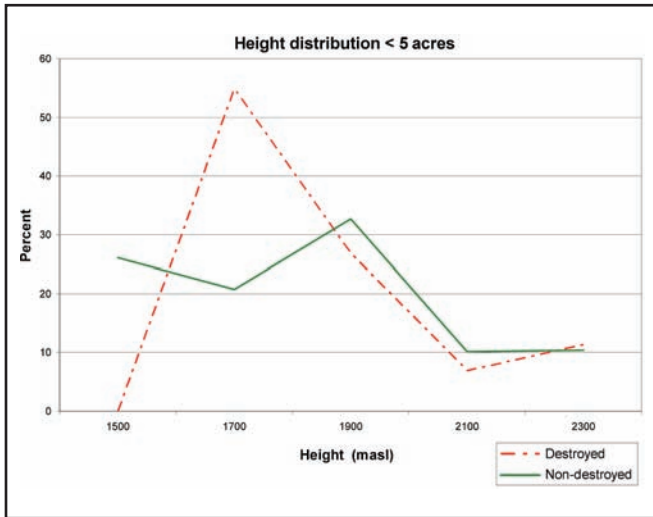
Figure 31. Distribution of elevation amongst San Bernardino parcels < 5 acres in size.

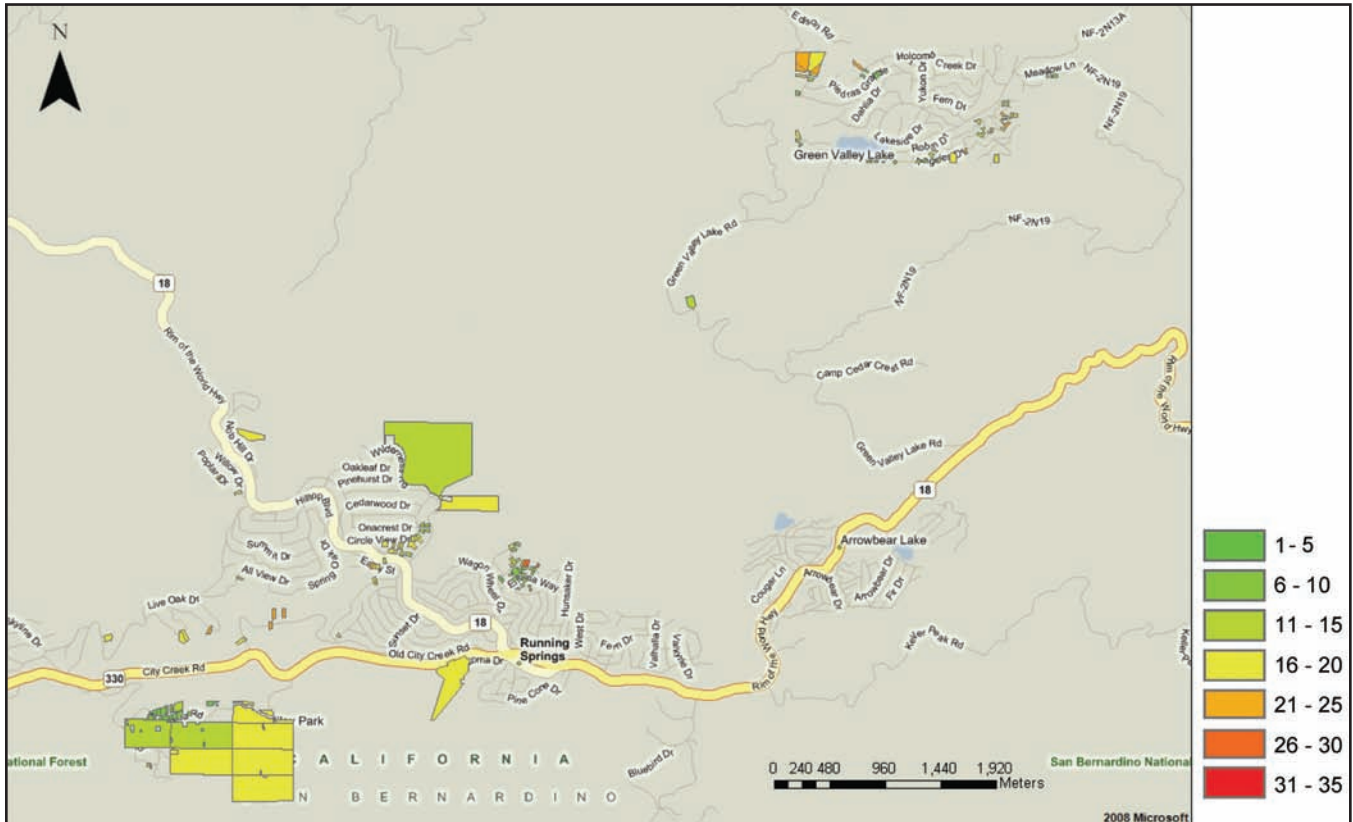
Figure 39. Close up of Slide fire destroyed parcels, showing slope distribution (degrees).
