DEVELOPMENT OF A PERFORMANCE-BASED SEISMIC DESIGN PHILOSOPHY FOR MID-RISE WOODFRAME CONSTRUCTION

SEISMIC TESTING OF A FULL-SCALE TWO-STORY LIGHT-FRAME WOOD BUILDING: NEESWOOD BENCHMARK TEST

Technical Report MCEER-09-0005 ■ July 22, 2009

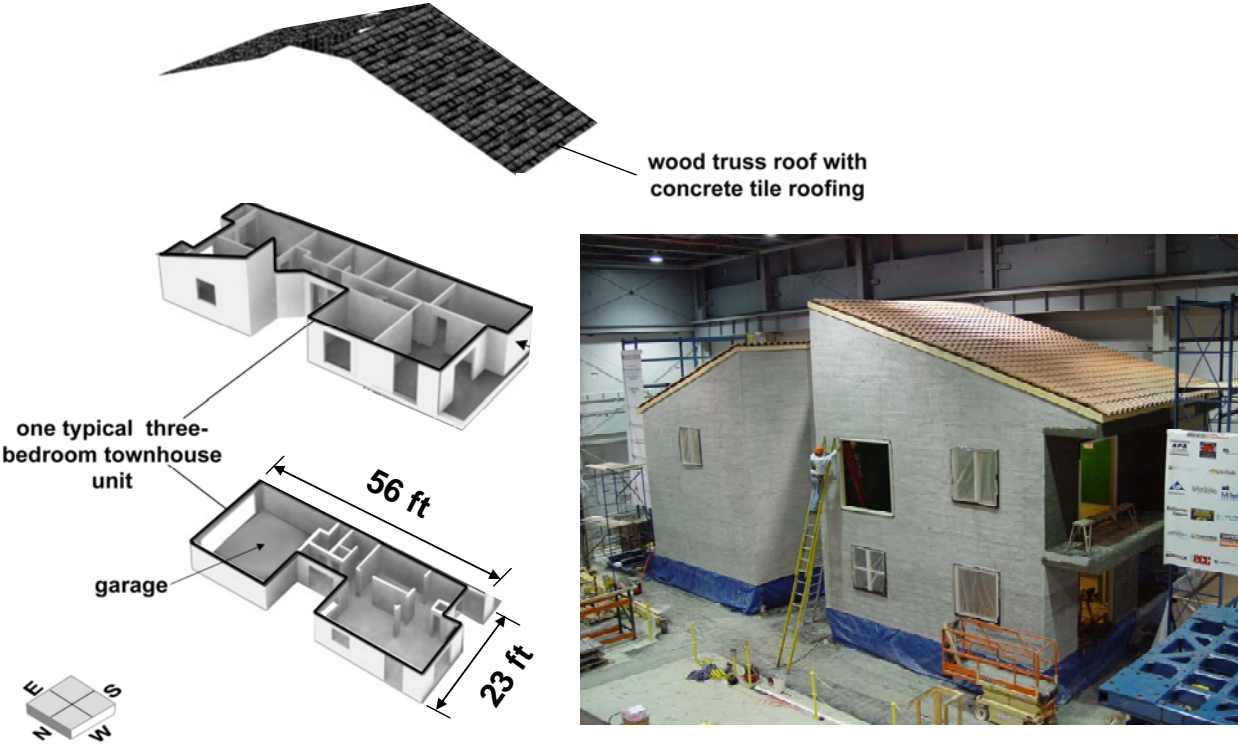
Figure 1.1: NEESWood benchmark test structure

The benchmark test structure is based on one of the four index buildings designed within the recently completed CUREE-Caltech Woodframe Project [1]. It represents one unit of a two-story townhouse containing three units, having approximately 1800 ft² of living space with an attached two-car garage, as shown in Figure 1.1. The height of the townhouse from the first floor slab to the roof eaves is 18 ft and its total weight is approximately 80 kips. The exterior walls of the townhouse test building are covered on the outside with 7/8 in. thick stucco over 7/16 in. thick OSB sheathed shear walls and 1/2 in. thick gypsum wallboard on the inside.

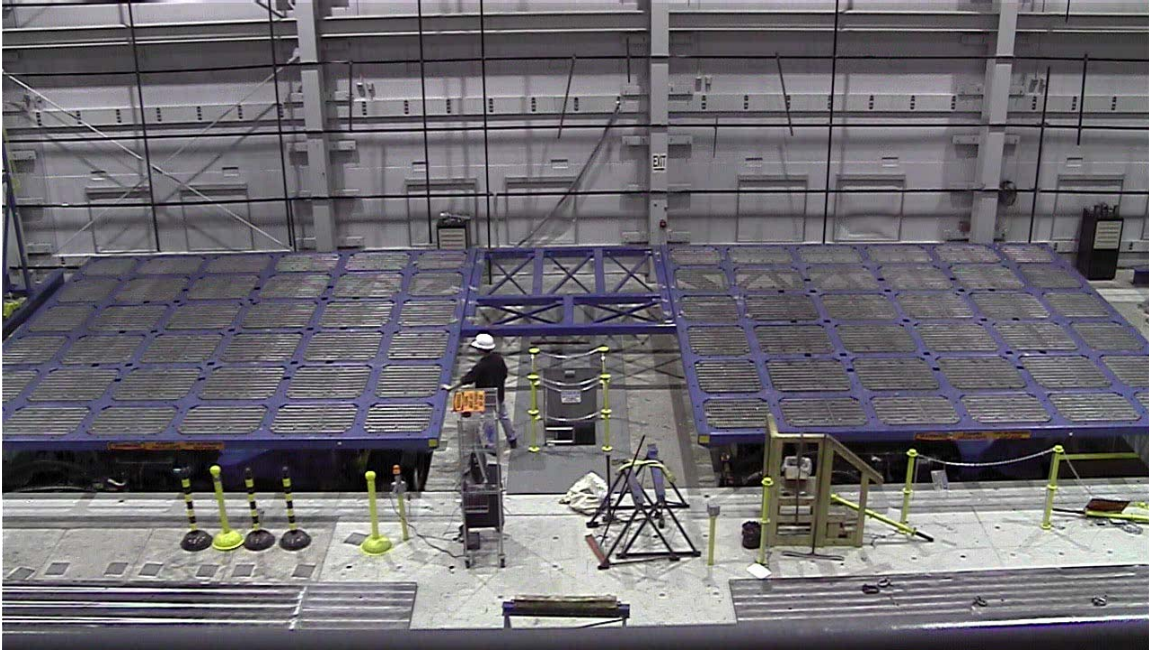
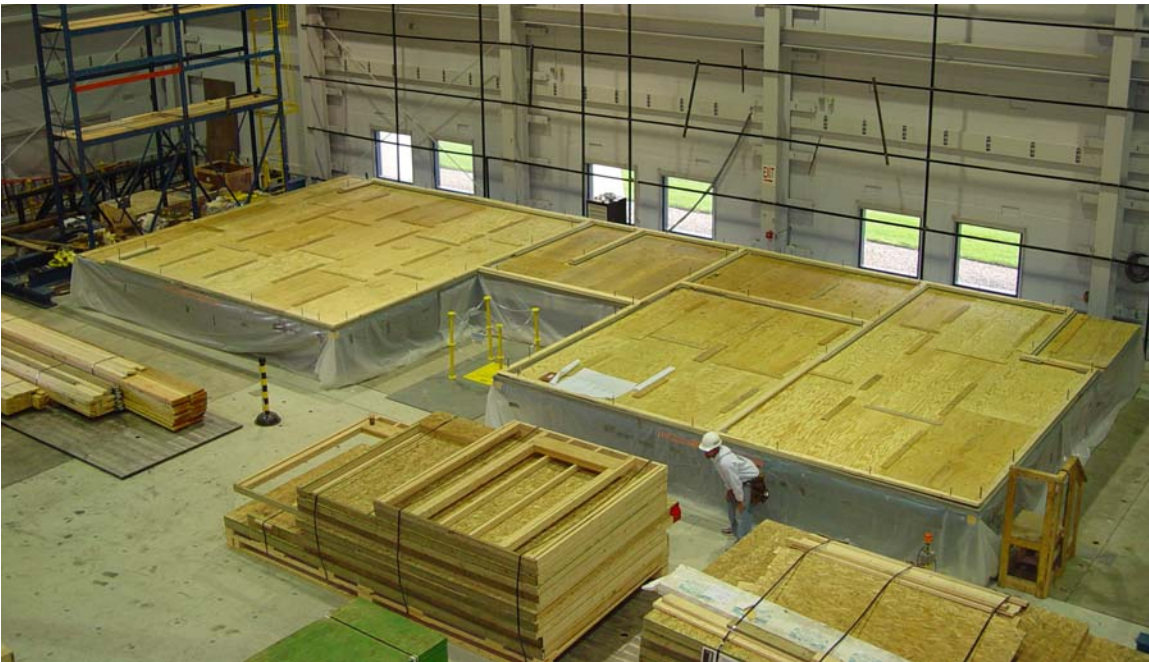
Figure 2.4: (a) Extension frame of shake tables connected by steel link structure, and (b) Foundation of Test Building under Construction

The two tables acting in unison were required to accommodate the weight of the full-scale test building. As shown in Figure 2.4a, the 23 ft x 23 ft extension steel frames available on both of the UB-SEESL shake tables were connected together by a steel link structure to support the entire woodframe structure across the two shake tables with minimal vertical deflection. Figure 2.4b shows a photograph taken during the construction of the foundation of the test building on the two shake tables and link structure.

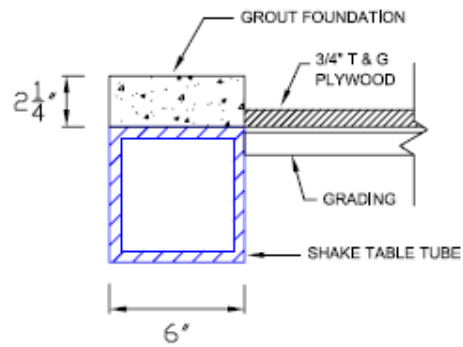
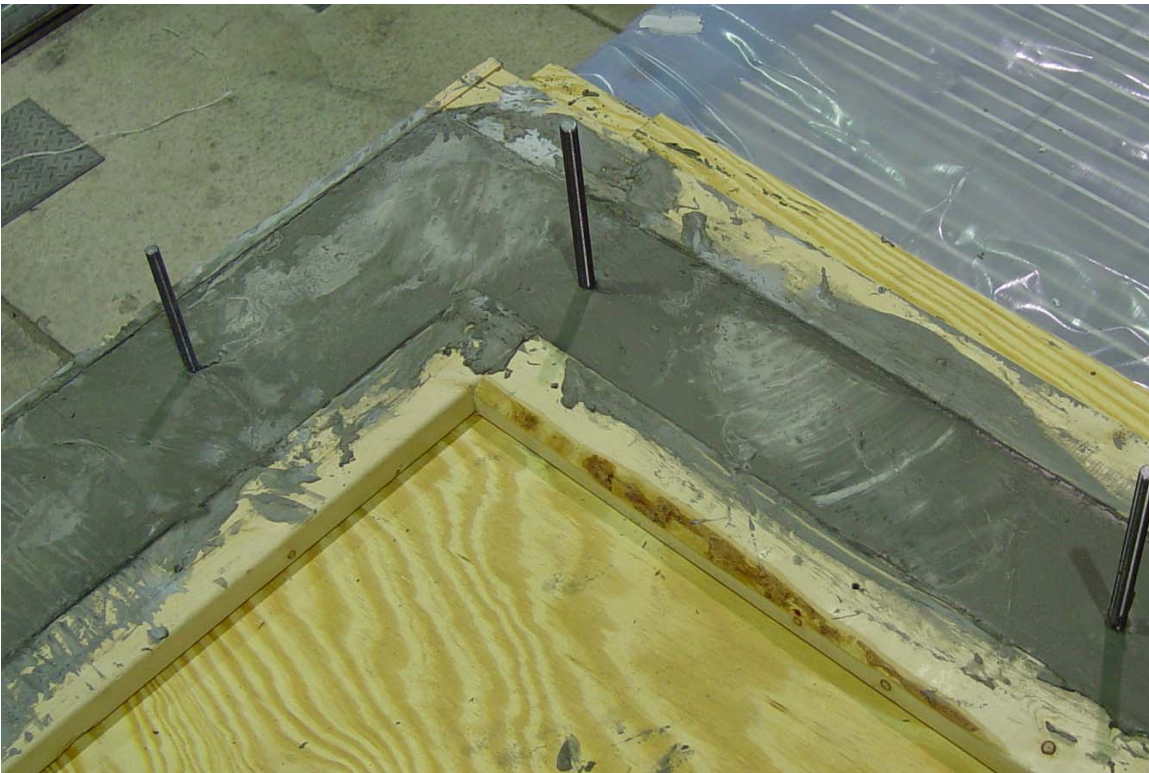
Figure 2.5: Foundation details, a) schematic, b) photograph

Threaded A-307 steel rods bolted to the existing hole pattern of the extension frame were used as anchor bolts for the sill plates, as shown in Figure 2.5a. Note that 2- $\frac{1}{4}$ in. x 2- $\frac{1}{4}$ in. x $\frac{1}{4}$ in. thick steel plate washers were installed at each anchor bolt location. At the locations of hold-down devices, $\frac{5}{8}$ in. diameter rods were used, while $\frac{1}{2}$ in. diameter rods were used at other locations. A 2- $\frac{1}{4}$ in. thick layer of grout was installed on top of the steel base beneath the pressure treated sill plates to represent a foundation, as shown in Figure 2.5b. The friction of the sill plate against the grout was similar to that of a true concrete foundation. The locations of the anchor bolts around the perimeter of the test building are given in Appendix A.

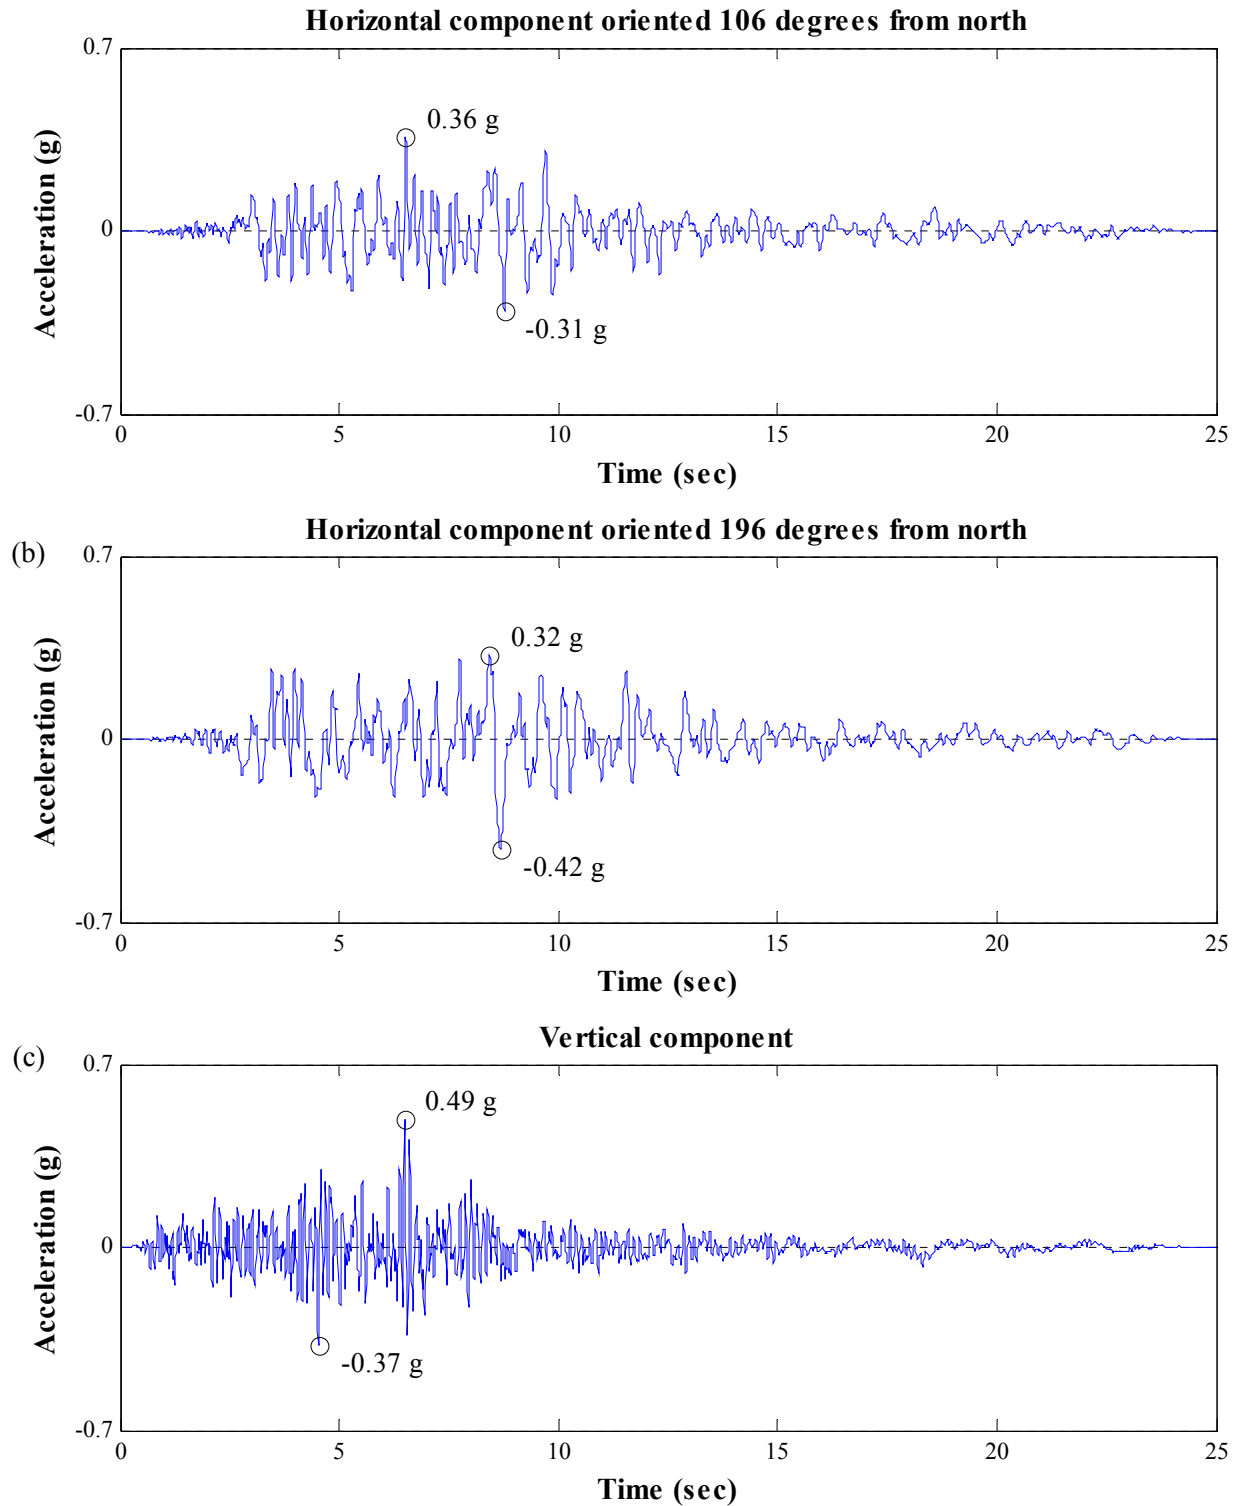
Figure 3.1: Acceleration time-histories of unscaled Canoga Park ground motions: (a) horizontal component at 106 degrees from north, (b) horizontal component at 196 degrees from north and (c) vertical component

The first set of ground motions was Canoga Park (CP), recorded at Topanga Canyon (USC Station 90053) at a distance of 15.8 km from the fault rupture. The acceleration time-histories of the three components of the Canoga Park record are shown in Figure 3.1. These ordinary ground motions with an amplitude-scaling factor of 1.20 were considered to represent a Design Basis Earthquake (DBE) event with a 10% probability of exceedance in 50 years or a return period of 475 years [3]. The acceleration response spectra of the three unscaled components of the Canoga Park record for 5% damping are presented in Figure 3.3.

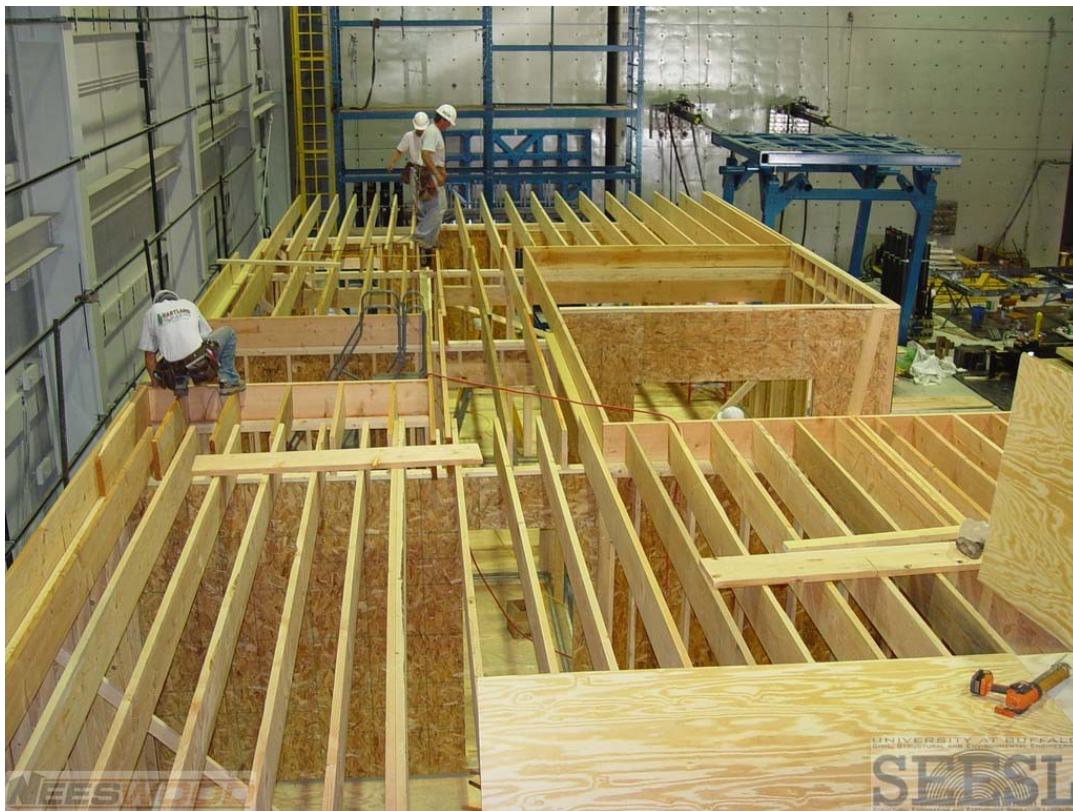
Figure 3.5: Installation of floor joists during construction

The floor joists were constructed of 2x12 Douglas Fir lumber spaced at 12 or 16 in. O.C., as shown in Drawing S-8 and illustrated in Figure 3.5. Roof trusses were constructed of SPF lumber and were spaced at 24 in. A photograph taken during the installation of the roof trusses on the structure is shown in Figure 3.6. The first floor shear wall sill plates were located on a 2-¼ in. thick concrete slab, which followed the perimeter of the building. The width of the concrete slab was 2 in. greater than the width of the sill plate. Drawings S-14 and S-15 present information related to the concrete slab.

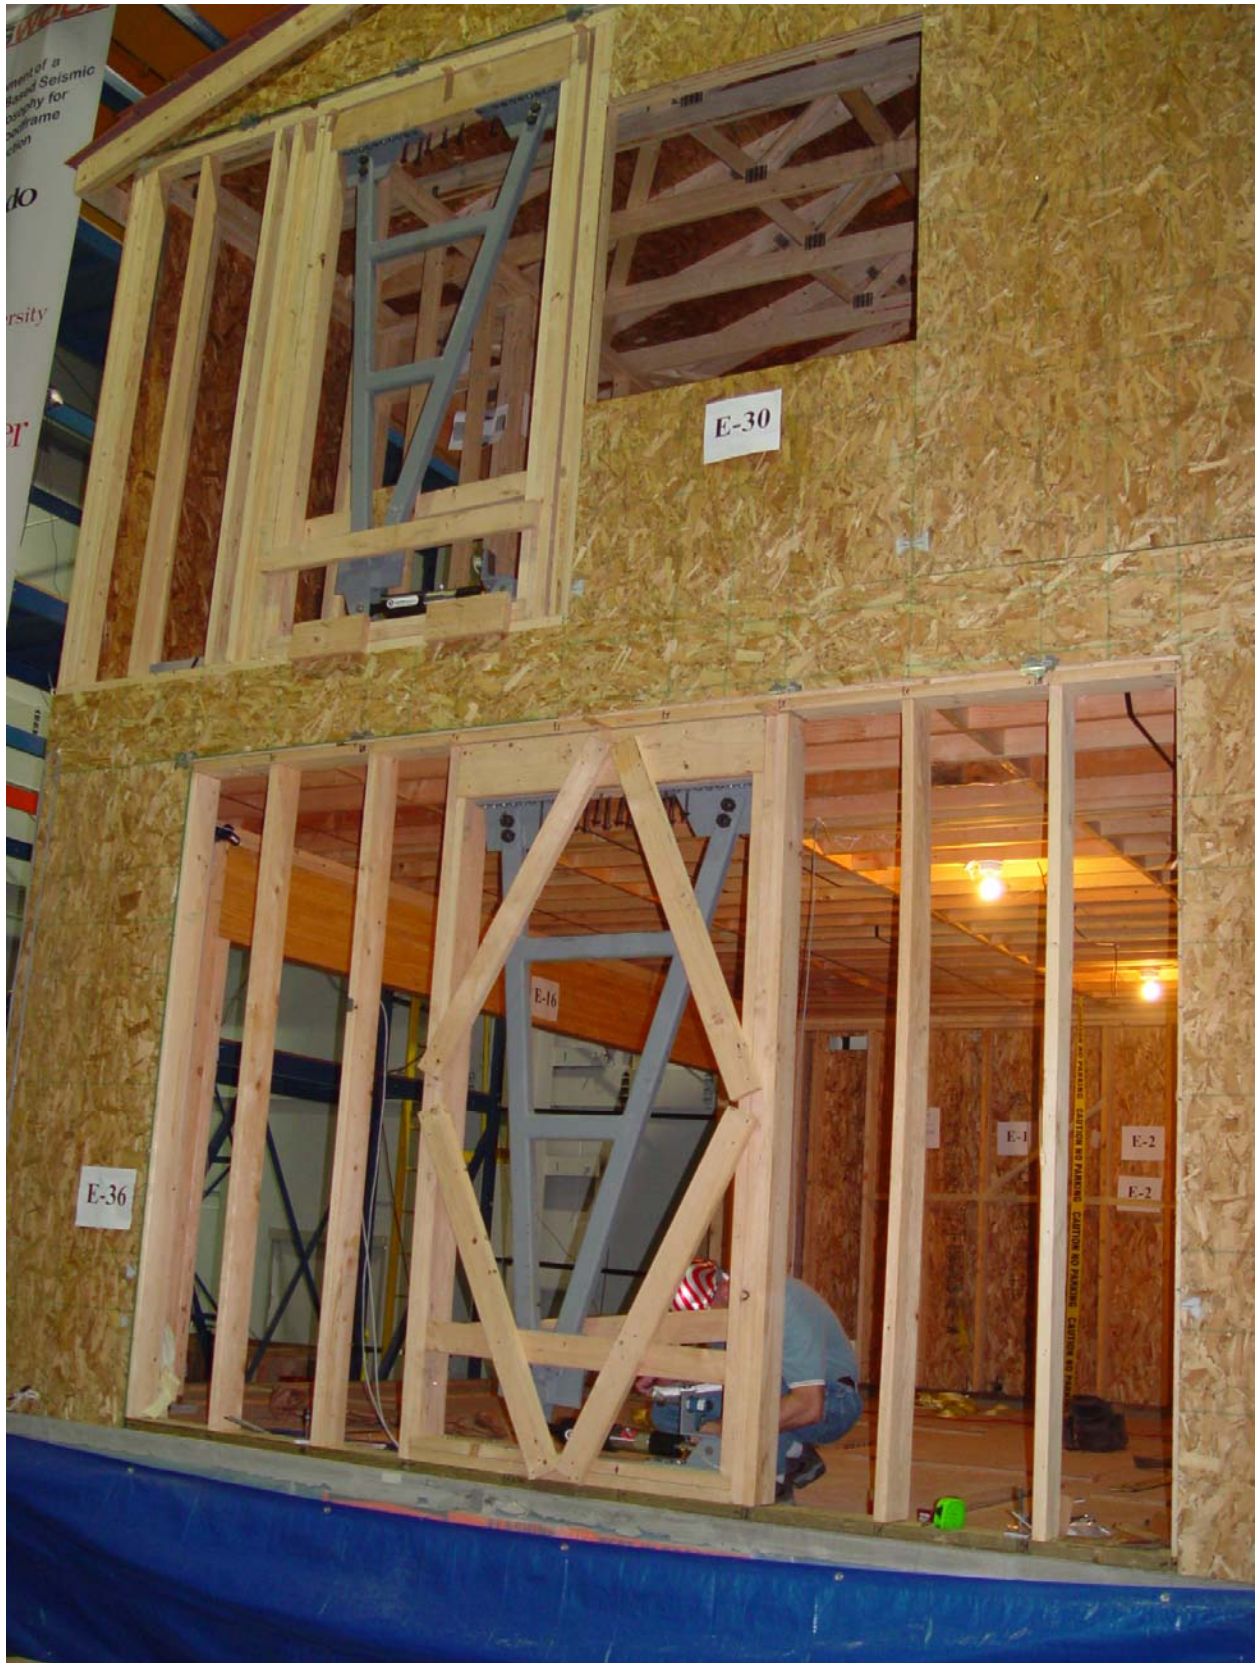
Figure 3.12: Installation of the damper-wall units on the south-west side of the structure

Figure 3.11 shows the benchmark structure before the installation of the damper-wall units and after the extraction of sheathing and wood framing of the existing walls. Figure 3.12 shows the installed damper-wall units at the southwest side of the townhouse before the application of the sheathing panels. Two of the wood shear walls of the benchmark structure were repaired before the beginning of Test Phase 2. These were the interior structural walls, I-1 and I-27 as identified in Appendix B, which were located at the first floor and oriented in the north-south direction. OSB Sheathing panels were replaced for both of the walls, except for the small sheathing pieces around the interior door. One damaged stud was also replaced from Wall I-27.

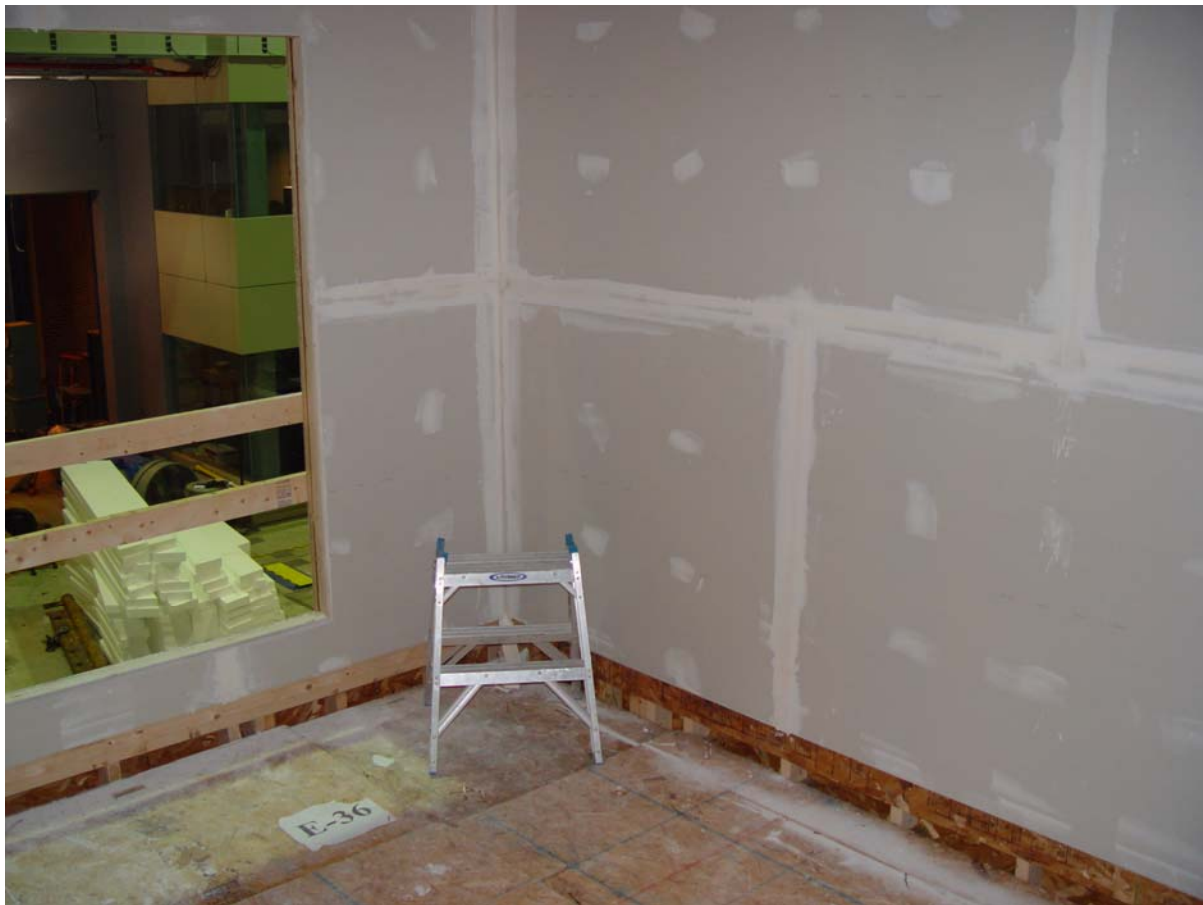
Figure 3.14: View of the interior wall finishes after mudding and taping

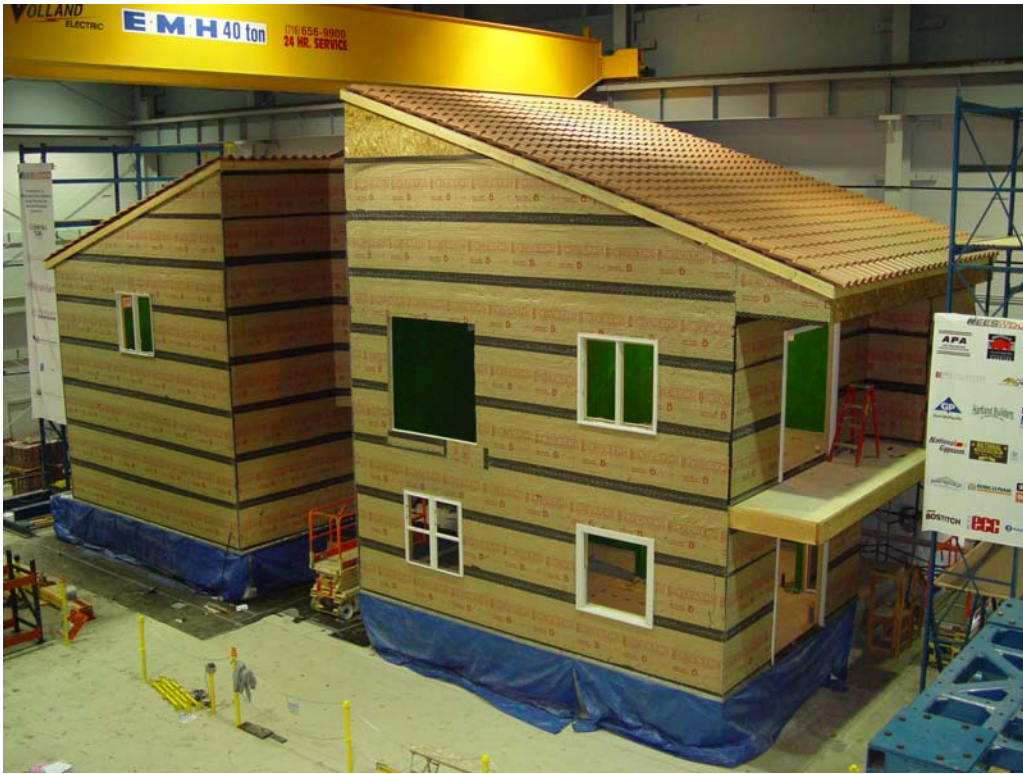
Figure 3.17: Installation of vapor permeable, water-resistant tar paper on the test structure

The stucco consisted of a mesh of wire lath (16 gauge steel wire mesh) and 3 coats of Portland cement-based plaster. First, vapor permeable, water-resistant tar paper was applied on the exterior surface of the structure (see Figure 3.17). The paper protected the sheathing and interior of the walls from outside moisture intrusion without trapping moisture vapor in the walls. Then, the wire mesh was attached to the exterior surface through 1-1/2 in. long leg staples, attached to the studs and spaced at 6 in. O.C. The first two coats of plaster were 3/8 in. thick each while the finish coat was 1/8 in. thick. Figures 3.18, 3.19 and 3.20 illustrate the exterior of the structure during application of the first, second and third coat, respectively, while Figure 3.21 shows the structure after the completion of this construction phase.

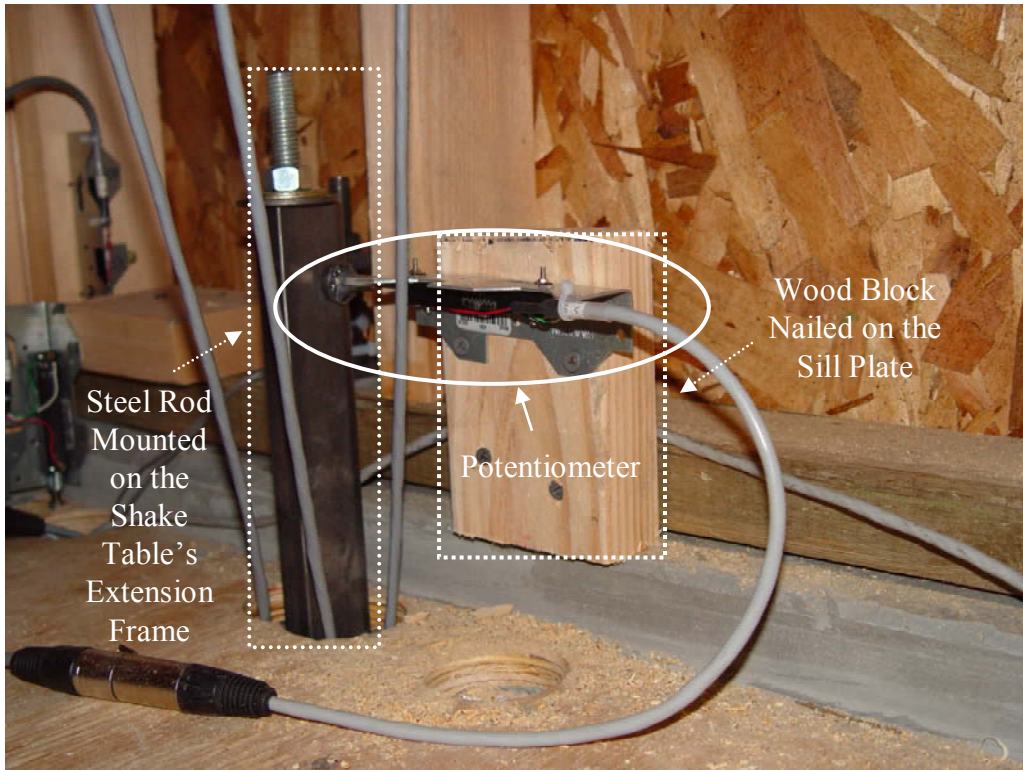
Figure 4.4: Potentiometer installed on the test structure to measure sill plate slippage

Another type of displacement measuring devices used was the linear potentiometers. These instruments were calibrated for a small displacement range (of the order of 2 in.). Ten potentiometers were used to capture the sill plate slippage of shear walls around the perimeter of the structure with respect to the foundation (see Figure 4.4). Twenty six pairs of potentiometers were installed to measure the uplift displacement of the sill plate of selected walls with respect to the foundation, as well as the uplift displacement of the external stud with respect to the sill plate (see Figure 4.5). Instrumentation plans for the location of the potentiometers are provided in Figures E.5 and E.6 of Appendix E.

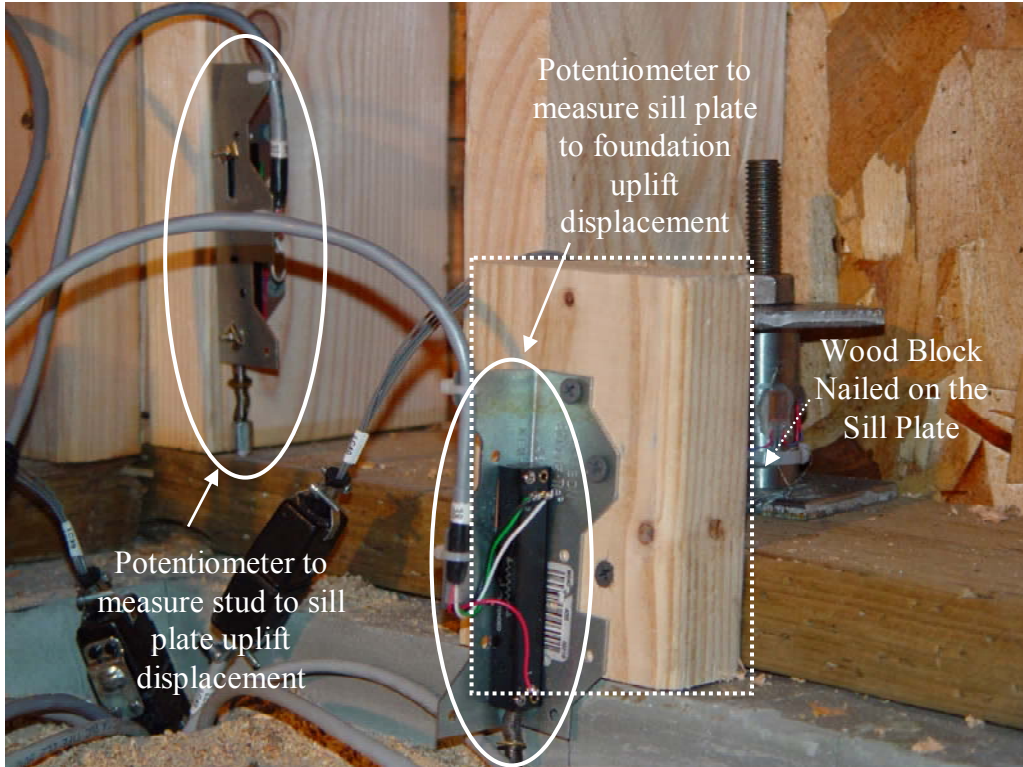
Figure 4.5: Two potentiometers installed on the test structure to measure uplift displacements of stud to sill plate and sill plate to foundation

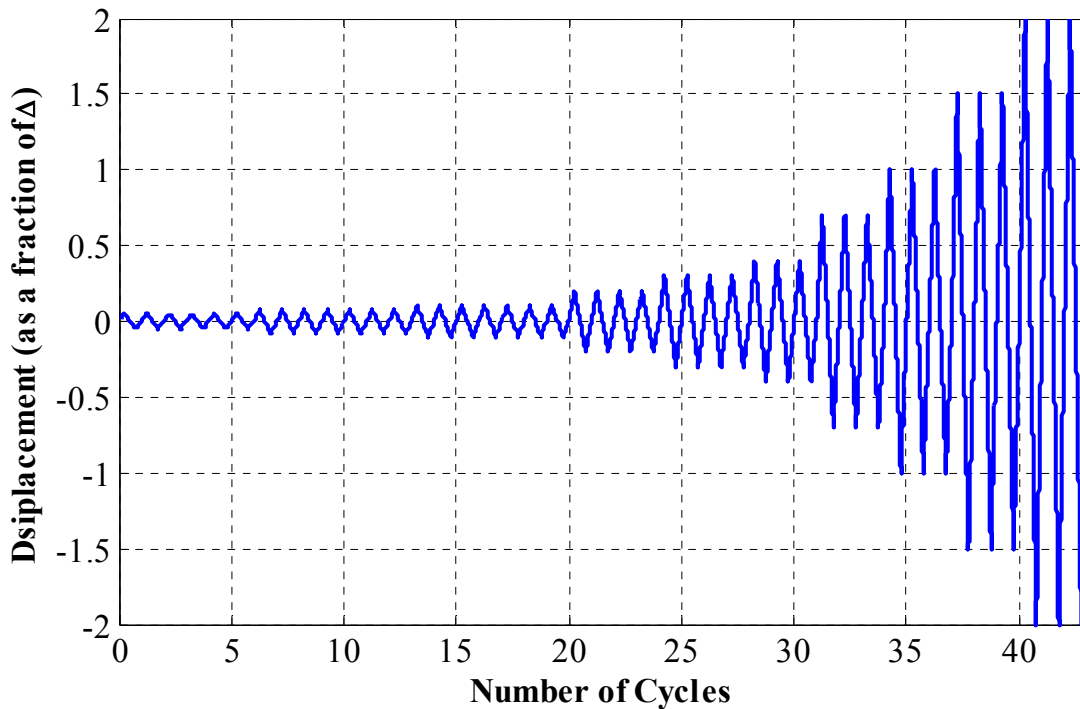
Figure 5.1: CUREe-Caltech Woodframe Project Simplified Cyclic Testing Protocol [3]

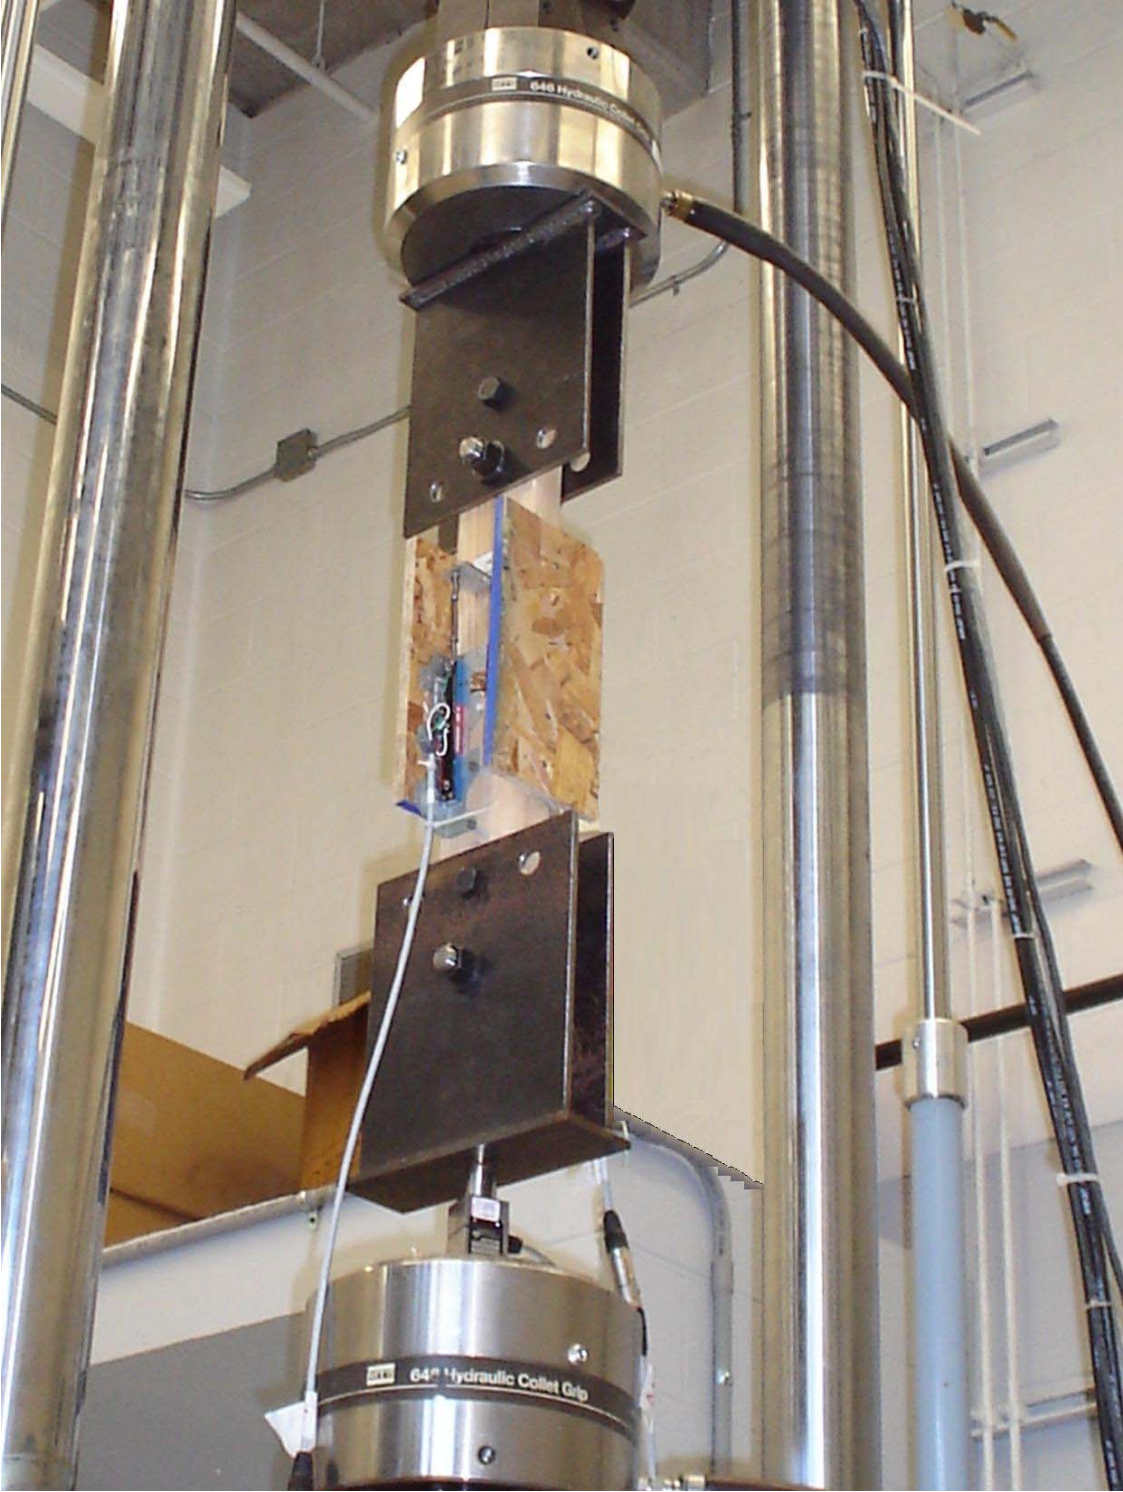
Figure 5.5: Parallel to grain connection test setup with 2x4 framing

Note that the potentiometers were installed directly on the specimen in order to measure the slip of the connection without the supplemental displacement caused by slipping of other connecting points.

Figures 5.5 and 5.6 show the connection test setup during parallel and perpendicular to grain testing, respectively.

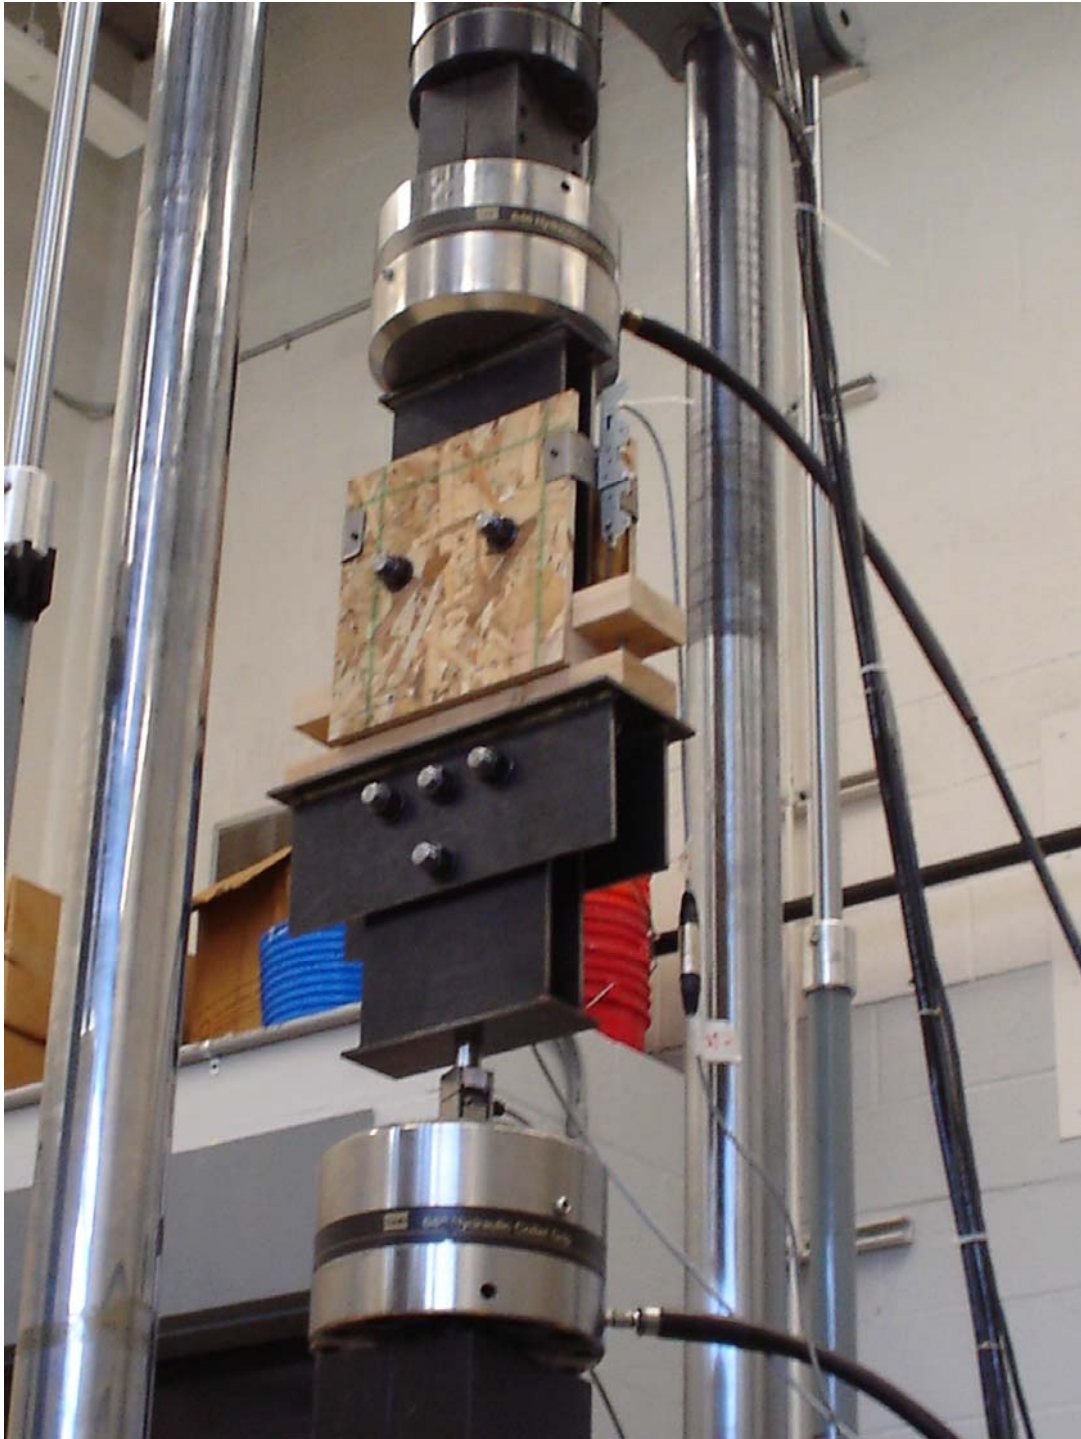
Figure 5.6: Perpendicular to grain connection test setup with 2x4 framing

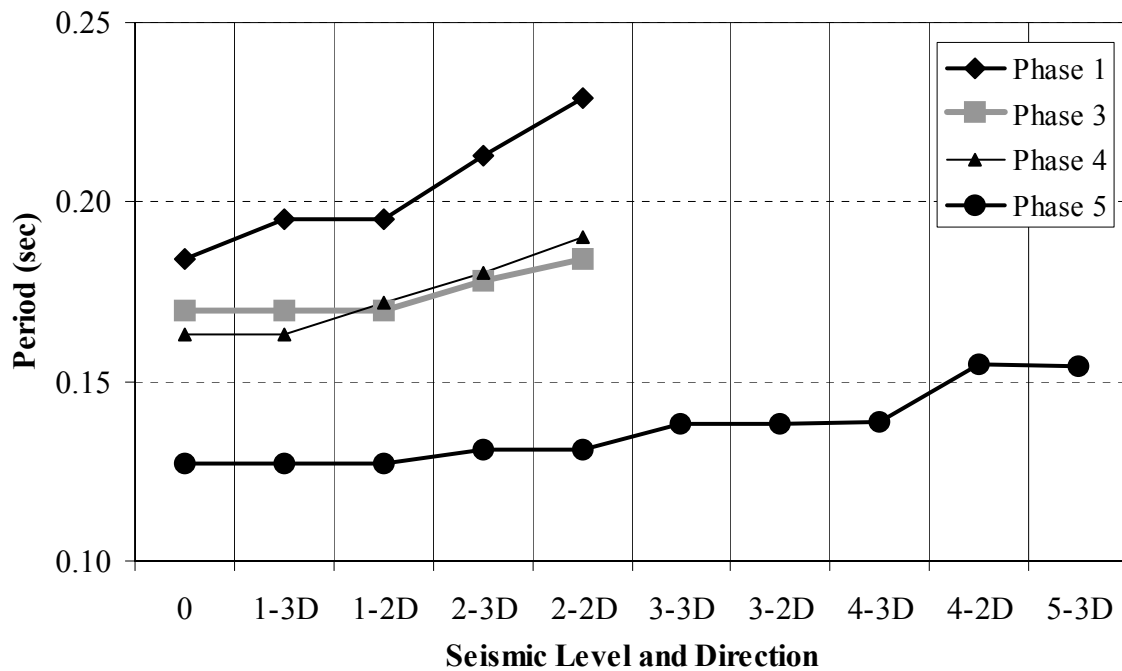
Figure 6.8: Evolution of the third natural period

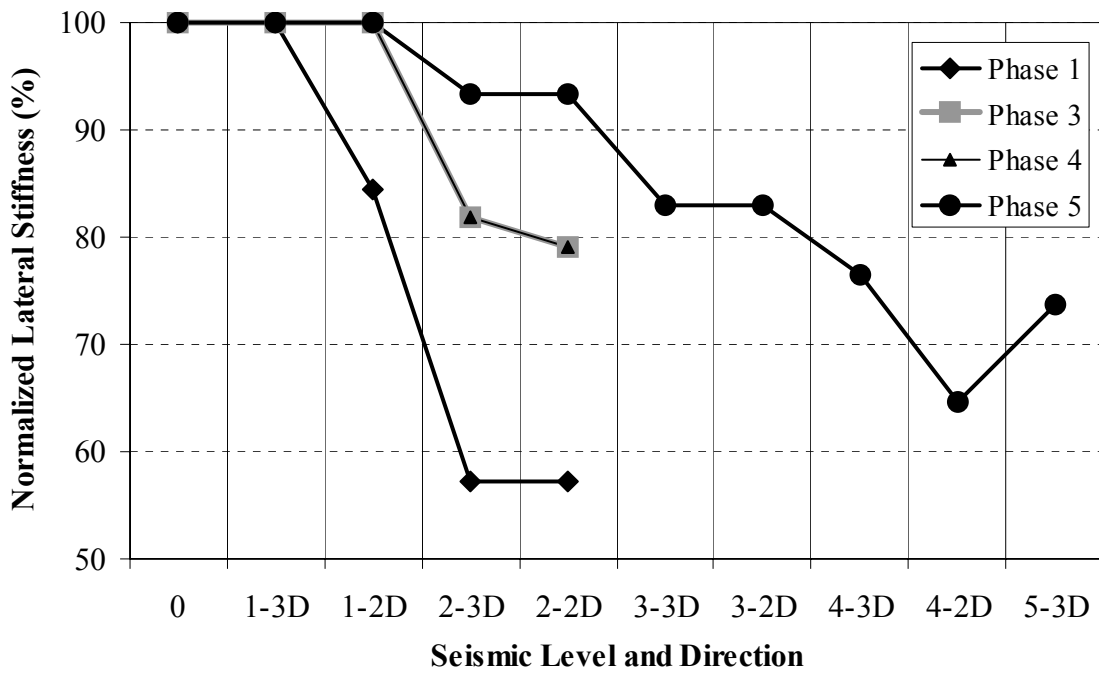
Figure 6.9: Variations of normalized lateral stiffness in the north-south direction

As mentioned above, the deterioration of the lateral stiffness is more pronounced for the structure of Test Phase 1. The stiffness at the end of this phase dropped to less than 60% of the initial stiffness after test Level 2. The lateral stiffness for the structures of Test Phases 3 and 4 was above 80% of their initial stiffness after Level 2 test; the corresponding value for the Test Phase 5 structure was above 90%. Even after the DBE Seismic Level 4 test, the lateral stiffness of the Test Phase 5 structure remained above 75% of its initial lateral stiffness. The deterioration was smaller when wall finishes were applied for the same level of shaking. Note that the increase of the stiffness that is observed after the final tri-axial test of Seismic Level 5 of Test Phase 5 was due to the repair of damaged anchor bolts in the two walls on the west (garage wall) and east side of the first floor of the benchmark structure, prior to the conduction of the Level 5 tri-axial test, which resulted in a stiffer structure. Figures 6.10 through 6.12 show the evolution of the modal damping ratios.

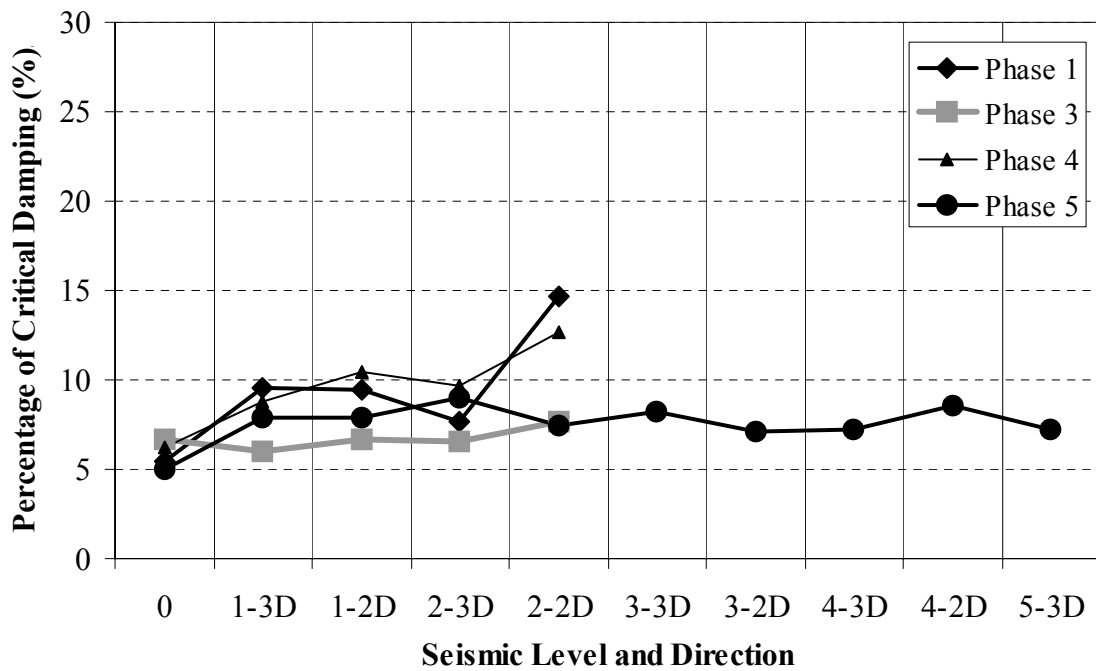
Figure 6.12: Evolution of the third modal damping ratio

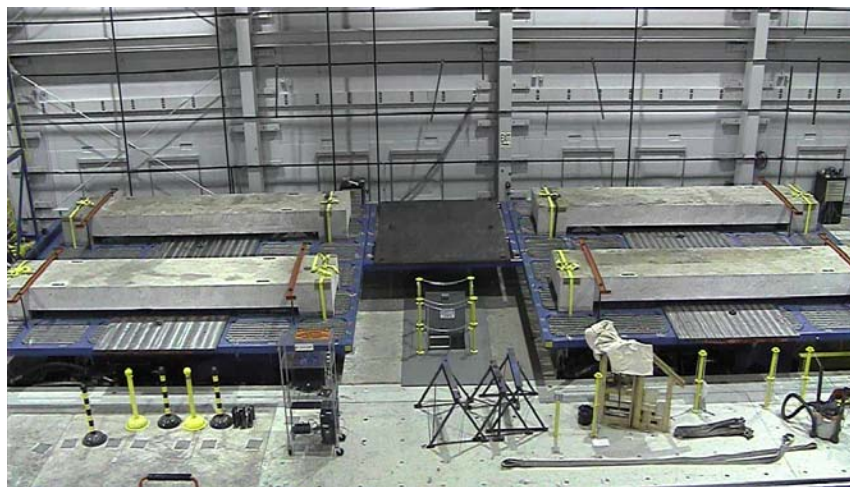
Figure 7.1: Ballast weights located on the shake tables and the connecting bridge

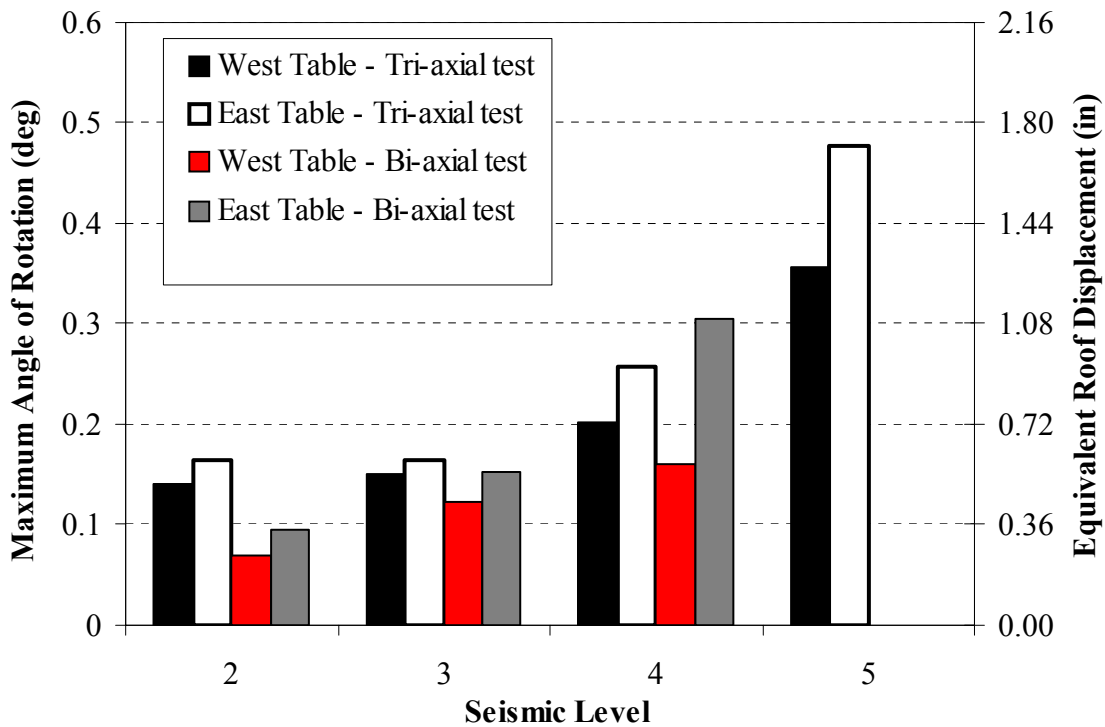
Figure 7.3: Maximum angle of rotation of the twin shake tables in the transverse direction for seismic tests of Test Phase 5

$$D_{\text{Roof}} = H_{\text{Roof}} \cdot \Phi = 206 \cdot (0.6 \cdot \pi / 180) = 2.16 \text{ in.} \quad (7.1)$$

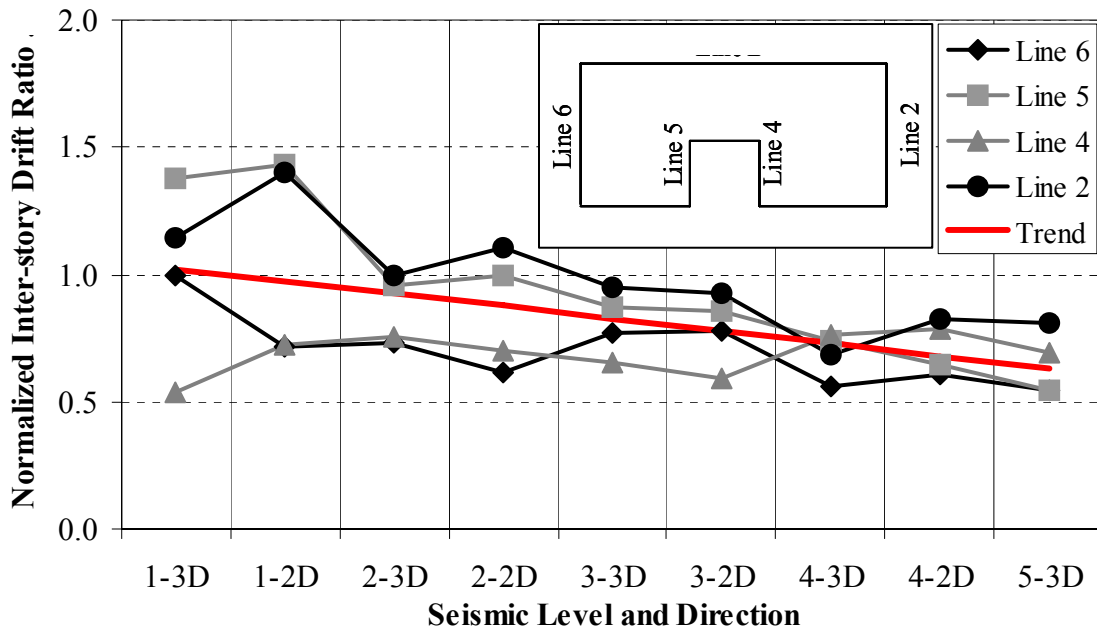
Figure 7.8: Second floor drift normalized by first floor drift of the same wall line along the transverse direction, for Test Phase 5

An interesting observation is the distribution of the building drifts between the two floors of the test structure as its response increases with seismic intensity. This is graphically illustrated in Figure 7.8, where the ratios between the second floor peak drifts are normalized by the first floor peak drifts at the same wall lines and plotted for the seismic tests of Phase 5. Only the four building lines along the transverse direction are included in Figure 7.8. This graph shows that as the seismic intensity is amplified, the drift ratios are decreasing, which indicates that a greater portion of the total building displacement occurs at the first floor. Eventually, a first floor side-sway collapse mechanism would be the most probable scenario in case of a potentially very destructive earthquake. This conclusion verifies numerical studies that have focused on the seismic collapse analysis of two and three story woodframe buildings [15].
