DEVELOPMENT OF A PERFORMANCE-BASED SEISMIC DESIGN PHILOSOPHY FOR MID-RISE WOODFRAME CONSTRUCTION

SEISMIC TESTING OF A FULL-SCALE TWO-STORY LIGHT-FRAME WOOD BUILDING: NEESWOOD BENCHMARK TEST

Technical Report MCEER-09-0005 ■ July 22, 2009

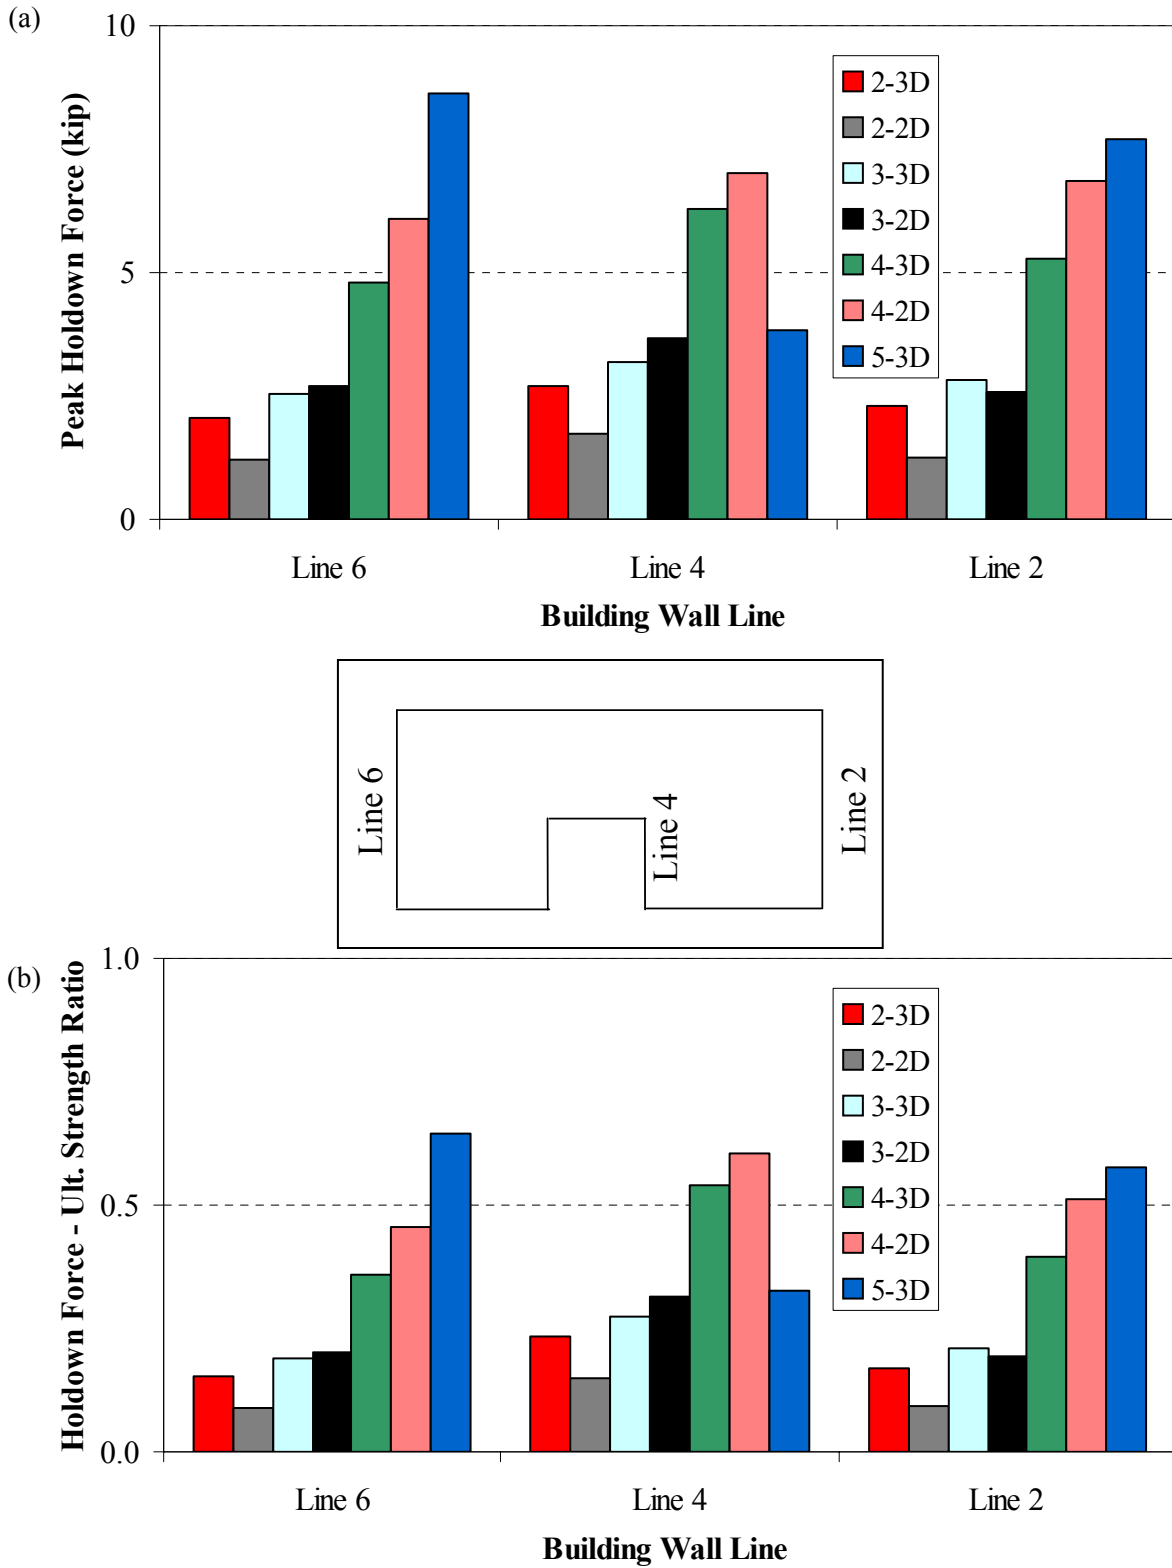
Figure 7.26: (a) Peak holdown force, and (b) peak holdown force to nominal ultimate strength ratio, for seismic tests of Phase 5

Similarly to Figure 7.25, Figure 7.26a presents the peak recorded holddown forces along the same three wall lines for the tri-axial tests (above Level 1) of Phase 5 and Figure 7.26b shows the normalized ratio with the nominal ultimate strength of the devices.

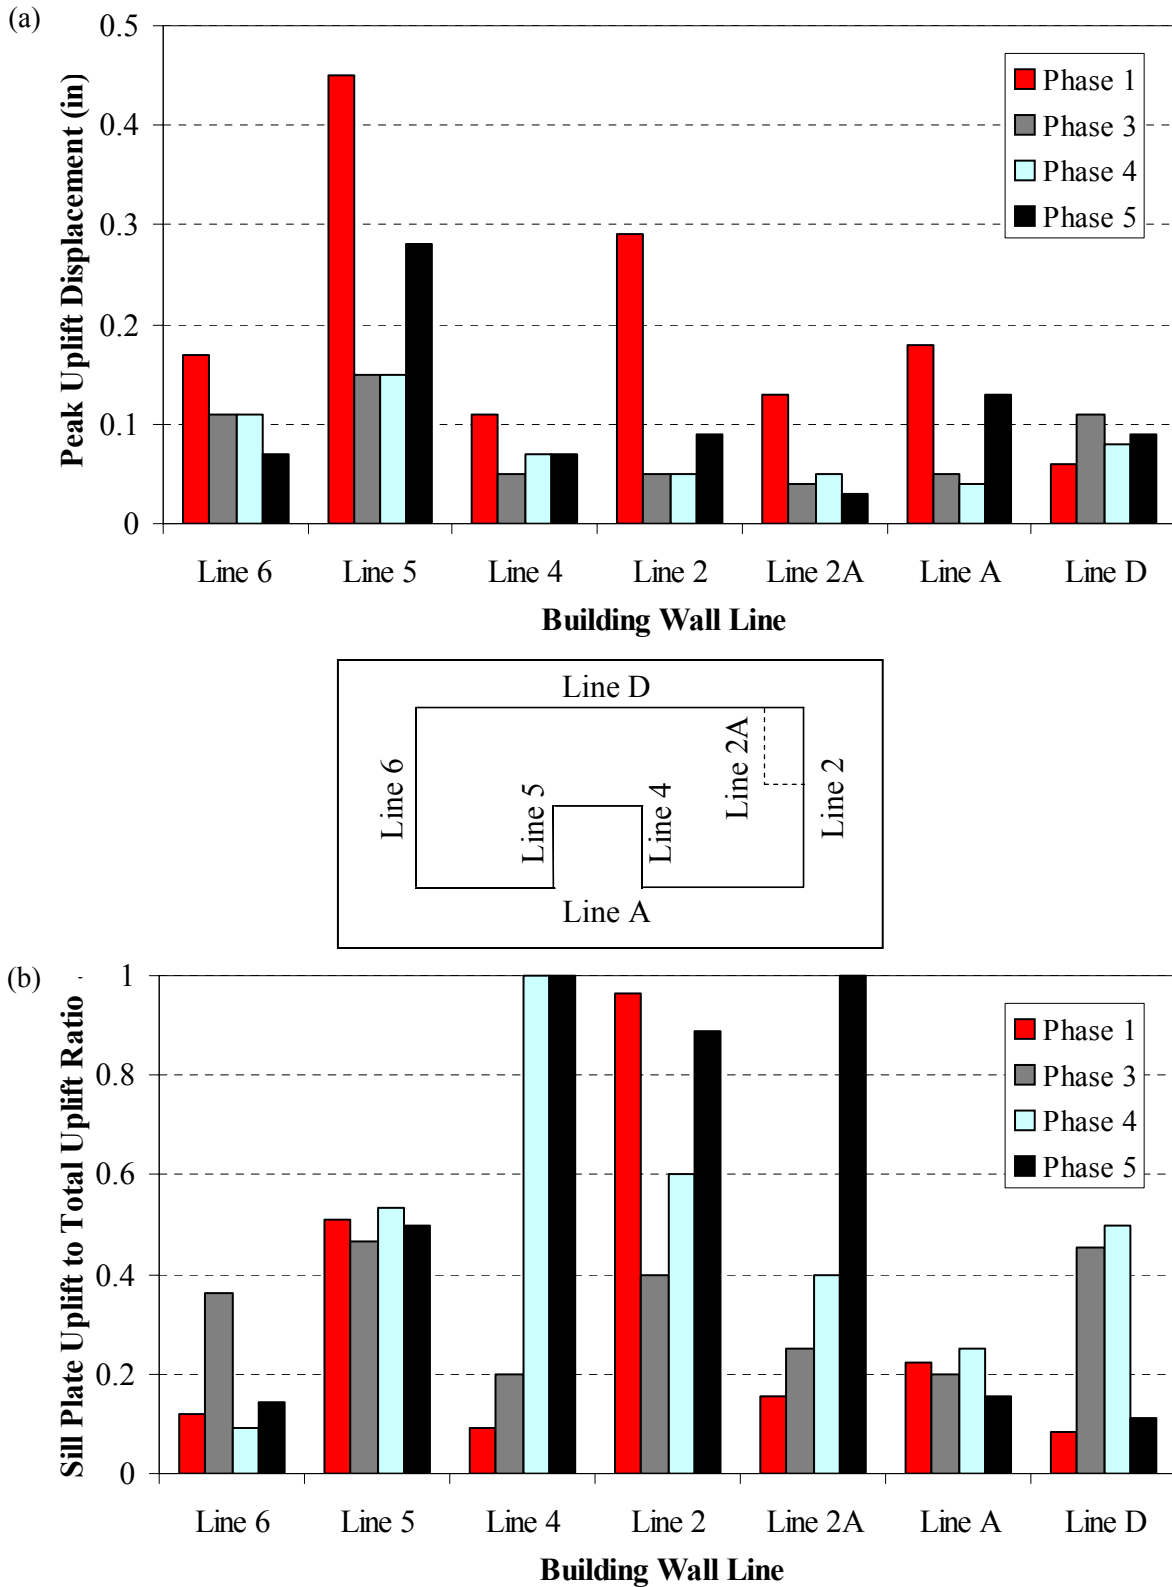
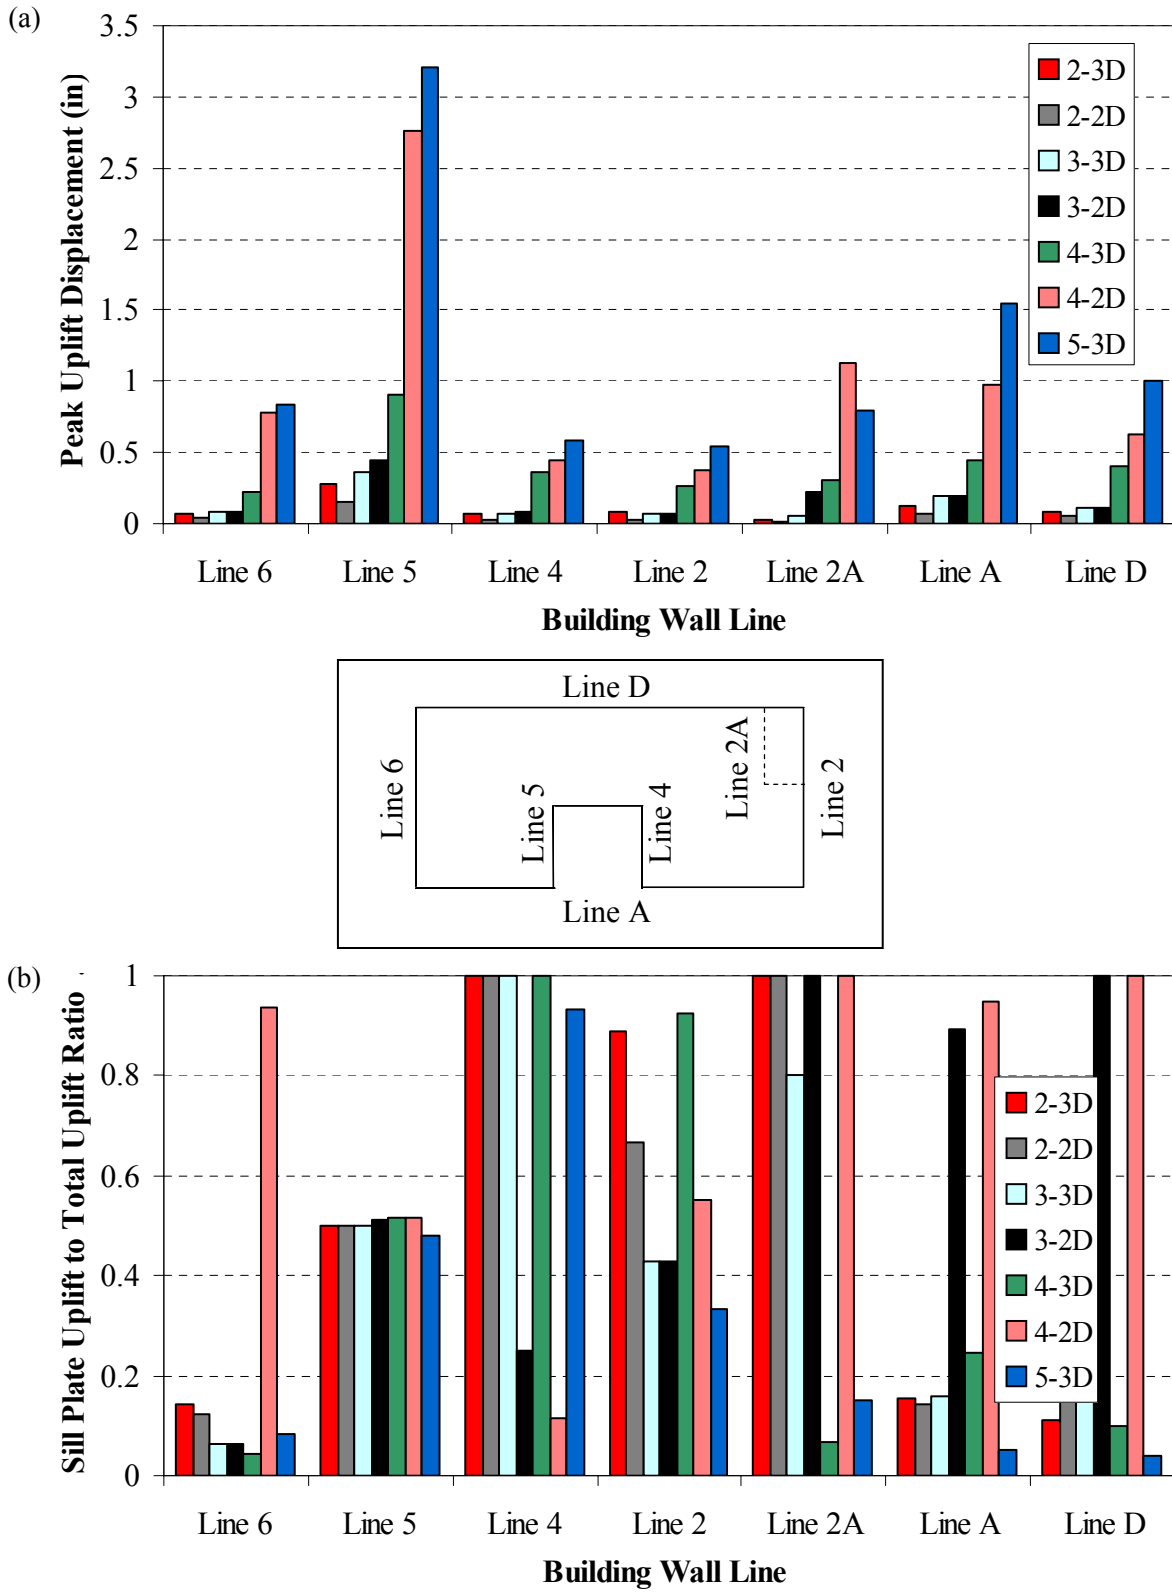
Figure 7.28: (a) Peak uplift displacement, and (b) sill plate uplift to total uplift ratio, for seismic tests of Phase 5

Figure 7.28a clearly indicates the significant increase of peak uplift displacements recorded during the bi-axial Level 4 and the final tri-axial Level 5 seismic tests of Phase 5. During the latter test, the peak displacements exceeded 0.5 in. at all wall lines and the maximum value (above 3 in.) was recorded at Wall Line 5.

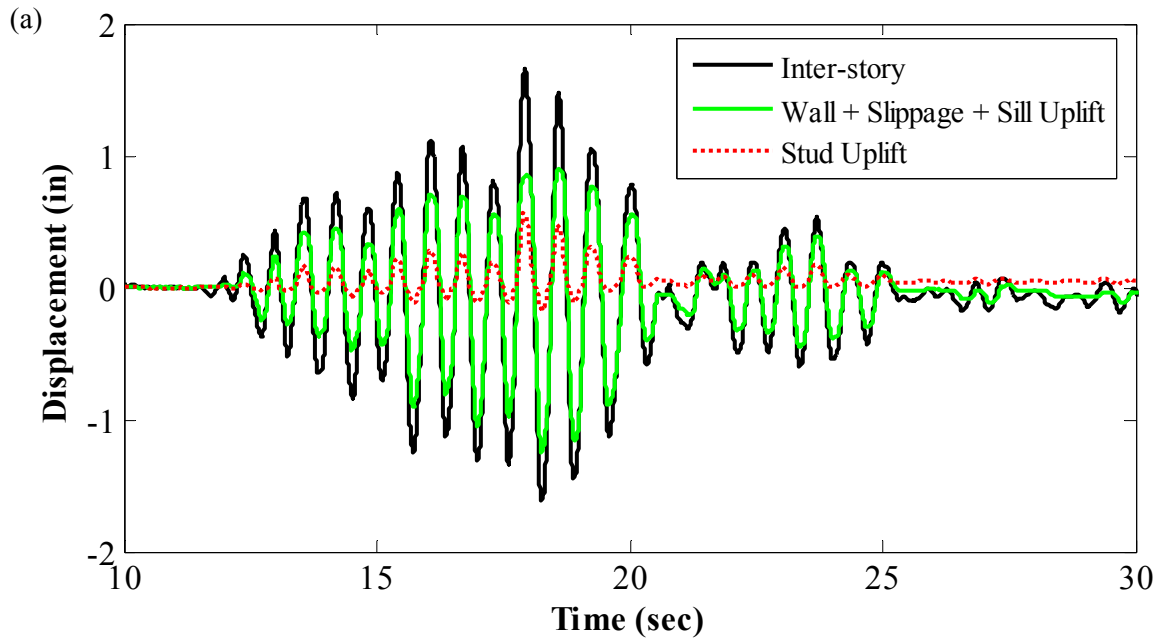
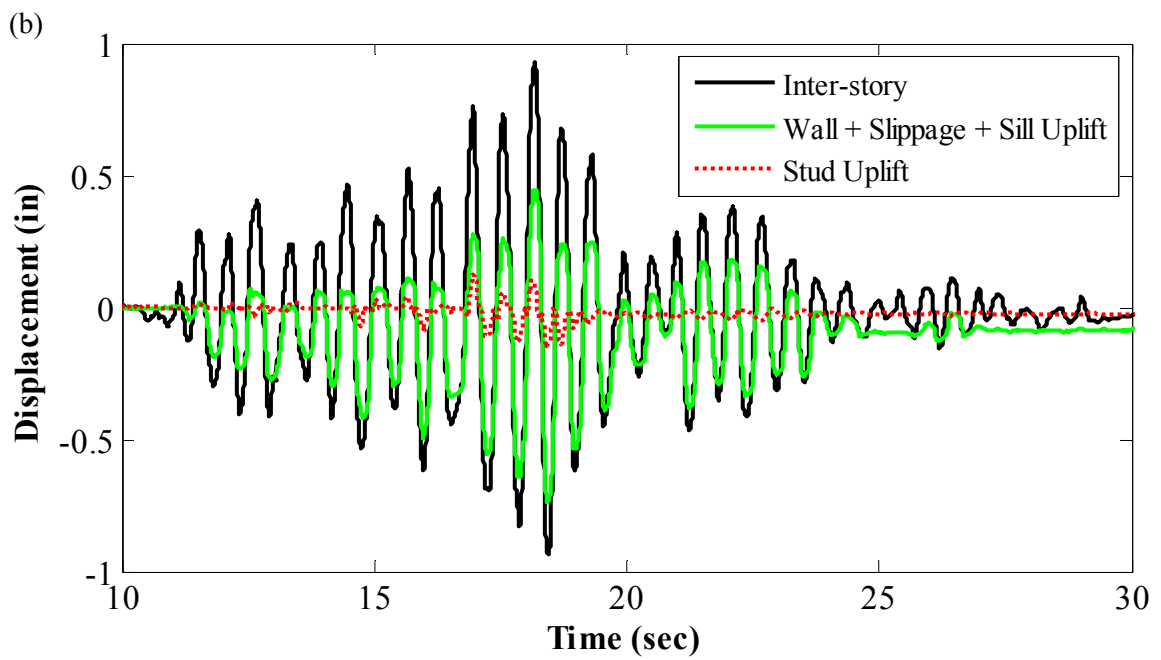
Figure 7.31: Displacement components of garage wall E16 for (a) Test NWP1S17 and (b) Test NWP4S03

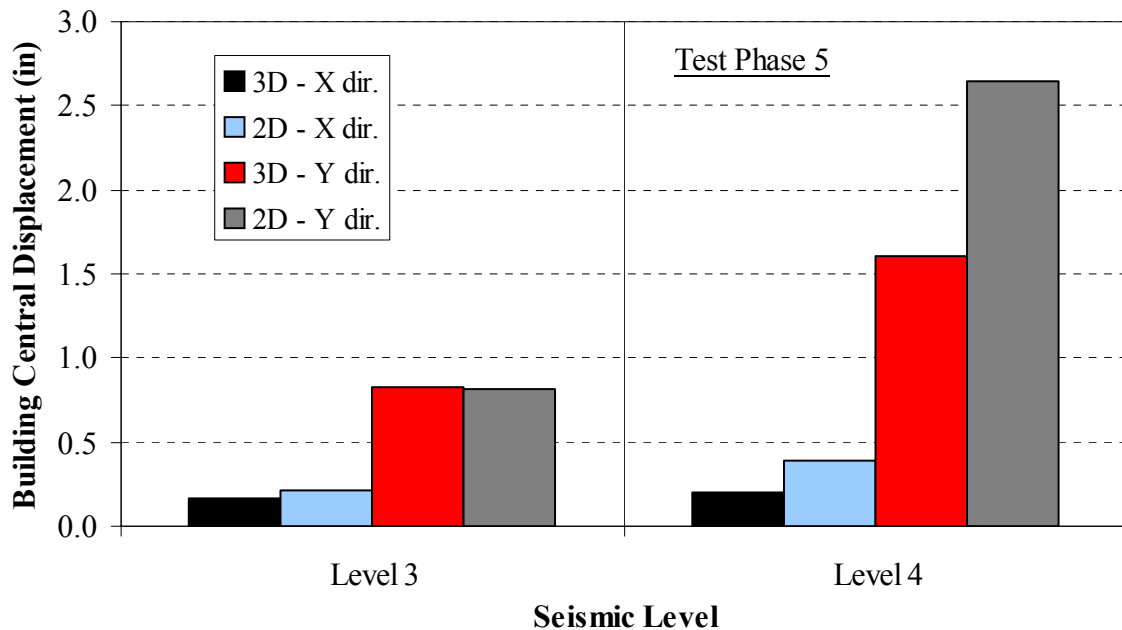
Figure 7.36: Building central displacements for Seismic Levels 3 and 4 tri-axial and bi-axial tests of Phase 5

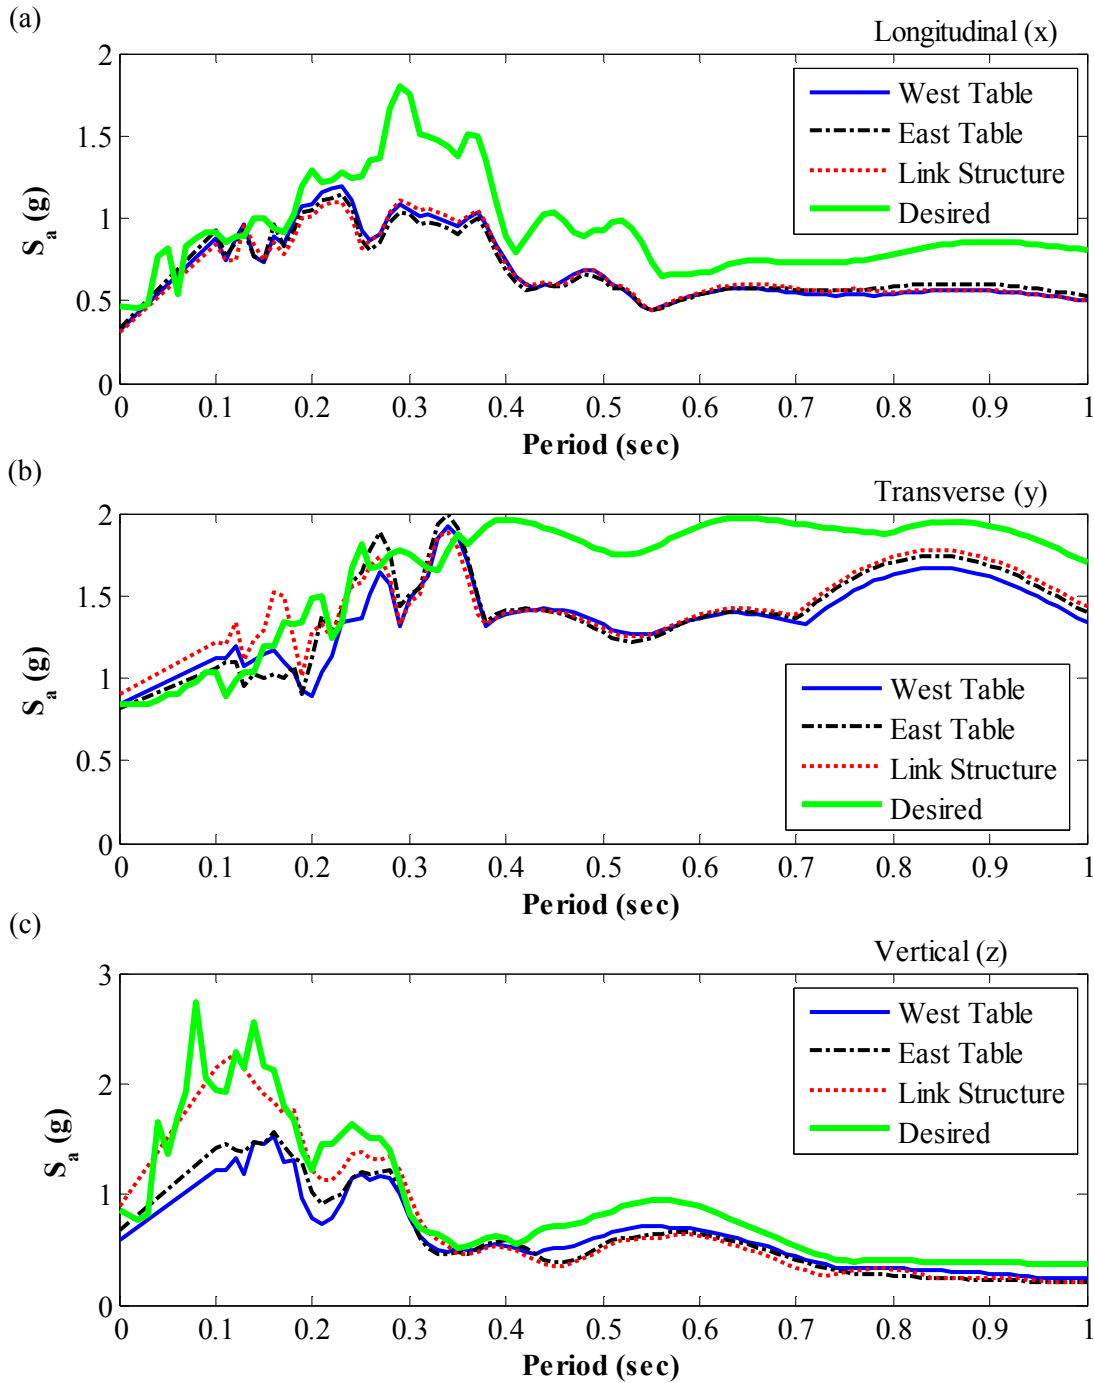
Figure I.51: Acceleration response spectra of shake table motion for 5 % damping in (a) longitudinal, (b) transverse, and (c) vertical direction, for Test NWP5S11

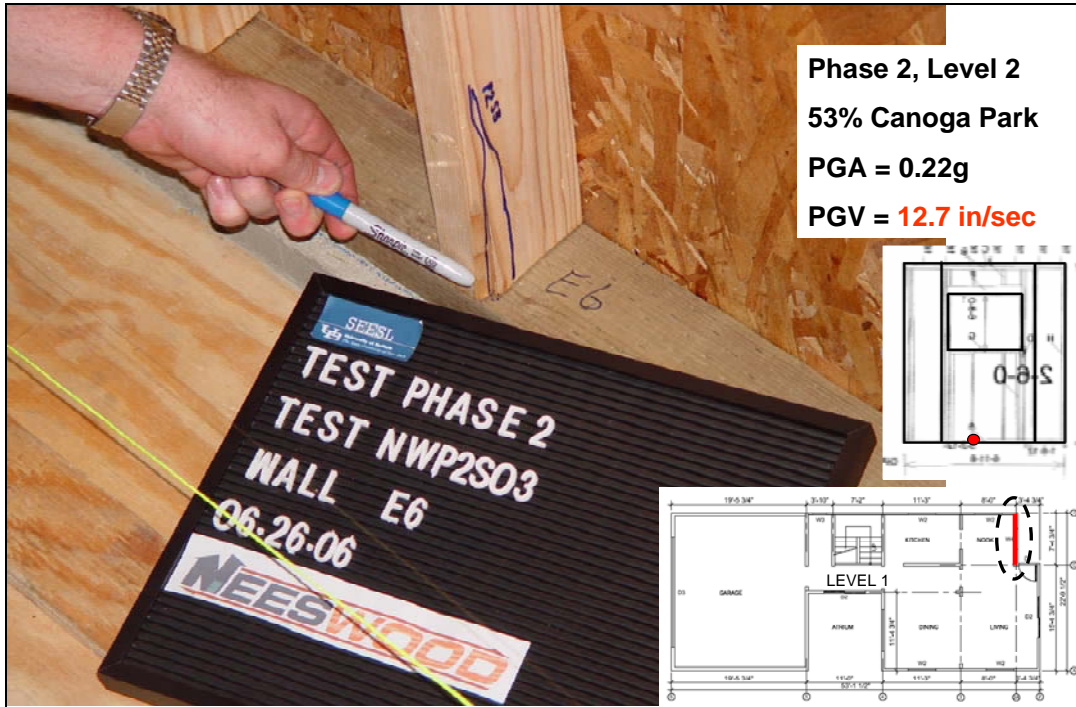
Cracking of vertical stud at connection with sill plate

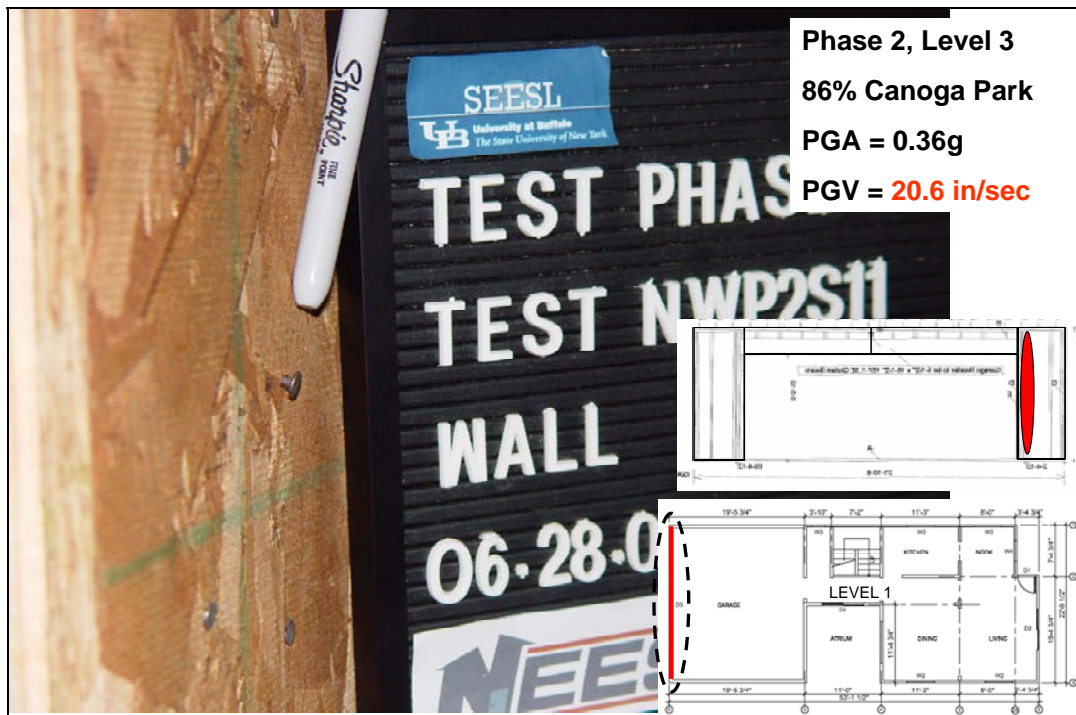
Nail partial pull-out at garage wall

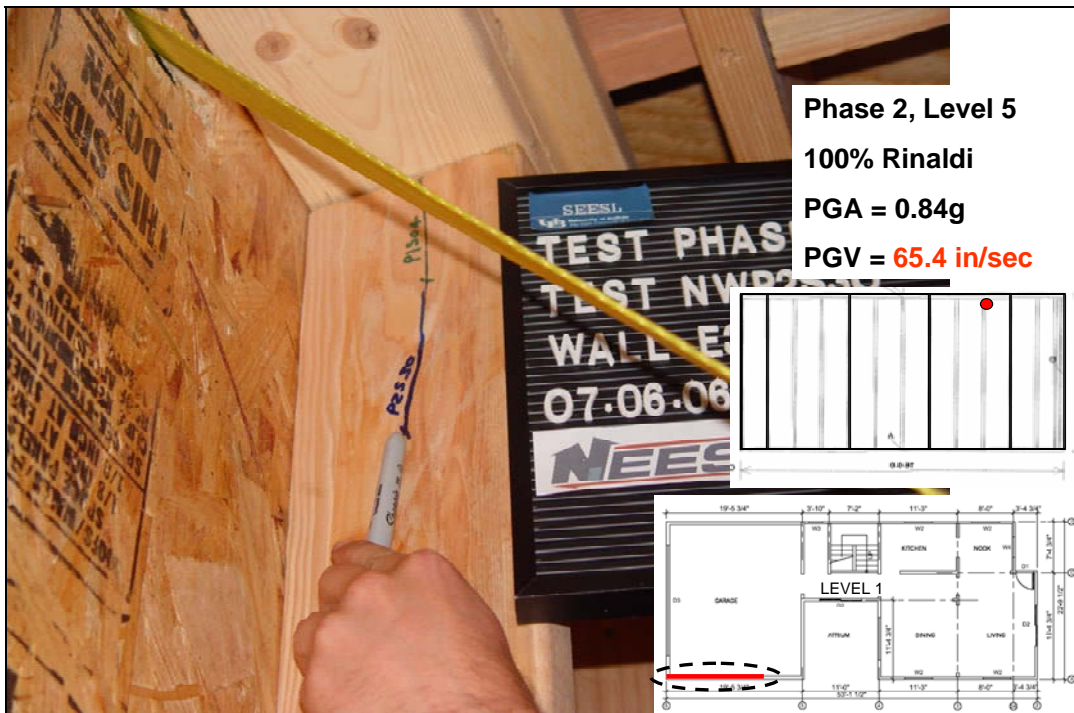
Cracking of vertical stud near connection with top plate

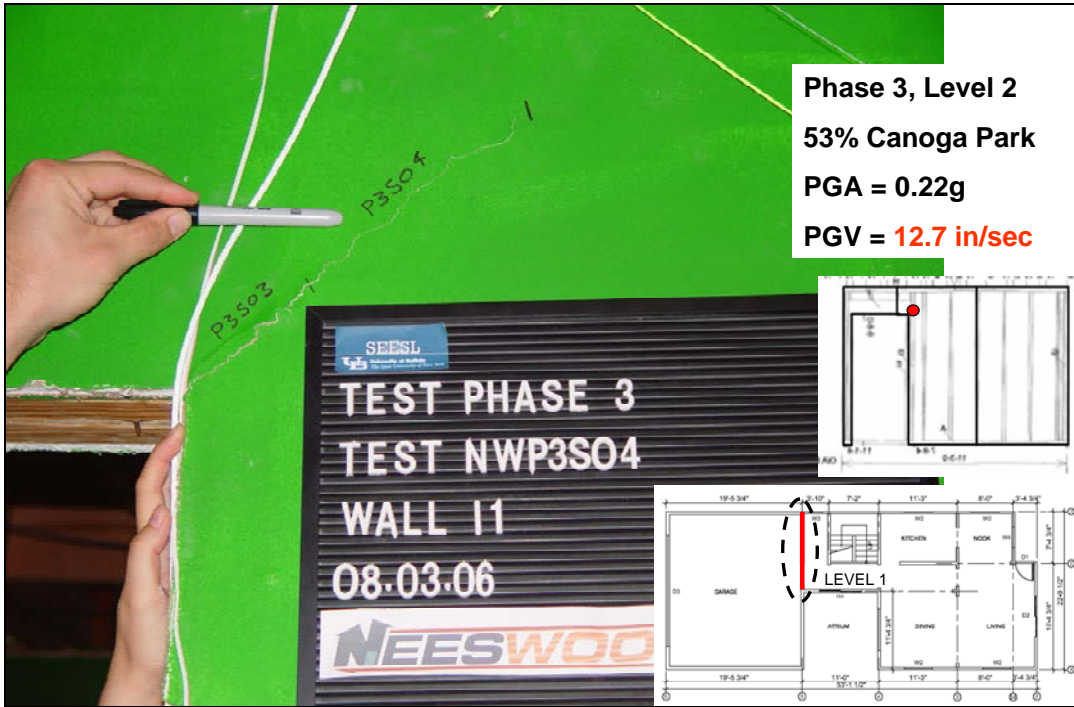
Cracking of gypsum wallboard and diagonal crack propagation at door frame

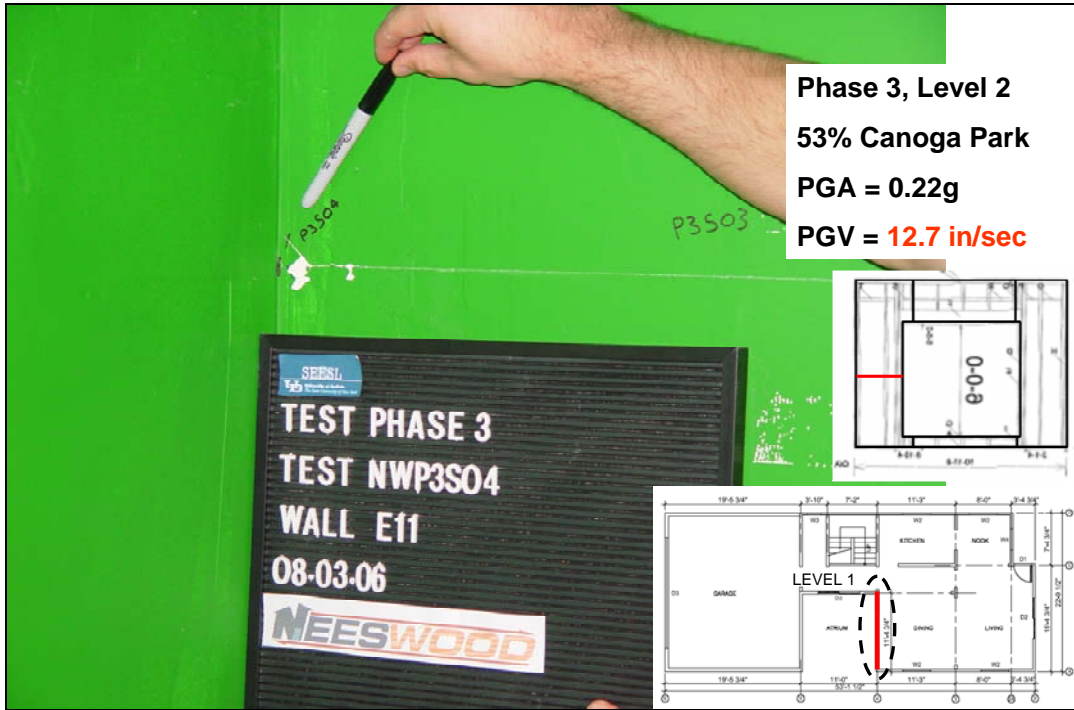
Tape cracking of gypsum wallboard at wall mid height

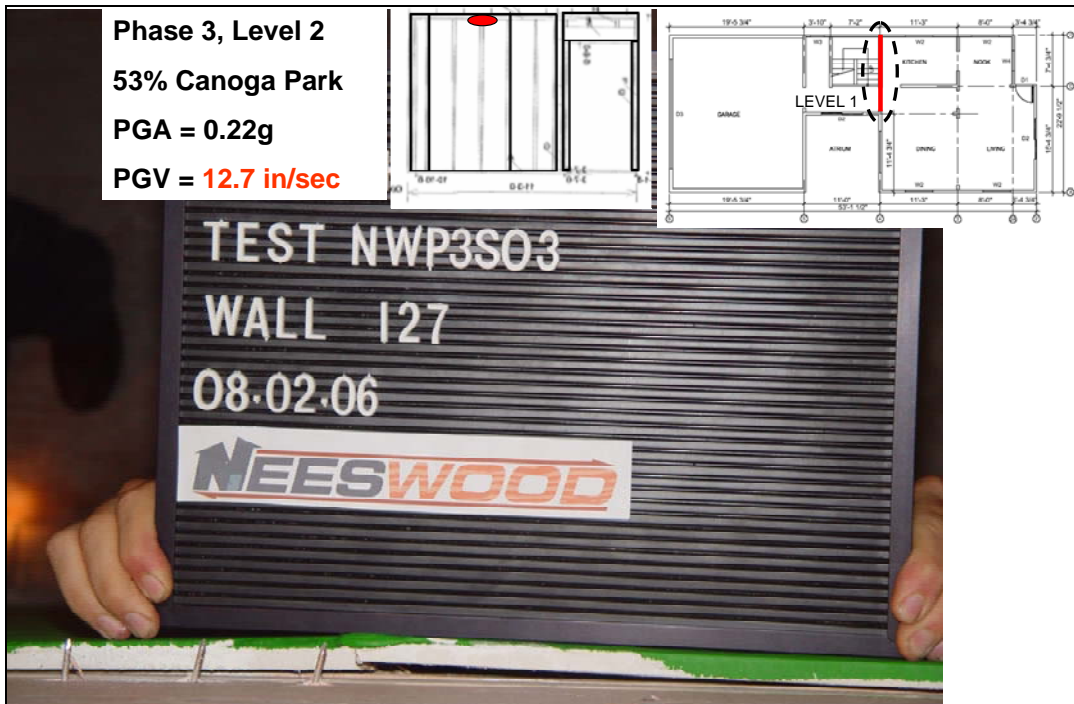
Screw pull-out and gypsum wall board cracking

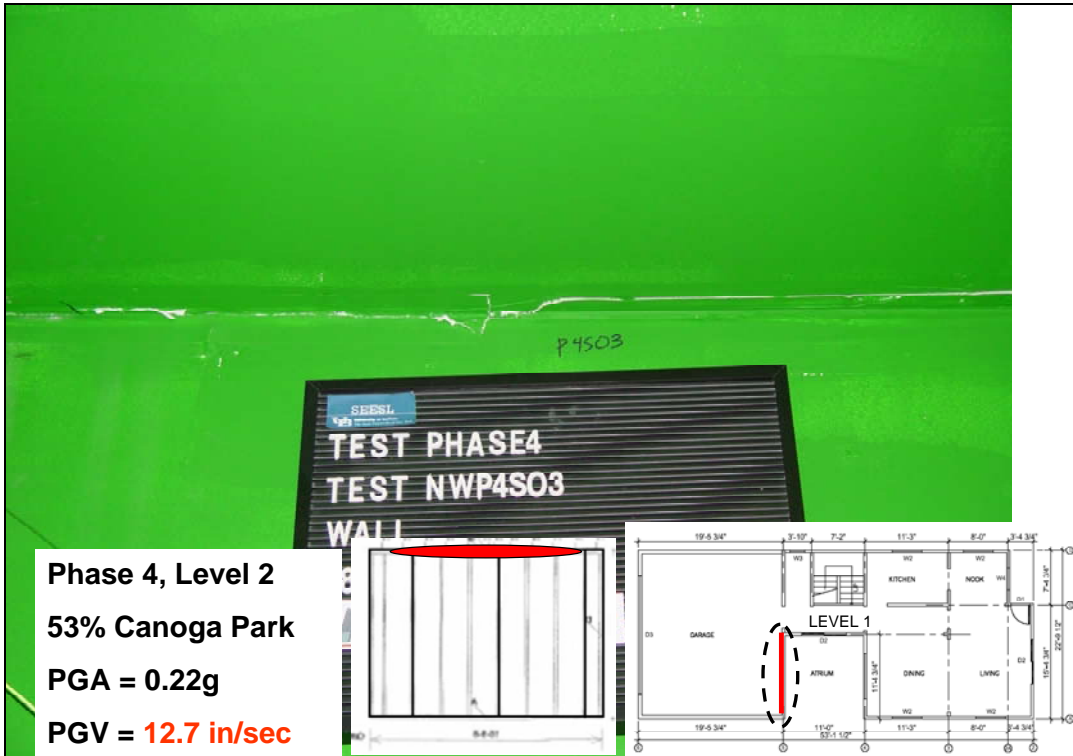
Cracking of gypsum wallboard at ceiling-wall connection

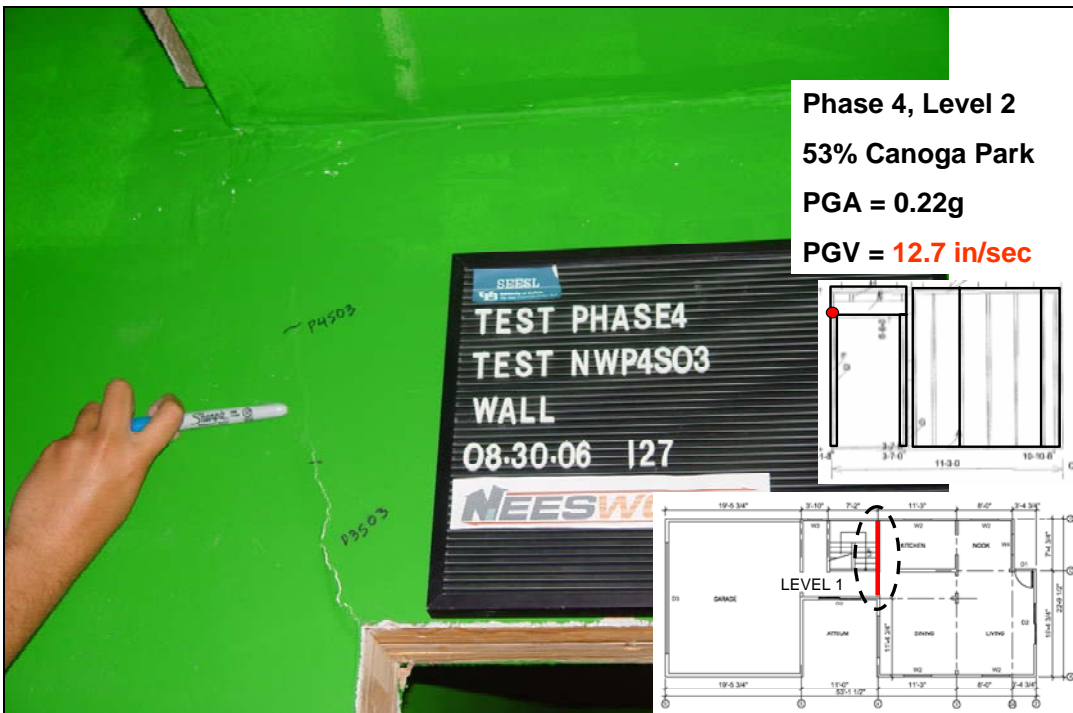
Cracking of gypsum wallboard and diagonal crack propagation at door corner

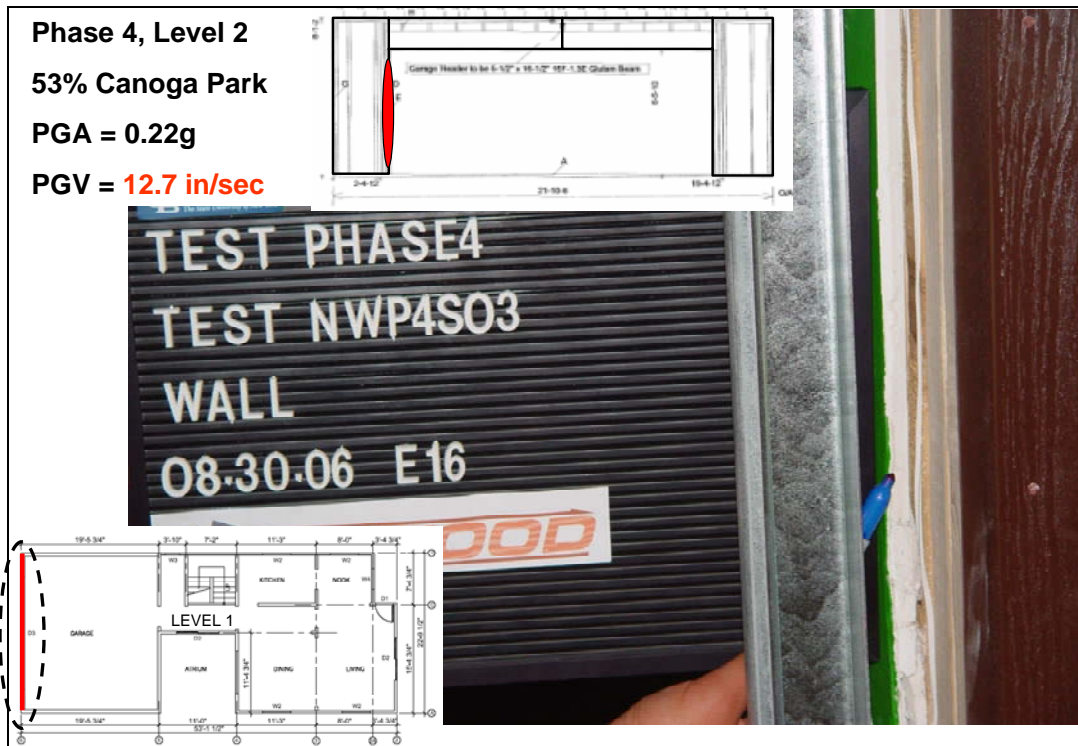
Screw pull-out in gypsum wallboard

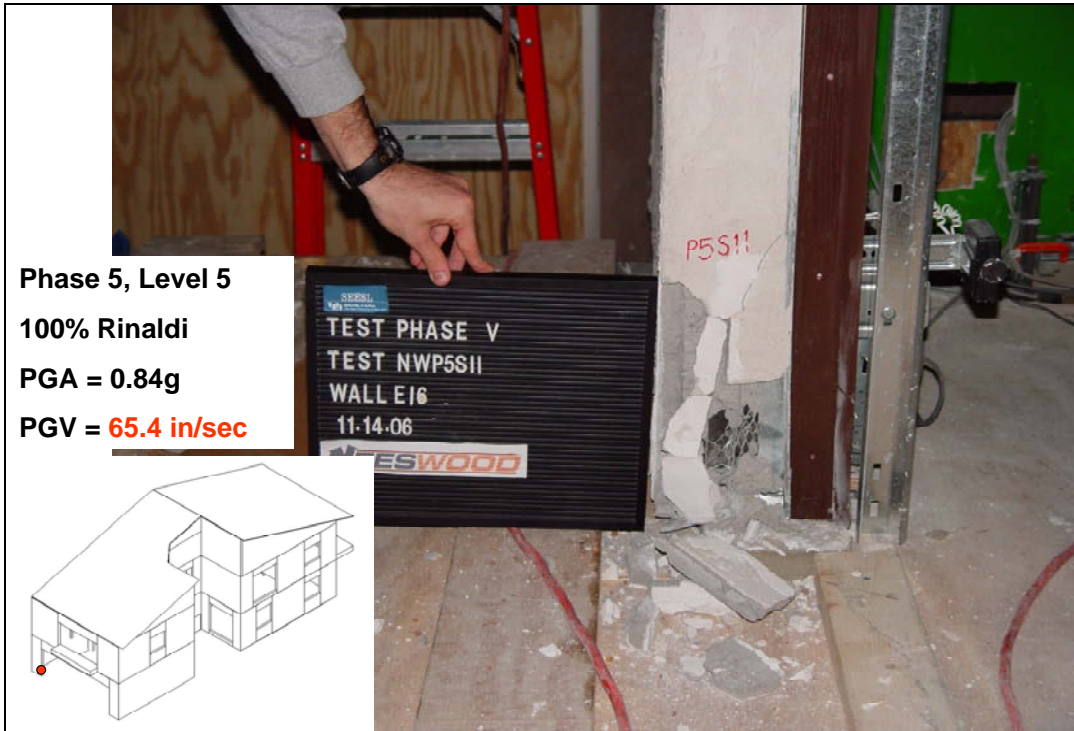
Cracking and spalling of stucco at bottom of garage wall

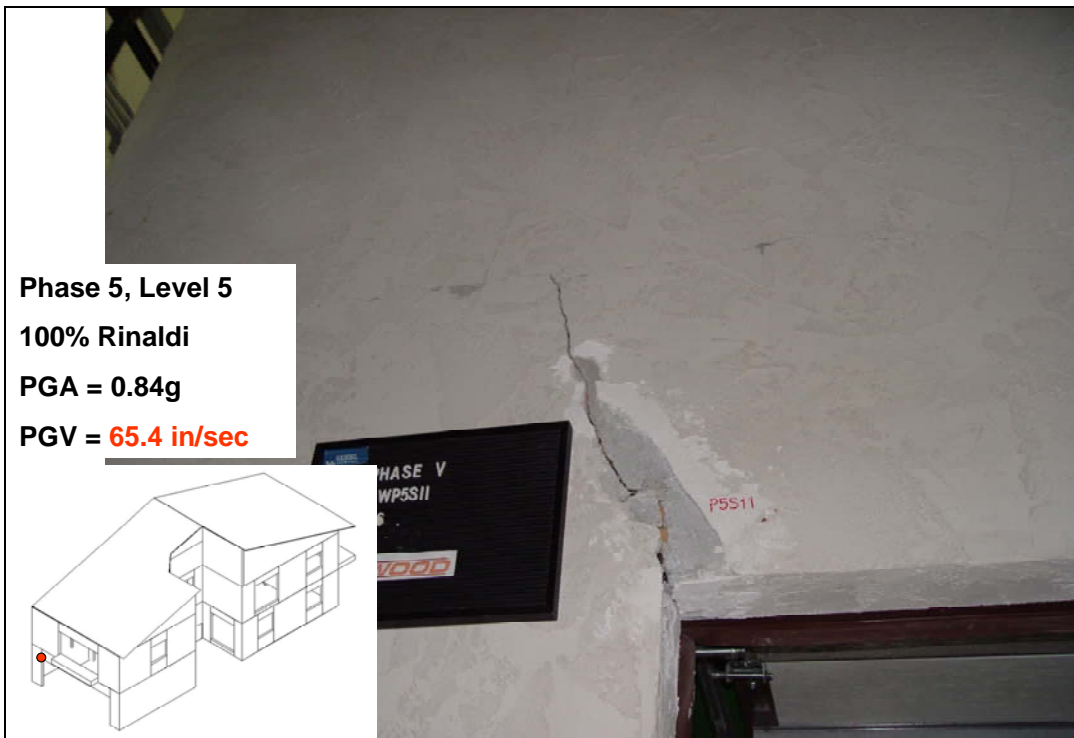
Cracking and spalling of stucco at corner of garage wall opening

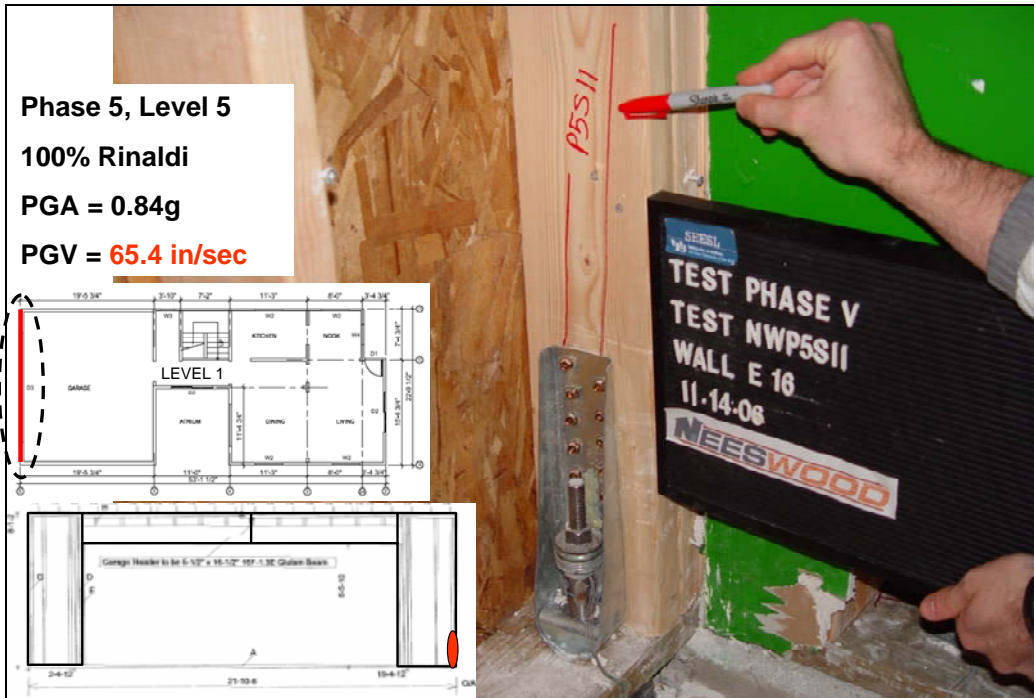
Cracking of stud above hold-down anchor

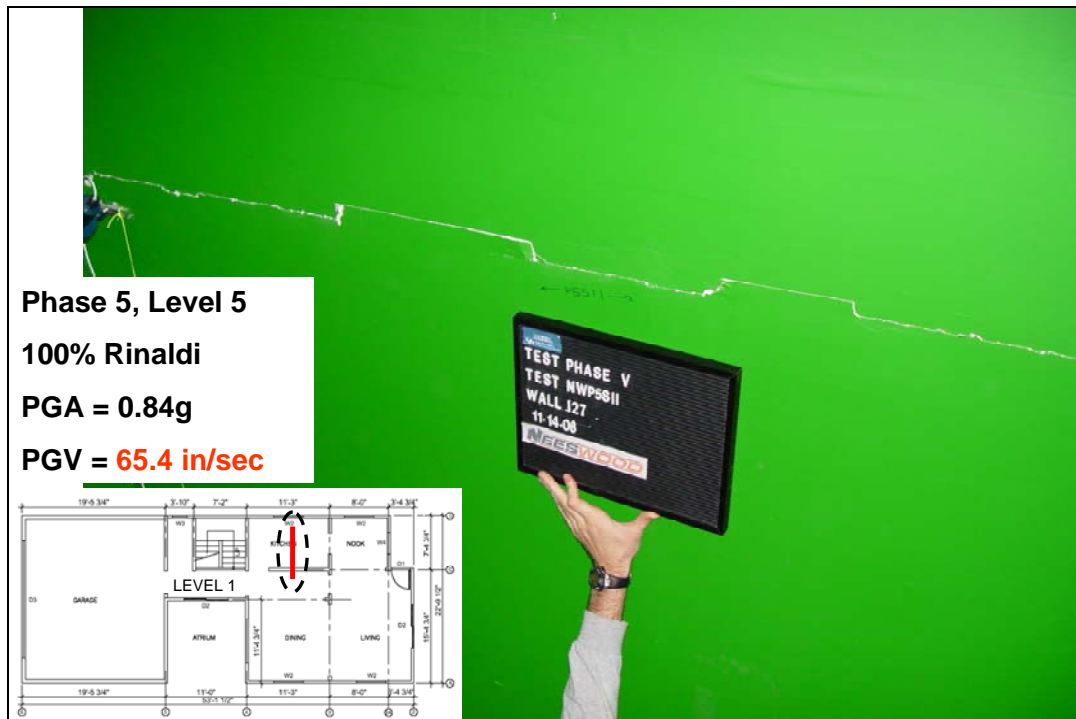
Horizontal cracking of gypsum wallboard at second floor level

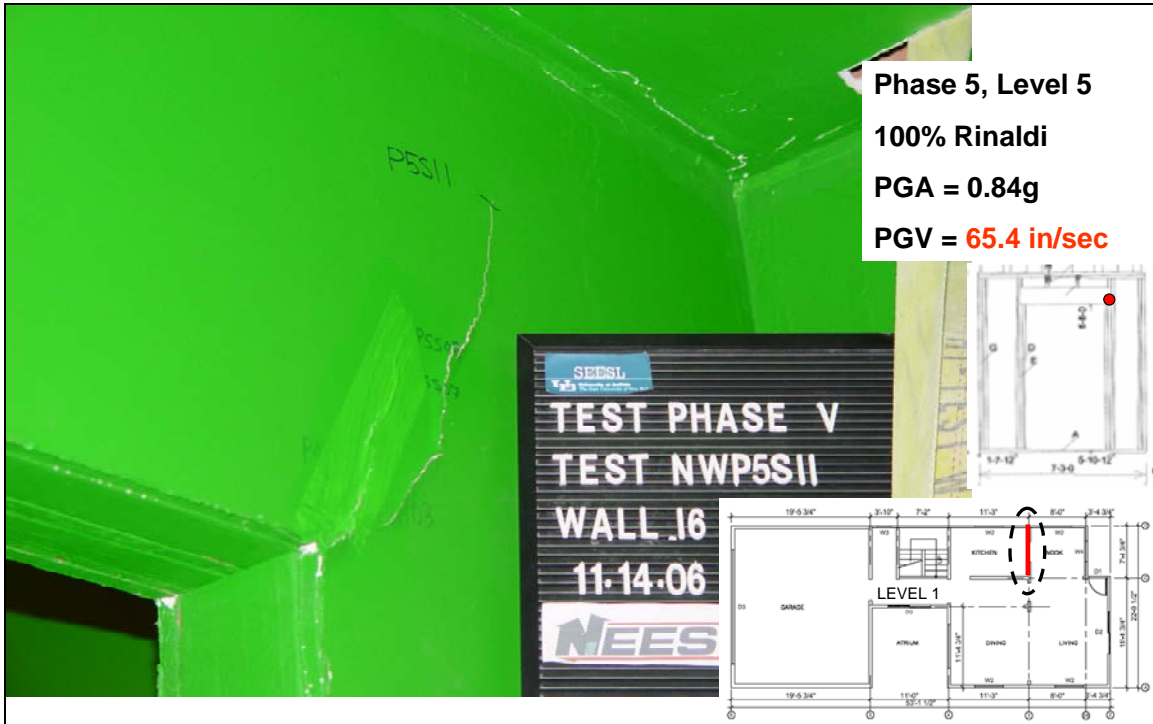
Cracking and buckling of gypsum wallboard at door opening
