SIMULATION OF THE SEISMIC PERFORMANCE OF NONSTRUCTURAL SYSTEMS

EXPERIMENTAL SEISMIC STUDY OF PRESSURIZED FIRE SPRINKLER PIPING SUBSYSTEMS

Technical Report MCEER-13-0001 ■ April 8, 2013

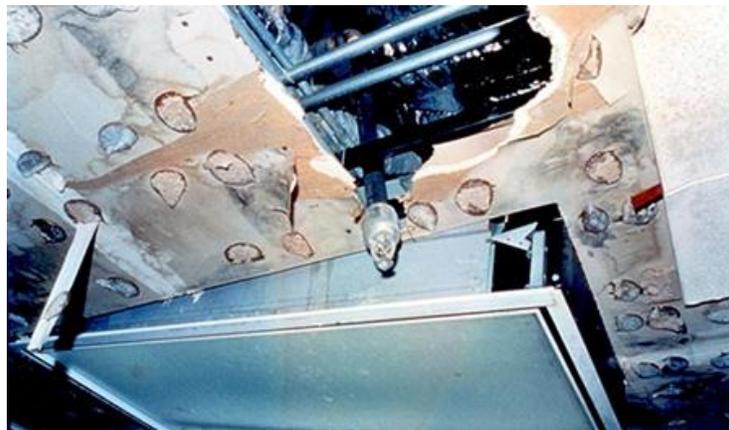
Figure 1-6 Rupture of sprinkler pipe at the elbow joint (from FEMA E-74, 1994)

separation, was activated due to pounding with other building components. The same failure occurred from Floors 4 through 8 as a result of insufficient flexibility provided by the installed 90-degree offsets on each side of the seismic separation. For Holy Cross Medical Center, short drops (6-10 inches long) to sprinkler heads encountered failures at screwed tee when pipe or heads struck the hard (rated) ceiling, and replacements of 1,200 sprinkler heads and 401 two-piece escutcheons were reported by sprinkler repair contractors. Besides, sprinklers damaged by impact against ceiling systems, vertical supports pulled out, and failures of branch lines of small size were also reported from other hospitals.

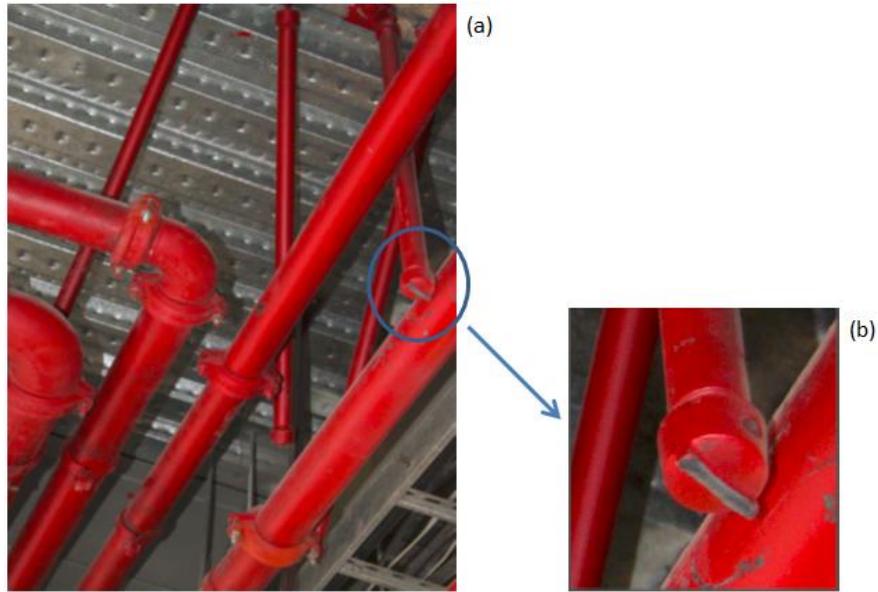
Figure 1-9 Brace sheared off at the Santiago Airport (from E. Miranda, 2011)

Fire sprinkler piping system damage was one of the major reasons that led to the shut-down of airport terminal at Santiago. Several braces were sheared off as shown in *Figure 1-9*. Fractures of tee joint threaded connections were also reported at the Santiago Airport (*Figure 1-10*).

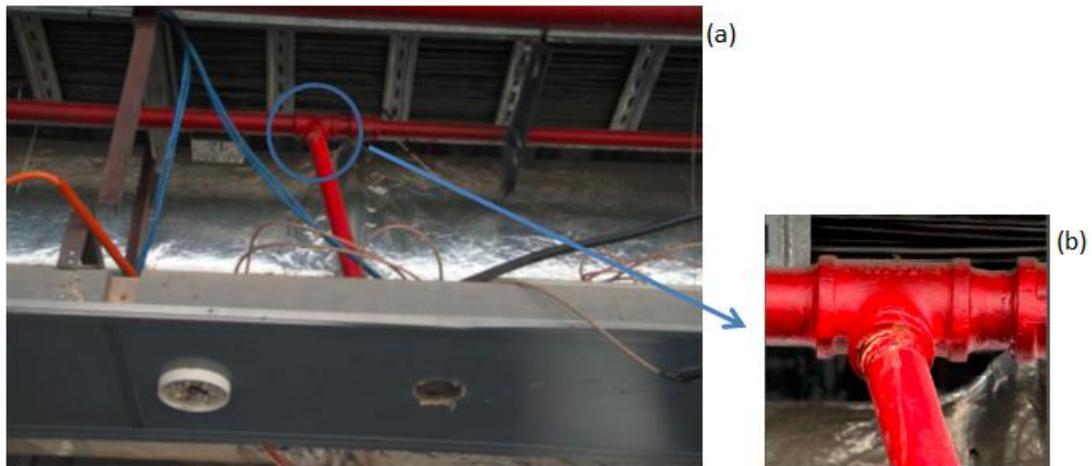
Figure 1-10 Fracture of tee joint threaded connection at the Santiago Airport (from E. Miranda, 2011)

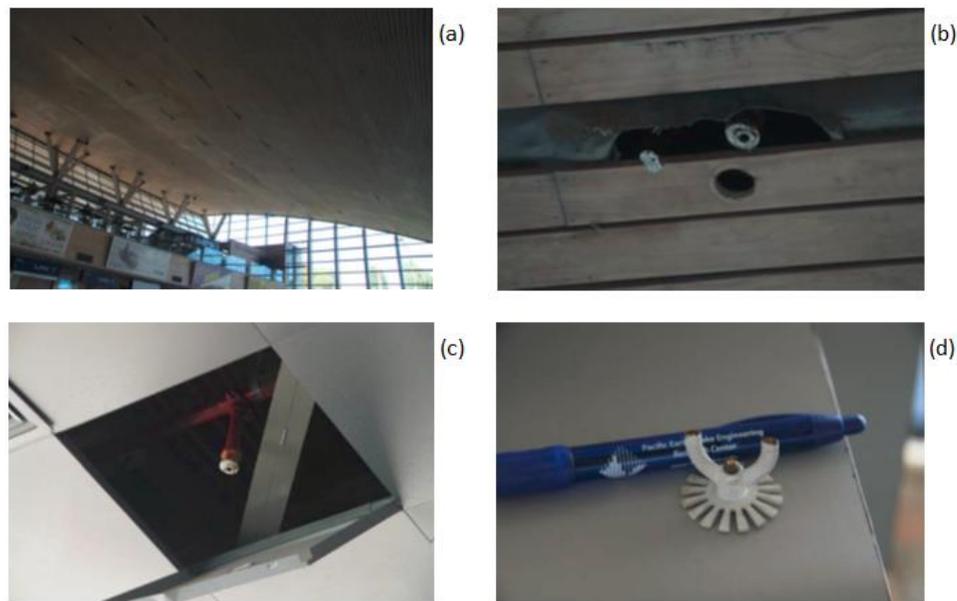
Figure 1-11 Water damage from broken sprinkler heads at Concepcion Airport (from E. Miranda, 2011)

system. For other cases, sprinkler heads were moved upwards and pushed through the wood ceiling because of the significant vertical accelerations effect.

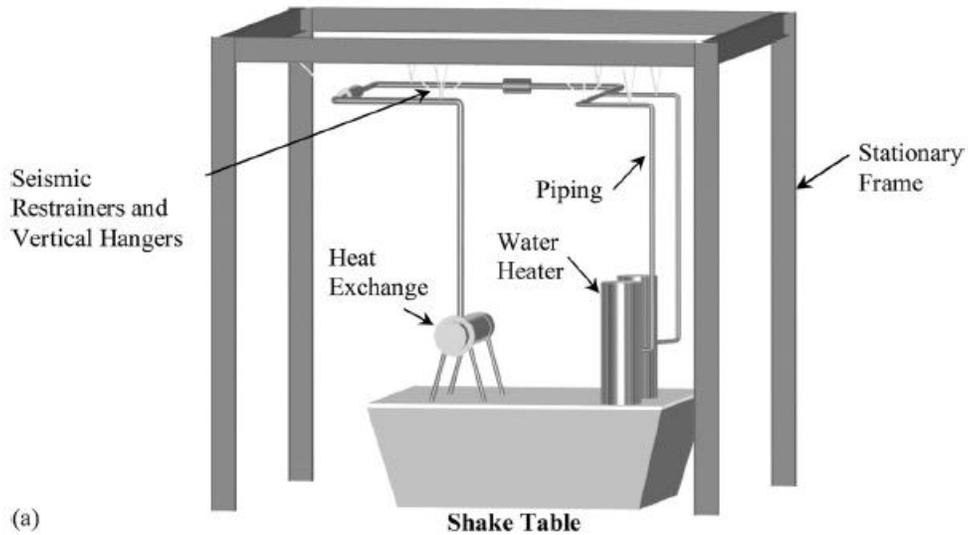
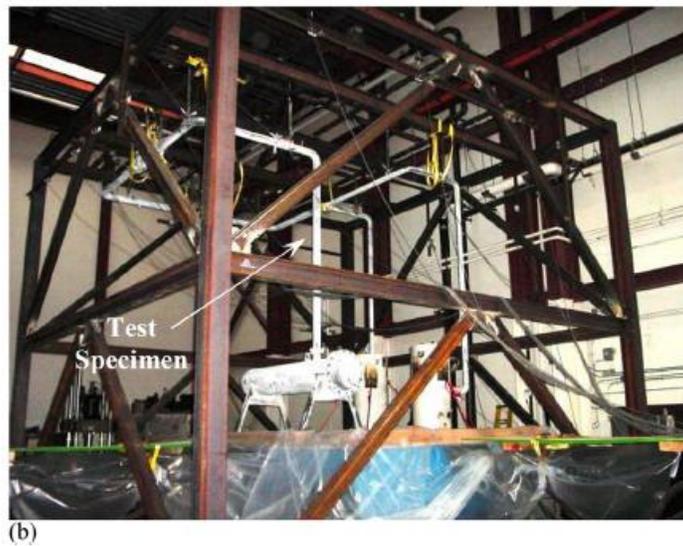
Figure 2-5 Experimental setup: (a) schematic of the setup; and (b) final setup (from Goodwin et al. 2007)

The objectives of this research program were to understand the seismic behaviors and identify the failure modes and drift capacities of the typical welded and threaded hospital piping systems under braced and unbraced conditions. A variety of instrumentation was installed to measure the accelerations and displacements on the pipes, as well as axial forces transmitted through the vertical hanger rods.

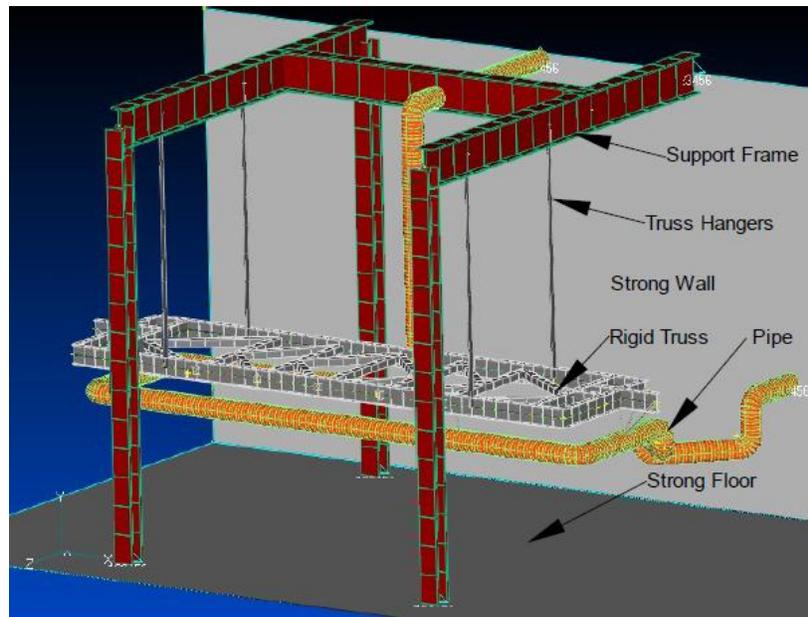
Figure 2-9 Finite element model of the Victaulic test setup in ABAQUS (from Martínez, 2007)

properties and seismic response. It was found that finite element models of water piping systems constructed using ABAQUS were not consistently accurate in predicting the response of seismic shake table tests. Roughly 70% of the recorded the uniaxial accelerations on the pipes were predicted accurately by the finite element models.

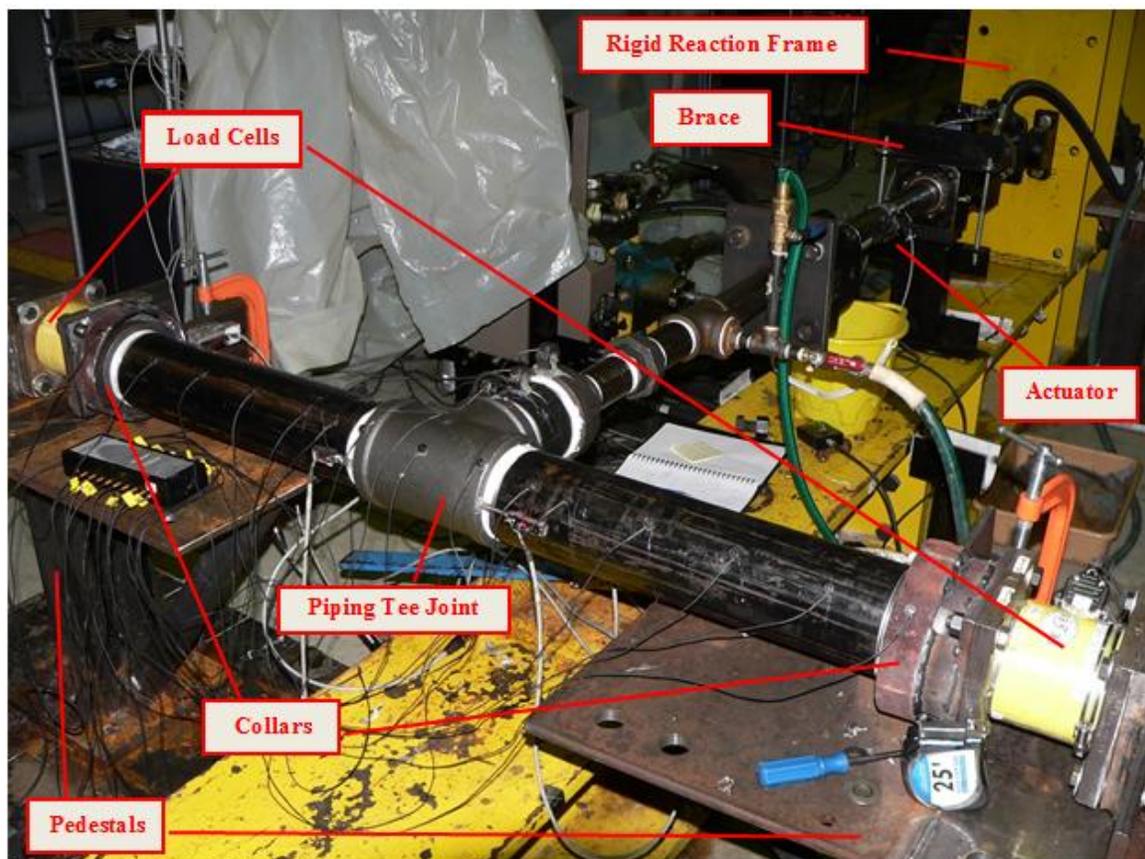
Figure 3-4 Specimen made of cast iron pipe with threaded connections

Visual inspection of each pipe component was first performed to ensure that the pipe threads were clean and in good condition. Teflon tapes, which acted as a lubricant allowing more thread engagement and prevented formation of spiral leak paths by filling the gap between the crests and roots of mating threads, were applied to the male threads at the end of pipes (CIRCOR, 2012). Special attention was paid to ensure the proper application of Teflon tapes to prevent tapes coming unwound as the pipe fittings were tightened. Pipes were screwed into the tee joint by hand with the help of pipe wrench.

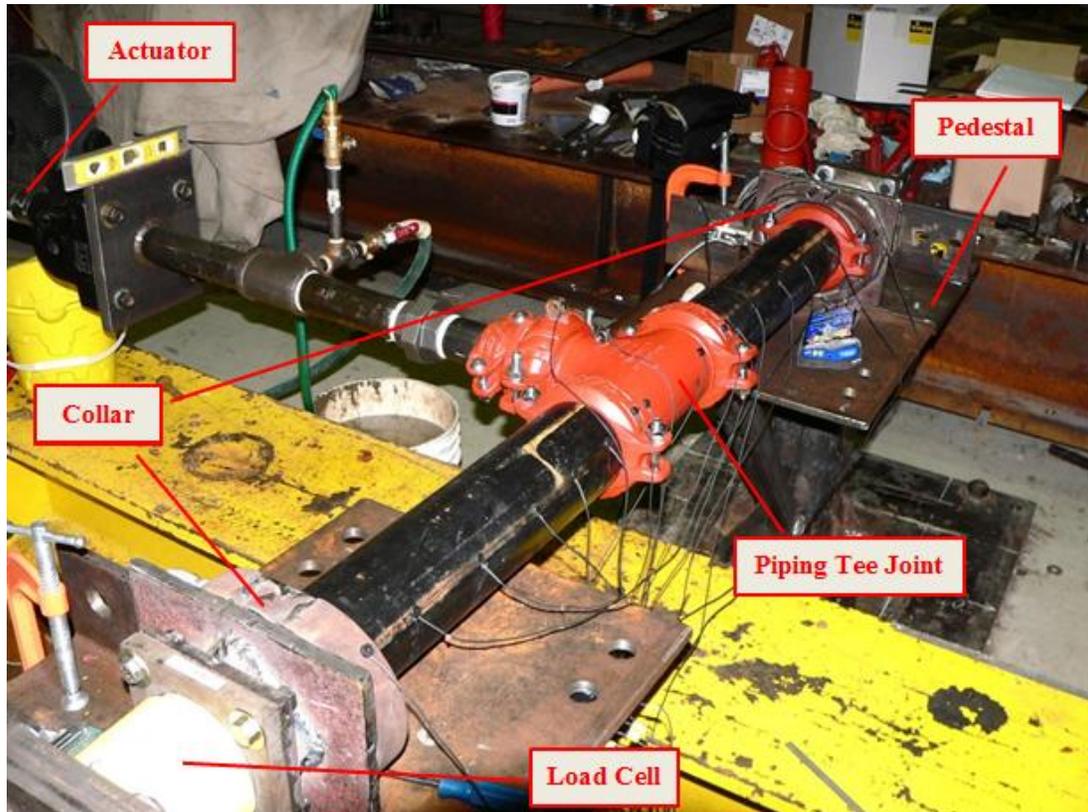
Figure 3-7 Specimen made of steel pipe with groove-fit connections

3-17 a) and perpendicular (*Figure 3-17 b*) to the loading direction of the actuator in order to consider any possible effect of the load direction on the failure modes of the coupling flanges and on the force required to reach the same kind of damage. A specimen made of steel pipe with groove-fit connections ready for test is illustrated in *Figure 3-7*.

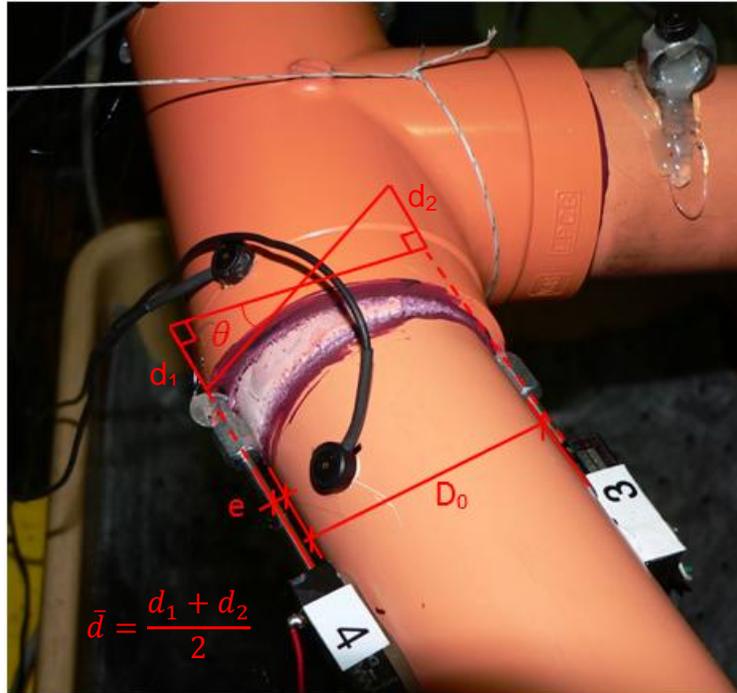
Figure 3-11 Illustration of calculation of rotation

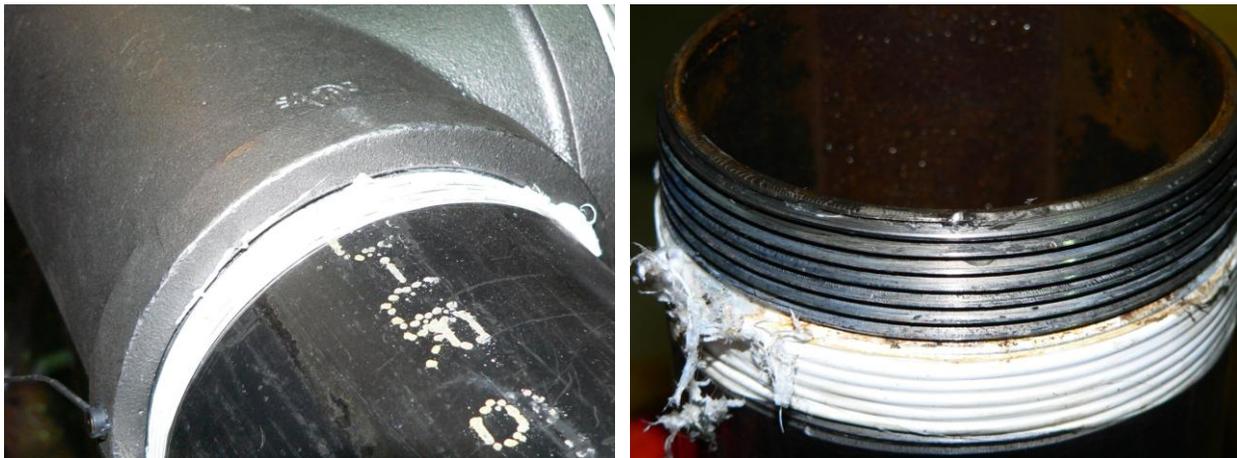
(a) *Spiral leak path and gap between tee joint and pipe*

A total of five nominal diameters ($\frac{3}{4}$ in., 1 in., 2 in., 4 in. and 6 in.) were selected for the testing of cast iron pipe with threaded connections. Similar damage and failure mechanisms were observed for all five configurations up to the first leakage. First leakage of the black iron pipe with threaded joints occurred when the threads in the pipes slipped from the mating threads in the tee joint. This was accompanied by degradation of the thread sealant (Teflon tape) and in some cases significant damage in the threads themselves. Eroding of threads due to slippage also led to the formation of spiral leak paths. Complete fracture of the pipes occurred simultaneously with the first major leakage for pipes with small nominal diameters ($\frac{3}{4}$ in. and 1 in.) Pipes with larger nominal diameters, on the other hand, did not reach the damage state DS₂ before the actuator reached its ± 3 in. stroke limit. The typical observed damage on black iron pipes with threaded joints is shown in *Figure 3-13*.

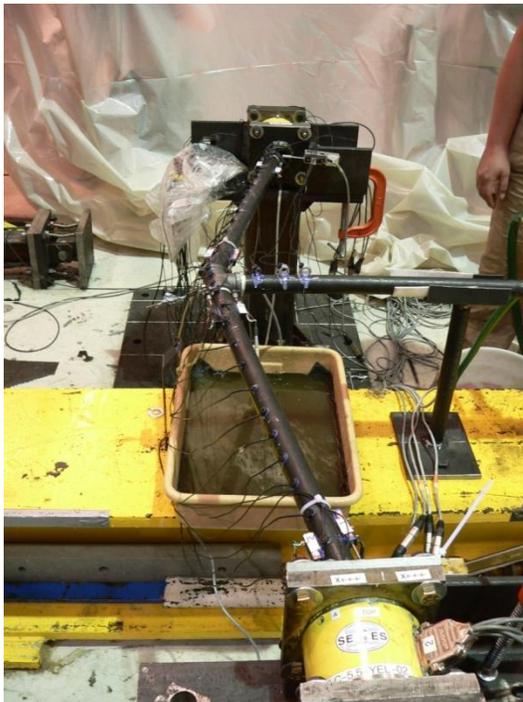
(a) Large inelastic rotation occurred at the ends of the pipes on both sides of the tee joint

compared to the crests of the threads in the pipes and threads in the tee joint. This was observed for all specimens with nominal diameters of $\frac{3}{4}$ in. and 1 in., which experienced both DS₁ (first leakage) and DS₂ (fracture of the pipe). The opening or fracture of the threads was initiated from the roots of the male threads in the pipes.

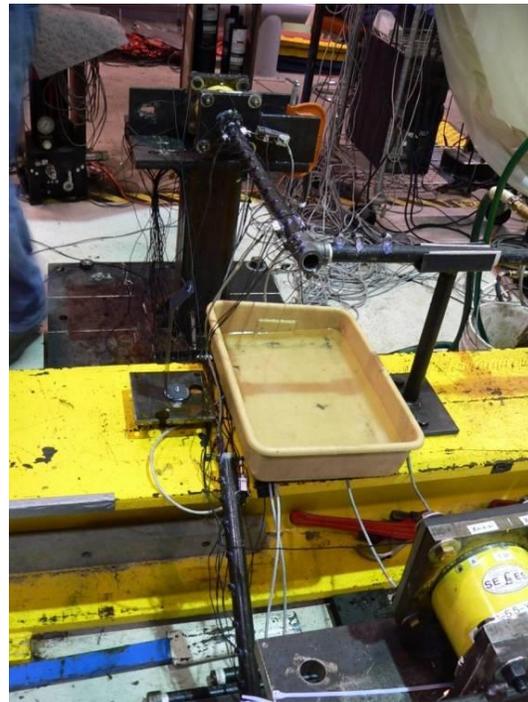
(b) Fracture of pipe occurred at the juncture of fitting and tee joint

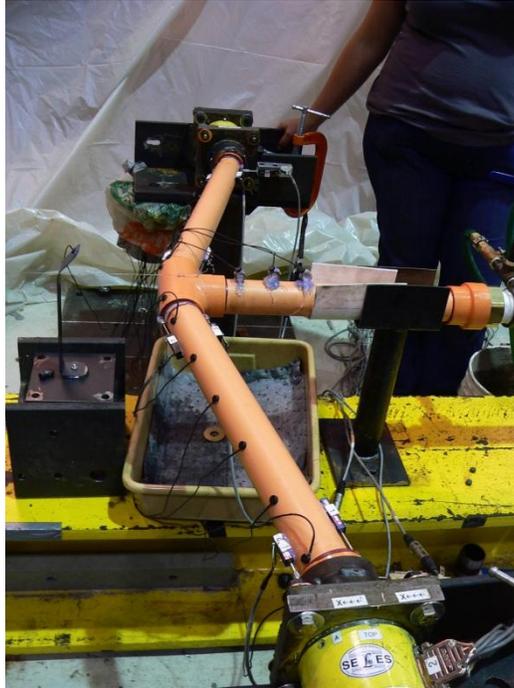
Figure 3-16 large inelastic rotation at the end of pipes

Again for all specimens, significant inelastic rotations, as shown in *Figure 3-16*, were concentrated at the ends of the pipes on both sides of the tee-joint. Note that both damage states DS₁ (first leakage) and DS₂ (fracture of the pipe) occurred simultaneously for the CPVC pipes with cement joints.

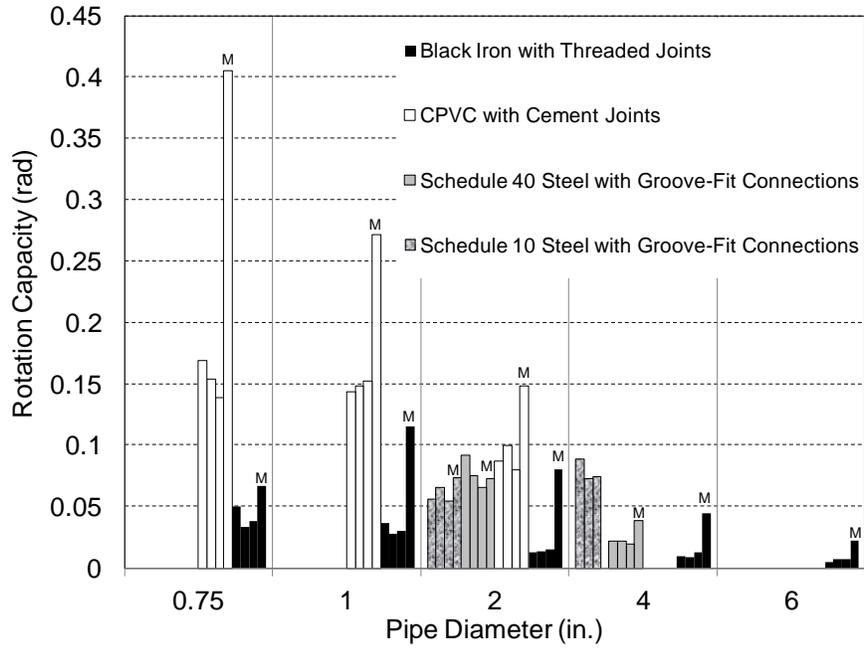
Figure 3-19 Rotational capacities at first leakage for all tee joint specimens; "M" indicates monotonic tests

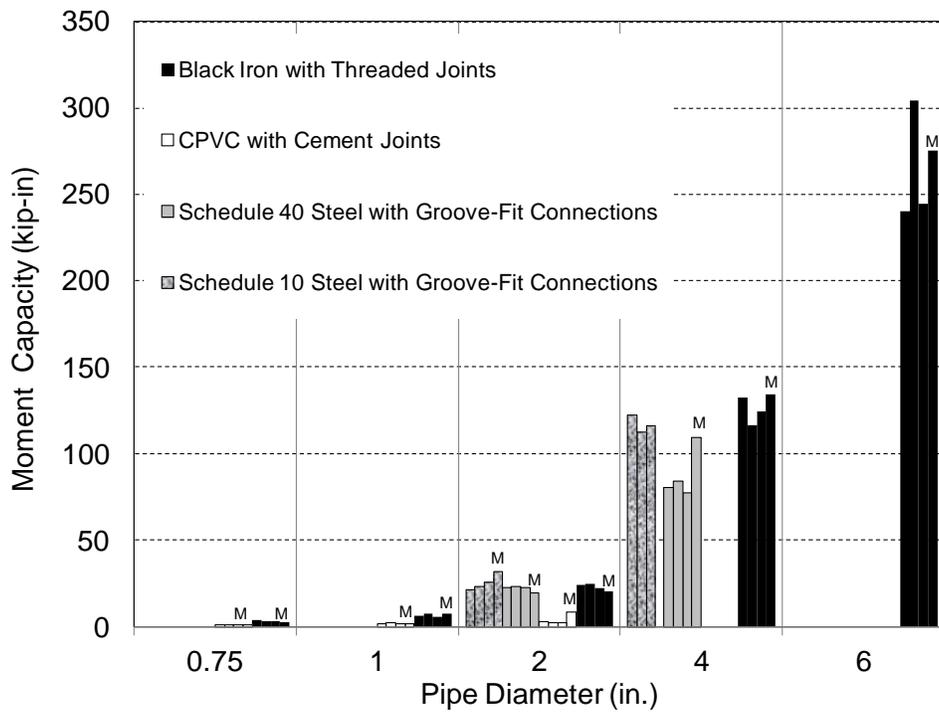
Figure 3-20 Moment capacities at first leakage for all tee joint specimens; "M" indicates monotonic tests

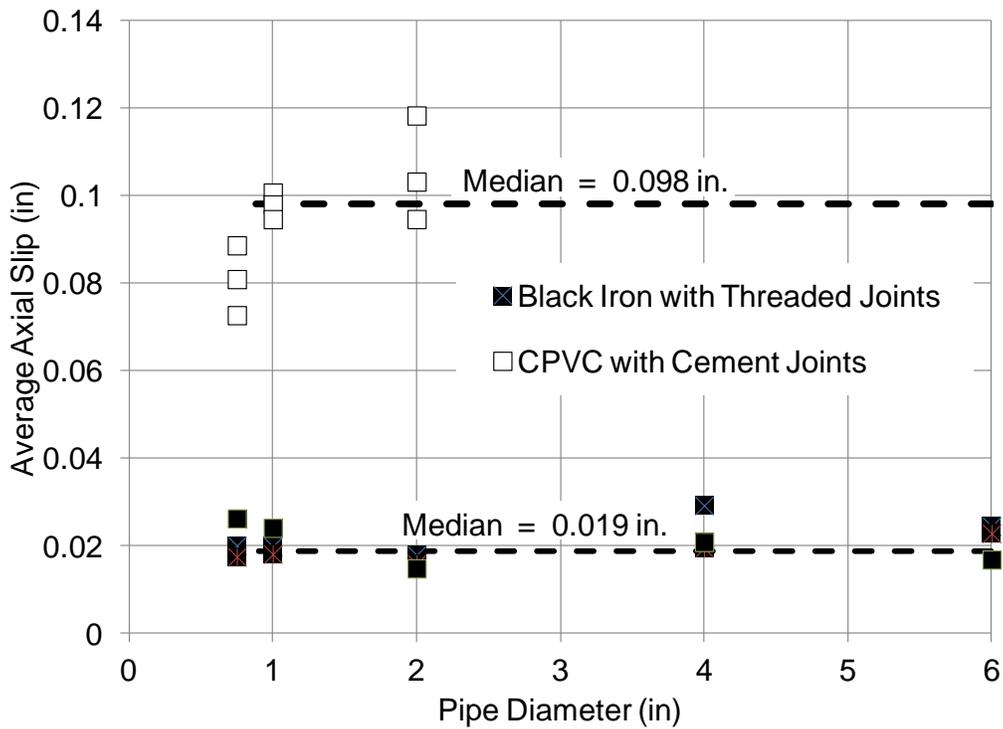
Figure 3-22 Variations of variation of average axial joint slip with pipe diameter

where θ_{leak} is the rotational capacity at first leakage (see *Table 3-3*). *Table 3-4* summarizes the average axial slip for all specimens made of black iron and CPVC. *Figure 3-22* shows the variation of \bar{s} with pipe diameters for black iron threaded and CPVC cement joints. The results shown in the figure are only from cyclic tests. It can be seen that \bar{s} for a given joint type is essentially a constant for all pipe diameters and can be characterized by the median values shown in the figure. This result indicates that black iron pipes with threaded joints and CPVC pipes with cement joints behave essentially as flexural beams with first leakage occurring when a “critical extreme fiber strain” is reached. Knowing \bar{s} for a given joint type allows for the prediction of rotation at leakage for any pipe diameter through Equation (3.3).

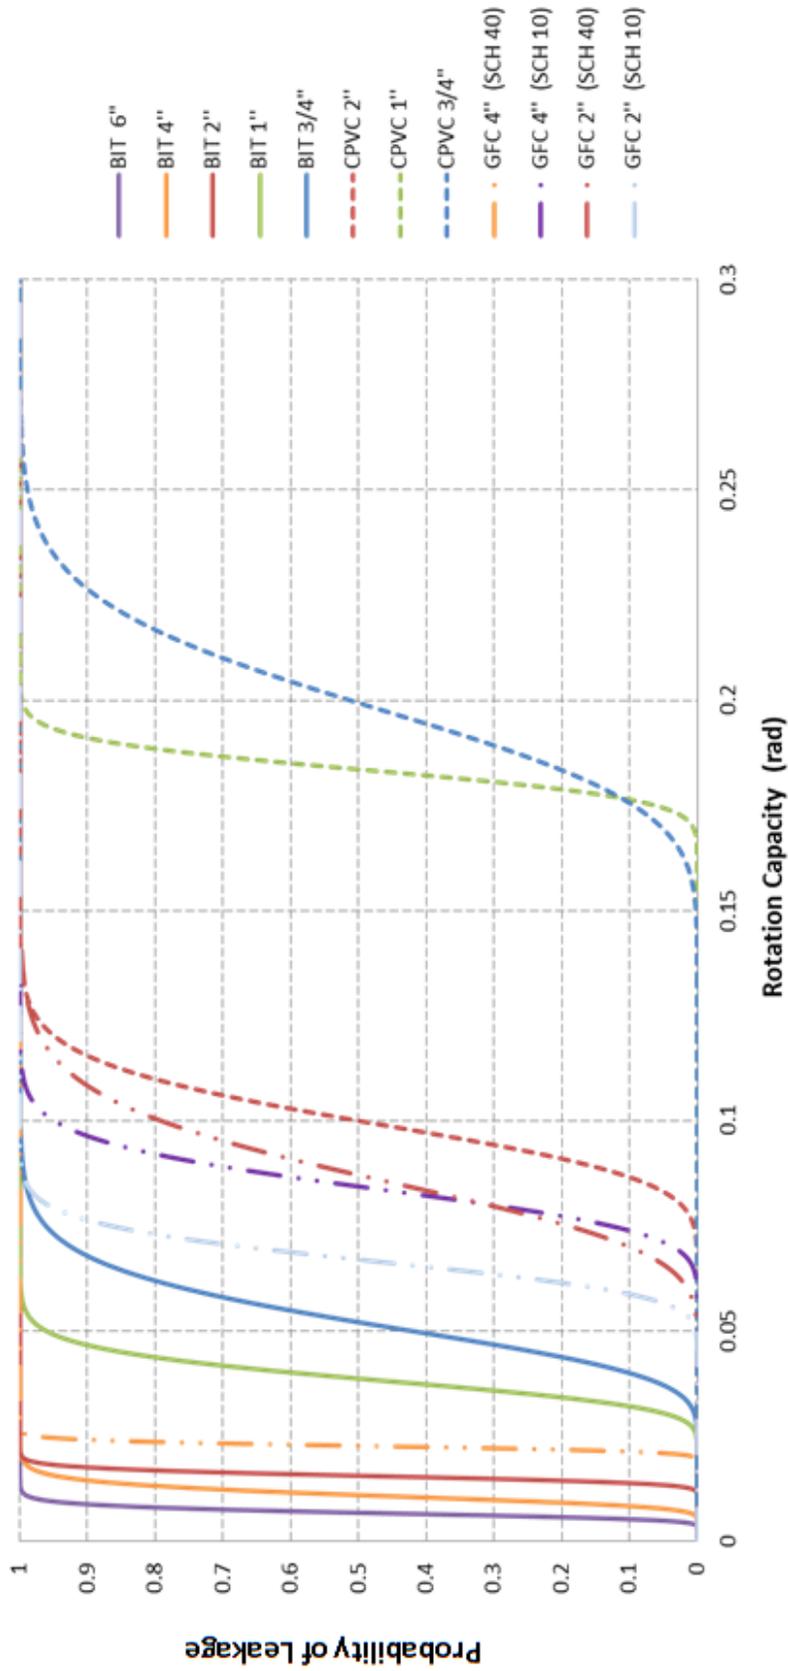
Figure 3-23 First leakage fragility curves for fire suppression sprinkler piping joints;

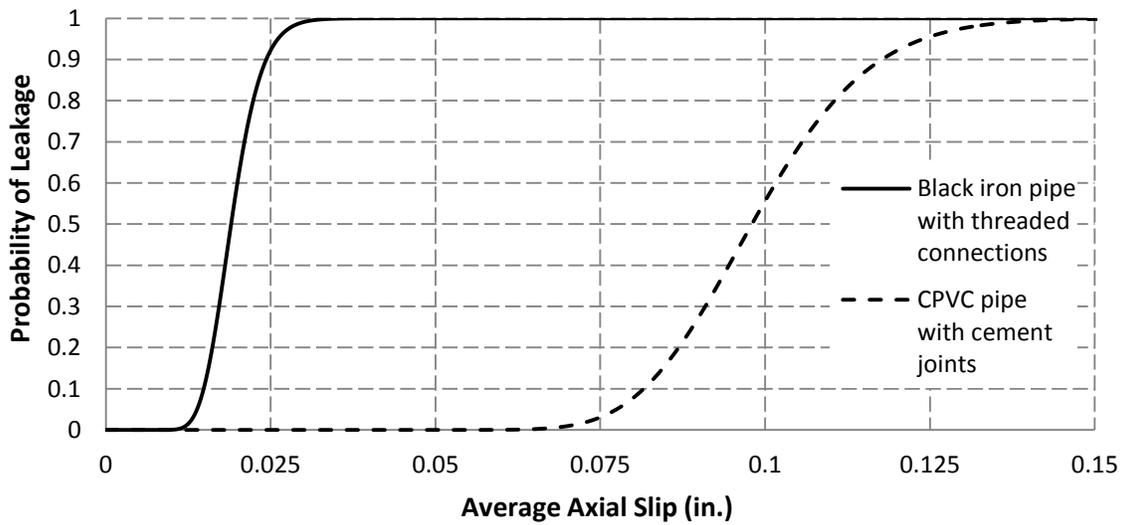
Figure 3-24 First-leakage fragility curves for black iron pipe with threaded connections and CPVC pipe with cement joints in terms of average axial slip

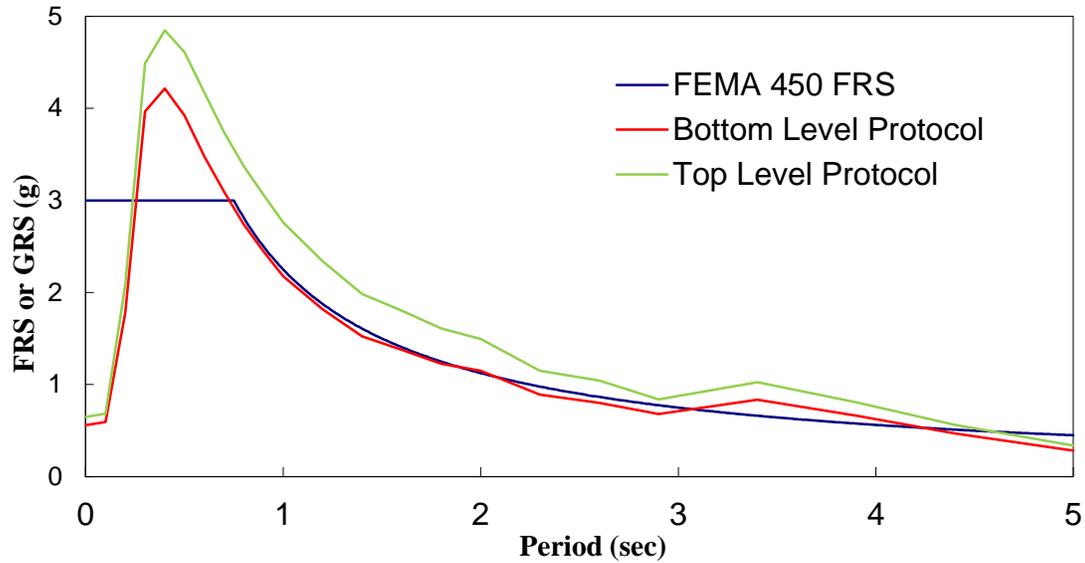
Figure 4-4 Floor response spectra

The Maximum Considered Earthquake (MCE) level response spectra for the top level protocol and the bottom level protocol are compared with the floor response spectrum defined by Equation 3.3-1 and Equation 3.3-2 in the FEMA 450 (FEMA, 2003) and the comparison is presented in Figure 4-4. It can be observed that the MCE level response spectra for both the top and bottom level protocol envelop the floor response spectra.

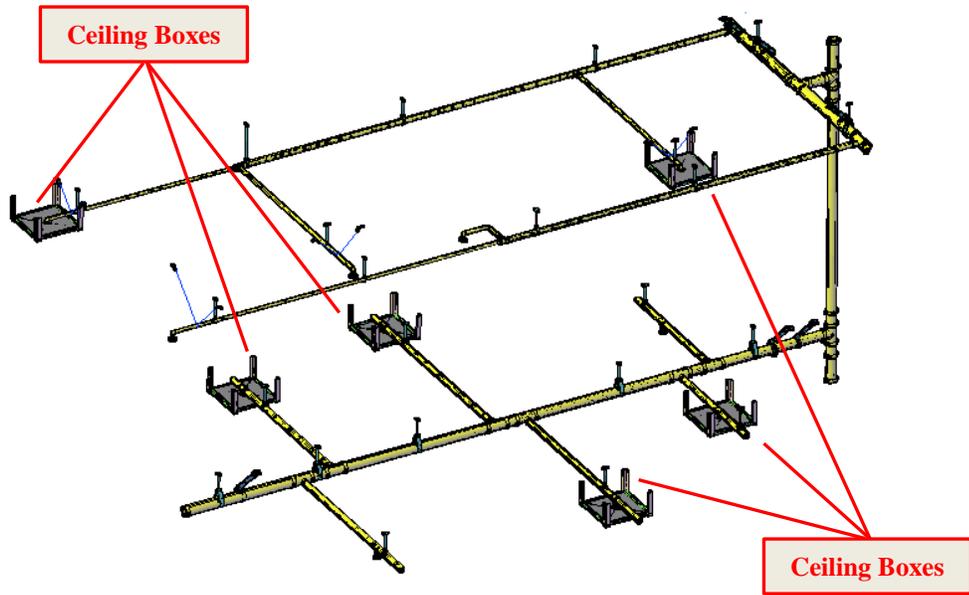
Figure 4-13 Locations of ceiling boxes

As shown in *Figure 4-13*, a total of six artificial ceiling boxes supporting a single tile were installed at various locations to assess the interaction between the suspended ceiling system and the fire sprinkler piping system during earthquake shaking. Since the dynamic properties of the entire suspended ceiling system are related to a number of factors and it is difficult to estimate and determine the stiffness of a representative suspended ceiling system for a given size, two extreme conditions were considered. Two types of ceiling boxes, the rigid frame and the flexible hanging frame, were incorporated in the experimental study. Each ceiling box was 2 feet by 2 feet, supported by two types of materials at the four corners. Steel angles (5/8'' x 5/8'' x 1/8'') were first selected to support the ceiling box and simulate rigid suspended ceiling subsystems (*Figure 4-14*). It should be noted that sprinkler piping does not run that close to the ceiling in practice and the short drop connecting the sprinkler heads to the pipes used in this series of dynamic testing may not be typical.

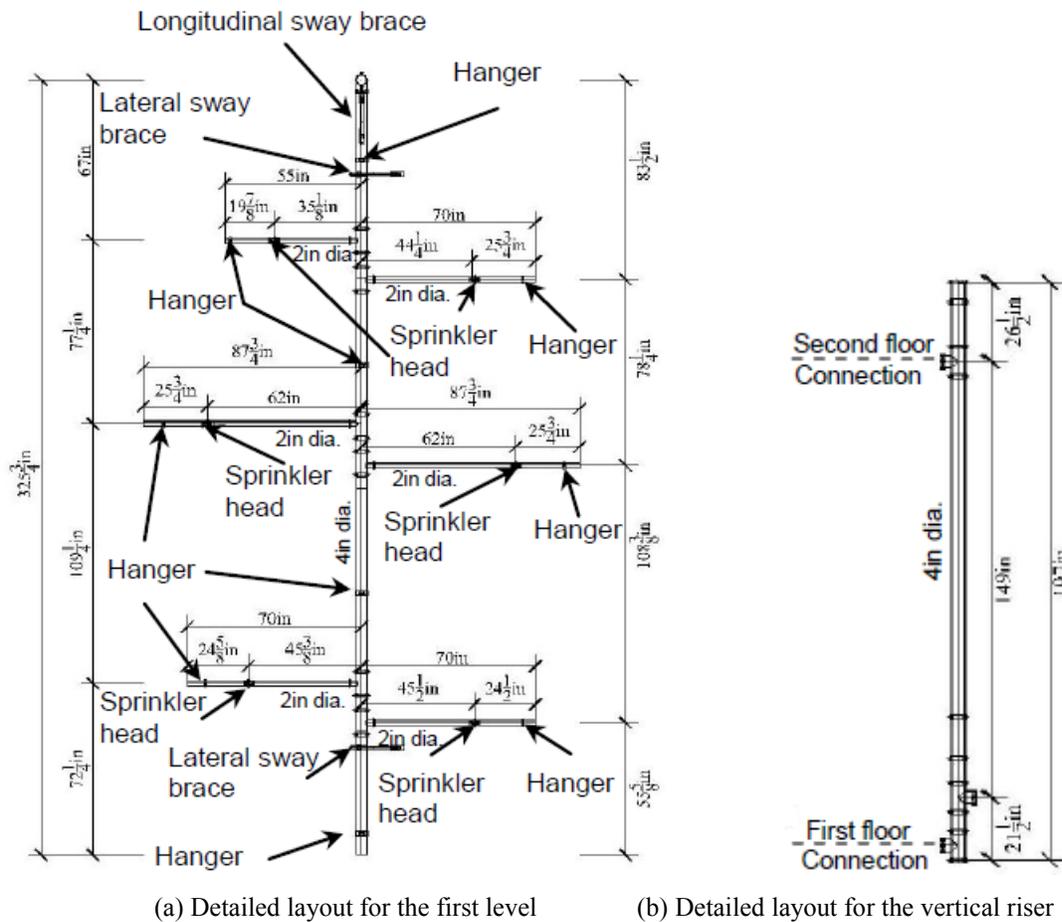
Figure 4-20 Layout of first level and riser

The two levels of the specimen were connected together by a 15-foot-long vertical riser (*Figure 4-20 b*) and turned into a complete two-story full-scale fire sprinkler piping system. To detect leakage, all pipes were filled with water under an average municipal water pressure of 40 psi.

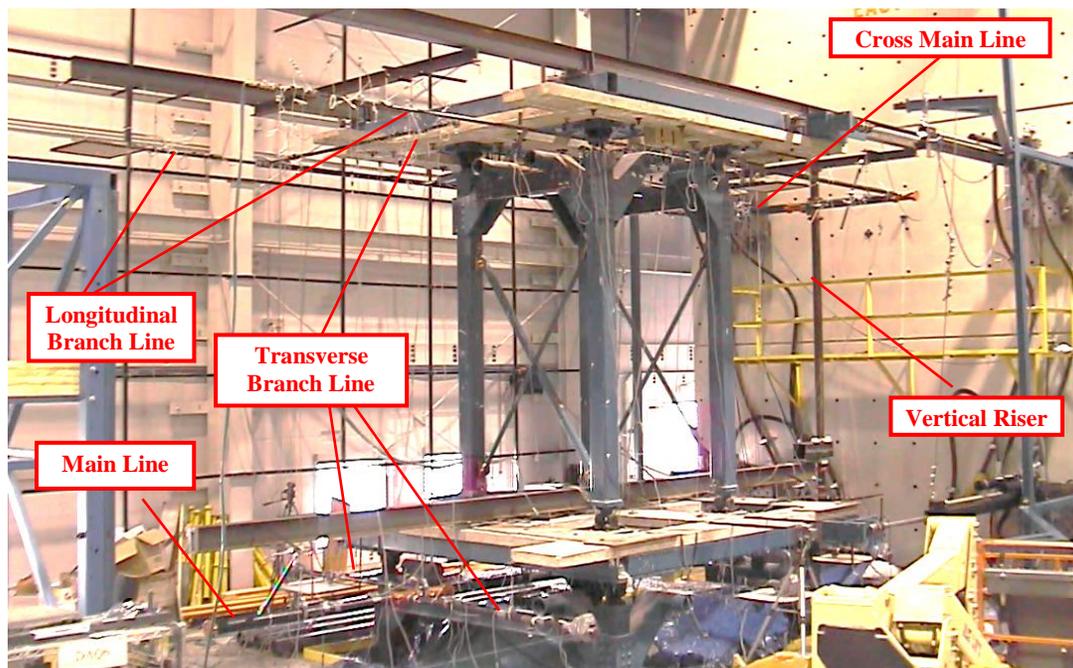
Figure 4-32 Overview of Specimen 1

The branch lines of the first specimen were made of black iron pipes (schedule 40) with threaded connections. An overview of the specimen ready for testing is presented in *Figure 4-32*.

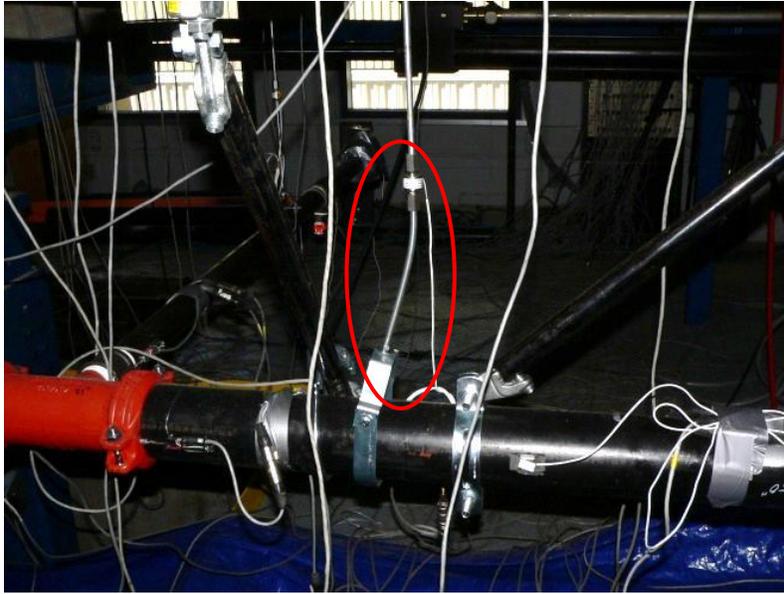
Figure 4-34 Buckling of vertical hanger (Configuration 1-6, 100% MCE level)

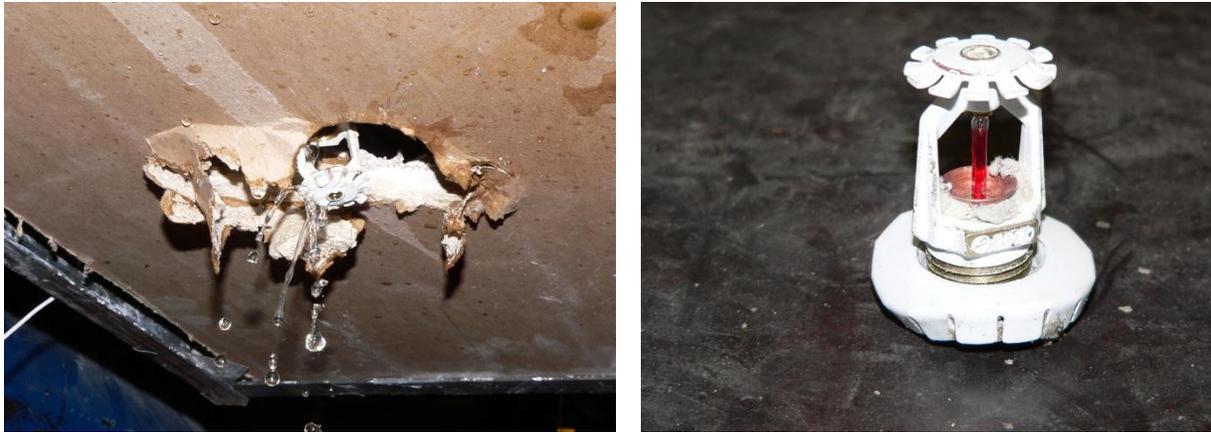
Figure 4-36 Failure of quick response pendant sprinkler head (Configuration 1-6, 100% MCE level)

flowing out, was broken and activated water release as the sprinkler head collided with the sharp debris around the opening of the ceiling tile.

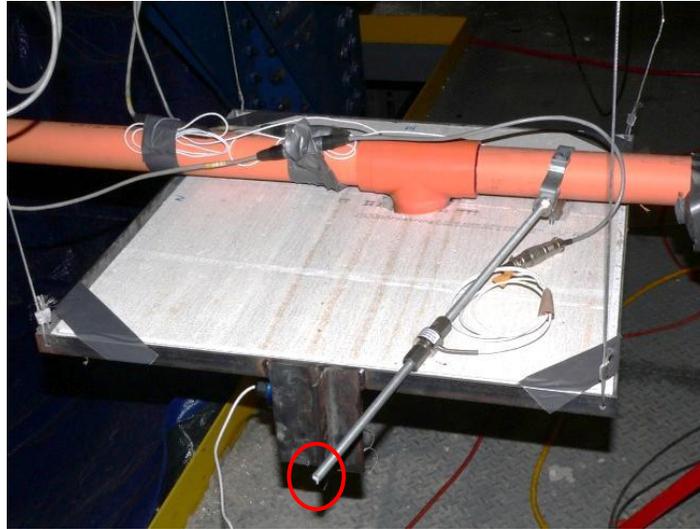
Figure 4-38 Rupture of vertical hanger (Configuration 2-3, 100% MCE level)

Two major failures were observed during testing of the second specimen. The first one occurred to the third configuration when the two-story specimen was subjected to 100% of MCE level of testing protocol and supported only by vertical hangers and braced with wire restraints. As shown in *Figure 4-38*, the vertical hanger attached to the LCR-18 load cell (*Figure 4-29*) supporting the branch line #5 at the first level ruptured due to local necking at the connection to the SAMMY screw.

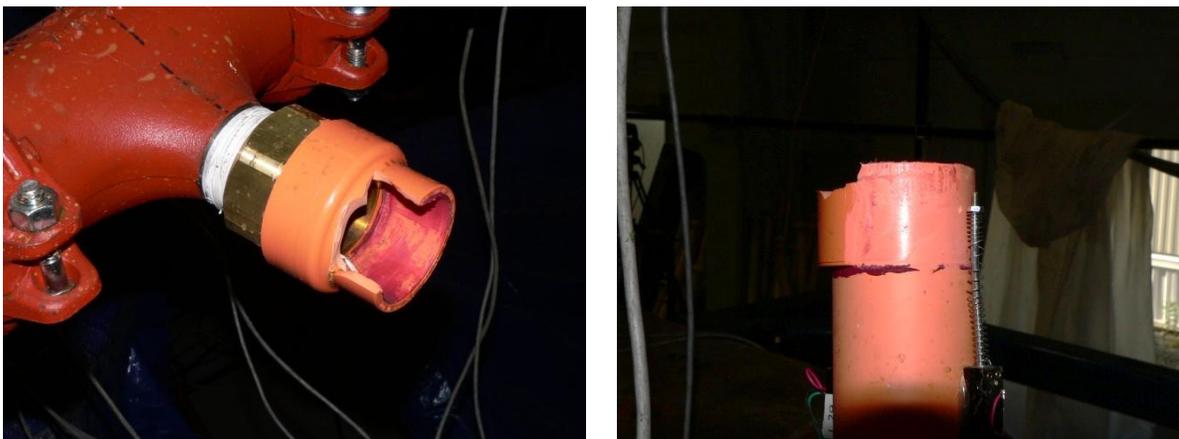
Figure 4-39 Fracture of the CPVC branch line (Configuration 2-4, 100% MCE level)

At the 100% MCE level of testing protocol, the fully unbraced specimen had a complete fracture at the tee joint of the branch line #1 at the first level, as shown in *Figure 4-39*. Unlike the failure mechanisms that were observed from the quasi-static tests on the piping tee joints described in Chapter 3, the complete fracture occurred at the root of the CPVC tee joint instead of at the end of pipes along the edge of the tee joints.

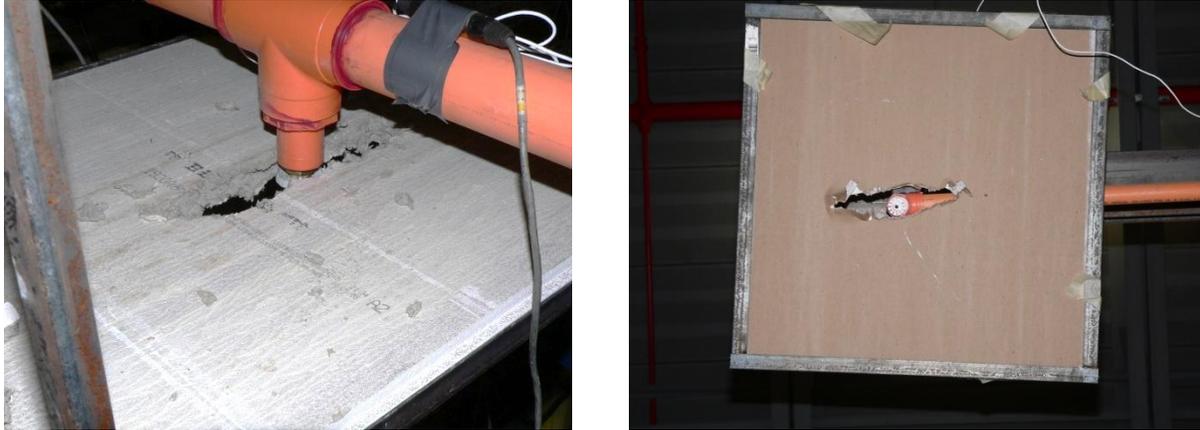
Figure 4-40 Damage of ceiling tiles (*Configuration 2-4, 100% MCE level*)

As shown in *Figure 4-40*, severe damage of ceiling tiles as a result of pounding with pendant sprinkler heads was again observed during the testing on the second specimen.

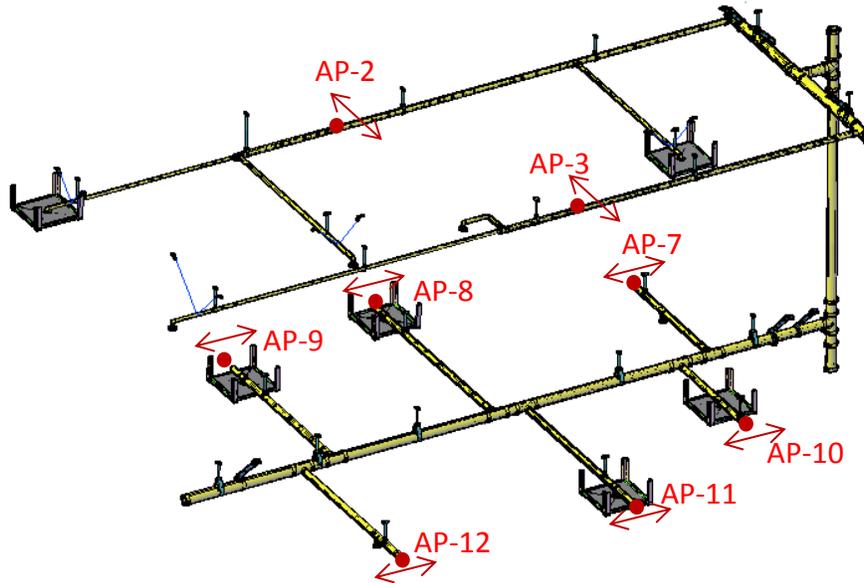
Figure 4-45 Locations and directions of accelerometers (Note: AP indicates accelerometers for pipes)

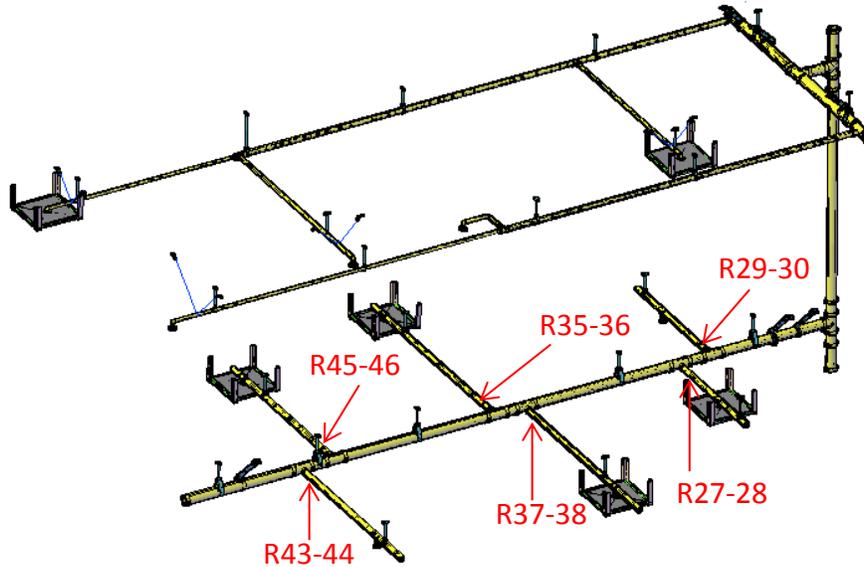
Figure 4-49 Locations of measurement for rotation

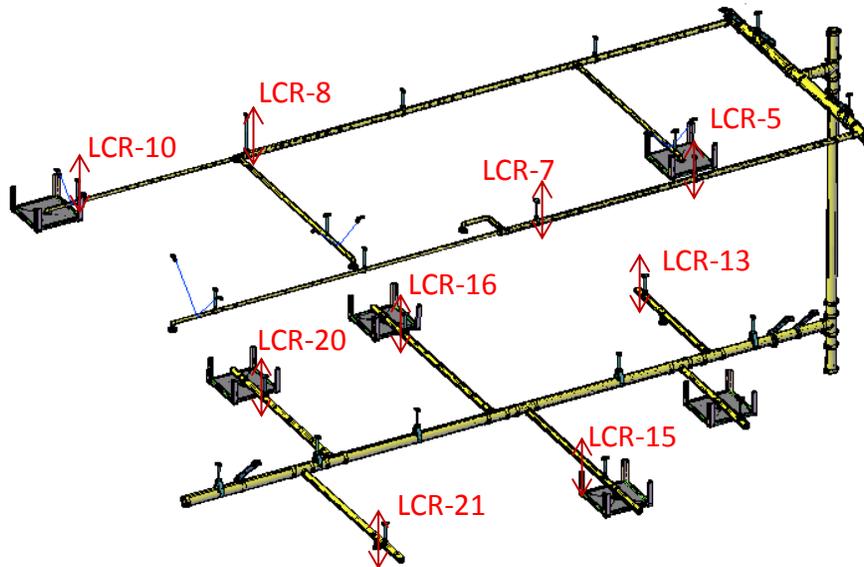
Figure 4-52 Locations of miniature load cells on vertical hanger rods

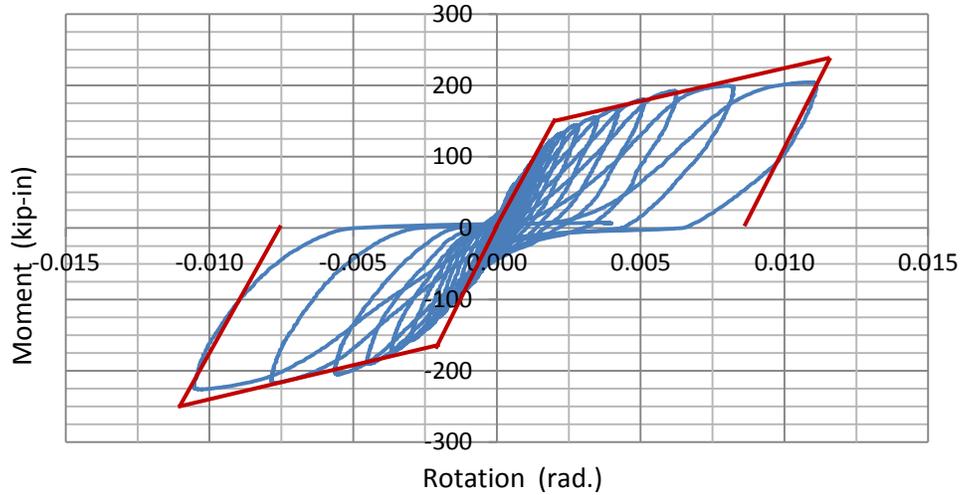
Figure 5-1 Moment-rotation cyclic response of 4-inch black iron pipes with threaded joints

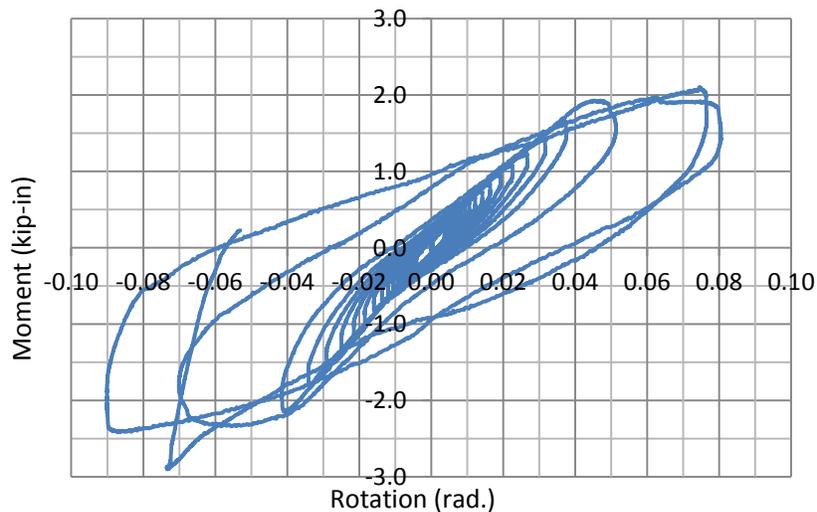
Figure 5-2 Moment-rotation cyclic response of 2-inch CPVC pipes with cement joints

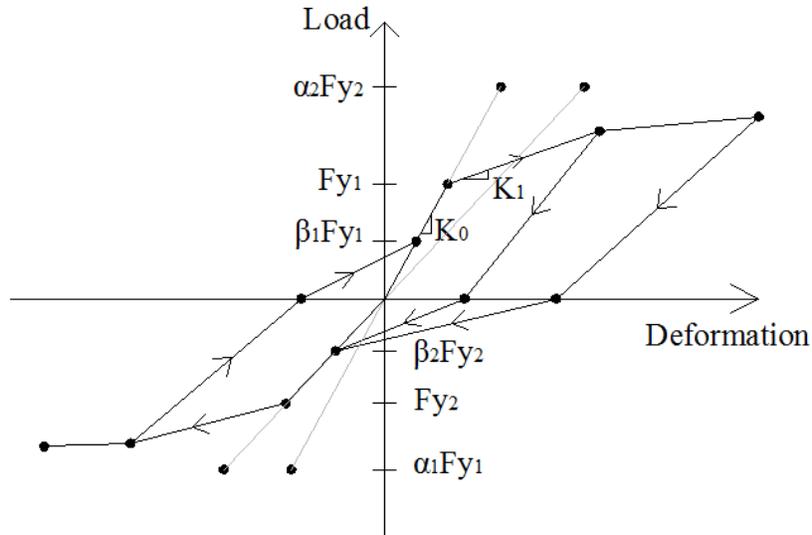
Figure 5-4 Multi-linear Pivot model (from CSI, 2012)
