SIMULATION OF THE SEISMIC PERFORMANCE OF NONSTRUCTURAL SYSTEMS

EXPERIMENTAL SEISMIC STUDY OF PRESSURIZED FIRE SPRINKLER PIPING SUBSYSTEMS

Technical Report MCEER-13-0001 ■ April 8, 2013

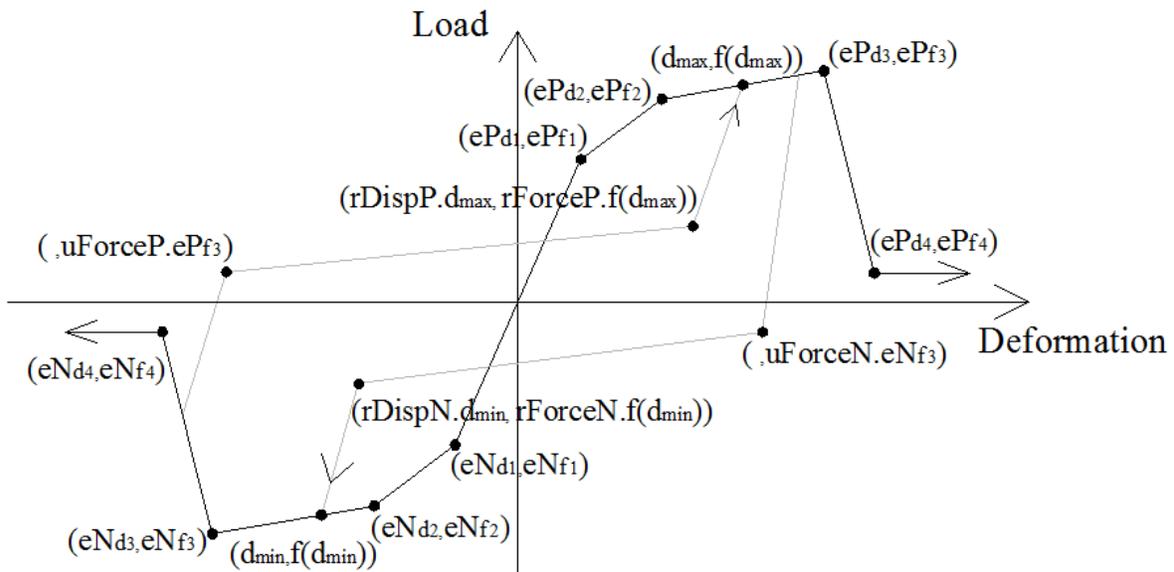
Figure 5-9 Pinching4 Material model (from OpenSeesWiki, 2012)

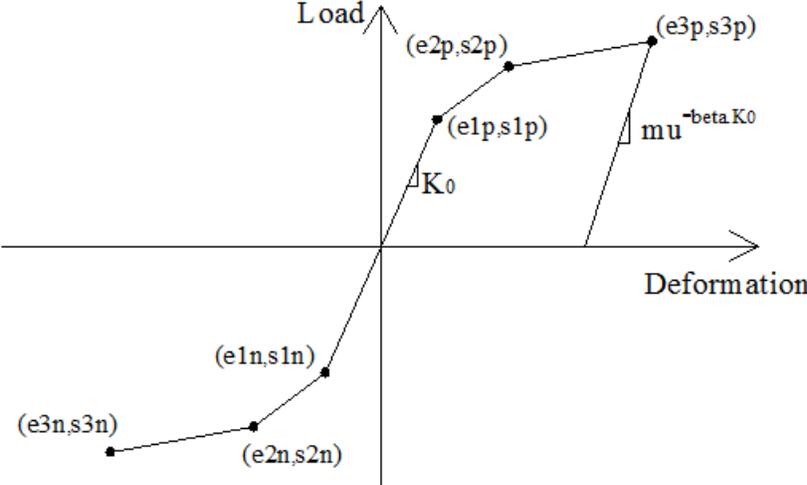
Figure 5-11 Hysteretic Material model (from OpenSeesWiki, 2012)

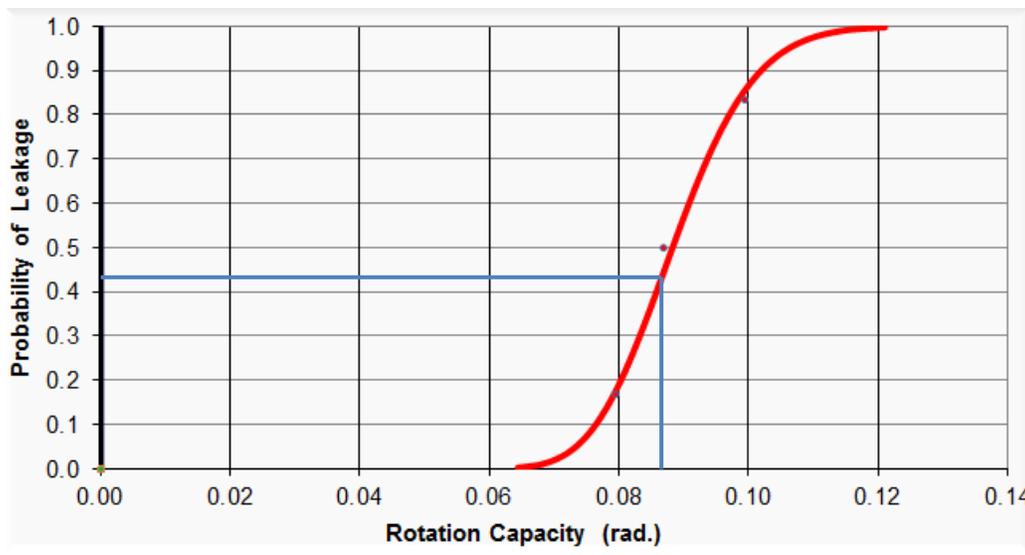
Figure 5-22 Comparison of the maximum joint rotation predicted by numerical model with probability of leakage predicted by the fragility curve for the 2-inch CPVC pipe with cement joints

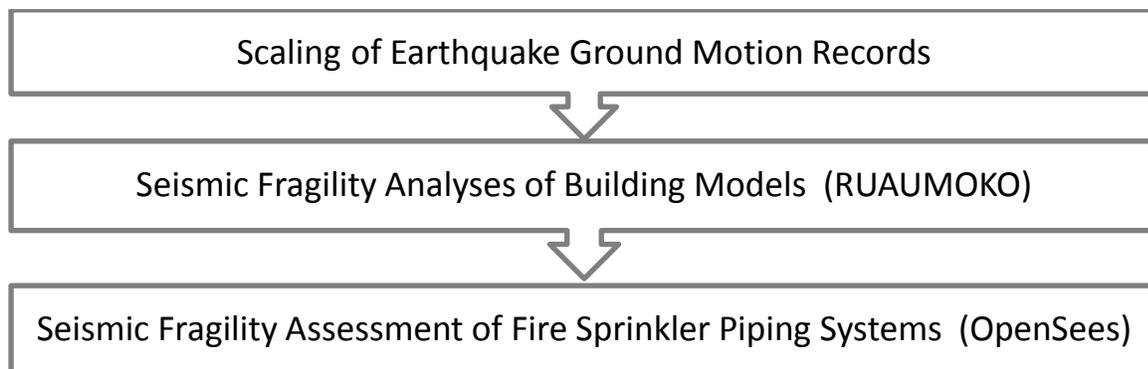
Figure 6-1 Process of IDA on fire sprinkler piping systems

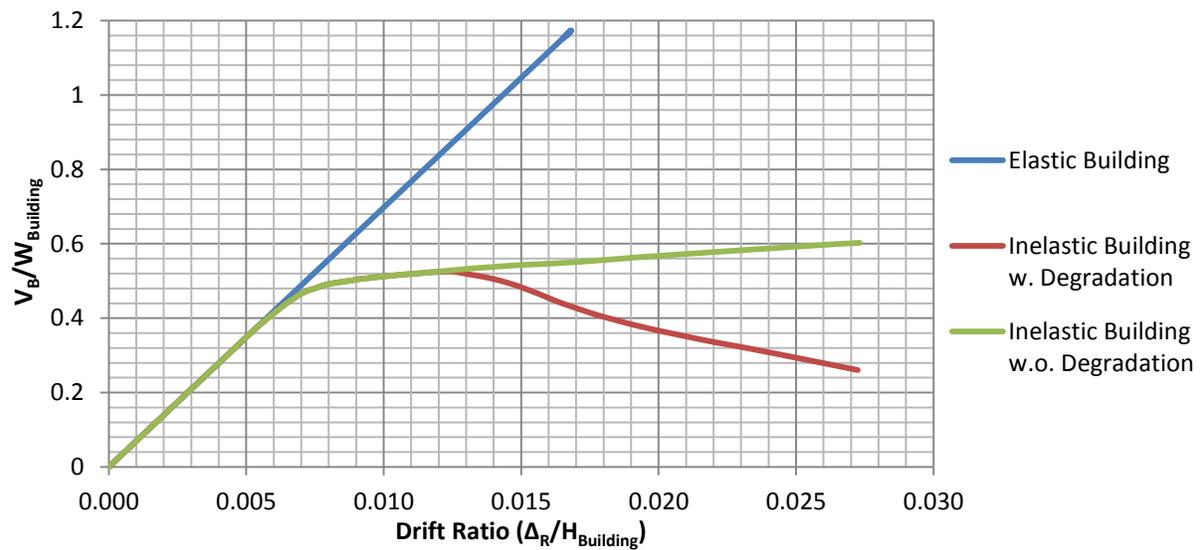
Figure 6-7 Static pushover curves

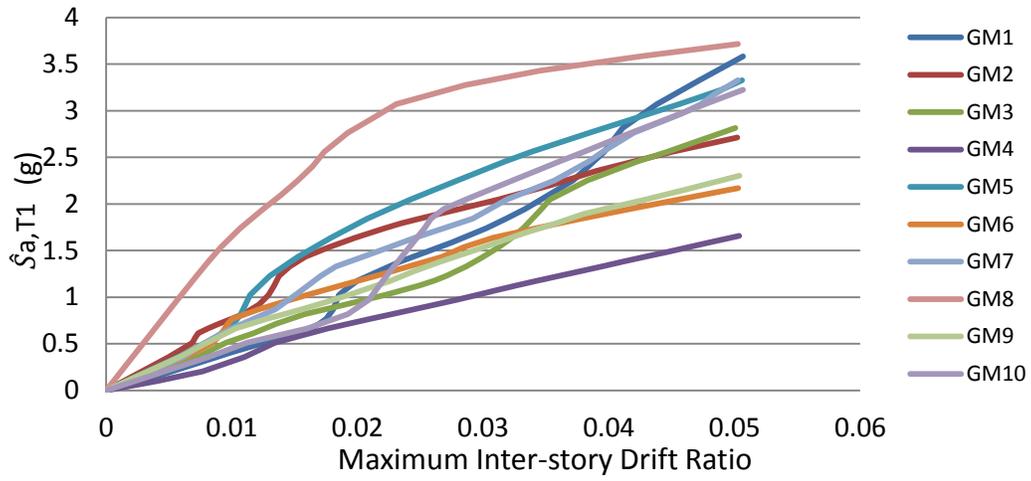
Figure 6-13 IDA curves for inelastic building without degradation

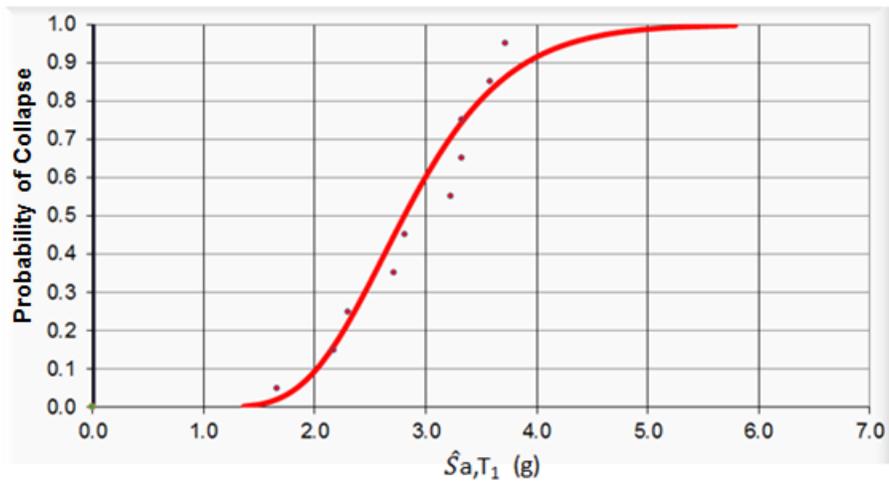
Figure 6-14 Collapse fragility curve for inelastic building model without degradation

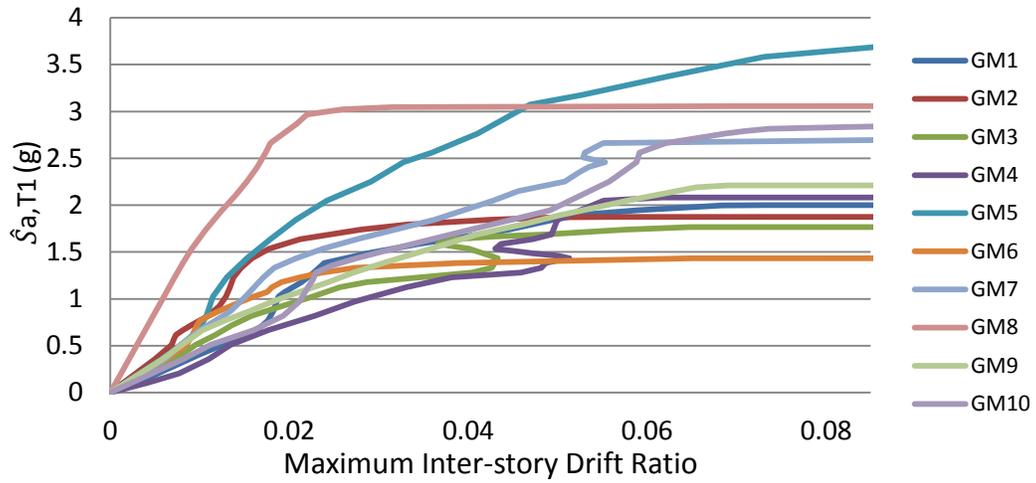
Figure 6-15 IDA curves for inelastic building with degradation

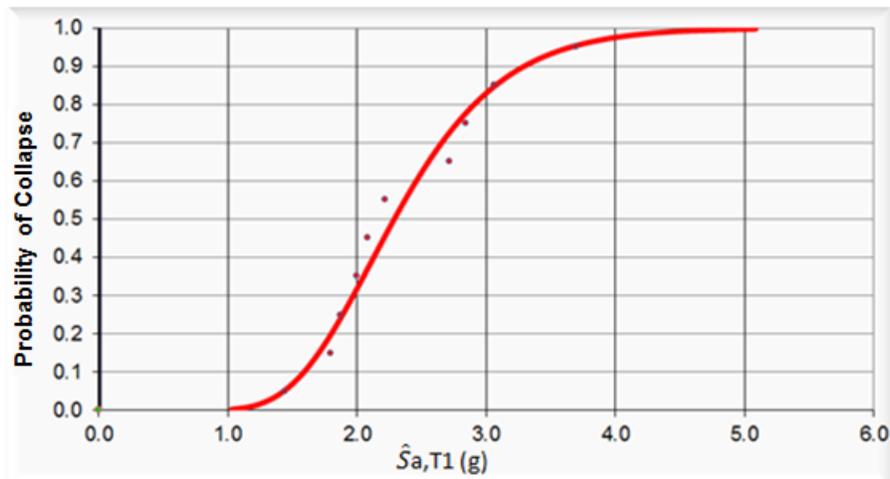
Figure 6-16 Collapse fragility curve for inelastic building model with degradation

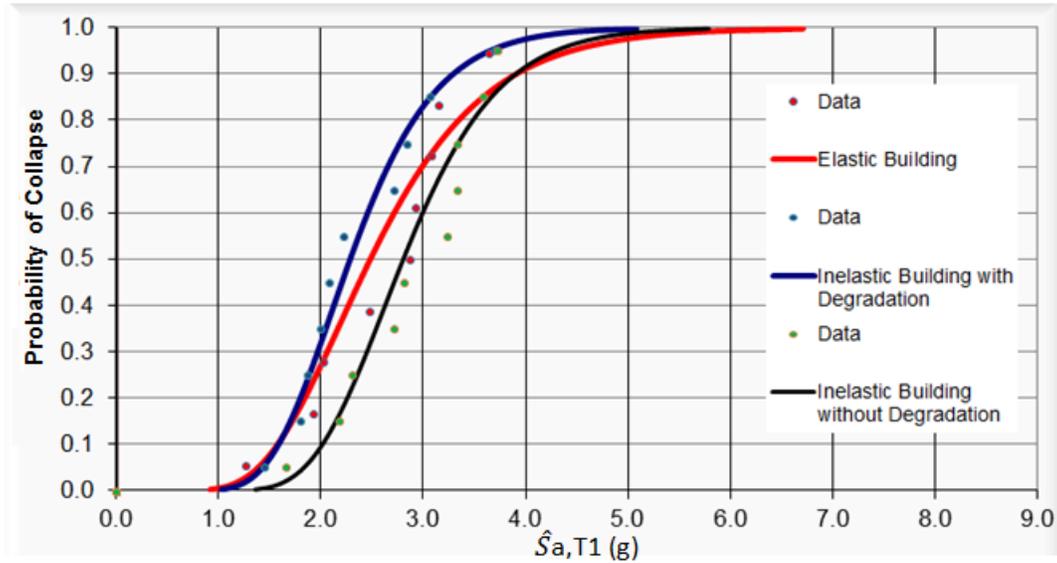
Figure 6-17 Comparison of collapse fragility curves for building models

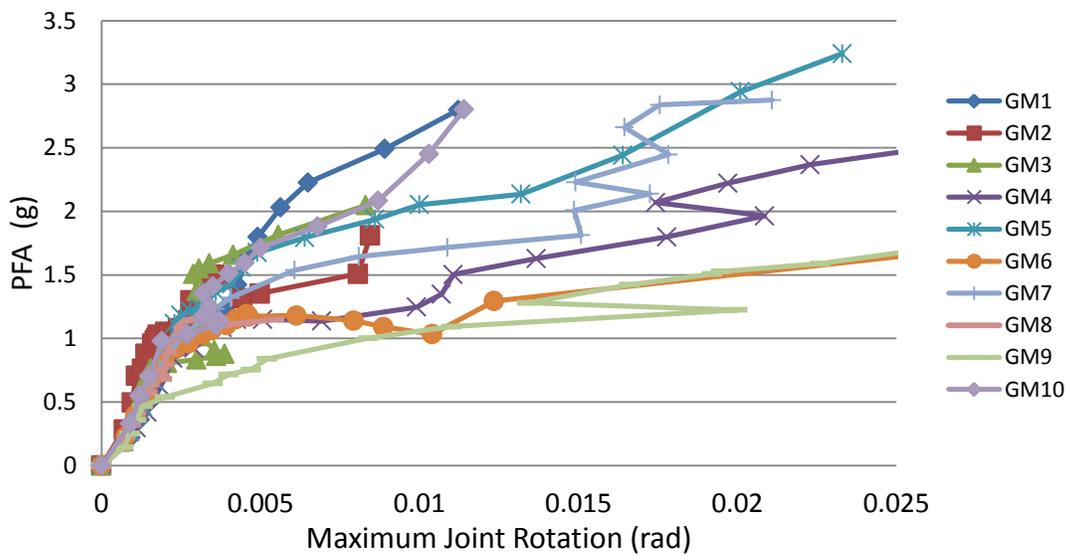
Figure 6-20 Illustration of IDA curves for fire sprinkler piping system

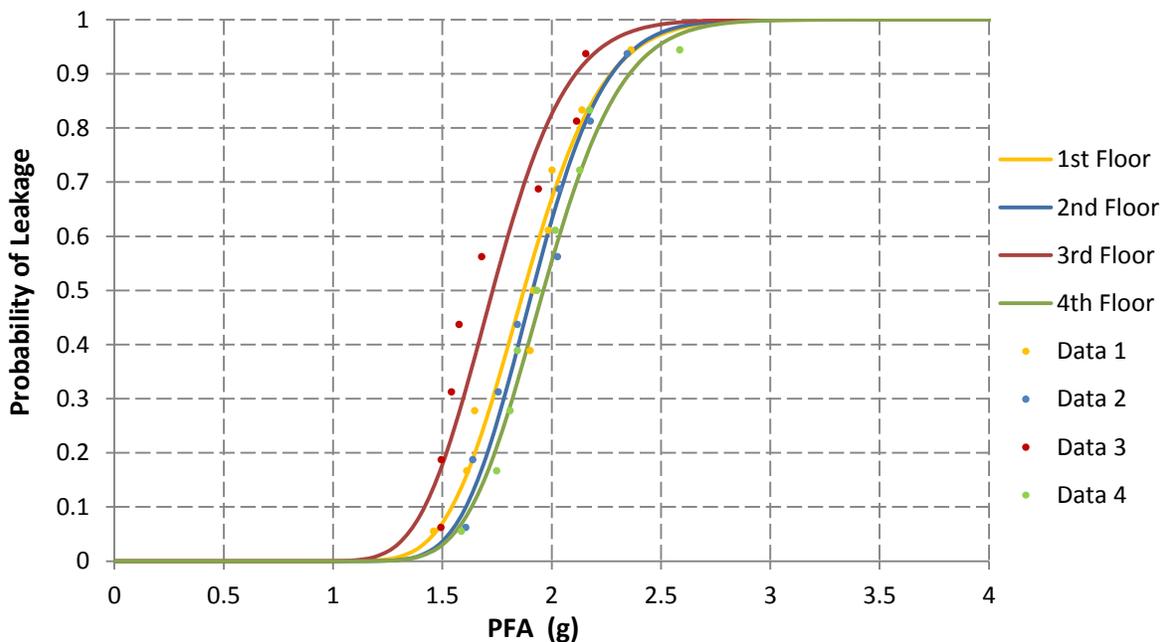
Figure 6-21 First-leakage fragility curves of fire sprinkler piping system (Combination #1)

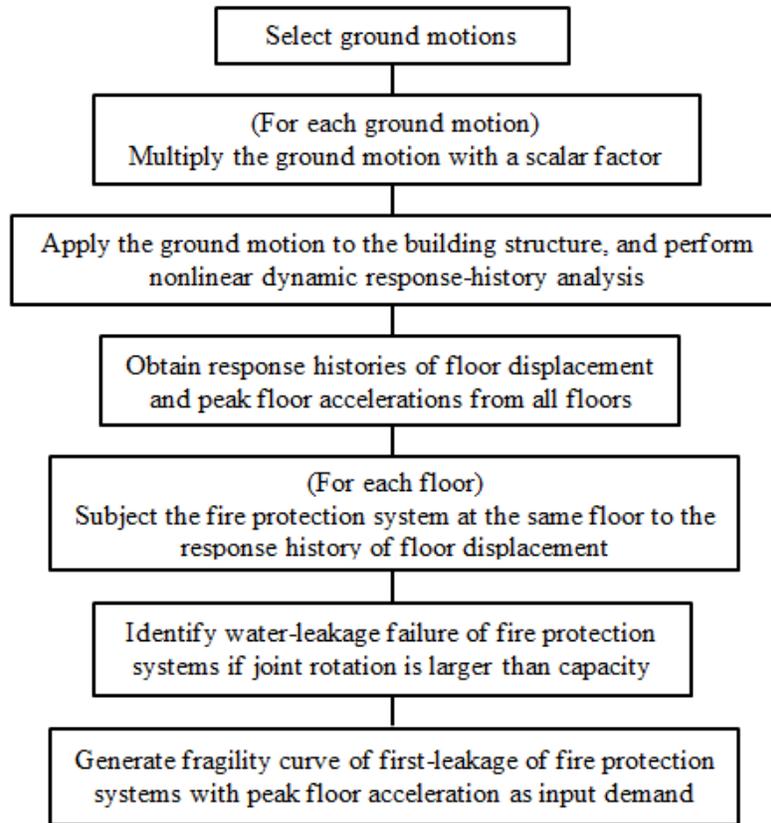
Figure 6-25 Procedures of conducting fragility analyses for fire sprinkler piping systems
