Tenth U.S. National Conference on Earthquake Engineering
Frontiers of Earthquake Engineering
July 21-25, 2014
Anchorage, Alaska

POST-EARTHQUAKE FIRE RESISTANCE OF DUCTILE CONCRETE FILLED DOUBLE-SKIN TUBE COLUMNS

R. Imani¹, G. Mosqueda² and M. Bruneau³

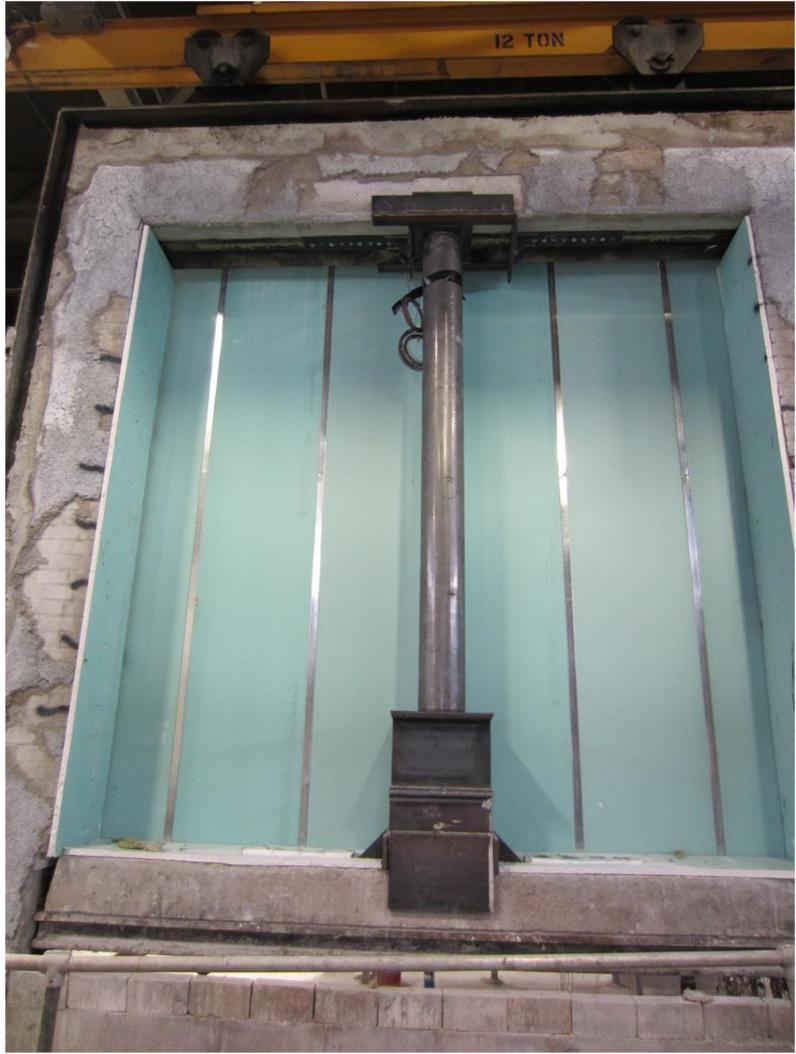
Figure 7. Specimen S3 installed in the vertical furnace

A vertical 10'x10' furnace available at the fire testing lab of the NGC Testing Services, an independent testing facility that performs fire, acoustic, and structural testing services, was used for the fire tests. The furnace is capable of accommodating members with the maximum height of 10' and applying a maximum axial load of 120 kips. The boundaries of the furnace were defined by two concrete beams at the top and bottom, a moving/replaceable wall on one side and a fixed wall that was built on the other side of the furnace for each specific test. The top beam was fixed in place working as a reacting member to the applied vertical loads. The bottom beam was attached to a railing that could move up or down with a total travel distance of 4" (± 2 "). The bottom beam was supported from below by four hydraulic actuators used for applying vertical loads to the test specimens. Fig. 7 shows a photo of the vertical furnace with the specimen between the top and bottom beams.

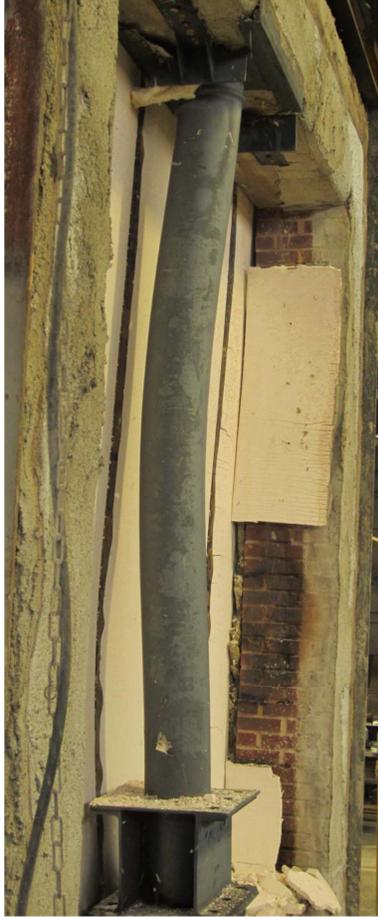
Figure 10. Final state of specimen S3 at the end of the fire test
