# Seismic retrofit of non-ductile concrete and masonry walls by steel-strips bracing

Mustafa Taghdi, Michel Bruneau, & Murat Saatcioglu

*Ottawa Carleton Earthquake Engineering Research Centre Department of Civil Engineering, University of Ottawa, Ottawa, Ontario, Canada*

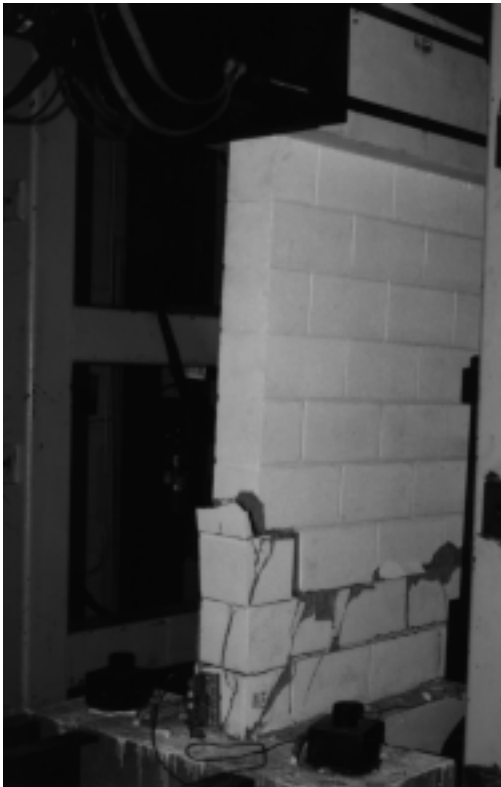
Figure 6. Wall 9 during testing

This wall behaved in a combination of rocking and sliding, as evidenced by the unsymmetric hysteresis loops of Fig. 12. The sliding developed in one direction, at an ultimate force of 64.5 kN, while the rigid-body rocking (with some small amount of sliding) developed in the other direction, at an ultimate force of -58.5 kN. The wall exhibited relatively large deformations with minor strength decay before failure. Rocking and sliding could only develop as a consequence of cracking along the bed joint. In this test, cracking did extend along the length of the wall, but, the path followed by the crack was unusual. Cracking did not occur at the base, nor at the first bed joint above the base, but in the bed joint above the second course of masonry, as indicated in Fig. 6. Another crack of a shorter length also appeared in the third bed joint above the base. After cracking, drift in both directions increased without any significant increase in lateral loading. Despite, the low strength of this wall, which indicates a certain strength deficiency, its sliding friction and rocking behavior noticeably dissipated energy.

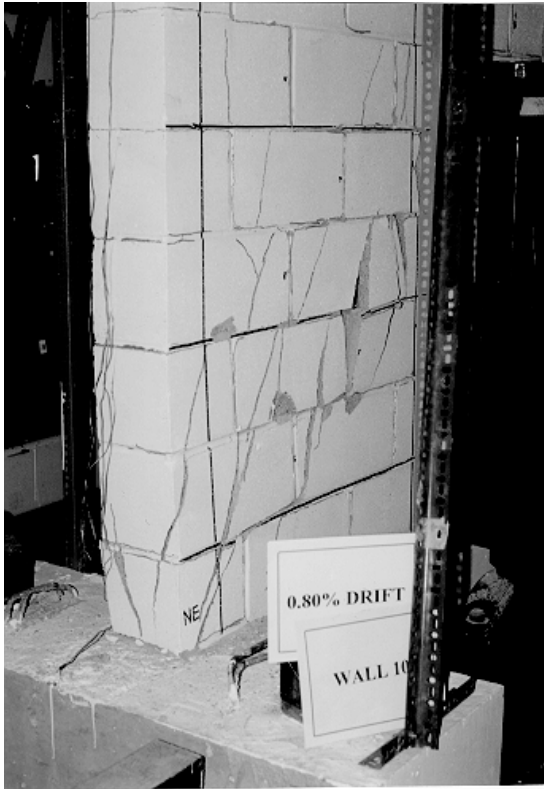
Figure 7. Wall 10: at 0.8% drift, diagonal crushing of masonry

Wall 10 exhibited symmetrical hysteretic force displacement relationship with relatively wide loops. This is shown in Fig. 12. However, it suffered shear failure, with progressive crushing of masonry diagonal struts (see Fig. 7), leading to early strength degradation and relatively low energy dissipation.

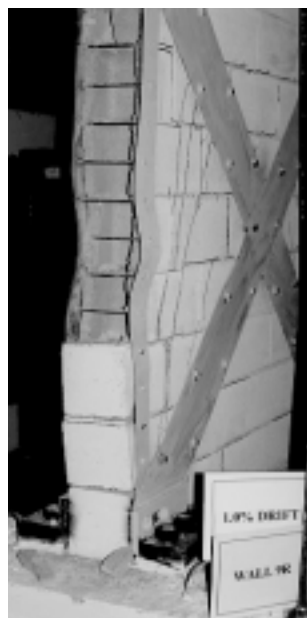
Fig. 10. Wall 9R: at the end of 1.0% drift, global buckling of vertical steel strips
