SEISMIC RESISTANCE OF FULL-SCALE SINGLE STORY BRICK MASONRY BUILDING SPECIMEN

Abstract

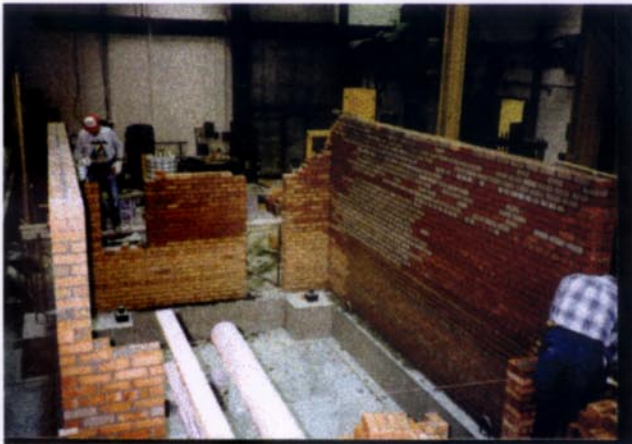
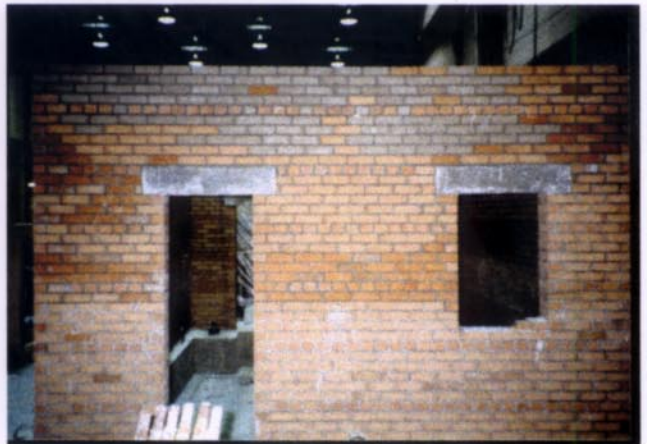
Figure 1: Full-scale URM specimen during (left) and after (right) construction.

The single-story full-scale unreinforced brick masonry building constructed for this experimental program is shown in Fig. 1. This rectangular shaped building was constructed with two wythes solid brick walls (collar joint filled) and type O mortar was used to replicate old construction methods and materials. The specimen has two load-bearing shear walls, each with two openings (a window and a door). Shear walls were designed such that all piers would successively develop a pier-rocking behavior during seismic response. This rigid-body mechanism is recognized by the UCBC to be a favorable stable failure mechanism. The specimen has a flexible diaphragm constructed with wood joists and covered with diagonal boards with a straight board overlay (Fig. 2). The diaphragm was anchored to the walls with through-wall bolts in accordance to the special procedure of the UCBC (Fig. 3). Material properties were obtained from simple component tests, such as a three-point flexural bending test (Fig. 4) of a small beam in order to determine the tensile strength of the mortar used.

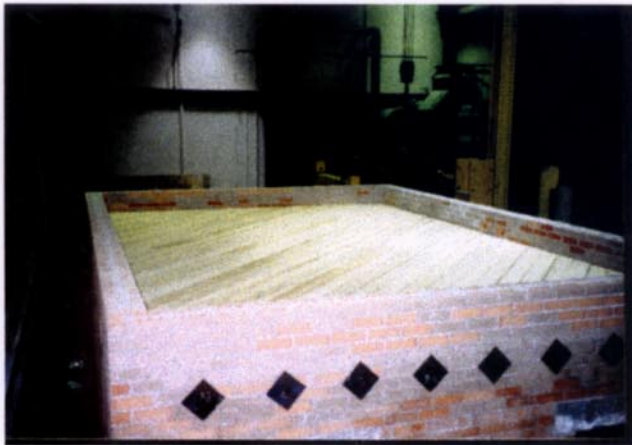
Figure 2: Anchored wood floor diaphragm

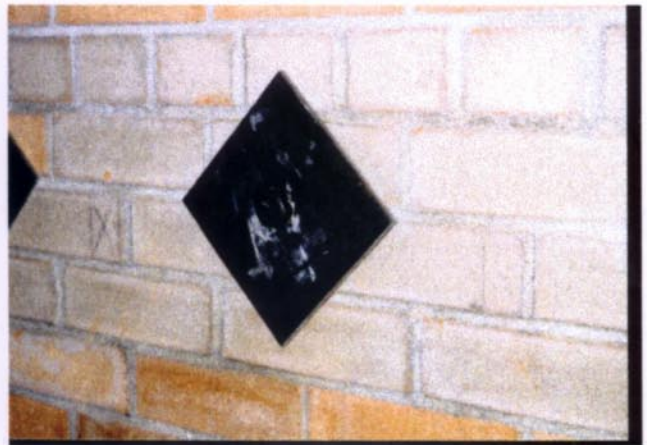
Figure 3: Typical anchor bolt and plate

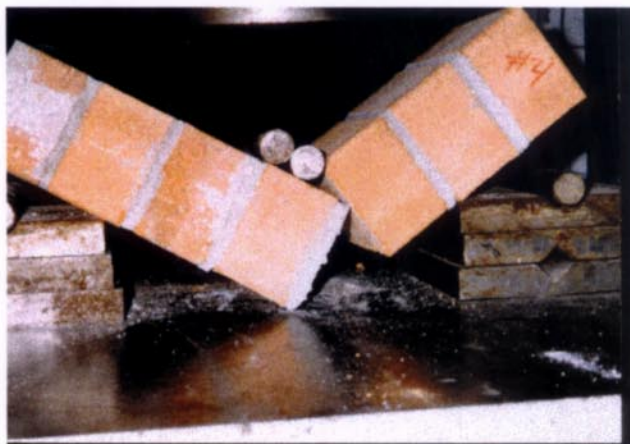
Figure 4: Three-point bending mortar tension-test

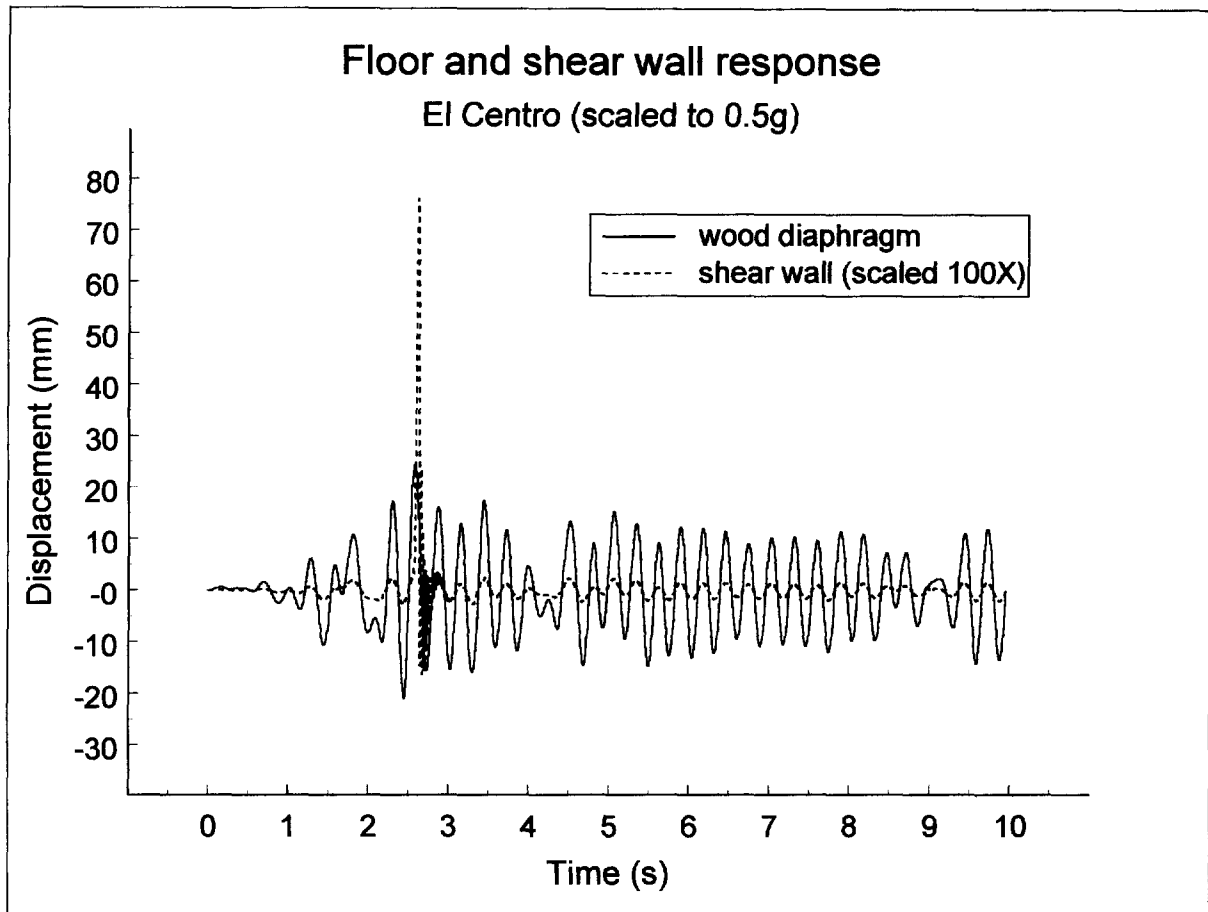
Figure 5: Comparison of wood diaphragm center-span response with magnified (100X) end-wall response

For a first series of analyses, elastic floor diaphragm response was considered. For the El Centro earthquake, the entire structure remained elastic until 0.5g, when first occurrence of inelastic rocking was observed. Displacement time histories of the floor diaphragm at mid-span is compared with that at the top of the shear wall in Fig. 5 (note that in Figs. 5 to 7, only approximately 10 seconds from the entire time-history response is plotted to better show the relative behavior of the structural elements of interest). The wood diaphragm, as expected being more flexible, dominate the response, with peak displacement of 24.5 mm versus 0.953 mm for the wall (response of the walls is magnified by 100 to make it visible on the same figure). The walls, with considerably higher frequency, are thus driven by the floor behavior, clearly vibrating in phase with them, as shown in Fig. 5. The only exception occurs at 2.62 seconds when rocking of the wall occurs. Upon return from its rocking excursion, the wall is seen to vibrate at its high natural frequency, but this motion damps itself rapidly as a consequence of that same high natural frequency (logarithmic decrement of peak amplitudes occurs over a

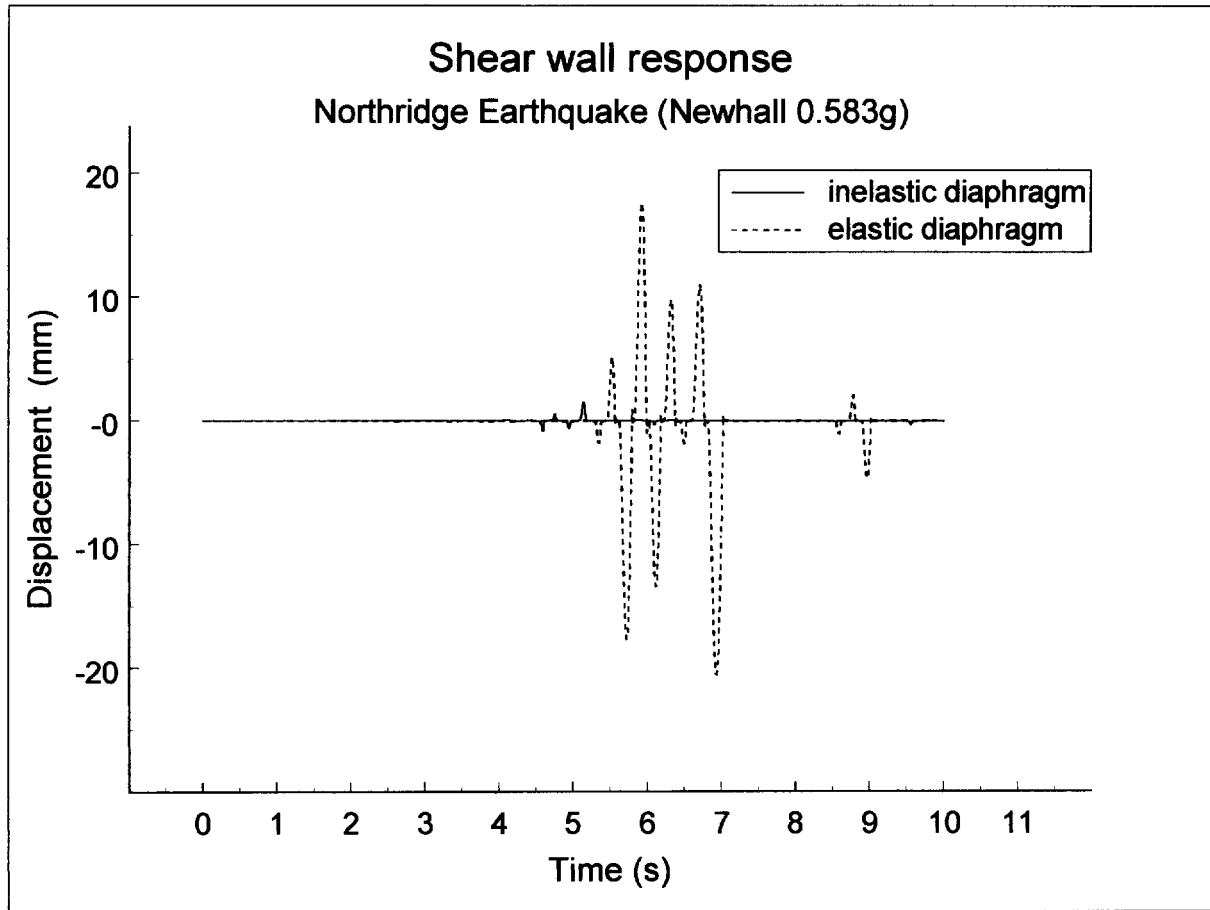
Figure 6: End-wall response considering elastic or inelastic wood floor diaphragms

Seismic response was then calculated considering inelastic response of the diaphragms. For this purpose, two types of wood floor diaphragms were considered: (a) 1" x 6" diagonal with 1"x6" straight sheathing overlay (having a shear strength of 29.8 kN/m); (b) 3/4" plywood with a second 3/4" plywood overlay (with a shear strength of 42.1 kN/m). Results are presented here

for the first floor type. As seen in Fig. 6, inelastic response of this rather weak diaphragm limits the force transmitted to the walls, to a magnitude below that needed to initiate significant pier rocking. A maximum wall displacement of 1.73 mm is observed, even though the peak diaphragm displacement (not shown here) remains 53 mm.

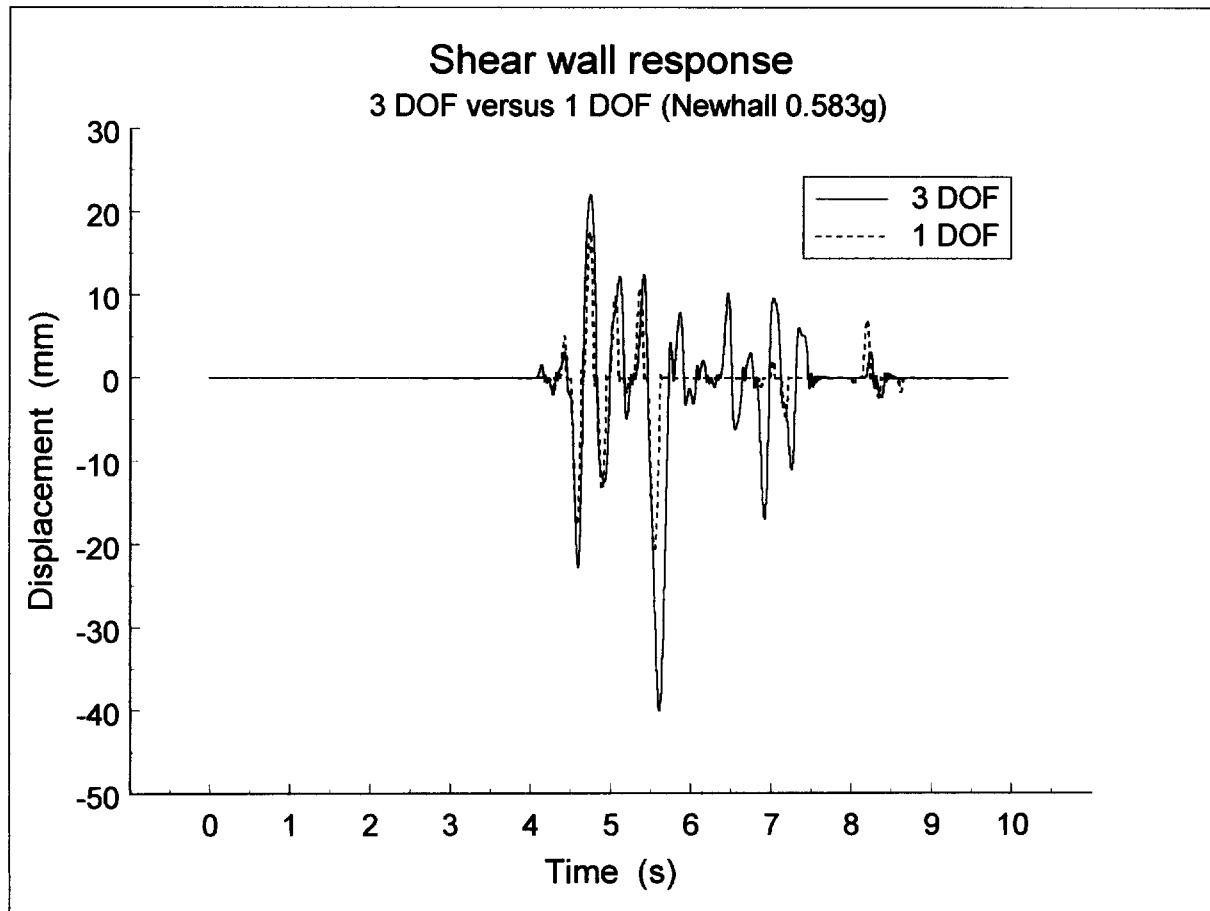
Figure 7: End-wall rocking response obtained considering 3 DOF or 1 DOF models

Although all analyses conducted to validate this concept and determine the effective tributary mass to consider are not shown here, results for the Newhall record are presented in Fig. 7. As shown in that figure, most of the instances and magnitudes of pier rocking that were observed using the 3 DOF analytical model are captured using the 1 DOF model. The high frequency wall vibrations that follow rocking, visible when using a 3 DOF model, are obviously missed by the 1 DOF model, but the previous discussion as well as Fig. 7 shows these to be of no significance. Given the supporting evidence from analytical studies, and the fact that using a single actuator results in a simpler test set-up, with considerable savings, the 1 DOF configuration is used in this testing program.
