Effect of Link-Beam Stiffener and Brace Flange Alignment on Inelastic Cyclic Behavior of Eccentrically Braced Frames

REZA IMANI and MICHEL BRUNEAU

ABSTRACT

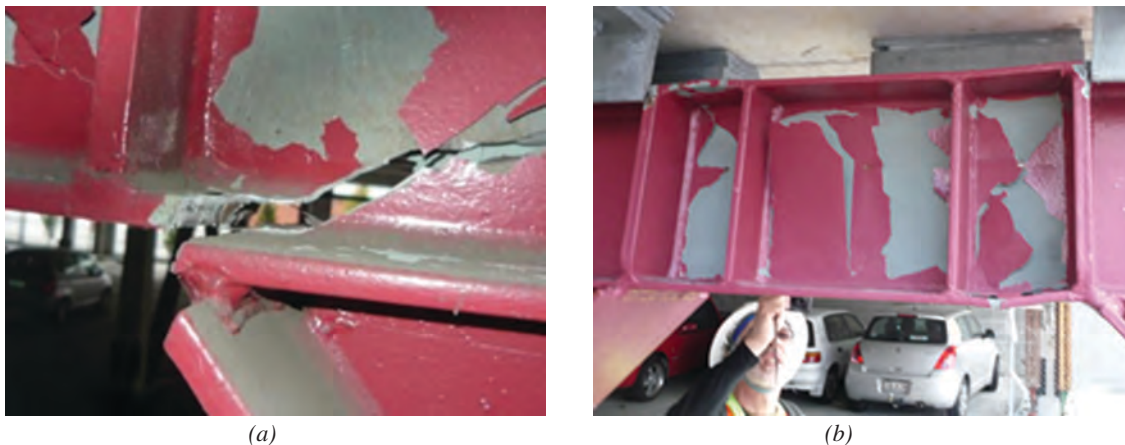
Although the fracture, shown in Figure 1a, didn't jeopardize the overall performance of the building and the structure survived on account of the redundancy of the system (at least 6 EBF frames existed at the story where the link failure was observed), it remains that this is an undesirable behavior that has raised questions regarding the design and detailing of EBF systems to ensure development of their expected capacity and ductility. Clifton et al. (2011) speculated that this failure was possibly caused by a local stress concentration due to an offset between the brace flange-to-beam connection point and the link end-stiffener. The AISC *Seismic Provisions* require the use of full depth stiffeners at both

A closer look at the details of the connection in Figure 1a reveals that the brace flange was connected to the beam with an offset from the edge of the link stiffener. As indicated above, it was speculated that this eccentricity might have caused stress concentrations in that location, leading to a premature fracture in the beam flange in the offset area between the link stiffener and the brace flange, which then continued into the web of the beam outside the link. However, there were other EBF frames in the same building, which did not have the mentioned offset in the brace-to-beam connection and that showed a significant amount of yielding in the link without any fractures. Figure 1b shows one such link located in an upper story of the same structure, in which the link stiffener and the brace flange were vertically aligned.

Fig. 1. Photos of EBFs taken inside a parking garage following the Christchurch earthquake of 2011 (Clifton et al., 2011): (a) fractured EBF (lower level); (b) evidence of plastic action without fracture (top level).

distribution contours in Figure 9 obtained from the static push-over analysis of EBF-1 with the link's bottom flange in compression. Contour line colors reveal that most of the plastic behavior is concentrated in the offset area with a limited yielding in the link (which is consistent with slight flaking of the paint seen in the link of the fractured EBF shown in Figure 1).

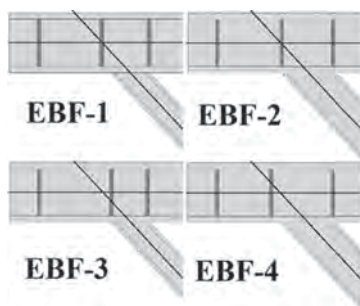
The work reported here expands on the prior work by assessing the effect of brace flange alignment and work-line eccentricity on behavior of the connection. Four detail geometries, shown in Figure 2, were arbitrarily selected in this study and investigated using finite element analysis when subjected to monotonic and cyclic displacements.

Case EBF-1 is similar to the configuration used in the reported fractured EBFs, in that the stiffener is placed at the intersection of the brace and beam centerlines but doesn't vertically line up with the edge of the brace flange. This

geometry is selected as a generic case of an EBF with a wide flange brace directly welded to the beam, with the specific misalignment conditions mentioned above, and does not represent the exact geometry of the EBFs fractured in Christchurch. Analysis of one of those actual fractured EBF links, based on as-built dimensions, is presented in the last section of this paper.

The piece of the beam's bottom flange that is located between the link end-stiffener and the point where the flange of the brace is welded to the beam is referred to as the offset area from this point on in this report. Case EBF-2 represents the ideal configuration in which the stiffener is at the intersection of the beam and brace centerlines and the brace flange connects to the beam under the vertical stiffener (achieved by using a deeper brace member than the one in the previous case). The third case, EBF-3, is similar to EBF-1, except that the link end-stiffener has been moved to align vertically with the point where the flange of the brace is welded to the beam (as a consequence, the work-line of the brace intersects that of the beam inside the link, which is described as permitted in the Commentary to AISC 341-10. The last case, EBF-4, combines the misalignment of case EBF-1 with the situation where the work-lines of the beam and brace intersect outside the link; this last case, while not permitted by the 2005 AISC *Seismic Provisions* (AISC 341-05) was accepted into the 2010 version (AISC 341-10) with the condition that the beam outside the link must be designed for the subsequent additional moments (AISC, 2005; 2010b). This case is investigated out of curiosity, to determine if the effect of brace flange misalignment is compounded when the stiffener is not at the intersection of the brace and beam centerlines.

Fig. 2. Detailing alternatives for brace-to-beam connection.

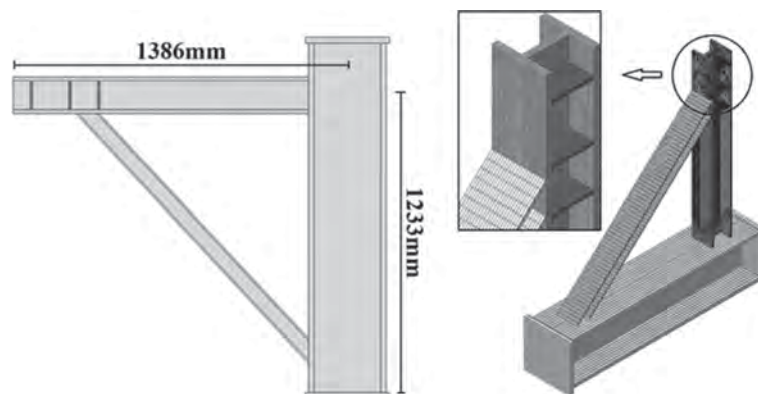
Fig. 3. Geometry and meshing of the finite element model.

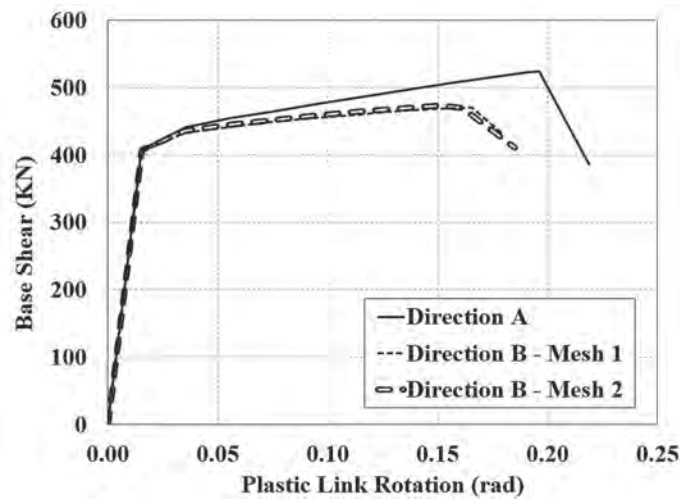
Figure 4 shows the graphs of base shear versus plastic link rotation for EBF-1 under monotonic applied displacements in two opposite directions. Both of the curves show significant strength loss at plastic link rotation values in the range 0.15 to 0.2 rad, which is expected for properly stiffened EBF frames. To distinguish the two opposite directions of applied displacements for push-over analyses, note that applying displacement in direction A causes tensile forces in the link bottom flange and applying displacement in direction B causes compression in the link bottom flange.

Results in Figure 4 show that EBF-1 loses strength at a relatively smaller plastic link rotation when monotonic loading is applied in the direction B. Loading in directions A and B creates positive and negative bending moments in the link, respectively. Significant loss of strength shows that a number of elements have surpassed the 15% strain limit (the onset of strength reduction) and are on the descending

Fig. 4. Push-over analysis results for EBF-1 half frame under monotonic displacements in two opposite directions (plastic link rotation at the onset of base shear loss = 0.196 rad for case A and 0.161 rad for case B).

model reaches a point where their von Mises stress is equal to the maximum stress defined at the end of the strain hardening branch of the material's behavior (the stress of 444.5 MPa corresponding to the strain of 15% for the problem at hand). Any fraction of added plastic strain from this point on takes the elements into the stress declining branch, leading to strength reductions and element distortions seen in Figures 4 and 5.

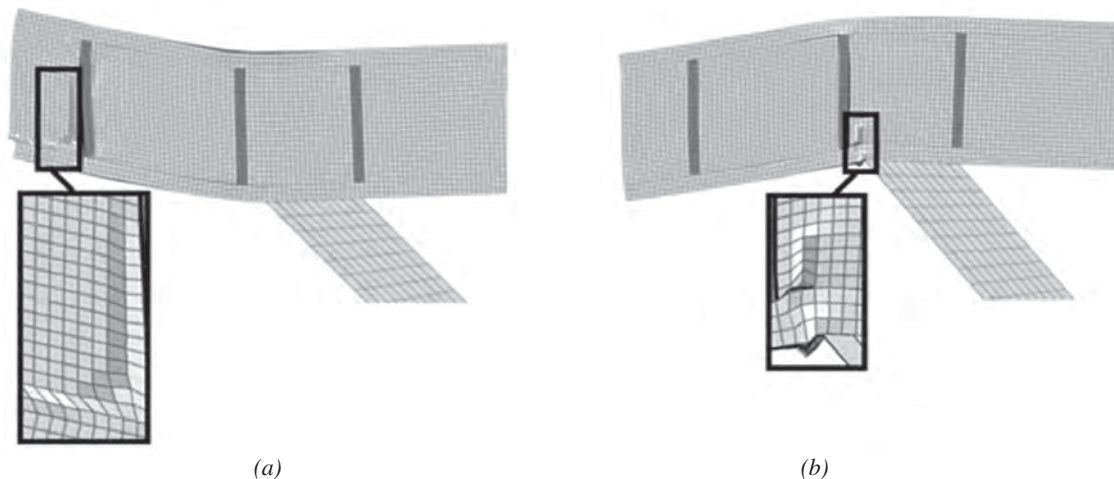
branch of the stress-strain material model. To further investigate the differences between the location and strain response of the critical elements that cause the strength loss of EBF-1 under oppositely applied push-over loads, strain distribution and deformation plots were extracted from the ABAQUS analysis results for the two cases. Figure 5 shows the final deformed shapes of the EBF-1 half frame for both loading directions. Case A shows excessive deformations and element distortions in the web of the link close to one of the intermediate stiffeners leading to the strength loss of the structure. This type of behavior can be expected of EBF frames because the plastic action is intended to happen mostly in the link. On the other hand, case B shows excessive distortions for a different group of elements that

are located in the offset area, which can be considered as a sign of improper behavior based on the design objective of EBF systems.

Fig. 5. Final deformation results from push-over analysis of EBF-1 in two opposite directions: (a) loading in direction A; (b) loading in direction B (plastic link rotation at the onset of base shear loss is 0.196 rad for case A and 0.161 rad for case B).

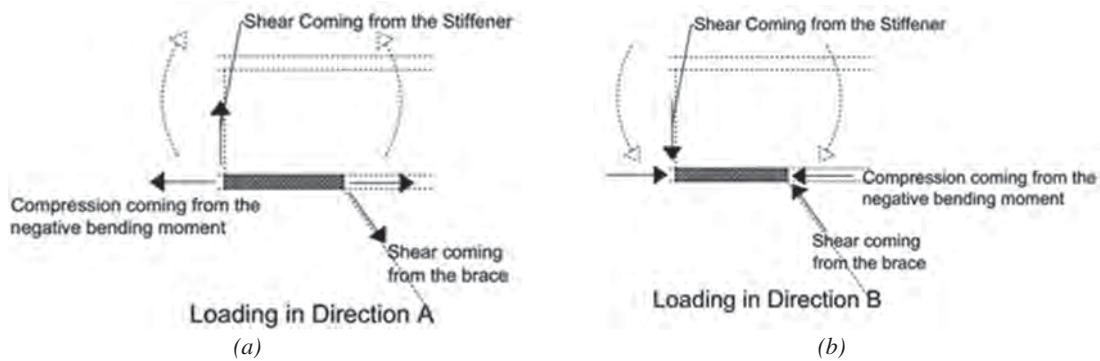
The difference in the mechanisms leading to strength loss under loading from two opposite directions is due to the different stress and strain distribution that occurs in the offset area for the two cases. The relatively small piece of beam flange that is located between the link stiffener and the edge of the brace flange is under combined axial and shear forces that are applied in opposite directions for cases A and B (Figure 6). The onset of base shear loss seen in Figure 4 for cases A and B is when, having reached the von Mises yield surface and progressed to larger equivalent plastic strain values, the state of 3D stress in a number of elements in the

Fig. 6. Loads applied to the segment of the beam flange located at the offset: (a) loading in direction A; (b) loading in direction B.

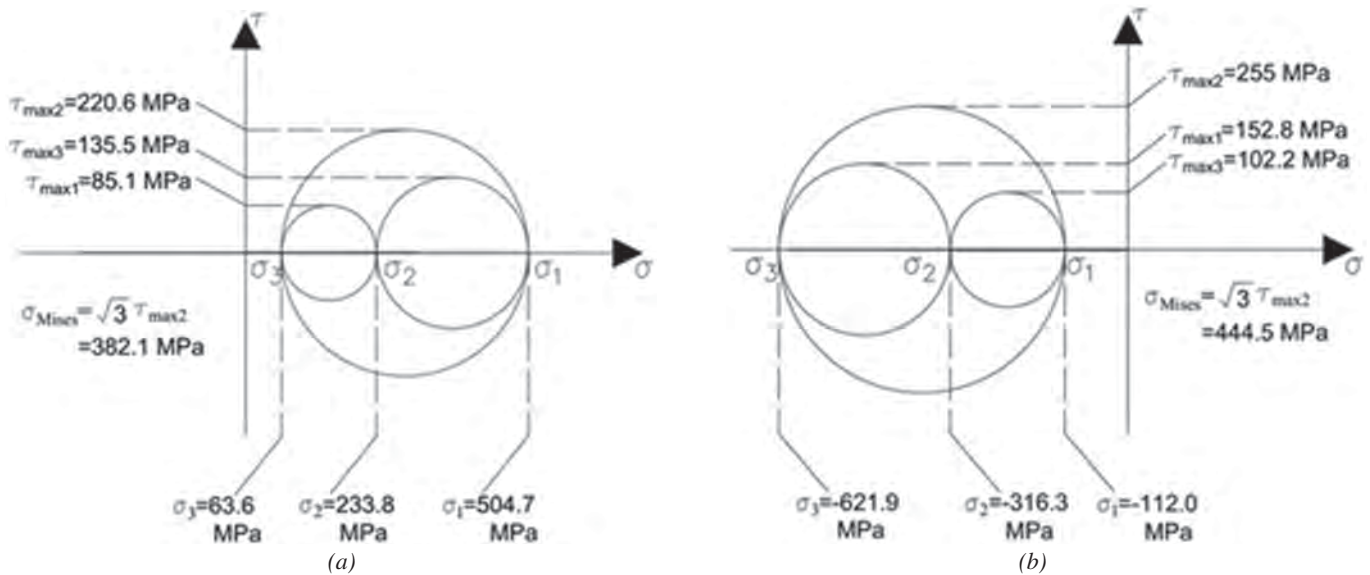
Cases A and B reach this limit at different plastic link rotation values and, more importantly for the purposes of this study, for elements located in different parts of the EBF model. Figure 7 shows Mohr's diagrams for the 3D state of stress at the offset area for cases A and B. Stresses were calculated based on average values for 342 elements located

in the offset area at the onset of base shear loss. The figure shows that for case A, von Mises stress of the elements in the offset area have not reached the set maximum stress limit, and the drop in base shear was caused by the failure of a group of elements in the web of the link, as shown in Figure 5a. This is a preferred failure mode, as it allows development of yielding over the entire EBF link, prior to ultimately reaching strength degradation. For case B, on the other hand, the von Mises stress of the elements located in the offset area reached the set maximum stress limit, leading to a maximum shear stress on one of the principal planes equal to the corresponding maximum shear strength limit of the material ($\cong 0.57 \times 444.5 \cong 255$ MPa). Analogous to slip planes for yielding, attainment of the set shear strength limit

Fig. 7. Mohr's circle for 3D state of stress for elements in the offset area: (a) push-over loading in direction A; (b) push-over loading in direction B.

can be attributed to causing the possible onset of subsequent fracture. This assessment of stress conditions confirms that the failure of case B will start in the offset area.

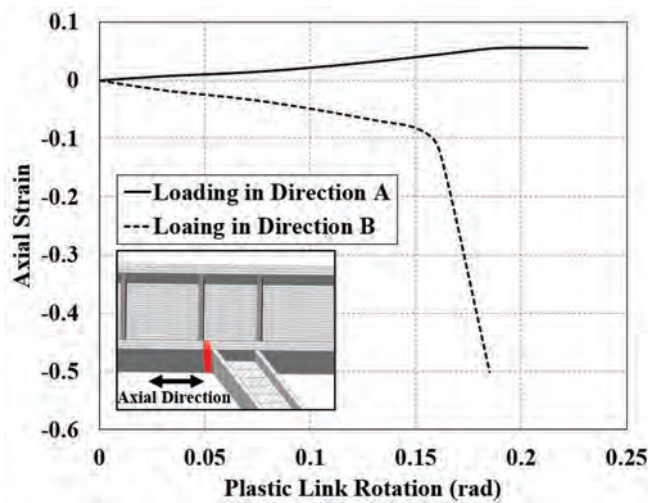
Fig. 8. Average axial strain values for a selected group of elements at the offset area from the push-over analysis of EBF-1 under loading in two opposite directions.

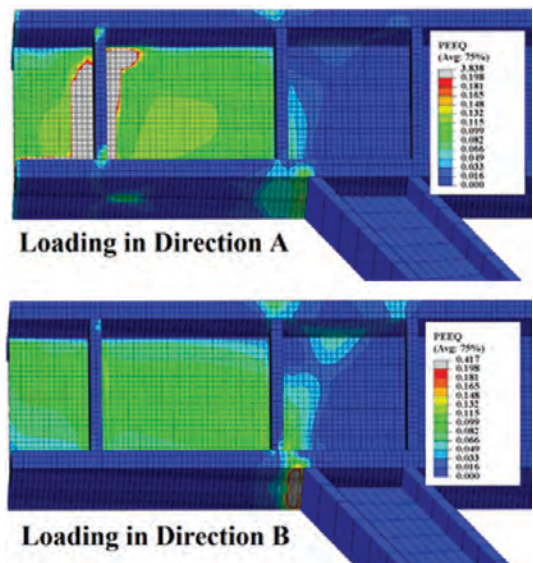
Figure 9 shows the distribution of equivalent plastic strain for EBF-1 under monotonic loading in two opposite directions. The contours are plotted on the undeformed shapes to get a clearer picture of the equivalent plastic strain distribution. Locations with $\bar{\epsilon}_0^{pl}$ values above 19.8% (areas shaded in gray) can be considered as those having exceeded the fracture initiation points. Results show that the elements reaching the fracture plastic strain limits are located at the web of the link for the frame loaded in direction A and at the offset area for the frame loaded in direction B (as indicated previously, in Figure 5). The color contours for EBF-1 loaded in direction B suggest that a fracture may initiate in the beam flange and propagate further into the beam outside the link, following a pattern that resemble the one reported for the EBF damaged during the Christchurch 2011 earthquake.

Fig. 9. Equivalent plastic strain distribution for EBF-1 under monotonic loading in two opposite directions (plastic link rotation at the onset of base shear loss is 0.196 rad for case A and 0.161 rad for case B).

Comparison of results in Figures 9 and 10 highlights the possible impact on behavior caused by slight differences in the detailing of the brace-to-beam connection, and how location of the link stiffener with respect to these two members can affect the ultimate inelastic behavior of the EBF frame. Under similar push-over analysis conditions, EBF-2 developed a maximum plastic link rotation of 0.27 rad and all significant plastic behavior concentrated in the link, whereas EBF-1 lost resistance at the significantly smaller plastic link rotation of 0.16 rad and developed substantial plastic behavior in the offset area (average stress values reached the maximum defined value).

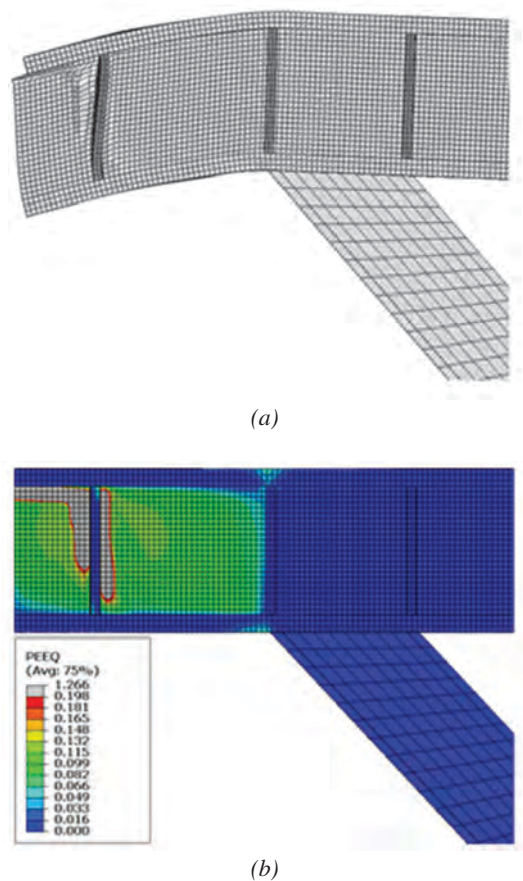
Figure 10 shows the final deformed shape of EBF-2 after the occurrence of excessive distortions, along with the equivalent plastic strain distribution for the elements plotted on the undeformed shape of the frame. Results show that, when subjected to a push-over loading conditions similarly to case B discussed above for EBF-1, the average von Mises stress values for the elements in the beam to brace flange connection point (close to the link stiffener), did not reach the maximum stress limit (and onset of strength loss) until

Fig. 10. Results from push-over analysis of EBF-2 with bottom flange of the link in compression after occurrence of excessive element distortions: (a) final deformed shape; (b) distribution of equivalent plastic strains on all elements (plastic link rotation at the onset of base shear loss = 0.27 rad).

the frame started to lose base shear strength because a number of elements located in the web of the link reached the maximum stress limit at the plastic link rotation of 0.27 rad, which is significantly larger than the onset of base shear strength loss for EBF-1 (i.e., 0.161 rad for case B). Thus, results show that proper alignment of the brace flange with the link stiffener (which was located at the intersection of the beam and brace centerlines) transferred the plastic action into the link, preventing the occurrence of yielding (and subsequently reaching the maximum stress level) in the brace-to-beam connection area.

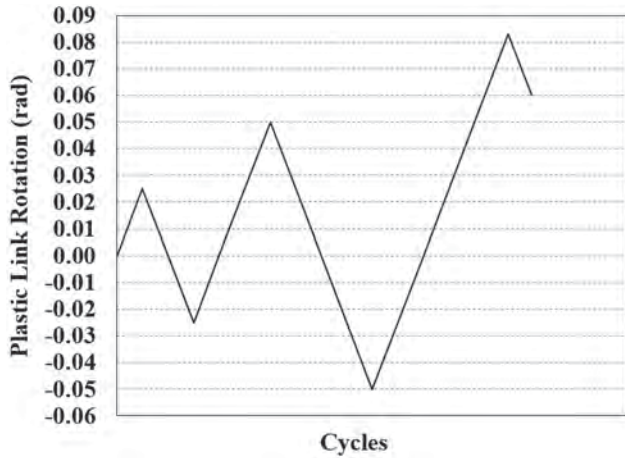
Cyclic lateral displacements were applied to all models to create the plastic link rotation cycles shown in Figure 11. The arbitrarily selected displacement protocol consists of inelastic cycles creating different amplitudes of plastic link rotation of the EBF frames. Starting with a plastic rotation of 0.025 rad, it increases in two steps up to 0.08 rad and stops at rotation of 0.06 rad during the final unloading segment. Actual maximum plastic link rotation was slightly above or below the 0.08 rad limit for some of the models considered because the link's geometry was changed slightly for the different models, but the same lateral displacements were applied to all models. As mentioned before, because low-cycle fatigue issues were not considered in this study, and for computational expediency, just a few inelastic

Fig. 11. Cyclic lateral loading protocol applied to the models.

cycles were applied to the structure to create imperfections, avoiding replicating the type of cyclic displacement protocols typically done in experimental studies (as this would have required substantially longer computational time). The arbitrarily chosen maximum equivalent plastic strain limit of 19.8% (used for push-over analysis) was kept as the limit for the cumulative plastic strain in the cyclic analyses. This limit was chosen to provide a uniform basis of comparison for all models while limiting analysis to a small number of cycles (for computational expediency), recognizing that a significantly higher limit would have to be used if the models were analyzed under the full AISC loading protocol to consider the qualification of EBFs (which is not necessary here, for the purpose of the current study).

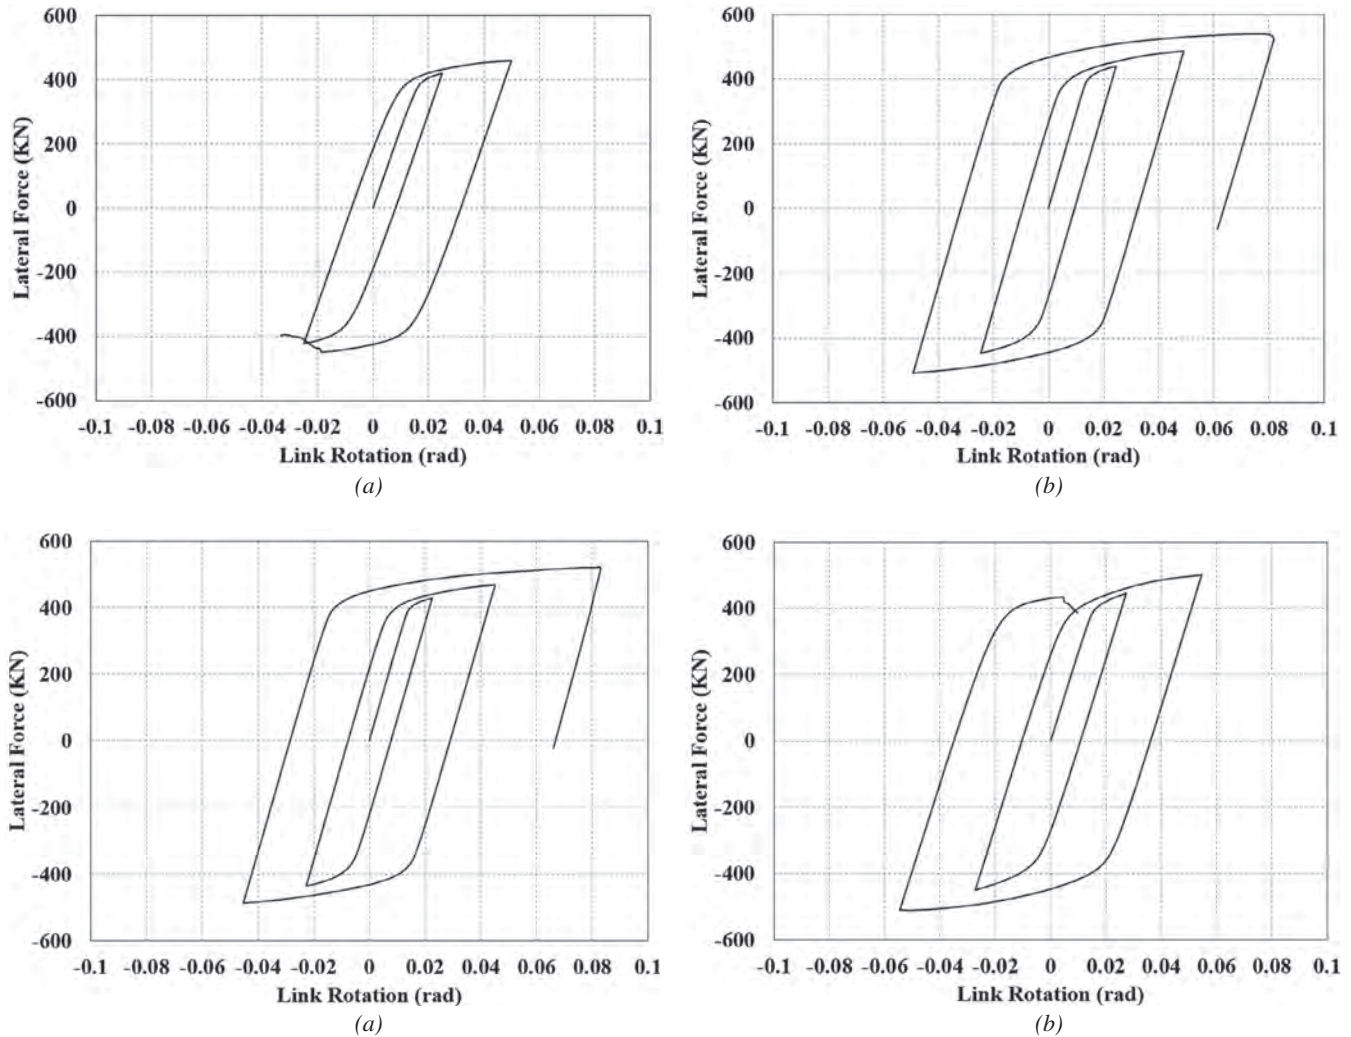
Figure 12 shows the resulting base shear versus plastic link rotation values from cyclic analyses for all four models.

Fig. 12. Base shear versus plastic link rotation results from cyclic analyses: (a) EBF-1; (b) EBF-2; (c) EBF-3; (d) EBF-4.

Analysis of model EBF-1 terminated due to high compressive strains and element distortions in the offset area, similarly to what was observed in the push-over analysis but at a relatively smaller plastic link rotation value (0.03 rad for cyclic analysis as opposed to 0.16 rad for the monotonic one). The difference is due to the fact that equivalent plastic strain for the elements in the offset area reaches the defined maximum limit (19.8%) much sooner in the cyclic analysis because of the accumulation of plastic strain during the cycles. Because plastic action is concentrated in the offset area rather than being distributed in the whole link, the accumulated plastic strain values reach the maximum limit in a few cycles.

EBF-2 exceeded the plastic link rotation of 0.08 rad without problem, showing the effectiveness of the adjustment made to the connection. The removal of the offset has transferred the plastic action into the link, preventing the elements at the connection point from reaching the maximum limit of the equivalent plastic strain. Interestingly, EBF-3 also exceeded the 0.08 rad plastic link rotation, which supports the AISC 341-10 recommendation, provided that the link stiffener lines up with the point where the brace's flange connects to the beam flange. This result shows that if the geometry of EBF-2 cannot be accomplished (due to limits in available brace depths), satisfactory ductile behavior of the frame can still be ensured by locating the stiffener such as to eliminate the stiffener-to-brace flange offset.

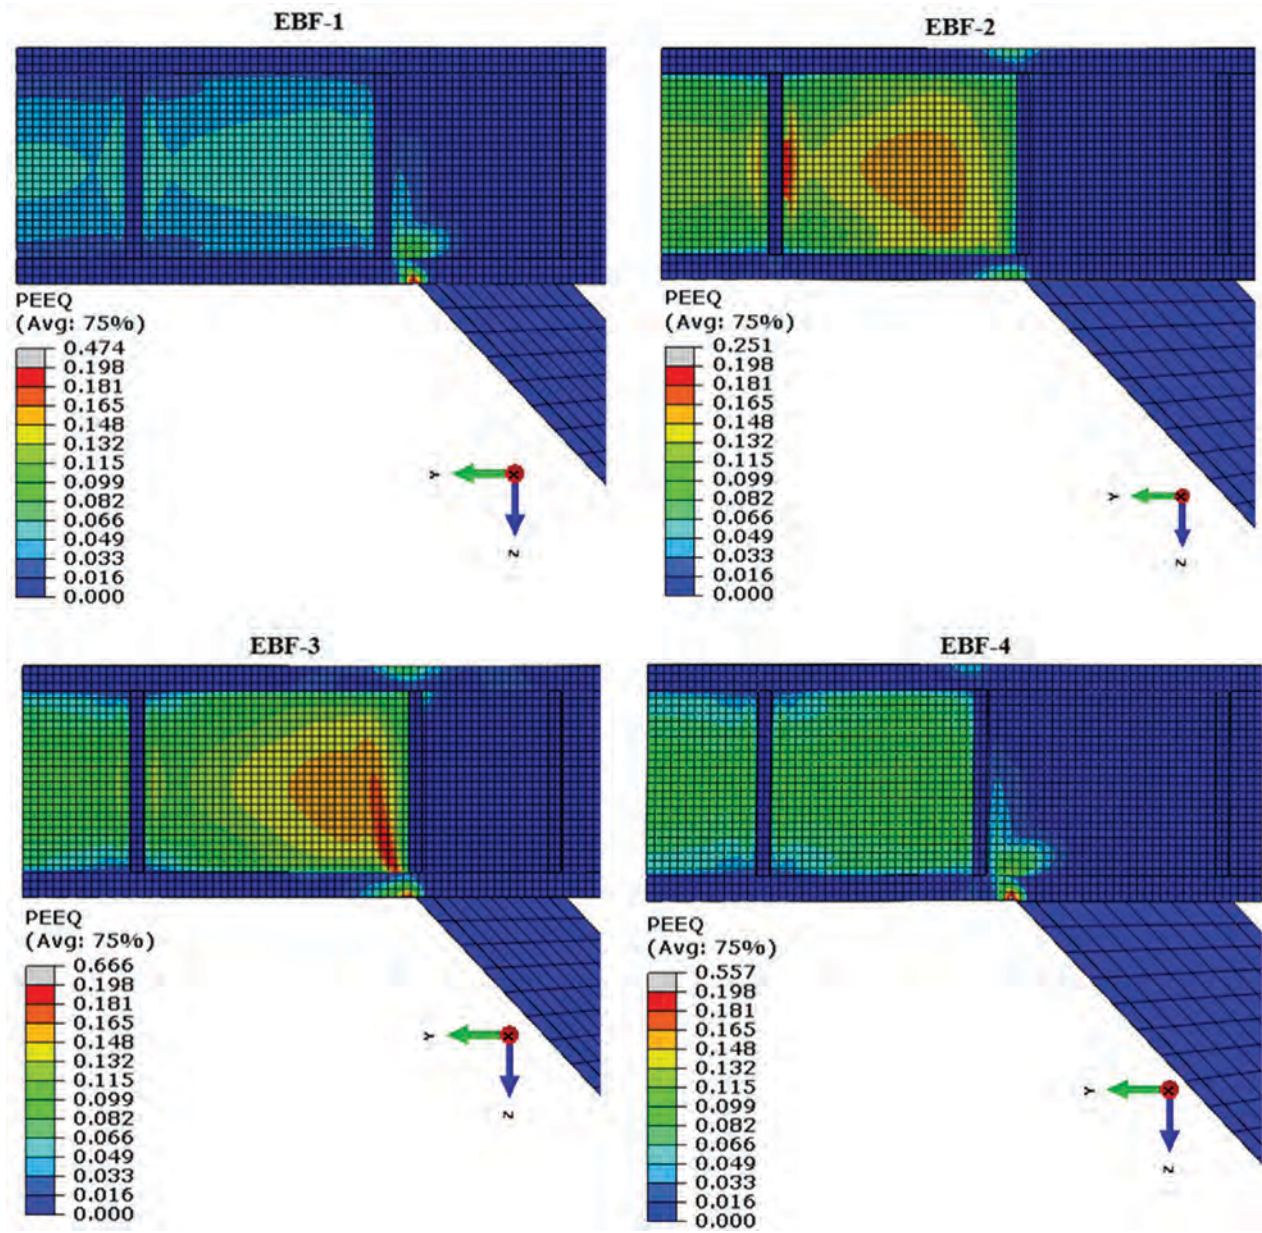
The orientation of the equivalent plastic strain contour lines in Figure 13 suggests (in ideal conditions) probable failure patterns that may occur once strains have reached extreme values. However, it is recognized that the ultimate

The plots in Figure 13 show that models EBF-1 and EBF-4 will have a failure at the offset between the link stiffener and the brace flange similar to what was seen following the Christchurch earthquake series. The stress contours reveal that the elements of the link for EBF-4 have equivalent plastic strain values in the range of 0.10 to 0.13 rad, which is considerably higher than the values for the link elements of EBF-1 (0.02 to 0.06 rad). The difference shows the more effective distribution of plastic action in the link of EBF-4 as the main reason for its better performance with respect to EBF-1. It should be mentioned that a closer look at the arbitrarily selected geometry of EBF-4 (Figure 2) reveals that the intersection of beam and brace centerlines (located outside the link) almost lines up vertically with the brace flange to beam connection point, although the stiffener is moved away to create the offset. This might be one possible reason for the EBF-4's being more effective in transferring the plastic action toward the link, as compared to EBF-1. Note that this is just a suggested interpretation of the simulation results and that, at any rate, a detailing similar to EBF-4 is unlikely to occur in real cases.

Model EBF-2 has experienced its maximum equivalent plastic strain value in the web of the link close to the intermediate stiffener. The contour colors show that if the applied displacement protocol was extended to continue the analysis, the first group of elements surpassing the fracture plastic strain limit would be located in the same area as expected of EBF systems. EBF-3 shows an acceptable ductile behavior by transferring the plastic action to the link and surviving during the applied displacement protocol. Although EBF-3 seems like an easier solution to implement than EBF-2 to eliminate the offset problem, the orientation of the contour lines and their colors, which are plotted at the same stage of analysis for both models (i.e., at the end of the displacement protocol, when plastic link rotation have reached 0.06 rad), show the possibility of a more premature failure for EBF-3 compared to the ideal case EBF-2. Figure 13 suggests that the possible fracture of EBF-3 may start in the link flange, close to its meeting point with the brace flange, and progress in a path toward the intersection of the link and brace centerlines. It appears that although moving the stiffener to line up with the brace flange has eliminated the offset for EBF-3 leading to an acceptable behavior, it may still ultimately fail by a fracture starting in the link flange (rather than in the web of the link) if higher displacement amplitudes are applied. Considering the plots of Figure 13 altogether, EBF-2 shows the best behavior among the four alternatives.

Fig. 13. Distribution of equivalent plastic strain values for all four models close to their failure under cyclic loading.

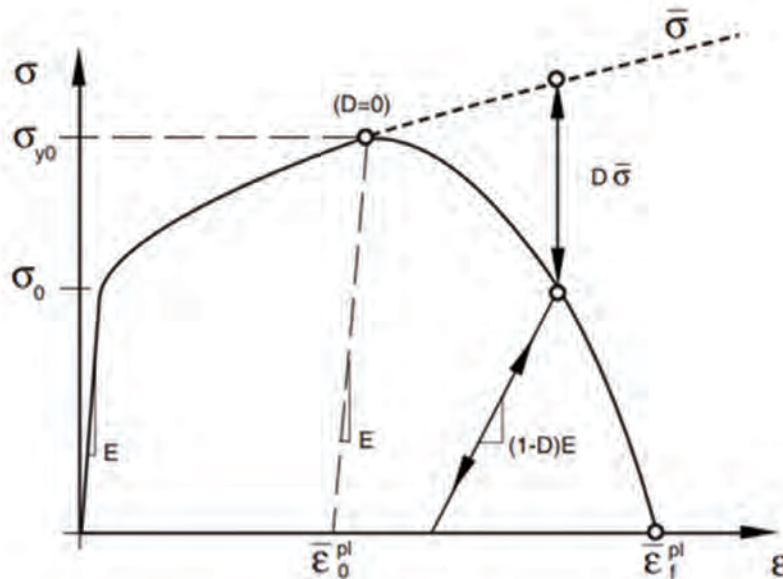
The damage evolution capability in this model works by progressive degradation of material stiffness leading to its failure. The model is based on mesh-independent measures, including plastic displacements and energy dissipation, to simulate the damage evolution of the material after the damage initiation. Figure 14 shows the stress-strain curve for a material with progressive damage degradation, where $\sigma_{y0}, \bar{\epsilon}_0^{pl}$ are the yield stress and equivalent plastic strain at the onset of the damage and $\bar{\epsilon}_f^{pl}$ is the equivalent plastic strain at failure when the overall damage variable reaches its maximum value ($D = 1$).

Because the value of $\bar{\epsilon}_f^{pl}$ depends on the characteristic length of the element, L , which is a mesh dependent parameter, the damage evolution law is either based on the equivalent plastic displacement, \bar{u}^{pl} , or fracture energy dissipation, G_f .

Fig. 14. Stress-strain curve for material with progressive damage degradation (Simulia, 2012).

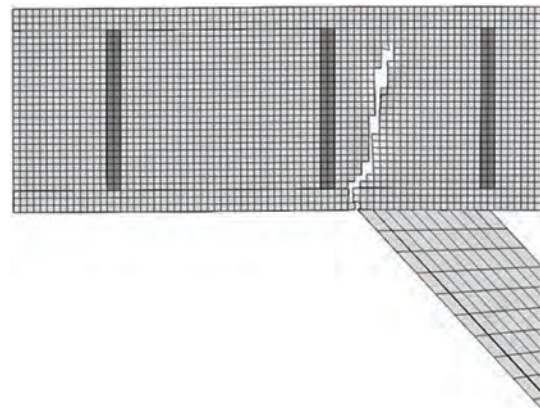
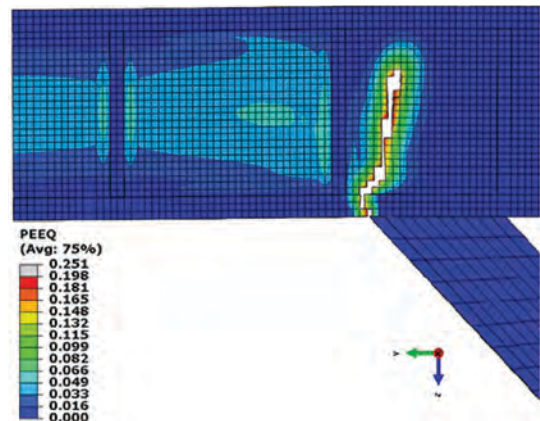
Figure 15 shows plots of the resulting simulated fracture in the EBF-1 model with and without the equivalent plastic strain contour lines. The simulated fracture initiated at almost the same location as the one reported from the Christchurch earthquake (Figure 1a) and progressed into the web of the beam outside the link. However, due to the mesh dependency of the fracture growth path and the fact the simulated fracture growth could only occur along the element edges, the simulated fracture progresses in a relatively more vertical path compared to the one occurred in the Christchurch earthquake. The problems of mesh size and mesh orientation sensitivity for fracture simulation can be resolved by using an adaptive mesh refinement strategy, where the new topology around the crack tip goes through mesh refinement for the next step of the analysis (similar to the study mentioned above by Roy and Dodds). However, using such computational techniques was beyond the scope of this study. Note that the fracture also follows a path similar to what was predicted from the equivalent plastic strain

Fig. 15. Simulated fracture at the offset between the link stiffener and the brace flange of EBF-1 (with and without the equivalent plastic strain contour lines).

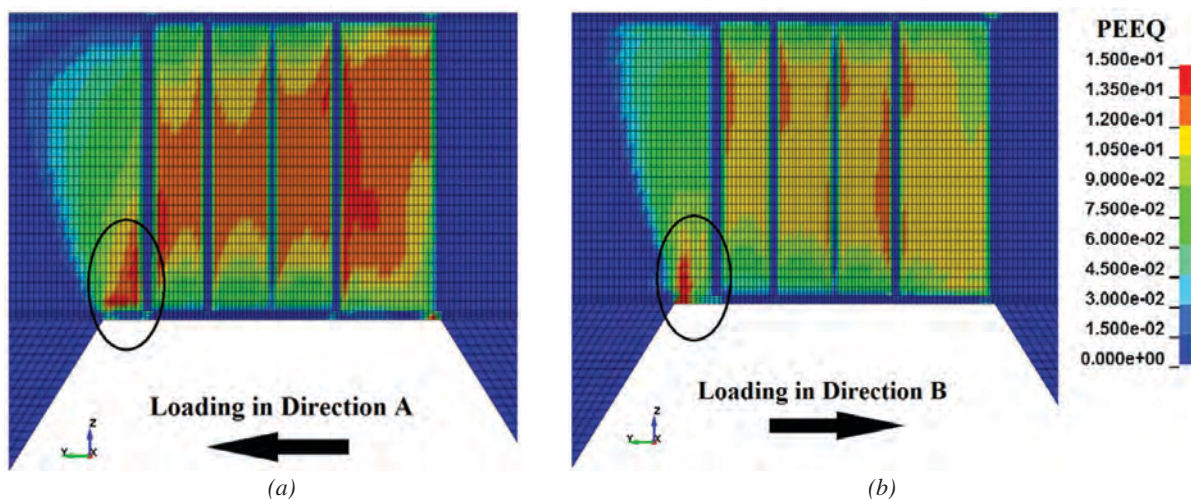
to have fractured during the Christchurch earthquake series. This model is referred to as EBF-5 from this point on in this paper. The dimensions of the members (i.e., 460UB67 and 250UC73 sections for the beam and brace) were adopted from a recent study on these fractures (Marshall, 2013) and the model was built as a complete frame to account for the fact the offset was only observed on one side of the fractured frame. Push-over analyses were conducted in two opposite directions and the results of equivalent plastic strain distribution at the onset of base shear loss is shown in Figure 16.

Figure 16a shows that for push-over loading in direction A (i.e., offset area in compression), considerable plastic action has occurred in the link, while the flange of the beam in the offset area remains well below the 15% equivalent plastic strain limit; in other words, no strength loss has occurred for the elements of the beam flange in the offset area when the elements in the link reached the onset of strength loss. Loading in direction B (i.e., offset area in tension), on the other hand, has caused a significant plastic strain concentration in the elements of the beam flange in the offset area, which can be considered as a possible premature fracture initiation point (Figure 16b). Note that this situation is somewhat different than what had been observed previously for push-over of EBF-1 (discussed above), as the critical stresses in the offset occur in tension rather than compression. The difference is due to the fact that EBF-5 has a much thinner and more flexible beam flange, and most of the compression load, when the frame is pushed in direction A, is sustained by the web of the beam. Note that no such strain concentration occurred on the right side of the link where brace flange aligned with the link end stiffener.

Even though loading in direction B has the more critical equivalent plastic strain distribution, the offset area can also be considered to cause problems for the frame when loading is applied in direction A. Overall, the behavior of EBF-5 under push-over loading underscored the possibility of the occurrence of premature EBF fractures due to the stress and strain concentrations in the offset area.

Fig. 16. Distribution of equivalent plastic strains at the onset of base shear loss for EBF-5 subjected to push-over loading in (a) direction A (plastic link rotation = 0.23 rad); (b) direction B (plastic link rotation = 0.18 rad).
