STATE-OF-THE-ART REPORT ON SEISMIC PERFORMANCE OF UNREINFORCED MASONRY BUILDINGS

By Michel Bruneau,¹ Member, ASCE

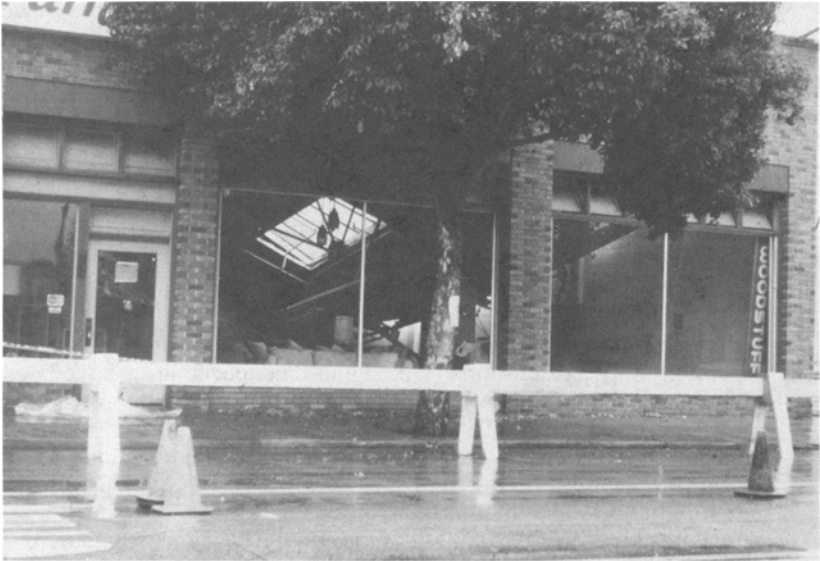
FIG. 1. Typical Failure due to Slip of Roof Joists off Their Wall Supports (Santa Cruz, Loma Prieta Earthquake)

In the absence of positive anchorage, the exterior walls behave as cantilevers over the total building height. The risk of wall out-of-plane failure due to excessive flexural stresses at the base of the wall obviously increases with its height, but, more importantly, global structural failure can occur by the slippage of the joists and beams from their supports (Fig. 1).

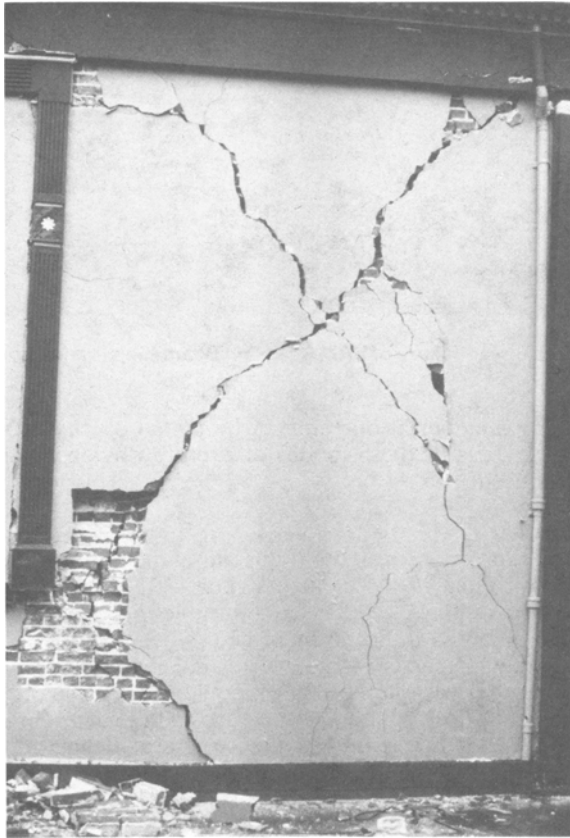
FIG. 2. In-Plane Shear Failure of URM Masonry Wall (Santa Cruz, Loma Prieta Earthquake)

Excessive bending or shear may produce in-plane failures, depending on the aspect ratios of the URM elements. For URM walls, shear in-plane failures are more common, as expressed by double-diagonal (X) shear cracking (Fig. 2). Fortunately, until the shear cracks become unduly severe, the gravity-load carrying capacity of the walls is not jeopardized.

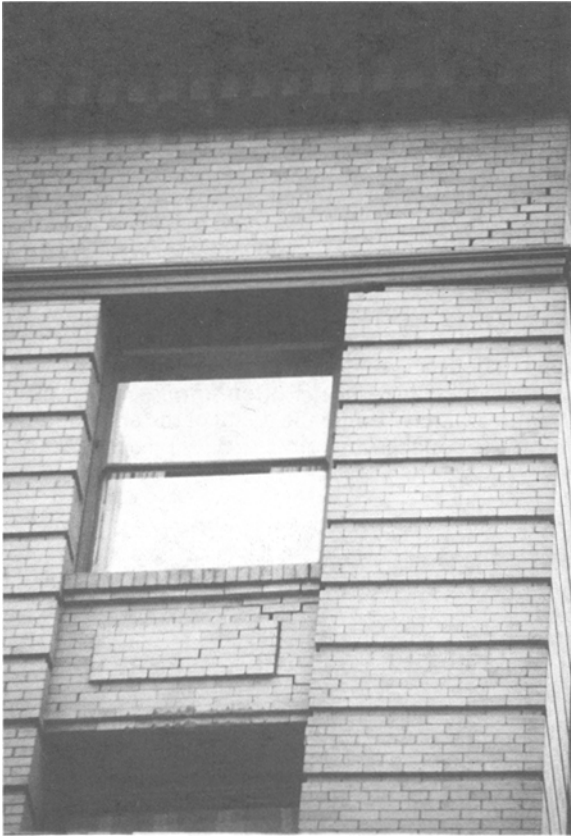
FIG. 3. In-Plane Shear Failure of URM Spandrel Beam (San Francisco, Loma Prieta Earthquake)

In masonry facades with numerous window openings, spandrels and the short piers between those spandrels may also fail in shear (Figs. 3 and 4). Usually the failure of one modifies the structural behavior significantly enough to preclude that of the other. Flexural failure of those structural elements is also possible, particularly for slender URM columns (Fig. 5); the resulting cracking at both ends of a URM element transforms it into a rigid body of no further lateral-load resisting capacity, unless gravity forces can provide a stabilizing effect.

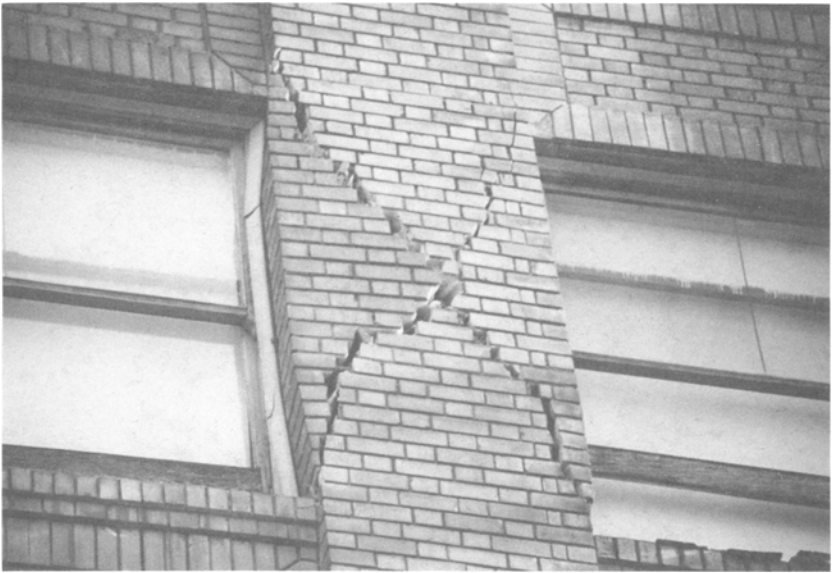
FIG. 4. In-Plane Shear Failure of URM Pier (Oakland, Loma Prieta Earthquake)

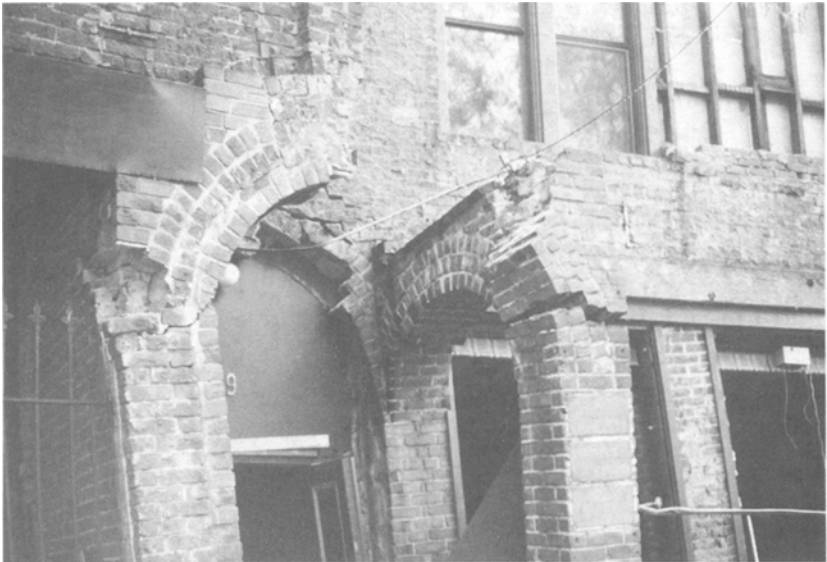
FIG. 5. Flexural Failure of Slender URM Column (Los Gatos, Loma Prieta Earthquake)

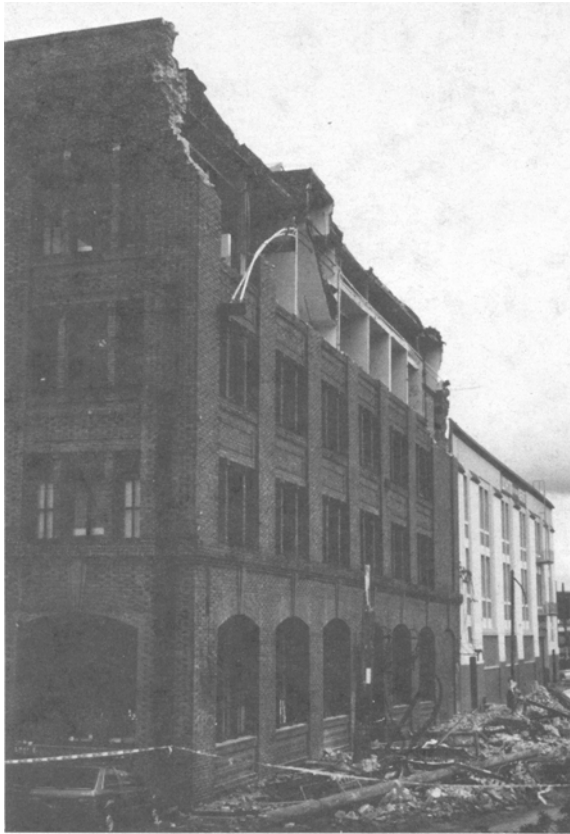
FIG. 6. Out-of-Plane Failure of URM Top-Story Wall (San Francisco, Loma Prieta Earthquake)

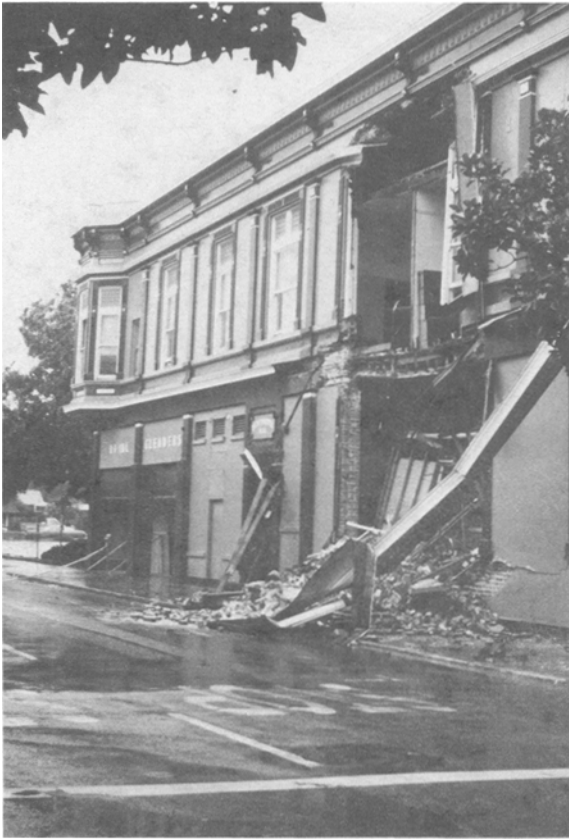
FIG. 7. Out-of-Plane Failure of URM Wall at Center of Building due to Excessive Diaphragm Flexibility (Santa Cruz, Loma Prieta Earthquake)

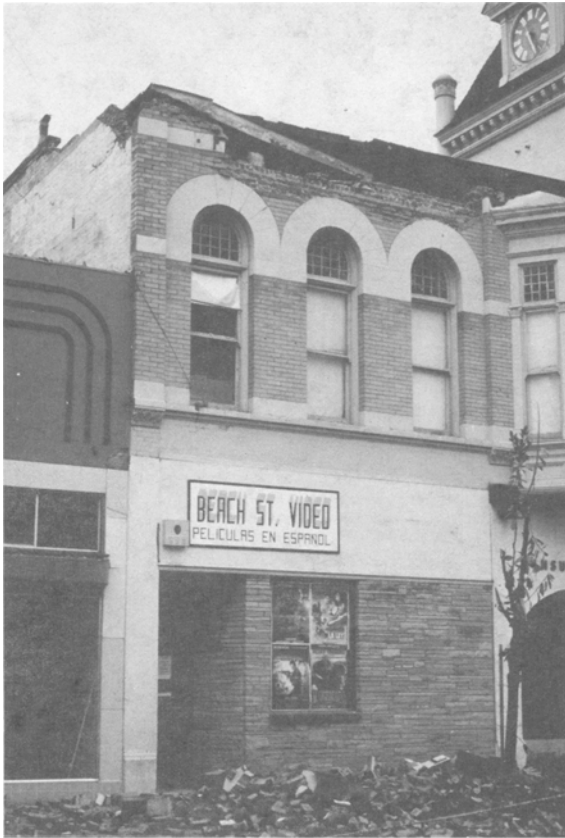
FIG. 8. Parapet Failure of 100 Front Street Building (Watsonville, Loma Prieta Earthquake)

Parapet failures fall in this category (Fig. 8). These nonstructural URM elements behave, if unrestrained, as cantilever walls extending beyond the roof line; located at the top of buildings, they are subjected to the greatest amplification of the ground motions, and consequently prone to flexural failures. Gables of churches and other buildings, when improperly anchored to the roof, behave much like parapets (Fig. 9).

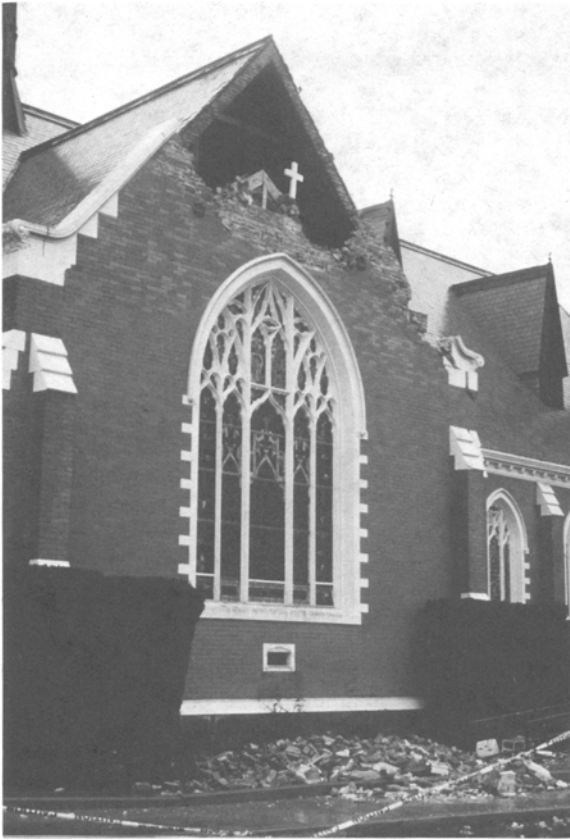
FIG. 9. Failure of Church Gable (Watsonville, Loma Prieta Earthquake)

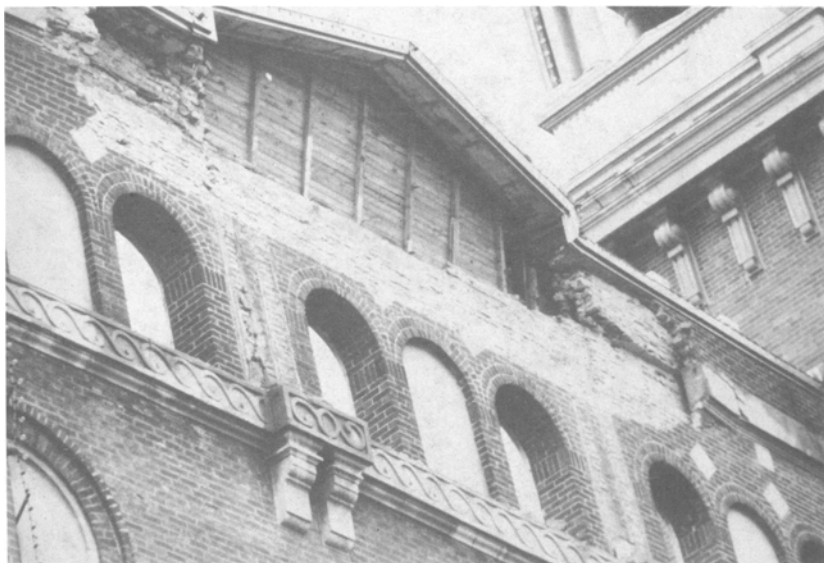
FIG. 10. Failure due to Combined out-of-Plane Failure of Parapet and Inadequacy of Collar Joint in Multiwythes URM Wall (Quebec City, Saguenay Earthquake)

Multiwythe walls improperly bonded along their collar joint (e.g., no or discontinuous mortar) are also extremely vulnerable, each wythe behaving independently as an individual thin wall. The exterior layers without contact to any other structural components will usually fail first, at very low level of seismic excitation (Fig. 10). This is also true for URM veneers.

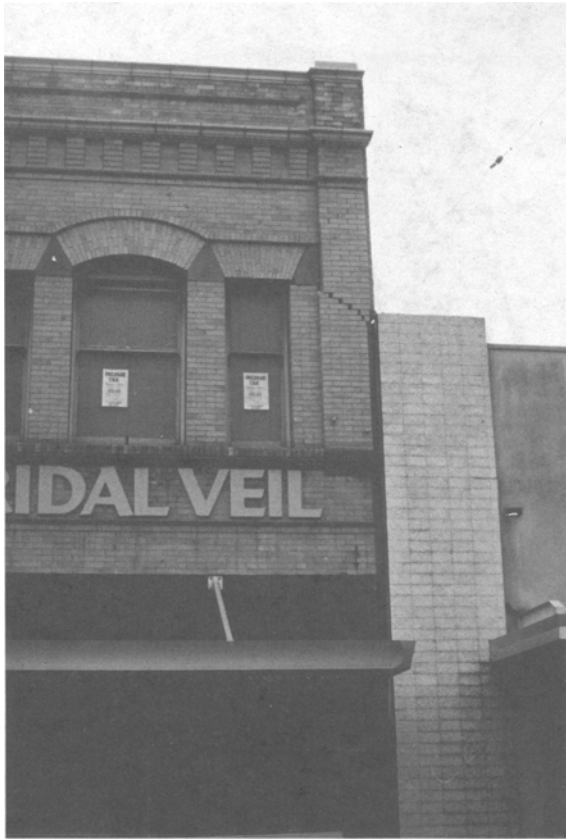
FIG. 11. Pounding-Induced Cracking (Watsonville, Loma Prieta Earthquake)

Pounding against adjacent structures can also accelerate this combined failure mode. The recognition of pounding as a cause of severe damage is relatively recent. Old North American URM buildings built without separation are most vulnerable to this type of damage (Figs. 11 and 12).

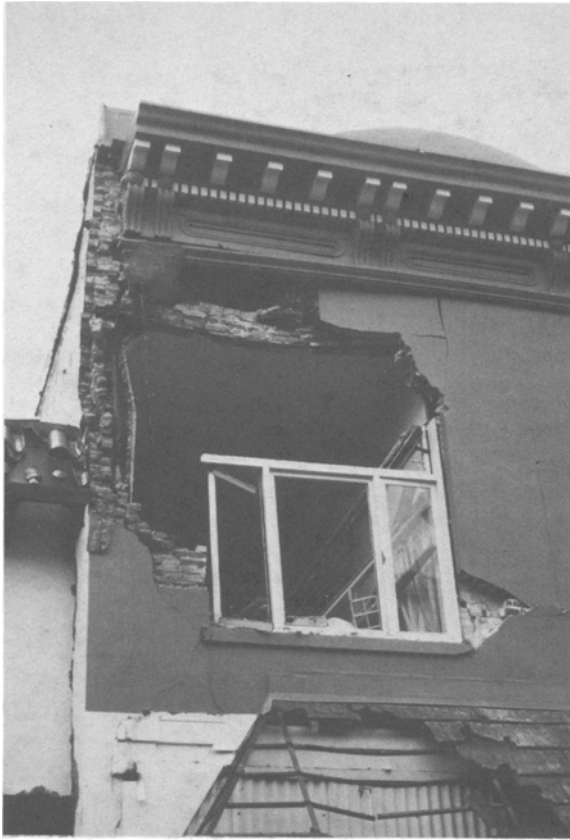
FIG. 12. Combined out-of-Plane/in-Plane/Pounding Failure (Santa Cruz, Loma Prieta Earthquake)

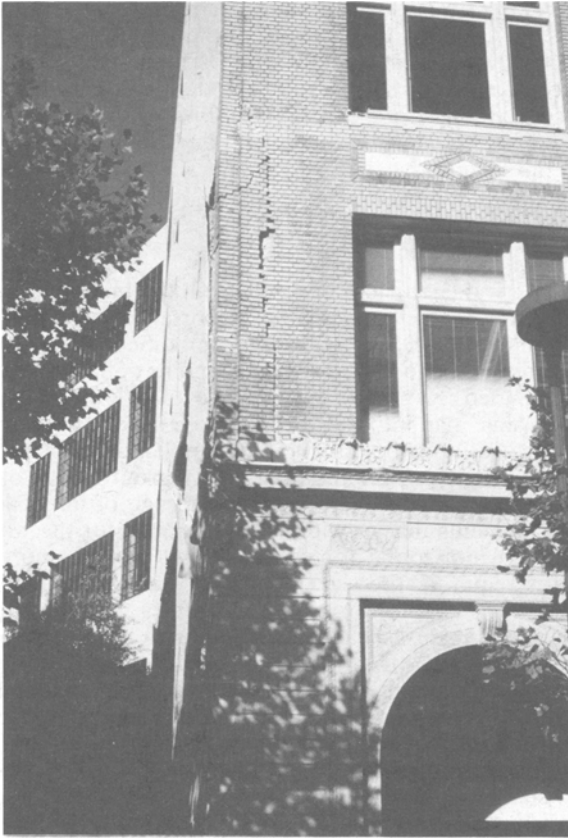
FIG. 13. Diaphragm-Induced Corner Damage to URM Pier (Oakland, Loma Prieta Earthquake)

The failure of the diaphragm itself is rarely observed following earthquakes. This could be attributable, partly, to the tendency of earthquake reconnaissance teams to mostly report observations made from the exterior of buildings. In most cases, damage to the diaphragm itself would not impair its gravity-load-carrying capacity. However, since flexible floor diaphragms behave as deep beams spanning between URM walls, the in-plane rotation of the diaphragm's ends can induce damage at the walls' corners. The absence of a good shear transfer between diaphragms and reaction walls also accounts for damage at the corners of walls, especially in long narrow buildings for which the diaphragm in-plane shear forces, due to bending in the long direction, cannot be transmitted over the small length of wall; the diaphragm will instead find its support by pushing on the URM walls in the transverse direction (Fig. 13).
