Modified Steel-Jacketed Columns for Combined Blast and Seismic Retrofit of Existing Bridge Columns

Pierre Fouché¹; Michel Bruneau, F.ASCE²; and Vincent P. Chiarito, M.ASCE³

Author keywords: Jacketed column; Retrofit; Blast testing; Inelastic response; Direct shear; Plastic hinging.

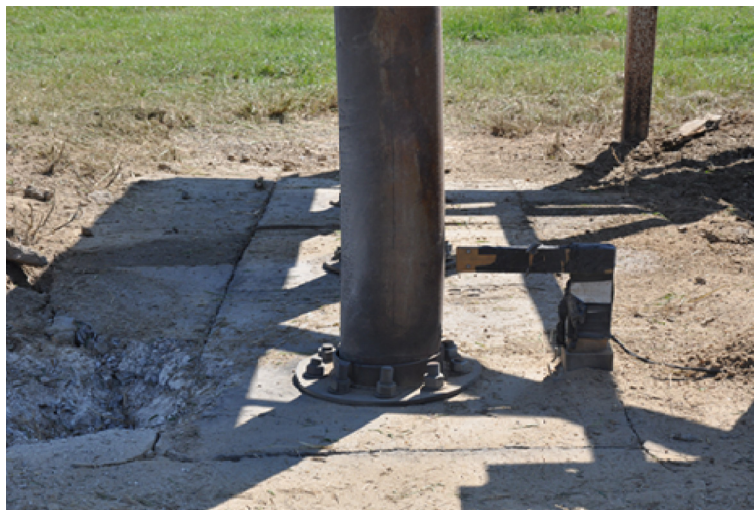
**Fig. 5.** Deformation of Specimen MSJC1 after first test

After the test, MSJC1 deformed to a maximum of 3.18 mm (0.125 in.) at a height of 305 mm (12 in.) above the top of the foundation. No direct shear failure was observed at the base of the specimen. Some deformation was observed in the collar, but it did not affect the capacity of MSJC1 to resist the blast load. In fact, the same specimen was retested twice to push it to its limit of resistance. Upon close inspection of the specimen after those tests, a horizontal crack was found at the top of the column, suggesting initiation of a direct shear failure at that location (Figs. 4

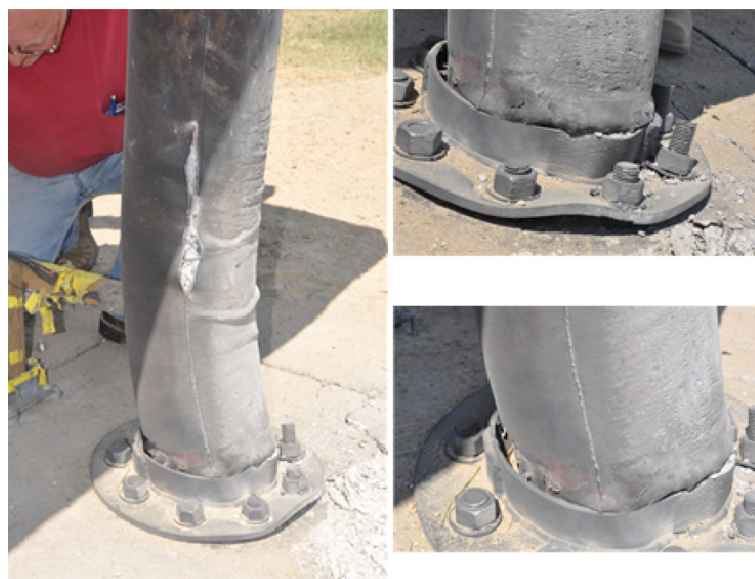
Fig. 7. Seam failure of Specimen MSJC1 and base deformation

After the test, several additional buckling waves on the front face of MSJC1 and failure of the vertical weld seam were visible (Fig. 7). The repaired collar did not suffer any damage. During its deformation, the steel jacket came into contact with the collar, leaving a visible horizontal indentation at that location (Fig. 8). The additional deformation demand on the specimen from this test caused the steel jacket to slip over the internal face of the collar on the side exposed to the blast. The back of the collar rotated and

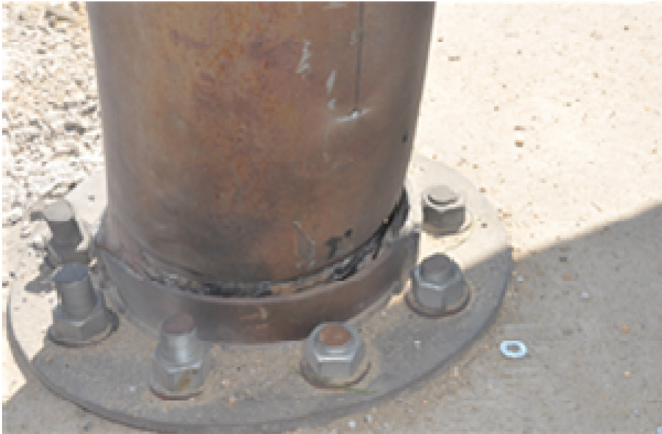
Fig. 8. Mark on steel jacket resulting from bearing on collar

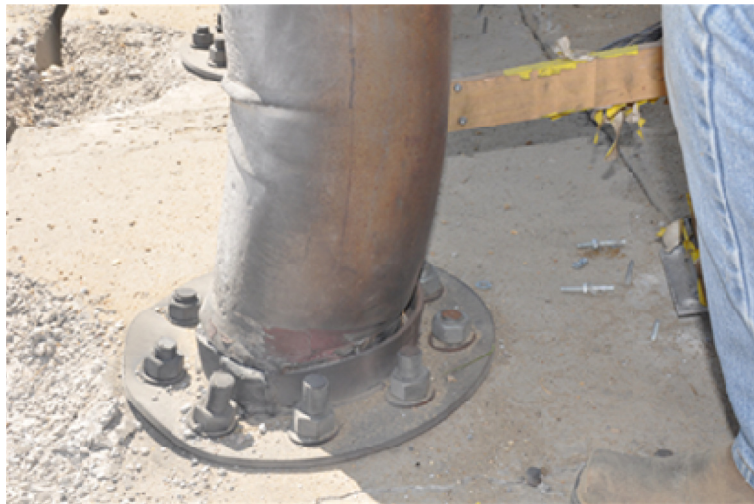
Fig. 9. Damage to Rulon tape and slip of Specimen MSJC1 over collar

deformed but did not fail. The lip of the base plate exposed to the blast deformed upward, causing some of the threaded rod in front of the blast to rotate (Fig. 9).

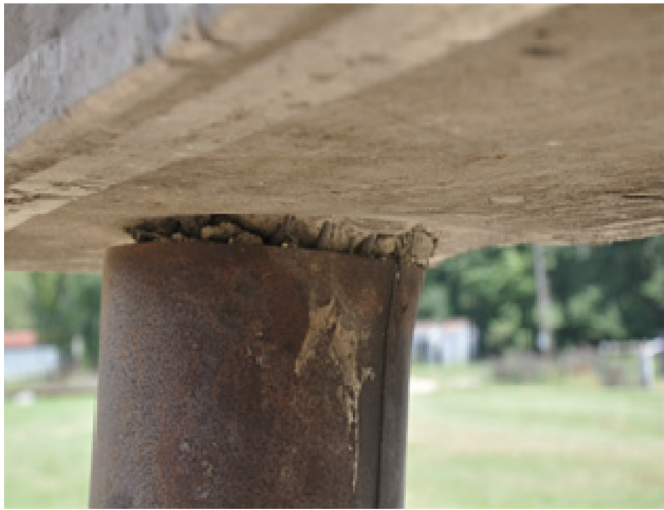
Fig. 11. Widening of crack at top of Specimen MSJC1

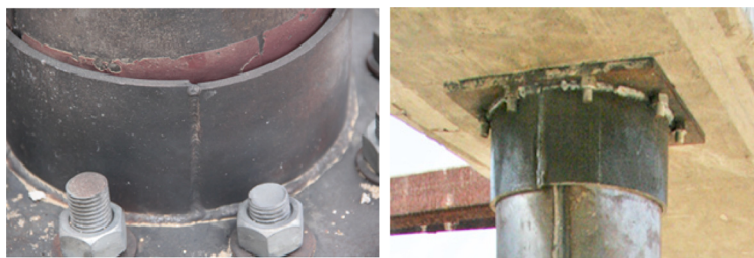
Fig. 12. View of collars of Specimen MSJC2

MSJC2 had 4-in. collars top and bottom (Fig. 12) and was tested only once. The length of the longer collar was established assuming that load transmitted from the specimen to the collar would result in the latter failing in flexure while following the rotation at the base of the specimen. The scaled distance of 1.57x was chosen such that direct comparisons could be made with MSJC1 and MSJC3, which were also tested at the same scaled distance and had 2-in. collars.

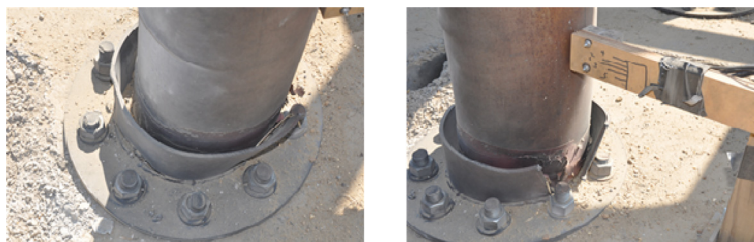
Fig. 13. Postshot failure of collar on Specimen MSJC2

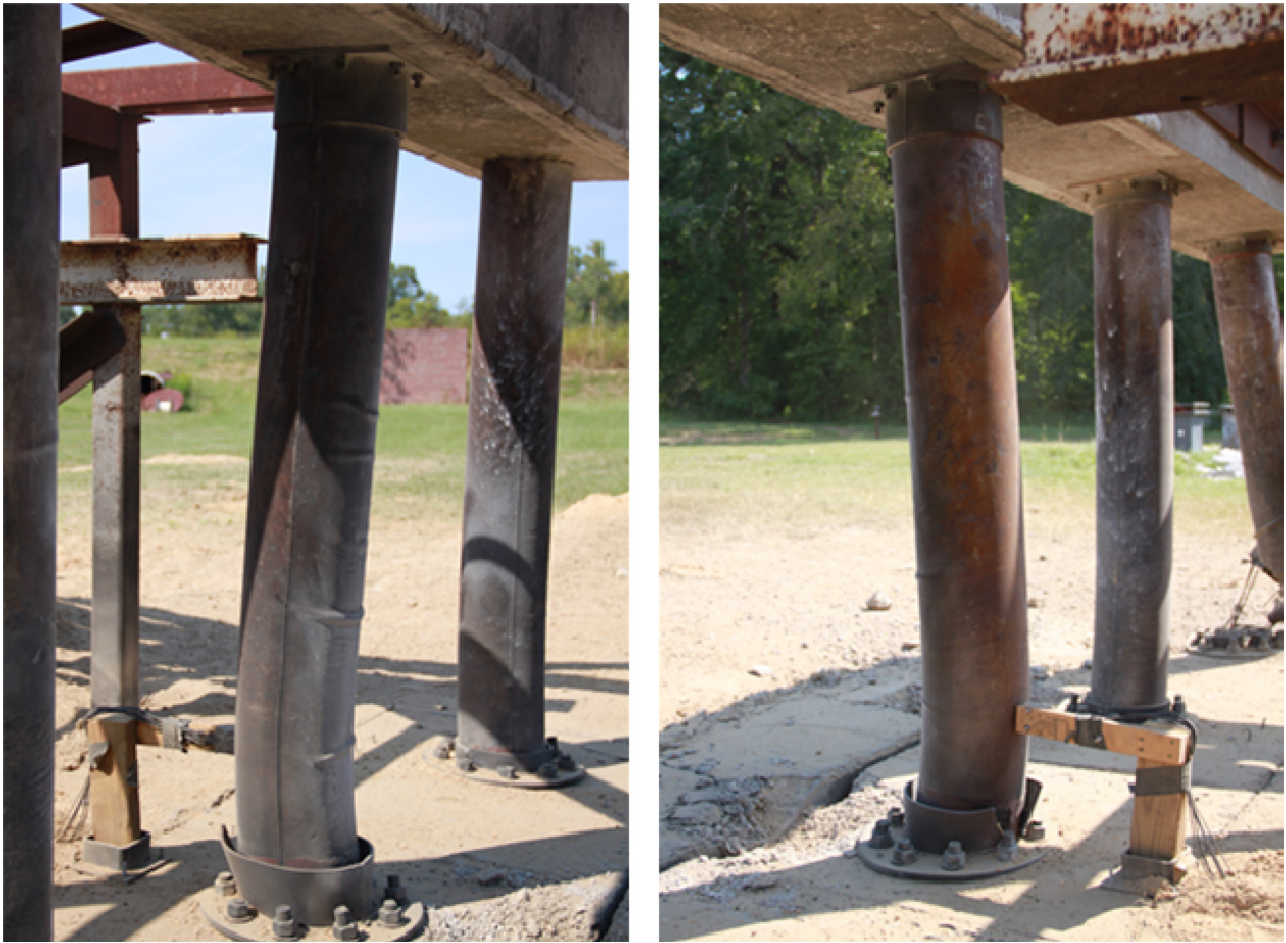
Fig. 14. Specimen MSJC2 after test

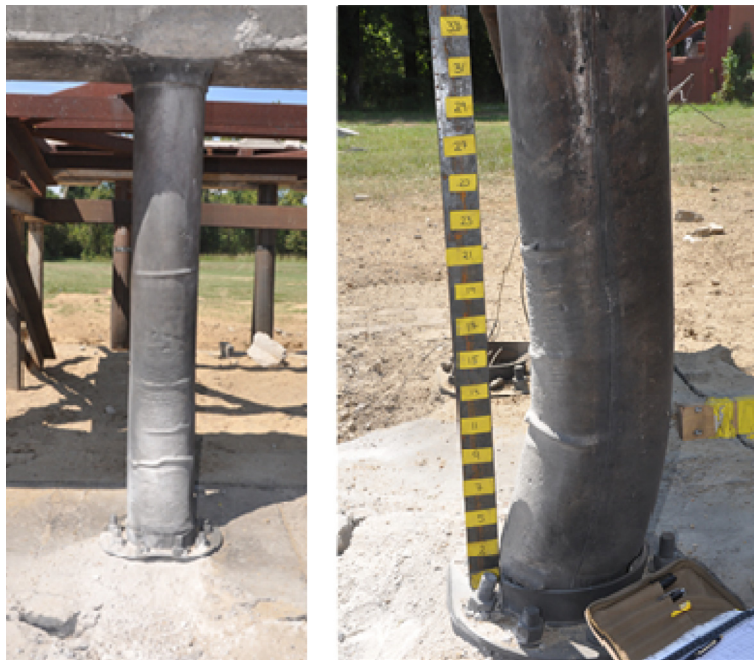
Fig. 15. Deformation of Specimen MSJC3 after second test

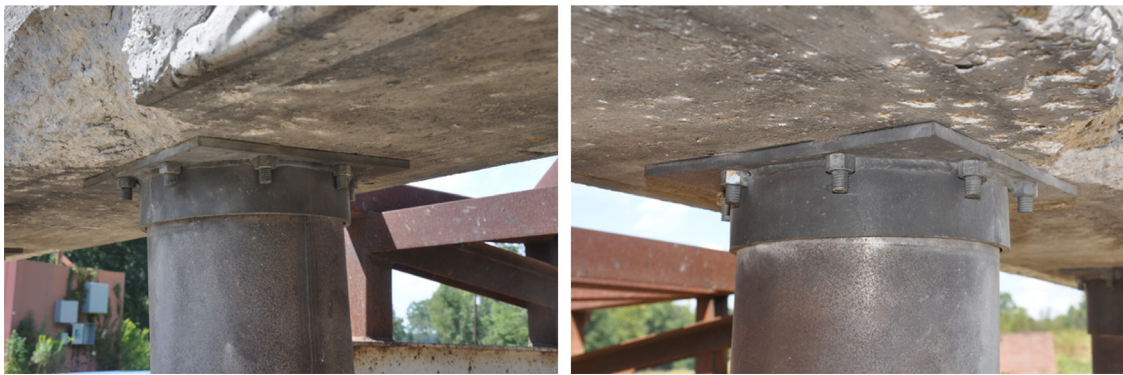
Fig. 17. State of top collar after second test of MSJC3

Plastic deformations (Fig. 16) in the bottom collar did not cause failure at the weld connection, as observed in the first test. Slippage between the collar and the steel jacket was observed in mostly the same fashion as in the last test on MSJC1 [Fig. 16(a)]. The top collar remained undamaged and virtually undeformed (Fig. 17).

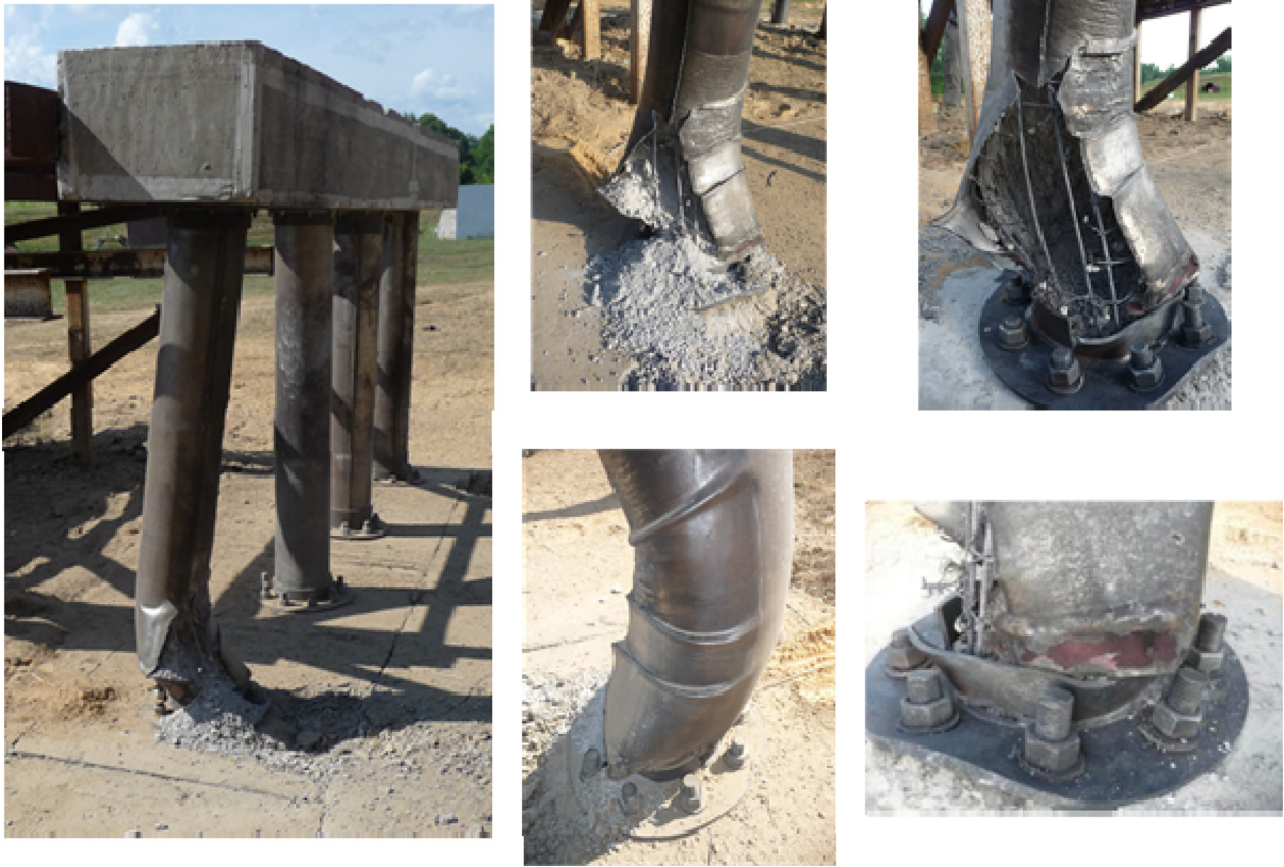
Fig. 18. Global view and close-up of base of Specimen MSJC4 after test

During the blast, the steel jacket was torn along its seam (Fig. 18). As a consequence, the concrete column became exposed, and several rebars and spiral reinforcements fractured near the base of the specimen. The observed unzipping of the seam was attributed to failure of its weld. Because the confinement provided by the steel jacket was lost and the RC column inside the jacket was not ductile, the column lost its capacity to carry load. As the weakest point of pipes/tubes used in structural engineering application is typically not the vertical seam weld, this failure possibly occurred as a consequence of fabrication errors due to the small scale considered here.

Notable deformations and failure at the weld connections of the collar were observed in both the front and back of the column (Fig. 18). This led to the conclusion that the front rim of the collar was subjected to significant overpressures, whereas excessive deformation of the specimen generated important hoop stresses in the back ring.

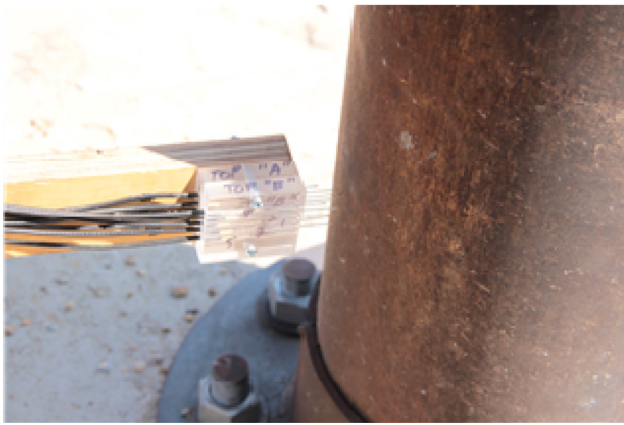
Fig. 19. Shorting pin assembly on back of MSJC2 (Block A is hidden behind Block B)

To enhance the resolution with which the velocity history at the back of the specimen was captured, the number of shorting pins in the assembly was increased to 10. The pins were divided between two blocks of five pins. All of the pins were shorted at the end of the test.
