# Cyclic Behavior of T-Shaped Composite Plate Shear Walls—Concrete Filled

**Abstract:** This paper presents findings from experiments conducted on four large-scale T-shaped concrete filled composite plate shear walls (C-PSW/CF) specimens subjected to axial force and flexure. A C-PSW/CF is a *sandwich* type of construction by which concrete (without rebars) is enclosed between steel plates connected by tie bars. One of the walls was subjected to a cyclic wind loading protocol and the other walls were cycled with a seismic loading protocol. Their dimensions were identical, but different axial loads (up to 30% of the crushing load of the infill concrete,  $A_c f'_c$ ) were applied. The plastic hinge development was investigated along with the composite behavior and compared with the calculated plastic moment of the corresponding cross section. These tests along with the results on C-shaped wall tests were conducted to establish the development of design guidelines for high-rise core-wall steel buildings having C-PSW/CF as the primary lateral force resisting system. DOI: 10.1061/JSENDH.STENG-11693. © 2023 American Society of Civil Engineers.

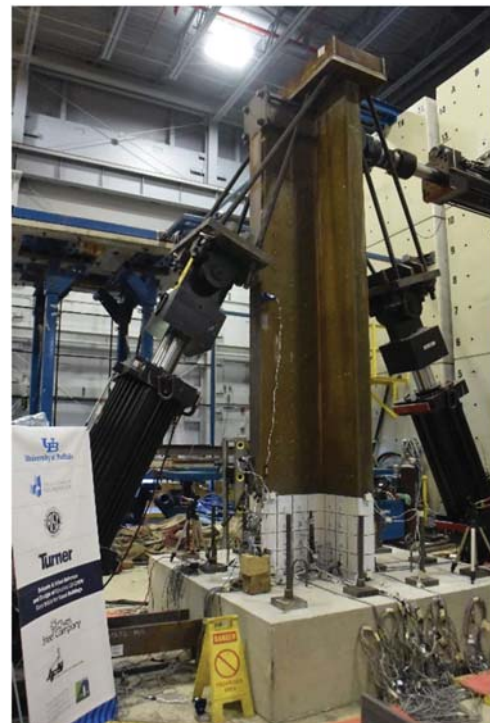
**Fig. 5.** Finished test setup of T-shaped wall specimen.

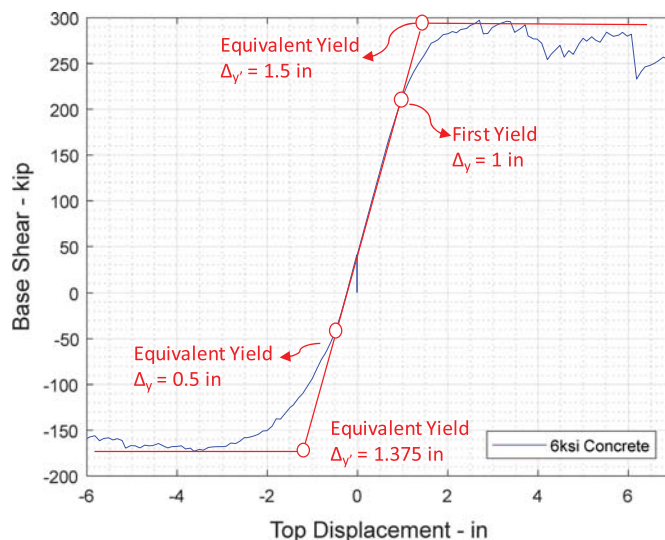
**Fig. 6.** Pushover result of the FEA model of Specimen T2 and bilinear approximation of the curves in positive and negative directions.

The FEA of the model of Specimen T2 under an axial loading equal to 30% of the concrete crushing load was also performed in order to construct the seismic loading protocol for Specimens T2 to T4. The details of this modeling can be found in Kizilarlan (2021). Due to the higher strength of concrete in that specimen compared to the other specimen, the equivalent yield displacements were measured to be 38.1 mm (1.5 in.) and  $-34.9$  mm ( $-1.375$  in.) in the positive (web in compression) and negative (flange is in compression) directions. Up to the equivalent yield displacements [ $38.1 / -34.9$  mm ( $+1.5 / -1.375$  in.)] obtained from the bi-linear envelope of the pushover curves (Fig. 6), Specimen T2 was cycled in a displacement-controlled mode. Two cycles were applied per drift amplitude for the first 10 cycles, after which it was increased to three until the maximum capacity of specimen was reached [ $114.3 / -104.9$  mm ( $+4.5 / -4.13$  in.)], and then the number of cycles was decreased to two at each displacement amplitude for the subsequent cycles. Note that the original protocol contained only two cycles at 6% drift, but as will be shown later, the specimen was cycled repeatedly at that drift, as needed to observe the further progression of fracture. Drifts were limited to 6% for safety reasons, to keep the specimen stable after substantial strength degradation.

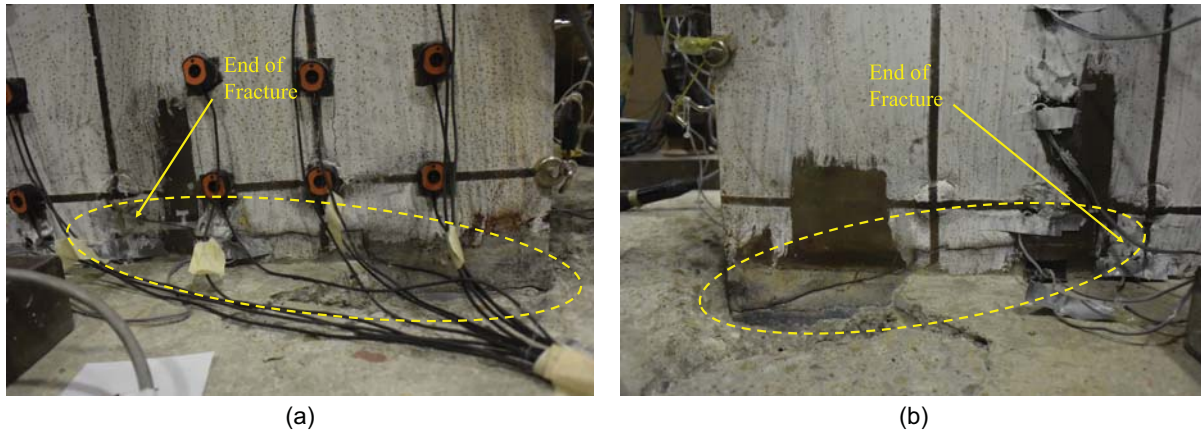
**Fig. 10.** Fractures after test is complete and local removal of concrete at (a) north face of the web (NW); and (b) south face of the web (SW).

In Specimen T1, it was observed after removing some concrete from the top of the footing that cracking had initiated just above the CJP weld connecting the wall steel plate to the thicker plate embedded in the concrete footing, and did so at the edge of the web closure plate (i.e., in the corner of the web where the wall plates orthogonal to each other were joined by a vertical weld). Therefore, before casting any concrete for Specimen T2, the horizontal CJP welds connecting the 4.76 mm (3/16 in.) thick plates of the wall to the 9.53 mm (3/8 in.) embedded plates of Specimen T2 were inspected by certified weld inspectors who performed visual inspection, magnetic particle inspection, ultrasonic inspection, and radiographic inspection. Visual inspection revealed that the welds in the corners were a cause of concern, as the welder apparently stopped/started all welds at these corners, which left the corners not fully welded. Magnetic inspections did not reveal any surface openings in the weld. Ultrasonic inspection detected porosity in welds at critical locations (most importantly at the corners that were already identified as problematic by visual inspection, and at some locations along the flange). X-ray photos from radiographic

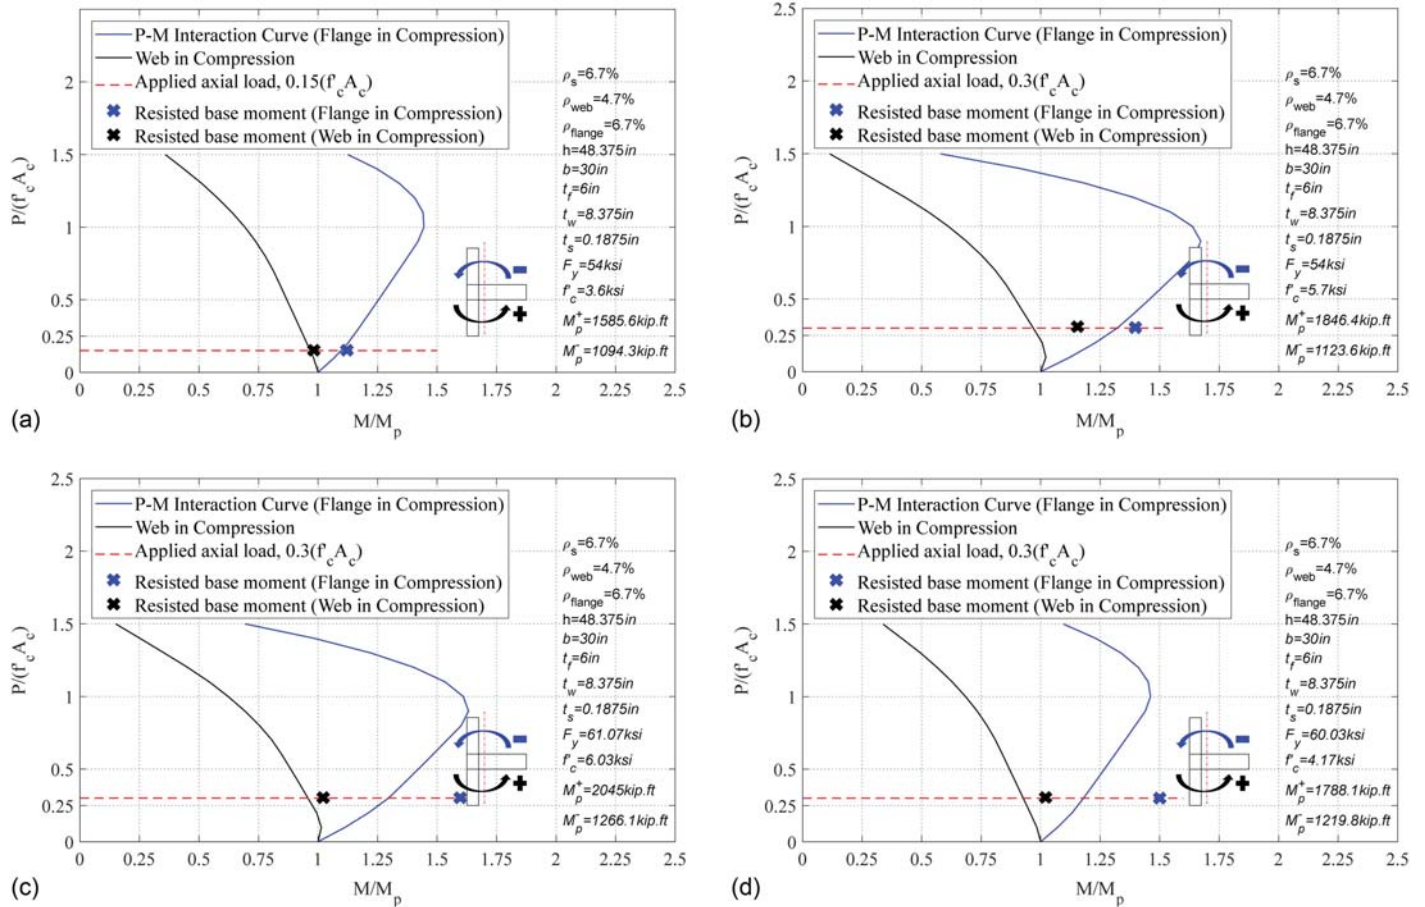
**Fig. 17.** Comparison of Specimens (a) T1; (b) T2; (c) T3; and (d) T4 flexural resistances with P-M interaction curve (1 in. = 25.4 mm; 1 ksi = 6.9 MPa; and 1 kip-ft = 1.36 kN-m).
