Bridge Piers with Structural Fuses and Bi-Steel Columns.

I: Experimental Testing

Samer El-Bahey¹ and Michel Bruneau, F.ASCE²

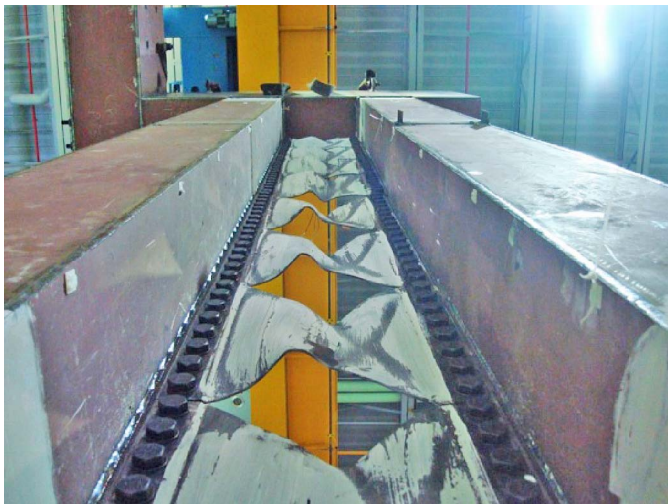
Fig. 7. SPSL's yielding at 1.6% drift

Testing restarted by repeating the cycles at a displacement of 75 mm (1.1% drift). At 112.5 mm displacement (1.6% drift), minor signs of yielding of the lower-west column were observed. At that drift, it was determined that the part of the experiment intended to illustrate the structural fuse concept had been completed because a further increase in displacement would have resulted in the columns yielding. Fig. 7 shows the links at this stage of the test.

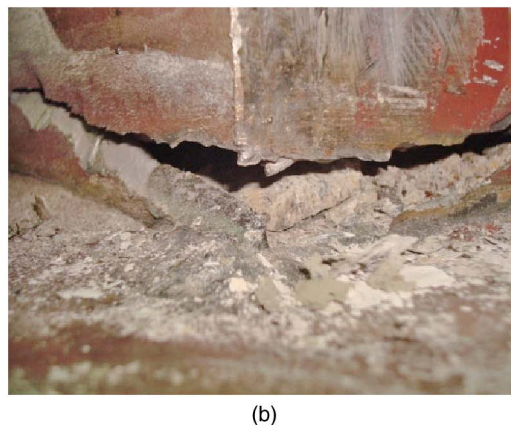
Fig. 8. (a) Local buckling of west column 2.2% drift; (b) fracture at 2.7% drift

The column was completely fractured along its west side as shown in Fig. 8(b) at 187.5 mm displacement (2.7% drift), and the load dropped from 700 kN to 420 kN at that point.

Nevertheless, testing continued for the specific purpose of observing the ultimate behavior of the bi-steel columns in this particular application. Local buckling at the west side of the lower-west column started to appear at 150 mm displacement (2.2% drift) as shown in Fig. 8(a), while fracture started to occur at the same drift level at the east side of the column and propagated rapidly.

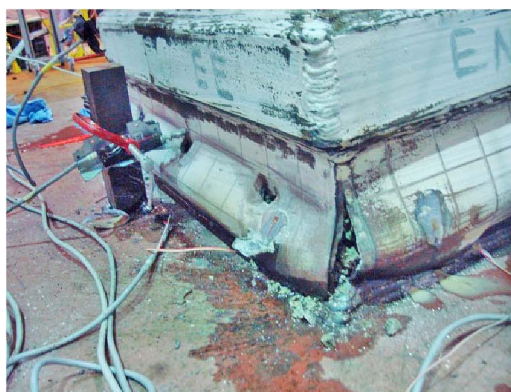
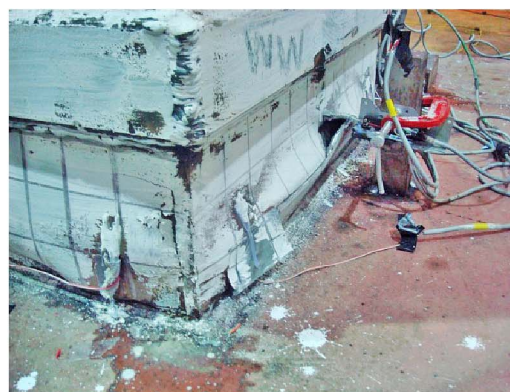
Fig. 10. (a) Damage at east column at 3.62% drift; (b) damage at west column at 4.35% drift

It was not deemed beneficial to cycle further beyond that point, but the west column was still intact, having suffered only from local buckling. So it was decided to apply one more half cycle up to a displacement that would make the west column totally fails. The fractured column would be in compression during that half cycle, making that last stage of testing possible. At 175 mm displacement (2.5% drift), a minor crack started to appear at the northwest corner of the bottom-west column. The crack started to grow and propagate as displacement was increased in the same direction. At the same time, the east column was suffering major damage at 200 mm displacement (2.9% drift). At 225 mm displacement (3.26% drift), the crack at the northwest corner of the west column propagated, and concrete started spalling from the southeast corner of the east column. At 250 mm displacement (3.62% drift), the applied load started to drop gradually as shown on the hysteretic curve, and the existing crack on the west face of the west column further propagated. At the same time, another large crack developed at the northeast corner of the bottom-east column, and concrete rubble started to escape from the crack opening as shown in Fig. 10(a). At 300 mm displacement (4.35% drift), the west column had developed 600 mm long cracking along its base and had extensive local buckling, and concrete rubble started escaping from the northwest corner crack as shown in Fig. 10(b). Testing was then terminated at that stage.

Testing continued to 175 mm displacement (2.5% drift), at which the lateral load resisted by the specimen dropped 44% from 711 kN to 400 kN. As testing continued, to better understand the progression of the failure mechanism (and because the specimen had a nonnegligible residual strength), the crack propagated across the south side of the east column, and the east column was totally damaged at this stage.

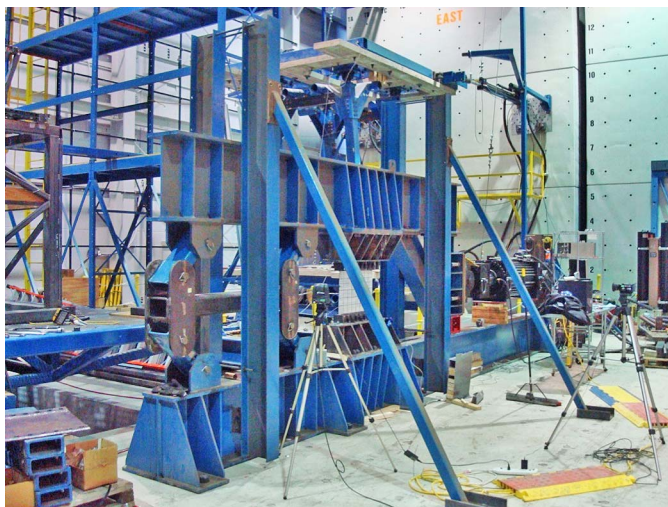
Fig. 12. Pantograph system

The test setup shown in Fig. 12 was originally designed by Berman and Bruneau (2005). The setup is a pantograph that was designed to apply a shear force on short-length specimens. The pantograph functions to prevent the rotation of the loading beam while allowing the link to deform unrestrained in the axial and horizontal directions, preventing the introduction of axial load in the link when deformed in shear and flexure. The loading protocol used for testing the SPSLs was the one specified by the 2005 AISC seismic provisions for eccentrically braced frames (EBFs). Hysteretic behavior of both restrained and unrestrained links are shown in Figs. 13(a) and 14(a), respectively. A comparison of the results obtained accompanied by an analytical investigation is presented in the companion paper (El-Bahey and Bruneau 2011).

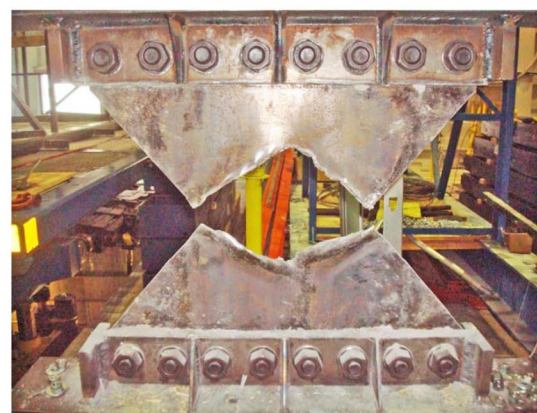
Fig. 13. (a) Link shear versus total rotation hysteretic curve for restrained specimen; (b) link condition after testing

Specimens restrained against out-of-plane buckling using the fiber-reinforced plastic (FRP) panels almost observed the same trend of behavior during testing. For illustration, a brief description of the test performed on the SPSL presented in Fig. 13(a) is presented. At $\gamma_{\text{tot}} = 0.002$ rad, and loss of stiffness was observed in the hysteretic curves at a shear force of 150 kN. Yielding started to occur at a total rotation of 0.015 rad and a shear force of 250 kN. No buckling was observed in the wedge parts because they were designed to remain elastic (observed after removal of the FRP panels at test termination), and consequently no significant loss in strength occurred at repetitive cycles for the same rotation level. This was attributed to the fact that the middle part was the only part yielding in the specimen and was designed to yield in pure shear. At a rotation level of 0.08 rad, a drop in strength from 400 kN to 380 kN was observed; this was attributed to a fracture that might have started to propagate somehow in the middle part of the link, but this could not be confirmed or seen at that time because of the presence of the restraints. This was approximately a 20% loss in strength from the maximum strength reached, and, by definition, the specimen was deemed to have failed in performance. However, testing continued until the specimen totally fractured. Loss of strength continued at the same rotation level for every cycle performed because of the propagation of the anticipated crack. A significant loss in strength was then observed at a rotation level of 0.1 rad, and the strength dropped to almost zero. At that point, testing was terminated, and the restraints were removed to investigate the link condition at the end of the test. Fig. 13(b) shows the specimen condition after removal of the restraints.
