EFFECT OF SEVERE CORROSION ON CYCLIC DUCTILITY OF STEEL

By Michel Bruneau,¹ Member, ASCE, and Seyed Mehdi Zahrai²

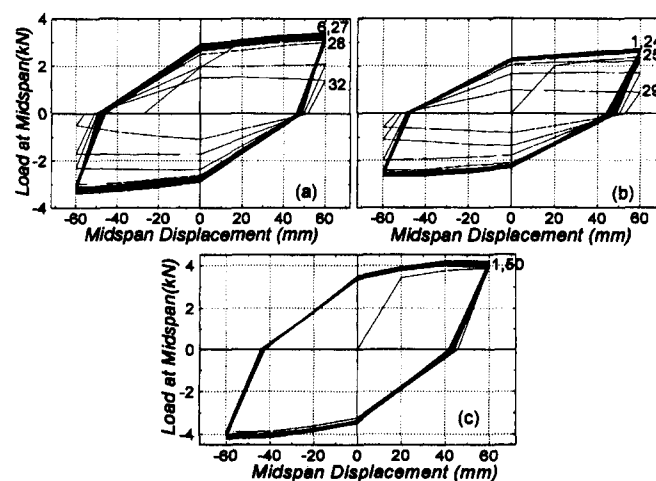
FIG. 7. Simplified Hysteretic Behavior of Plate Specimens: (a) Rusted Specimen 1, for Cycles 6 to Failure; (b) Rusted Specimen 2, All Cycles; (c) Unrusted Specimen for All Cycles

corresponding to a hysteretic energy of 362 kN/mm (normalized hysteretic energy of 39). This time, strength degradation became noticeable during the 25th cycle as shown in Fig. 7(b), after a cumulative normalized hysteretic energy of 960. Examination of the specimen's surface revealed that fine cracking had occurred across the width of the member about 10 mm from the center span. Crack propagation and strength degradation in the subsequent cycles followed the pattern previously established, thus validating previously obtained results. Final state of the specimens and cross-width cracks are shown in Fig. 8. Close-up view of the rusted specimens' surface texture in the vicinity of the crack is shown in Fig. 9. Fig. 10(a) shows a typical cross-thickness view at the crack failure surface, with noticeable thickness variations, and Fig. 10(b) illustrates other cracks of finite lengths that typically developed in parallel to the failure surface.

more than 800 cycles, and the preceding results thus indicate a considerable drop in low-cycle fatigue resistance. However, to confirm that the results obtained were not inadvertently influenced by the particular test setup adopted and provide an approximate experimental comparison benchmark, a new plate of mild steel (of 300-MPa yield strength) and same width as that of the rusted plates also was tested. Its thickness was chosen to be approximately equal to the least value measured on the rusted specimens (i.e., 6.3 mm). This new steel plate was subjected to 50 inelastic cycles at a center displacement of 60 mm, corresponding to a displacement ductility of 9, curvature ductility of 20, and cumulative hysteretic energy of 26,800 kN/mm for 50 cycles (normalized cumulative hysteretic energy of 1,640) without any sign of cracking or strength reduction. Results are shown in Fig. 7(c) for comparison.

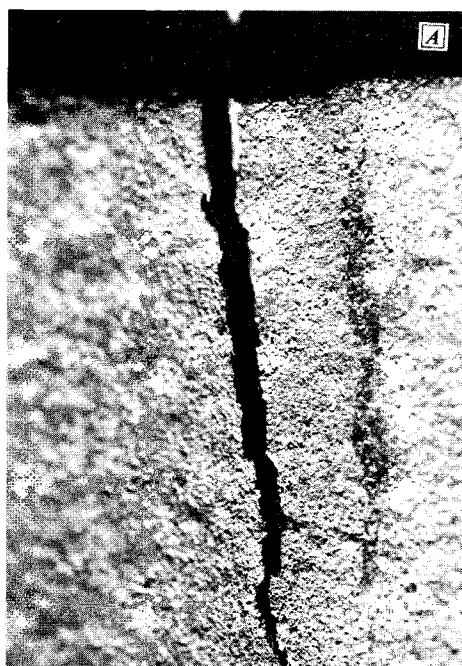
FIG. 9. Close-Up View of Surface Texture for Three-Point Bending Specimens: (a) First Cracking Side for Specimen 1; (b) Last Ruptured Side for Specimen 2

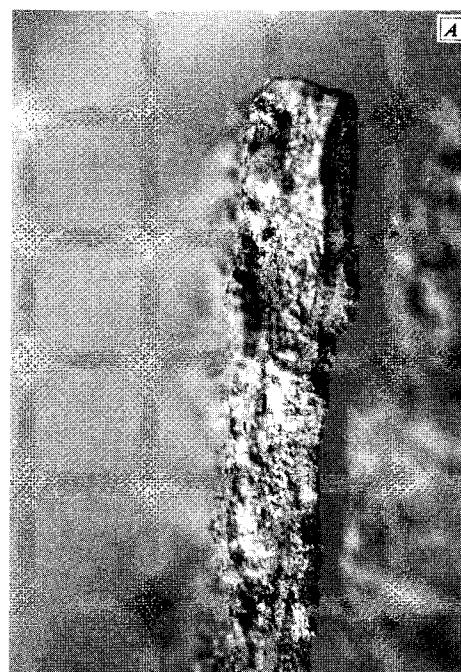
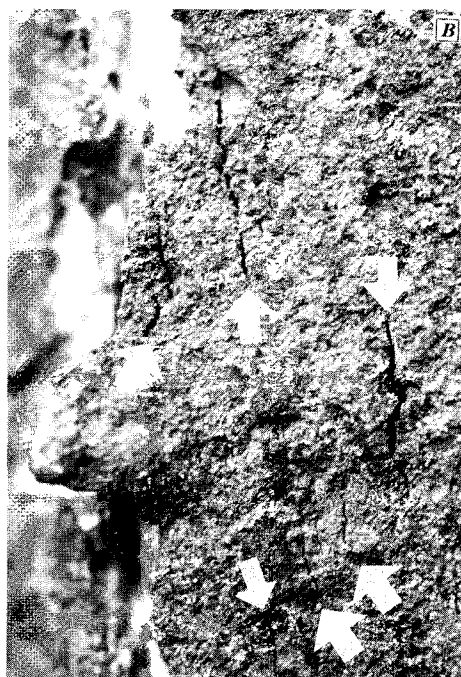
FIG. 10. Close-Up View of: (a) Typical Failure Surface of Irregular Thickness; (b) Other Cracks of Finite Lengths Parallel to Failure Surface

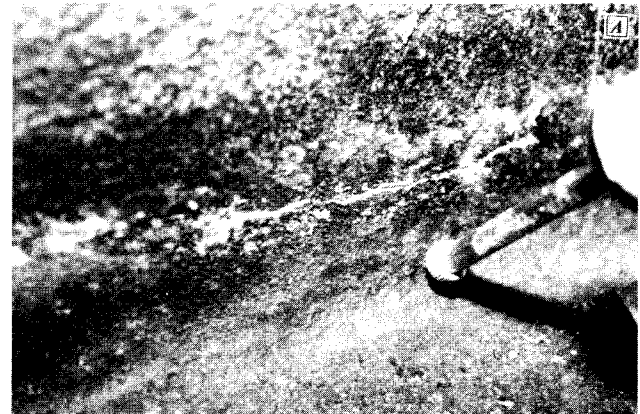
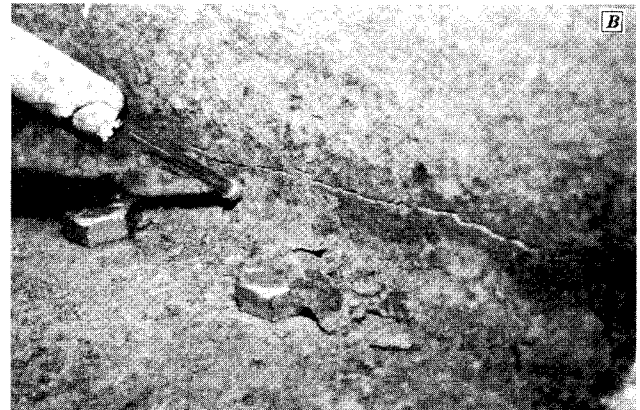
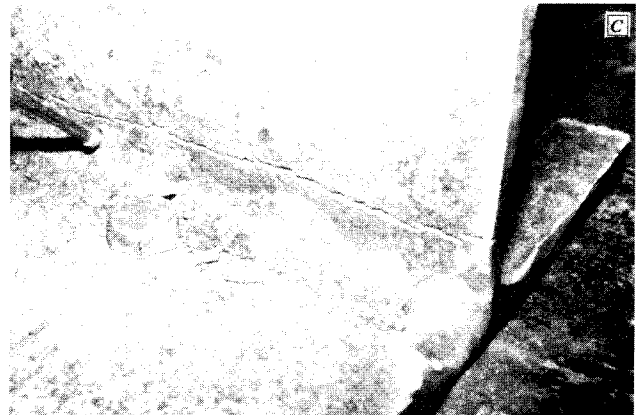
FIG. 16. Progression of Cracking in Specimen SW-II: (a) Early Cracking on East Face; (b) Same on West Face; (c) Significant Crack Propagation on West Face

The specimen was very closely inspected throughout testing and a small 40-mm-long hairline crack was first observed on the east face 150 mm from the south edge of the specimen at the 83rd cycle (corresponding to the 17th cycle at $\pm 4.0\delta_y$) as shown in Fig. 12. First visible crack on the west face was only observed at the 88th cycle; it was 20 mm long and located 135 mm from the south face, at 40 mm above the base of the specimen. Cracks rapidly grew in length and width on further cycling, as shown in Fig. 16, with lengths of 65, 75, and 194 mm on the east face and 132, 140, and 165 mm on the west face at the 90th, 98th, and 102nd cycles, respectively. Strength degradation of 20% was observed after the 96th cycle (i.e., after 30 cycles at $4.0\delta_y$). Cracking reached the south edge of the specimen on both the east and the west faces simultaneously at the 105th cycle (still at a displacement of $4.0\delta_y$) and reached the north edge on the west face at the 108th cycle (at a displacement of $6.0\delta_y$, since the 107th cycle), with 40 mm left of uncracked steel on the east face. Testing was stopped after the 110th cycle, after a strength loss of 80%.
