SEISMIC RETROFITTING OF LOW-RISE MASONRY AND CONCRETE WALLS USING STEEL STRIPS

By Mustafa Taghdi,¹ Michel Bruneau,² and Murat Saatcioglu³

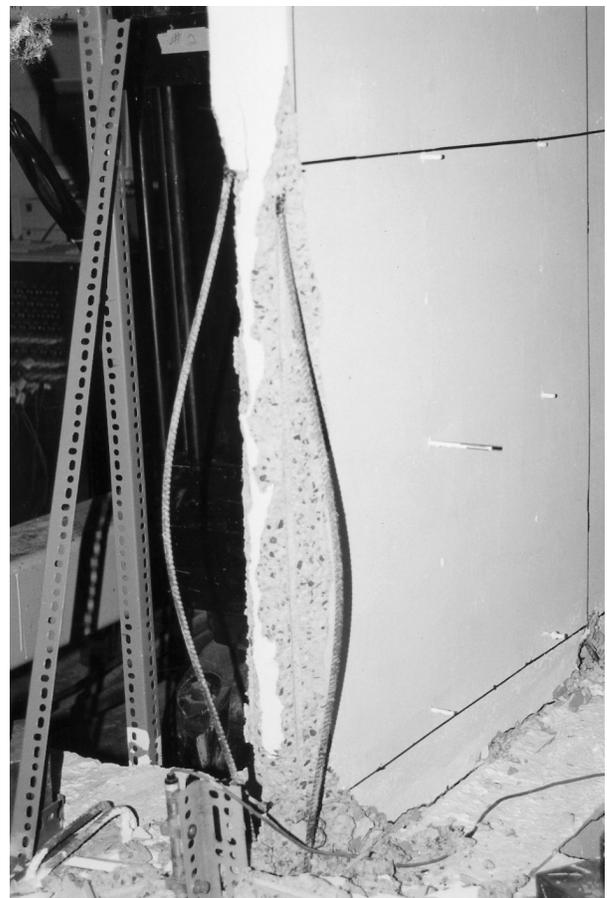
FIG. 8. Localized Damage in Wall 11

wall panel above the base (Fig. 8). The wall ends severely crushed and the vertical rebars elastically buckled. While the strains in the end bars were not large, the rebars in the middle of the wall experienced extensive yielding and developed strain hardening at higher drifts. The wall did not experience any strength degradation until this middle reinforcement ruptured. At that stage, the wall was left to rely on pure rocking behavior to resist the lateral loads, much like the unreinforced masonry wall (Wall 9). Although the performance of this wall can be considered satisfactory in terms of ductility and energy dissipation, its lateral load resistance could be inadequate to resist earthquakes and may still require retrofit.

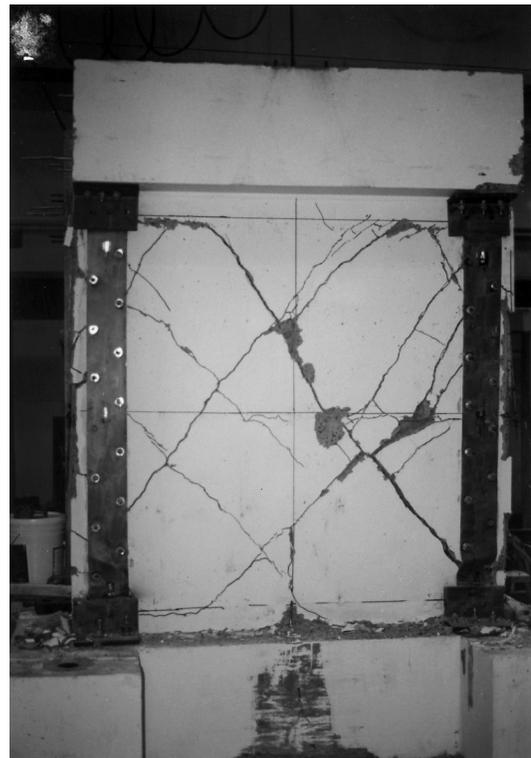
FIG. 11. Cracking Pattern of Wall 11RP
