Seismic vulnerability evaluation of axially loaded steel built-up laced members I: experimental results

Abstract: An experimental program was initiated to investigate the seismic performance of built-up laced steel brace members. Quasi-static testing of twelve typical steel built-up laced member (BLM) specimens was conducted. These were designed to span a range of parameters typically encountered for such members based on findings from a survey of commonly used shapes and details that have been historically used. The specimens were subdivided into groups of three different cross-sectional shapes, namely built-up I-shape section, and built-up box shapes buckling about the x or the y axis. Within each group, global and local buckling slenderness ratios had either kl/r values of 60 or 120, and b/t ratios of 8 or 16. The specific inelastic cyclic behavior germane to each specimen, and general observations on overall member hysteretic behavior as a function of the considered parameters, are reported. A companion paper (Lee and Bruneau 2008) investigates this observed response against predictions from analytical models, and behavior in the perspective of system performance.

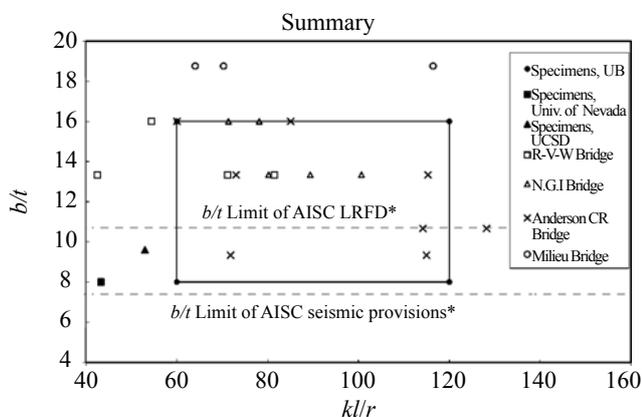
$$*b/t(\text{AISC LRFD}) = 200 / \sqrt{F_y} (= 76 / \sqrt{F_y}) = 10.7, F_y = 345 \text{ MPa} (= 50 \text{ ksi})$$

$$b/t(\text{AISC Seismic Provisions}) = 137 / \sqrt{F_y} (= 52 / \sqrt{F_y}) \\ = 7.4, F_y = 345 \text{ MPa} (= 50 \text{ ksi})$$

Fig. 1 Distributions of b/t ratios and kl/r ratios

Drawings were obtained for a few existing bridges having truss substructures with BLMs. Design provisions and steel design textbooks published at the time when laced compression members were being used, were also reviewed (Ketchum, 1920; Kunz, 1915), along with recent research work conducted for the major crossings in California (Uang and Kleiser, 1997 and Dietrich and Itani, 1999). This provided a range of parameters typically encountered for such members that could be extracted, including typical built-up member configurations and lacing geometry, typical b/t and kl/r ratios for the built-up members and their lacings, connection details, and other lacing characteristics. As a result of this work (and considering the limited resources available), research focused on investigating the impact of the b/t and kl/r ratios on member cyclic inelastic behavior, selected values ranging from 8 to 16 and from 60 to 120, respectively. These are the two parameters with the greatest impact on compressive strength, and have been observed to have the greatest variability from the collected data. Typical values obtained in this survey for selected bridges are overlaid to this considered range of values in Fig. 1. While some bridges' members were observed to have b/t ratios in excess of 16, it was decided to restrict testing to specimens having b/t values of 8 and 16 to allow a comparison of the cyclic performance of members with considerably different expectations in terms of local buckling behavior. Likewise, it was judged that testing braces with slenderness of kl/r of 60 and 120 would encompass the range of member slenderness observed in bridges, while allowing for comparisons of the cyclic inelastic behavior of members expected to have significantly different levels of inelastic buckling.

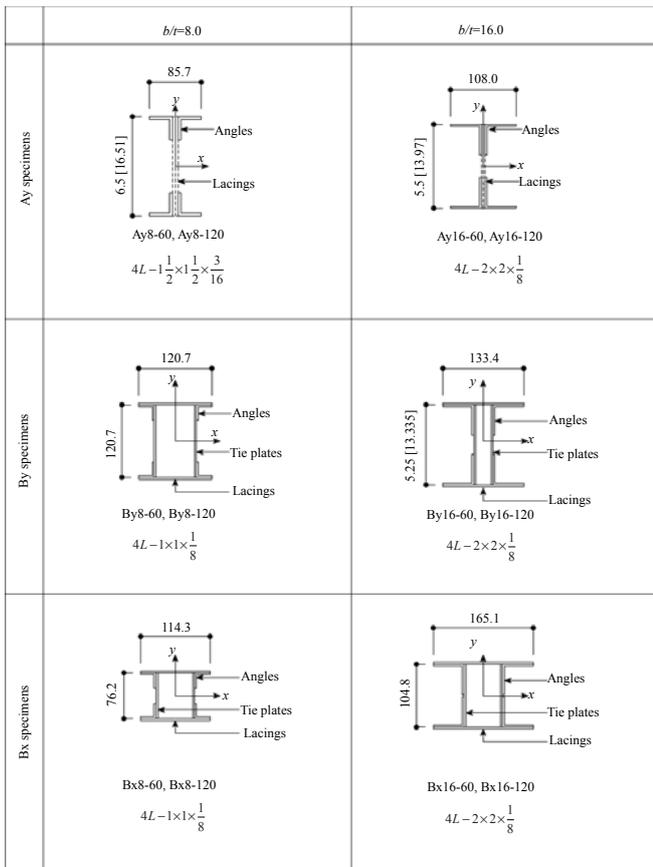
Fig. 2 Cross section shapes of the specimens (Length unit: mm)

Three different types of cross-sections, again representative of data collected from existing bridges, were selected for this project. As shown in Fig. 2, specimens Ay were built using four angles, and specimens By and Bx using four angles and two tie plates. Cross-sections satisfying the target width-to-thick ratios, b/t , of 8 and 16, were built-up from angles $25 \times 25 \times 3.2$ ($1 \times 1 \times 1/8$), $38 \times 38 \times 4.8$ ($1-1/2 \times 1-1/2 \times 3/16$), and $51 \times 51 \times 3.2$ ($2 \times 2 \times 1/8$). Lengths of the specimens and cross-section of the built-up shapes were then selected to provide the target slenderness ratios. Note that when calculating the cross-sectional properties of the specimens, the lacing members were not included, but the two tie-plates of the section shape of the "B" specimens were included. For the specimens with section shape "B", the direction of buckling was also controlled in the design by changing the width and depth of the test specimens. Note that the interest in testing section shape of the "B" specimens was to allow a comparison between different box-shaped members; in some cases, the lacing members would be in shear, and in others, they would not. Cross-sections for specimens with a kl/r of 60 and kl/r of 120 were identical for a given specimen name designation.

The resulting specimens designed based on the above considerations are presented in Fig. 2. Individual specimen names reflect the cross-section shape (A or B), the axis around which buckling may occur, and the kl/r and b/t values. Detailed drawings for specimens are presented in Lee and Bruneau (2004). Coupon tests for the steel used indicated the yield strength of 352 MPa for the angles, and 324 and 255 MPa for the 3.2 and 9.5 mm thick plates, respectively. Corresponding tensile strengths were approximately 483, 379 and 352 MPa, respectively.

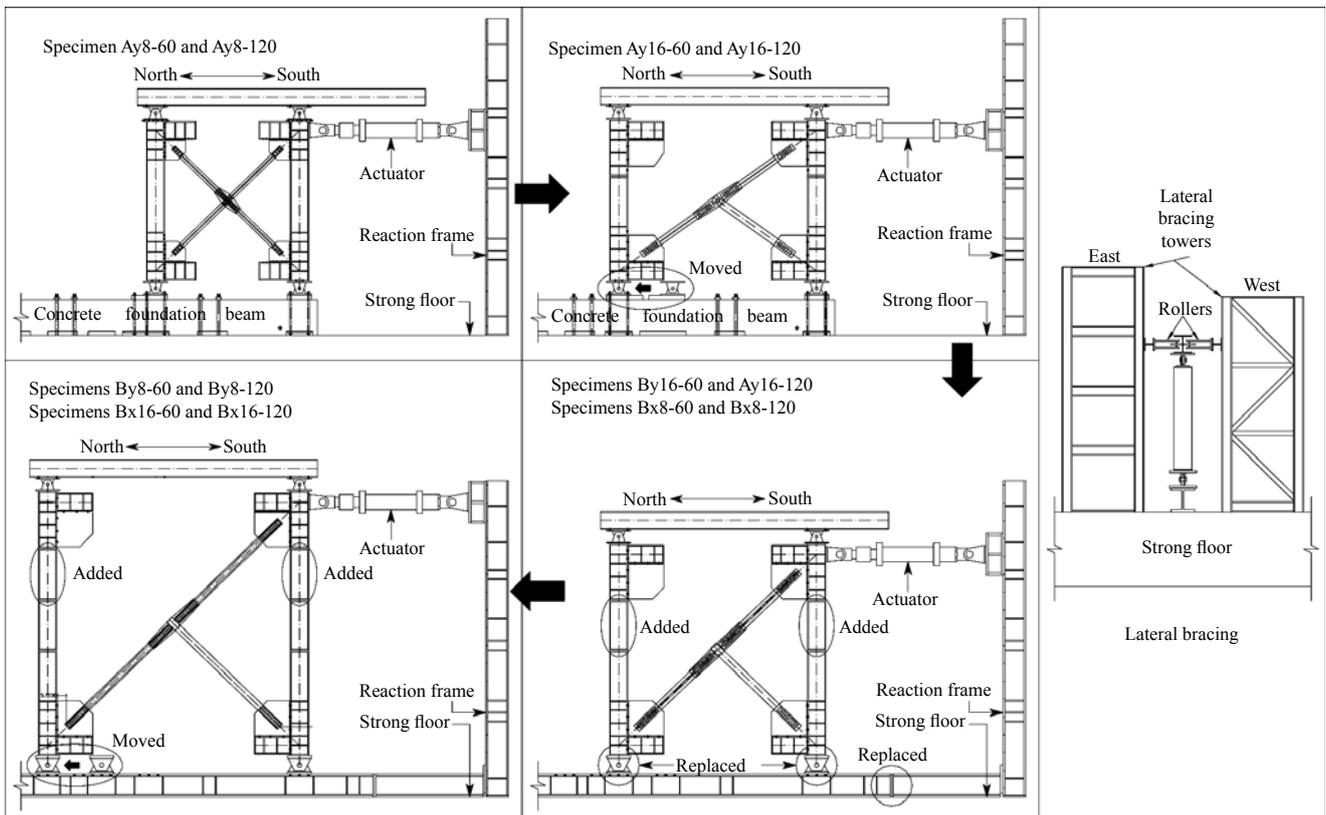
Fig. 3 Test set-ups and lateral bracing

The test set-up is shown in Fig. 3 (Lee and Bruneau 2004). The original idea in designing the test set-up was that specimens having kl/r of 60 would be tested in an X-shape configuration, but with one of the braces not connected at its top end. This effectively made the braces with kl/r of 60 resist the tension and compression forces while the other brace in the X-braced configuration resisted no axial forces other than providing a bracing point at mid-length of the other member. The concept was then to remove the specimen having kl/r of 60 after it was tested, connect the top of the other brace, and test the second specimen having kl/r of 120 without having to change the configuration of the test set-up. However, this concept did not work as expected because it was not possible to fail and fracture the specimen having kl/r of 60 without introducing possible plastic deformations in the specimen having kl/r of 120. Therefore, to be able to test the specimen kl/r of 60 without introducing damage

in the other specimen, for all subsequent tests following the Ay8 series, dummy bracing members were used to provide the bracing point at the mid-length of the kl/r of 60 specimens. These dummy bracing members were designed to provide the same in-plane and out-of-plane flexural stiffness as would be encountered in the real X-braced frame configuration.

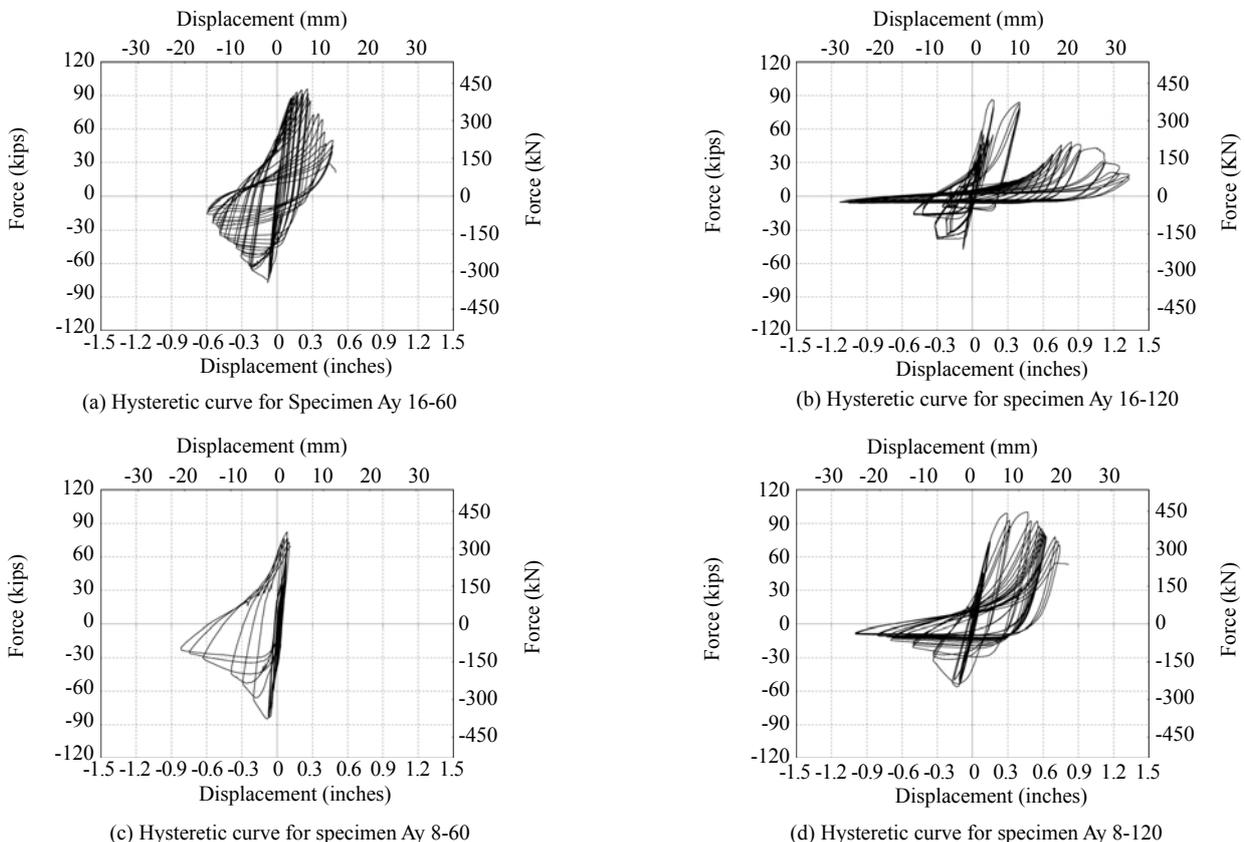
Fig. 4 Hysteretic curves for Ay specimens

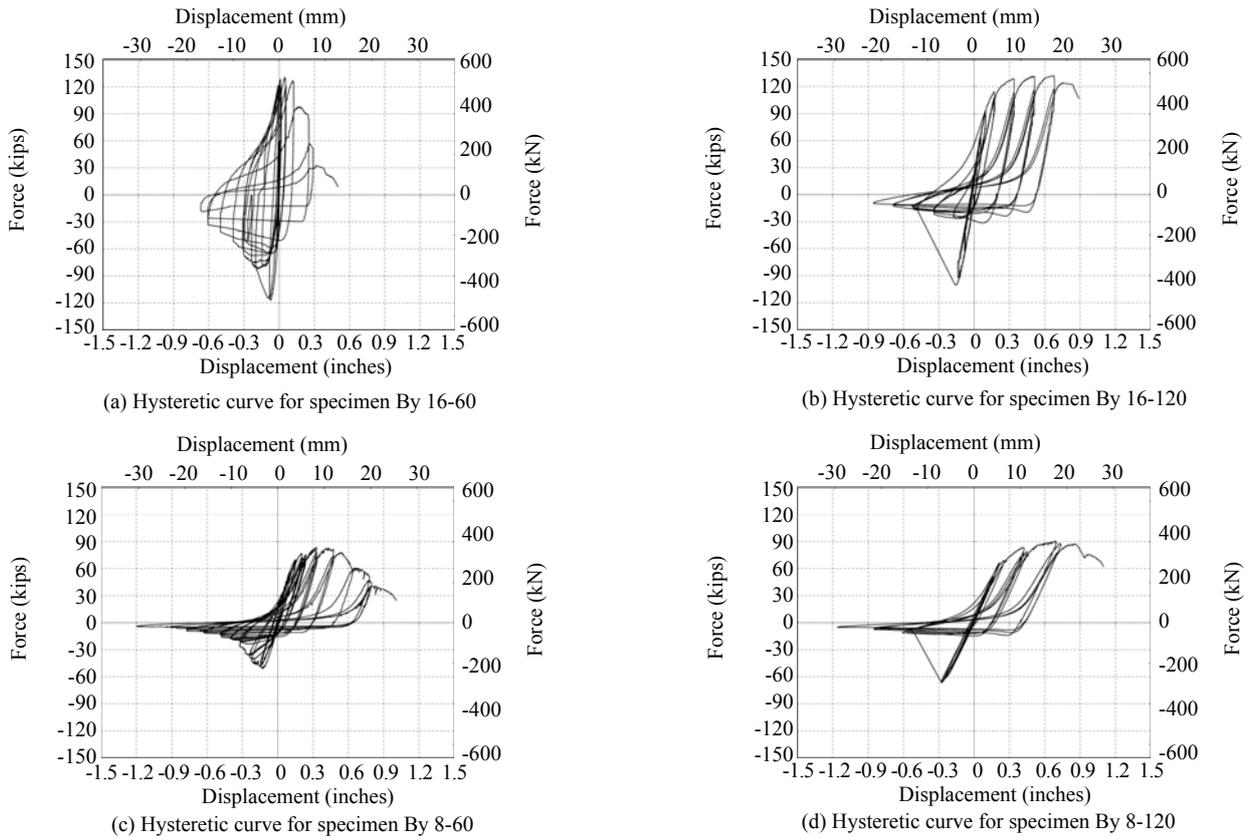
Fig. 5 Hysteretic curves for specimens By

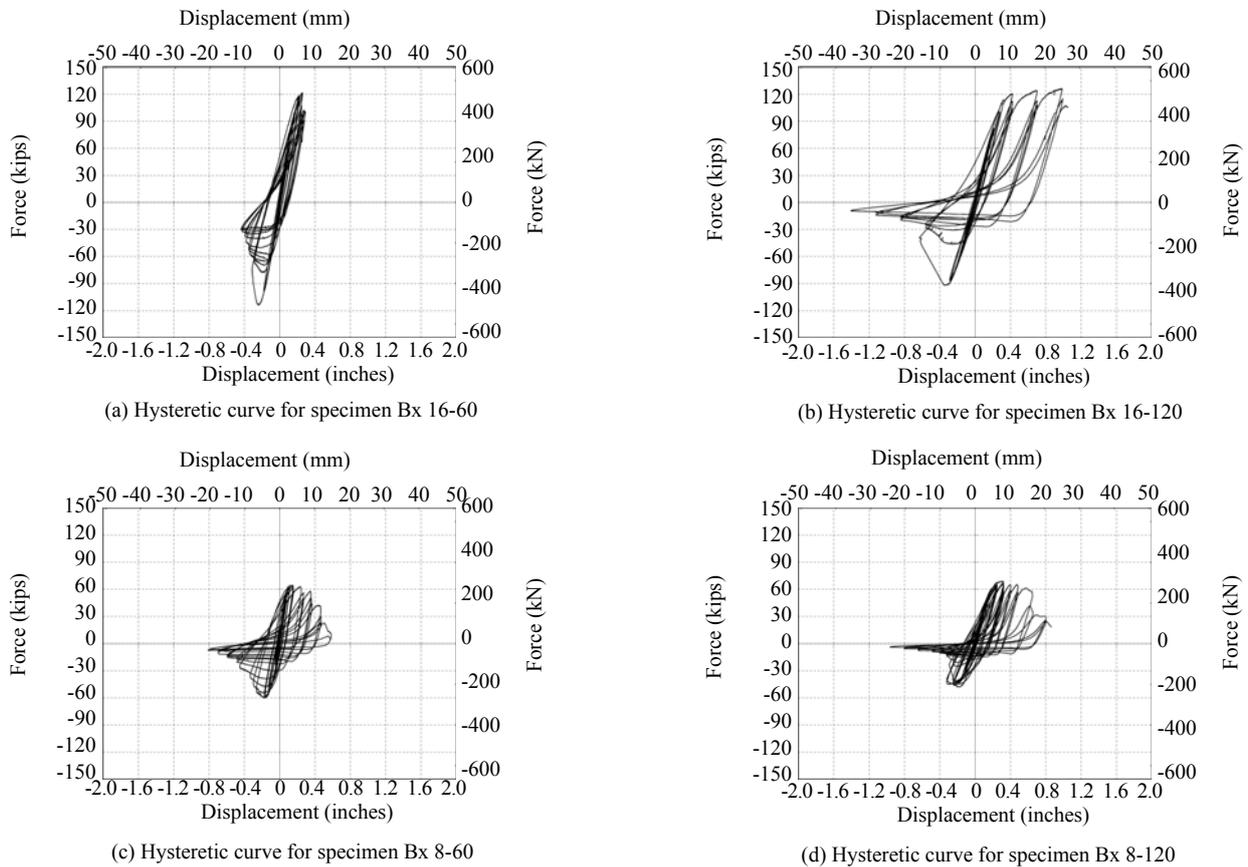
Fig. 6 Hysteretic curves for specimens Bx

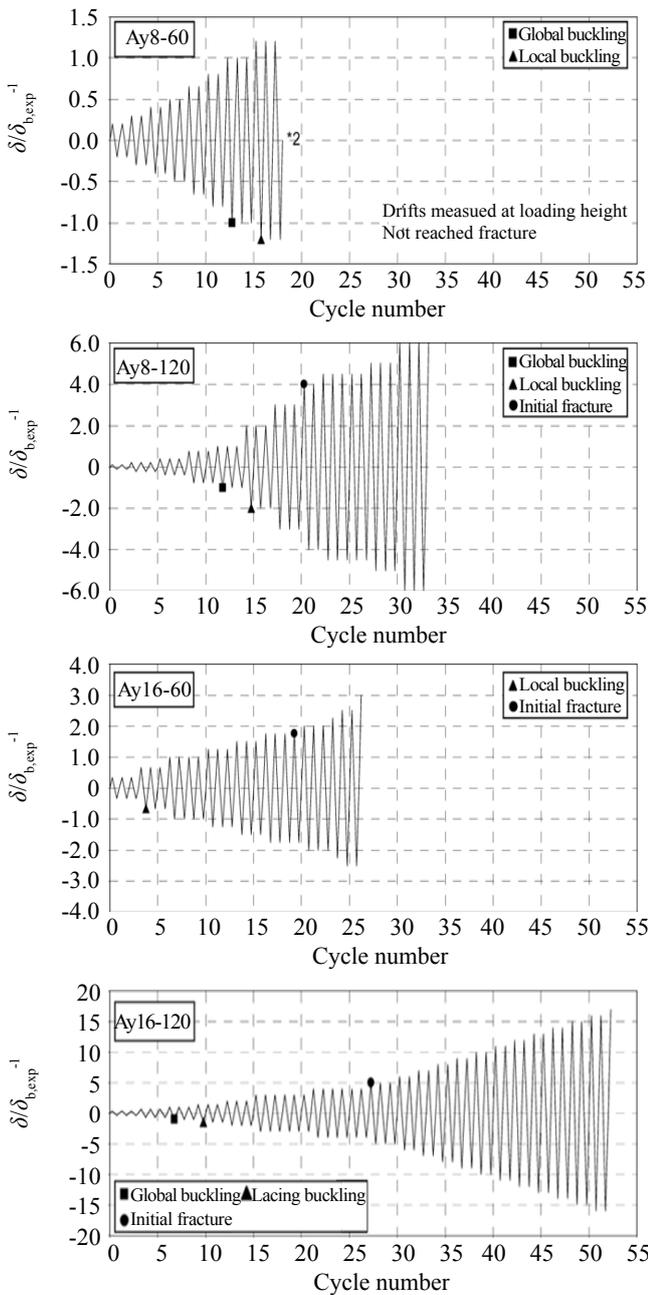
Fig. 7 Loading histories for specimens Ay

The experimental observations made during testing of the twelve specimens are presented in this section. The diagonal axial forces referred to in this section are converted from the horizontal forces applied by the hydraulic actuator, and diagonal axial displacements were directly measured by Temposonics displacement transducers installed diagonally. The hysteretic curves for three cross-section types (i.e., specimens Ay, By, and Bx), are presented in Figs. 4 to 6, respectively. The corresponding loading histories are shown in Figs. 7 to 9 to document the sequence of limit states reached

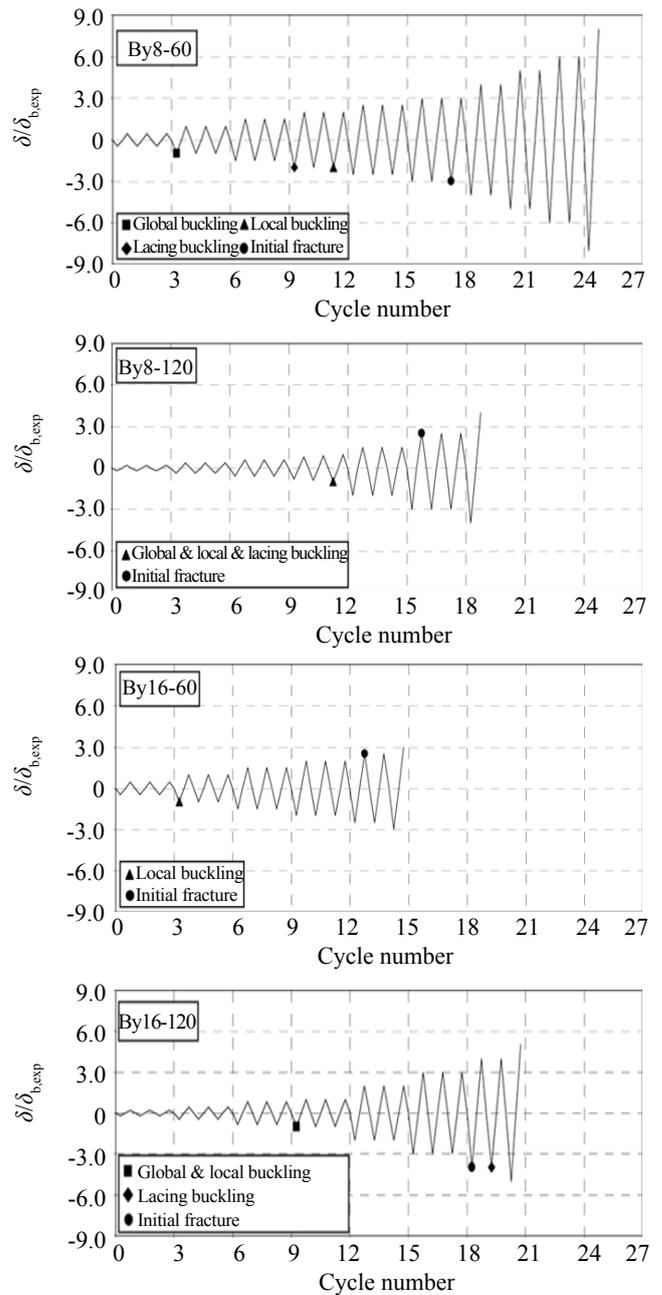
Fig. 8 Loading histories for specimens By

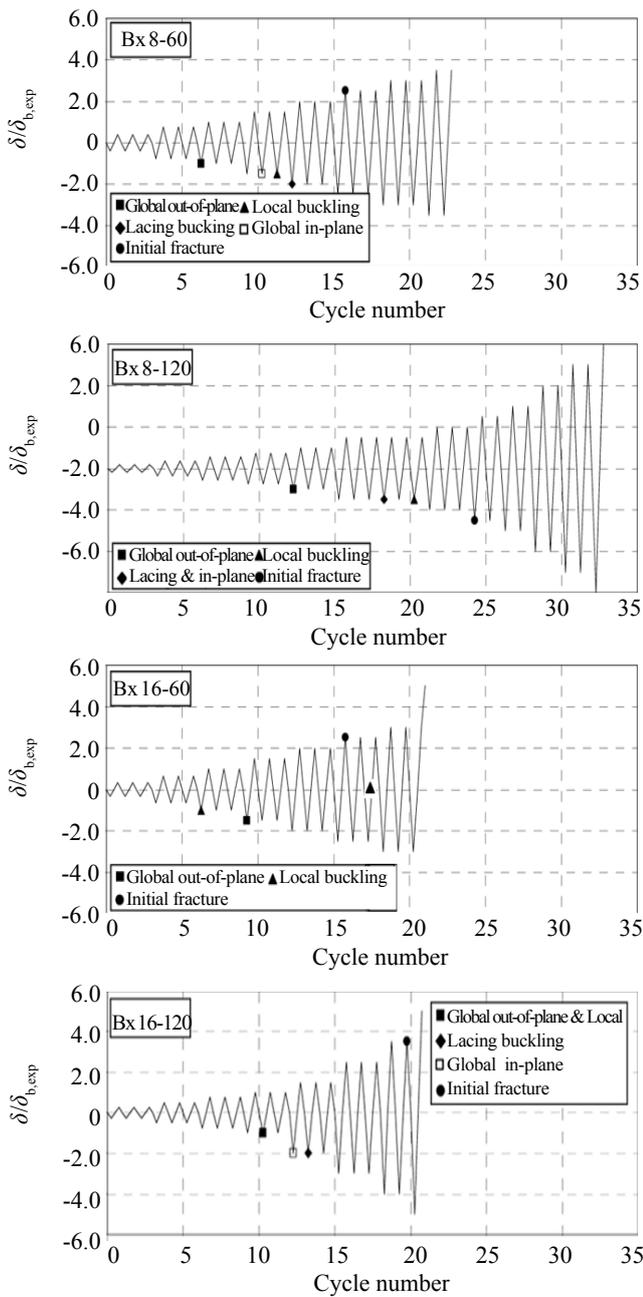
Fig. 9 Loading histories for specimens Bx

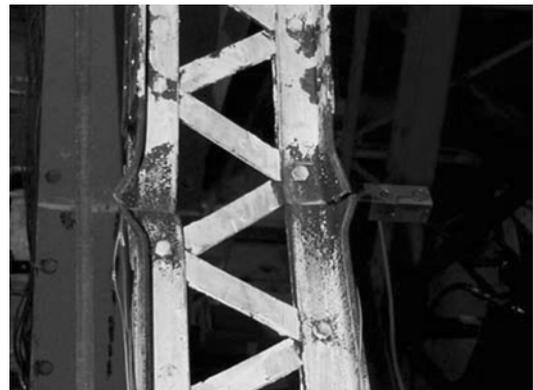
Fig. 10 Fractured shape of specimen Ay 8-120

During the first compressive cycle at $2.0 \delta_{b,exp}$, both the larger global and local bucklings were observed, at the location of initial buckling and near the mid-length brace plastic hinge, respectively. During the first tensile cycle at $4.0 \delta_{b,exp}$, initial fracture was observed on the upper angle at the global and local buckling location. Entire fracture of the specimen occurred at $6.0 \delta_{b,exp}$ and the fractured shape is shown in Fig. 10.

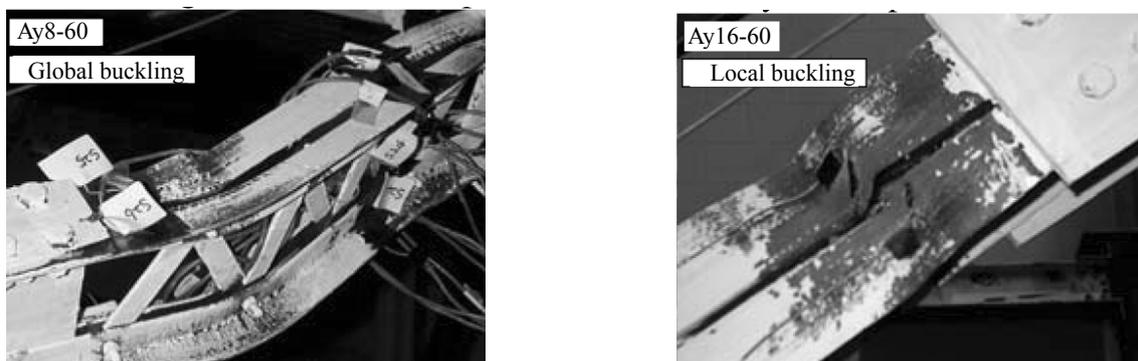
Fig. 11 Buckled shapes of specimens Ay 8-60 and Ay 16-60

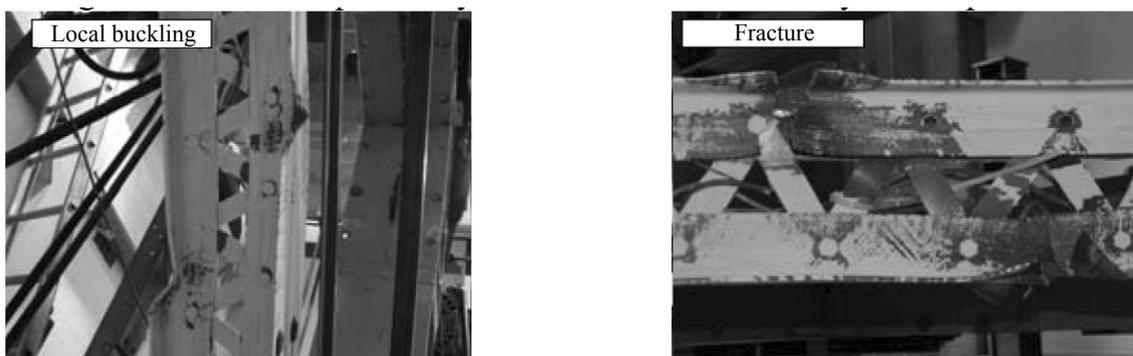
Fig. 12 Local buckling and fracture of specimen Ay16-120

During the first tensile cycle at $5.0 \delta_{b,exp}$, initial fracture was observed on the lower angle near the mid-length of the specimen and another local buckling was also observed on the upper angles near the North gusset-connection. At the loading cycles of $14.0 \delta_{b,exp}$,

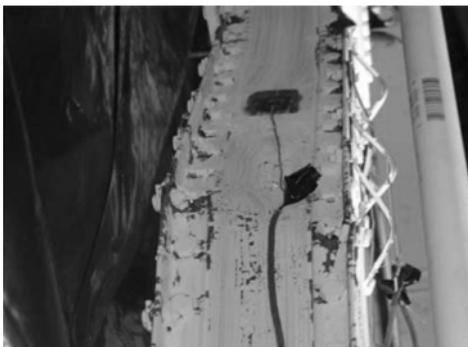
Fig. 13 Lacing buckling of specimen By 8-60

During the first compressive cycle at $2/3 P_H = 160.2$ kN corresponding to the $2/3 \delta_b$, the onset of global buckling was observed in the North segment of the specimen and the experimental buckling displacements, $\delta_{b,exp} = 3.6$ mm, were identified. During the first compressive cycle on the way to the target value of $1.5 \delta_{b,exp}$, global buckling occurred suddenly in the North segment of the specimen when the control displacement had only reached 4.3 mm. During the first compressive cycle at $2.0 \delta_{b,exp}$, lacing buckling on the North segment was observed. Lacing buckling gradually spread to the locations of the North segment during the second and third cycles at $2.0 \delta_{b,exp}$ as shown in Fig. 13. Lacing buckling caused the two channels that constituted the cross-section to move closer together, resulting in a smaller moment of inertia (I) for the specimen and consequently a greater drop in compression strength during compressive cycles. During the third compressive cycle at $3.0 \delta_{b,exp}$, initial fracture was observed on the lower angle near the 5th lacing from the top of the North segment. During the first tensile cycle at $8.0 \delta_{b,exp}$, entire fracture was observed at the initial fracture location.

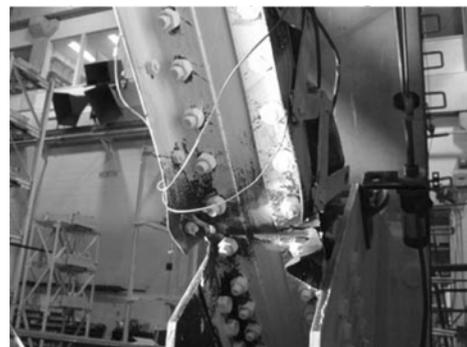
Fig. 14 Fractured shape of specimen By 16-60

Three loading cycles at $1.5 \delta_{b,exp}$ of the specimen were applied to better observe the local buckling. During the first compressive cycle at $1.5 \delta_{b,exp}$, local buckling on the tie-plates near the gusset-connection in the North segment of the specimen was observed and during the second compressive cycle, local buckling on the plates was so severe that bolts on the adjacent deformed upper and lower tie-plates came in contact. Initial fracture was observed on the lower angle near the gusset-connection during the first compressive cycle at $2.5 \delta_{b,exp}$ and during the first tensile cycle at $3.0 \delta_{b,exp}$, entire fracture was observed at this location as shown in Fig. 14.

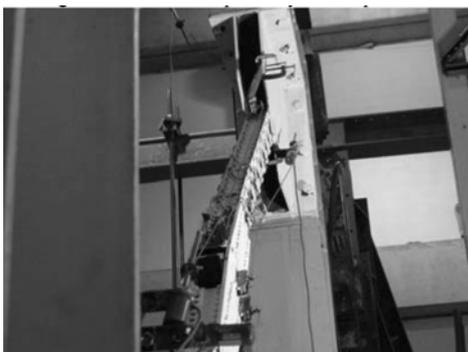
Fig. 15 Out-of-plane buckling of specimen Bx 8-60

During the first compressive cycle at $1.5 \delta_{b,exp}$, global out-of-plane buckling was observed in the South segment as shown in Fig. 15. However, during the second compressive cycle, the out-of-plane buckling behavior permanently changed into an in-plane mode of buckling. This buckling axis change into in-plane was observed during subsequent testing of all the Bx specimens, which were originally designed to develop out-of-plane buckling. Lacing buckling and lacing bolt failure due to shearing effect, which was initiated with in-plane buckling, was observed during subsequent loading cycles. Initial fracture on the lower angle near the gusset-connection of the South segment of the specimen was observed during the first tensile cycle at $2.5 \delta_{b,exp}$ and entire fracture near the middle connection plate of the South segment of the specimen was observed during the second tensile cycle at $3.5 \delta_{b,exp}$.

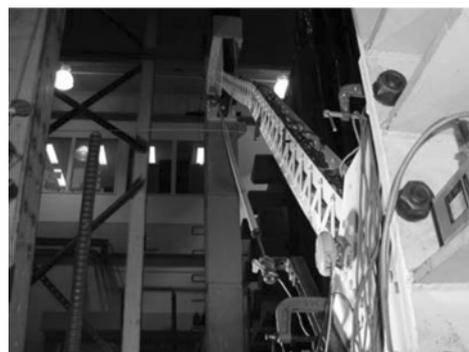
Fig. 16 In-plane buckling of specimen Bx 16-120

Three cycles at $1.5 \delta_{b,exp}$ in tension and $2.0 \delta_{b,exp}$ in compression of the specimen (i.e., unsymmetrical control displacements) were applied to prevent unexpected fracture during the following tensile cycle before significant buckling could be observed in compression. During the first compressive cycle at $2.0 \delta_{b,exp}$, local buckling on the upper angle near the South gusset-connection was observed at $\delta_b = 7.1$ mm and larger global in-plane buckling was observed at $\delta_b = 14.2$ mm as shown in Fig. 16. During the second tensile cycle at $4.0 \delta_{b,exp}$, initial fracture on the lower angle at the global buckling location and during the first tensile cycle, entire fracture was observed at this location.
