MULTI-HAZARD (BLAST AND SEISMIC) RESISTANCE OF VARIOUS TYPES OF BRIDGE COLUMNS

Keywords: Blast resistance, seismic resistance, bridge columns, composite columns, concrete-filled steel tubes.

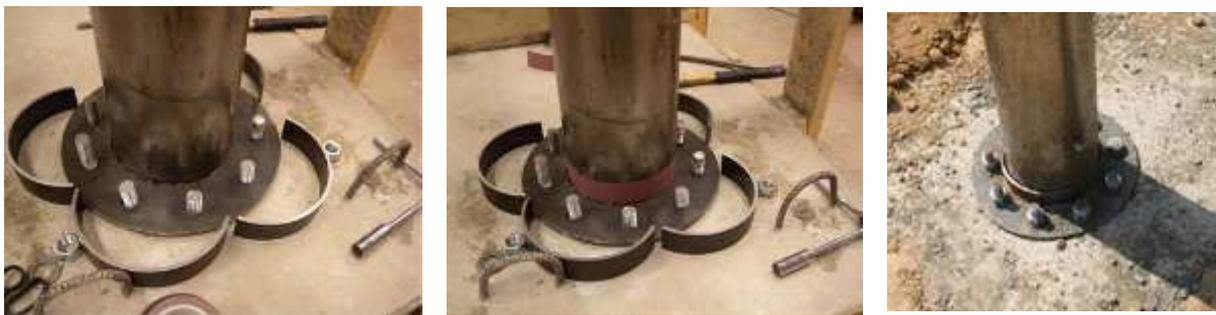
Figure 10: Steel Collar: Components (Left and Middle) and Construction (Right)

Structural steel collars were placed around the gaps and tied to the adjacent elements with post-installed anchors (as shown in Figure 10) to help increase the shear strength locally. A non-stick interface material was also inserted between the collar and the column to allow only smooth contact, thus increasing only shear strength while leaving flexural strength of the column virtually unchanged (as intended by the initial jacketing design).

The materials properties for the MSJC were the same as in Fujikura and Bruneau (2008). A 9.5mm A36 steel plate was used for the base of the collar, whereas the lip of the collar was cut from an A53 steel tube (216mm in diameter and 8mm-thick).

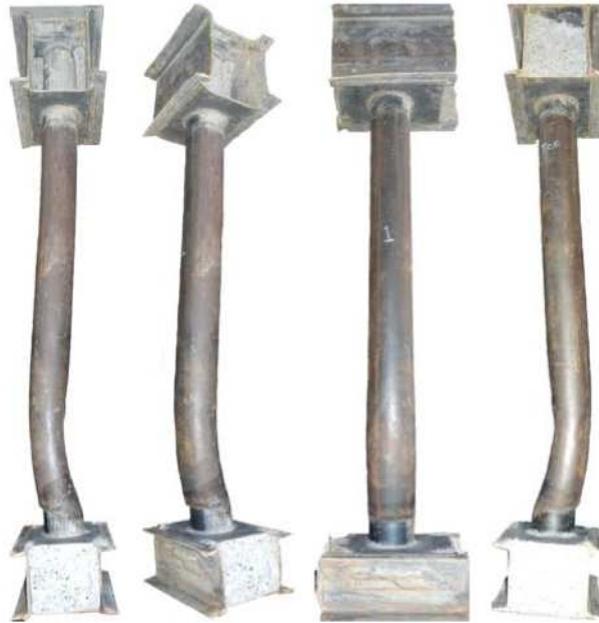
Figure 11: Plastic Deformation of CFST under Blast

The CFDST and MSJC column bents were tested under blast overpressures. Measured plastic rotations after the blast tests were well in excess of 2 degrees for CFDSTs and MSJC (Figures 11 and 12, respectively). For reinforced concrete columns, blast-induced plastic rotations of 2 to 4 degrees would lead to “moderate to heavy damage” (UFC, 2008) suggesting that repairs or complete replacement would be necessary. However, comparable test results for both CFDSTs and MSJCs showed that repair would be needed for aesthetical reasons only, and that the deformed columns would be able to perform their functions. For more severe blast charges, plastic rotations in excess of 4 degrees were accompanied with moderate to important local denting of CFDST section and, in one case, seam failure of MSJC’s jacket. For near contact charge condition (defined here as a scaled distance below $0.5\text{ft}/\text{lb}^{1/3}$), fracture of the outside tube of the CFDST occurred, but the inner tube prevented complete failure of the columns.
