MCEER RESPONSE

POST-TSUNAMI URBAN DAMAGE SURVEY IN THAILAND USING THE VIEWS® RECONNAISSANCE SYSTEM

Shubharoop Ghosh, Beverley J. Adams, Charles K. Huyck, Michael Mio, Ronald T. Eguchi, Fumio Yamazaki and Masashi Matsuoka

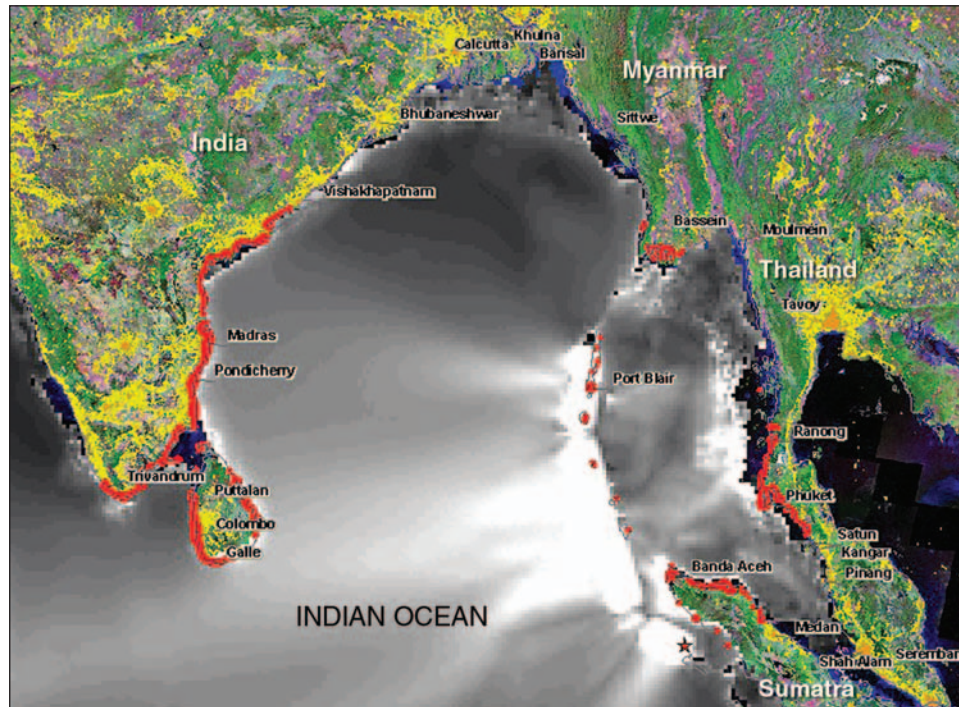
Figure 1 shows results of the preliminary assessment, using satellite imagery to identify areas of potential devastation. This figure was developed by cross referencing population data from NOAA's (National Oceanic and Atmospheric Administration) DMSP sensor (in yellow and orange) with wave height modeled by Vasily Titov (NOAA, 2005) and proximity to the coastline. The resulting zones of potential damage (in red) were used to prioritize areas for field investigation, and the acquisition of high-resolution satellite images from DigitalGlobe.

Figure 1. Assessment of potential devastation to coastal populations from the Indian Ocean tsunamis, using satellite imagery. Population data from NOAA's DMSP sensor is shown in yellow and orange. Areas marked in red are zones of potential damage.

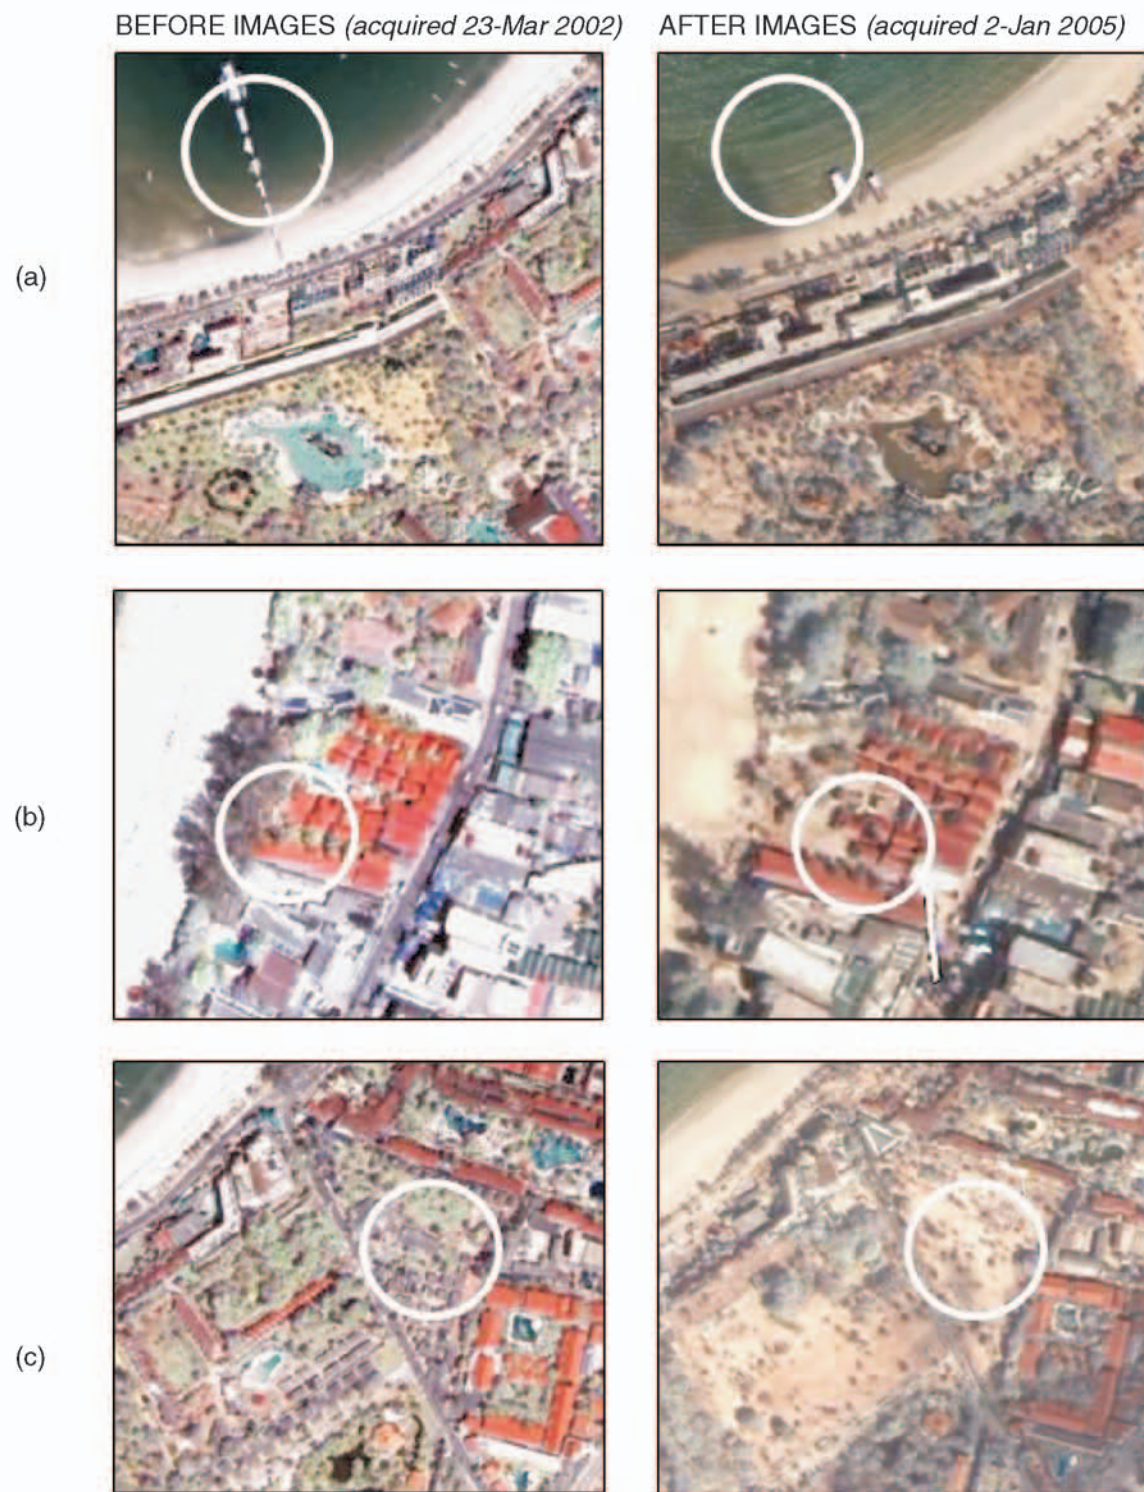
Figure 9. Selected examples of pre-event and post-event satellite imagery for Phuket: (a) Changes in color of water in water bodies and missing pier in after image; (b) Beach front damage to hotel units in after image; (c) Major change in urban development (it is difficult to infer whether this is due to tsunami damage or cleared for urban re-development due to the large difference in acquisition date between" before" and "after" images).

Figure 9 (continued). Selected examples of pre-event and post-event satellite imagery for Phuket: (d) Debris evident in hotel complex; (e) Changes in beach and stream configuration in after image; (f) Major change in urban development (it is difficult to infer whether this is due to tsunami damage or cleared for urban re-development due to the large difference in acquisition date between "before" and "after" images).

- Wash-over of sea water has filled swimming pools and other water bodies in many areas. These look murky green rather than blue [see Figure 9(a)].
- A pier in the "before" imagery has been washed away in "after" imagery [see Figure 9(a)].
- Wash-over of sand has caused a change in road color from grey to brown [see Figure 9(b), 9(c), 9(d)].
- Beach front damage to hotel units. Some are completely destroyed. [see Figure 9(b)].
- Major change in urban development. In some cases, it is difficult to infer whether this is due to tsunami damage or cleared for urban re-development due to the large difference in the acquisition date between "before" and "after" images [see Figure 9(c) and 9(f)].

- Debris evident in hotel complexes in coastal areas [see Figure 9(d)]
- Change in beach and stream configuration [see Figure 9(e)].

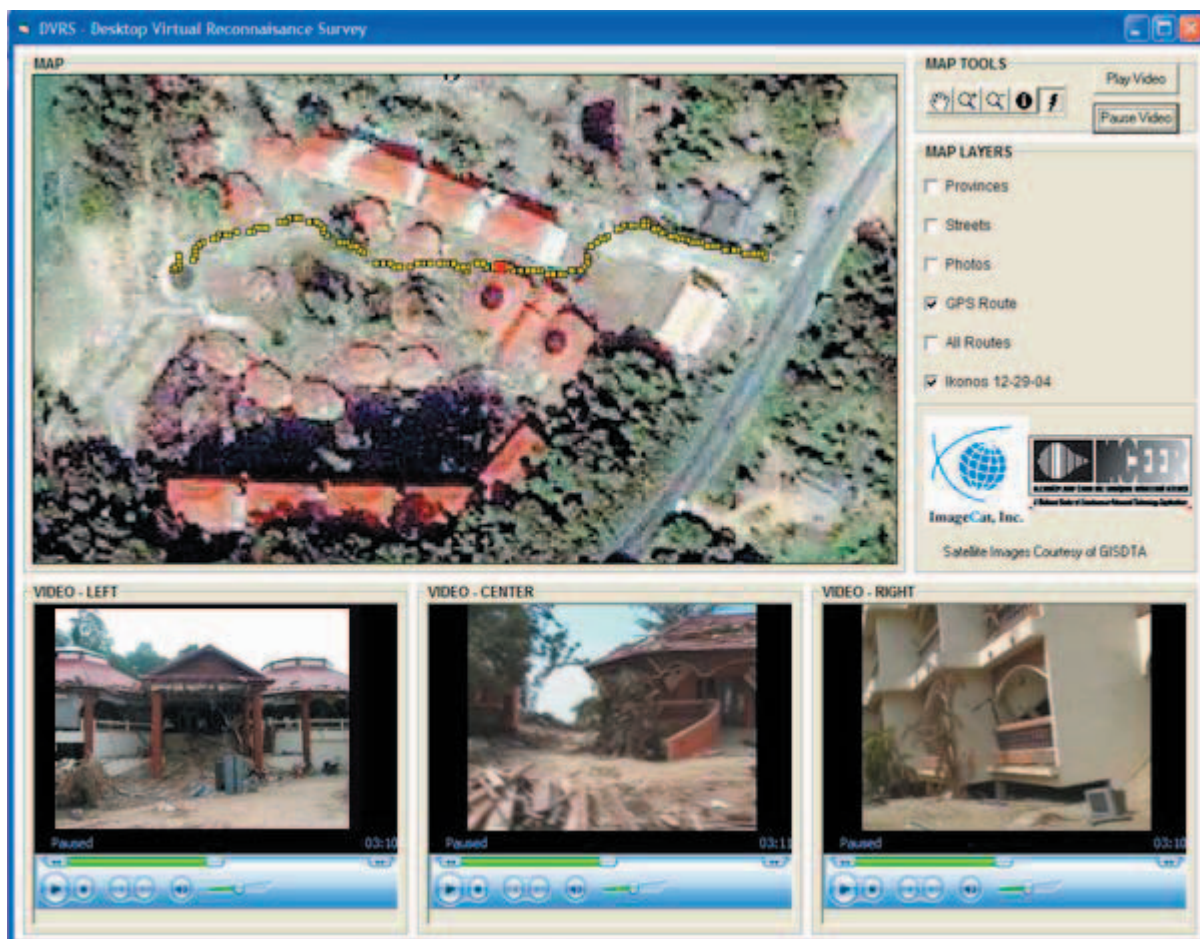
Figure 10. Screen shot from the D-VRS virtual reconnaissance system, showing satellite imagery, GPS readings, and video footage from three video cameras collected in Phang Nga, Thailand.

In addition to the uni-directional visualization for this study, a multi-look angle version of the D-VRS interface was developed. From Figure 10 (see page 13), three windows (front, left, and right) play video footage from the three cameras that were simultaneously deployed within heavily affected areas. This video collection and visualization process provides an enhanced field of view.
