The Marmara, Turkey Earthquake of August 17, 1999: Reconnaissance Report

Technical Report MCEER-00-0001
March 23, 2000

Edited by
Charles Scawthorn¹

Technical Report MCEER-00-0001

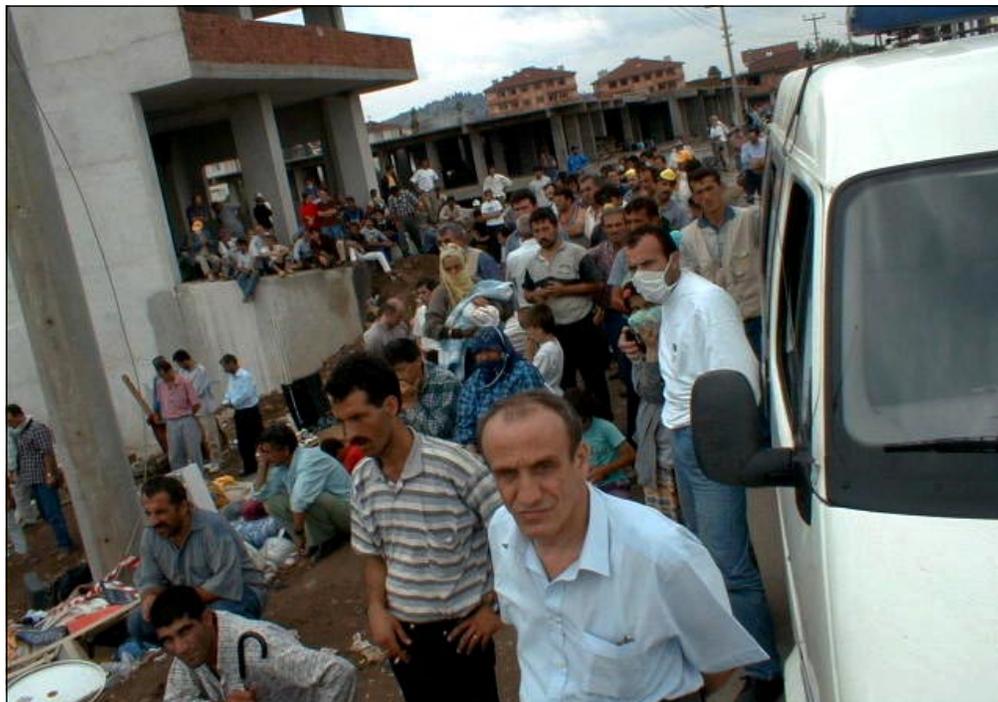
Figure 1-1 Crowd observing a rescue on Aug. 24 east of Gölcük – asked to remain silent and motionless so that rescuers can listen for the victim, buried in a 'pancake' collapse

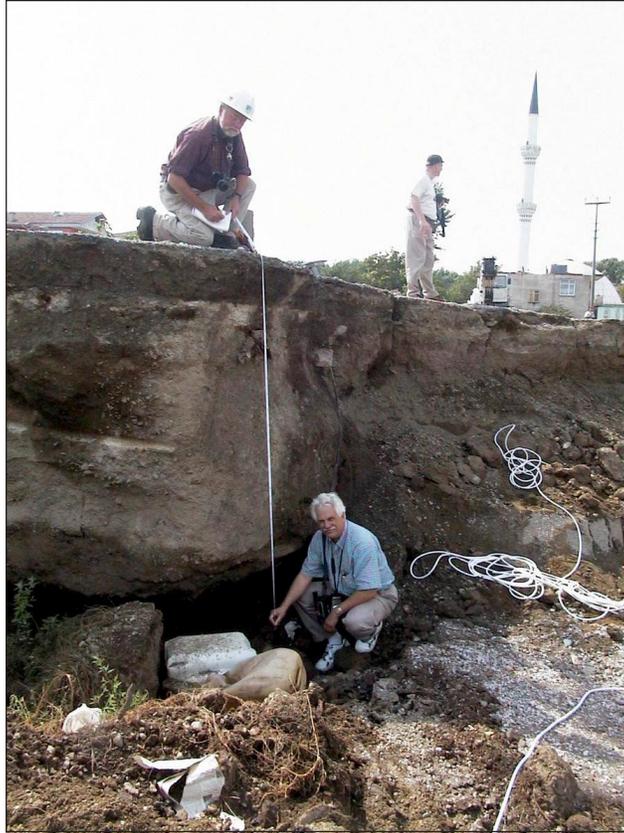
Figure 2-7 Approximately 2.2 m vertical offset measured on main fault, Gölcük

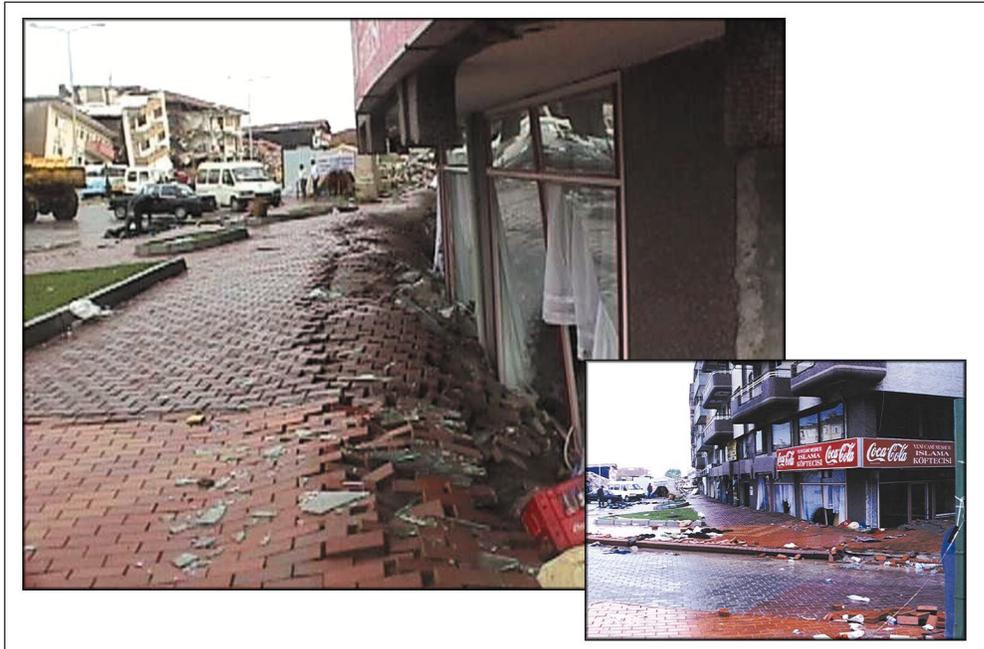
Figure 3-3 Building in Adapazarı that sank 1.5 m uniformly into the ground when the soil beneath it liquefied and was pushed outward from beneath the building. Magnitudes of sinking were generally proportional to weight of building.

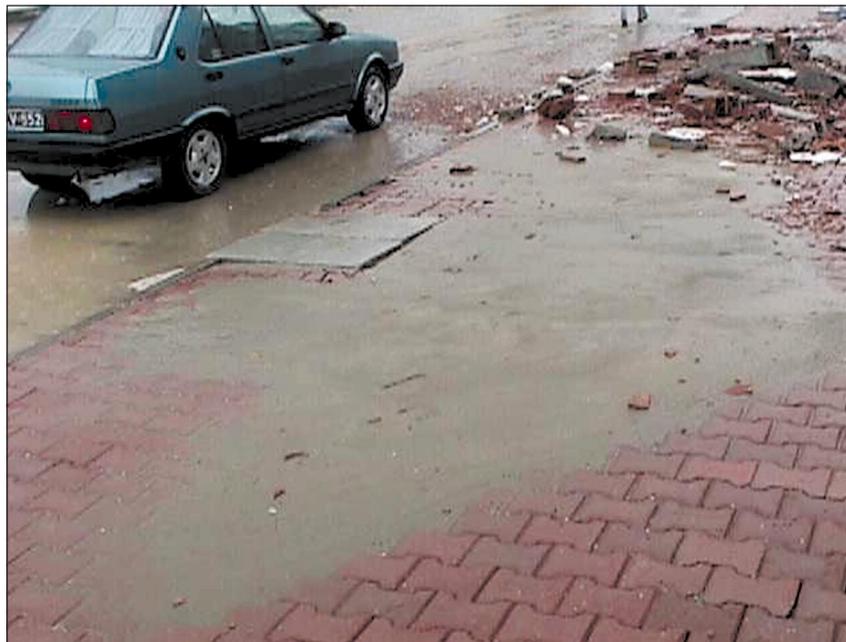
Figure 3-5 Sand boil on sidewalk in Adapazarı. Sand ejected from underground when sandy soils beneath the ground-water table liquefied during the earthquake.

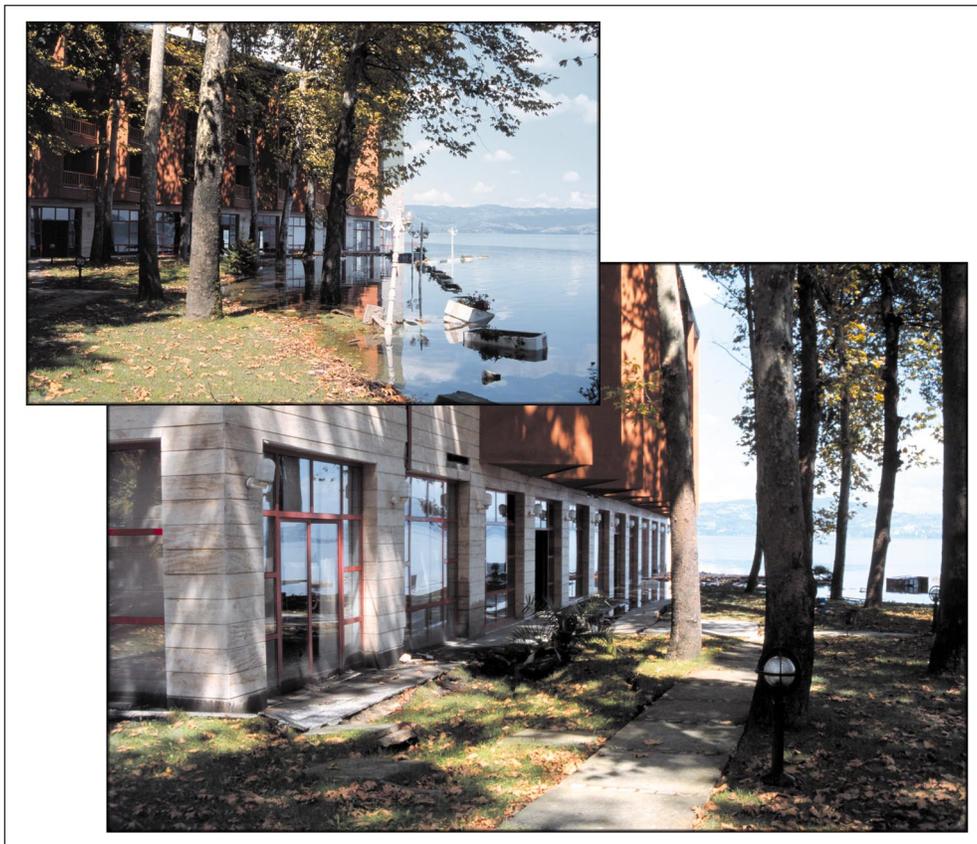
had prograded into Lake Sapanca, sank about 0.3 m into the ground. The regional land surface around the hotel also lowered causing the shoreline to submerge (Figs. 3-6, 3-7). In addition, the hotel was displaced about 0.5 m toward the lake by a lateral spread along the shoreline of the lake. Large quantities of subsurface sand vented to the surface and covered much of the driveway and the landscaping around the hotel.

Figure 3-6 Submergence of shoreline at Lake Sapanca and settlement of Sapanca Hotel. "Moat" adjacent to wall indicates the hotel has sunk into the ground because of liquefaction of underlying sandy soil.

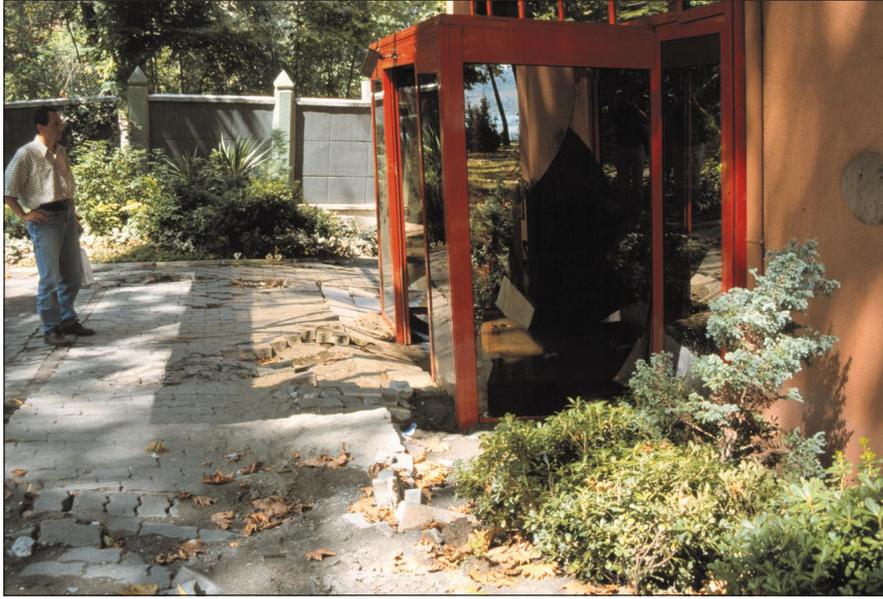
Figure 3-7 Sunken entryway into Sapanca Hotel created when building sank into liquefied soil

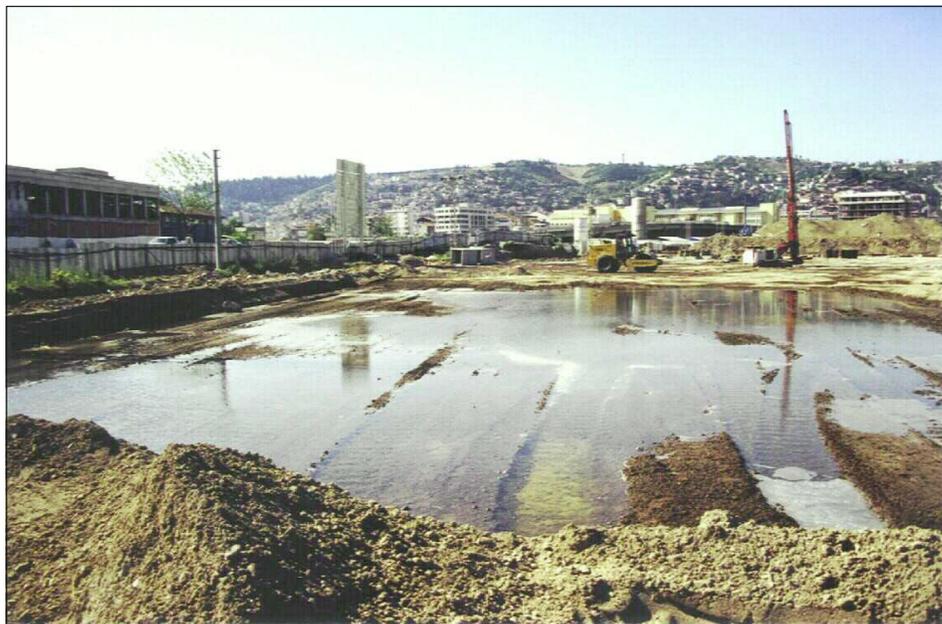
The Lot C area was found inundated with water the morning following the earthquake, as may be seen in Figure 3-9. Field inspection supported the conclusion that the surface water was discharged from the wick drains as a result of the seismically induced pore pressure generation leading to liquefaction of the sand layer. By comparing settlement readings obtained immediately before and following the earthquake, the seismically in-

Figure 3-9 Lot C area of Carrefour site showing ground surface inundated with water following the morning of the earthquake. Water is attributed to pore pressure buildup and subsequent drainage of the underlying loose sand layer through wick drains that were in place at the time of the earthquake.

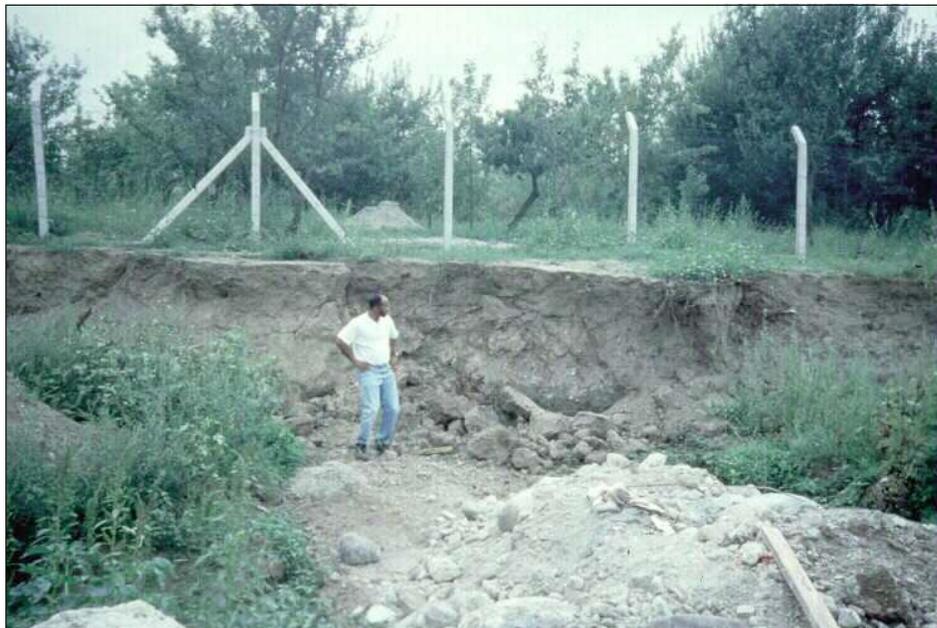
Figure 3-10 Vertical displacement of approximately 2.5 meters due to fault movements adjacent to the Ford-Otosan Plant east of Gölcük

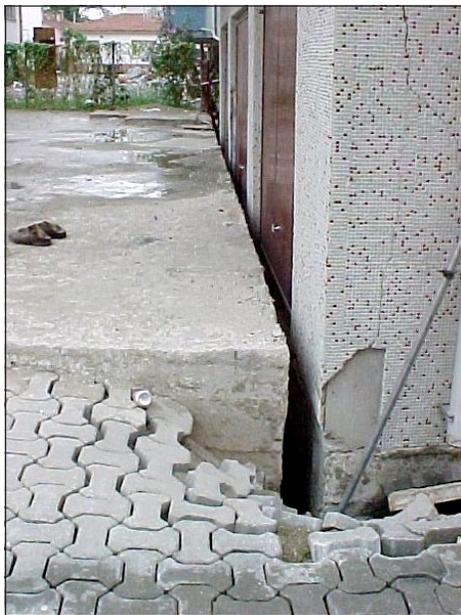
3. Shallow foundation movements were associated with three types of soil deformation, in the following decreasing order of frequency:
 - Settlement due to volume change. Settlements of up to about 50 cm were observed, with no evidence of soil bearing failure. Fig. 3-11 is an example of this type of behavior.
 - Bearing failure. Heave of the ground surface was observed in areas around the building or of interior floor slabs. Fig. 3-12 is an example of this type of failure.
 - Lateral movement. This was essentially a rigid body type displacement. The largest observed movement in Bray and Stewart's study, shown in Fig. 3-13, was 44 cm settlement, 50-55 cm laterally to the west (away from the sidewalk) and 100 cm laterally to the south (away from the photographer).

Figure 3-11 Example of building settlement in Adapazarı due to volume change of liquefied soil. Near vertical settlement of 48 cm was measured at the corner of the building.

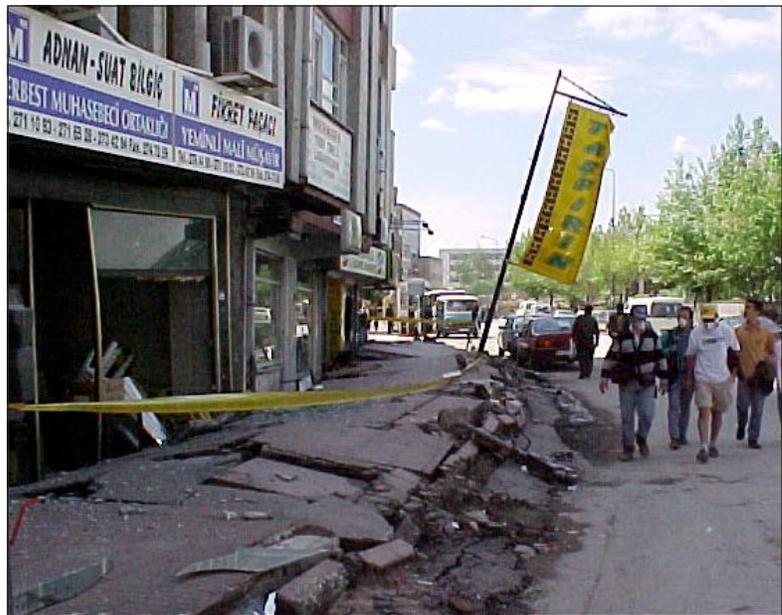
Figure 3-12 Example of settlement in Adapazarı as a result of bearing failure of the foundation soil as evidenced by ground heaving adjacent to the buildings

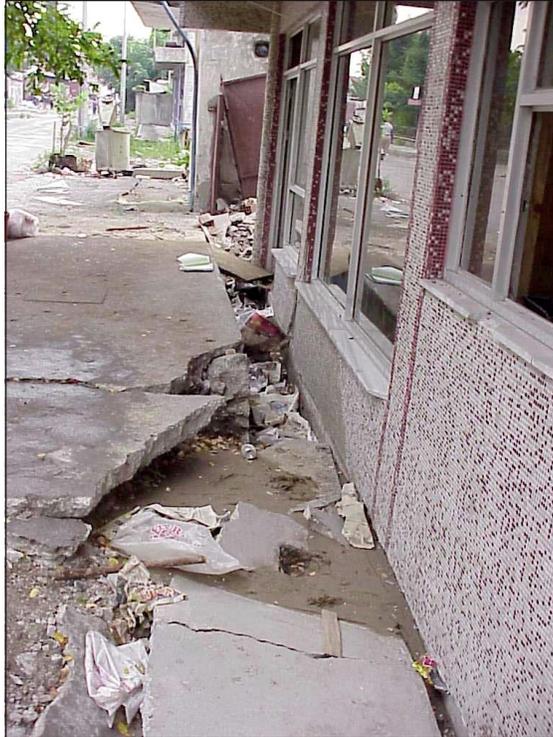
Figure 3-13 Building that experienced about 100 cm of lateral displacement

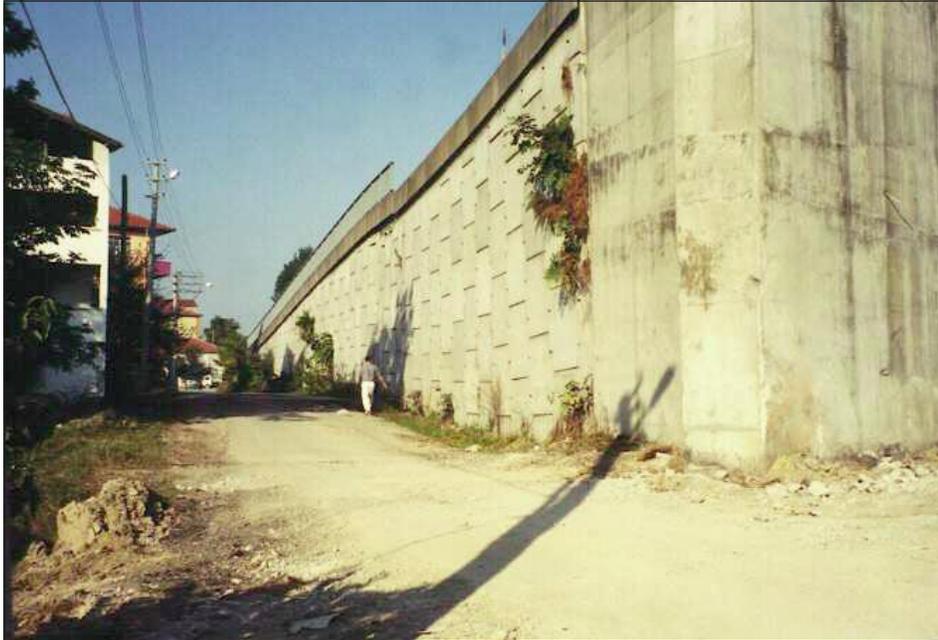
Methods of ground improvement that had been used for the different projects included preloading, wick drains, jet grouting, stone columns, compacted fills and earth reinforcement. Overall, the ground treatment and soil reinforcement were generally effective in mitigating earthquake-induced damage, especially liquefaction related ground movements. The fault rupture crossed the site of the Arifiye bridge (see Fig. 3-15) producing large displacements, of the order of 3.5 m laterally and 0.45 m vertically, and causing collapse of the four simple spans crossing the TEM. In spite of these large movements, the distorted reinforced earth abutments retained their integrity and did not fail, as may be seen in Fig. 3-16.

Figure 3-16 Reinforced earth wing walls and bridge abutment for the Arifye Bridge overpass. The reinforced earth structure retained its integrity in spite of the large deformations.

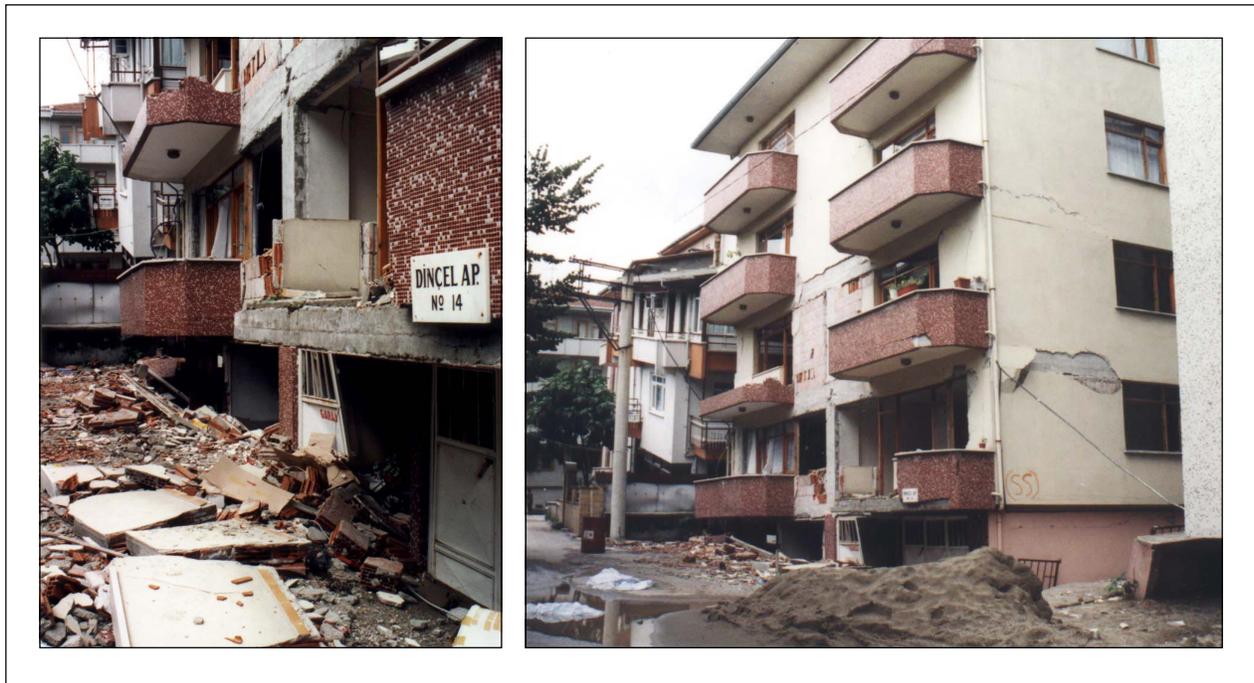
Figure 4-1 Damage due to foundation failure

An example of severe settlement is shown in Figure 4-1. Taking the distance from balcony to balcony as a reference, one may observe the short-distance left between the second floor balcony and ground level. This provides a qualitative measure of the magnitude of settlement that occurred. Figure 4-2 also shows the extent of ground heave all around the building as the soil under the building is pushed outward during settlement.

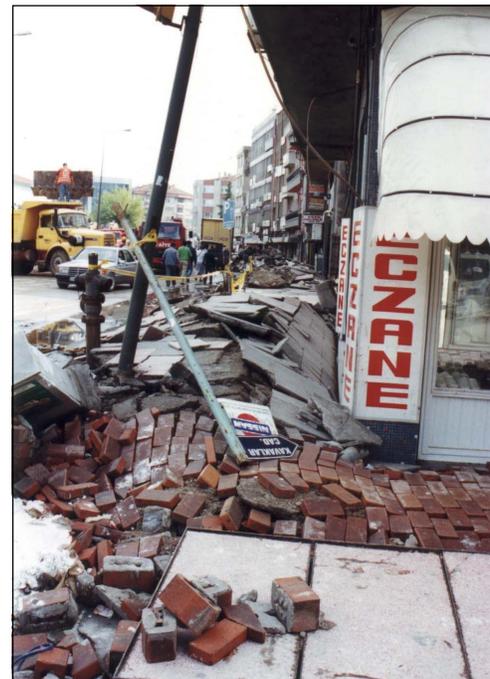
Figure 4-2 Ground heave was extensive all around this building

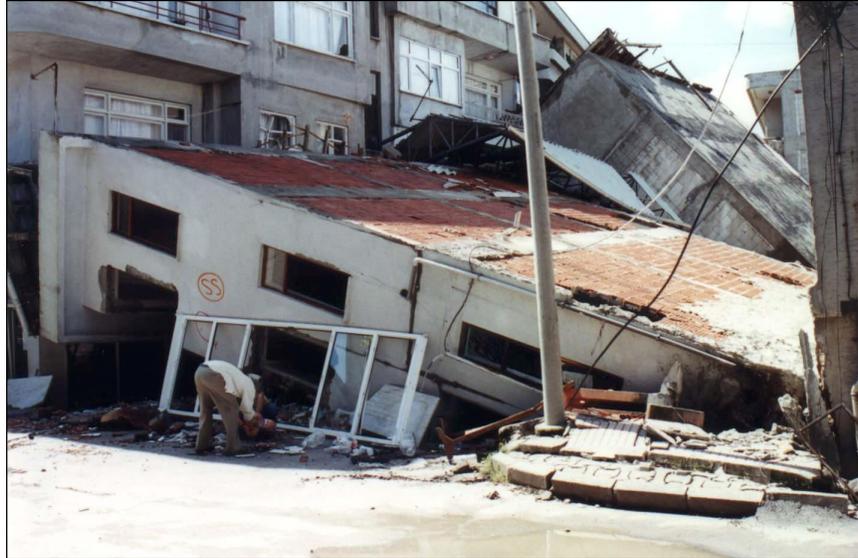
Examples of overturned buildings are shown in Figures 4-3 and 4-4. In the latter case, force vectors are superimposed on the building to illustrate its significant resistance to lateral loads (Figure 4-4b). As shown in that figure, the resultant weight of the structure, schematically located at the center of gravity of the above-ground portion of the toppled building, can be decomposed into its components perpendicular and parallel to the building's original vertical axis. Calculations indicate that the building, in its new

Figure 4-3 Overturned building due to foundation failure

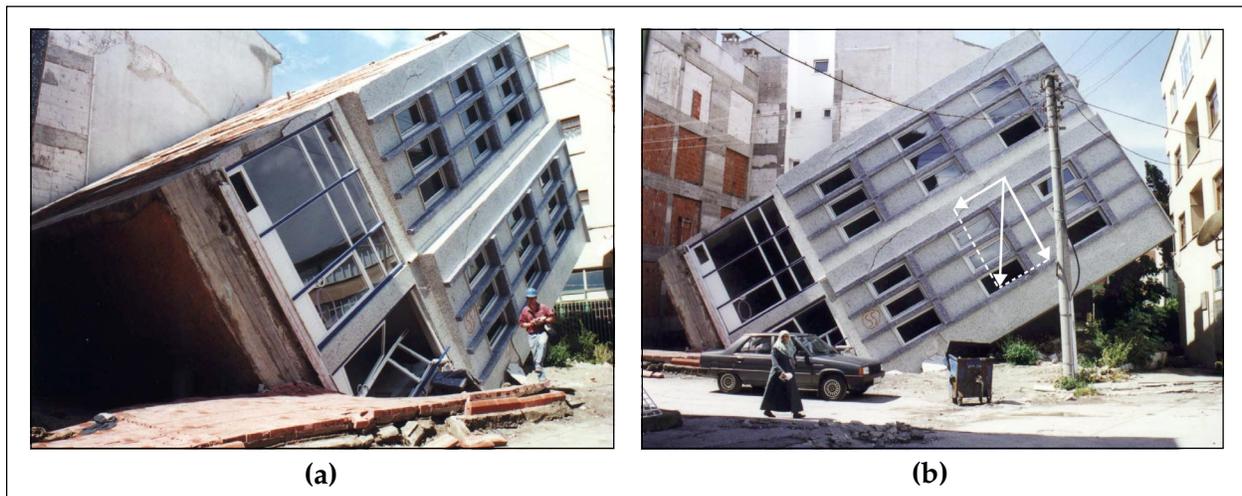
Figure 4-4 Overturned building due to foundation failure

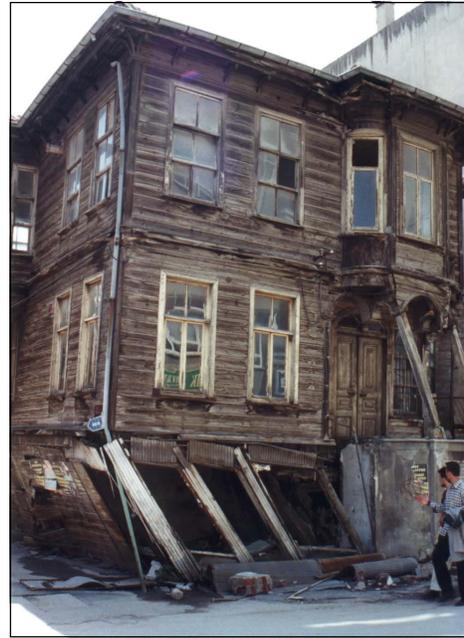
Figure 4-5 Failure of soft first story in a timber building

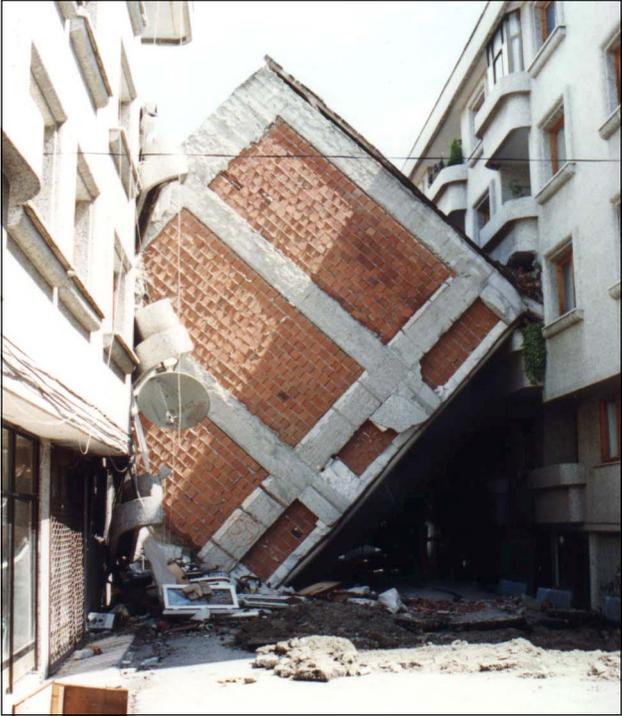
Figure 4-8 Failure of soft first story

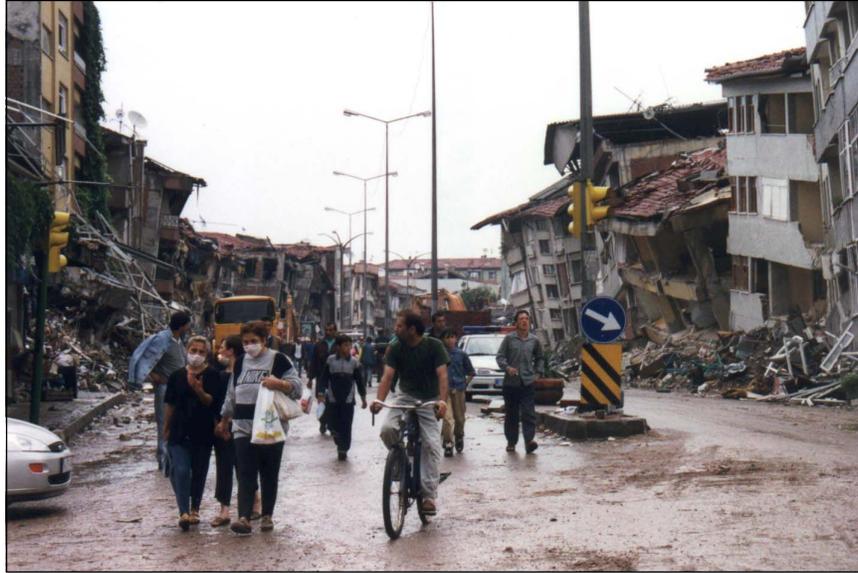
Soft-story buildings having open street facade and solid back-walls tend to collapse toward the street as a result of the torsional plan eccentricity. Story sway is greater on the more flexible facade side, resulting in greater displacement and ductility demands on the more vulnerable columns on the facade side (Figure 4-8). This was particularly evident on a commercial street where nearly all the buildings collapsed towards the street (Figure 4-9).

Figure 4-9 Buildings in this commercial area collapsed towards the street due to open facades (soft story) and walls on back side adding torsional eccentricity

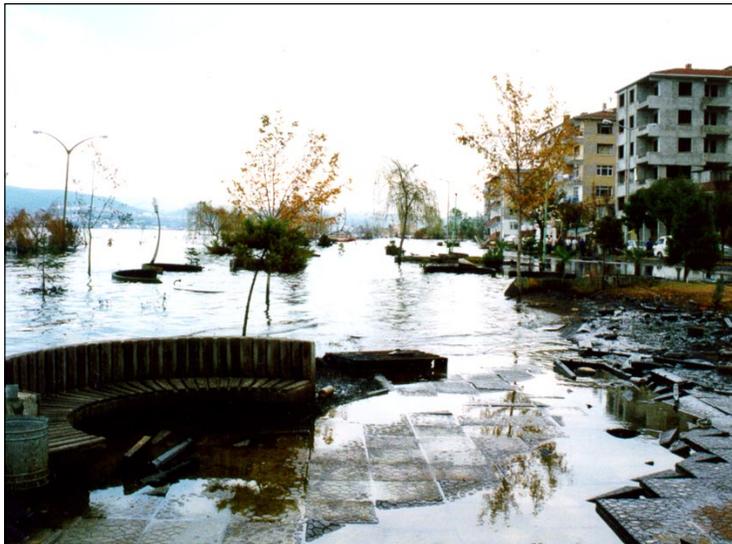
Soft-story failures combined with ground failures were also observed along the waterfront in Gölcük. As shown in Figure 4-10, the water of the Marmara Sea submerged parts of the waterfront as a result of ground lateral spreading. Some buildings located along the waterfront (e.g., Figure 4-11) were thus impacted by both geotechnical and structural deficiencies.

Figure 4-10 Marmara Sea submerged parts of the waterfront as a result of ground lateral spreading

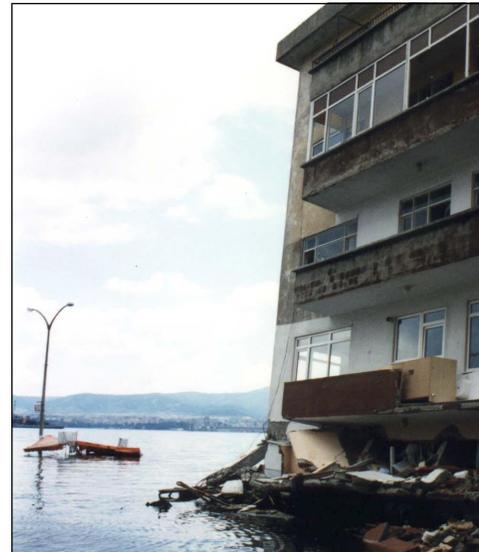
Figure 4-11 Some waterfront buildings were impacted by both geotechnical and structural failures

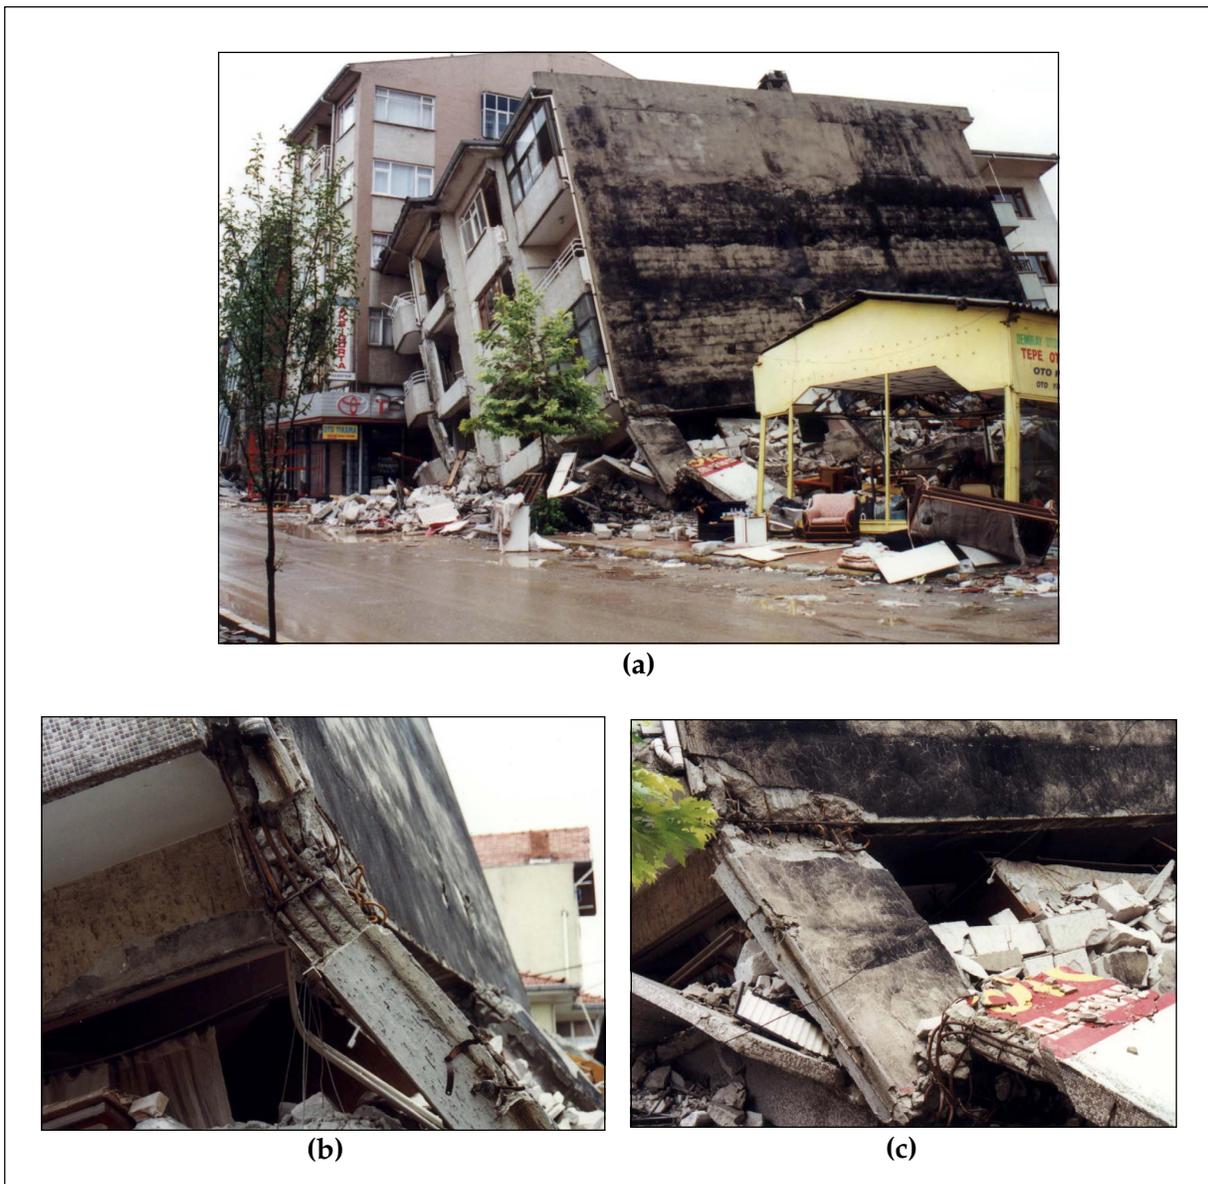
In most frame structures, the beams were strong and remained elastic, and the columns were weaker and suffered damage and failure in the form of compression crushing, plastic hinging, or shear failure. In many cases, relatively deep beams were used with flexible columns, contributing to a strong-beam weak-column behavior. This undesirable behavior is illustrated in Figure 4-12 and 4-13. In Figure 4-12, for example, the column depths are sizeable along the building alley sides, but they are narrow and thereby less able to resist by flexure the seismically-induced horizontal forces parallel to the front street, particularly when compared to the beam depth and strength at the story above. Not surprisingly, the building collapsed swaying in the direction of weakest column flexural strength.

Figure 4-12 Damage due to strong beams and weak columns

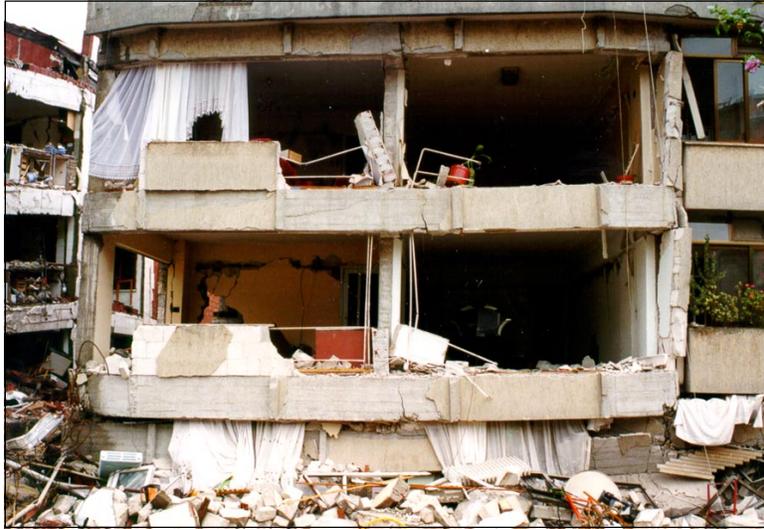
Figure 4-13 Damage due to strong beams and weak columns

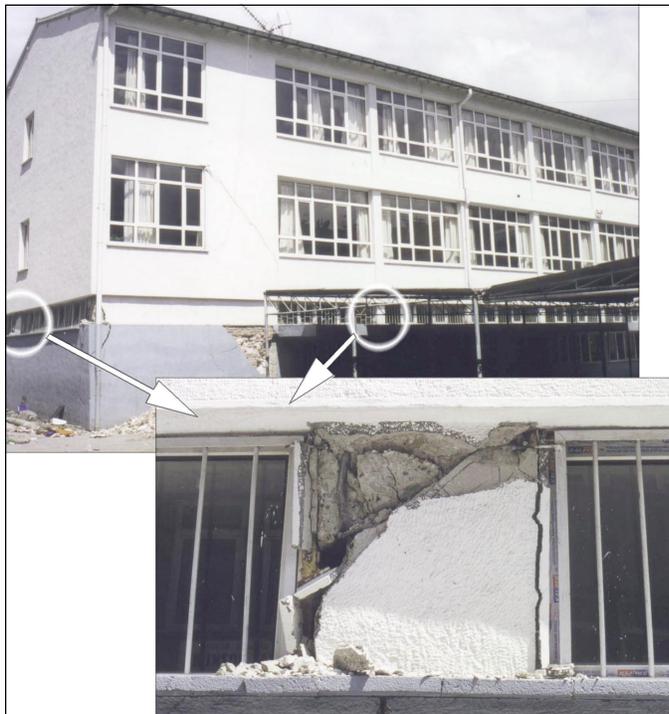
Figure 4-14 Damage due to short (trapped) columns

Column damage varied as a function of column geometry and detailing. Examples in Figure 4-14 and 4-15 illustrate shear failure in short captive columns “trapped” between partial height infills, and flexural failure in non-ductile reinforced concrete plastic hinges, respectively.

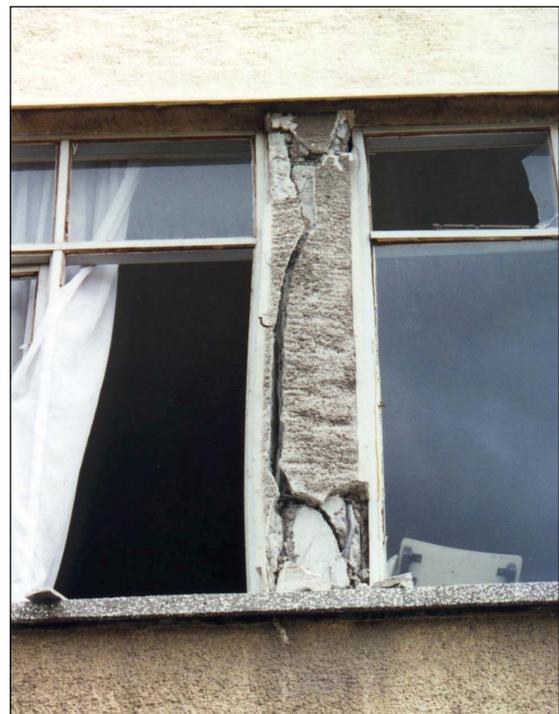
Figure 4-15 Damage due to flexural failure in non-ductile plastic hinges

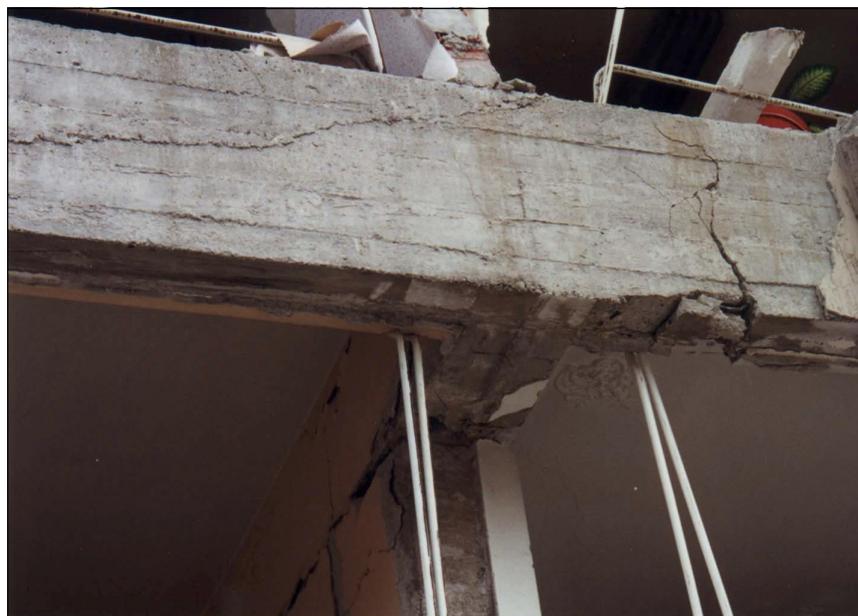
Most of the structural damage observed in frame buildings was concentrated at column ends. Unfortunately, confinement reinforcement was virtually nonexistent in these members, making them unable to maintain the required ductility. A number of detailing deficiencies were observed in the damaged structures. This included lack of anchorage of beams and columns reinforcement, insufficient splice lengths, use of 90° hooks, poor concrete quality, less than full height masonry infill partitions, and frequent combinations of many of the above. These errors were often compounded by geometric irregularities such as eccentric beam-to-column connections that induced severe torsion in short perpendicular stub beams (Figure 4-16).

Figure 4-16 Damage due to eccentric beam-to-column connections

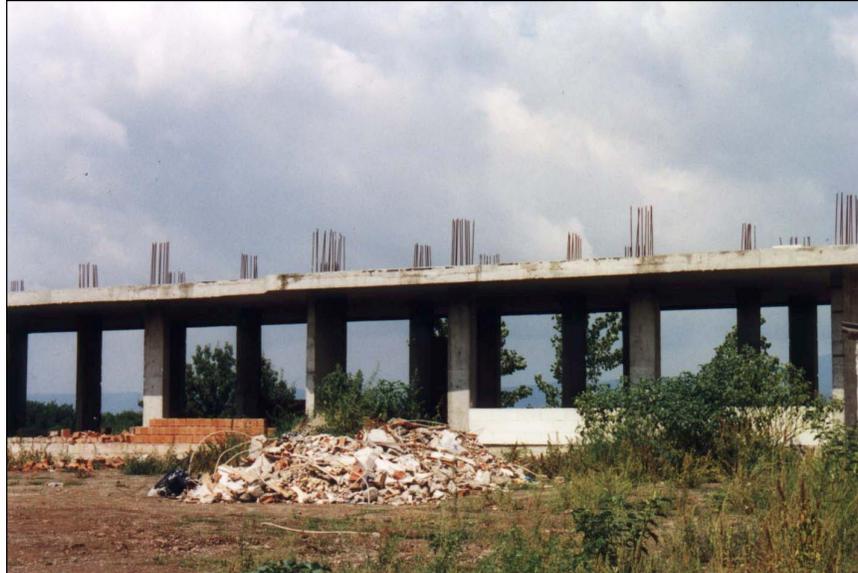
The construction sequence adopted in Turkey’s residential buildings is partly responsible for some significant failures due to lack of column reinforcement anchorage. Typically, residential buildings are constructed over a large number of years, one story at the time. Families do not wait for completion of the entire building prior to occupancy, and usually elect to live in the lower completed stories. Additional stories are added as the need arises. Figure 4-17 illustrates a one-story building during construction. Note the column vertical reinforcement extended above the roof line. Infill walls will be added to the first story and residents will move in, and this reinforcement will be left extending above the slab until the day (maybe years ahead) when construction will resume to add another story. As a result of this practice, and because smooth bars are frequently used, anchorage of the column

Figure 4-17 One-story building during construction with column bars extended above roof slab to accommodate possible construction of other stories in future years

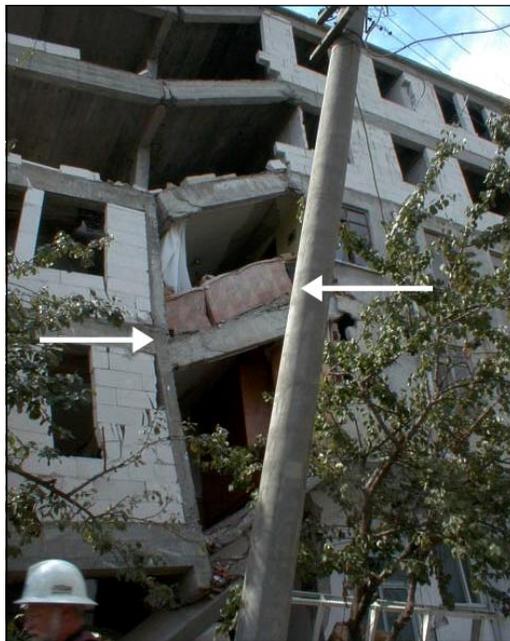
A number of buildings sitting directly on the fault were also destroyed by the relative movements of the fault (Figure 4-19). However, numerous buildings immediately adjacent to the fault survived without structural damage. For residential buildings, this is generally attributable to the additional strength unintentionally provided by the infills, as indicated previously. Industrial buildings similarly located, however, survived on the merit of their explicit design. For example, an industrial complex being constructed 100 feet from the fault had very well confined columns. Extensive ground settlements induced large structural permanent displacements to parts of the structure, but damage was generally limited to minor spalling as the spacing of the column's transverse reinforcement was adequate to ensure ductile behavior (Figure 4-20).

Figure 4-19 Collapsed five story building intersected by faulting. Arrows show where fault intersected the building, with attendant differential settlement.

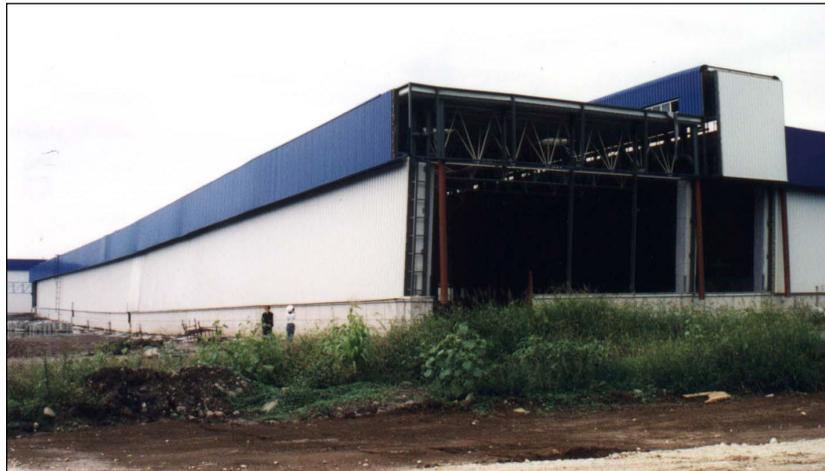
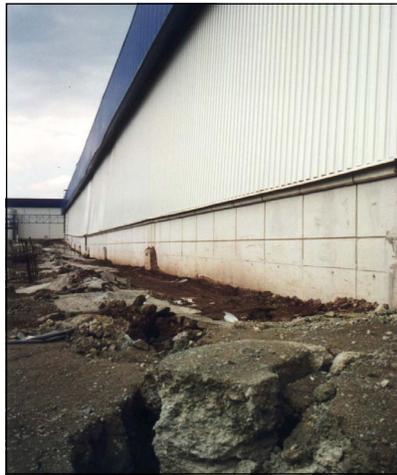
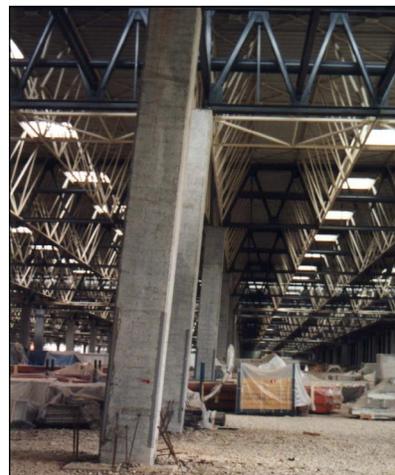
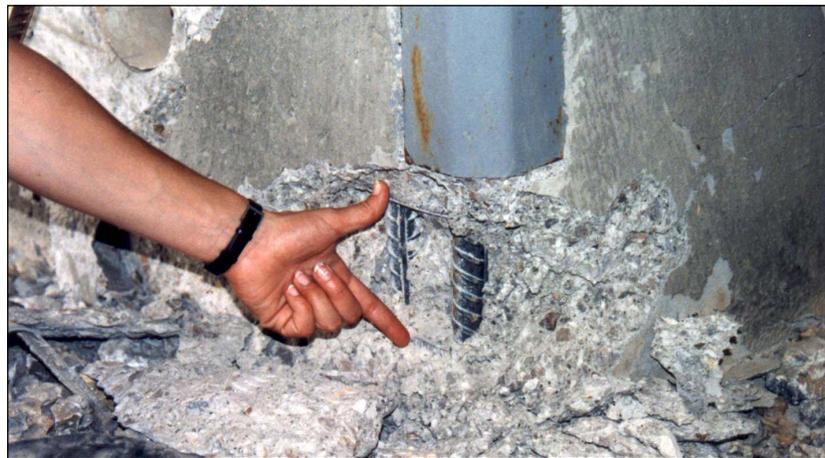
Figure 4-20 Industrial facility near the fault: (a-b) Global views of damage due to large ground settlements; (c-d) leaning column with limited damage at base as a result of ductile details (spacing of transverse reinforcement is indicated by thumb and index fingers)

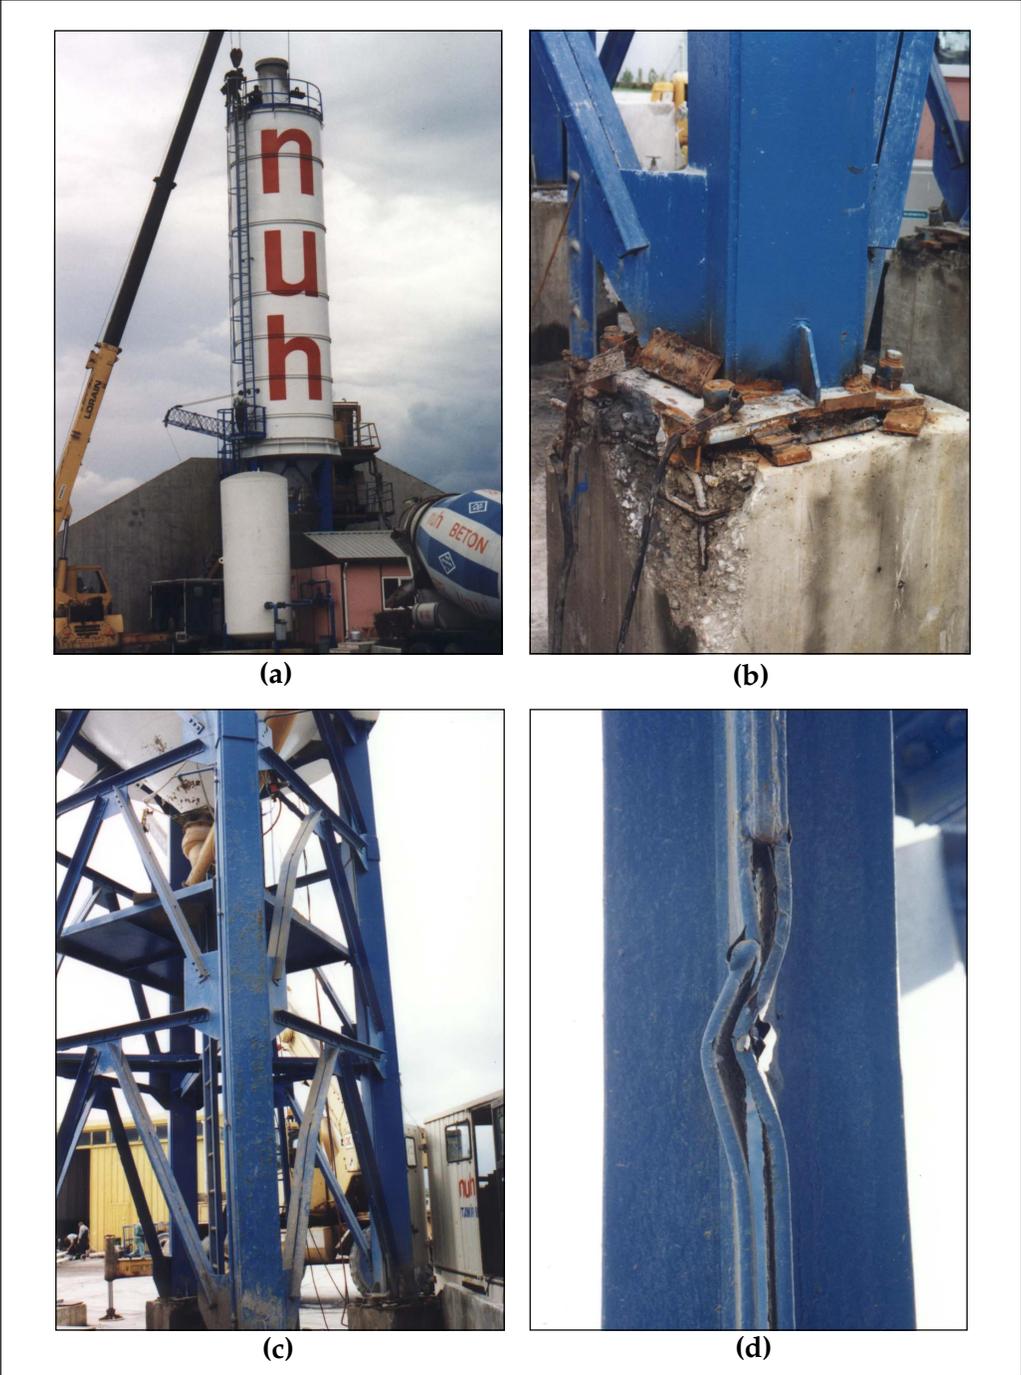
An interesting comparison between ductile and non-ductile steel details for nearly identical structures is shown in Figures 4-21 and 4-22. In Figure 4-21, the anchor bolts of the tank supports of the NUH concrete producing facility yielded in tension, and concrete of the 2.8 m deep pedestals spalled under the compression impact. Although this is not a ductile detail, the braces would be in partial compliance with the AISC seismic design provisions.

Figure 4-21 Damage to steel structures at NUH concrete plant: (a) global view; (b) spalled pedestal; (c) global buckling of braces; (d) local buckling at brace mid-length

The 2,400 mm long braces are 2L80x80x8 back-to-back 10 mm from each other with batten plates at the 1/3 points, resulting in members having slenderness KL/r of 97 and b/t of 10; note that the AISC limits for ductile concentrically braced frames are 101 and 7.35 respectively for Grade 50 steel, 120 and 8.7 for Grade 36 steel. Connections were also stronger than $A_g F_y$ of the members. Hence, these braces partially met (intentionally or not) the AISC 1997 requirements for ductile concentrically braced frames (DCBF). Inelastic action developed in

the braces, allowing ductile structural response through dissipation of hysteretic energy in a stable manner, with the exception of the deficient anchor bolts detail and somewhat premature local buckling, and the braced frame survived. Global brace buckling, and local buckling at the brace mid-length plastic hinge (Figure 4-21d) illustrate this ductile plastic response. Also typical of braced-frame with Chevron brace configurations, buckling of the diagonal in compression occurred prior to yielding in tension; this led to force redistribution within the structure and resulted in plastic hinging at mid-span of the horizontal member and slight permanent vertical deformations was visible at that point. This typical mechanism of Chevron braced frames is well known and explained in greater detail elsewhere (Bruneau et al., 1997).
