The Marmara, Turkey Earthquake of August 17, 1999: Reconnaissance Report

Technical Report MCEER-00-0001
March 23, 2000

Edited by
Charles Scawthorn¹

Technical Report MCEER-00-0001

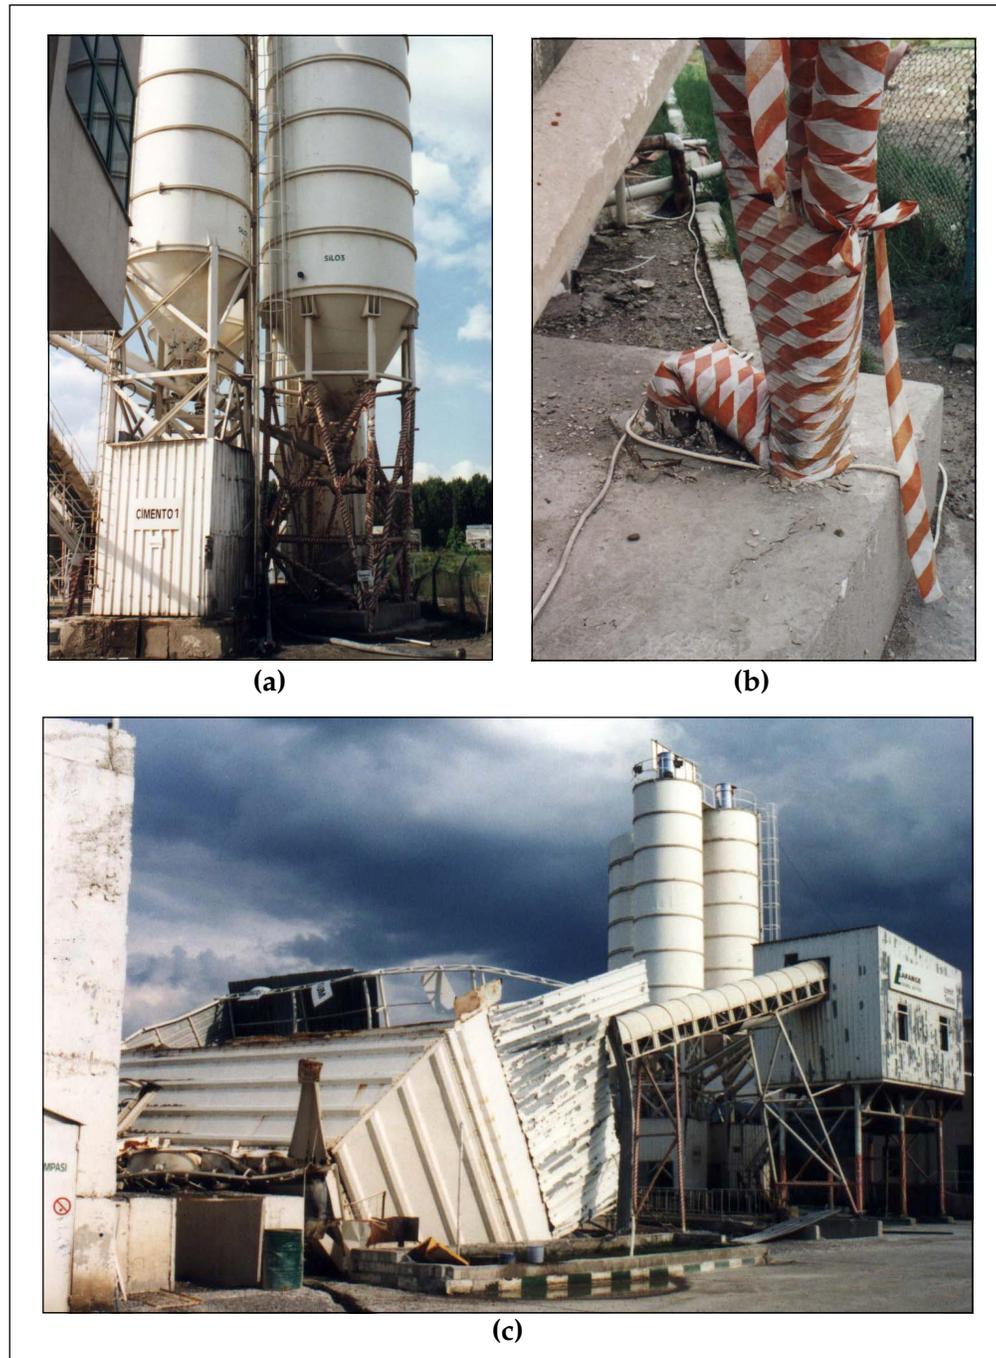
Figure 4-22 Damage to steel structures at Lafarge concrete plant: (a) global view; (b) buckled leg; (c) overturned sand bin.

By comparison, structures serving the same purpose at the Lafarge concrete plant suffered excessive damage. In this case, all members of the braced towers were hollow structural circular steel members, 150 mm in diameter and approximately 3 mm thick, for a resulting D/t slenderness ratio of 50, greatly in excess of the limit of 26 imposed for Grade 50 steel braces by the aforementioned AISC seismic provisions. However, braces did not buckle in this particular case. Because the lower brace was connected to the tower leg 16" above the base, the tower behaved as a rigid braced structure supported on a 16" tall moment frame, and the tower leg buckled at that location under the combined axial and flexural stresses resulting from this localized severe eccentricity (Figure 4-22). Steel locally fractured in some locations as a result of the large strains induced by this collapse. Note that the most severely damaged tower was estimated to be 85-90% full (85 m³ out of a 110 m³ capacity) at the time of the earthquake, while the other towers were approximately 65% and 90% full. Incidentally, a gravel and sand bin (approximately 25% full) adjacent to these towers, overturned and collapsed. It was supported on six legs, each tied with a 24 mm diameter bolt to a concrete base. The legs buckled on one side, and the anchor bolts pulled out of the foundation or tore out of the leg as the bin collapsed (Figure 4-22c). Note that damage or collapse of elevated reservoirs was common throughout the affected area (Figure 4-23).

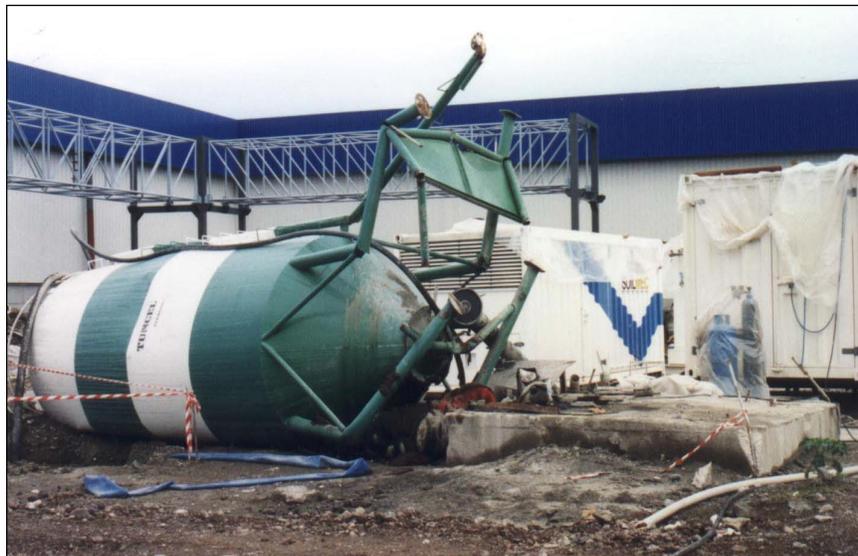
Figure 4-23 Overturned reservoir

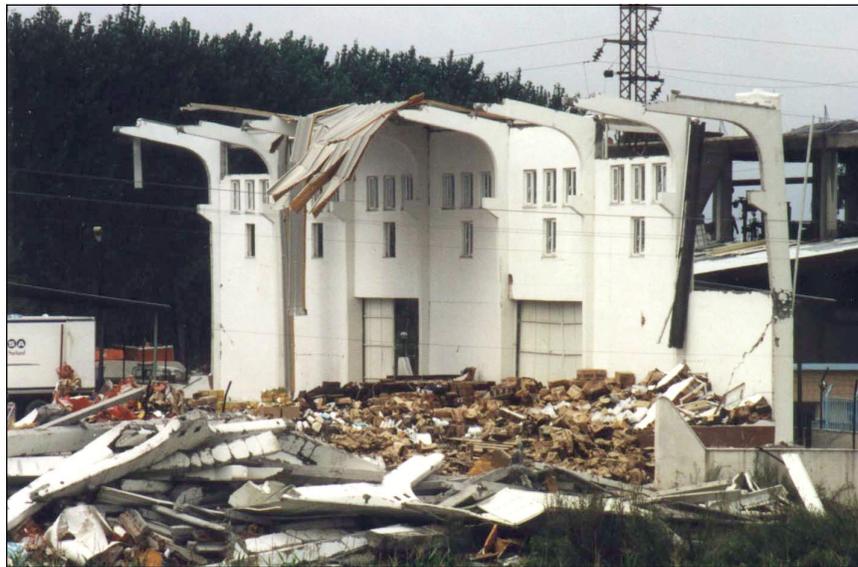
Damage to buildings of other construction materials was also observed throughout the affected area. For example, many industrial facilities of pre-cast concrete collapsed as a result of failures at the beam to column connections (Figure 4-24). Damage to unreinforced masonry buildings was also sometimes observed. For example, the building shown in Figure 4-25 suffered severe shear failure of its corner wall, as a result of bi-axial seismic action. The number of such buildings was, however, small in proportion to the overall building inventory.

Figure 4-24 Damage to a precast concrete building

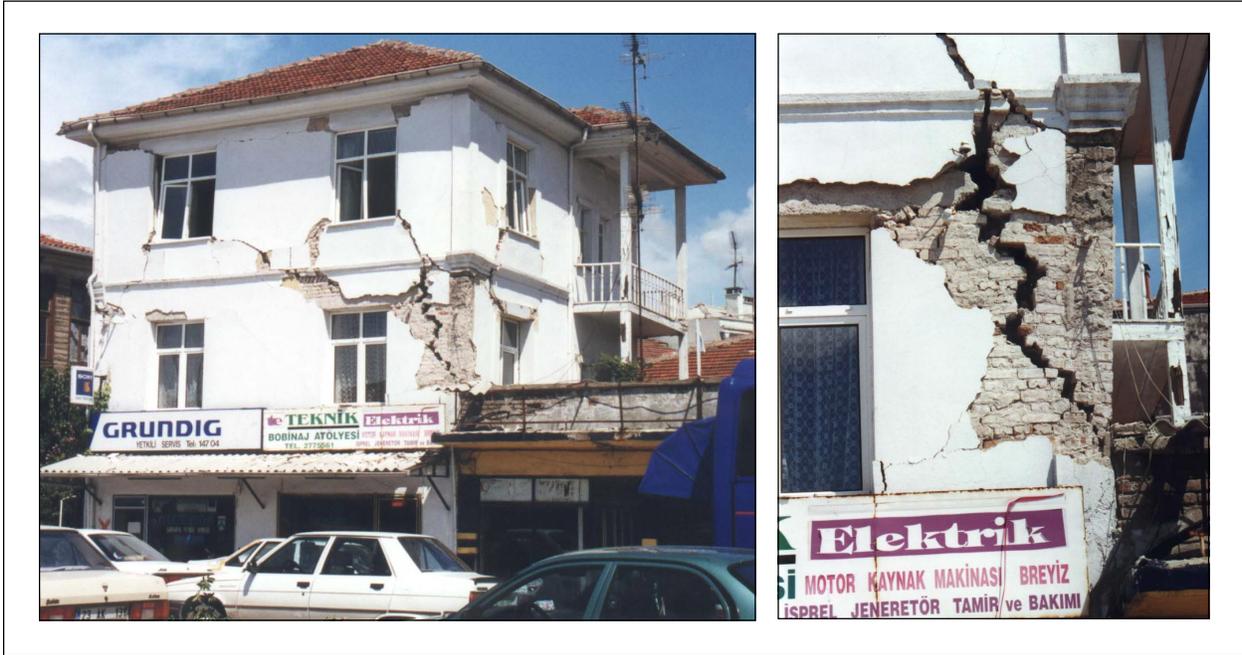
Figure 4-25 Damage to an unreinforced masonry building

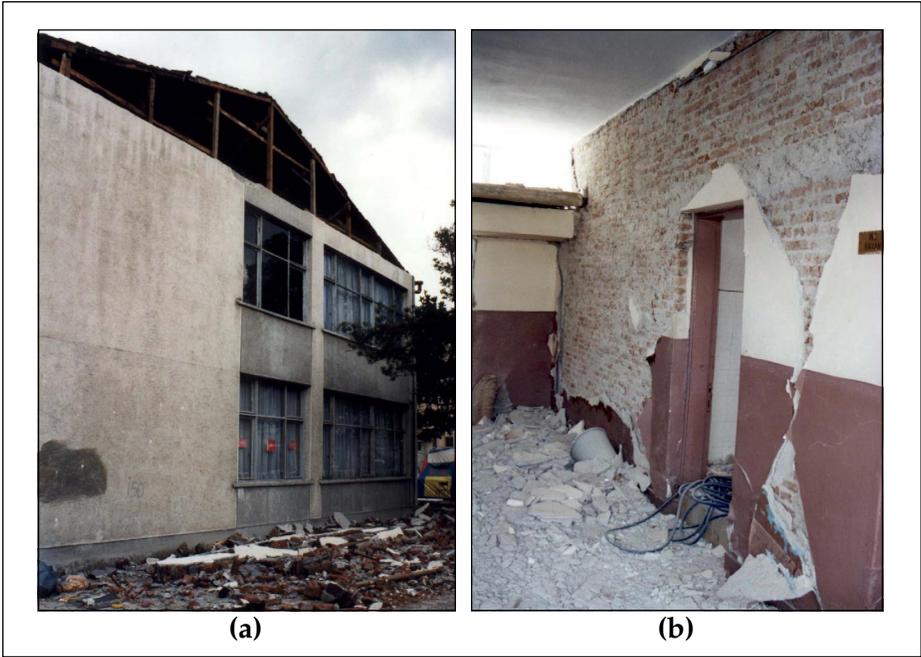
ing shown in Figure 4-26a, out-of-plane failure of an unreinforced masonry gable due to inadequate anchorage to its backing could have killed or maimed many children had this earthquake occurred at a time when the school yard was being used. Likewise, failure of the plaster wall finishes inside the corridors of the same school (Figure 4-26b) could also have hurt many small children.

Figure 4-26 Nonstructural damage to a school building

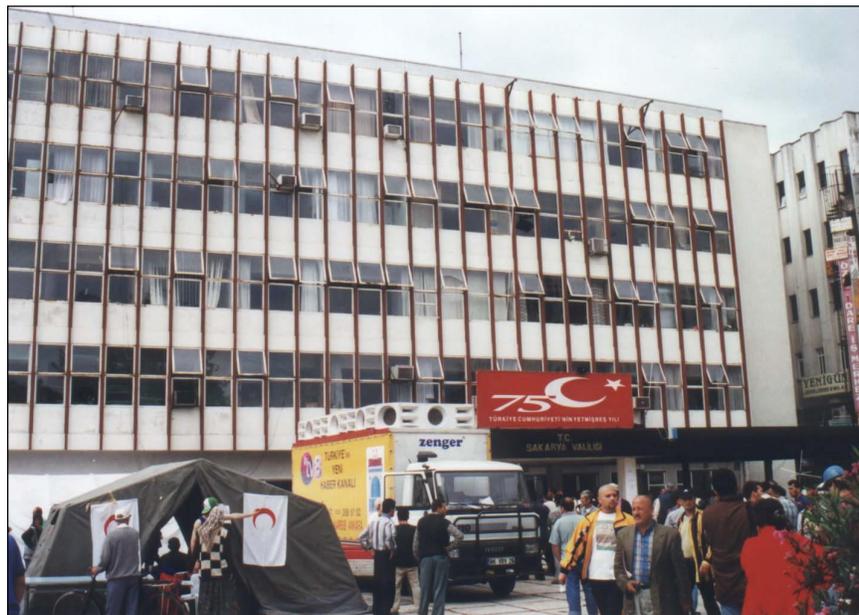
Figure 4-27 Undamaged Sakarya "province" government building retrofitted with shear walls prior to the earthquake

Finally, the importance of a sound geotechnical foundation and the benefits of seismic retrofit have been clearly illustrated by this earthquake. The latter is particularly important to support efforts to formulate seismic retrofit policies to mitigate future earthquake-induced damage and ensure building performance compatible with societal expectations.

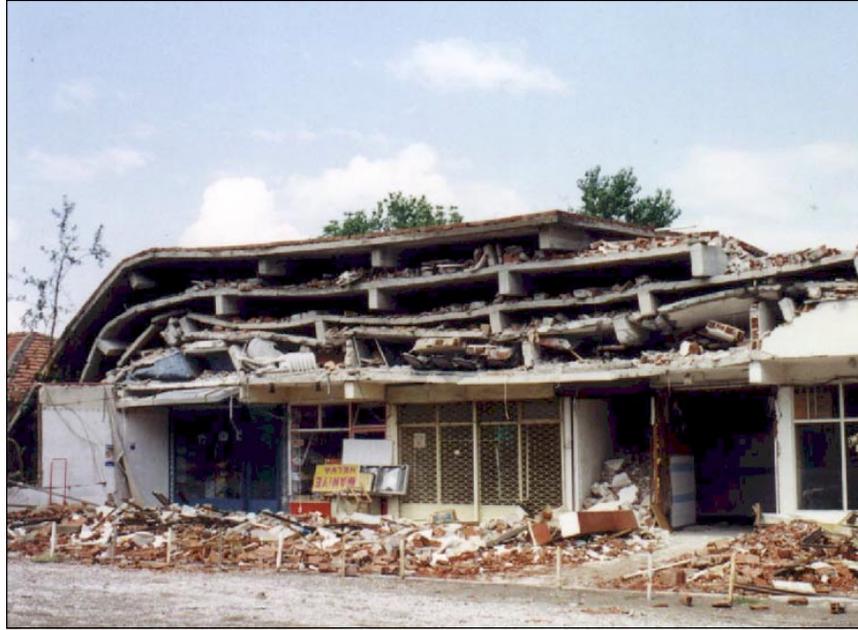
As noted earlier, at the time of the earthquake, seismic awareness in Turkey had not reached a level that made it possible to focus on the seismic hazard posed by the structures designed without due attention to earthquake-resistant design. This may explain why, to the author's knowledge, only one building in the severely affected region had apparently been seismically retrofitted prior to the earthquake. The Sakarya "province" government building, shown in Figure 4-27, was allegedly retrofitted by the addition of shear walls some years prior to the earthquake. This building was undamaged and fully operational following the earthquake, which is significant considering that it was literally surrounded by collapsed and severely damaged buildings, such as the one shown in Figure 4-28.

Figure 4-28 Typical building adjacent to the retrofitted Sakarya “province” government building

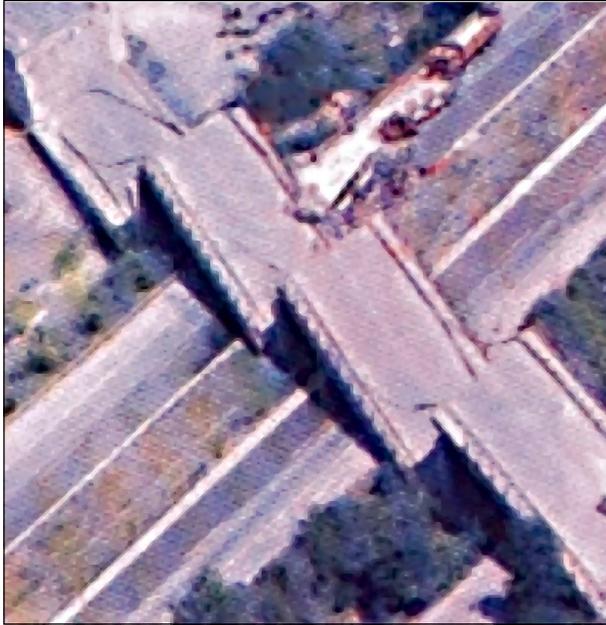
Figure 5-2 presents an aerial view of the D650 E-80 Trans European Motorway (TEM) overpass bridge that collapsed. This bridge structure consisted of bathtub style pre-cast concrete box beams with a cast in situ slab, each span being 26.0 m in length. The spans were simply supported for dead load, and as a result of the continuity provided by the deck,

Figure 5-2 Collapse of the Motorway overpass that carries the D650 road over the E-80 Trans European Motorway (north abutment at top of photo)

essentially continuous for live load. The piers were skewed 20° . During the earthquake, the fault rupture propagated between the third pier and the northern abutment, as seen in the top left-hand corner of Figure 5-2. As the seat widths for the north span were insufficient to sustain the large (> 1.5 m) right-lateral offset movements, it unseated and fell from its support. In so falling, the fourth span, via deck continuity, also dragged the other three spans off their seats. Direct support to the soffit of the girders (south end of each girder) was lost—the deck slab possessed insufficient strength to carry the tributary weight of the span, and as a result, failed in shear. Consequently, as shown in Figure 5-2, the south end of each span fell off its seat and came to rest on the ground. Unfortunately while falling off the seat, the third span (between piers 2 and 3) collapsed onto a passing bus killing ten people.

For this particular bridge, several measures could have been taken to avoid such a failure. Design improvements that might have been made in this structure would be to ensure full continuity is provided for dead loads as well as live loads. In this way, perhaps only one span would have collapsed with the fault passing directly beneath that span. As an alternative to providing continuity, significantly increased seat width or cable restrainers that have the ability to restrain at least 50% of the weight of a span could be provided. This would stop the span from falling.

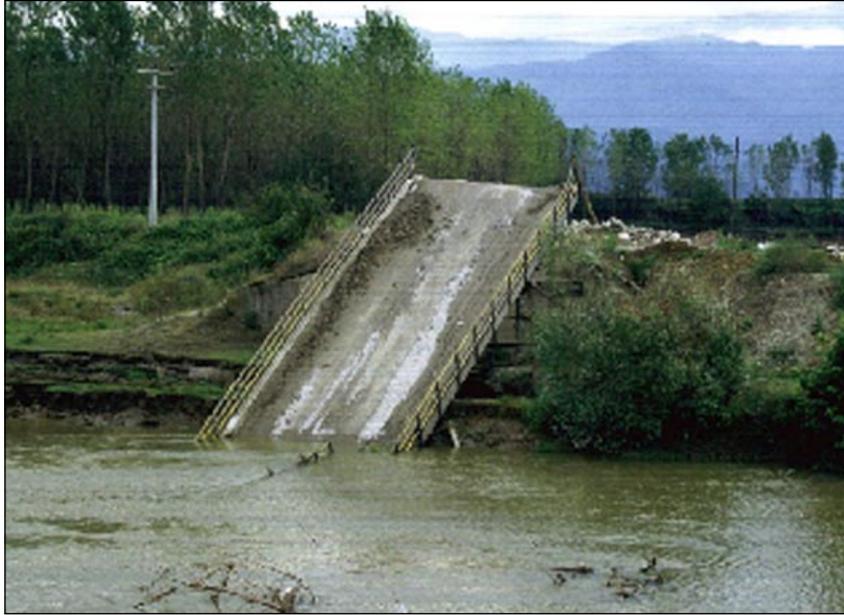
Approximately 8 km east of the D650 E-80 Motorway overpass bridge was a bridge that collapsed into a river near the town of Akyazı (see Figure 5-3). Little is known about the owner or details of this structure. The bridge was a three-span steel girder with concrete slab deck. The piers consisted of a relatively lightweight steel frame located on both banks of the river. Evidently the piers had insufficient axial capacity to sustain the ground shaking and permanent ground displacement as a result of the fault rupture. Both piers failed by

Figure 5-3 A local river crossing near the town of Akyazı

what appears to be axial compression failure of the steel columns in the pier bents. It should be noted that near this facility the critical ground motions were in the order of at least 0.4 g. Although only a minor road, the bridge provided the only access to two small villages. As a result of the bridge collapse, the people in those villages were isolated. It appears that failure of this bridge could have been prevented if the piers were of a more substantial nature and more capable of carrying the higher vertical loads. Nevertheless, it is not surprising that the bridge failed as the fault rupture passed through the northern abutment.

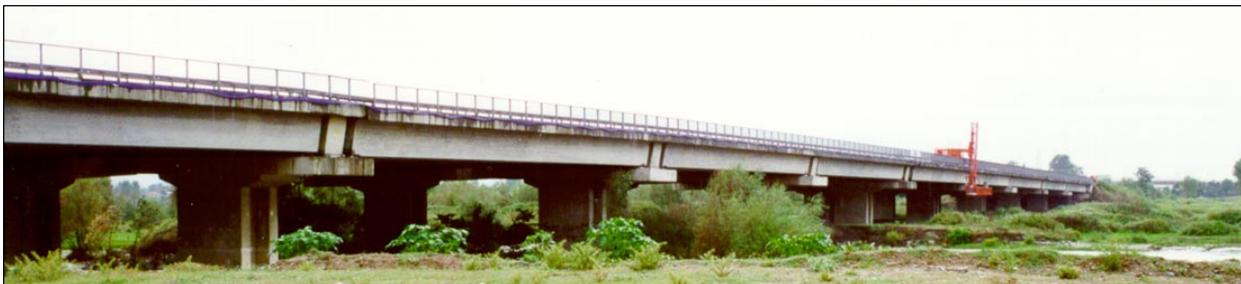
Figure 5-4 presents an elevation view of the twin highway bridges carrying the E-80 Motorway across the Sakarya River. These bridges are essentially identical and consist of ten 40.0 m spans. Each span is constructed from four pre-cast, prestressed (bathtub) girders with a reinforced concrete deck slab. The bathtub girders are seated on elastomeric bearing pads with the deck slab continuous over every second support. In this way, the spans are designed to act as pairs with expansion joints located at every second pier (Figure 5-5). Each girder is seated on two bearing pads and between each bearing pad is a

Figure 5-4 A view looking south showing the side elevation of the twin E-80 Motorway bridge over the Sakarya River

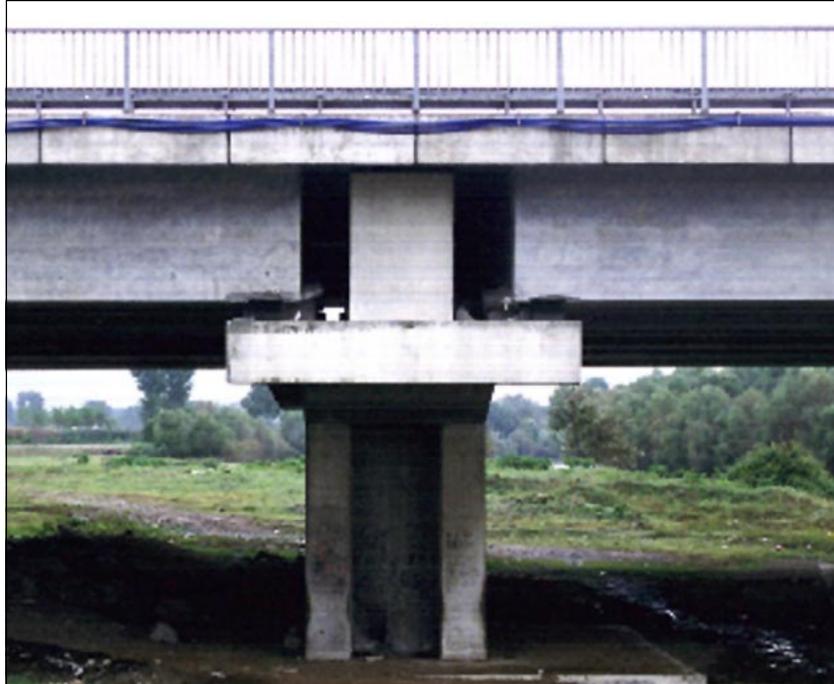
Figure 5-5 A side elevation of one of the pier of the northbound E-80 Motorway bridge over the Sakarya River. Note the concrete rubble located between the span ends and the diaphragm upstand.

shear key that is intended to inhibit transverse movement of the girders relative to the axis of the bridge. The bridge piers consist of rectangular sections that are quite stiff, as shown in Figures 5-5 and 5-7.

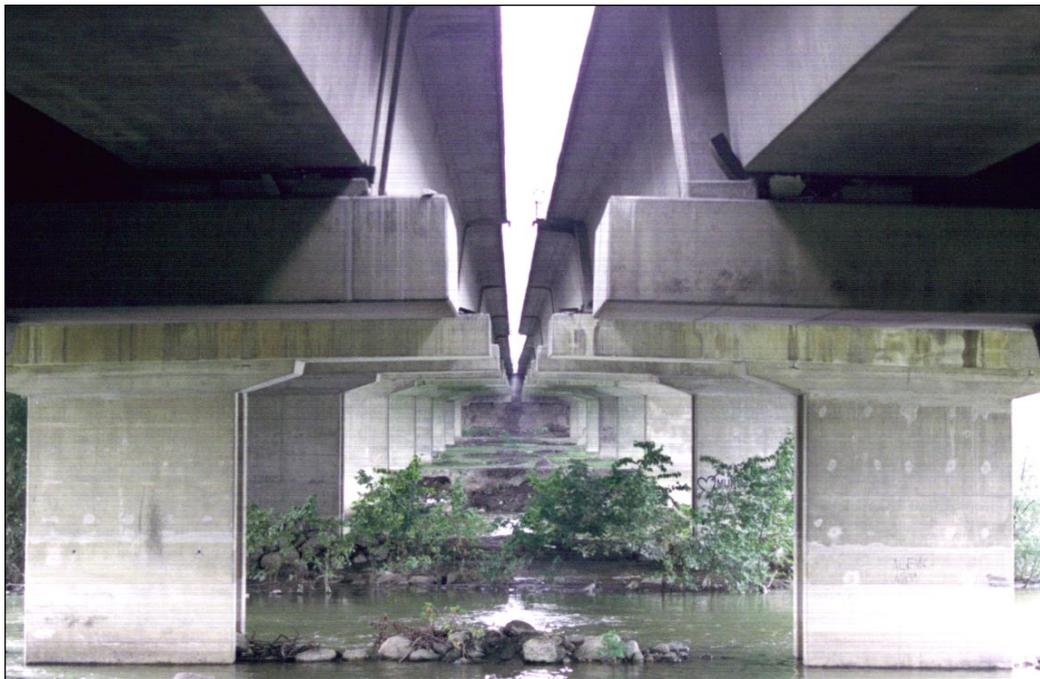
Figure 5-7 shows an underdeck view of the two bridges and their piers. On the eastbound bridge, the elastomeric bearing pads have started to “walk-out,” but were still supporting the spans. However, for the westbound bridge, the spans shifted their seating onto the shear key, many of the bearing pads being nonfunctional.

Figure 5-7 A longitudinal view of the twin E-80 bridges crossing the Sakarya River. The left bridge is the eastbound structure that showed minimal effect on the bearing seats, whereas the westbound bridge (on the right) showed considerable damage to the shear keys and bearing seats. Note the dislodged bearing and the 500 mm right lateral offset of the girder directly above the right hand pier.

It is apparent that much of the damage to these bridges could have been avoided by providing stronger shear keys. Perhaps, better still, much of the damage could have been entirely avoided if full continuity between the spans had been provided. Fortunately, the damage sustained by the eastbound bridge was insufficient to warrant closure. Immediately following the earthquake, the westbound traffic was rerouted over the eastbound bridge. The westbound bridge was considered to be sufficiently damaged to warrant closure to enable

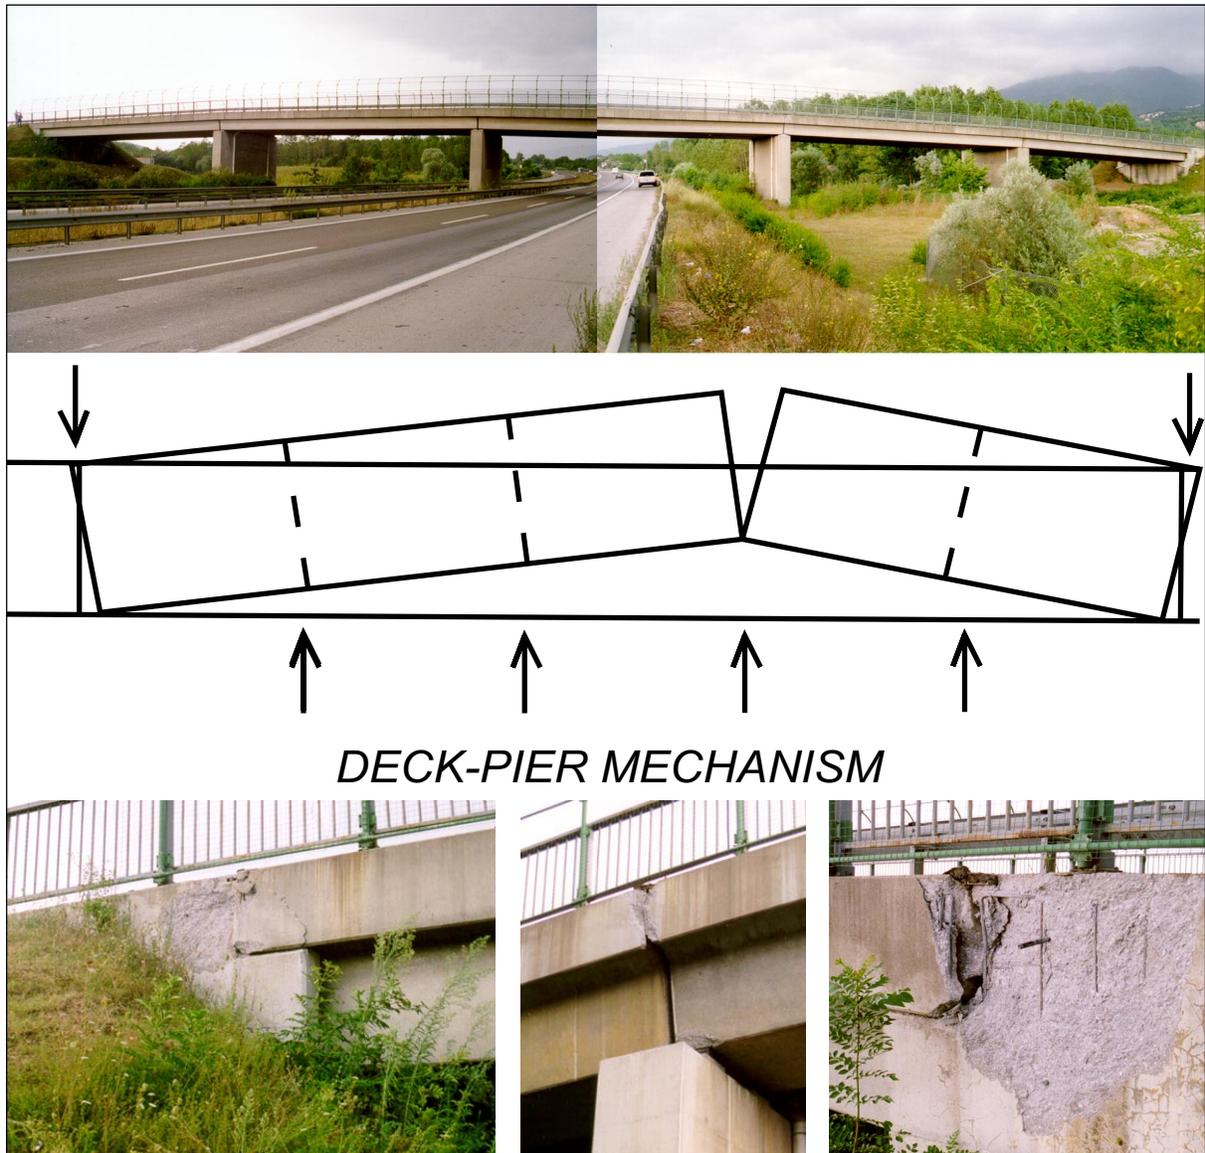
This bridge is typical of the overpasses that cross the E-80 Motorway. It consists of five spans, each span having pre-cast, prestressed concrete beams with a cast in situ deck slab. There are expansion joints at each abutment and at the second pier (when viewed from the south abutment). The bridge was located within 500 m of the fault rupture and oriented normal to the fault. It appears that fault-parallel ground shaking caused substantial move-

Figure 5-8 The overpass carrying the D31 road across the E-80 Motorway. The upper photograph shows a side elevation of the bridge looking eastward. In the center, a plan view sketch depicts the deck-pier mechanism that formed at the joints that were located at the abutments and the third pier. The lower photograph shows spalled concrete damage located at the deck at these joint connections.

ment of the deck segments resulting in some minor damage to the outside faces of the prestressed concrete girders. It is evident that the ground shaking caused a deck-pier mechanism to occur as shown in Figure 5-8. In addition to this damage resulting from fault parallel shaking, there is some evidence of pier tilting due to foundational settlement of the above-mentioned second pier. It is not clear whether this pier tilting has resulted from fault-normal shaking or is an outcome of the deck pier mechanism. This feature requires further analysis.

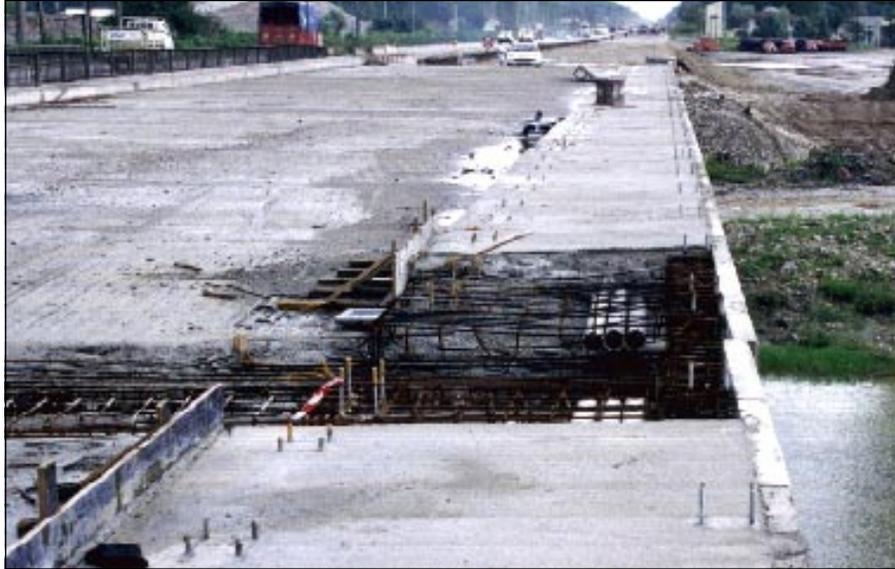
Figure 5-10 The new two-lane bridge for the D100 Highway over the Sakarya River looking east. Notice the 50 mm offset of the fascia girders. The pouring of the construction joints was incomplete at the time of the earthquake.

The new bridge, which is currently under construction, consists of closely-spaced prestressed concrete I-girders. These girders typically moved 50 mm on their bearing seats resulting in some misalignment of each of the spans. This is evident in Figure 5-10. However, as traffic was not interrupted, the damage to both of these bridges could be regarded as “slight.”

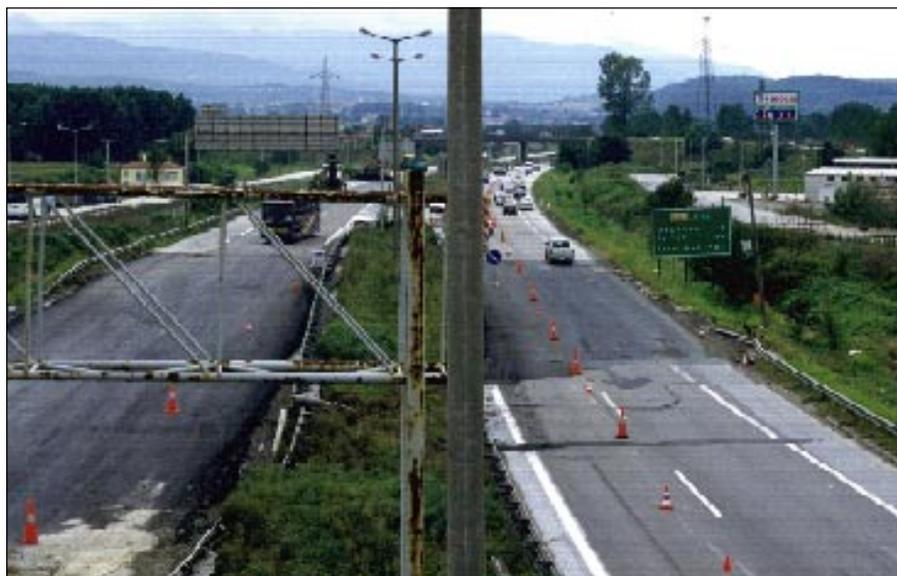
When traveling east, the E-80 Motorway passes near the southern shores of Lake Sapanca. In this vicinity and some 30 km east, there was substantial damage to the roadway. Much of this was a result of the close proximity to the fault rupture. Indeed, in many instances the fault rupture traversed the road itself causing substantial damage to the pavement. There were numerous instances of damage to the road surface and a typical example is shown in Figure 5-11. This damage led to several vehicles careering off the road and also resulted in temporary closure of the Motorway. As shown in Figure 5-12, the damage was quickly repaired and the Motorway brought back into service soon after the earthquake. Within one week, most of the surface damage was repaired and the Motorway was operating at its usual 120 km/h speed limit.

Figure 5-12 A view of the E-80 Motorway taken from an overpass near Akyazı showing the restored roadway that had been severely damaged by the fault rupture

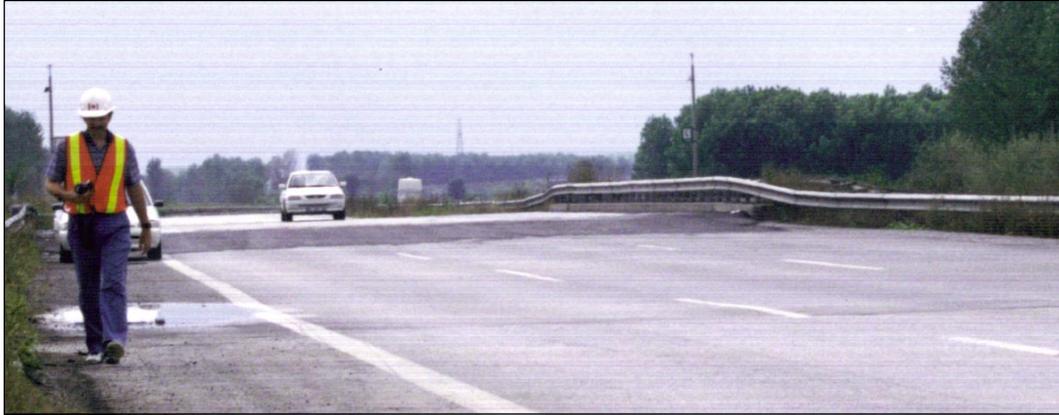
Another major problem associated with the E-80 Motorway, particularly when it runs immediately adjacent to Lake Sapanca, was related to substantial settlements sustained by the embankments. Embankment settlements of 500 mm were commonplace. This resulted in two problems. First, the roadway was left in a substantially wavy nature, and secondly, there were serious bump-onto-the-bridge problems at both culverts and single-span bridges, as shown in Figure 5-13. Immediately following the earthquake

Figure 5-13 One of the numerous bridges on the E-80 Motorway that is some 500 mm above the road surface. The severe shaking caused bearing capacity settlements of the road embankment leading to classic bump-onto-the-bridge problems.

It is difficult to speculate whether this damage was a result of a bearing capacity failure, or settlement due to liquefaction, or a combination of the two. Although the surrounding soils appeared to be quite damp over to the crossing proximity at the lake, it is considered that the cause of failure was mostly due to the former rather than the latter. It is considered that liquefaction was unlikely as there was little evidence of sand boils in this vicinity.

and after the major highway debris had been cleared, asphalt was brought in and used to provide ramps onto and off the bridges at those locations where the bumps were very abrupt. Then within one week of the earthquake, major repairs were commenced. Where the bridges sat up high with respect to the surrounding roadway, the asphalt roadway was removed and the road was repaved and reprofiled to enable vehicles to travel at the regular full speed.

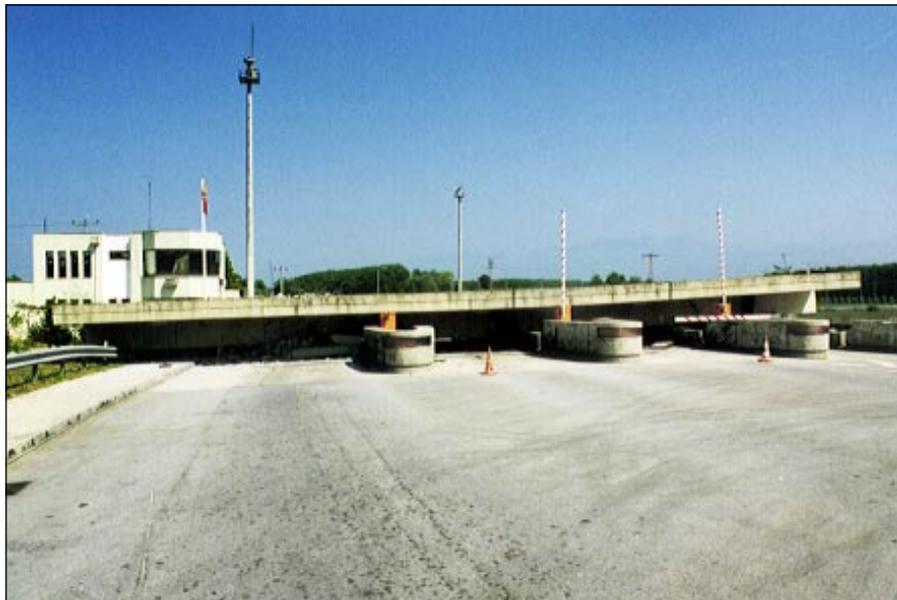
It is also of interest to mention the structural damage that led to partial closure of the Trans European Motorway. A toll plaza at one of the entrances of the Motorway collapsed, as shown in Figure 5-14, completely closing the entrance to the Motorway. This heavy reinforced concrete canopy structure was supported on small columns with inadequate detailing to sustain the large lateral sidesway. Following the earthquake, the collapsed structure

Figure 5-14 Collapse of the toll plaza at an entrance to the E-80 Motorway

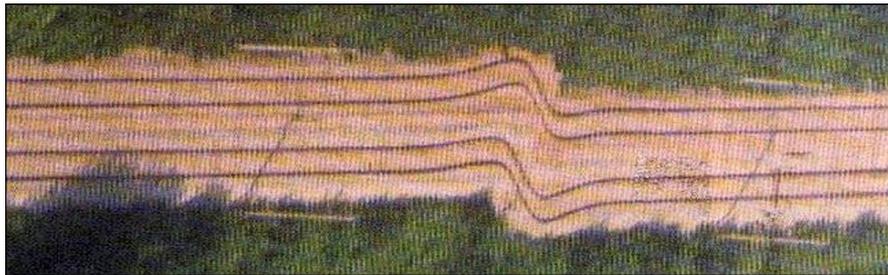
Like the E-80 Motorway, the main railway system is dual track and runs in a general east-west direction. In the Sapanca area, it runs adjacent to the E-80 Motorway. In this location, the fault rupture transverses both the highway and the railway with the damage shown by the aerial view in Figure 5-15. From this photograph, it is evident that the magnitude of the right lateral offset on the fault is about 1.5 m—this is roughly equal to the track gauge. Although the damage to the tracks is substantial as shown from the ground view in Figure 5-16, repairs were implemented rather quickly. However, in one nearby branch line near Adapazarı, an electric traction pole was brought down from the track requiring the restringing of the overhead traction wires. Such repairs to the electric

Figure 5-15 An aerial view of the railway track buckling in the Sapanca area. Note there is a right lateral offset on the fault roughly equal to the track gauge of 1.5 m.

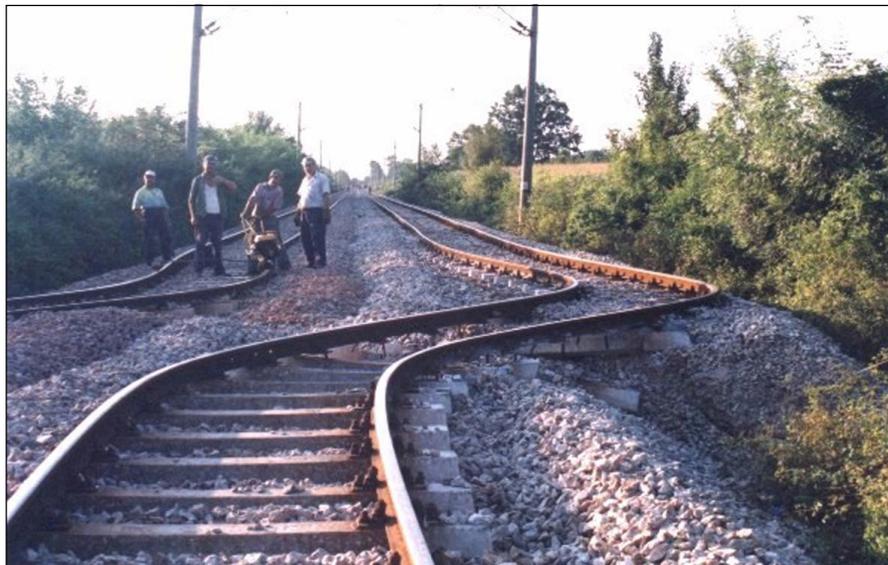
Figure 5-16 A view of the fault passing through the railway embankment showing the substantial (2 m) right lateral offset

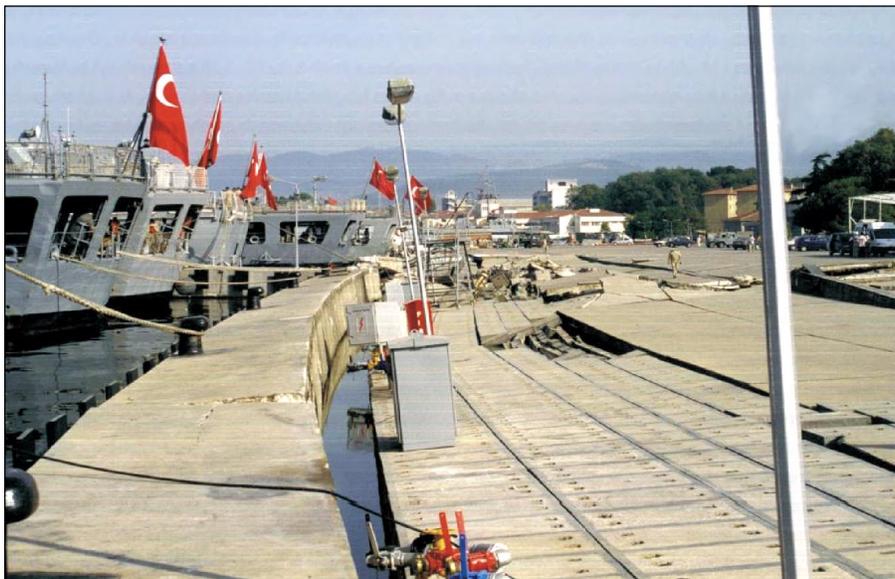
Figure 5-17 The Naval Port at Gölcük looking east. Notice the bow of the quay wall resulting from proximity to the fault rupture.

It is worth emphasizing the important role that the military was expected to play as part of civil defense following a natural disaster. Due to the collapse of the buildings on the naval compound, as well as the failure of the wharf structures, many of the ships that were tied up (as seen in Figures 5-17 and 5-18) had a full complement of personnel aboard, who could not be gainfully employed on post-earthquake clean-up activities. Clearly such facilities are critical and essential to the response and recovery requirements of natural disasters.

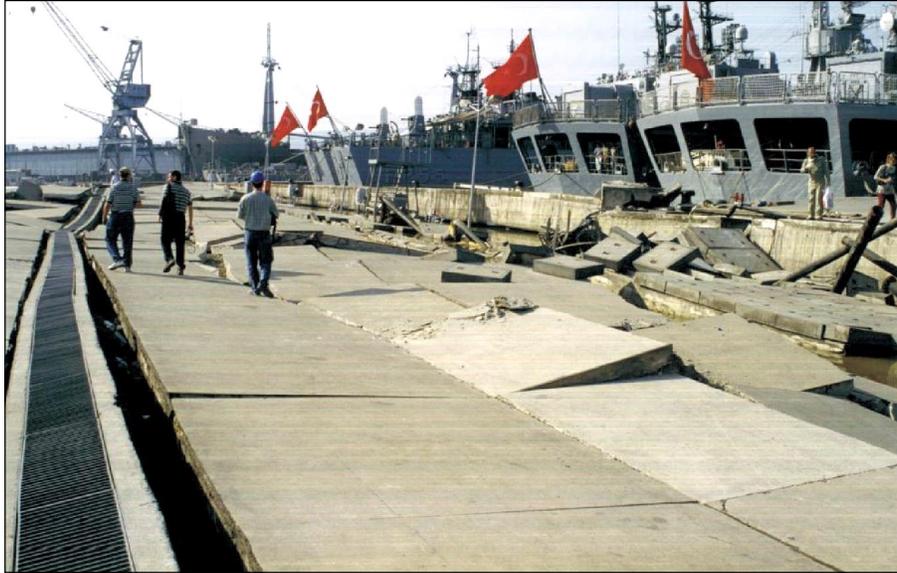
Figure 5-18 Failure of the wharf structure at the naval port at Gölcük

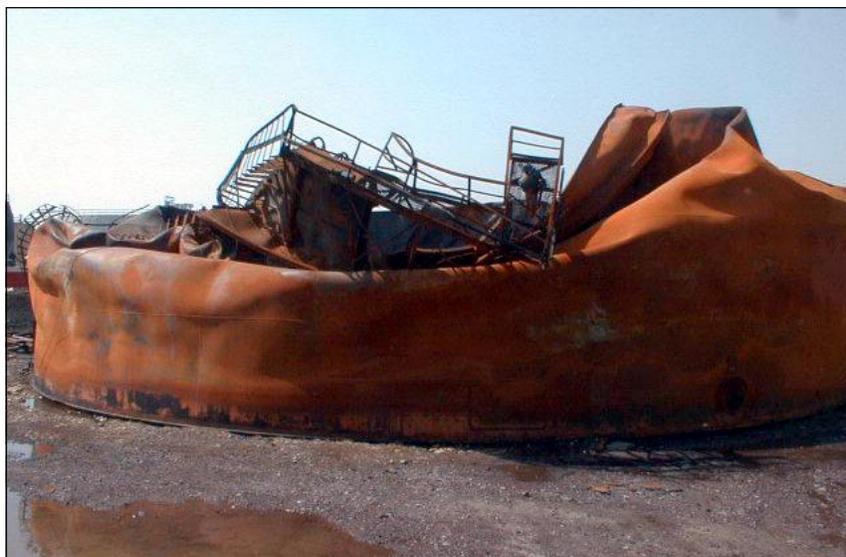
The fire and heat eventually damaged numerous tanks in the tank farm. It was reported that at least 17 tanks were considered to be total losses. These tanks were generally buckled by the intense heat, with one tank expanding as if ready to explode (Figures 6-3 to 6-5).

Figure 6-3 Collapsed tank due to fire at Tüpraş refinery

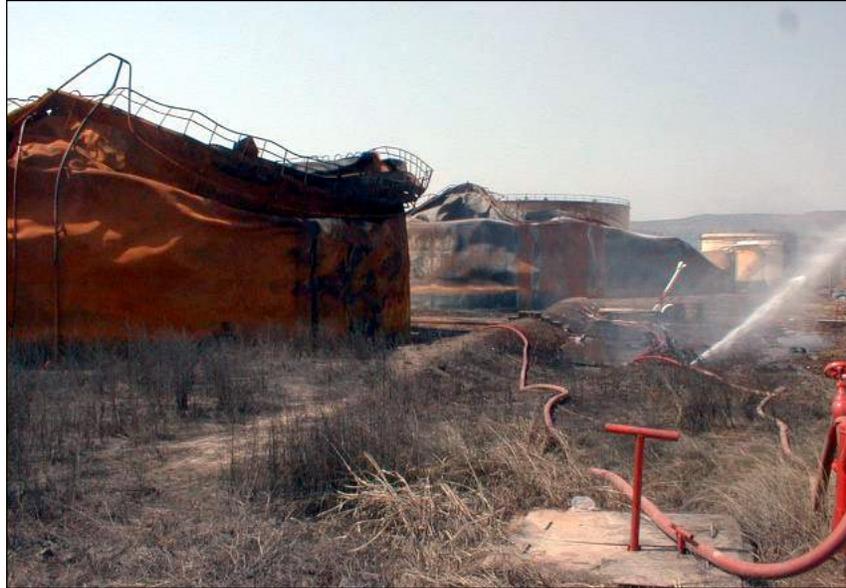
Figure 6-4 Collapsed tanks due to fire at Tüpraş refinery

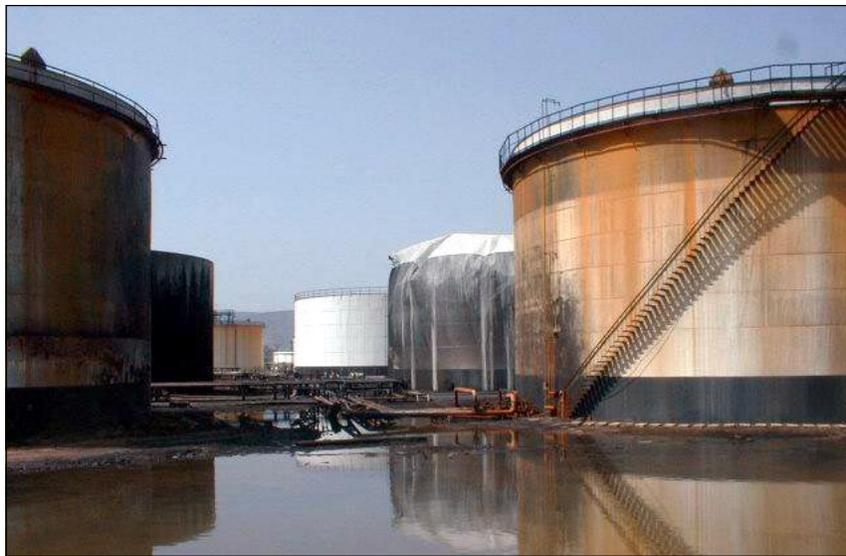
Figure 6-5 "Expanded" tank due to fire at Tüpraş refinery

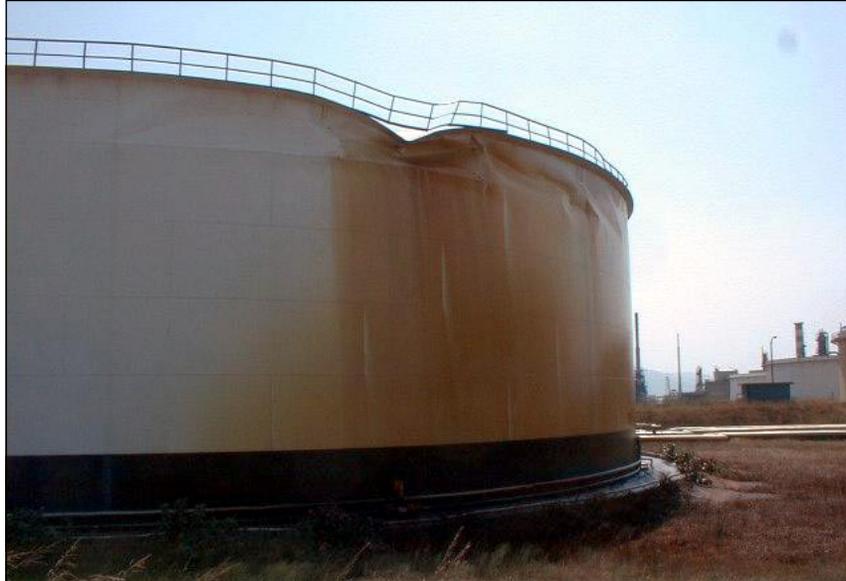
In addition to the tanks directly damaged by fire and heat, several tanks appeared to be damaged by sloshing of fluid (Figure 6-6). A few had ruptured walls near their tops and clear evidence of loss of material down the tank wall.

A large number of tanks (on the order of 50) were reported to have had floating roofs "sink." The sloshing of fluid in the tanks apparently caused damage to seals and allowed fluid on top of the floating roofs. The extra weight then caused the roofs to sink into the tank. Each of these tanks must be drained, and the roofs decontaminated and often repaired or replaced. Sloshing is a long period response, and the amount of damage was likely amplified by the long duration of shaking.

Figure 6-6 Failure at top of tank due to sloshing of fluid at Tüpraş refinery

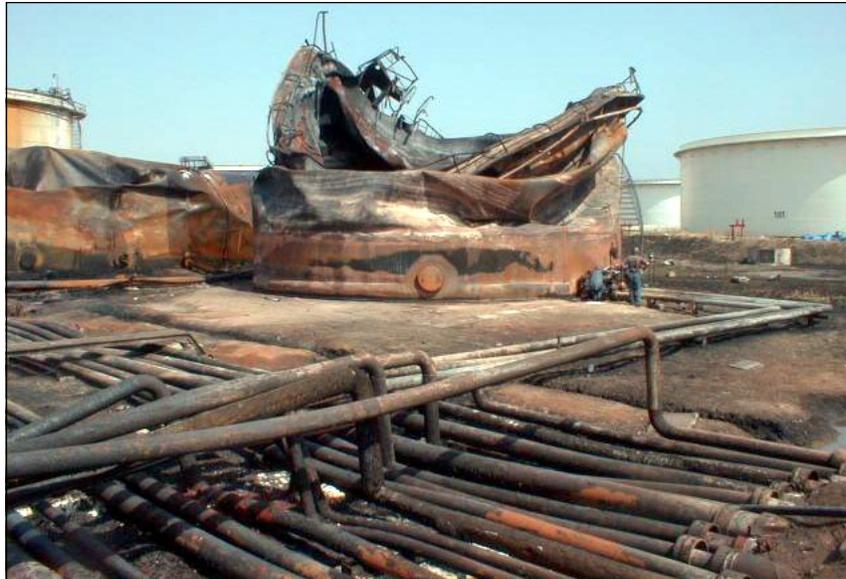
No evidence of piping rupture was observed. This is primarily attributed to the typical configuration of running piping in a flexible manner down central pipe runs between the tanks (Figure 6-7). Some leakage was reported in piping in the area of burned tanks.

Figure 6-7 Pipes between tanks in Tüpraş tank farm typically run above ground

Photograph by G. Johnson

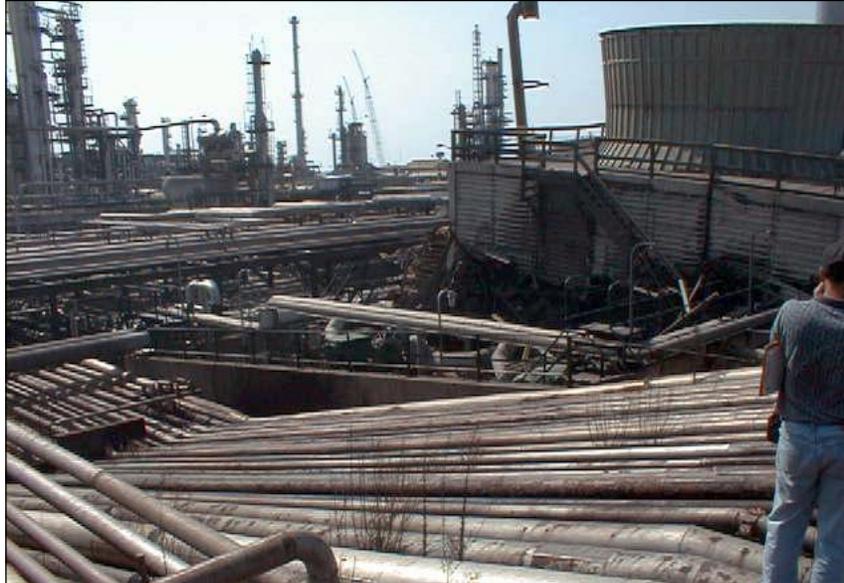
Figure 6-11 Location of burned out and collapsed cooling towers next to Tüpraş tank farm

Photograph by G. Johnson

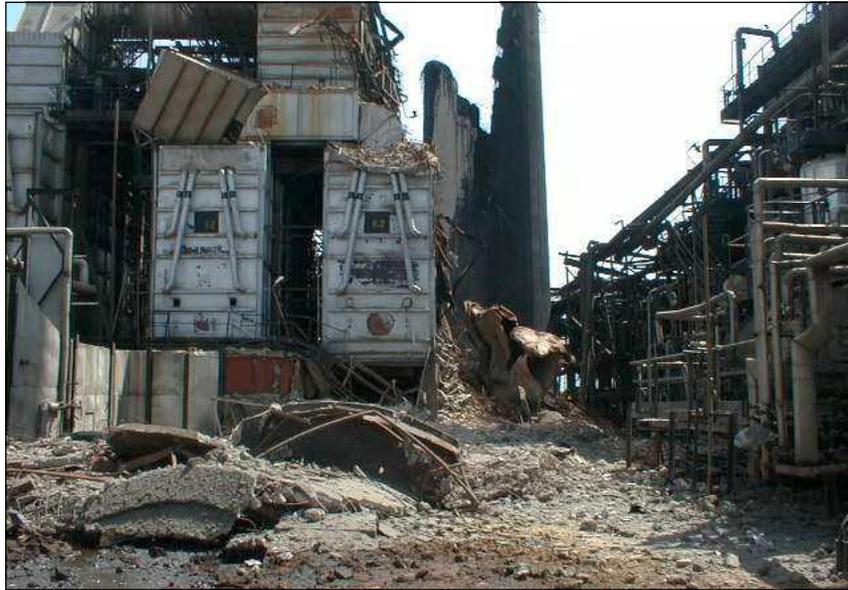
diameter heater duct. The cause of the failure was not immediately obvious from sifting through the rubble of the stack (Figures 6-13 to 6-15).

Photograph by G. Johnson

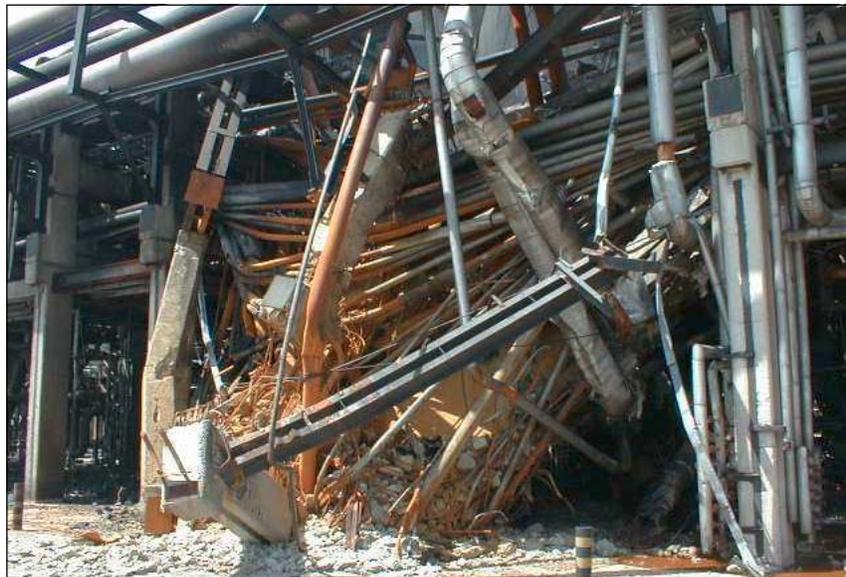
Figure 6-14 Collapsed stack in background was attached to furnace in foreground by a large duct

Photograph by G. Johnson

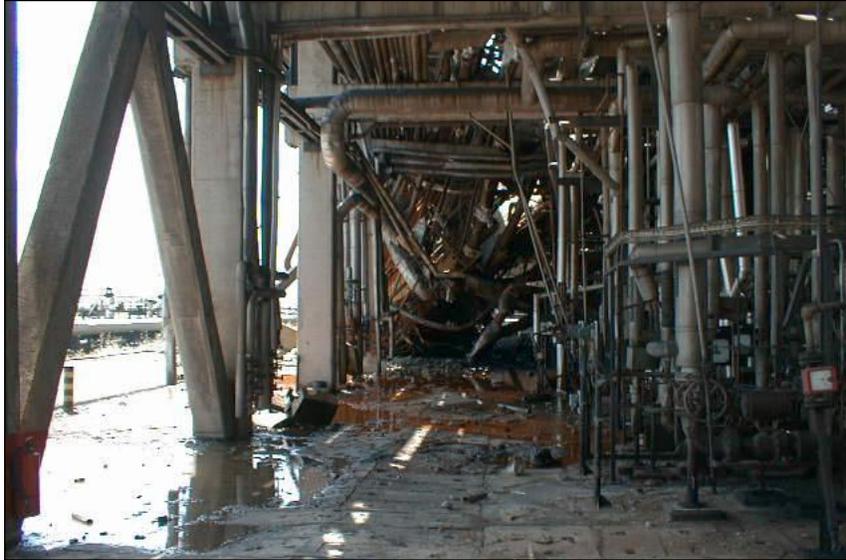
heavily congested with piping from all over the refinery. It is likely to take several months to identify, isolate, and repair damaged piping in this area (Figures 6-16 to 6-17).

Photograph by G. Johnson

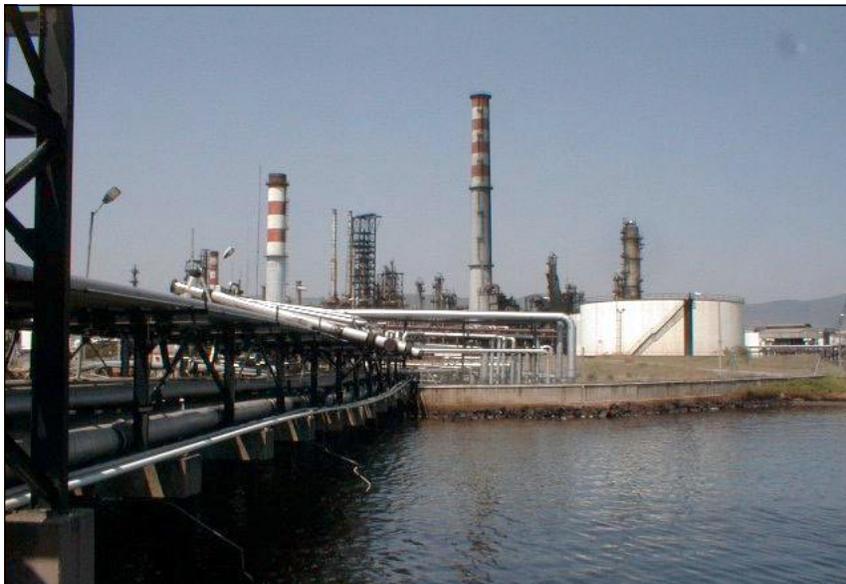
The Tüpraş refinery has its own private port facility. Water depth is approximately 15 meters. The wharf structure reportedly had several sheared piles at the waterline. This was attributed to a combination of earthquake loads and existing heavy corrosion.

Photograph by G. Johnson
