The Marmara, Turkey Earthquake of August 17, 1999: Reconnaissance Report

Technical Report MCEER-00-0001
March 23, 2000

Edited by
Charles Scawthorn¹

Technical Report MCEER-00-0001

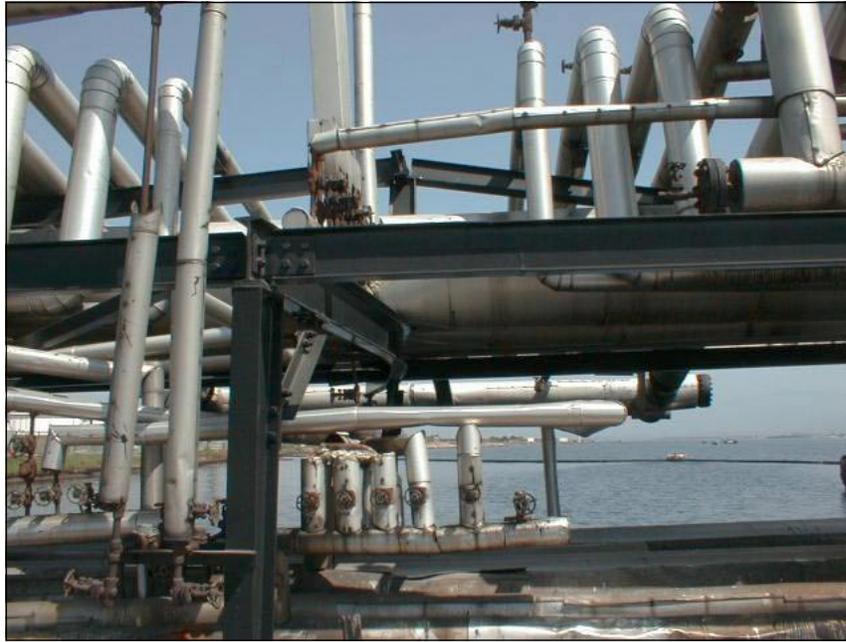
The Tüpraş refinery has its own private port facility. Water depth is approximately 15 meters. The wharf structure reportedly had several sheared piles at the waterline. This was attributed to a combination of earthquake loads and existing heavy corrosion.

Photograph by G. Johnson

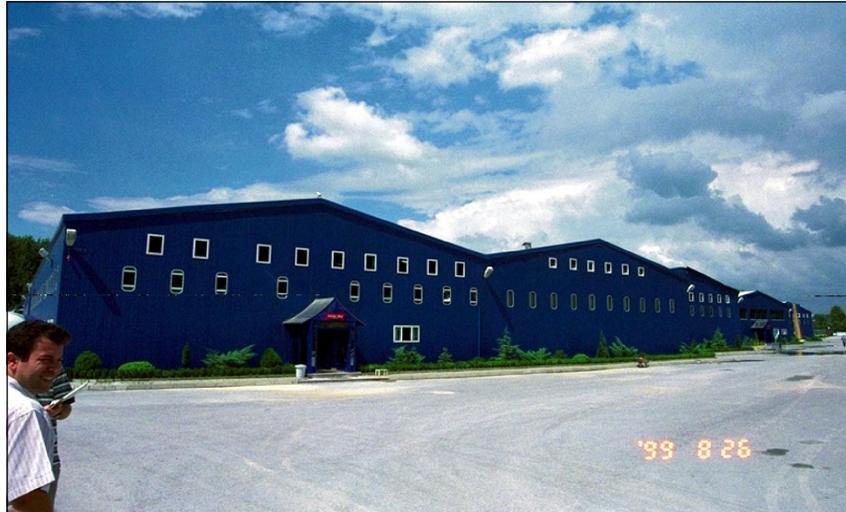
Photograph by H. Sezen

Many of the industrial buildings, especially warehouse structures, are constructed of precast concrete frames. These buildings generally performed better than residential concrete construction. This would be expected, because of generally better quality control and inspection likely to be found in industrial facilities.

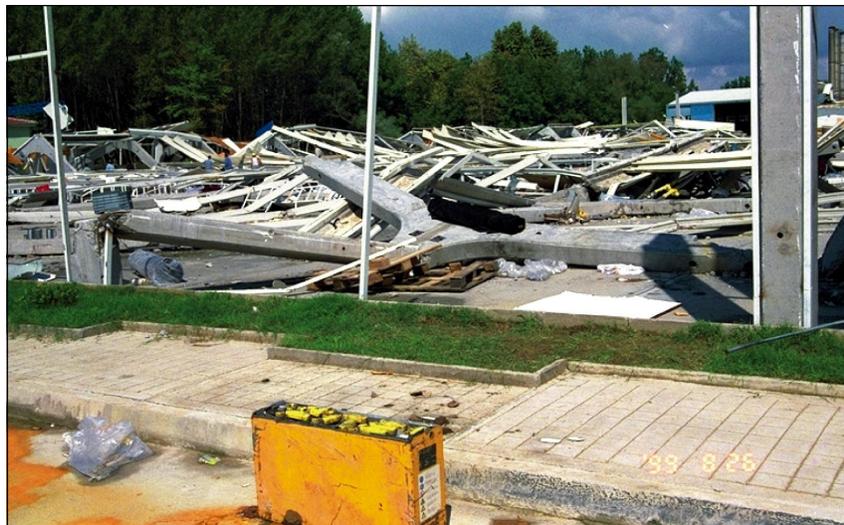
Photograph by H. Sezen

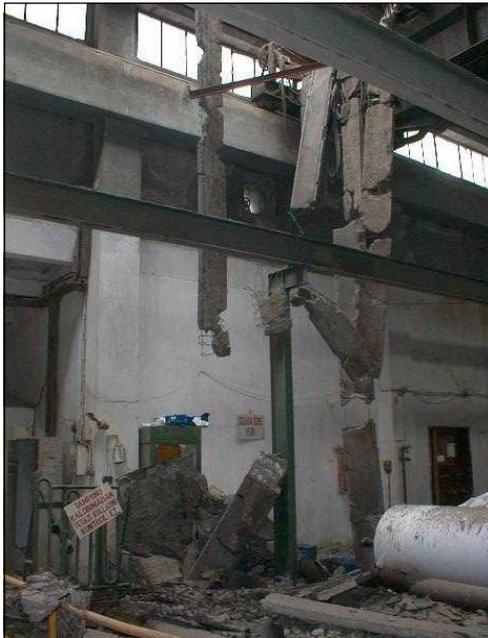
Figure 6-24 One building at Çap textile plant completely collapsed.

Photograph by G. Johnson

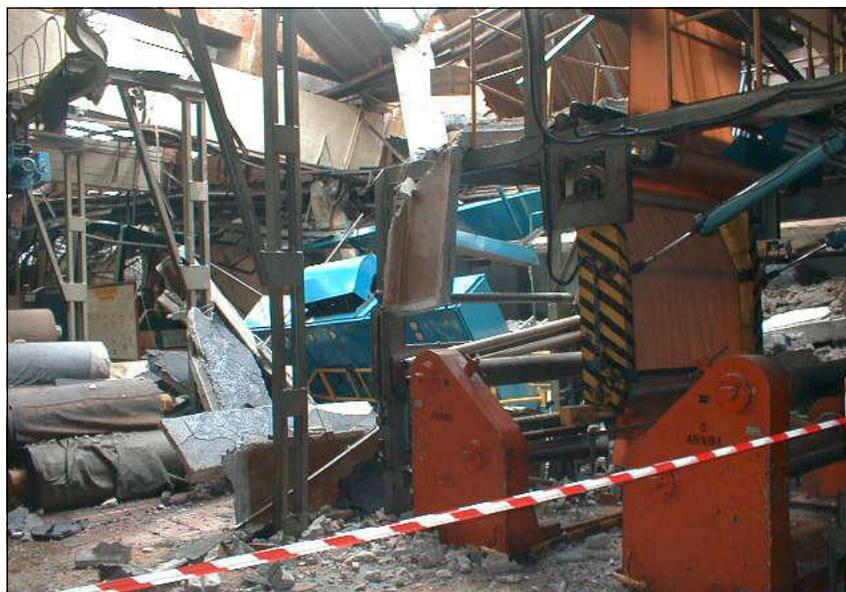
Figure 6-28 Collapsed roof in storage structure at KordSA

Photograph by G. Johnson

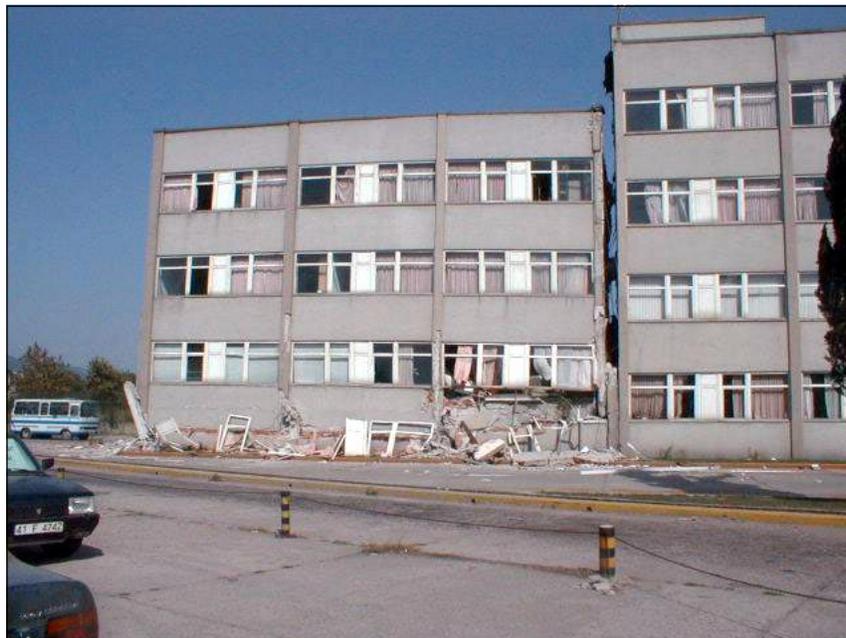
One other complete building failure was at the Pirelli tire factory in İzmit. One of the older buildings at the plant, constructed in the 1960s, totally collapsed, killing one worker and injuring twenty (Figures 6-29 and 6-30).

Figure 6-30 Severe damage to building adjacent to collapsed building at Pirelli. This building houses critical equipment and cannot be used because of the building damage.

Photograph by G. Johnson

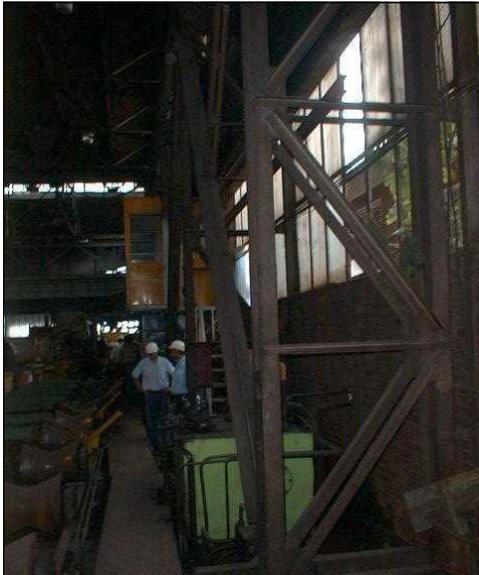
building and a warehouse, where adjacent building sections had very different window opening heights (Figure 6-35). The shorter columns experienced much more severe damage than the adjacent taller columns.

One steel frame production building at the Mannesmann Boru large pipe area uses steel moment resisting frames. Anchor bolts on these columns stretched and fractured. It was

Photograph by G. Johnson

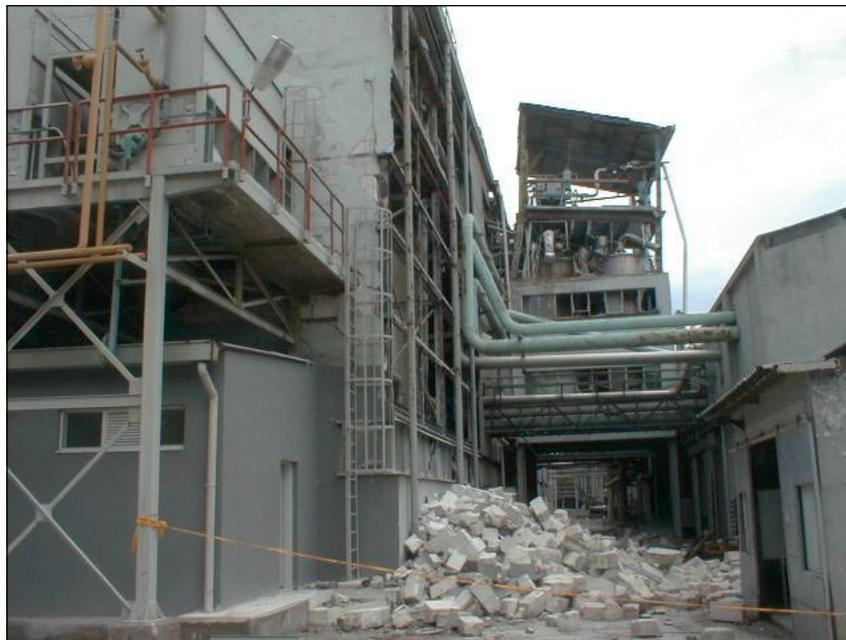
Steel frame buildings generally performed well, with some exceptions. The Toyota plant in Adapazarı used very heavy steel construction and had no damage. That plant had columns with flange thicknesses of up to 5 inches. The Hyundai plant in İzmit used heavy steel bolted frames, and reported numerous failures of connection bolts in the steel frames.

Photograph by G. Johnson

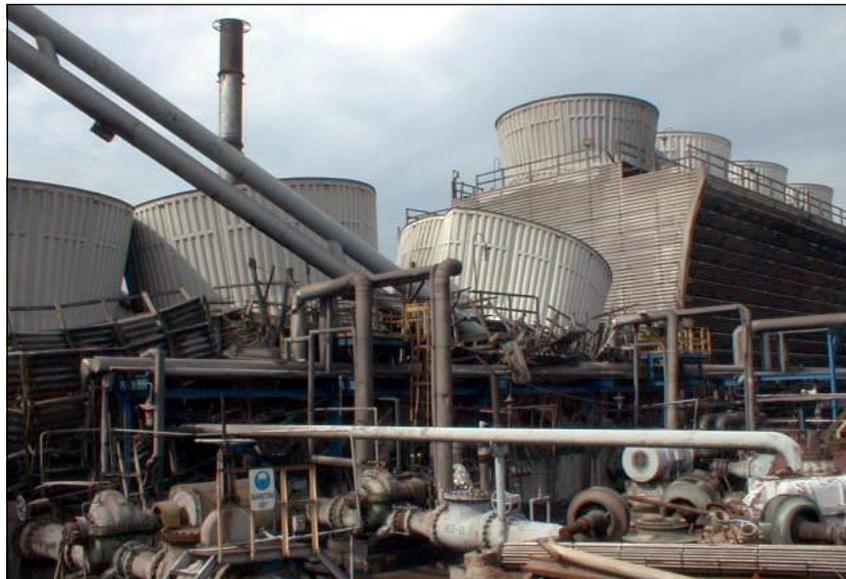
In addition to the damage previously described at the Tüpraş refinery, there were numerous other instances of damage to non-building structures.

Photograph by G. Johnson

Figure 6-41 Collapsed cooling tower at Petkim

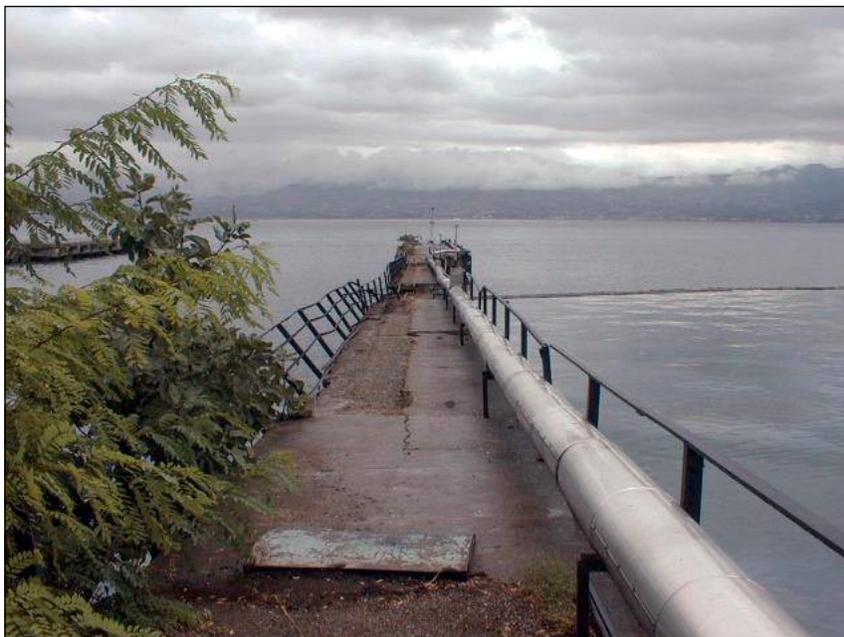
Numerous ports in the area were damaged, either structurally or by ground settlement or spreading. The port at the SEKA paper mill was severely damaged by the total failure of the approach bridge. The approachway was supported on single reinforced concrete piers that failed along the entire length of roadway (Figures 6-44 and 6-45). A second wharf there was also severely damaged (Figures 6-46 and 6-47).

Figure 6-47 Pipelines did not appear to be damaged, but second port structure at SEKA is also unusable

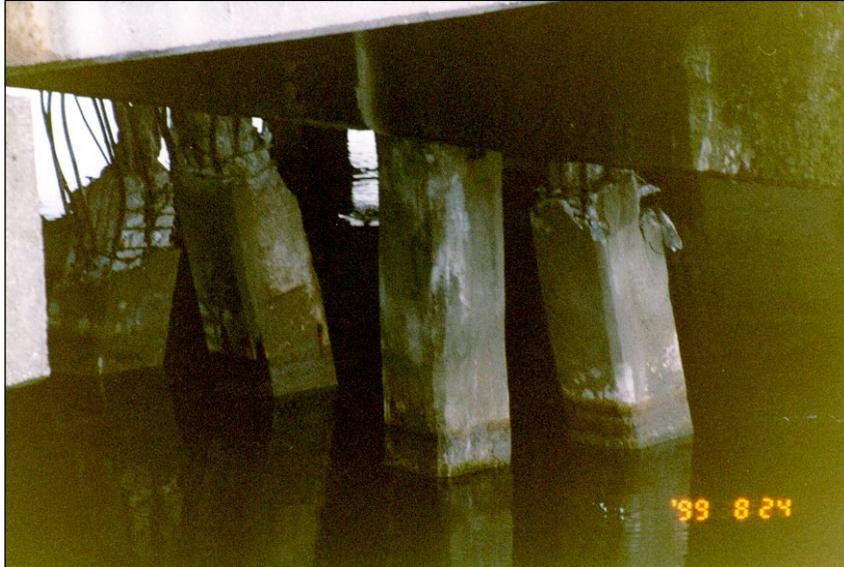
Figure 6-48 Damage battered piles at Petkim port

The wharf structure at Petkim had severe damage to 10 battered piles. Every pile was also severely damaged on both dolphins (Figures 6-48 and 6-49).

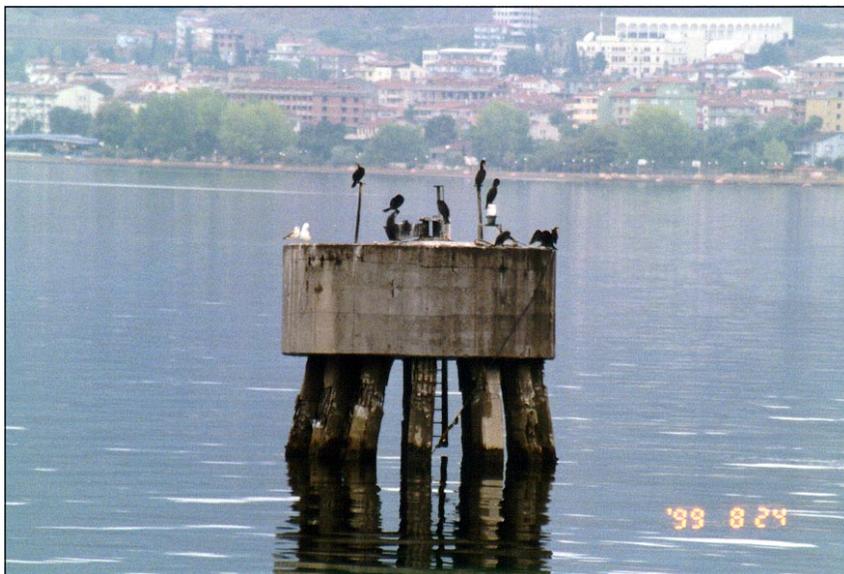
Figure 6-49 All piles severely damaged on dolphins at Petkim port

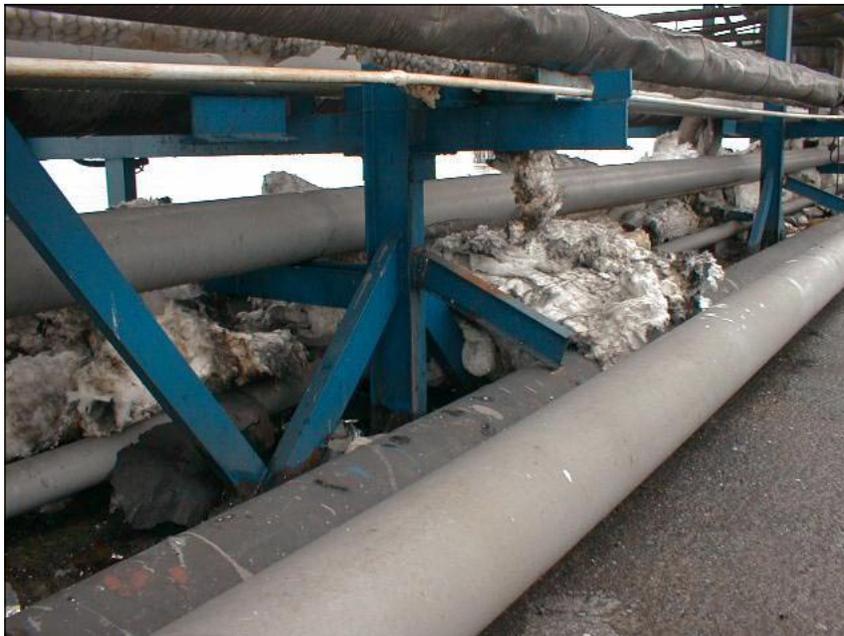
Petkim also had severe damage to pipeways at the wharf. Fractured cantilever supports dropped over 100 meters of fire protection pipe onto the deck, although the pipe itself was undamaged (Figures 6-50 and 6-51).

**Figure 6-51 Pipe support failure that led to falling of fire
protection pipeline at Petkim port**

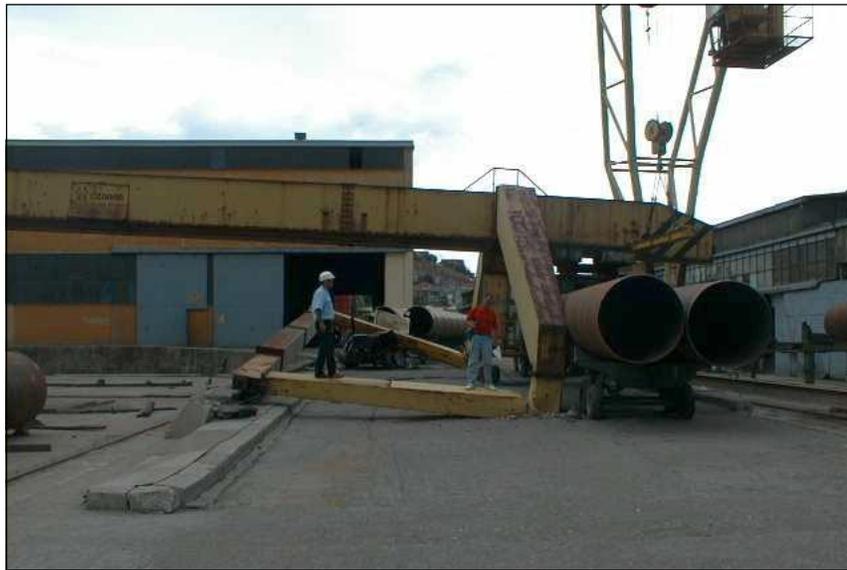
The port at the Gölcük naval base was heavily damaged by fault rupture throughout the wharf area. A crane jumped off its base at this location also. Cranes also jumped off their rails at Petkim. Two identical cranes collapsed at the Mannesmann Boru pipe factory (Figures 6-52 and 6-53).

Figure 6-52 Collapsed crane at Mannesmann Boru large pipe factory yard

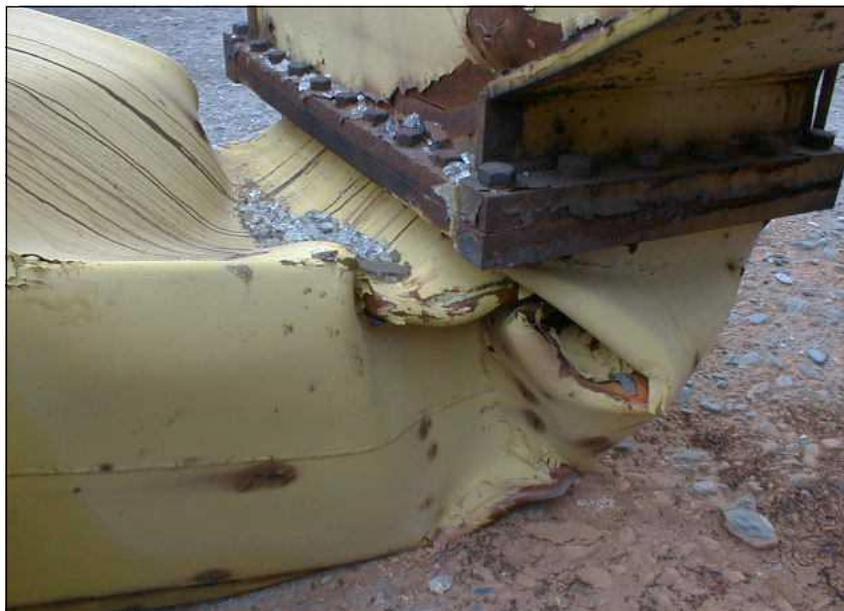
Figure 6-53 Box section of crane leg buckled Mannesmann Boru. A second crane experienced an identical leg failure but did not fall.

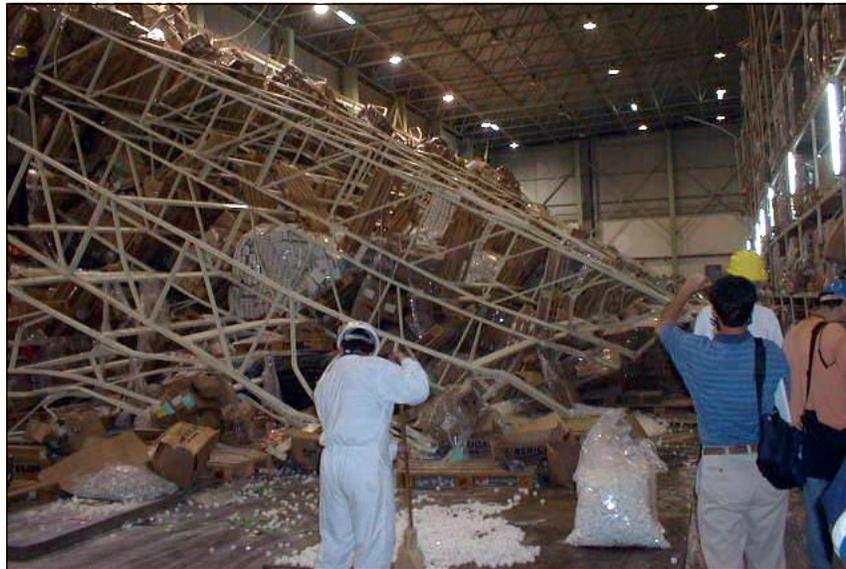
Storage racks collapsed at the Toprak pharmaceutical plant and the Toyota factory, both in Adapazarı (Figures 6-54 and 6-55).

Figure 6-54 Collapse of storage racks at Toprak İlaç pharmaceutical plant in Adapazarı

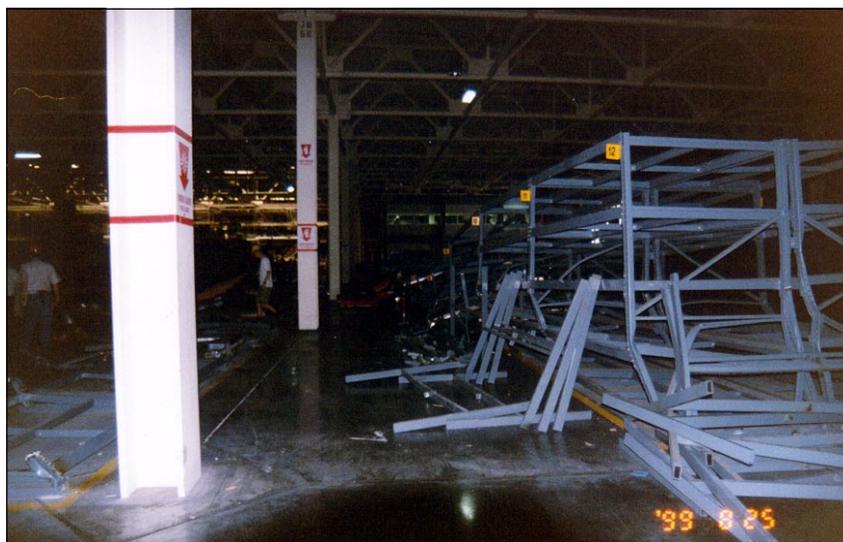
Figure 6-55 Collapsed storage racks at Toyota plant

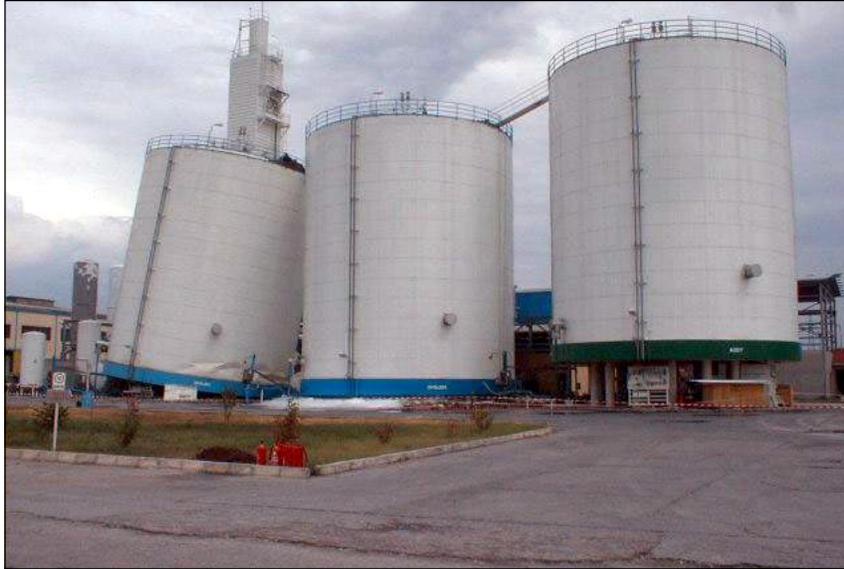
Figure 6-56 Three identical tanks at Habaş. Tanks to left were full of liquid oxygen. Third tank to right was apparently 1/4 full of liquid nitrogen and did not collapse.

The Habaş plant in İzmit provides liquefied gases to commercial plants and medical facilities. The major damage observed at Habaş was the collapse of two out of three large storage tanks (Figures 6-56 and 6-57). Three identical 48 foot diameter tanks were built in

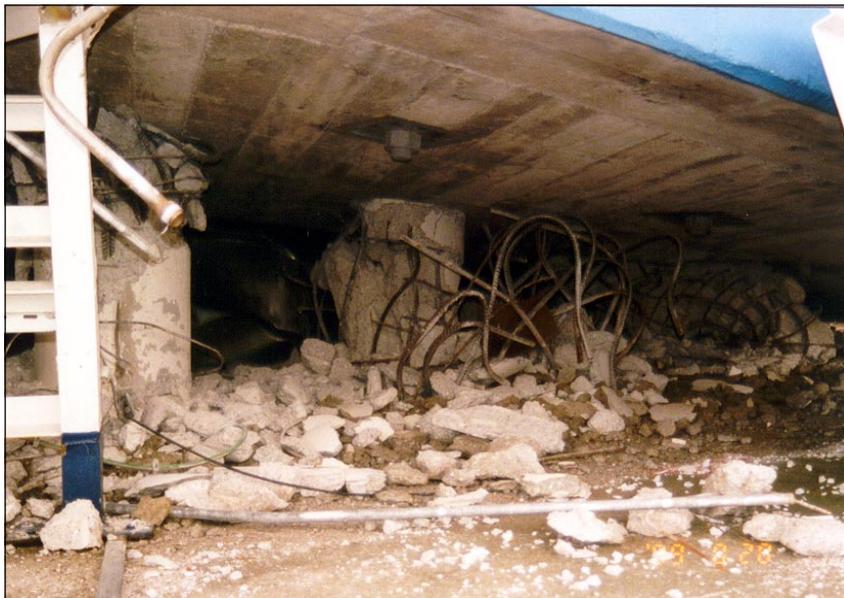
Figure 6-57 Tanks at Habaş collapsed due to failure of reinforced concrete columns and support base. Support structure was built in 1995.

1995 and consisted of stainless steel shells with an interior diameter of 42 feet. The tanks were each supported on a 42 inch deep reinforced concrete platform, with sixteen 20-inch diameter reinforced concrete columns, 100 inches tall. Two of the three tanks were filled with liquid oxygen at the time of the earthquake. Their column supports were not strong enough to resist lateral loads induced by the earthquake under high axial load leading to collapse of the entire support frame in a brittle manner. An identical third tank is immediately adjacent to the collapsed tanks. This tank was reportedly 1/4 full of liquid nitrogen and had no apparent damage.

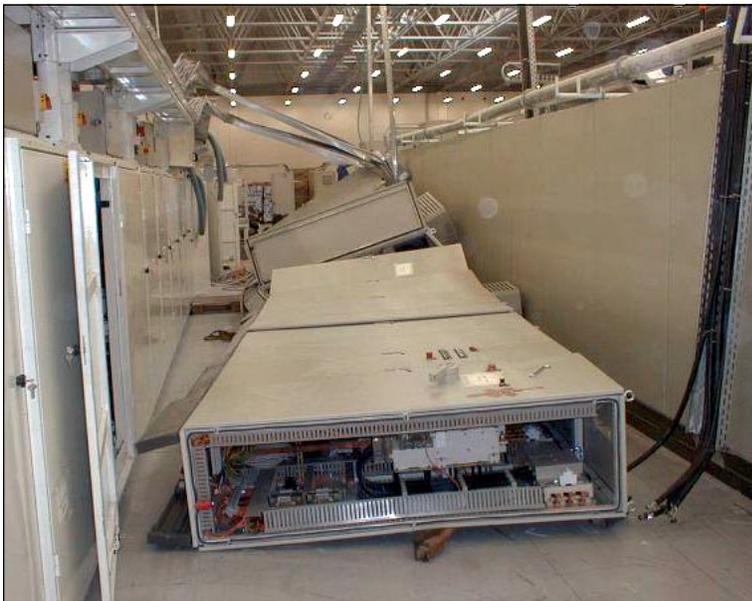
Most of the equipment damage observed was to unanchored equipment. Examples include the electrical equipment and small tanks at the Toprak facilities in Adapazarı (Figure 6-58).

Figure 6-58 Unanchored electrical cabinets fell at Toprak Sağlık's paper products plant in Adapazarı

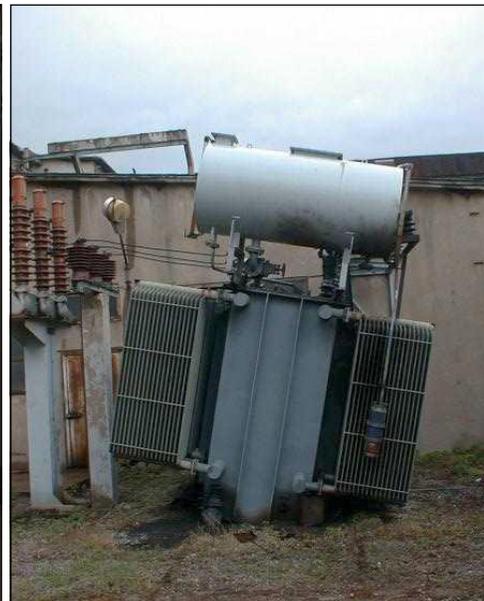
Transformers were damaged in several locations, including the SEKA paper mill, Toyota car factory, EnerjiSA power plant, Adapazarı substation, and Ambarlı power plant (Figures 6-59 to 6-61).

Figure 6-59 Damaged transformer at SEKA plant 4 will cause the plant to be shut down for two months

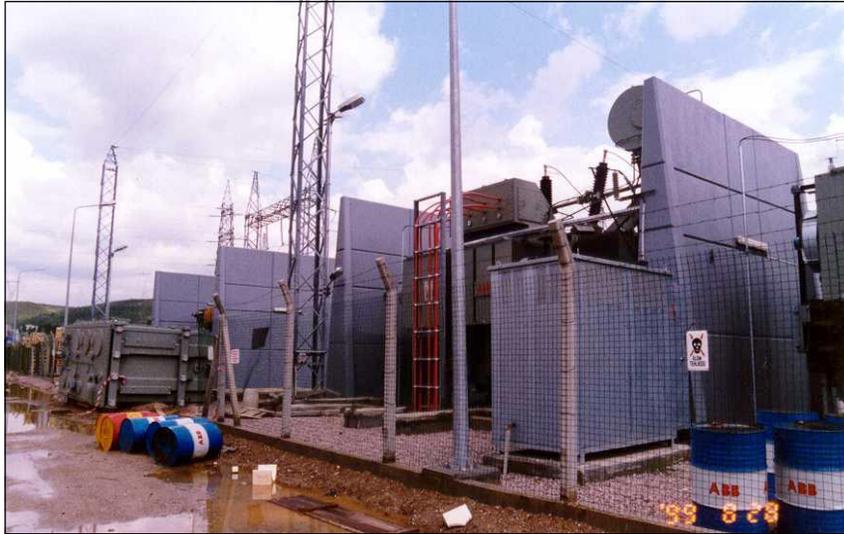
Figure 6-60 Transformers at EnerjiSA. End transformer rolled and tipped.

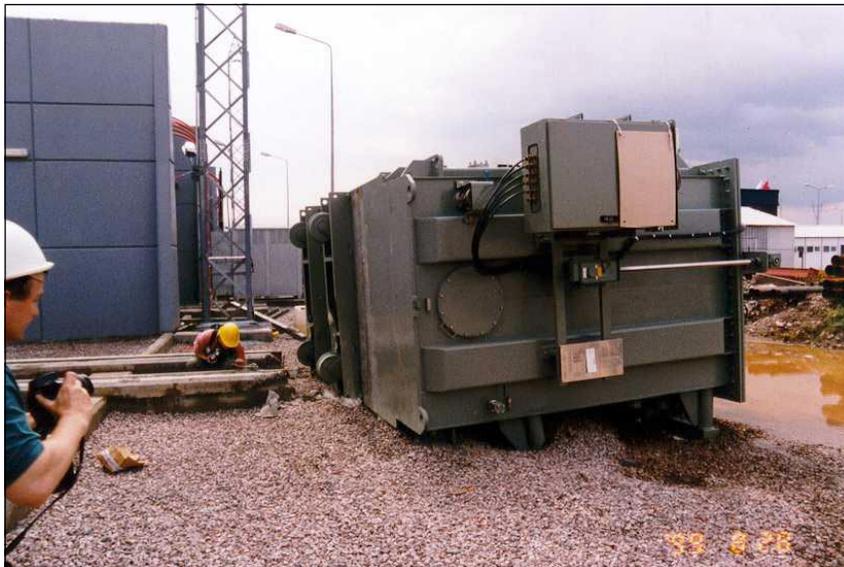
Figure 6-61 Transformer at EnerjiSA rolled several feet and tipped on its end

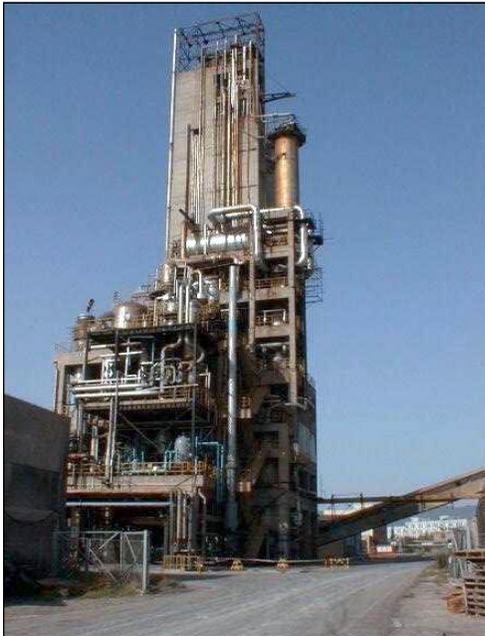
An elevated reactor vessel at the İGSAŞ fertilizer plant had broken steel braces hanging from the vessel near the top of its concrete frame support structure. Because of the Tüpraş

fire, İGSAŞ had not yet had the opportunity to inspect the structure and vessel at the time of the site visit. The concrete support frame itself was reported to be severely damaged (Figure 6-62).

Figure 6-62 Severely damaged reinforced concrete reactor support structure at İGSAŞ. Braces near top of reactor are hanging disconnected after earthquake.

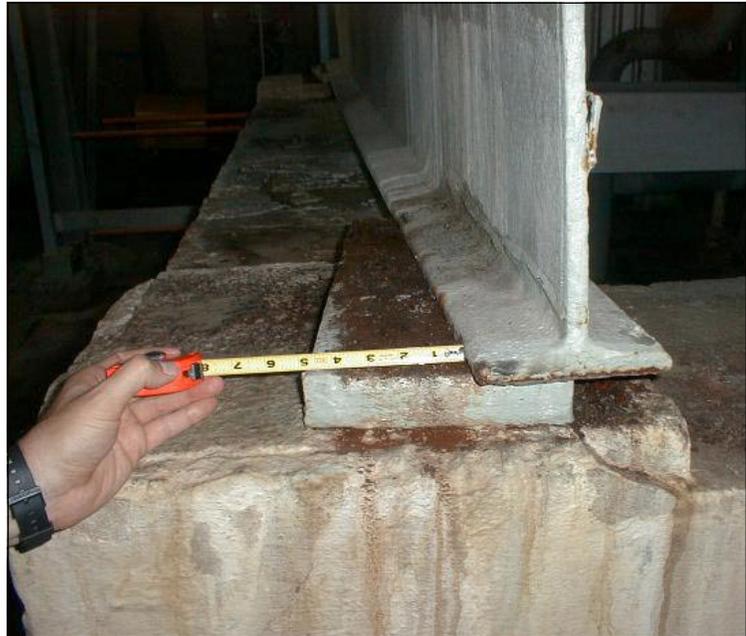
Pakmaya had numerous bioreactor vessels, unanchored on pedestals in their process building. Several of these vessels appeared to have shifted many inches on their supports, buckling skid beams and shifting supports (Figure 6-63). Piping was reportedly damaged due to shifting of the vessels.

Figure 6-63 Skid beams buckled and shifted due to displacement of large bioreactors at Pakmaya food processing plant

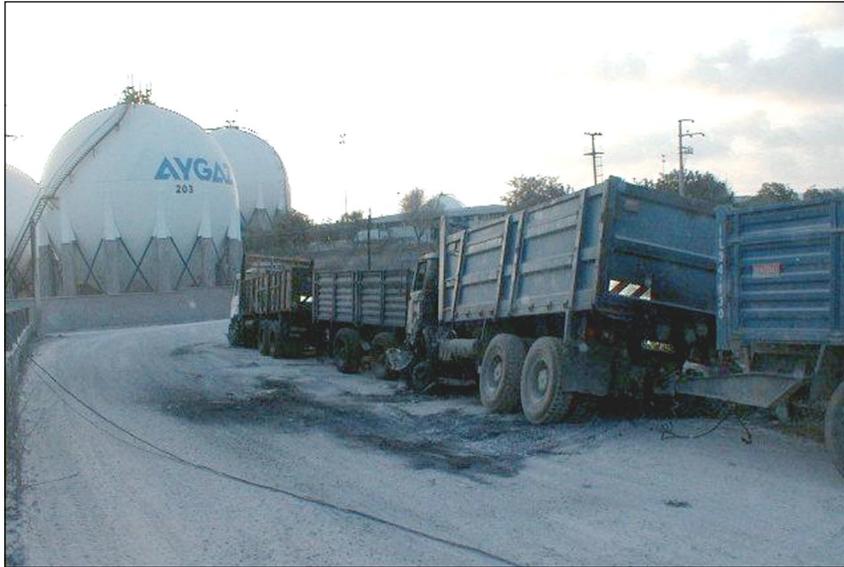
Although no major structural damage was observed at LPG plants in the epicentral area, two truck drivers were killed in a fire ignited by driving through a gas leak from one of the facilities. Security cameras at one facility captured the drivers leaving the facility across the street, beginning to run down the road on foot, changing their minds and returning to their trucks, and driving away. The remains of their burned out trucks and a burned out building in the facility could be found less than a mile down the road (Figures 6-64 and 6-65).

Figure 6-64 Burned out trucks drove through gas cloud leaking from facility

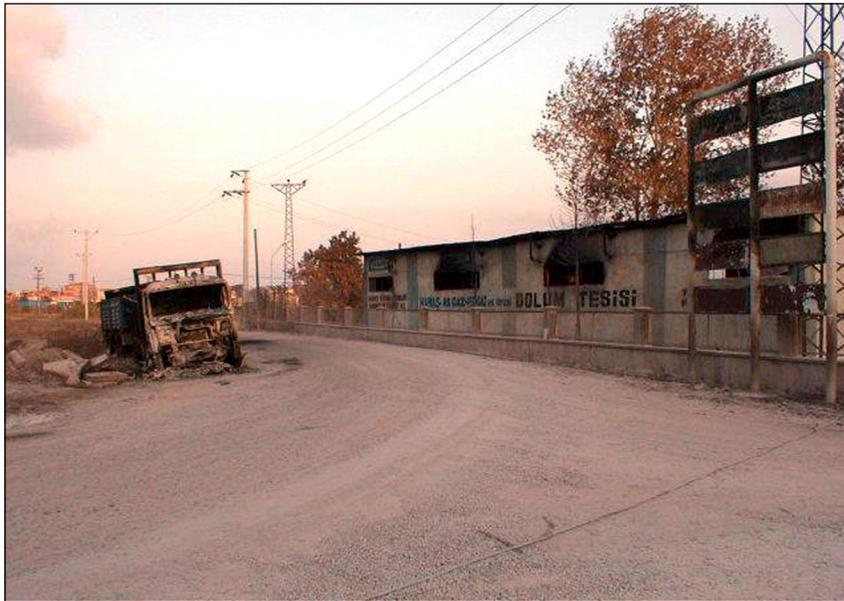
Figure 6-65 Fire from trucks burned down building at facility (to right) and killed drivers

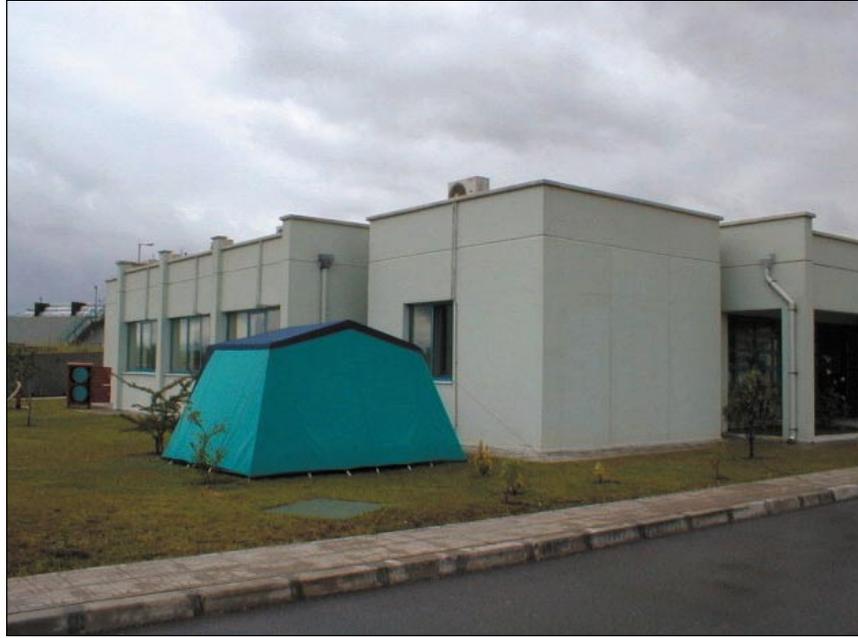
Figure 7-3 İzmit Water Project

undamaged (see Figure 7-3) with the exception of fiberglass piping in the clarifiers, which are cantilevered downward approximately 3 m. In basins which were not in use at the time, and empty, these 'trident' pipes cracked and/or broke at their upper (base) end. However, sufficient capacity remained for the plant to operate. Daily demand at the time of the earthquake is 2,500 l/s but, following the earthquake, demand increased to 3,200 l/s, which was attributed to leakage along the transmission line. Downstream of the plant, water is conveyed to retail customers via a 2.2 m spiral-welded steel pipe, which was

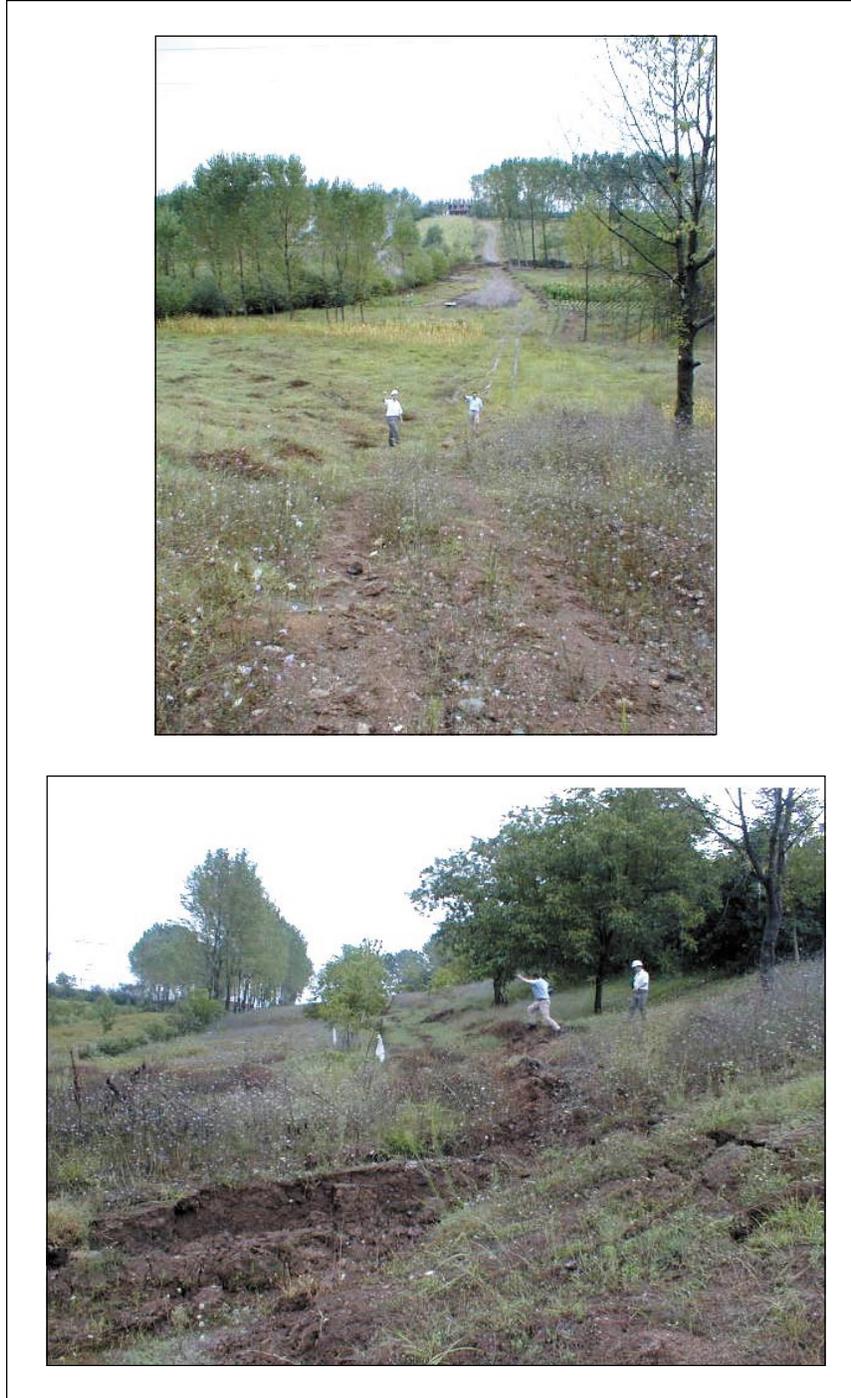
Approximately one km downstream of the plant, the steel transmission line crosses the fault trace. This location was inspected and found to have approximately a 2 m right lateral offset but, while some water flowing to the surface was observed (it was raining at the time, however), the pipe was reportedly undamaged at this location¹ (see Figure 7-4).

Figure 7-4 Top photo was taken looking north along pipeline alignment. The two men are at the location of the pipe-fault intersection, showing the approximately 2 m fault offset. Bottom photo taken looking east along the fault, with the pipeline alignment in foreground. The man is leaping across fault scarp, to east of pipeline. Note that the scarp appears to alter alignment northwards right at pipe (in foreground).

- The İzmit Water Project 2.2 m diameter steel transmission line crossed the main trace of the fault, sustaining about 2 m of lateral offset, yet not catastrophically failing. That a pipe could sustain such large offsets and not fail is remarkable, and the detailed strains in the repaired pipe, and site soil properties, require detailed study to understand the specifics of this situation (which offers important lessons for other fault crossing situations).

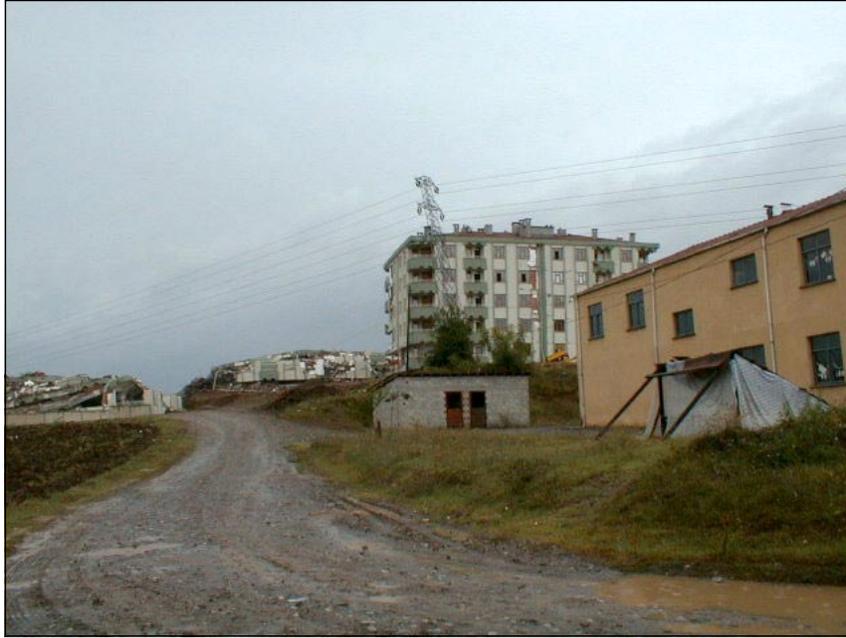
Figure 7-8 Electric transmission tower pulled to left (north) due to conductors being put in tension due to right lateral fault displacement (fault is to north, or left, of the tower)

Transmission lines and towers did not appear to be damaged, except where the lines crossed the fault. Figure 7-8 shows a tower leaning over due to the conductors being put in tension at the fault crossing. Distribution within the high intensity shaken area was heavily damaged, due to building collapse and other damage.

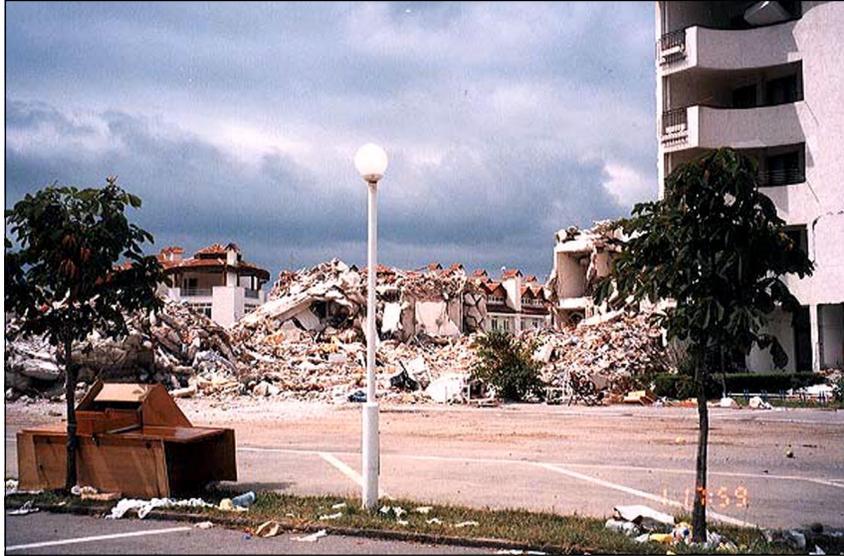
Figure 8-3 Totally destroyed apartment building near Karamursel

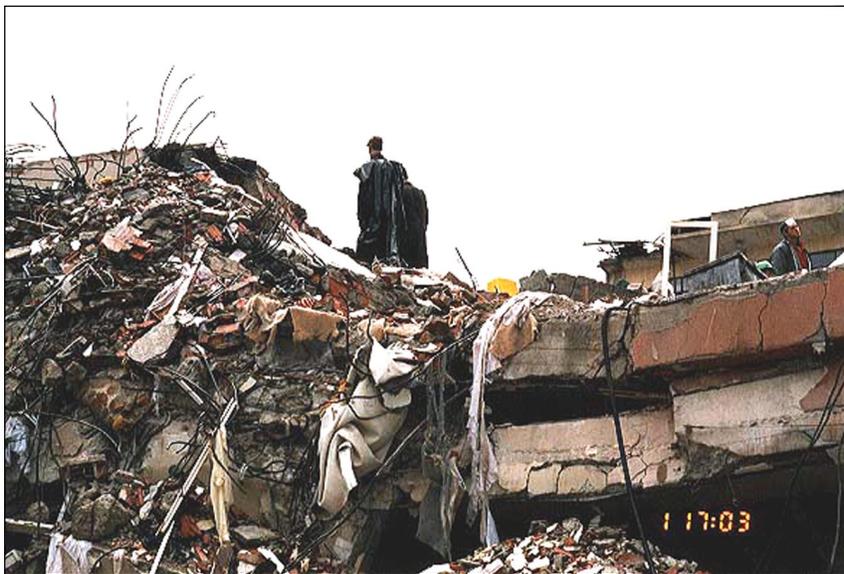
Figure 8-4 Collapsed apartments in Gölcük

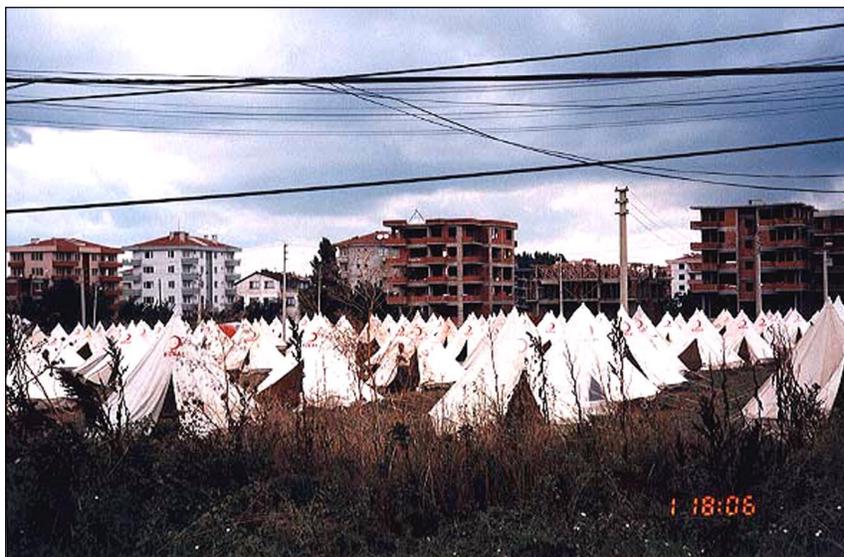
The Turkish Red Crescent (Kızılay) was harshly criticized for its slow response, and for the quality of its floorless, canvas tents (see Figure 8-9). It was also criticized for selling burial shrouds for the deceased. Perhaps the strongest criticism was of the leader of the Red Crescent, Mr. Kemal Demir, who was frequently referred to as a “dinosaur” because of his age and slow response, while reportedly living in a five-star hotel in Ankara (“Quake Provides Reminder of Turkey’s Split Identity,” Turkish Daily News, 26 August 1999).

Figure 8-9 Canvas Red Crescent tents without floors

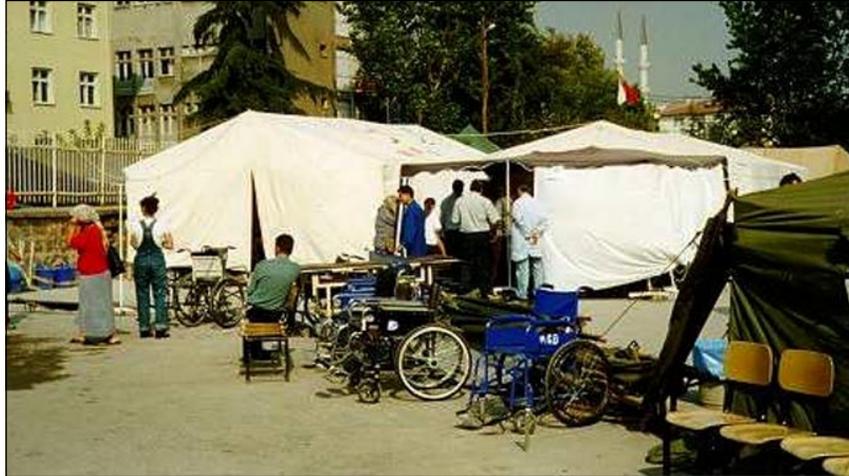
In both İzmit and Adapazarı, several hospital buildings experienced major physical damage during the earthquake. At a hospital in İzmit, for example, two buildings and the pedestrian walkway connecting them sustained serious damage from the shaking. Immediately after the earthquake, medical staff were forced to evacuate the building and move existing patients outside. As people began bringing the injured to the hospital's emergency department, it quickly became congested and overcrowded. To alleviate the crowding, hospital staff began assembling the injured in a school yard across the street, sorting and tagging them by severity of injury, and transporting them to other regional facilities. Similarly, existing patients who could not simply be discharged early were also transferred to other facilities.

What is most interesting about this particular hospital is that even five weeks after the earthquake, staff still had not yet reentered the buildings. On two occasions they tried to reenter, but when major aftershocks occurred, they returned outside. Because they were forced to set up operations in tents in the parking lot (shown in Figure 9-9), the hospital

Figure 9-9 A hospital in İzmit

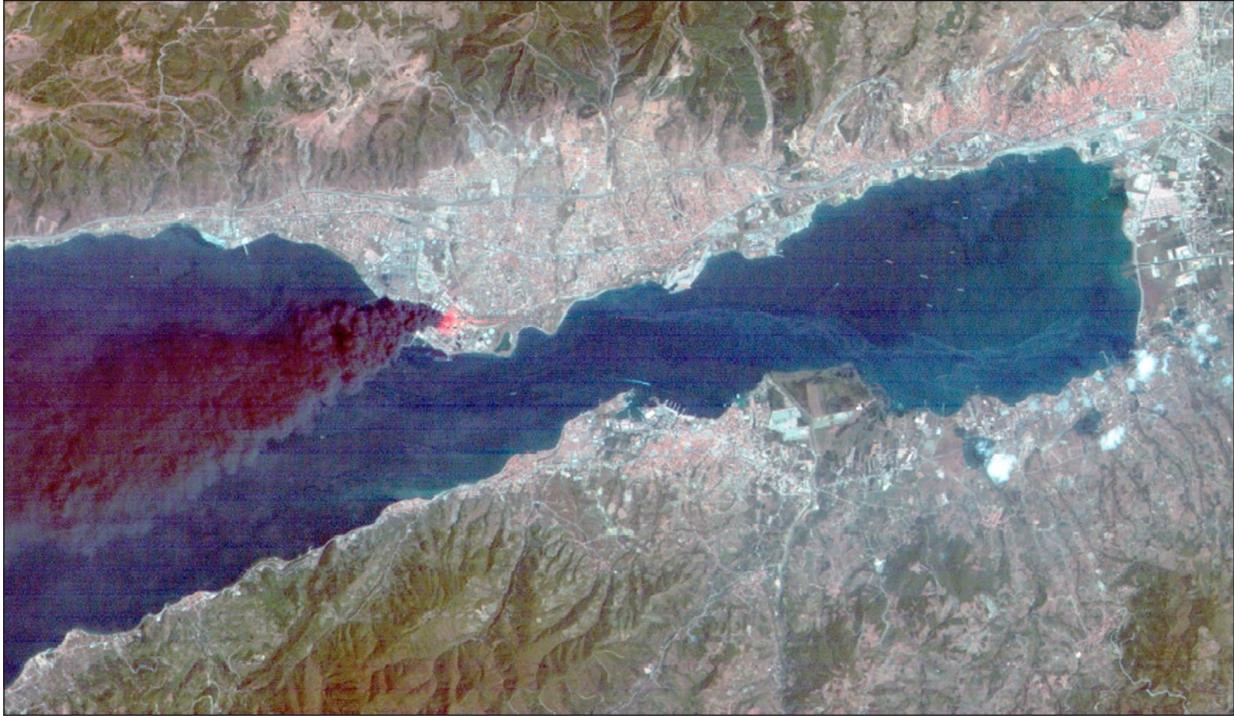
Figure 10-1 Landsat 5 Image of İzmit Bay taken on August 19, 1999. Note the fire and smoke plume originating from the Tüpraş Refinery, seen at the center of the figure.

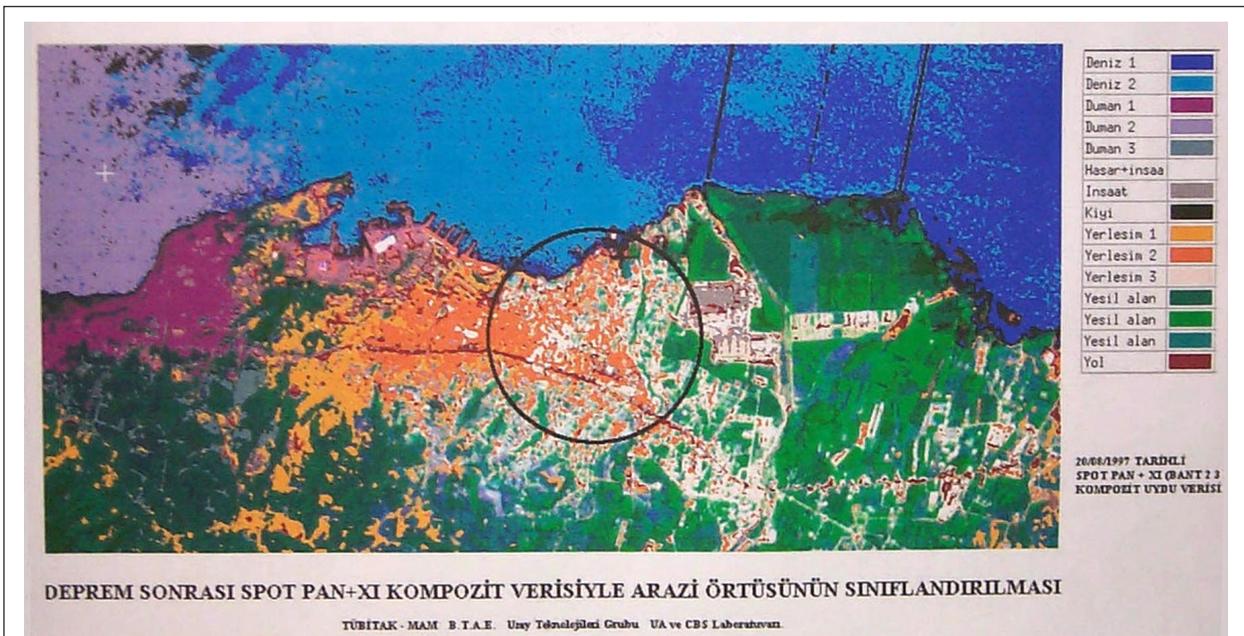
Figure 10-3 Image of Gölcük created after the earthquake. (SPOT image taken on 8/20/99). Note that the white or light areas identify city blocks where significant damage to buildings occurred.

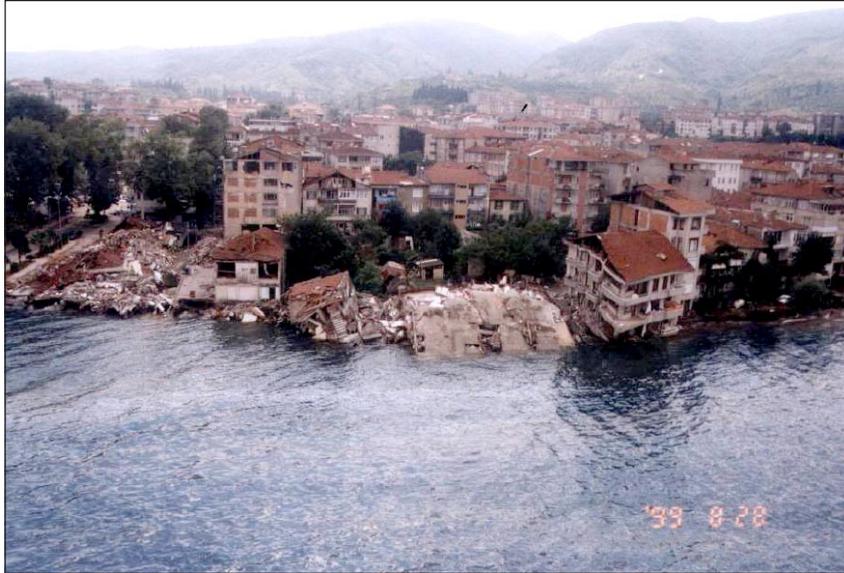
Figure 10-4 Aerial view of earthquake damage in Gölcük. This area was affected by ground subsidence caused by liquefaction.

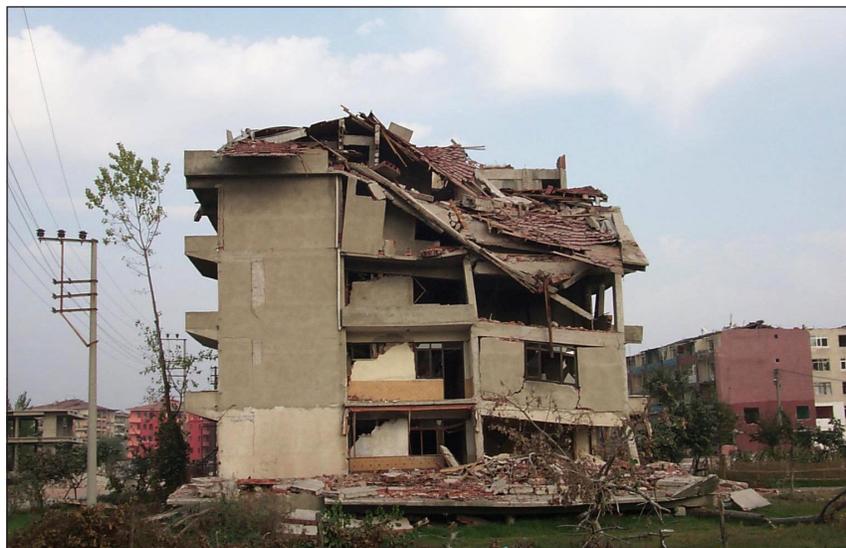
Figure 10-8 Isolated building in Seymen. This building experienced first floor collapse and well as damage to the top floor. This building should be visible from aerial photos; it may be detectable using radar pre- and post-event images.
