The Marmara, Turkey Earthquake of August 17, 1999: Reconnaissance Report

Technical Report MCEER-00-0001
March 23, 2000

Edited by
Charles Scawthorn¹

Technical Report MCEER-00-0001

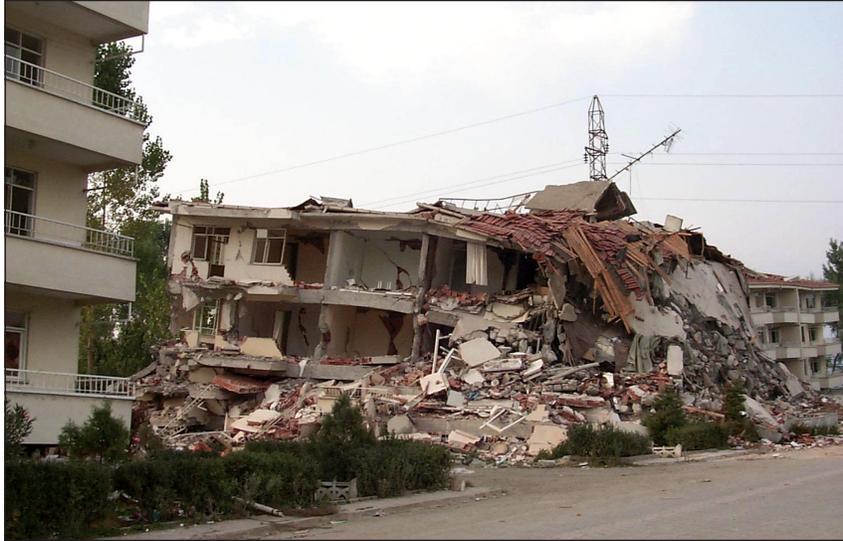
Figure 10-9 Near complete collapse of a five-story concrete structure. Should be visible from both aerial photos and SAR imagery.

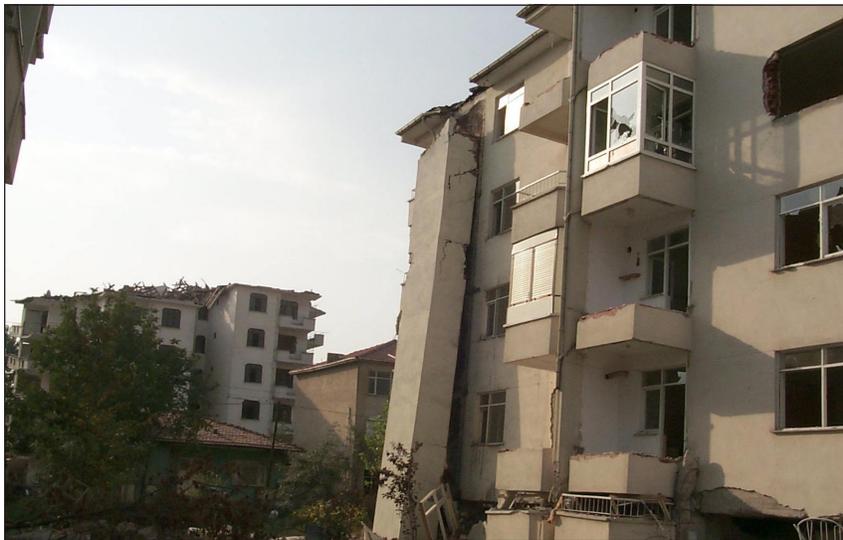
Figure 10-10 Severe damage to multi-story apartment buildings. Lower floors have “pancaked” and building is not tilted. May be visible from aerial photos; collapse of lower floors may be detectable from radar imagery.

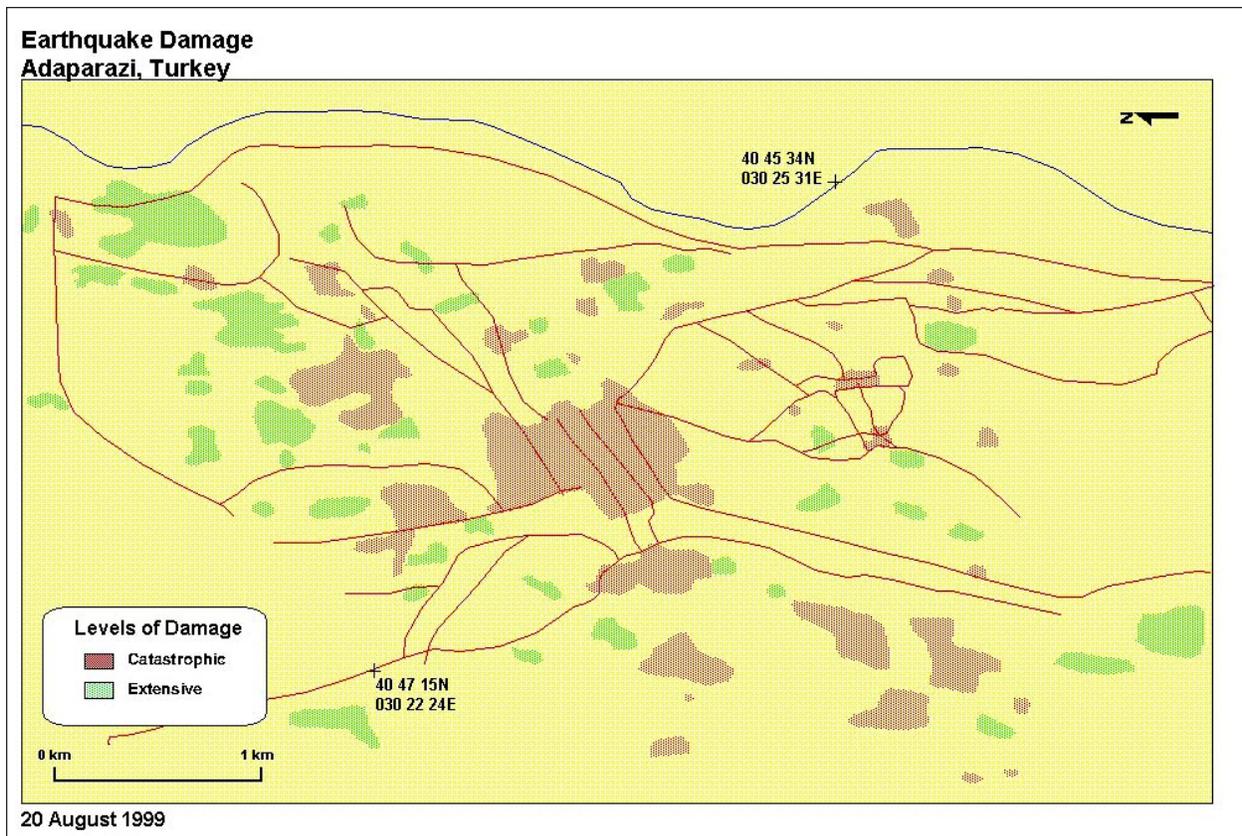
One example of the type of map distributed by the State Department is seen in Figure 10-11 for the Adapazari area. The map identifies areas of catastrophic and extensive damage. This map was put on the Internet on August 20, 1999, three days after the earthquake. According to officials at the State Department, high-resolution satellite images were used to classify the town into these two damage categories. Our purpose in validating these maps was to create a “ground truth” database that could eventually be used to calibrate a series of interferograms developed from this earthquake.

Unfortunately, the scale and projection of these maps was a little misleading. When compared directly with Landsat images – which were in a valid geographical projection – many of the obvious features (roads, rivers, and city boundaries) – did not match. The State Department maps appeared to present a distorted image of the affected areas.

Figure 10-11 Earthquake damage map produced by the U.S. State Department for the Adapazarı region (August 20, 1999) - uncorrected

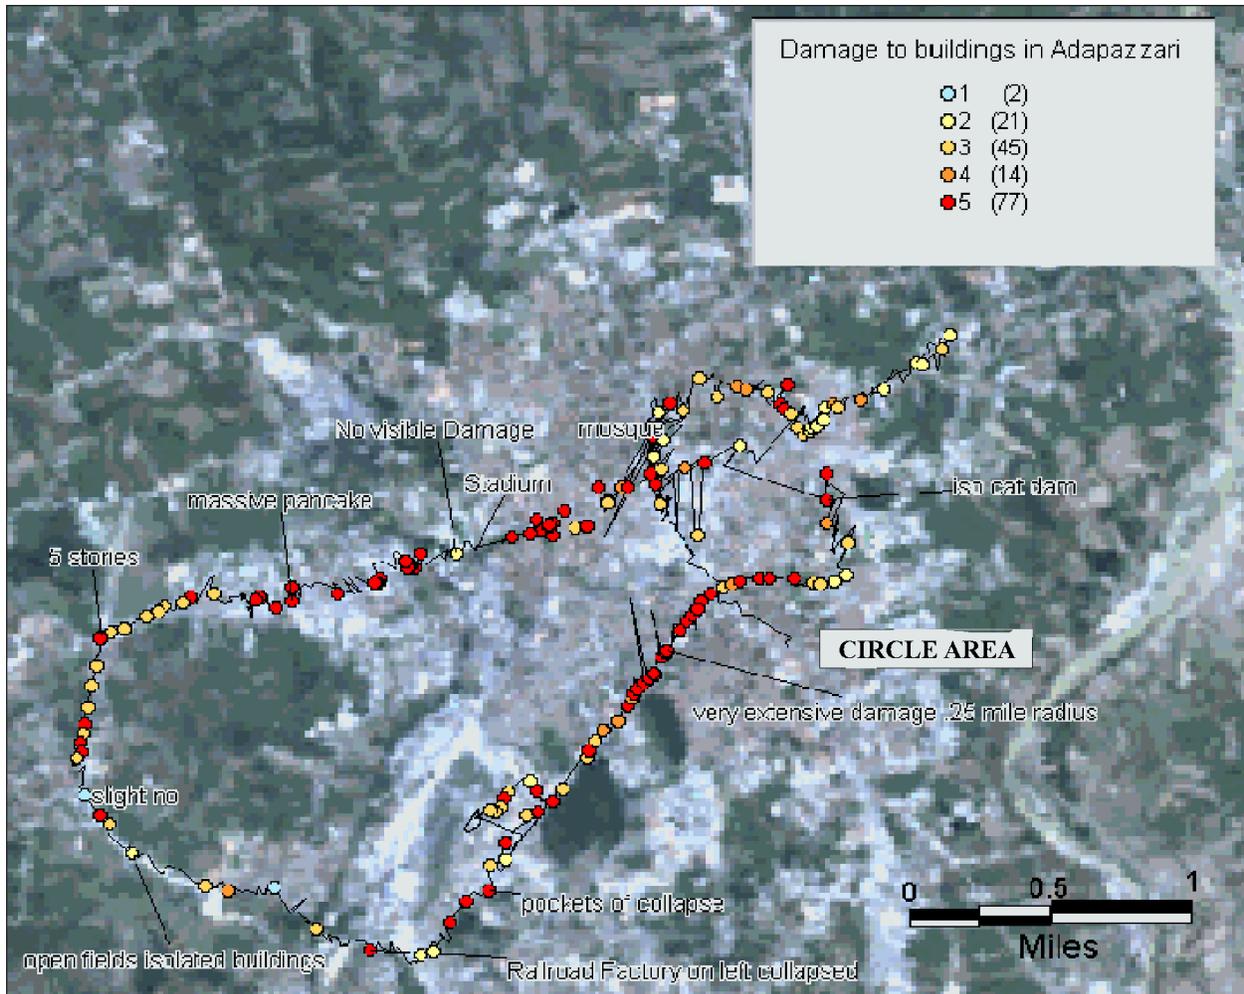
The route, shown in Figure 10-12 as a black line, began near the Mosque (center of the figure) and proceeded in a counterclockwise direction. Also noted on Figure 10-12 are color-coded circles that represent various levels of site damage (on a city block level), ranging from none or slight to catastrophic damage. Unlike the Avclar survey, we did not have access to Differential GPS. Therefore, some wavering of the route trace is noted. In theory, the coordinates that are registered are within a block of the actual location.

Figure 10-12 Landsat 5 image showing Adapazari (light area in center of figure) and the route taken by the MCEER/EDM team on October 2, 1999 (route shown as a continuous black line). Also seen are individual damage assignments that were made along the route. Note: A damage index of 1 is associated with an observation of slight to no damage; an index of 5 reflects catastrophic damage.

In addition to assigning damage levels to each block, we attempted to record this information via (1) digital still cameras, and (2) digital video camera.³ Also recorded via laptop computer were written comments regarding our damage observations at specific sites. Some of these comments appear on Figure 10-12. Note on the figure, the area designated as “Circle Area.” This was one of the most devastated areas in the city.

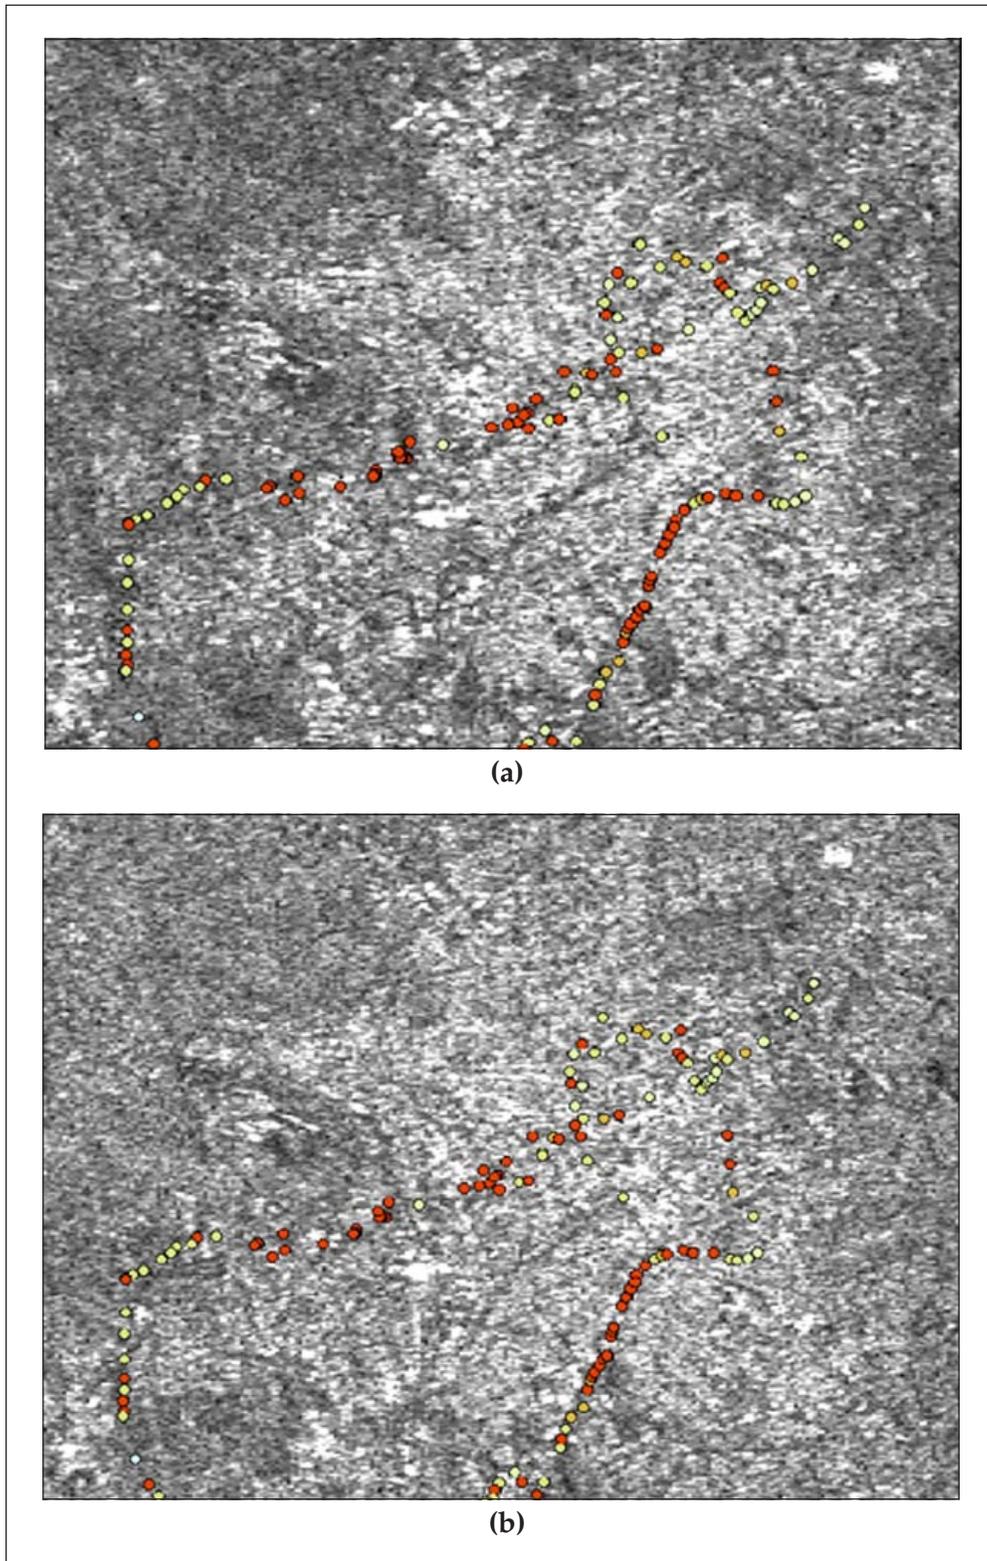
In general, pixel intensity will depend upon vegetation level, the density of buildings and their shapes, moisture levels, season, etc. Brighter areas are those that reflect more of the radar energy sent down from the sensor. In Figures 10-13a and 10-13b, the brighter areas are associated with the built-up area of Adapazarı. Both images were exported to MapInfo where they were geo-referenced to the Landsat 5 data. Since the resolution of these images is fairly coarse, we generally see only the major features of the region, e.g., major roadways and streets and some very large buildings. A cursory examination of both images does show some differences between the two figures. In order to view these changes in detail, we must concentrate on smaller portions of these images.

Figure 10-13 Intensity images of Adapazari based on before and after earthquake SAR data (Data Source: ESA). The light areas correspond to built-up areas, which generally demonstrate a higher degree of reflectance or brightness. A median and Frost filter were applied to reduce white noise and maintain edges.

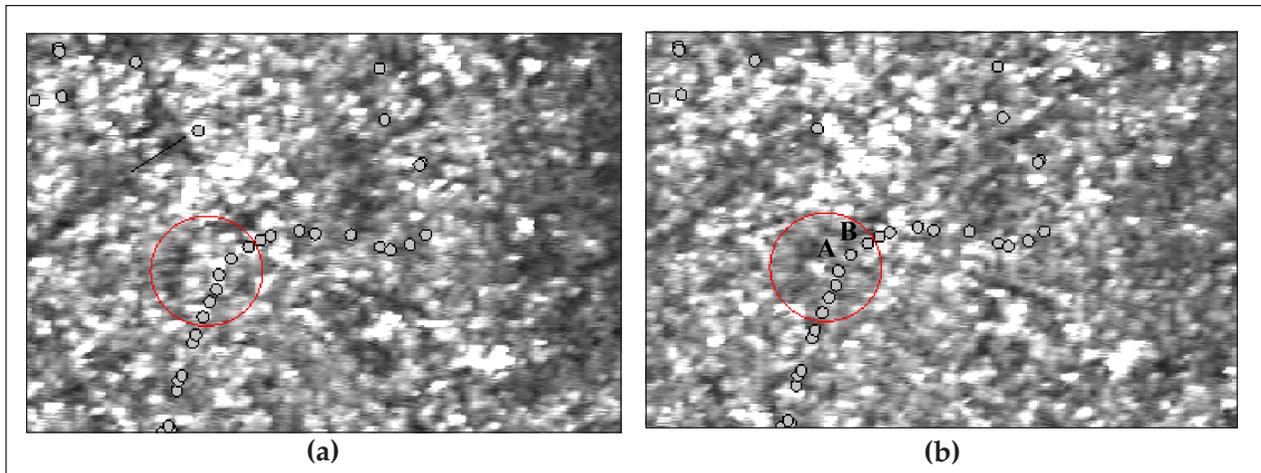
Figure 10-14 Close-up of “Circle Area” in Adapazari (see Figure 10-12 for location). Note the designations (a) and (b) in Figure 10-14b which refer to photographs (a) and (b) in Figure 10-15. North is up. Raw data supplied by ESA.

between the two images, we drew a circle of 0.25-mile radius around this area. Comparison of the two images reveals that the after-earthquake image (Figure 10-14b) contains fewer bright spots. As was explained before, many of the buildings in this area had either completely failed (total collapse) or were severely damaged (many tilted buildings). It is expected that this type of damage would result in more scattering and thus, duller images.

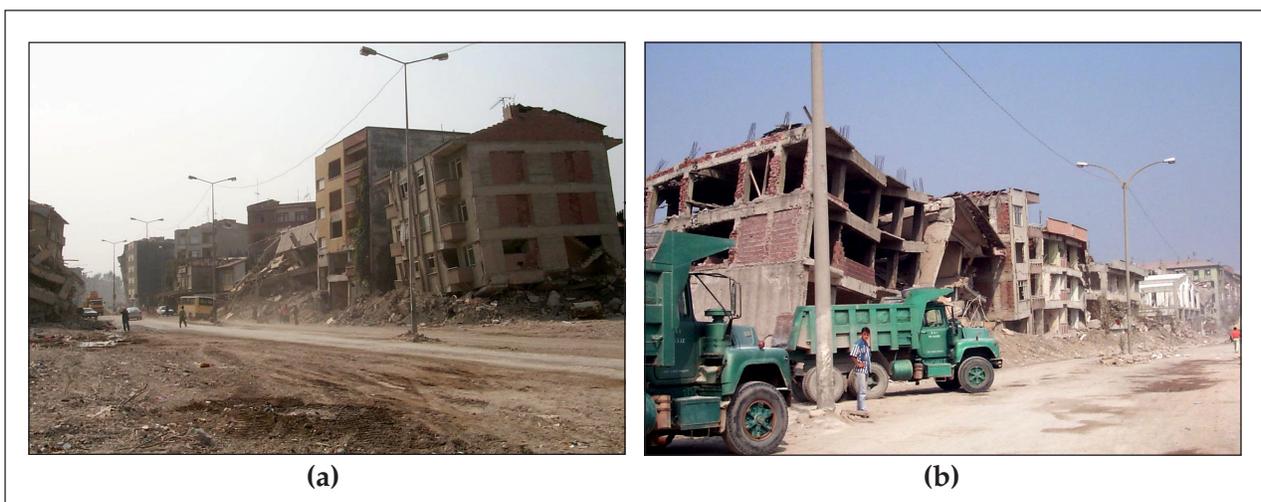
Figure 10-15 shows two photographs of damage in the “Circle Area.” The first photograph (Figure 10-15a) is taken looking west along the main road. The second photograph is taken from the same location, looking northeast. Note that many of the damaged buildings have been torn down and the debris hauled away (Figure 10-15a). Since the second image was taken about one month after the earthquake, it is possible that the bare ground was being imaged at that time. At any rate, the second image was able to pick up this change.

Figure 10-15 Damage to apartment buildings in the “Circle Area” of Adapazari. Left image is view (a) in Figure 10-14b. Right image is view (b) in Figure 10-14b.
