The Chi-Chi, Taiwan Earthquake of September 21, 1999: Reconnaissance Report

Technical Report MCEER-00-0003
April 30, 2000

Edited by
George C. Lee¹ and Chin-Hsiung Loh²

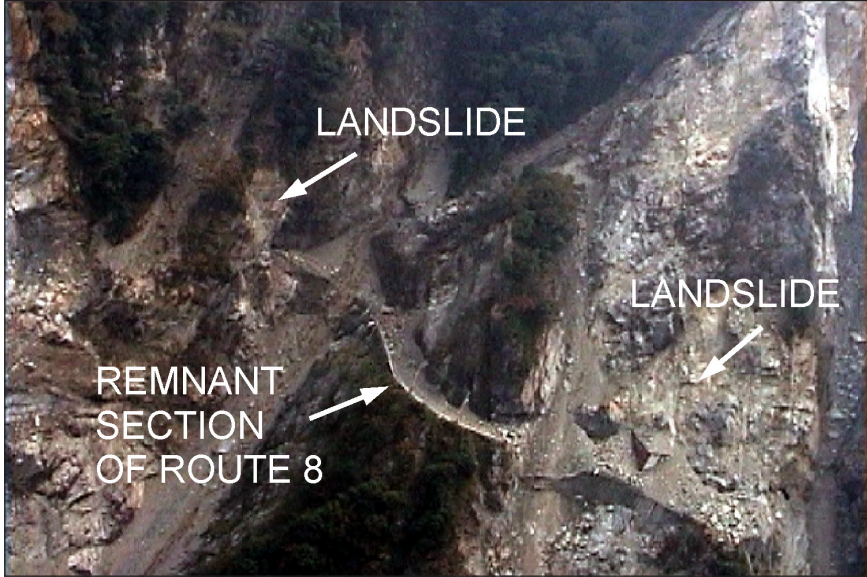
Figure 3-2 Landslide along Route 8

Figures 3-2 and 3-3 show aerial views of the landslides along Route 8. As indicated in the photos, there was substantial destruction of the highway, with relatively long sections of road both undermined by landslides and blocked by landslide debris. Figure 3-3 shows that the portal of one of the Route 8 tunnels was partially collapsed and was blocked by landslide debris.

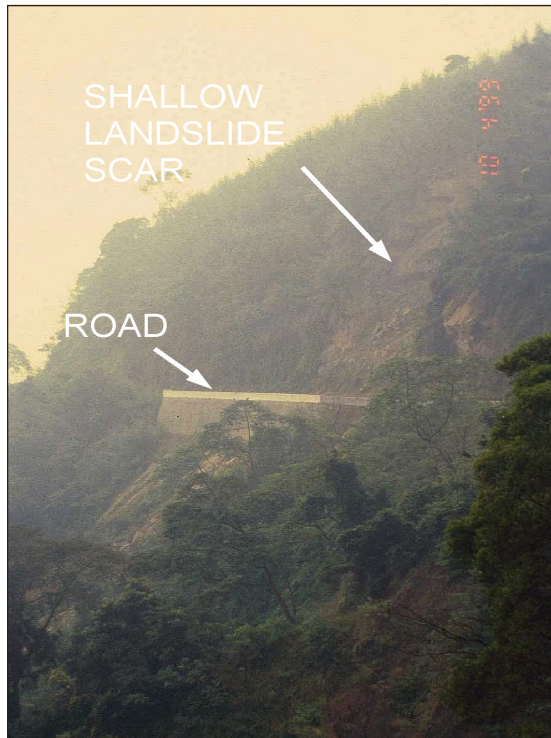
Figure 3-4 Typical shallow landslides intersecting a mountain road

Figure 3-4 shows landslide scars typical of most soil and rock falls along the highway system in the mountains. The slides were relatively shallow, extending through the soil mantle into the weathered rock. Debris, cascading from higher elevations, blocked roadways in hundreds of locations.

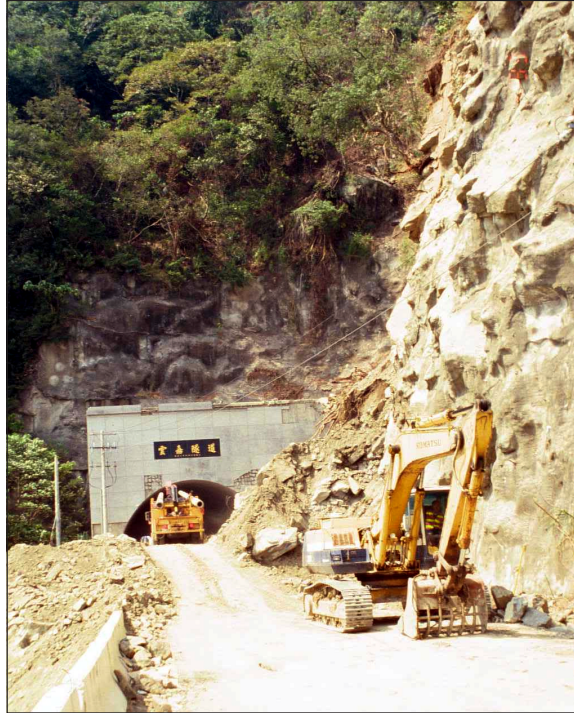
Figure 3-5 Landslide at portal of Yun-Chia Tunnel near Tsao-Ling

Figure 3-5 shows a landslide location near the Yun-Chia Tunnel in the Tsao-Ling area. Although some instances of tunnel collapse were reported along Route 8, most ground failures at tunnels were confined to soil and rock falls near tunnel portals.

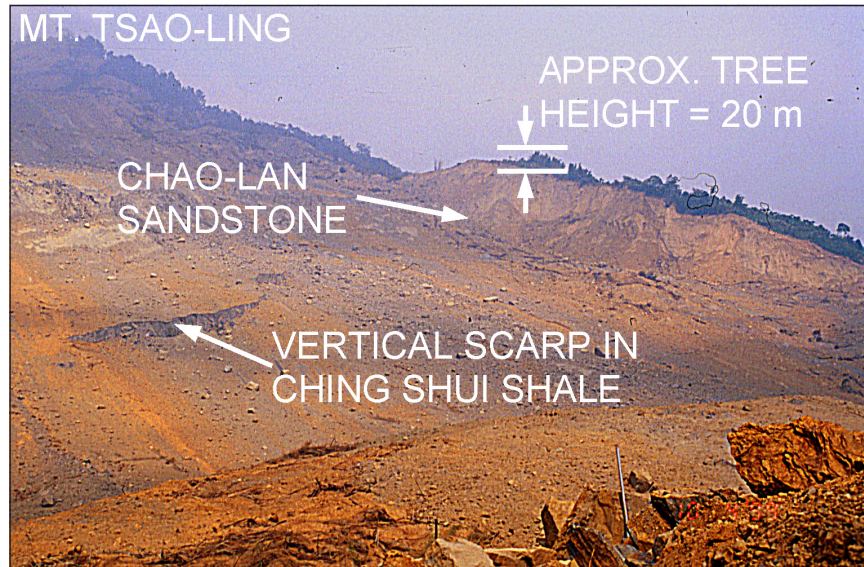
Figure 3-7 Eastern boundary of Tsao-Ling landslide

Figure 3-6 shows a three dimensional view of the terrain at the Tsao-Ling landslide site that was developed with SPOT digital imagery. The use of remote satellite imagery to evaluate Chi-Chi earthquake effects is discussed in Section 8 of this report, and is used here to show the locations of ground-based photographs that were taken at the site of the landslide. Figures 3-7 and 3-8 show views of the landslide at its eastern and western margins, respectively.

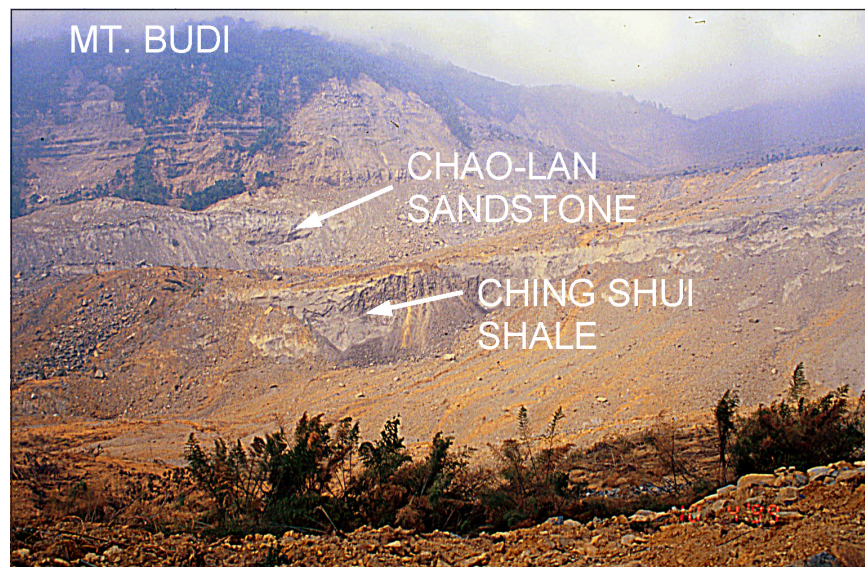
Figure 3-8 Western boundary of Tsao-Ling landslide

The landslide triggered by the Chi-Chi earthquake appears to have mobilized a volume of failed material similar to that involved in the 1941 earthquake. The landslide was generated primarily by failure of the Chin-Shui Shale Formation that underlies the Chao-Lan Sandstone (see Figures 3-8 and 3-10). The shale is a friable, silty mudstone with weak cementation that deteriorates readily upon wetting and drying. The shale exhibits very low compressive strength that is highly dependent upon time of submergence in water (Lin and Hung, 1982).

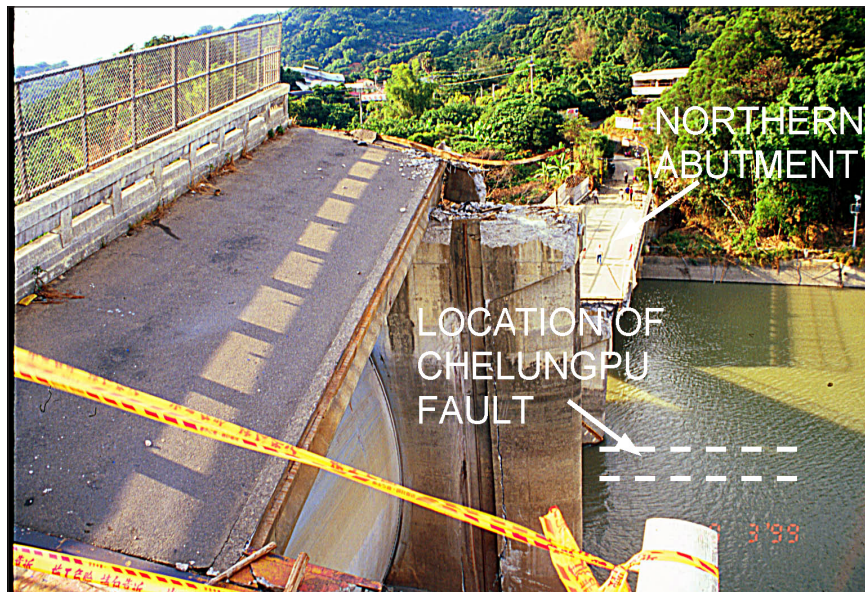
Figure 3-12 View from upthrust side of Shih-kang Dam looking north

Fault rupture with a vertical offset exceeding 9 m was responsible for failure of the Shih-kang Dam and subsequent release of approximately two million m³ of water. This loss represents 40% of the raw water supply for Taichung County. Figure 3-11 is a photograph of the northern abutment area taken downstream of the dam, and Figure 3-12 is a photograph of the northern abutment from the vertically displaced southern part of the dam.

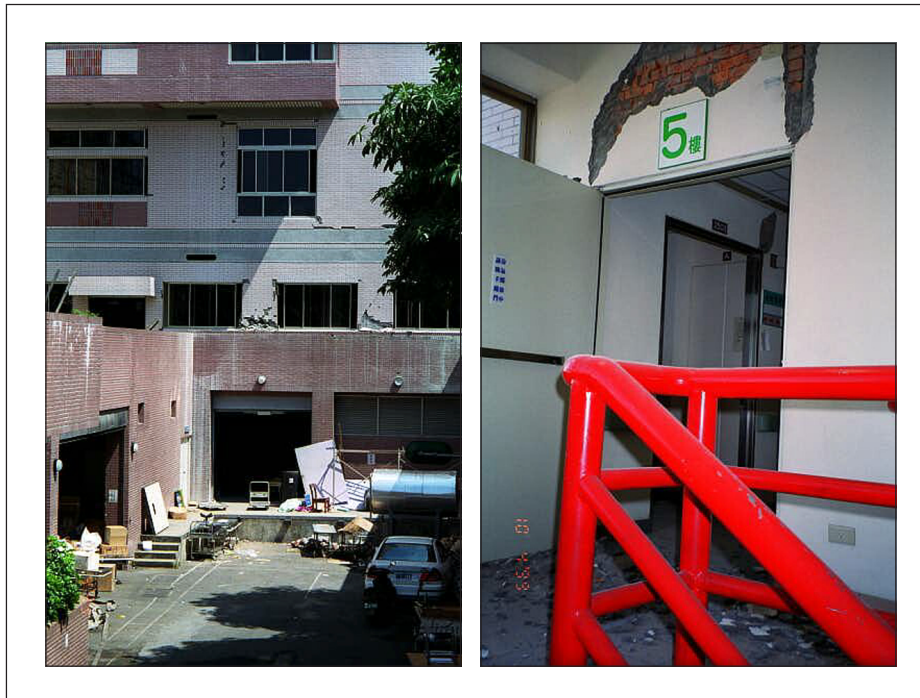
A major facility in Puli and surrounding communities, the Christian Hospital is a 400-bed facility of reinforced concrete (RC) construction consisting of a new (about 4-yr. old) section and an old (about 20-yr. old) section (Figure 4-1).

Figure 4-1 The Christian Hospital sustained considerable damage. Photos show (left) part of the exterior damage to the hospital; and (right) interior damage to partitions and ceilings.

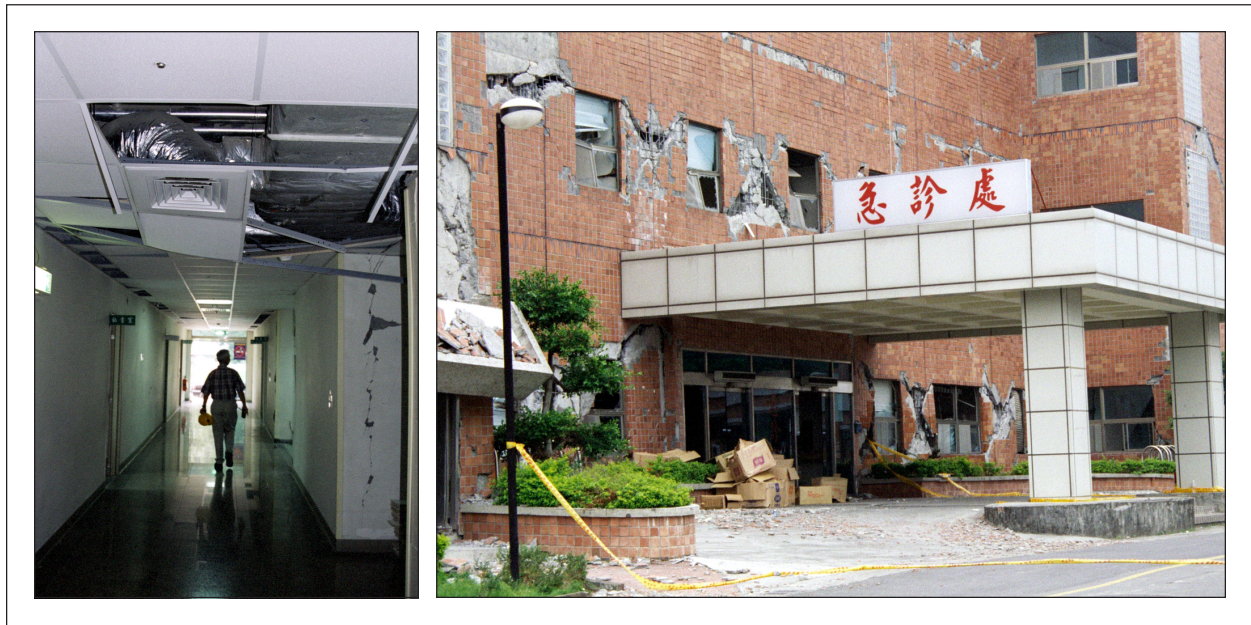
Figure 4-4 The Veterans Hospital sustained both exterior damage (left) and interior damage (right) to the newest buildings of the medical center.

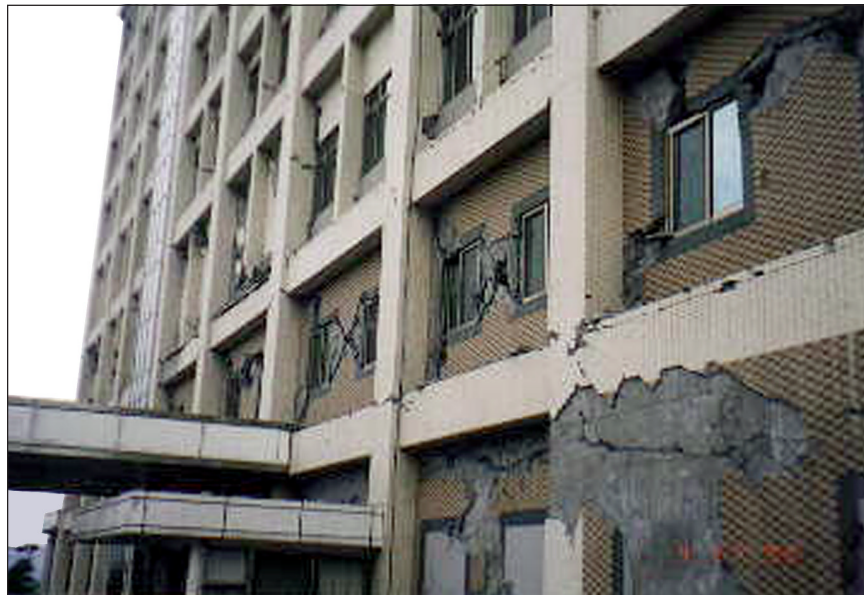
- Structurally intact, it suffered considerable nonstructural damage as in the case of the other two hospitals (Figures 4-5 and 4-6). Interior damage was most severe at the second- and third-floor levels where, unfortunately, some of the major facilities, such as operating and recovery rooms, were located. Patients were moved to open hospital ground and subsequently transferred to other hospitals.
- Hospital closed.

Figure 4-6 Damage to an exterior wall of the Shiu-Tuan Hospital in Nantou county

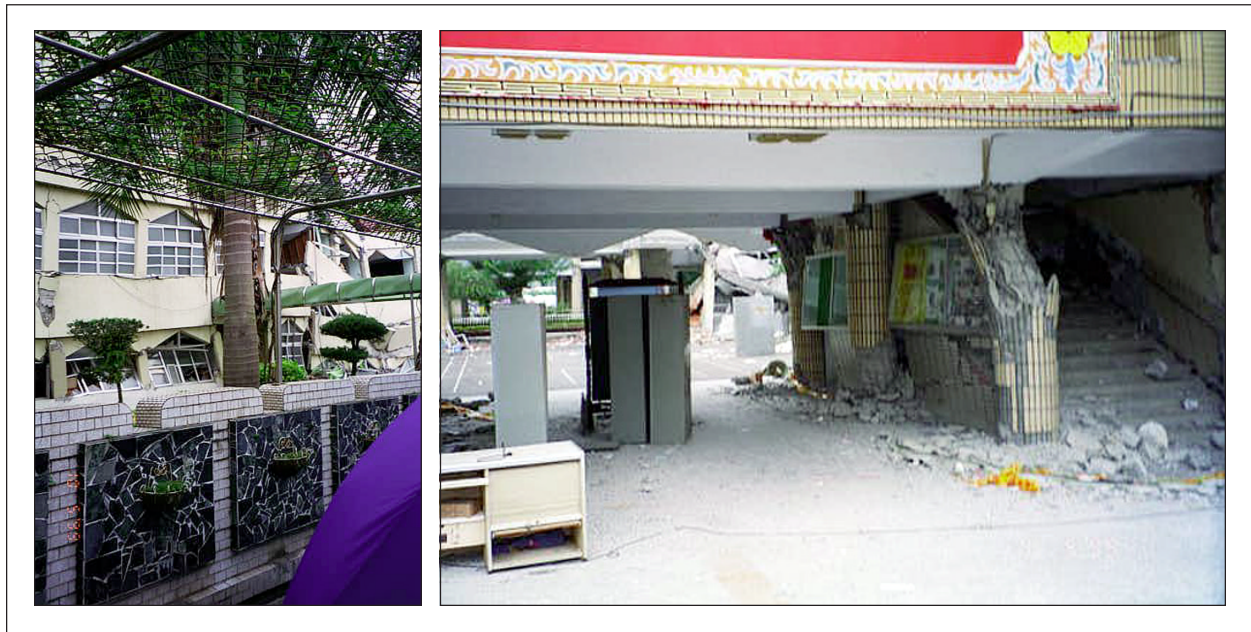
Figure 4-7 Typical damage to schools due to short-column effect and eccentricity

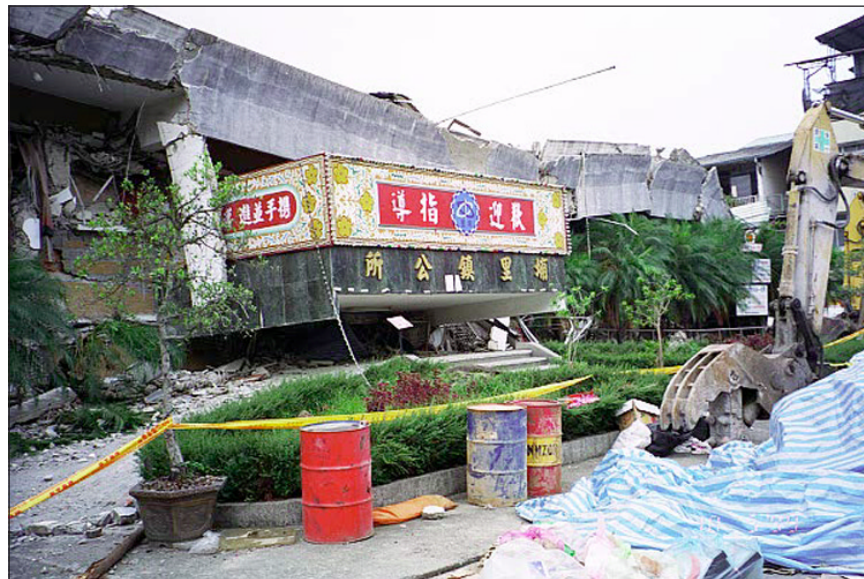
Figure 4-8 Total collapse of Puli Town Hall

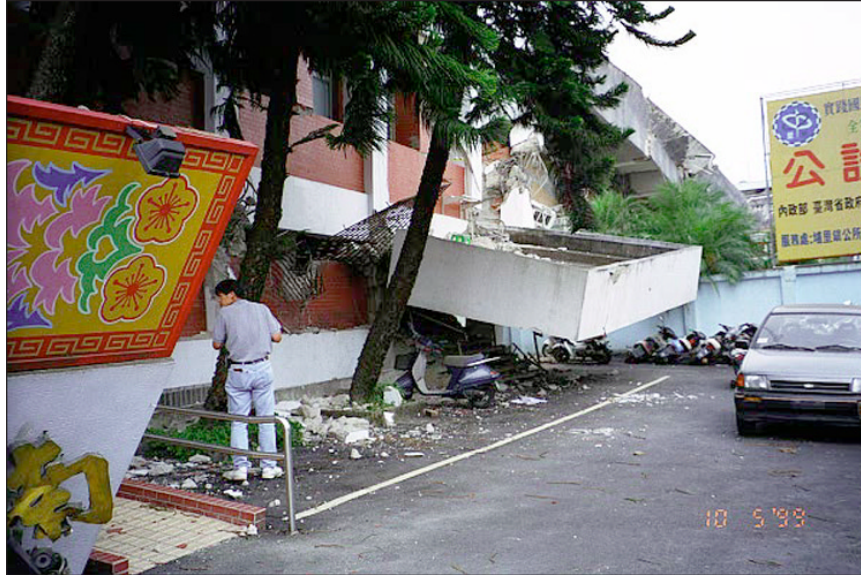
Figure 4-9 Heavily damaged Puli Police Station

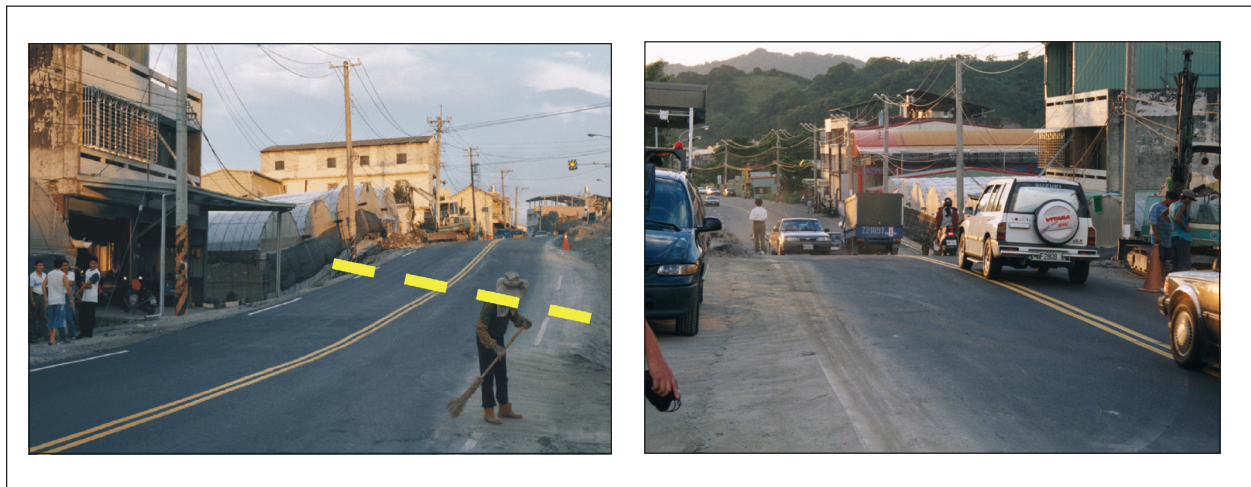
sets, as shown in Figure 5-2, buildings obviously cannot be easily repaired, particularly when large displacements have afflicted them with considerable damage. Inexpensive concepts to construct buildings across faults have not been developed to date, and the best strategy remains to avoid building at such locations. Unfortunately, this presupposes the availability of reliable maps of active fault locations, and legislation that effectively prevents constructions across such faults. Generally, these are still largely unavailable except in the most active seismic areas.

Figure 5-2 Road was originally level, uplifted by fault rupture, and repaved to restore service

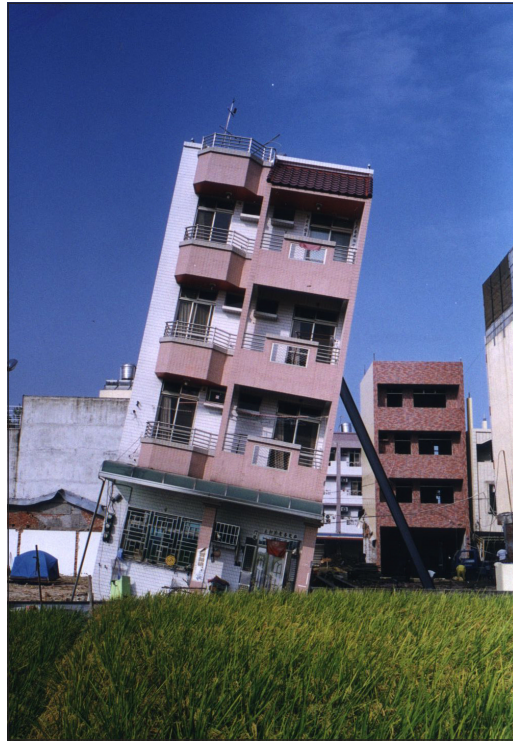
Numerous instances of geotechnical failures that had an impact on the seismic performance of buildings were also observed, such as settlement due to liquefaction (Figure 5-3); however, these are not discussed in this chapter.

Figure 5-3 Damage due to settlement caused by liquefaction

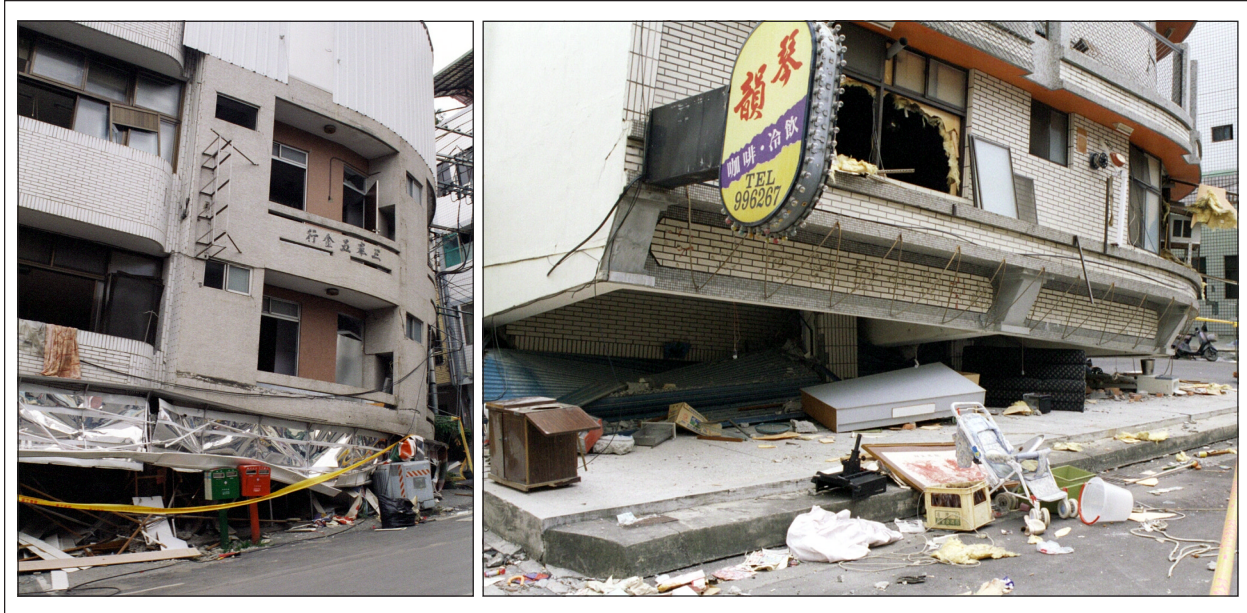
structural frame than on the back-side where walls with few openings are generally found. This structural eccentricity accelerates the soft-story damage on the street side, often resulting in toppling of the building toward the street (Figure 5-7), or toward the intersection in the case of buildings located on street corners and thus having two open sides (Figure 5-8). Note that buildings in Taiwan often project over the sidewalk, which is one common architectural feature that increases this structural eccentricity.

Figure 5-8 Buildings located on street corners toppled toward the intersection as a result of soft-story damage

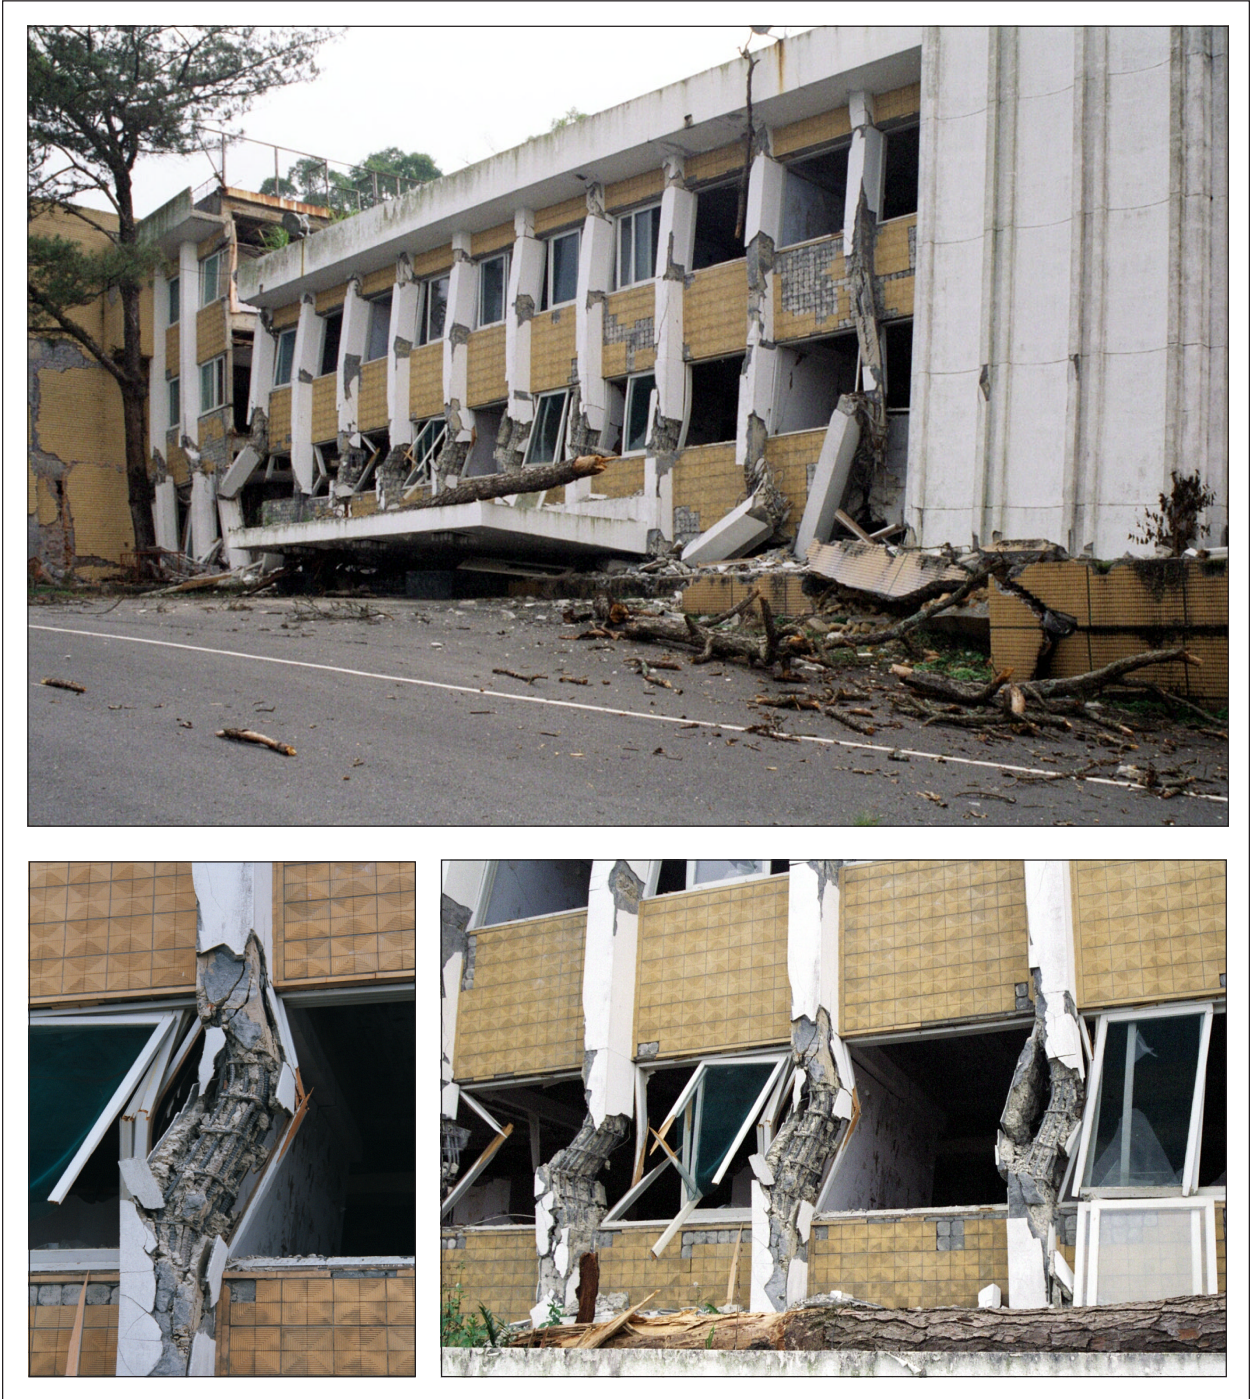
In other instances, although trapped columns may develop flexural plastic hinging instead of shear failures, it remains that damage in columns is not desirable. The partial height infills thus promote the strong-beam weak-column behavior described earlier. Examples of such failures are shown in Figure 5-9 for a column having moderate stirrup spacing that provided sufficient transverse reinforcement, along with a favorable column

geometry, to prevent this shear failure. Also note on that figure the conspicuous asymmetric column cover concrete in that instance.

Figure 5-9 Damage due to trapped columns having “moderate” stirrups spacing

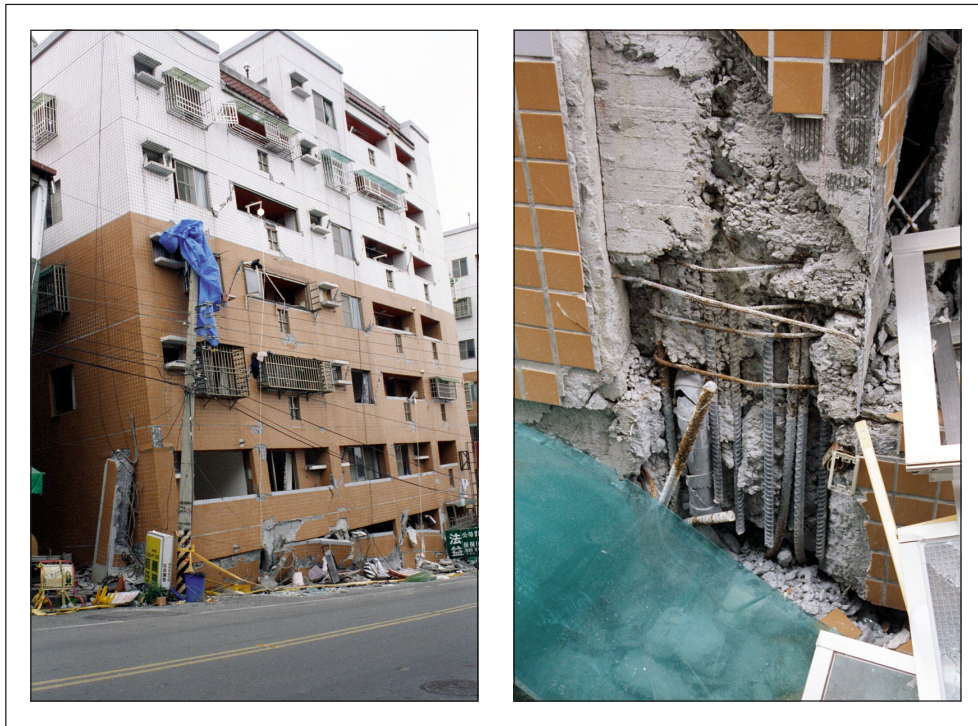
Figures 5-10 to 5-14 illustrate some examples of such undesirable detailing practices. The columns shown in Figure 5-10 had widely spaced stirrups and were therefore poorly confined, which led to their rapid degradation in the hinge region. Poor transverse reinforcement detailing also led to the shear failure and soft-story failure of the building shown in Figure 5-11. A closer look at another building that experienced soft-story failure and shown in Figure 5-12 revealed the presence of poor detailing, with columns bars spliced in the joint region. An example of total absence of transverse joint reinforcement (among other things) is shown in Figure 5-13. And, of course, some buildings suffered from many (if not all) of the above deficiencies, as shown in Figure 5-14.

Figure 5-12 Example of collapsed building with column bars spliced within the joint

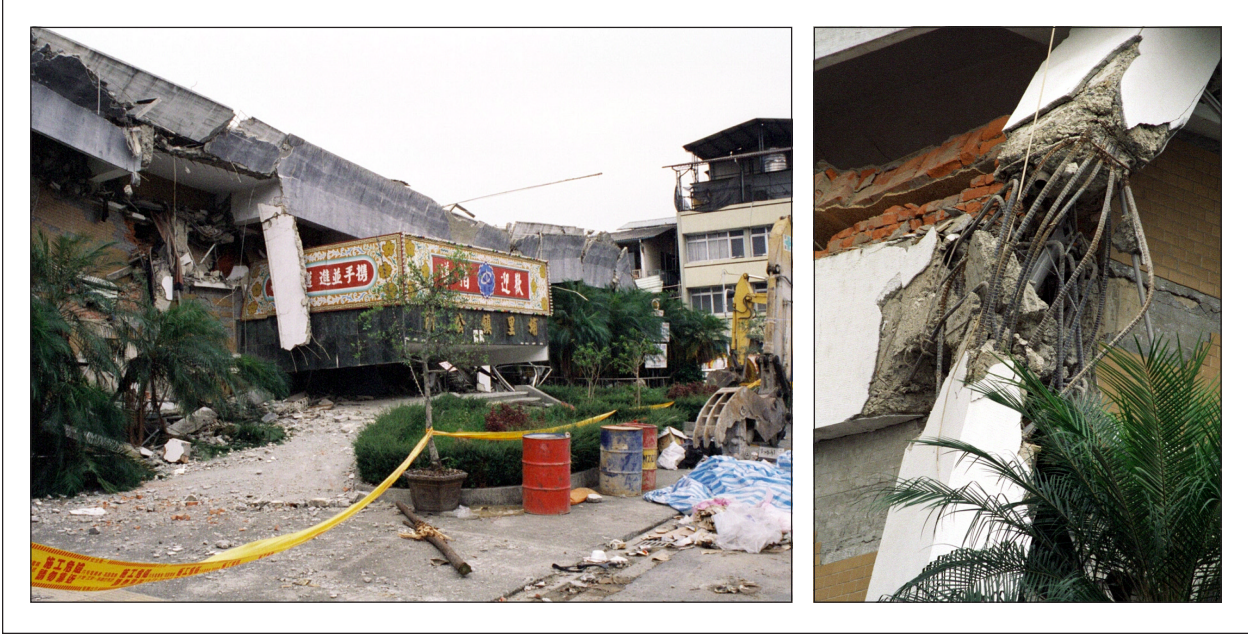
Figure 5-13 Example of collapsed building having no transverse joint reinforcement

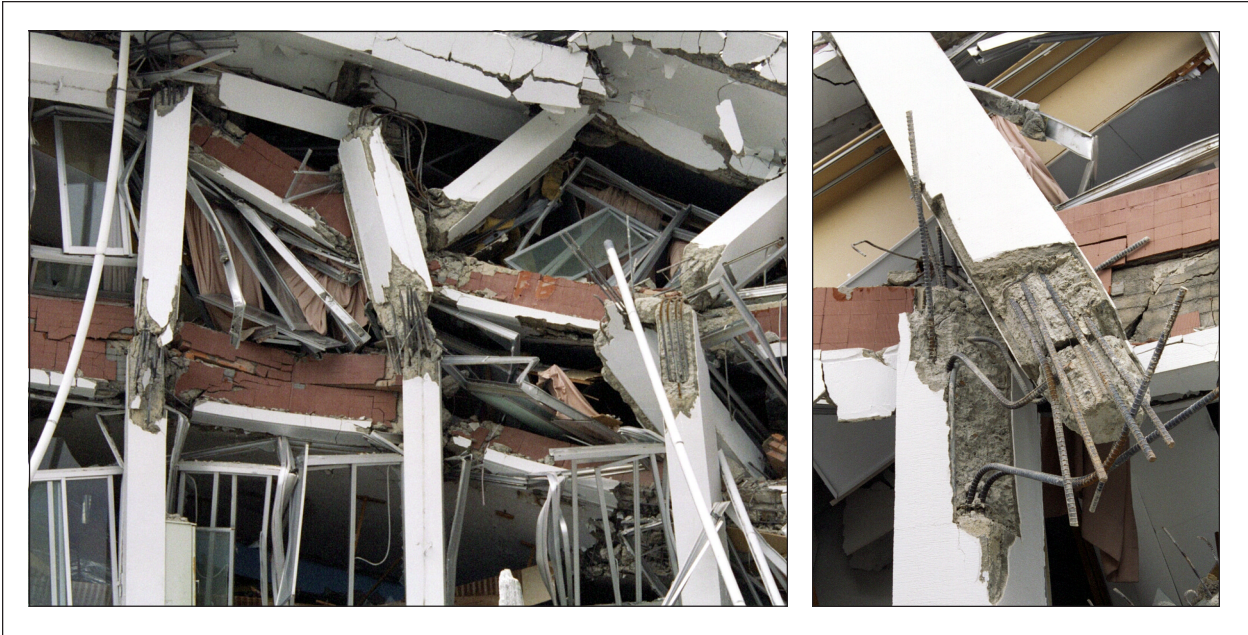
Figure 5-14 Damage due to poor detailing

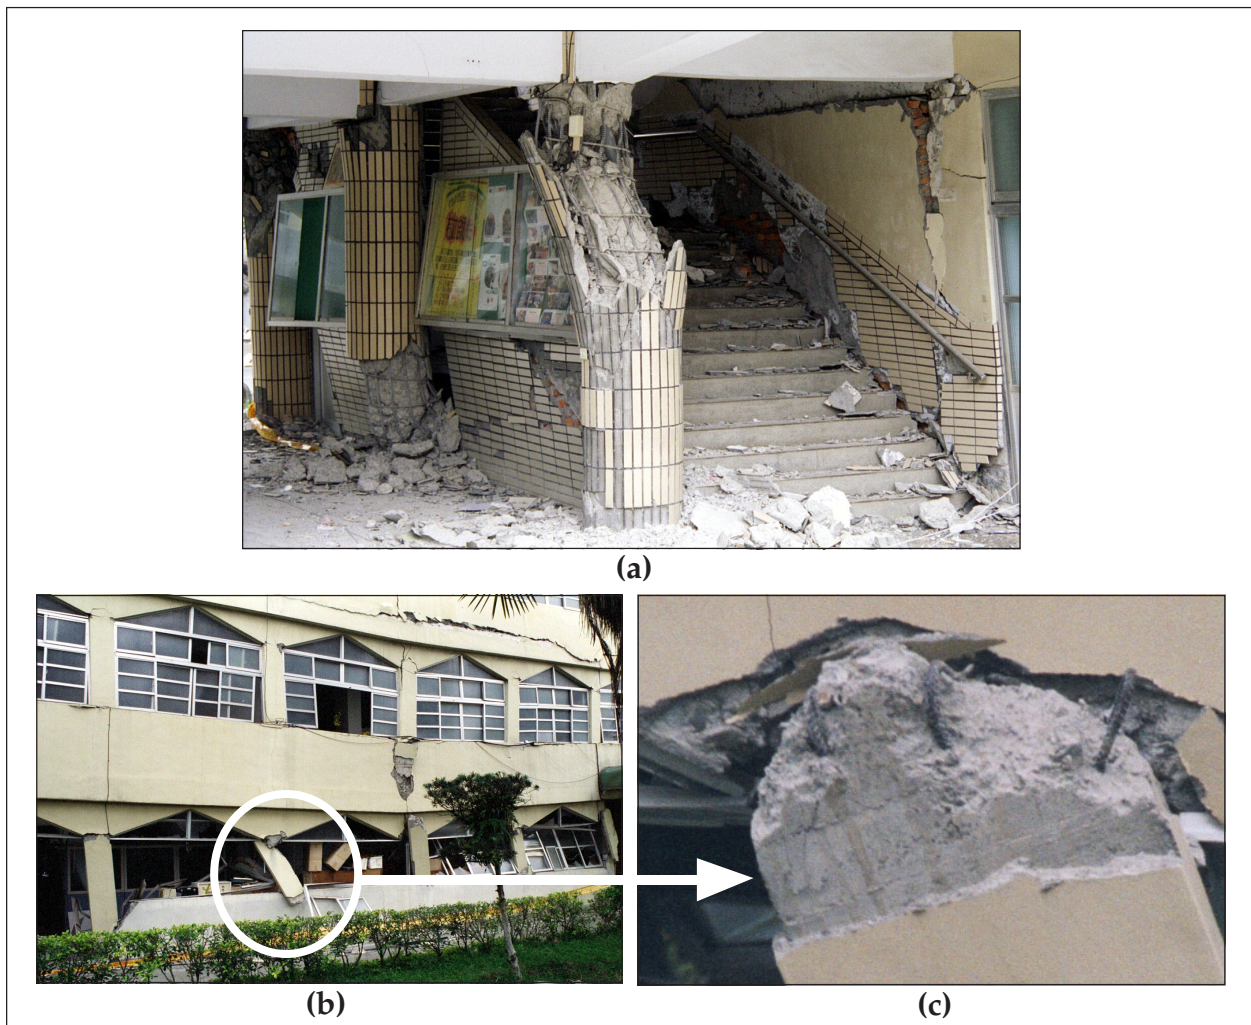
This earthquake also provided reminders of the significance of recognizing compatibility of deformations during the design process. Some engineers, when conducting structural analysis and design of buildings, systematically de-couple the structural elements that are part of the lateral-load resisting system from the others intended to solely provide gravity-load resistance. While this is convenient, it is important to verify that the gravity-load resisting structural element can displace without undesirable damage to the same maximum seismic-induced lateral drifts calculated for the lateral-load resisting system. Even in buildings having the most ductile lateral-load resisting systems, failure to perform this verification may jeopardize the ability of the structure to sustain its gravity loads, with dire consequences. Damage to the building shown in Figure 5-15 illustrates this behavior. The large residual lateral displacement of the first floor due to column damage is clearly visible on that figure. The small columns between windows along the

Figure 5-15 Example of damage to gravity-only columns (i.e. columns assumed not part of lateral load resisting system); (a) residual drift; (b) circled area is a typical gravity-only column; (c) close up view

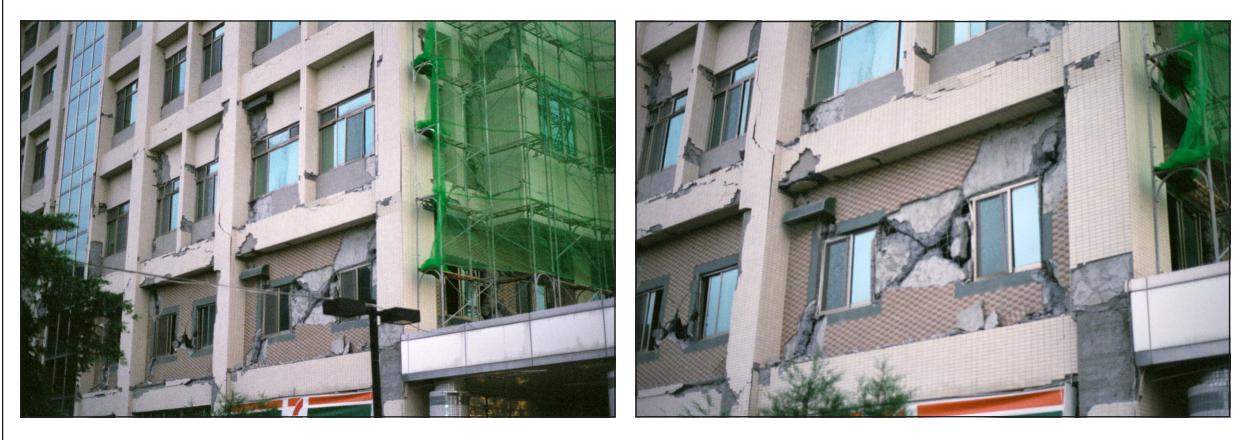
Figure 5-17 Hospital with severe damage to nonstructural infill walls but minor (cosmetic) damage to structural elements

In other instances where large columns were used, as shown in Figure 5-17, these columns only suffered minor cosmetic damage in spite of extensive infill damage. In such cases, although the infills may not have totally prevented undesirable frame behavior, they stiffened the more flexible frames and provided energy dissipation, thus significantly contributing to seismic survival.

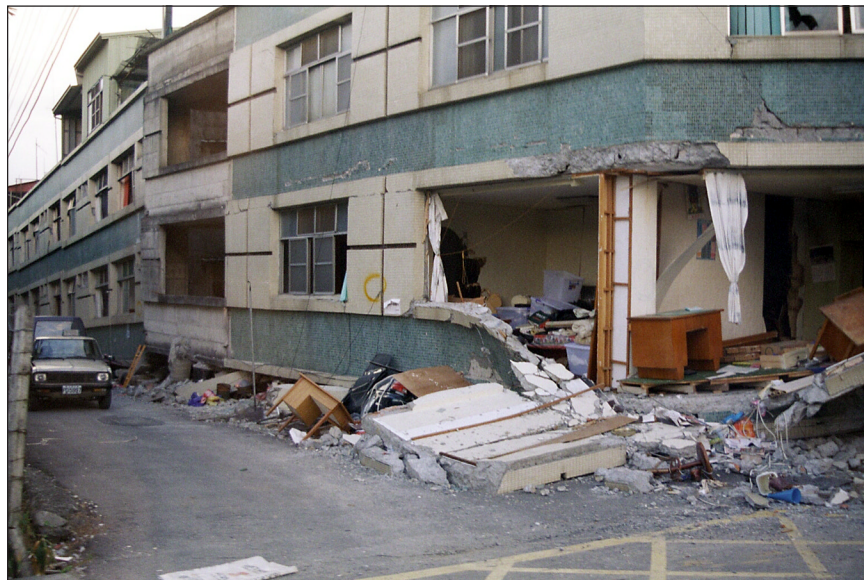
Infills that were not adequately tied to the surrounding frames, even though they may have partly contributed in the manner described above, were not as effective, and were sometimes dislodged by out-of-plane seismic excitations. Figure 5-18 illustrates one such infill panel that fell outward as a result of being poorly tied to its surrounding frame. Another example is shown in Figure 5-19 in a building adjacent to one that completely collapsed as

Figure 5-18 Out-of-plane collapse of an infill panel poorly tied to the surrounding frame

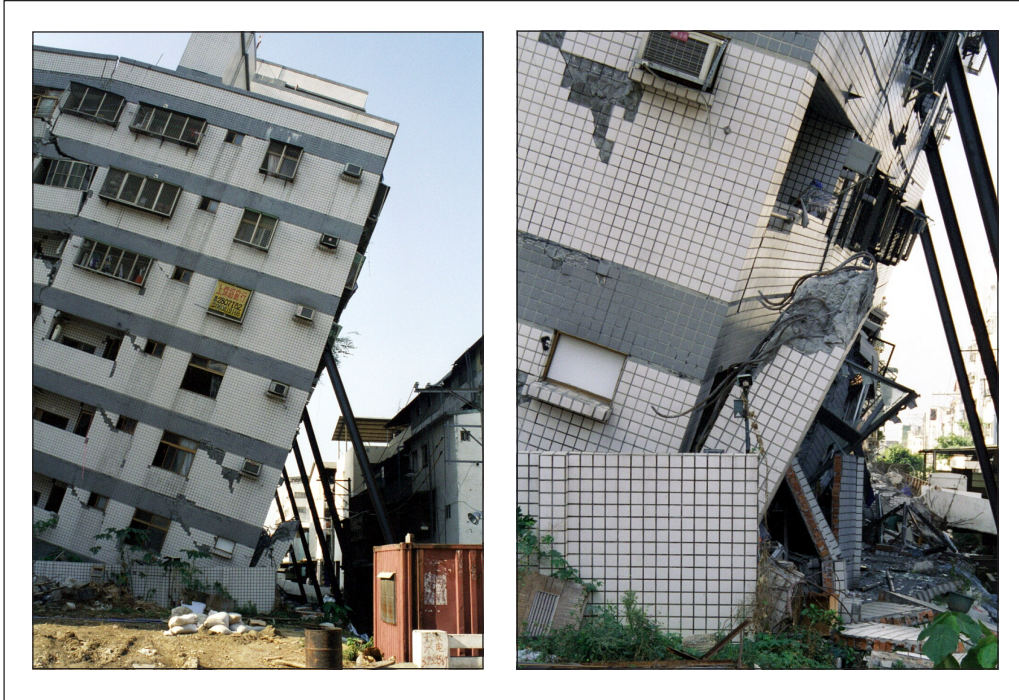
a result of damage at that same story. Note however, that although this absence of continuity between the infills and frame did not help, discontinuous infills are not inferred to have been the cause of the observed collapse. These buildings suffered from many other poor detailing practices, as shown in Figure 5-20.

Figure 5-20 Collapse due to poor detailing practice

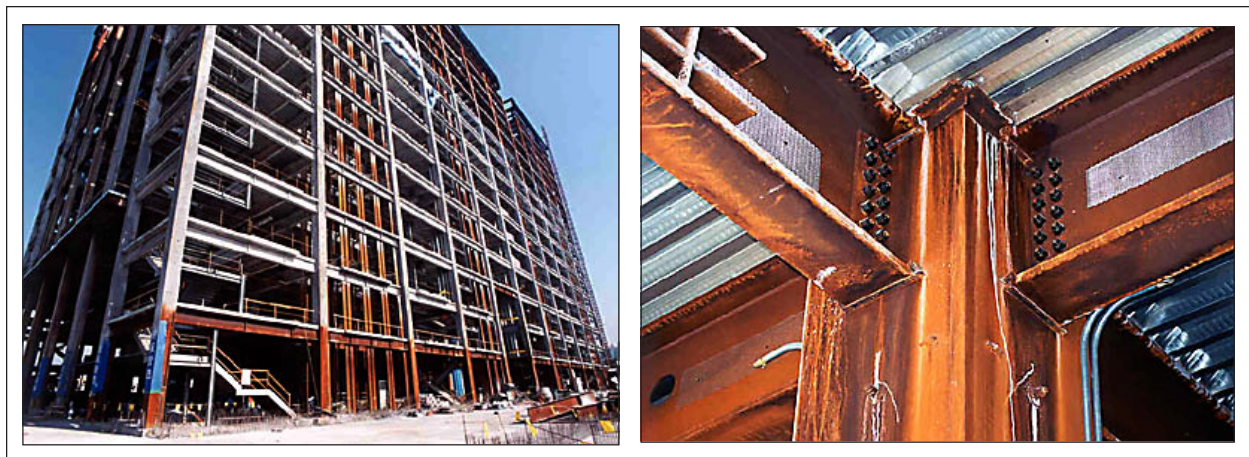
In Taichung City, about 50 km northwest of the epicenter, where the recorded peak ground accelerations obtained from the main shock range between 0.2 and 0.3 g, several tall steel buildings have been constructed in the past decade. During the Chi-Chi earthquake, there were two steel buildings under construction, one 14-story (MRF) department store (Figure 5-21) and one 45-story (MRF/EBF dual system) office/hotel tower. Before the earthquake, most of the steel frames in these two buildings had been completed and the concrete slabs were poured. However, fire proofing, window walls and partitions were not installed yet and all the steel beam-to-column joints were still visible following the earthquake. Note that the 14-story building adopted the typical details described above and the 45-story structure employed reduced beam sections with radius cut details. Detailed inspections conducted for these two buildings following the earthquake indicated no apparent connection damage.

Figure 5-21 14-story steel building under construction with undamaged moment-resisting steel frames

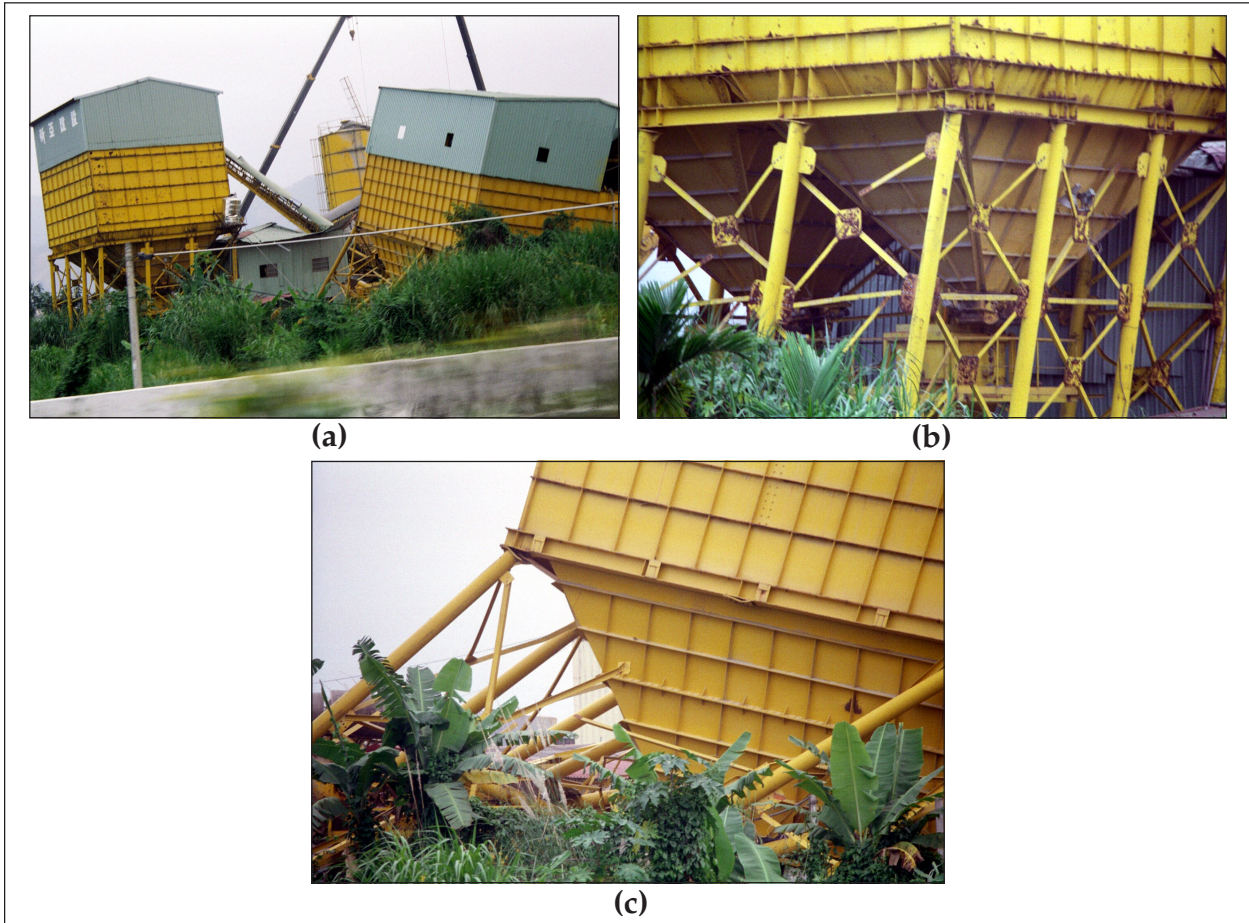
Brace fractures and other damage was observed to bin and tank supports in many aggregate-producing plants. Damage to the elevated bins shown in Figure 5-23 illustrate well the typical progression of failure observed in many such structures. First, as shown in Figure 5-23b, fracture of non-ductile braces developed at their bolt holes. Because net section fracture occurs before gross section yielding of the brace, this occurs without any effective global structural ductility. Without braces, the remaining structure now behaves as a moment frame, but its column-to-beam connections do not have the details and strength (let alone the ductility) necessary to resist the seismically induced forces. As a result, significant damage occurs at the column connections (e.g., Figure 5-23c), and collapse

Figure 5-23 Collapse and damage of non-ductile steel structures supporting elevated industrial bins

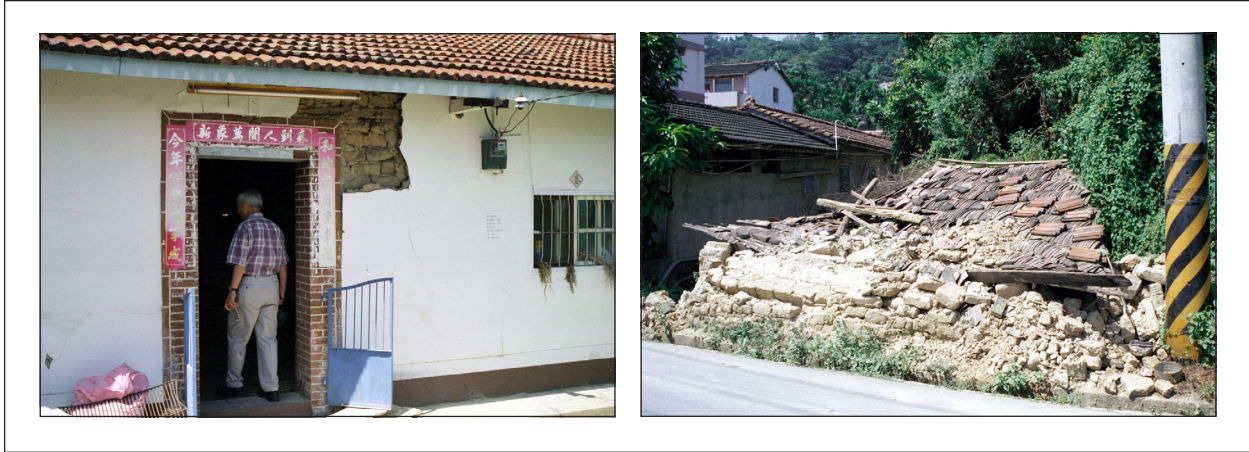
Unreinforced masonry was often used in small villages. Behavior of these non-engineered buildings constructed using bricks of miscellaneous quality (for example, standard clay brick for exposed finishes and mud-bricks for walls hidden by stucco finishes, as shown in Figure 5-25) varied considerably. The two buildings shown in Figure 5-25 were approximately 15 feet from each other; one survived with cosmetic damage, the other collapsed.

Figure 5-25 Cosmetic damage (left) and complete collapse (right) of unreinforced masonry structures located 15 feet apart

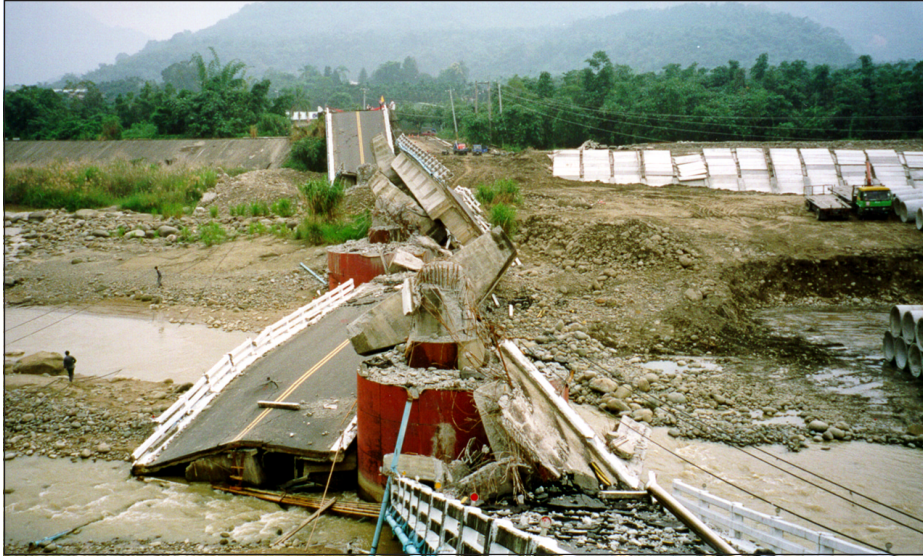
All four simply supported spans of the *Tong-tou bridge* on Route 149, (Figure 6-2) collapsed due to shear failures in the single column bents comprising the three river piers (Figure 6-3). These columns were supported on large diameter caissons, which extended well above the river bed thus shortening the overall height of the columns themselves. The columns appeared to have been shear critical but did not fail simultaneously. Instead, one probably failed before the other, leading to an asymmetrical collapse of spans 2 and 3

Figure 6-3 Collapse of the Tong-tou bridge due to shear-critical columns

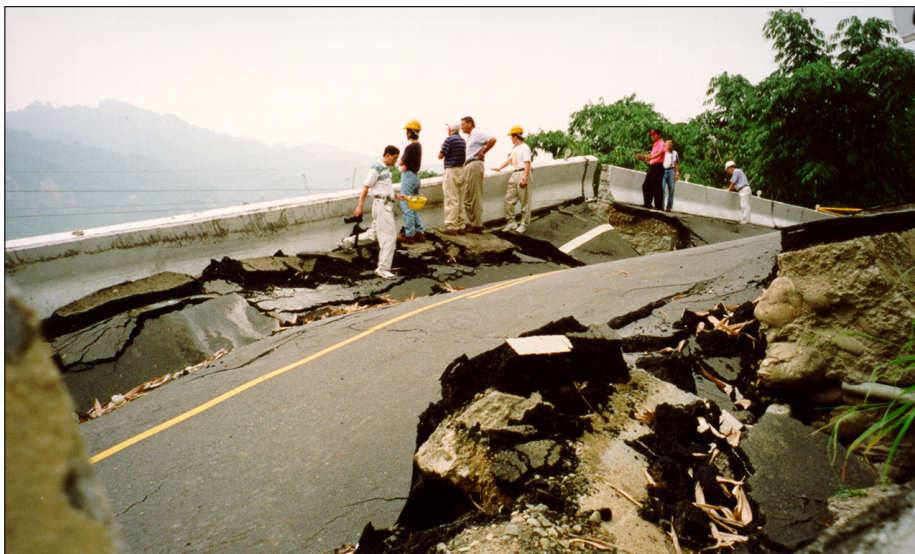
(one fell upstream and the other downstream of the bridge centerline). In addition, the northern abutment suffered considerable structural damage that appears to have been due to large earth movements arising from either fault rupturing or ground failure behind the abutment, or both. Significant settlement of the approach pavement occurred (Figure 6-4).

Figure 6-4 Failure of the approach-fill behind north abutment of Tong-tou bridge
