The Chi-Chi, Taiwan Earthquake of September 21, 1999: Reconnaissance Report

Technical Report MCEER-00-0003
April 30, 2000

Edited by
George C. Lee¹ and Chin-Hsiung Loh²

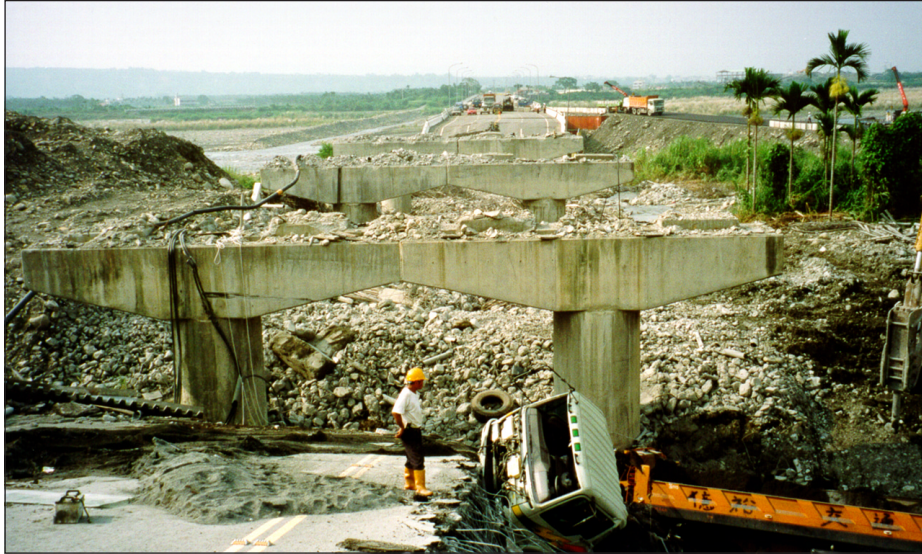
Constructed in 1990, the *Ming-tsu bridge* on Route 3 comprises 28, 25 m spans for a total length of 700 m. Figure 6-5 shows that the fault rupture passed the southern end of the bridge and caused eight of these spans to collapse (Figure 6-6). Although the superstructure comprised multiple spans of simply supported girders, they had been made continuous by a cast-in-place reinforced concrete deck slab which was continuous over intermediate bents. Thus the bridge was a series of continuous segments, and at least two of these segments collapsed at the south end of the structure. At the time of our site visit, the northern-most segments had been demolished and only the southern segment remained 'standing'. Whereas liquefaction may have been responsible for pier tilting and collapse of the northern segments, the spans in the southern segment became unseated when the southern abutment failed. During strong longitudinal motion the superstructure impacted the back-wall of the south abutment, which was unable to arrest the motion. The wall and its back-fill failed and were driven back about 0.5 m into the back-fill, followed by the superstructure (Figure 6-7). This longitudinal movement was sufficient to cause unseating of the adjacent spans comprising this segment.

Figure 6-6 Ming-tsu bridge after removal of many of the collapsed spans

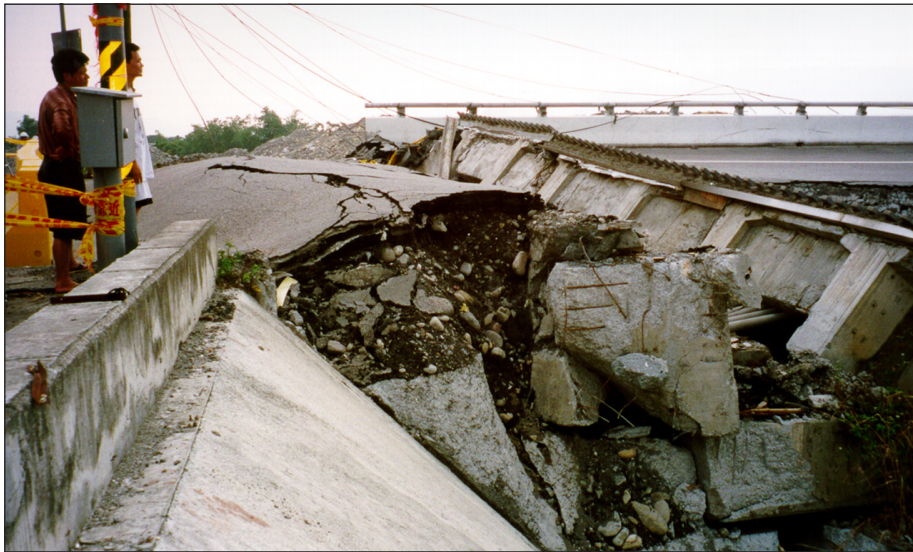
Figure 6-7 Failure of the back-wall and back-fill behind south abutment of the Ming-tsu bridge, leading to the unseating of adjacent spans

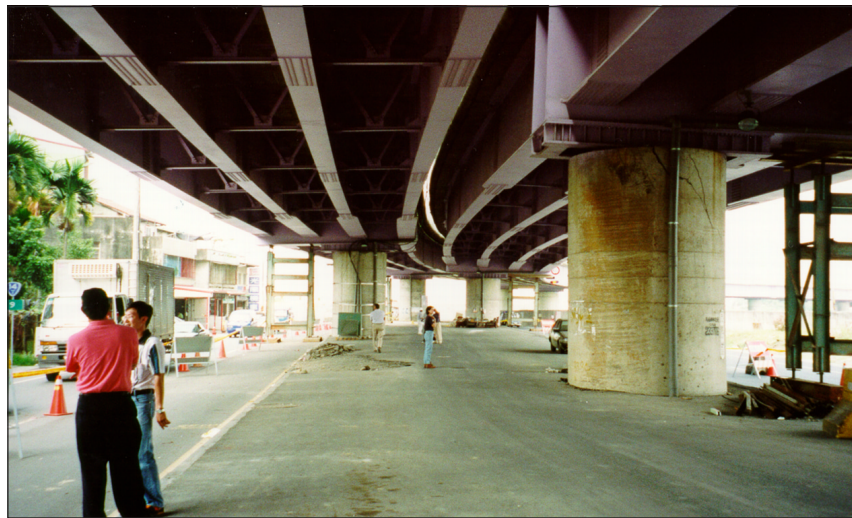
The *Mao-luo-shi bridge* on Route 3 is a multiple-span viaduct comprising a set of continuous segments, each constructed from steel plate girders supported on concrete, single-column bents. In one 8-span segment (Figure 6-8), four of these bents are 'C-bents' where the column is eccentrically connected to the cross-girder. Although there were no collapsed spans in this viaduct, all of the eccentric connections showed distress, particularly in the column. Shear cracking was evident in the upper third of each column and increased in severity with increasing eccentricity (Figure 6-9). Despite the absence of gross deformations in the superstructure, the cross-girders were temporarily shored and the bridge closed until permanent repairs could be made.

Figure 6-8 Mao-luo-shi bridge, showing single-column concrete bents supporting continuous steel girders

The first phase was well advanced in the Nantou and Taichung counties by the first week in October (two weeks after the earthquake). Bypasses had been constructed (Figure 6-15), shoring erected (Figures 6-8 and 6-9), Bailey bridges installed, overturned bearings reinstated, and settled approach fills repaved. Only about 45 km of highway remained closed at the beginning of October and these were mainly roads in the mountainous regions of the two counties where extensive landslides had yet to be cleared.

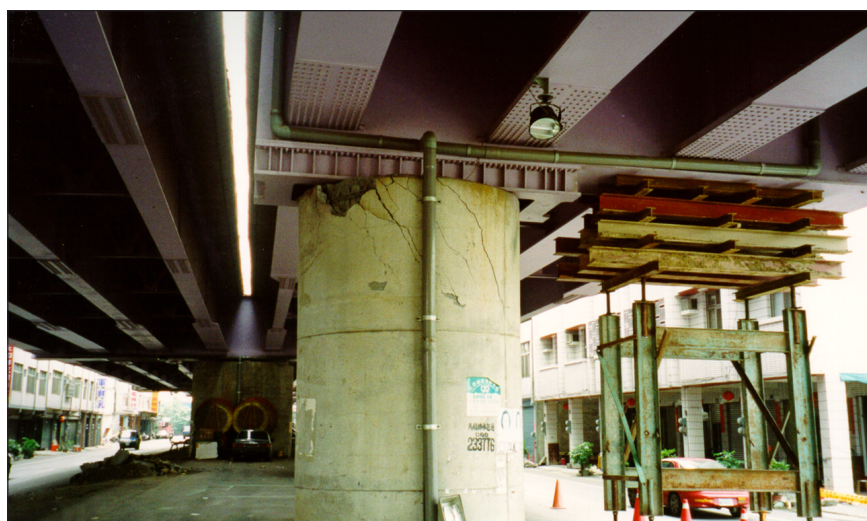
Figure 6-9 Typical distress in an eccentric, column-to-cap beam connection in the Mao-luo-shi bridge

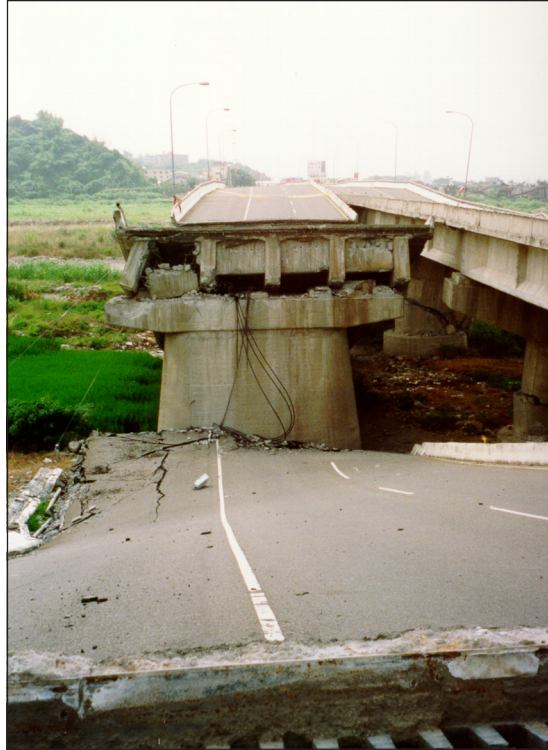
The *Wu-shi bridge* on Route 3 (Figure 6-10) is in fact two bridges on a parallel alignment (Figure 6-11). Both are 18 spans long for a total length of 624 m. The first bridge was constructed in 1981 and the second one, two years later, in 1983. Both were of similar design (simple spans supported on wall-type piers) with one exception. The piers of the second bridge were not as wide as those of the first and in some cases (e.g., at Pier 3) they were about one-half of this width. Despite the fact that both bridges experienced similar ground motions, they failed in different ways. Ground failure occurred behind and under the northern abutment of both bridges, triggered by fault rupture parallel to the abutments. Soil deformation at the base of these wall-abutments was approximately 0.3 m towards the river. There was similar ground deformation under the first and second piers, but of lesser magnitude (perhaps 0.2 m). The two bridges accommodated this movement in different ways, as described below.

Figure 6-11 Collapsed span in the Wu-shi bridge (east)

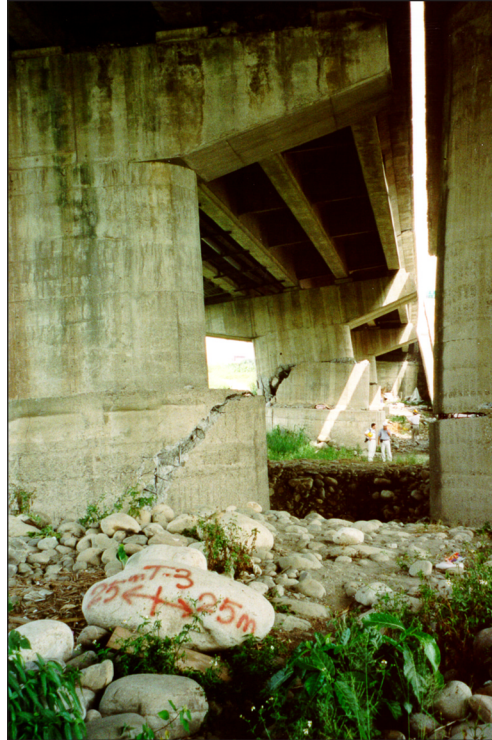
In addition to the ground failure, there was strong ground shaking transverse to both bridges, which caused massive shear failures in the first five piers and/or caissons of the second bridge (Figure 6-12). This did not happen in the first bridge, possibly due to the greater shear capacity of its wider columns. Instead, the first two spans of this bridge became unseated at Piers 1 and 2, due to the movement of these piers towards the river. Lesser soil deformations were experienced at the remaining piers and these were accommodated at the pier caps without unseating. But the shear keys at these caps were heavily damaged due to the transverse motion, and at Pier 2 they failed completely (Figure 6-13). As a consequence, although the superstructure was not unseated at this pier, it came to rest with a permanent transverse offset and with the outside girder overhanging the pier cap. In the second bridge, the longitudinal movement of the foundations under Piers 1 and 2 did not lead to span collapses. Instead, this movement was accommodated within the plane of the massive shear cracks in both piers. Examination of these cracks showed longitudinal offsets of about 0.15 m (in addition to large vertical and transverse offsets), which was sufficient to allow the girders to remain on their seats.

Figure 6-12 Shear failures in the columns and caissons of the Wu-shi bridge (west)

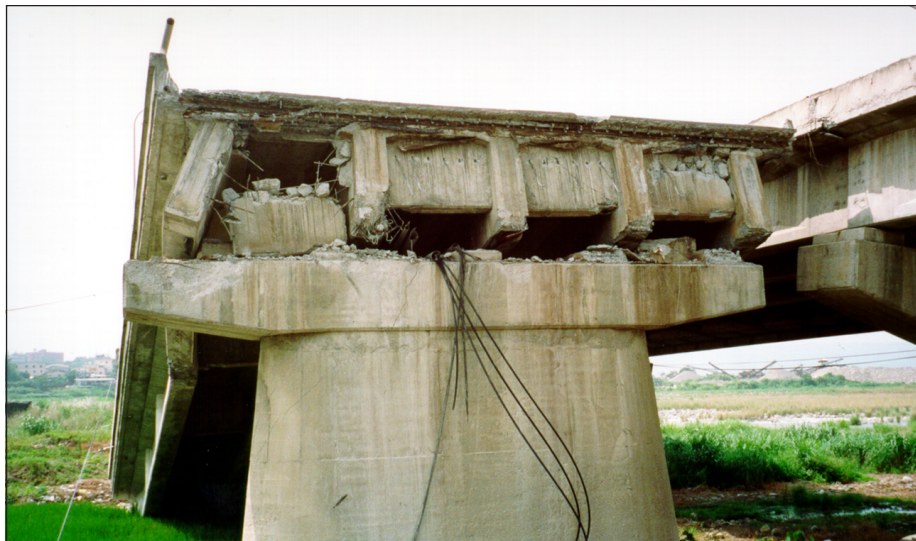
Figure 6-13 Diaphragm and shear key failures at Pier 2 of the Wu-shi bridge (east)

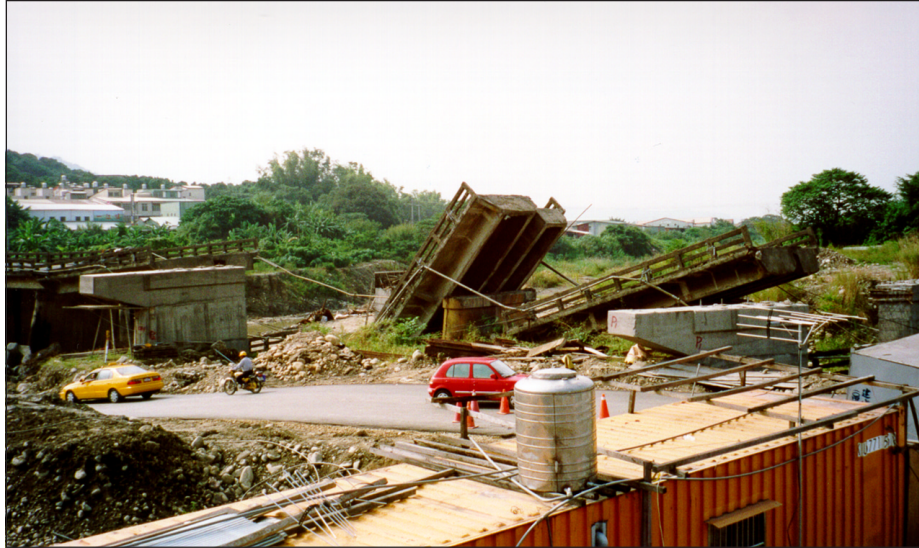
Constructed in 1972, the *E-jian bridge* on Route 129 has 24, 11 m spans providing a total length of 264 m. The superstructure comprises a pair of simply supported, reinforced concrete, double-T girders. Each pier is an unreinforced concrete wall on a spread footing. The structure was being widened at the time of the earthquake and new piers had been constructed, but at a different spacing than for the original bridge. During the earthquake, fault rupturing occurred under the north abutment with about 1.5 to 2 m of uplift (Figure 6-14). Consequently, twelve spans collapsed from the northern abutment to the center pier of the bridge (Figure 6-15). The remaining twelve spans to the south abutment remained standing with little apparent damage. Examination of the collapsed girders showed little distress and the field evidence suggests that collapse was due to large movements of the pier foundations towards the center of the river channel. At or near the abutment, where uplift occurred, these unreinforced piers were crushed, or snapped at mid height, but the remaining piers moved as rigid bodies towards the river or rotated with their footings due to slumping

Figure 6-15 Collapsed spans of the E-jian bridge due to massive ground movement towards the river (left)

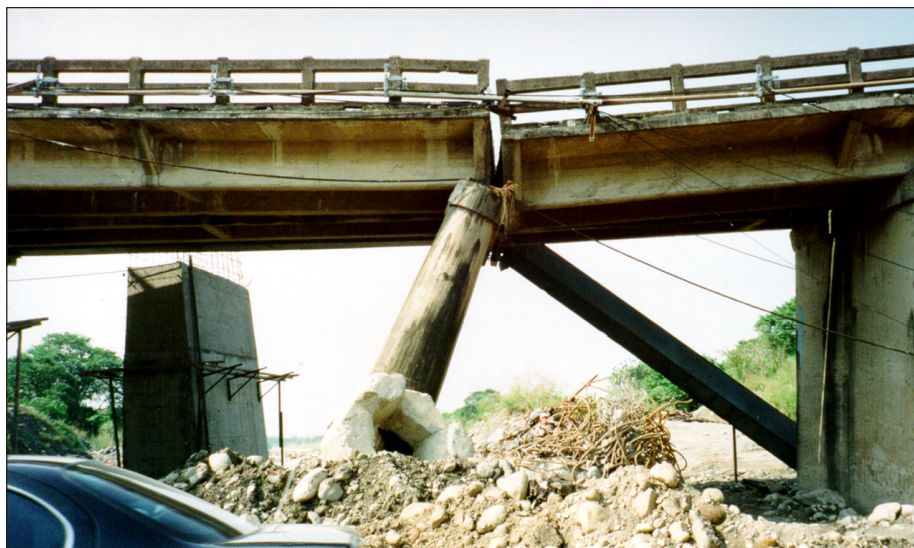
and flow of the uplifted material (Figure 6-16). In doing so, the piers were driven in under the adjacent 'downhill' span while unseating the adjacent 'uphill' span. Corresponding overhangs of the superstructure girders occurred, which at Pier 9 measured 3 m. There is little evidence of residual displacements in the southern half of the bridge (which remains standing), and this appears to confirm the scenario that the collapses were due to gross movements of the northern foundations rather than unseating due to structural vibration. The extent of these movements appears to have been of the order of 5 m near the abutment, decreasing to about 3 m near the river channel.

Figure 6-16 Tilting of Pier 10 of the E-jian bridge due to ground movement towards the river (left)

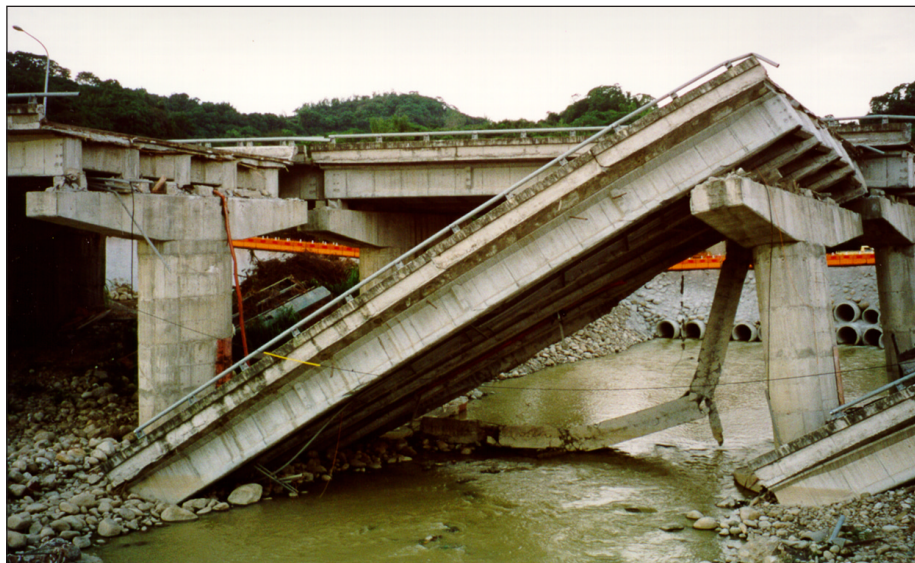
second pier (column and caisson) in both bridges tilted away from the abutment by approximately 10 to 15 degrees (Figure 6-18). There was no sign of abrasion on the vertical faces of either column to indicate sliding of the span down the face of the column. It therefore appears that titling happened first, followed by the 'free' fall of the end spans. The reason for the collapse of the middle span of the second bridge is not so clear, but it may have been due to the skewed nature of this span (Figure 6-19). Since the bridge is curved, there are angle changes between the straight girders in adjacent spans at common piers and thus the middle span, of both bridges, has skewed supports. Such spans are known to exhibit excessive in-plane displacements due to rigid body rotations of the spans about a vertical axis during strong earthquakes. Unless generous seat widths are provided, collapse is likely. The fact that the middle span of the second bridge did not collapse may have been because it is on the 'inside' of the curve with shorter girders, and the displacements due to skew would not have been as large.

Figure 6-18 Collapse of the middle span of the Shi-wei bridge and tilting of Pier 2 (right); span to the right has also collapsed

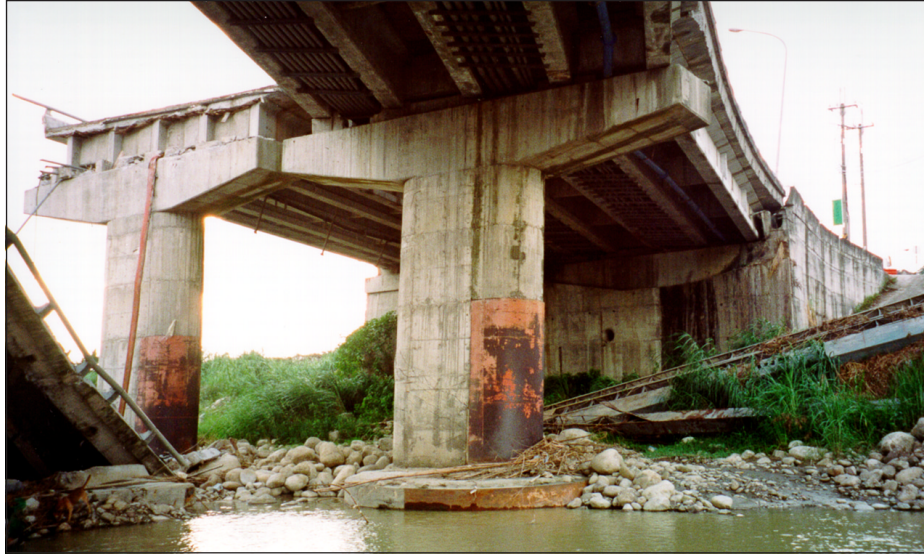
Figure 6-19 Shi-wei bridge showing curvature and skewed alignment of superstructure girders

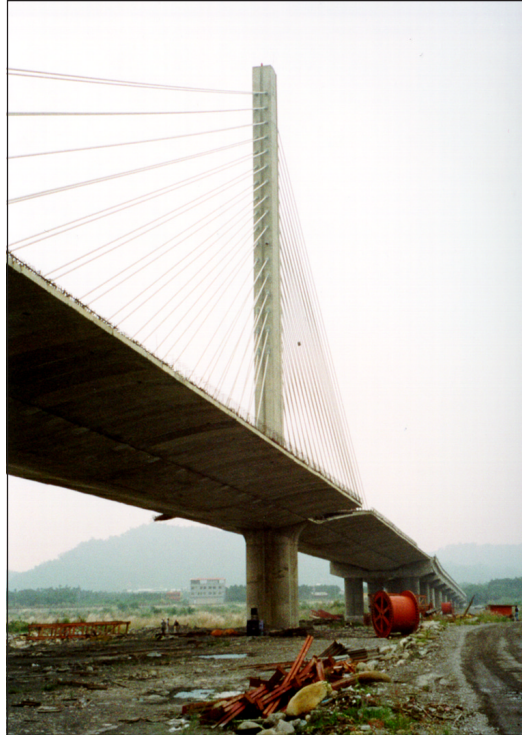
Damage to the structure included a fractured cable, flexural and torsional cracking at the base of the tower and in the superstructure, and vertical and lateral pounding of the superstructure into the 'abutment' substructures (Figures 6-21, 6-22, and 6-23). These substructures provide the transition between the cable-stayed spans and the approach spans and consist of two-column bents with a cap beam. It is not clear why this structure should suffer such distress, but the missing section of the superstructure (Figure 6-22) and the loss of one cable would lead to unbalanced loads and reduced stiffness, which in turn would generate asymmetric response and potentially large excursions of the girder in both torsion and in-plane flexure. Furthermore, the severity of the ground motions, particularly in the vertical direction, could have been responsible for the vertical pounding at the abutments, as evidenced by shear cracks in the abutment cap beams (Figure 6-23).

Figure 6-20 Ji-lu cable-stayed bridge; empty cable socket visible mid-height of the tower

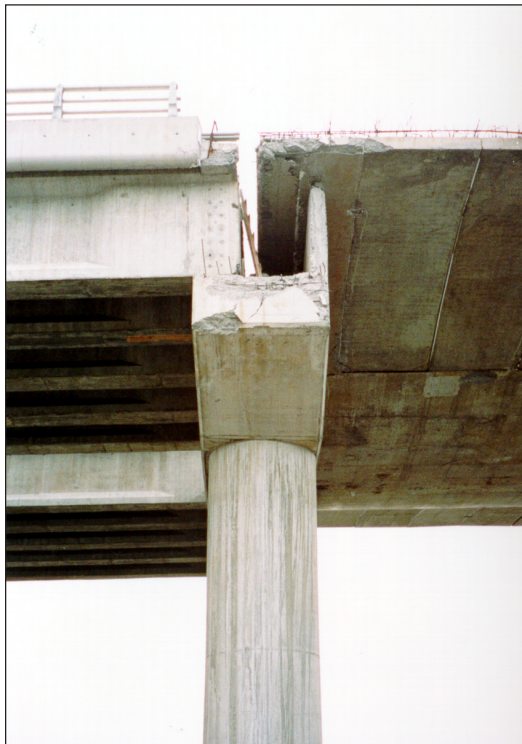
Figure 6-21 Damage at bent cap of south abutment, Ji-lu bridge; bent cap wall has been knocked off

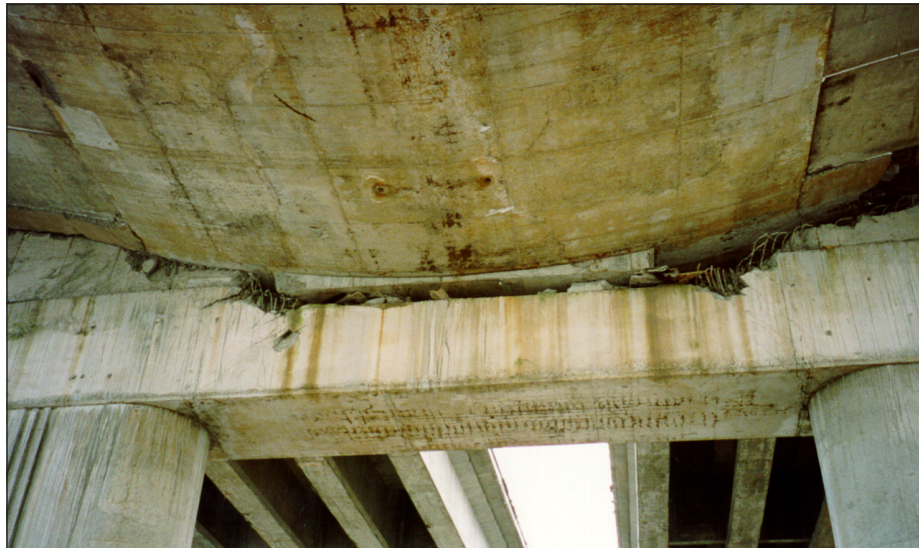
Figure 6-23 Pounding damage and shear cracks in the bent cap of the north abutment of the Ji-lu bridge

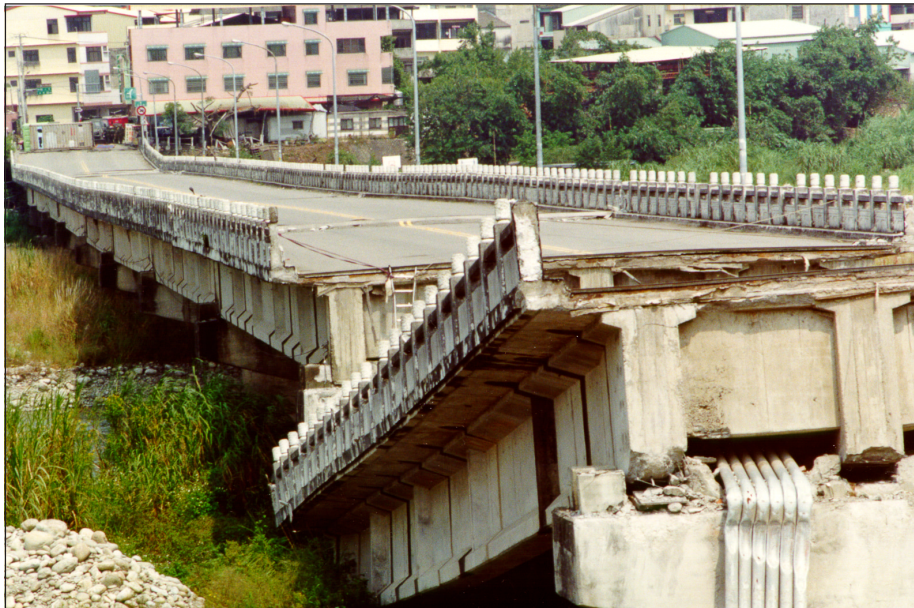
The *Bei-feng* and *Chang-gang* bridges are both located near the Shih-kang dam on the Tachia River (Figure 6-24). They are long, multiple span, simply supported bridges similar to those described above. Both suffered collapsed spans due to fault rupture at or near their abutments (Figures 6-25 and 6-26).

Figure 6-26 Collapse of span of Chang-gang bridge due to unseating of girders triggered by fault dislocations

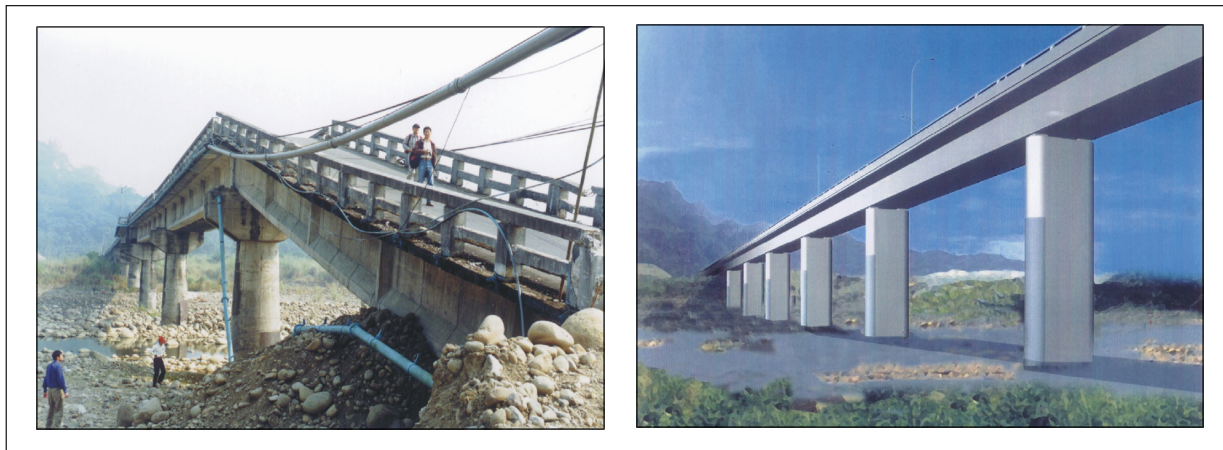
Figure 6-27 Long-men Bridge after earthquake (left) and after reconstruction (right)

The Long-men Bridge (figure 6-27) is a 500 m long, 8.6 m wide bridge with 13 spans of PC box girders with reinforced concrete piers and pile foundations. The Li-yu Bridge is very similar, at 575 m long, 8.6 m wide, with 15 spans. Both bridges were opened to traffic on 5/31/2000, after 123 days and 131 days, respectively, total construction time.

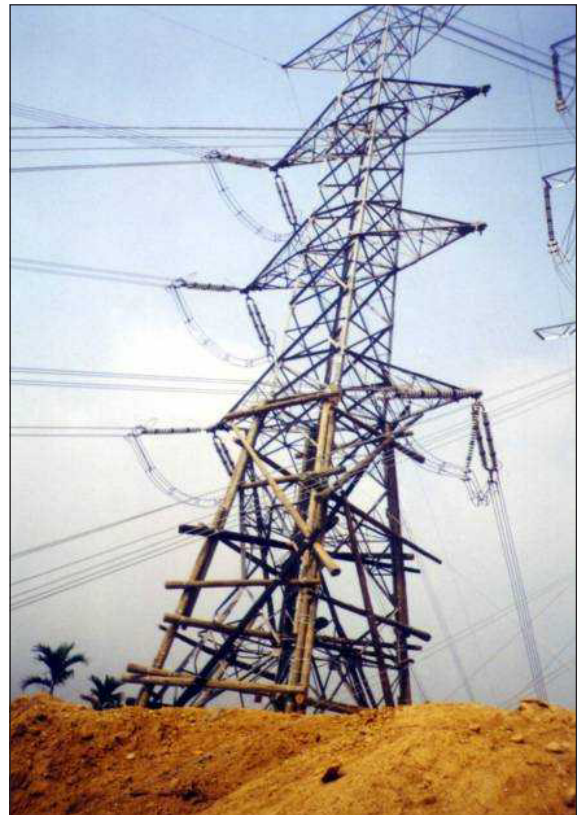
Regarding the 345 Kv transmission system, a significant number of transmission towers suffered from structural problems, and were tilted and displaced (Figure 7-1) causing a large number of transmission lines to fail (marked with an X in Figure 7-2). This in turn caused the initial blackout throughout the middle and northern areas of Taiwan. In addition, 161 Kv (Figure 7-3) and 69 Kv transmission systems in the affected area also suffered from similar failures. Figure 7-4 shows a damaged transmission tower and Figure 7-5 shows a temporary tower standing next to one that was damaged.

Figure 7-1 Transmission tower tilted and deformed

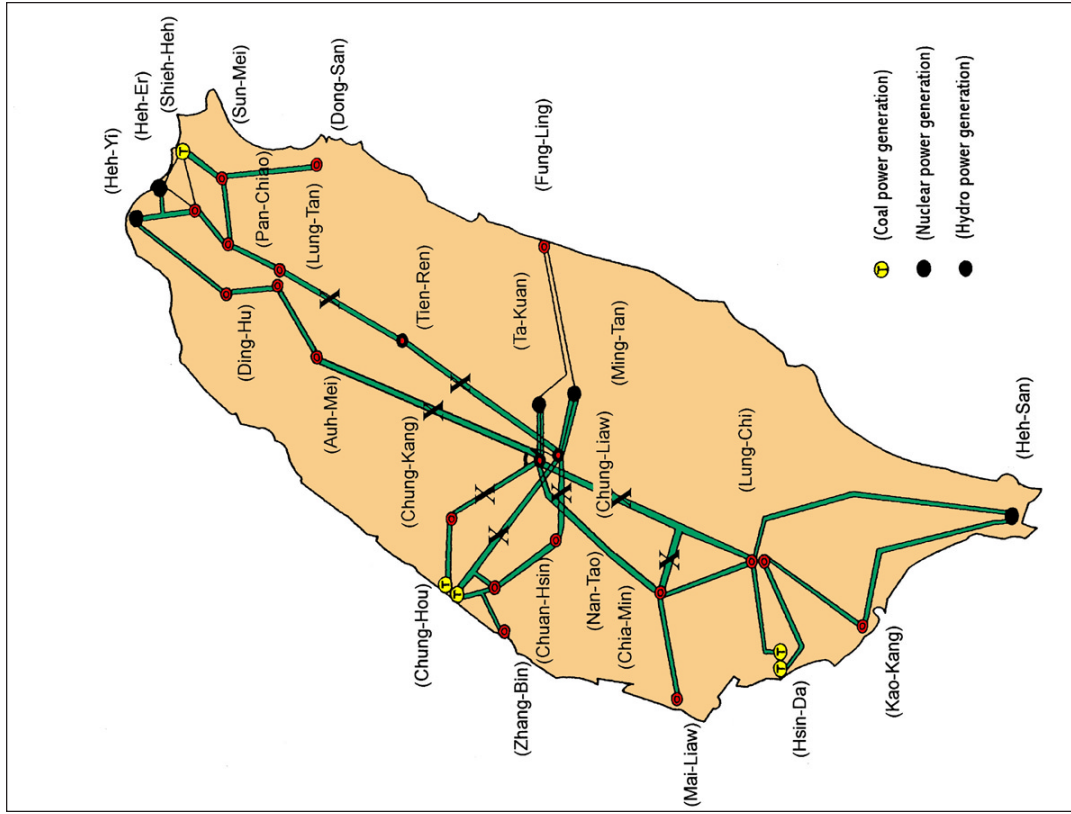
Figure 7-2 345 Kv electric power transmission system
 Courtesy of Taiwan Power

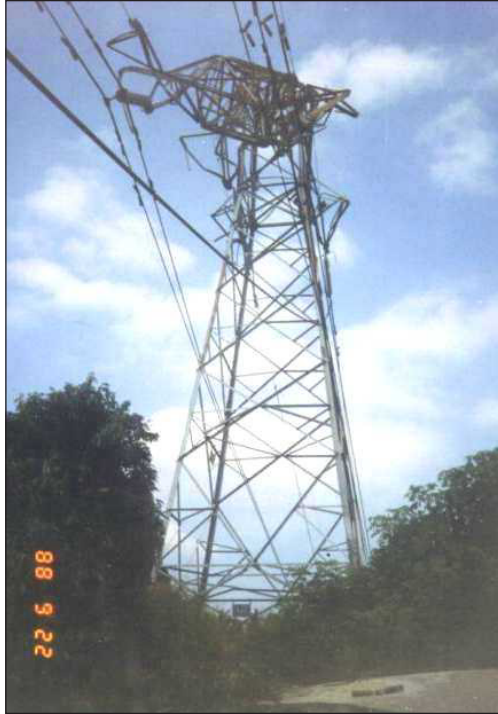
Figure 7-4 Transmission tower with top portion collapsed

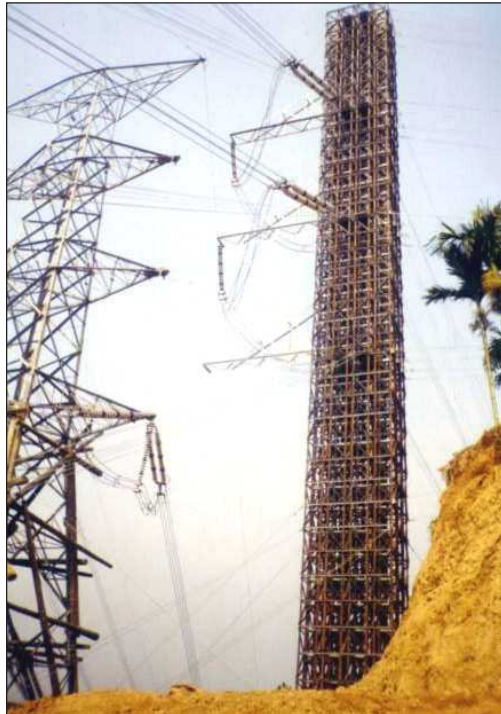
Figure 7-5 Failed transmission tower replaced by a temporary tower

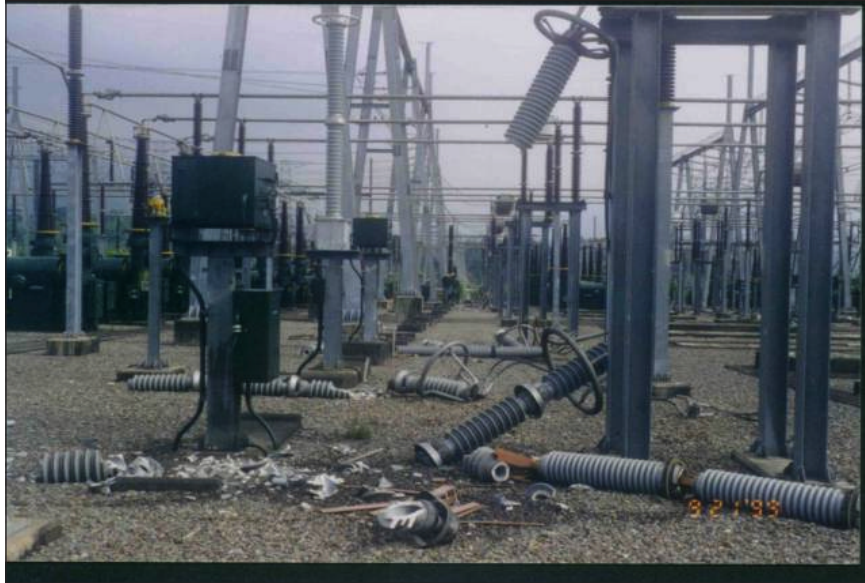
yard and the north yard) that were both significantly damaged. Figures 7-6 and 7-7 show some of the damage observed at the Chung-Liaw switchyard. Figure 7-8 shows similar damage at Tien-Lui substation between Chung-Liaw and Lung-Tan (see Figure 7-1). In fact, the loss of 53 potential transformers, 46 lightning arresters, and many bushings on buses, in addition to other equipment, rendered the yards inoperational. The functionality of these two yards is pivotal to power transmission in Taiwan, as can be seen from Figure 7-1, and hence the functional loss of these yards was at least partially responsible for the post-earthquake power interruption. Table 7-1 shows a summary of damage sustained by Taiwan Power's systems and facilities (Shih, 1999). Table 7-2 further breaks down the transmission tower failure to different modes (Shih, 1999).

Figure 7-6 Damage at Chung-Liaw switchyard

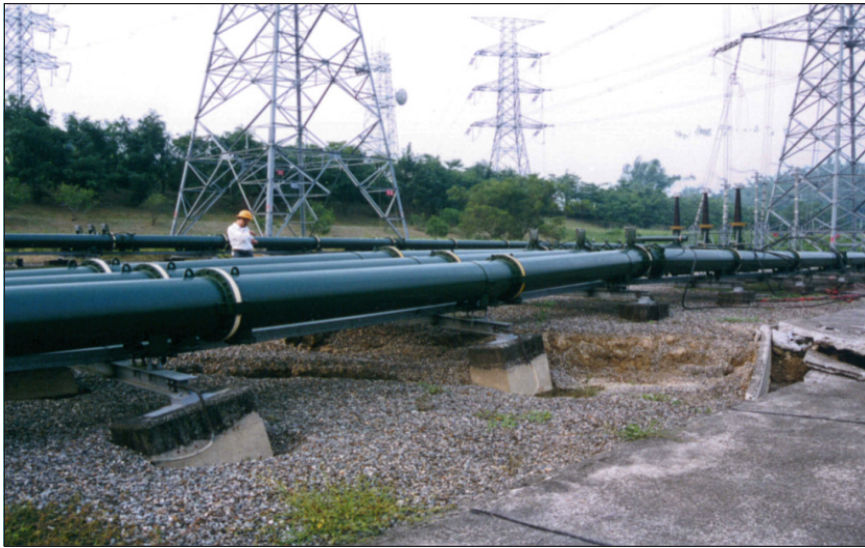
Figure 7-7 Failure of 345 Kv gas insulated line due to liquefaction induced settlement

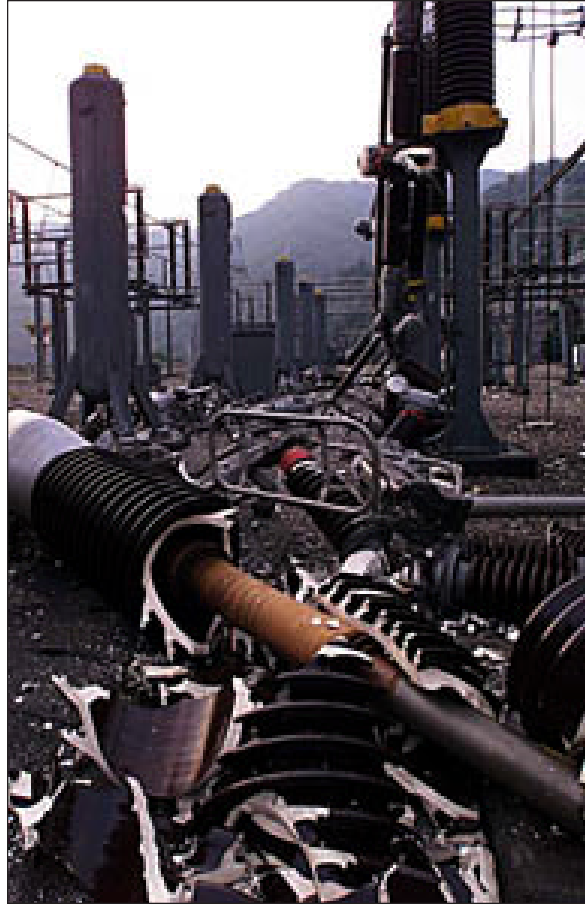
Figure 7-8 Damage at Tien-lun substation

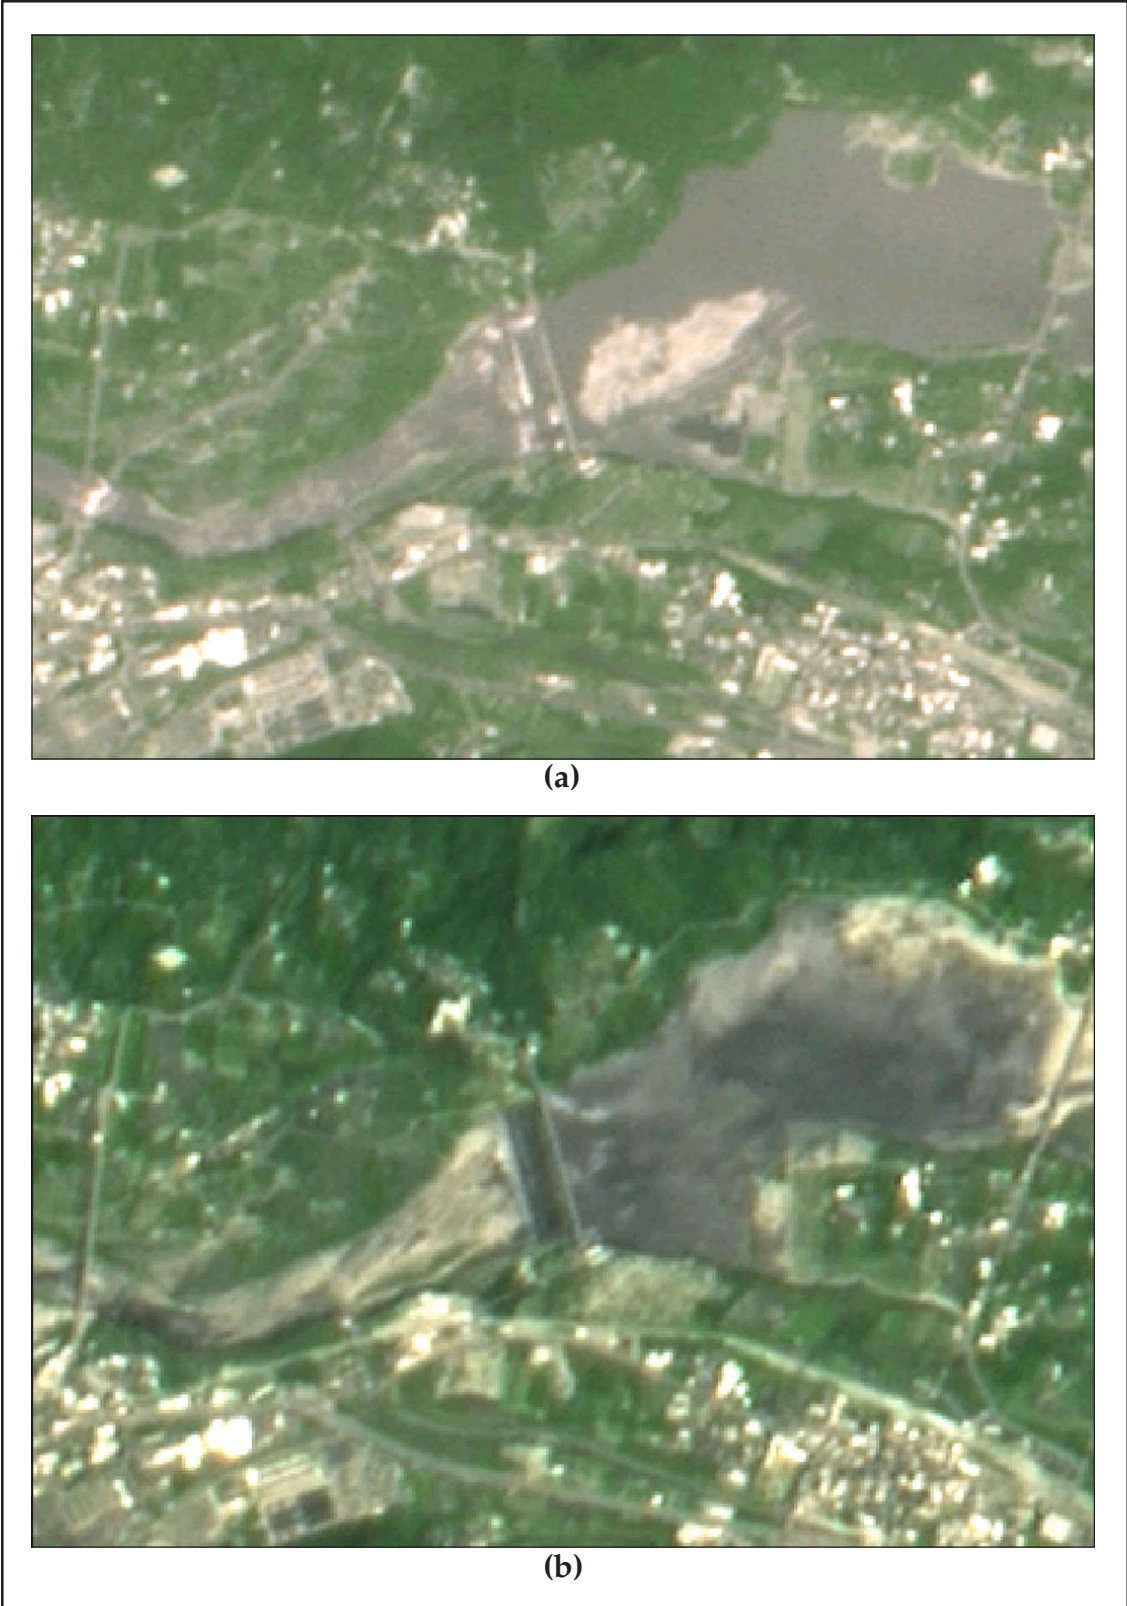
Enlarged SPOT images at the site of failure of the Shih-kang dam after and before the event are shown in 8-3a and b, respectively. In the center of Figure 8-3a, the bottom of the man-made lake behind the Shih-kang dam is shown exposed due to the discharge of water from the lake through the water gates damaged by the earthquake, while the lake bed was covered by water before the earthquake as shown in Figure 8-3b.

Figure 8-3 Images of Shih-kang Dam area after (a) and before (b) the event

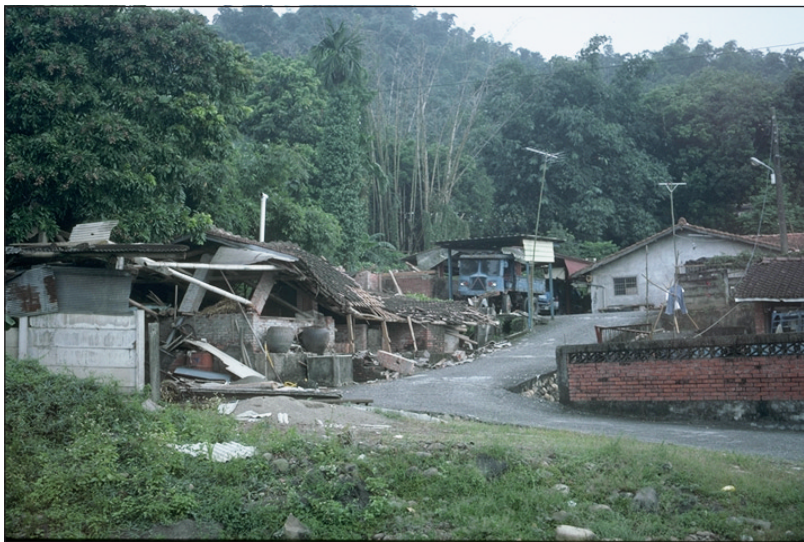
Figure 9-2 Damaged farm structures outside Chusan, Nantou county

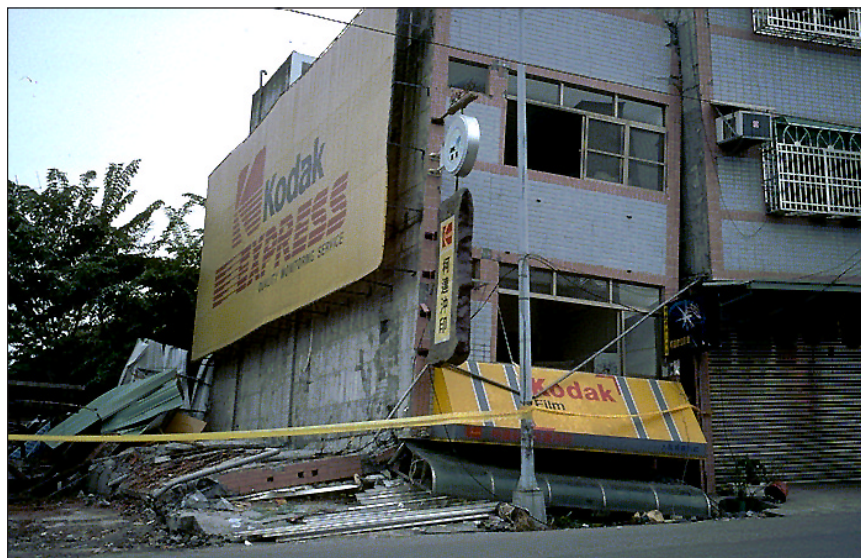
Figure 9-3 Structural collapse destroying ground-floor store in Ji-Ji, Nantou county

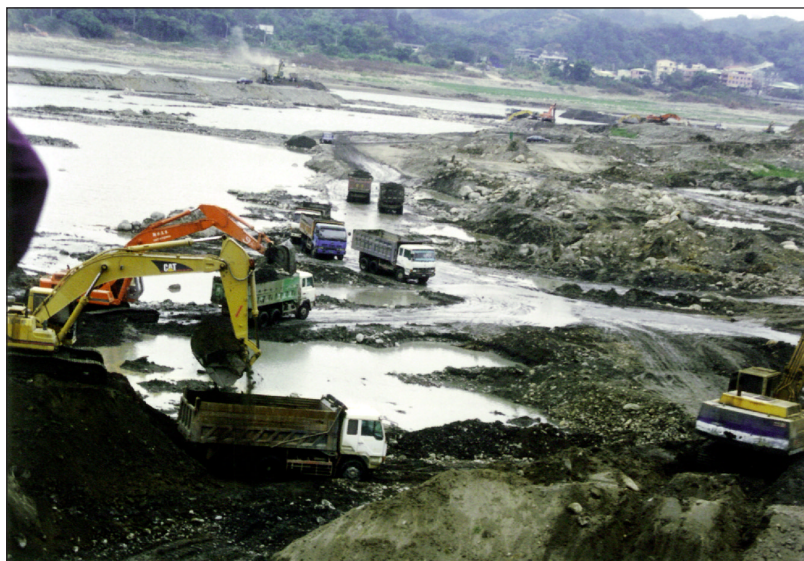
Figure 10-8 Restoration work underway at Shih-kang Dam

- The restoration of reservoirs, dikes, embankments, regional flood prevention and drainage structures. The restoration work underway at the Shih-kang Dam that failed due to surface faulting exemplifies the monumental work that lies ahead (Figure 10-8).

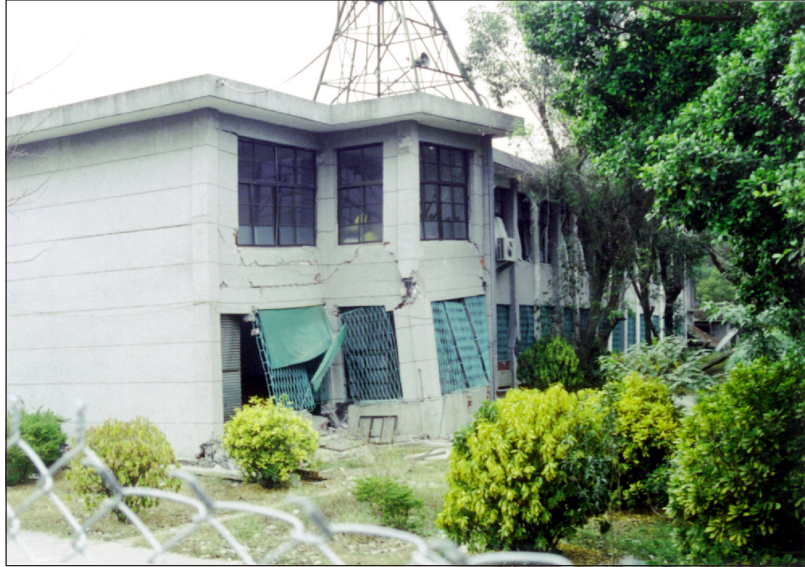
Figure 10-9 Damage to secondary school in Wu-feng Hsiang City, Taichung County

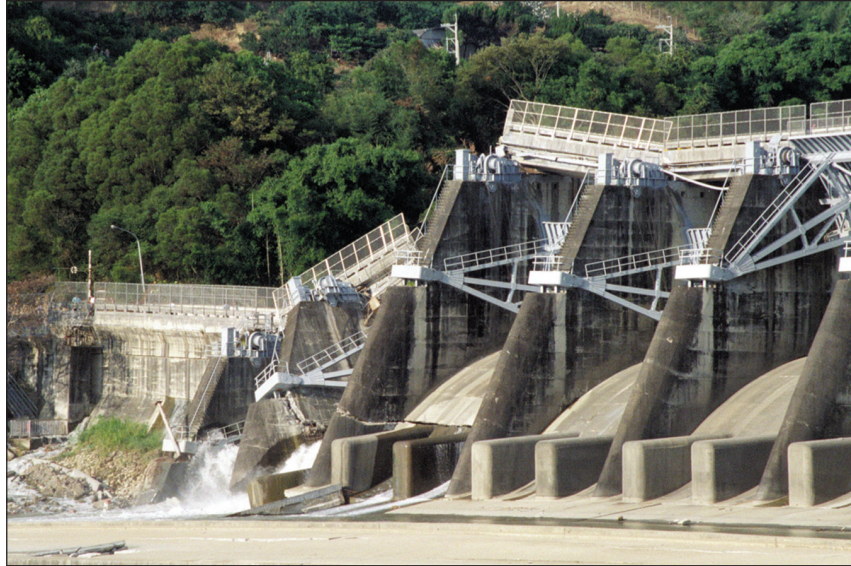
Figure 11-1 Surface faulting caused major damage to the Shih-kang Dam

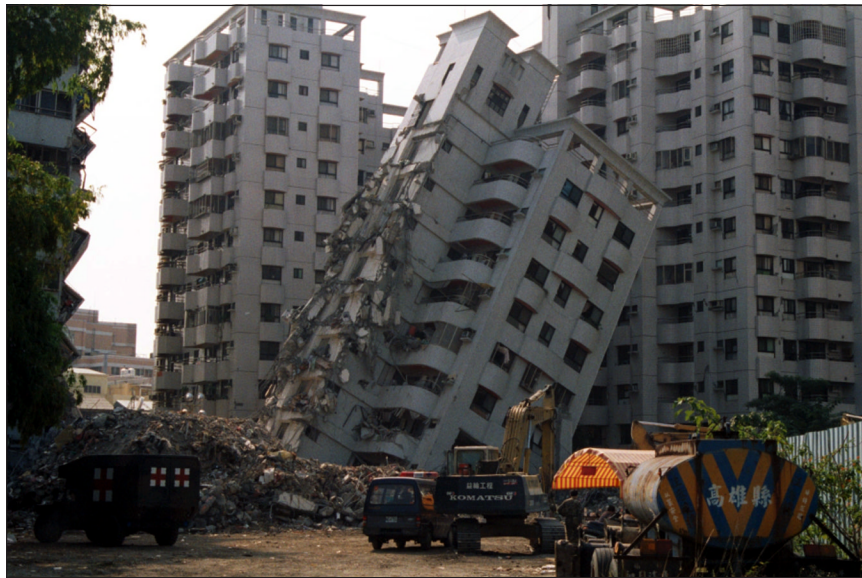
Figure 11-2 Newly constructed buildings suffered severe damage

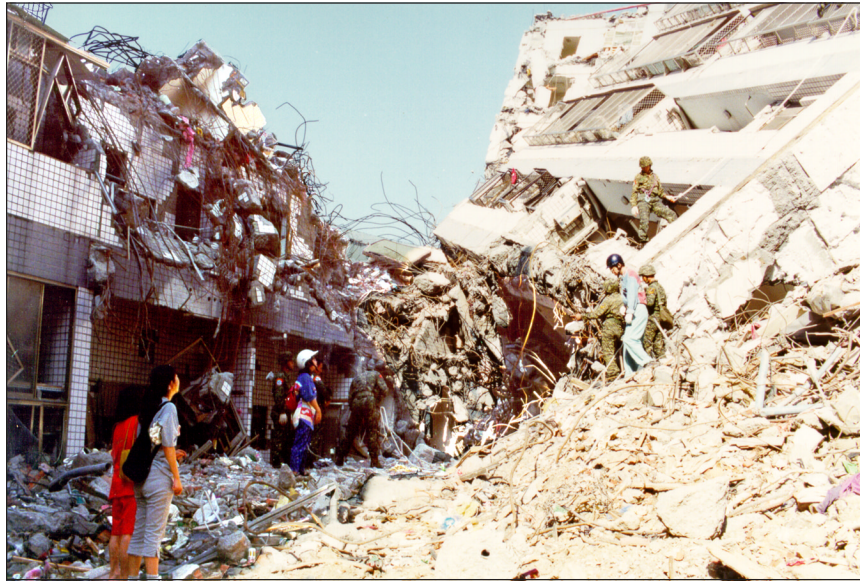
Figure 11-3 Damage to buildings and bridges was widespread throughout the epicentral area

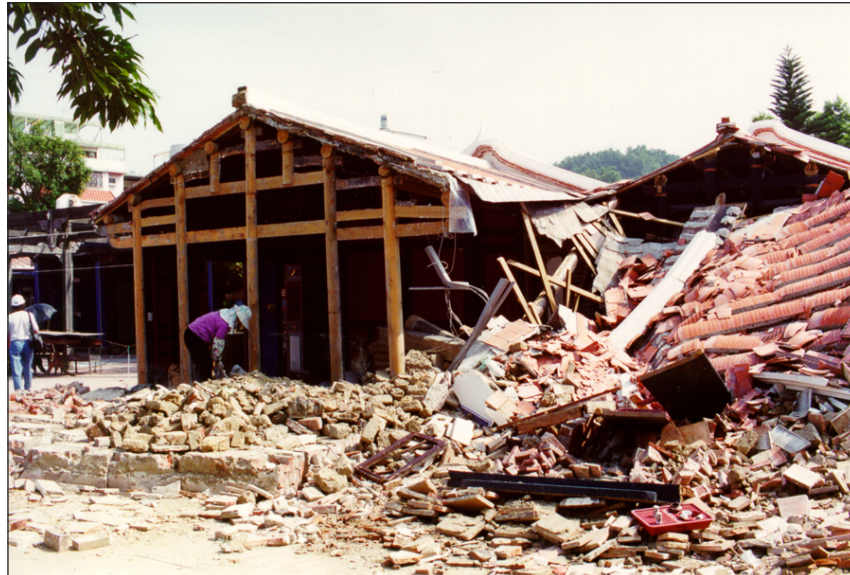
Figure11-4 The beautiful historic site of Lin's Garden was completely destroyed

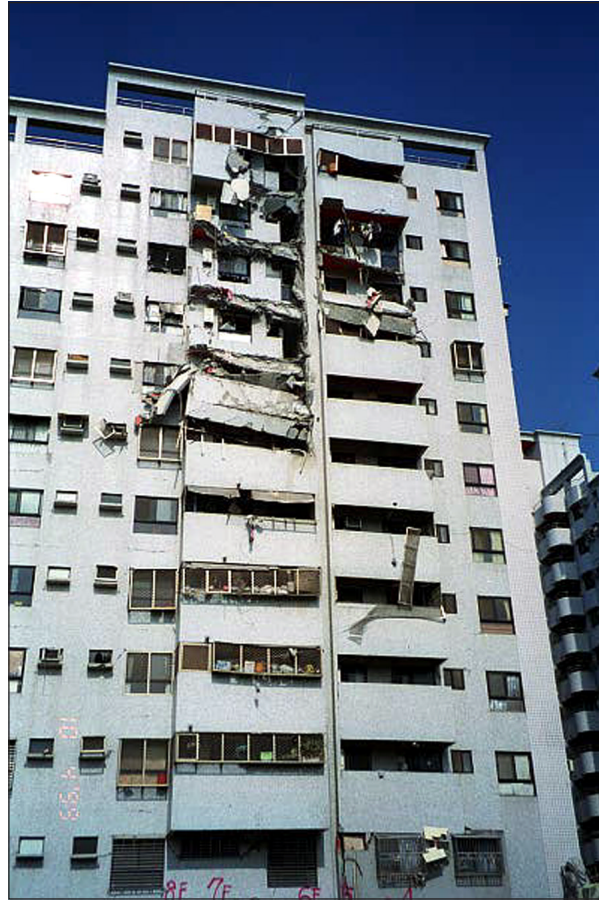
Figure 11-5 Reliable methods to evaluate the extent of damage are needed

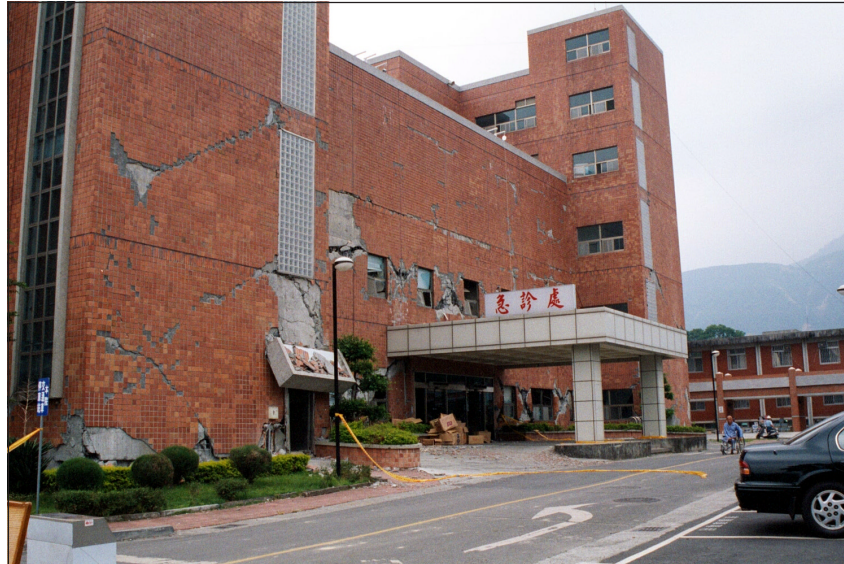
Figure 11-6 Damage to the Veteran's Hospital in Puli reduced its capacity to about 50% at a time when demand was highest

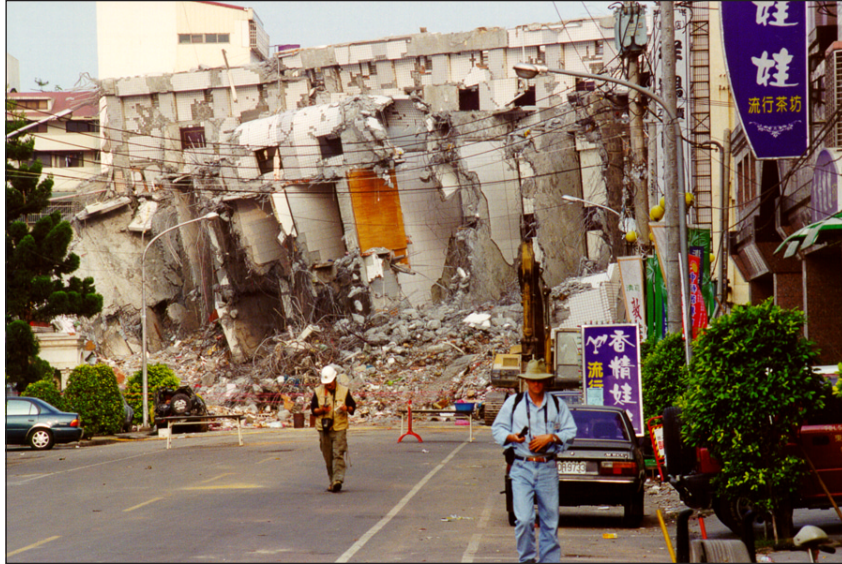
4. One of the most pressing issues in short-term restoration is that of construction quality (Figure 11-7). This has always been an ill-defined factor that makes the evaluation of existing damaged facilities more difficult. It also becomes a factor of importance in the time immediately following an earthquake, as reconstruction begins. Other issues such as public education, research, institutional effectiveness and building code improvements are longer term efforts. However, working with the real estate and construction industry can and should begin immediately with the restoration efforts. A workshop might be organized to review the current practice in building inspections (see item 2 above) and construction monitoring. Additional guidelines or recommendations would be issued as necessary. Building inspection and construction quality assurance should be examined from the overall perspective of planning, design, construction, decision-making processes (in the case of public works) and cost.

Figure 11-7 Construction quality both prior to an earthquake and during the reconstruction phase is an important issue
