**Engineering and Organizational Issues Related to  
The World Trade Center Terrorist Attack**

**Reconnaissance and Preliminary  
Assessment of a Damaged Building  
Near Ground Zero**

**Volume 2:  
Reconnaissance and Preliminary Assessment of a  
Damaged Building Near Ground Zero**

April 2002

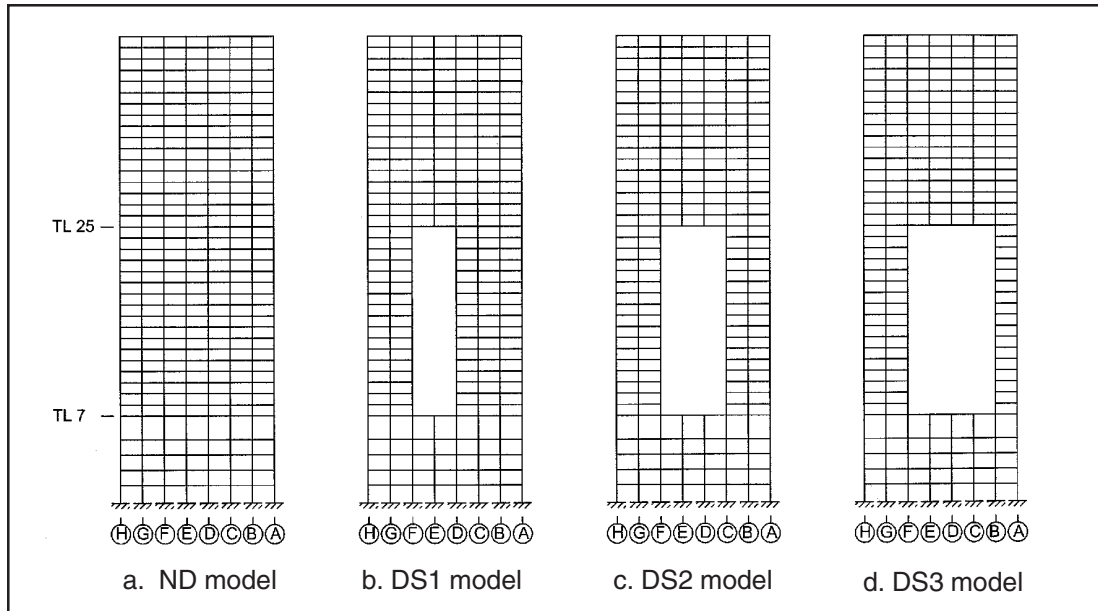
Figure 3.1. Two-dimensional mathematical models of framing on Line 8

Two- and three-dimensional finite element models were constructed using SAP2000 (CSI, 2000). First, a two-dimensional model (Figure 3.1a) was prepared that considered structural framing over all 39 stories along Line 8 (Figure 1.2). This model was constructed to study the response of a single frame with varying degrees of damage (or damage states). Second, a three-dimensional model was prepared that considered structural framing over all 39 stories along Lines 6, 7, and 8, including intermediate perpendicular framing (Figure 3.2). This model was prepared to better understand the response of the building for the observed damage state and to compare the results of two- and three-dimensional analysis. The red dashed line in Figure 3.2 identifies the zone of observed damage per Figure 3.1b.

The analyses presented below considered only gravity loads with a dead load and reduced live load of 50 psf each. A uniform distributed load of 260 lb/ft per story was assumed to account for the curtain wall loading. Mathematical models were analyzed for the undamaged state, denoted ND, and three damage states, one of which corresponds to the existing damage shown in Figure 2.1a. Each damage state involved the removal of columns on Line 8 from TL 7 to TL 25. The three damage states involved the removal of (1) the column on Line D (the observed damage per Figure 3.1b); (2) the columns on Lines D and E; and (3) the columns in Lines C, D, and E, denoted DS1, DS2, and DS3 in Figure 3.1,

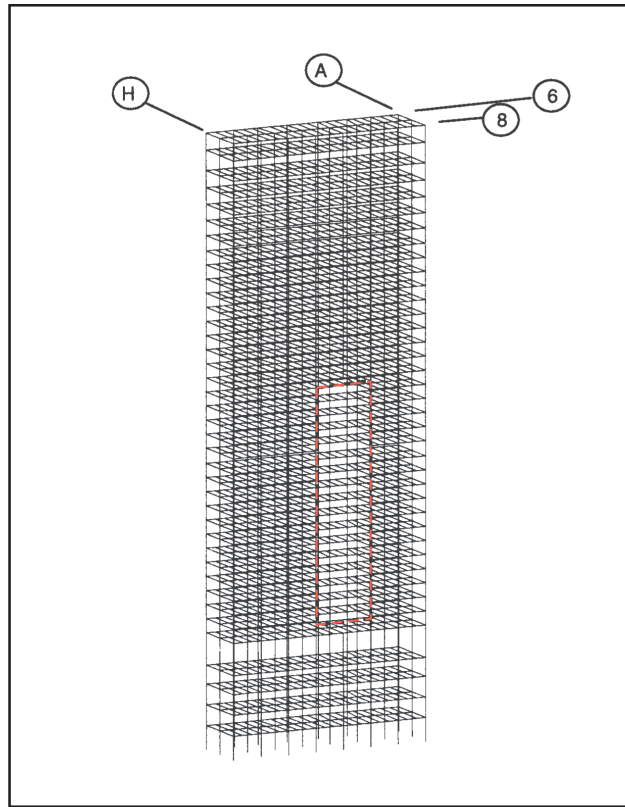
Figure 3.2. Three-dimensional mathematical model of framing on Lines 6, 7 and 8 for DS1

Damage state DS1 (the observed damage) and the two-dimensional analysis is considered first. All D/C ratios are substantially less than one. The three-dimensional analysis shows similar results. These results provide an explanation for the observed behavior of the framing along Line 8 following the impact of debris from WTC 2 and the loss of a column on Line D, namely, that the moment-resisting framing above TL 25 provided an alternate (redundant) path for gravity loads around Line D and to the foundation without distress to the structural framing. As observed from DS1, models with increasing levels of damage (i.e., DS2 and DS3) showed that the moment-resisting framing above the damage provided an alternate path for gravity loads. For DS2 and DS3, Vierendeel truss action becomes more apparent.

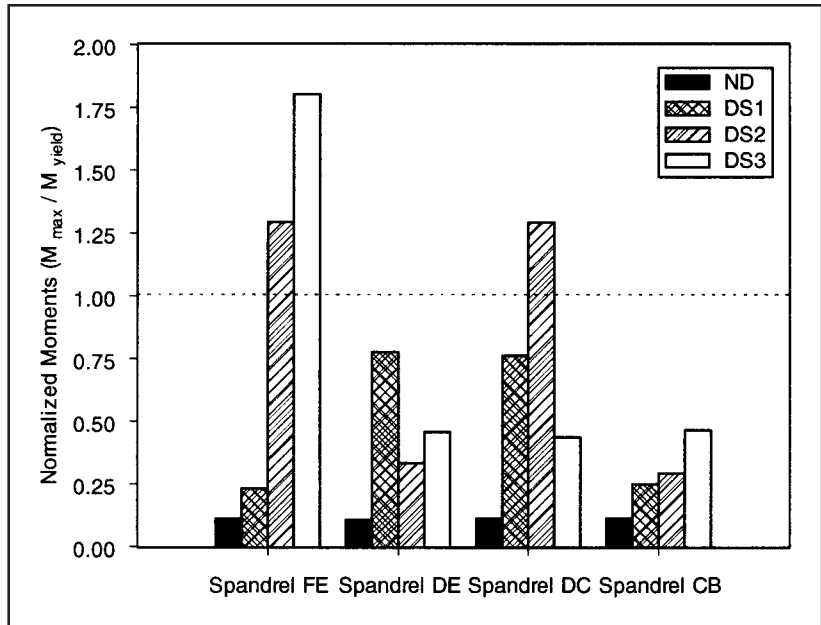
Figure 3.3. Demand-to-capacity ratios for two-dimensional linear elastic analysis

Figures 3.3 and 3.4 present some of the results of the two- and three-dimensional analyses, respectively. Shown in these figures are moments normalized by the yield moment for the assumed beam section sizes at TL 25; the floor level immediately above the observed damage. The spandrel beam designation (e.g., DE) refers to the grid lines between which the beam spans (e.g., Lines D and E). The girder designation (e.g., E87) refers to the grid line along which the girder is aligned (e.g., Line E) and the grid lines between which the girder spans (e.g., Lines 8 and 7). Such normalized moments represent demand-to-capacity (D/C) ratios for these elements, albeit not exactly, because  $M_{yield}$  is used in lieu of  $\phi \cdot M_{nx}$  and each beam is assumed to be fully braced.

The mathematical models for damage states DS2 and DS3 were prepared to evaluate the robustness of a building frame with characteristics similar to those of 130 Liberty Plaza, where robustness herein is judged by the ability of the framing system to support gravity loads following the loss of multiple perimeter columns. The results of the two-dimensional analysis of the DS2 model (see Figure 3.3) show that the frame on Line 8 would have been compromised by the loss of columns on Lines D and E unless the moment-resisting connections were ductile (i.e., possessed some degree of inelastic rotation capacity). Review of the three-dimensional analysis results of Figure 3.4, however, shows that using the results of the two-dimensional analysis leads to conservative conclusions and that the moment-resisting framing perpendicular to Line 8 also participated in the redistribution of load around the lost columns on Lines D and E. Analyses for both the two- and three-dimensional models of DS3 (the loss of columns on Lines C, D, and E) show modest overloads in both instances. For the three-dimensional analysis, the D/C ratios are greatest in the framing perpendicular to Line 8, namely, Girders C87, D87, and E87.

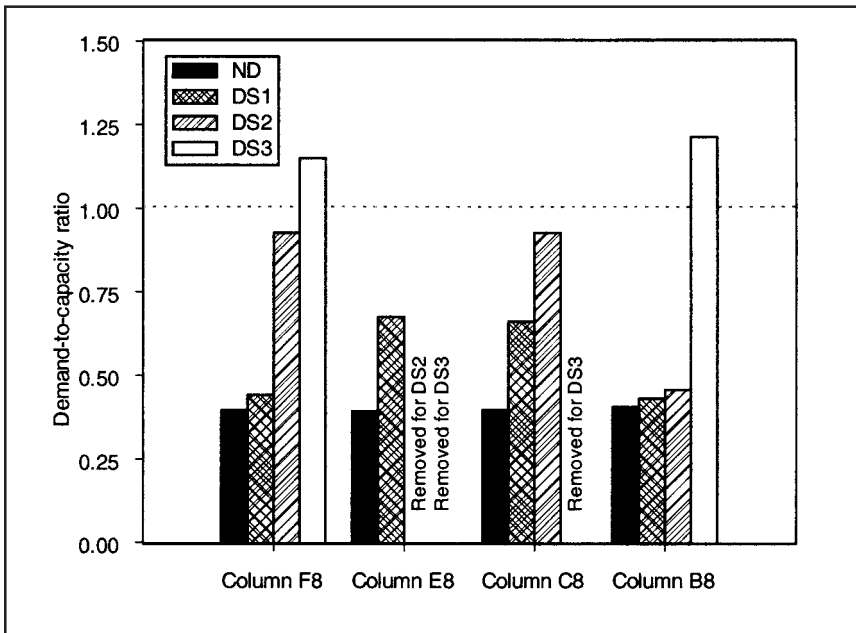
Figure 3.5. Demand-to-capacity ratios for two-dimensional linear elastic analysis

designation (e.g. F8) in Figures 3.5 and 3.6 refers to the column between TLs 24 and 25 at the intersection of Lines F and 8. Shown in Figures 3.5 and 3.6 are column D/C ratios. These ratios were calculated using the 1998 *Edition of the AISC Manual of Steel Construction, Load and Resistance Factor Design* (AISC 1998) nominal strength equation for members under combined forces (LRFD Eqn. H1-1a), namely,

The results of the two-dimensional analyses shown in Figure 3.5 indicate D/C ratios less than unity for the undamaged state, ND, and damage states, DS1 and DS2. For damage state DS3, the D/C ratios for columns F8 and B8 exceed unity. Ratios greater than unity can be attributed to an increase in both axial forces and moments due to the removal of columns C8, D8 and E8. This observed increase in bending moment for the two-dimensional analyses ranged from essentially zero for ND to approximately  $0.25 M_p$  (where  $M_p$  is the plastic moment of the section) for DS3. Noting that the span between adjacent columns for DS3 is four times the span in the undamaged state ND, an increase in moment demand is expected. The D/C ratios for the three-dimensional model (Figure 3.6) are less than unity for ND and DS1, DS2, and DS3. Again, the results of the three-dimensional analyses indicate that the use of two-dimensional analysis leads to conservative conclusions and that the presence of perpendicular framing provides additional redundancy and capability for gravity load redistribution to adjacent framing.

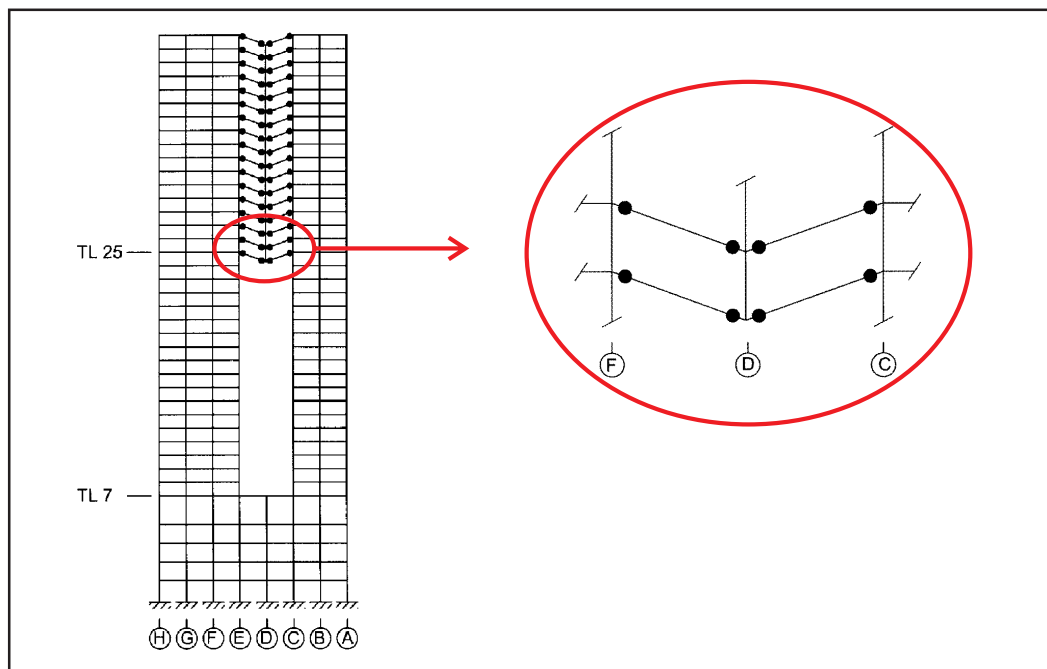
Figure 3.7. Two-dimensional collapse mechanism for DS1

These analyses support the results of the elastic analysis, namely, that the framing system could have tolerated the loss of two columns without collapse. Note the additional load-carrying capacity that results from considering the framing perpendicular to Line 8.

However, it must be noted that the cover-plated moment-resisting connections employed in the construction of the building likely have limited plastic rotation capacity as demonstrated by a series of tests conducted following the 1995 Northridge earthquake (Kim et al., 2000). Therefore, the results of the simple plastic analyses must be interpreted with care.

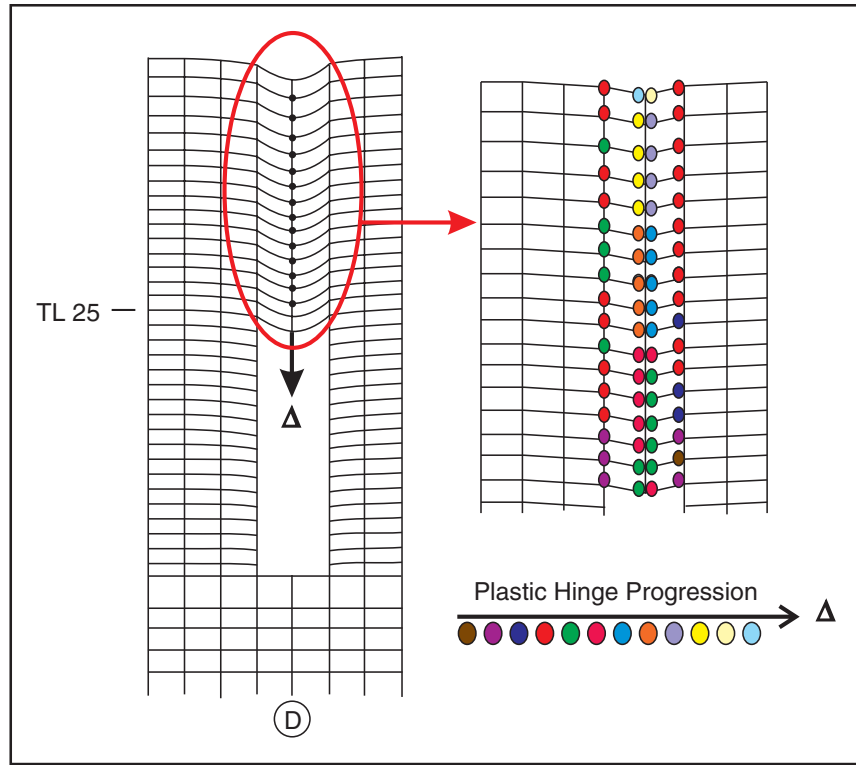
Figure 3.8. Progression of plastic hinge formation in DS1

Two-dimensional nonlinear static or "pushdown" analysis of the framing along Line 8 was performed for the three damage states to obtain insight as to the displacements that could be expected at the maximum floor loads predicted by simple plastic analysis. Elastic-perfectly plastic moment-rotation relationships were assumed for all beams. Connections were assumed to have infinite rotation capacity. The analyses were run using SAP2000 under displacement control and used the node at Frame Line D and TL 25 as the control node. The loading pattern was a series of equal valued point loads at the locations where the floor beams and perpendicular girders frame into the spandrel elements on Line 8. Prior to running the displacement controlled nonlinear static analysis, the curtain wall load was applied as a single force controlled step because it had been accounted for in the plastic analyses. Figure 3.8 shows the observed progression of plastic hinging for DS1. The hinging patterns for DS2 and DS3 were similar to DS1. Hinging started at the beam-to-column connections on Lines E and C near TL 25, progressed to the connections on Frame Line D, and then vertically up through the framing on Line 8.

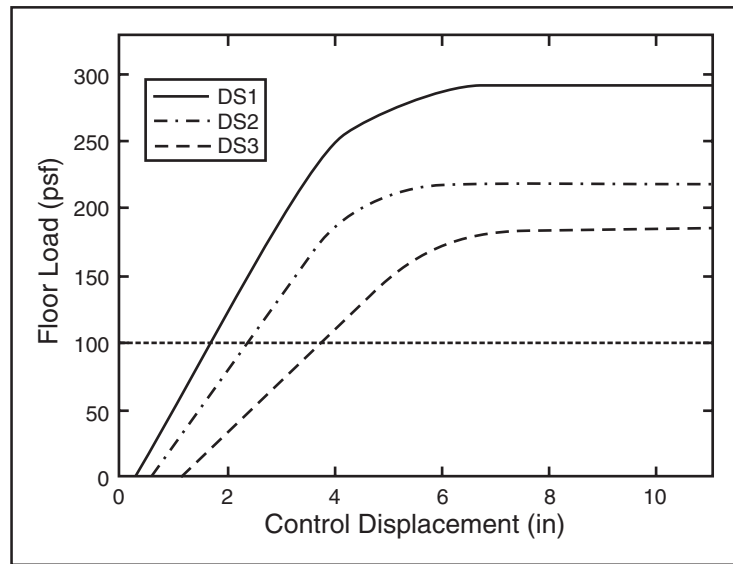
Figure 3.9. Two-dimensional pushdown curves for DS1, DS2, and DS3

Figure 3.9 shows the resulting relationships between floor load (psf) and the deflection of Line D at TL 25 for the three damage states, where the floor load is assumed to be present over the entire width of the damaged zone (i.e., between Lines C and E for DS1, Lines C and F for DS2, and Lines B and F for DS3). The initial displacements seen in the figure correspond to the deflection due to the prior application of the curtain wall load. Also shown in this figure is the research team's estimate of the likely maximum floor loading at the time of the attacks of September 11, 2001, of 100 psf. As expected, an increase in damage led to an increase in structural flexibility and reduced the maximum permissible floor load. The results of the nonlinear static analysis and those of the simple plastic analysis are in good agreement for all damage states.
