MCEER SPECIAL REPORT SERIES  
Engineering and Organizational Issues Before,  
During and After Hurricane Katrina

Damage to Engineered Buildings and Lifelines  
from Wind, Storm Surge and Debris in the  
Wake of Hurricane Katrina

Gilberto Mosqueda and Keith A. Porter

Volume 4

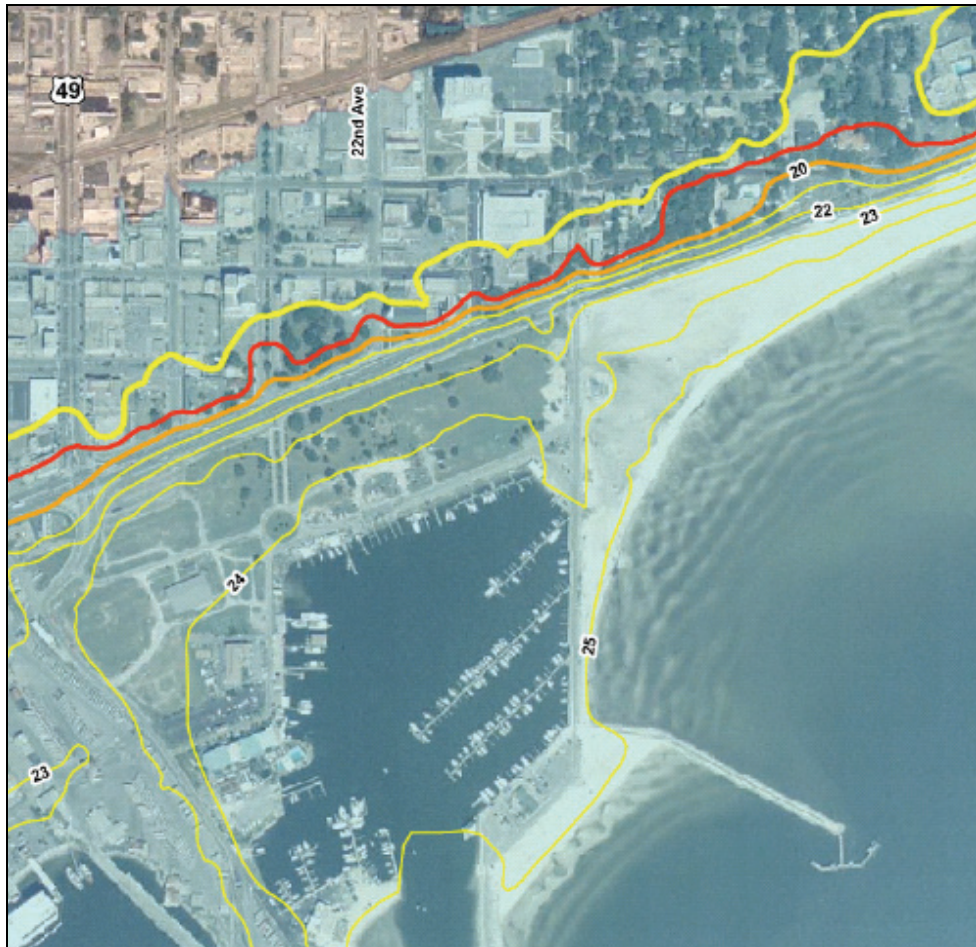
Loading from storm surge and surge-borne debris did appear to exceed conditions provided for in building codes. For example, storm surge appears to have reached farther inland than advisory base flood elevations, even including Katrina among flooding statistics (Figure 2-5). Furthermore, impact from objects transported by floodwaters (surge-borne debris) is only superficially treated by modern building codes (e.g., ASCE 7-05 [2006] Sec 5.4.5, which simply calls for impact loads to "be determined using a rational approach as concentrated loads acting horizontally at the most critical location at or below the DFE"), but in several cases such impact appears to have caused serious damage.

*Figure 2-5. Extract of map showing surge inundation in Hurricane Katrina (blue shading) and advisory base flood elevations including wave effects (heavy yellow line), from FEMA (2006). Inundation in Katrina reached farther inland than 1% annual chance (100-year) stillwater elevations plus estimated wave effects.*

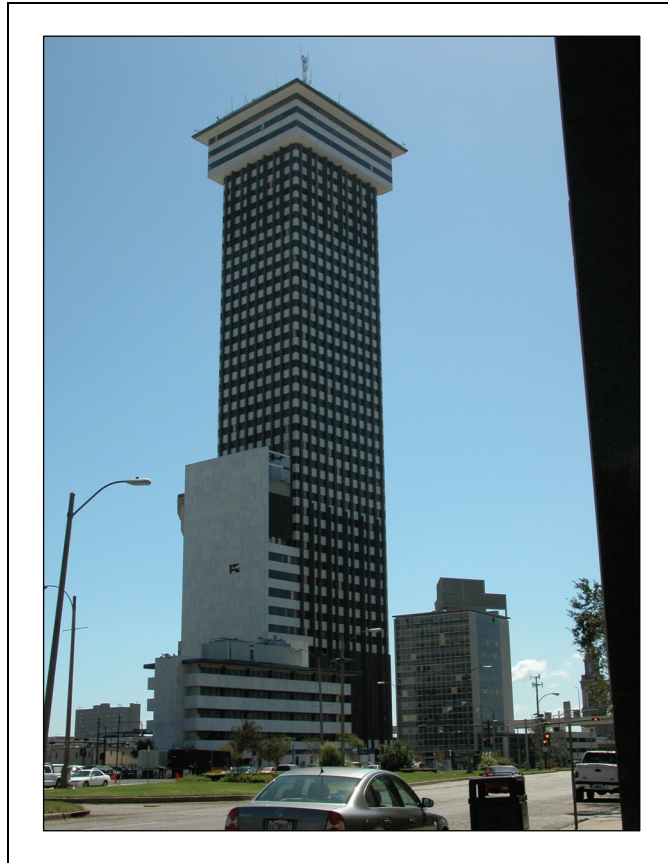
The 41-story Plaza Tower located at the intersection of Howard and Loyola is a reinforced-concrete-frame building with various vertical setbacks up to the 16th level and with a mushroom top extending the square footage of the top three stories. This high-rise building shown in Figure 3-10 was isolated from other tall buildings that could generate any rooftop debris by at least two city blocks. The south side of the building houses an eight-level parking structure with sheet metal cladding, where five of the metal sheets were missing. On the north facade, at least one precast cladding panel had been lost (note the spot around 10<sup>th</sup> floor level). Broken windows were spotted around the building, with the majority concentrated on the lower stories of the north and west facade. The building appeared closed at the time of investigation.

*Figure 3-10. Office building in the New Orleans Business District at a distance from other high-rise structures.*

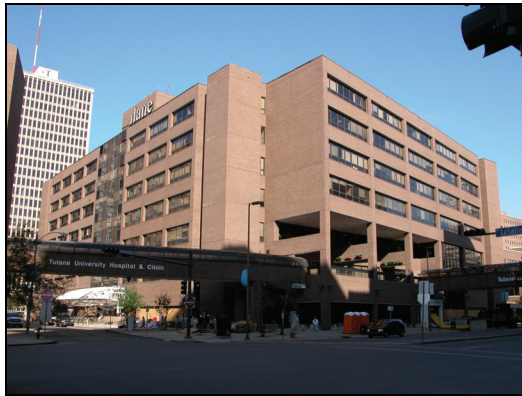
(a) Tulane Hospital

Tulane University Hospital Clinic is housed in a seven-story steel-frame building that flooded to a depth of approximately 1m for about two weeks. It has no basement, no major building service equipment at first-floor level, and few broken windows, so damage was limited primarily to architectural finishes at the ground floor. At the time of the MCEER reconnaissance, a contractor was demolishing ground floor drywall and drying the building as evident in Figure 3-18(a). Subsequently, Tulane University Hospital & Clinic

*Figure 3-18. Hospitals in New Orleans were closed after flooding.*

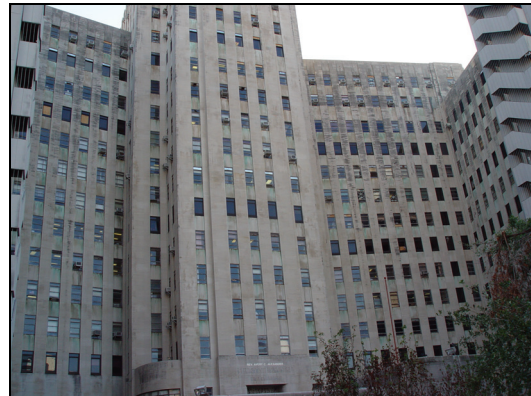
(b) Charity Hospital

The 13-story Charity Hospital of New Orleans, one block away from Tulane Hospital, was also rendered inoperative by Hurricane Katrina and the flooding. Various windows on all side of the building were broken. Watermarks showing the height of flooding indicate that the first floor entry level, elevated about four feet from the street level, was not flooded. The basement, however, was still flooded at the time of inspection. No remediation efforts appeared to be underway as in Tulane Hospital. Figure 3-18(b) shows the north facade of the main building with a view of the damaged windows.
