Engineering and Organizational Issues Before,
During and After Hurricane Katrina

Damage to Bridges from Wind, Storm Surge and
Debris in the Wake of Hurricane Katrina

**Damage to Bridges from Wind, Storm Surge and
Debris in the Wake of Hurricane Katrina**

MCEER-08-SP05
Red Jacket Quadrangle
Tel: (716) 645-3391; Fax: (716) 645-3399; Email: mceer@buffalo.edu
World Wide Web: <http://mceer.buffalo.edu>

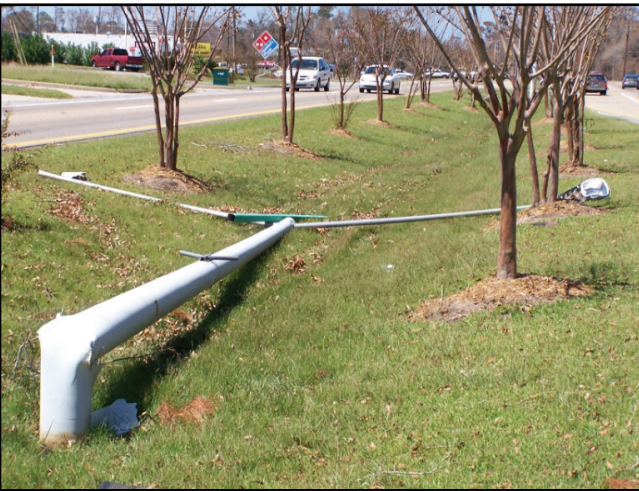
- c. On US-90 in Gautier, MS, numerous fiberglass light poles broke off near the base due to wind and surge waters. Missing street signs and traffic signals complicated travel after the storm.

(c) Light poles were downed.

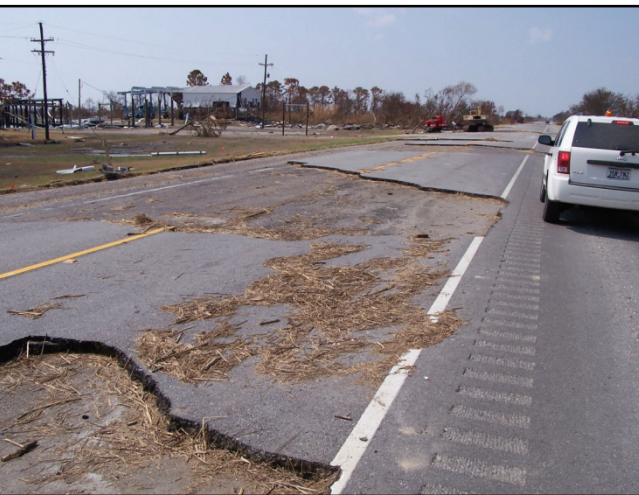
(e) Courses of asphalt pavement peeled up.

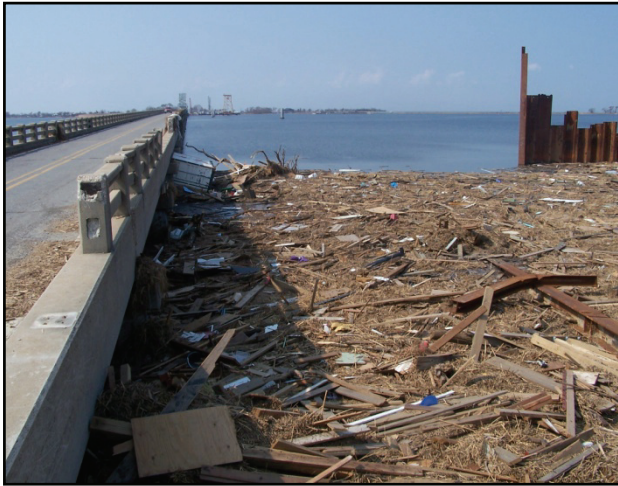
- f. Layers of asphalt pavement on US-90 were peeled up and transported 50-100 feet away.
- g. Debris fields were left behind after the storm. This material was hazardous because of nails and glass but also because it could contain hazardous chemical waste. This scene was at Rigolets.

(g) Debris fields made walking hazardous.

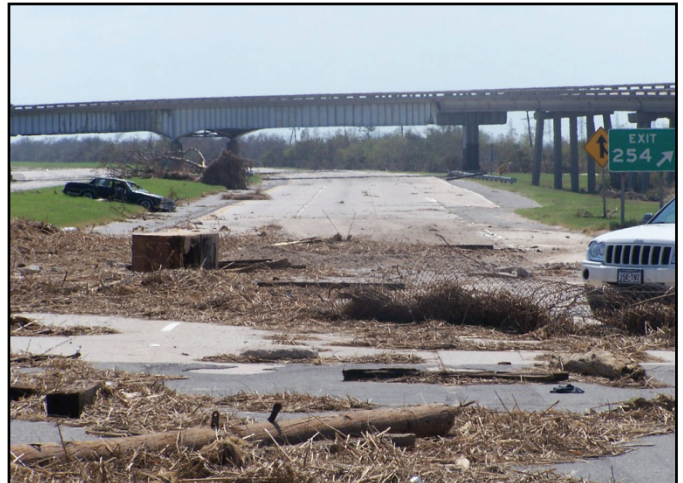
- l. Most highways needed clearing after the storm in order to become passable. This view is in Louisiana near the west end of I-10 bridges.
 - m. Broken tanks and pipelines polluted water resources and caused environmental damage.

(l) Debris covered highways.

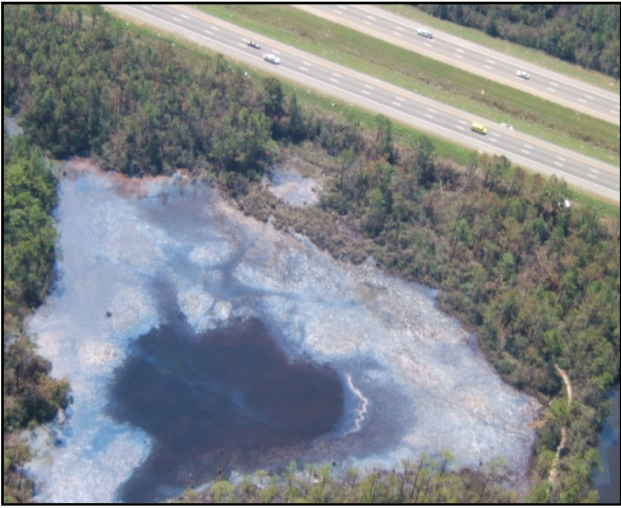
(m) Oil spill in a pond.

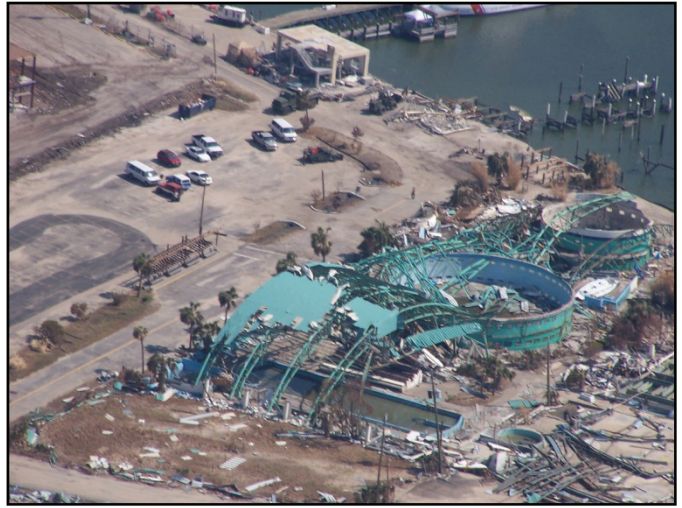
- n. This is one of many buildings that were destroyed by wind and surge.
 - o. The concrete floor of a warehouse at the State Port Authority in Gulfport, MS was destroyed when it was flooded by surge water. The floor was supported by a network of concrete piles and beams; the air cavity under the floor may have worsened the damage.

(n) Destroyed buildings.

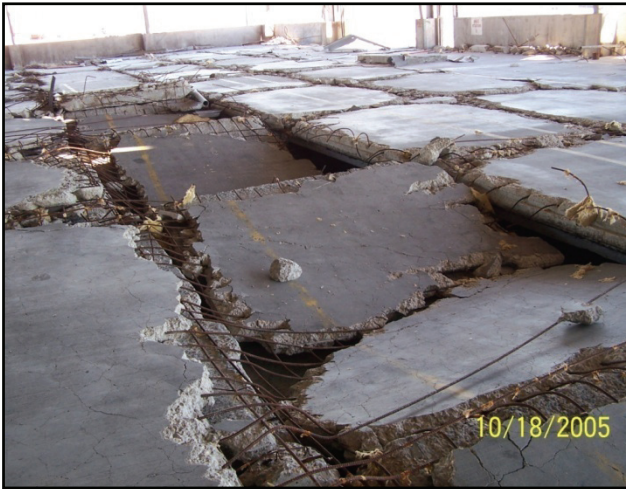
(o) Warehouse slab at the Port Authority.

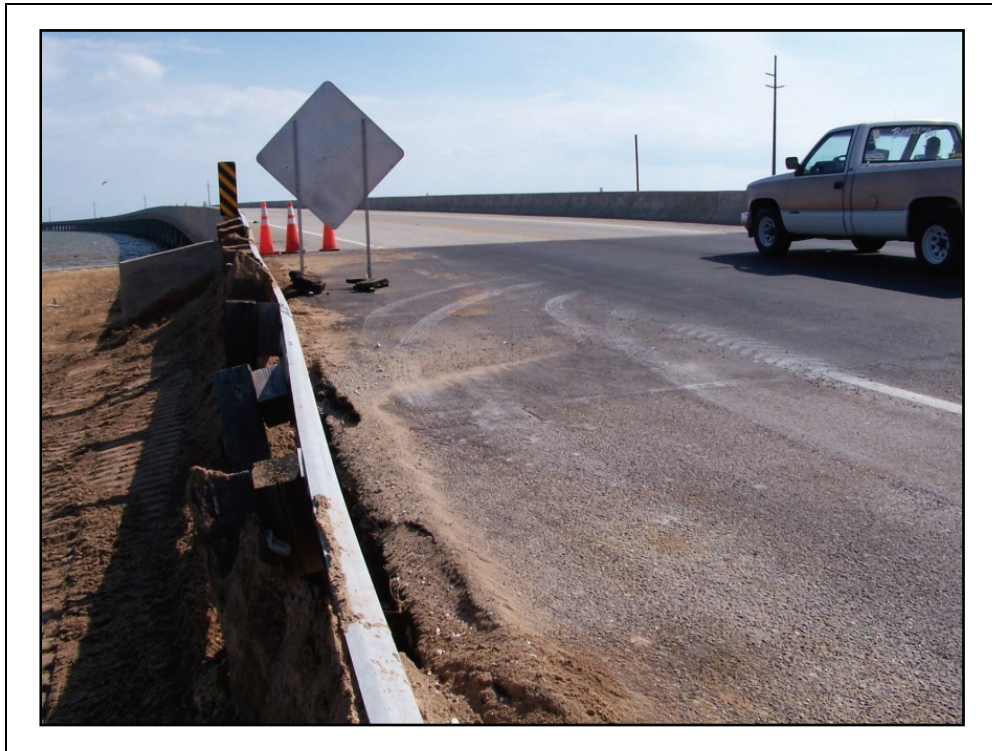
About 40 miles south of the City of Mobile is Dauphin Island. It is joined to the mainland by a concrete multi-girder bridge built in 1982 identified as Route 193 over Grant's Pass. The bridge remains in excellent condition but was partially closed to traffic after the Hurricane due to a washout of the north approach. The bridge is in good structural condition but access to the island is restricted for security reasons (to prevent looting). The checkpoint guard said that there was always one lane of traffic open, though it was necessary to escort vehicles through the washed out areas. The approach and nearby roadway had already been repaired (Figure 2-4). Alabama Department of Transportation (ALDOT) said that this area repeatedly washes out though, recently repaired stretches where geotextile reinforcement were used are holding up well. The elevation is less than six feet above sea level.

Figure 2-4. Approaches had been partially washed out.

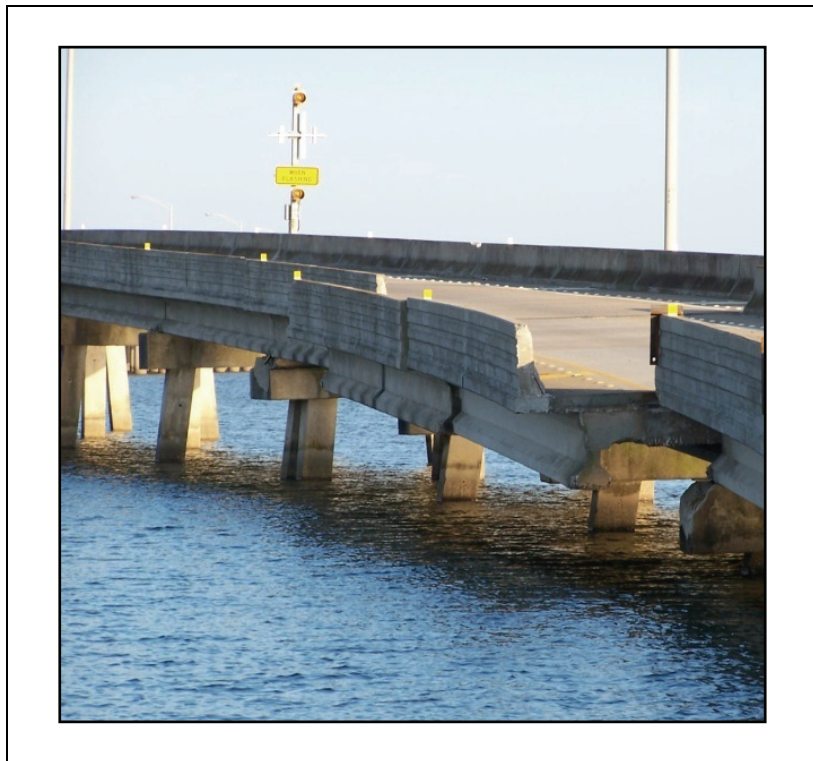
Figure 2-16. Facing east toward spans that were pushed to the north.

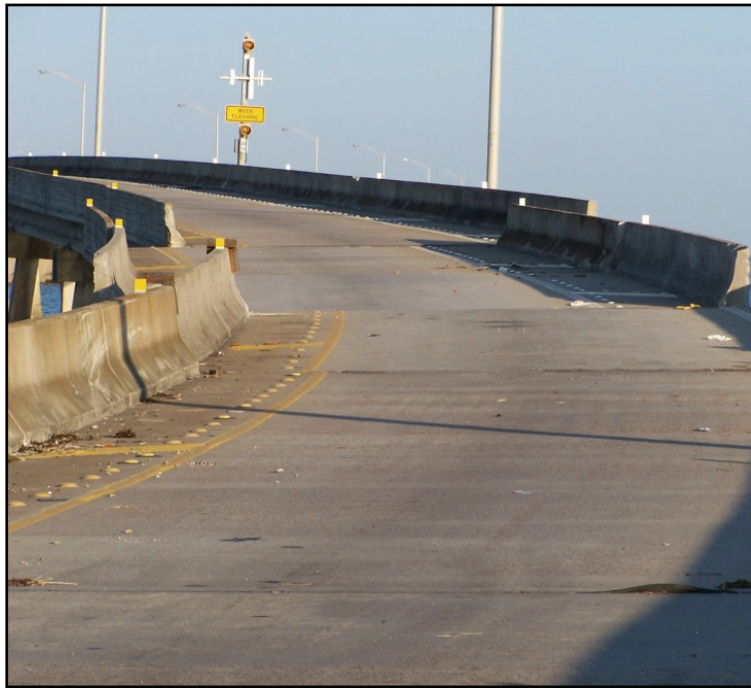
Figure 2-17. Looking east at the displaced spans.

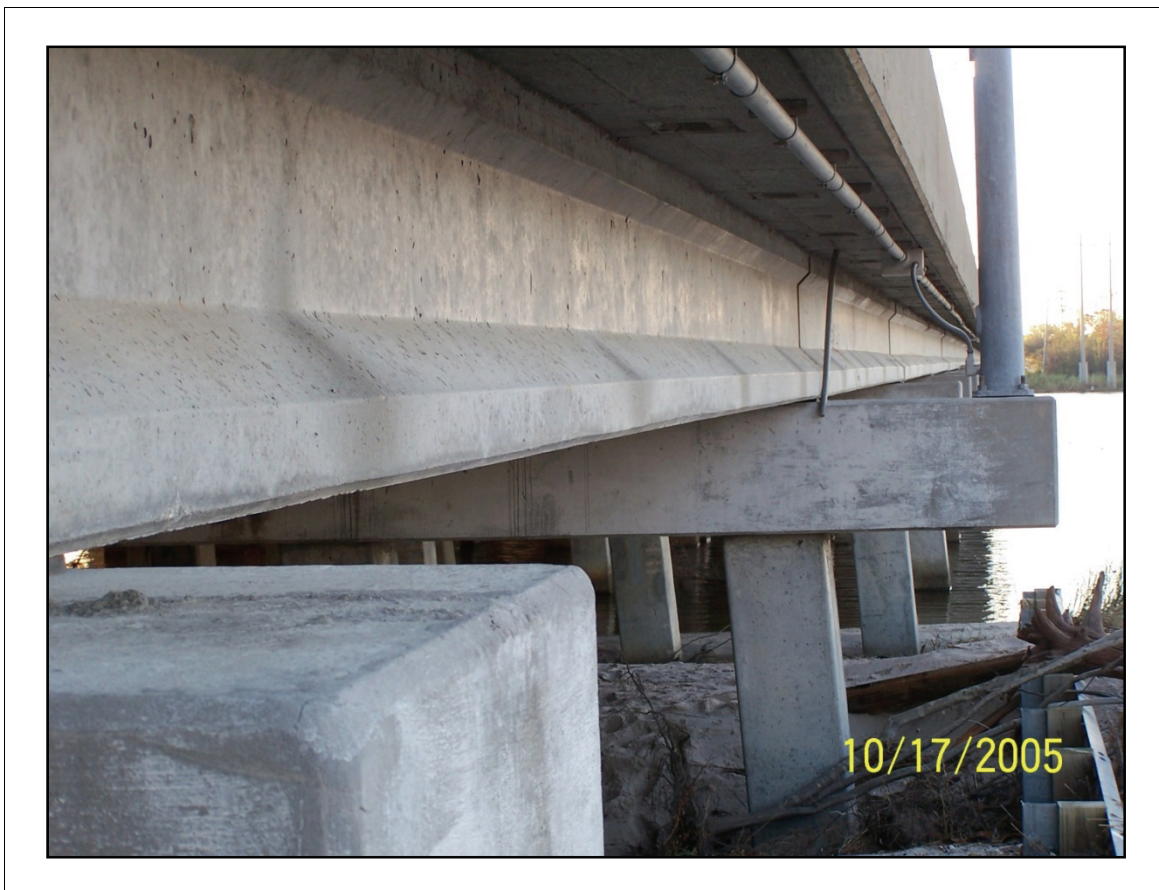
The bridge carrying US-90 over the west branch of the Pascagoula River is a multiple span bridge built with simply supported P/S concrete beams. Although the CSX railroad bridge just to the south was destroyed when its superstructure was washed off the piers, this bridge survived well. It may have benefited from a deck made continuous for live load. This would serve to join spans together for more mass to resist lateral loads.

Figure 2-21. P/S concrete beams on concrete piers.

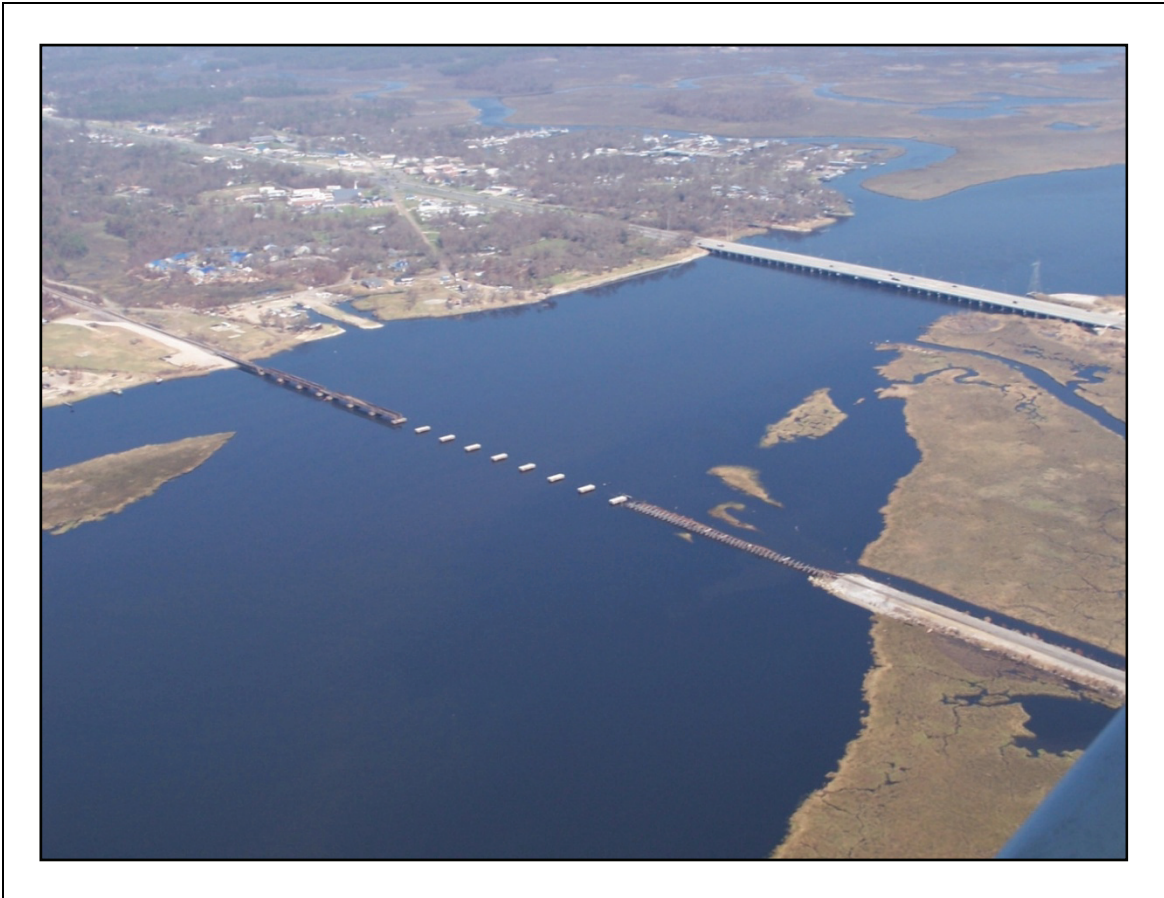
Fifteen steel girders spans of the CSX railroad bridge were taken off the piers by surge. The bridge seat is less than 10' above the water.

*Figure 2-22. CSX railroad bridge lost the tracks and superstructure.
US-90 is in the background.*

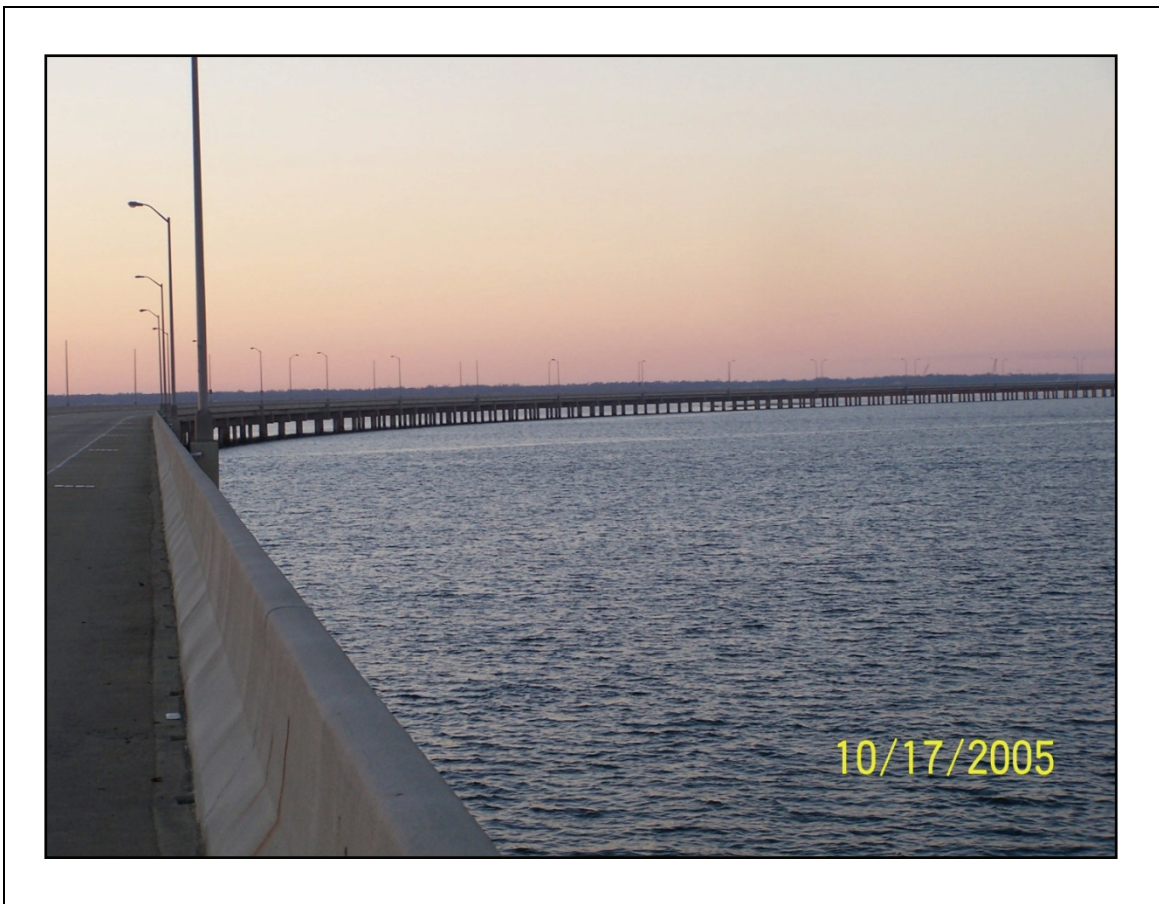
The 3.2 mile long bridge near the Pascagoula Naval Station performed well, despite its precast construction. The deck is 17 feet above mean sea level. This is probably due to better detailing at the joints and a deck that tied then spans together.

Figure 2-23. This bridge, connecting the Pascagoula Naval Station to the mainland performed well.

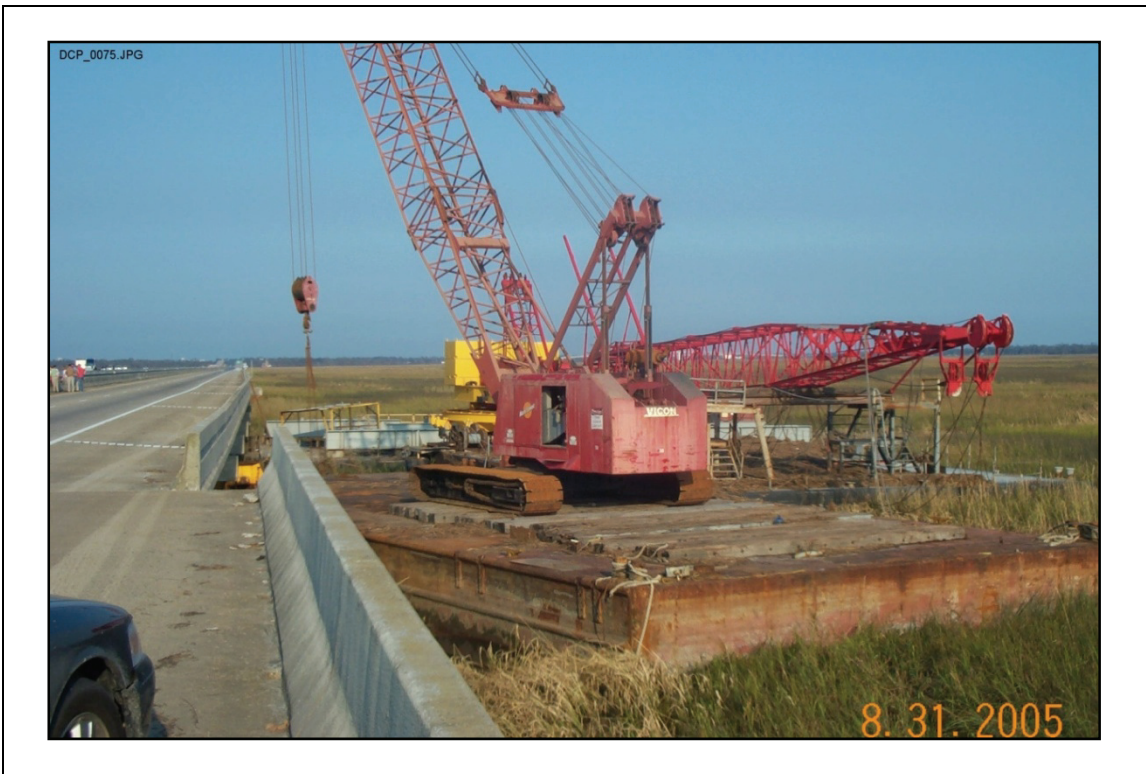
Figure 2-28. I-10 EB was hit by this barge and pushed four feet to the north.

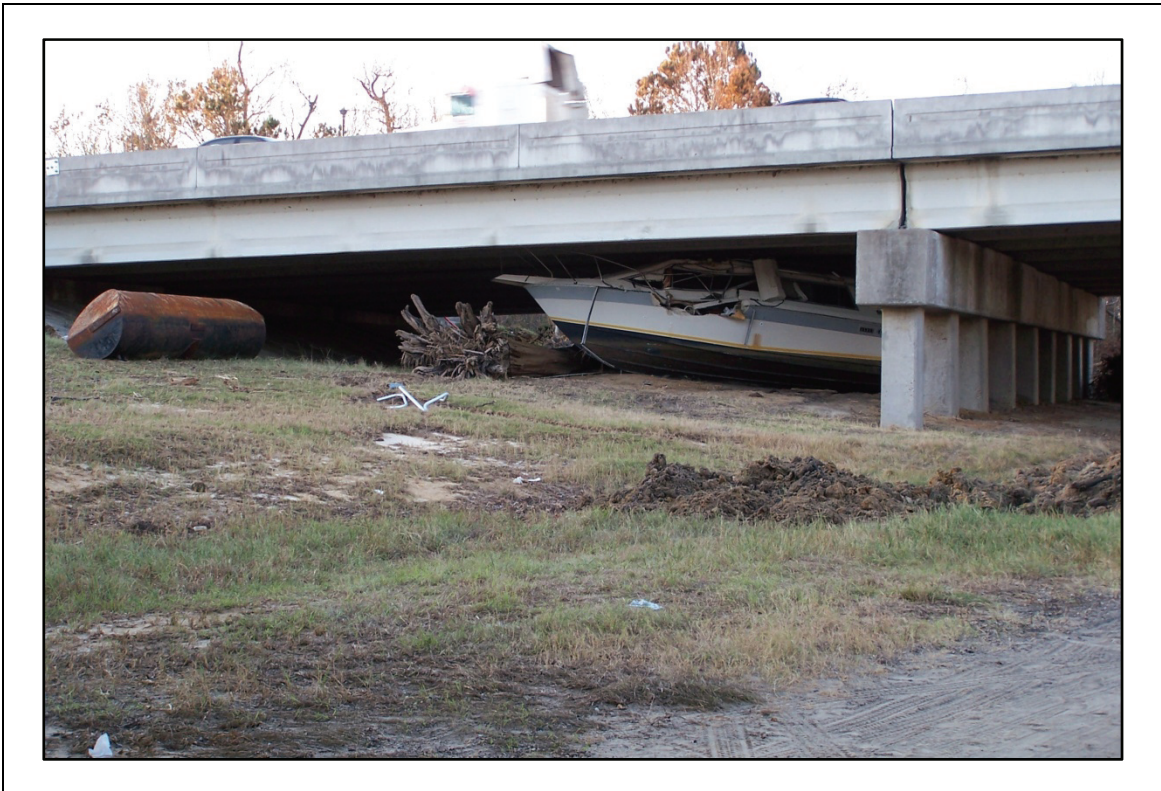
Figure 2-30. Large debris was lodged under the WB lanes of I-10 (a boat, tank, and a log).

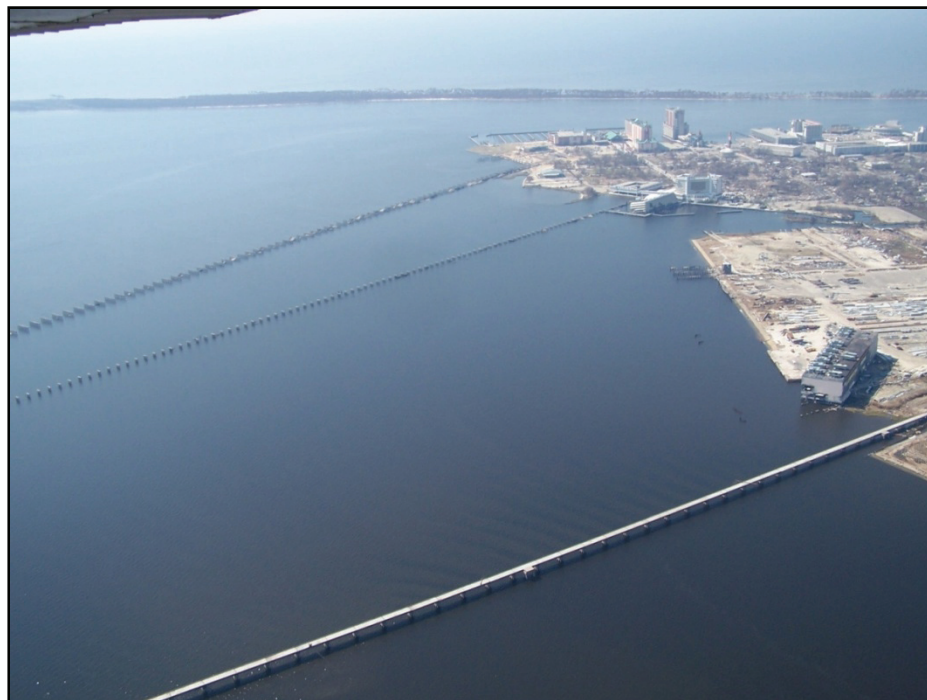
(b) Biloxi Bay, facing south toward the City of Biloxi. From top to bottom, the bridges are US-90, old route 90, and the CSX railroad.

Figure 2-35(b) provides a good perspective facing south toward the City of Biloxi. From top to bottom, the bridges are US-90, old route 90, and the CSX railroad bridge. Despite the loss of tracks, the CSX bridge was considered a success. All spans survived with relatively little displacement. The concrete deck is seen in the picture.

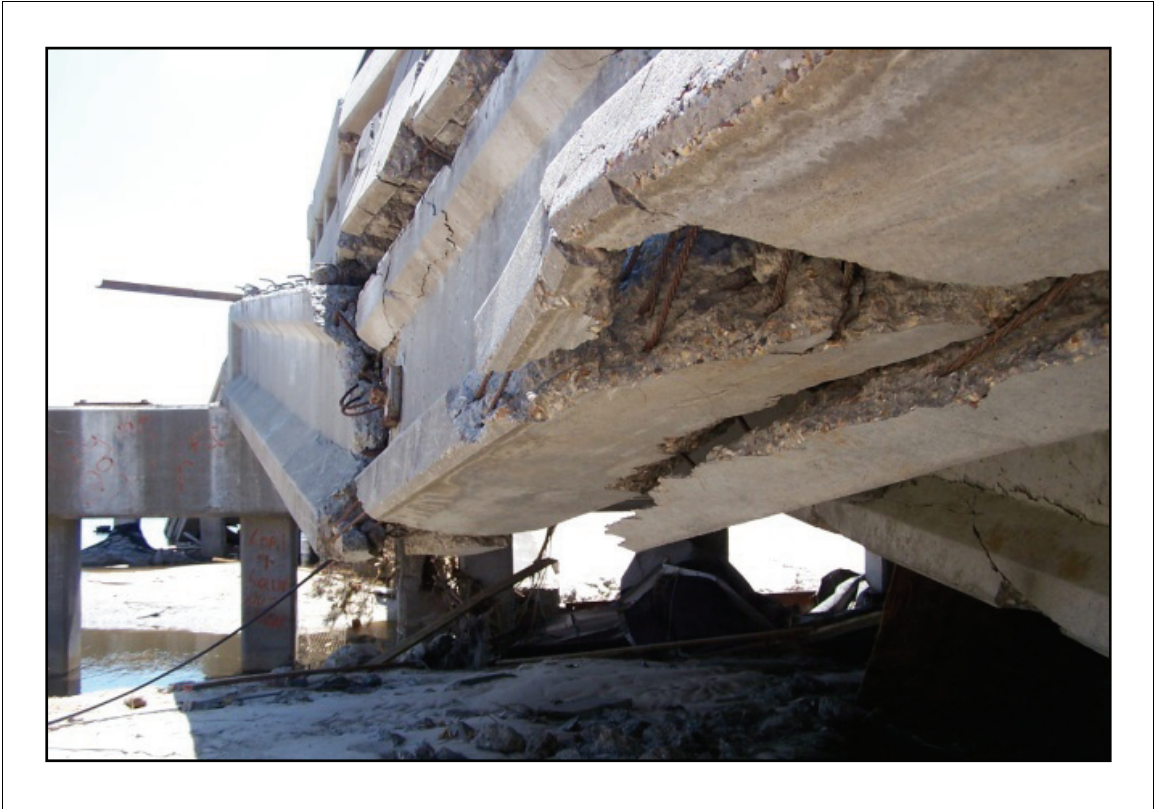
Many P/S girders were wrecked before they were tossed off the piers. The remains of spans looked like they were hit repeatedly by waves during the storm. Some appear to have broken up when buoyant uplift forces relieved the dead weight, allowing the prestressing forces to crack the beam (Figure 2-43). The twisting of beams also contributed to destruction of the seven inch concrete deck (Figures 2-44 to 2-47).

Figure 2-43. Uplift forces probably helped destroy this beam.

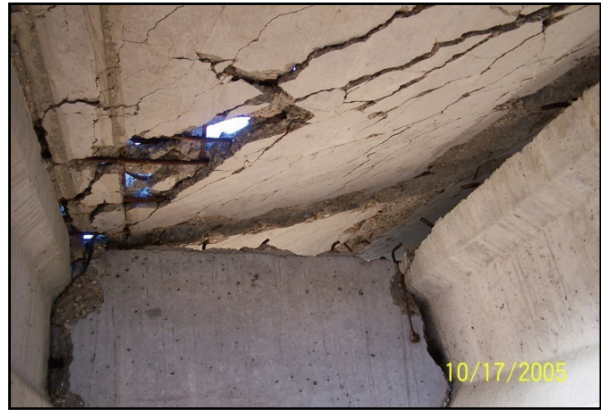
Figure 2-45. A view of the deck underside.

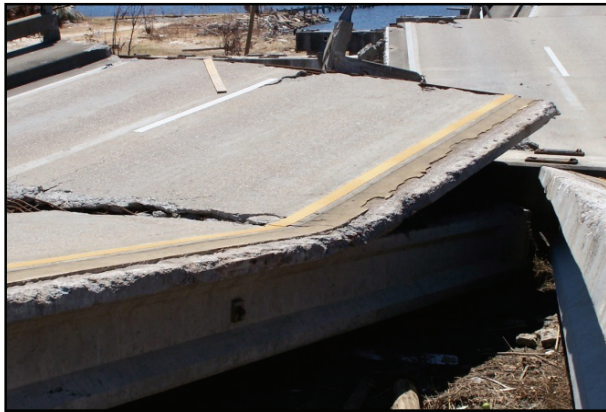
Figure 2-46. The 7 inch CIP composite deck has been peeled away from the P/S concrete beam and has broken transversely, exposing its steel reinforcement. This photo was taken at the east end of the US-90 bridge.

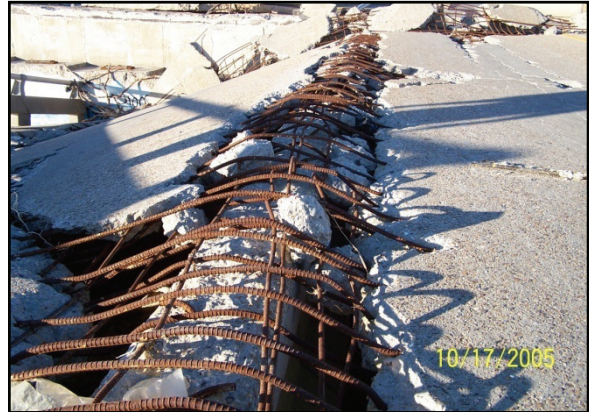
Figure 2-47. Steel reinforcing bars is all that remains of the concrete deck above the concrete girder. This photo was taken at the west end of the US-90 bridge.

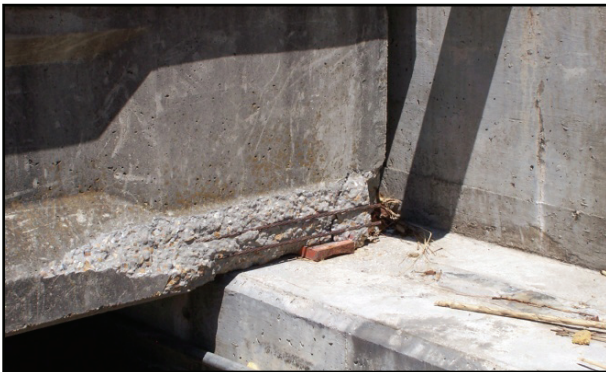
The bearings for the US-90 bridge were simple steel bearing plates as shown in Figures 2-48 and 2-49. The weight of the superstructure and friction provided the resistance to forces that the bridge was designed to withstand. There was no positive connection to attempt to prevent uplift and only small steel angles to resist horizontal forces. When the bridge was hit with wave forces from the surging tide, the beams pushed to north. Figure 2-48 shows the plate under the end of the beam at the east abutment and Figure 2-49 shows where it was before the storm. Note the small steel angle on the left side that was bent over when the beam slid to the left.

Figure 2-48. Note the bearing plate under the end of the P/S concrete beam. This beam slide to the north (left), bending down the retainer angle and anchor bolt seen in Figure 2-49.

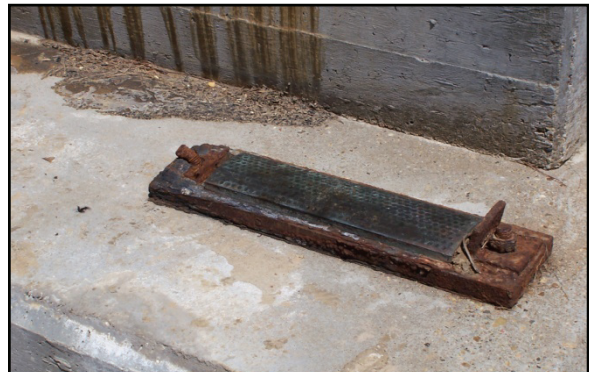
Figure 2-49. This bearing plate on the east abutment of US-90 over Biloxi Bay is typical of all bearings

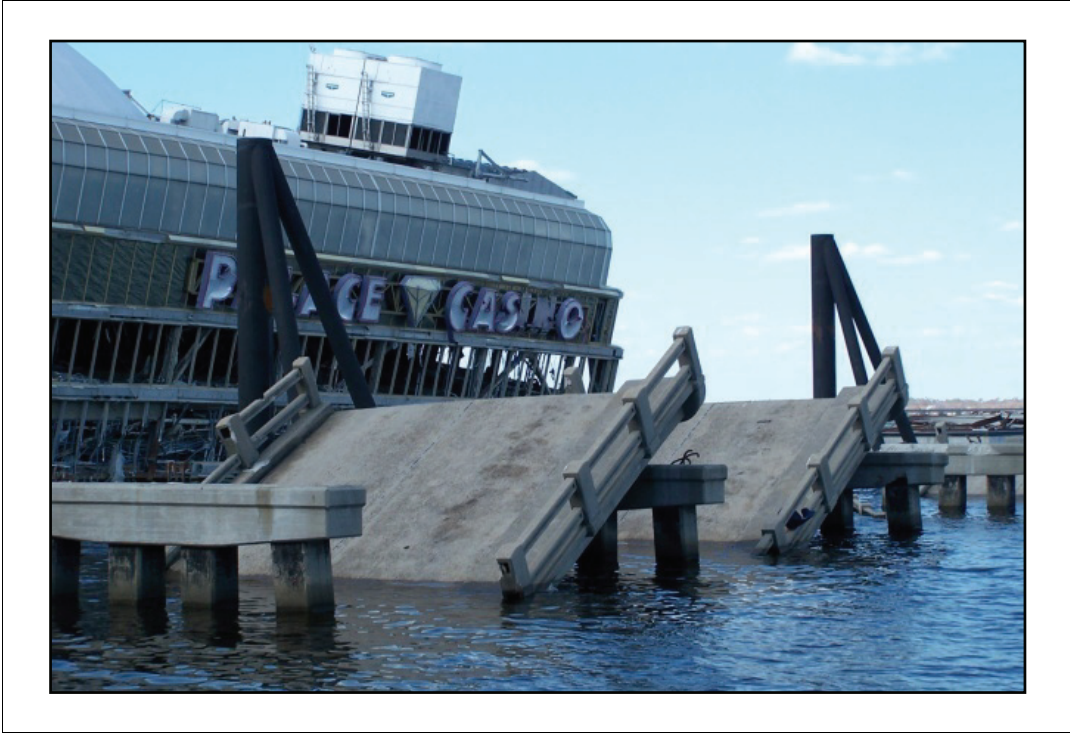
Figure 2-51. Looking east from the west end of old route 90.

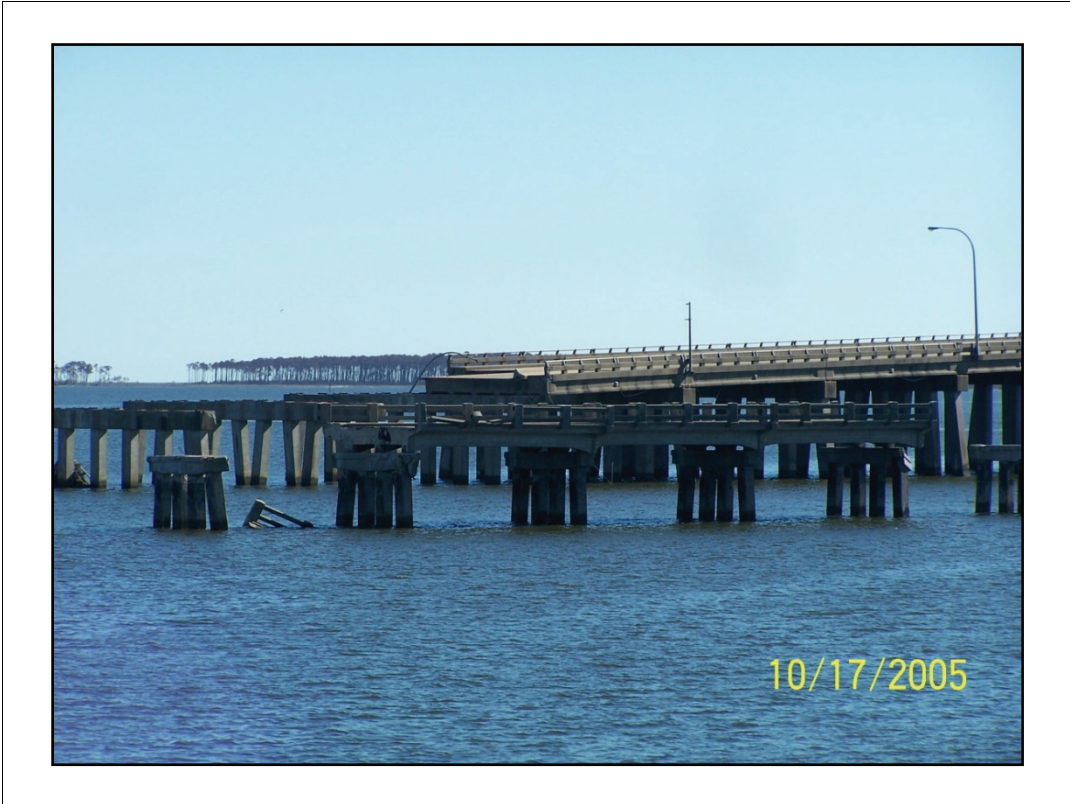
Figure 2-52. Facing south at old route 90 with the higher spans of US-90 near the navigation channel behind it.

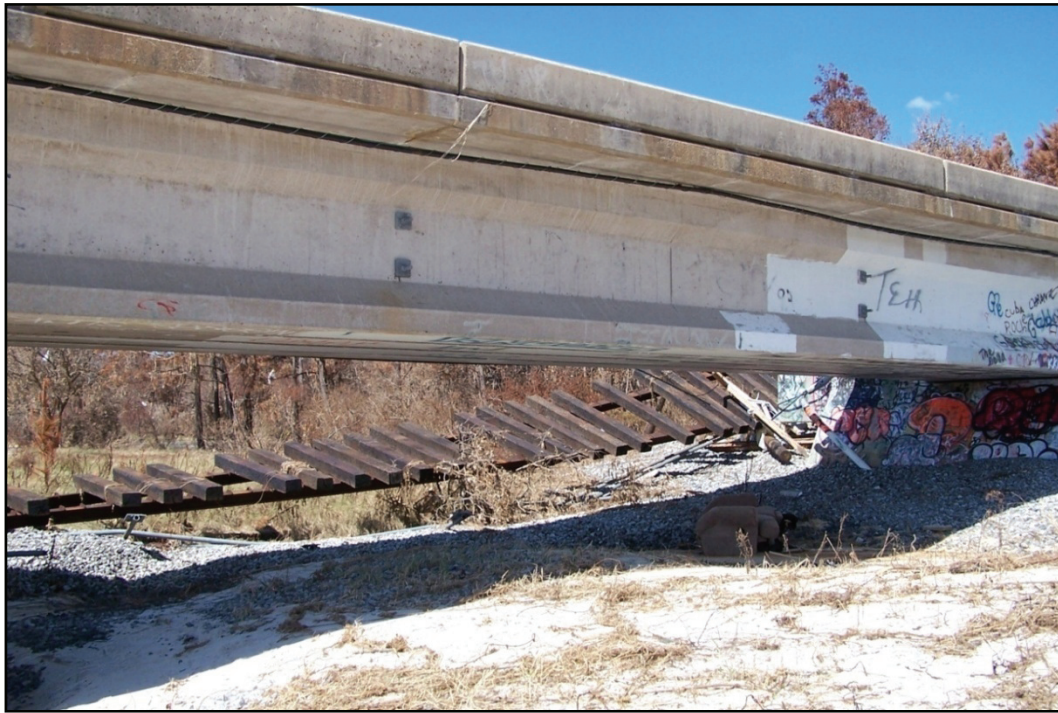
Figure 2-55. The tracks near the east end are upside down on the north side.

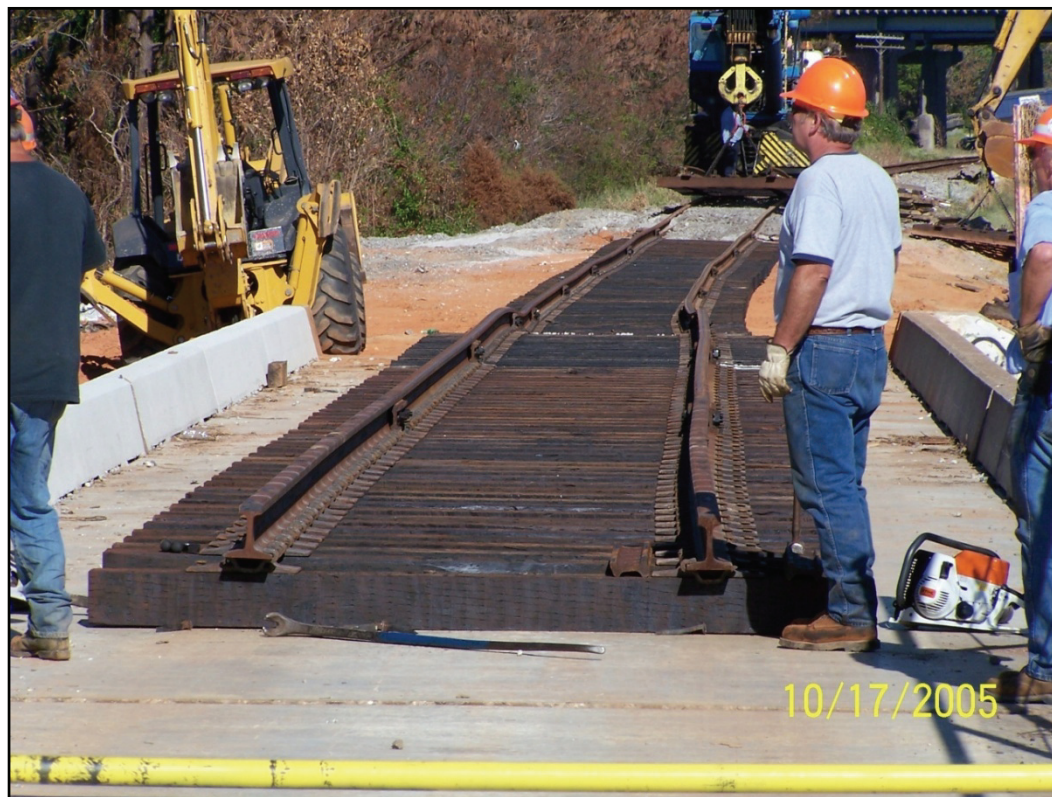
Figure 2-57. Modular sections of track were used to restore the line to service.

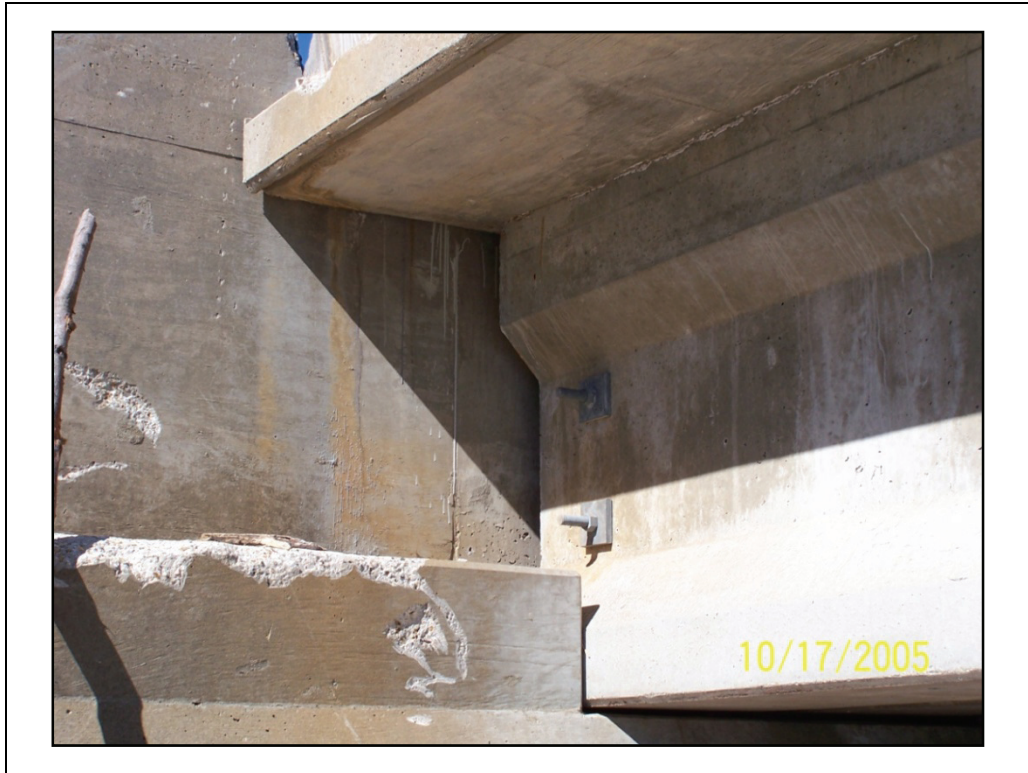
- Concrete shear blocks restricted lateral movement on each pier and at the abutments (Figures 2-58, 2-60 and 2-61).
- Since the shear blocks were tight against the beams (Figure 2-60), any uplift component of force would be met by frictional resistance from the vertical face of the block.

*Figure 2-58. Lateral restraint blocks at the west abutment.
Note the scars from debris.*

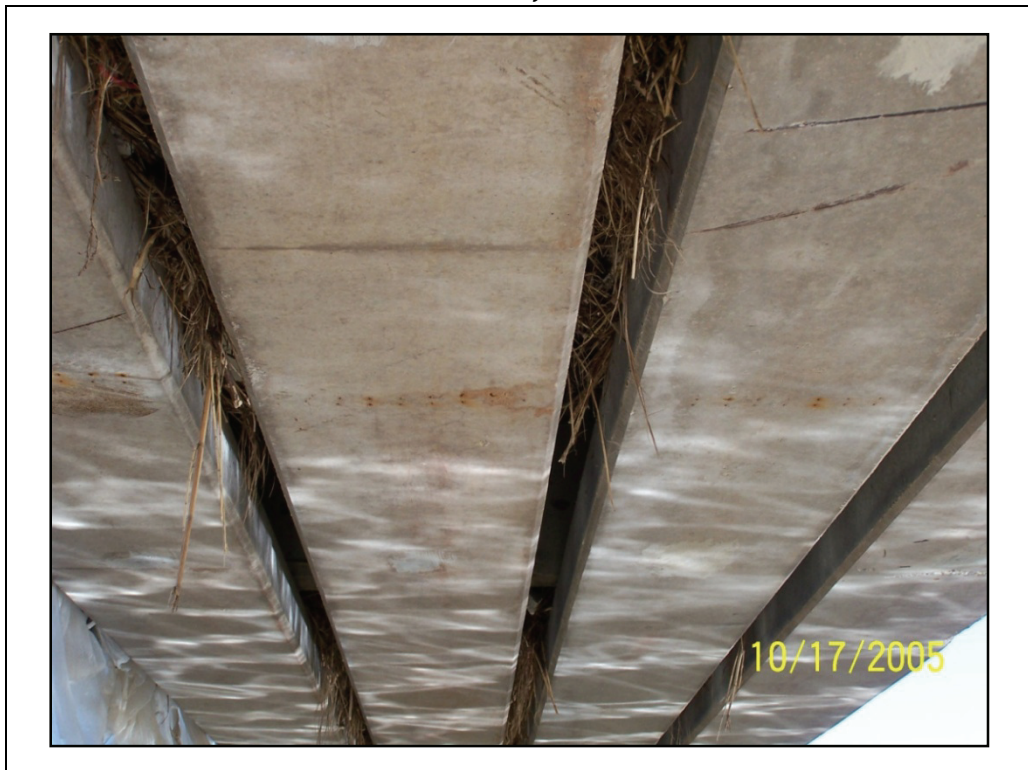
- The P/S beams were tightly spaced to accommodate live loads. This minimized the amount of air that could be trapped and contribute to buoyancy (Figure 2-59).

- Concrete diaphragms kept the structural system geometrically stable. Having the beams fixed relative to one another also provided a direct load path for lateral forces from the south side to the north. Wave forces applied to the south face could be transmitted efficiently to the shear blocks on the north side. The diaphragms can be seen between the beams in Figure 2-59.

Figure 2-59. Tightly spaced prestressed beams with concrete diaphragms.

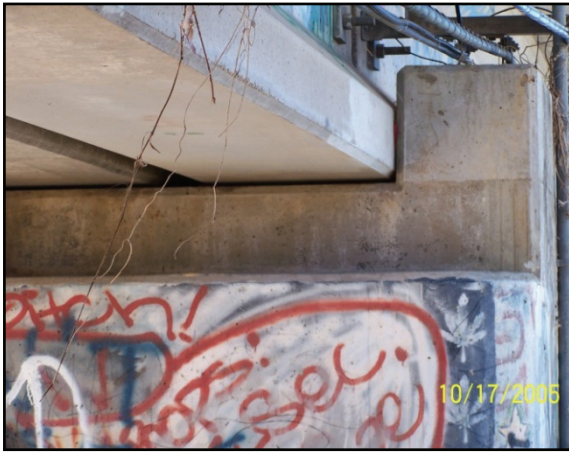
Figure 2-60. Massive shear blocks on each side of the superstructure successfully restricted horizontal forces imposed by wind and waves.

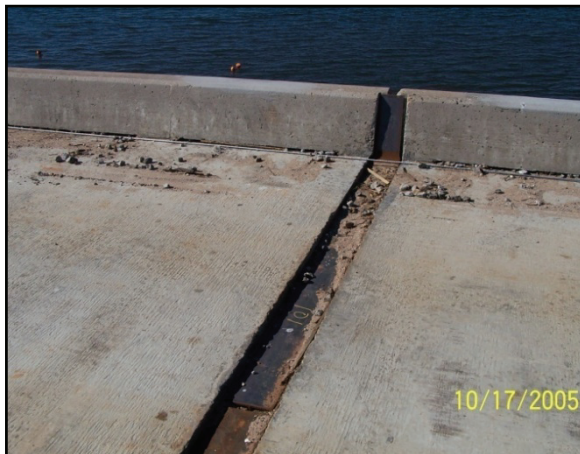
- Steel shear keys in the deck joints locked the sections together and prevented rotation in a horizontal plane (see Figures 2-62 and 2-63).

Figure 2-62. This steel plate prevents debris from falling through the joints between spans but also tightens up the superstructure assembly to restrict movement.

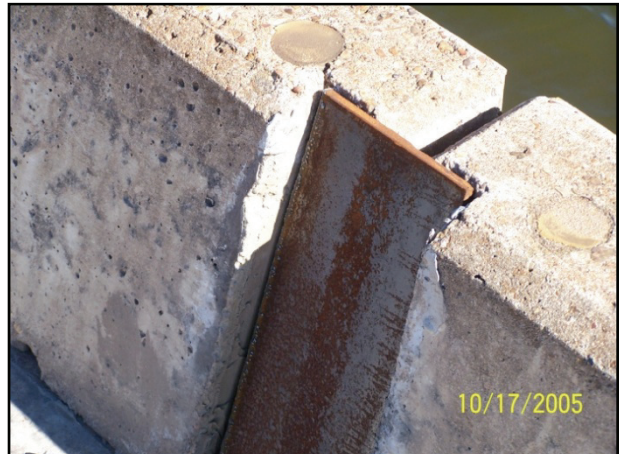
Figure 2-63. Though not anchored into the concrete, the tight-fitting steel joint plate probably acted as a shear key to resist relative horizontal displacement and restrain rotation between spans.

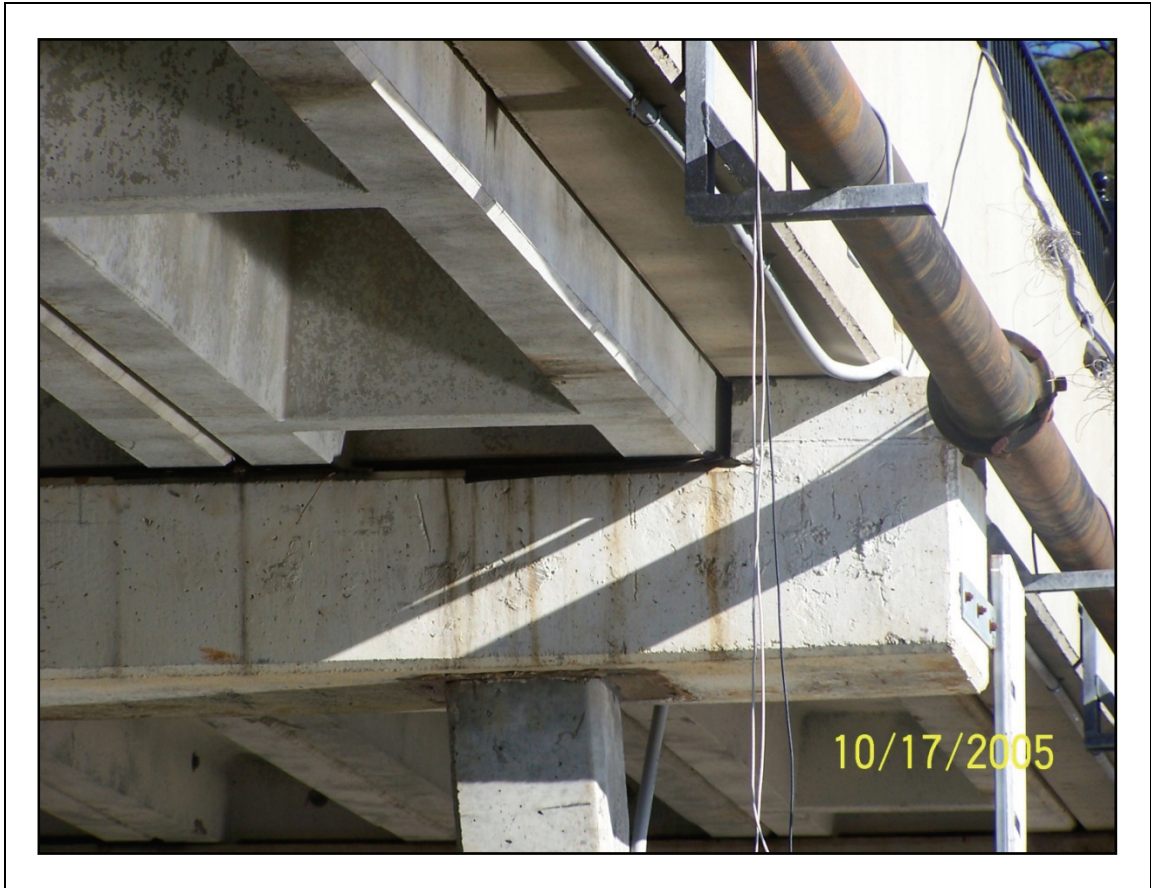
The Shearwater Bridge in Ocean Springs, MS was built in 2003. It is very close to Biloxi Bay and had evidence of being overtopped. Inspectors discovered the broken railing visible in Figure 2-64 and saw that washouts at the approaches had been repaired (Figure 2-65) but there was no apparent damage to the superstructure. Shear blocks (Figure 2-66) helped secure the superstructure from lateral movement, preventing significant damage.

Figure 2-66. The shear block at the end of the pier cap restrained the precast superstructure units.

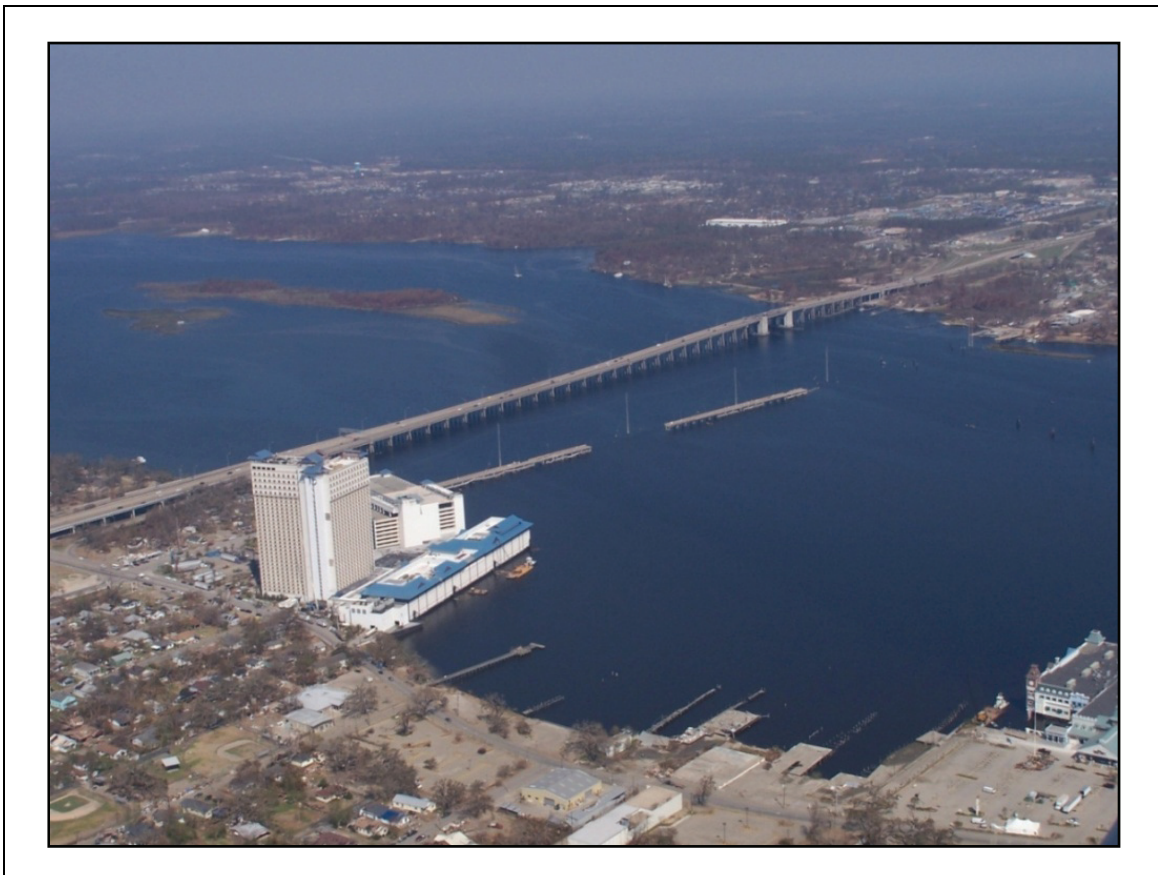
Figure 2-69. This photograph was taken facing NW. A hotel and floating casino are shown in the foreground. Near it is the bridge referred to as old route 110, with several sections missing. I-110 at the top of the picture was hit by a barge and debris but remained functional.

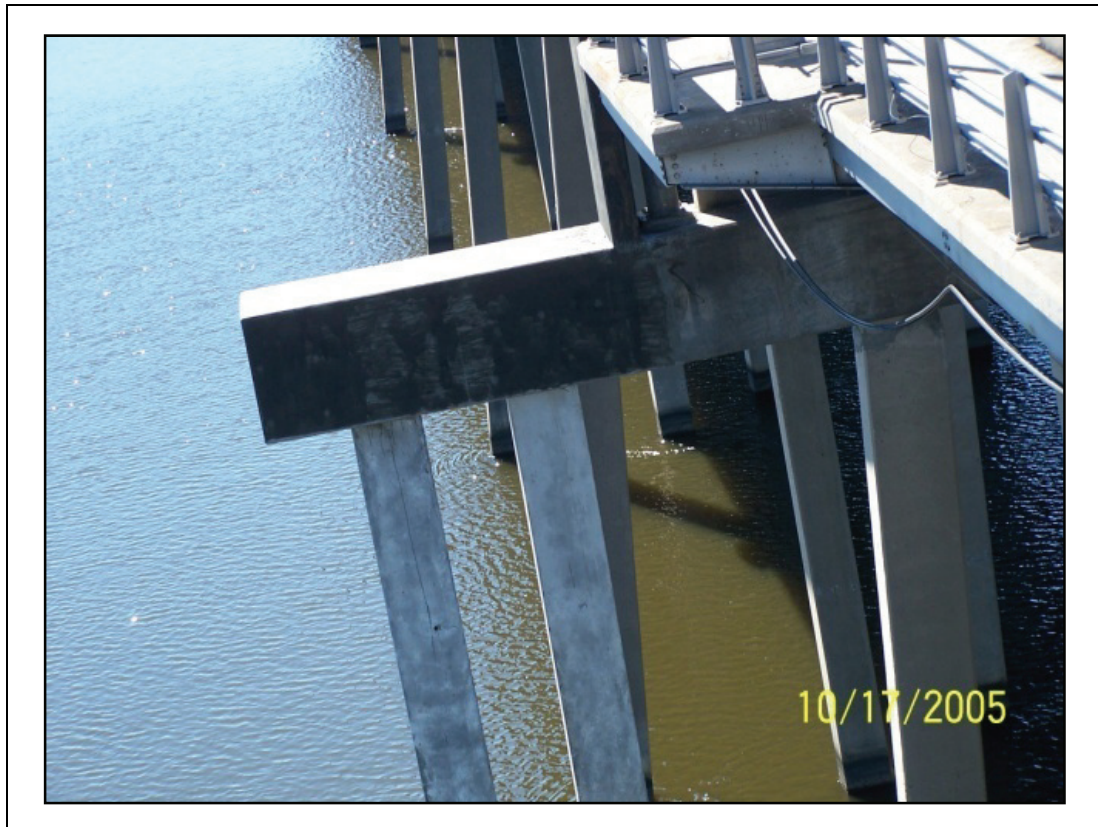
Figure 2-73. Repairs were made within a few weeks, allowing the bridge to be returned to full service.

When the bridge was inspected on September 7, northbound traffic was restricted to one lane. Piers on the east side were hit by a barge or other items carried by the surge. When the site was visited a second time on October 17, MSDOT had already shored up the damaged area by driving additional piles adjacent to the damaged ones (Figure 2-73) and had reopened all lanes. The railing and sidewalk on the east side were also damaged from debris (Figure 2-74).
