Engineering and Organizational Issues Before,
During and After Hurricane Katrina

Damage to Bridges from Wind, Storm Surge and
Debris in the Wake of Hurricane Katrina

**Damage to Bridges from Wind, Storm Surge and
Debris in the Wake of Hurricane Katrina**

MCEER-08-SP05
Red Jacket Quadrangle
Tel: (716) 645-3391; Fax: (716) 645-3399; Email: mceer@buffalo.edu
World Wide Web: <http://mceer.buffalo.edu>

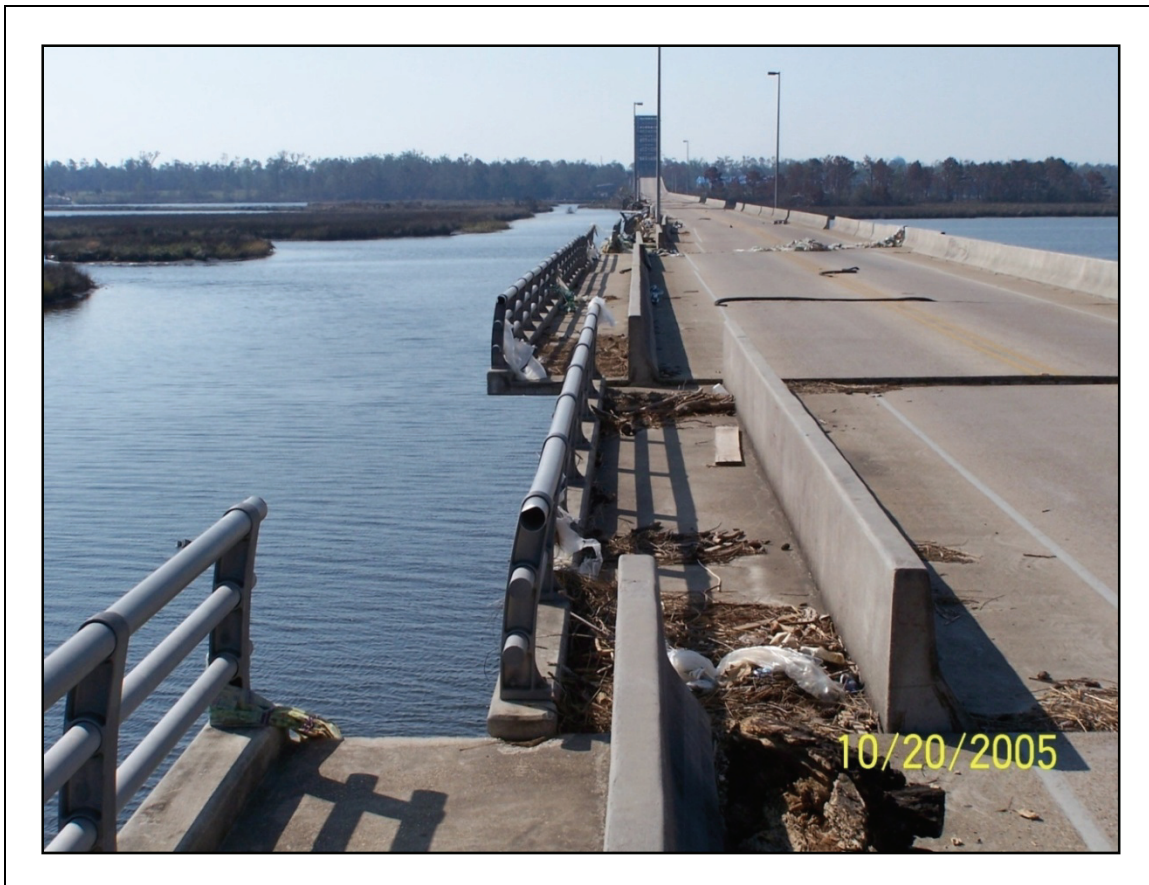
Figure 2-75. Numerous prefabricated spans were shifted to the west. None tipped over into the water. Note the black joint strip seal on top of the deck.

addition to the bascule span becoming inoperable, the P/S concrete spans were pushed laterally (west) off their bearings by a blockage of surge borne debris. Though the spans did not drop, the bridge became unusable (see Figures 2-75 and 2-77). The moveable span remained stuck in the open for several months, until it could be repaired (Figure 2-76).

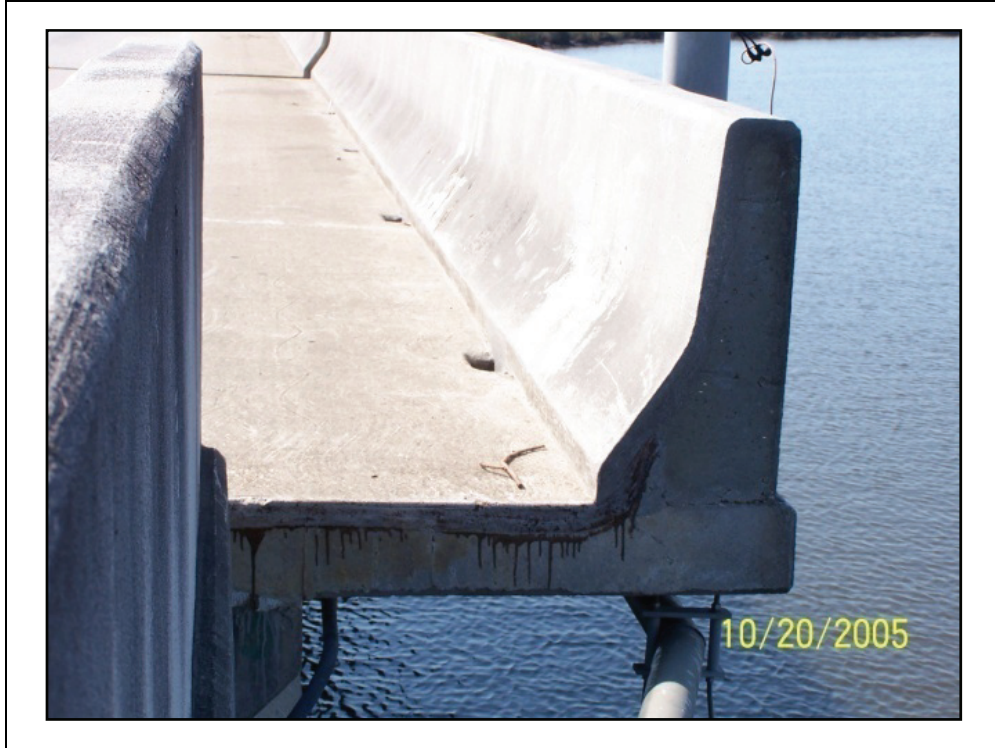
Figure 2-77. Spans shifted horizontally on the pier caps as much as three feet. This photo was taken looking south at the west fascia.

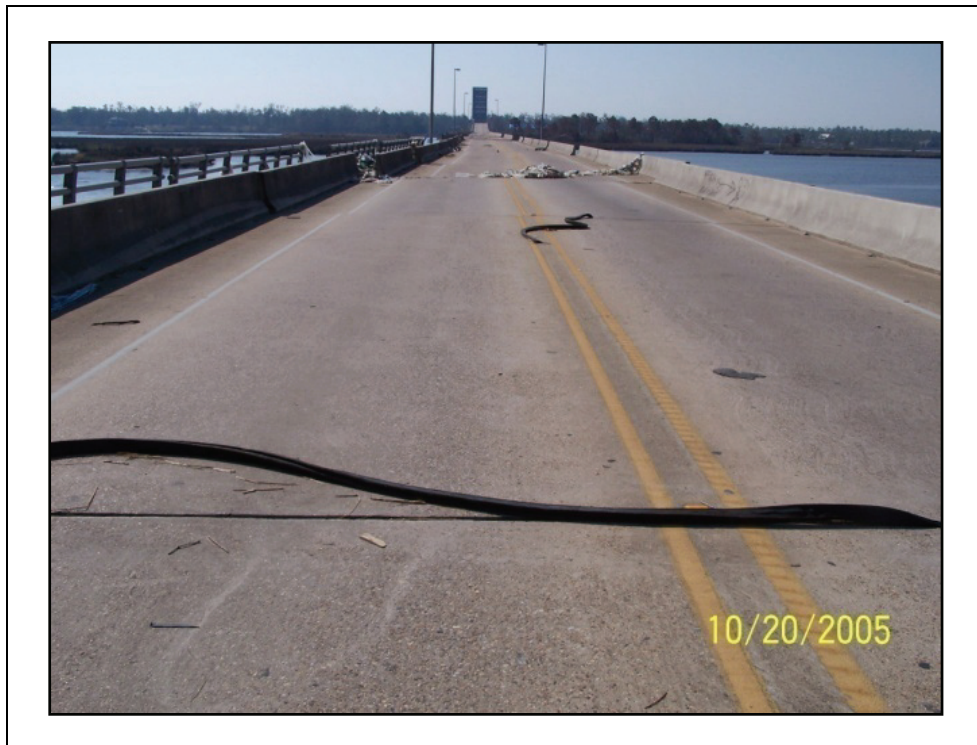
Inspectors were at first puzzled by the rubber joint seal that popped out of several joints (Figure 2-81). However, this could be explained by the buildup of pressure underneath the slab. Entrapped air under a head of several feet of surge water was apparently enough to force the seal out.

Figure 2-81. Several bridge joints had the seal blown out, indicating the possibility of pressure from entrapped air below the deck.

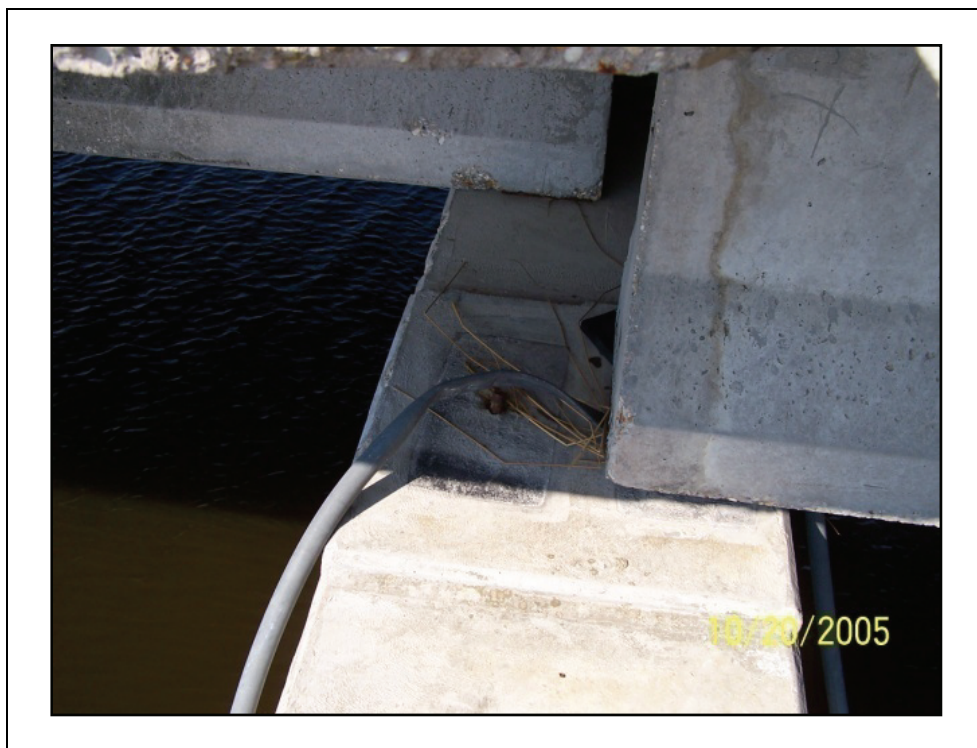
Figure 2-82. A look down at the top of a pier cap shows that the span on the left moved to the west by as much as four feet.

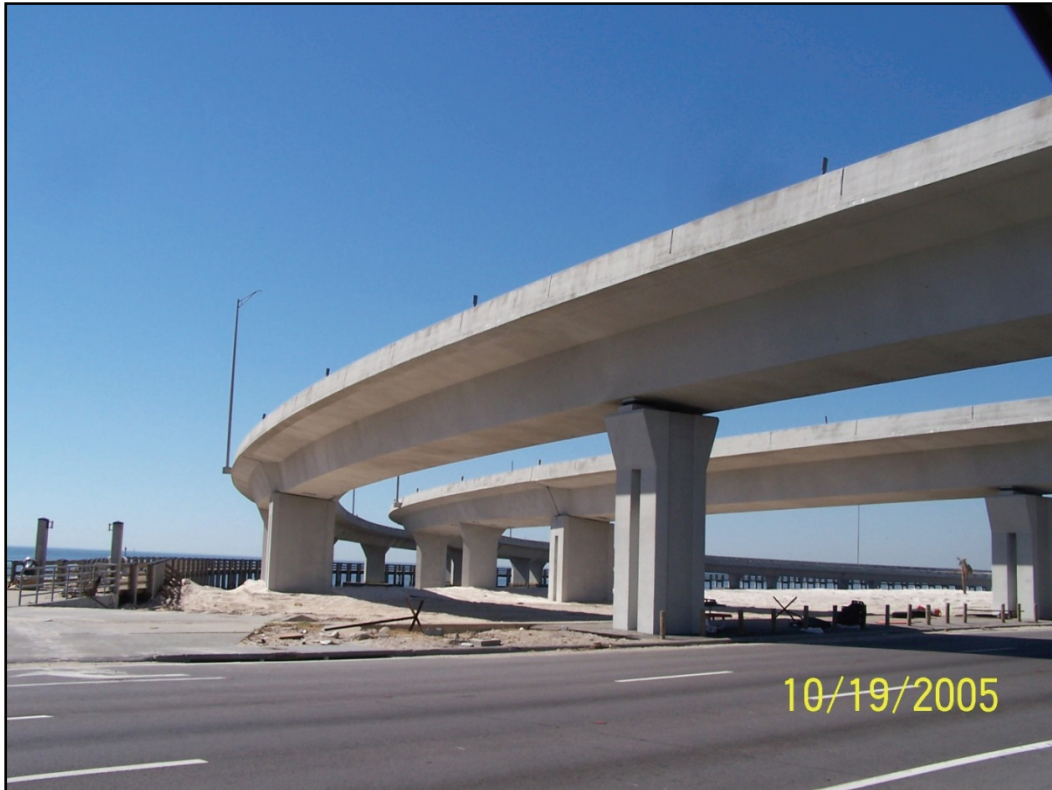
Figure 2-83. Southern terminus of I-110, with the Gulf in the background.

Note the proximity of these ramp bridges to the Gulf of Mexico in the background. This southern terminus of I-110 in Biloxi was built in 1975. It was subjected to extreme surge but survived intact due to the fact that it was cast-in-place construction, rather than precast. Its mass, integral construction and continuity were characteristics that played a role in its survival, despite the perilous location.

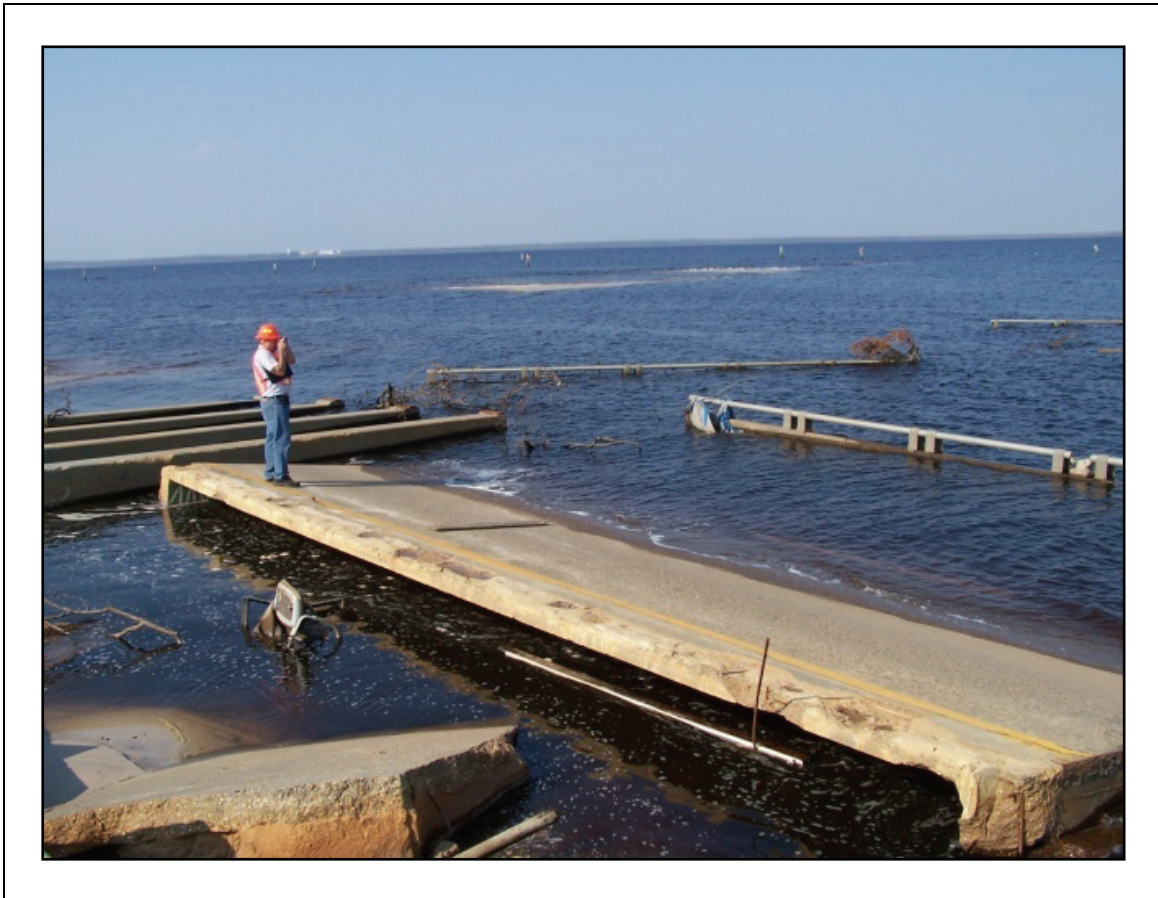
The photograph in Figure 2-95 shows the right half (south side) of the westernmost span. It was tossed off the pier and rotated 90 degrees so the railing visible in the photo is pointing north. Note the yellow centerline stripe. Aside from being in the wrong place, the unit appeared to be structurally intact. Figure 2-96 shows the left half (north side) of the westernmost span. It flipped over and was thrown to the north of the bridge a distance of 100 feet. Note the bearing plates attached to the bottom of the prefabricated unit and the concrete diaphragms that would have been at the abutment.

Figure 2-95. This precast span unit was tossed off the pier and rotated 90 degrees.

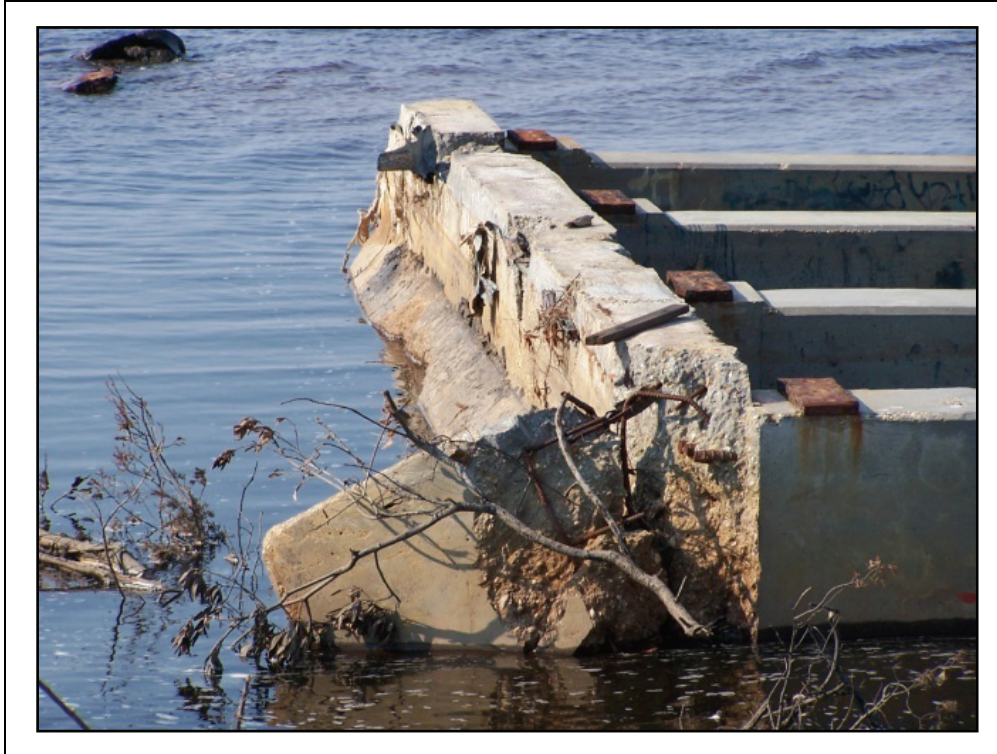
Figure 2-96. The north side of the westernmost span was flipped over and thrown 100 feet.

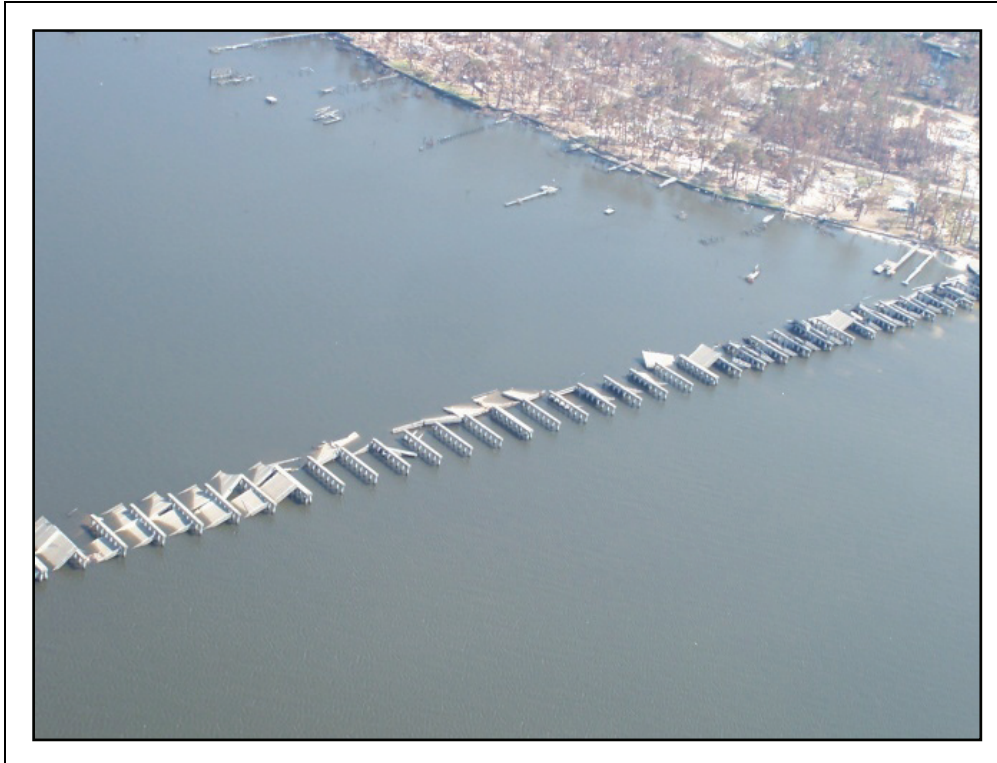
Figure 2-97. This photograph was taken facing NE at the east end of the US-90 bridge.

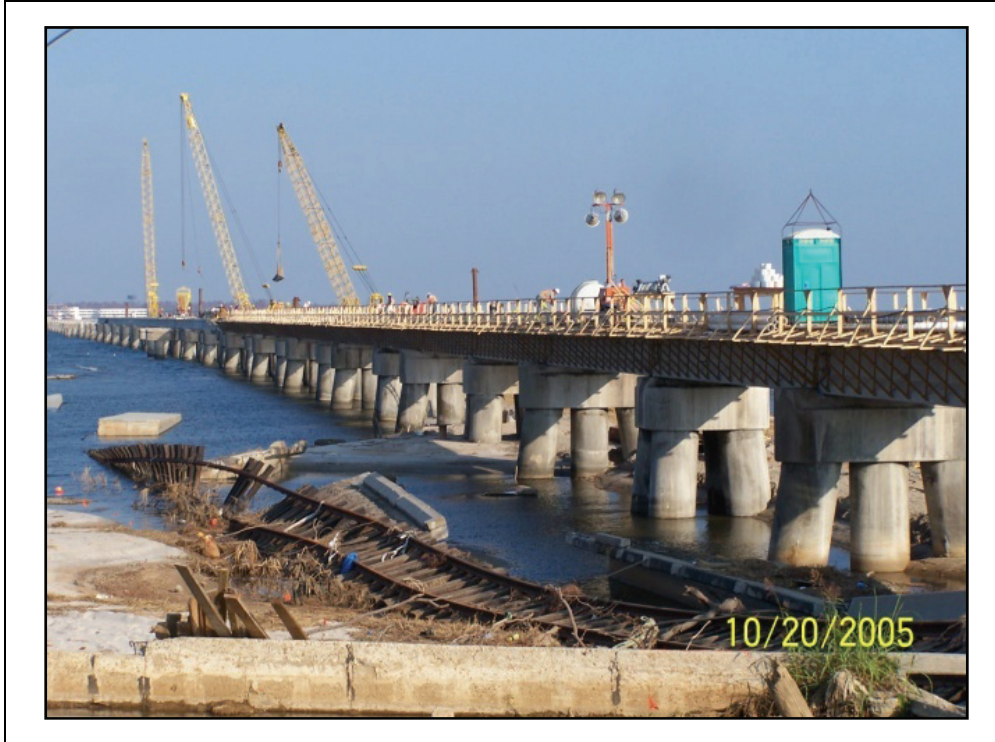
Figure 2-99. By October 20, repairs the CSX bridge had already begun. In the foreground, on the north side of the bridge, the tracks that had been washed off can be found.

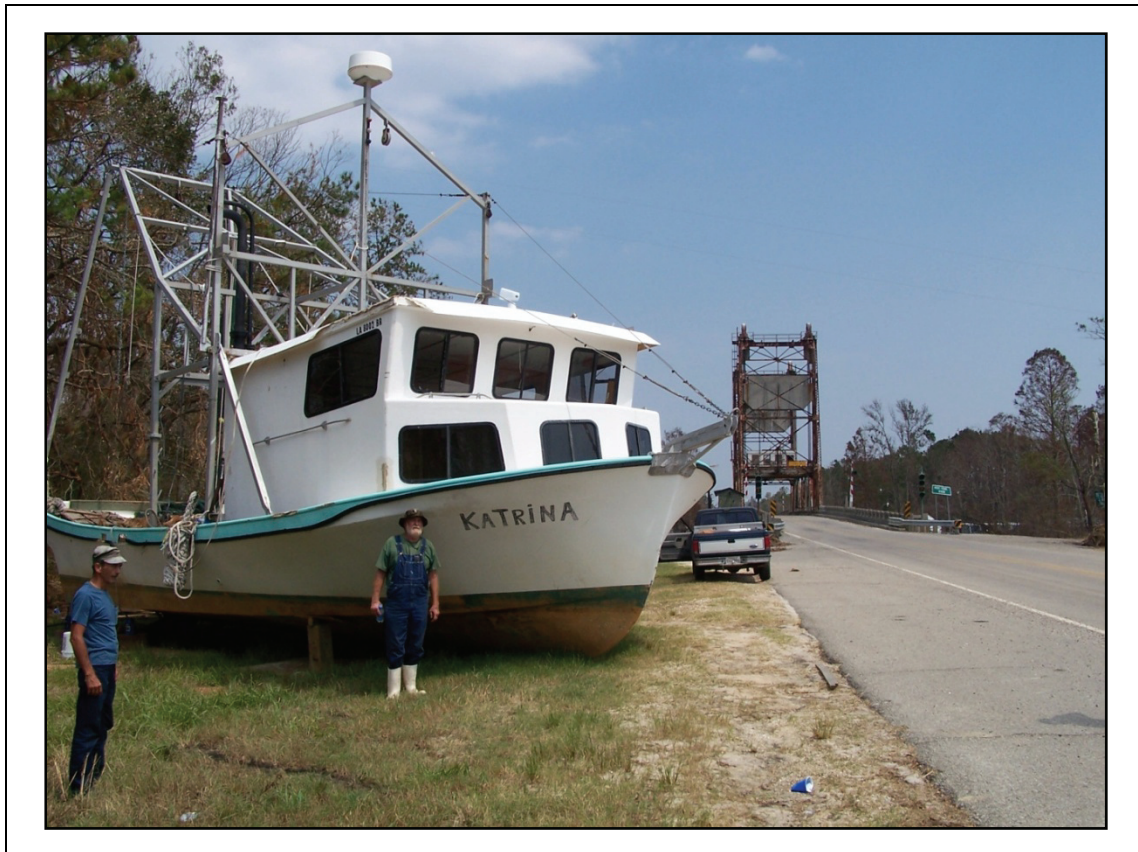
Figure 2-104. US-90 at West Pearl River.

The three truss bridges were no doubt inundated but seemed to survive quite well. The two moveable bridges were damaged by the storm. According to some locals, the lift span in the background of Figure 2-104 was not working properly, even before Katrina.

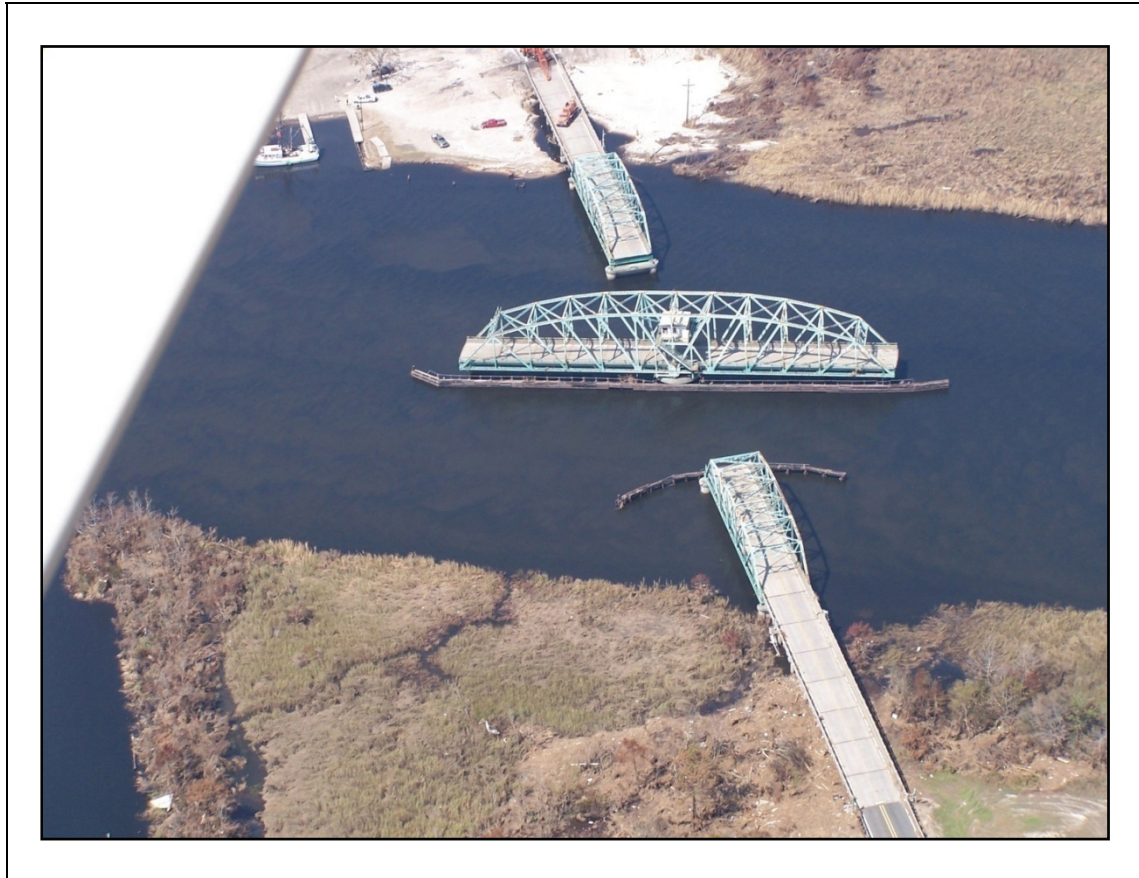
Figure 2-106. US-90 at East Pearl River; facing west.

East Pearl River forms the state line between Louisiana and Mississippi and is very close to where the eye of the storm struck landed. The swing bridge in Figure 2-106 became stuck in the open position, preventing its use for motor vehicles. On September 10, 2005, DOT crews were repairing the west approach pavement that had washed out.

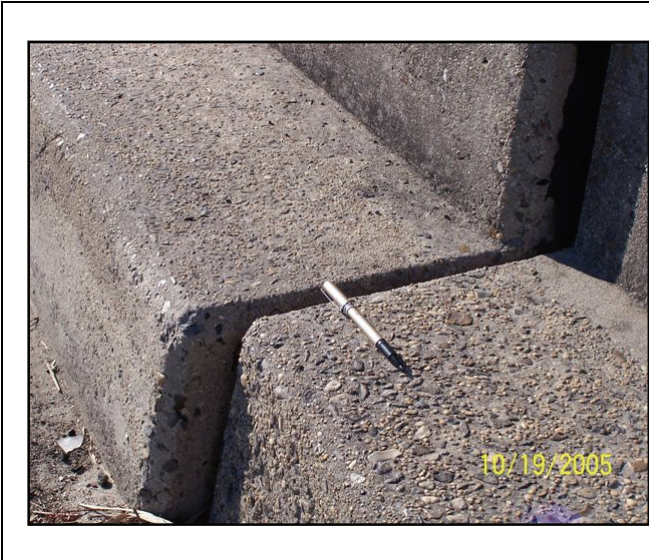
Figure 2-108. There was minor misalignment of the curb on the east side of the bridge.

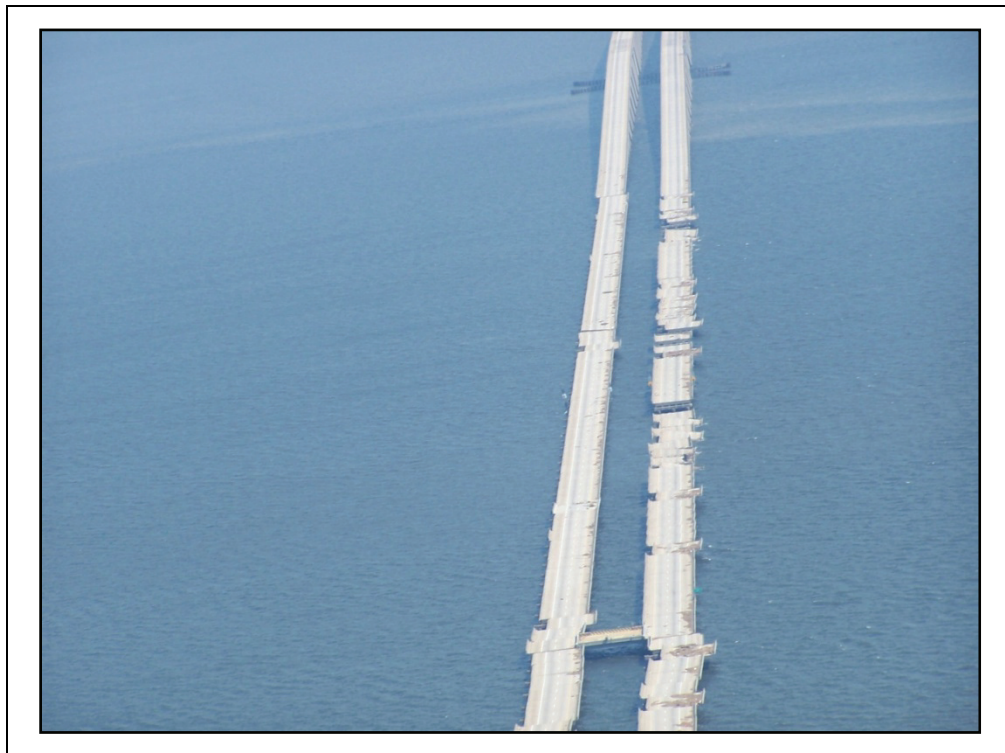
Figure 2-116. I-10 WB & EB, showing numerous displaced spans.

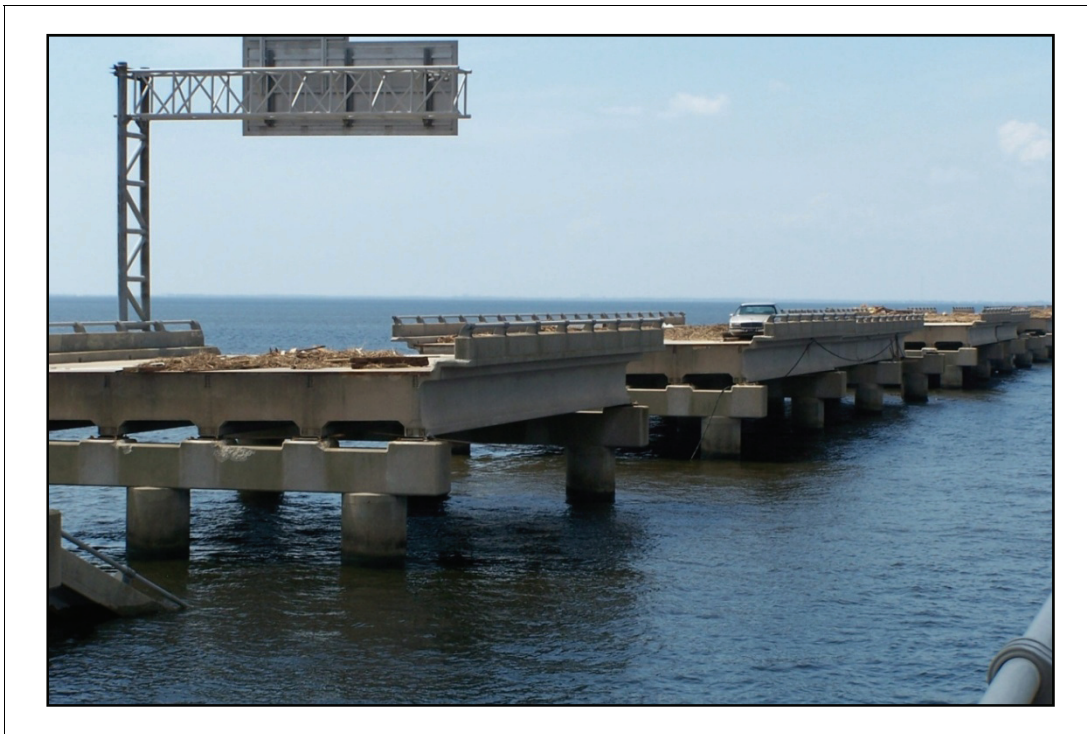
Figure 2-120. I-10 EB facing west.

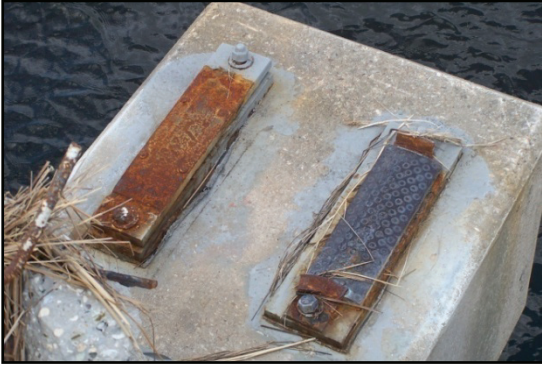
Figure 2-121. Bearings were not designed to provide resistance to uplift or lateral loads.

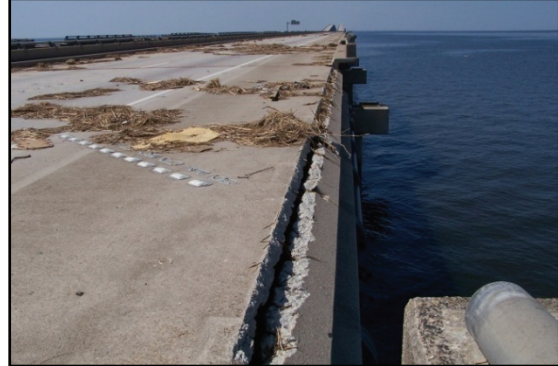
Figure 2-122. The north parapet broke off and is dangling down in the picture. Note uniform shift to the south.

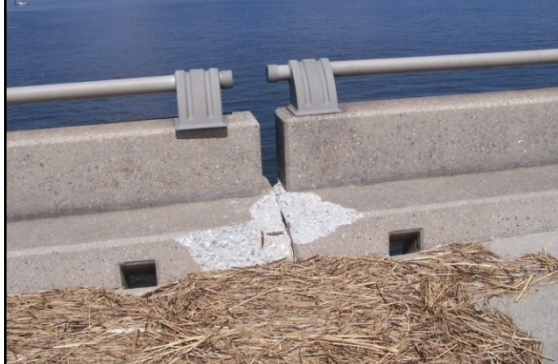
Figure 2-124. The wave action exerted on the spans must have been violent as evidenced by the spalled concrete resulting from longitudinal pounding between spans.

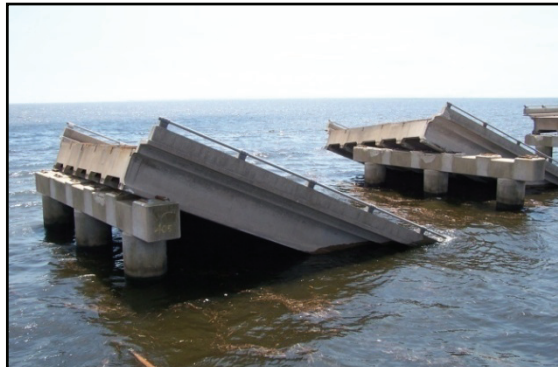
Figure 2-126. Span units of the EB bridge dropped.

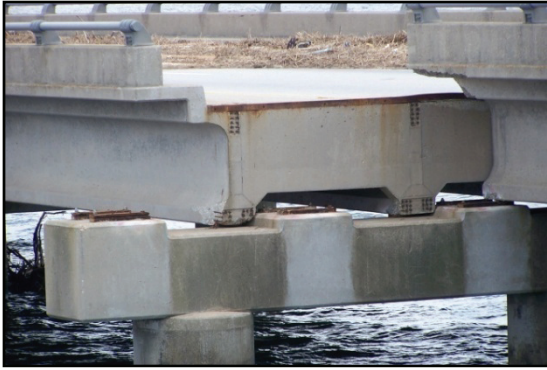
Figure 2-127. Lateral movement may have been restricted by the short pedestal (riser).

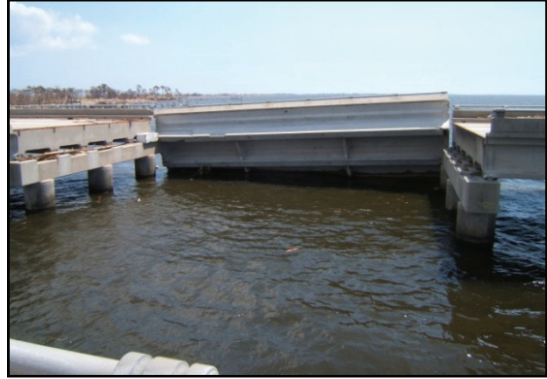
Figure 2-128. This EB span worked its way out laterally even as the adjacent spans stayed on the pier cap.

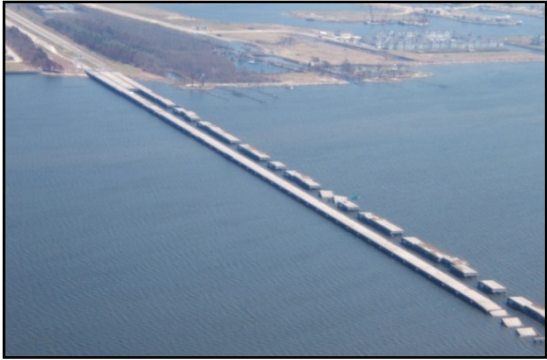
Figure 2-129. This view is looking SE so the EB bridge is on the far side. On this section of the bridge, the EB side lost many more spans.

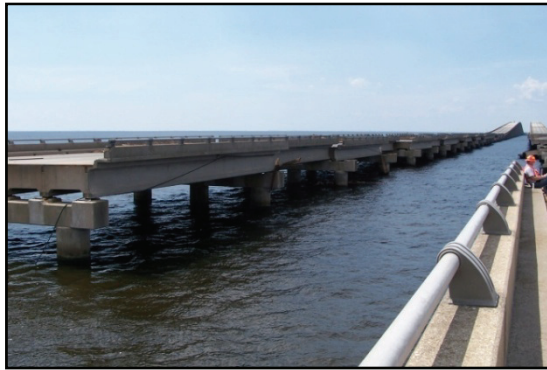
Figure 2-130. This view is looking SW from the deck of the WB bridge. Spans not dropped into the water completely were displaced to the south.

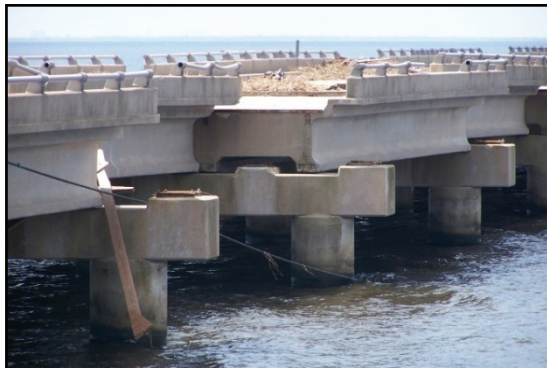
Figure 2-132. Span units are relatively intact.

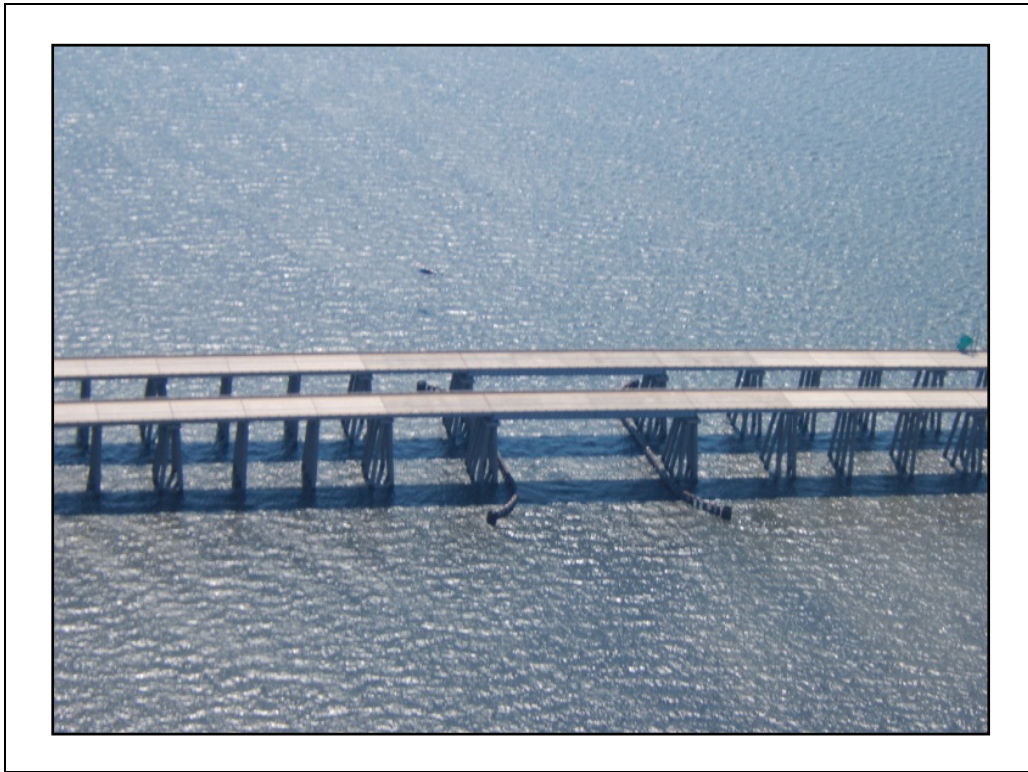
Figure 2-133. The highest spans of the I-10 bridges survived.

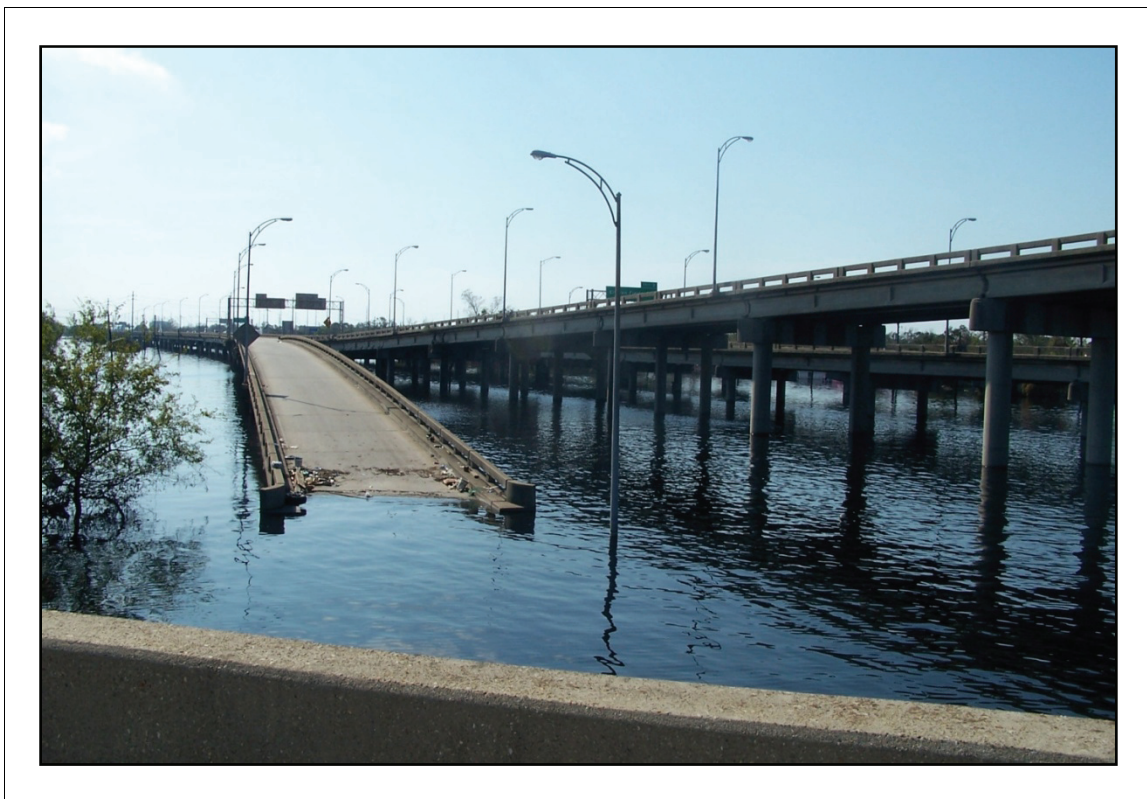
Figure 2-139. On the date of this photo (September 8, 2005), many ramps in the city of New Orleans were flooded and not useable except as a boat launch.

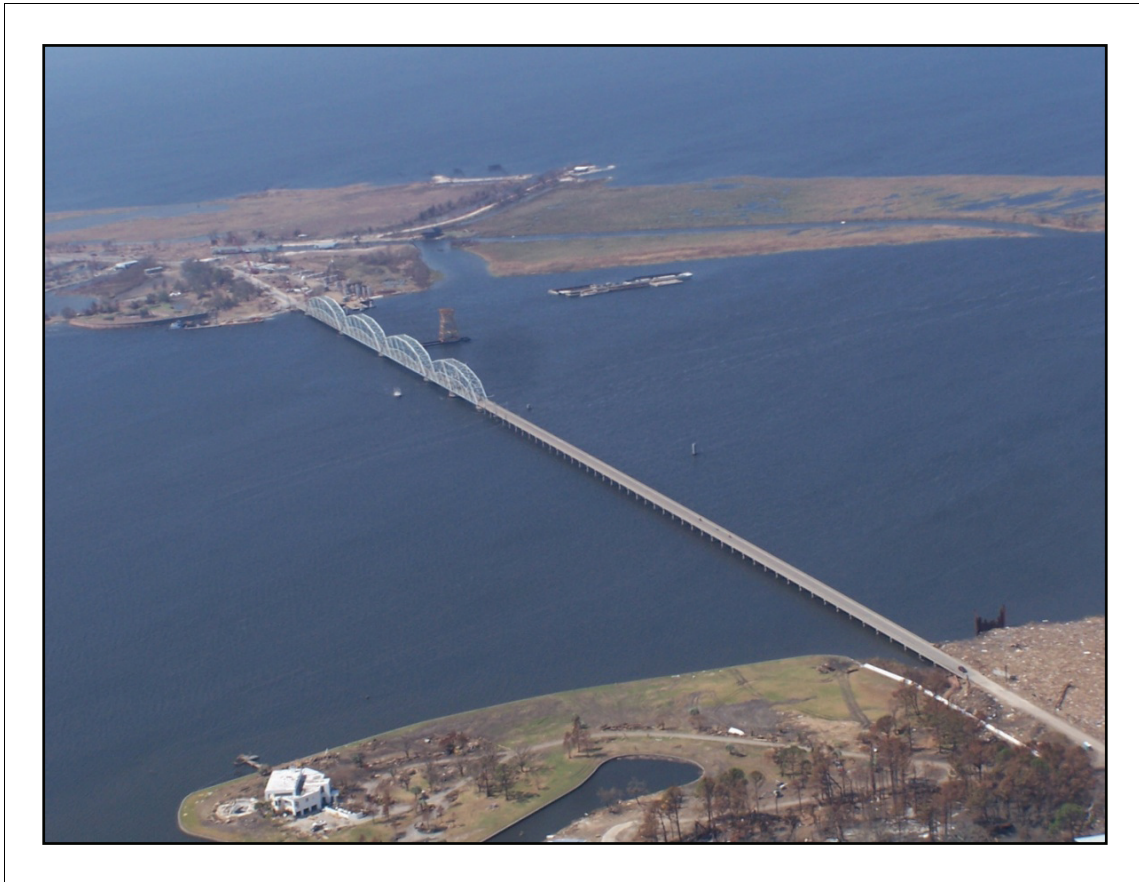
Figure 2-146. Rigolets Bridge carries US-90 This photograph was taken facing west.

Trusses endured quite well. This may be attributable to the mass associated with an entire span that provided enough inertia to resist the surge forces, or the fact that wind and water could pass through the superstructure instead of catching it like a sail (see Figure 2-146).

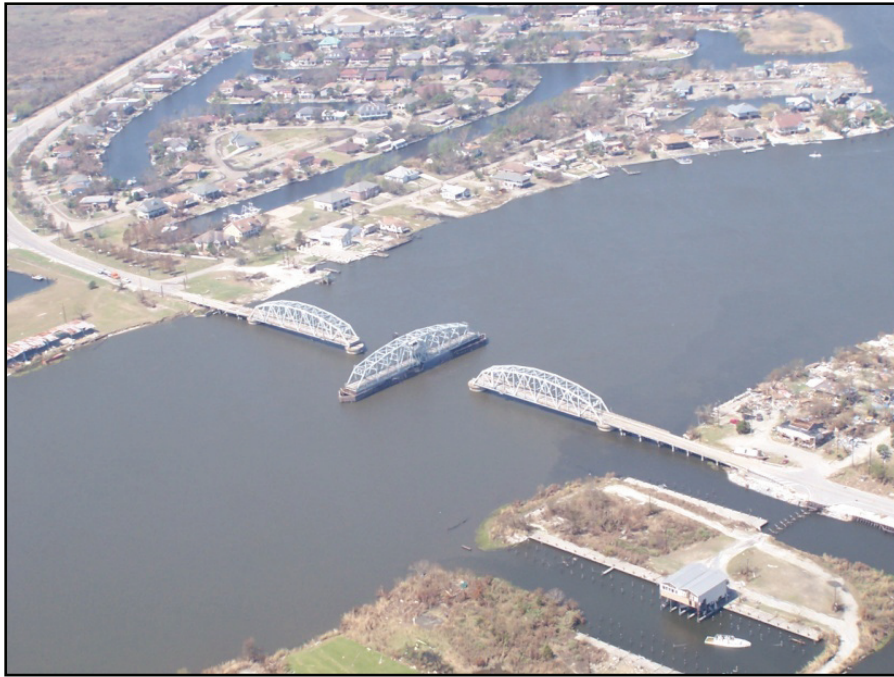
There was damage to the moveable span so that it remained in the open position (available for use by marine traffic). The concrete barrier on the northwest corner was impacted by some sort of floating debris (Figure 2-149). Scour damage had occurred in the past because it was obvious that there had been various attempts to stabilize the approach spans. A pier was tipped (Figure 2-151). There was also evidence of new settlement, indicating that there was additional scour action from Katrina.

Figure 2-148. Facing NW. The swing span became inoperable.

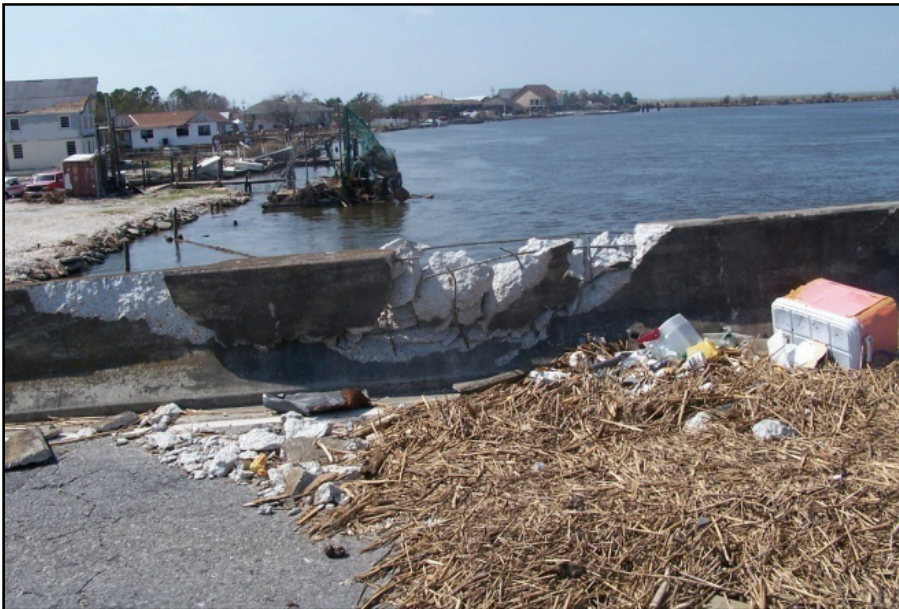
Figure 2-149. The north side of the approach barrier was hit.

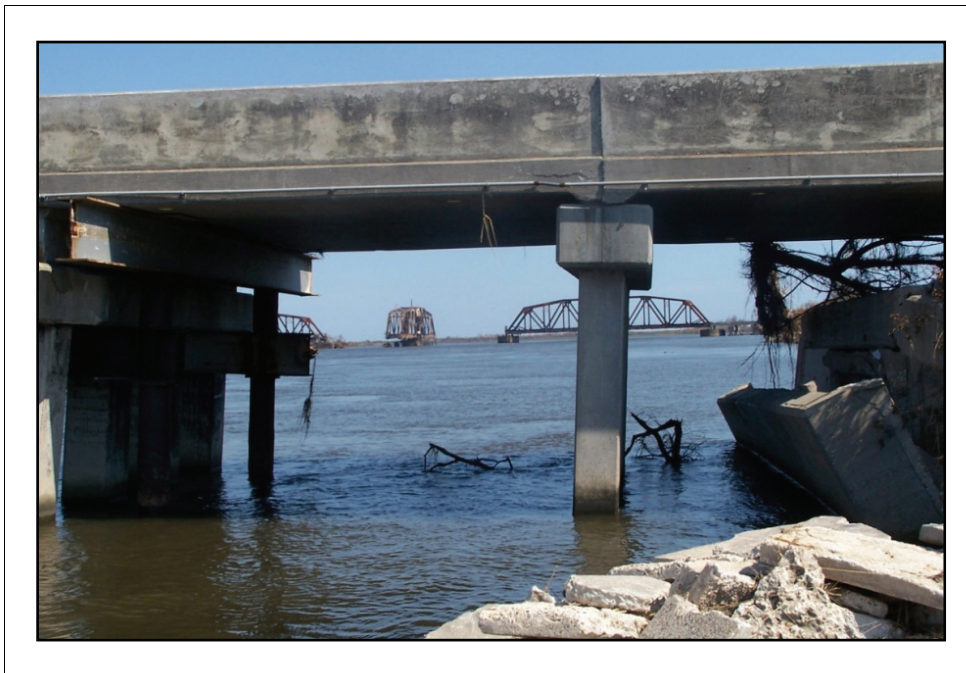
Figure 2-151. A tipped pier indicates that scour has occurred.
