L'AQUILA EARTHQUAKE OF APRIL 6, 2009 IN ITALY: REBUILDING A RESILIENT CITY TO WITHSTAND MULTIPLE HAZARDS

by
**Gian Paolo Cimellaro, Ioannis P. Christovasilis,
Andrei M. Reinhorn, Alessandro De Stefano
and Tatiana Kirova**

Technical Report MCEER-10-0010

December 29, 2010

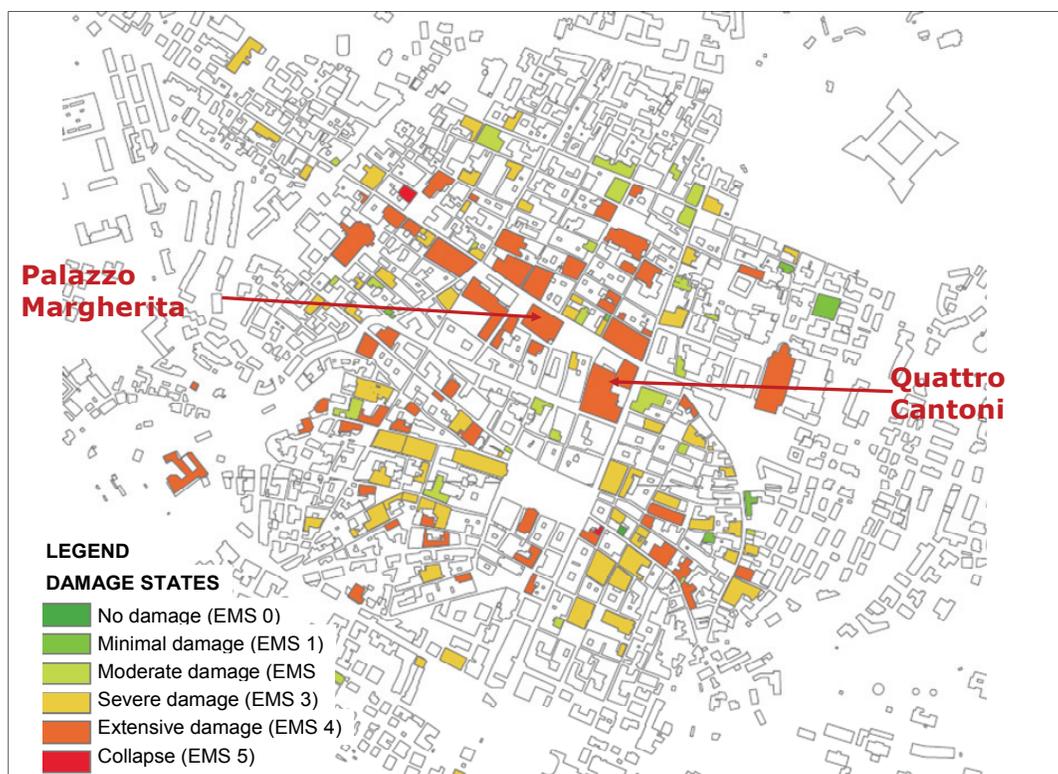
The observation of damage caused by the main earthquake showed that the dominant type of collapse for existing masonry structures is associated with out-of-plane kinematic mechanisms at the local and global level, due to loss of equilibrium of walls or assemblies of walls. The limitations of some traditional reinforcement techniques were also highlighted. Significant damage has been reported in buildings that had previously been consolidated after the earthquake of 1997 (e.g., Santa Maria di Collemaggio), particularly due to questionable technical choices and incorrect or poor execution of the retrofit interventions themselves (Cimellaro et al., 2010). Severe damage to old masonry buildings (Figure 4-1) due to earthquakes has caused negative

Figure 4-1 Damage State Map of downtown L'Aquila (Courtesy of ITC-CNR-L'Aquila)

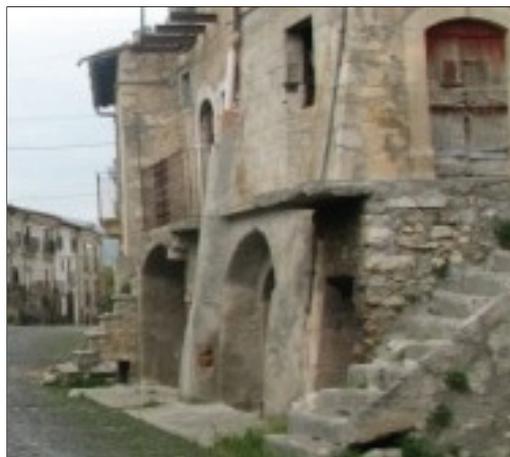
- Wooden beams that were built in the wall thickness as small tie rods to improve connections between walls
- External wooden posts to connect the roofs to the top of the walls
- Buttress (Figure 4-2)
- Built-on scarp walls

Figure 4-2 Buttress structure

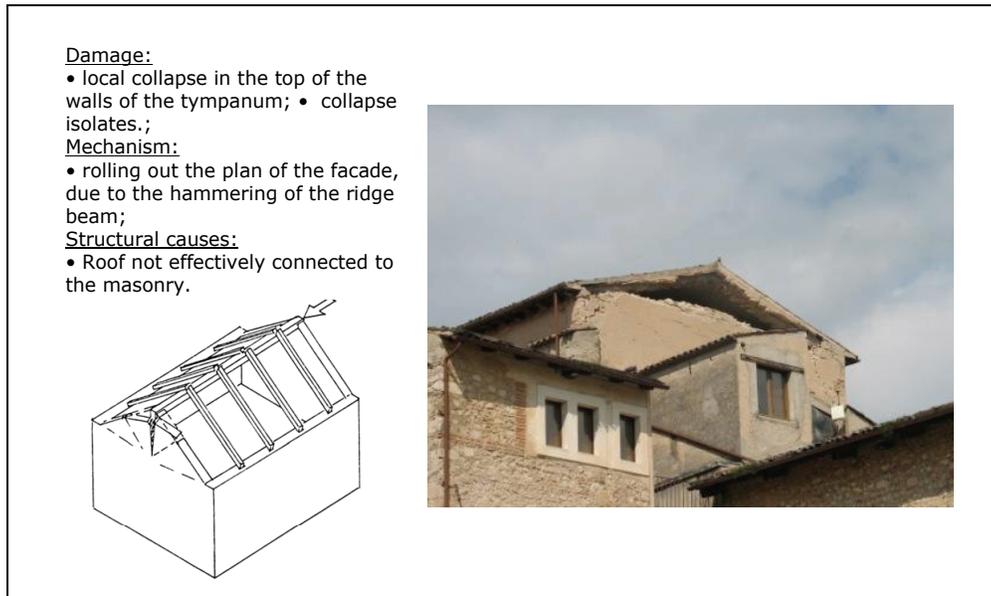
Several historic buildings, retrofitted within recent decades, have suffered partial and total collapses during L’Aquila earthquake in Abruzzo due to the incompatibility of materials and retrofit intervention techniques used. One of these examples is the out-of-plane collapse triggered by the roof in the Convent of Santa Maria di Collemaggio (Figure 4-5), where the

hammering of the ridge beam generated a local collapse of the tympanum at the top of the walls, due to the fact that the roof was not effectively connected to the masonry.

Figure 4-5 Convent of Santa Maria di Collemaggio

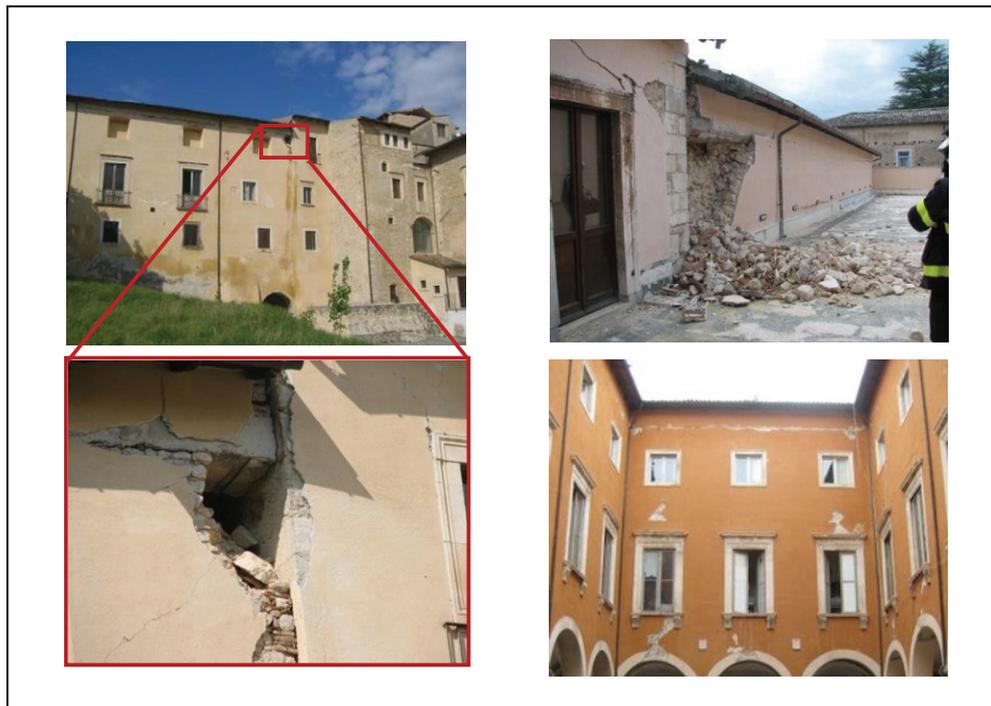
Figure 4-6 Poor connection between the ring beam and the masonry in the Convent of Santa Maria di Collemaggio and in Palazzo Margherita

The replacement of floor slabs and roofs (Figure 4-8) and inclusion of RC ring beams in the masonry (Figure 4-6) can have both positive and negative effects. In fact, the lack of or the poor connection between the ring beams and masonry generate eccentricity of the loads on each floor and collapse of walls for out-of-plane forces (Figure 4-6).

A clear example has been observed again in the Convent of Santa Maria di Collemaggio where a RC ring beam was placed at the top of the masonry walls below the roof to strengthen the masonry walls. The smooth surface at the interface between the masonry and the ring beam shows lack of connection between the two structural elements. Additionally the external lateral walls are made with poor quality mortar and they are not connected properly to each other.

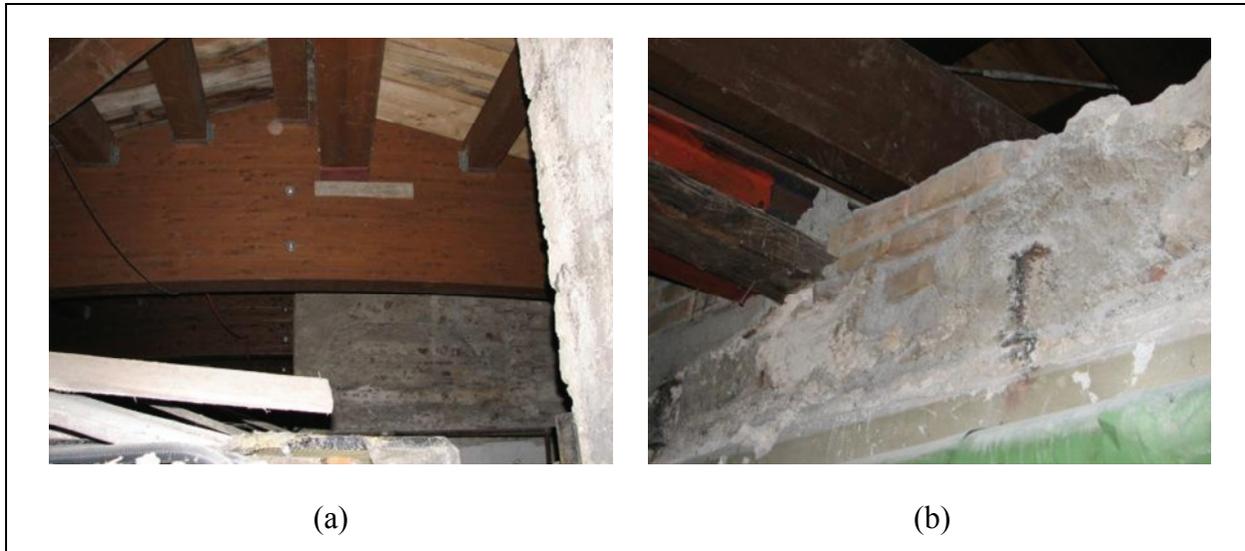
Figure 4-7 Wooden roof and ring beam of Palazzo Margherita

Another example where the RC ring beam had a positive aspect is the case of Palazzo Margherita where, in the early 90's, the architect Macrì made the retrofit intervention of Palazzo Margherita creating a RC ring beam under the roof cover with the aim of giving a box behavior to the whole building. The roof is a light non pushing wooden roof as shown in Figure 4-7a, and the ring beam was properly designed, but it was realized with poor quality mortar and poor quality of construction as shown in Figure 4-7b.

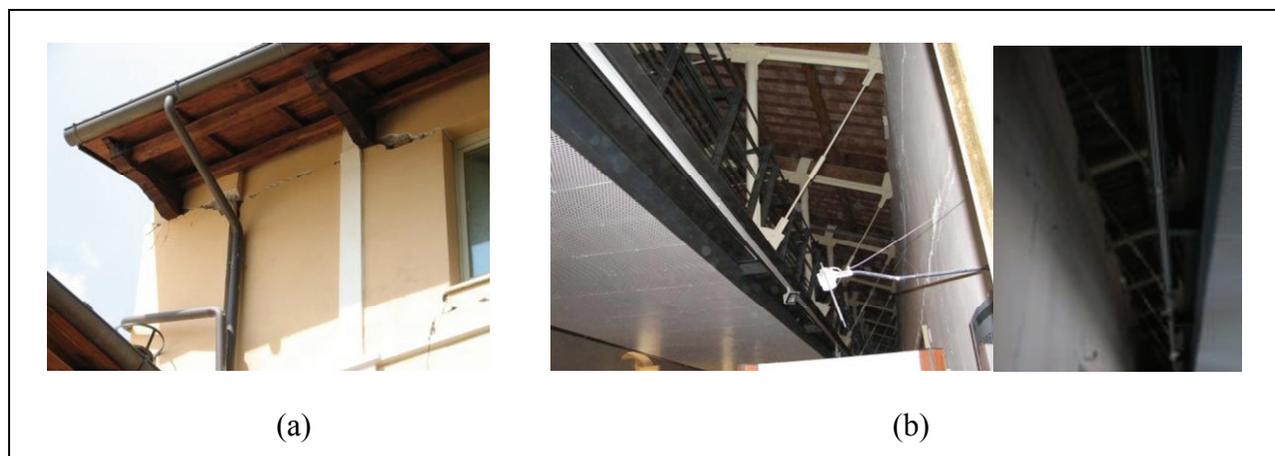
Another example of incorrect design due to improper choices of nonstructural elements inside the structure is given in the Ex Convent of Santa Maria dei Raccomandati. In this particular case the designer of the interior museum decided to realize a metal walkway that was hanged to the wooden trusses of the roof that in this case is a pushing roof, making the entire roof heavier than before.

The consequences of this choice made by an architect are clearly visible in Figure 4-9.

Figure 4-9 Collapse of the roof due to the presence of a (b) metal walkway anchored to the wooden roof trusses in the ex-convent of Santa Maria dei Raccomandati

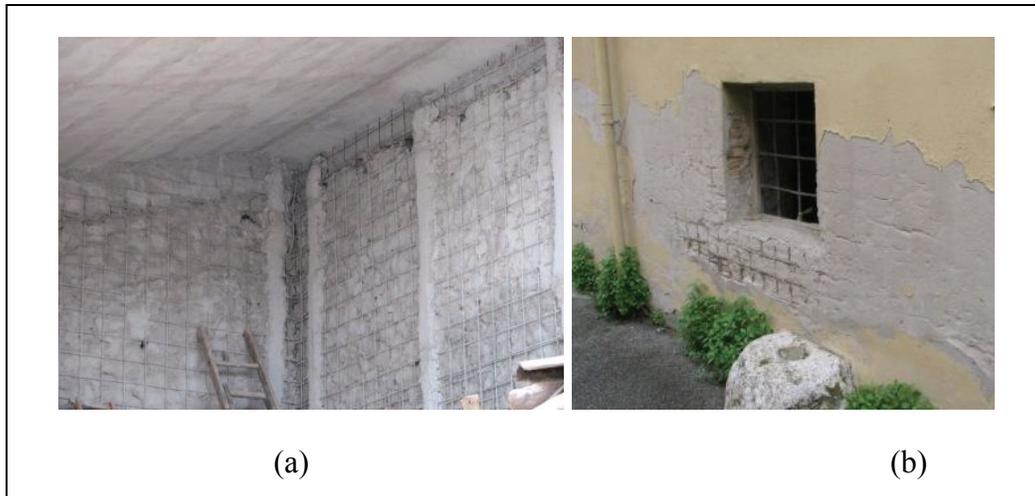
Most common errors in the application of reinforced plasters (Figure 4-10) are: (i) lack of connection between rebar applied to the perpendicular walls; (ii) lack of overlap between adjacent rebar; (iii) lack of uniform distribution of the rebar; (iv) low durability.

Figure 4-10 Reinforced plaster in Onna (a) and in Sulmona (b)

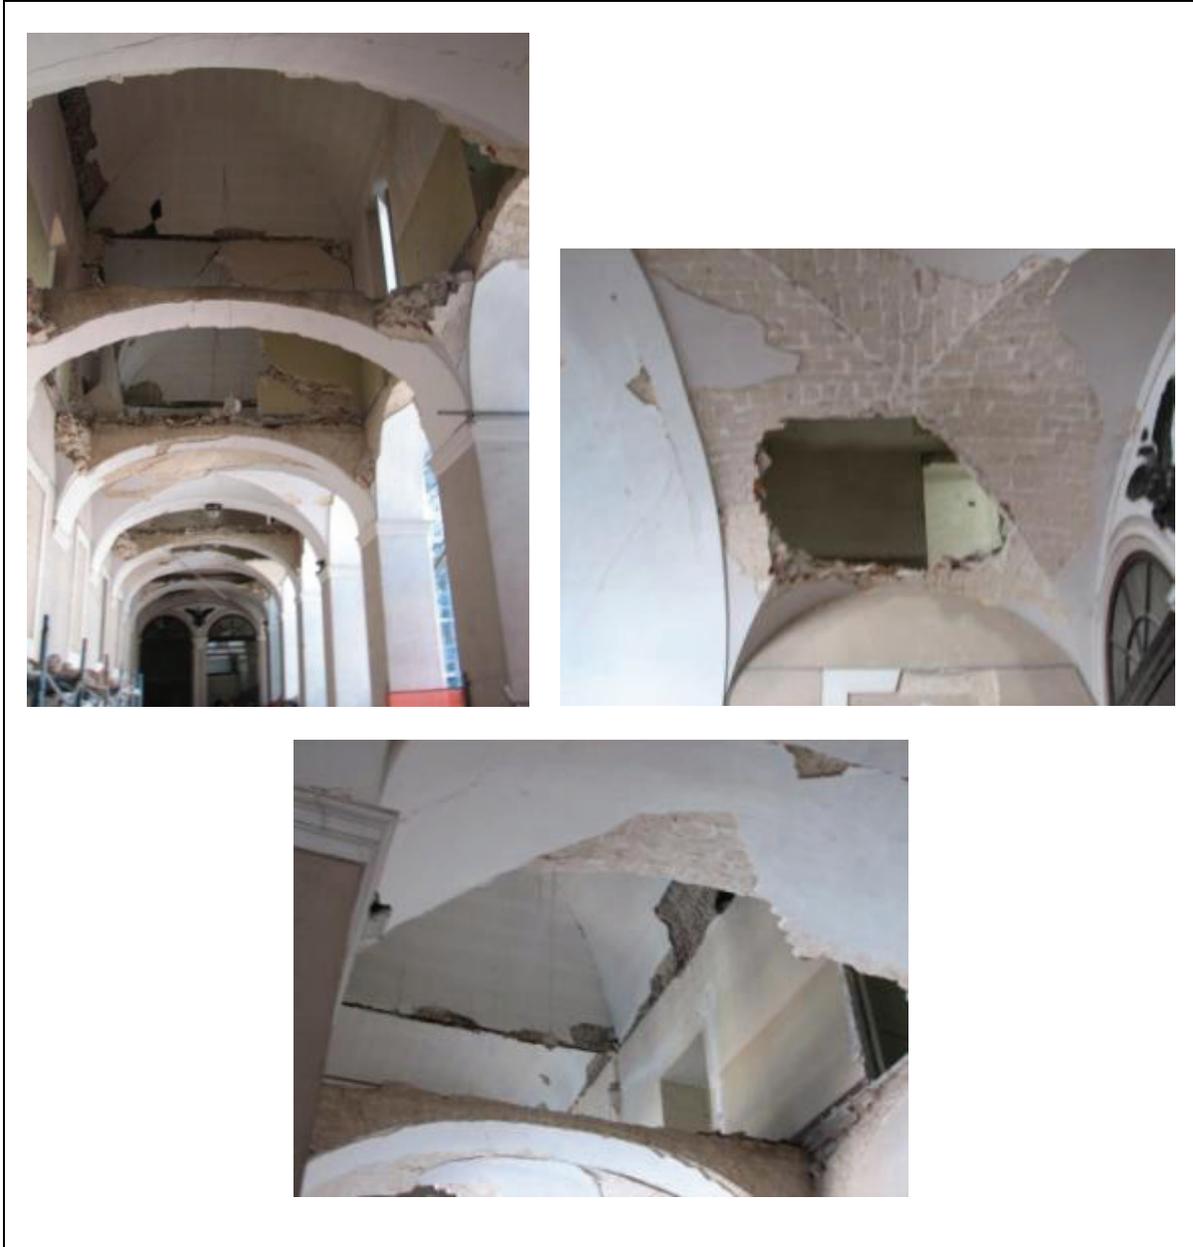
Low material strength, including weak mortar and lack of proper connections between perpendicular walls and between walls and roof and non homogeneous roofs are but a few parameters that contribute to the general weakness of these elements (Figure 4-13).

Figure 4-13 Collapse of vaults in the Convitto Nazionale inside the Quattro Cantoni block complex due to the movement of end support wall.

The main point of weakness of masonry vaults that contributed to poor seismic response is the inability of the roof to act as a diaphragm, because the load carrying mechanism of these types of roofs is primarily in compression. As a result, they are not capable of restraining the top of their supporting walls during ground shaking, nor are they capable of transferring excessive horizontal inertia forces. Furthermore, another point of weakness is their excessive weight.

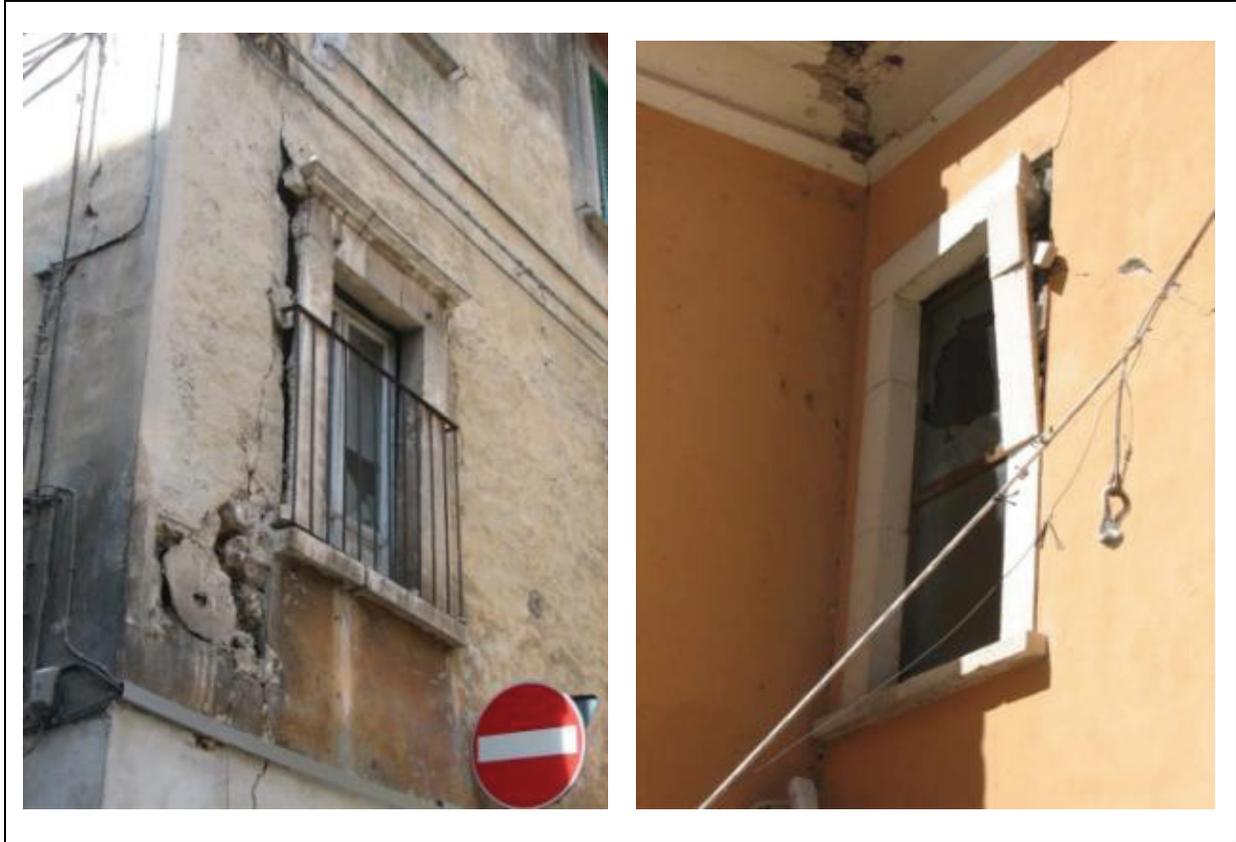
The squared stone elements placed around the window openings were rarely connected to the masonry walls and this led to their detachment (Figure 5-2), developing an element of seismic vulnerability of many buildings.

Figure 5-2 Detachment of squared stone elements around the openings in L'Aquila historical center

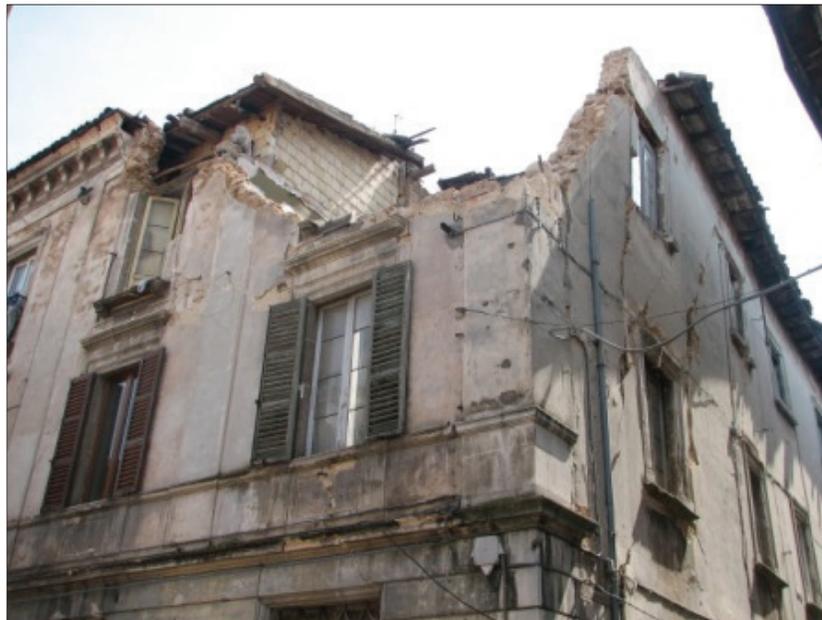
Out of plane overturning of walls was observed in the region, but was very limited because of the systematic use of tie rods in building walls. This collapse mechanism was triggered in cases of poor connection quality at the corners and involved failure of portions of the orthogonal walls (Figure 5-4; Figure 5-5).

Figure 5-5 Collapse of the corner walls in L'Aquila historical center

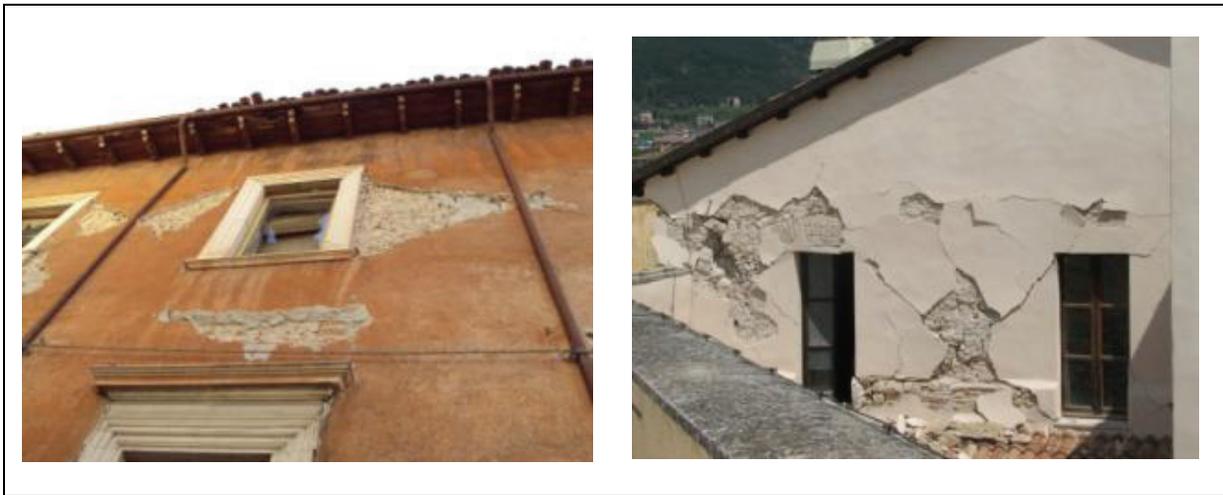
The presence of shear fractures in masonry walls is a consequence of the box-like behavior of the building, allowing significant energy dissipation and reducing the risk of collapse, therefore, this type of damage should be considered as a positive sign of the good behavior of the masonry building (Figure 5-6).

Figure 5-6 Shear cracks in masonry walls near window openings

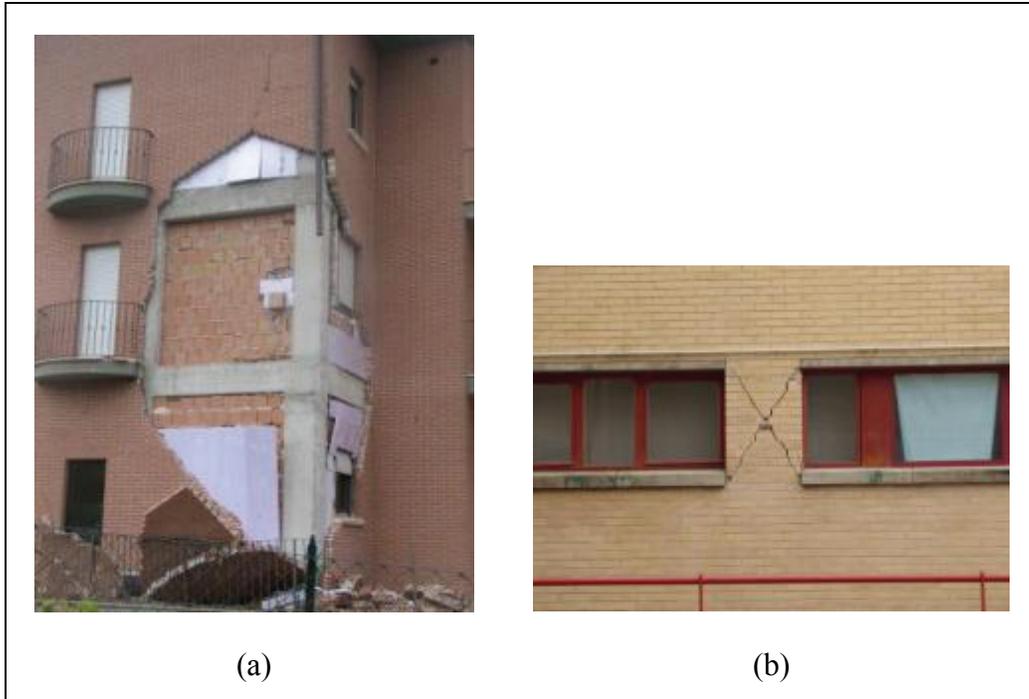
Reinforced concrete (RC) buildings—particularly mid-rise, multi-family condominium structures—experienced significant damage in the 2009 L’Aquila earthquake. The most frequent type of damage consisted of cracking and, in some cases, failure of nonstructural masonry infill walls, as shown in Figure 5-8. Windows or door openings represent a discontinuity in the infill panel, modifying its stiffness and failure mechanism (Figure 5-8b).

Figure 5-8 Damage to nonstructural masonry infill walls in Pettino

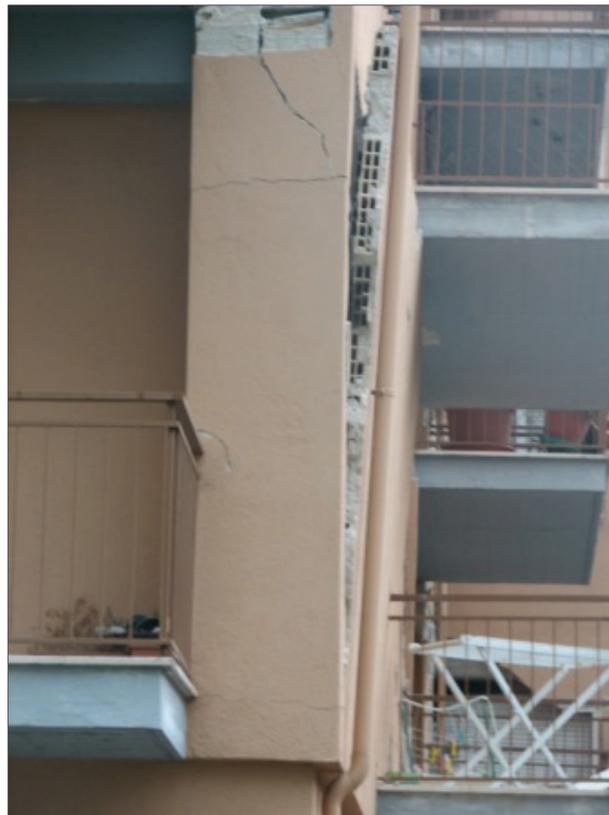
Figure 5-9 Out of plane mechanism of infill wall

Many structures in this area were not damaged, and where damage occurred, it generally involved relatively minor cracking to relatively severe cracking or collapse of the masonry infill walls (Figure 5-9). Severe structural damage was relatively rare. The reasons of collapse must be found in the older RC buildings in the region that use smooth reinforcing bars, unconventional lap splices, and in some cases, poorer quality construction materials. The frames are almost always designed with no consideration for the layout of masonry infill walls both in plan and elevation, as these are considered to be nonstructural elements, and their exclusion is thought to lead to conservative design. The framing is filled in with one or two wythes of hollow clay or concrete blocks, and sometimes finished with wrap-around clay brick facades or plaster. Partitions are of thin hollow clay blocks.

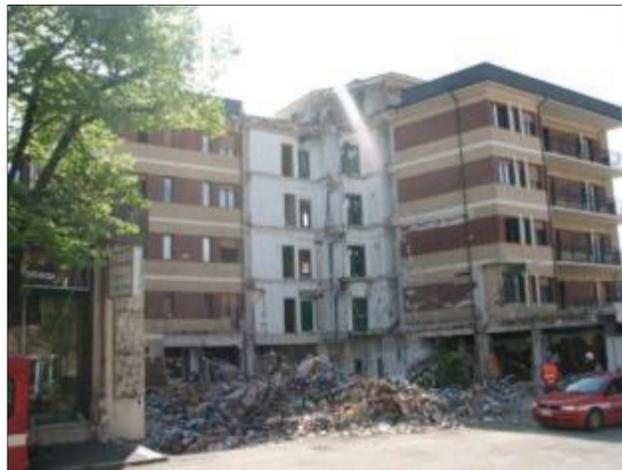
The most dramatic RC building failure was the multi-story section collapse of a five-story L'Aquila University dormitory (Figure 5-10), which caused the death of eight young students.

Figure 5-10 Collapsed wing of the L'Aquila House Dormitory due to the lack of one column

The reason of the collapse has been identified in the lack of one of the columns at the base. Furthermore the entire building was not designed to be earthquake resistant. There were no moment resisting frames (Figure 5-11) and the hoop spacing were not properly designed in order to guarantee confinement effects in the concrete at the joints (Figure 5-13, Figure 5-14). Also

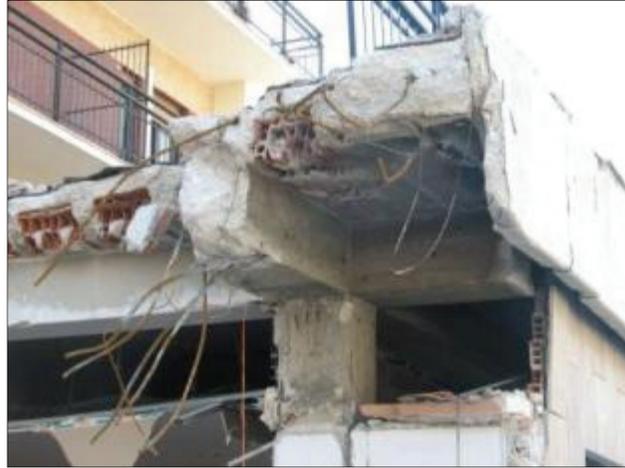
Figure 5-11 Part of a collapsed beam at the ground floor

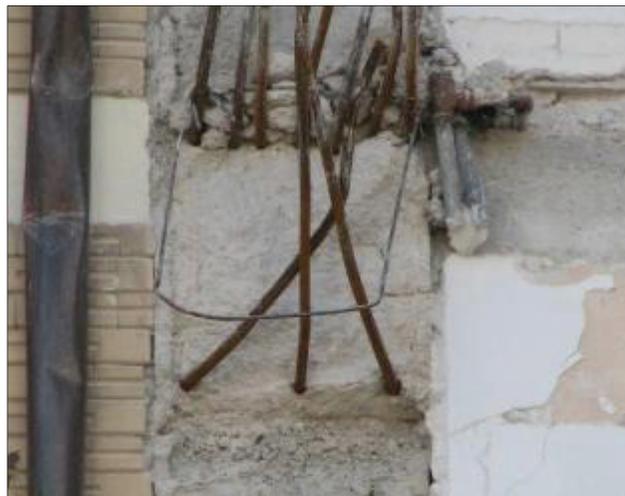
the quality of the concrete is poor and the electrical, thermal and air conditioning systems were not properly located in the structure generating additional damages as shown in Figure 5-12.

Figure 5-12 Poor quality of construction with thermal pipeline passing through the beam column node

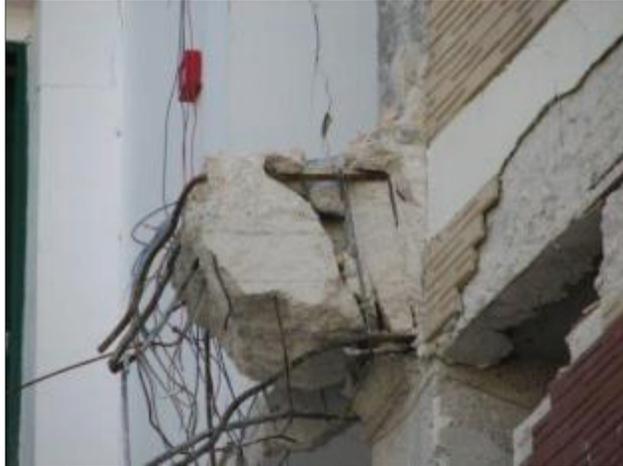
Figure 5-13 Lack of hoops at the beam-column intersection

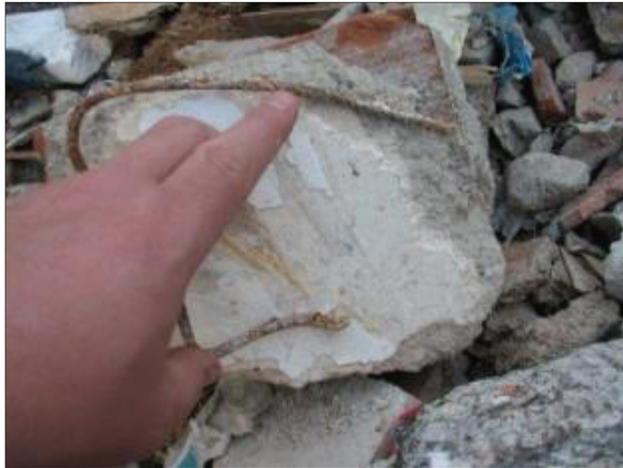
Figure 5-14 Detail of a hoop with diameter of 6 mm

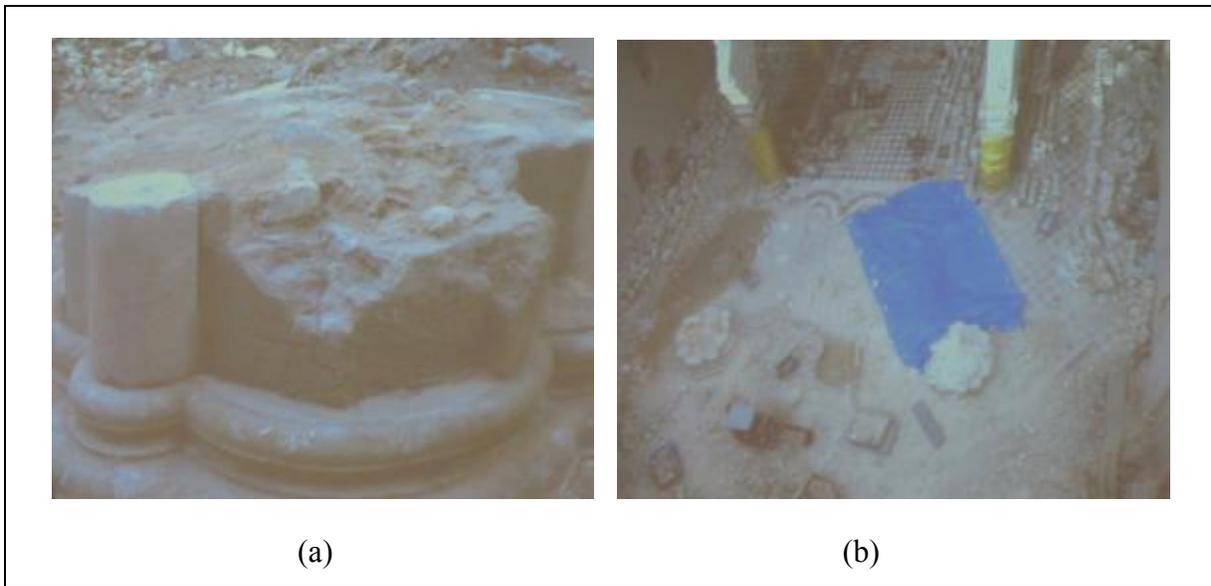
*Figure 5-20 (a) Pillar section filled with calcareous stones;
(b) aerial view of the two central pillars*

1. Collapse of the vault of the transept, of the Triumphal arches and the reinforced concrete dome (Figure 5-26) due to the collapse of the two central pillars (Figure 5-20a);

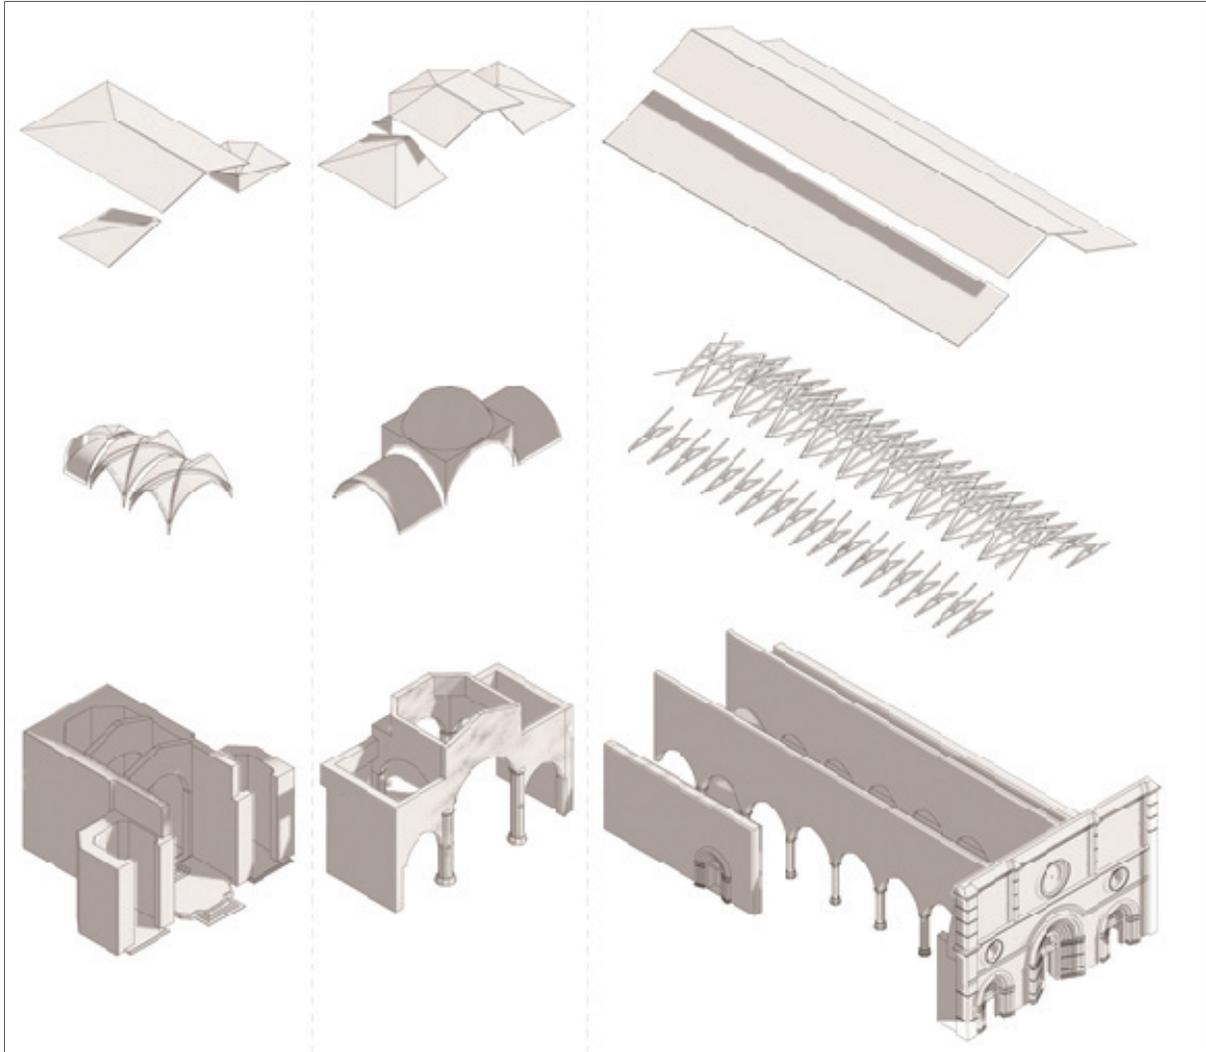
Figure 5-24 Geometric survey of the Church

The two side aisles are respectively 7.8 and 8 m width with 2 external walls 12.5 m high. Seven pillars, not evenly spaced, on each side separate the nave and two side aisles (Figure 5-21, Figure 5-22, Figure 5-23). The pillars are about 5.25 m high; a covering of well-laid stones encloses their core, which is filled with calcareous stones irregularly arranged in a poor quality mortar (Figure 5-20). The transverse section, approximately circular, is on average about 1.00 m in diameter. The thickness of the external masonry walls varies between 0.95 m and 1.05 m; it is 0.9 m for the two walls of the nave, over the columns. The four walls are connected on one side to the facade of the basilica and, on the other side, to the transept (Figure 5-24).

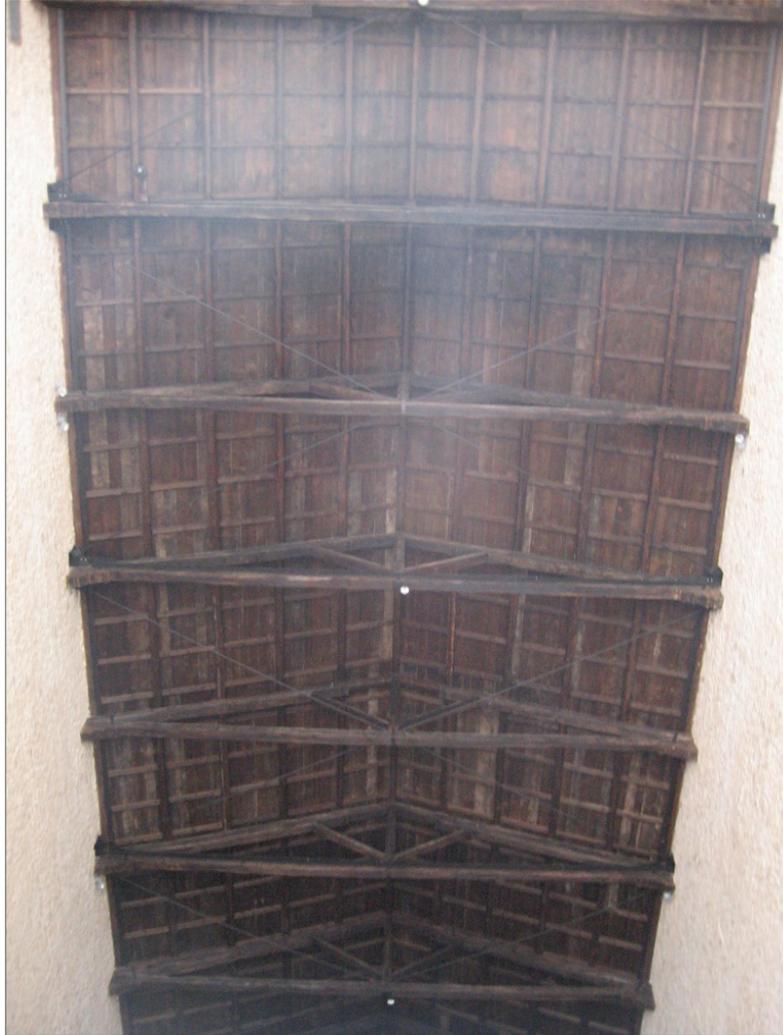
The facade is attached to a squat octagonal tower on the right corner; another masonry building is adjacent to a part of the wall, about 40% of it, behind the tower. The wooden roof is supported by trusses placed in the cross sectional direction to the walls (*Figure 5-25*).

Figure 5-25 Diaphragm behavior of the wooden roof due to the horizontal truss braces

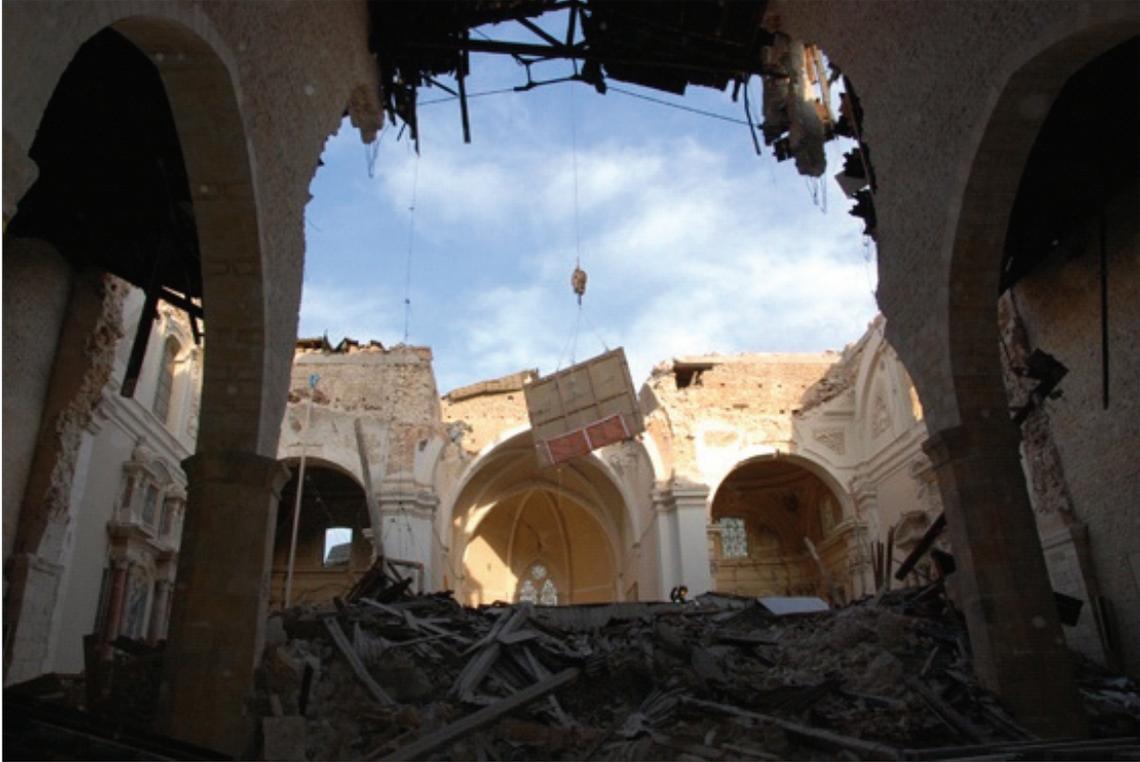
-
2. Collapse of the “tamburo” and of the dome (Figure 5-26);
 3. Collapse of the roof elements of the transept (Figure 5-27);
 4. Slight damage on the stone and the rose window of the façade; overturning of the right side front wall, with moderate cracks in the stones of the Tower.
 5. Crushing of the pillars of the nave (Figure 5-28) and broken chains at the anchorages on the North wall;
 6. Damage to the frame of the “Holy Door” that is inserted in the masonry (Figure 5-29). The stiffness variation between the masonry walls and the portal is the cause of damage to the marbles of the portal.
 7. Severe cracks with imminent collapse in the apse and in the presbytery (Figure 5-45, Figure 5-46, Figure 5-47, Figure 5-48, Figure 5-49).

Figure 5-27 Interior of Santa Maria di Collemaggio

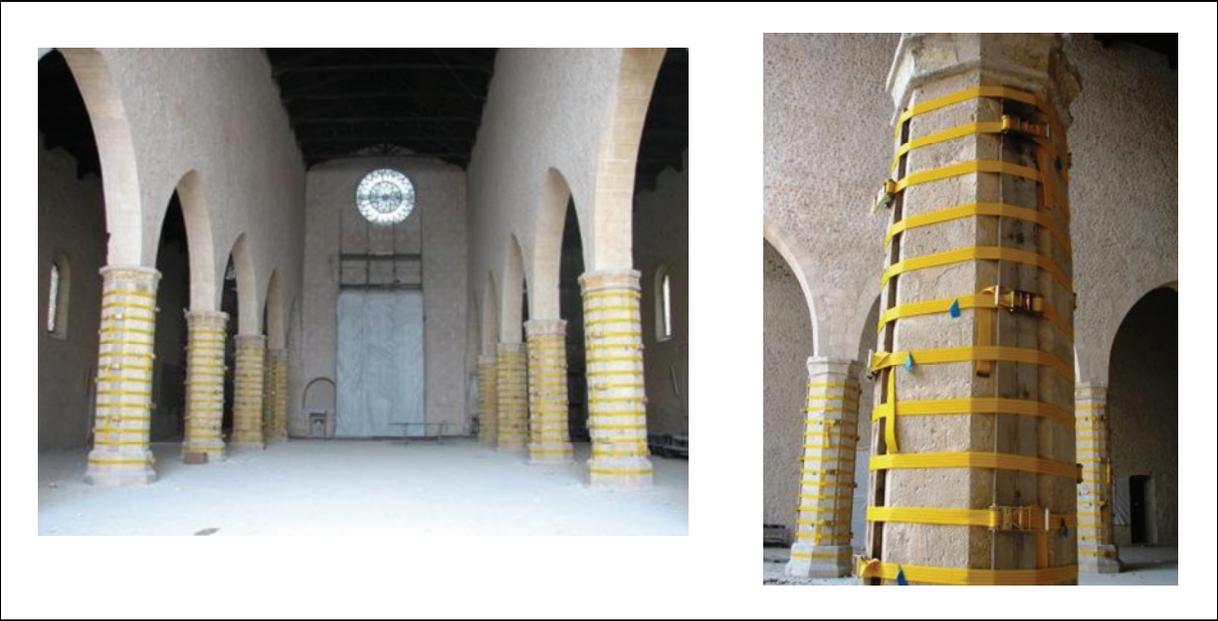
Figure 5-28 Shoring up of the columns of the nave through confinement to increase their axial capacity

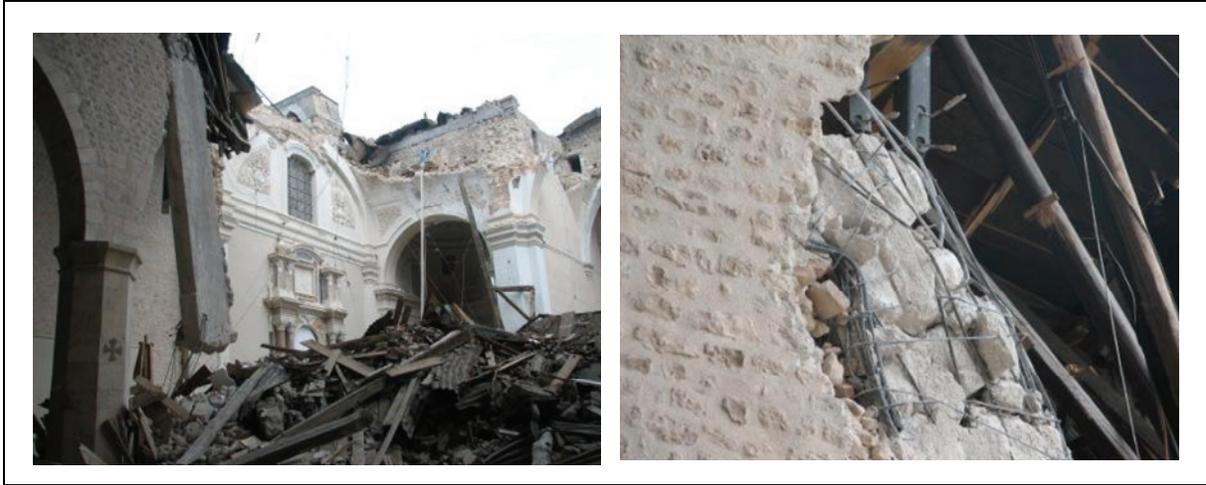
In Figure 5-30, the remains of the reinforced concrete ring beam located on top of the main walls of the nave are visible. The smooth surface at the interface between the masonry and the ring beam show lack of connection between the two structural elements. Additionally, the lateral walls are made with poor quality mortar and are not properly connected to each other. It is not common to observe wooden ties inside the masonry that are not sufficient to guarantee the “box behavior” of the masonry walls.

Figure 5-30 Detail of the top R.C. ring beam

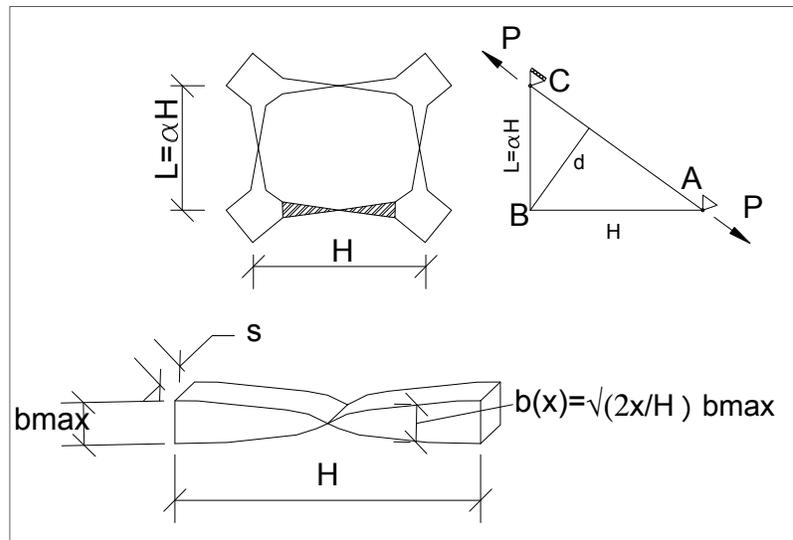
The basilica of “Santa Maria di Collemaggio” in L’Aquila was slightly damaged in the 1997 Marche and Umbria earthquake despite its large distance from the epicenter, therefore the local government of L’Aquila decided to retrofit the church inserting quadrilateral steel hysteretic dampers (Ciampi et al., 1990, Cartapati, 2000) at the roof level that were manufactured by ALGA (Ciampi and Marioni, 1991), an Italian company. The installed devices can be classified as *displacement-activated devices* (Soong and Dargush, 1997; Christopoulos and Filiatrault, 2006), because they were expected to be able to dissipate energy through the relative displacement between the two adjacent walls as shown in Figure 5-31.

its length more than the other one, and so the entire bracing system is stretched. However, laboratory experimental tests of the quadrilateral steel damper performed at ENEA showed that the slender braces did not always remain in tension as claimed, but they buckled out-of-plane in compression without dissipating energy at large displacements. Therefore, the geometrical nonlinear effects (hardening) at large displacements did not play a role in the structural control of Santa Maria di Collemaggio basilica. In designing damper device after selecting the yielding force and the material, its geometric parameters are selected opportunely by varying the cross section $b(x)$ of the quadrilateral steel damper in order to achieve a uniform yielding of the steel section according to the formula given below (Ciampi *et al.*, 1990)

Figure 5-31 Quadrilateral steel hysteretic damper (Ciampi *et al.*, 1990)

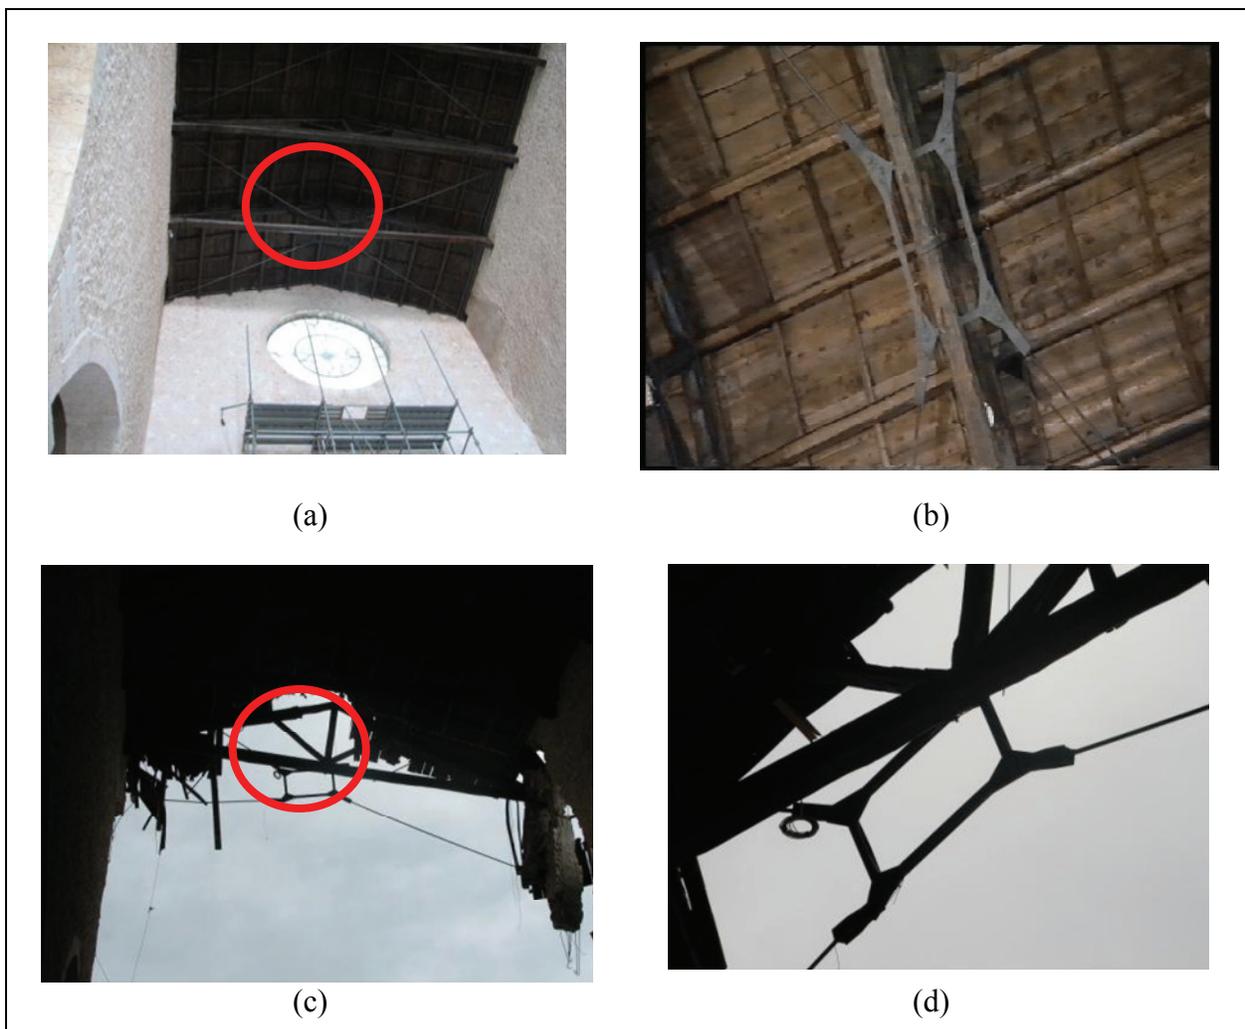
Figure 5-32 Location of the two hysteretic steel dampers at the two edges of the nave (Ciampi et al., 1990)

Two hysteretic steel dampers were installed at the roof level, at the two edges of the main nave (Figure 5-32) in the transept and at the frontal façade, respectively. The position in plan of the two dampers is also shown in Figure 5-34.

4. The global rotational movement is probably due to the contemporary presence of both the temporary scaffolds at the entrance of the church and the improper location of the steel hysteretic devices in the nave (Figure 5-32, Figure 5-33). In fact, the unlikely presence of a scaffolding system (Figure 5-53 and Figure 5-54) in the frontal façade when the earthquake occurred contributed to increase the distance between the center of mass (CM) and the center of stiffness (CK). Thus, torsion forces developed that caused the collapse of the two central pillars (*Figure 5-25*) and consequently of the dome above.

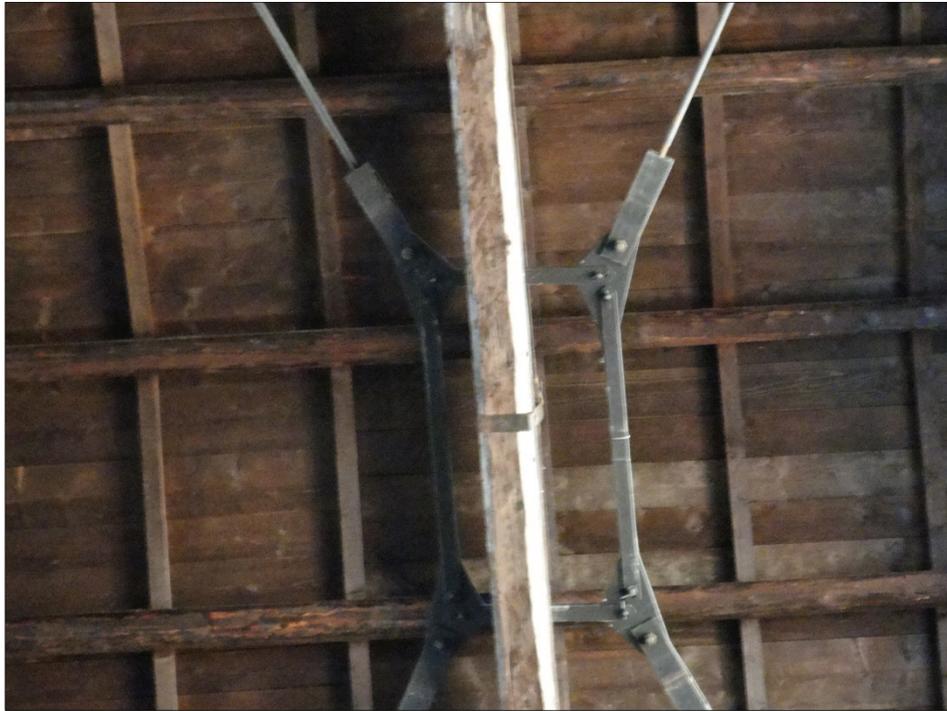
Figure 5-33 No evidence of yielding in the steel hysteretic damper near the frontal facade (Ciampi et al., 1990)
