L'AQUILA EARTHQUAKE OF APRIL 6, 2009 IN ITALY: REBUILDING A RESILIENT CITY TO WITHSTAND MULTIPLE HAZARDS

by
**Gian Paolo Cimellaro, Ioannis P. Christovasilis,
Andrei M. Reinhorn, Alessandro De Stefano
and Tatiana Kirova**

Technical Report MCEER-10-0010

December 29, 2010

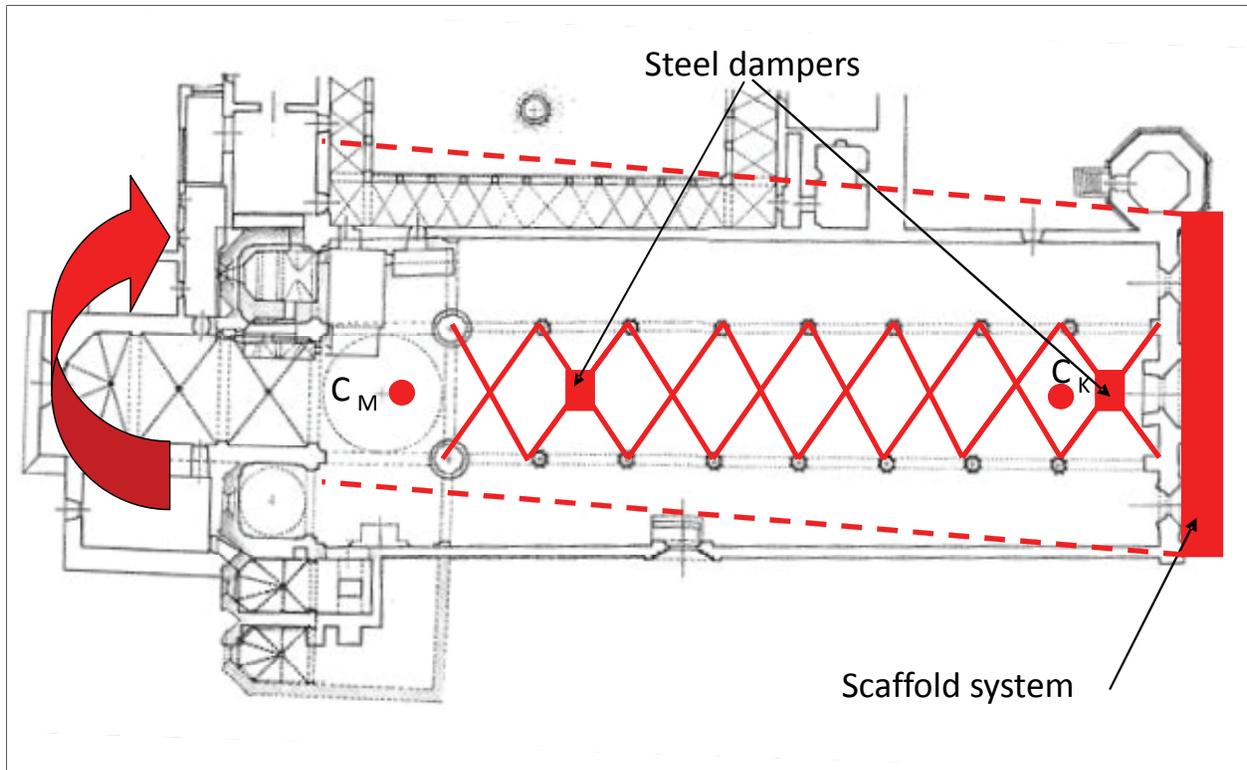
The main idea of the horizontal brace system at the roof level is to connect the two lateral walls of the main nave generating a diaphragm behavior (Figure 5-40; Figure 5-41). The effect of this connection is the development of a stiffer nave with translation of the stiffness center (CK) toward the frontal façade (Figure 5-34). The stiffening effect of the retrofit is illustrated by Antonacci et al., (2001), which performed numerical analysis by finite element models that were calibrated by dynamic identification tests performed before and after the retrofit, and concluded that the retrofit intervention produced an increment of the first frequency from 1.20 Hz before retrofit to 1.41 Hz after retrofit, while increment of the second mode is from 1.79Hz before retrofit to 2.24 Hz after retrofit.

Figure 5-34 Schematic representation of the torsional effects due to the retrofit

The global behavior of the basilica during the earthquake is illustrated in Figure 5-34, where the presence of the horizontal diaphragm at the wooden roof level generated a stiffer nave with the consequent translation of the stiffness center (CK) toward the frontal façade. The 2000 retrofit generated a stiffer nave with respect to the transept where most of the mass of the basilica (CM) is concentrated; therefore, the dampers included in the basilica generated an irregular structure, by moving the center of stiffness away from the center of mass which in turn initiated a global rotational behavior of the church during the earthquake around the frontal facade. Evidence of the global behavior described in Figure 5-34 can be found in several parts of the church, and are summarized in Figure 5-42.

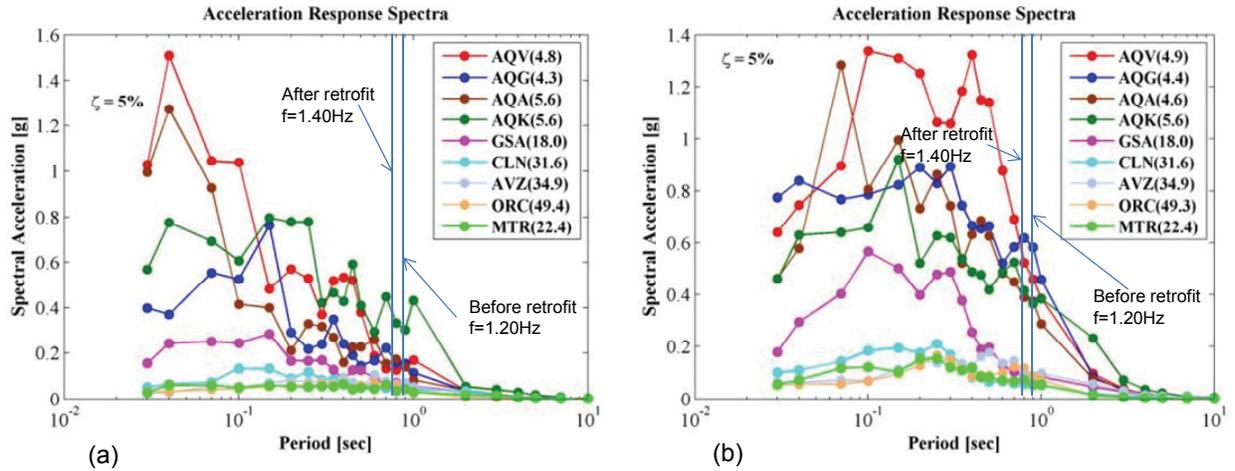
The participating modal mass ratios of the first two modes reach 85% of the total mass in the transverse direction of the church (Figure 5-40; Figure 5-41). Therefore, the peak displacements at the roof level can be estimated using the modal combination of the first two modes. The period shift due to the retrofit generated larger reaction forces at the end support of the central nave, because of increments of the spectral demand in the response spectra obtained using the accelerograms recorded in the stations near the Basilica (Figure 5-35).

Figure 5-35 (a) Vertical response spectra; (b) Horizontal response spectra of April 6th L'Aquila Earthquake

-
-
- retrofit, while an increment of the second mode is from 1.79 Hz before retrofit to 2.24 Hz after retrofit.
2. The period shift of the main mode due to the retrofit generated larger reaction forces at the supports of the central nave because of increments of the spectral demand in the response spectra (Figure 5-35) obtained using the accelerograms recorded in the stations near the Basilica.

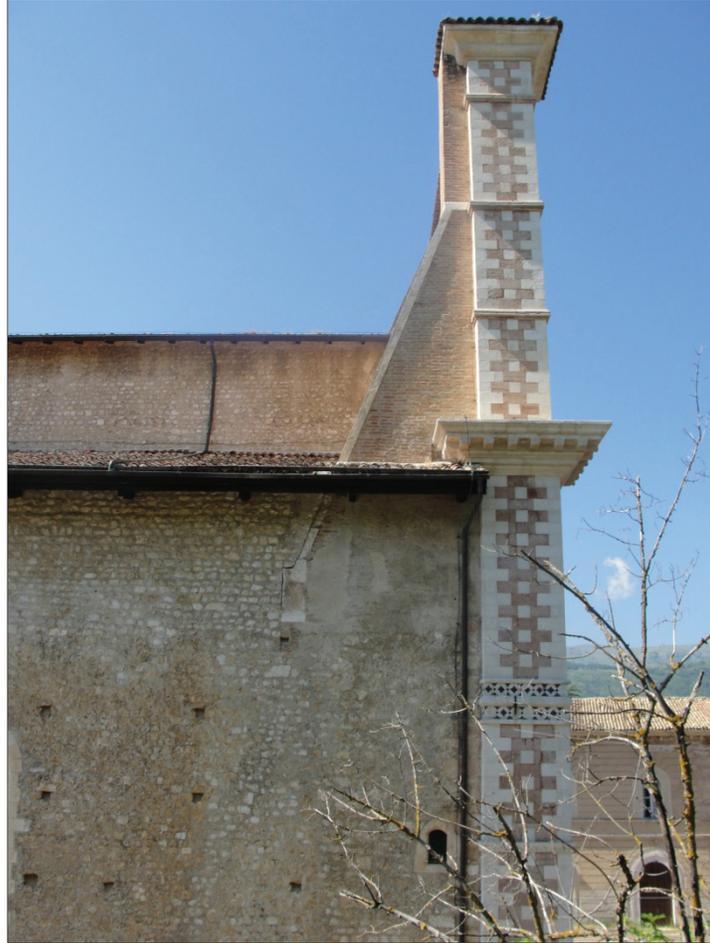
The main assumption of the first model is that the central nave is fixed at both ends due to the presence of the frontal façade, external buttresses and heavy walls (Figure 5-36) on one side and the transept on the other side. Using this model, the dampers are located in their optimal position, because in both modes, they are located where the maximum drift (beam rotation) is obtained.

Figure 5-36 Buttress of the frontal façade

3. The failure occurred at the supports due to the global rotational movement of the presbytery and the transept shown in Figure 5-43 to Figure 5-46 from the North side toward the South side, which is shown by clear evidence of movements in the North South direction in the altar-transept area, while no evidence of movements can be found in the main entrance (Figure 5-36, Figure 5-38).

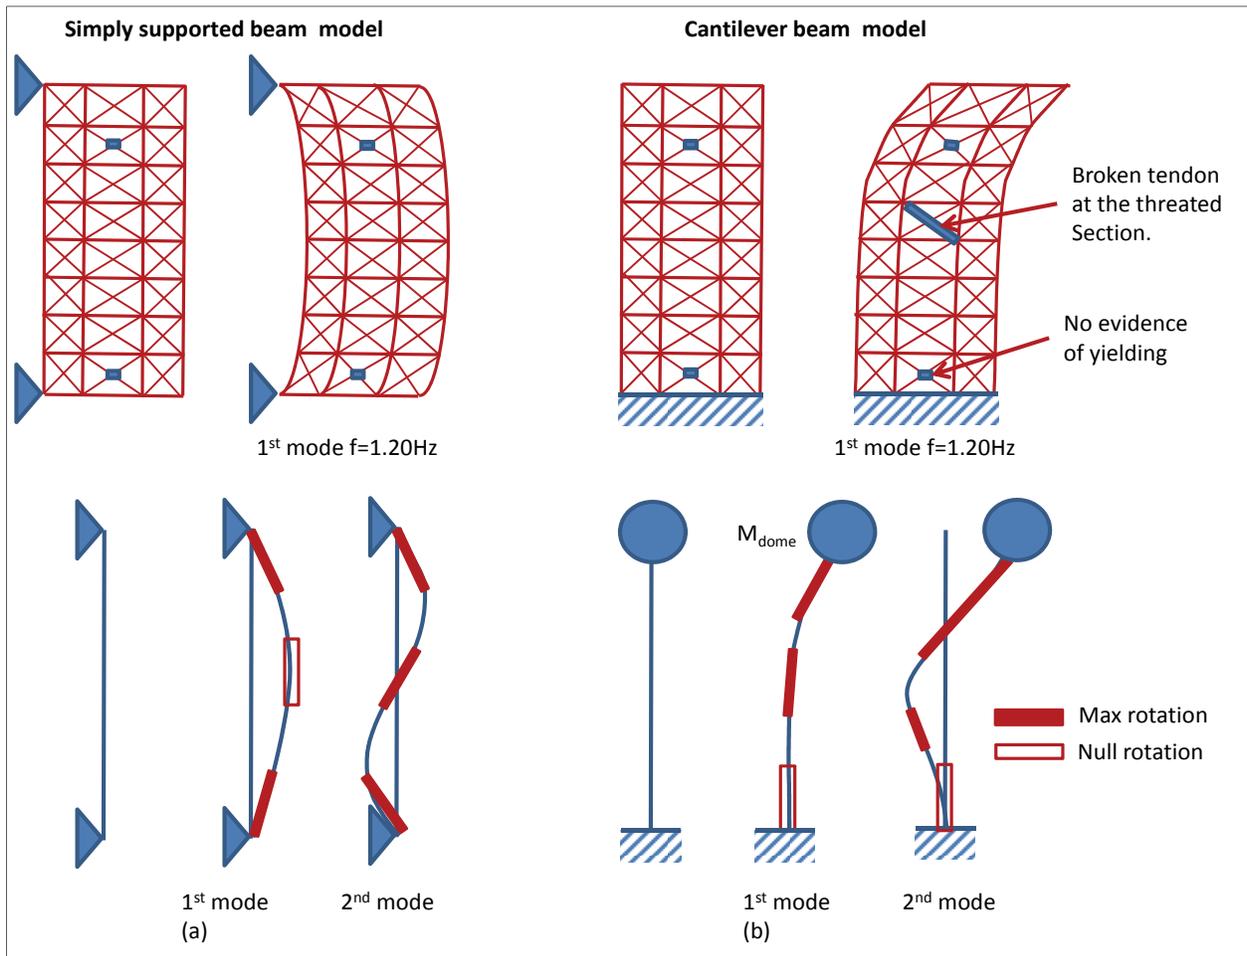
By observing the damage inside the basilica, two simplified models can be assumed (Figure 5-37):

If this had been the most reasonable model, then both dampers should have yielded and cracks near the frontal façade should have been observed.

The second model (cantilever beam model) assumes that there is only one fixed point in the frontal façade, while the other side of the transept is free to move. This assumption is reasonable and proved by the fact that the damper near the frontal façade could not be activated during the seismic event of April 6th (no evidence of yielding) (Figure 5-38) because it was located near a fixed point with minimum drift (beam rotation), while the maximum drift was achieved in the middle of the central nave as proved by the presence of a broken tendon at the threaded section (Figure 5-37b, Figure 5-39). If the device was properly designed and located, it would have been the only member that behaved in a nonlinear manner during the design earthquake, while the rest of the structure remained in the elastic range. Instead, from field observations, it is clear that the device was not effective.

Figure 5-37 Simply supported beam model vs. cantilever beam model

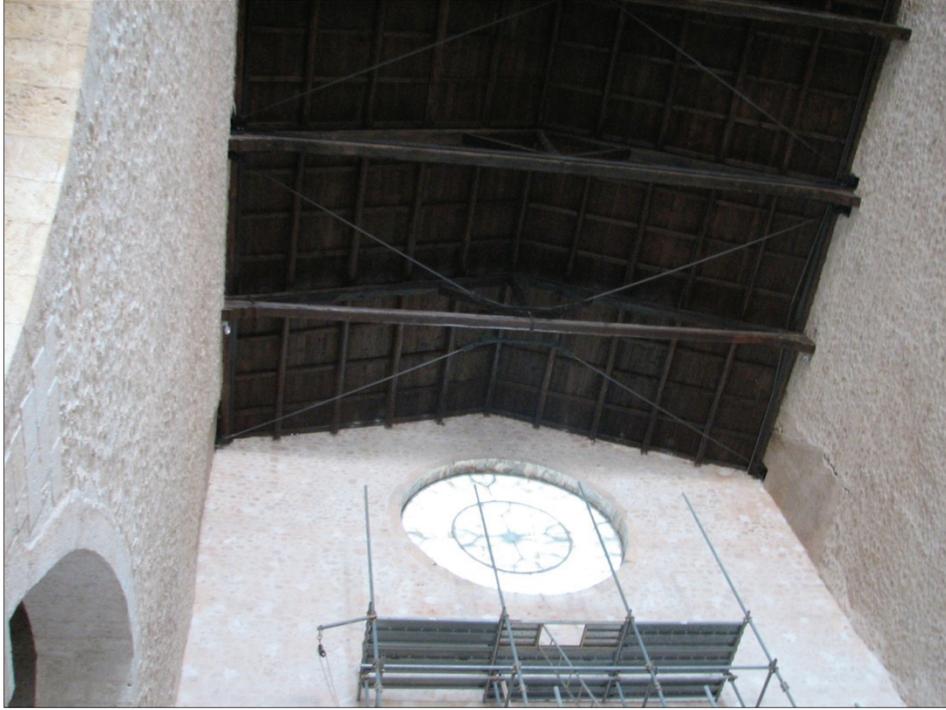
Figure 5-38 No evidence of yielding in the steel hysteretic device and of any damage in the West side of the Church was observed

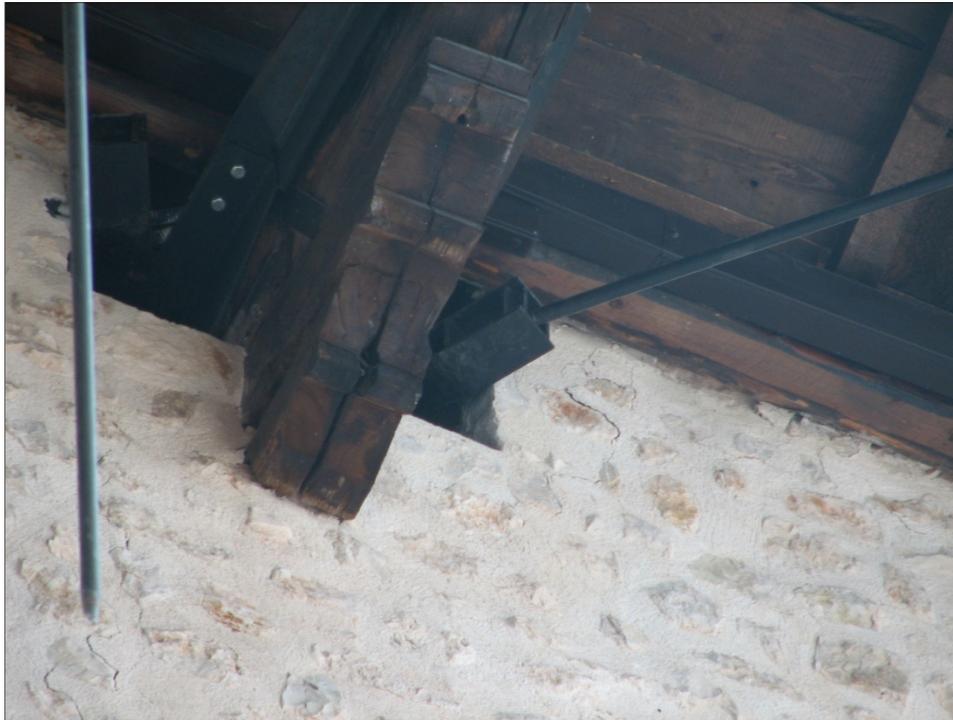
Figure 5-39 Broken tendon at the threaded section

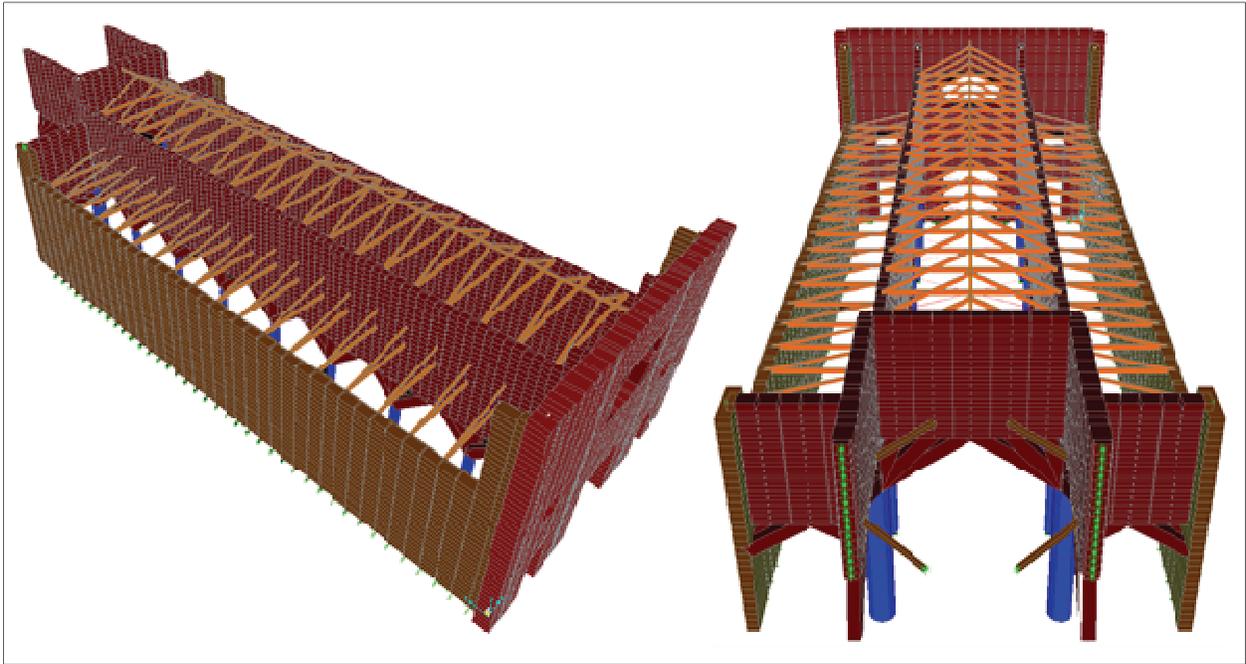
Figure 5-40 FEM model of the Church

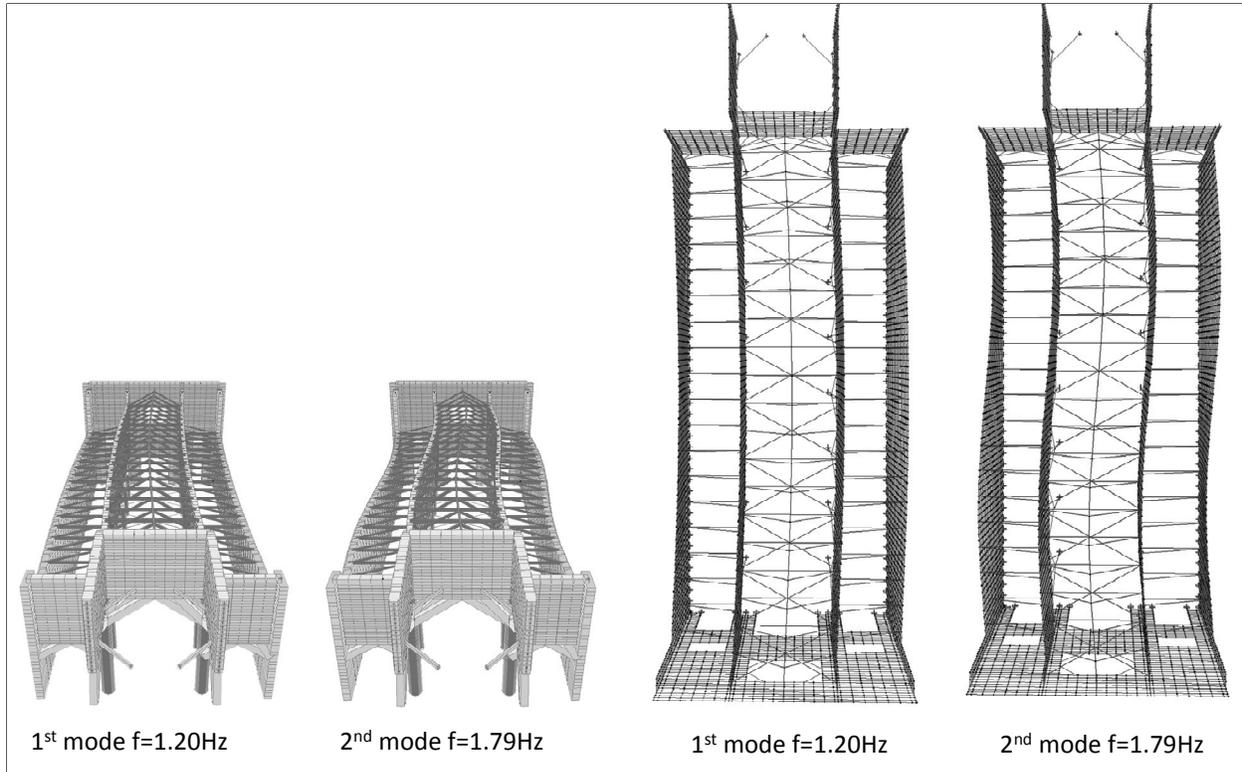
Figure 5-41 Calculated natural mode shapes of the Basilica before retrofit

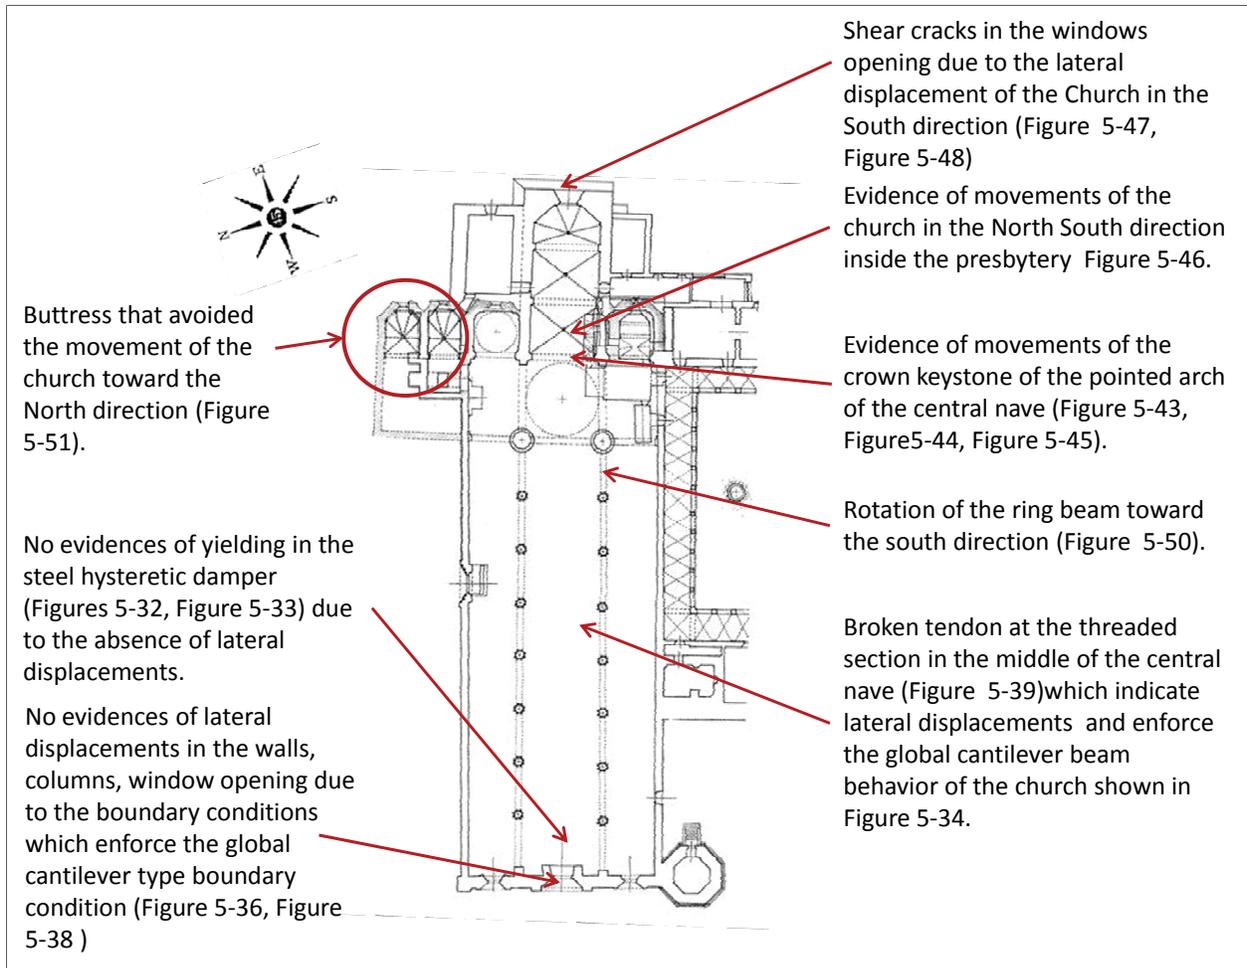
Figure 5-42 Evidence of the global behavior of the church described in Figure 5-34

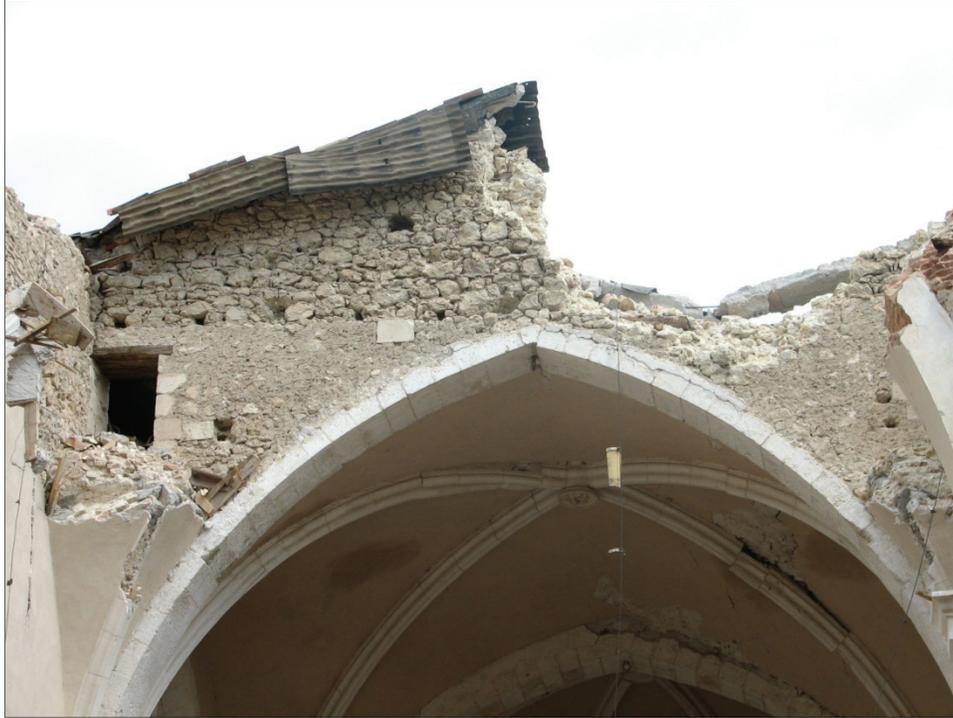
Figure 5-43 Evidence of movements in the North South direction in the central altar

The pointed arch (Gothic arch) of the central altar shown in Figure 5-43, Figure 5-44 and Figure 5-45 is formed by two curves meeting at the crown with a sharp angle. From Figure 5-44, it is possible to clearly see that the arch collapse mechanism is due to the presence of four plastic hinges at the intrados and extrados which are large enough to transform the arch in a mechanism. Related damage is shown in Figure 5-46, Figure 5-47, Figure 5-48, Figure 5-49, Figure 5-50, and Figure 5-51.

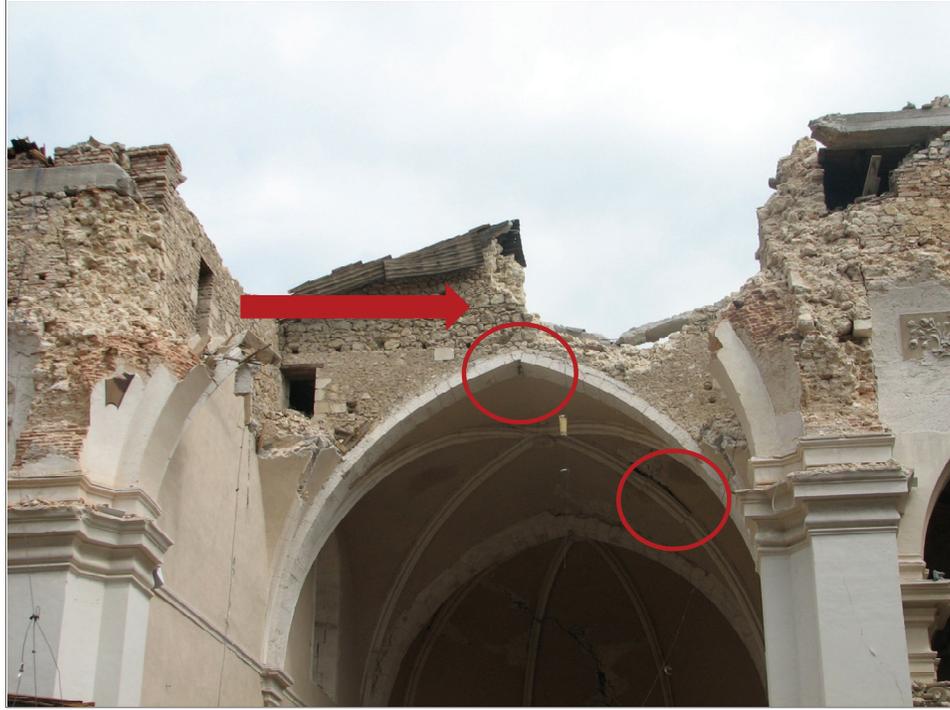
Figure 5-44 Evidence of the lateral displacements in the South direction in the pointed arch and in the presbytery vault

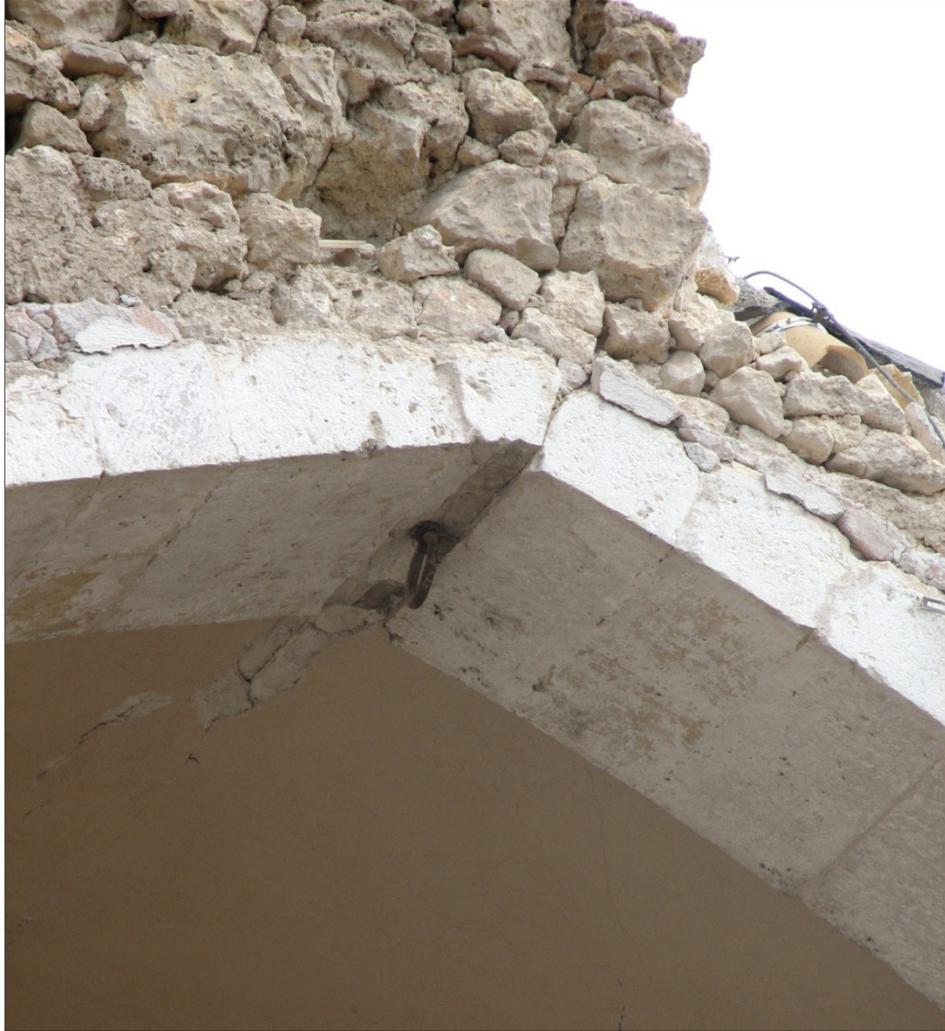
Figure 5-45 Detail of the North South movement of the church in correspondence of the crown keystone of the pointed arch of the central altar

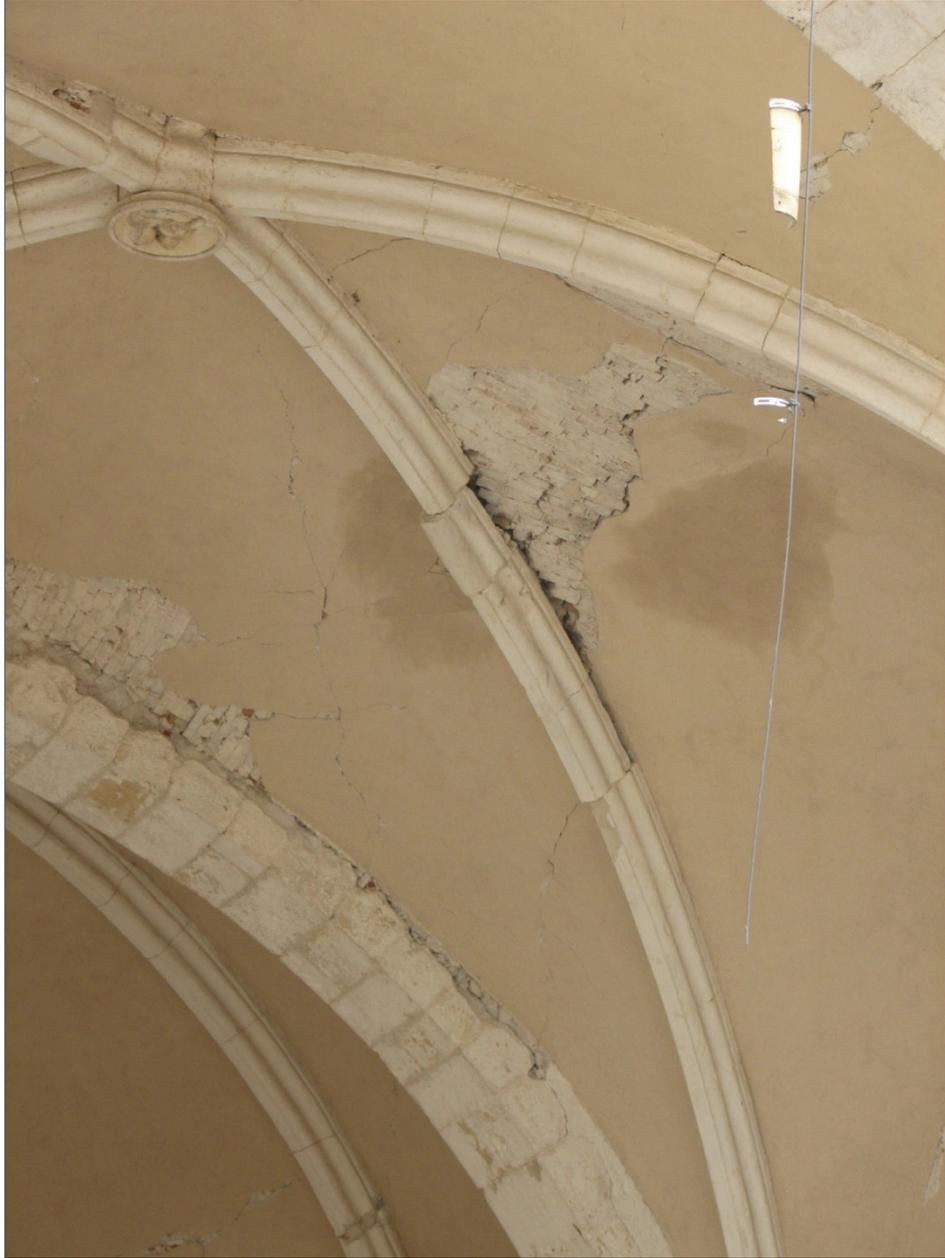
Figure 5-46 Evidence of the lateral moment in the North South direction inside the presbytery

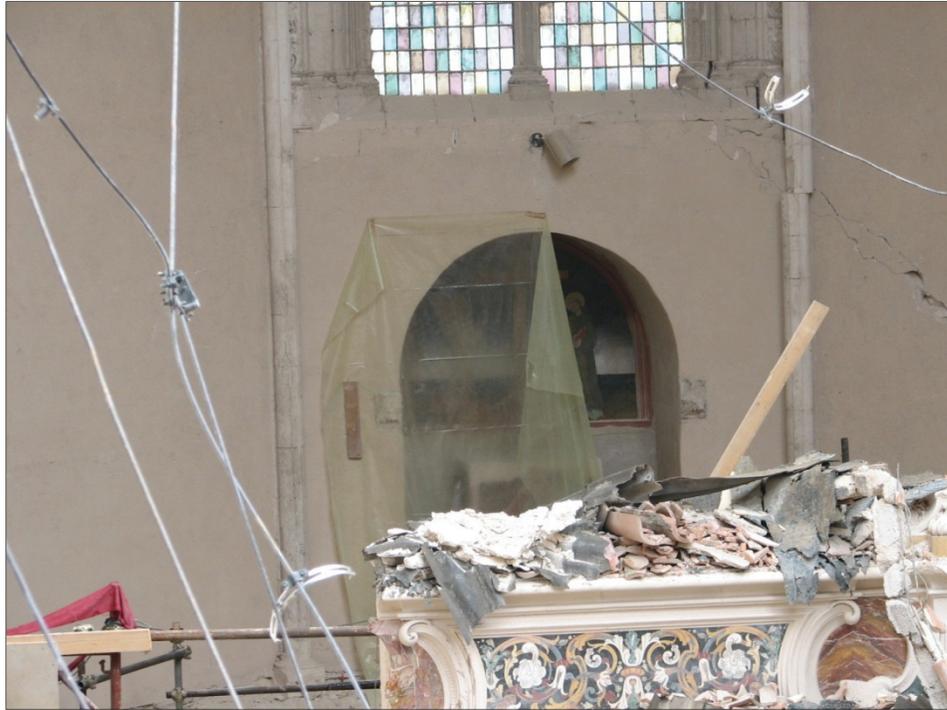
Figure 5-47 Shear cracks due to lateral displacement in the wall of the central altar initiated by the presence of the window opening

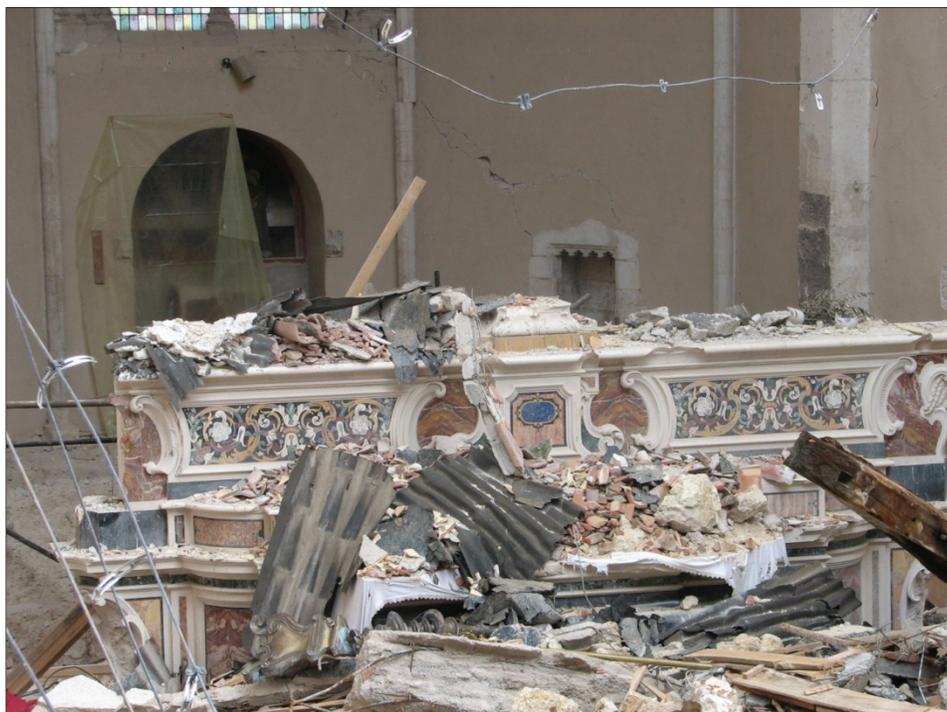
Figure 5-48 Shear cracks due to lateral displacement in the wall of the central altar initiated by the presence of the window opening

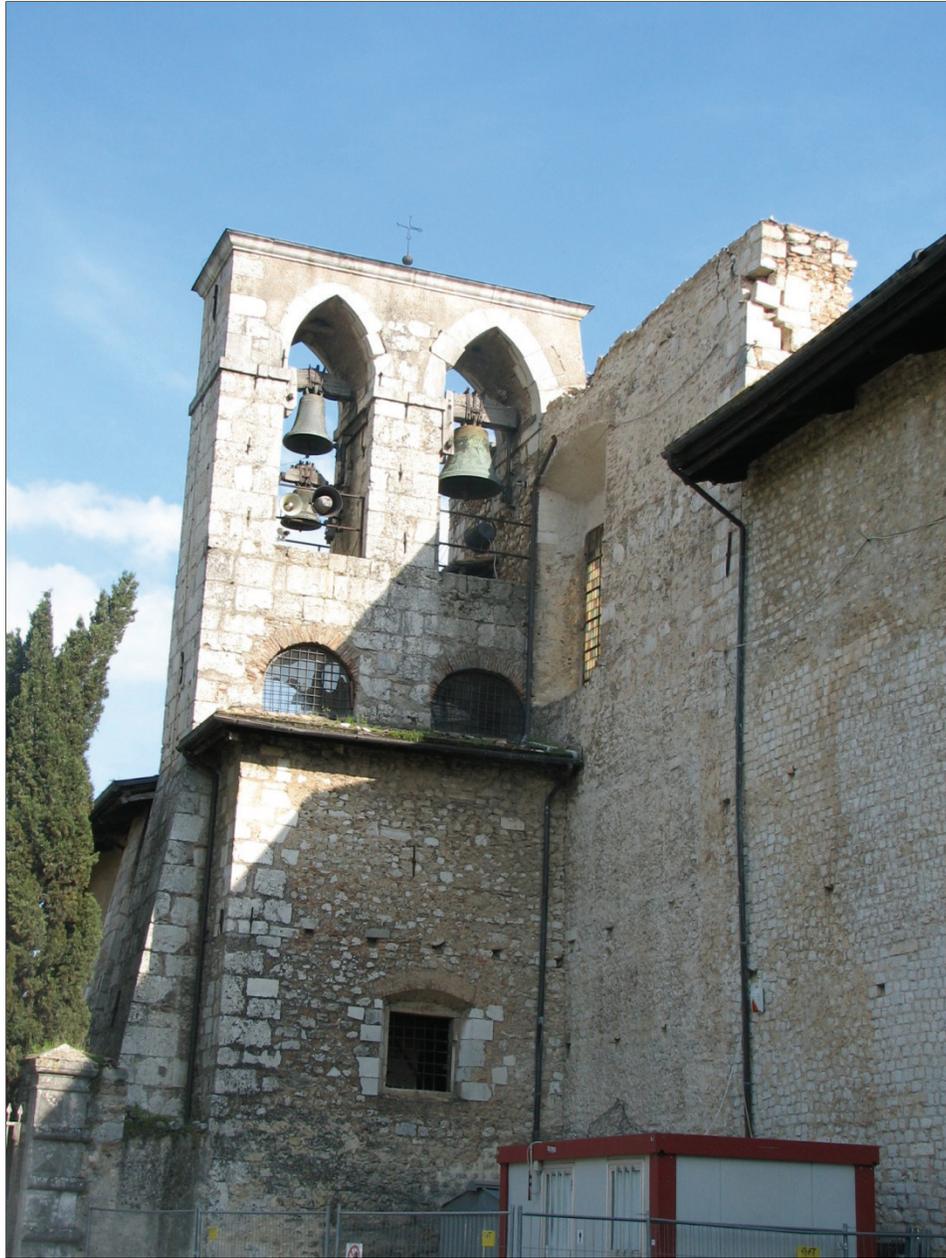
Figure 5-51 Buttress in the North side of the Church which avoided the movements toward that direction

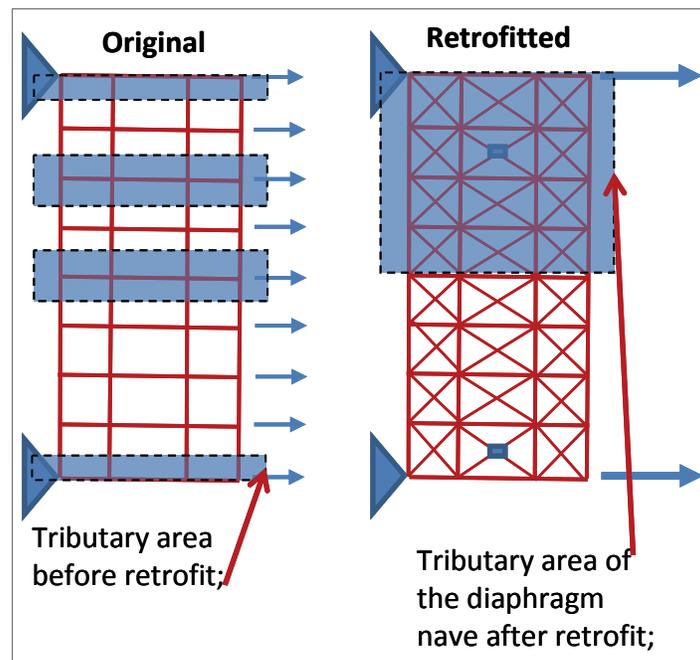
The initial wooden roof system of the nave before the retrofit was flexible and the resultant lateral loads due to the inertial forces during the earthquake were transferred to the portion of the wall just below the transversal truss. In other words, the tributary mass acting on the boundary was limited as shown in Figure 5-52 a.

Following the retrofit, the additional cross horizontal tendons introduced below the roof generated a diaphragm behavior in the nave which increased the tributary mass acting on the boundary shown in Figure 5-52 b and therefore the inertial forces applied at the boundary of the transept (in the frontal façade and in the pillars supporting the dome).

The failure of one side of the church probably was due to the concentration of seismic forces through the horizontal truss which established a diaphragm behavior at the roof level. The tributary area (mass) of the roof increased and therefore the seismic horizontal forces transferred at the supports also increased with respect to the inertial forces before retrofit.

Figure 5-52 Increase of the tributary mass due to the retrofit

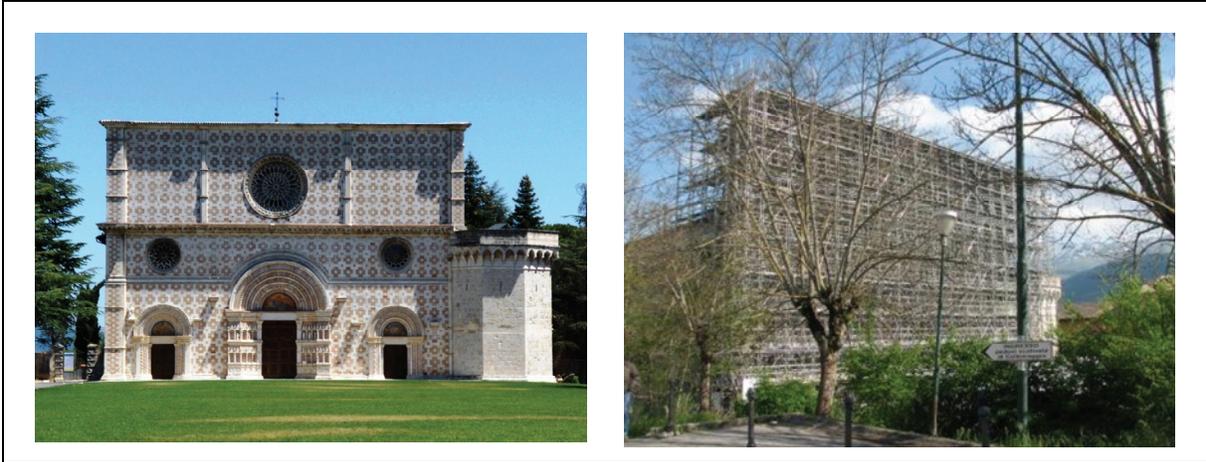
4. The global rotational movement is probably due to the contemporary presence of both the temporary scaffolds at the entrance of the church and the improper location of the steel hysteretic devices in the nave (Figure 5-32, Figure 5-33). In fact, the unlikely presence of a scaffolding system (Figure 5-53 and Figure 5-54) in the frontal façade when the earthquake occurred contributed to increase the distance between the center of mass (CM) and the center of stiffness (CK). Thus, torsion forces developed that caused the collapse of the two central pillars (*Figure 5-25*) and consequently of the dome above.

Figure 5-53 Facade of the church before the earthquake and at the moment of the earthquake

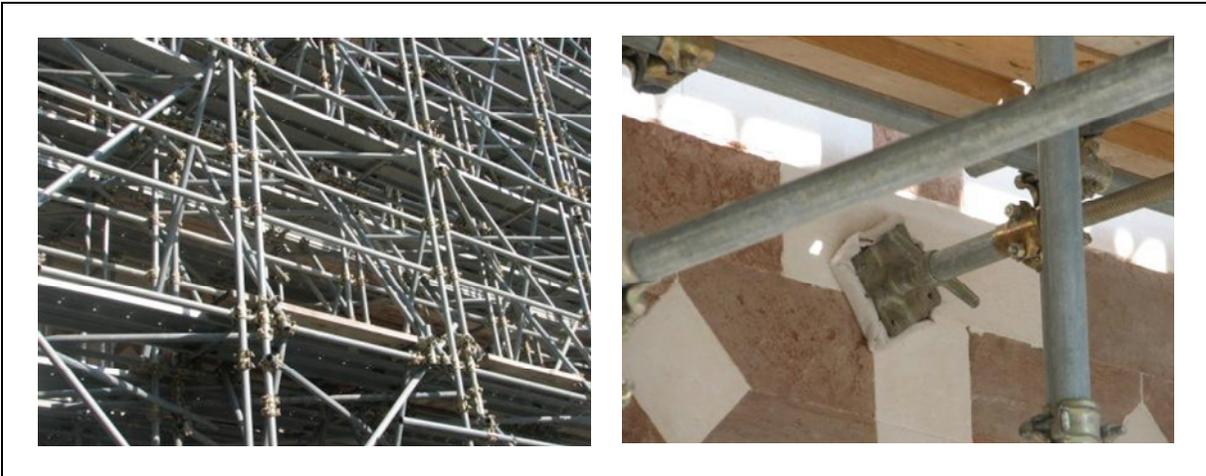
Figure 5-54 Structural scaffolds supported the front façade avoiding the collapse (Salvatori)

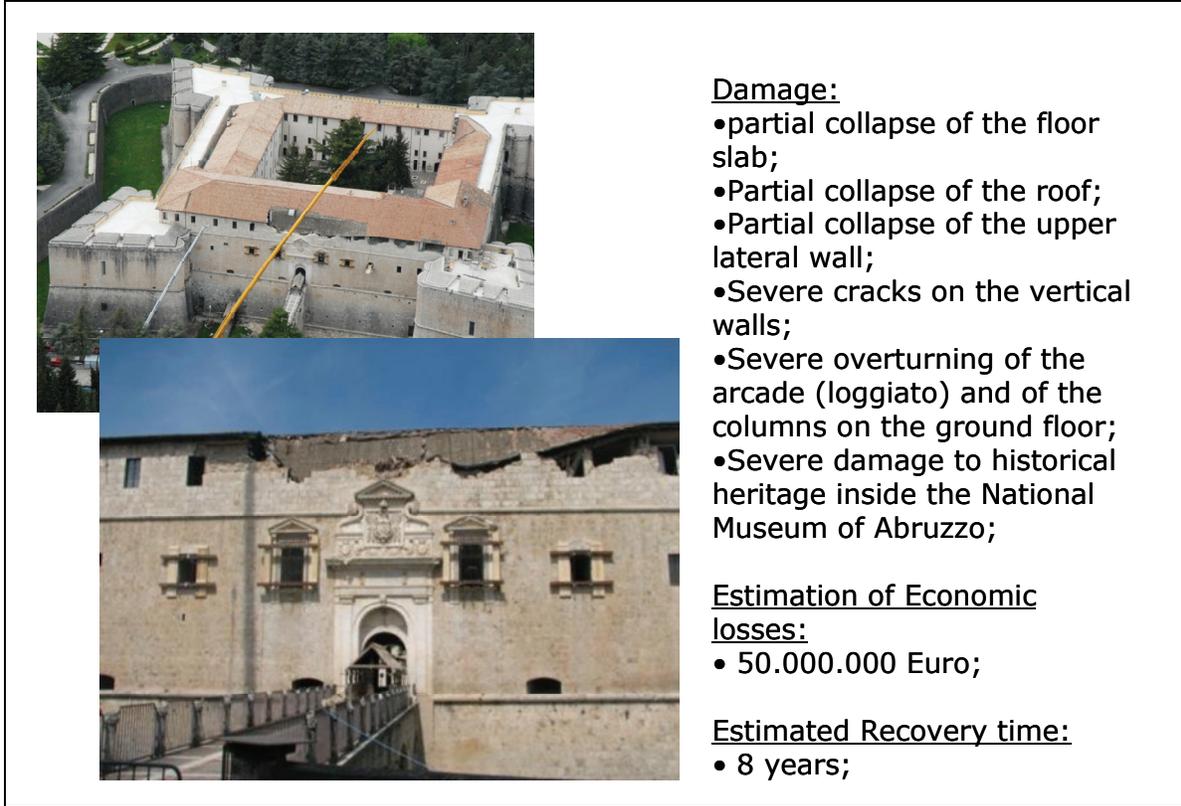
Figure 5-56 Field damage reconnaissance of the Spanish Fortress

The observed damages in the Spanish Fortress are mainly in the new addition to the building as shown in Figure 5-56 and listed in Table 5-1. The details are described in the following sections.

- partial collapse of the floor slab;
- Partial collapse of the roof;
- Partial collapse of the upper lateral wall;
- Severe cracks on the vertical walls;
- Severe overturning of the arcade (loggiato) and of the columns on the ground floor;
- Severe damage to historical heritage inside the National Museum of Abruzzo;

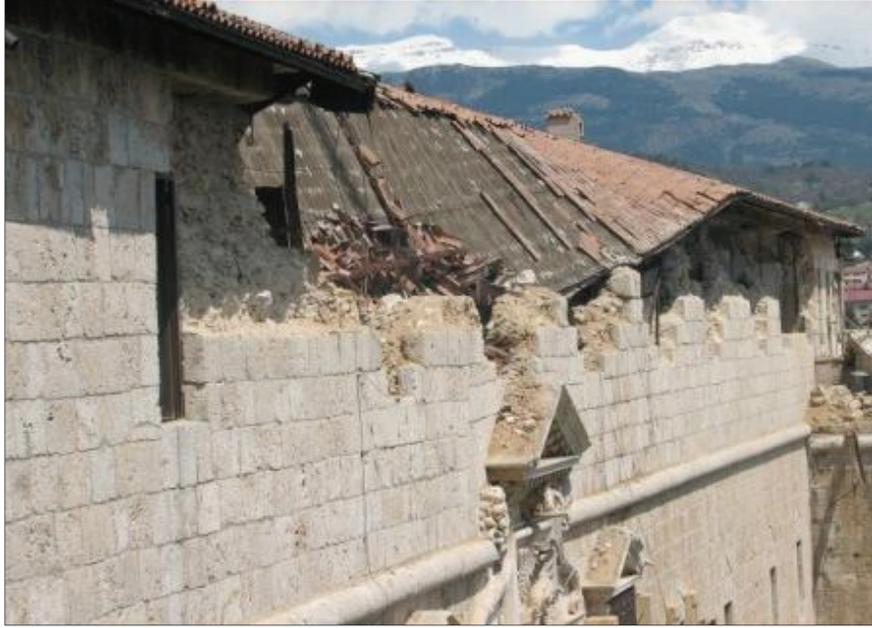
Figure 5-57 and Figure 5-58 show the partial collapse of the upper lateral wall due to the new addition in the old building that is also visible in Figure 5-70. The collapse was triggered by the openings of the lateral walls that make the wall weaker and together with the poor quality of the masonry generated the partial collapse of the roof.

Figure 5-57 Partial collapse of the upper lateral wall

- Poor connection between the roof slab and the lateral wall weaker due to the presence of openings;
- Poor quality of the masonry;

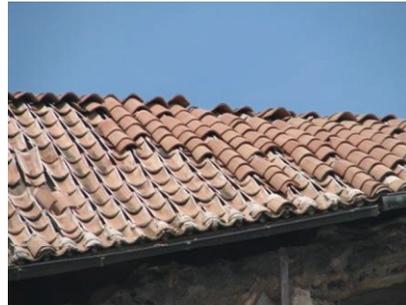
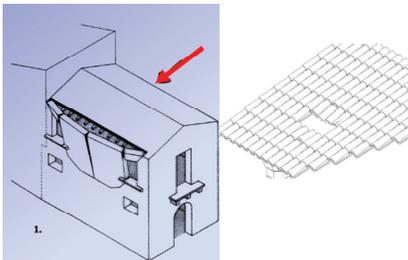
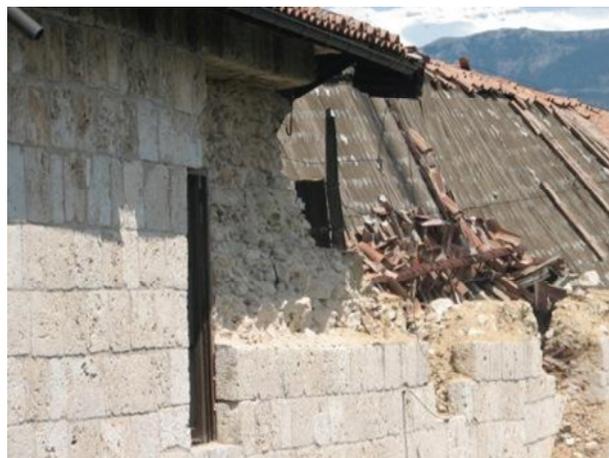
Figure 5-58 Damage to the roof coverage

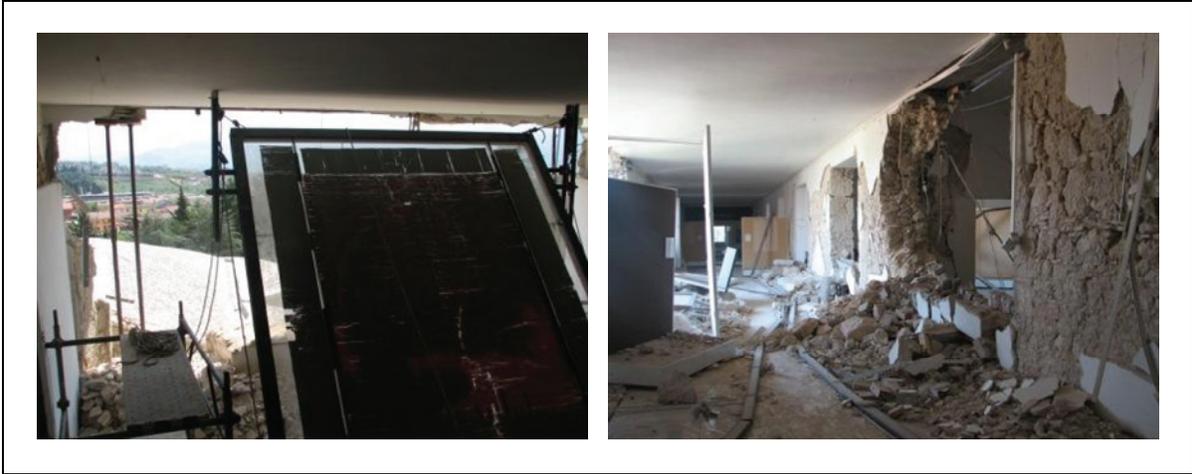
Shoring up interventions started right after the earthquake and, as shown in Figure 5-70, the majority of damages were concentrated in the third floor due to an additional stiffer part in the fortress that was the location of the National Museum of Abruzzo. The majority of masterpieces and statues were rescued by firemen (Figure 5-71) through the opening that was generated on the third floor using cranes from the outside (Figure 5-72).

Figure 5-70 Damage on the third floor

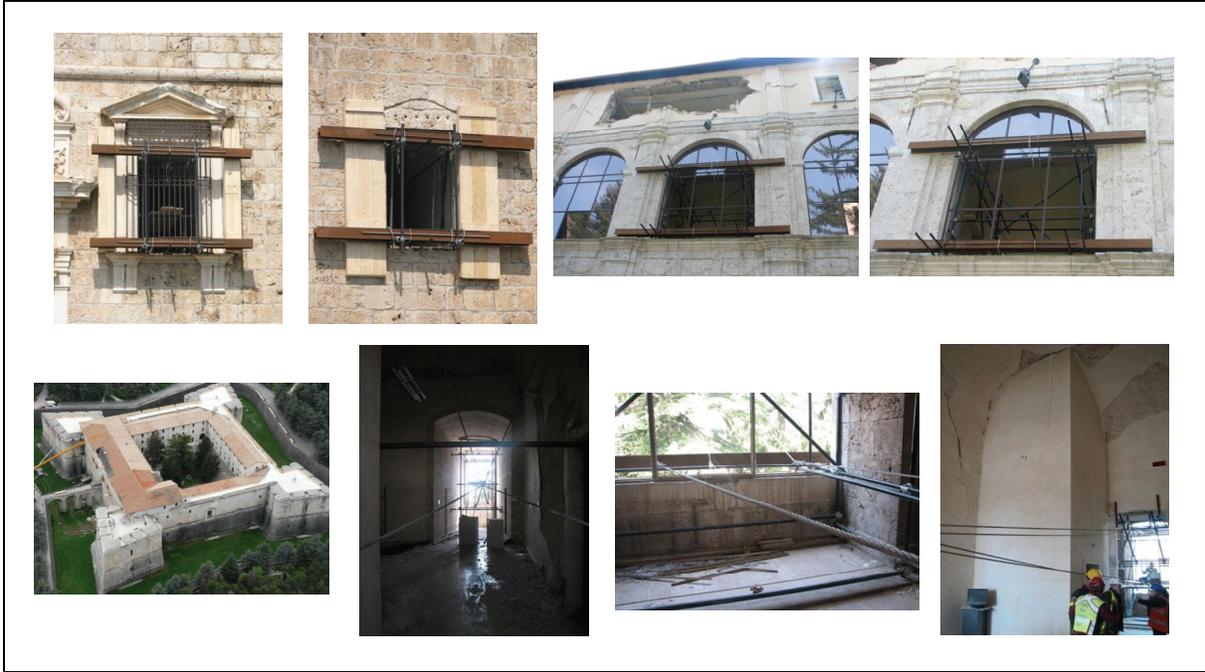
Figure 5-73 Shoring up of the Spanish Fortress

The main shore up retrofit intervention in the castle consisted of the insertion of steel rods through the windows to connect the external walls facing the courtyard with the external lateral walls of the castle (Figure 5-73). In this way, it was possible to control the overturning mechanism of the internal lateral walls of the court yard. Additionally, in the main entrance of the castle, a wooden roof cover was built (Figure 5-74) to avoid the risk of being hit by falling debris material that was present in the upper part of the external lateral walls.

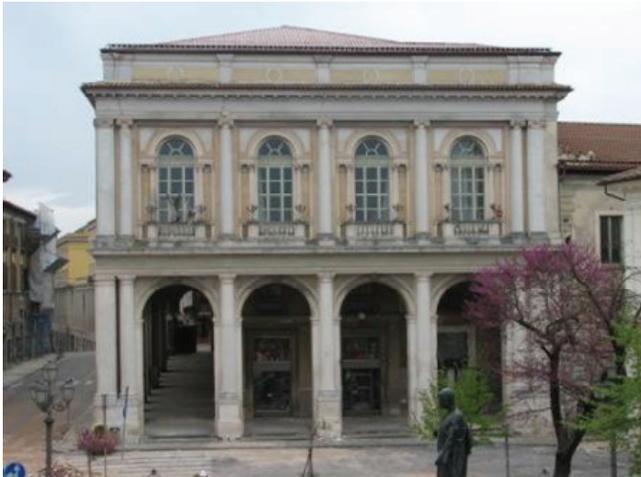
Figure 5-77 Damage assessment of the Quattro Cantoni complex

Damage:

- Severe overturning of the façade with signs of compressions on the column of the ground floor;
- Severe shear cracks on the external lateral walls;
- The internal vaults in the stairs are seriously damaged;

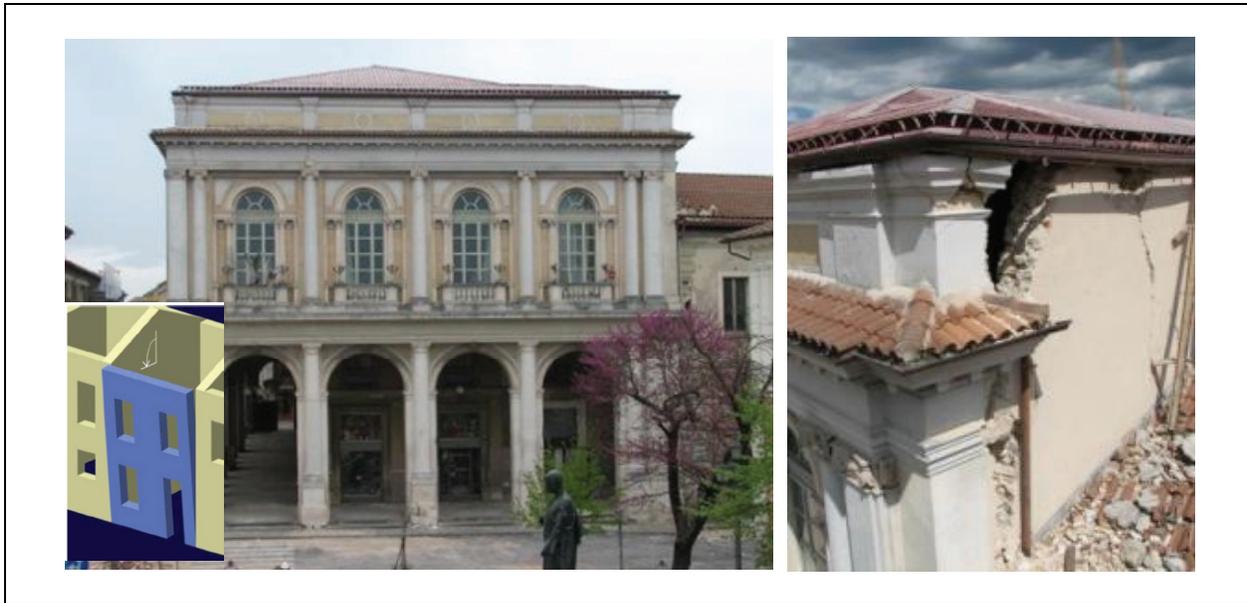
The principal observed damage in the Quattro Cantoni complex is the simple overturning wall mechanism that is a collapse mechanism characterized by a rigid rotation of portion of the wall around a horizontal cylindrical hinge located at the base, as shown in Figure 5-78.

Figure 5-78 Overturning of the frontal façade of the National library
