L'AQUILA EARTHQUAKE OF APRIL 6, 2009 IN ITALY: REBUILDING A RESILIENT CITY TO WITHSTAND MULTIPLE HAZARDS

by
**Gian Paolo Cimellaro, Ioannis P. Christovasilis,
Andrei M. Reinhorn, Alessandro De Stefano
and Tatiana Kirova**

Technical Report MCEER-10-0010

December 29, 2010

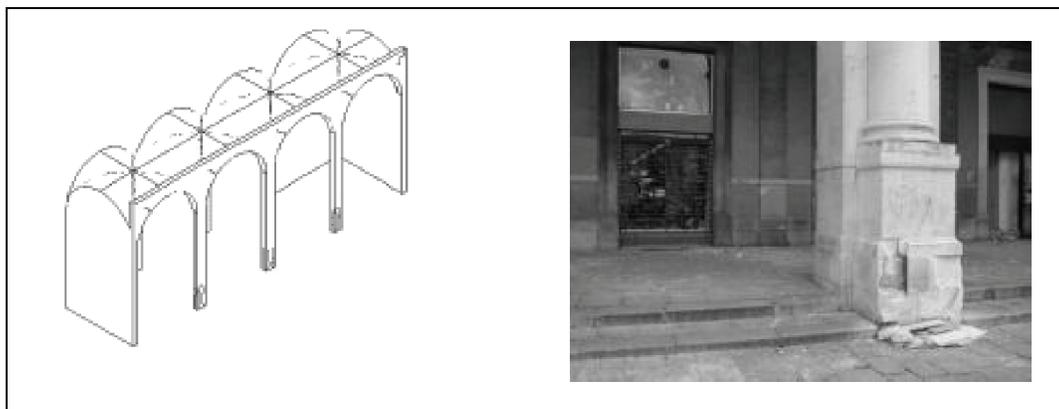
This rotation initiated another type of damage due to axial compression of the columns of the frontal façade of the National Library (Figure 5-79) that has also been characterized by pounding effects with the adjacent building of the Quattro Cantoni block (Figure 5-80).

Figure 5-79 Damage due to axial compression at the base columns initiated by the rotation of the frontal façade of the National library

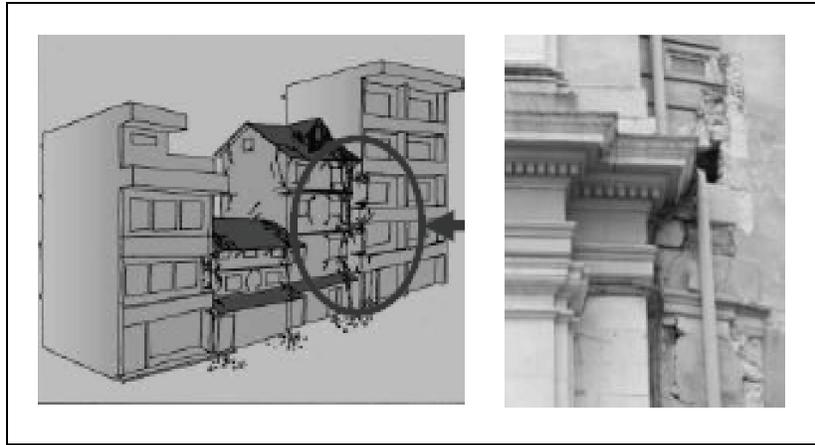
Figure 5-80 Pounding effects between adjacent buildings

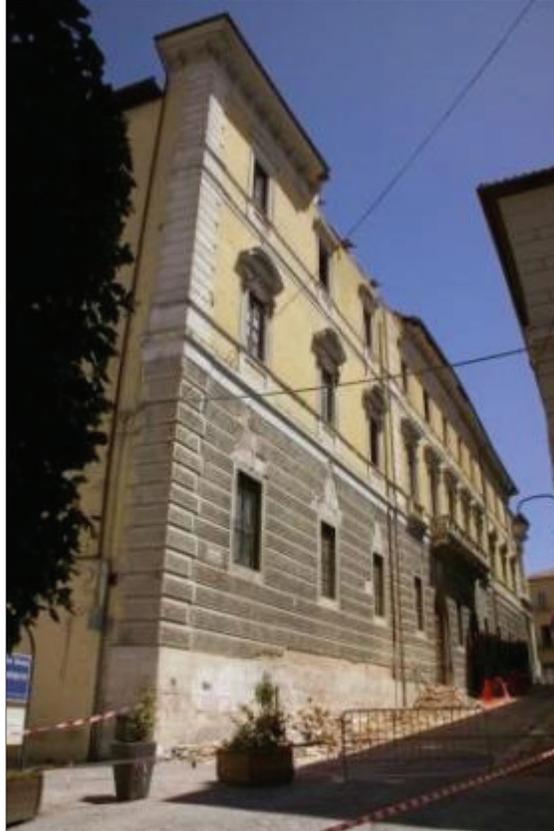
The other main external damage mechanism has been observed in Via Sallustio (Figure 5-81 and Figure 5-82) where the entire external wall is characterized by the horizontal flexure damage mechanism that is probably initiated by the hammering effect of the roof beams on the top of the lateral wall.

Figure 5-82 Horizontal displacement of the frontal façade of Via Sallustio of the National Convitto

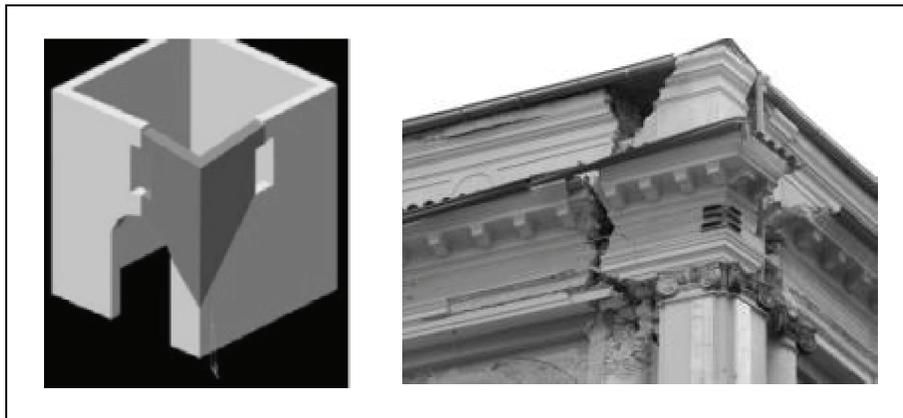
Finally, the most representative damage mechanism of the complex appeared in the cantonal between Frederick II and Corso Umberto I street where the overturning mechanism was promptly retained by the work done by the firefighters (Figure 5-83).

Figure 5-83 Overturning of the corner walls

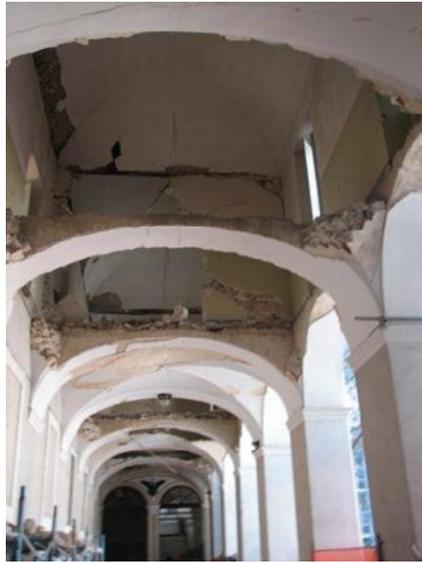
Several vaults in the arcades of the internal yards of the complex collapsed due to poor construction quality and rotation of the vertical lateral walls as shown in Figure 5-86.

- poor construction of the masonry vaults.

Figure 5-86 Total collapse of the vaults of the arcades of the main internal yard

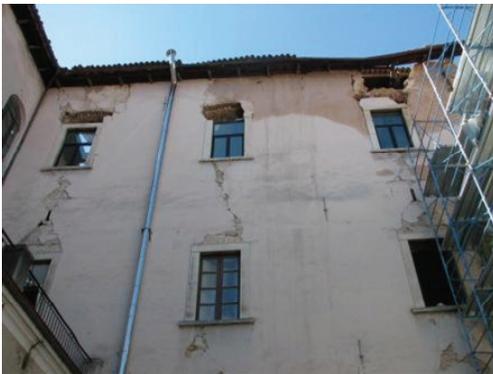
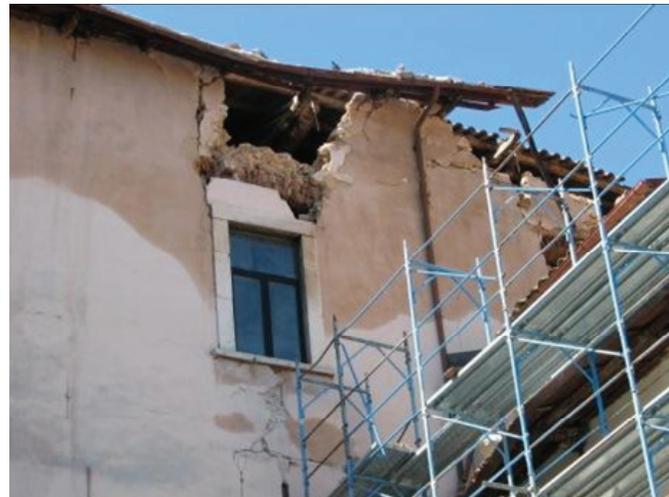
The poor connection between the upper lateral walls and the roof coverage generated overturning horizontal flexure mechanisms (Figure 5-87).

Figure 5-87 Overturning of the upper lateral wall

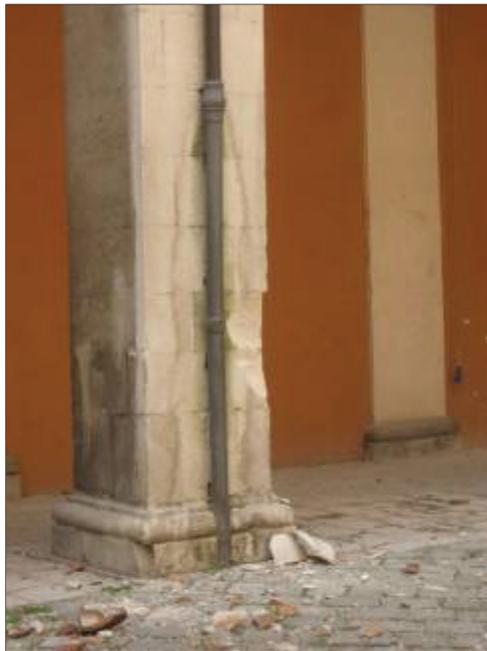
The rotations of the internal walls of the courtyard developed cracks in the limestone square blocks of the columns of the courtyard due to compression effects visible in Figure 5-100.

Figure 5-100 Cracks in the columns due to compression

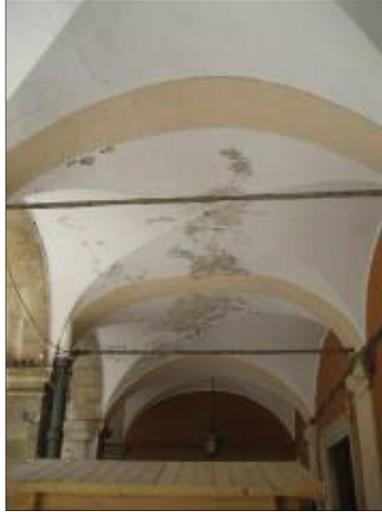
The presence of tie rods on the East and West side of the courtyard (Figure 5-101) prevent the rotations of the walls and avoided the cracks in the vaults of the arcade.

Figure 5-101 Tie rods in the arcades of the West side of Piazza Margherita

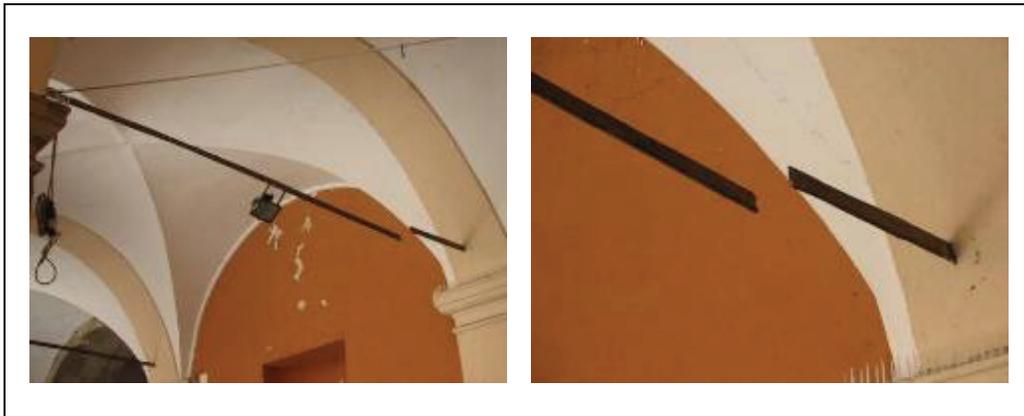
A broken tie rod was found in the East wing of the courtyard (Figure 5-102), proving the traction of the tie rod during the seismic event in that direction.

Figure 5-102 Breakage of the tie rod located on the East side of the arcades facing Piazza Palazzo

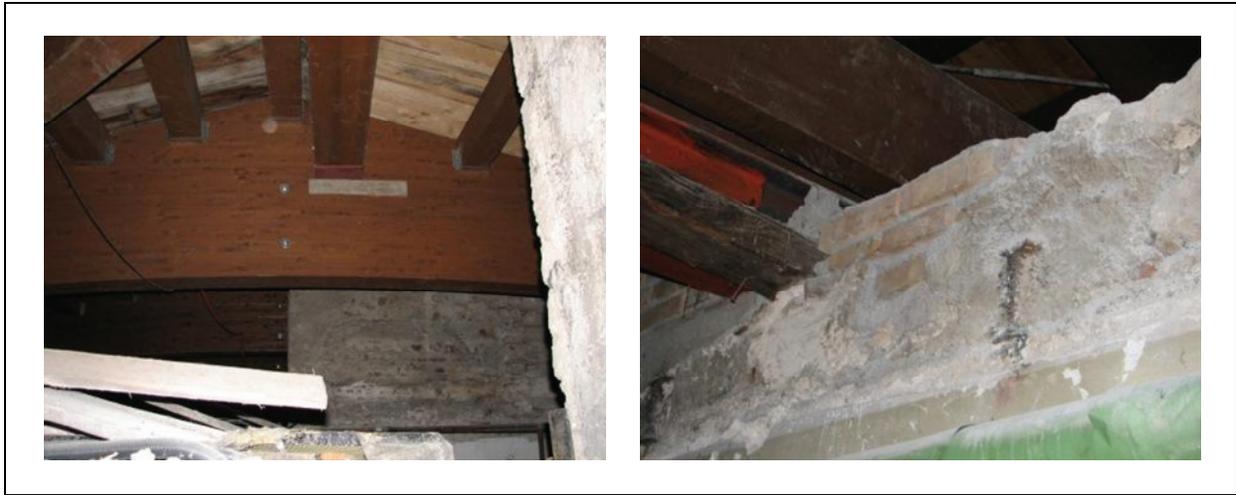
Figure 5-103 Wooden roof and ring beam of Palazzo Margherita

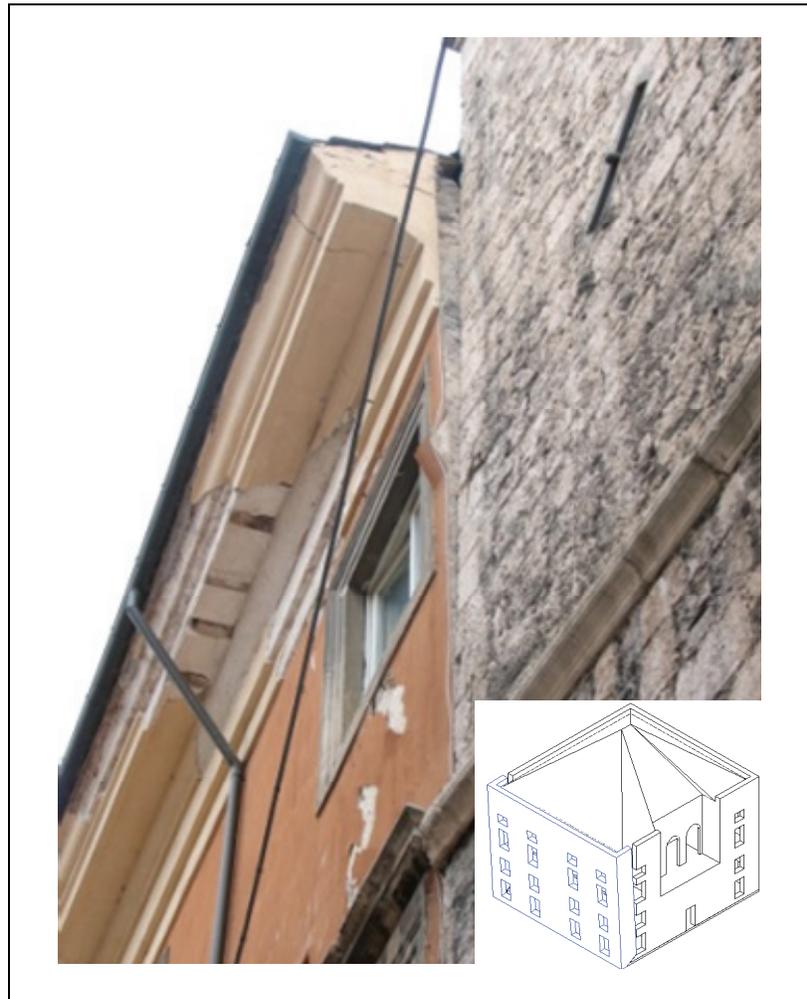
The absence of tie rods on the exterior south wall facing Via delle Aquile, developed a simple overturning of the facade with displacements at the top bigger than 10cm, well visible in Figure 5-104. The presence of the top RC ring beam was not sufficient to guarantee the box behavior of the building, but it was essential in avoiding the collapse of the palace. The wooden roof was restored in early 1990 and it is a no pushing wooden roof (Figure 5-103).

Figure 5-104 Overturning of the external wall in Via delle Aquile

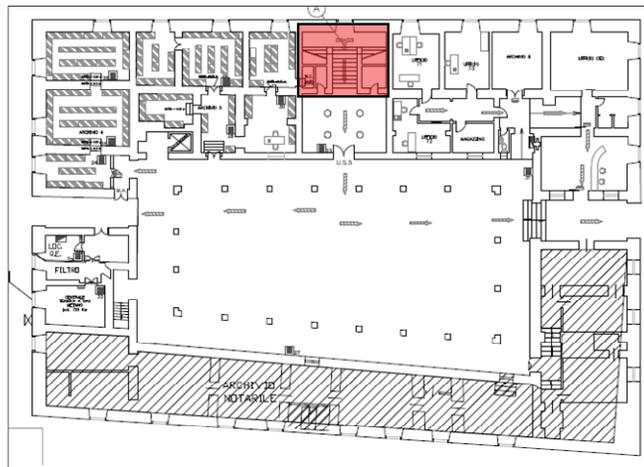
Figure 5-109 Location of the stairs in the plan

In Figure 5-107 and Figure 5-108, visible cracks due to shear in the vaults of the stairs that are highlighted in red in the plan view in Figure 5-109 are clearly seen. The higher stiffness of the stairs with respect to the rest of the building attracted the seismic forces.

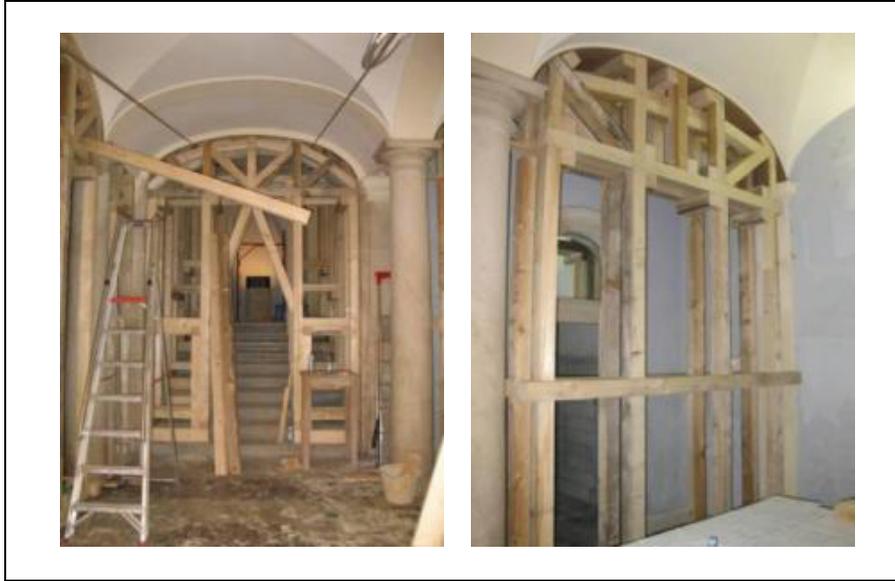
Figure 5-110 Shoring up retrofit interventions in the stair of Margherita Palace with wooden restraint props

In order to avoid collapse of the low vaults, wooden restraint props were located to support the weaker part of the building (Figure 5-110).

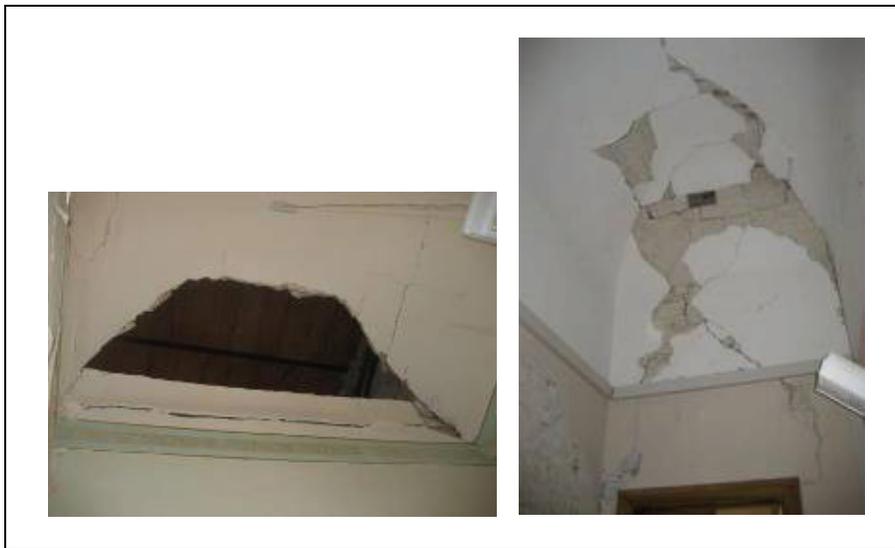
In many places inside the building, collapse of slim false vaults such as the one shown in Figure 5-111 have been observed.

Figure 5-111 Partial collapse of the brick cross vaults (vaulted brick sheet)

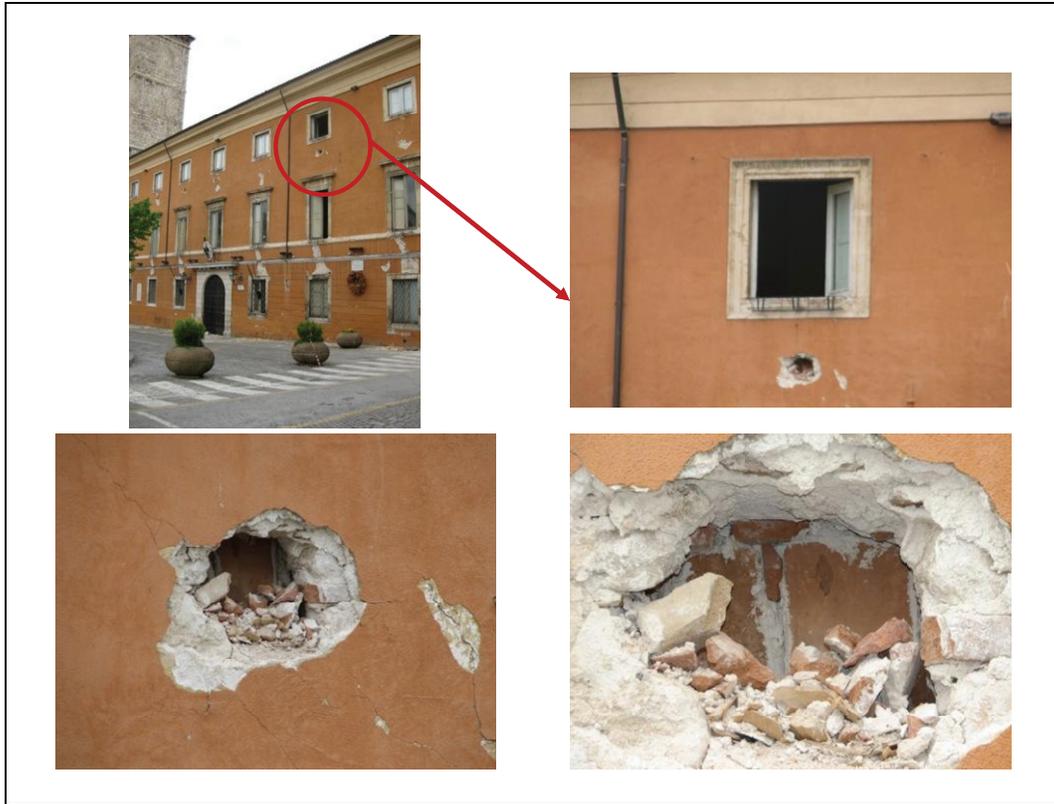
cracks were higher with respect to the floor level and they were in correspondence of each window. The presence of the radiators located below the windows and the pipelines connecting the radiators to the walls, determined the spill out of the cover of the hole that was used in the old times to support the scaffolding system (Figure 5-112, Figure 5-113 and Figure 5-114).

Figure 5-114 Detail of the hammering of the pipelines of the heating system that spill out the cover of the holes that were used in the old times to support the scaffolding system on the facade of Piazza Palazzo

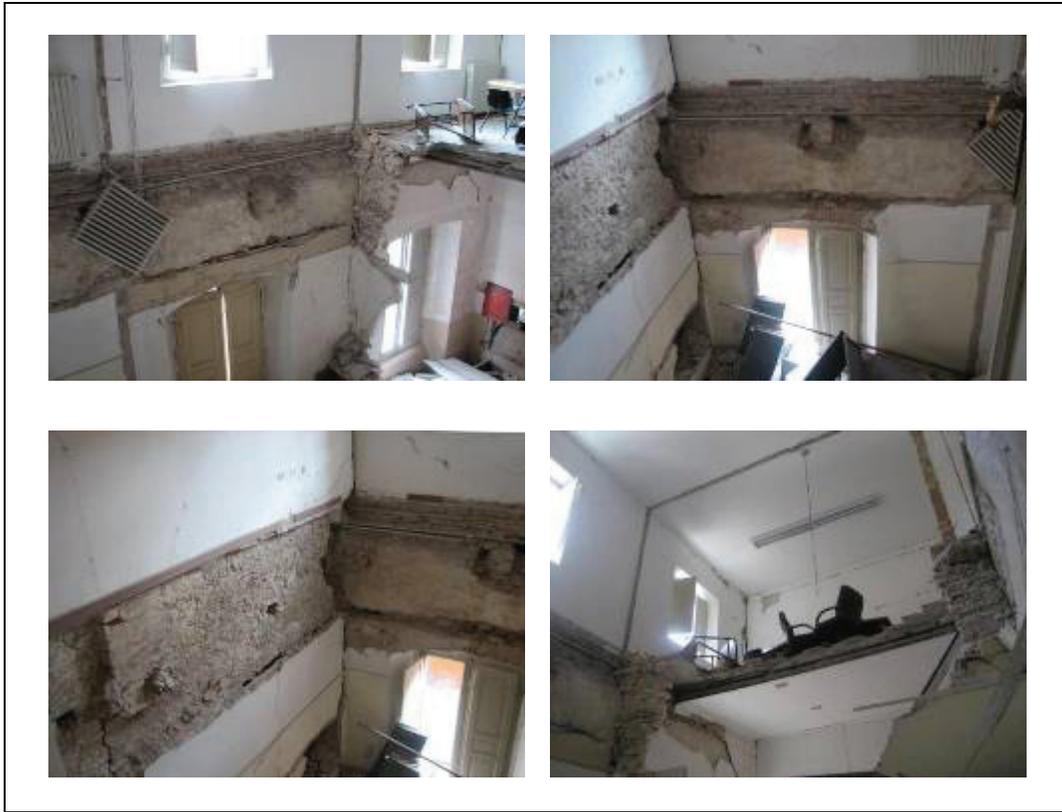
The absence of tie rods on the North side and the presence of vaults in conjunction to the poor connectivity between the floor beams and the masonry walls, determined the local collapse of the floor slab at the second level (Figure 5-115 and Figure 5-116). In addition, it contributed to the collapse of the floor also because of the large distance (more than 7m) between the main orthogonal walls.

Figure 5-115 Collapse of the floor slab on the north wing (Via Bafile)

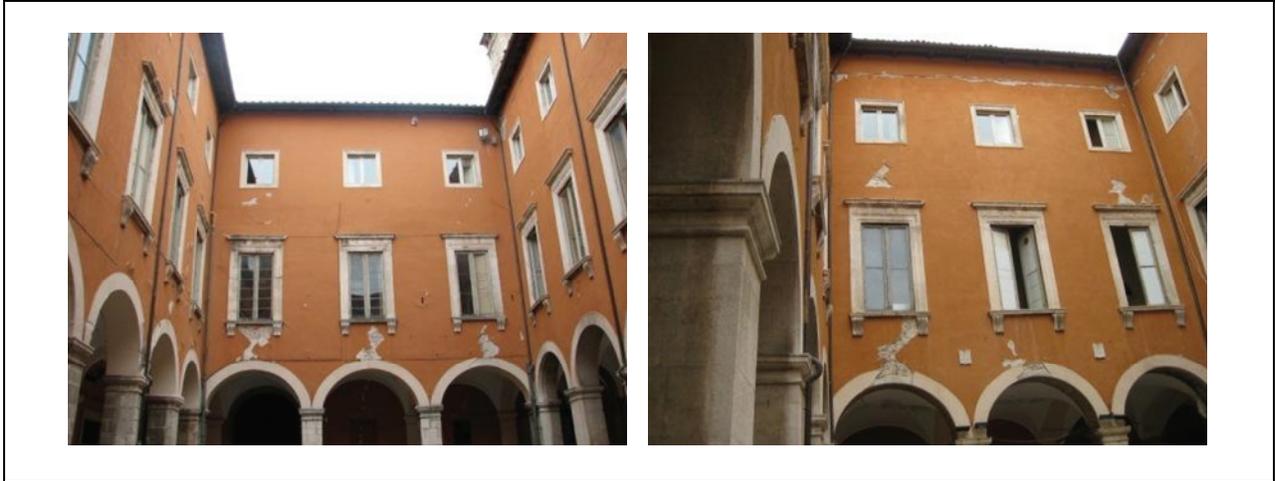
The damage mechanism presented in Figure 5-117 can be observed frequently in the buildings damaged by a seismic event, however it is not considered dangerous for the stability of the building, because damage due to shear cracks in the building allows carrying vertical loads anyway. The presence of shear cracks in the inter-story strips is explained due to the small thickness and the lower strength of the masonry strip with respect to the main bearing walls. This mechanism can be observed in the internal walls of the courtyard in Figure 5-118.

Figure 5-118 Cracks in the masonry strips of the internal walls of the courtyard

In Figure 5-118, the RC ring beam located at the top below the roof and realized by the architect Macri` in the early 90's can be observed. The goal of the intervention was to guarantee a box behavior according to the seismic standard. This can be considered as one of the few examples where the ring beam had a beneficial effect in preventing the collapse of the building.

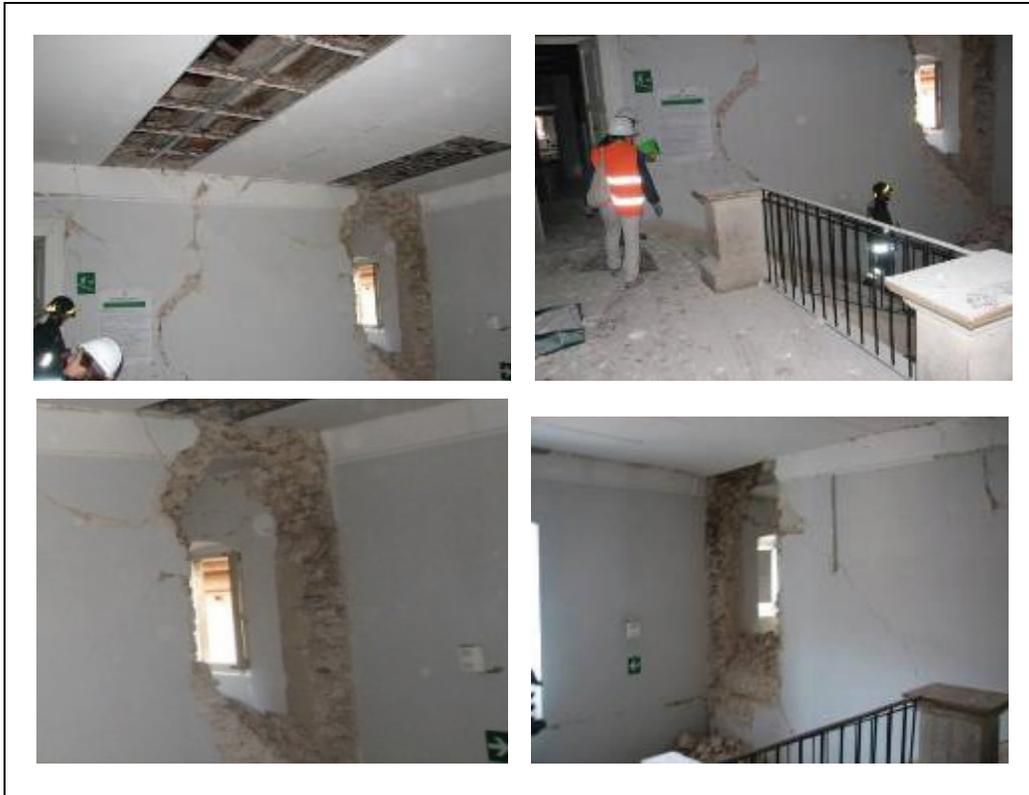
The partial overturning of the orthogonal wall occurred nearby the stairs and was triggered by the bad quality of the masonry structure (Figure 5-119). Similar overturning mechanisms appeared to the internal partition walls (Figure 5-120).

Figure 5-119 Simple overturning of the masonry at the second floor nearby the stairs due to the bad quality of the masonry

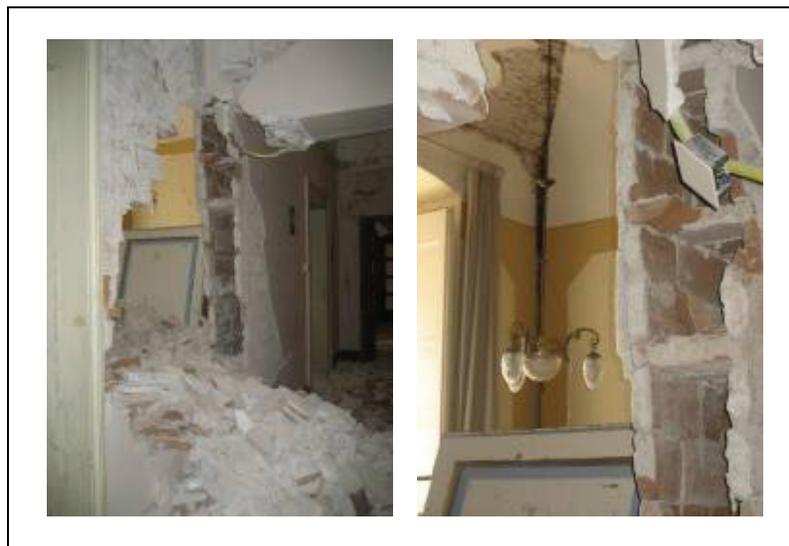
Figure 5-120 Simple overturning mechanism of a partition wall made with brick sheet

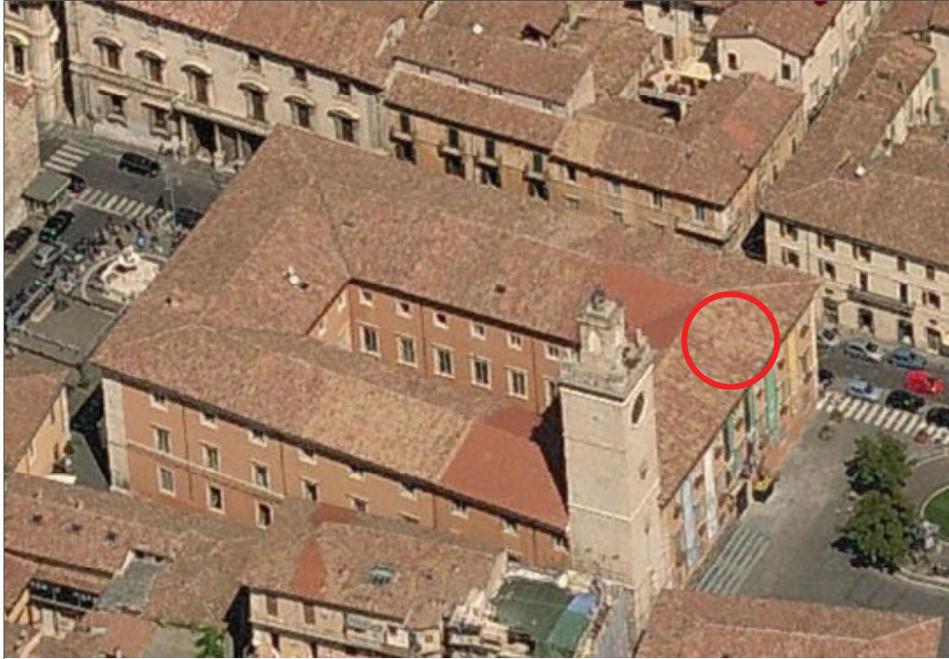
Figure 5-121 Aerial view of the roof of the Palace

Flexural deformations of the beam supporting the roof was observed at the east wing of Piazza Palazzo (Figure 5-123), at the location marked with a red circle in Figure 5-121.

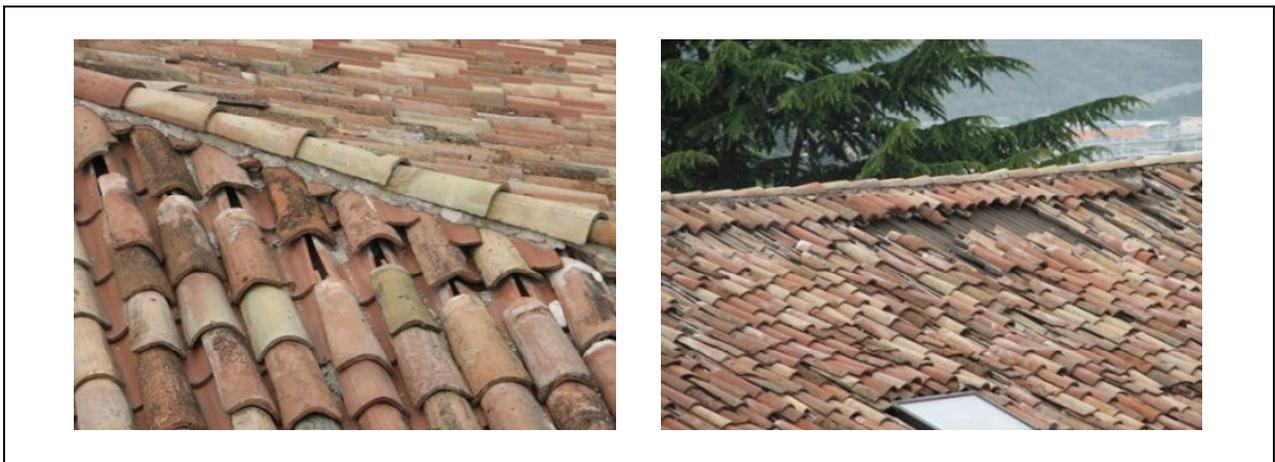
Tails have been moved at the roof level due to the seismic event (Figure 5-122).

Figure 5-122 Damage to the roof cover

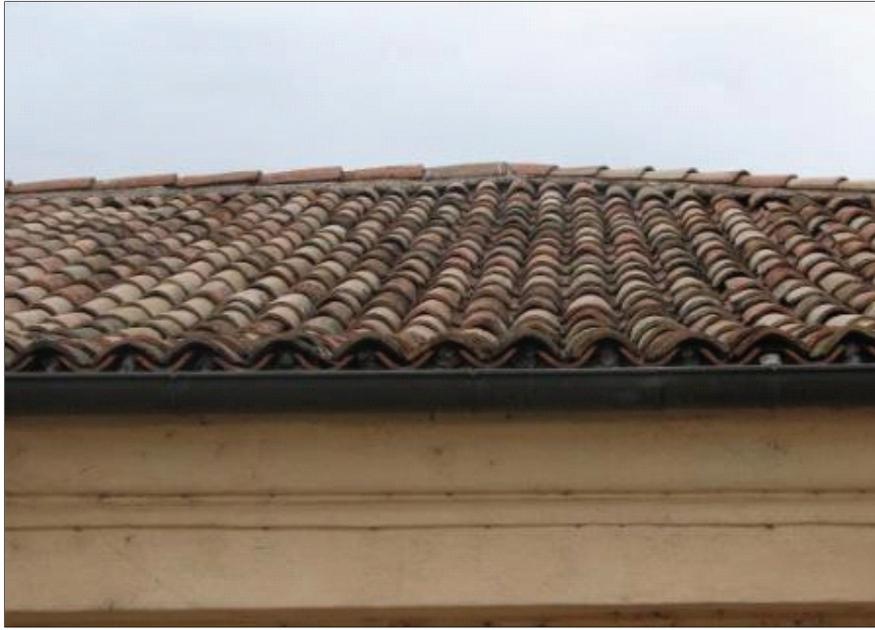
Figure 5-123 Bending of the beam supporting the roof

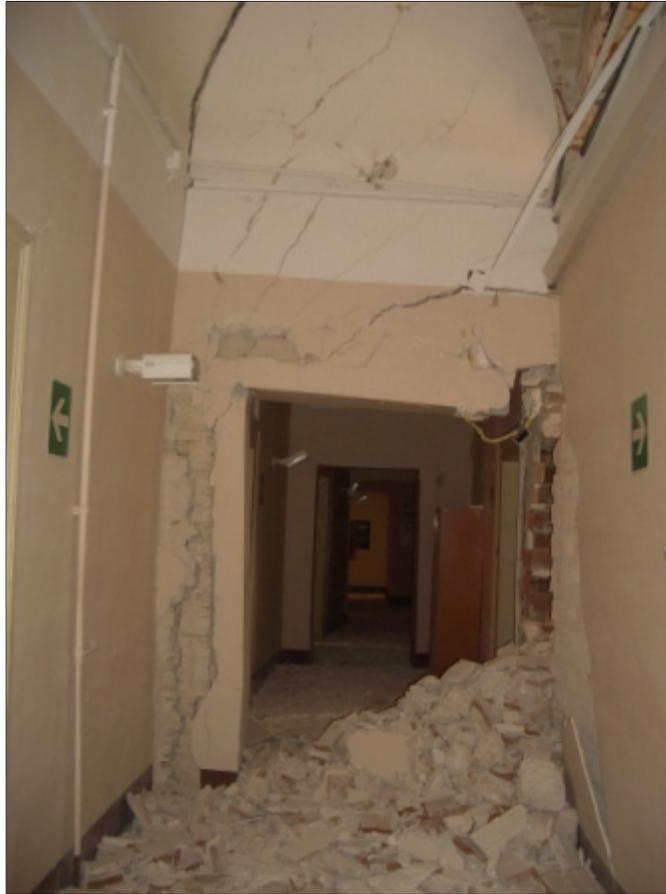
In several offices and corridors, X-shaped cracks were observed at the internal walls (Figure 5-124), typically close to the openings that most likely weaken the masonry walls. The internal walls damaged due to shear cracks are always able to carry gravity loads, therefore this mechanism is not considered dangerous for the stability of the building. However, the presence of irregular and spread cracks as the ones shown in Figure 5-124 is an indicator of masonry without monolithic behavior.

Figure 5-124 Cracks due to shear in the internal masonry walls of the corridor

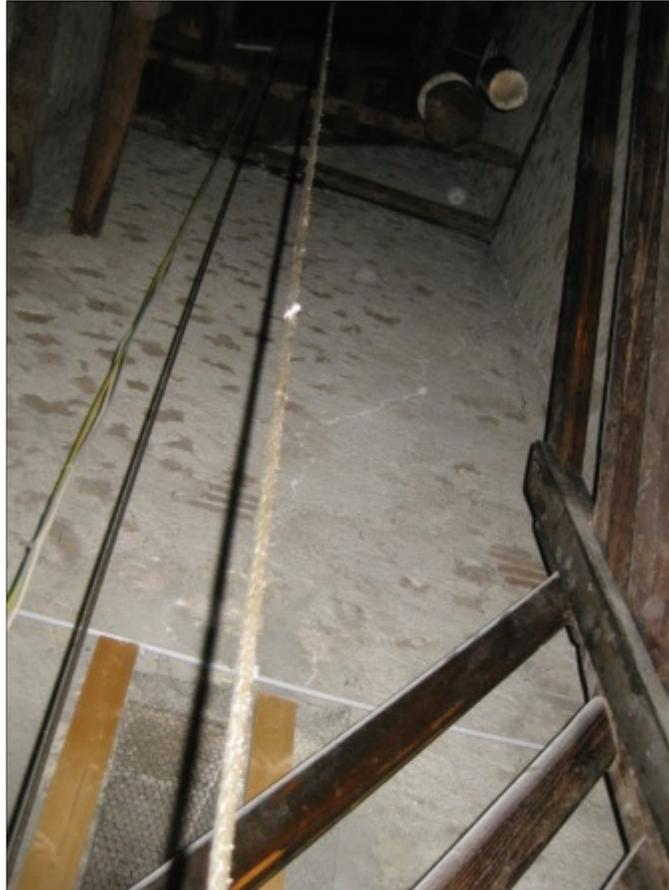
about 2 m with an external cover of limestone squared blocks. In correspondence of the second level there is an internal cladding of one head topped brick inside the tower (Figure 5-125). It was realized probably after the earthquake of 1703 and it reduces through the tower height. The access to the tower clock is possible through a wooden stair that rotates around the tower and is shown in Figure 5-125.

Figure 5-125 Brick internal cover inside the Civic Tower

In Figure 5-125 and in Figure 5-126 are visible the vertical cracks along the entire West wall of the tower. The presence of tie rods in Figure 5-126 avoided the effects of buckling from 10 m up. In fact, the wise location of the tie rods (Figure 5-127) in both directions of the Civic Tower conferred to the tower a box behavior especially in the upper part, thus avoiding collapse during the earthquake of April 6th.

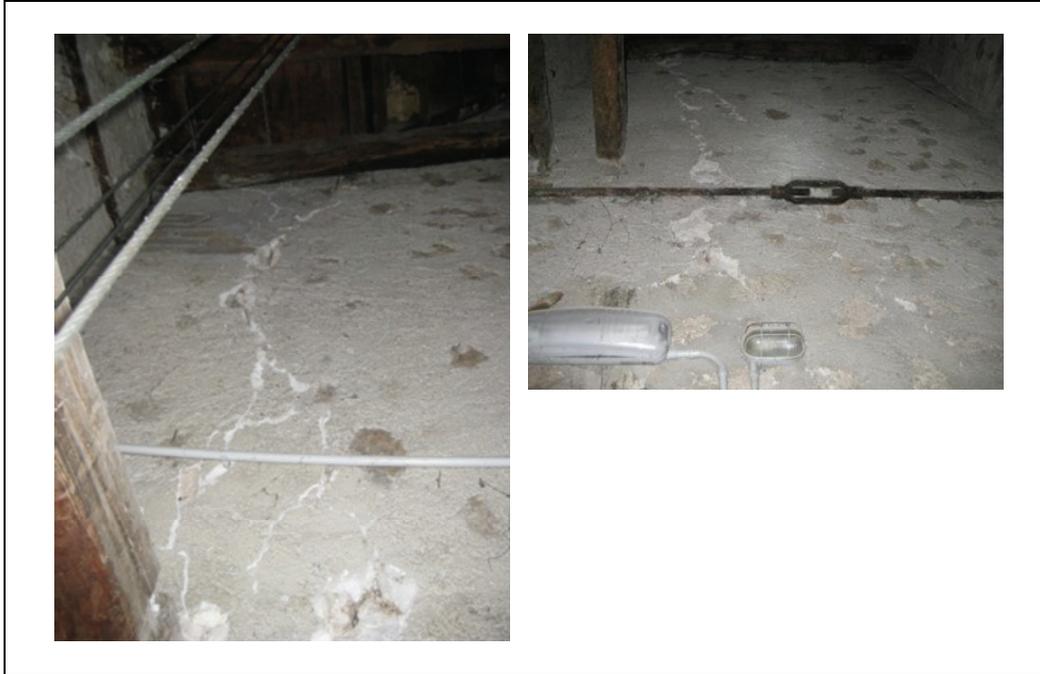
Figure 5-126 Observed vertical cracks in correspondence of the second level

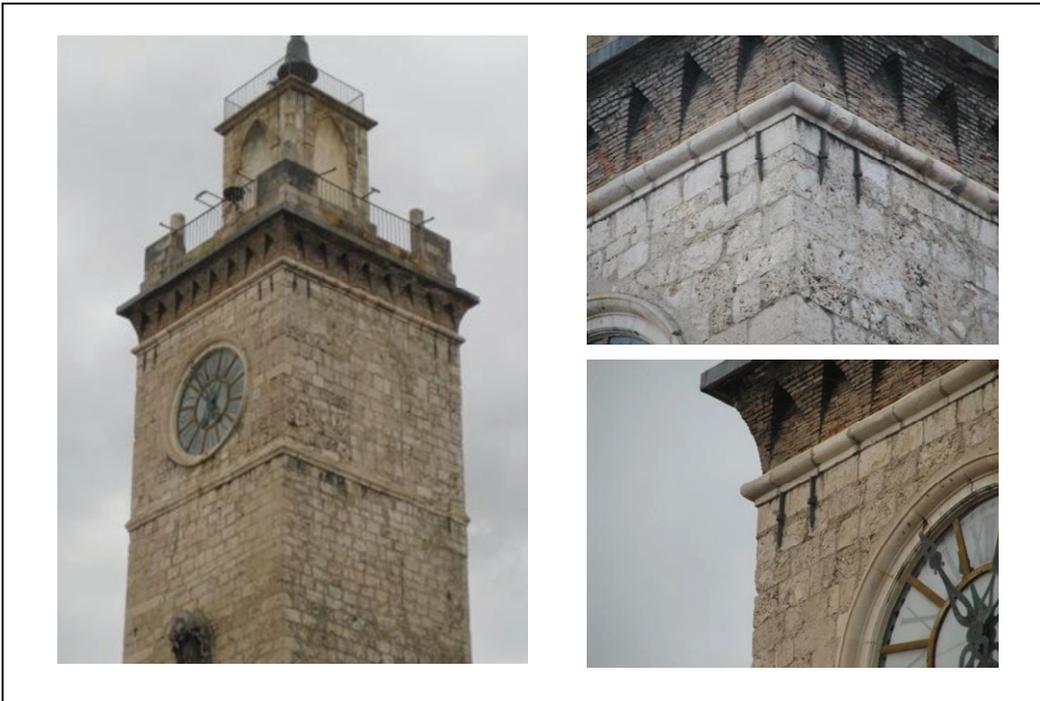
Figure 5-127 Tie rods located near the tower clock

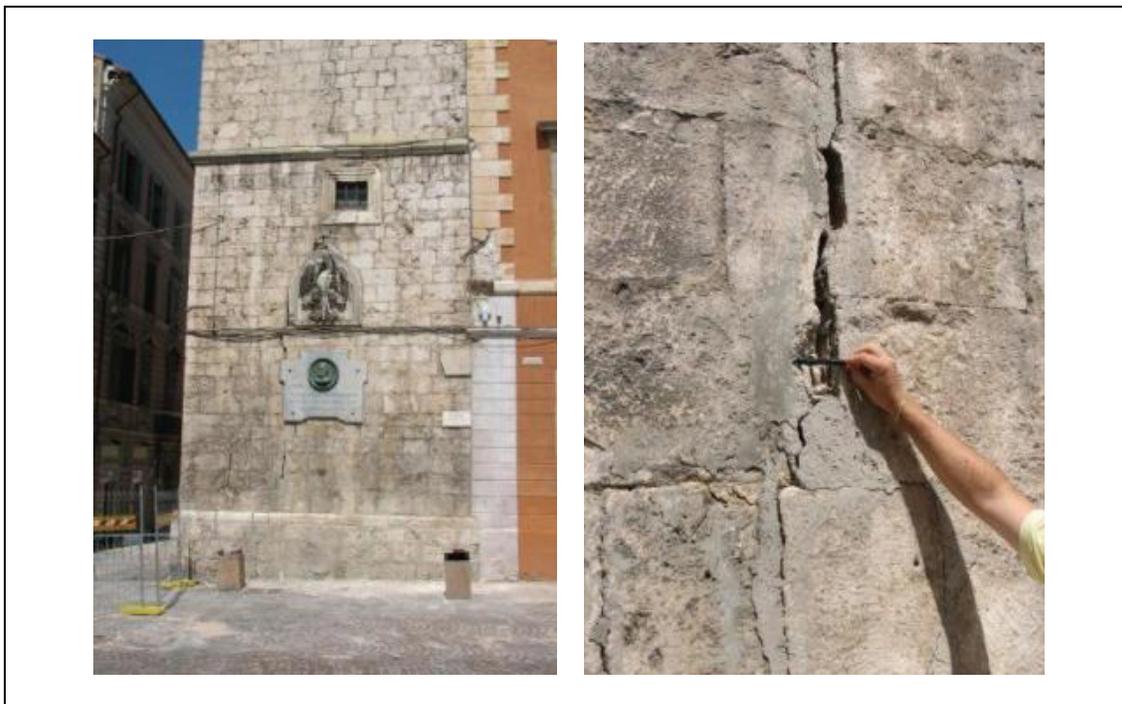
Figure 5-128 Vertical cracks at the base of the tower in the East side of Piazza Palazzo

The tower was supported by the adjacent palace on the north and west side, but the lack of an equivalent stiffness in the south and east side has led to a stress concentration in the southeast corner at the base that caused the formation of cracks and the subsequent rupture of one of the rods on the south wall (Figure 5-129). The extent of cracks is more than 2 cm as shown in Figure 5-128. The presence of the crack pattern in Figure 5-128 was generated by the poor confinement effects of the tie rods at the base of the tower that have less density distribution with respect to the top. The cracks are also visible inside the chapel in Figure 5-130 and in Figure 5-131 and were probably favored by the presence of the opening in the walls.

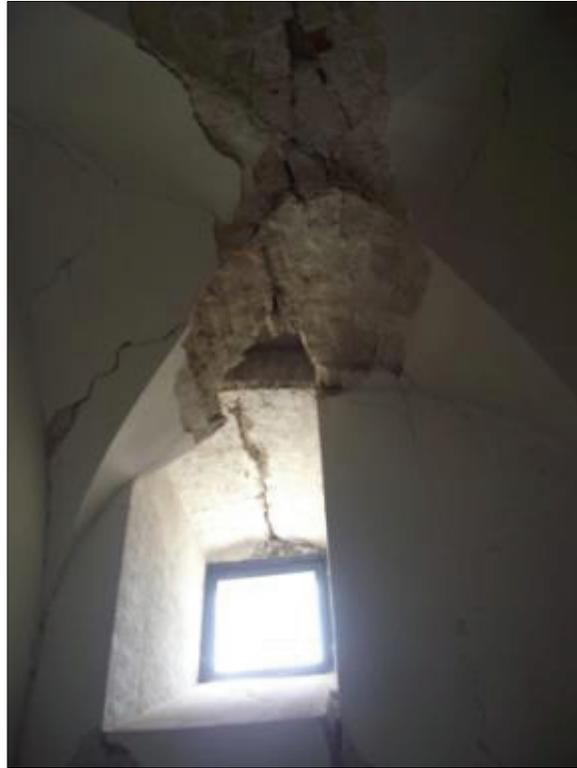
*Figure 5-130 Cracks in the cross vault and at the window of the chapel inside the Civic Tower
(Photo by Giacosa and Degiovanni)*

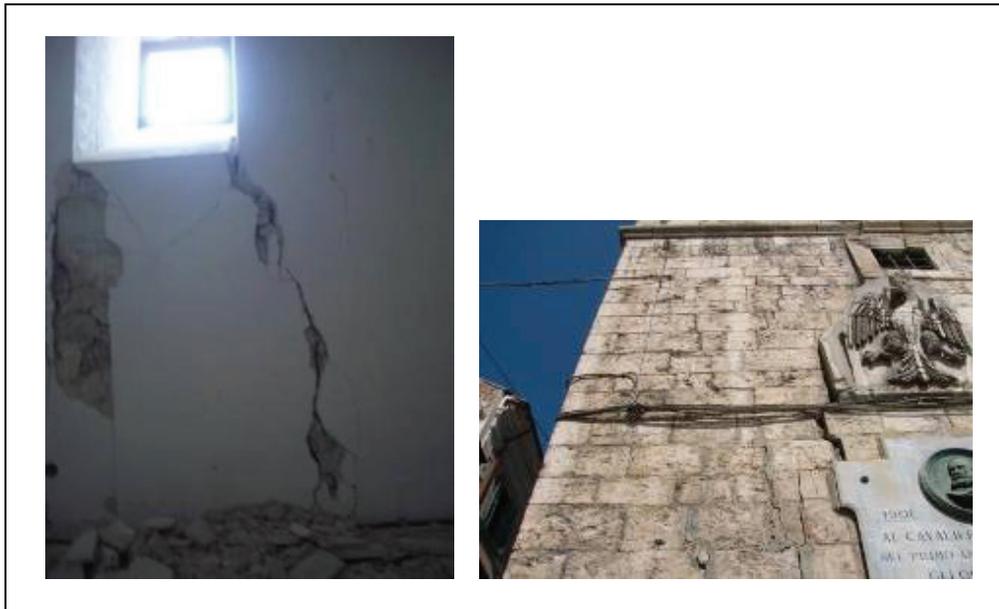
Figure 5-131 Cracks nearby the opening visible also from the outside

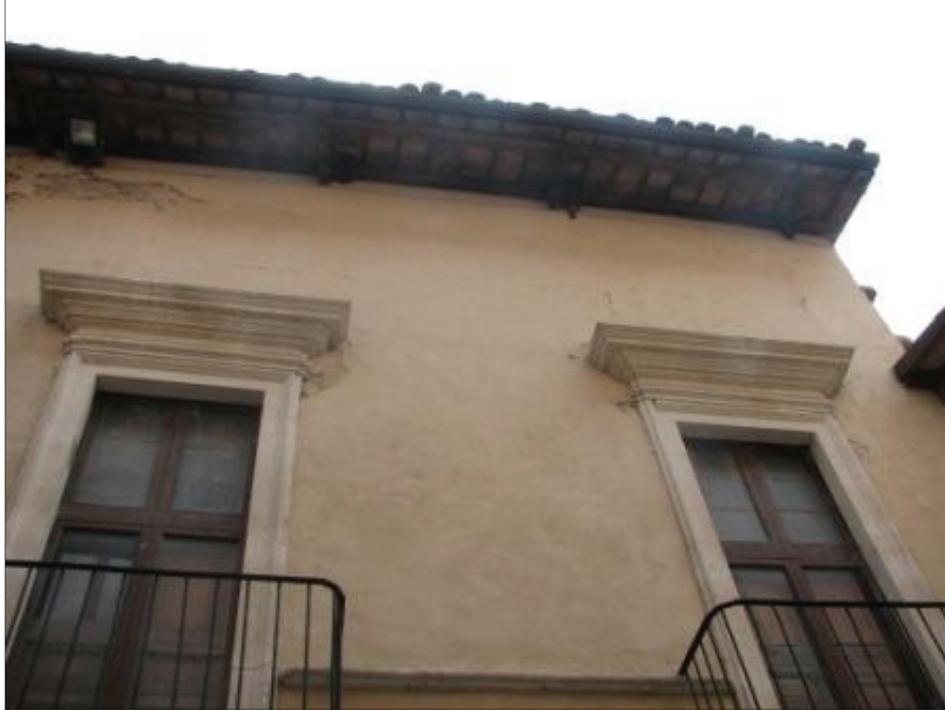
Previous restoration interventions were done recently in 2003 at the roof level and they had a positive effect on the seismic performance of the whole palace, because displacements between the roof and the external walls were limited as shown in Figure 5-135.

Figure 5-135 Horizontal cracks due to small displacements of the wooden roof

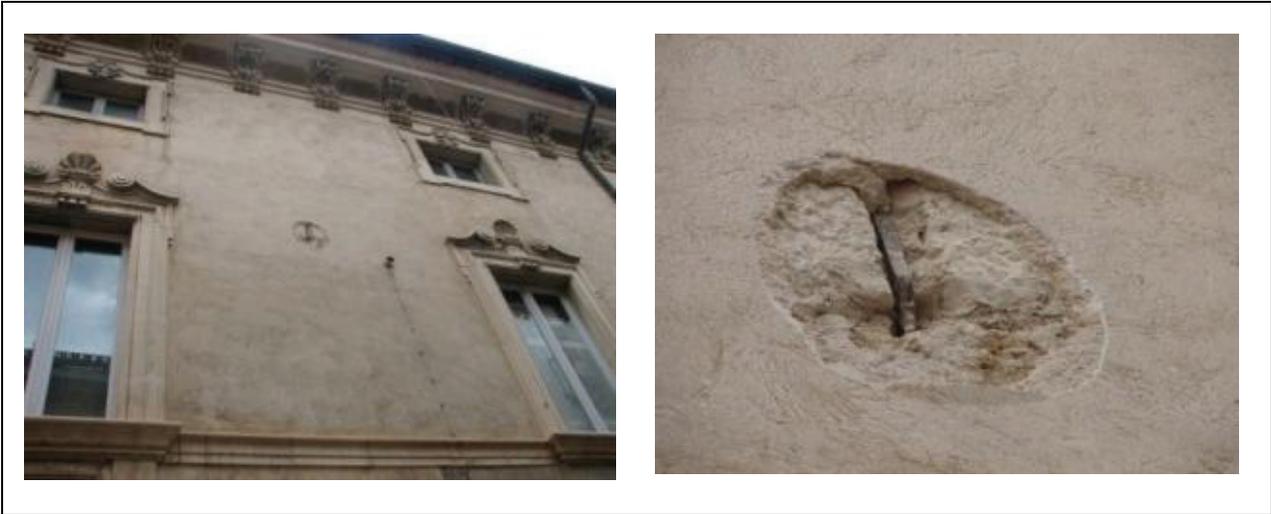
Damages were observed in the perimeter walls of the posterior court yard in the form of instabilities and shear cracks (Figure 5-136). Rotation of external perimeter walls was limited by the presence of tie rods that worked pretty well in tension and limited the damage inside the palace (Figure 5-137). However these retrofit interventions were not able to avoid the collapse of one of the floors due to excessive rotation of the vertical walls as shown in Figure 5-138.

Figure 5-137 Sign of tension in the tie rods located in the external perimeter walls

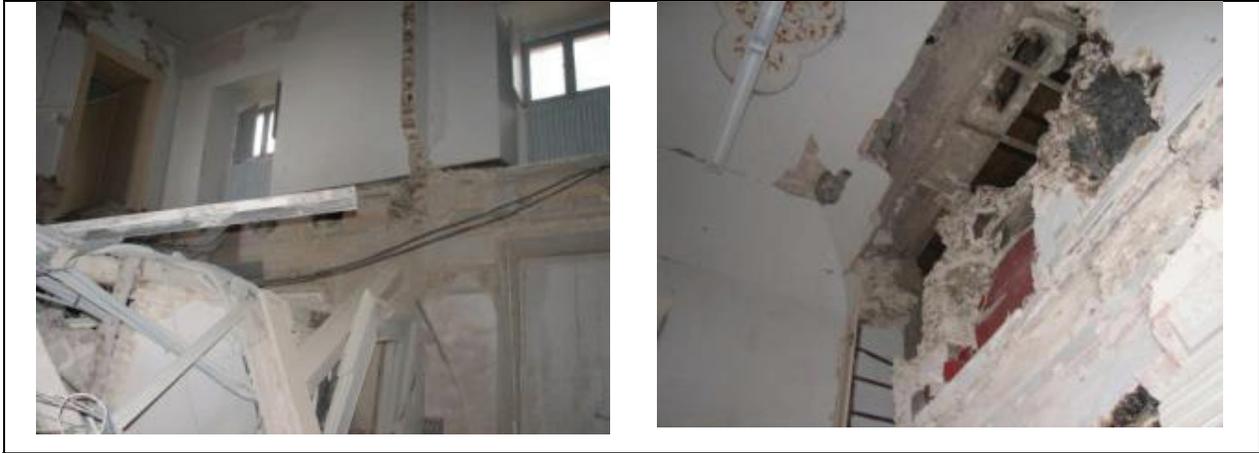
Figure 5-138 Collapse of the horizontal floor due to rotation of the lateral walls

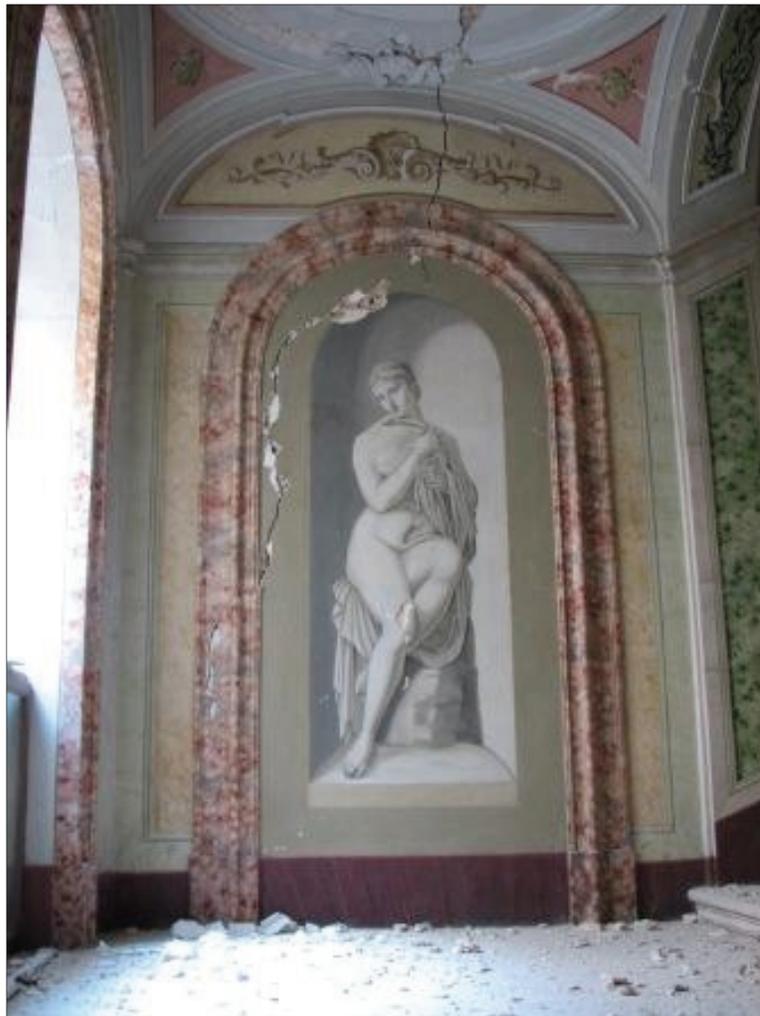
Figure 5-139 Vertical cracks in the vault staircase

Many cracks in the ceilings of the painted vaults of the staircase (Figure 5-139) and in the rooms of the first floor (Figure 5-140) were observed. Shear cracks (Figure 5-141) are present in the interior walls, proof of the good capability of dissipating energy of the whole structure.

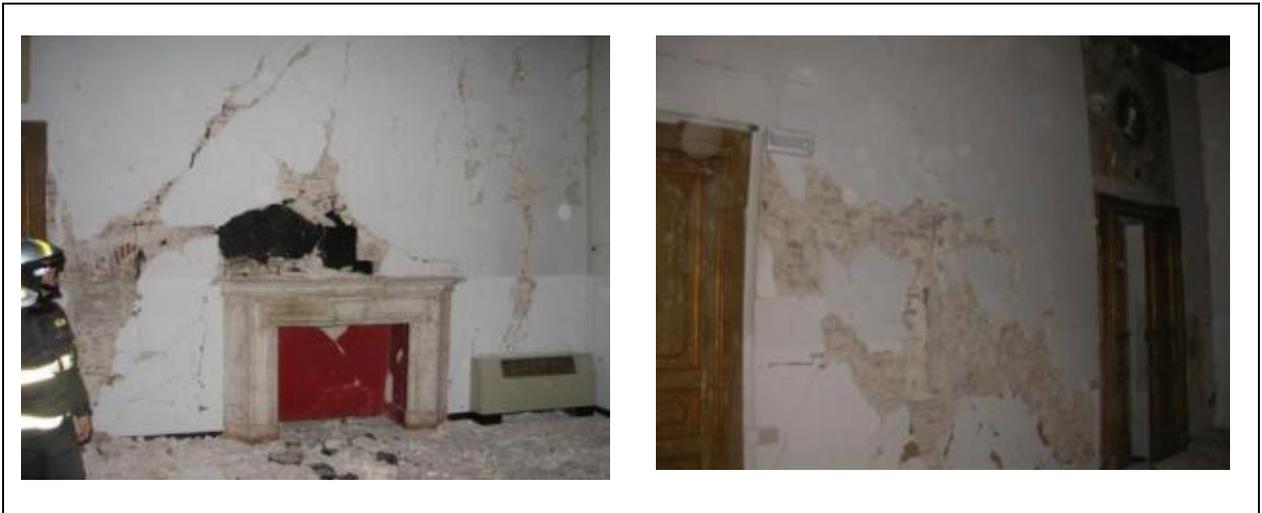
Figure 5-141 Shear cracks in the internal walls
