L'AQUILA EARTHQUAKE OF APRIL 6, 2009 IN ITALY: REBUILDING A RESILIENT CITY TO WITHSTAND MULTIPLE HAZARDS

by
**Gian Paolo Cimellaro, Ioannis P. Christovasilis,
Andrei M. Reinhorn, Alessandro De Stefano
and Tatiana Kirova**

Technical Report MCEER-10-0010

December 29, 2010

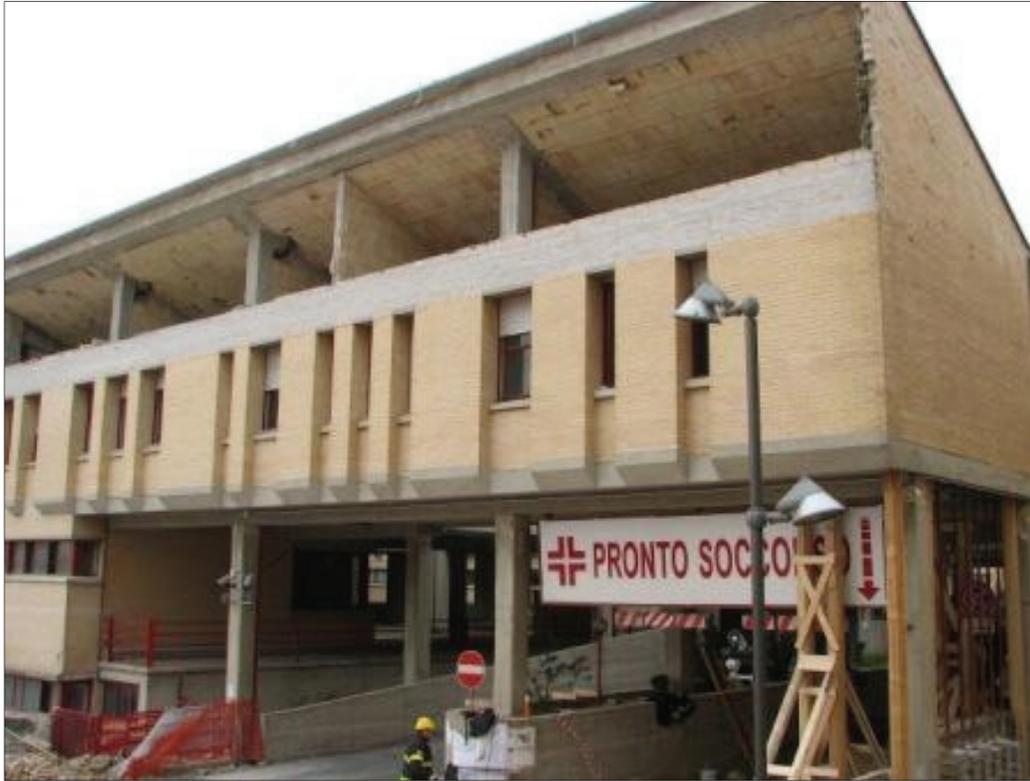
In the case shown in Figure 6-3, the out of plane mechanism was initiated by the attachment at the exterior walls of the advertisement signs of the San Salvatore hospital that collapsed blocking the entrance to the emergency walkway (Figure 6-4).

Figure 6-3 Out of plane mechanism of the exterior masonry walls at the entrance of the emergency walkway

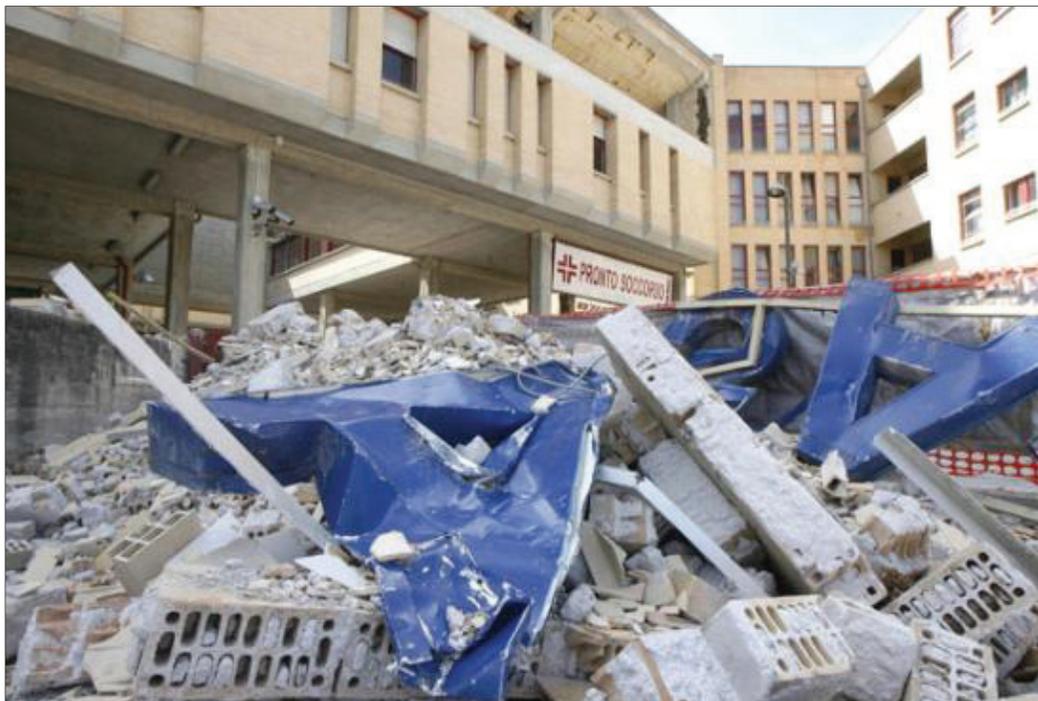
Figure 6-4 Entrance of the emergency walkway

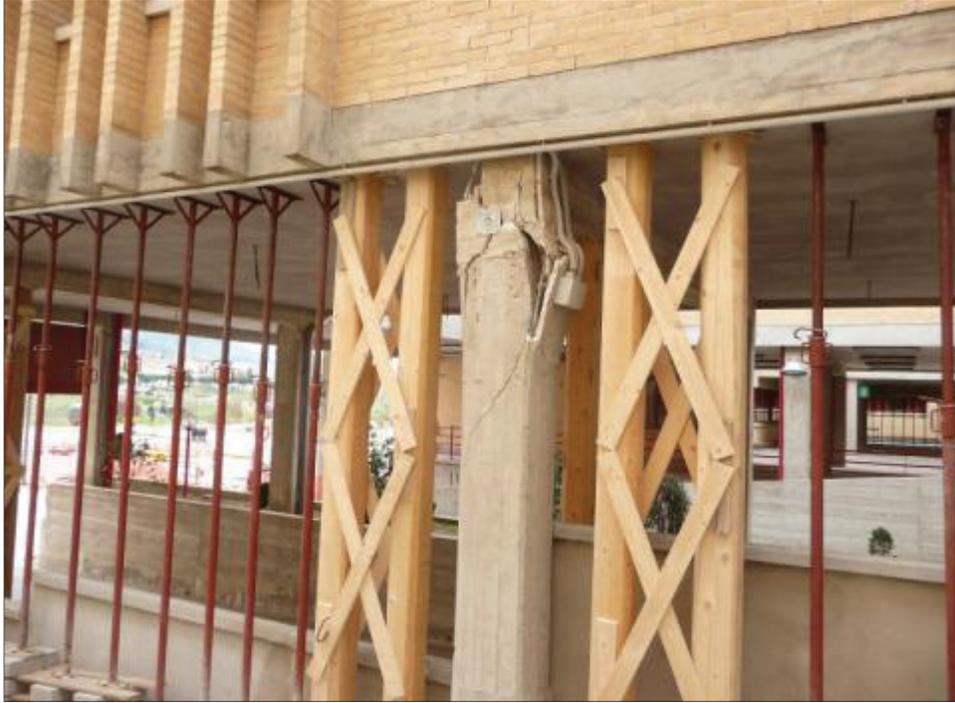
The hospital was shut down some hours after the earthquake, likely because of damage to various floors and to a few concrete columns in three of its many buildings (Figure 6-7). Patients were transferred elsewhere. Only 3 buildings out of 15 suffered considerable structural damage in the hospital, while there was relatively limited nonstructural damage in only a few buildings. The most widespread nonstructural damage was on the exterior façade bricks (Figure 6-2) that were partially or completely detached, because they were not attached to the interior walls.

The main structural damage was the shear failure of some columns of the covered walkway over the driveway to the Emergency Room (Figure 6-7) with spalling of the concrete cover with the consequent instability of the longitudinal reinforcement (Figure 6-8) due to the absence of transverse reinforcement.

Figure 6-7 Damage to column due to poor construction quality and propping intervention

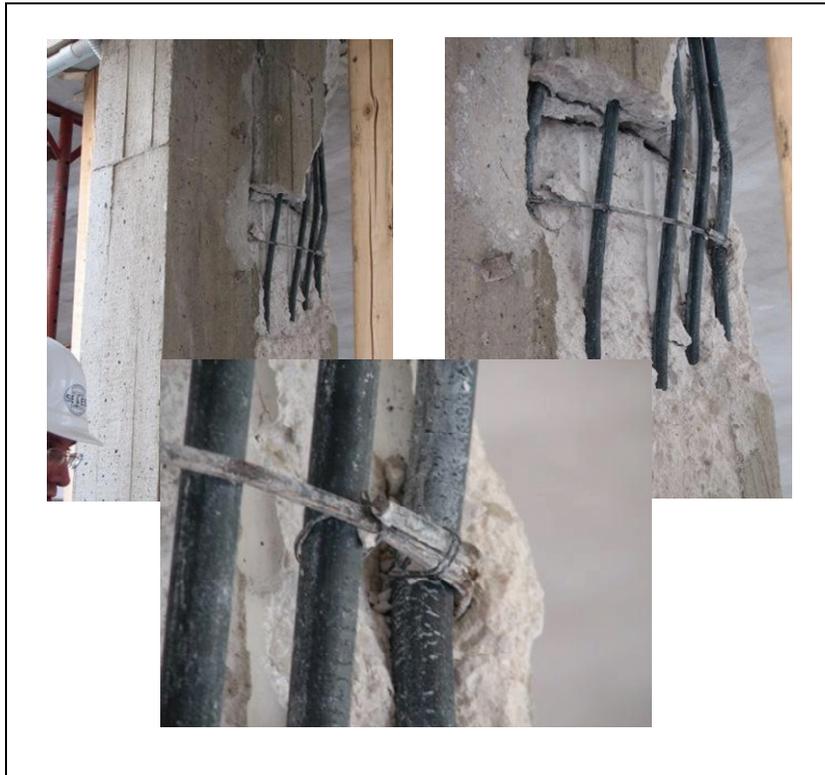
Figure 6-8 Instability of the longitudinal reinforcements due to inadequate transverse reinforcement with hoops of 6 mm and spacing of more than 25 cm

The presence of smooth bars indicates an old construction practice, but it cannot be considered as a cause of the failure of the column, because experimental tests proved their good performance during cyclic testing.

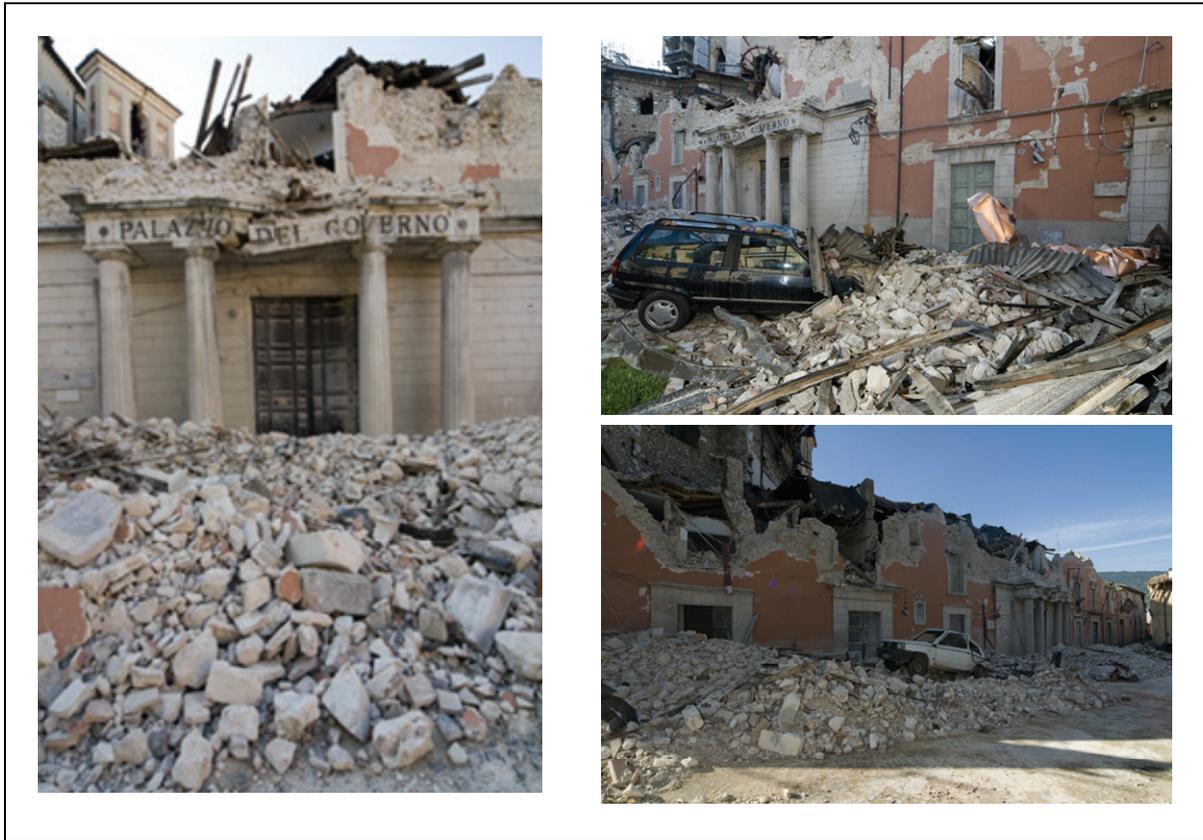
The Palazzo del Governo in Piazza della Repubblica, should have been the location of the emergency response of the Civil Protection Department. This building was declared as seismic vulnerable in a report written in June 2008, about a year before the earthquake. Due to April 6th

earthquake it completely collapsed, as shown in Figure 6-11, and only the four columns of the main entrance remained standing.

Figure 6-11 Governmental building

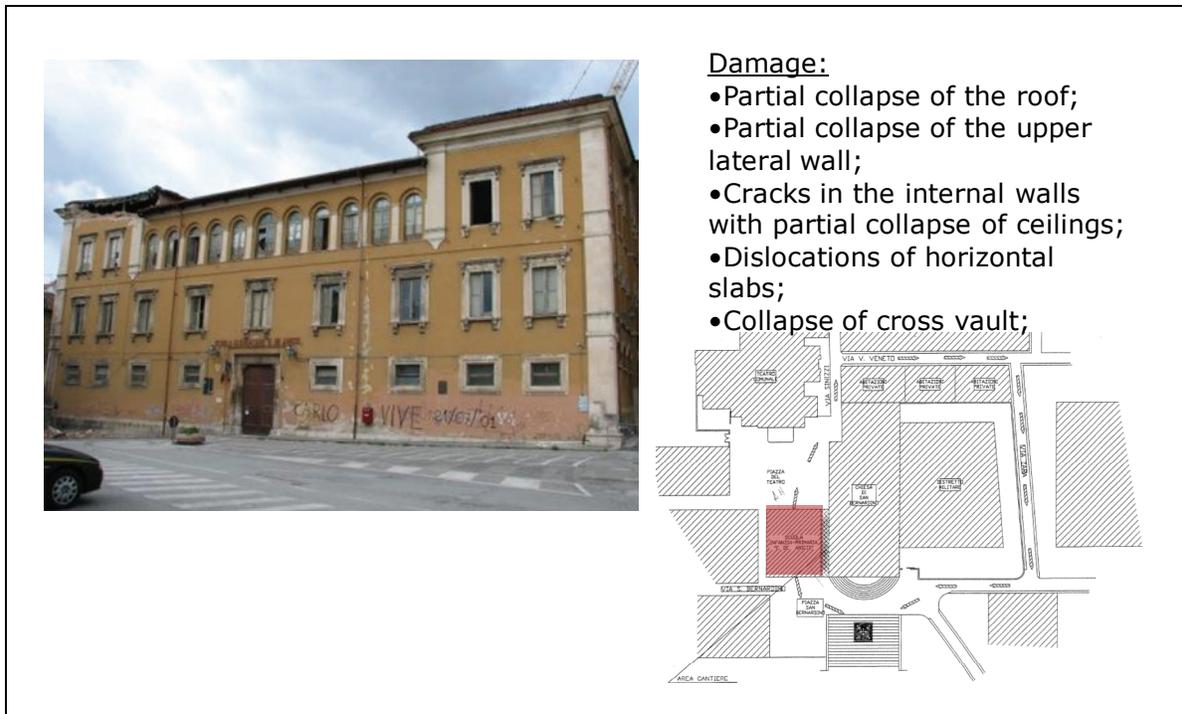
Figure 6-12 De Amicis Elementary school

Damage:

- Partial collapse of the roof;
- Partial collapse of the upper lateral wall;
- Cracks in the internal walls with partial collapse of ceilings;
- Dislocations of horizontal slabs;
- Collapse of cross vault;

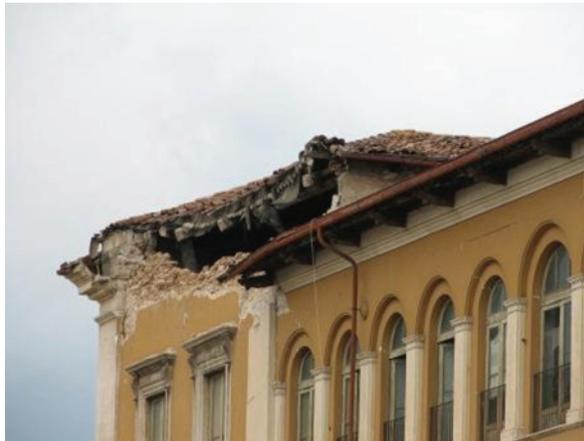
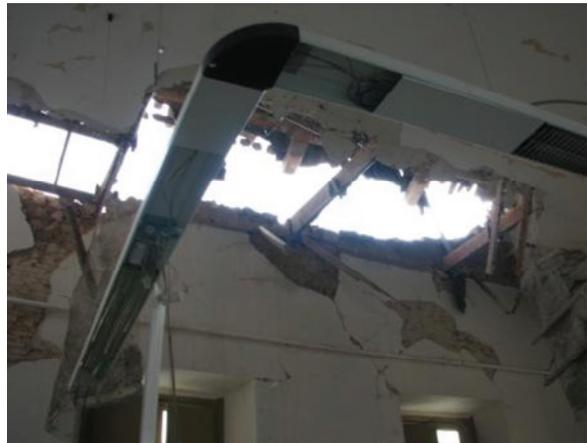
Damage:

- Overturning of the upper corner lateral wall;
- Partial collapse of the roof cover;

Figure 6-15 Damage to roof coverage due to composite tilt mechanism

The composite tilting mechanism was accompanied by dragging a piece of masonry belonging to the unconstrained corner. The mechanism has been probably triggered by the hammering of the roof wooden beams and by the poor quality of the masonry walls.

The horizontal flexure mechanism of the upper lateral walls has been triggered by the poor quality of connections between orthogonal walls and horizontal slabs, but also by the presence of the window openings, as shown in Figure 6-15.

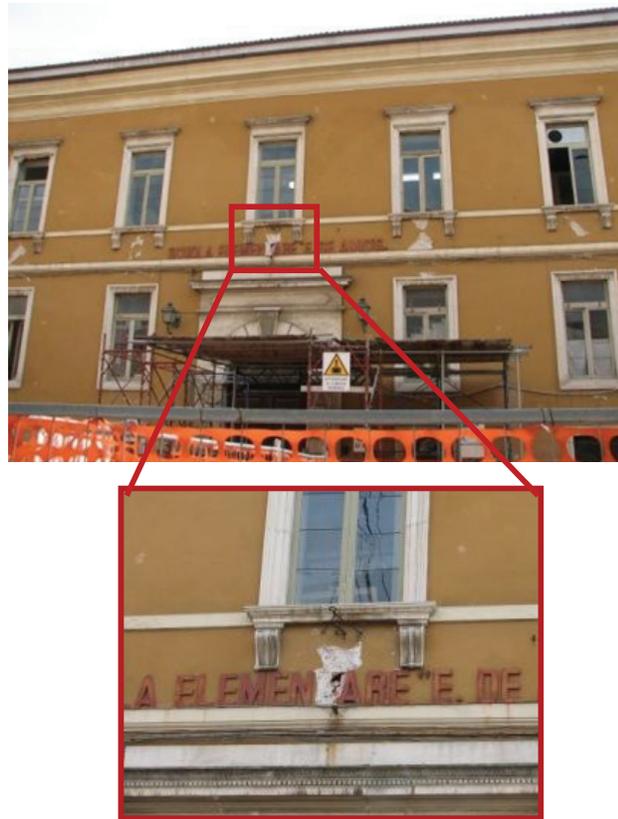
An interesting damage in the frontal facade has been observed both in the Elementary School “De Amicis” and in Margherita Palace (City Hall). Holes were observed in the external masonry walls below each window, therefore based on first observation it was thought that it was due to the hammering effect of the floor beams (Figure 6-17).

Damage:

- local damage in correspondence of the wall strips in the facade;

- damage to the front facade, due to the hammering of the radiator of the heating system;

Structural causes:

- radiator not effectively connected to the wall masonry.

Figure 6-17 Hammering of the radiators of the heating system that reopen the holes made for hanging the scaffold system

However, after checking the hole and its height more closely, it was concluded that that hole was already in the masonry and it was used in the last century to support the scaffold system. Eventually the holes were re-opened by the hammering effect of the radiators of the heating systems located below each window.

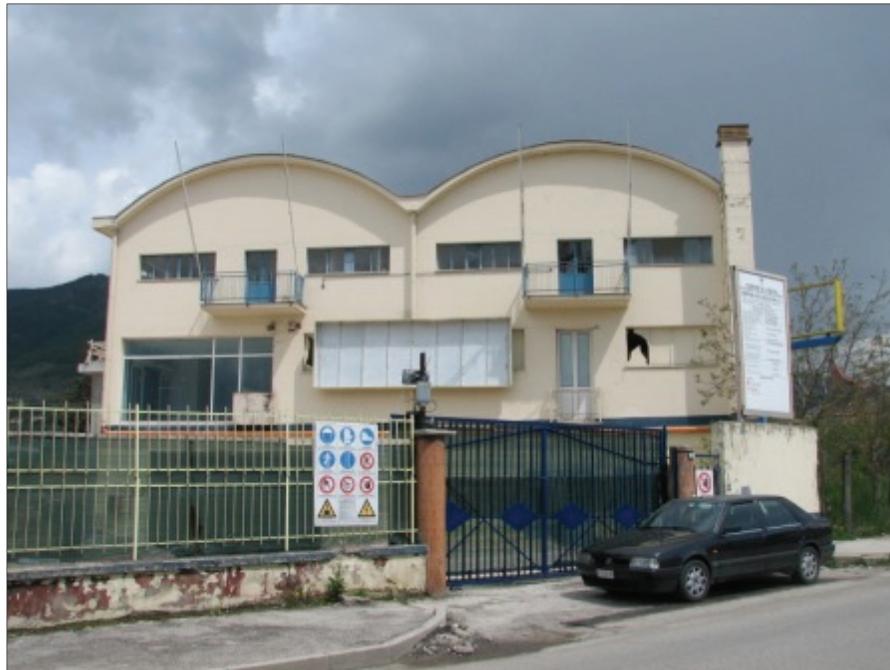
Several factories and industrial plants were located in the earthquake-affected area and suffered minor (Figure 6-21) to heavy damage during April 6th 2009 L'Aquila earthquake. The damage sustained by electrical and mechanical equipment, special structures e.g., on grade steel tanks, industrial buildings, and nonstructural and secondary components caused several industrial

Figure 6-21 Damage to windows

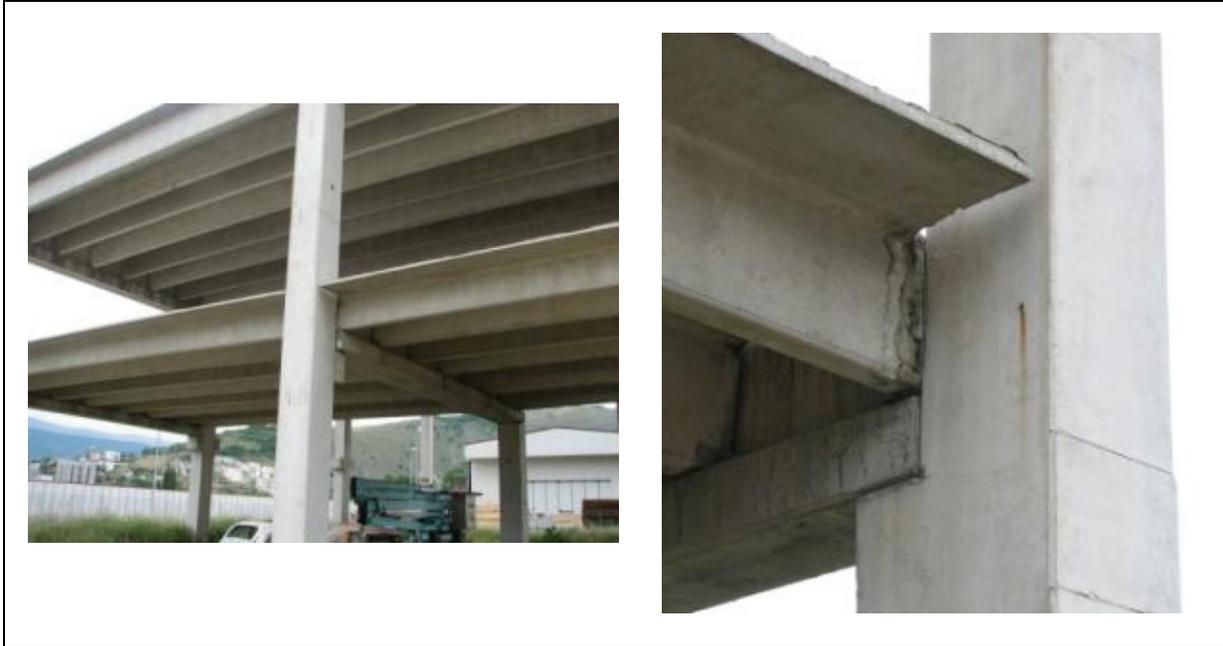
Most of the damage of the precast industrial buildings depends on the relative displacements at the connections between structural elements (Figure 6-22).

Figure 6-22 Relative displacement at the beam-column connection of precast elements

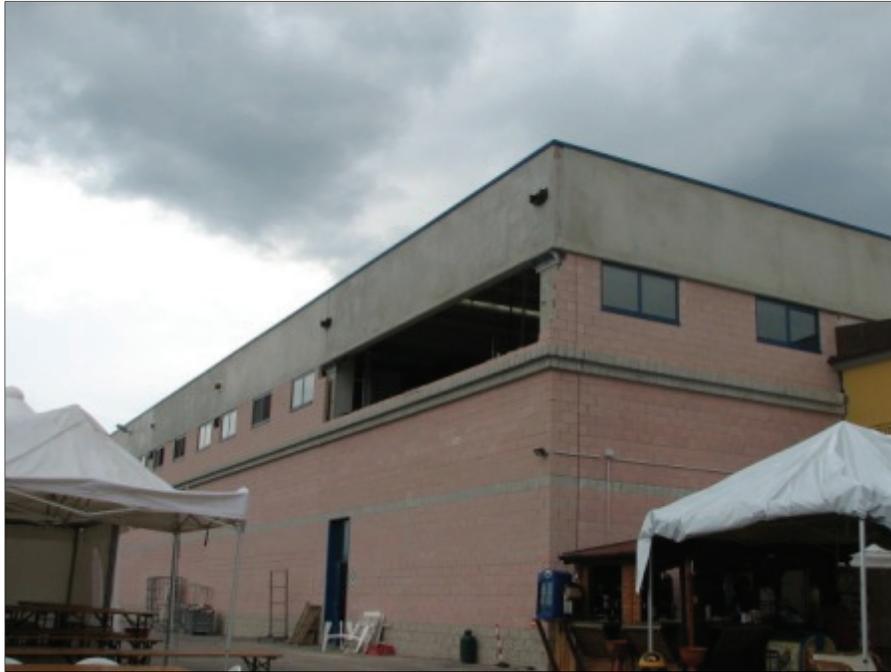
- Out-of-plane failure of the infill walls (Figure 6-24)
- Vertical cracks close to the wall-to-frame junction (Figure 6-25)
- Diagonal cracks at the wall panels

The observed damages are mostly related to their flexibility and to the inadequate performance of the connections. Lack of vertical and horizontal anchors and poor detailing were the main reasons for the damage.

Figure 6-24 Failure of the infill wall due to the lack of anchorage to the frame

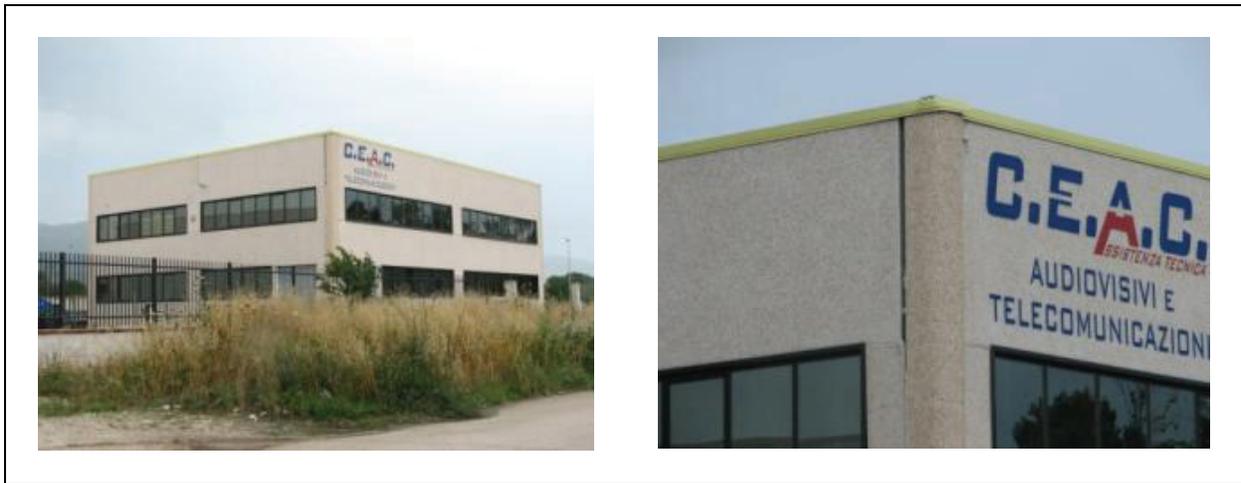
Figure 6-25 Vertical cracks close to the wall-to-frame junction

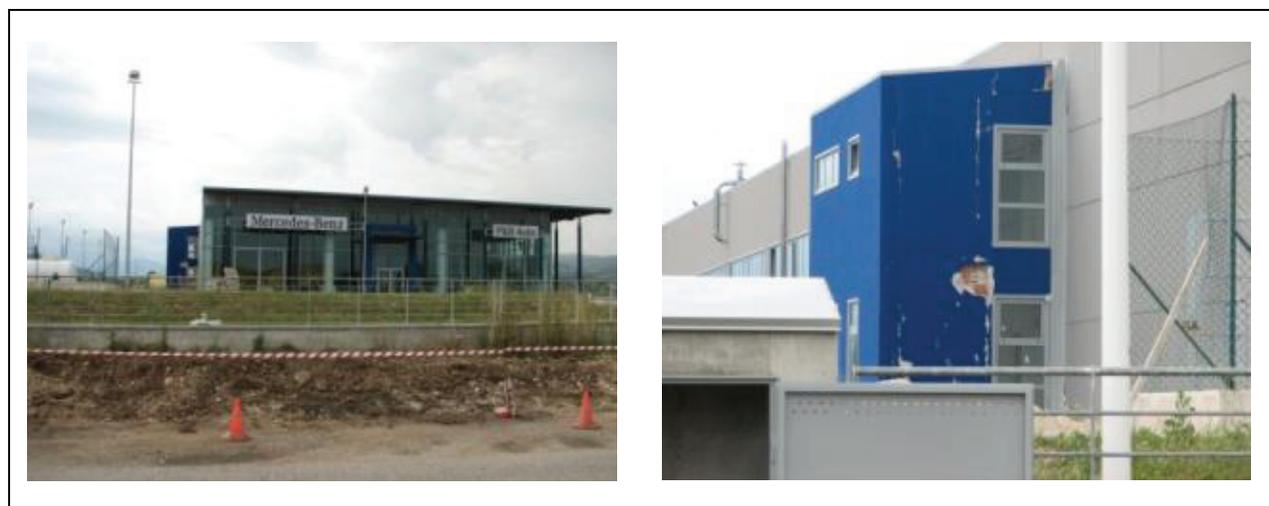
Figure 6-26 Car dealer

Many car dealers' shops in the region experienced structural and nonstructural damage (Figure 6-26).

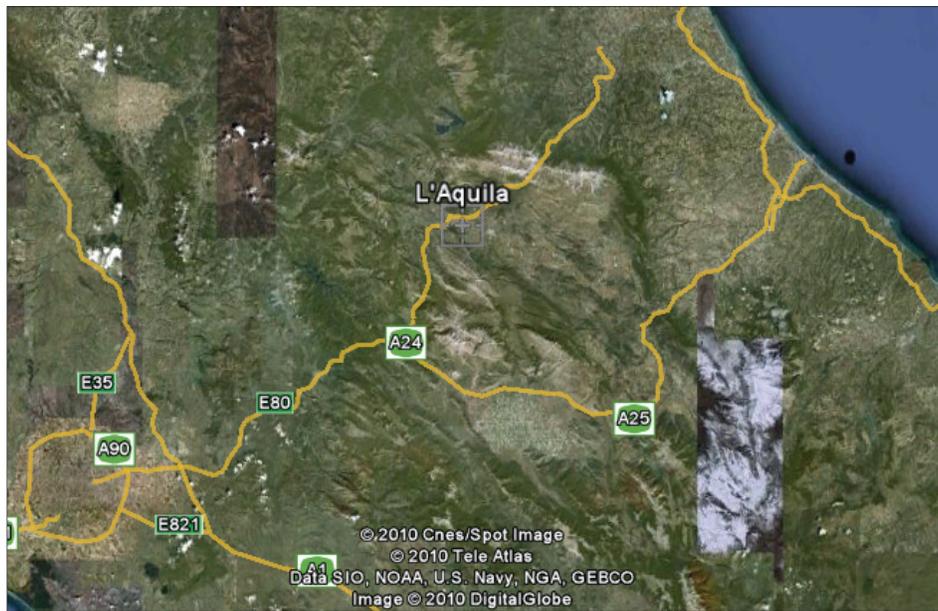
Figure 6-29 Map of the two main highways A24 and A25

The road network performed very well during this earthquake. The highway connecting L’Aquila with the city of Rome (A24) (Figure 6-27 and Figure 6-29) was closed only the day after the earthquake for security reasons in order to inspect bridges and viaducts, fixing all the dangerous situations that posed a safety threat.

Bearing failure has been observed in the viaduct of the A25 highway close to the town of Popoli at almost 40 km from the epicenter.

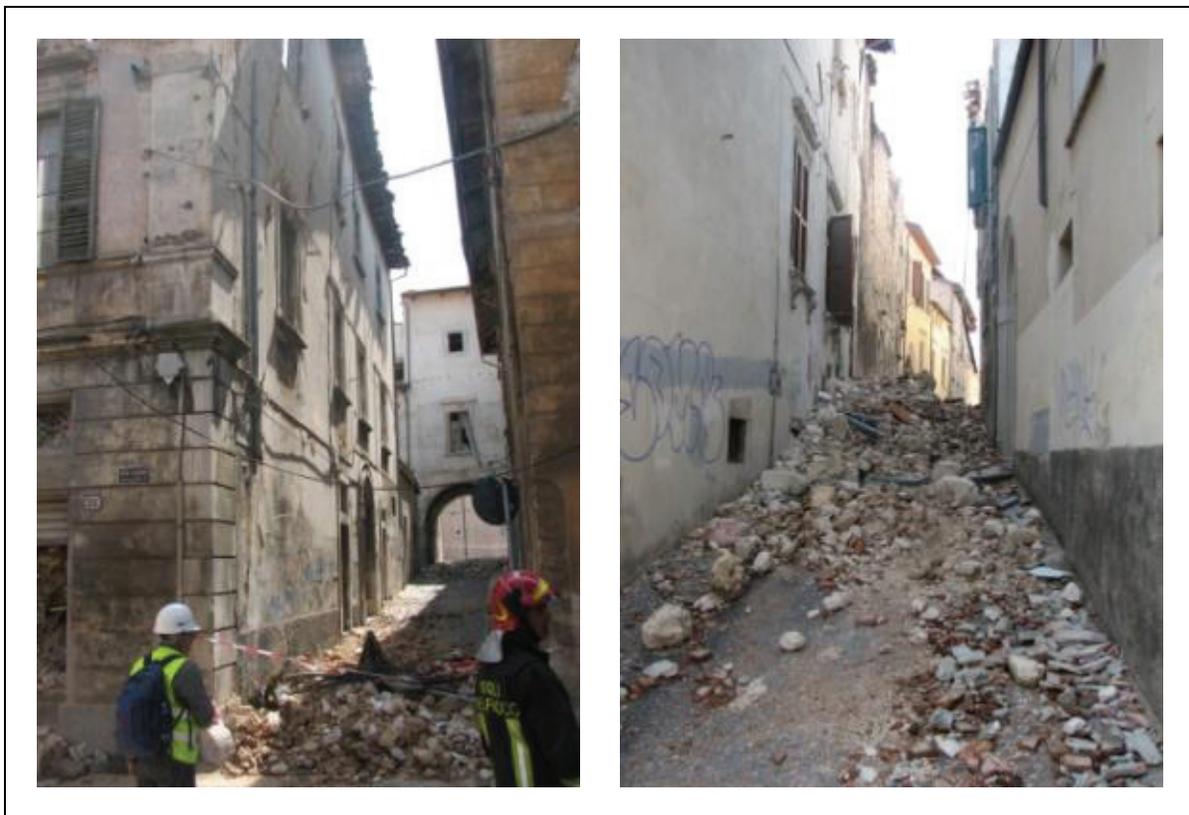
Regarding the historical center of L'Aquila and neighborhood towns, many roads were closed to traffic (Figure 6-30) for safety reasons due to the presence of debris and bricks that fell down from the buildings along the road or due to the permanent displacement of the deck of the viaduct (Figure 6-33). One of the first issues of the emergency response was to handle the traffic in L'Aquila due to the closure of the main road that ran through the city. Later, the new traffic requirements developed by the new provisional accommodations for rescuers needed to be satisfied.

Figure 6-30 Closed road in L'Aquila historical center

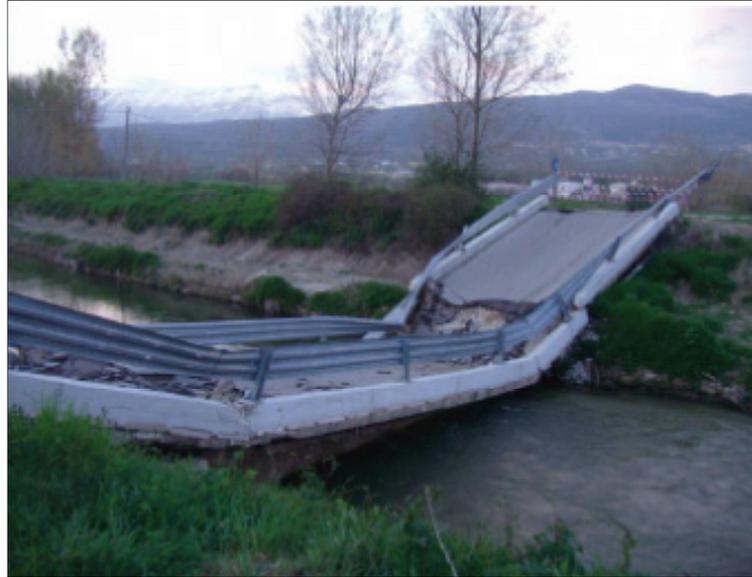
Heavy damages were observed only on two bridges crossing the Aterno river near Onna (Figure 6-31 and Figure 6-32). The bridge shown in Figure 6-31 collapsed because the

displacement exceeded the limit of the bridge bearings, while the second bridge shown in Figure 6-32 failed due to ground failure at the abutment.

Figure 6-31 Collapse of Bridge on the Aterno River

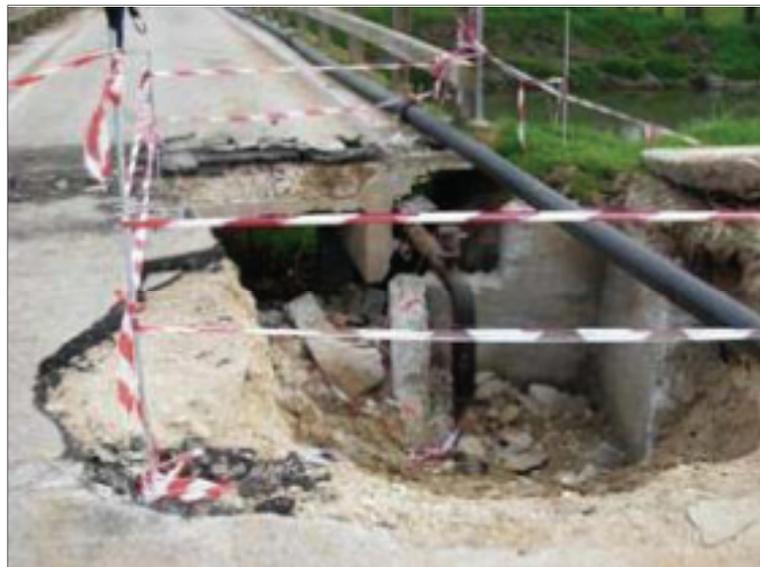
Figure 6-32 Collapse of Bridge on the Aterno River

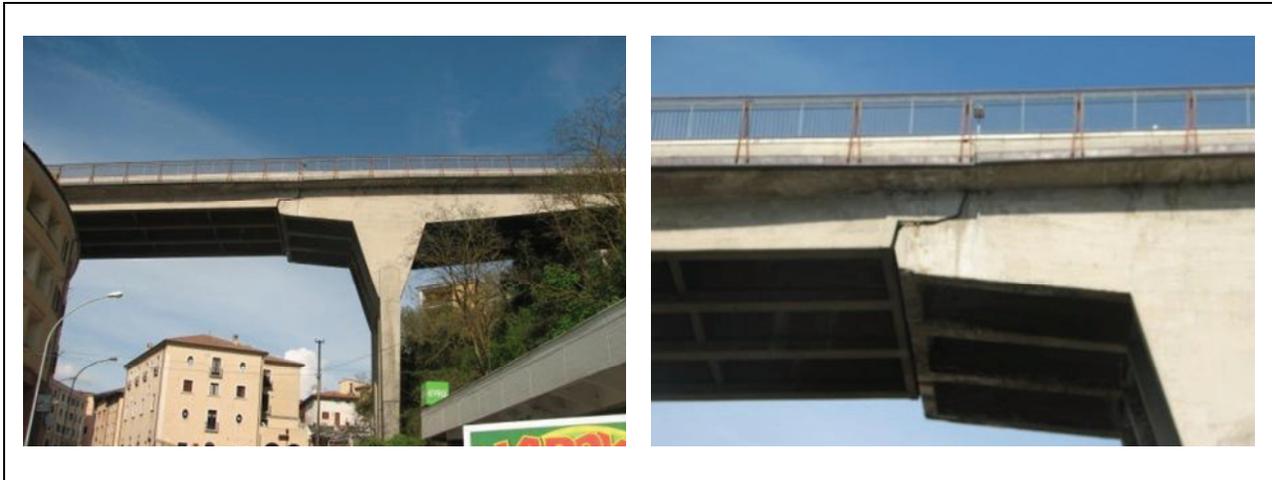
Figure 6-33 Viaduct closure to the traffic in L'Aquila due to permanent displacement of the deck

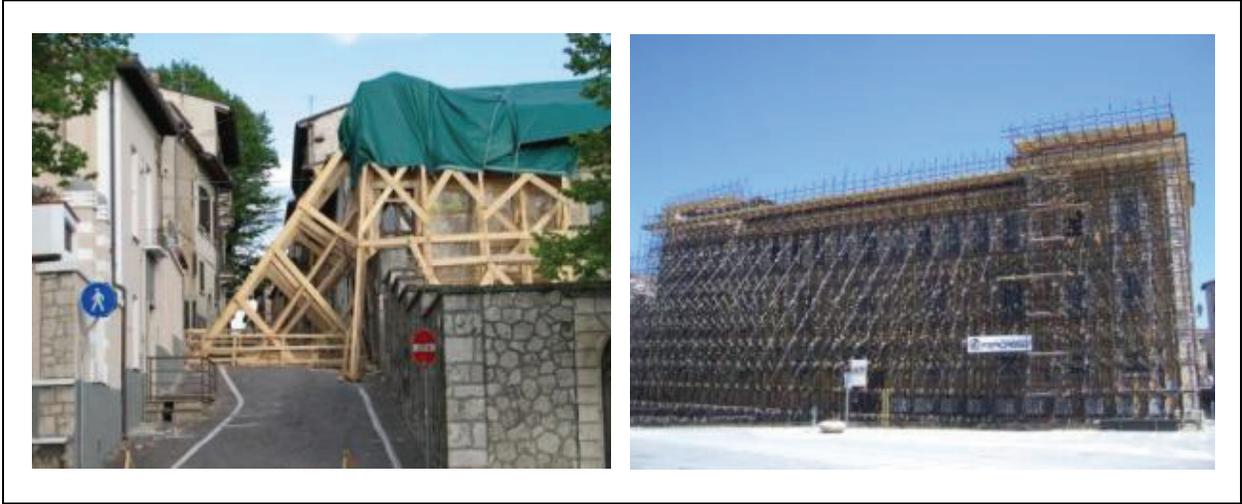
Figure 8-3 (a) Wooden props and (b) metal props of De Amicis school in L'Aquila

The fundamental elements of shoring are the props that can be made of either steel or wood (Figure 8-3). Wooden props should be made with good quality materials, free of cracks and with

few knots and seasoned (Figure 8-2a). Nailing should be perpendicular to the strength path. Steel props can be adjusted in height with length that can vary between 1.7 and 4.0 m (Figure 8-2, Figure 8-3b).

The damage develops due to lack of connection between the facade and the orthogonal walls or to the absence of ring perimeter beams. The retrofit intervention can be obtained through wooden props up to a height of 6-7 meters, and metal props can be used for greater heights (Figure 8-3b), or with the hoops of the whole building (Figure 8-11). It's important that the props are arranged all in the same way. The shoring wall will then split into equal parts and each strip corresponds to a shore. When the area below the building should need to be cleared, it is possible to use the propped up against another building provided the following conditions: (i) the adjacent building must be robust and in good condition; (ii) the two buildings should be close; (iii) the props on the adjacent wall should be located in correspondence of the orthogonal wall; and (iv) the props must be connected with both walls so that in case of an earthquake, they can avoid becoming detached and start hammering on one of the two walls.

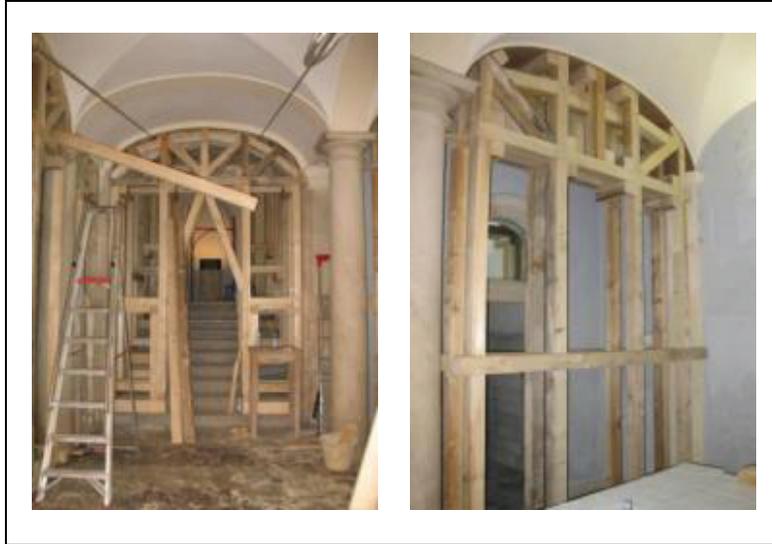
Figure 8-4 Shoring of the stairs of Margherita palace

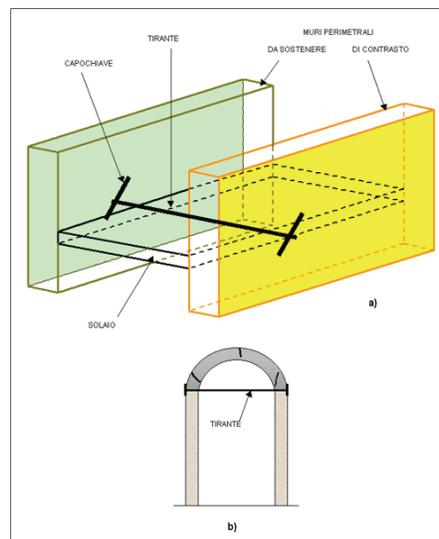
Figure 8-5 (a) Rods on walls and (b) rods on cracked arch

Rods or chains are steel elements linking two parallel walls to keep them stuck to the floor or to the orthogonal walls (Figure 8-5). They eliminate the possibility of wall openings due to the absence of ring beams or to the presence of a “pushing roofs”. They can be used to keep together vaults and arches (Figure 8-5b).

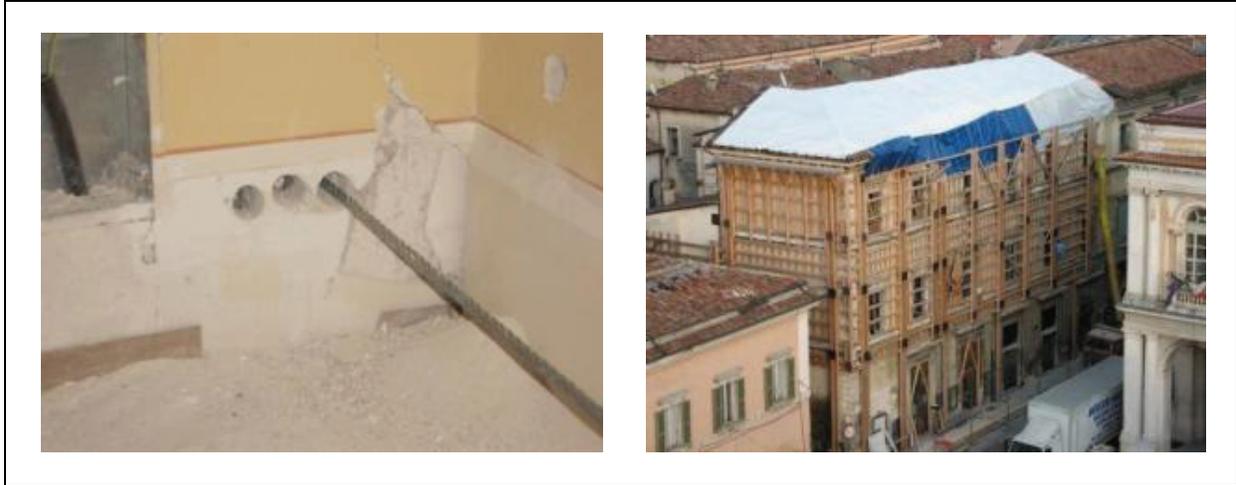
Figure 8-7 Detailed view of holes inside the building to pass the rods

They have the disadvantage of requiring operations inside the building to pass the rod through the walls (Figure 8-7), unless they are placed outside to achieve a hoop of the building (Figure 8-6). Installation of provisional roofing of resistant plastic is necessary for some buildings to protect their content against rain and snow.

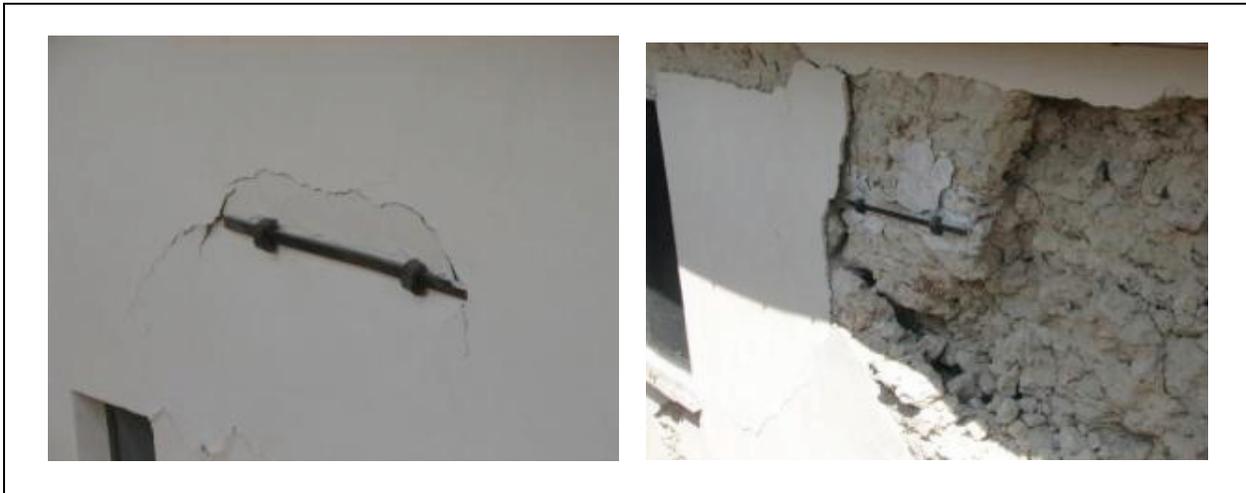
Figure 8-8 Close up of the bolts of the tie rod in the Spanish fortress

Tie rods are anchored to the walls through bolt or circular plates (Figure 8-8). The masonry wall around the plate should be of good quality in order to guarantee a proper behavior of the tie rod.

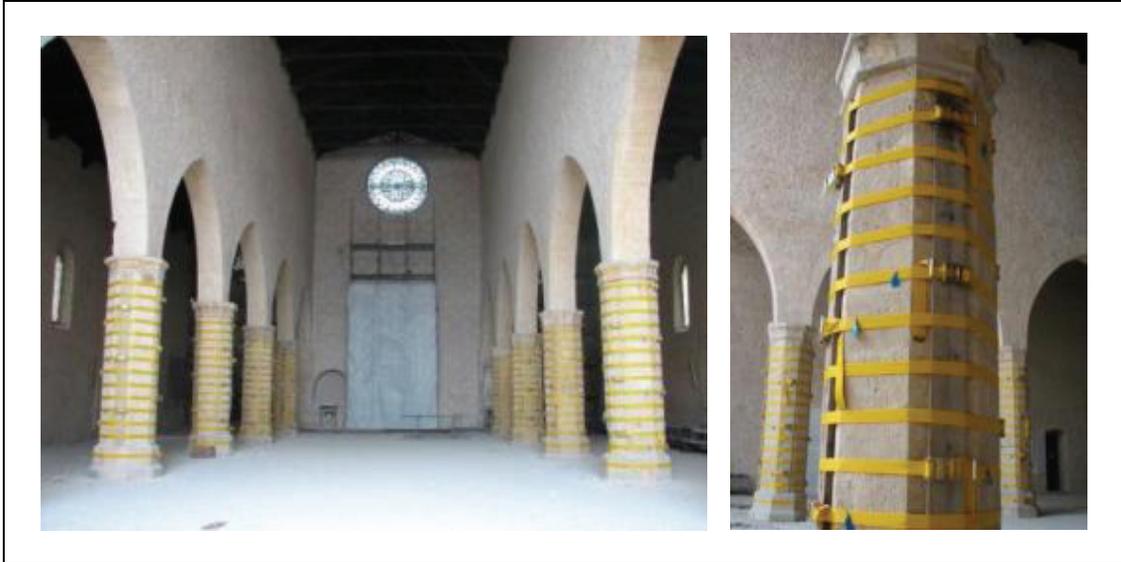
Figure 8-9 Hoops retrofit intervention of the columns of Santa Maria di Collemaggio Basilica

Structural elements subjected to vertical compression tend to shrink vertically and expand transversally. Hoops avoid transversal expansion, thereby increasing the resistance to compression, by including rings equally distributed, or spiral bands of high-strength polyester (Figure 8-9, Figure 8-10).

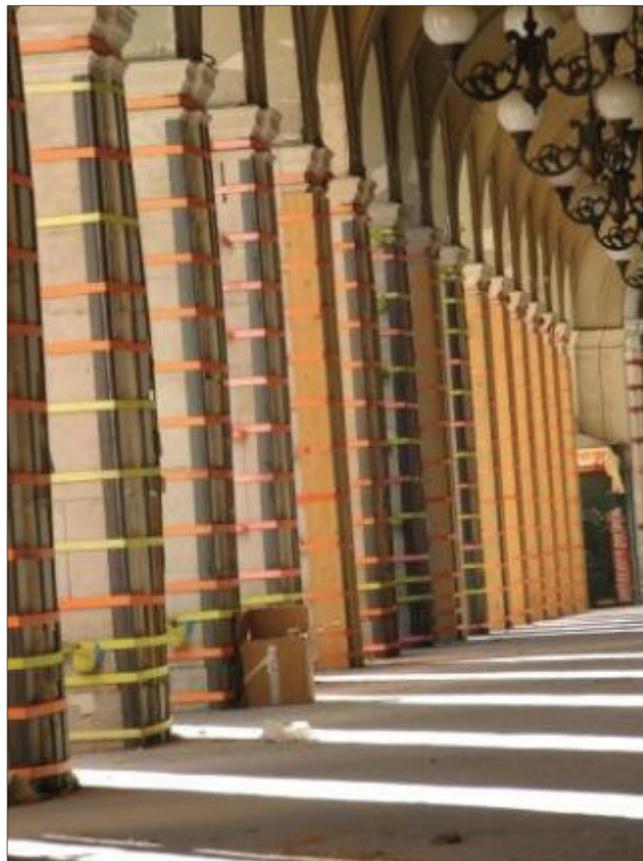
Figure 8-10 Hoops intervention of the columns of the “Quattro Cantoni” complex block

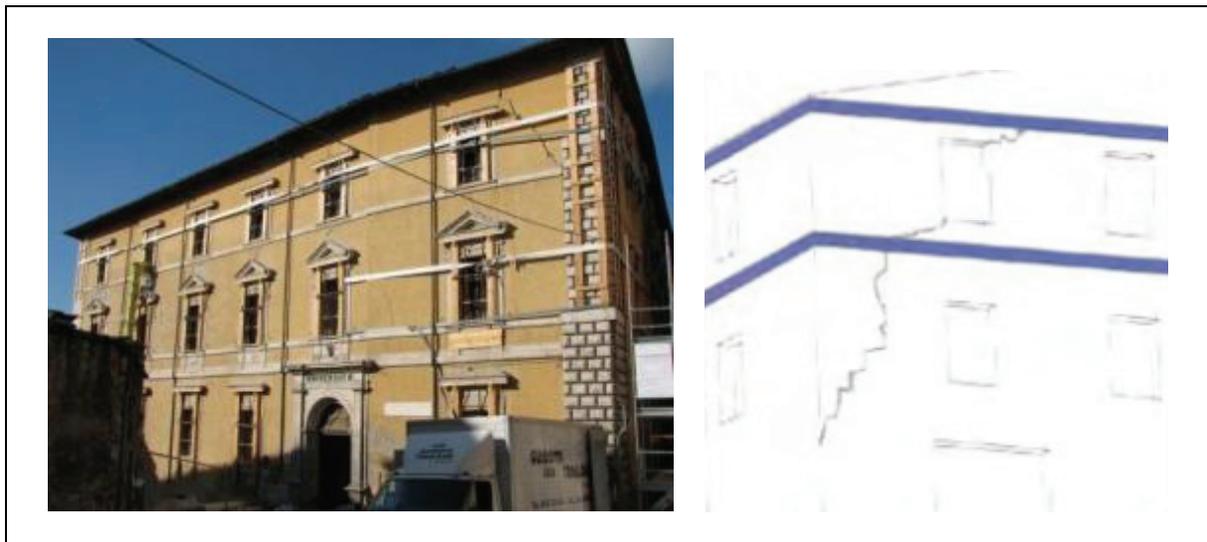
Figure 8-11 Hoops intervention of the whole building of the University: Palazzo Carli

The hoops can also be made on whole buildings, as an alternative to the shore intervention (Figure 8-11).

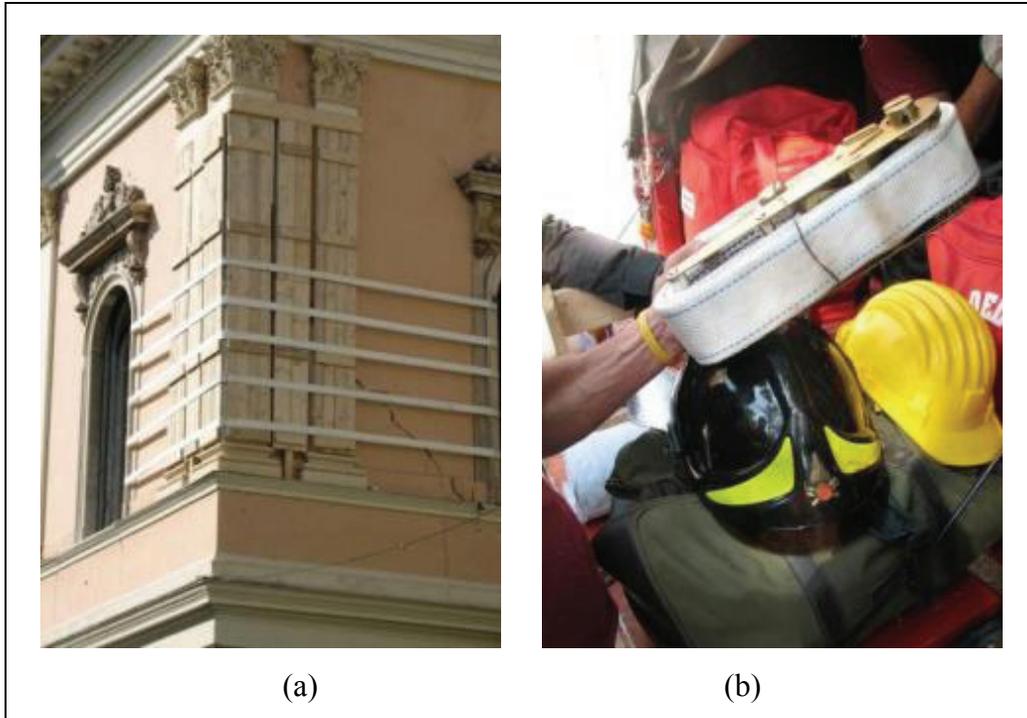
The damage occurred due to poor connection of the perimeter walls, for lack of ring beams, and/or the presence of openings (doors or windows) in the vicinity of the corners.

Figure 8-12 (a) Hoop retrofit intervention on damaged corner in L'Aquila with (b) high-strength polyester bands

The retrofit intervention can be done through the prop of the two sides involved or through the hoops of the building (Figure 8-12, Figure 8-13).

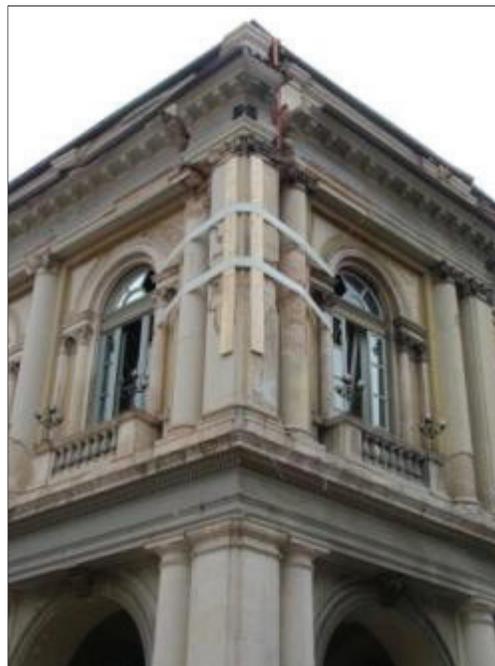
Figure 8-13 Retrofit intervention of the damaged corner of Quattro Cantoni with hoops

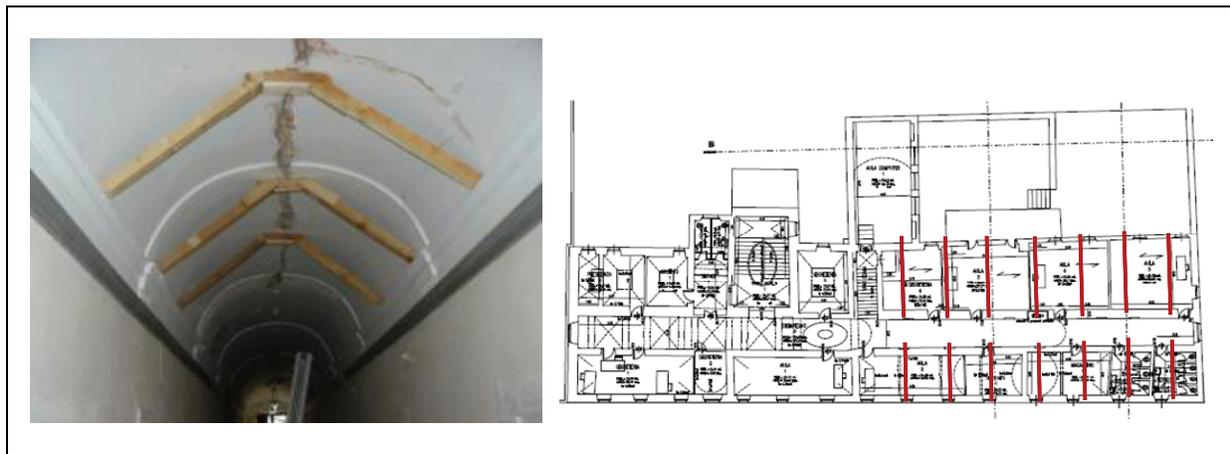
The longitudinal crack openings in the barrel vault of the corridor appeared first after the foreshock of March 30th. They tried to shore the vault using wooden props located as shown in

Figure 8-15. However, the presence of the pushing wooden props created an extra horizontal force that increased the crack openings after the seismic event of April 6th.

The longitudinal crack opening in the corridor was in building A, but not in the corridor of building C, because building A was retrofitted with chains that were stopped at the corridor level (Figure 8-15), probably for esthetic reasons, and therefore during the seismic event the building behaved as two independent structural elements.

Additionally, the hammering effect of the ridge beam of the orthogonal building B also increased the longitudinal crack opening of the barrel vault of building A. In conclusion, the retrofit intervention, before the seismic event and also the provisional shoring intervention after March 30th not only were ineffective, but they contributed to increase the structural damage of the ex monastery.

Figure 8-15 Pushing props that increased the damage in the barrel vault of the Ex monastery of Lauretane

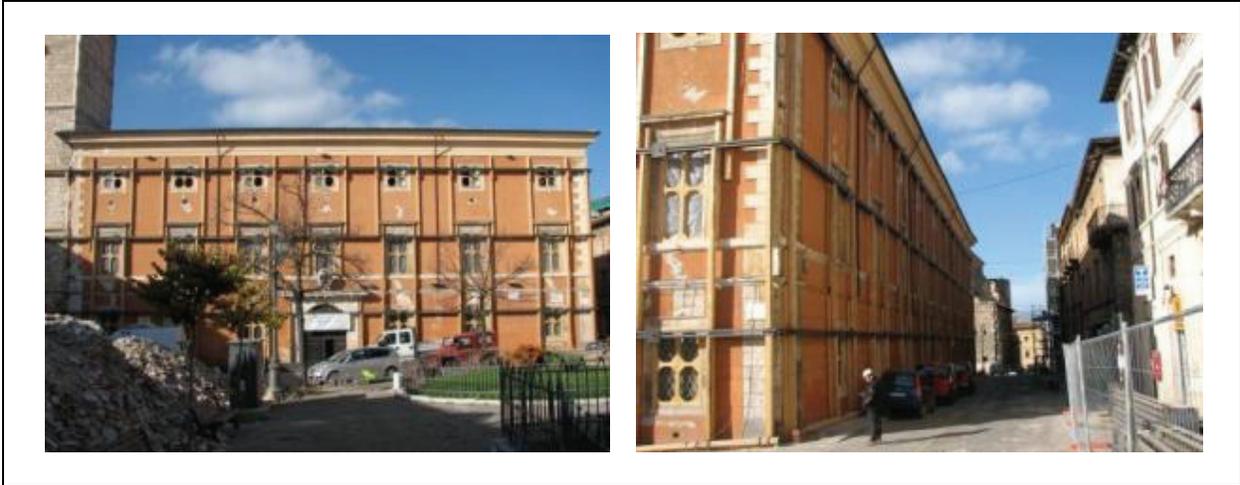
Figure 8-16 Provisional intervention with rods in Palazzo Margherita

The principal damage mechanism of Palazzo Margherita is the “simple overturning wall mechanism”. This collapse mechanism is characterized by a rigid rotation of portion of the wall around a horizontal cylindrical hinge located at the base. The overturning mechanism of the

internal wall on the North side of the courtyard developed longitudinal cracks in the cross vaults of the arcades and other damages inside the building.

The street of via Bafile is a main road for downtown L'Aquila, therefore it needs to be maintained as a viable road and props could not be used, because they would have occupied the entire road. Then rods were used, because they occupy less space and they use less material. In order to reduce intervention inside, the building rods passed through the windows and were able to connect the external walls with the internal walls of the courtyard (Figure 8-16). The retrofit intervention on the civic tower was done with external rods that were used until the top of the tower. The authors question the necessity of this retrofit intervention, because tie rods were already inserted inside the tower and they guarantee a good box behavior. For the reason above, the shoring intervention of the tower could possibly be limited to the lower part where more cracks were visible.
