L'AQUILA EARTHQUAKE OF APRIL 6, 2009 IN ITALY: REBUILDING A RESILIENT CITY TO WITHSTAND MULTIPLE HAZARDS

by
**Gian Paolo Cimellaro, Ioannis P. Christovasilis,
Andrei M. Reinhorn, Alessandro De Stefano
and Tatiana Kirova**

Technical Report MCEER-10-0010

December 29, 2010

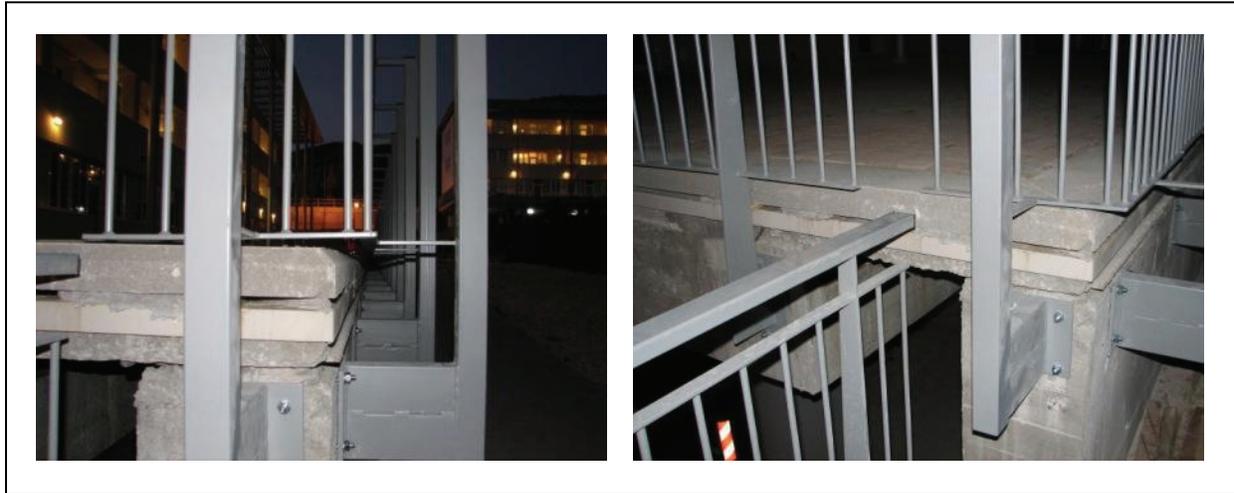
During field observations in the construction site of the C.A.S.E. project, several problems with construction details of the nonstructural components were noticed such as the installation of a metal railing (Figure 10-3) perpendicular to the RC plate that would create an obstacle to its movement during the earthquake, resulting in the possible development of dangerous torsional site effects.

Figure 10-3 Problems in the construction details of the nonstructural components

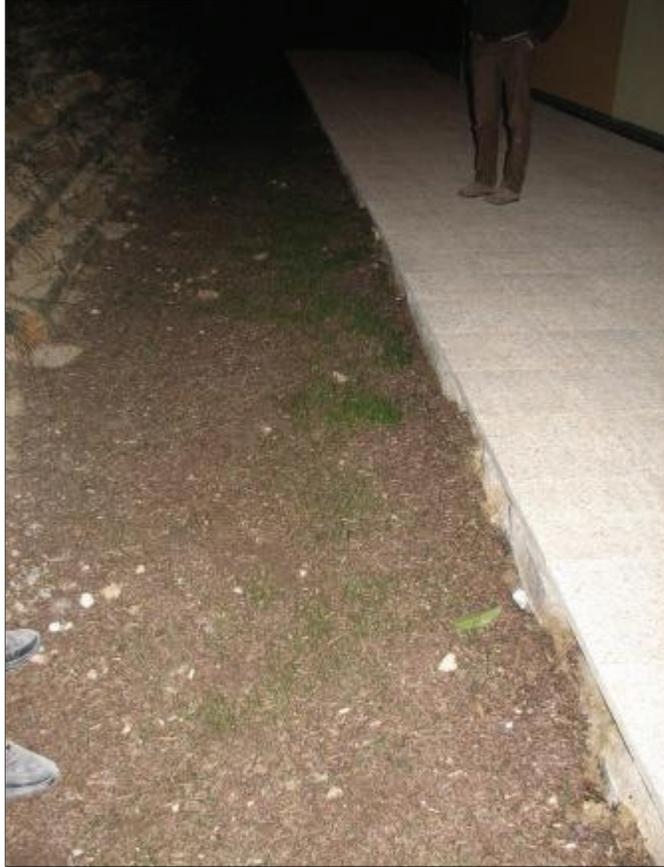
Figure 10-4 Gap filled with ground soil hindering the lateral movements of the plate

On one side of a realized plate (Figure 10-4), the gap between the plate and the ground wall was filled with soil, also hindering the lateral movement of the plate in this case. These two examples show the potential dangers of miscommunication between the building designers and the companies installing the nonstructural components.
