EMILIA EARTHQUAKE OF MAY 20, 2012 IN NORTHERN ITALY: REBUILDING A COMMUNITY RESILIENT TO MULTIPLE HAZARDS

by
Gian Paolo Cimellaro, Marco Chiriatti,
Andrei M. Reinhorn and Lucia Tirca

Technical Report MCEER-13-0006

June 30, 2013

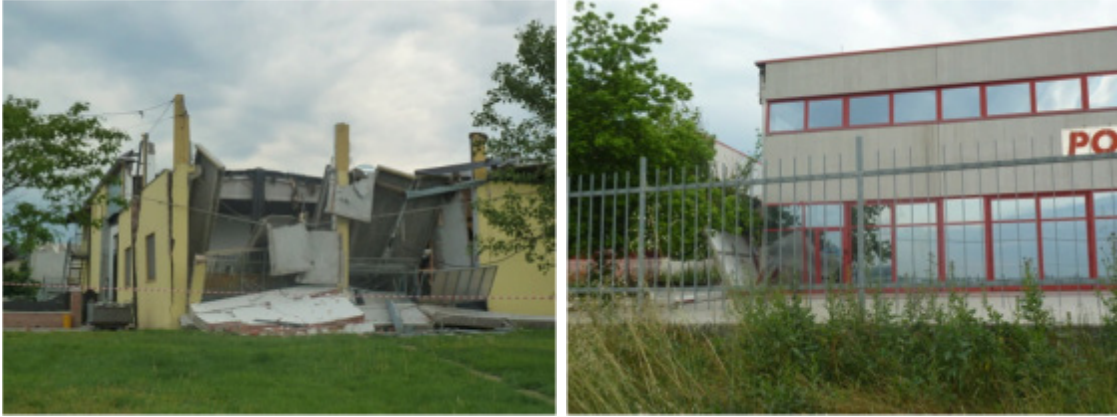
The town of San Carlo suffered liquefaction of soils and encountered a large amount of damage to residential buildings, elementary schools and industrial facilities built with precast reinforced concrete.

Figure 4-4 Damage to industrial facilities in San Carlo

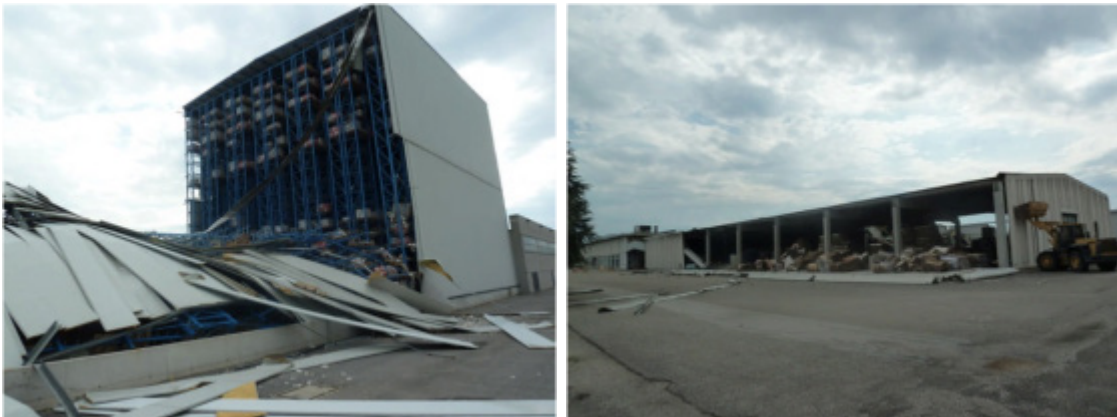
The church and the town hall in Sant'Agostino collapsed and were declared inaccessible. However, the greatest damage occurred to industrial facilities. Here, the collapse of a warehouse of the S. Agostino Ceramic Factory caused the death of two workers.

Figure 4-5 Collapse of a ceramic tile warehouse in S. Agostino

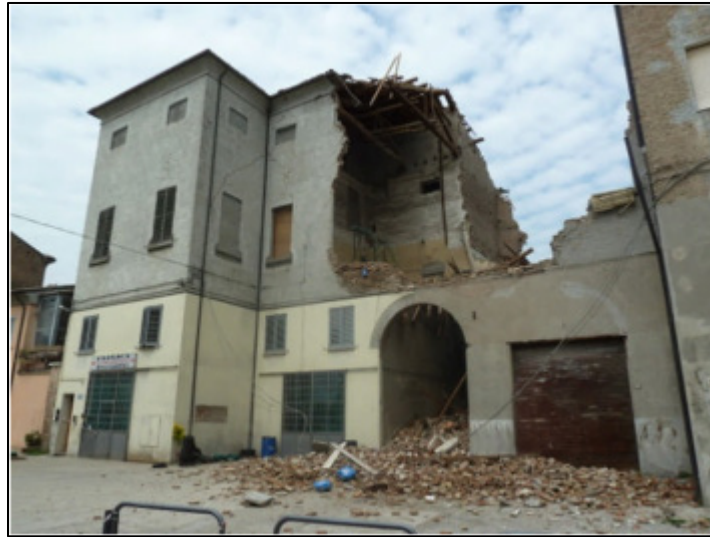
Many people were displaced in Finale Emilia. In fact, a lot of damage was reported, especially for old and poorly maintained masonry structures. However, new private houses did not have accessibility and/or livability issues.

Figure 4-6 Collapse of a masonry house in Finale Emilia

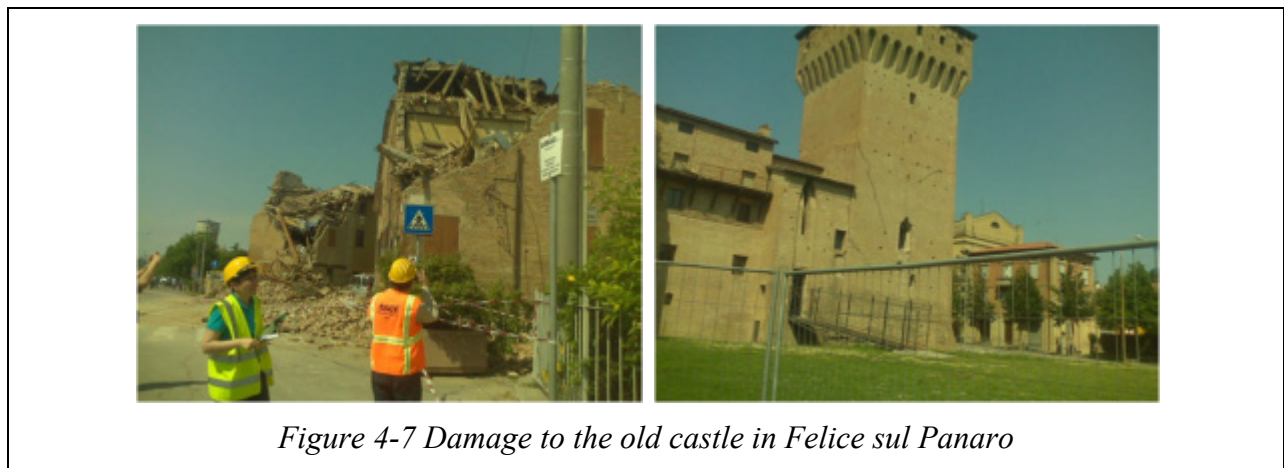
In Felice sul Panaro, residential buildings were either not damaged or only slightly damaged, while monumental and historical buildings, including the old castle, suffered major damage. Industrial and commercial buildings suffered damage when conditions of structural vulnerability were present.

Figure 4-7 Damage to the old castle in Felice sul Panaro

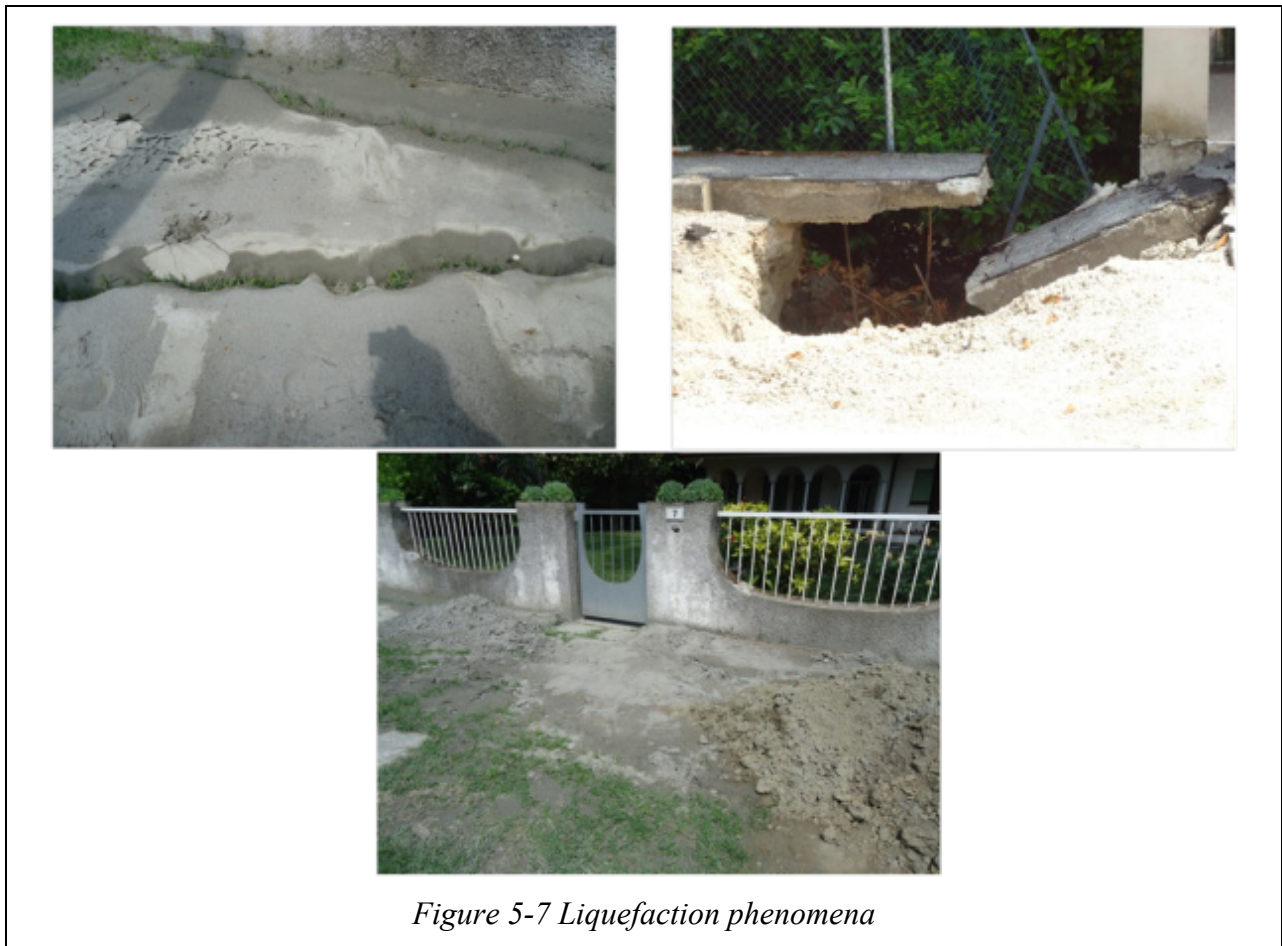
In the towns, liquefaction is often linked to the presence of artifacts that may have functioned as preferential escape routes.

Figure 5-7 Liquefaction phenomena

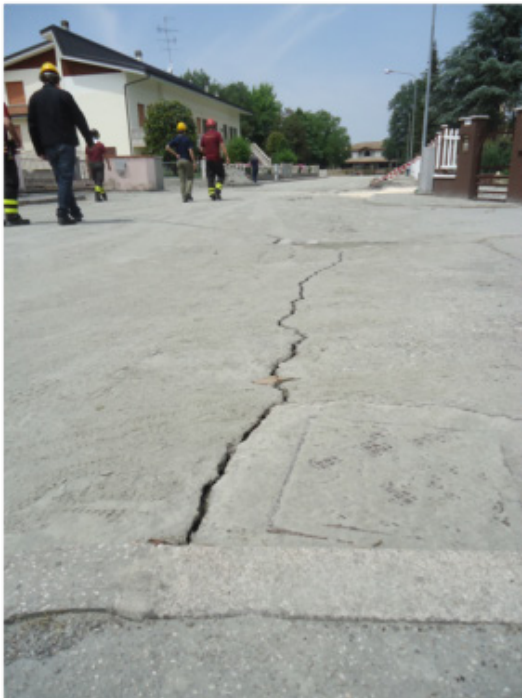
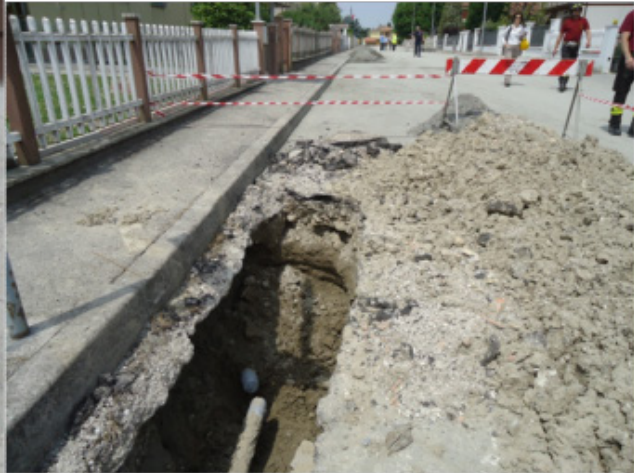
Figure 5-12 Damage due to liquefaction

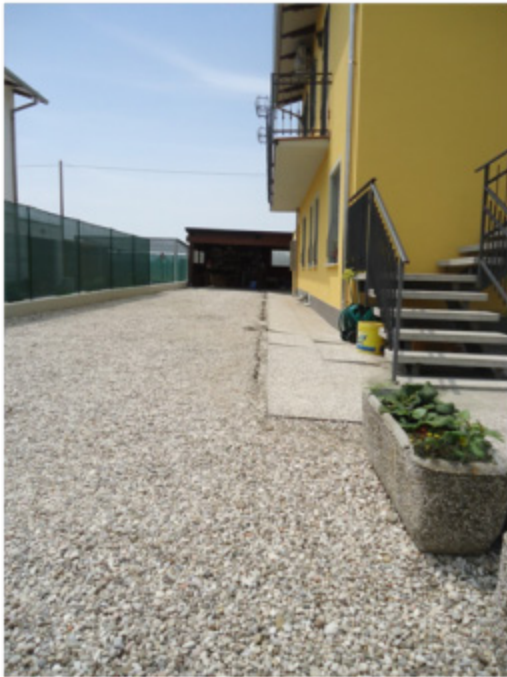
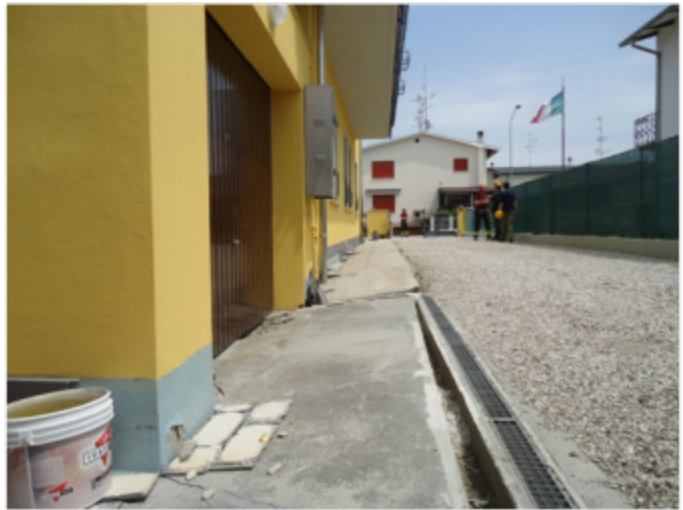
They consist of fractures ten meters long, often in en-echelon apparent, which leak a large amount of fine sand gray.

Figure 5-14 Structural damage due to liquefaction in San Carlo (Sant'Agostino)

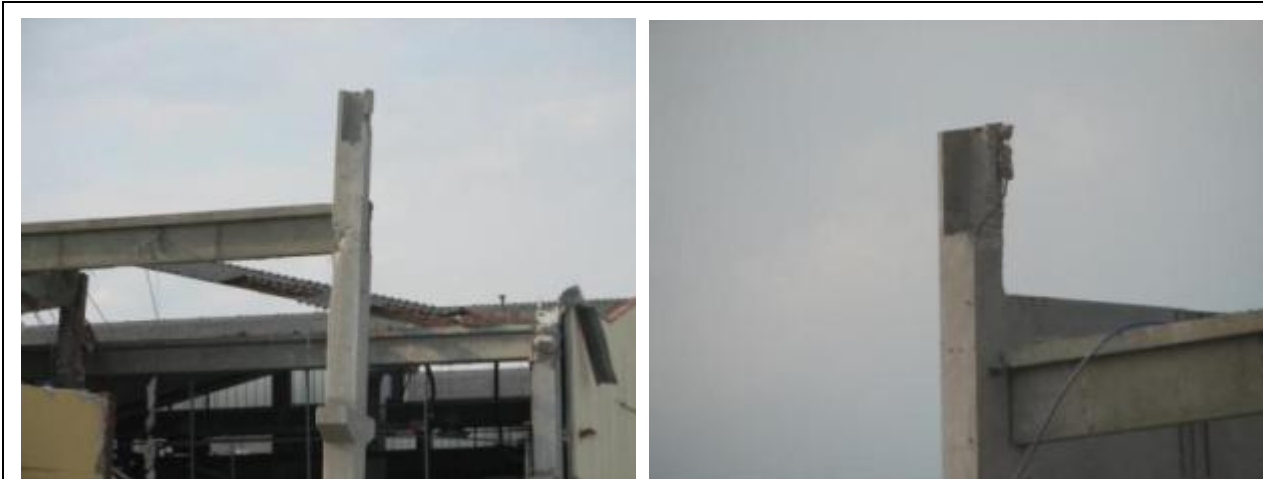
These shear keys were not properly reinforced and were the only restraint to horizontal transversal forces caused by the earthquake (Figure 6-5, Figure 6-6).

Figure 6-5 Shear keys with no reinforcement of BBG.srl

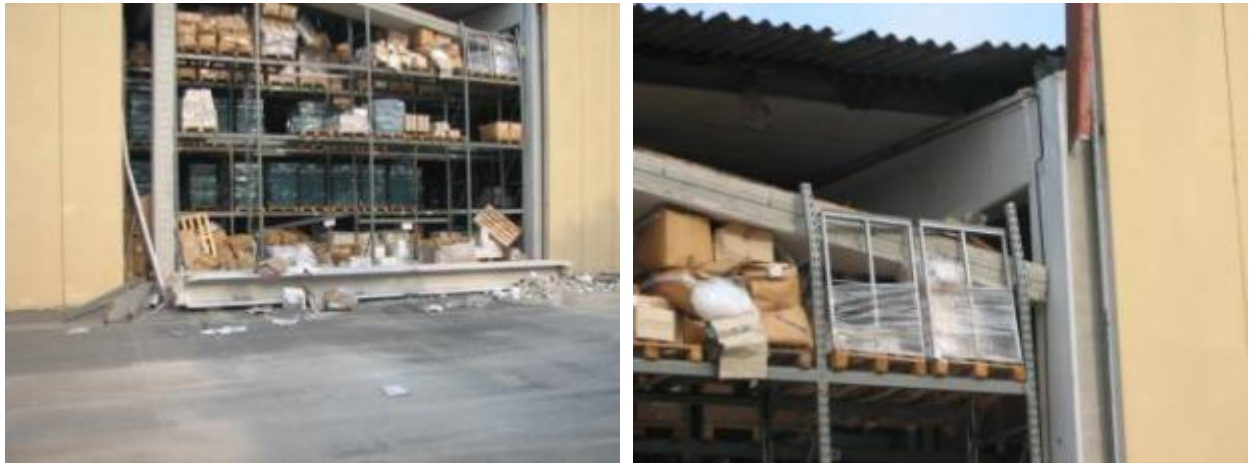
Figure 6-7 shows the interaction between the lateral precast vertical panels and the internal scaffold system. Due to the horizontal movements, the heavy material on the shelves shown in Figure 6-7 started pushing against the vertical panels which were hung from the lateral beam at the roof level.

Figure 6-8 Roof collapse due to the movement of the vertical panels hung from the roof cover (Mirandola)

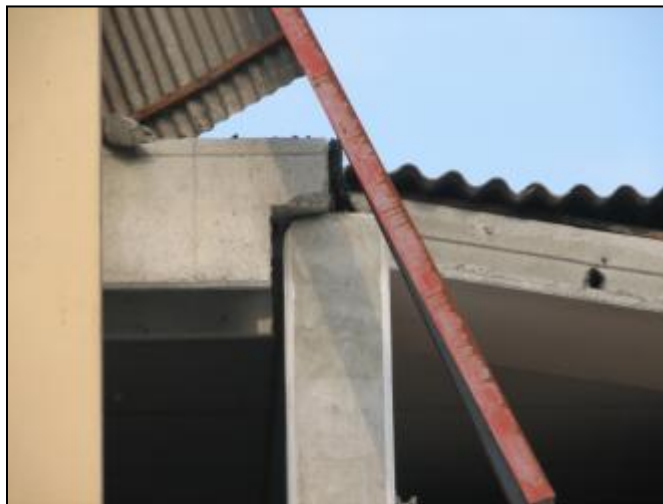
The insufficient beam column connection shown in Figure 6-9 moved the beam out of place and generated the collapse of the part of the roof supported by the beam.

Figure 6-9 Insufficient beam-column support without restraints (Mirandola)

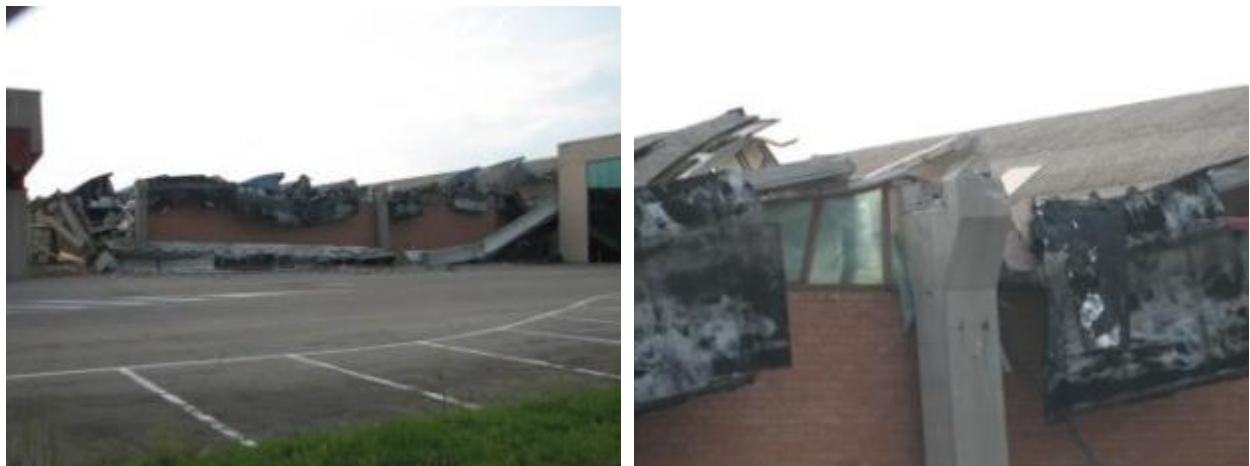
Another example of roof collapse due to the lateral overturning of the supporting beam is shown in Figure 6-10 and Figure 6-11.

Figure 6-11 (a) Lateral overturning of the beam (b) structural detail

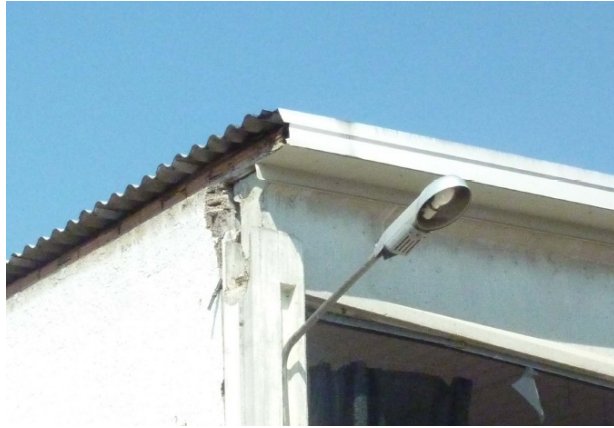
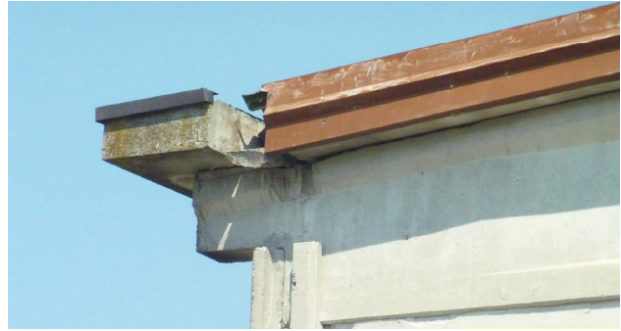
In some industrial sheds of the first type (see section 6.3.2), dangerous and heavy nonstructural components (Figure 6-12) caused damage, due to the fact that the sheds were built following the simply supported technique.

Figure 6-12 Dangerous heavy nonstructural elements

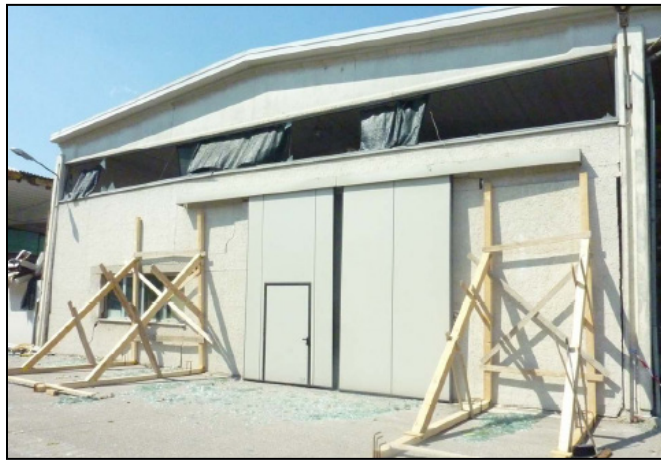
Figure 6-13 Panels without connection with the main structural frame CF

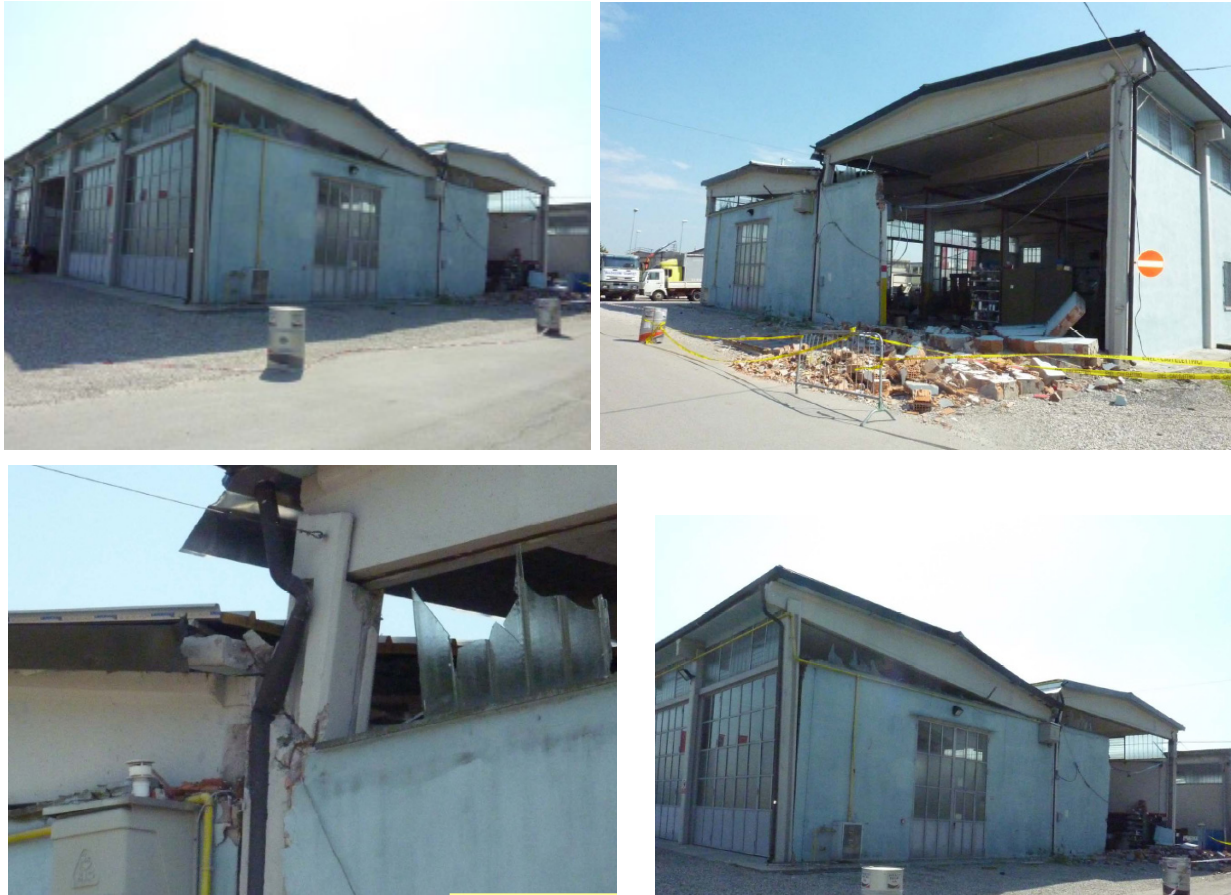
Exterior cladding had a positive effect when it was regular, because in this case, the cladding performed as dampers (Figure 6-15). However, the cladding had a negative effect when it was irregular, for example, due to the presence of windows (Figure 6-16, Figure 6-19, Figure 6-20, Figure 6-21) just below the beam supporting the roof, which caused partial collapse of some parts of the shed. The Emilia earthquake has shown that interaction with nonstructural components such as infill walls should be taken into account during the analysis; otherwise, it can cause the collapse of the structure.

forces at the support will be 30% of the vertical loading, which will be absorbed by the friction force at the support. In the presence of irregular cladding, the left pillar will have a short column effect. In this case, the horizontal force on the left pillar will be double with respect to the right pillar of the portal frame. This is the reason for the collapse of many industrial sheds near Mirandola.

Figure 6-16 Negative effect of irregular cladding (San Felice sul Panaro)

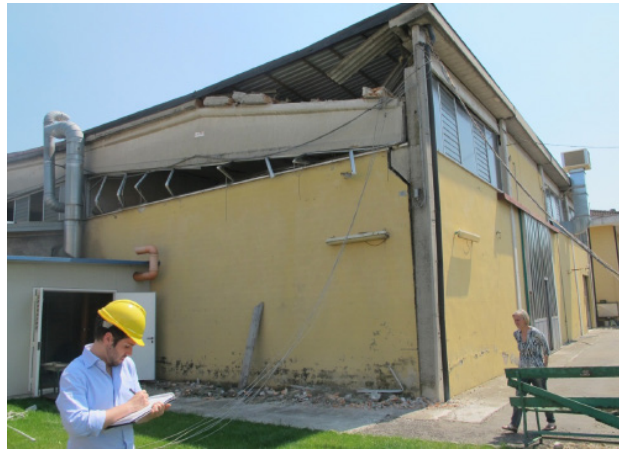
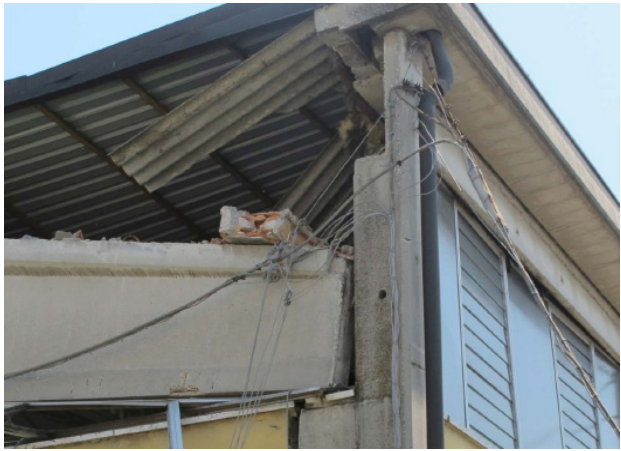
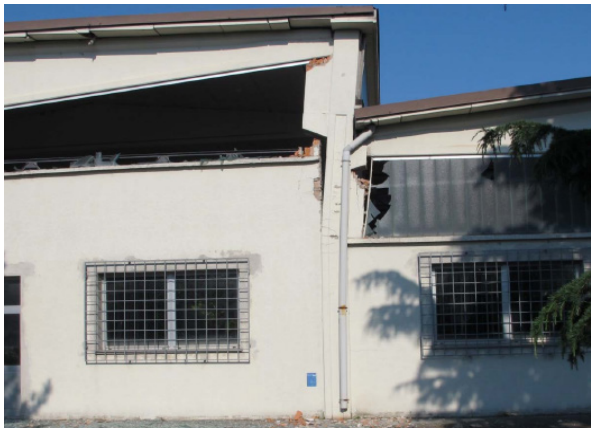
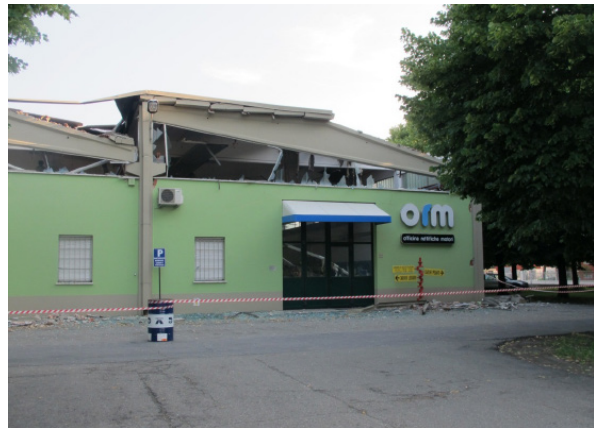
Some examples of collapse due to the irregular cladding behavior described in Figure 6-18 can be observed in Figure 6-19, Figure 6-20 and Figure 6-21. In some cases, plastic hinges at the mid height of the column were observed due to the presence of irregular claddings (Figure 6-22).

Figure 6-19 Collapse of industrial shed due to seismic behavior of irregular cladding

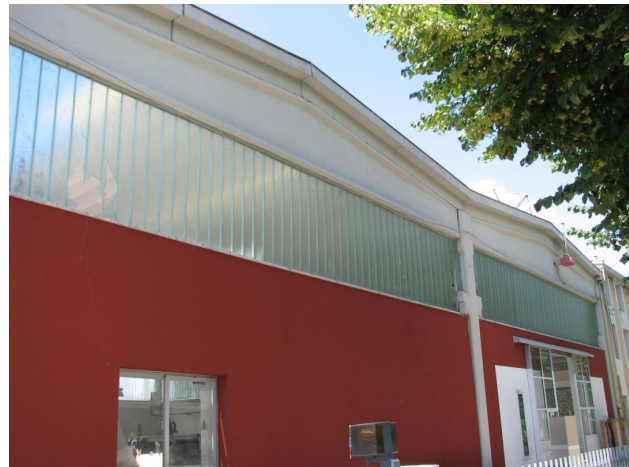
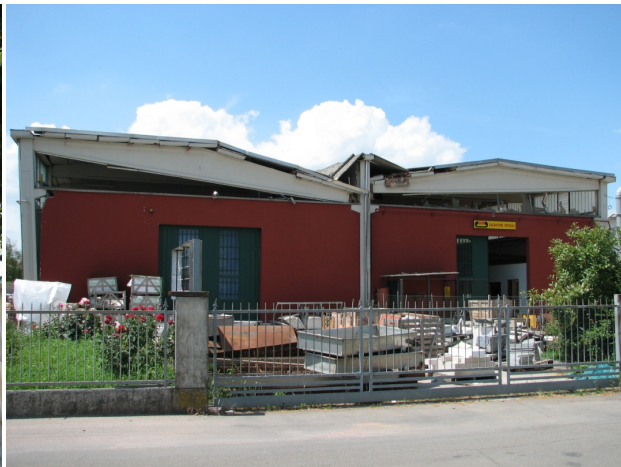
Figure 6-20 Before and after the earthquake in San Giacomo Roncole (Mirandola)

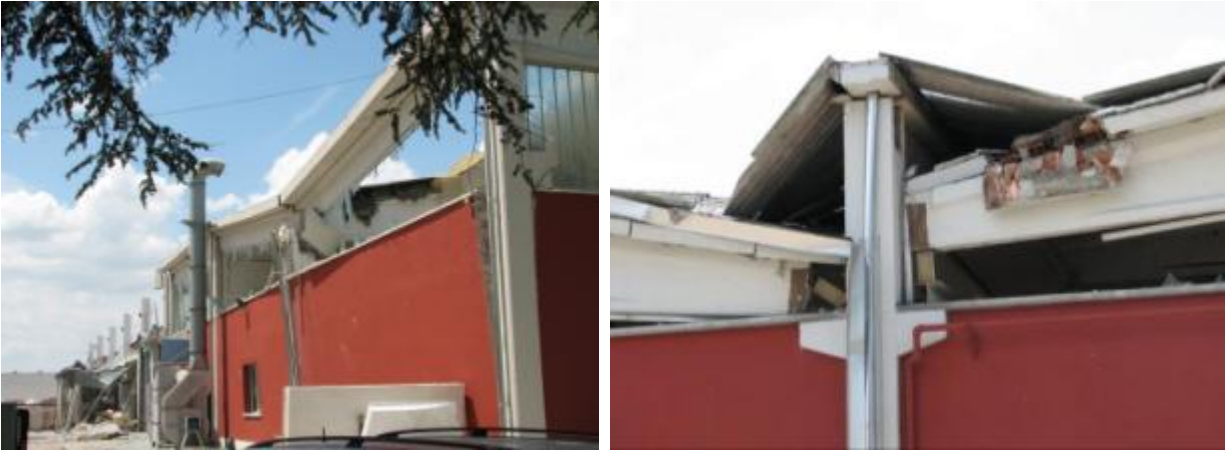
Figure 6-21 Seismic behavior of industrial shed in San Giacomo Roncole (Mirandola)

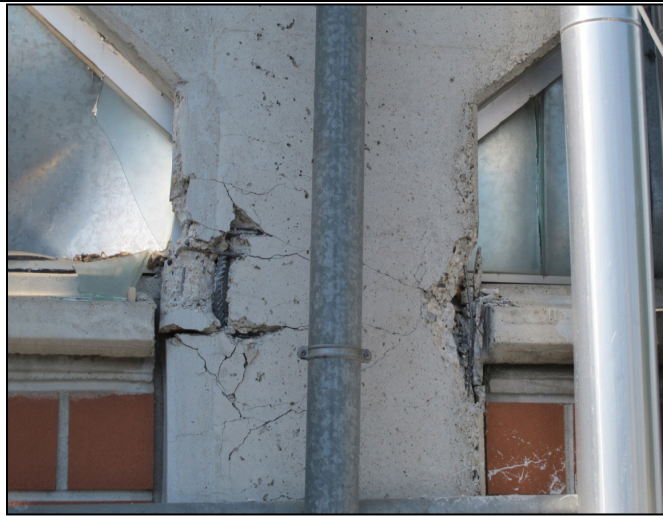
Figure 6-22 Plastic hinge in the column due to the presence of irregular cladding

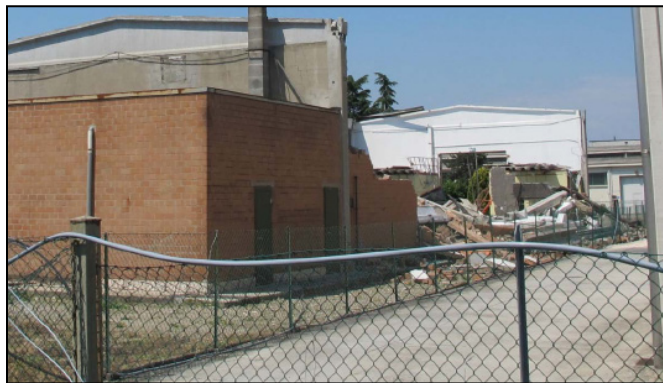
Figure 6-23 Collapse of the intermediate span due to the presence of cladding

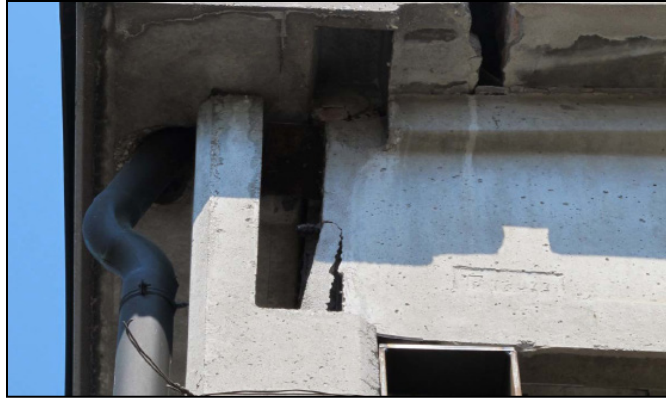
Figure 6-24 shows an example of a beam head without adequate reinforcement, due to the fact that they were not designed to resist earthquake forces. Some examples of proper reinforcement are shown in Figure 6-25.

Figure 6-24 Beam-column connection without sufficient reinforcement in the beam head

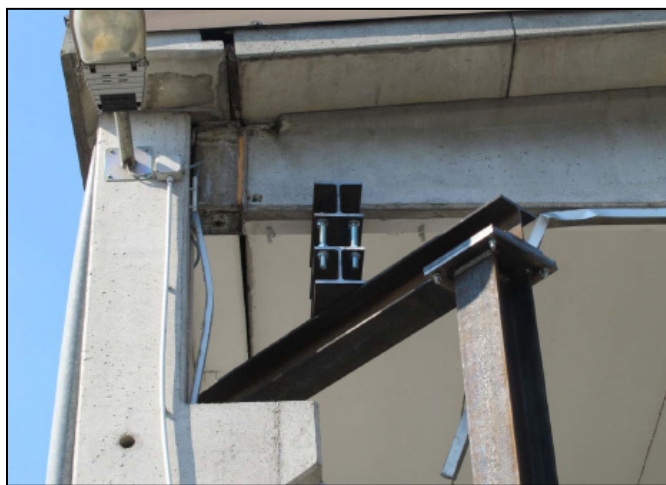
Figure 6-26 Emergency intervention to avoid collapse of the industrial shed due to beam slippage

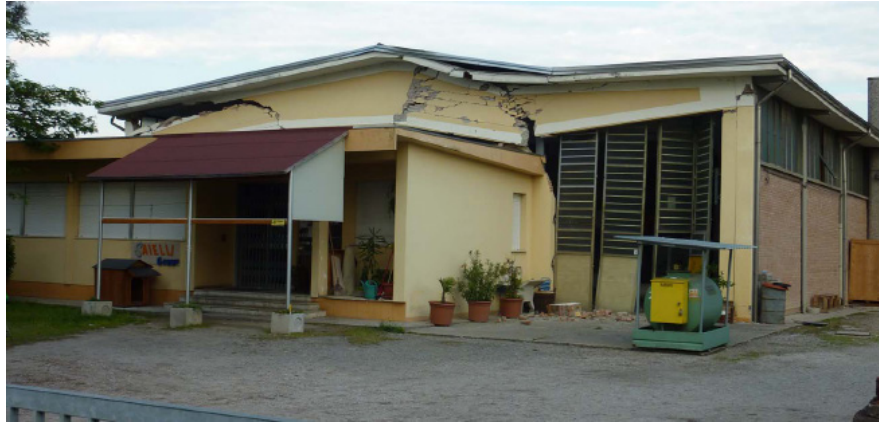
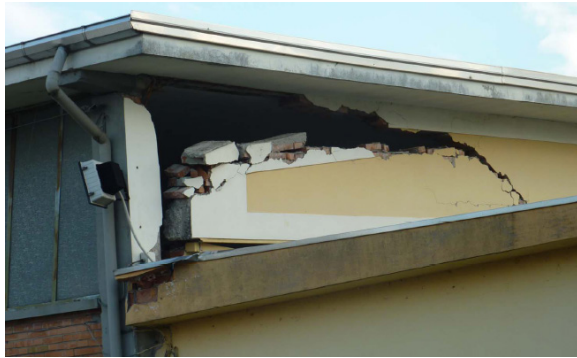
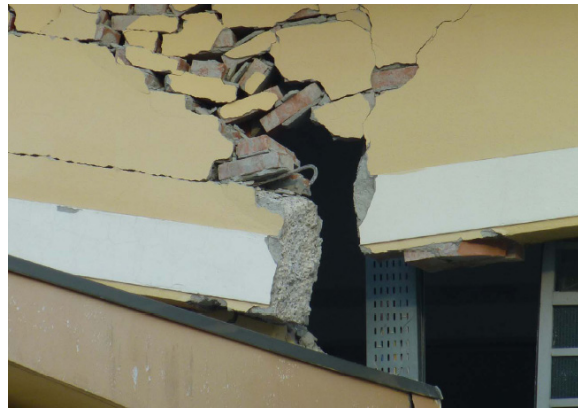
Figure 6-28 shows an example of cladding made with clay bricks with an out-of-plane failure.

Figure 6-28 (a) Overview (b) Failure of out of plane claddings in Sant'Agostino

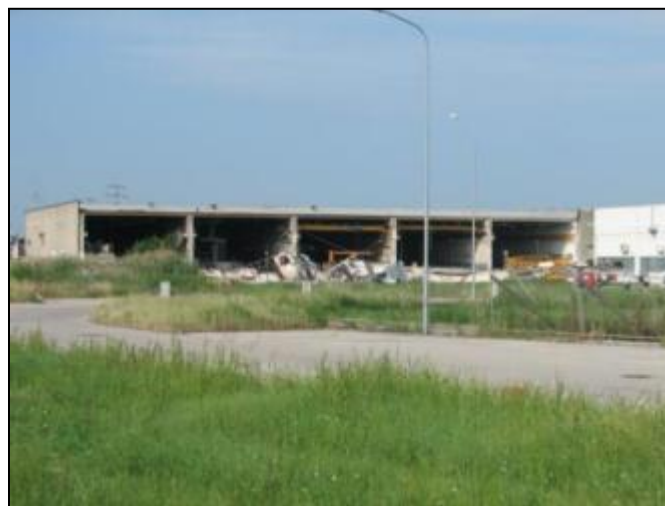
Figure 6-29 Collapse of vertical panels

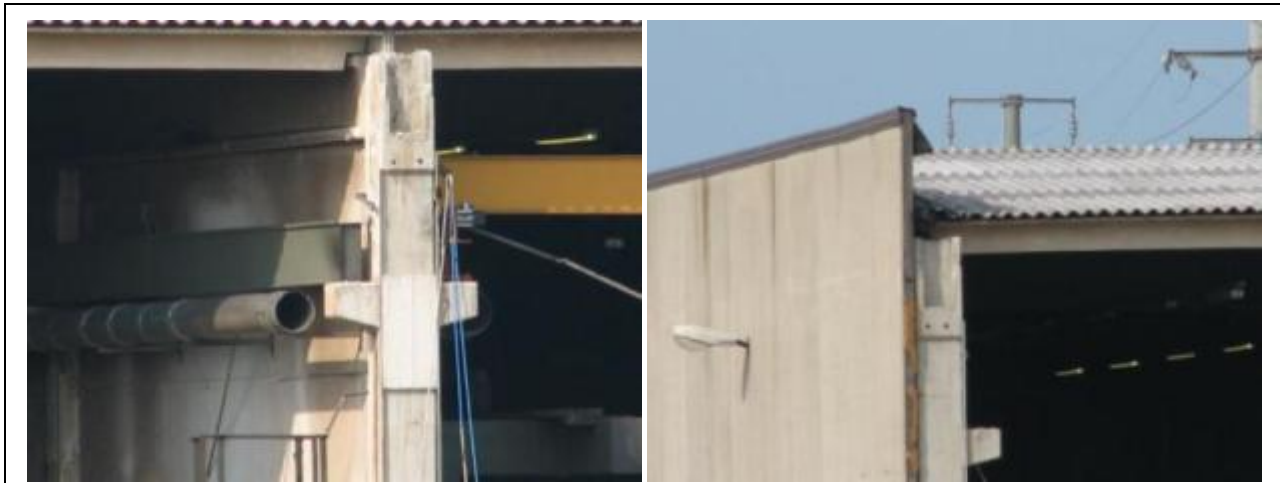
Figure 6-30 Structural detail

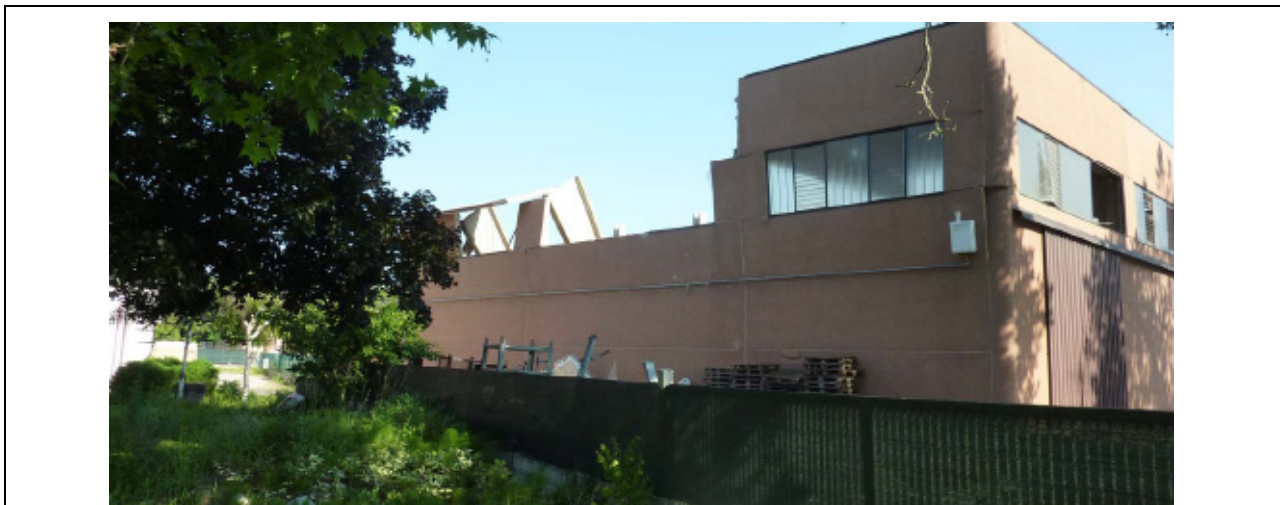
Figure 6-31 Recent industrial shed with horizontal panels connected to the pillars

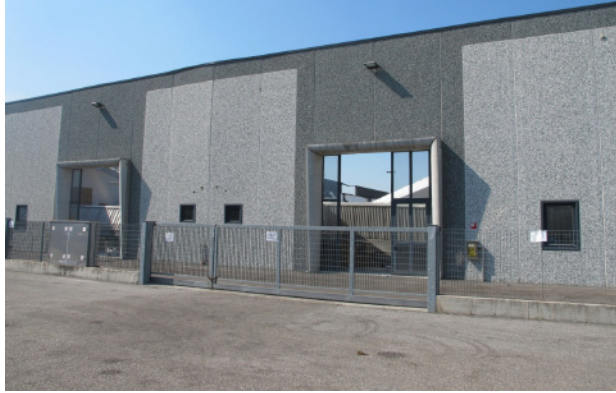
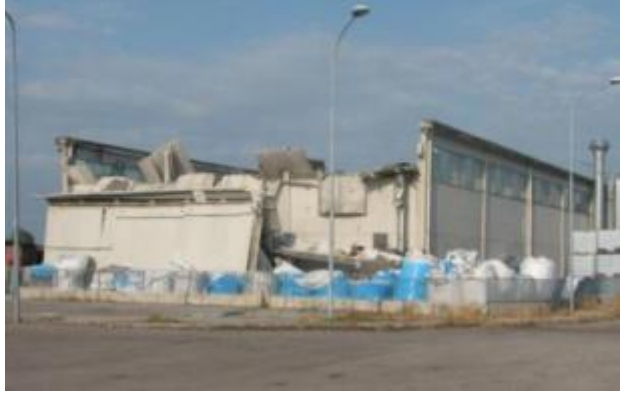
Figure 6-32, Figure 6-33, Figure 6-34 and Figure 6-35 show some recently built industrial sheds with internal collapse due to probable failure of one of the internal columns caused by the statically determined behavior of the structure and the lack of redundant supports.

Figure 6-32 Recent industrial sheds with internal collapse

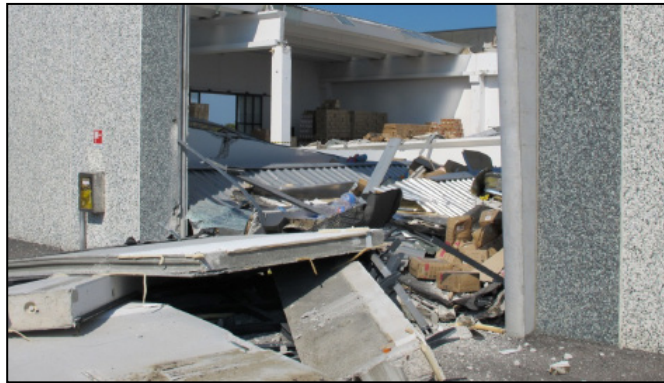
Figure 6-33 Probable collapse of internal pillar

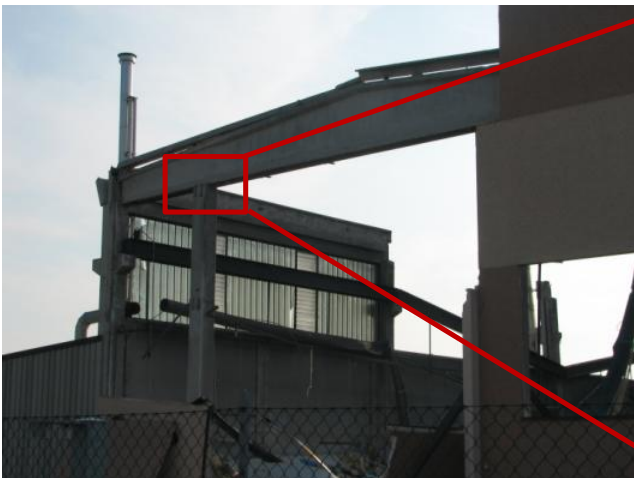
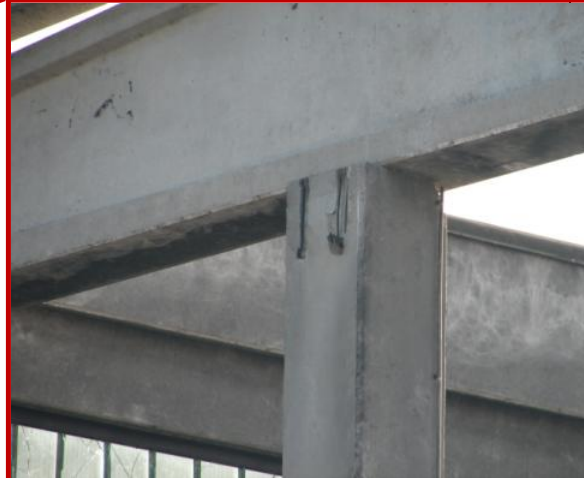
Figure 6-34 Beam-column connection without sufficient reinforcement in the beam head

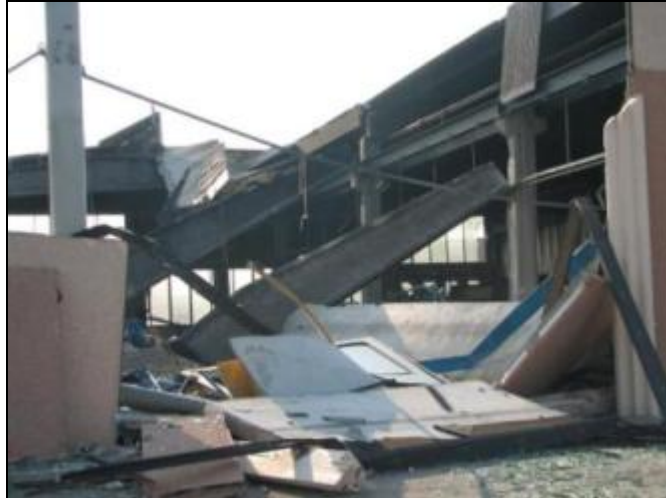
Figure 6-35 Longitudinal toppling of beams for displacement limit

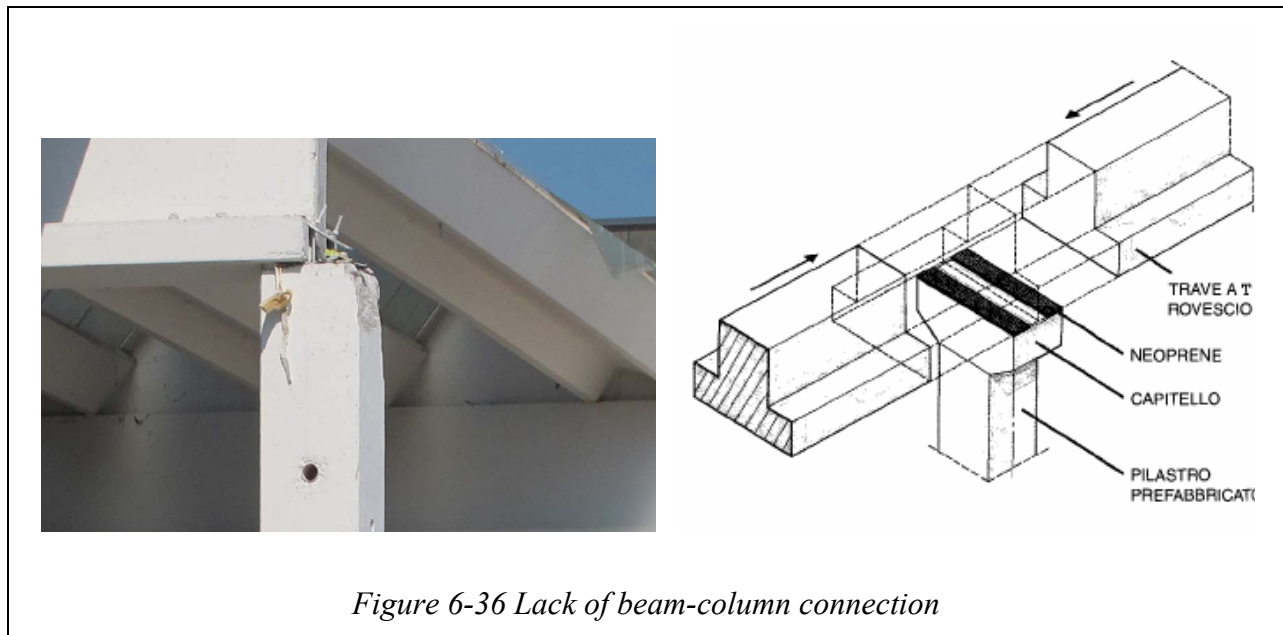
Figure 6-36 Lack of beam-column connection

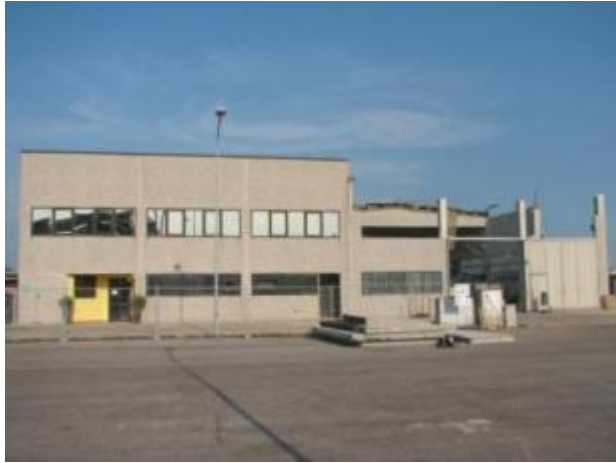
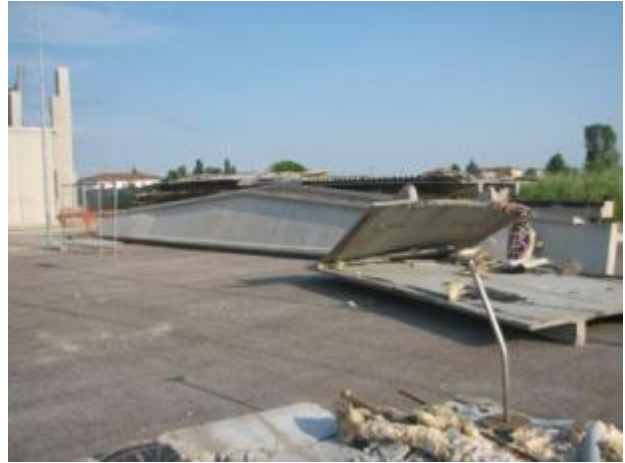
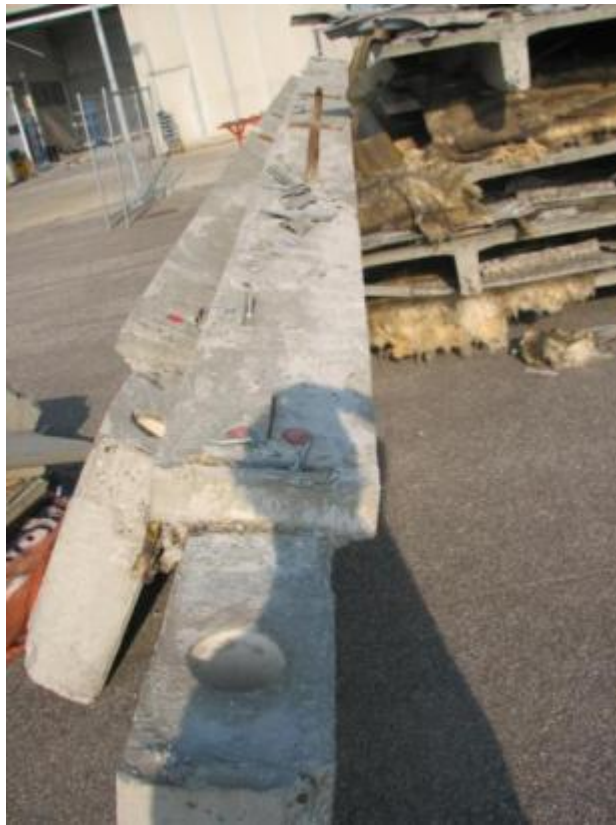
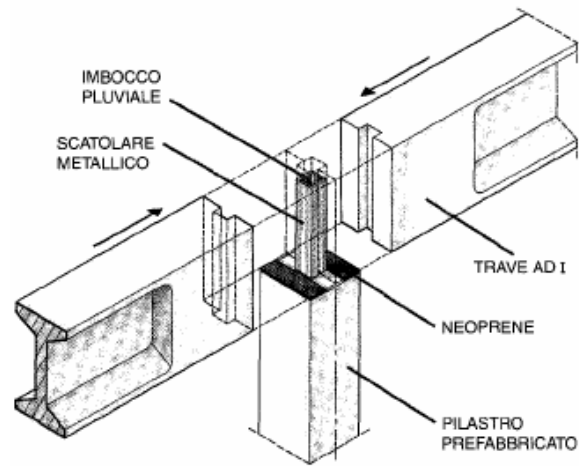
Figure 6-37 Probable roof collapse due to the slip of the beam from the shear key

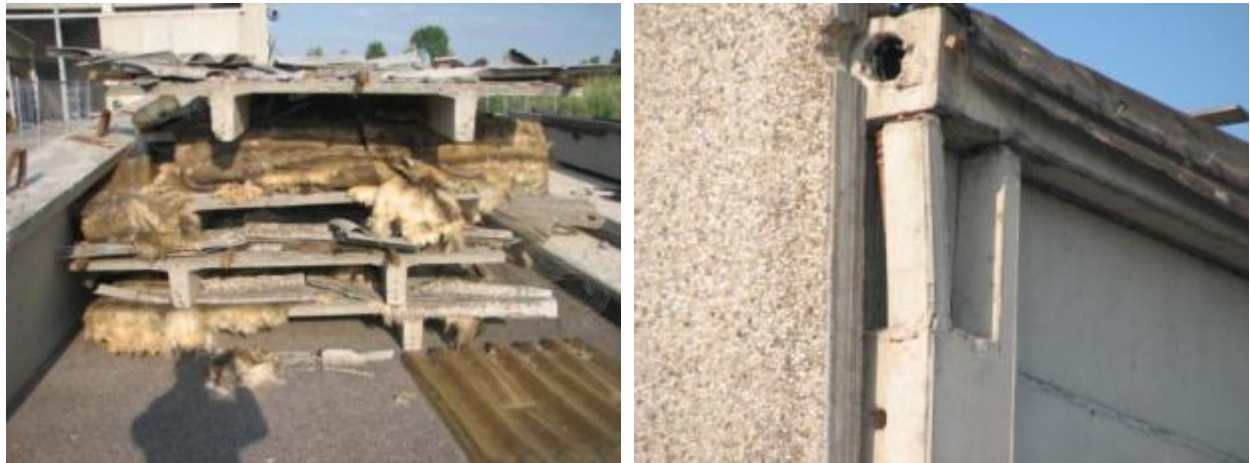
Plastic hinges were also observed at the base of the columns (Figure 6-54, Figure 6-55). In most cases, the shear key also failed (Figure 6-5, Figure 6-6). It was observed that the latter was not adequately detailed with reinforcement, and no redundancy provisions were provided to make a monolithic connection (Figure 6-6, Figure 6-38).

Figure 6-38 (a) Remains of the collapsed roof; (b) failure of shear key due to lack of reinforcement

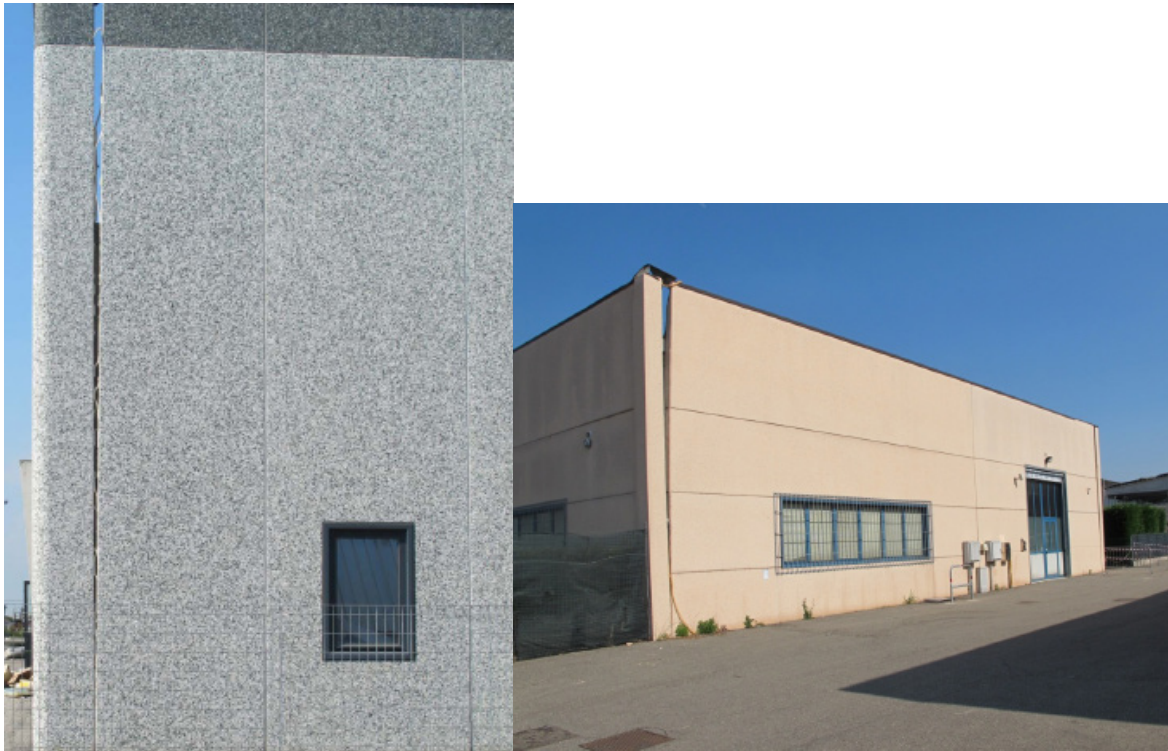
External panels can be classified as horizontal and vertical panels (Figure 6-39). Vertical cantilever panels (Figure 6-40) behave properly with respect to horizontal panels and, in some cases, they increased the horizontal strength of the industrial sheds. Vertical panels failed only when they were not rigidly connected at the base, as shown in Figure 6-41.

Figure 6-40 Vertical panels behave properly when connected at the base

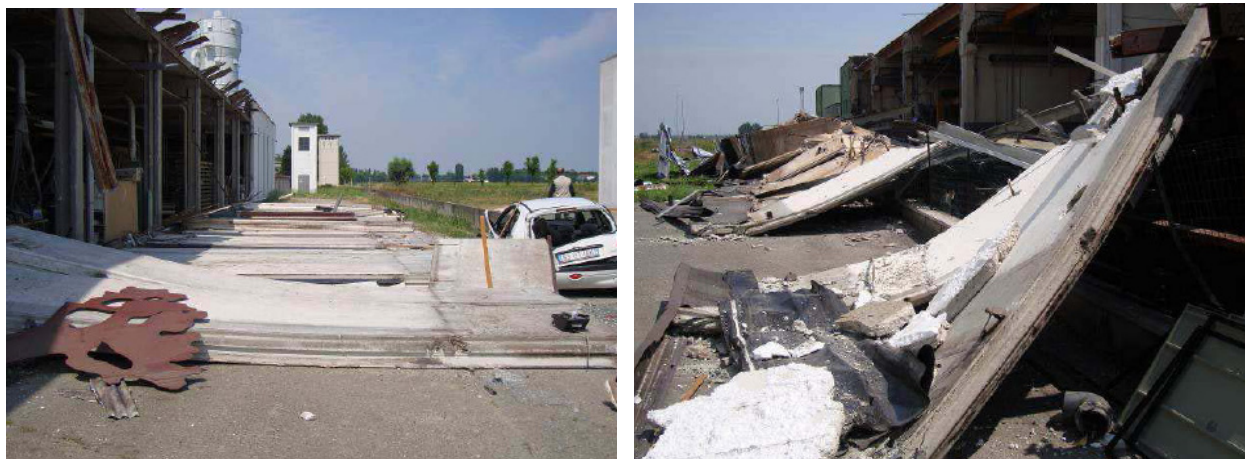
Figure 6-41 Collapse of vertical panels not attached to the foundation curb

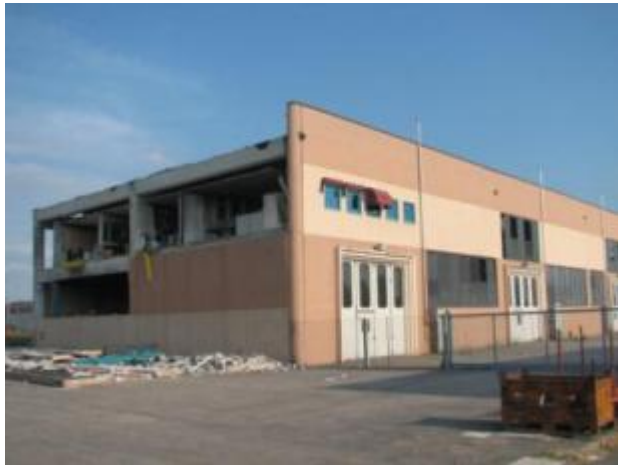
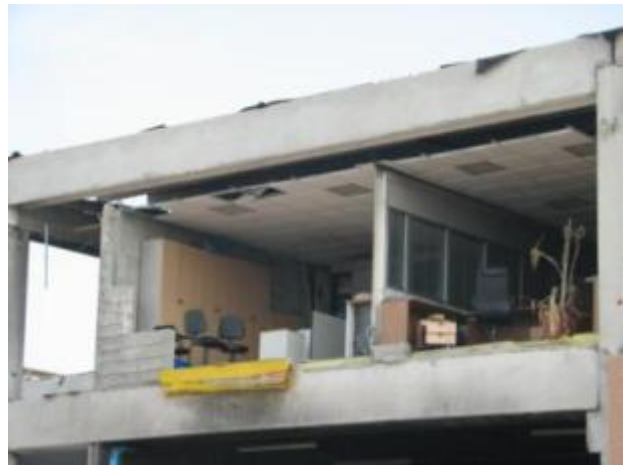
Pre-cast RC horizontal panels added mass to the columns and were attached with steel plate connectors. They were observed to fail in several industrial sheds (Figure 6-42, Figure 6-43, Figure 6-44), because they were not able to resist to the earthquake forces (Figure 6-45, Figure 6-46).

Figure 6-42 Horizontal panels only added mass and did not add stiffness to the structure
