EMILIA EARTHQUAKE OF MAY 20, 2012 IN NORTHERN ITALY: REBUILDING A COMMUNITY RESILIENT TO MULTIPLE HAZARDS

by
Gian Paolo Cimellaro, Marco Chiriatti,
Andrei M. Reinhorn and Lucia Tirca

Technical Report MCEER-13-0006

June 30, 2013

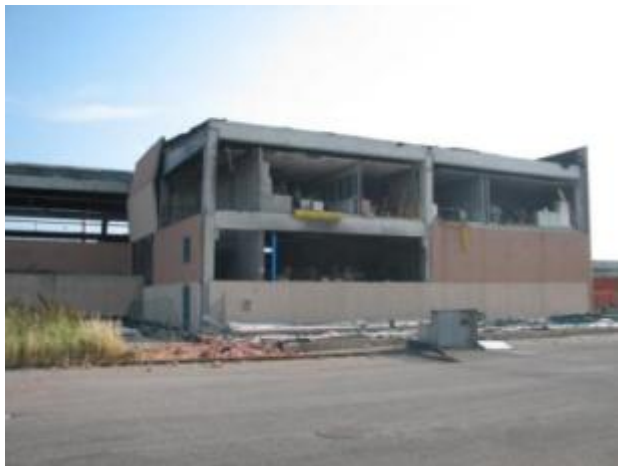
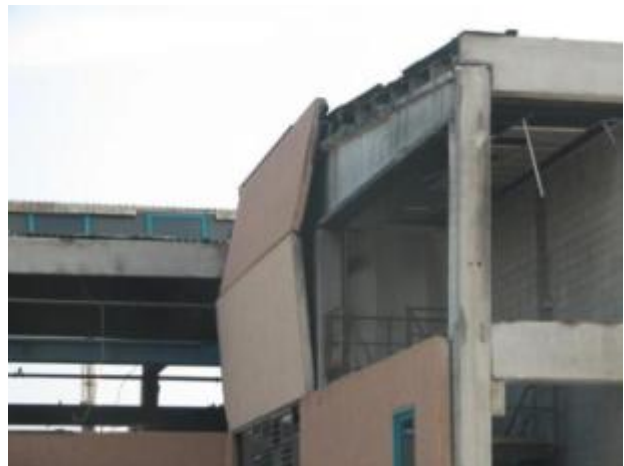
Pre-cast RC horizontal panels added mass to the columns and were attached with steel plate connectors. They were observed to fail in several industrial sheds (Figure 6-42, Figure 6-43, Figure 6-44), because they were not able to resist to the earthquake forces (Figure 6-45, Figure 6-46).

Figure 6-43 Detachment of horizontal panels that were not well-connected to the pillar

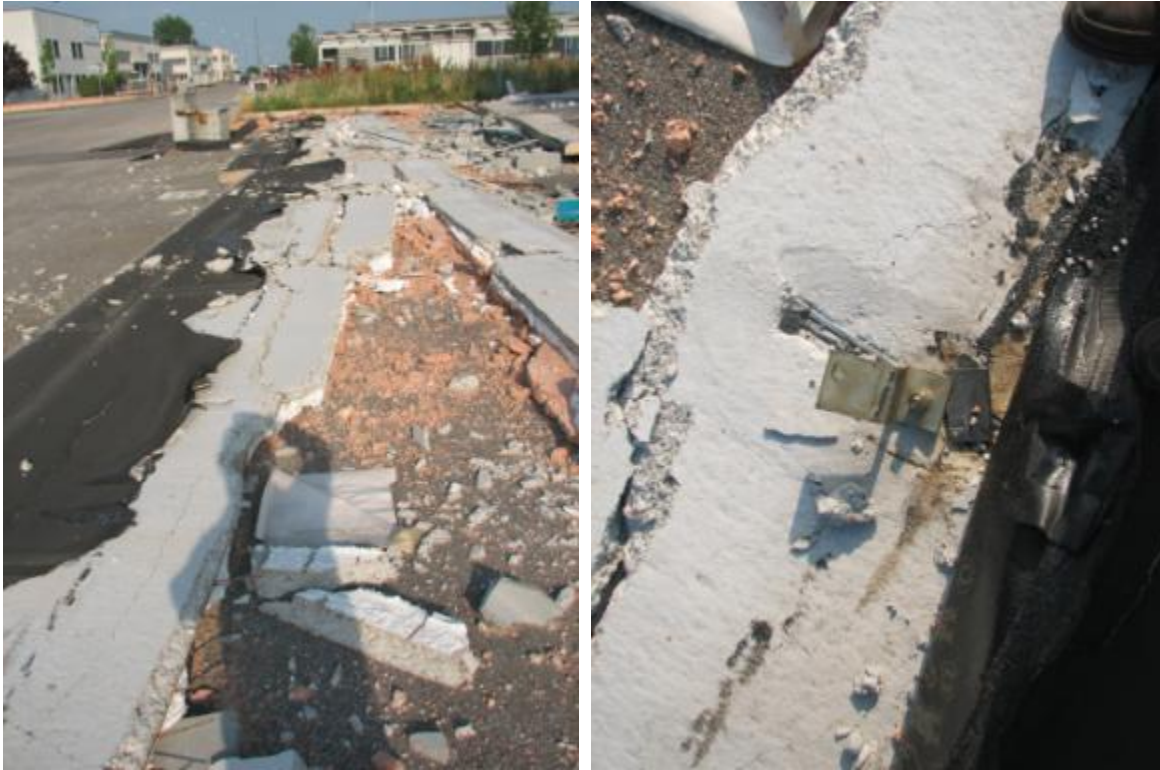
Some of the columns have an I-shaped cross section in order to support precast wall panels between successive columns. For rectangular columns, the precast RC cladding is connected to the columns using metal plate connectors and bolts (Figure 6-44), which were not able to resist the earthquake forces when the panels were located horizontally.

Figure 6-44 Collapse of horizontal panels due to insufficient connections to the beams

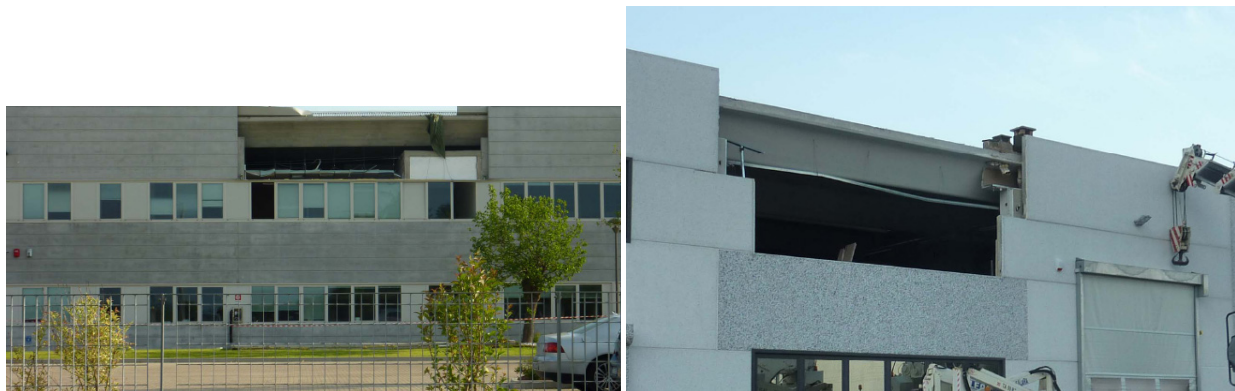
Figure 6-45 Detachment of horizontal panels that were not well connected to the pillar in Sant'Agostino

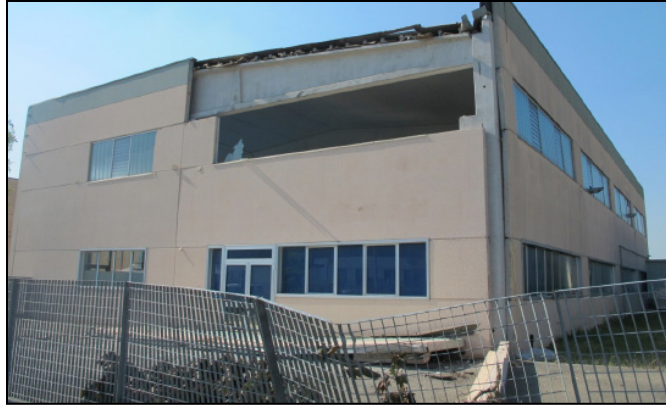
Figure 6-46 Detachment of horizontal panels (Mirandola)

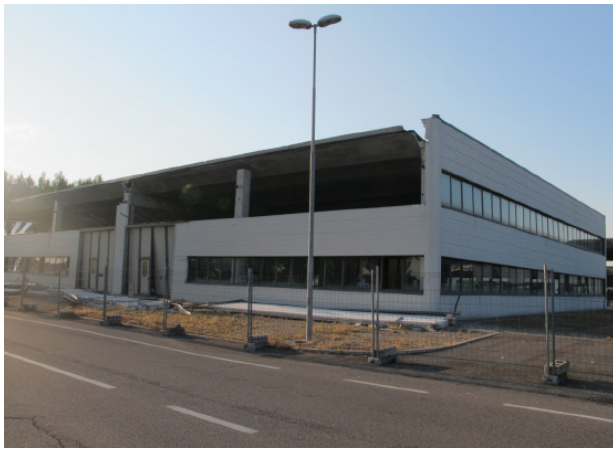
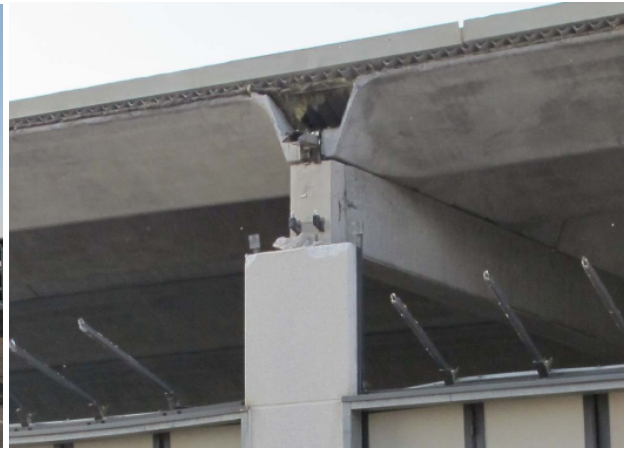
Figure 6-47 (a) Overview (b) steel plate connector failure (Mirandola)

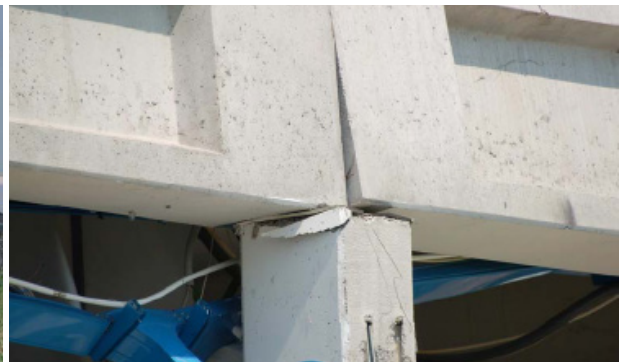
Figure 6-48 (a) Overview (b) collapse of horizontal panels due to lateral overturning of a beam

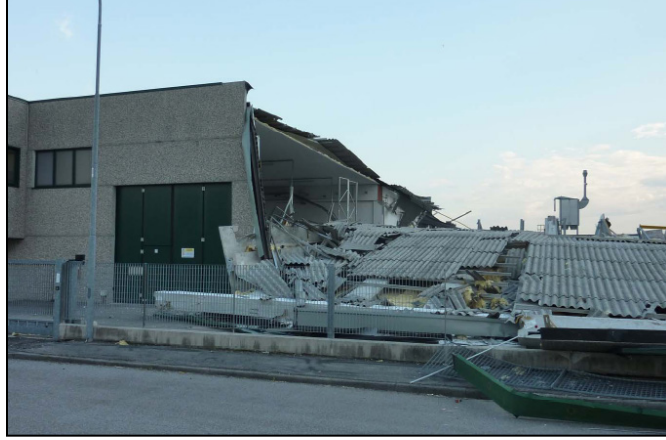
Figure 6-49 Sant'Agostino ceramics

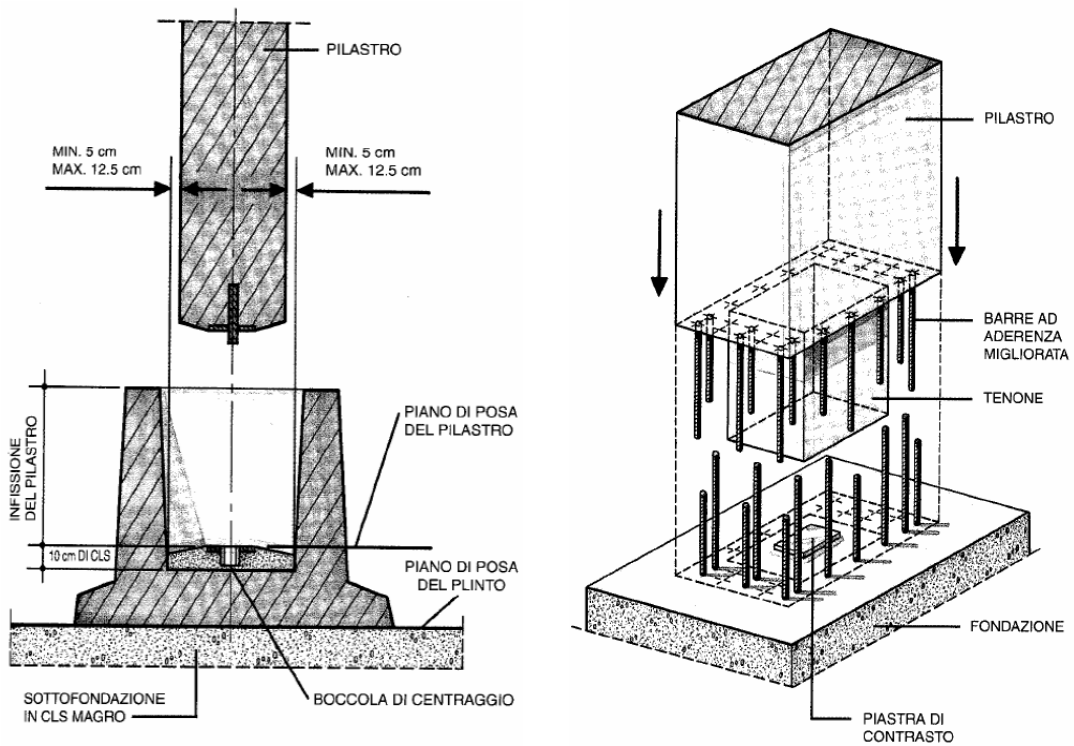
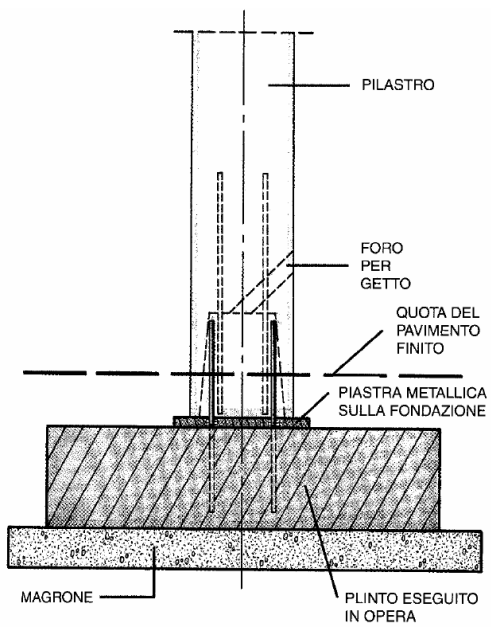
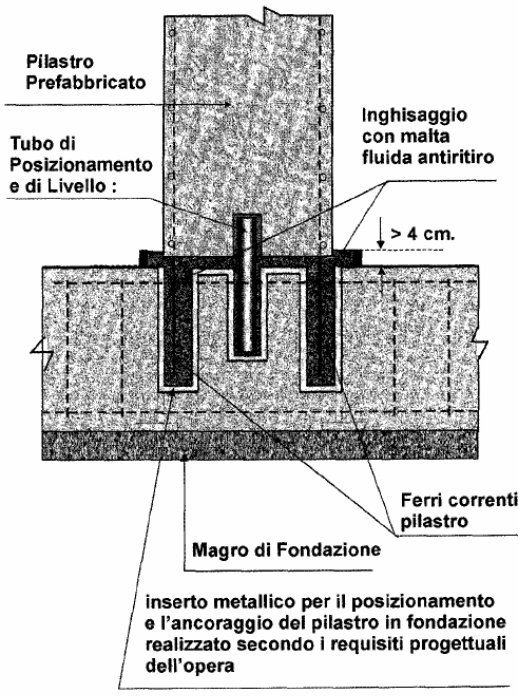
Problems related to the rotation of footings at the foundation have also been observed in industrial sheds. Typical plinths in precast structures are connected to the structure, as seen in the drawings shown in Figure 6-50 and Figure 6-51. Often, the loss of support of the beam is a consequence, not the cause of the collapse (Figure 6-52, Figure 6-54). In these cases, connecting the beam to the column might not be sufficient; instead, it might be necessary to connect different plinths (Figure 6-53). Examples of entire rotation of the columns at the base can be observed in Figure 6-54.

Figure 6-50 Typical plinth column connection at the base

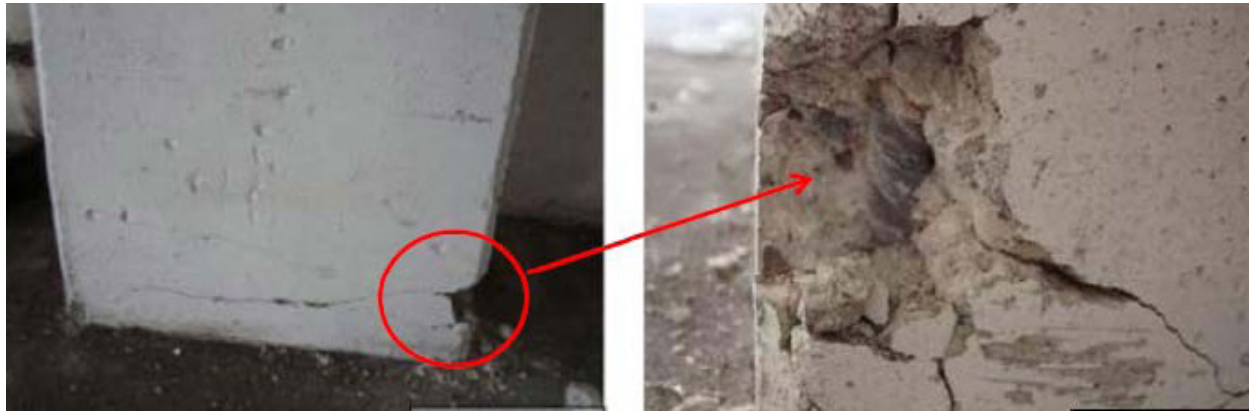
Plastic hinges were also observed at the base of the columns (Figure 6-54, Figure 6-55). In most cases, the shear key also failed (Figure 6-5, Figure 6-6). It was observed that the latter was not adequately detailed with reinforcement, and no redundancy provisions were provided to make a monolithic connection (Figure 6-6, Figure 6-38).

Figure 6-55 Plastic hinge at the base of the pillar

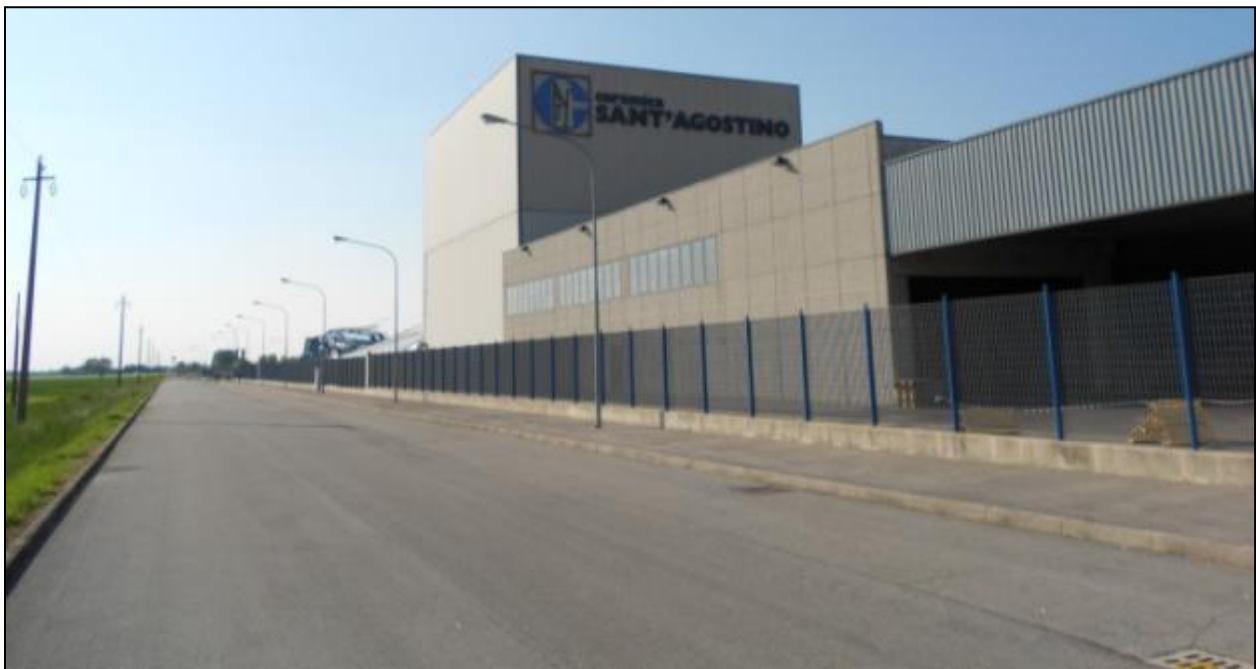
The automated storage warehouse of the Sant'Agostino ceramics factory was heavily damaged during the earthquake (Figure 6-56, Figure 6-57). The warehouse was a large shelving facility for boxes of ceramics tiles.

Figure 6-56 Automated storage warehouse of Sant'Agostino ceramics factory: overview

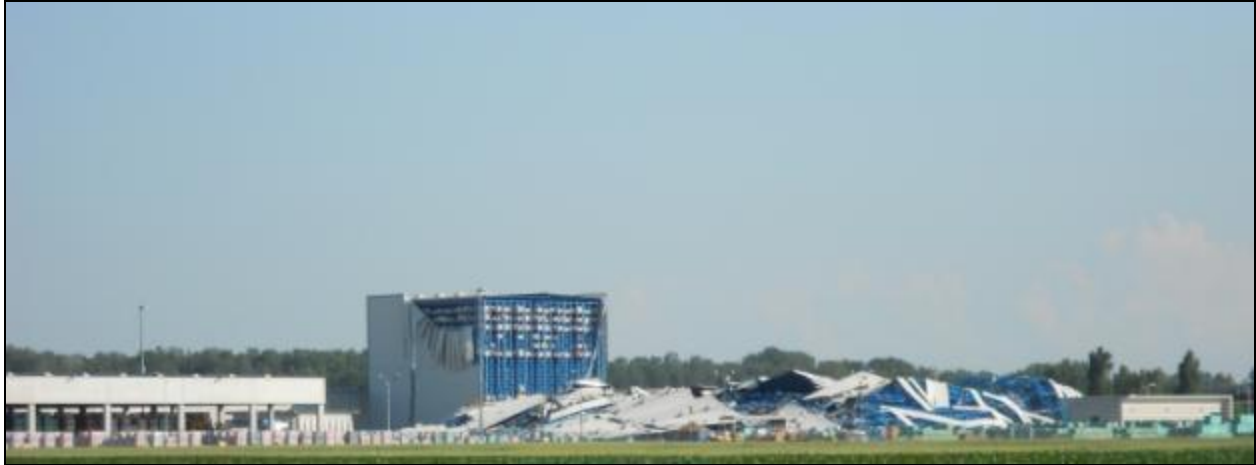
Figure 6-57 Damage overview of automated storage warehouse of Sant'Agostino ceramics factory

Approximately 70% of the structure collapsed in the longitudinal direction (Figure 6-57). The horizontal sections appear to have only been connected with the vertical section by means of an L-Plate and 1 bolt, forming a pivot and providing negligible lateral resistance in that direction. In the transverse direction, the lateral resistance of the truss system of each individual shelf is very small, because they are slender. From Figure 6-59b, it can be observed that, at the moment of the earthquake, only the upper levels of the shelves were filled with heavy boxes of tiles, which might have contributed to larger roof displacements and overall instability. The connection of the frames with the foundation was also very weak as the vertical elements were observed to fail at the vertical element-foundation interface (Figure 6-59a).

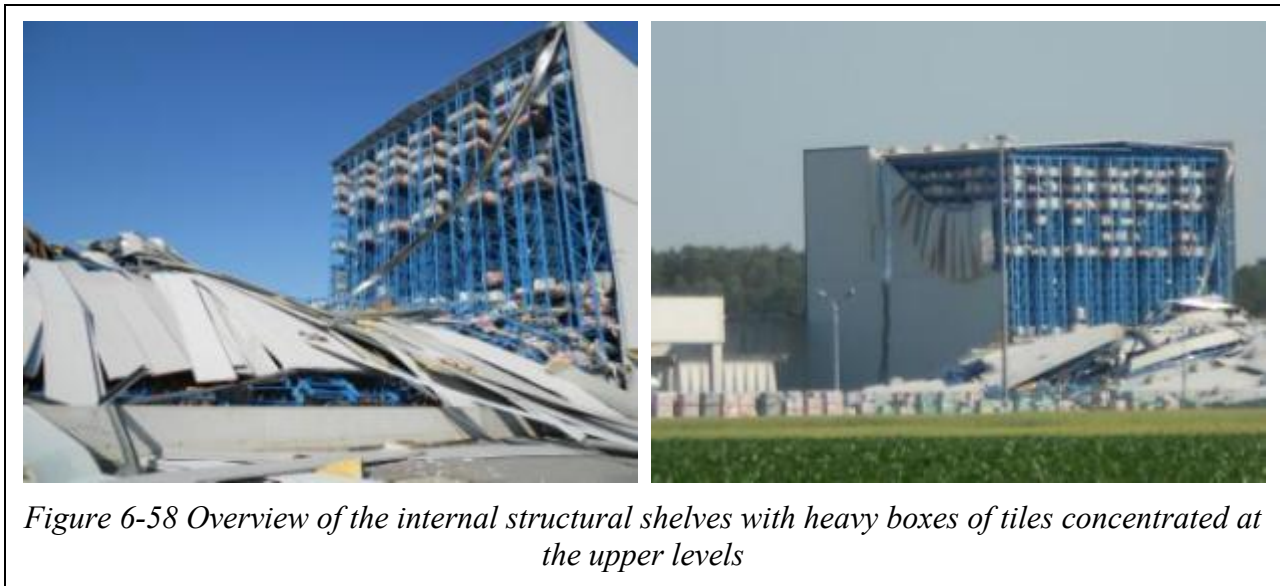
The internal shelves are made of 12 singular internal rows and each shelf is composed of two parallel multi-level frames that are connected transversally with a diagonal truss system. The parallel frames are connected in the transverse direction at the foundation level and with a truss system at the roof level (Figure 6-58). The internal shelves constitute the main structural component of the warehouse.

Figure 6-58 Overview of the internal structural shelves with heavy boxes of tiles concentrated at the upper levels

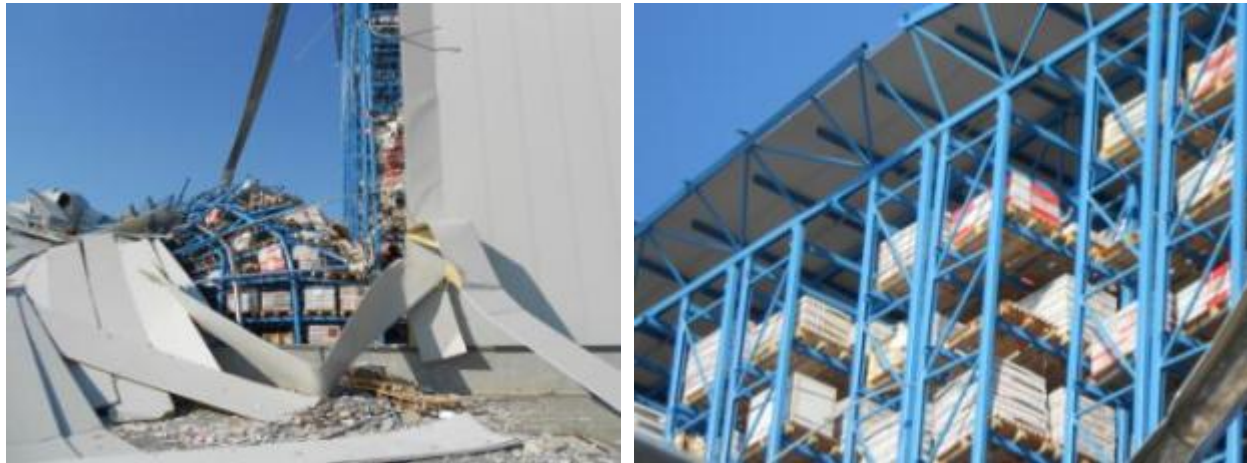
Sandwich panels (Figure 6-59) cover the entire warehouse and are connected directly to the external shelving steel frame or to a truss system in the longitudinal direction.

Figure 6-59 (a) Damage to the sandwich insulation panels; (b) roof detail

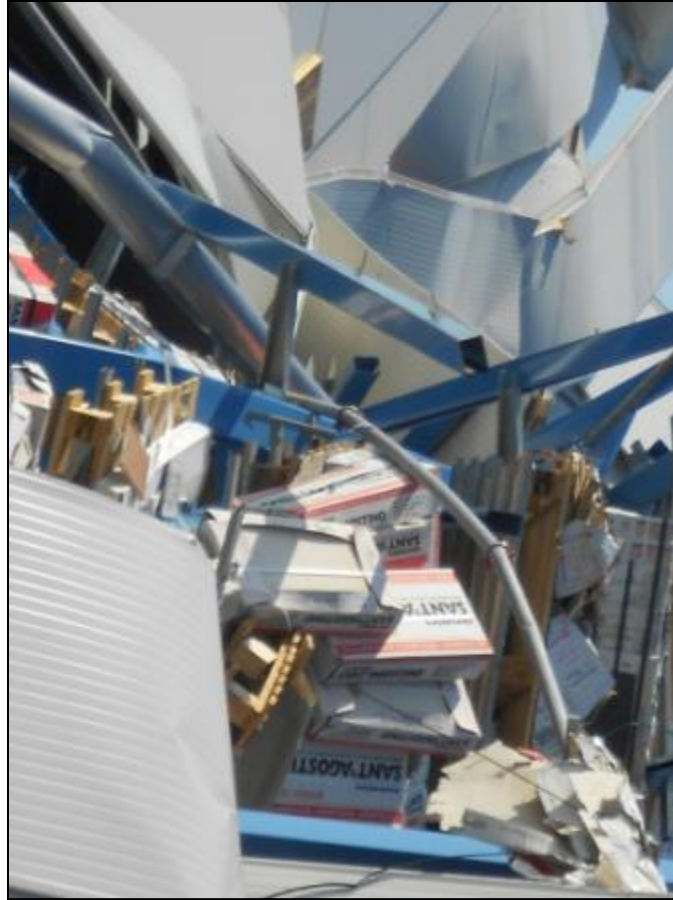
Vertical and horizontal elements consisted of U-shaped sections and in many sections were observed to experience warping failure effects, particularly at intersections with other elements (Figure 6-60).

Figure 6-60 Warping failure effects of U-shaped sections

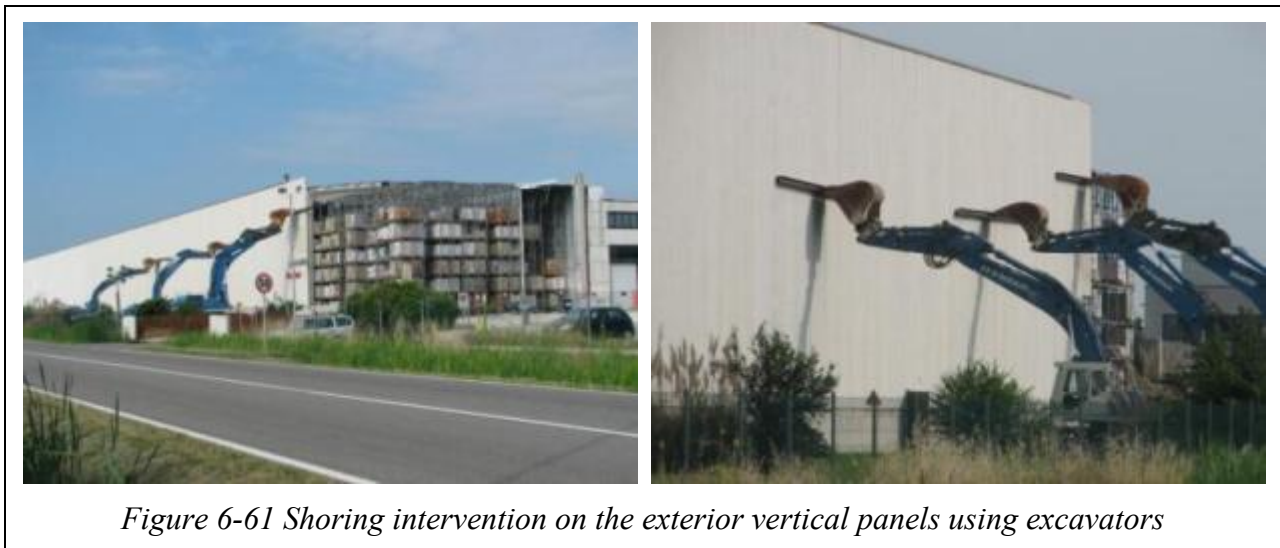
Another example of collapse of a steel storage warehouse is shown in Figure 6-61 and Figure 6-62.

Figure 6-61 Shoring intervention on the exterior vertical panels using excavators

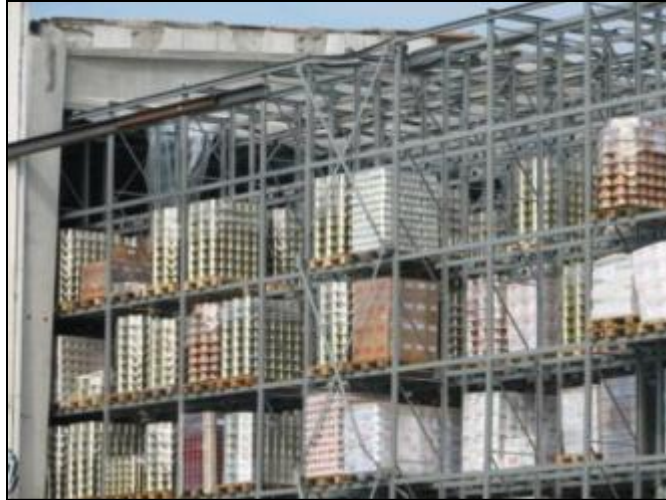
Figure 6-62 Detail of the internal scaffolds

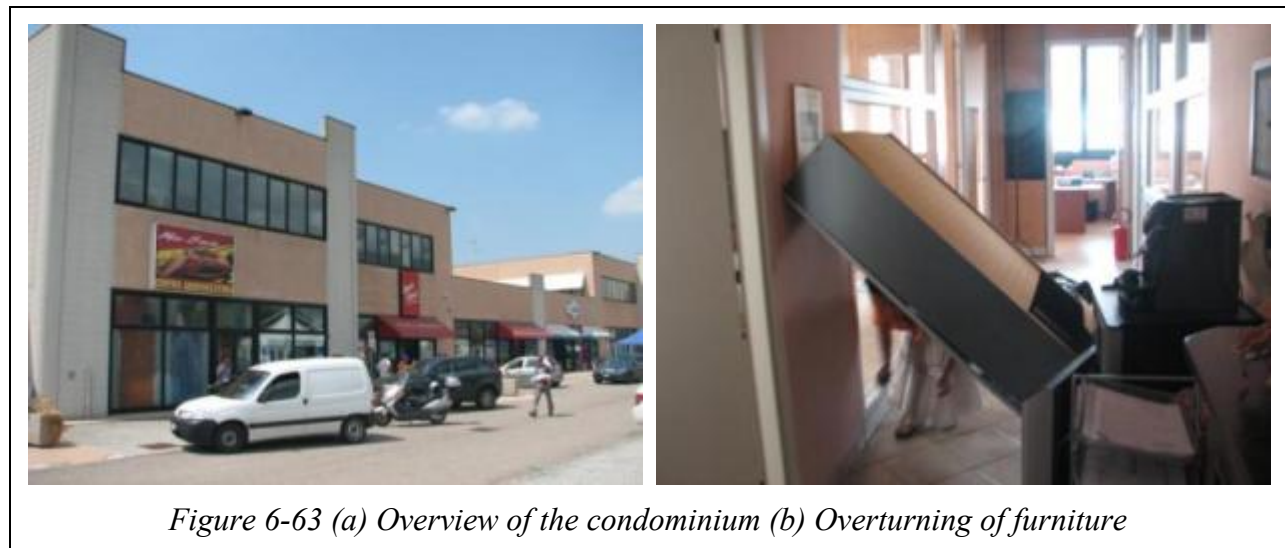
In Emilia, several schools, as well as malls and condominiums (Figure 6-63) were constructed with the same typology as the industrial sheds. Few of them collapsed, but there were internal failures of nonstructural components (Figure 6-63, Figure 6-64, Figure 6-65). Whenever seismic connections were used, the structure may have been damaged, but it did not completely collapse (Figure 6-67).

Figure 6-63 (a) Overview of the condominium (b) Overturning of furniture

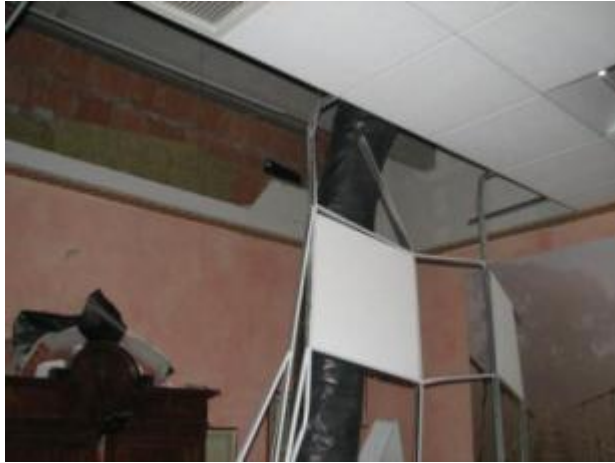
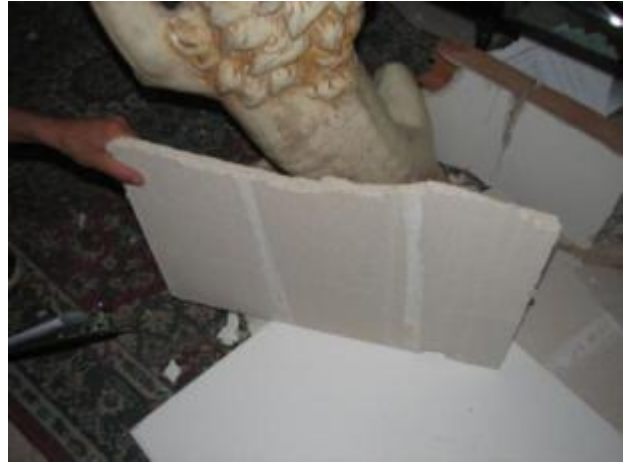
Figure 6-64 Broken suspended ceiling tile

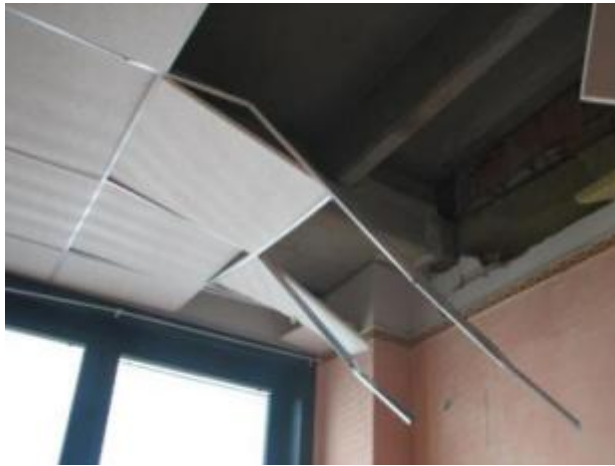
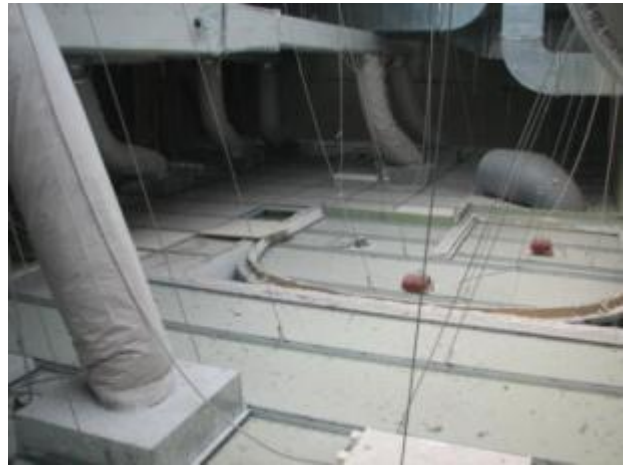
Figure 6-65 (a) Collapse of suspended ceiling system; (b) Suspended ceiling system (internal view)

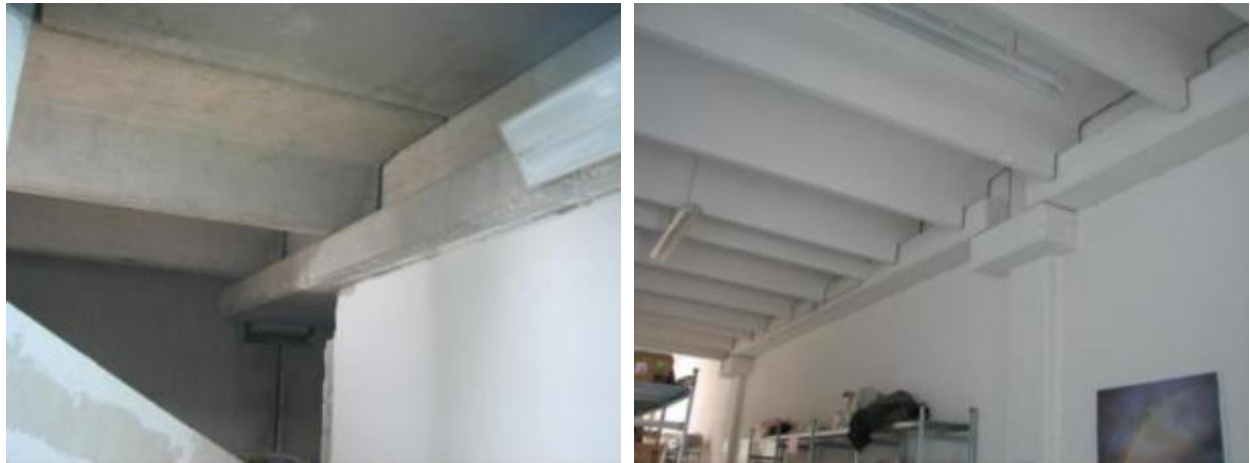
Figure 6-66 Absence of seismic connections

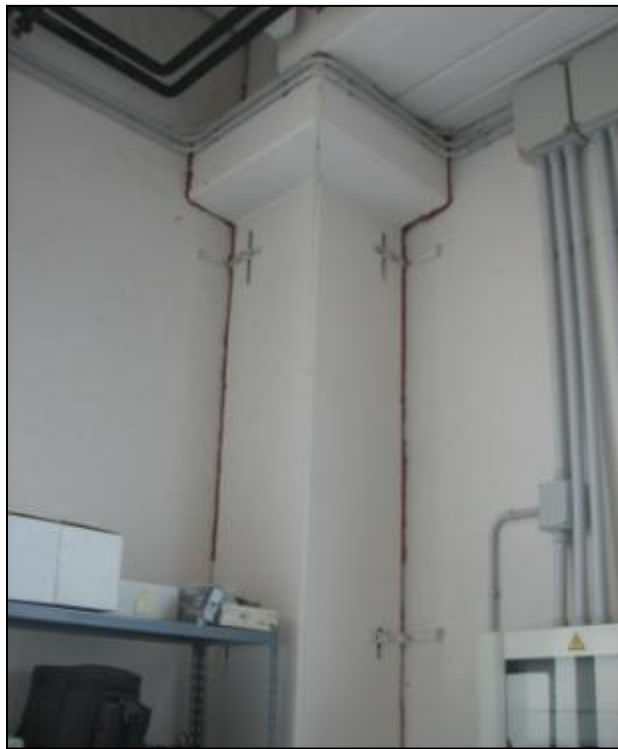
Figure 6-67 Structural detail of panel-structure connections

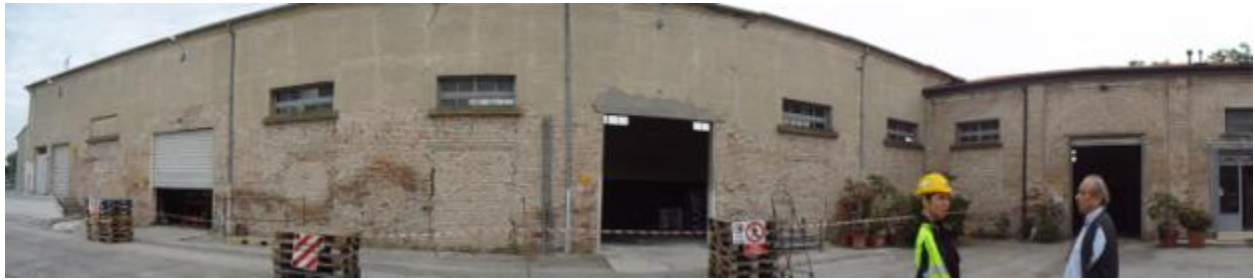
An abandoned industrial structure in Reno Centese made of masonry walls with a wooden roof performed reasonably well during the earthquake. The roof consisted of wooden trusses (Figure 6-69).

Figure 6-68 Masonry industrial structure in Reno Centese

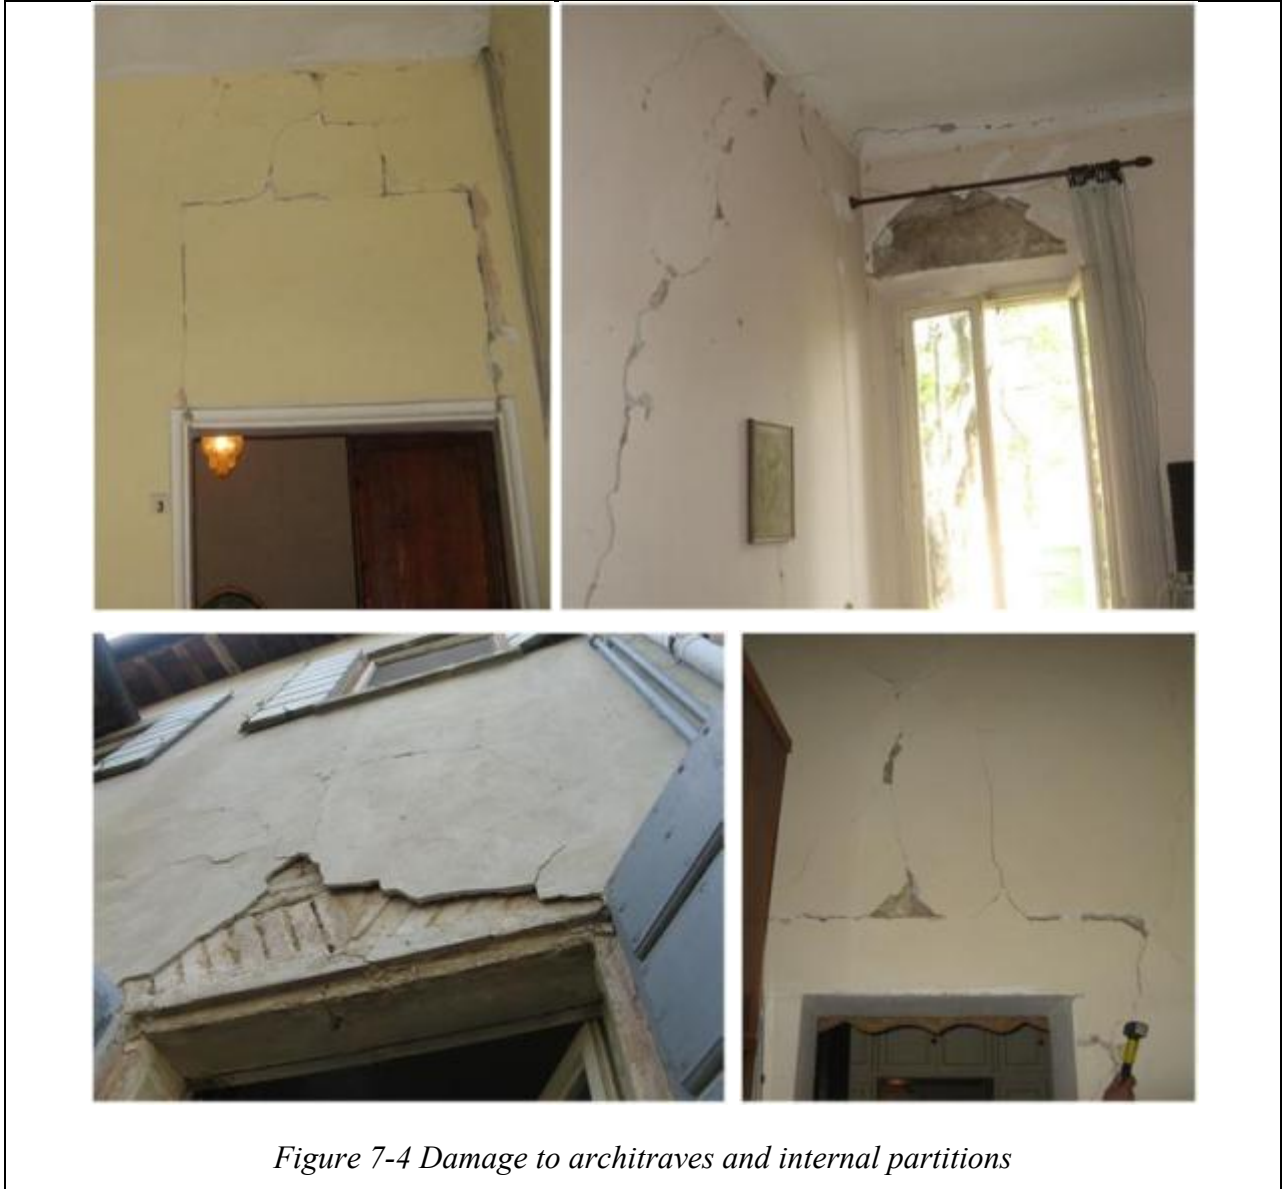
Shear cracks appeared on the load bearing walls as well as in the internal partitions and in the architraves (Figure 7-4).

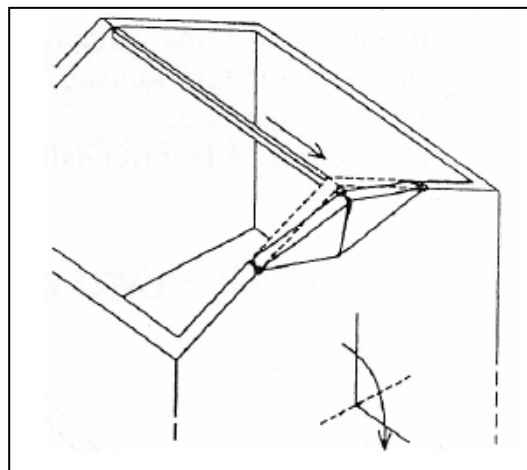
Figure 7-28 Mechanism to break through the wall of the tympanum

The mechanism that caused the collapse of the roof is shown in the Figure 7-28. The force generated by the timber trusses during the earthquake caused the collapse of the upper part of the façade. Without this support, the roof collapsed.

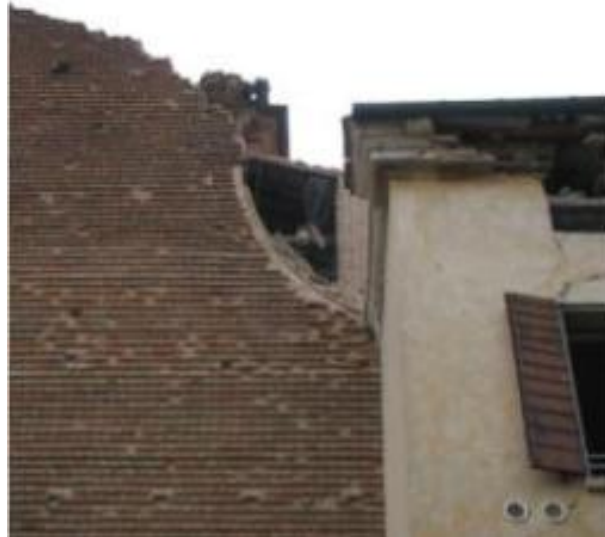
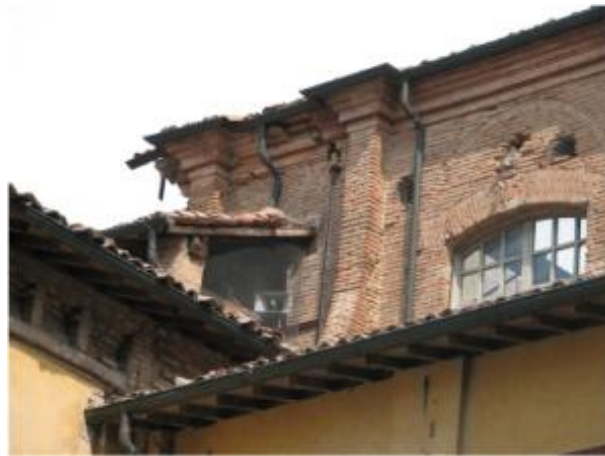
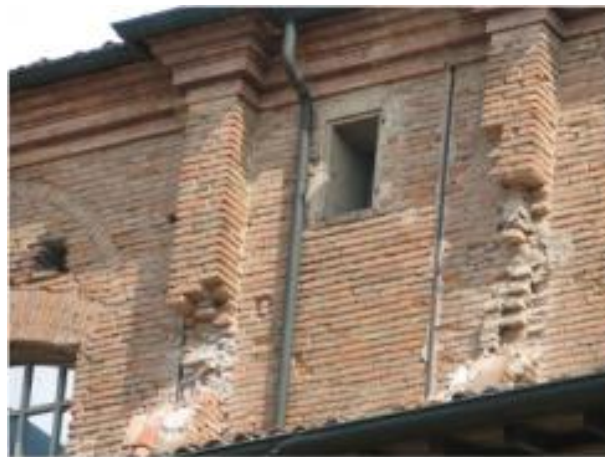
The earthquake caused severe damage to the church. The external wall presents numerous cracks and some buttresses have collapsed (Paupério et al., 2012).

Figure 7-29 External damage and collapsed buttresses

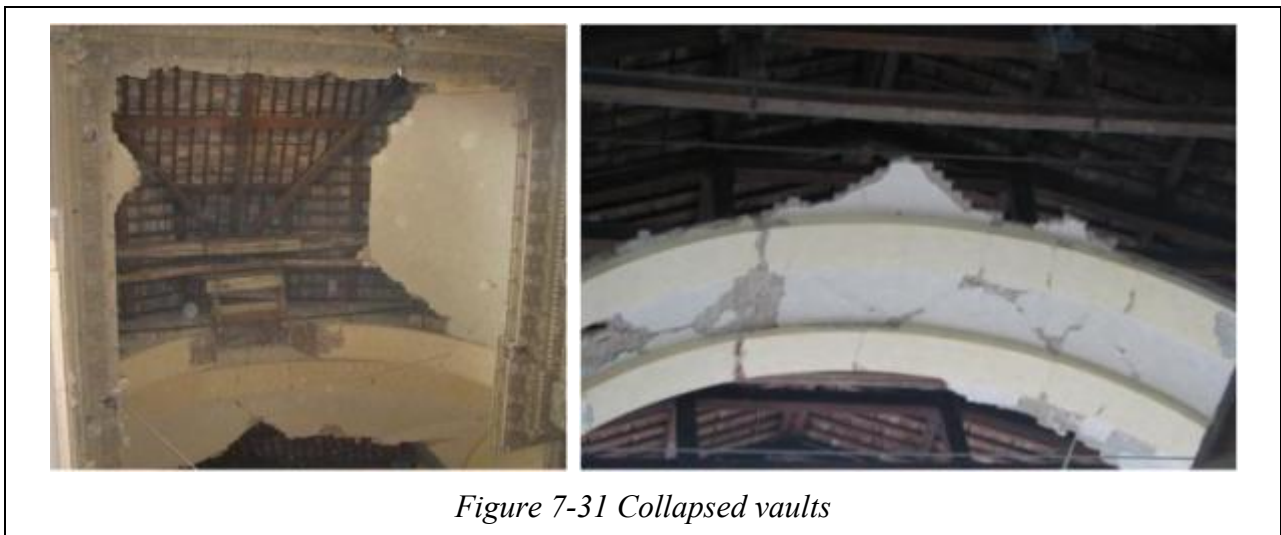
The internal vaults were made of brick masonry and totally collapsed, causing severe damage at the internal works.

Figure 7-31 Collapsed vaults

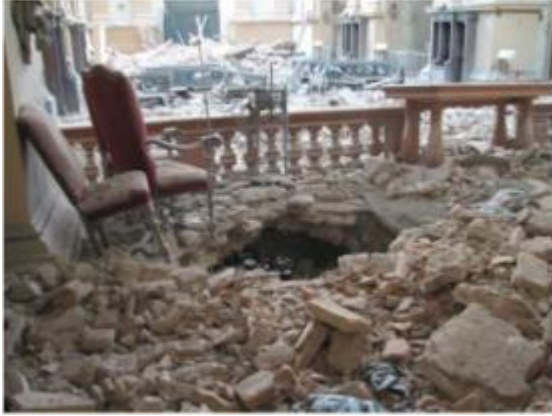
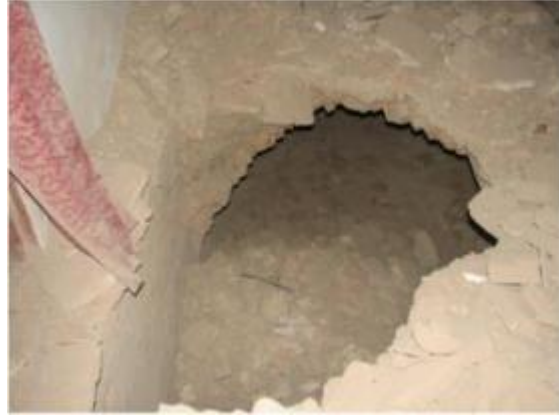
The debris that fell from the roof also opened some subterranean crypts.

Figure 7-32 Subterranean crypt

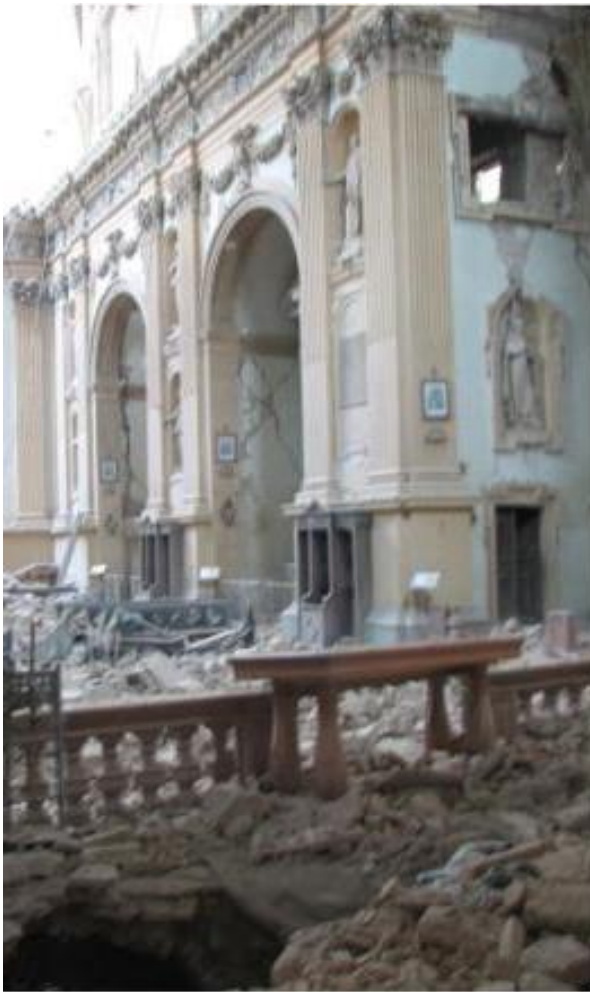
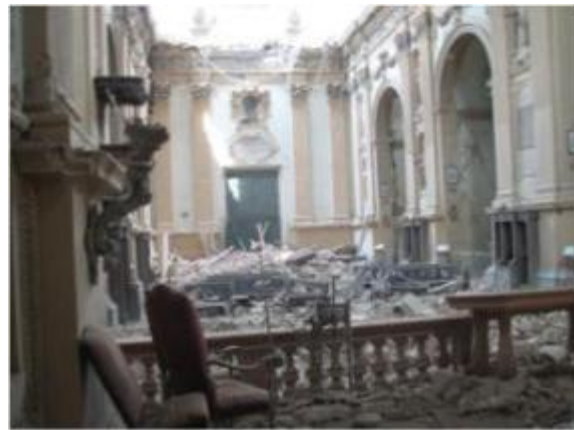
Figure 7-33 Internal view of the church after the earthquake

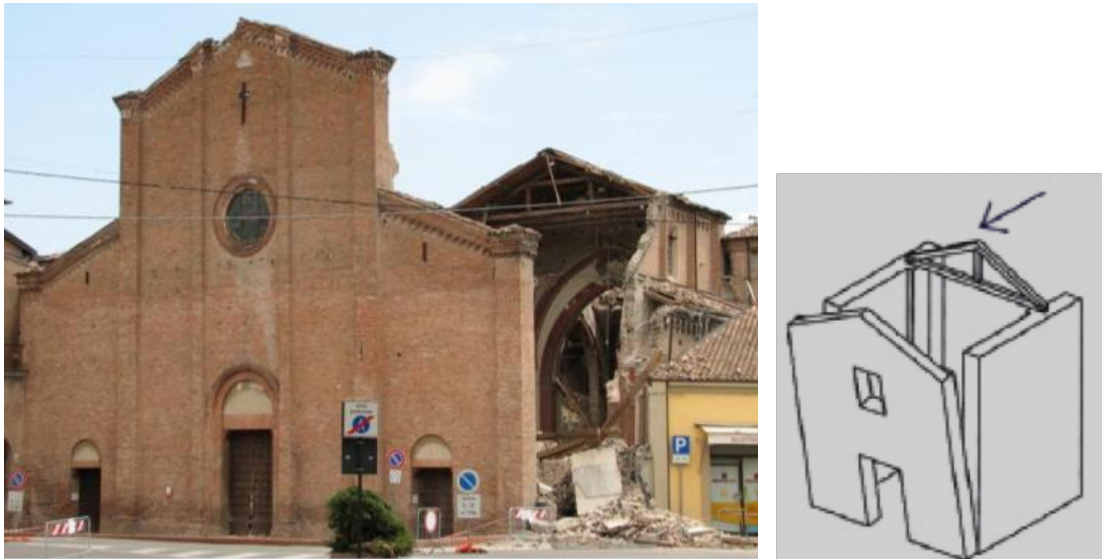
After the earthquake, the structure of the church was destroyed. The timber collapsed as well as the lateral walls. The cause of this collapse was the detachment of the façade, which is clearly visible in the following figure. In fact, the façade of this particular building is an important element in limiting the push on the side walls.

Figure 7-36 San Francis Church in Mirandola after the earthquake and critical mechanism

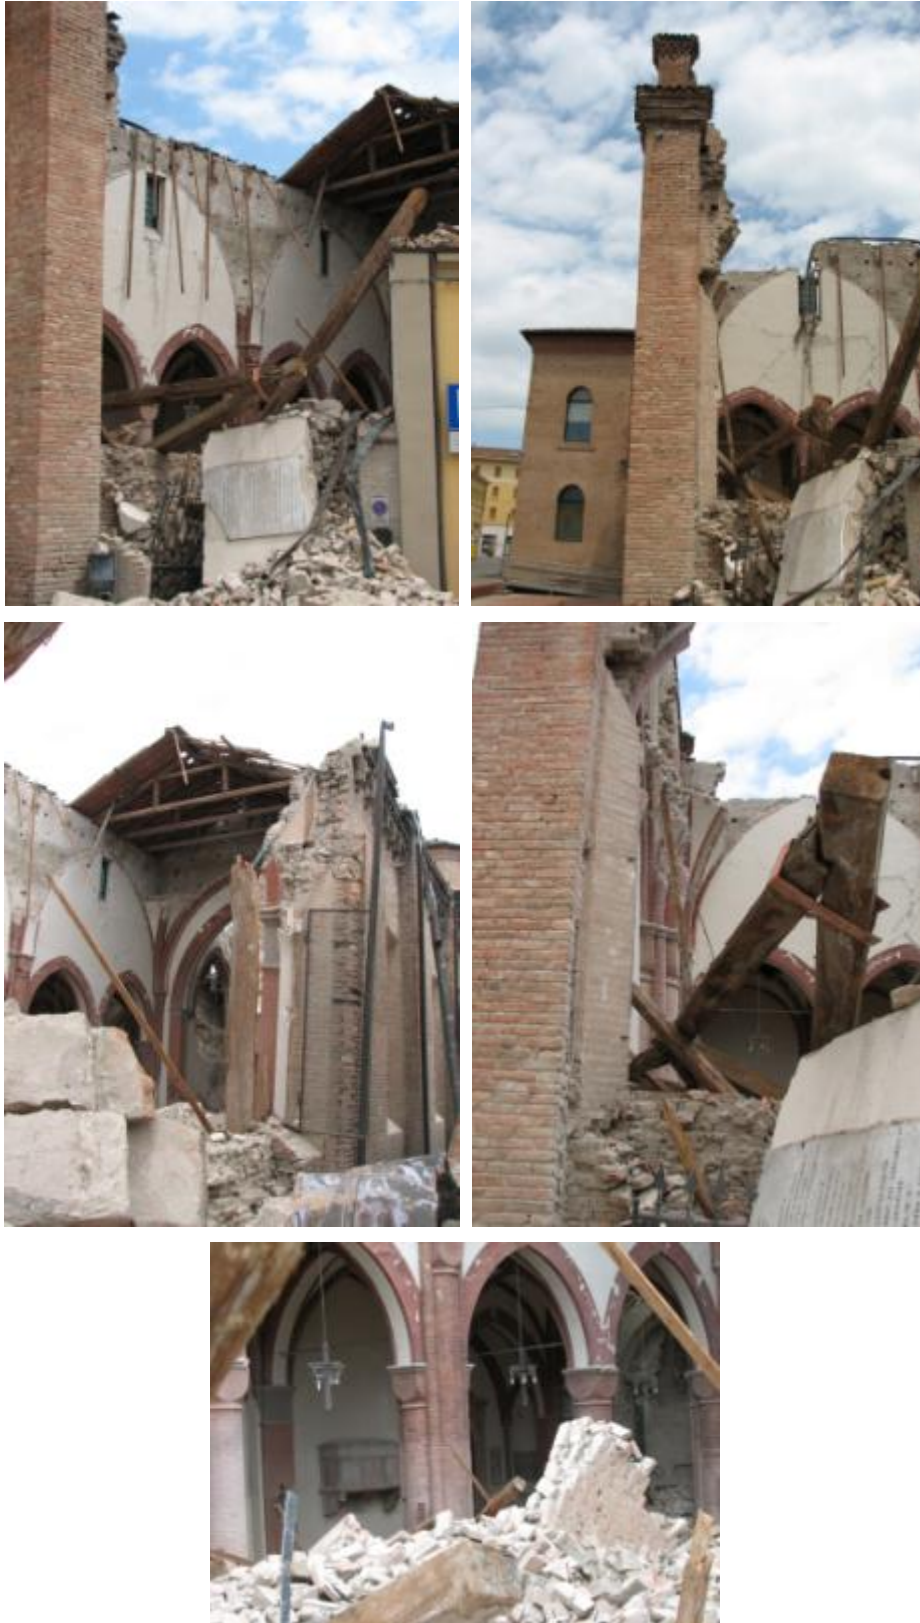
Figure 7-38 Internal view of the church after the earthquake
