EMILIA EARTHQUAKE OF MAY 20, 2012 IN NORTHERN ITALY: REBUILDING A COMMUNITY RESILIENT TO MULTIPLE HAZARDS

by
Gian Paolo Cimellaro, Marco Chiriatti,
Andrei M. Reinhorn and Lucia Tirca

Technical Report MCEER-13-0006

June 30, 2013

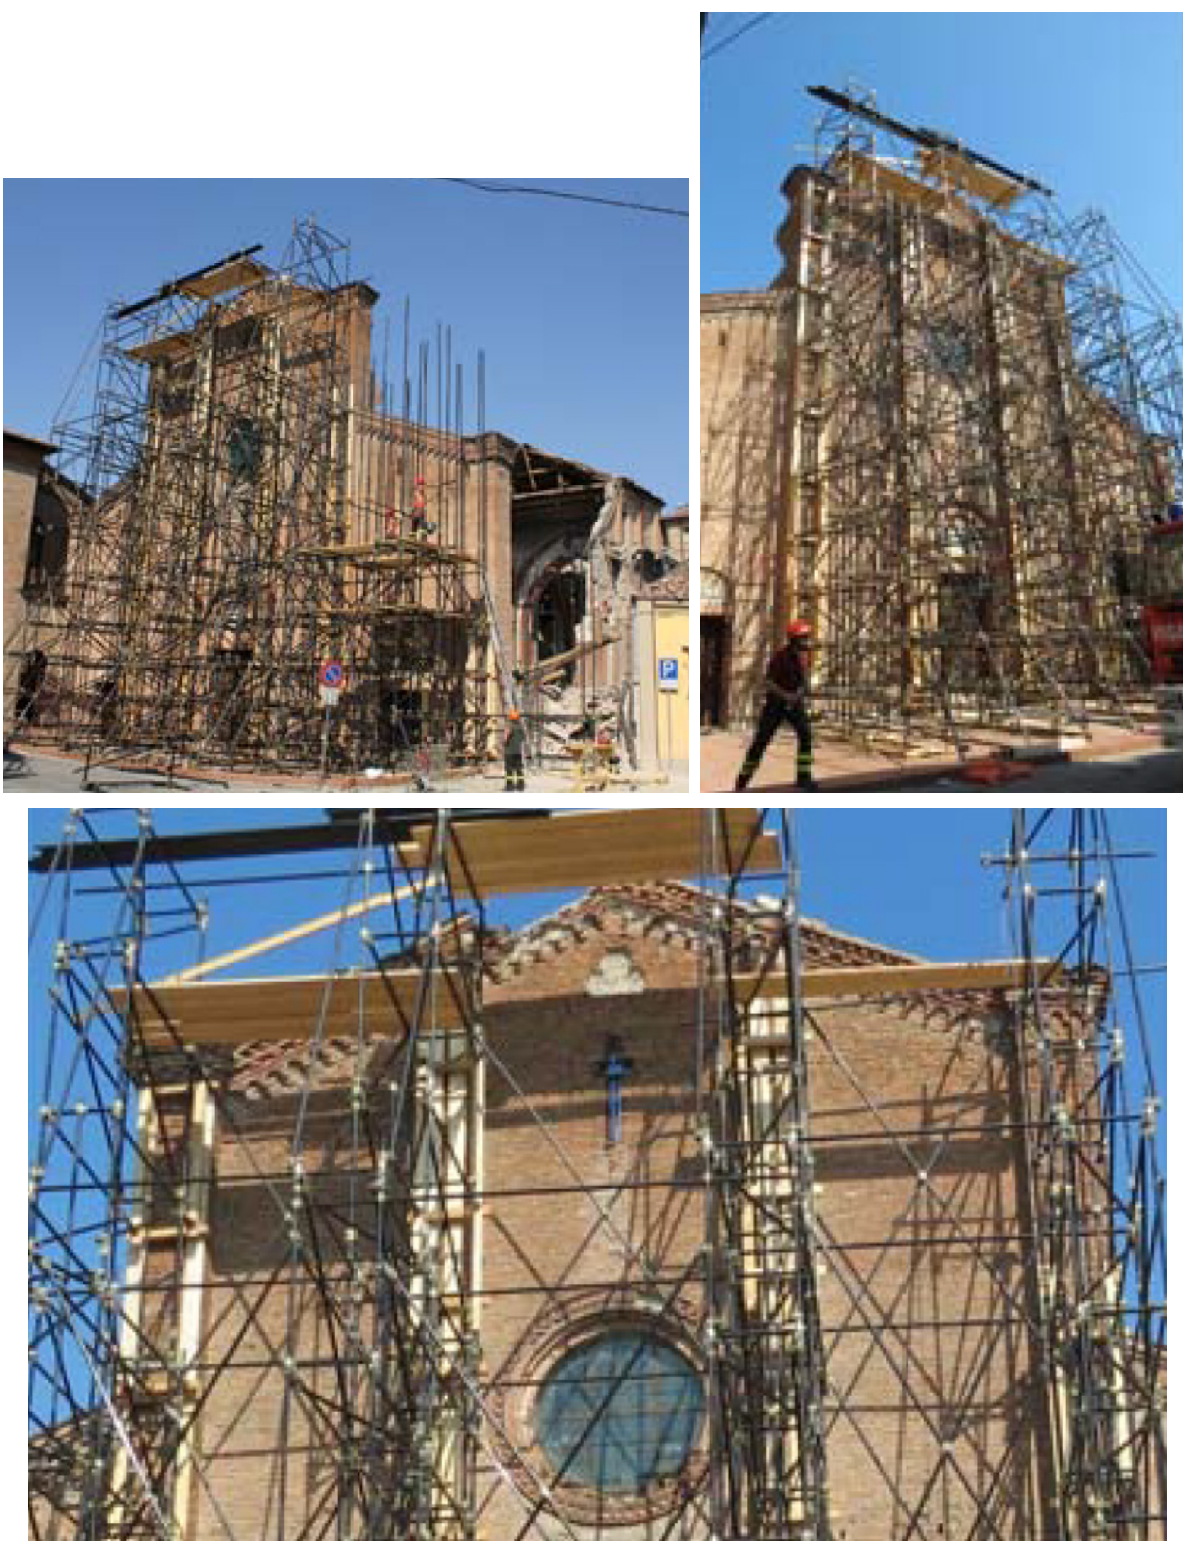
Figure 7-39 Emergency interventions

The first emergency interventions were shoring of walls with steel bars and the placement of wood shore at the openings.

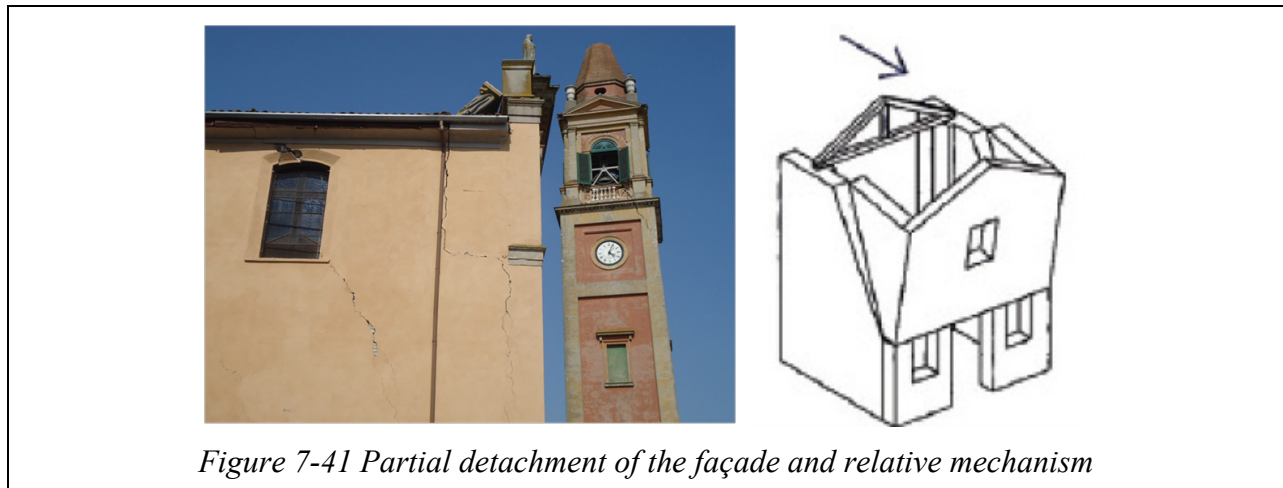
The fall of a decorative statue from the roof may be the primary cause of the damage. The church also has some shear cracks in the north wall and the bell tower is leaning. A partial detachment of the façade is clearly visible.

Figure 7-41 Partial detachment of the façade and relative mechanism

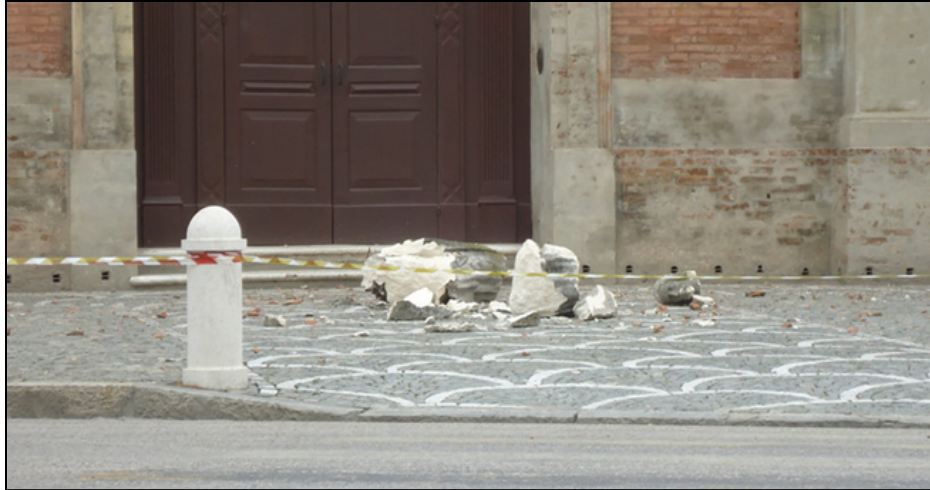
Figure 7-42 Collapse of the statue located at the roof level

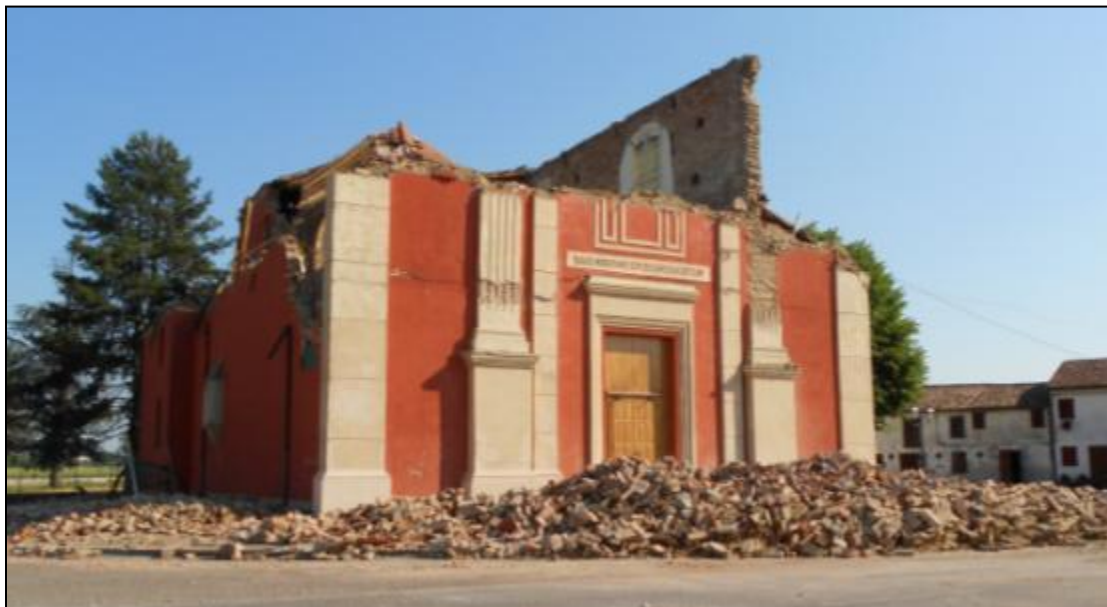
After the earthquake, the structure of the church was destroyed. The timber collapsed as well as the lateral walls. The major cause of this collapse was the use of poor materials; in fact, the damage spread throughout the whole structure.

Figure 7-45 San Martino Church after the earthquake

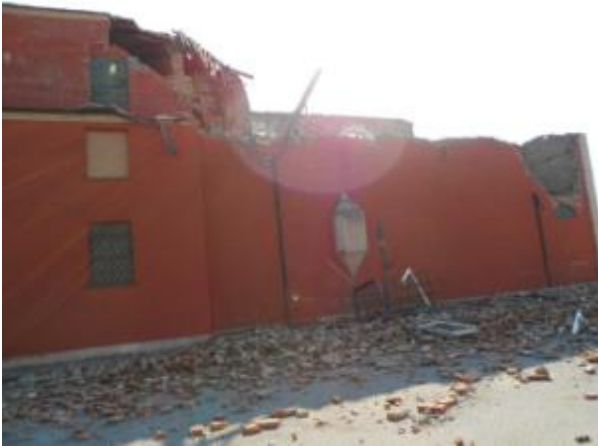
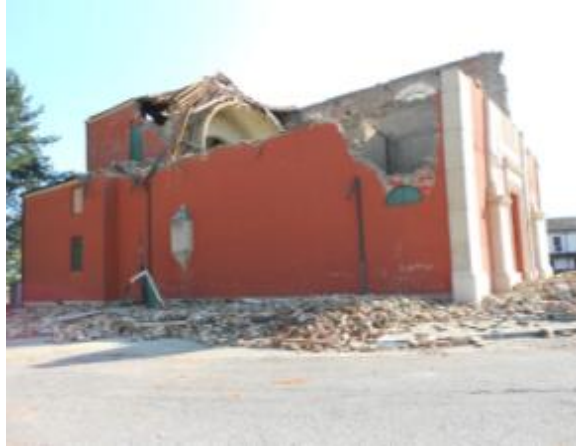
Figure 7-46 San Martino Church after the earthquake: lateral view

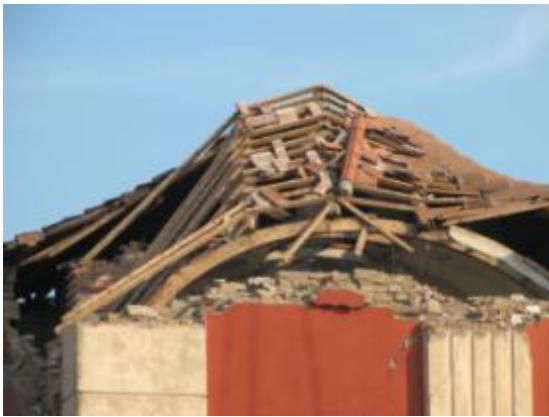
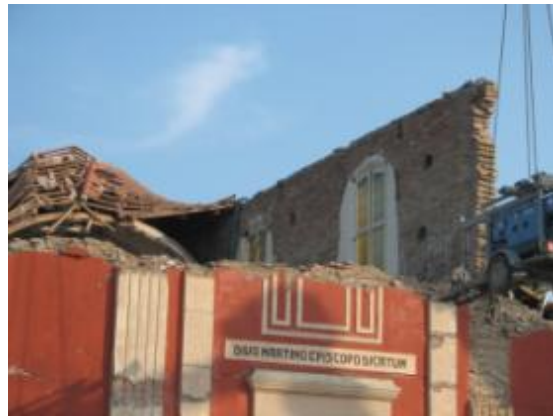
Figure 7-47 Collapsed roof

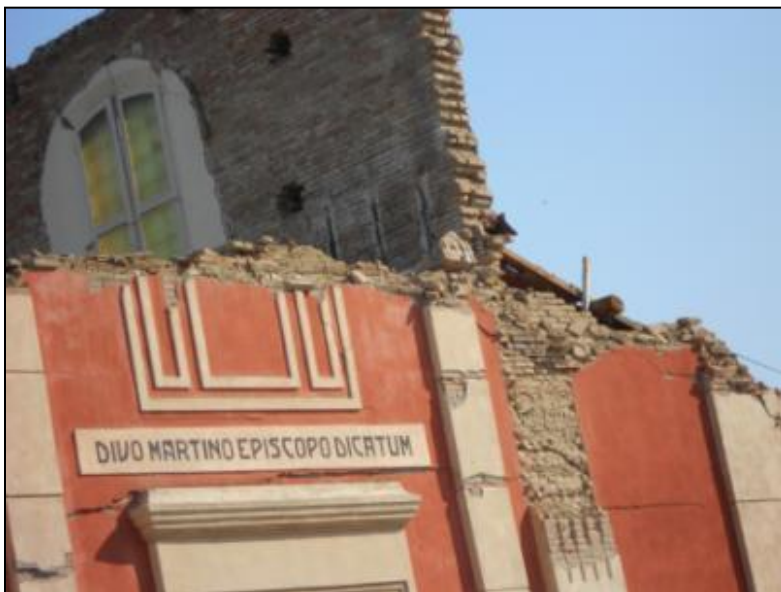
Figure 7-48 Close up of San Martino Church

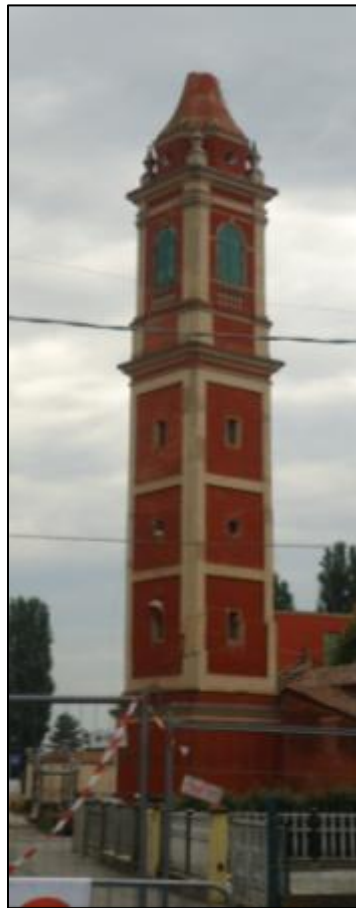
After the earthquake, the bell tower was very unsafe. Some shear cracks in the middle of the tower caused a sliding surface. In order to avoid an unsafe collapse, it was demolished.

Figure 7-49 San Martino bell tower after the earthquake and before the demolition

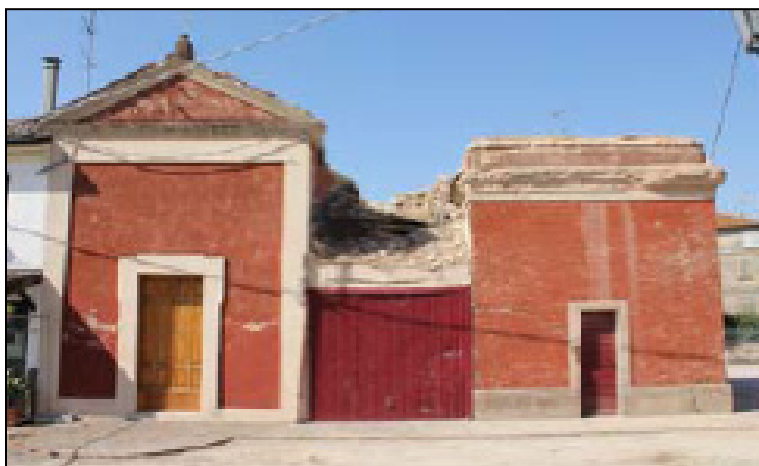
Figure 7-50 San Martino bell tower after the earthquake and after the demolition

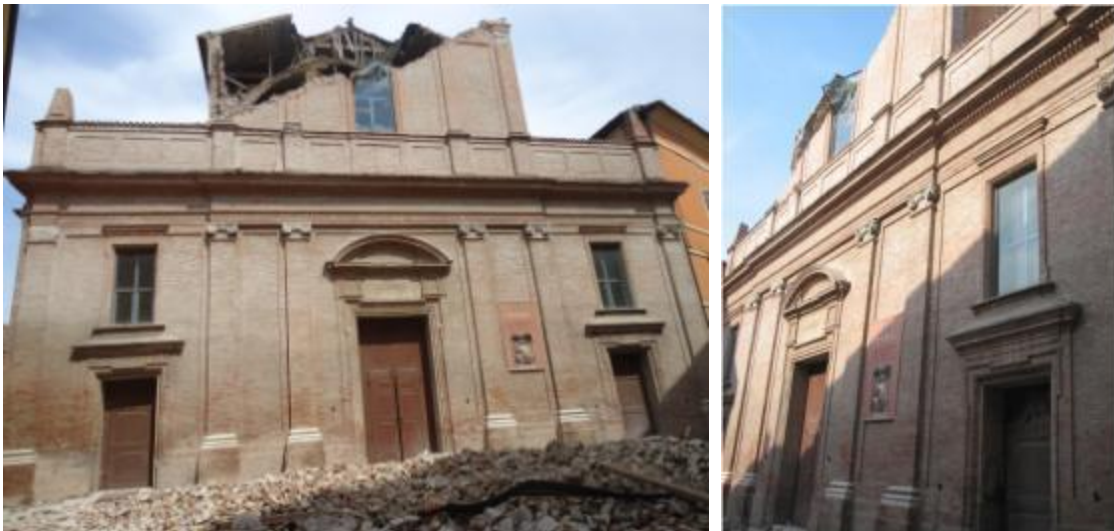
The earthquake caused severe damage to the structure of the church. The roof was partially collapsed, as was the top of the façade. The mechanism involved in this collapse is the same one that afflicted the Chiesa del Gesù in Mirandola.

Figure 7-53 Duomo in Finale Emilia after the earthquake

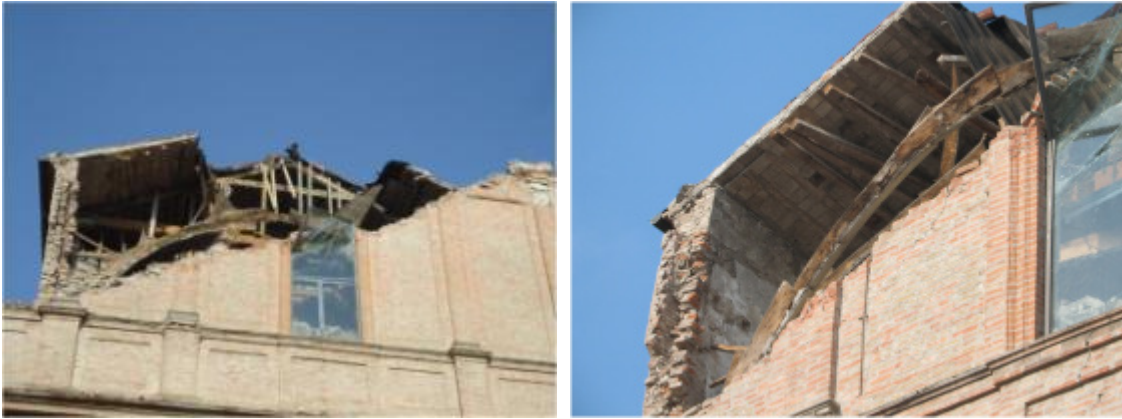
Figure 7-54 Collapsed roof

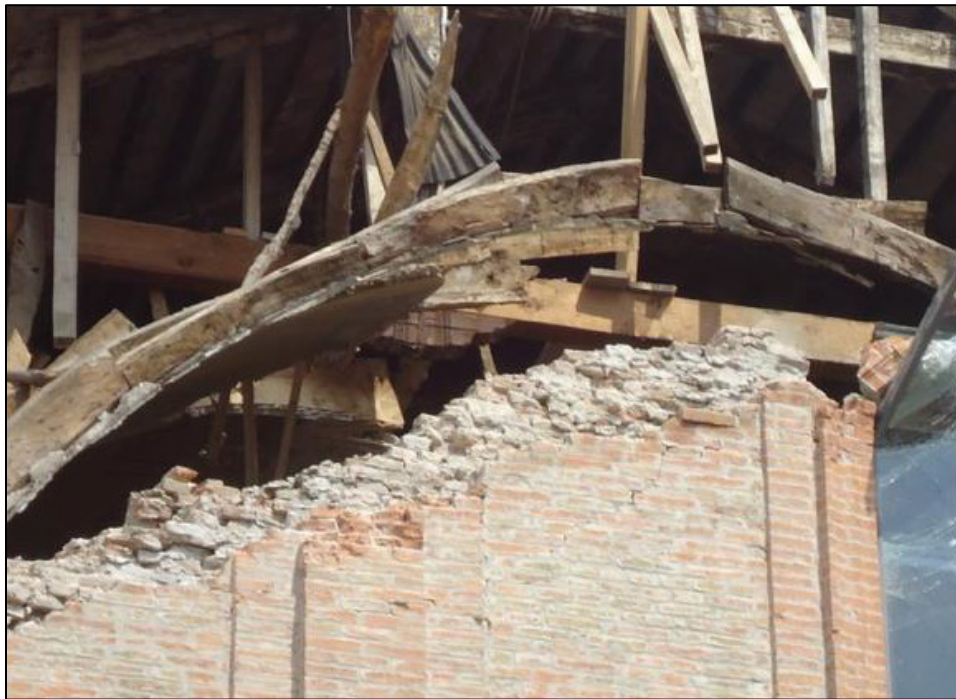
Figure 7-55 Close up of Duomo in Finale Emilia

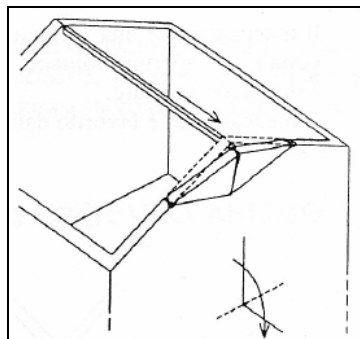
Figure 7-56 Mechanism to break through the wall of the tympanum

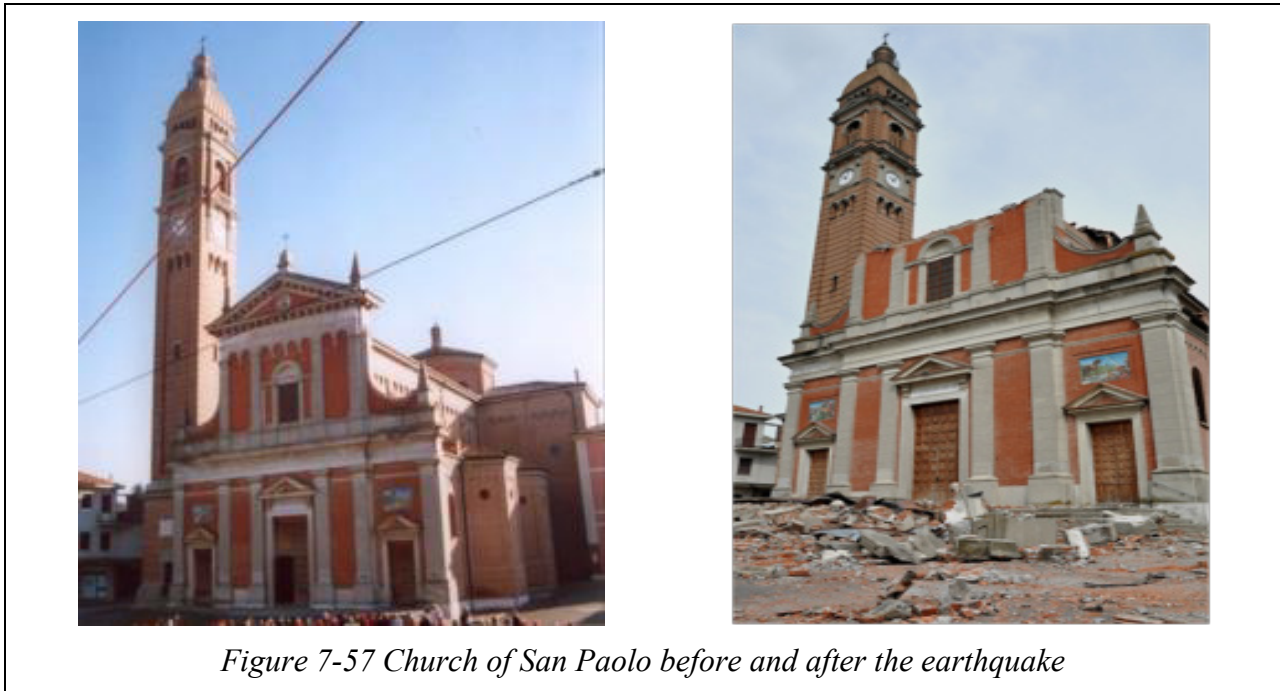
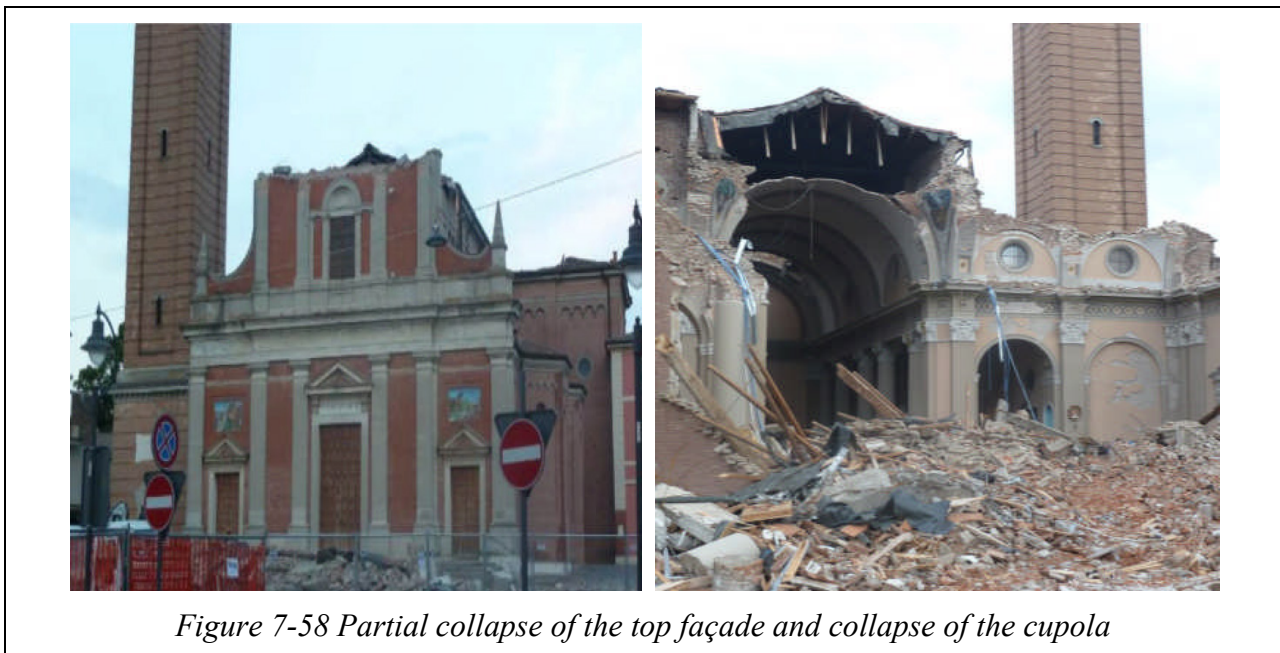
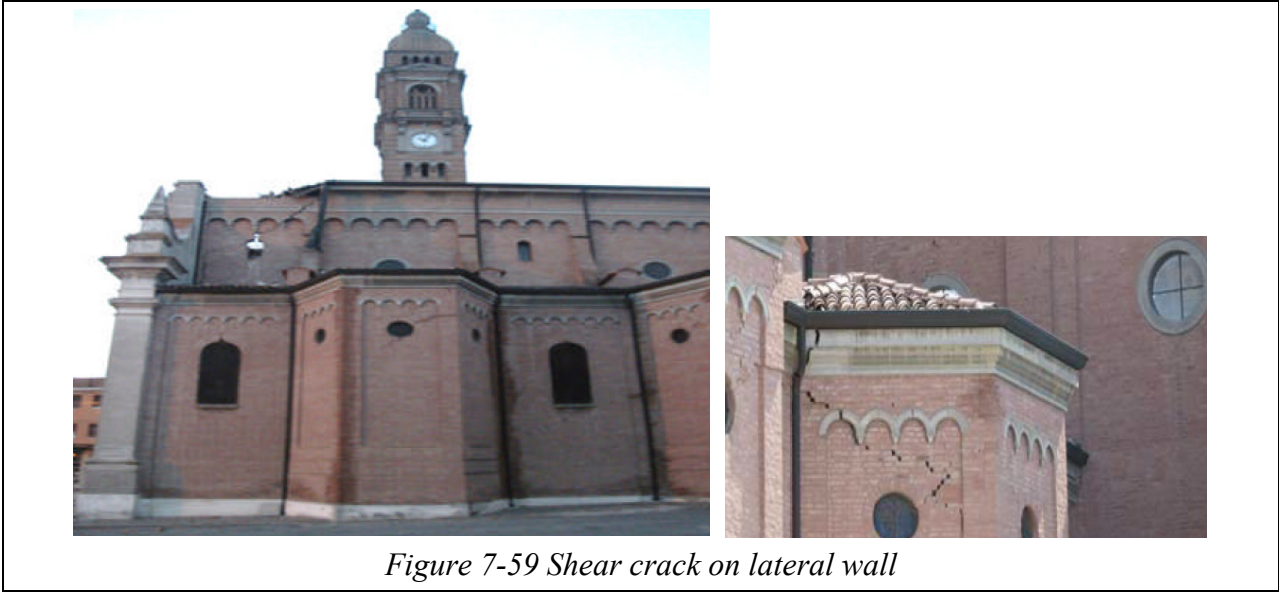
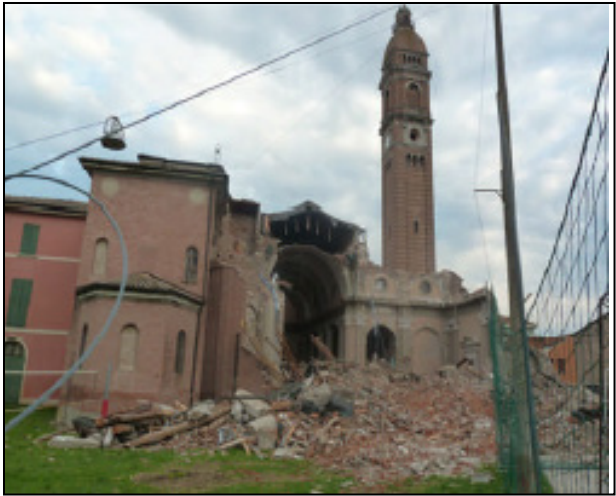
The church of San Paolo in the town of Mirabello sustained a partial collapse of the façade and a total collapse of the transept and apse. The bell tower of the church was declared salvageable because it did not sustain structural damage. Locals reported that the bell tower foundations had been strengthened in the past.

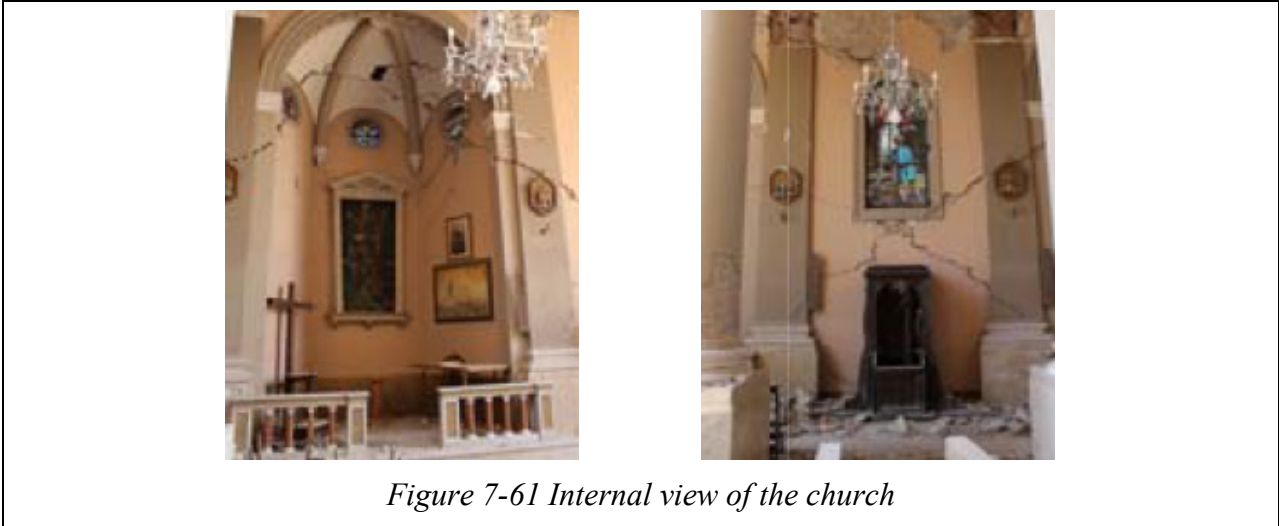
As shown in the previous figure, the main cause of the collapse of the structure was the use of poor materials. Some figures also show the presence of reinforced concrete elements that may have been used for some restoration.

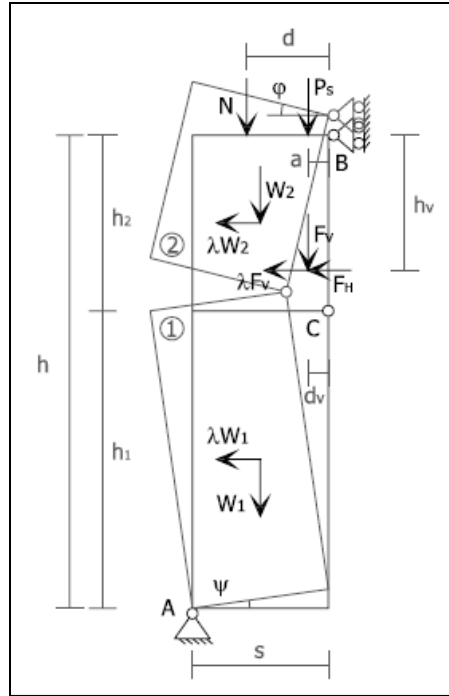
Figure 7-64 Calculation scheme

There are extensive diagonal cracks in both side walls, and the connection of the side walls with the front wall seems to be destroyed. This forms a wedge which caused the out of plane failure of the portico. On the lateral wall, the collapse mechanism is shown in Figure 7-56. It is a mechanism of vertical deflection, with a very complex calculation scheme; this is due to the complexity of the shapes of the wall and to the difficult identification of the masses.

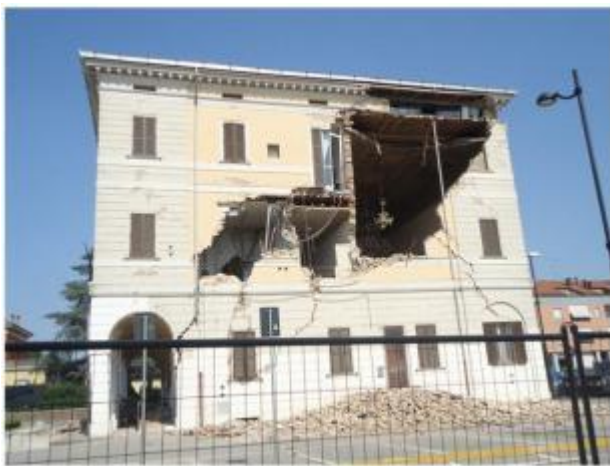
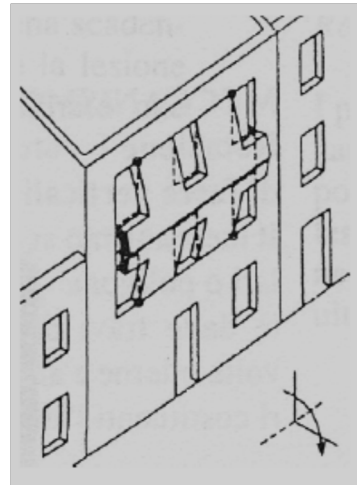
Figure 7-65 Partial collapse of the side wall and loss of the connection to the external wall in the front

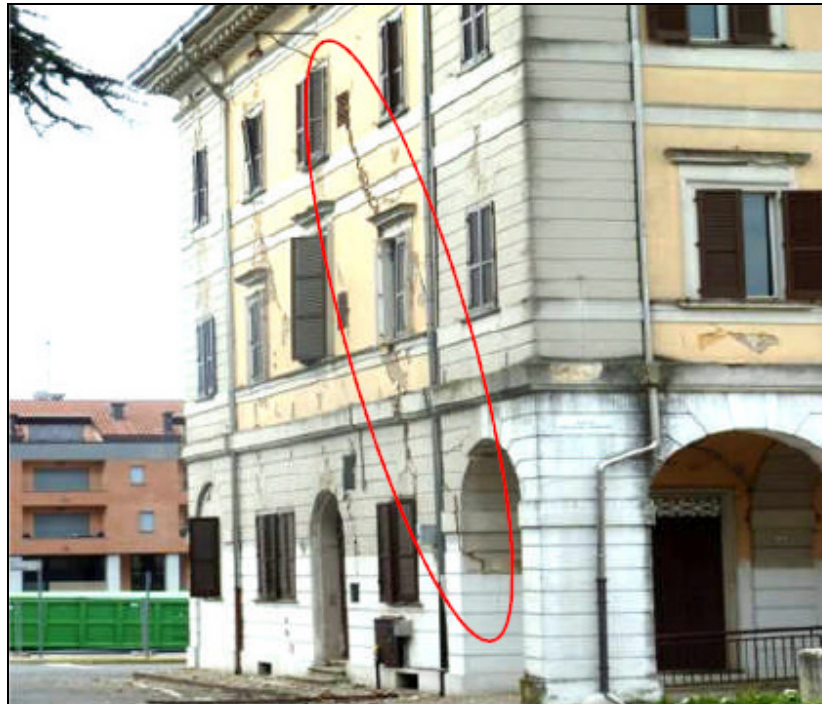
Figure 7-67 Large and extensive crack in a side wall

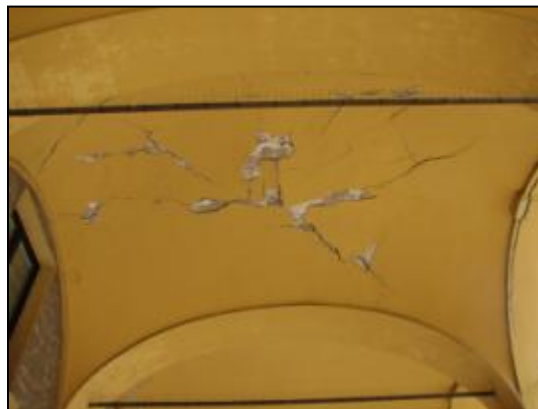
A floor located over a vault of the colonnade collapsed and caused a dangerous situation in the vault below.

Figure 7-72 Vault damaged by floor failure

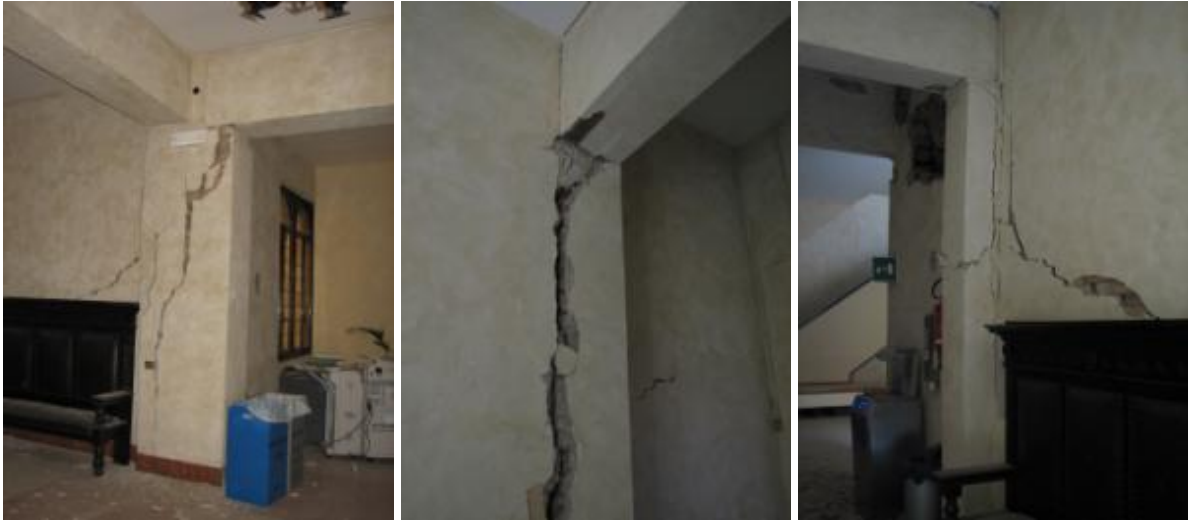
Figure 7-73 Cracks on internal walls

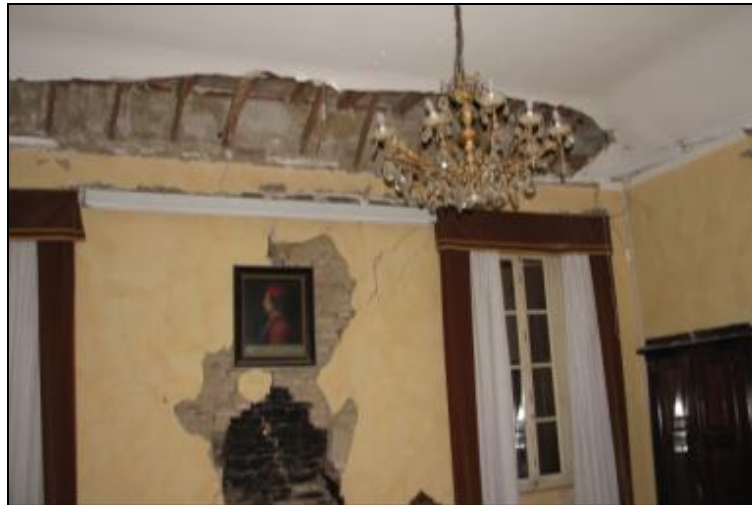
Figure 7-74 Partial collapse of the floor

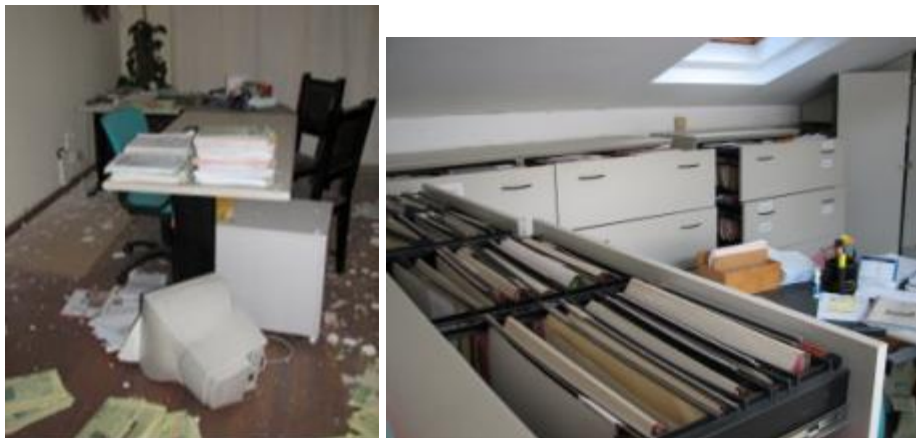
Figure 7-75 Sliding phenomena

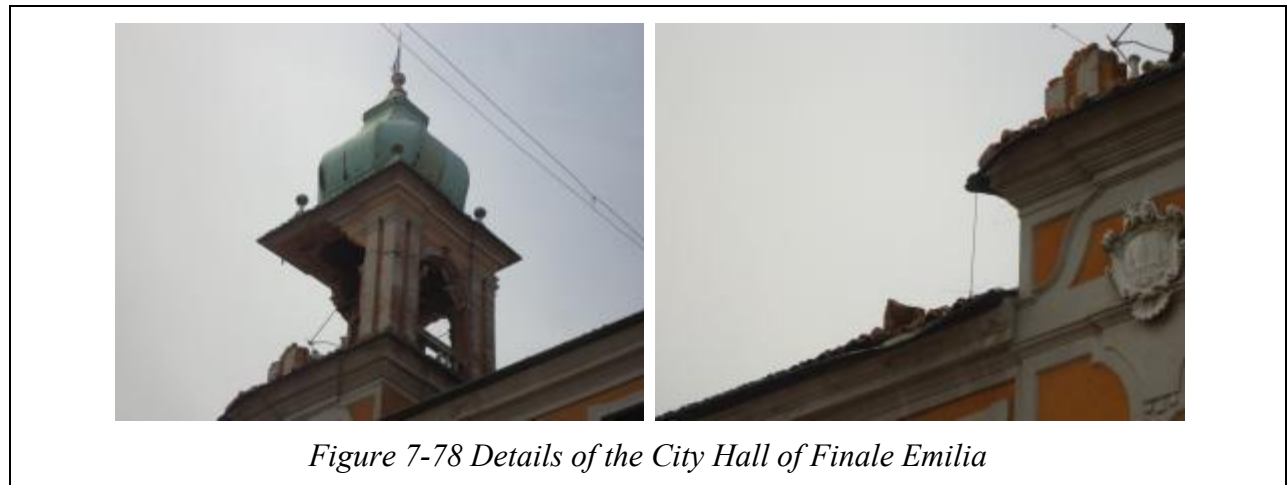
The City Hall is located near the Duomo of Finale Emilia. The tower in the façade of this structure suffered a partial collapse. The fallen debris damaged the roof of the structure.

Figure 7-78 Details of the City Hall of Finale Emilia

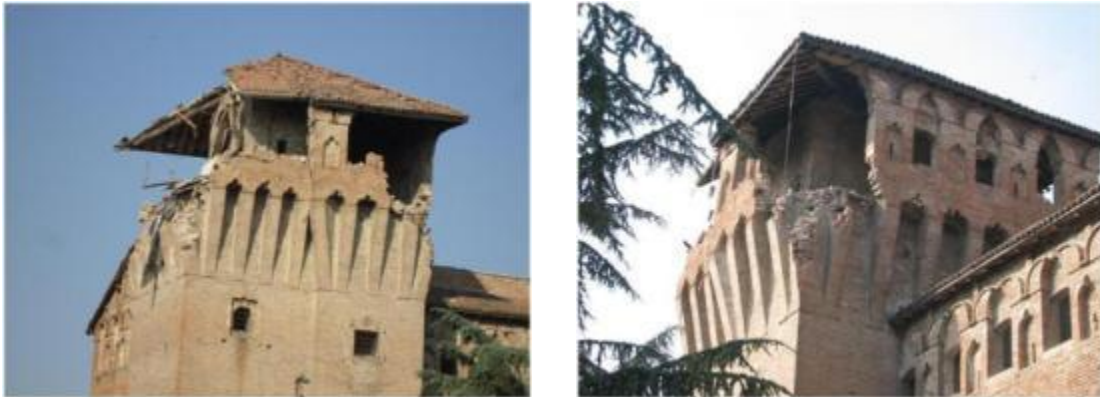
From a structural point of view, the castle is an unreinforced brick masonry structure with four towers. The earthquake caused extensive damage to the castle. Three towers partially collapsed and the fourth sustained significant large and extensive diagonal cracks.

Figure 7-80 Collapse of the tower of the castle in Finale Emilia

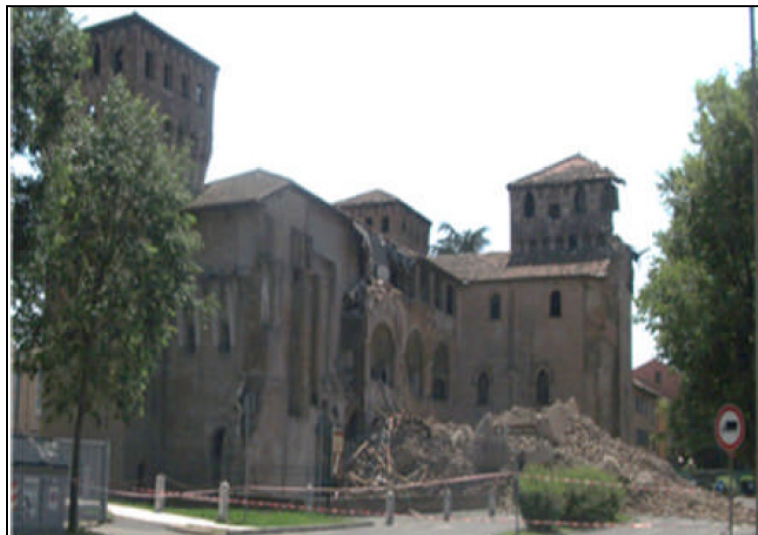
Figure 7-81 Partial collapse of the east side of the castle

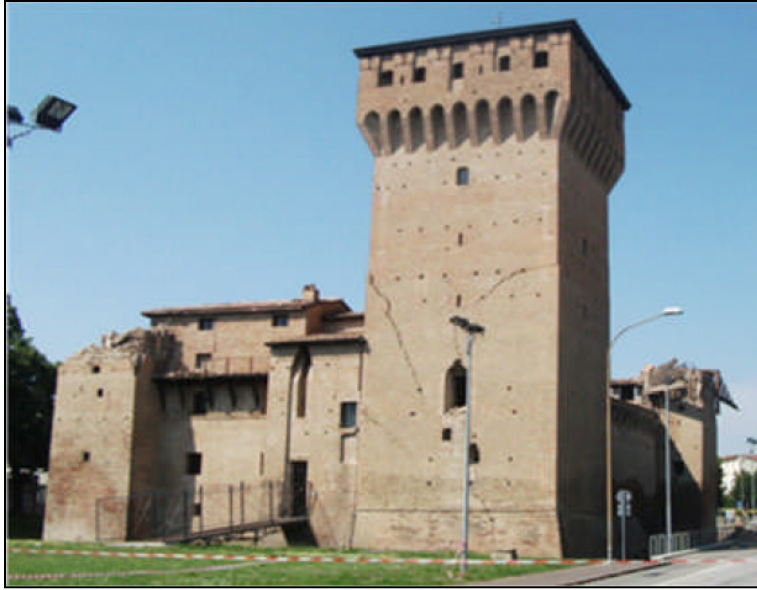
Figure 7-82 Partial collapse of the two towers and severe damage to third tower

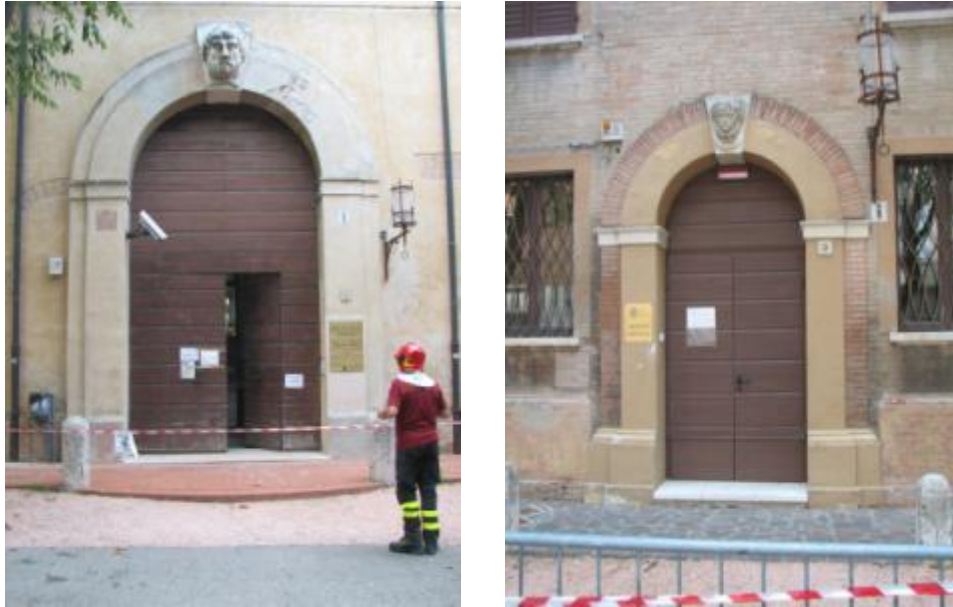
The earthquake caused severe damage to the structure. Although, from the outside of the structure, it is possible to see only some cracks, the damage found inside is quite significant.

Figure 7-84 Entrance to the library (left), and archive entry (right)

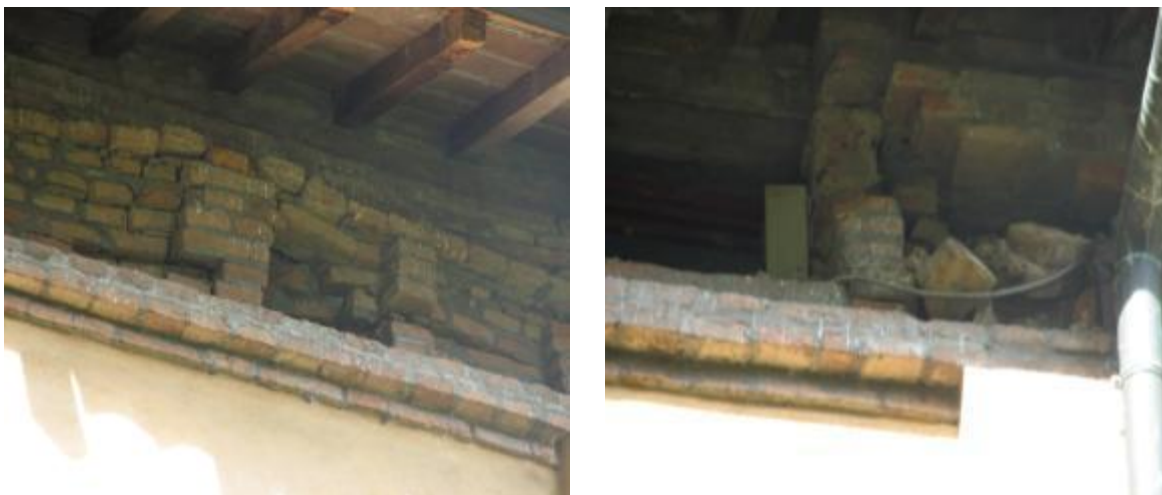
A more detailed external analysis has shown that the attic suffered a seismic swarm. As shown in the following photos, some walls that supported the roof collapsed. This is probably due to some openings in the wall under the roof, as well as the use of poor quality materials.

Figure 7-85 Walls under the roof

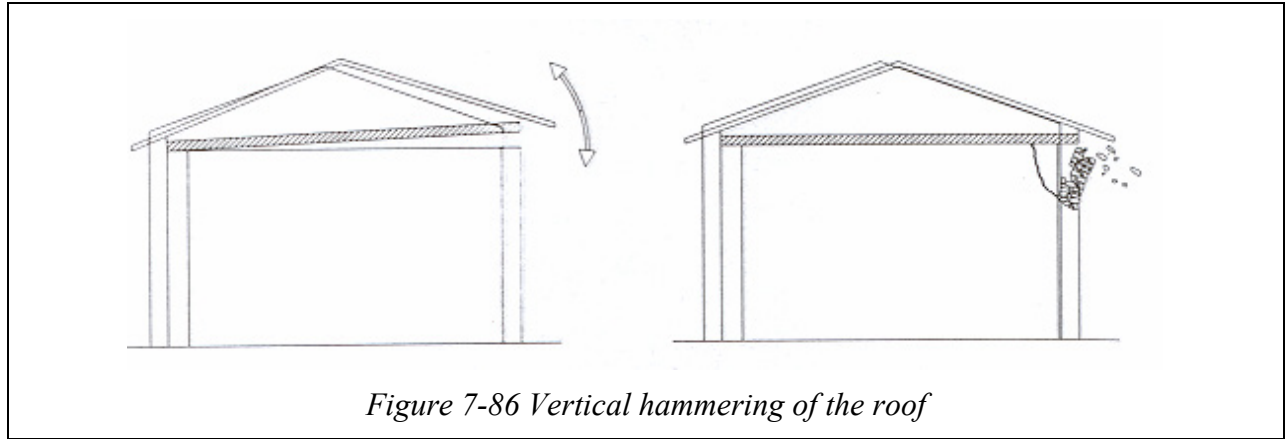
The cause of interior damage may also be due to a vertical hammering of the roof.

As shown in Figure 7-86, this mechanism may be associated with the cracks found on the internal vaults. Some vaults also suffered partial collapse.

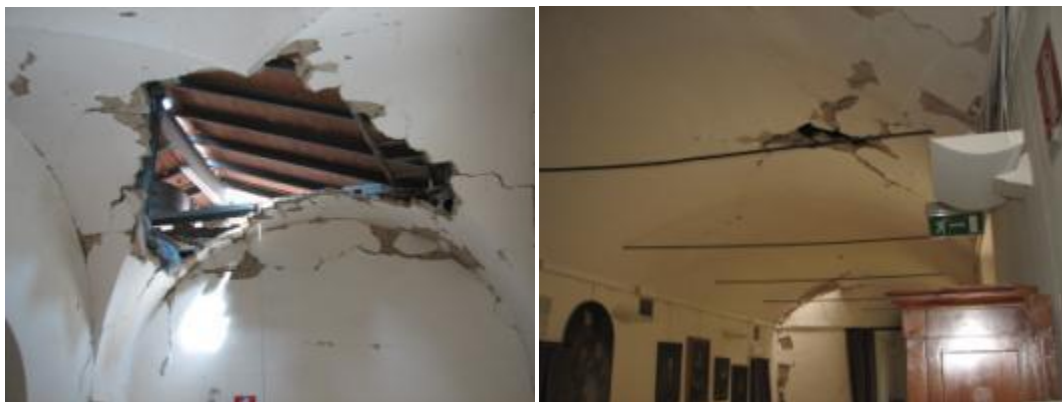
Figure 7-88 Partial collapse of the roof

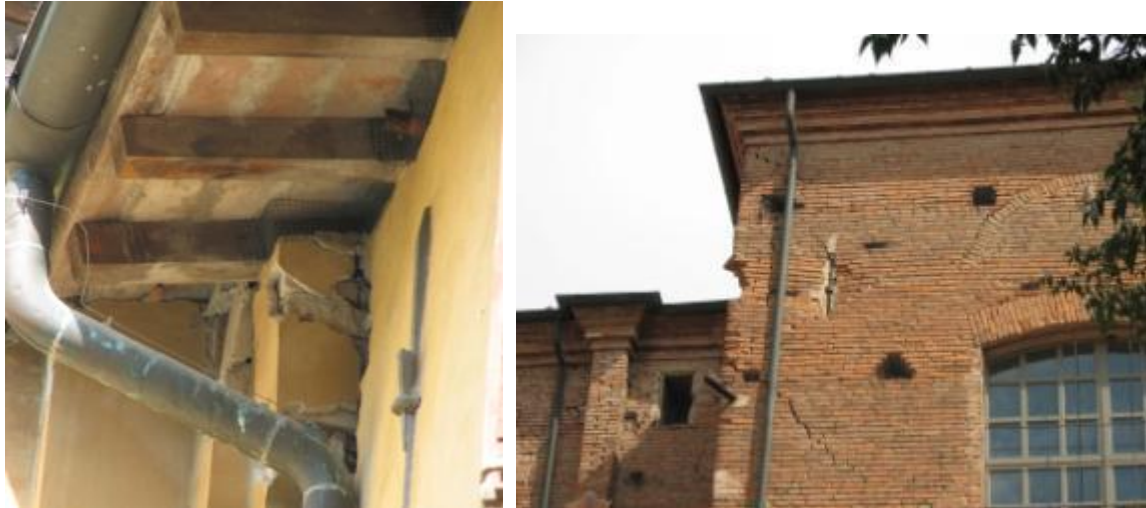
Tie rod anchorage in some parts of the structure is present, but the large force involved caused crushing of the masonry.

Figure 7-89 Masonry crushing at the tie rod anchorage

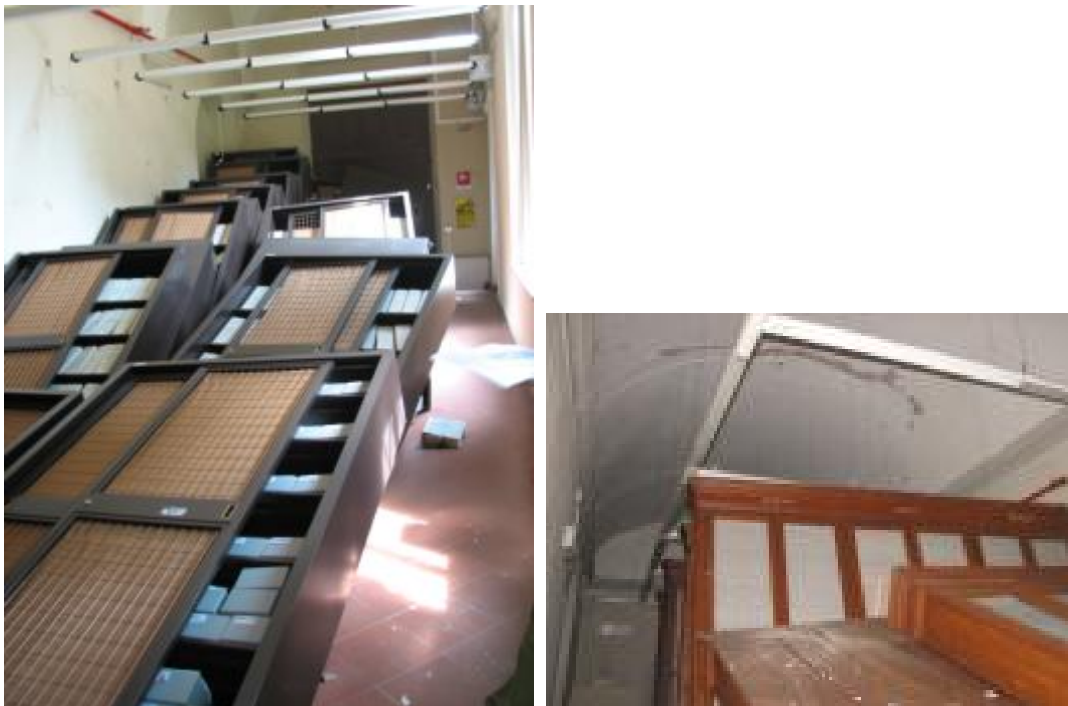
The entire property is not secure and many bookshelves fell over.

Figure 7-90 Overturning phenomena

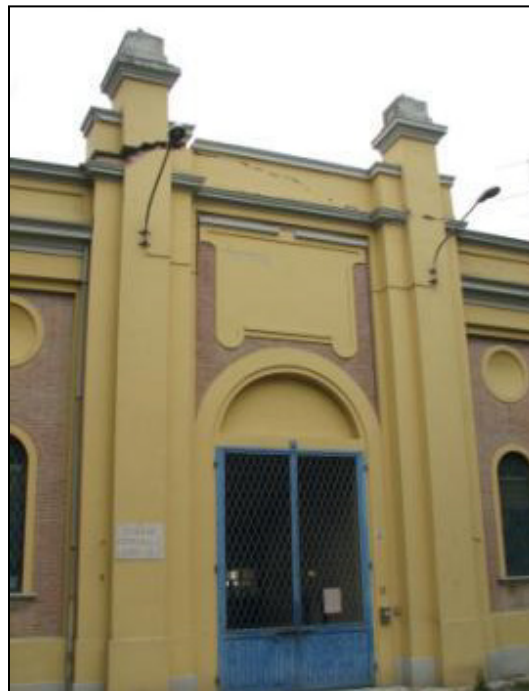
The stadium “Libero Lolli” of Mirandola was declared unsafe after the earthquake. Some architectural elements of the façade were unsafe and were removed.

Figure 7-92 Façade of the stadium

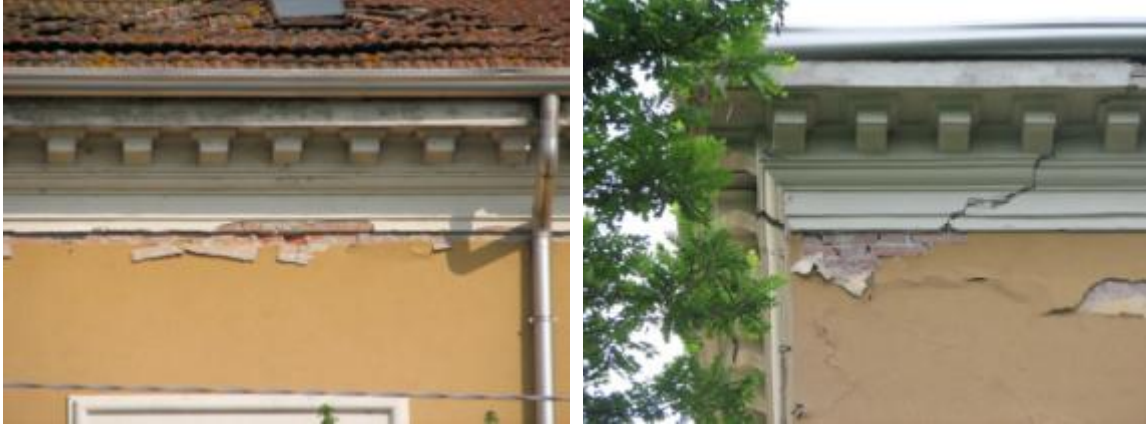
Figure 7-95 Crack on external walls

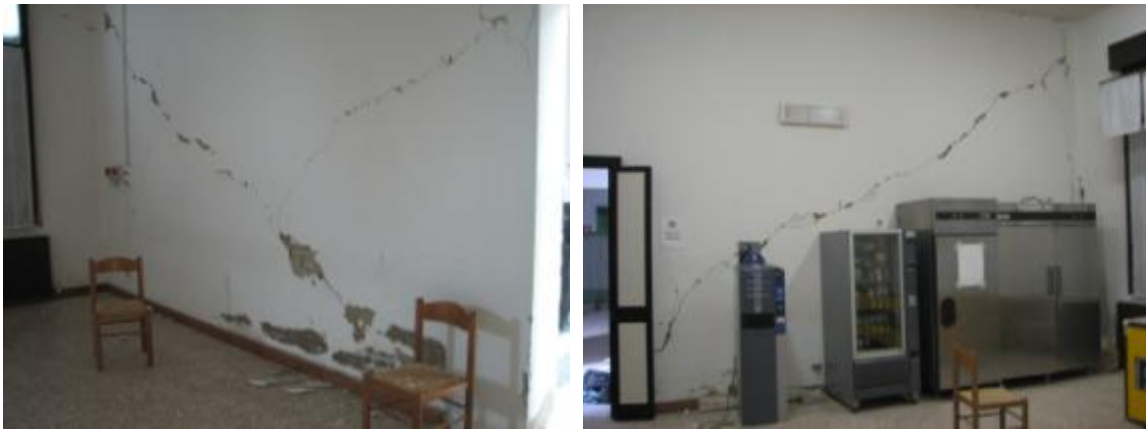
Figure 7-96 Shear crack on internal walls

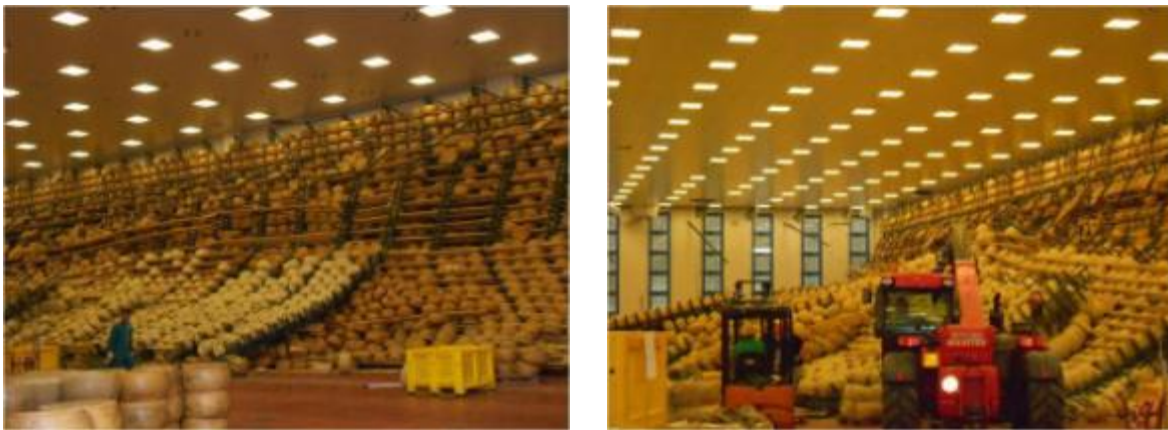
The Po Valley is famous for the production of one of the most famous Italian cheeses: Parmesan. To produce a cheese of good quality, it is necessary to store it for many months at a precise temperature with controlled humidity. This process takes place in large sheds where the cheese is placed on special shelves. The earthquake overturned these slender shelves, causing enormous economic losses to the cheese factories.

Figure 7-97 Collapse of shelves filled with Parmesan cheese

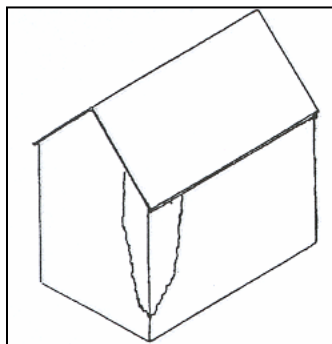
After the earthquake, the connection between the external walls and the roof was corrupted and the structure was declared unsafe. Some cracks are clearly visible on the external walls. These cracks were caused by the pushing force of the strut coverage.

Figure 7-103 Cracking phenomena triggered by the pushing of the strut coverage
